Alkali - Silica Reactions in Concrete Dams

Alkali Leaching in the Votna Dam

Master of Science in Civil and Environmental Engineering

Submission date: June 2016

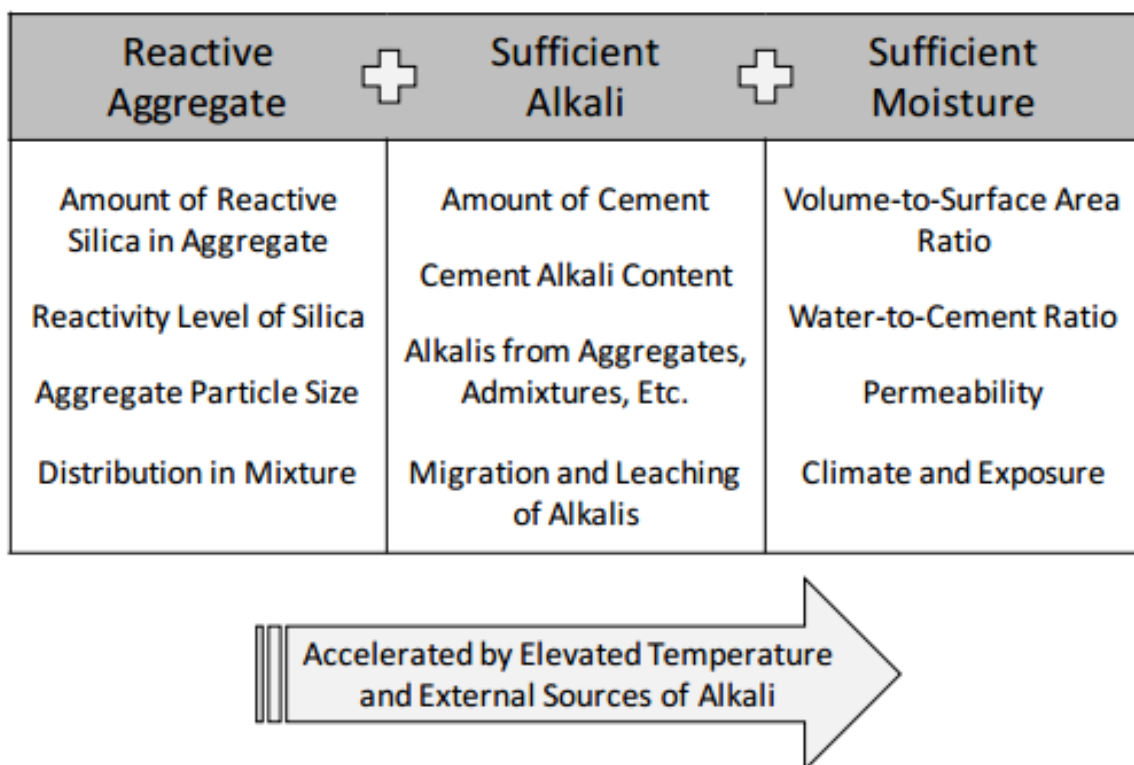
Figure 1.1: Three necessities of ASR (Deschenes et al., 2009)

In Norway, one of the main deterioration mechanisms in concrete is ASR (Larsen et al.). ASR occurs only if three conditions are fulfilled simultaneously: sufficient moisture content, reactive aggregate and high alkali content of concrete (Figure 1.1). If one of these three conditions is absent, the reaction will not take place (Lingård et al., 2015).

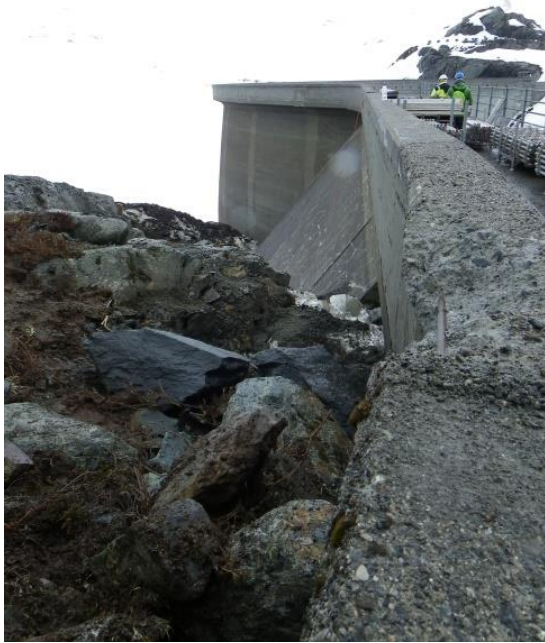
Figure 1.3: Sideview of Votna 1 – May 2015
(Photo: G. Plusquellec)

The Votna dams are situated in the south – western part of Norway 950 m above sea level. There are four dams owned by Hydro Energy Production AS. They were constructed in the years 1964 – 1966, and form the intake reservoir for the Novle Power Plant. This study focuses on the main dam, Votna 1, which is a double curved arch dam connected to a slab dam (Figure 1.3 and Figure 1.4), with a total length of 185 m and maximum height at 55 m. The thickness decreases from 4 m at the bottom to 0,95 m at the top for the arch, while the slab has a thickness that decreases from 70 – 80 cm at the bottom to 30 cm at the top (Lindgård et al., 2015). The second dam, Votna 2, is a concrete slab dam while the two other dams at Votna are just gravity dams creating the spillway sections. The water level at the reservoir is regulated each year for about 20 m, where it is high during summer/autumn and low during the winter (Larsen et al.).

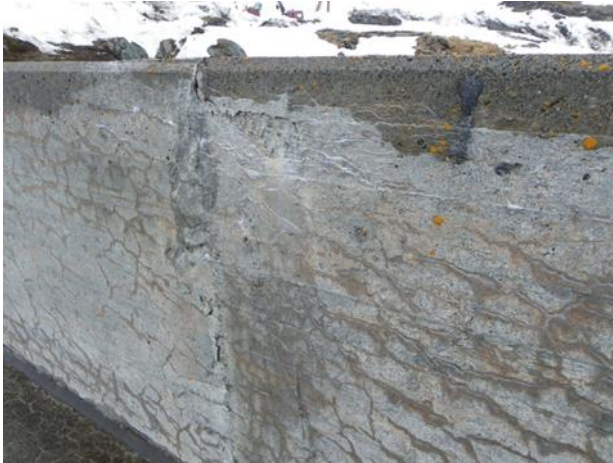
Figure 1.5: The typical map cracking pattern at Votna 1 - May 2015 (Photo: G. Plusquellec)

It was in the years between 1987 and 1988 that Votna 1 was diagnosed with ASR. The typical map cracking pattern was observed (Figure 1.5), and after investigation of the concrete one could confirm that ASR had started. The results from regularly deformation measurements made once a year from 1990 to 2003 at the top of the arch dam showed that an expansion of the concrete was increasing linearly with time (Larsen et al.). High tension occurred in the concrete due to the deformation at the connection point between the arch dam, the abutment wall and the slab dam (Figure 1.4) (Lindgård et al., 2015). Recent inspection in May 2015 also revealed the presence of the alkali silica gel (Figure 1.6).

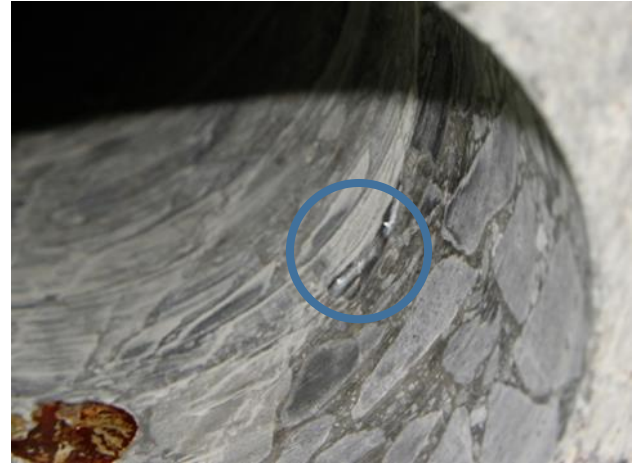
Figure 1.6: Presence of alkali silica gel at Votna 1 - May 2015 (Photo: G. Plusquellec)

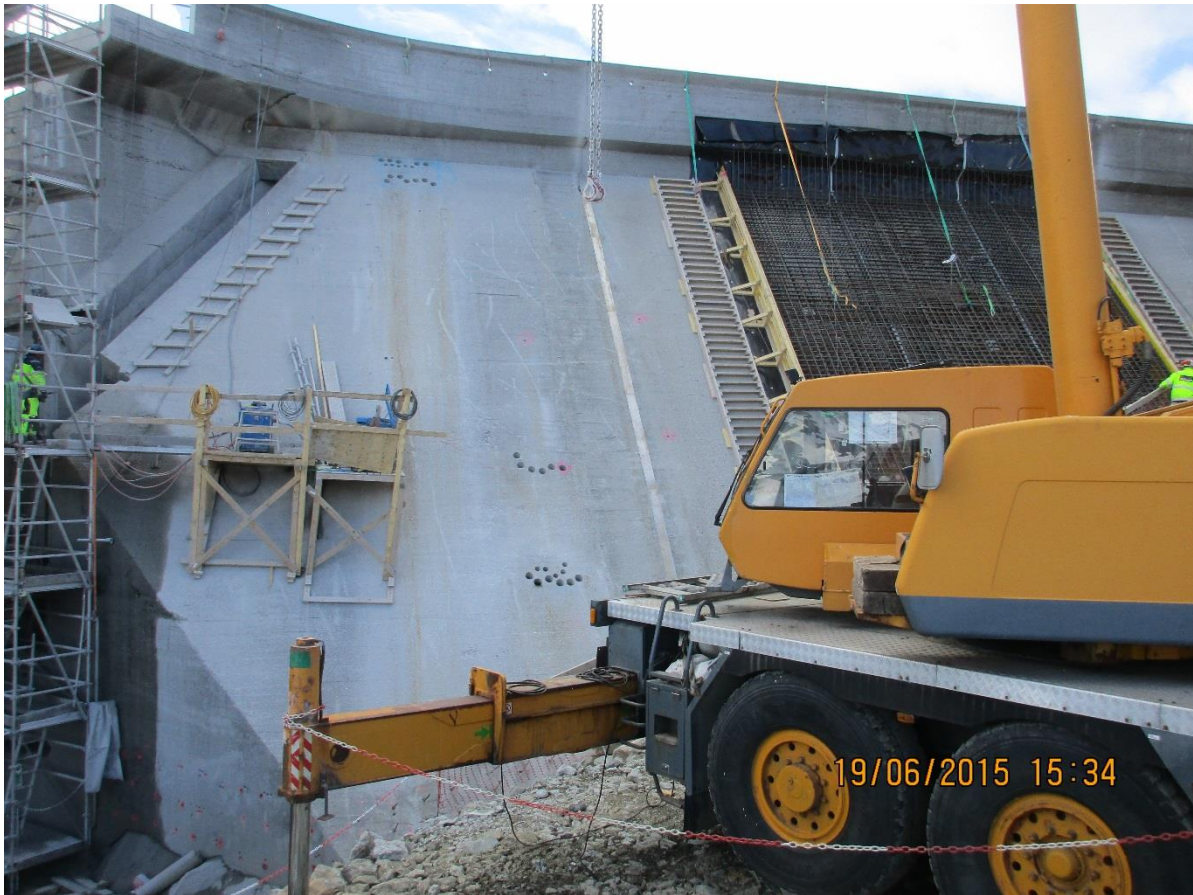
Figure 2.3: Slab dam after drilling (Provided by J. Lindgård).

The samples used for the separation of aggregates (see 2.4 The aggregate separation) was taken from large blocks cut from the slab (Figure 2.3). The coarse aggregate is originally from a local reactive rock, while the origin of the sand is different (Lindgård et al., 2015).

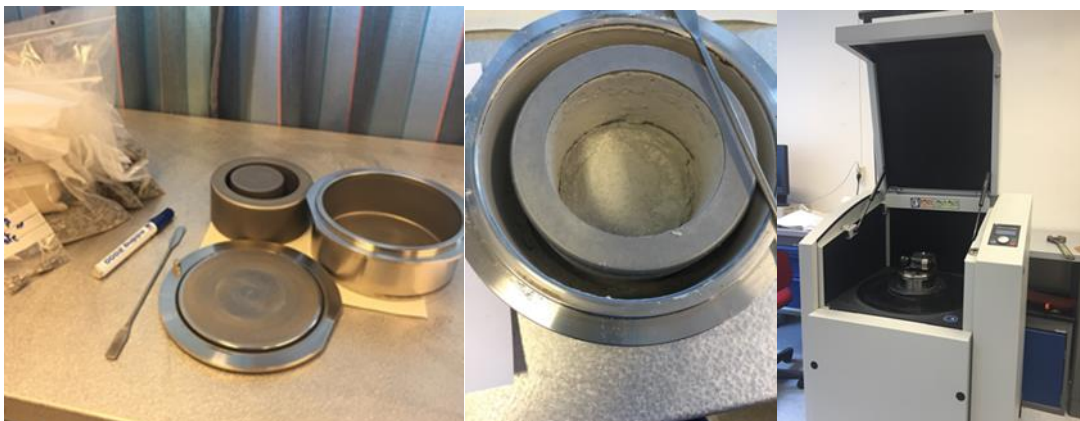
Figure 2.6: The grinding process (Photo: H. Vurucu).

After the marking, the cores were sent to Sintef for sawing and further crushing by a jaw crusher. The sawing was done with a diamond blade, and a minimum amount of cooling water was used during the sawing process, to avoid leaching as much as possible. The discs were crushed with a jaw crusher, and collected in sealed plastic bags, and numbered. The bags were then stored in a desiccator with soda lime at the bottom to avoid carbonation. The next step was to finely grind the crushed slices. In this study, the grinding was done with a vibratory disc mill RS200 from Retsch (1500 rpm during 30 seconds). The powder was then collected from the grinding elements, and put in new sealed plastic bags to be stored in a desiccator.

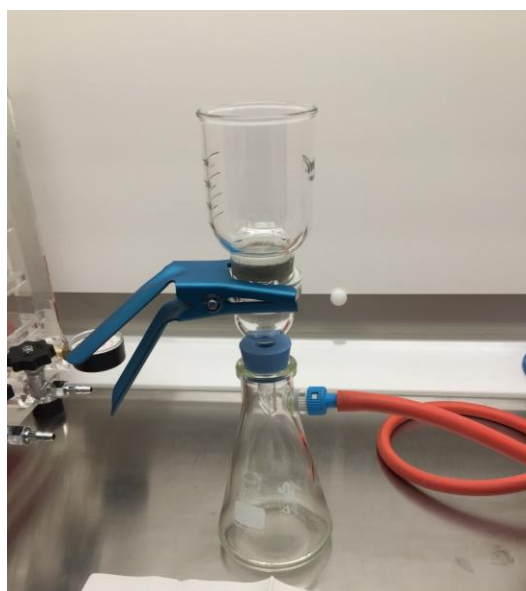
Figure 2.7: The filtration during CWE (Photo: H. Vurucu)

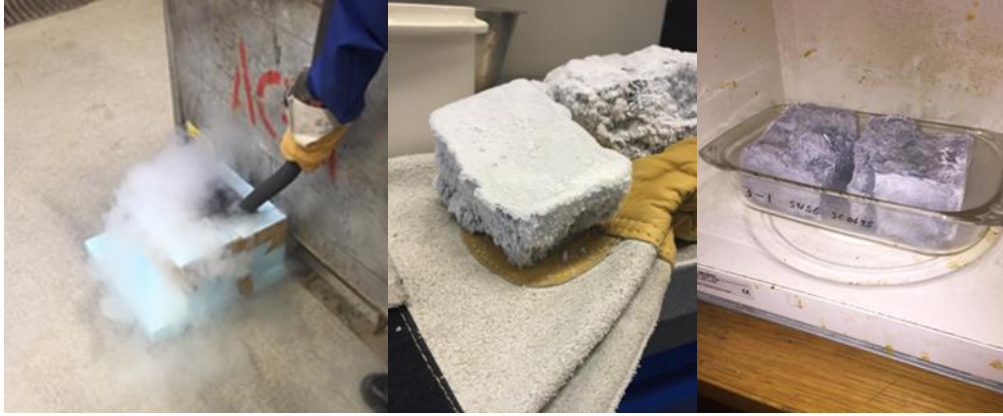
Figure 2.9: The freeze/thaw process using liquid nitrogen and microwave (Photo: H. Vurucu)

The first step of this separation method was to cut a concrete block into smaller samples, approx. 10*10*10 cm, and immerse them in water for minimum 3 days to fill the pores with water. After the saturation, the samples were frozen rapidly in order to provide a rapid expansion of the water in the pores. This step was done by putting the samples in liquid nitrogen (temperature -196°C). The samples were then shock heated in the microwave (7 min heating at maximal power). This freeze/thaw process was repeated 3 times for each sample, creating cracks in the concrete (Figure 2.9). Simple hammering was then enough to separate the coarse aggregates from the mortar (Figure 2.10). Finally, the aggregates were washed in a diluted HCl solution. The goal was to completely remove the cement paste from the aggregates (Haugen et al., 2004).

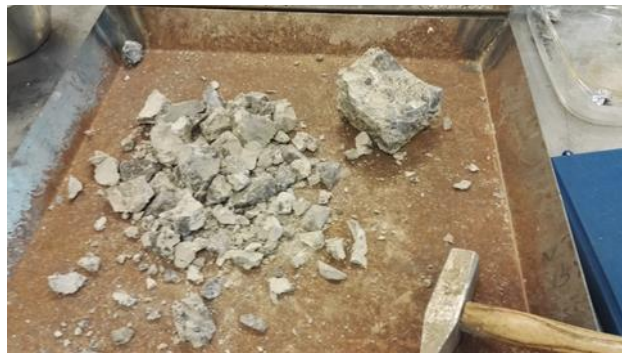
Figure 2.10: Hammering to separate the coarse aggregates from the mortar
(Photo: G. Plusquellec)

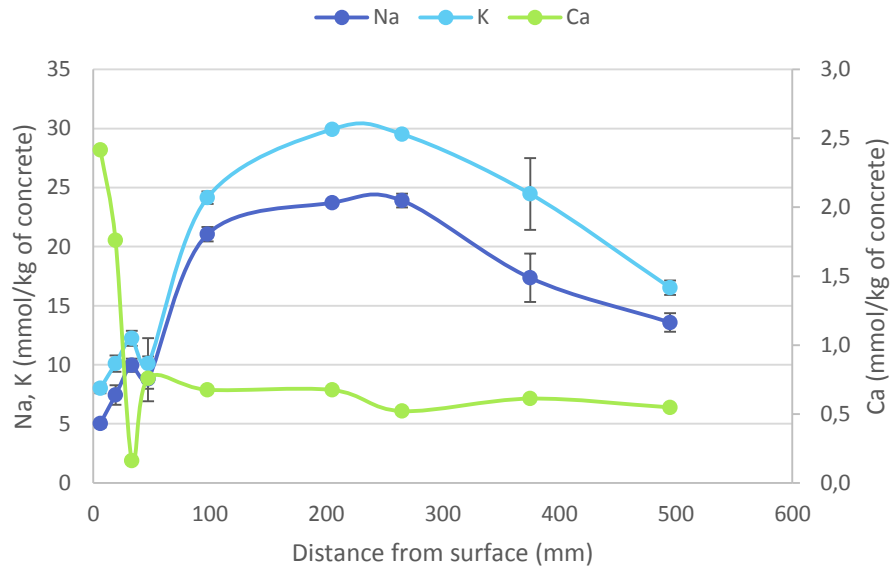
Figure 3.4: ICP results of core II-13 (partially submerged core on the upstream side).

The ICP results of the partially submerged core II-13 (Figure 3.4) also indicate the presence of a plateau as for the previous core I-14 (Figure 3.3), and a similar depth affected by leaching. The plateau is observed between 10 and 40 cm depth. The entire core with a length of 630 mm (see appendix 5 Figure 7.3) was analyzed up to 500 mm. A steep curve showing the decrease of alkalis is observed between 5 cm and 10 cm from the exposed surface (Figure 3.4). The alkali content is also decreasing in a depth from 5 cm towards the exposed surface, but a slight increase is observed at 5 cm depth. The reason for this increase is still unclear. It is assumed that the increase is caused by the different water levels during a year, leading to the concrete being either submerged or exposed to air. The different exposures will cause wetting and drying of the concrete and will lead to movement of ions. The calcium concentration on the other hand is very low at this point around 5 cm from the exposed surface. However, a steep increase in calcium is observed from 5 cm depth towards the exposed surface.

The submerged and partially submerged cores have profiles indicating leaching (Figure 3.2, Figure 3.3 and Figure 3.4). The leaching profiles are dependent on the exposure conditions. Figure 3.3 shows a very smooth leaching profile for the permanently submerged core I-14, and it is possible to see that the other permanently submerged core III-7 (Figure 3.2) also shows a tendency to a smooth leaching profile. The partially submerged core II-13 (Figure 3.4) indicates a clear leaching profile, but there are some variations around 5 cm from the exposed surface. These variations can be caused by the exposure conditions, as this core was exposed to either water or air due to different water levels. Hence, the profile is not as smooth as the permanently submerged core I-14 (Figure 3.3) in comparison. Core VI-2 (Figure 3.5) which was exposed to rain and core VII-5 (Figure 3.6) sheltered inside the dam do not show any leaching profiles. As mentioned, the alkali content is decreasing towards 5 cm from the exposed surface. From 5 cm and towards the outermost points at the surface, some variations are observed. The reason for these variations is still unknown.

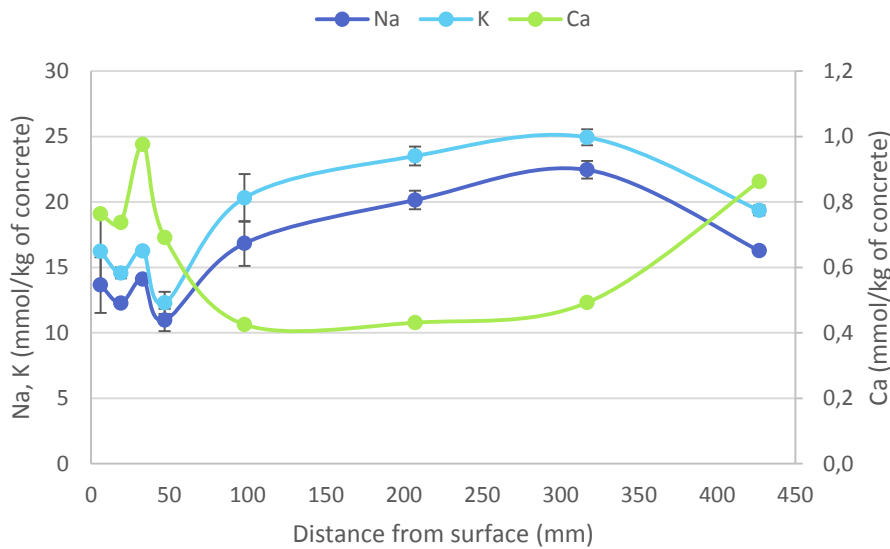
Figure 3.5: ICP results of core VI-2 (exposed to rain on the downstream side).

Figure 3.5 shows the ICP results for core VI-2 exposed to rain. The entire length of this core was 480 mm and only up to 43 cm was analyzed (see appendix 5 Figure 7.4). The alkali concentration is decreasing towards the surface, but the concentration up to 5 cm depth from the exposed surface is unclear. There is a remarkable decrease of the alkali content towards the surface between 5 and 10 cm. An indication to the presence of a plateau between 10 cm and 32 cm is observed both for the alkali and the calcium concentration. There is an increase in the calcium concentration starting from 10 cm depth and going towards the exposed surface up to 4 cm depth. The obtained ICP results for this core exposed to rain show lower alkali content in the concrete than the previous analyzed cores from the slab. The reason can be the use of different concrete for this location i.e. supporting pillar, compared to the slab.

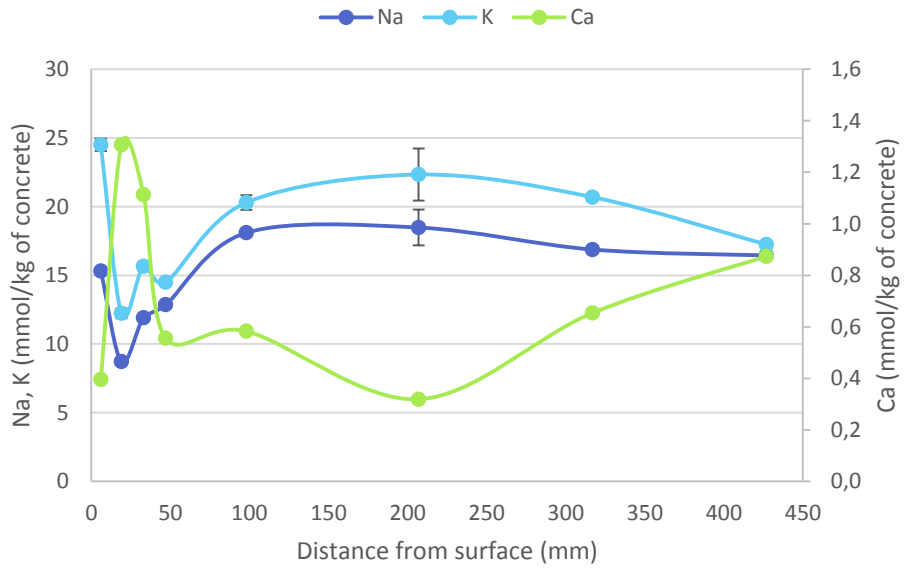
Figure 3.6: ICP results of core VII-5 (sheltered inside the dam).

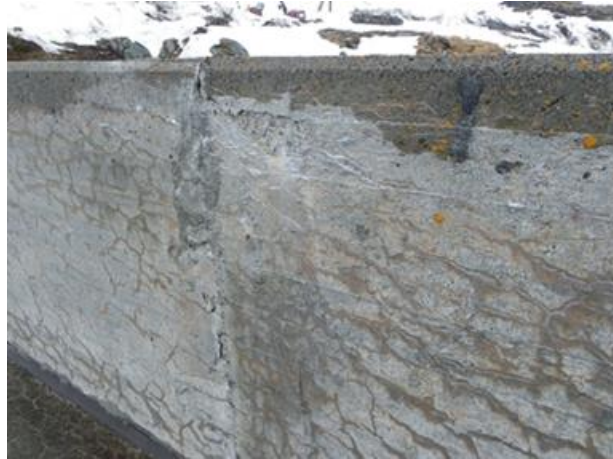
**Figure 7.6: The typical map cracking pattern at Votna 1
(Photo: Gilles Plusquellec).**

ASR occurs only if three conditions are fulfilled: alkali reactive aggregate, high pH in the pore solution and high moisture content. Under these conditions, alkali – silica gel may form. This gel may absorb water and swell. This volume increase in the concrete makes the concrete expand and results in a characteristic crack pattern at the surface called map cracking.
