Norwegian University of
Science and Technology

Cathodic Protection of Steel-Aluminium Galvanic Couples for a New Generation of Lightweight Subsea Structures

Chemical Engineering and Biotechnology

Submission date: June 2016

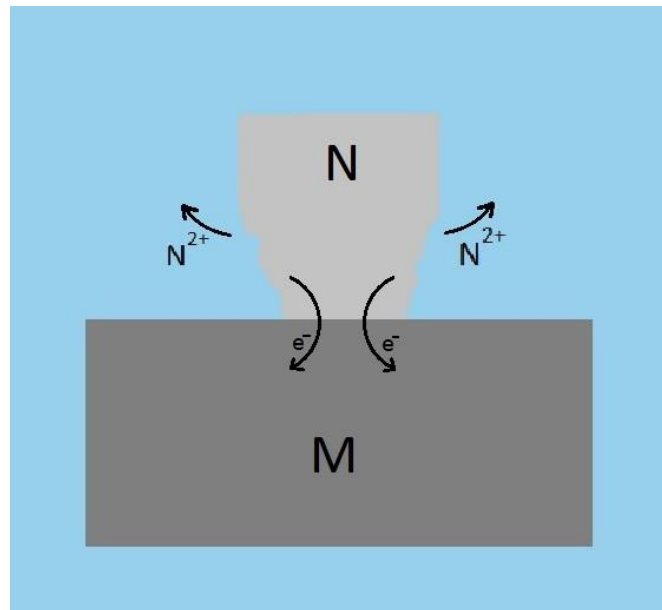
Figure 2.1. Illustration of galvanic corrosion between a noble metal M, and a less noble metal N. For a noble metal M, and a less noble metal N, the following applies in an M-N coupling without ohmic potential drop [4]:

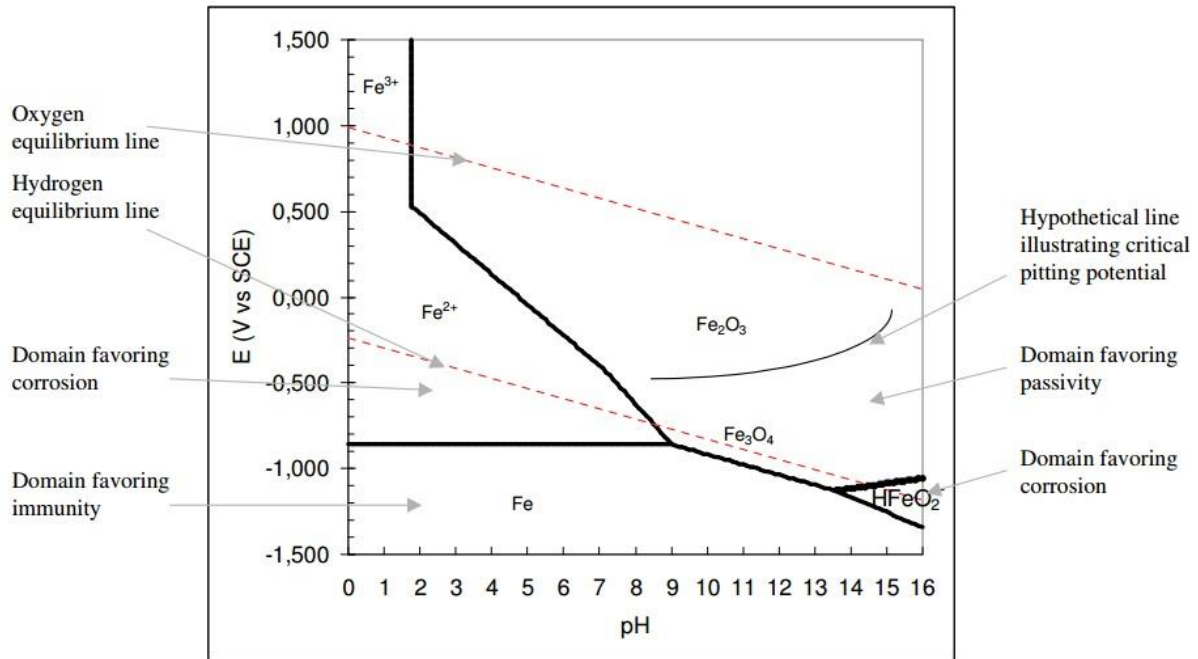
Figure 2.4. Pourbaix diagram of iron in water [10].

When the potential of the metal to be protected is lowered from the open circuit potential, or corrosion potential, E_{corr} to a protection potential, E_p , the oxidation rate on the metal is reduced, and the corrosion decreases. If the metal is polarized below the reversible potential of metal dissolution, it will be completely protected. In a Pourbaix diagram, this will be in the immune region, see figure 2.4.

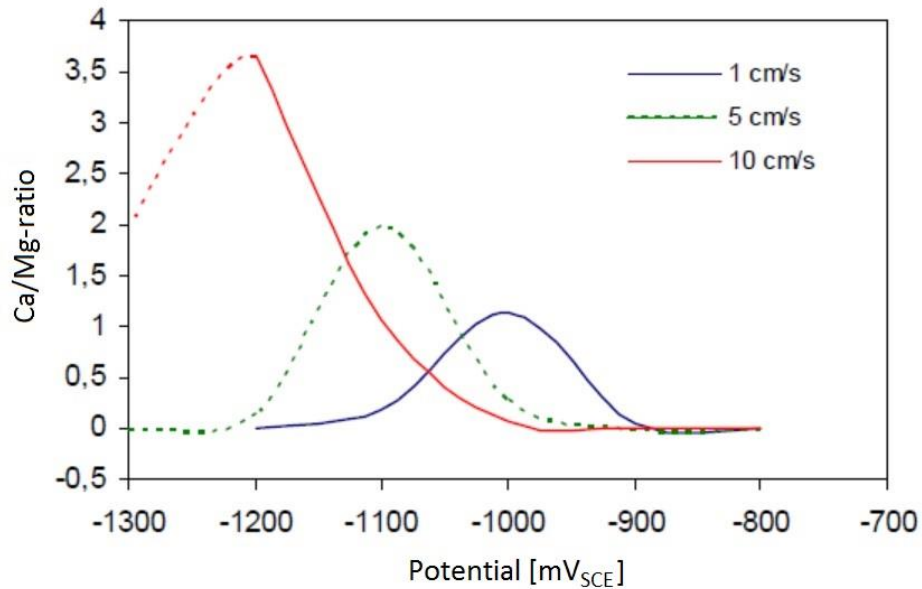
Figure 2.5. Ca/Mg ratio in calcareous deposits as a function of applied potential and flow velocity. Results are based on EDS-analysis and visual observations by Okstad. Dashed lines represent assumed data. Adapted from Okstad [15].

The protective properties of the calcareous deposits is greatly affected by the Ca/Mg ratio. Okstad studied the properties of calcareous deposits on carbon steel as a function of applied potential and flow velocity. It was reported that the kinetics for precipitation of $Mg(OH)_2$ was faster than for $CaCO_3$; $Mg(OH)_2$ was formed at all applied potentials (-800 to -1200 mV versus SCE), and all flow velocities (1, 5 and 10 cm/s). No calcium phase was found for the most noble potentials due to low pH on the steel surface and inhibition by Mg. Also, no $CaCO_3$ was found for the most active potentials with low flow velocity where the pH was high, which gives a high driving force for $Mg(OH)_2$ precipitation. $CaCO_3$ was formed at -1000 and -1100 mV_{SCE} for all flow velocities. Increased convection resulted in precipitation of $CaCO_3$ at more active potentials. For the lowest flow rate, 1 cm/s, the Ca/Mg ratio was highest at -1000 mV_{SCE} and decreased for both increasing and decreasing potential. Figure 2.5 illustrates the findings [15].

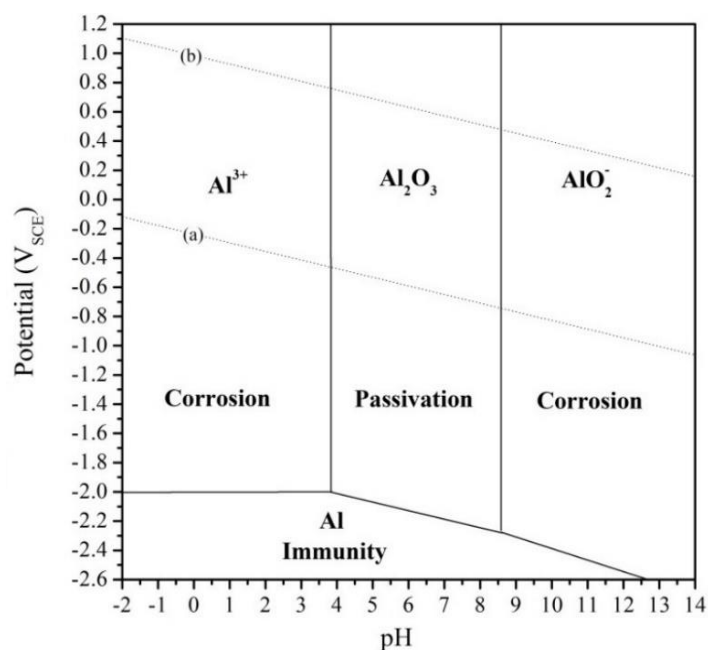
Figure 2.6. Pourbaix diagram of pure aluminium in aqueous solution at 25 °C. Lines (a) and (b) correspond to reduction of oxygen and hydrogen [20].

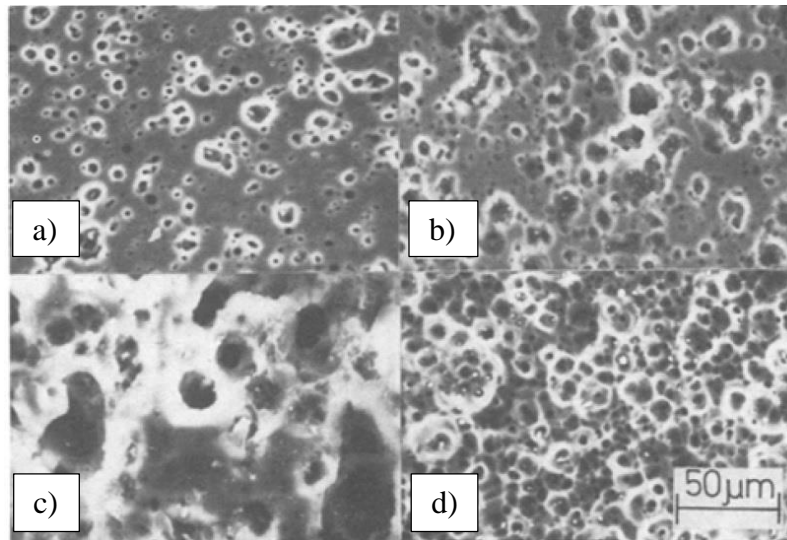
Figure 2.10. Pit morphology on Al specimens polarized for 24 hours in 0.52 M NaCl solutions. a) -1.3V, b) -1.35 V, c) -1.37V, e) -1,38V. All potentials are with respect to SCE. Adapted from Nisancioglu et al. [22].

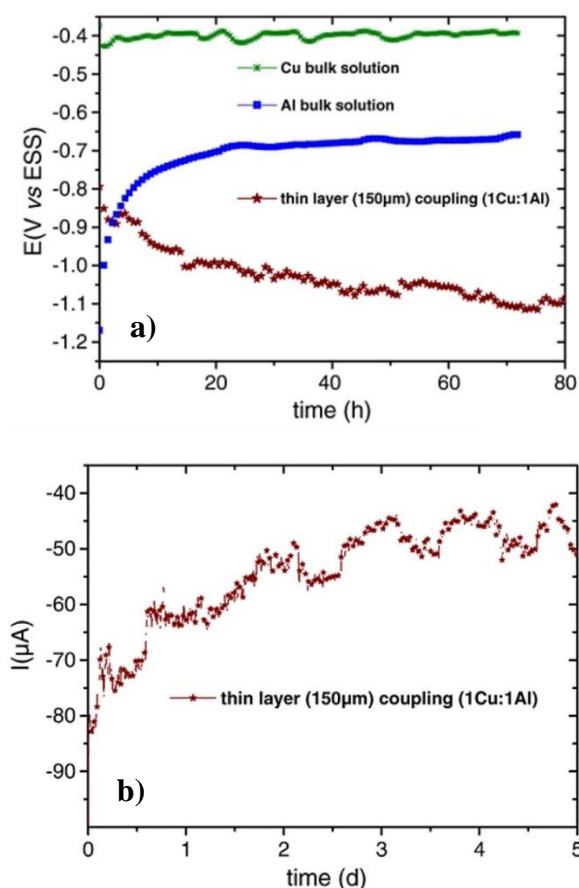
Figure 2.11. a) Comparison between the OCP for pure Al and Cu in a bulk solution, and the galvanic potential for Al-Cu coupled samples in a thin-layer electrolyte ($0.1\text{M Na}_2\text{SO}_4$). b) Evolution of the galvanic current as a function of time (surface area = 7 cm^2 for both samples) [23].

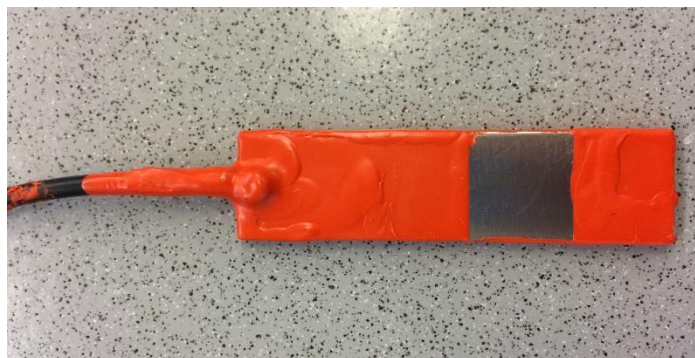
Figure 3.2. Steel sample coated with Micro Super XP 2000 Stop-Off Lacquer.

Steel samples were coated with Micro Super XP 2000 Stop-Off Lacquer, shown in figure 3.2. The reason for using different coatings is that bee wax has poor adhesion when applied to steel, and the Micro lacquer does not adhere well on aluminium, resulting in crevice corrosion. Similar to bee wax, the Micro lacquer was also applied by immersing the samples into the liquid coating, but the masking tape was removed immediately after immersion, before the lacquer was allowed to cure.

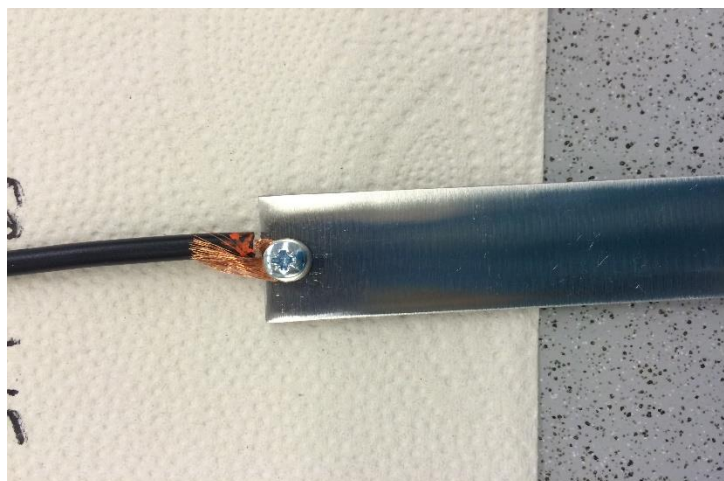
Figure 3.3. Connection of wire to metal sample. The insulation on one end of a banana plug wire is stripped off and forced in contact with the sample with a screw and a washer.

In order to reduce ohmic resistance between metals during testing, a connection method was introduced to exclude the use of extra clamps and long wires, which contribute to resistance in the electric circuit. Screw holes were made at the top of the samples, making a connection point. One end of a two-end banana plug wire was cut off and the insulation was removed, exposing about 3 cm of the conducting copper wire. The wire was forced against the metal sample by using a screw and a washer (3 mm) as shown in figure 3.3.

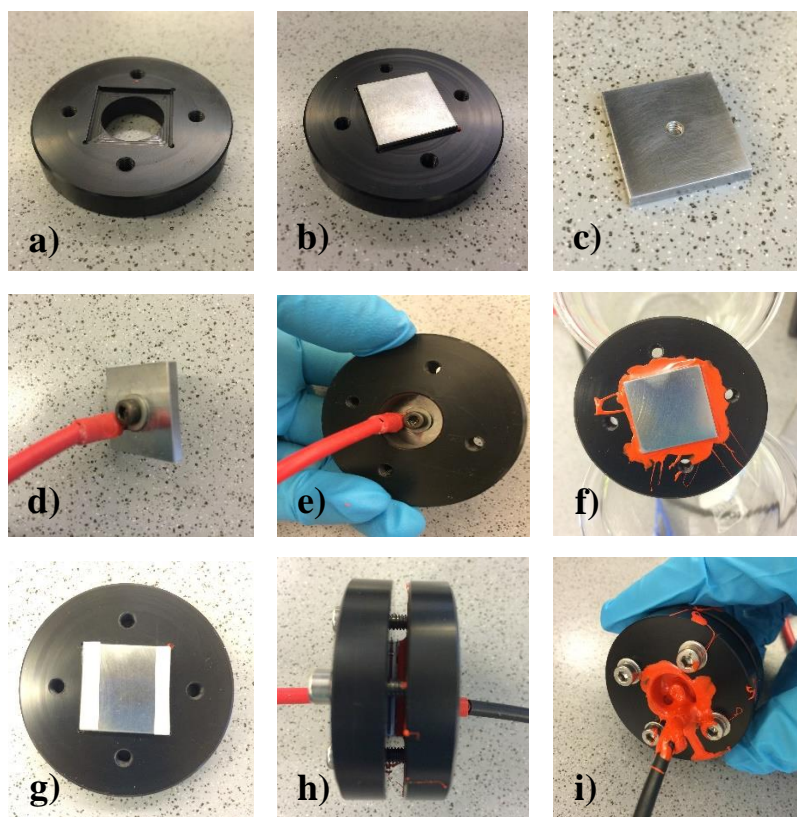
Figure 3.4. Crevice device coupling. a) Plastic sample holder. b) Sample placement. c) Backside of sample with connection point. d) Sample connected to wire. e) Backside of sample holder with connection. f) Steel sample with coating covering all areas except the exposed crevice-area. g) Teflon strips placed onto the Al sample. h) Complete coupling. i) All electrical connections coated before testing.

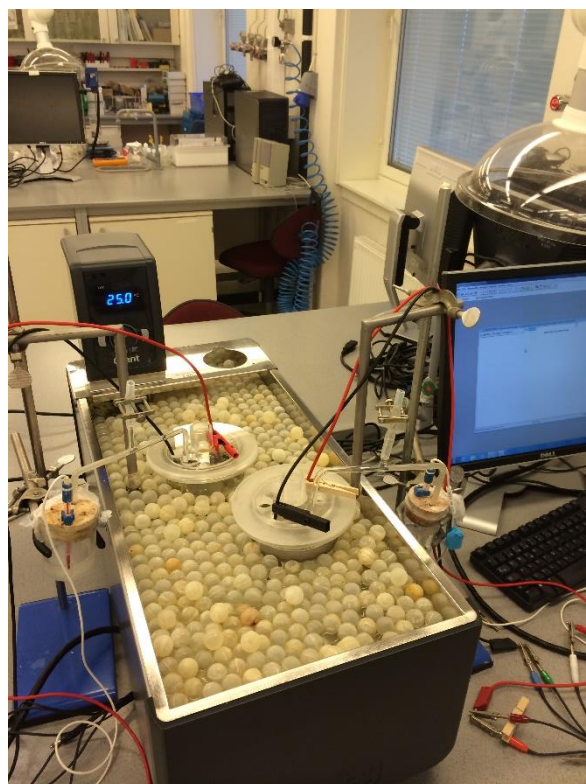
Figure 3.5. Experimental setup. The cells are placed in a water bath keeping a constant temperature of 25 °C. A salt bridge maintains ionic contact between the test cell and the reference electrode. Metal samples are connected to a potentiostat (computer).

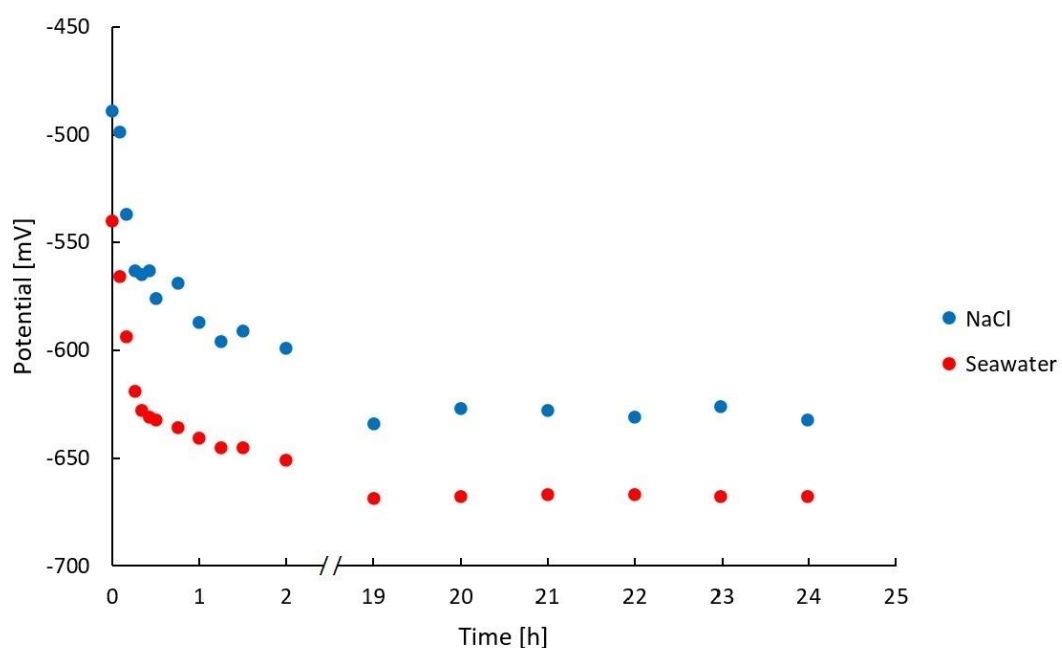
Figure 4.1. Open circuit corrosion test of X65 carbon steel in NaCl and seawater.

The results from open circuit testing can be seen in figure 4.1-4.3. The potential was measured frequently during the first hours of the experiment, and during the final hours.

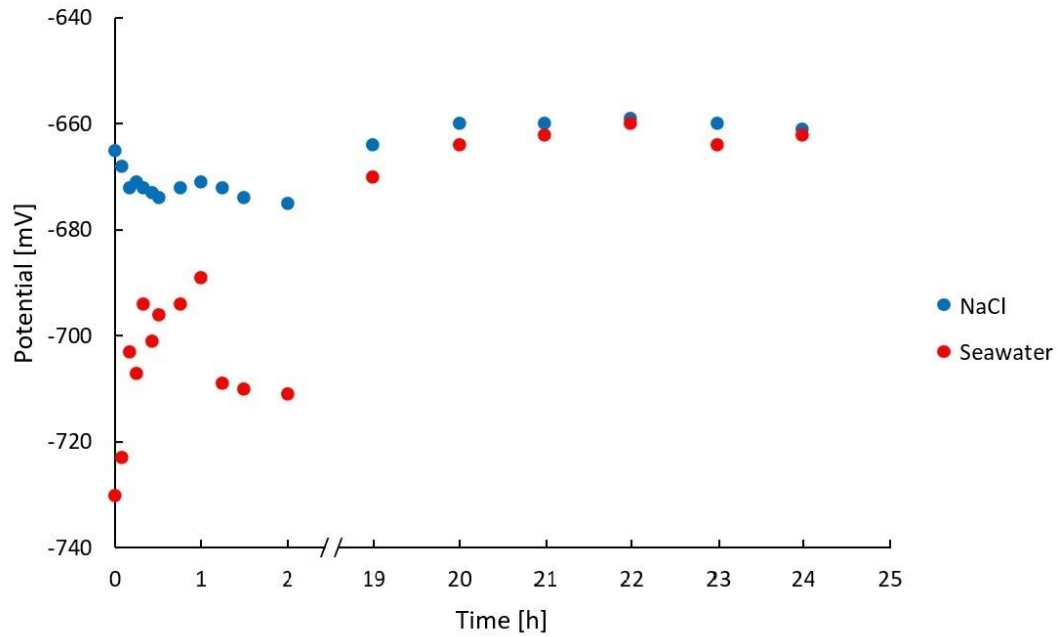
Figure 4.2. Open circuit corrosion test of 6005 aluminium in NaCl and seawater.

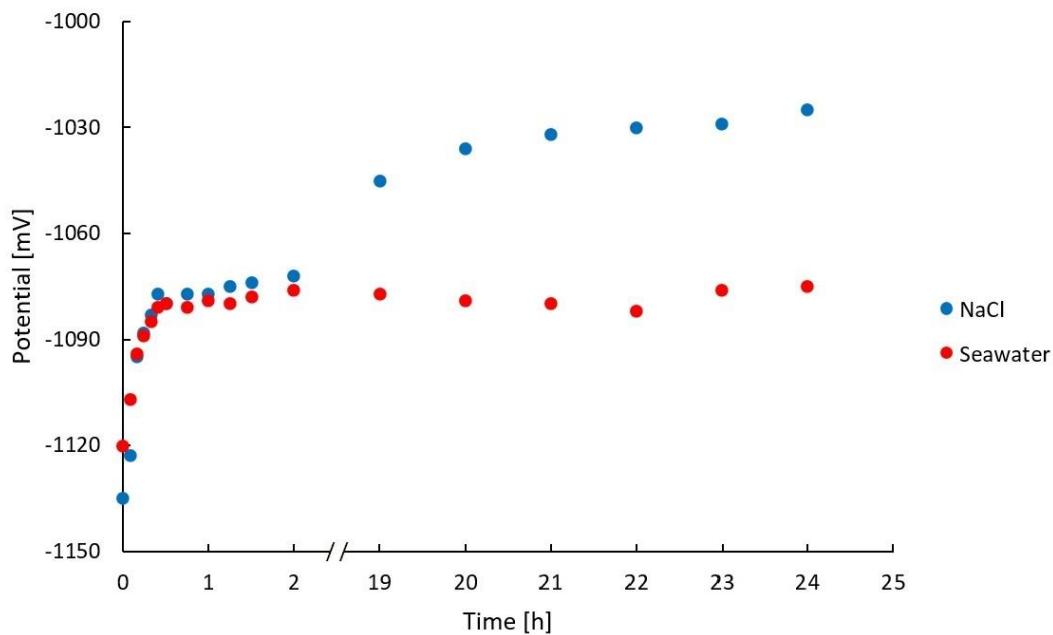
Figure 4.3. Open circuit corrosion test of AlZnIn in NaCl and seawater.

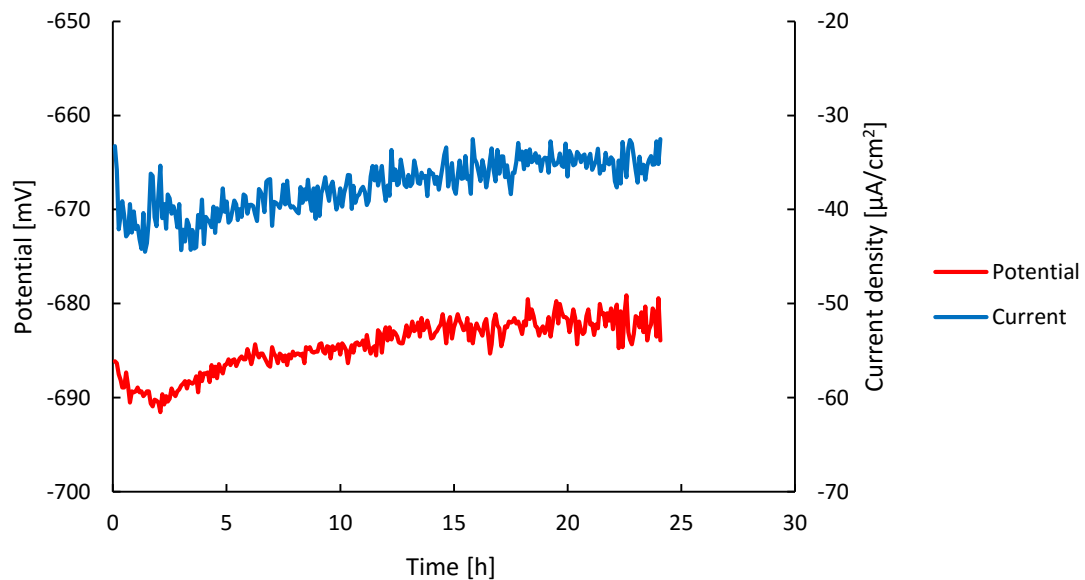
Figure 4.4. Galvanic corrosion test between X65 carbon steel and 6005 aluminium in NaCl. Recorded coupling potential and galvanic current as a function of time.

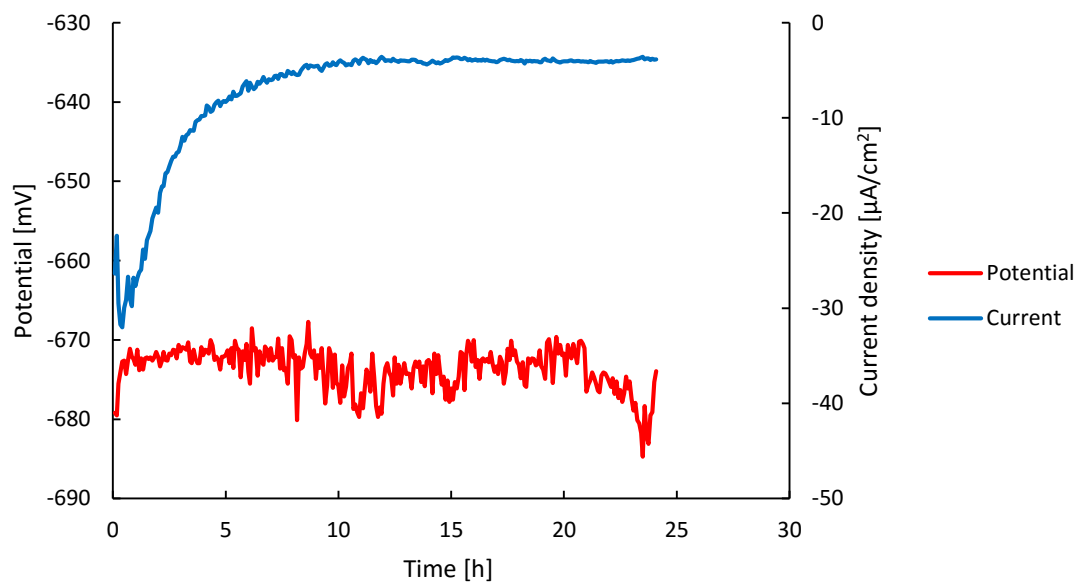
Figure 4.5. Galvanic corrosion test between X65 carbon steel and 6005 aluminium in seawater. Recorded coupling potential and galvanic current as a function of time.

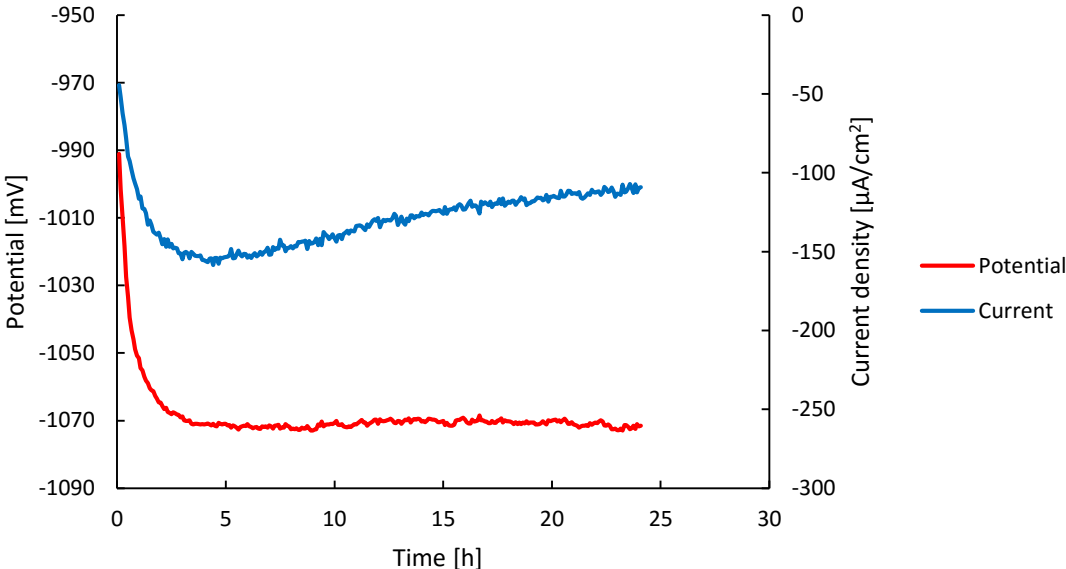
Figure 4.6. Galvanic corrosion test between X65 carbon steel and AlZnIn in NaCl. Recorded coupling potential and galvanic current as a function of time.

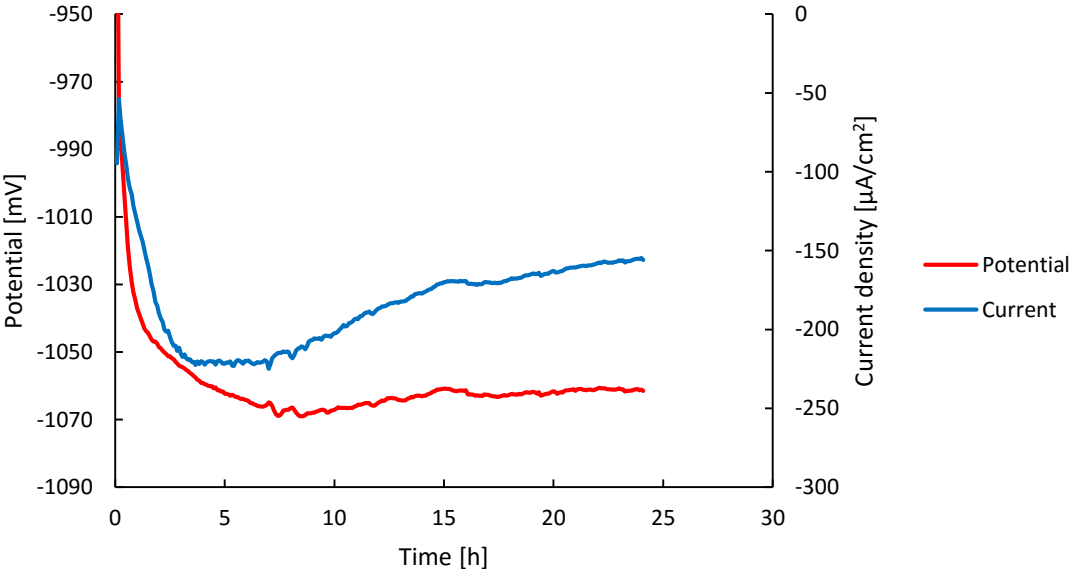
Figure 4.7. Galvanic corrosion test between X65 carbon steel and AlZnIn in seawater. Recorded coupling potential and galvanic current as a function of time.

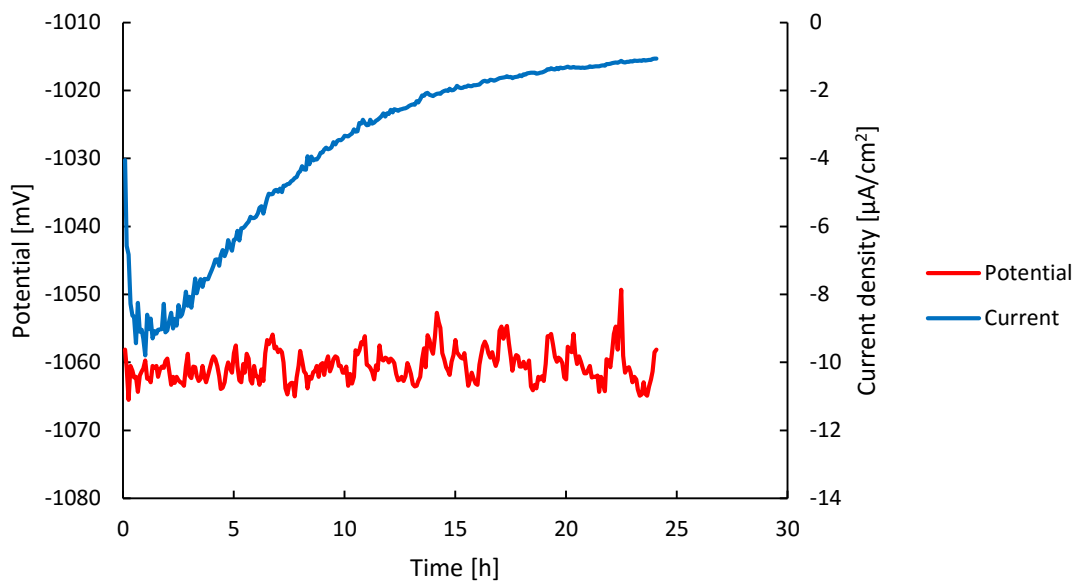
Figure 4.8. Galvanic corrosion test between 6005 aluminium and AlZnIn in NaCl. Recorded coupling potential and galvanic current as a function of time.

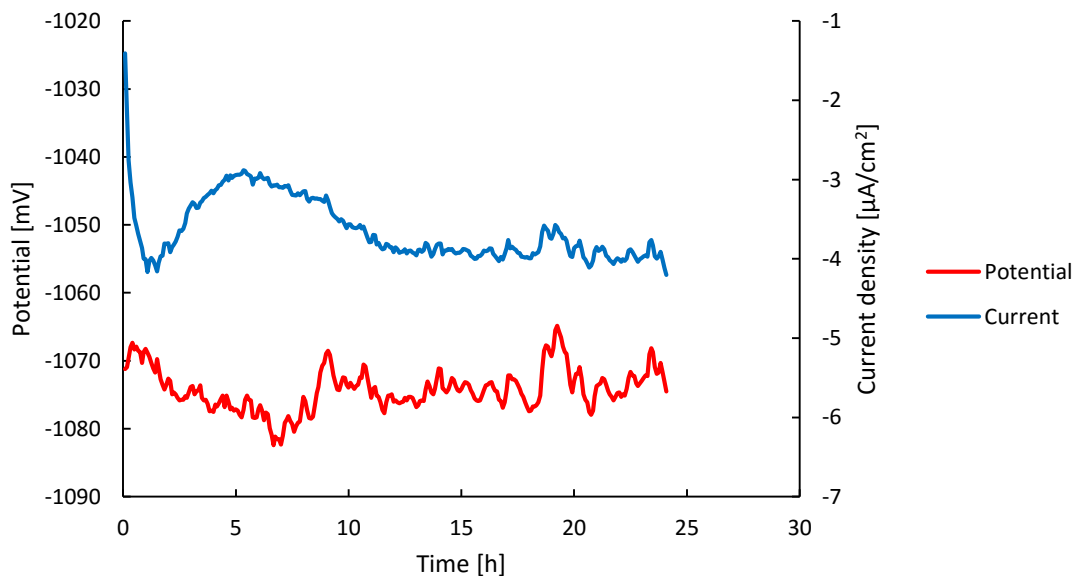
Figure 4.9. Galvanic corrosion test between 6005 aluminium and AlZnIn in seawater. Recorded coupling potential and galvanic current as a function of time.

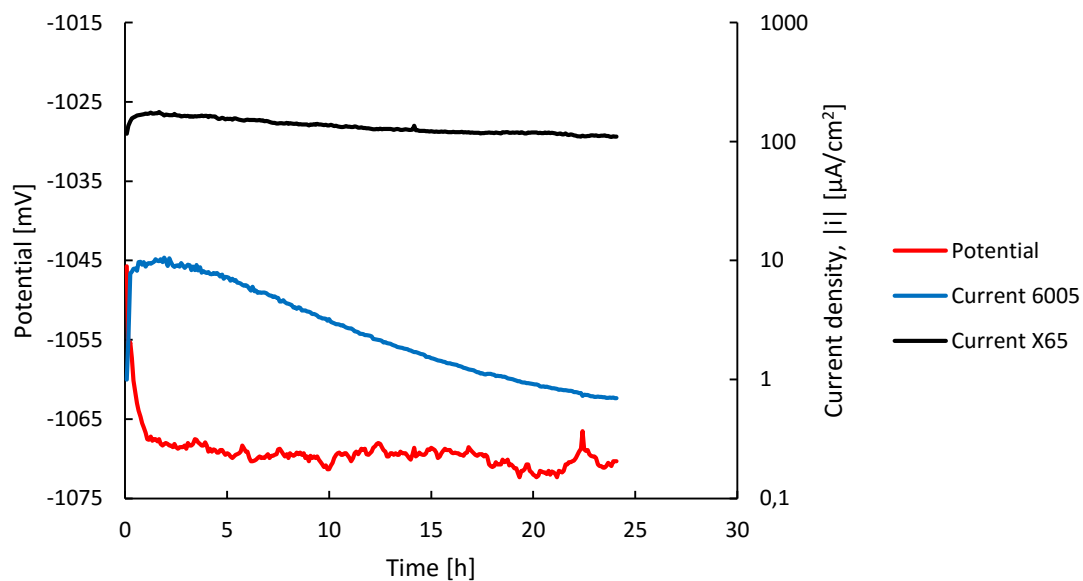
Figure 4.10. Galvanic corrosion test between X65 carbon steel, 6005 aluminium and AlZnIn in NaCl. Recorded coupling potential and galvanic current as a function of time.

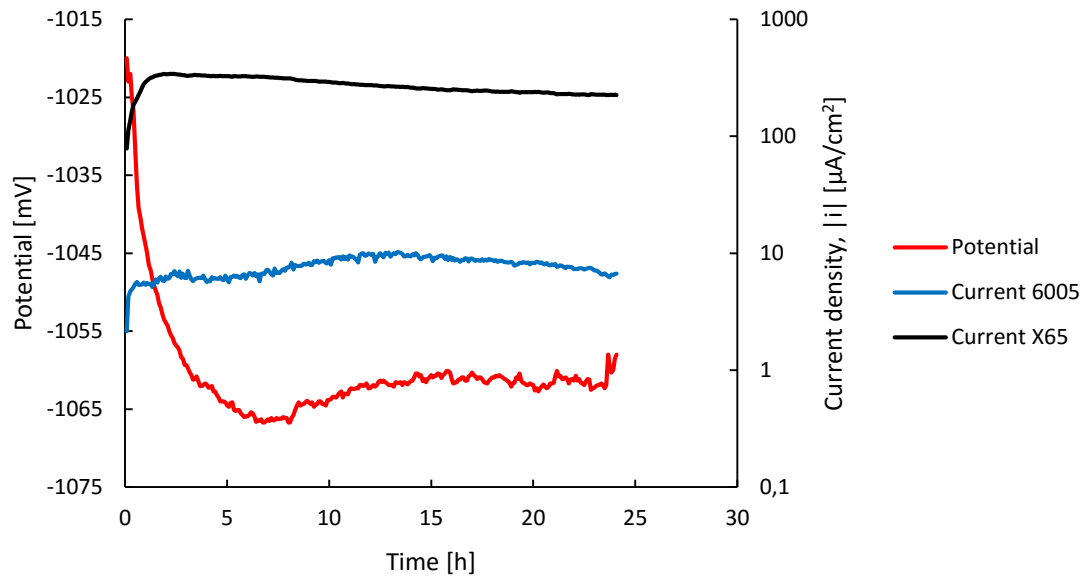
Figure 4.11. Galvanic corrosion test between X65 carbon steel, 6005 aluminium and AlZnIn in seawater. Recorded coupling potential and galvanic current as a function of time.

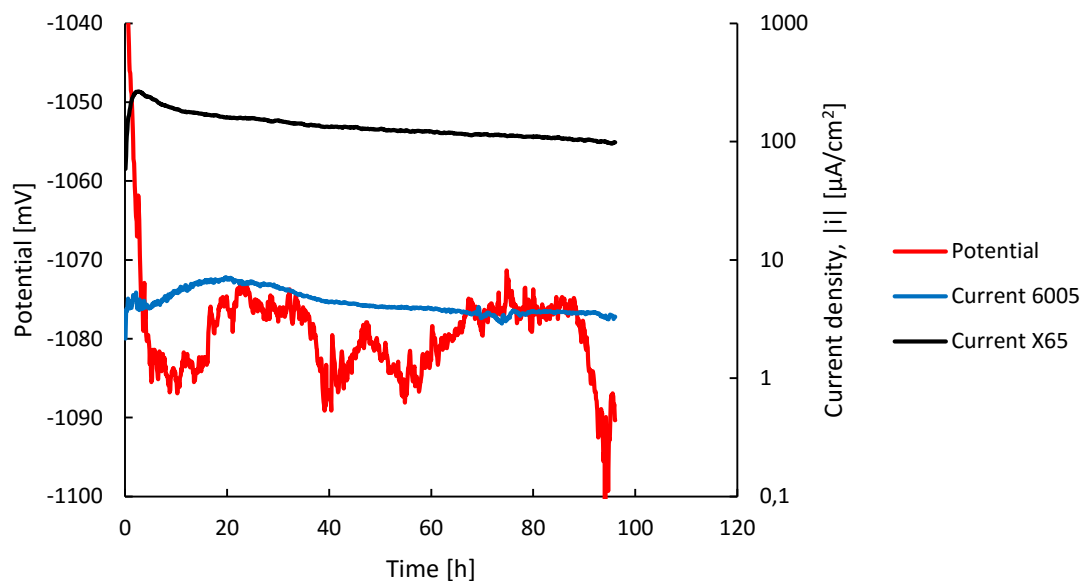
Figure 4.12. Long-term (96h) galvanic corrosion test between X65 carbon steel, 6005 aluminium and AlZnIn in seawater. Recorded coupling potential and galvanic current as a function of time.

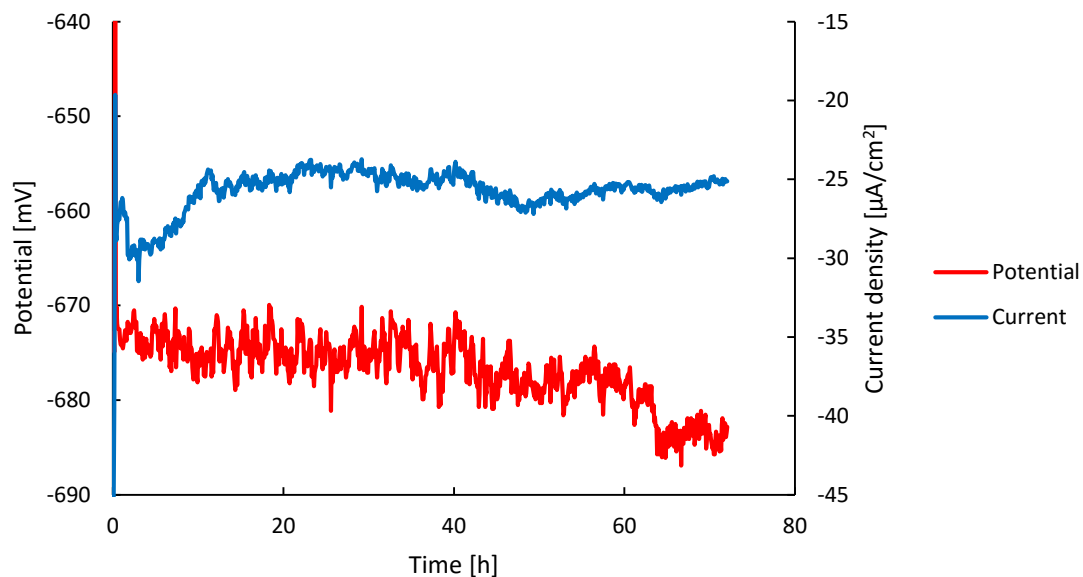
Figure 4.13. Galvanic crevice corrosion test between X65 carbon steel and 6005 aluminium in NaCl. Recorded coupling potential and galvanic current as a function of time. The samples were coupled in a simulated crevice of 100 μm .

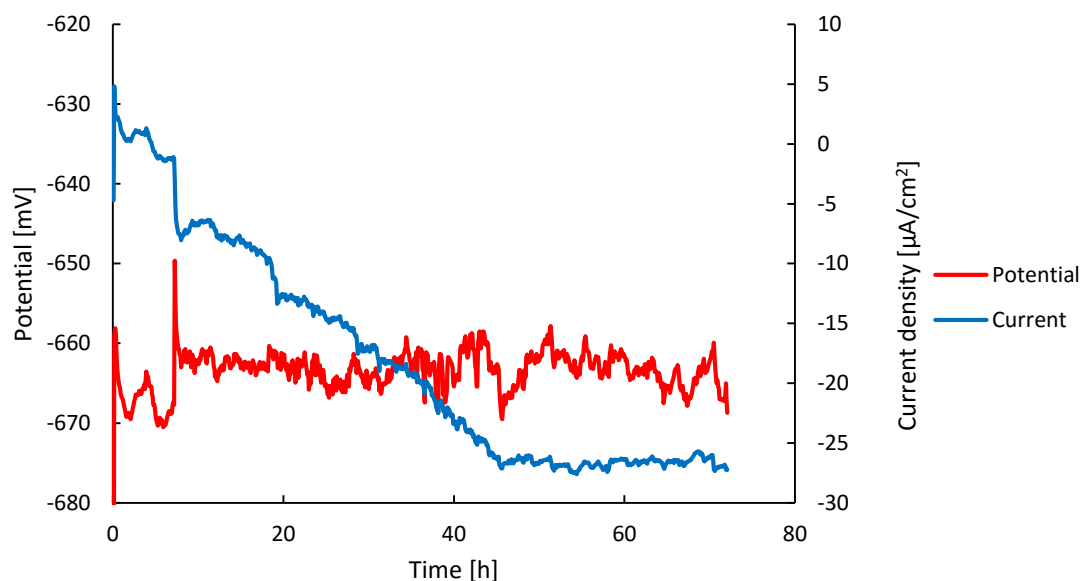
Figure 4.14. Galvanic crevice corrosion test between X65 carbon steel and 6005 aluminium in seawater. Recorded coupling potential and galvanic current as a function of time. The samples were coupled in a simulated crevice of 100 μm .

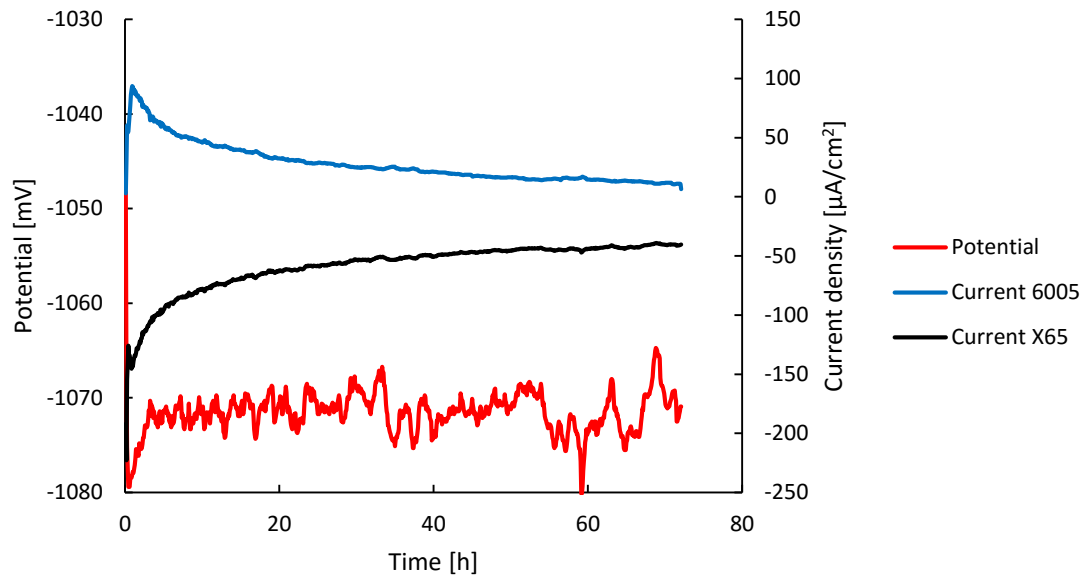
Figure 4.15. Galvanic crevice corrosion test between X65 carbon steel and 6005 aluminium with cathodic protection in NaCl. Recorded coupling potential and galvanic current as a function of time. X65 CS and 6005 Al were coupled in a simulated crevice of 100 μm .

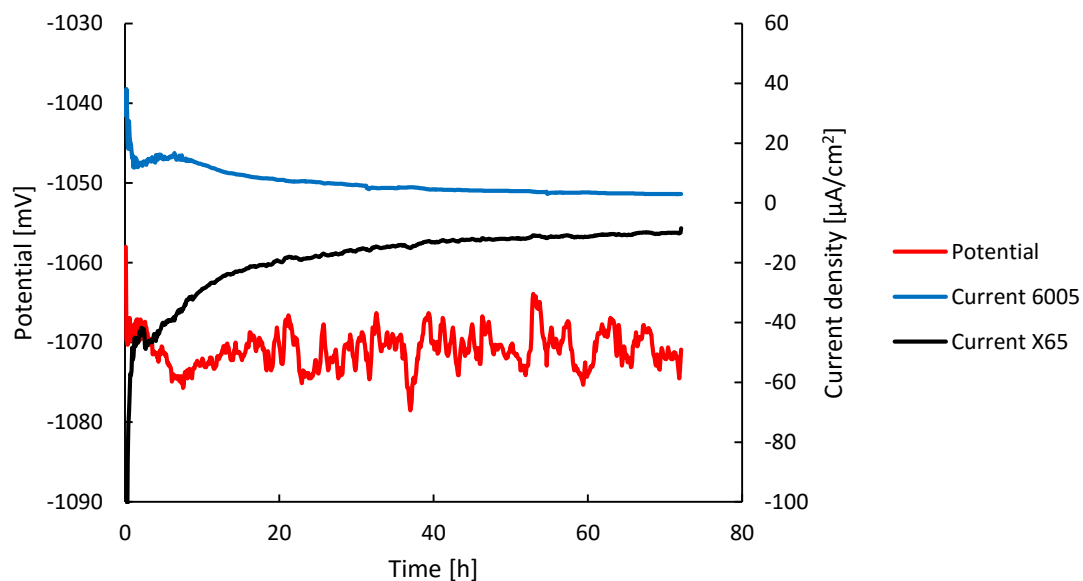
Figure 4.16. Galvanic crevice corrosion test between X65 carbon steel and 6005 aluminium with cathodic protection in seawater. Recorded coupling potential and galvanic current as a function of time. X65 CS and 6005 Al were coupled in a simulated crevice of 100 μm .

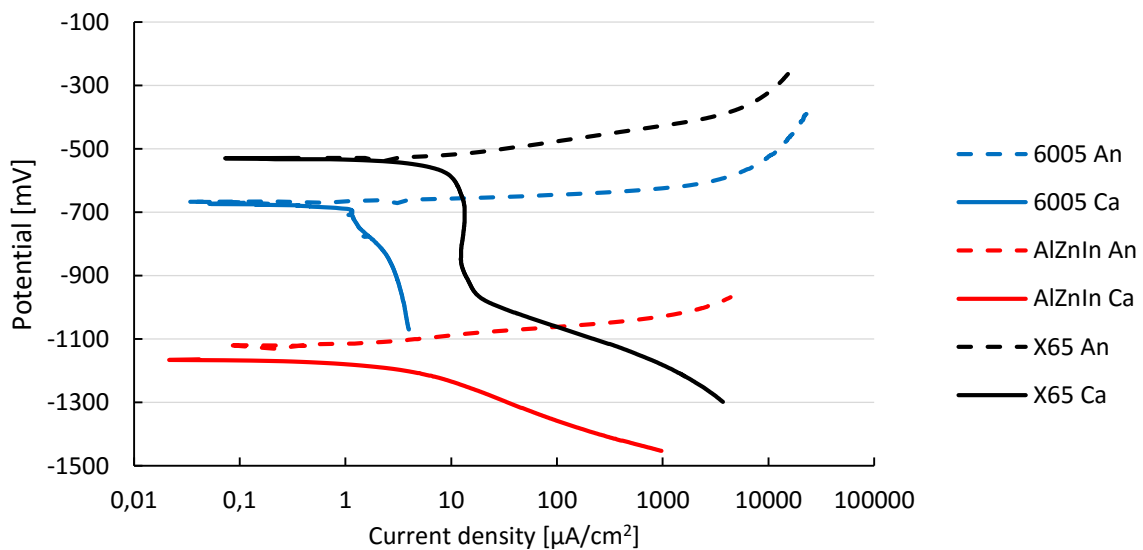
Figure 4.17. Polarization curves for X65 carbon steel, 6005 aluminium and AlZnIn in 3.5% NaCl solution. Recorded in the author's specialization project [30].

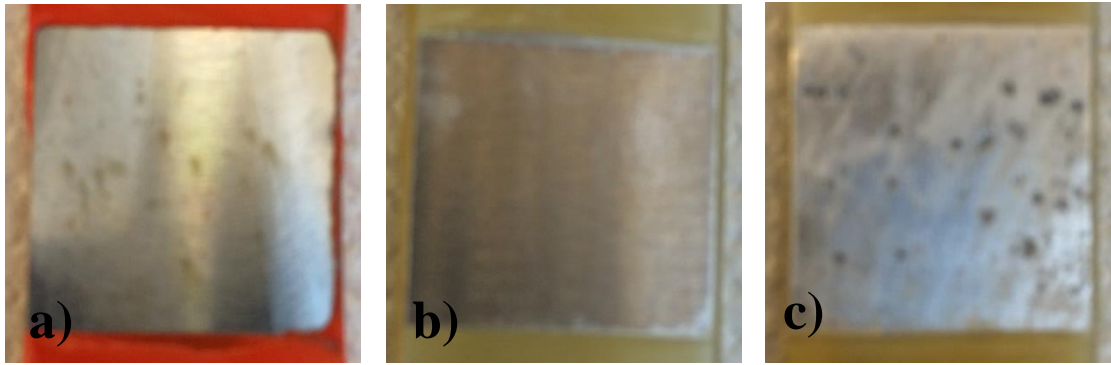
Figure 4.26. Pictures of samples after three-metal galvanic corrosion testing in NaCl. a) X65 CS, b) 6005 Al, c) AlZnIn.

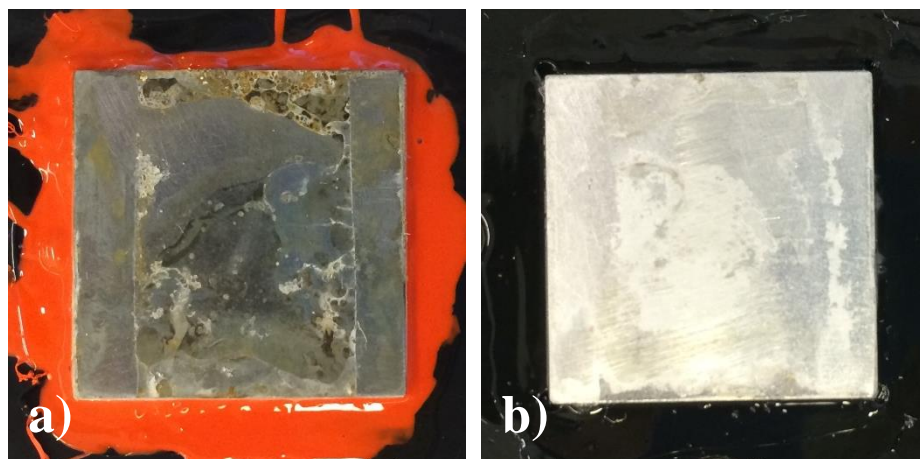
Figure 4.28. Pictures of samples after galvanic crevice corrosion testing in NaCl. a) X65 CS, b) 6005 Al.

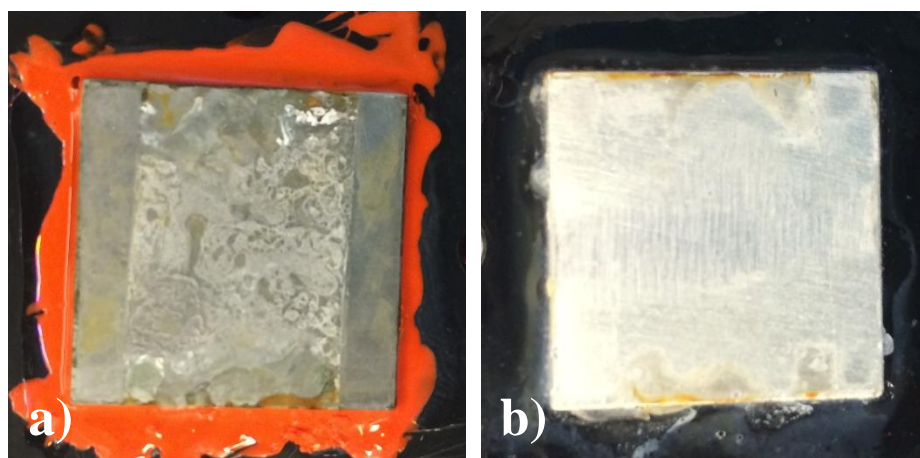
Figure 4.29. Pictures of samples after galvanic crevice corrosion testing in seawater. a) X65 CS, b) 6005 Al.

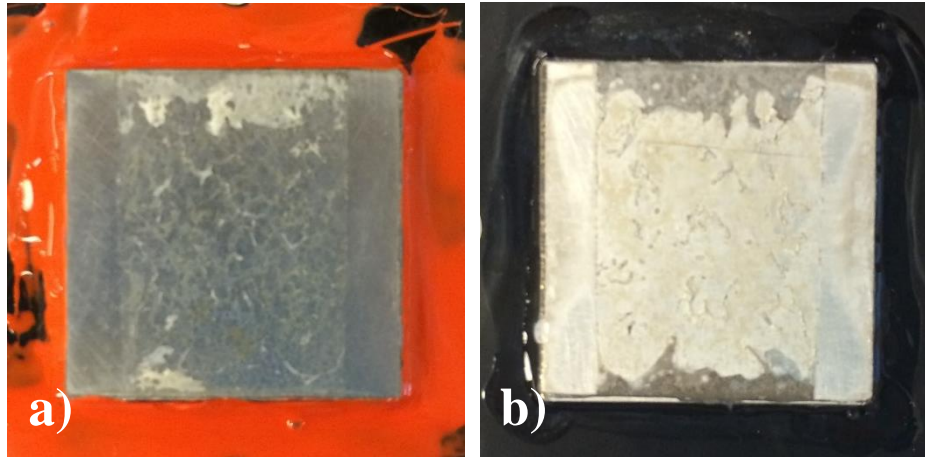
Figure 4.30. Pictures of samples after galvanic crevice corrosion testing with cathodic protection in NaCl. a) X65 CS, b) 6005 Al.

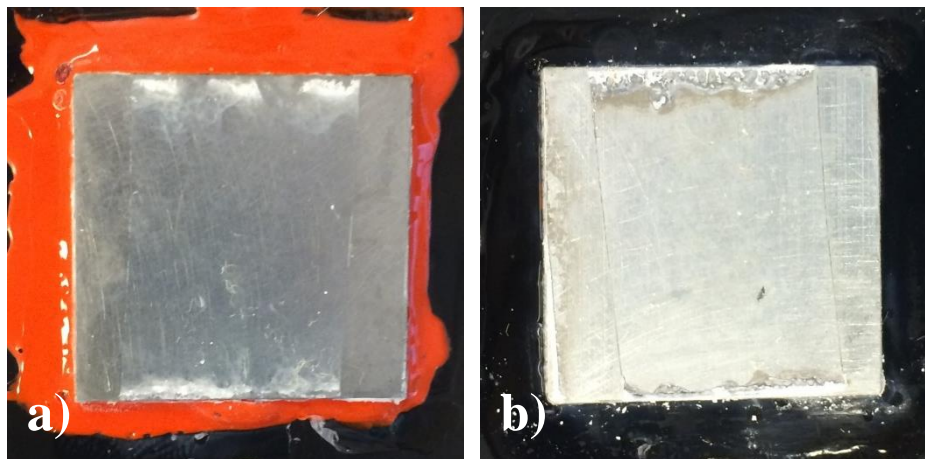
Figure 4.31. Pictures of samples after galvanic crevice corrosion testing with cathodic protection in seawater. a) X65 CS, b) 6005 Al.

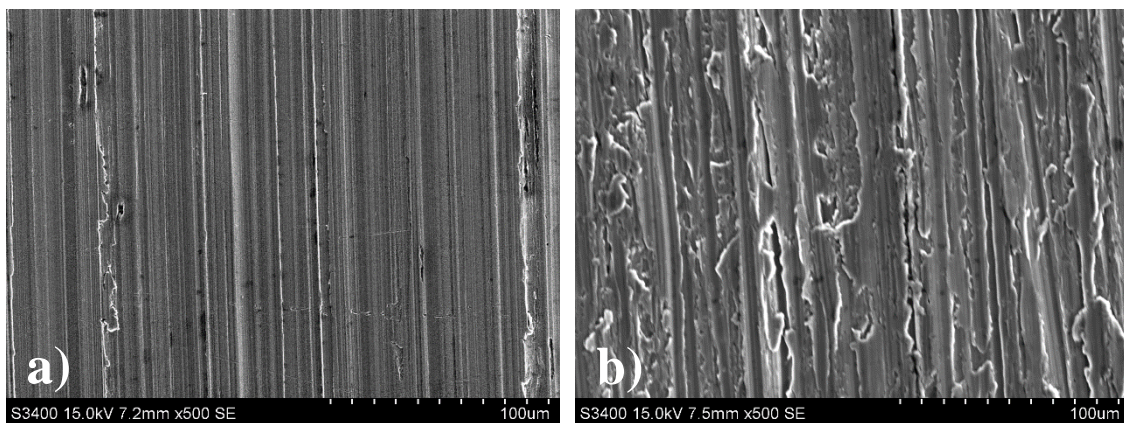
Figure 4.32. SEM images of the surfaces of alloys used in galvanic corrosion testing, as received. a) X65 CS, b) 6005 Al.

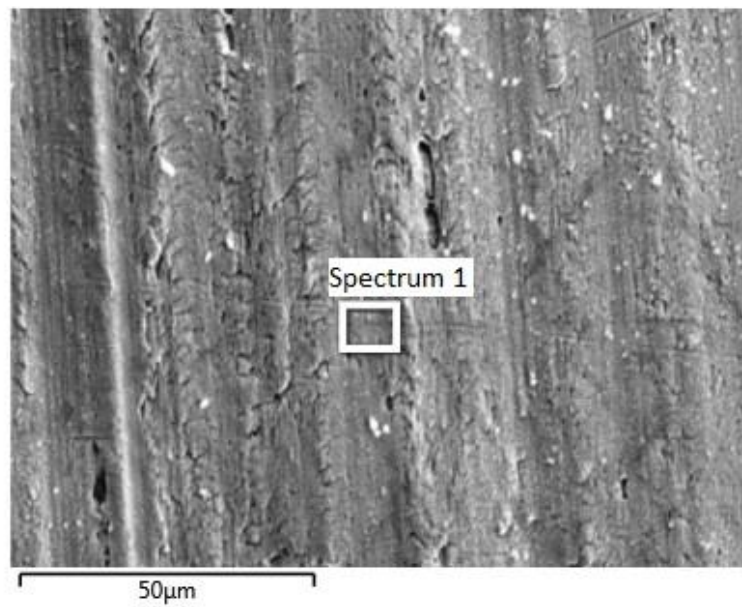
Figure 4.34. SEM image of an X65 CS sample after galvanic corrosion testing with 6005 Al in seawater, including area for EDS analysis. The image was taken prior to chemical cleaning.

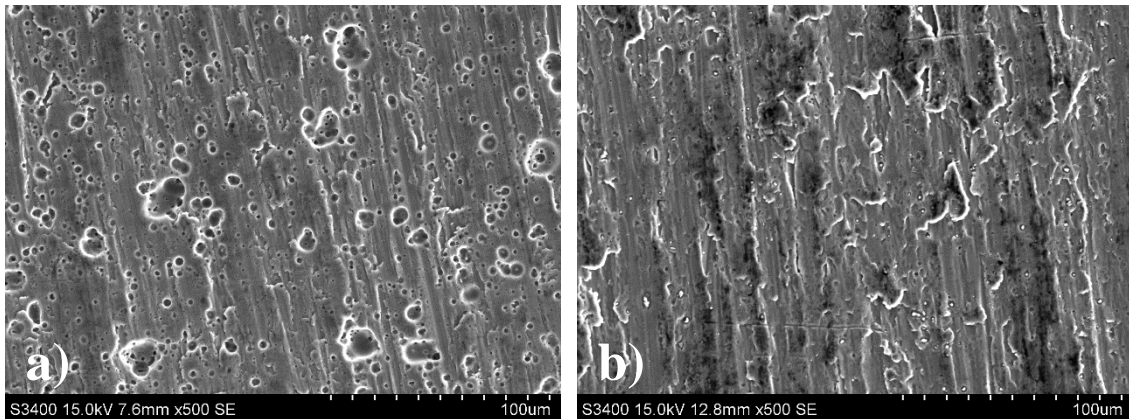
Figure 4.35. SEM images of 6005 Al samples from galvanic corrosion testing against AlZnIn in a) NaCl, b) seawater. The images were taken post chemical cleaning.

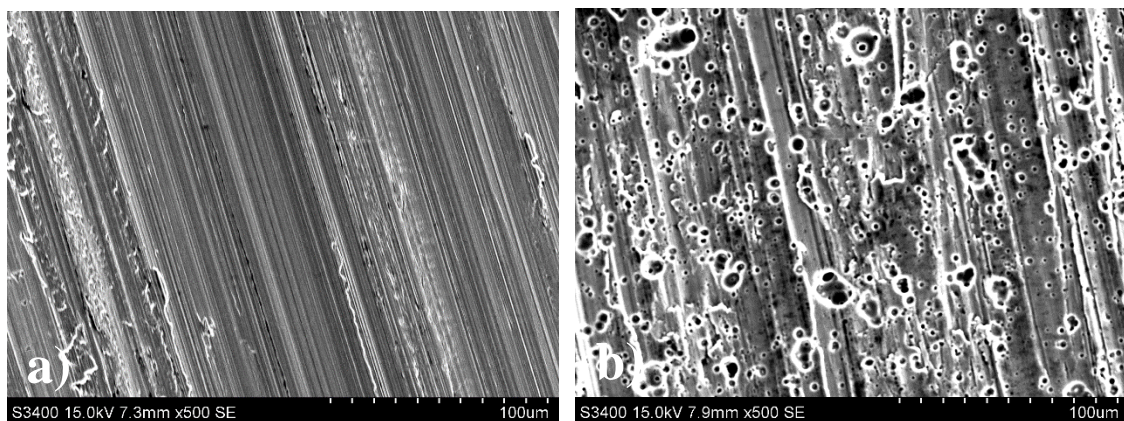
Figure 4.36. SEM images of a) X65 CS and b) 6005 Al samples from three-metal galvanic corrosion testing in NaCl. The images were taken post chemical cleaning.

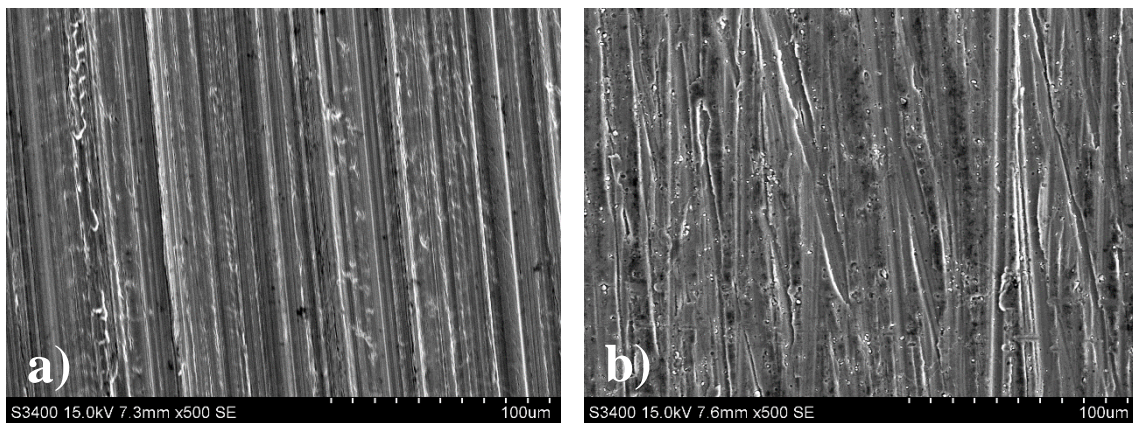
Figure 4.40. SEM images of a) X65 CS and b) 6005 Al samples from three-metal galvanic corrosion testing in NaCl. The images were taken post chemical cleaning.

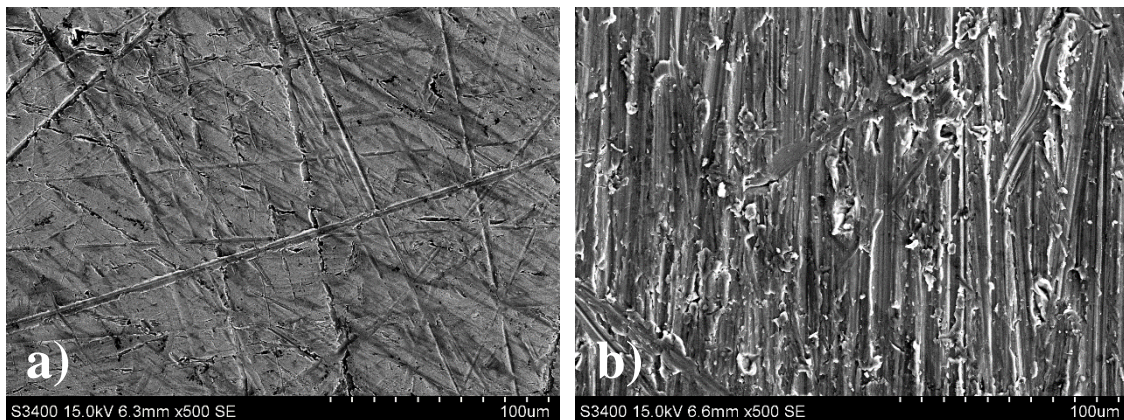
Figure 4.42. SEM images of the surfaces of alloys used in galvanic crevice corrosion testing, as received. a) X65 CS, b) 6005 Al.
