Norwegian University of
Science and Technology

Cathodic Protection of Steel-Aluminium Galvanic Couples for a New Generation of Lightweight Subsea Structures

Chemical Engineering and Biotechnology

Submission date: June 2016

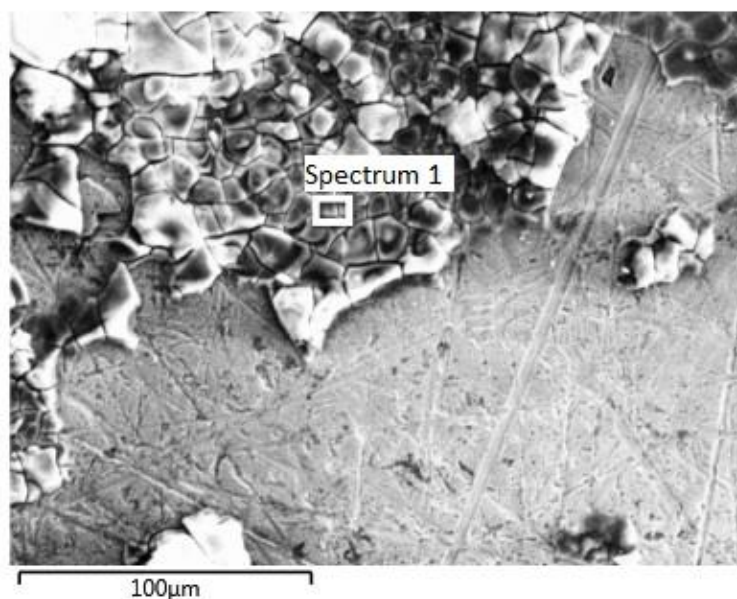
Figure 4.43. SEM image of the steel sample from two-metal galvanic crevice corrosion testing in NaCl. The image was taken prior to chemical cleaning.

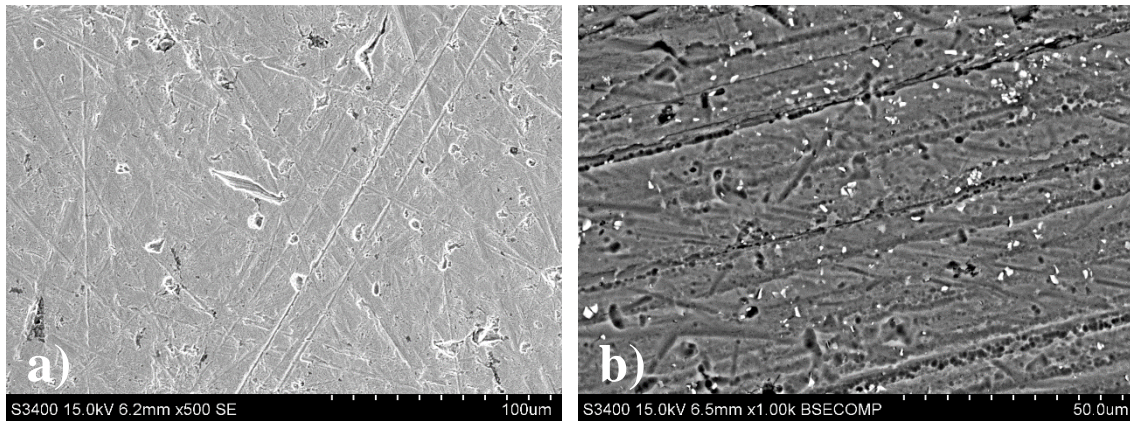
Figure 4.44. SEM images of a) X65 CS and b) 6005 Al samples after two-metal galvanic crevice corrosion testing in NaCl. The images were taken post chemical cleaning.

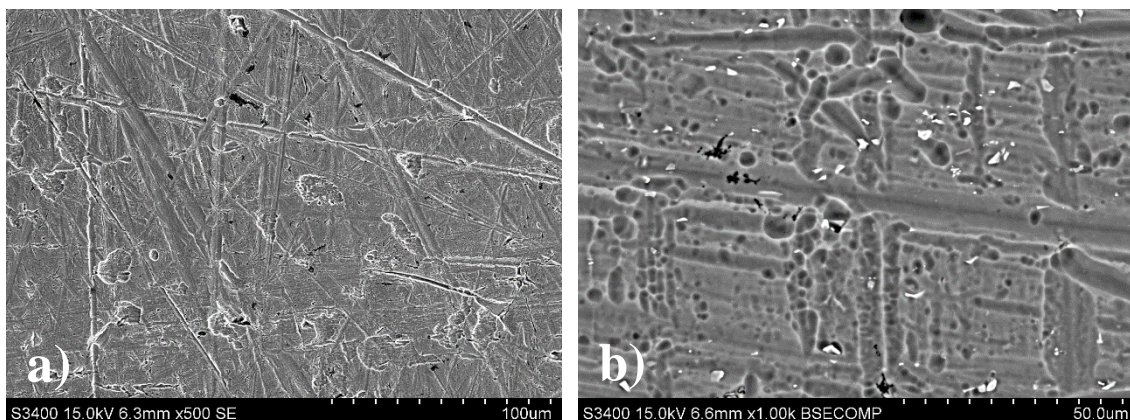
Figure 4.45. SEM images of a) X65 CS and b) 6005 Al samples after two-metal galvanic crevice corrosion testing in seawater. The images were taken post chemical cleaning.

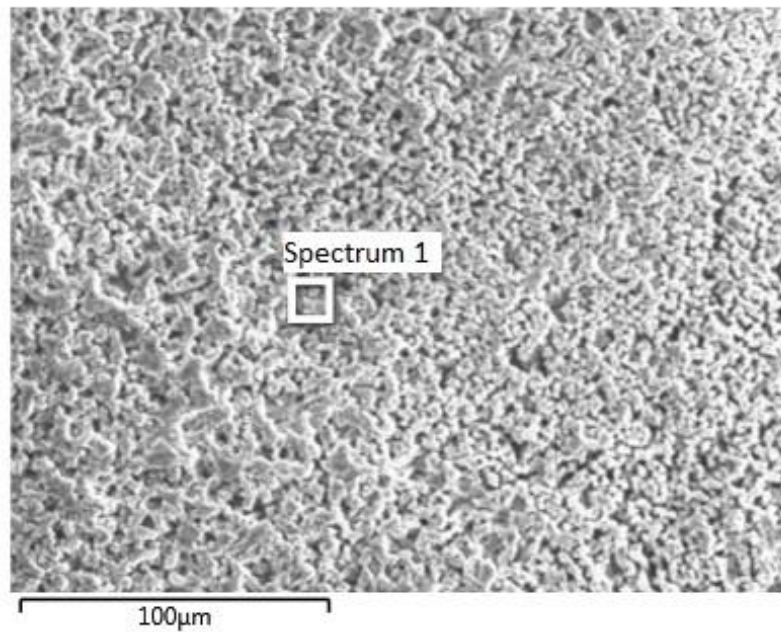
Figure 4.46. SEM image of the white deposits seen on the steel sample from galvanic crevice corrosion testing with cathodic protection in NaCl.

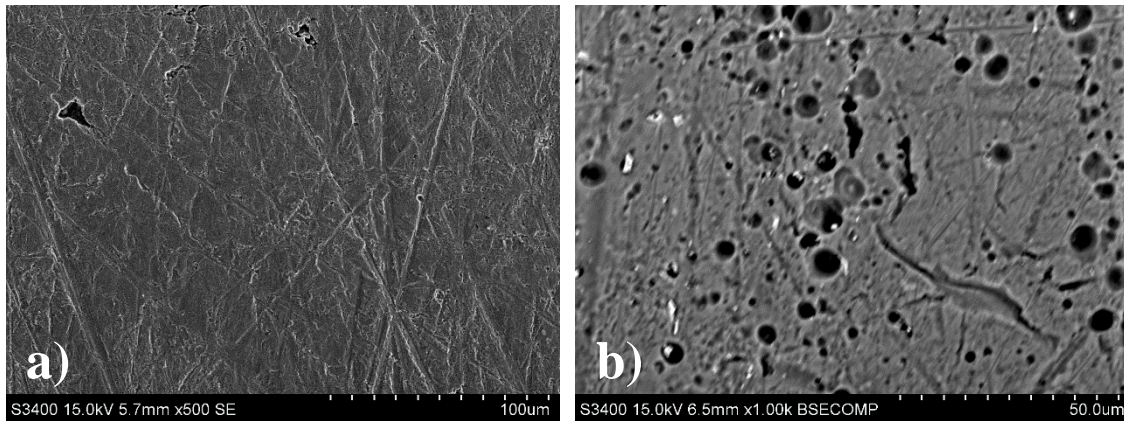
Figure 4.47. SEM images of a) X65 CS and b) 6005 Al samples after galvanic crevice corrosion testing with cathodic protection in NaCl. The images were taken in the middle of the samples, post chemical cleaning.

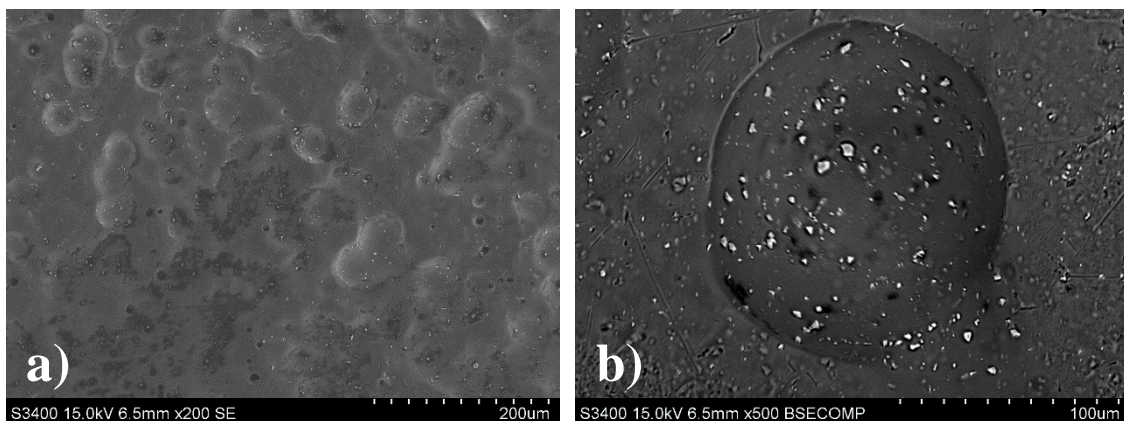
Figure 4.48. SEM images of the 6005 Al sample from galvanic crevice corrosion testing with cathodic protection in NaCl. Both images were taken near the crevice mouth, post chemical cleaning. a) Area near crevice mouth, b) adjacent area.

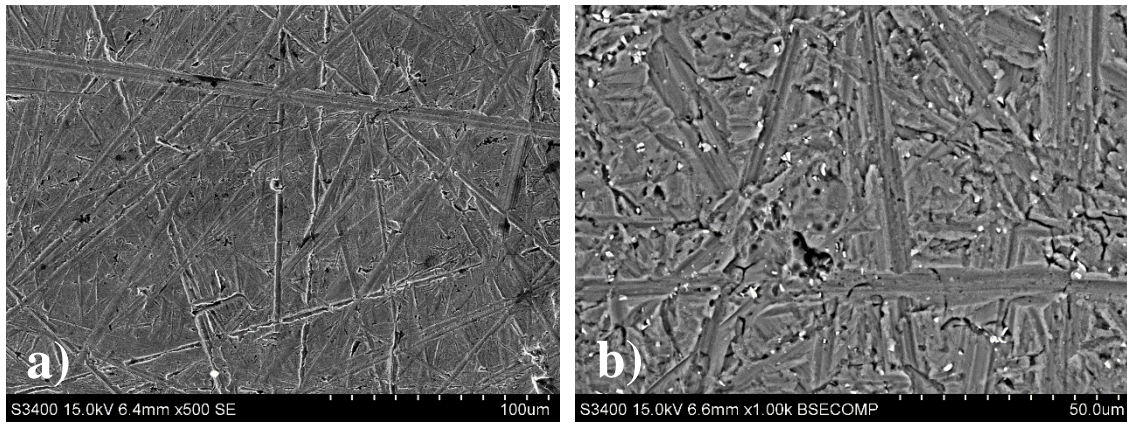
Figure 4.49. SEM images of a) X65 CS and b) 6005 Al samples after galvanic crevice corrosion testing with cathodic protection in seawater. The images were taken in the middle of the samples, post chemical cleaning.

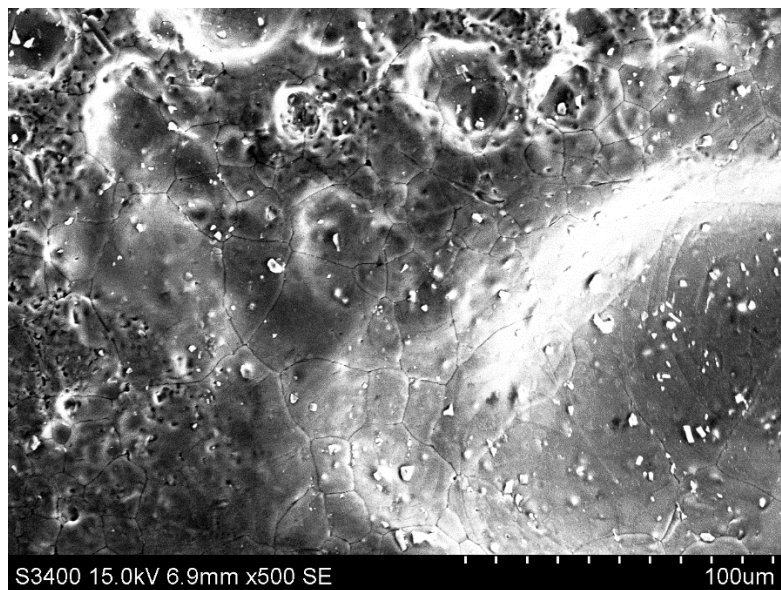
Figure 4.50. SEM image of the 6005 Al sample from galvanic crevice corrosion testing with cathodic protection in seawater. The image was taken near the crevice mouth, post chemical cleaning.

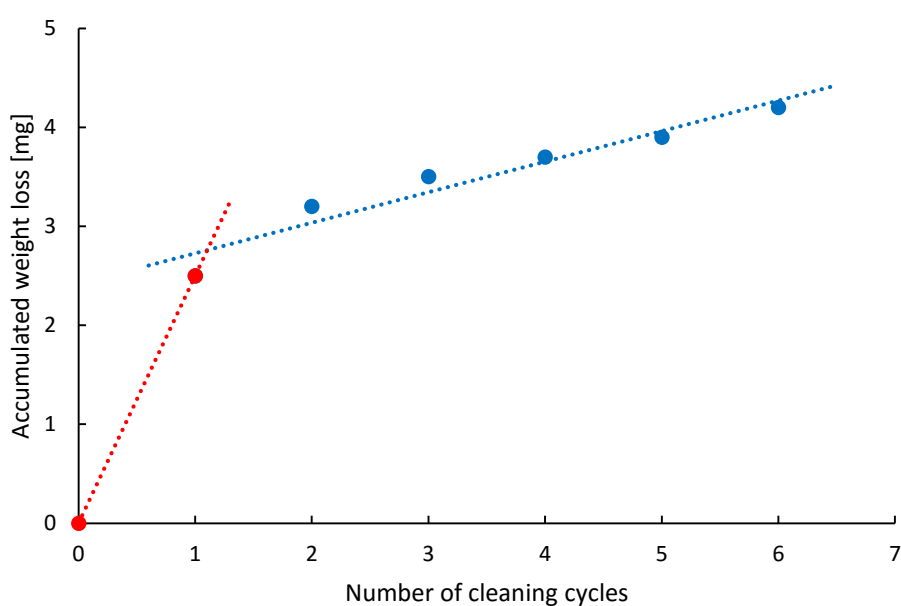
Figure A.1. Weight loss graph for X65 carbon steel.

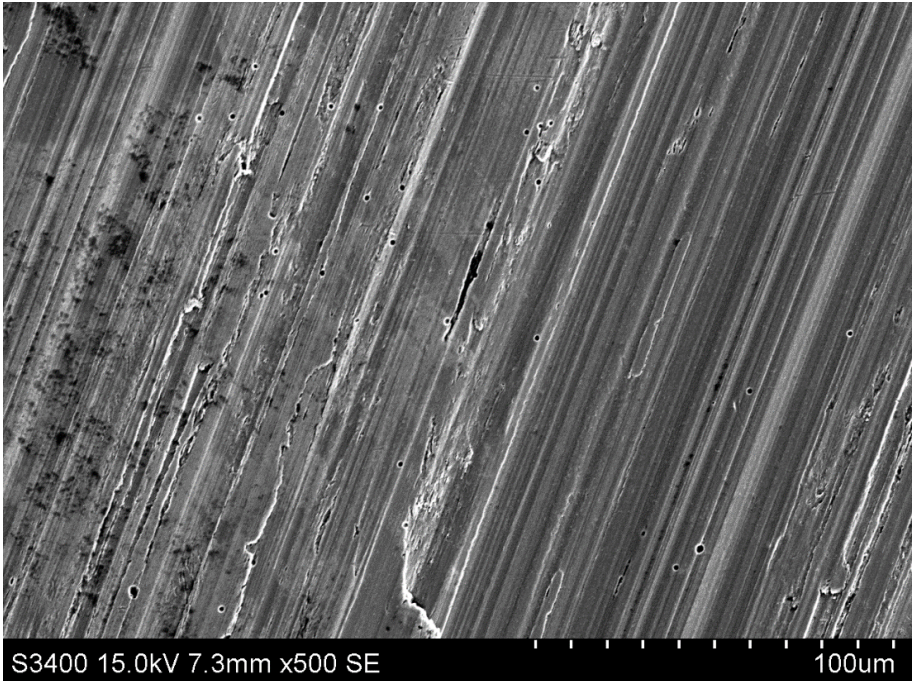
Figure B.1. SEM image of an X65 CS sample from galvanic corrosion testing between X65 CS and 6005 Al in NaCl. The image was taken post chemical cleaning.

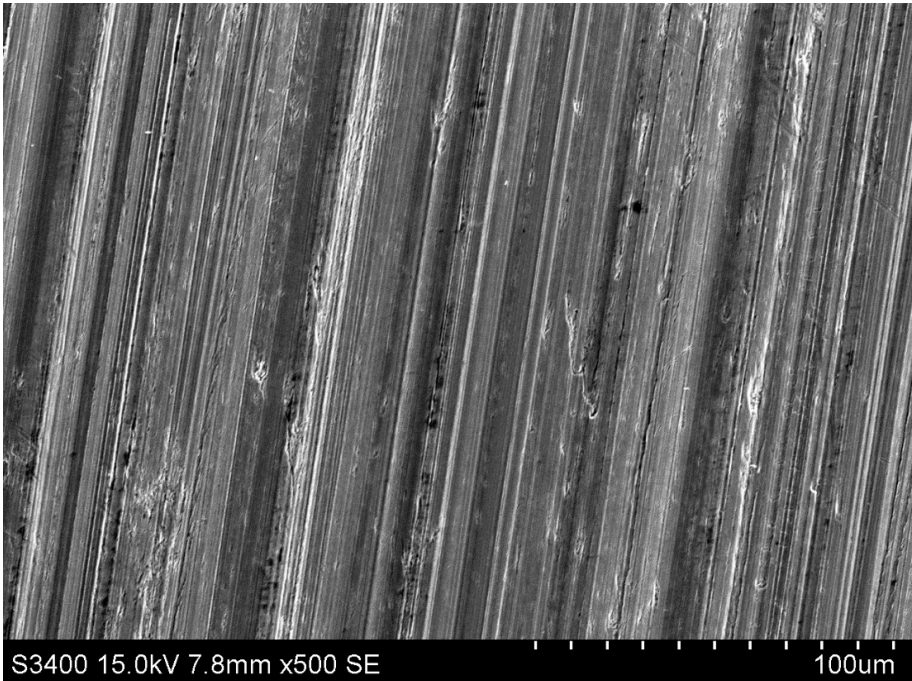
Figure B.2. SEM image of an X65 CS sample from galvanic corrosion testing between X65 CS and 6005 Al in seawater. The image was taken post chemical cleaning.

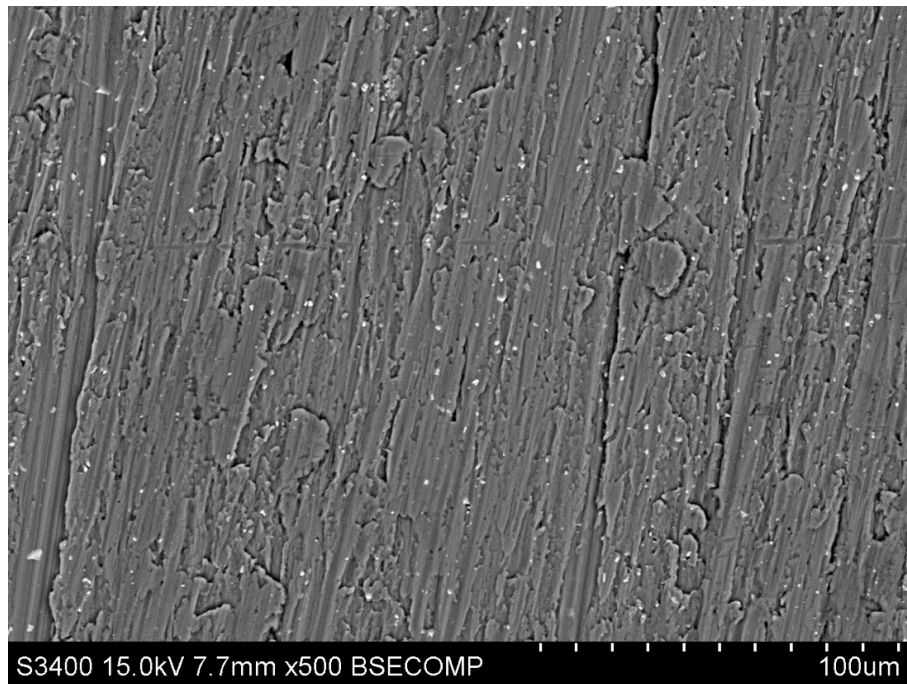
Figure B.3. SEM (backscatter) image of a 6005 Al sample from galvanic corrosion testing between X65 CS and 6005 Al in seawater. The image was taken post chemical cleaning.

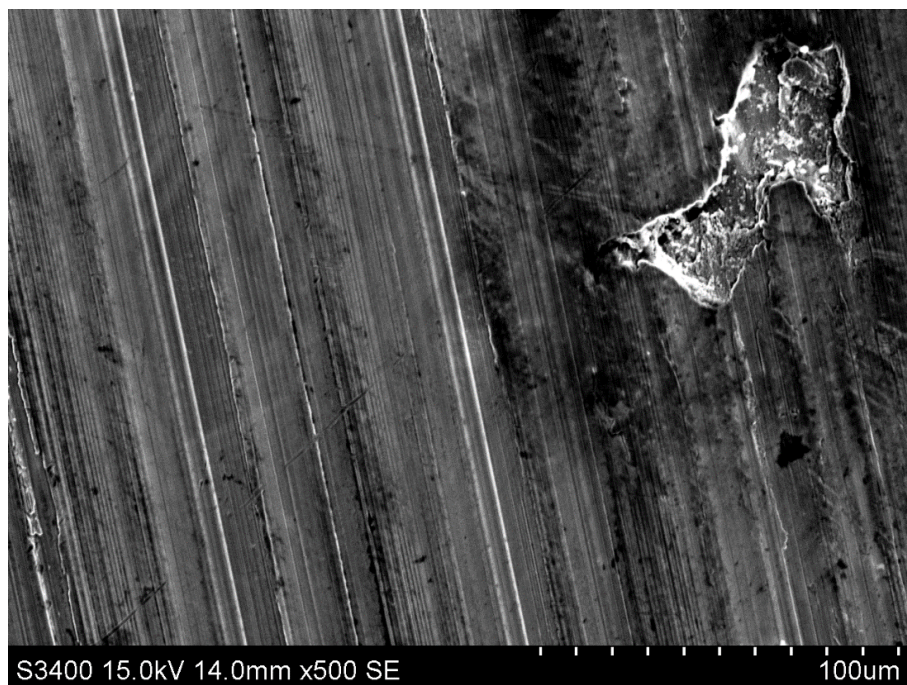
Figure B.4. SEM image of an X65 CS sample from galvanic corrosion testing between X65 CS and AlZnIn in NaCl. The image was taken prior to chemical cleaning.

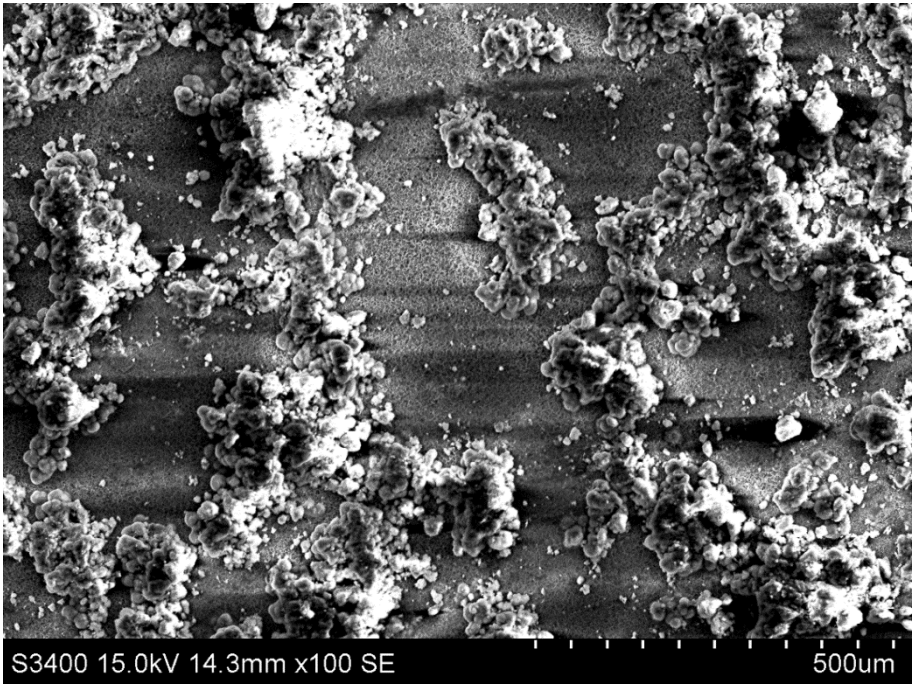
Figure B.5. SEM image of an X65 CS sample covered with calcareous deposits from galvanic corrosion testing between X65 CS and AlZnIn in seawater.

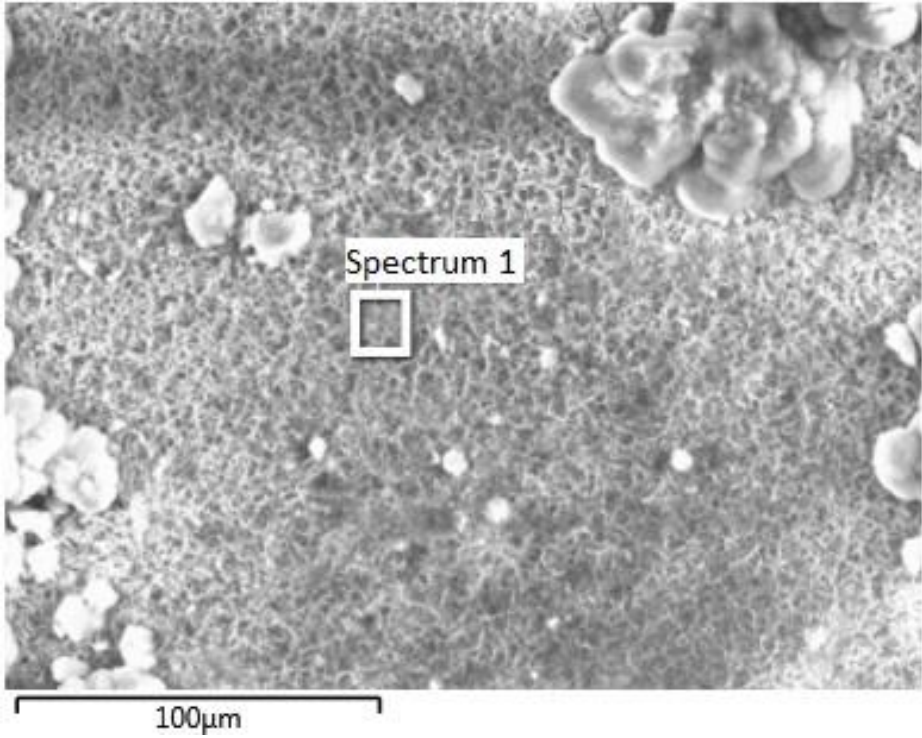
Figure B.6. SEM image of an X65 CS sample covered with calcareous deposits from galvanic corrosion testing between X65 CS and AlZnIn in seawater, including area of EDS analysis.

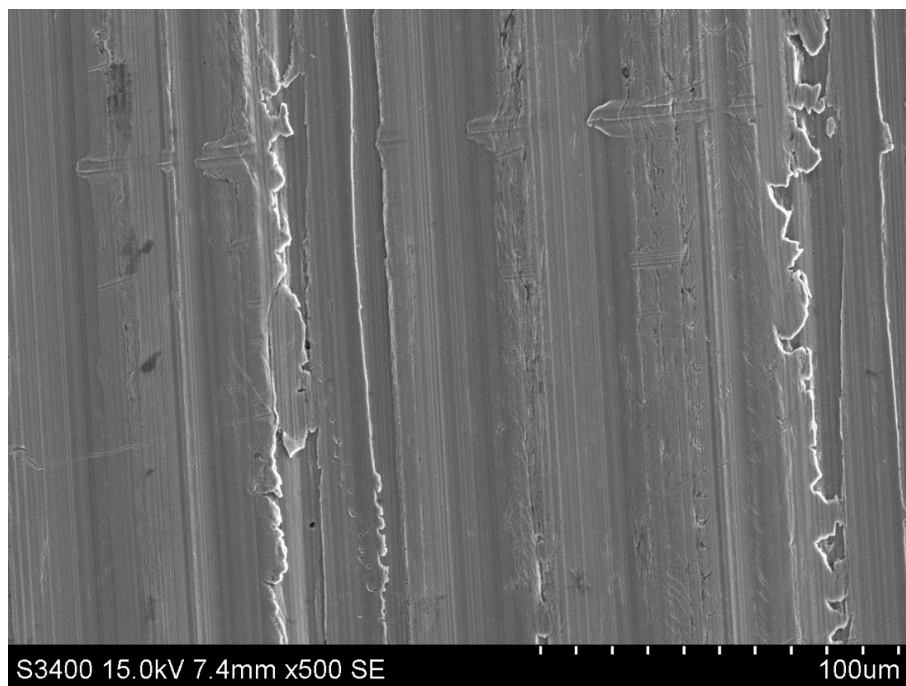
**Figure B.7.** SEM image of an X65 CS sample from galvanic corrosion testing between X65 CS and AlZnIn in seawater. The image was taken post chemical cleaning.

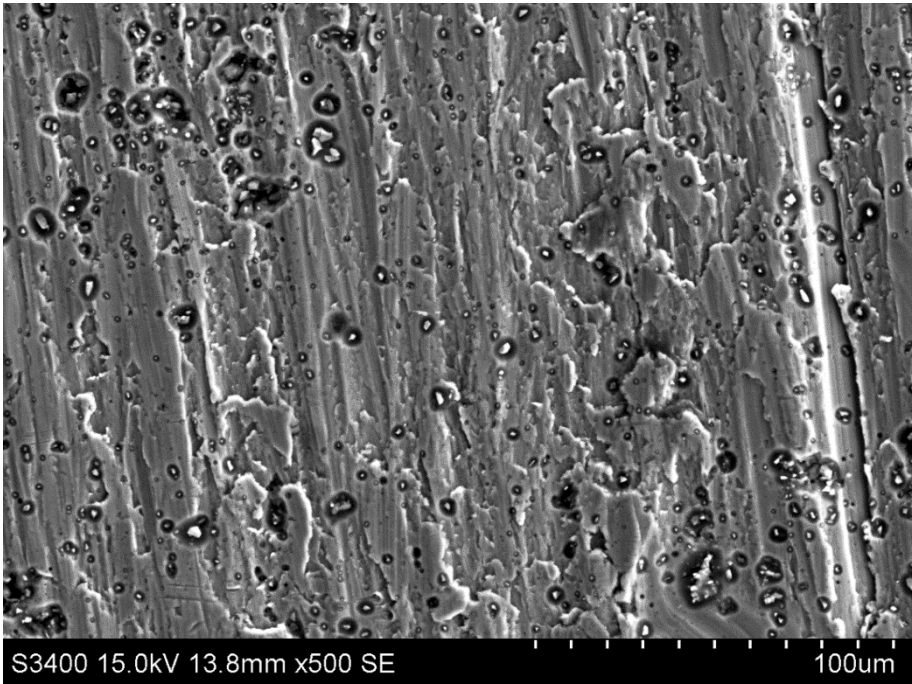
Figure B.8. SEM image of a 6005 Al sample from galvanic corrosion testing between 6005 Al and AlZnIn in NaCl. The image was taken prior to chemical cleaning.

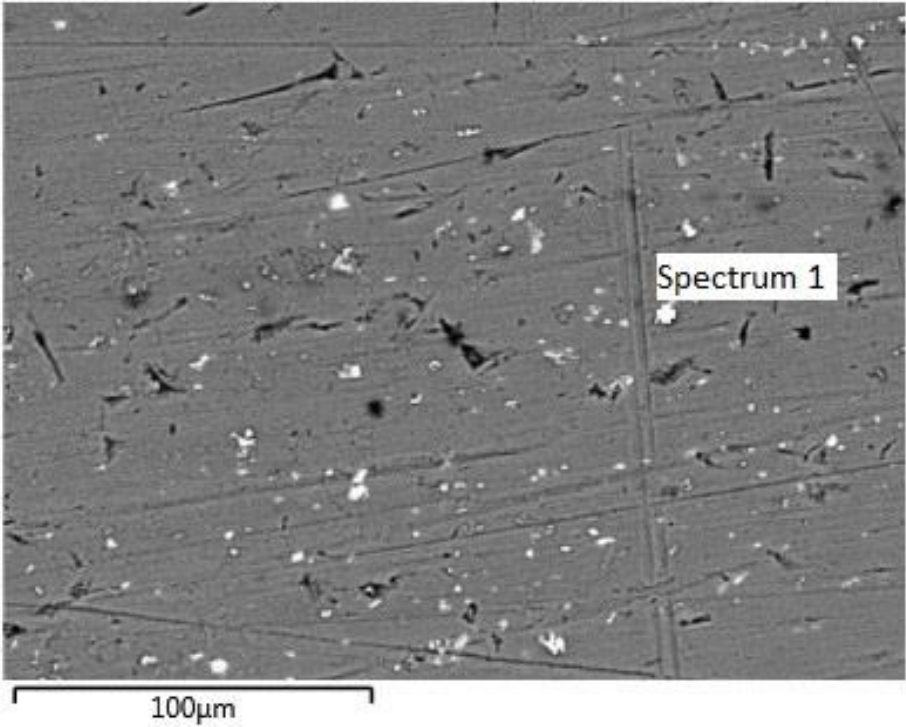
Figure B.9. SEM (backscatter) image of a 6005 Al sample from galvanic corrosion testing between 6005 Al and AlZnIn in seawater, including area of EDS analysis. The image was taken post chemical cleaning.

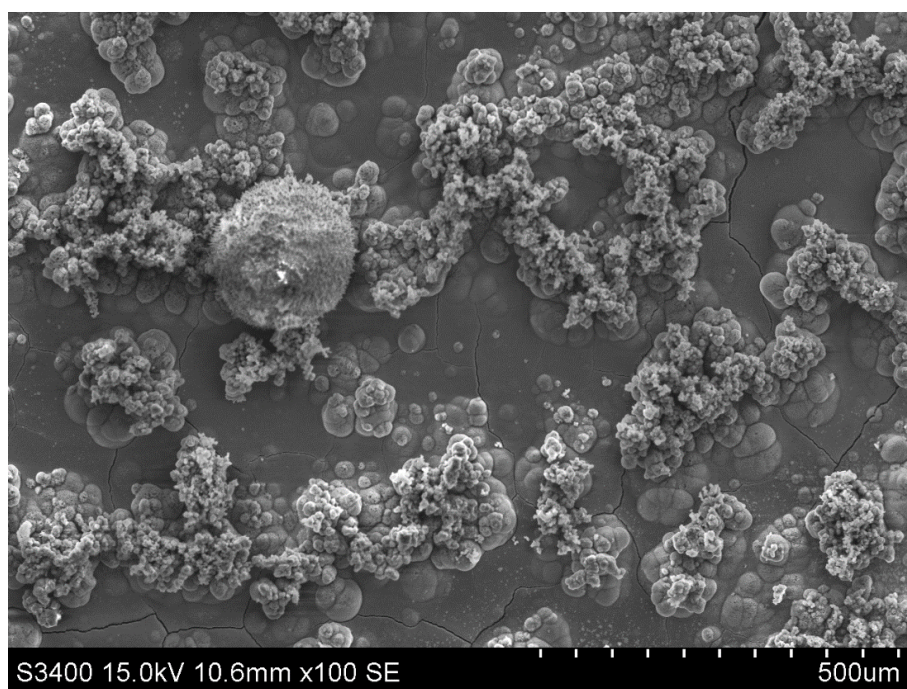
**Figure B.10.** SEM image of an X65 CS sample covered with calcareous deposits from 96-hour three-metal galvanic corrosion testing in seawater.

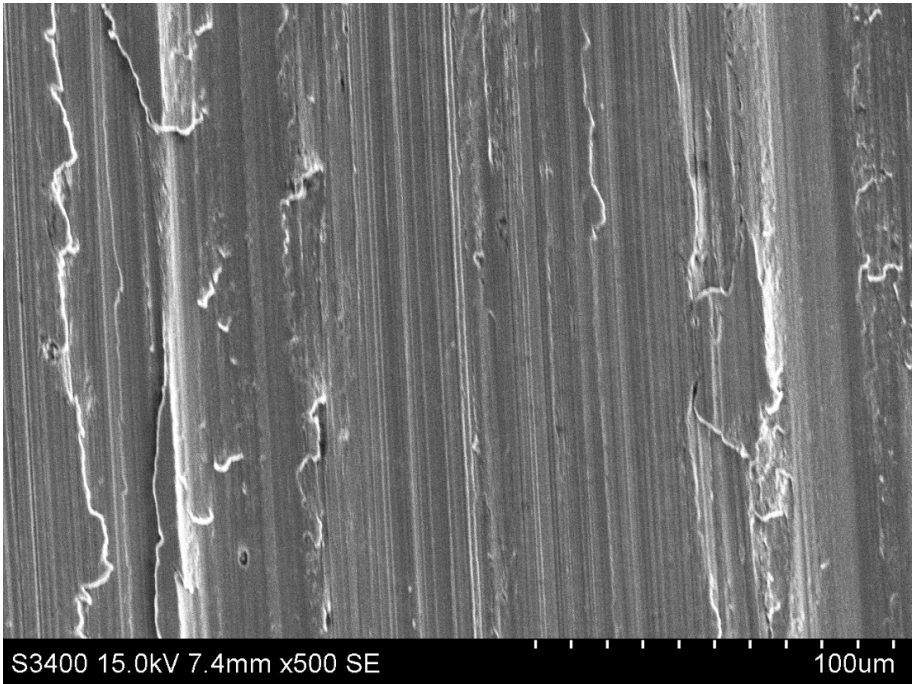
Figure B.11. SEM image of an X65 CS sample from 96-hour three-metal galvanic corrosion testing seawater. The image was taken post chemical cleaning.

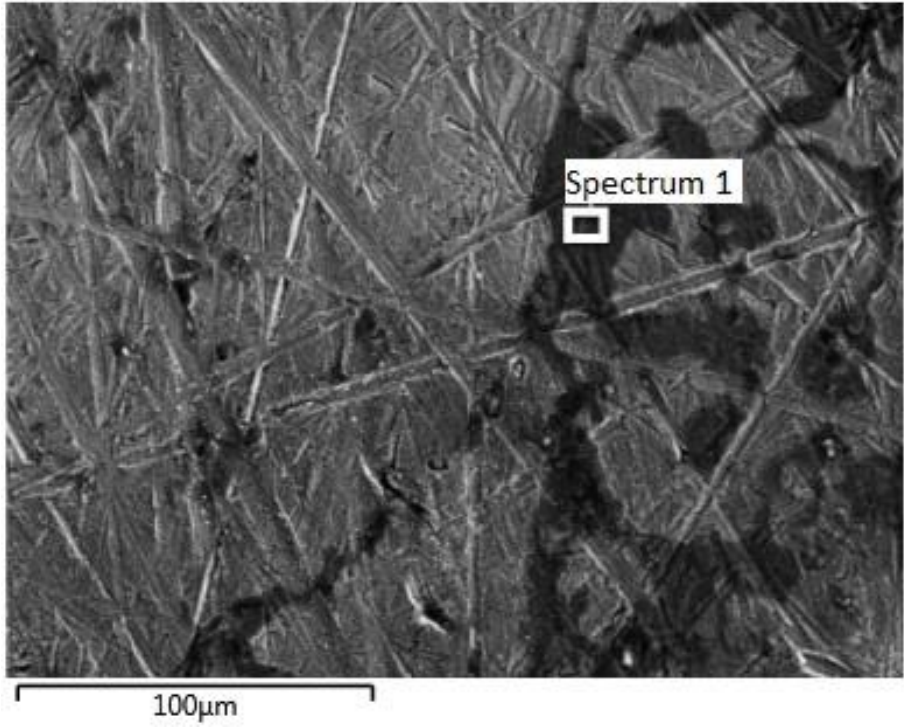
Figure B.12. SEM image of an X65 CS samples after two-metal galvanic crevice corrosion testing in seawater, including area of EDS analysis. The image was taken prior to chemical cleaning.

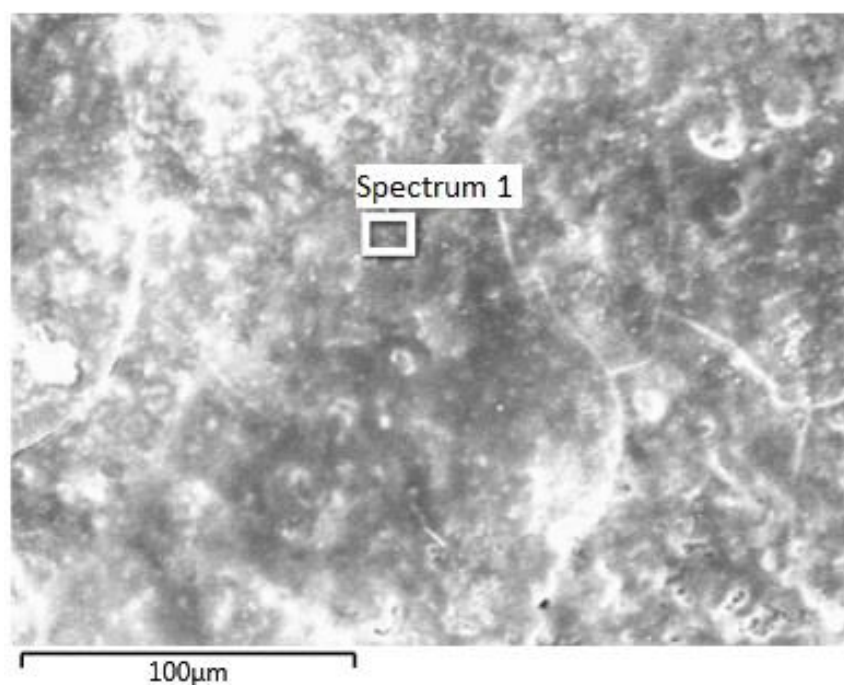
Figure B.13. SEM image of the white deposits seen on the 6005 Al sample from galvanic crevice corrosion testing with cathodic protection in seawater, including area of EDS analysis. The image was taken near the crevice mouth, prior to chemical cleaning.

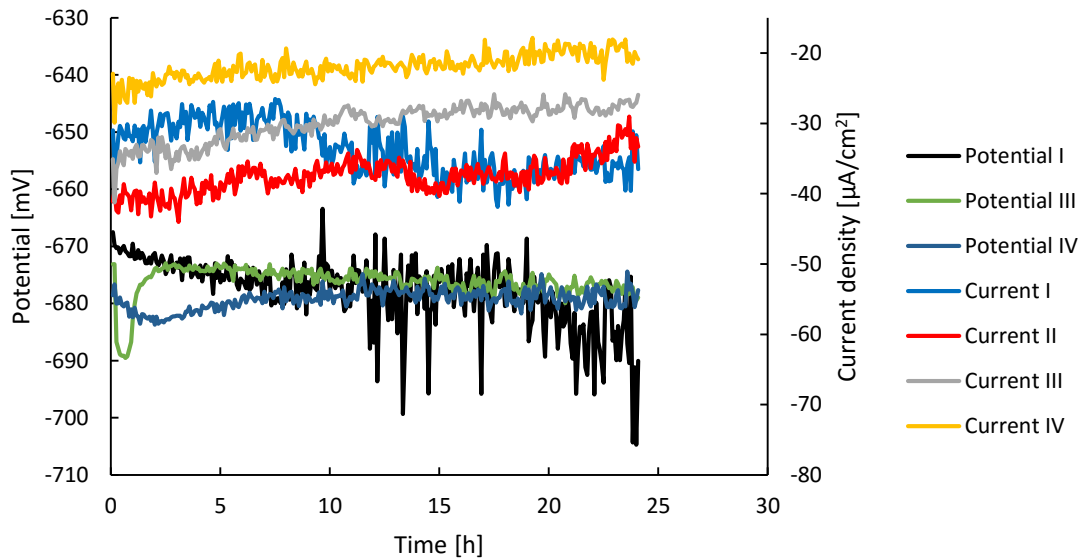
Figure C.1. Galvanic corrosion test between X65 carbon steel and 6005 aluminium in 3.5% NaCl solution. Recorded coupling potential and galvanic current as a function of time.

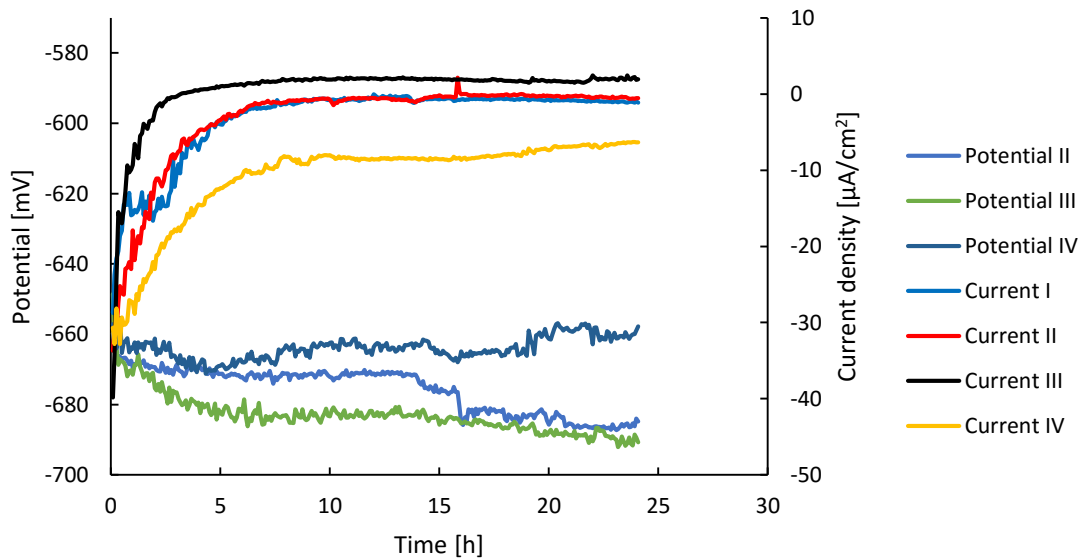
Figure C.2. Galvanic corrosion test between X65 carbon steel and 6005 aluminium in artificial seawater. Recorded coupling potential and galvanic current as a function of time.

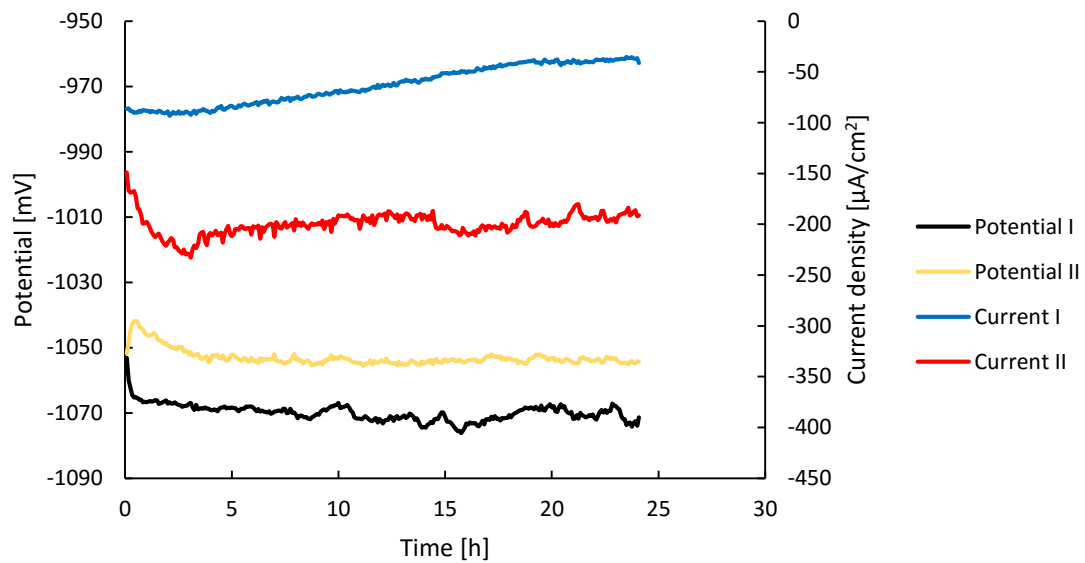
Figure C.3. Galvanic corrosion test between X65 carbon steel and AlZnIn in 3.5% NaCl solution. Recorded coupling potential and galvanic current as a function of time.

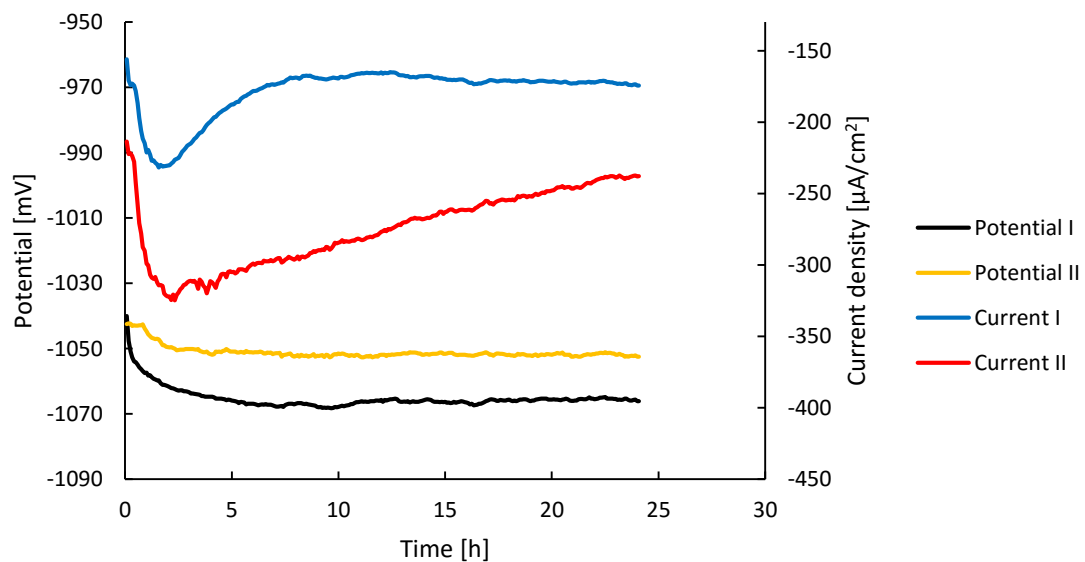
Figure C.4. Galvanic corrosion test between X65 carbon steel and AlZnIn in artificial seawater. Recorded coupling potential and galvanic current as a function of time.

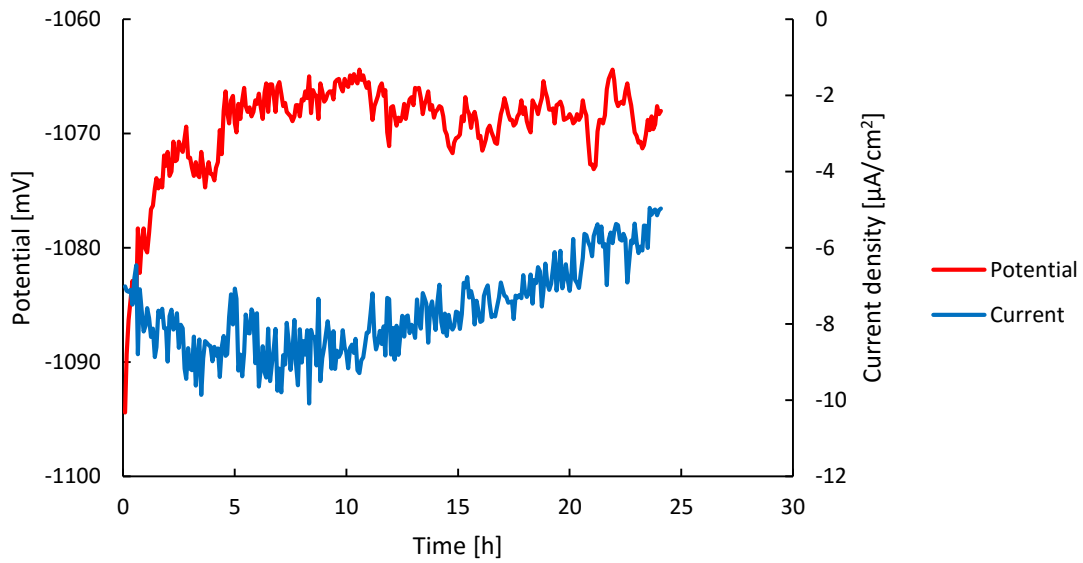
Figure C.5. Galvanic corrosion test between 6005 aluminium and AlZnIn in 3.5% NaCl solution. Recorded coupling potential and galvanic current as a function of time.

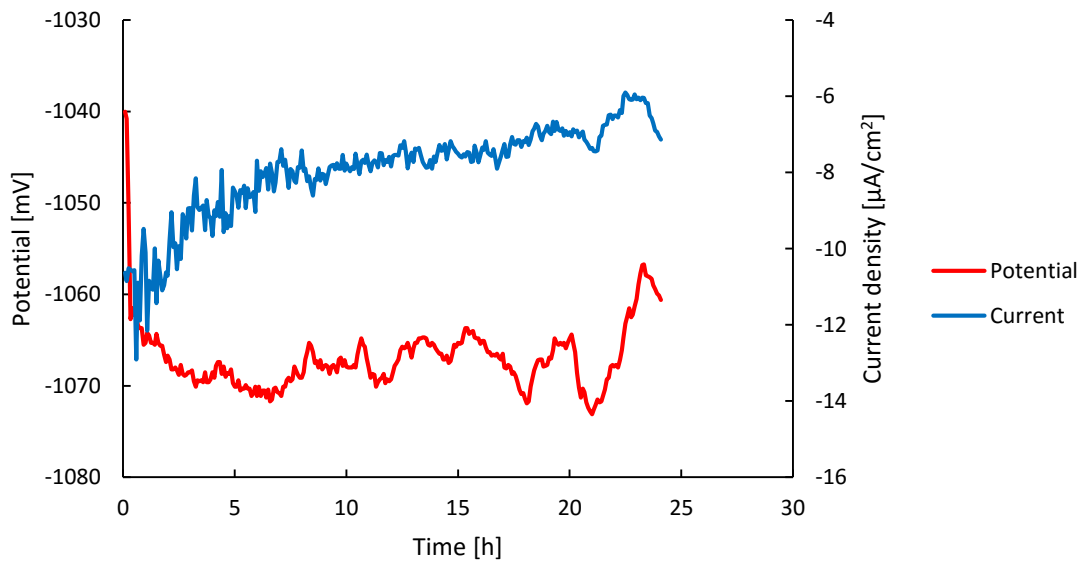
Figure C.6. Galvanic corrosion test between 6005 aluminium and AlZnIn in artificial seawater. Recorded coupling potential and galvanic current as a function of time.
