Earthquake and Monsoon Induced Slope Failure Effects on Hydropower Projects - An Analysis Along the Sunkoshi Valley, Nepal

Hydropower Development

MASTER'S THESIS: TGB4910

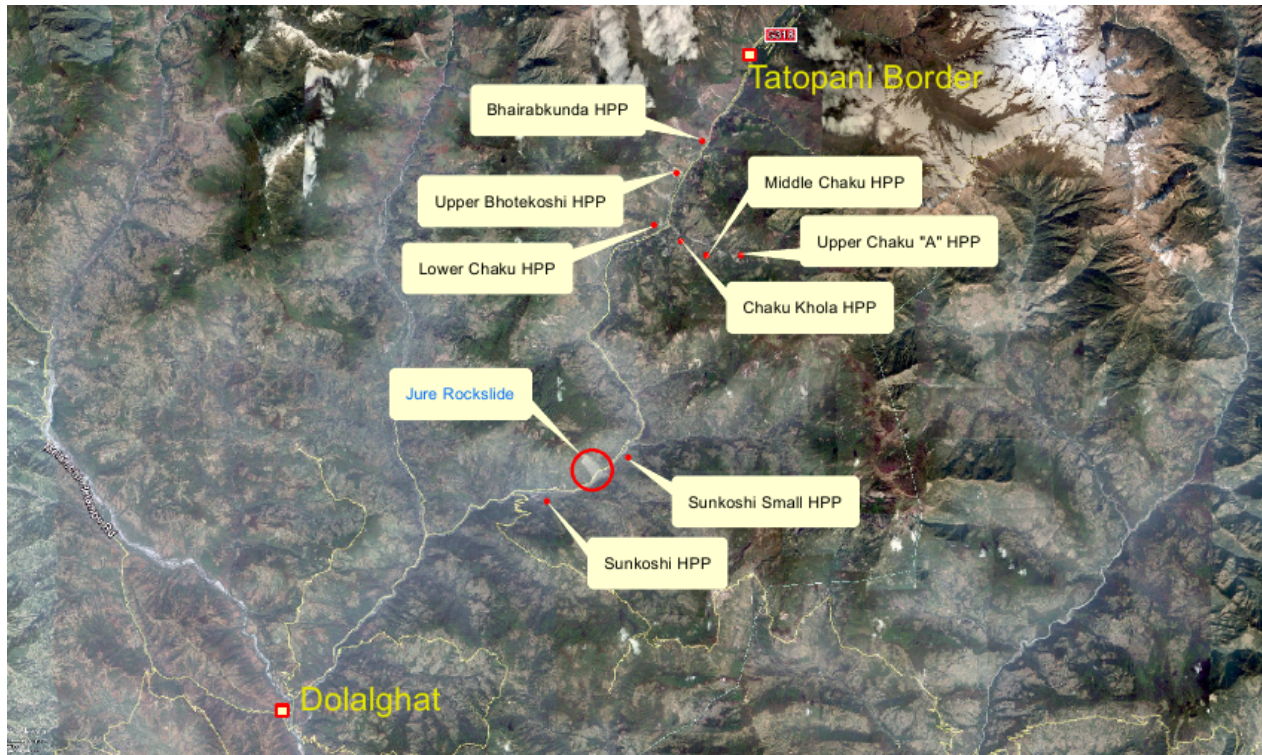
For this study, a rockslide site and eight different hydropower projects (HPPs) which are located in the Sunkoshi Valley are chosen as shown in figure 2.3. The Araniko highway follows the study area all the way from Dolalghat up to the Nepal-China border. All the hydropower projects are located in the main corridor except Upper Chaku "A", Middle Chaku and Chaku Khola, which lie in the Chaku river corridor.

Figure 2.3: Location of Jure rockslide and the hydropower projects in the Sunkoshi Valley.

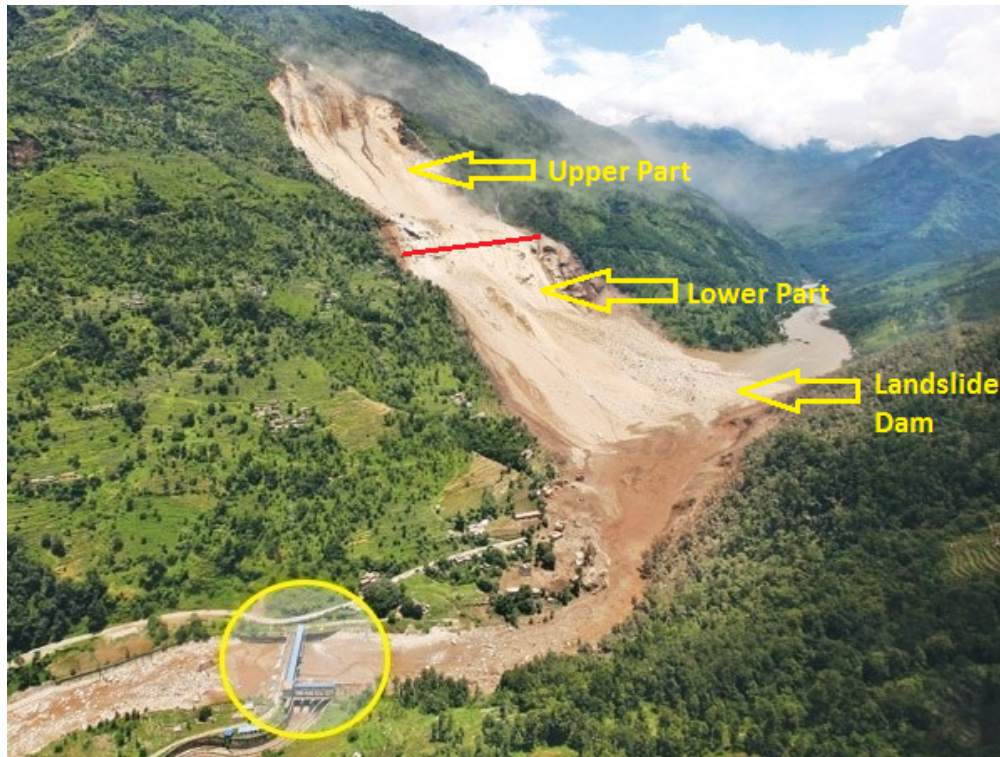
Figure 2.6: Jure landslide components with landslide dam. The red line is the resistant layer dividing the upper and the lower part. The intake of Sunkoshi Hydropower Project is shown in the yellow circle (Modified from KathmanduPost (2014))

The Jure rockslide dammed the river, creating a 2 km long lake as seen in figure 2.6. It took 45 days for the authorities and the army to drain the lake to prevent a potential dam failure and a disaster by flooding downstream side. Also, a temporary road was built very quickly in the opposite slope of the rockslide. After the dam was breached, the intake of Sunkoshi hydropower plant located about 1

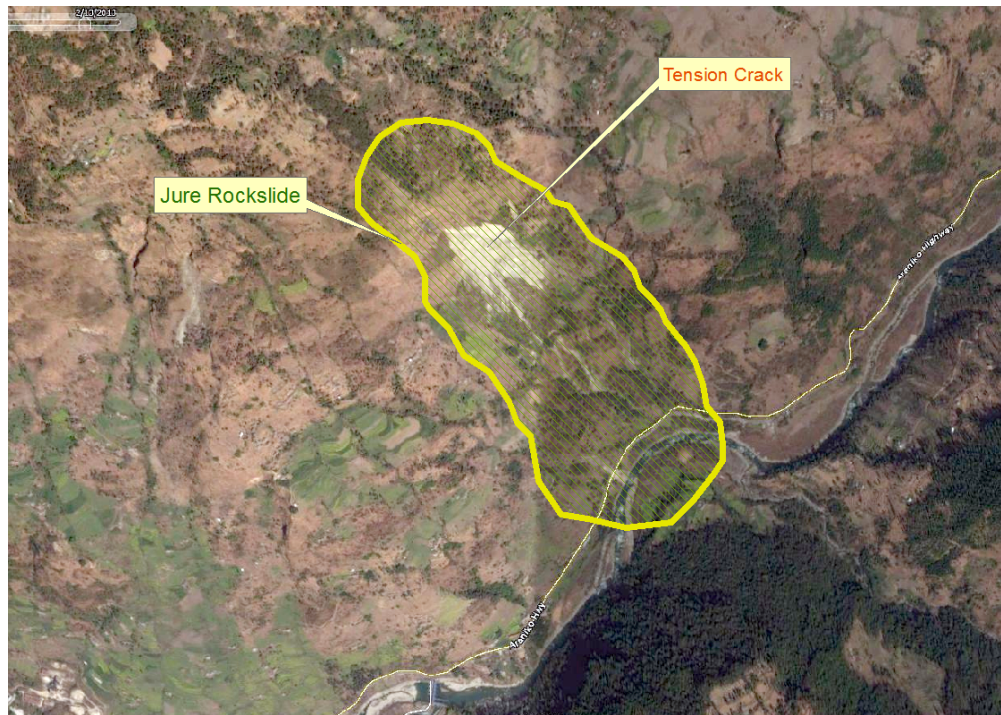
Figure 2.7: Tension cracks seen in Jure rockslide as of 13th of February 2013. Modified from [GoogleEarth \(2016\)](#) historical archives.

Before the disaster, some movements were seen in the slope face as early as 2012 as seen from GoogleEarth (2016) historical imagery archives as shown in figure 2.7. It shows the possible tension cracks and also outlines the final boundaries of the rockslide. The report published by MoI (2014) also confirms the presence of the tension cracks in the crown part of the rockslide during the field visits after the disaster.

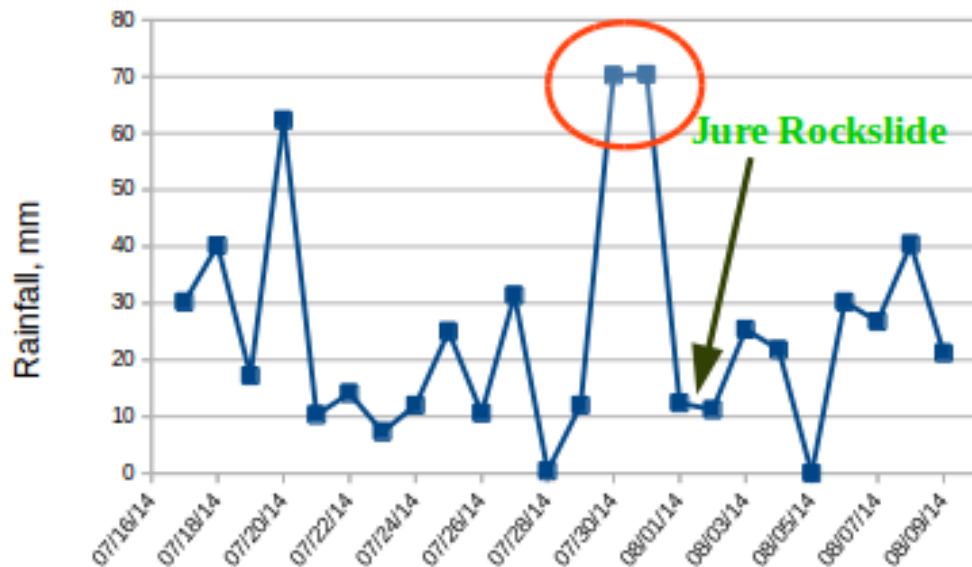
Figure 2.8: Rainfall data before and after the disaster recorded at Barhabise station. The highest rainfall records were observed just before the catastrophe. Modified from [MoI \(2014\)](#).

As observed in figure 2.8, two of the highest rainfall records of 70.2 mm and 70.4 mm have been registered on 30th and 31st of July while the actual disaster occurred on the early morning of 2nd of August. The heavy rainfall obviously increased the water table in the Jure slope which already had some movements earlier. The effect of the high groundwater is analysed using the limit equilibrium method in chapter 6 as well as in the numerical model of the rockslide in chapter 7.

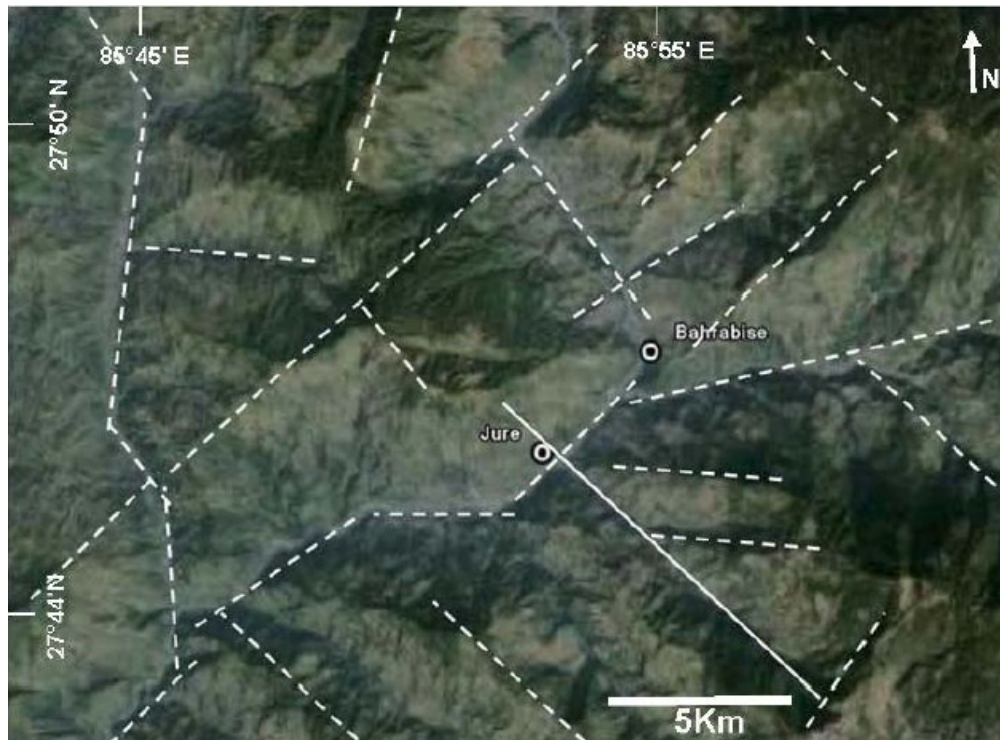
Figure 2.9: Major lineaments (dashed lines) near the rockslide area. The most prominent lineament in NW-SE direction is through the landslide zone (solid line) (Champati Ray and Chatteraj, 2014).

An NW-SE lineament (shown as a solid line in figure 2.9) passes through the landslide zone showing the overall weakness in the structure of the strata. The entire landslide mass can be divided into two distinct zones with one resistant layer in between (refer figure 2.6). On 2nd of August 2014, failure occurred on both portions; where rockslide was seen in the upper portion whereas rock and debris slide was observed in the lower part ([Champati Ray and Chatteraj, 2014](#)). In this study, only the upper portion has been analysed through kinematic, LEM and numerical modeling.

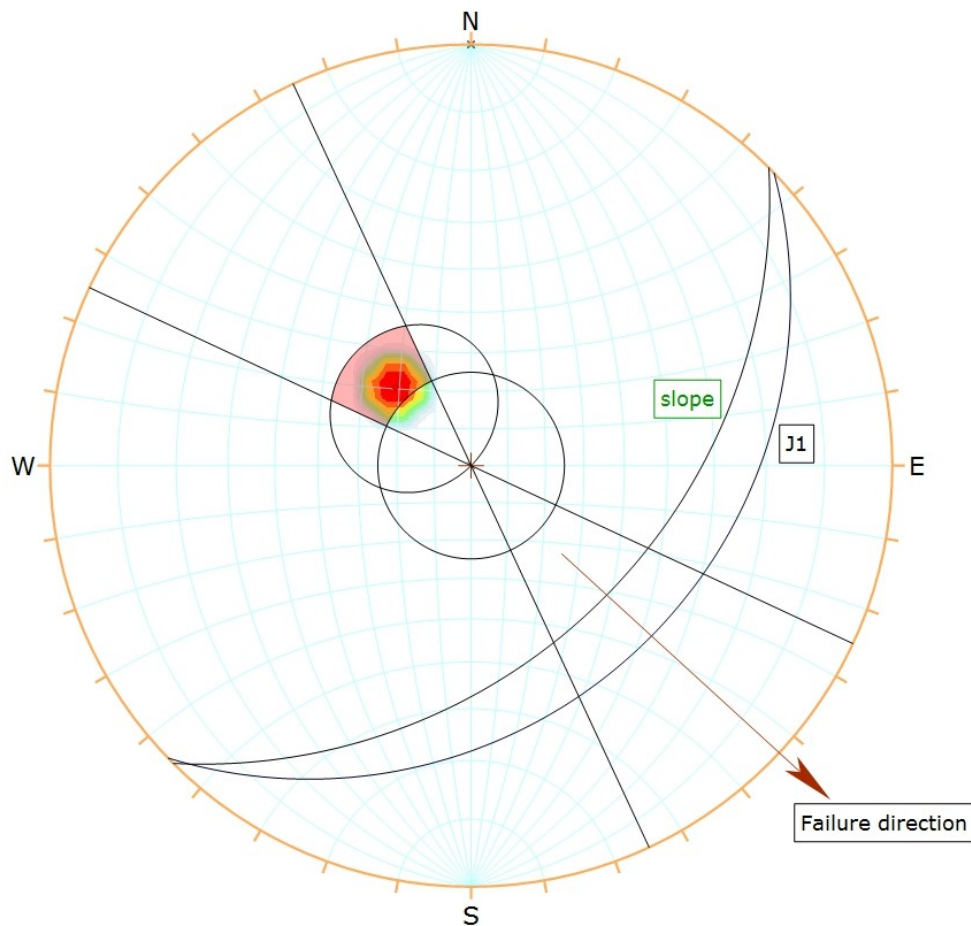
Figure 6.2: DIPS output: Plane failure (with 20° lateral limits)

pling) tends to happen when the dip direction of planes is within a certain angular range of the slope dip direction. Normally, a range of $\pm 20^\circ$ or 30° is considered, and poles outside of this range represent a low risk of plane failure (Hudson and Harrison, 2000).

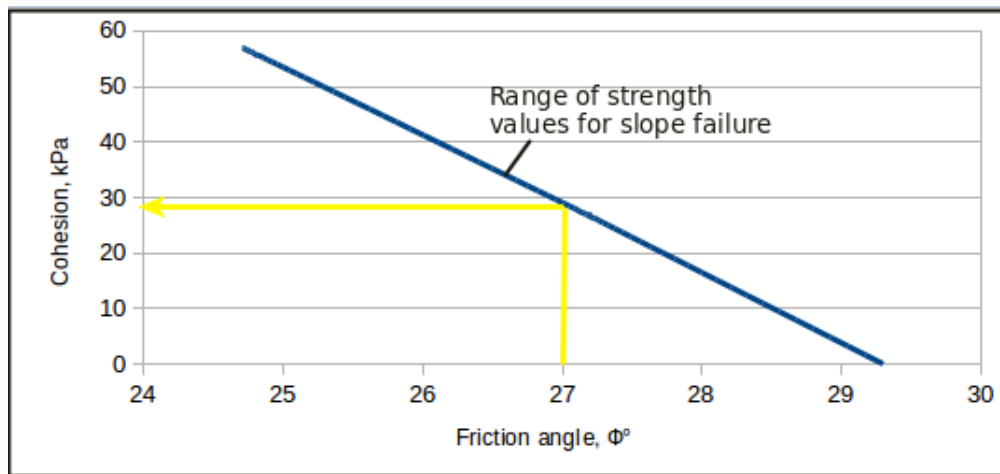
Figure 6.4: Mobilized shear strength for slope failure

In this case without water and seismic forces, ϕ_a is equal to the slope of potential failure plane (ψ_f) which can also be found out from equation 6.8 by assigning FOS as 1 and c as 0.

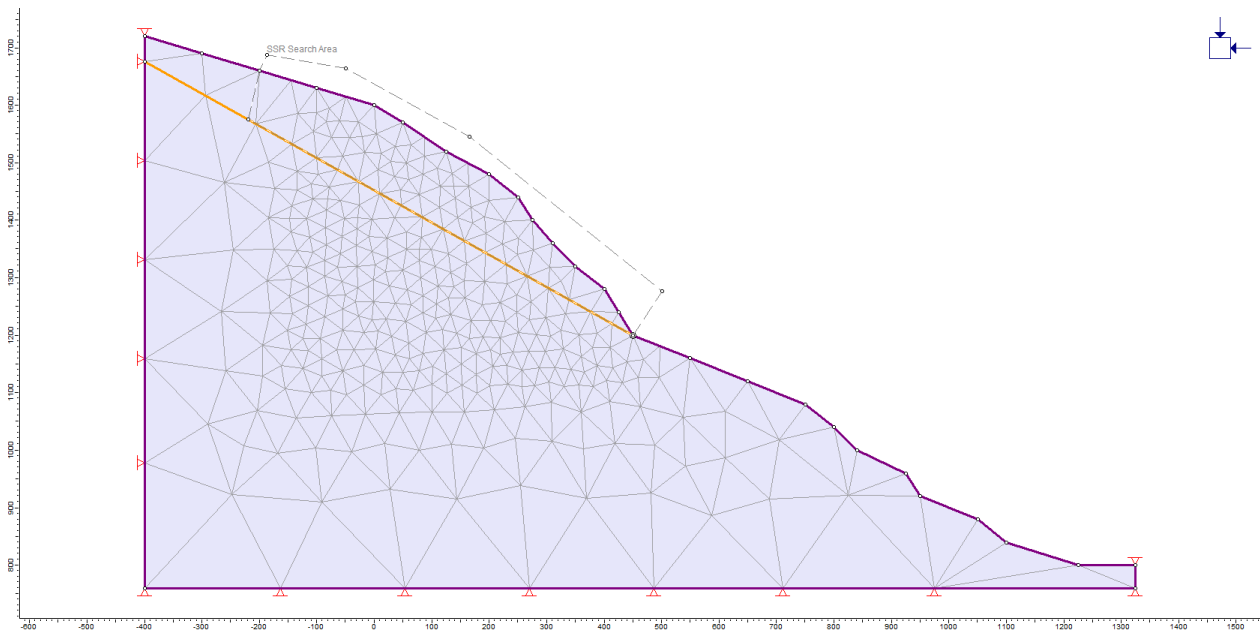
Figure 7.4: Final Phase² profile of Jure rockslide with SSR search area

Applying the above-mentioned settings, a final profile model was generated as shown in figure 7.4.

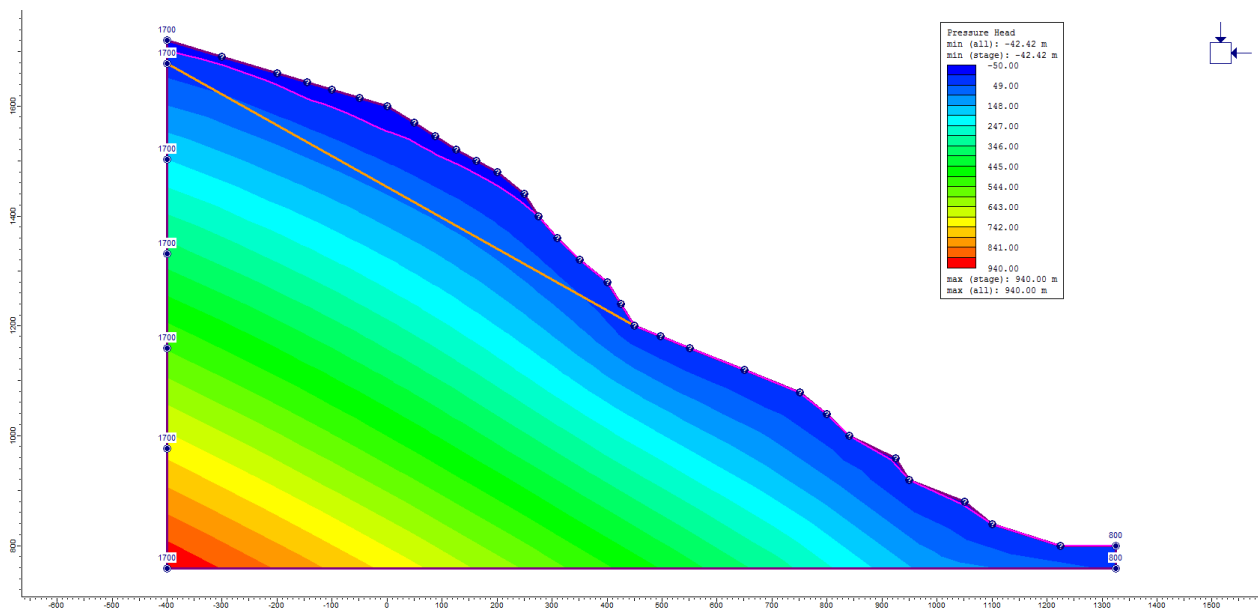
Figure 7.5: Result of finite element groundwater analysis used as an input for stress computations. The pink line shows the computed water table.

Boundary	Condition
Ground Surface	Unknown ($P=0, Q=0$)
Left Side	Fixed Total Head, $H= 1700$ m
Right Side	Fixed Total Head, $H= 800$ m

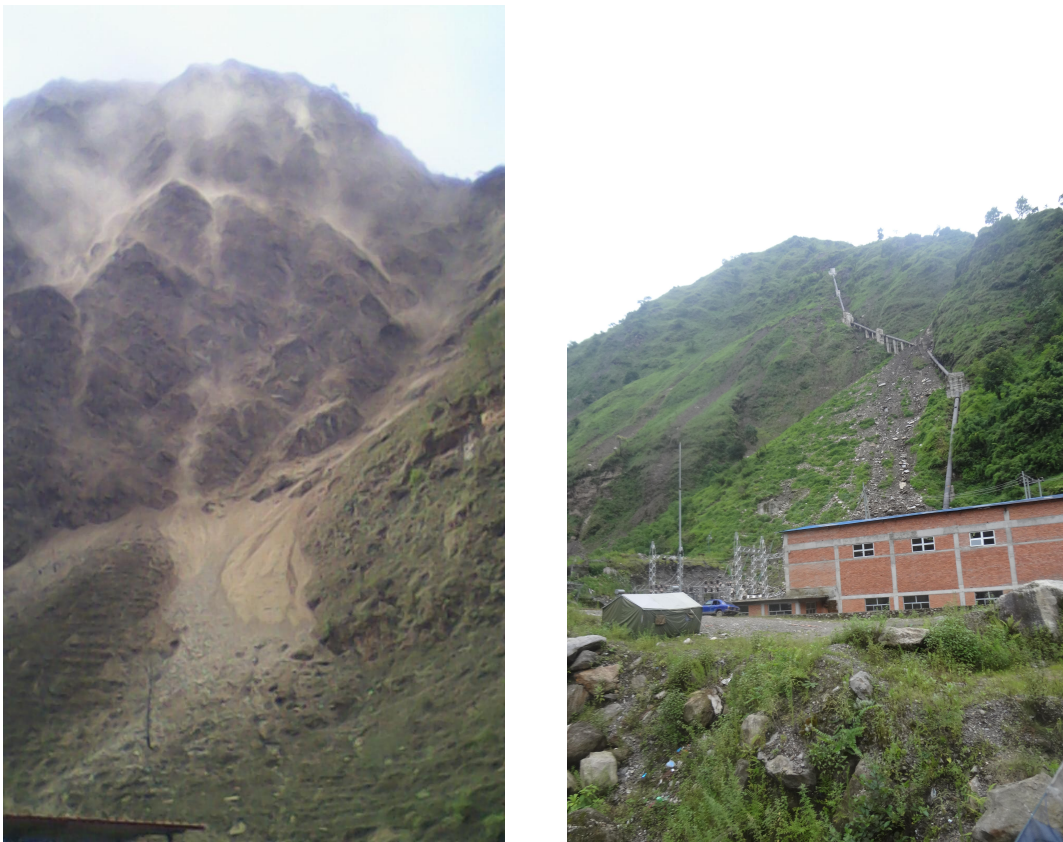
Figure 8.1: (LEFT) Debris fall in the intake area of Bhairabkunda HPP. (Photo Credit: Surya Thapa/Bhairabkunda HPP) (RIGHT) Penstock, powerhouse, and switchyard of Bhairabkunda HPP. The penstock and the switch yard were heavily damaged.

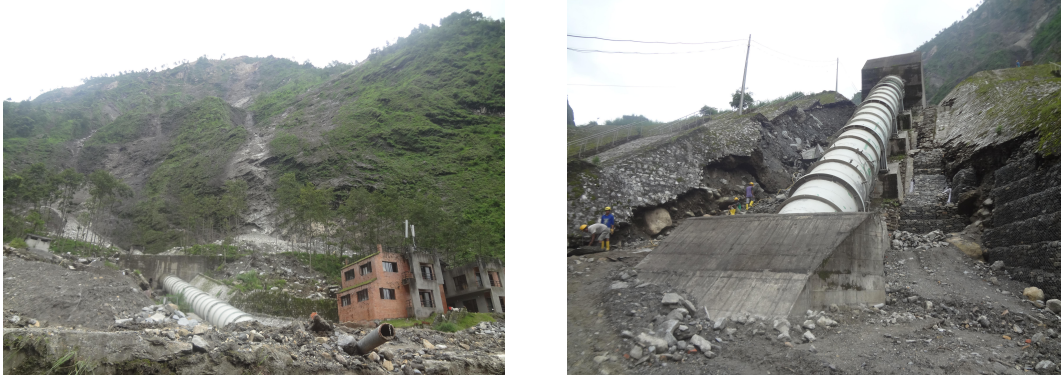
Figure 8.2: (LEFT) Penstock of Bhotekoshi HPP, which was burst due to the rockfalls from the cliffs in the background. (RIGHT) Scouring due to flooding after the penstock burst.

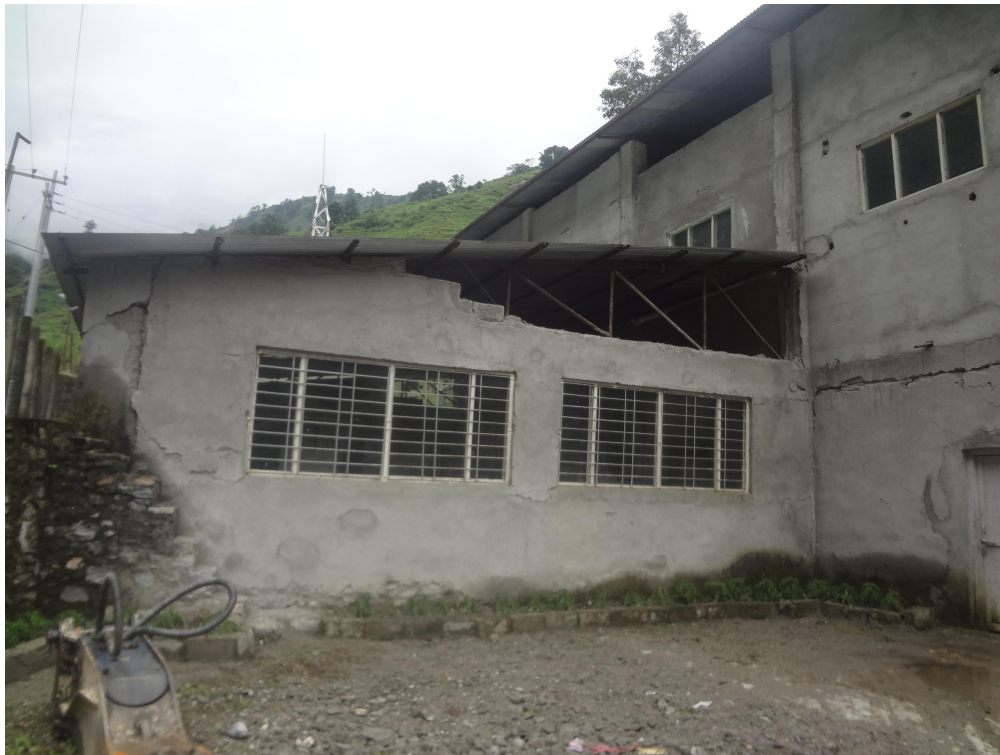
Figure 8.3: Cracks seen in the powerhouse of Middle Chaku HPP. The damages seen are mostly due to the shaking.

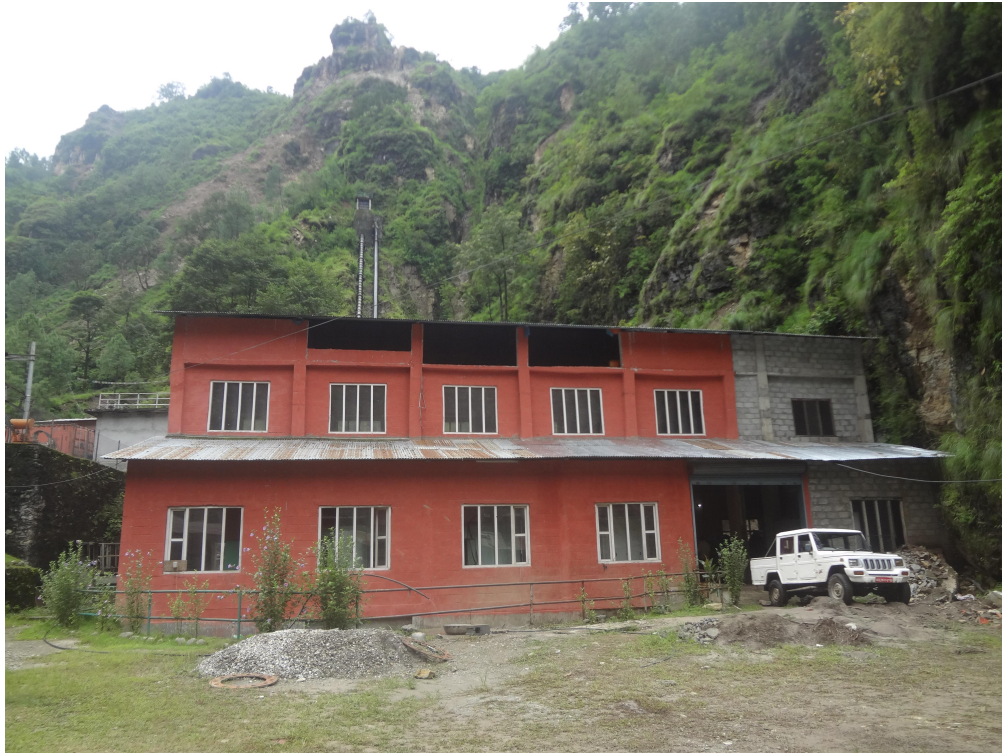
In Chaku Khola HPP, the penstock, powerhouse and staff quarters suffered minor damages due to the shaking as well as rockfall during the earthquake. The penstock was aligned along the surface of a cliff which suffered some dents from the rockfall. Some cracks were observed on the cliff on the right side as shown

in figure 8.4 which indicates that there is still a risk of shallow slope failures.

Figure 8.4: Powerhouse of Chaku Khola HPP with penstock in the background.

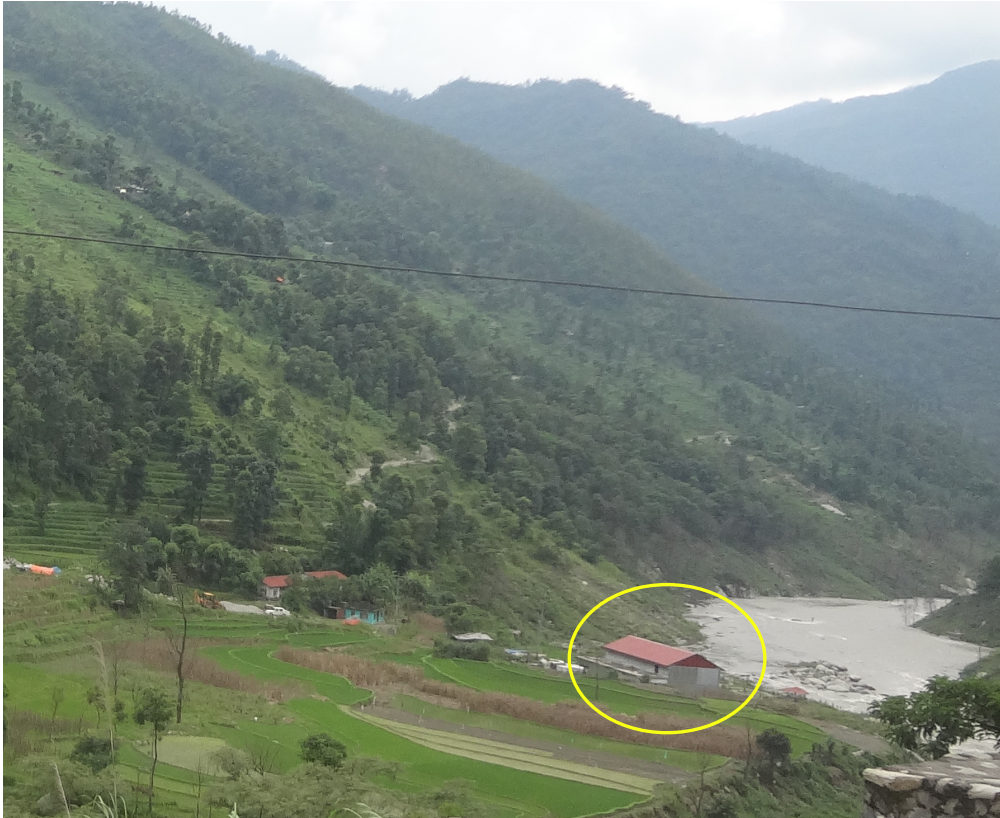
Figure 8.5: Powerhouse of Sunkoshi Small HPP (inside the yellow circle) located on the banks of the Sunkoshi River. It was completely submerged due to the formation of a dammed lake because of Jure rockslide.

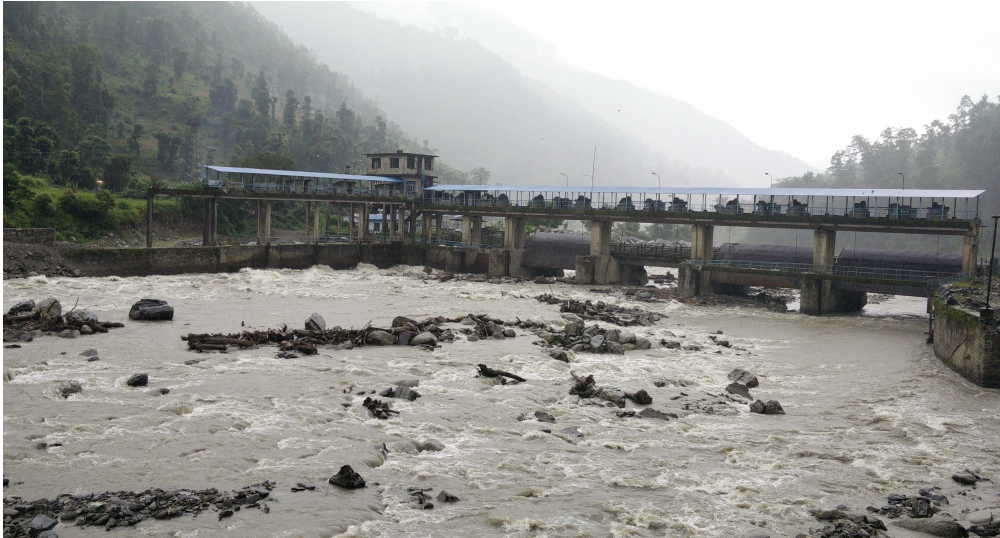
Figure 8.6: Intake of Sunkoshi HPP which bore the brunt of Jure rockslide as well as Gorkha Earthquake and the series of aftershocks.

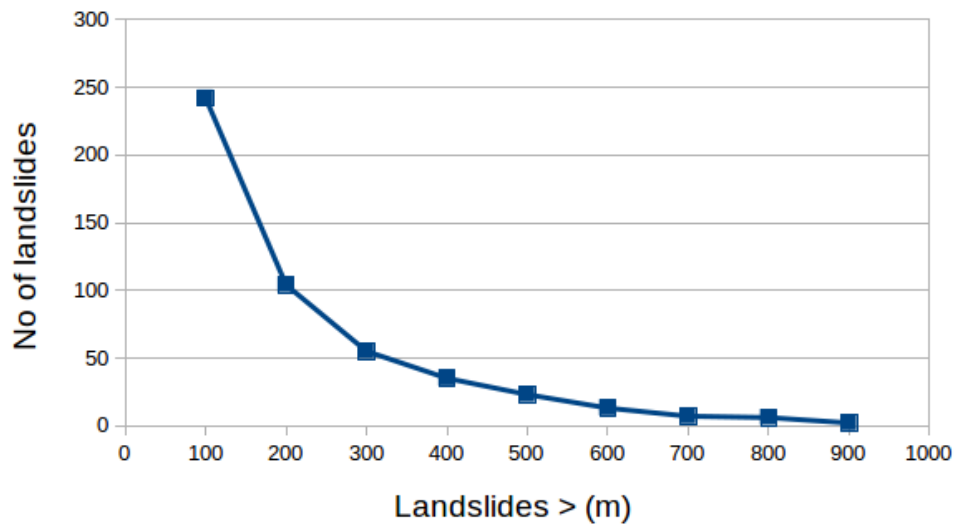
Figure 8.8: Distribution of >100 m landslides in the Sunkoshi Valley. Data modified from [DurhamUniversity \(2015\)](#).
