Corrosion of Thermal Sprayed Aluminium (TSA) in Marine Mud

Lars Krogstad Lien

Subsea Technology

Submission date: June 2013

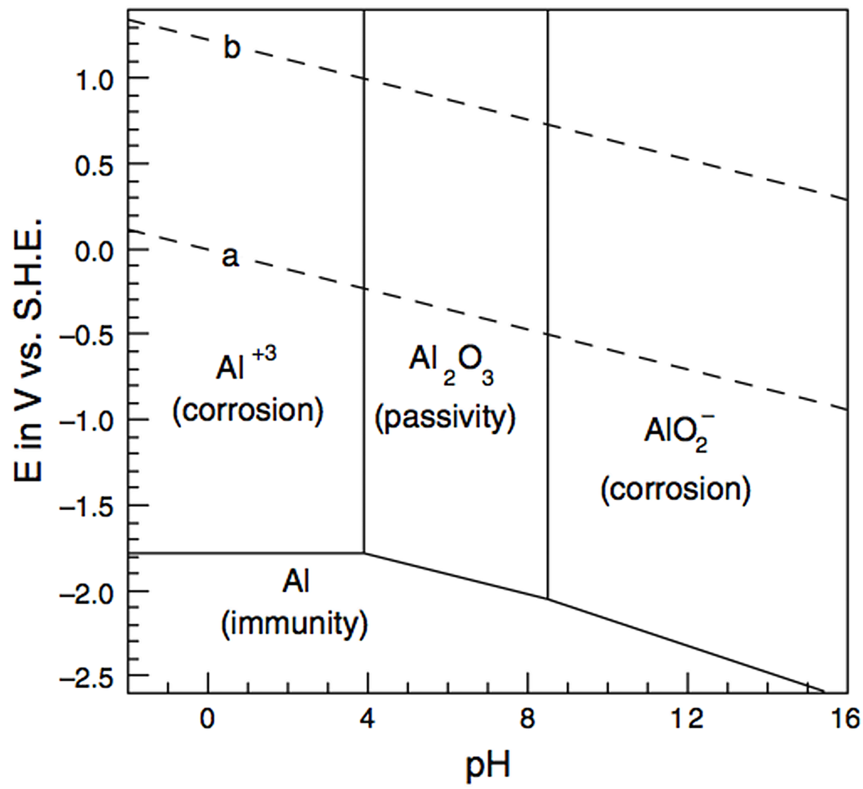
FIGURE 1 POURBAIX DIAGRAM FOR PURE ALUMINIUM AT 25°C [3]

Aluminium is passive in an environment with near neutral pH and has good anti-corrosion qualities. Yet as the pH changes the stability of the oxide changes. The oxide is thermodynamically unstable both in acidic and alkaline environments for all potentials higher than -1.7 V vs. SHE according to the Pourbaix diagram in Figure 1. The diagram is presenting the equilibrium potential between the metal and its different oxidized species plotted as a function of pH. The Pourbaix diagram is constructed by utilising the Nernst equation (1) where T is the absolute temperature, R the universal gas constant, F the Faraday constant and z the number of electrons in the reaction. The concentration of the products of all the species that appears on the reduced and oxidized side is notated as [reduced] and [oxidized] respectively.

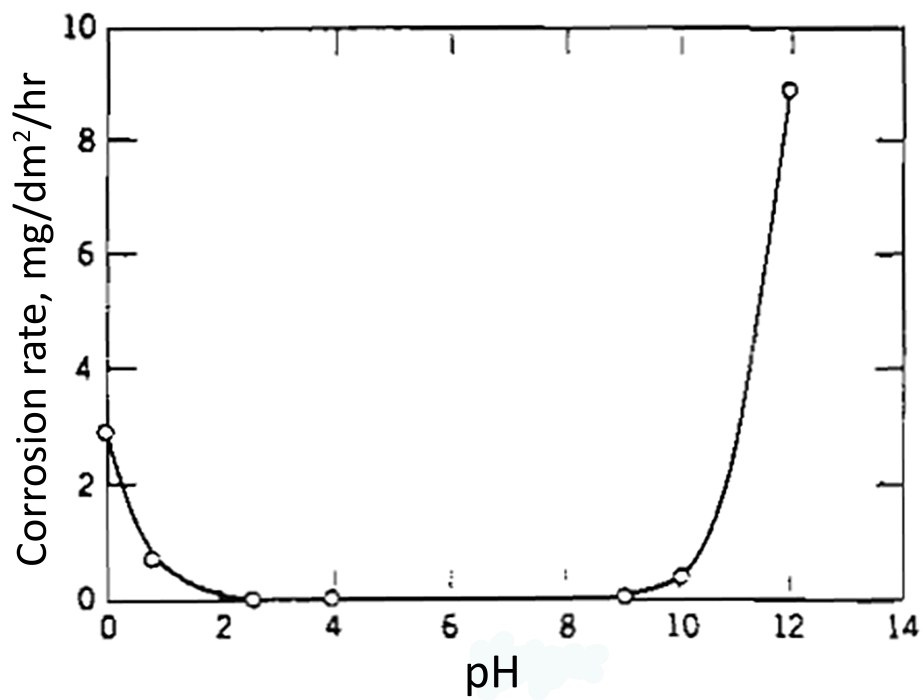
FIGURE 2 CORROSION RATE FOR ALUMINIUM AS A FUNCTION OF PH [4]

One of the most vital factors for corrosion of aluminium regarding the environment the aluminium is the pH. As the environment gets acidic or alkaline will the corrosion rate of aluminium increase, see Figure 2.

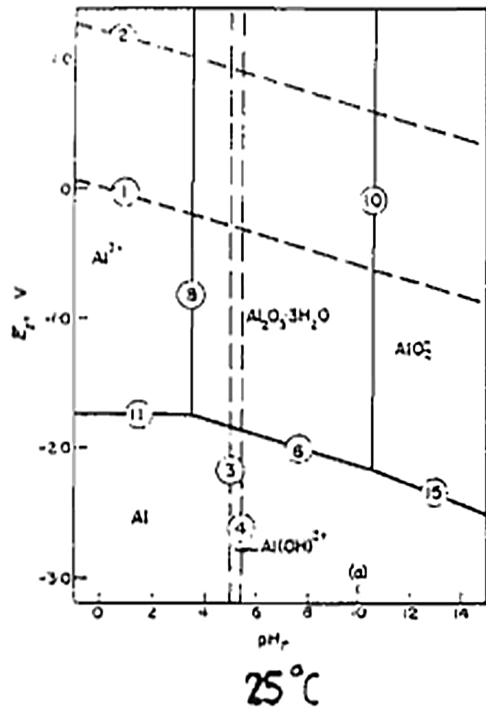
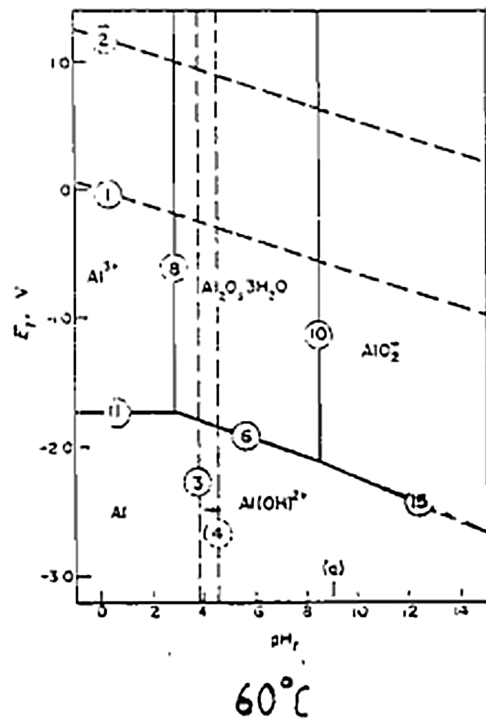
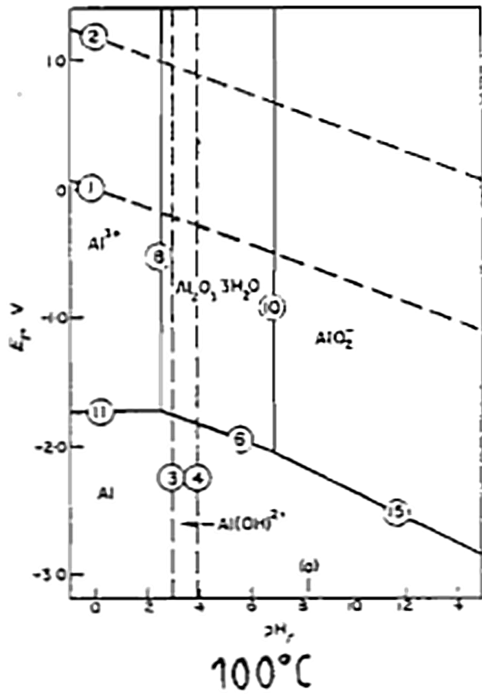
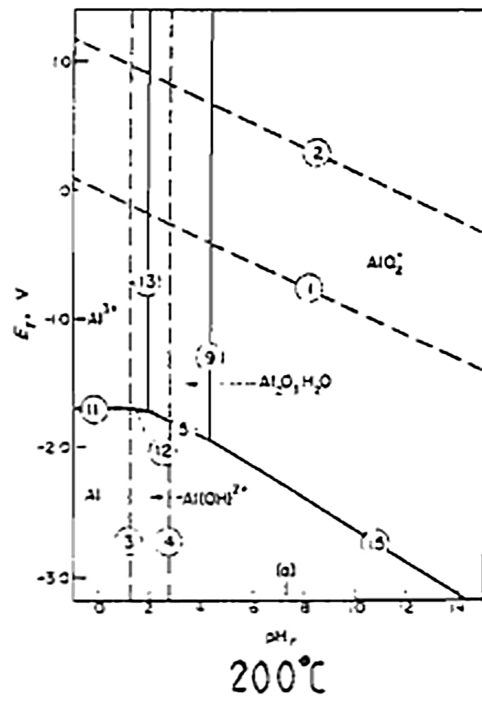
FIGURE 3 PORBAIX DIAGRAM FOR ALUMINIUM AT HIGH TEMPERATURES[7]

Compared with observations from experiments, the theory does not fit well to what is observed. At a temperature of 80°C there is observed an increase of the corrosion rate, but at higher pH values than 8.0 as the theory suggests. The increased corrosion rate is not mainly from the effect of a narrower pH range where the aluminium oxide is stable, but from the known fact that the corrosion reactions will speed up at higher temperatures. [5] Fischer et al. monitored the corrosion potential and current demand at different temperatures as a function of time in a study of flame sprayed aluminium coatings in seawater. [6] The results showed that there was an increased corrosion rate the first ten days in seawater with a temperature of 60°C compared to seawater with 20°C. Afterwards the current demand was about the same for 60°C and 20°C indicating that the corrosion rate nearly is the same for the two temperatures over a long time period.

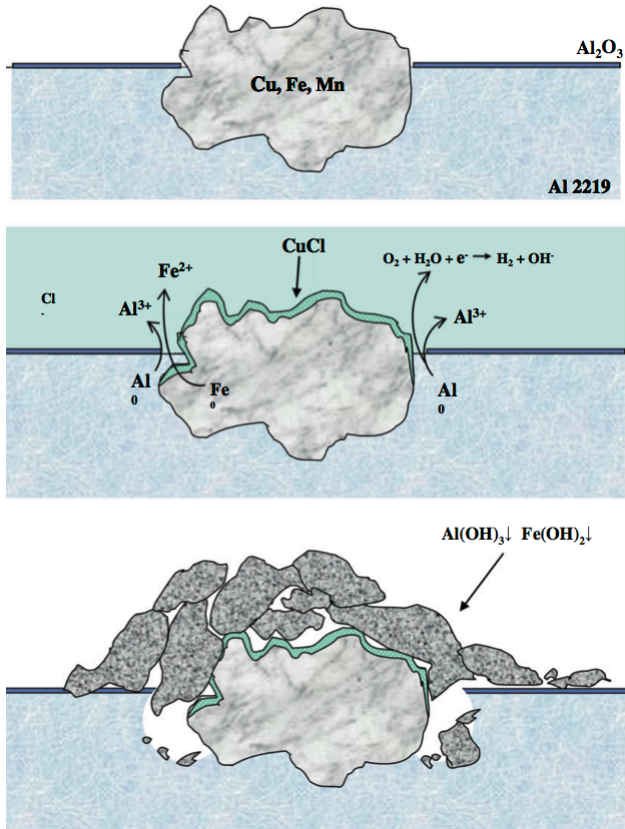
FIGURE 5 INTERMETALLIC CORROSION [14]

In the case of that the intermetallic particle unfastens from the aluminum matrix but remains on the surface without being in contact with the matrix. By been separated from the surface from a layer of corrosion products, which has been formed between the particle and the surface. Then the particle will be electrically isolated from the matrix by the corrosion products. The corrosion products will fill the crevice between the particle and the matrix, and lead to a repassivation of the aluminum surface.

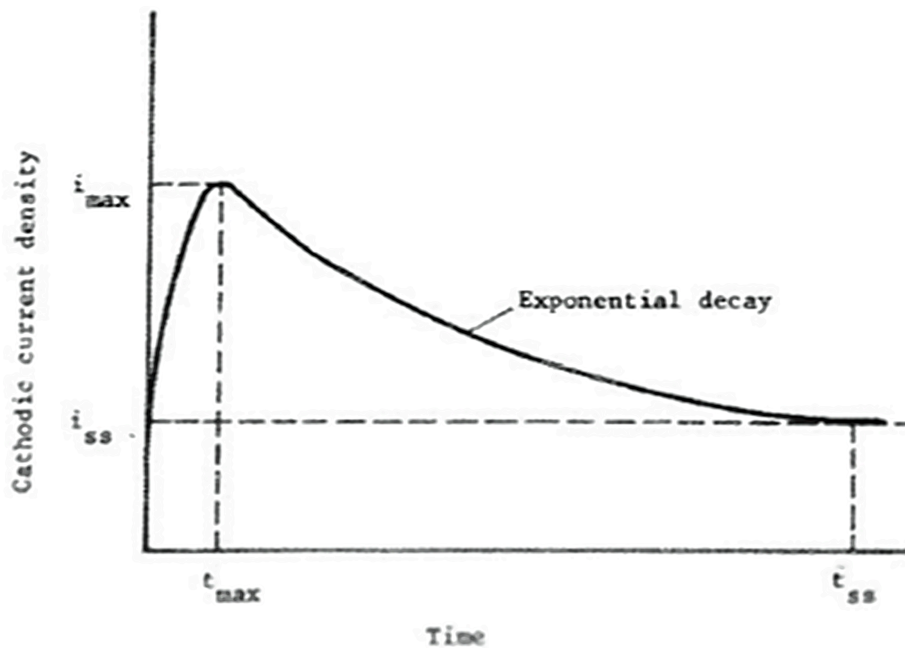
FIGURE 6 CURRENT -TIME CURVE FOR AN ALUMINUM ALLOY UNDER CATHODIC PROTECTION[15]

In combination with cathodic protection, the described mechanism of alkalization around the cathodic sites will occur with an even faster rate. The repassivation of the surface described above will lead to a quickly protection of the surface, because if the aluminum oxide that forms on the surface. Gundersen and Nisancioglu described this effect and the resulting current time curve in [15]. The corrosion and depassivation around the intermetallic particles will lead to an increase of the current density in the start of the exposure. After a certain period of time, will the current density reach a maximum value and from there decrease exponentially. The decrease is a result of the repassivation of the surface. This mechanism will lead to a current-time curve as shown in Figure 6.

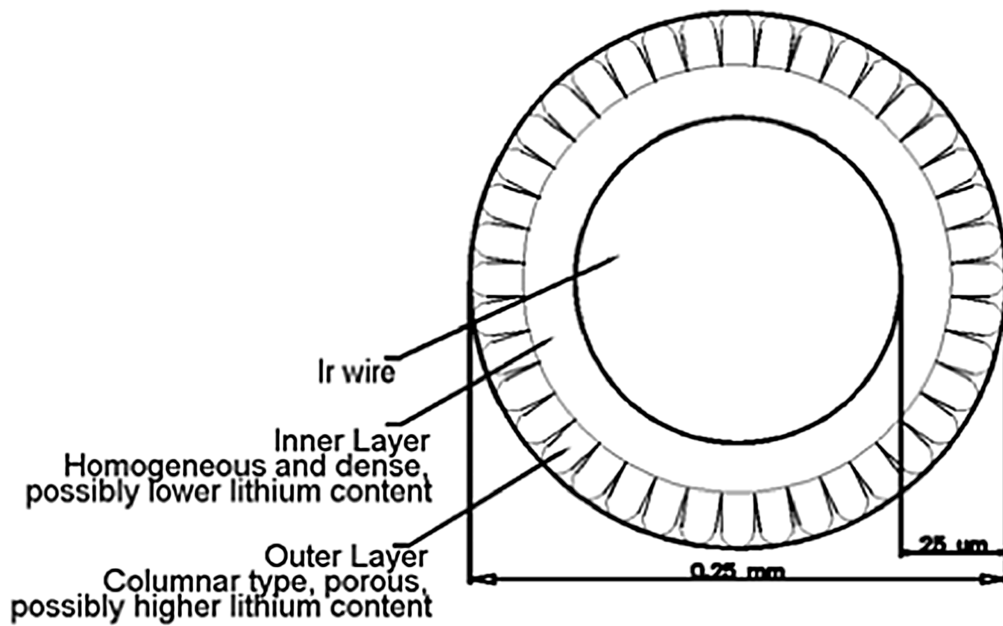
FIGURE 7 SCHEMATIC STRUCTURE OF THE IRODIUM OXIDE ELECTRODE[31]

The thickness of the iridium oxide is about $25\text{-}30 \mu\text{m}$ [29, 31] the oxide is growing outwards perpendicular to the surface of the iridium wire with a columnar structure. The grains are well defined and have a size from one to several microns. [29] Santi reported a two-layered structure with a dense inner layer and porous outer layers see Figure 7. [31]

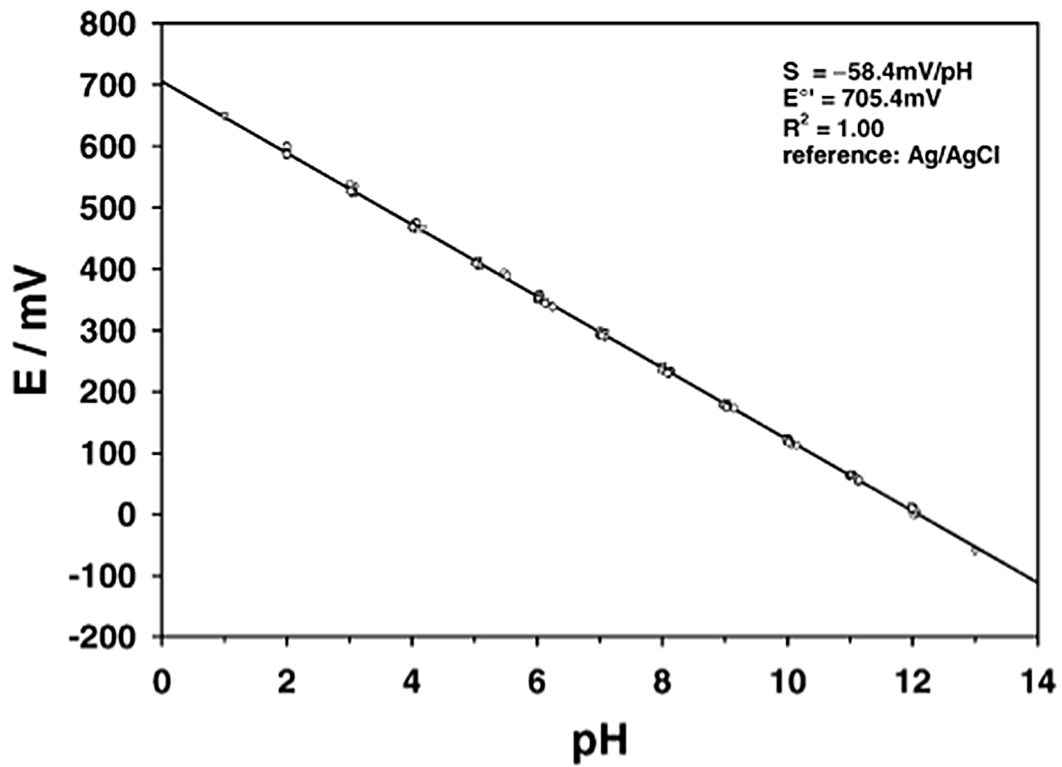
FIGURE 9 EXAMPLE ON CALIBRATION CURVE FOR IRIIDIUM OXIDE ELECTRODE [30]

Measuring the potential between a reference electrode and the iridium electrode in the electrolyte is the method for doing the pH measuring. Note that a measurement of the pH response of the electrode is needed in advance. The pH response is measured by measuring the potential between the iridium electrode and the reference electrode at different pH, in that way can a pH-response curve be obtained. Such curve can be seen in Figure 8. From such measurement can a calibration curve be made, an example is presented in Figure 9.

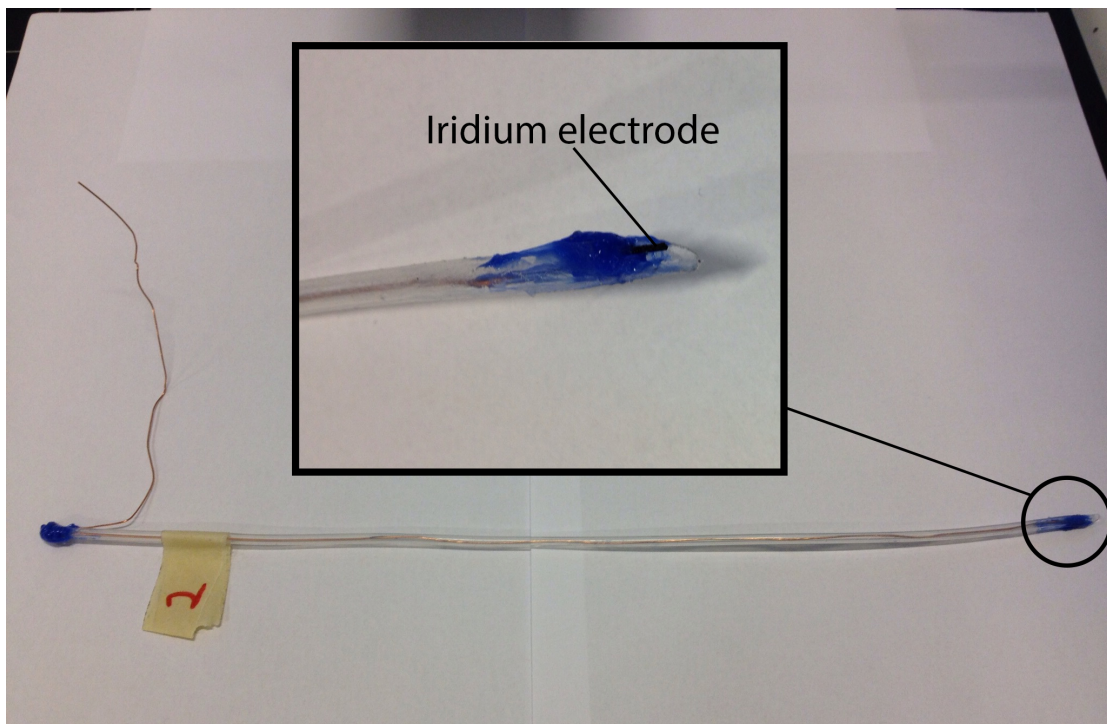
FIGURE 12 IRIDIUM ELECTRODES READY FOR USE

also as adhesive to mount the electrode in a plastic pipe, see Figure 12. A schematic drawing of the assembly is presented in Figure 13. The plastic pipe served as housing for the sensor, and provided some protection in addition to make it possible to stick the sensor through the mud down to the TSA surface.

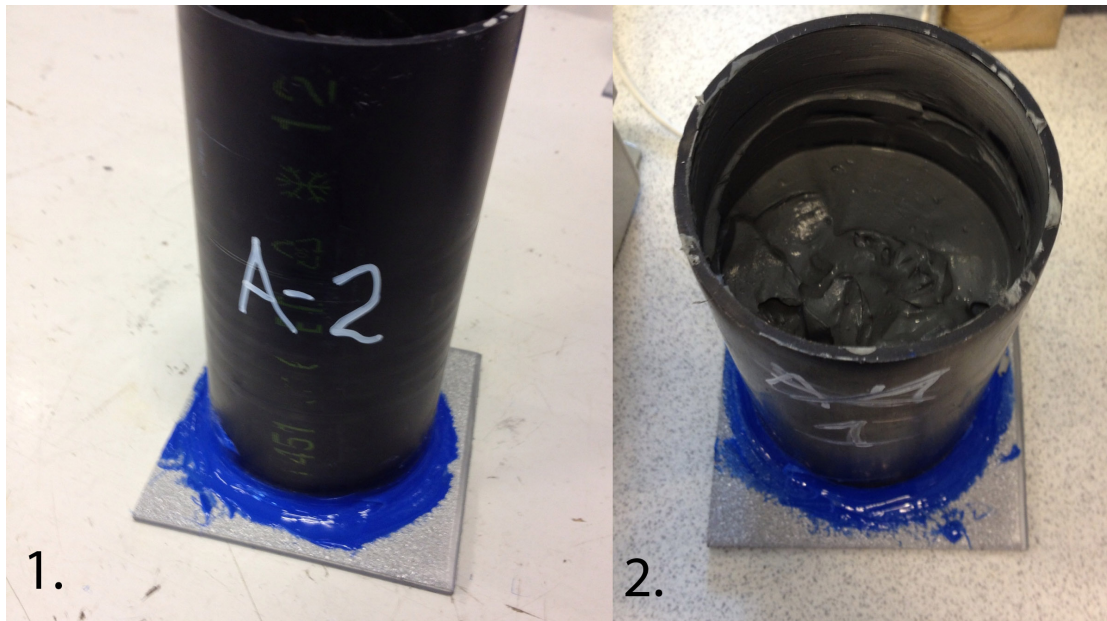
FIGURE 15 1. GLUING OF THE MUD CELL 2. MUD

In order to isolate a certain area of the TSA surface that should be exposed to the saline mud a plastic pipe was mounted on the surface. The inner diameter of pipe was 71 mm and height 150 mm. The pipe was glued to the TSA surface with blue silicone of the make Loctite 5926 see Figure 15.1. The cell was left to dry for 24 hours before anything more was done with the cell. When the silicone had dried the cell was filled with mud until the mud was about 10 cm deep. See Figure 15.2. Because of the consistency of the mud it was difficult to make sure that there was no air trapped inside or between the mud and the TSA surface. To be sure of that there was no air trapped the samples were placed in an autoclave and a small vacuum (0,2 bar) was applied for about three minutes. After this the rest of the plastic pipe was filled with synthetic seawater. The synthetic seawater hinders the mud to dry out. A lid was put on the cell to limit evaporation.

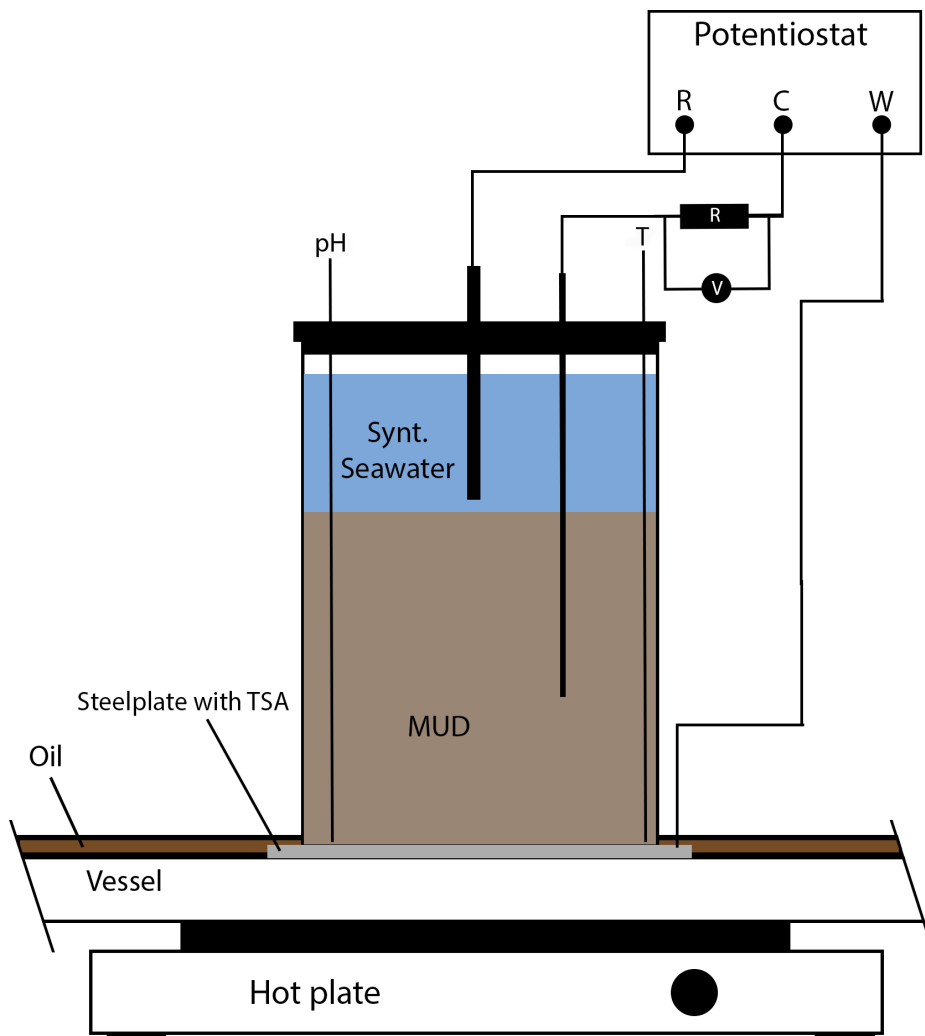
FIGURE 16 TEST SET-UP SCHEMATIC

The test period was 5 weeks. Tafel curves were obtained at termination of the experiment. After termination of the experiment was the mud cell detached from the steel plate and the TSA surface and the cross section of the samples was examined.

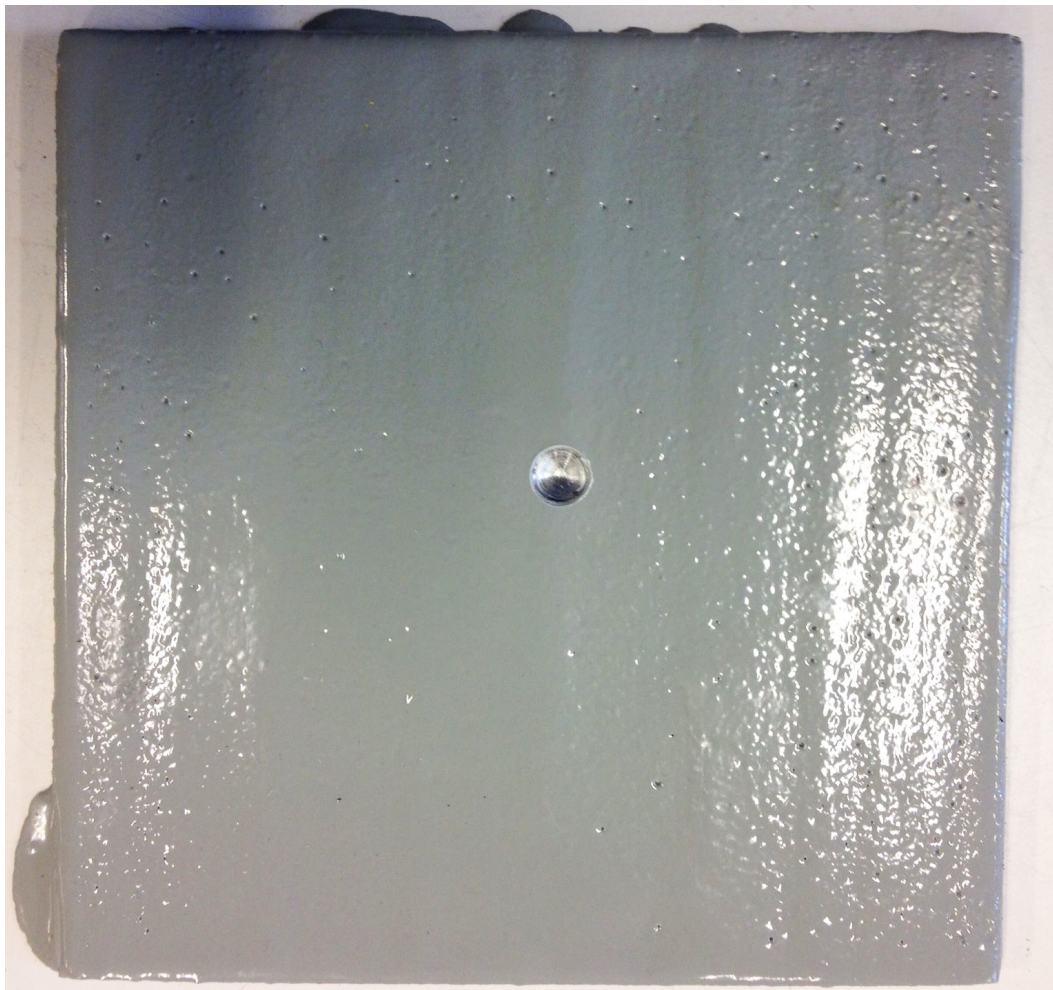
FIGURE 19 TSA WITH EPOXY COATING AND COATING AND MANUFACTURED COATING FAILURE.

In order to investigate and confirm the TSA duplex problem a sample was coated with an epoxy coating. Simply drilling a 6mm hole in the epoxy and TSA coating made a coating failure, such that bare steel was exposed see Figure 19. A plastic pipe was glued onto the sample with blue silicone (Loctite 5926) in order to make a cell. After 24 hours of drying was the cell was filled up with synthetic seawater.

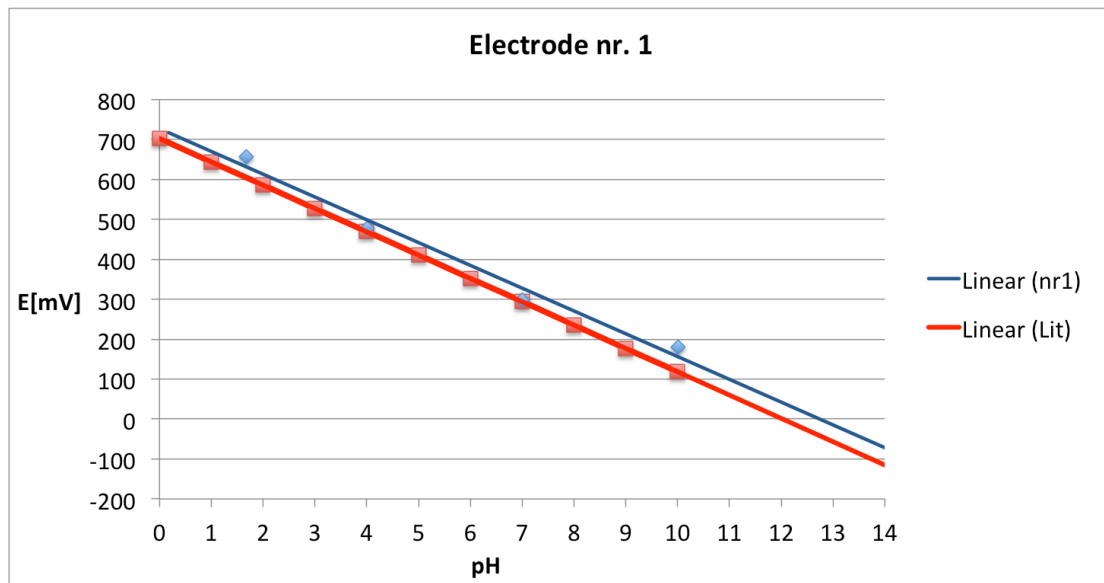
FIGURE 20 CALIBRATION CURVE ELECTRODE 1

Seven iridium oxide electrodes for pH measuring were made. The electrodes were organized with numbers, one to seven. In order to get as good measurements as possible the pH response of each electrode was mapped. The pH response was mapped by measuring the OCP of the electrodes in four different pH buffer solutions obtained from Radiometer Analytical. The pH value of the buffer solutions is presented in Table 5. The pH response curve, which was made by linear regression of the four measured point, was compared to the calibration curve found in the literature see Figure 9. The curve for electrode 1 is shown in Figure 20, the curves for rest of the electrodes are to be found in appendix A. The blue line in the charts represents the calibration curve for the pH sensors made in this project, the red line represents the calibration curve presented in the literature and is obtained from [32].

Electrode 1, 3, 4, 6 & 7 showed a pH response close to the calibration curve from the studies done by Wang et.al. Since only five electrodes were needed in the corrosion test those five electrodes was preferred for the corrosion test.

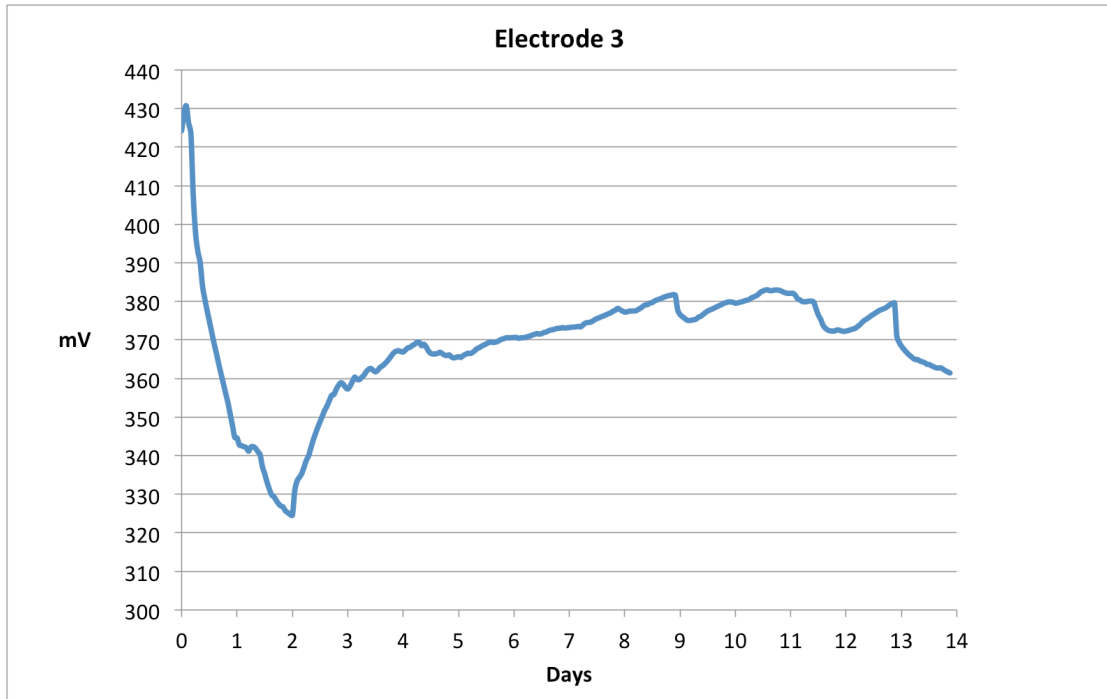
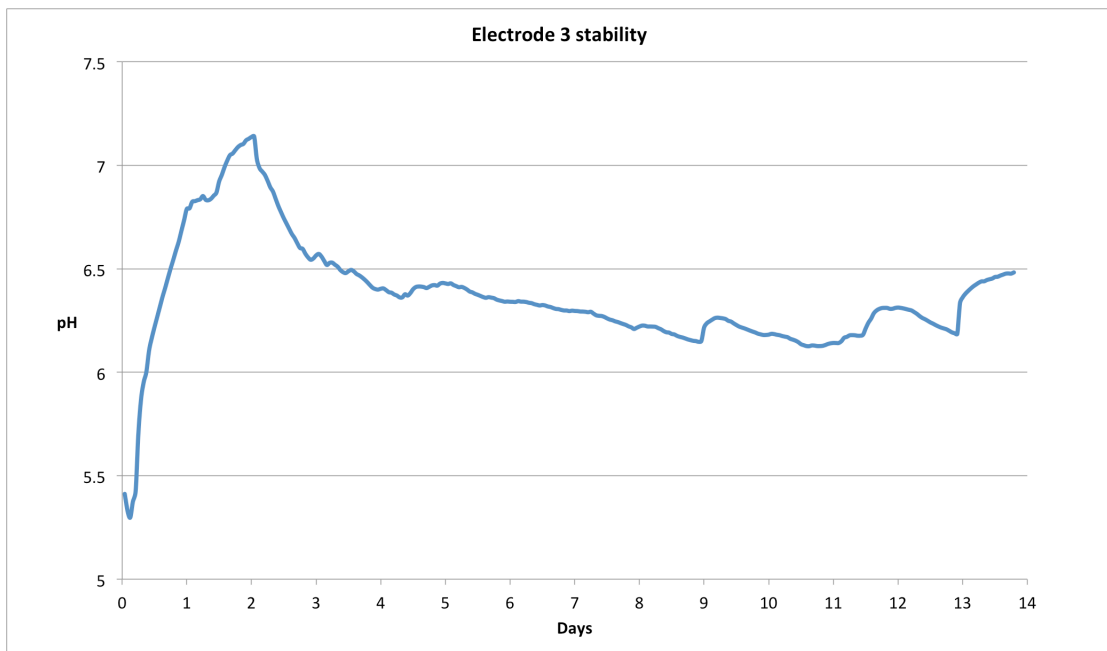
FIGURE 22 STABILITY OF IRIIDIUM ELECTRODE IN 7.000 PH BUFFER SOLUTION

A stability test was carried out to document the stability of the fabricated electrodes. Electrode number 3 was used for measuring the OCP between an iridium oxide electrode and an Ag/AgCl reference electrode in a buffer solution of pH 7,000 (obtained from Radiometer Analytical) over two weeks. The result is presented in Figure 21 with respect to the potential and in Figure 22 with respect to the pH.

The result showed a significant drift, in the order of about 2 pH values the first 3 days, and about 0.5 pH values the rest of the period.

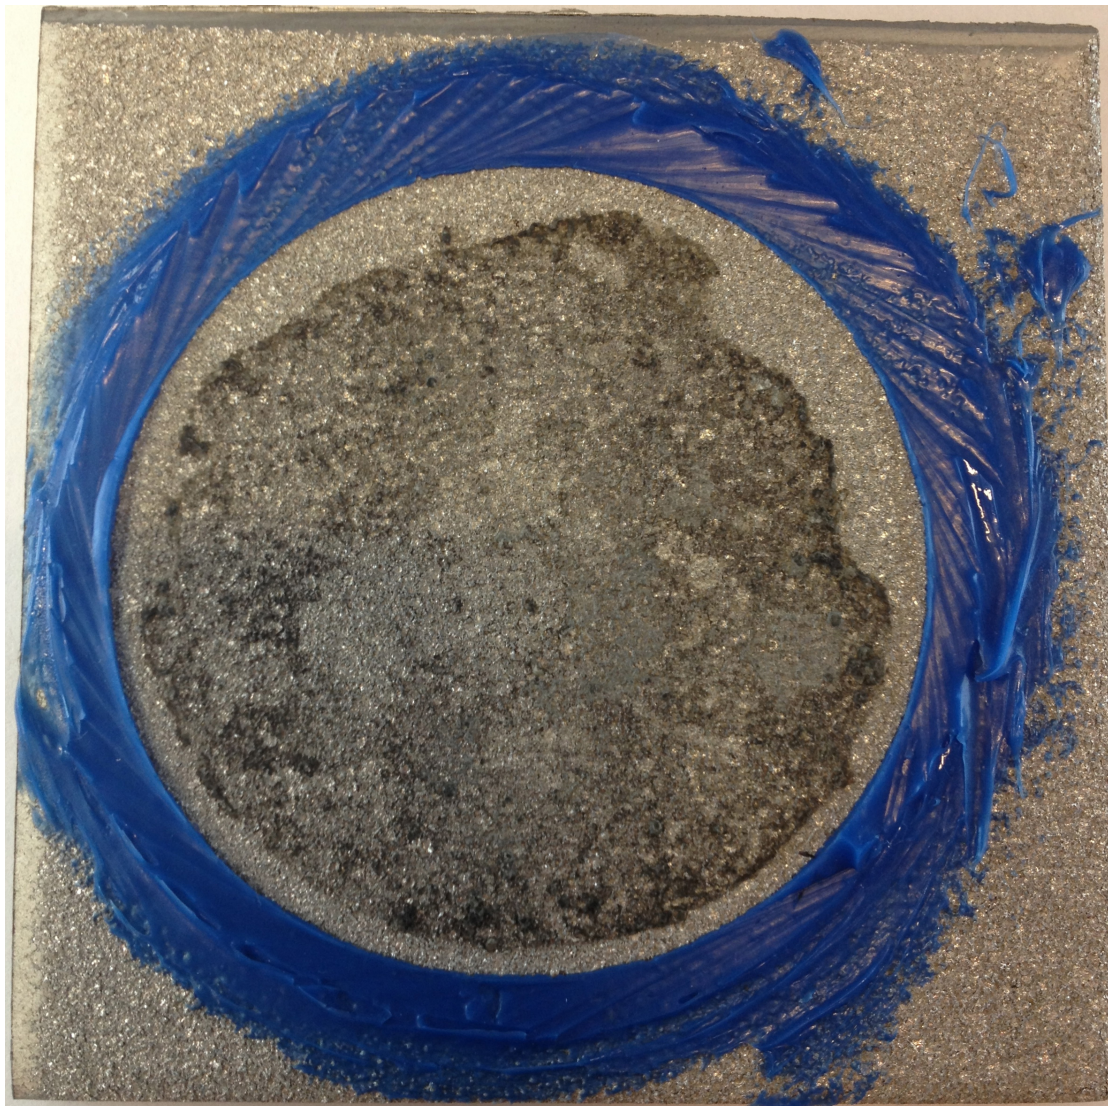
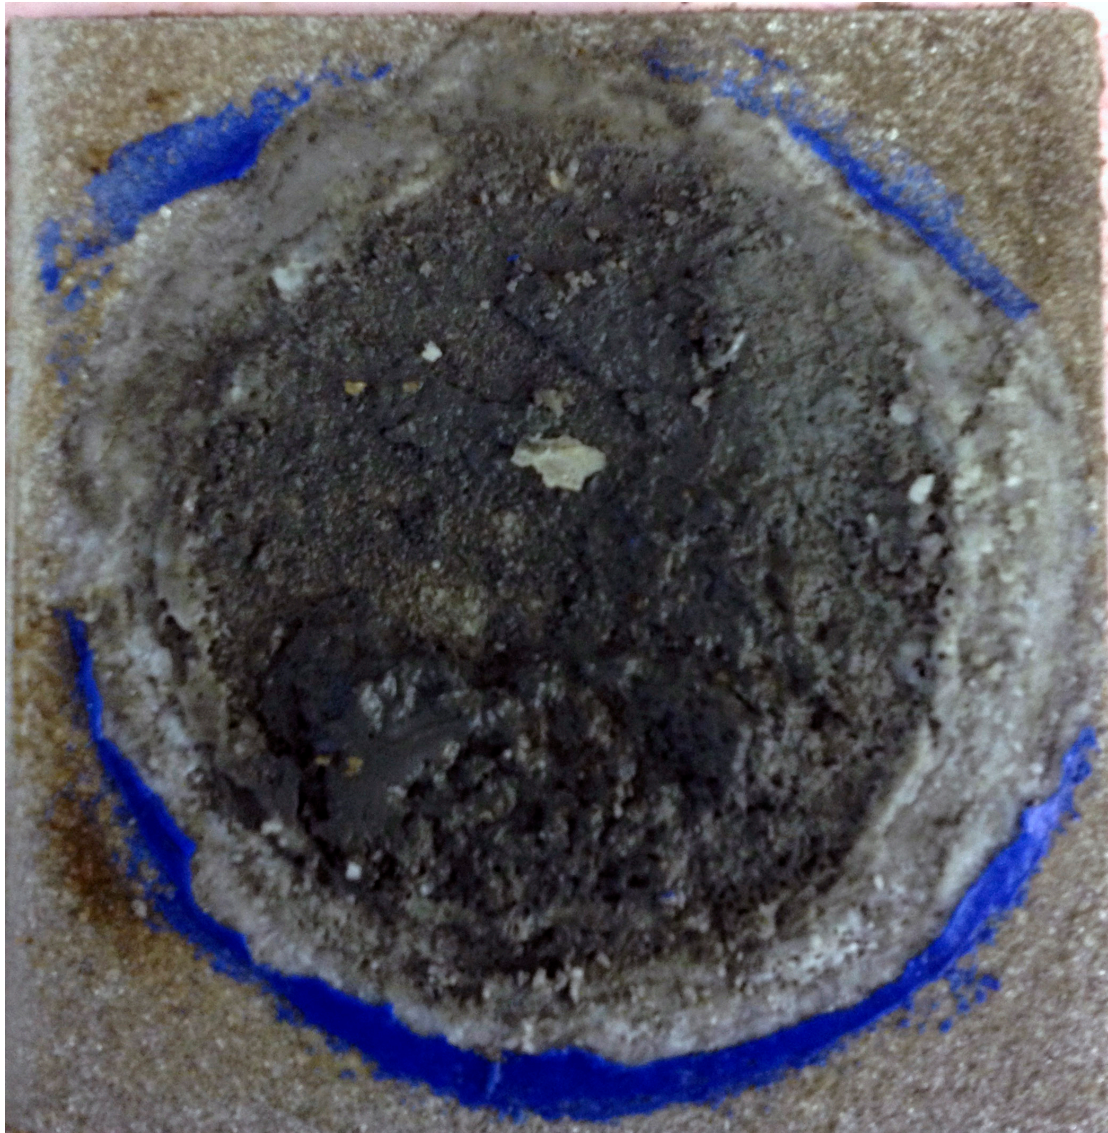
Neither of the samples showed any signs of coating degradation, except for sample 3. Sample 1 and 3 is shown in Figure 23 and Figure 24 respectively, pictures of the other samples can be found in appendix B. The dark and gray spots on the surface are mud remnants. The mud had attached itself very hard to the TSA and was nearly integrated to the TSA surface. It was impossible to remove all of the mud by brushing.

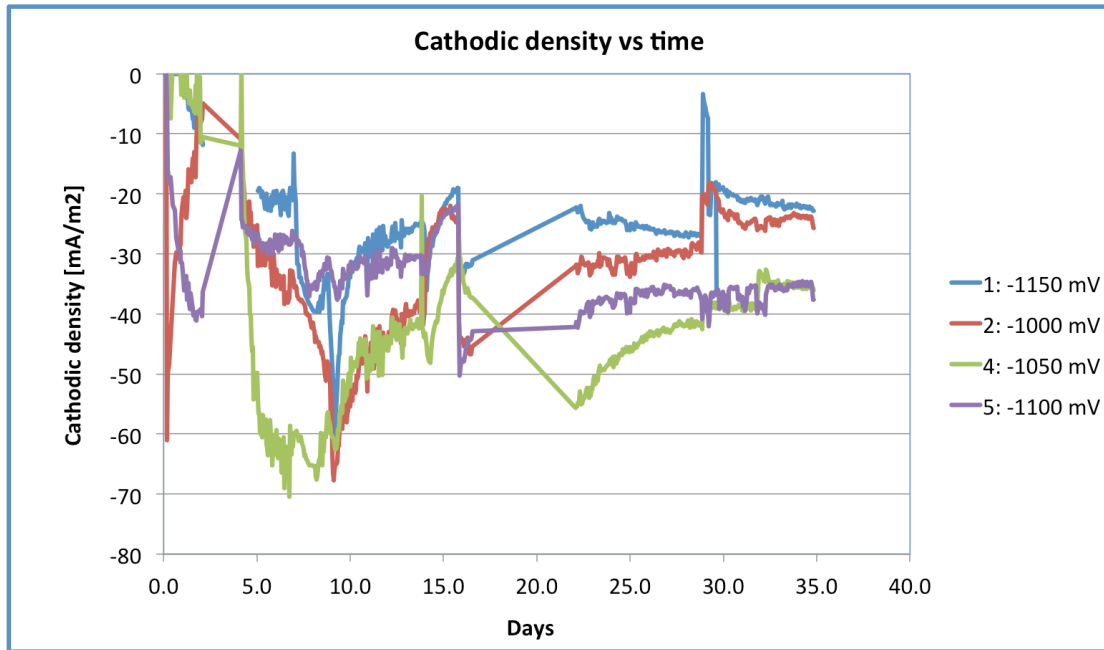
FIGURE 25 CATHODIC DENSITY VS TIME

The potentiostatic polarization curves displays the current density needed to hold the potential of the samples at the given potentials. The cathodic current densities for sample 1,2 4, and 5 are presented in Figure 25. The anodic current density for sample 3 is shown in Figure 26. The individual charts for each sample can be found in Appendix C. The potential and the temperature logging curves are also to be found in the appendix, respectively in Appendix E and Appendix F. The temperature and potential was stable through the whole test period.

The figure shows an initial increase in the current density the first ten days, and stabilization occurs after about 20 days of exposure.

Note that the logging equipment stopped between day 2 and 4, and stop breakdown between day 16 and 22 of the test period. The current density values in those periods are therefore not obtained. In the graphs are these periods shown as straight lines. However, the polarization was stable these periods as well.

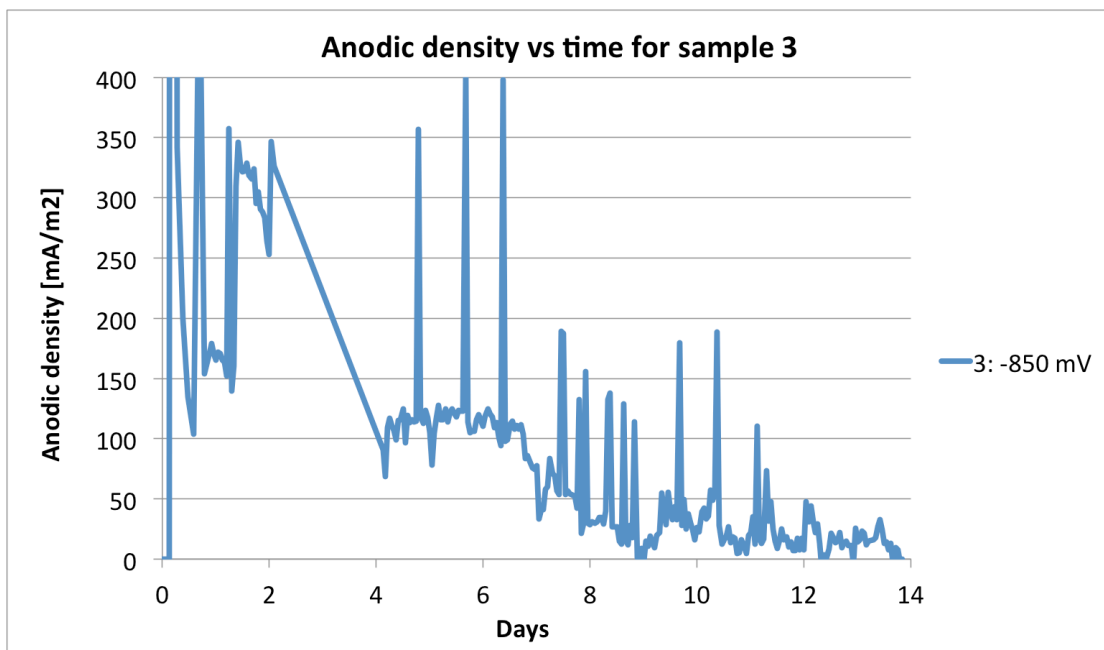
FIGURE 26 ANODIC DENSITY VS TIME

Sample 3 was the only sample that was polarized anodic, as can be seen from the chart is the initial current large with a decreasing trend.

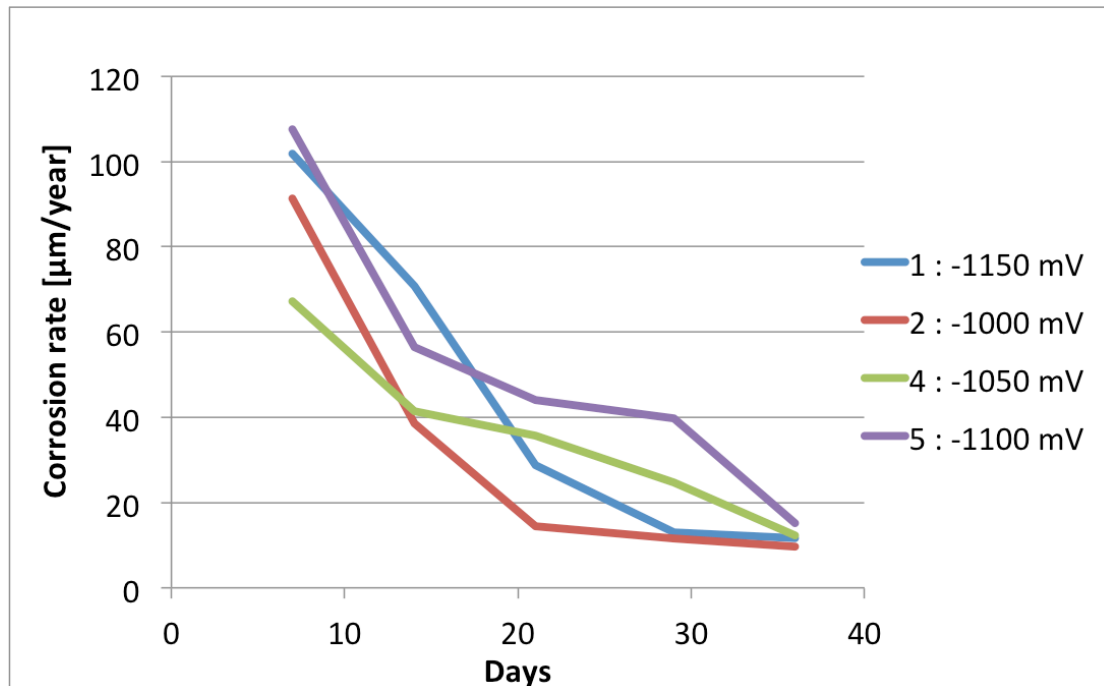
FIGURE 27 LPR MEASUREMENTS

The corrosion rate was logged during the test period by doing linear polarization resistance (LPR) measurements. Measurements were done weekly. The result is presented in Figure 27.

The corrosion rate showed a similar trend as for the current densities, as described by Gundersen and Nisancioglu.[15] The corrosion rate is initially very high, but decreased throughout the experiment. A tendency to stabilization can be seen after 20 days. The exact corrosion rates are presented in Table 12. For calculation of the corrosion rate individual Tafel constants for each sample were used. The Tafel constants were calculated from cathodic and anodic polarization curves obtained at the end of the tests, shown in the next section.

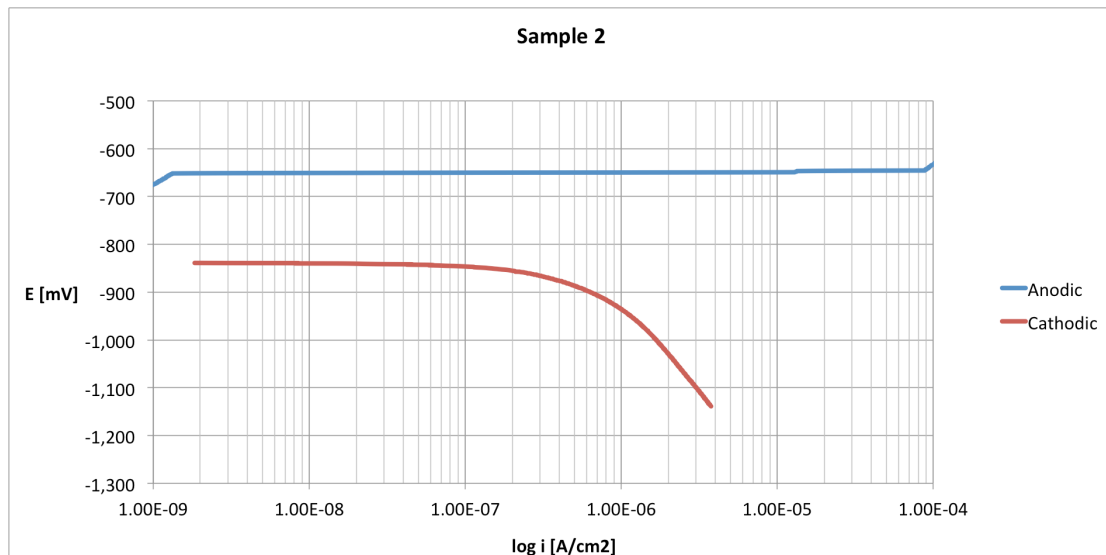
FIGURE 29 TAFEL CURVE FOR SAMPLE 2

As can be seen the anodic curve for sample 2 is useless for doing corrosion rate measurements, hence the corrosion rate estimated with tafel extrapolation for sample 2 is only based on the cathodic curve. The reason for this shape of the anodic curve is probably the sealer. The sealer has probably limited the current demand for some time, before it suddenly broke down resulting in a straight line

on the Tafel curve. A chart where the whole anodic curve can be seen is to be found in appendix K.

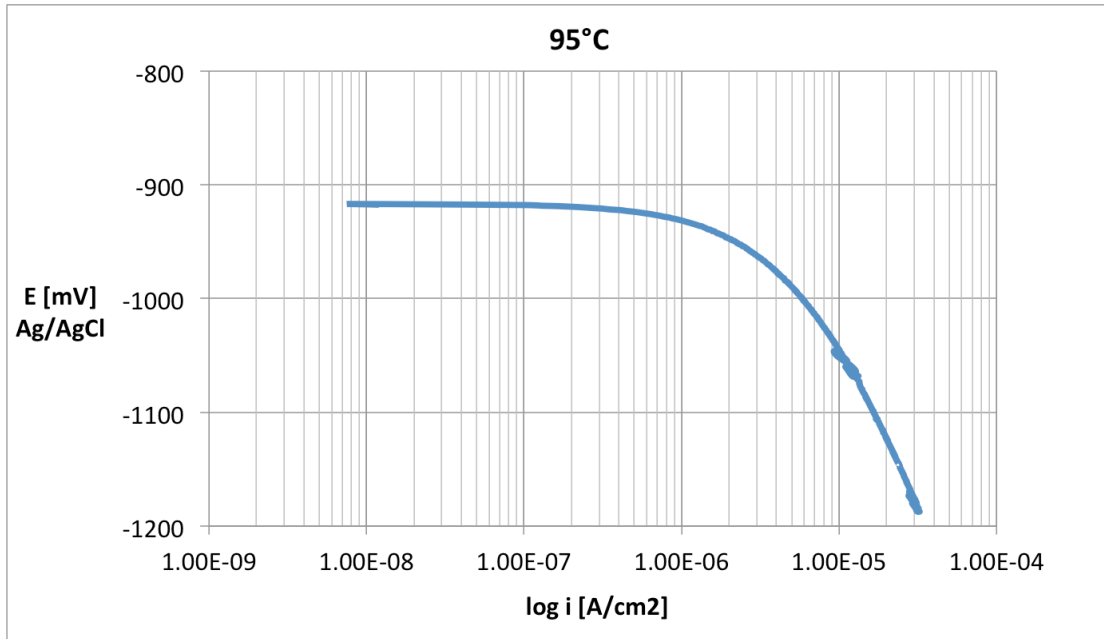
FIGURE 34 CATHODIC TAFEL CURVE AT 95°C

Surprisingly did the sample exposed at 95°C shows lowest current demand at -300 mV vs. OCP.

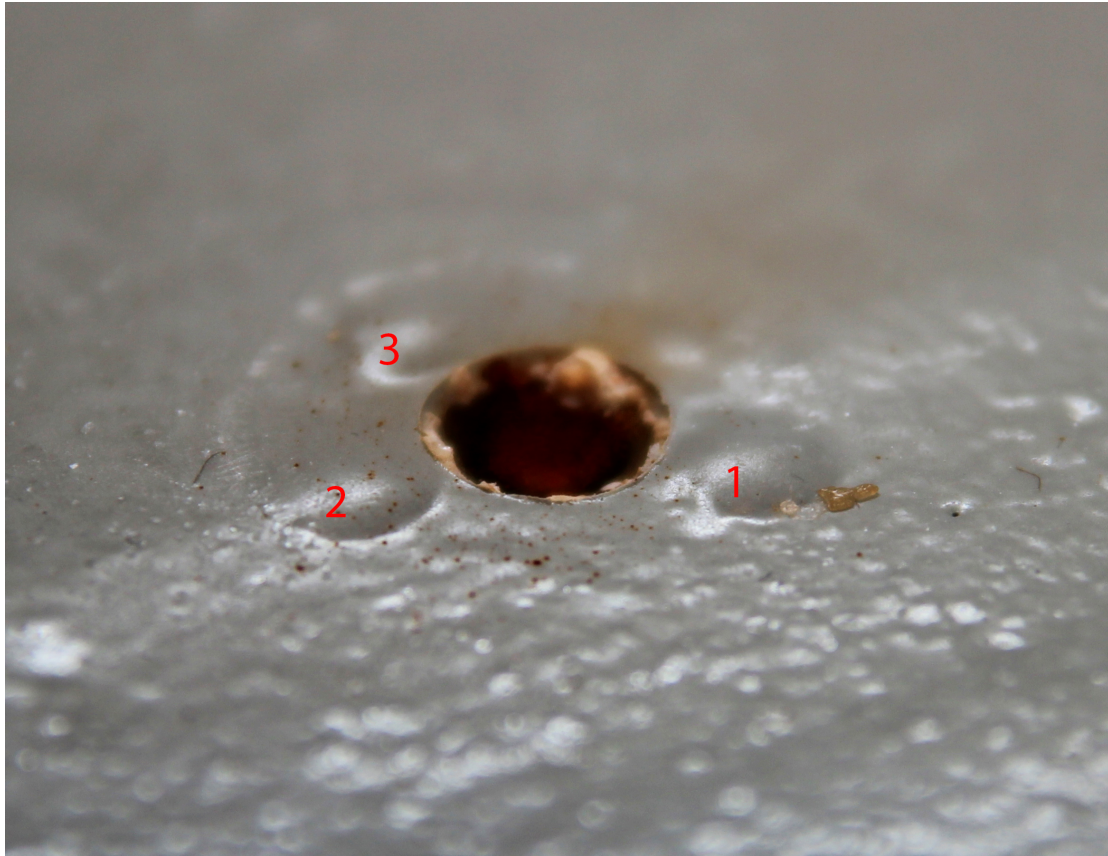
FIGURE 43 TSA DUPLEX COATING FAILURES

The epoxy coated TSA sample was exposed to an environment that replicated submerged service in seawater. After two week was there clear signs of coating degradation at the surface see Figure 43. Three blisters had developed around the constructed coating holiday.

The combination of TSA with a tick overcoat was confirmed to have a very harmful influence on the corrosion protection qualities of TSA. The initiation of the blisters will create an acidic environment under the epoxy coating, which will lead to rapid corrosion of the TSA.

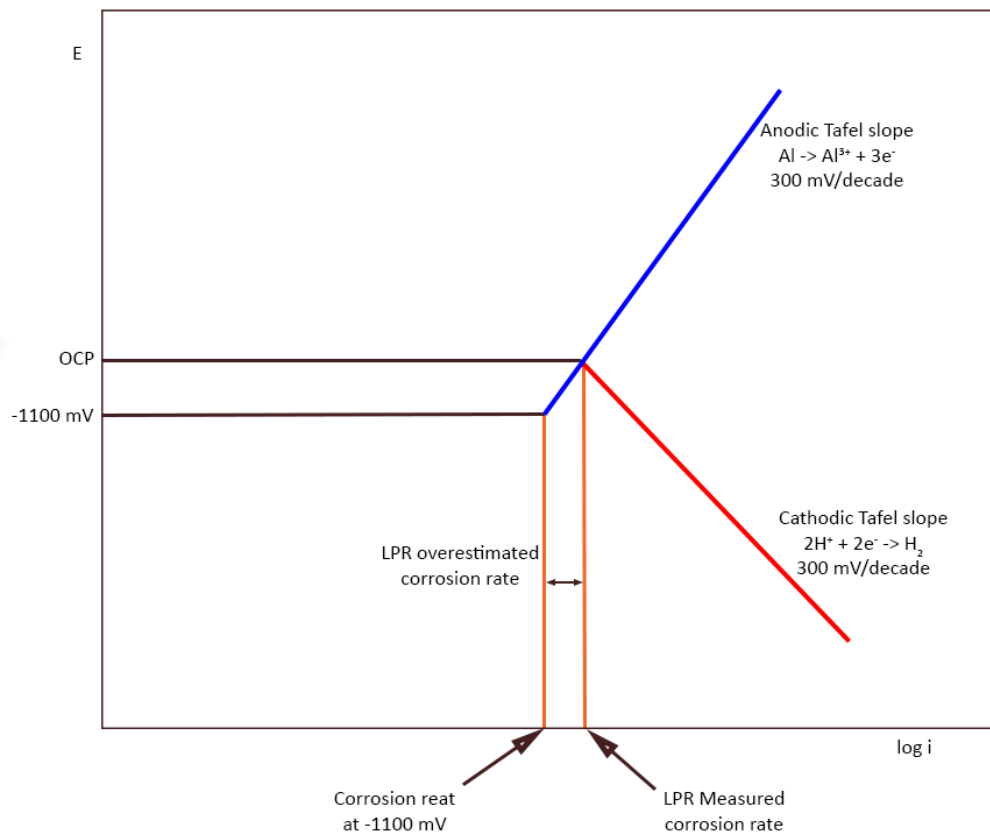
FIGURE 44 LPR OVERESTIMATION

The two utilized corrosion rate measurement methods gave some differences in the results see Table 12. An effect that is noteworthy is an overestimation of the corrosion rate when utilizing the LPR method on polarized aluminum. In Figure 44 is the effect illustrated. When doing corrosion rate measurements with LPR is the corrosion rate measured at OCP, i.e. not at the potentials applied in this project. From the figure can it be seen that the measured corrosion rate is depending on the anodic Tafel slope, when the sample is polarized away from OCP. The result is an over measured corrosion rate, how big the error gets, is depending on the Tafel slope. With a high slope is the error small, while as the slopes gets lower will the error increase.

All the samples that completed the corrosion test were polarized to a lower potential than OCP, hence the corrosion rates obtained by LPR is estimated to be big. This effect is probably the reason for the differences seen in Table 12. By taking the effect of overestimation into account will the corrosion rates measured by LPR and Tafel extrapolation be in good accordance to each other.
