Corrosion of Thermal Sprayed Aluminium (TSA) in Marine Mud

Lars Krogstad Lien

Subsea Technology

Submission date: June 2013

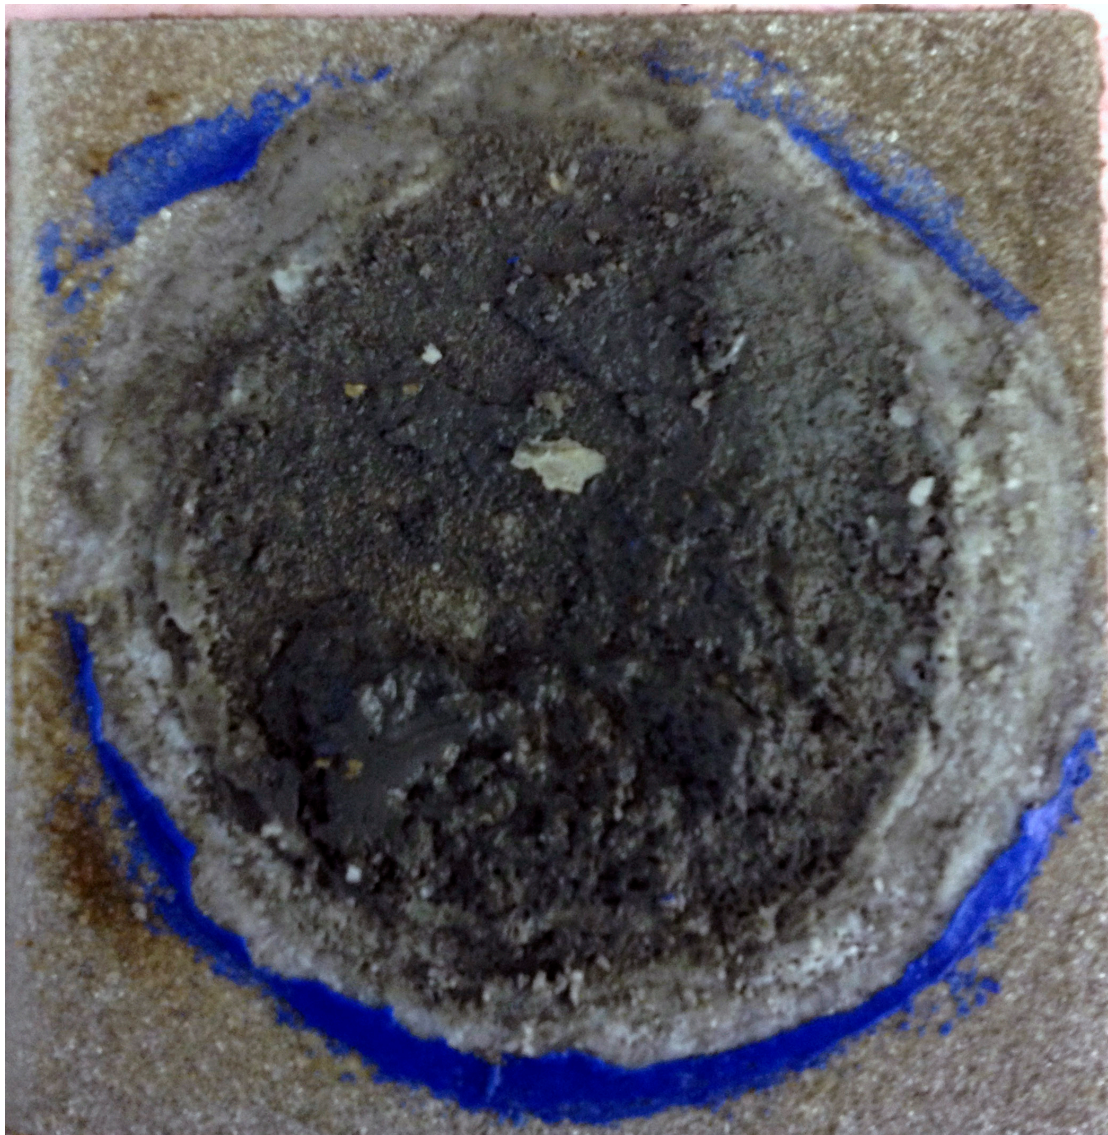
Sample 3:

Note: sample 3 suffered from a leakage in the mud cell seal after 14 days of exposure, and was then taken out of the experiment.

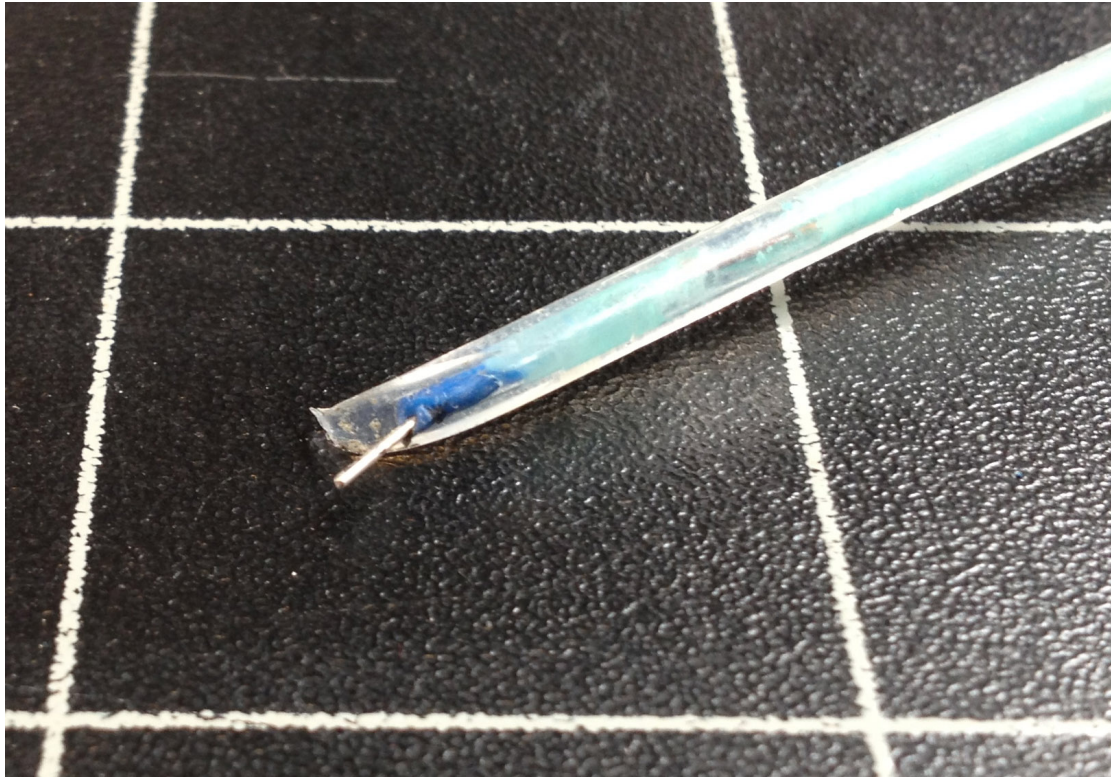
In the picture below is an iridium oxide electrode that has suffered from detachment of the oxide layers shown
