Considerations of road condition in relation to ground conditions

Case study in Nedre Eiker municipality

Master Thesis

Norwegian University of Science and Technology - Gjøvik, 2016

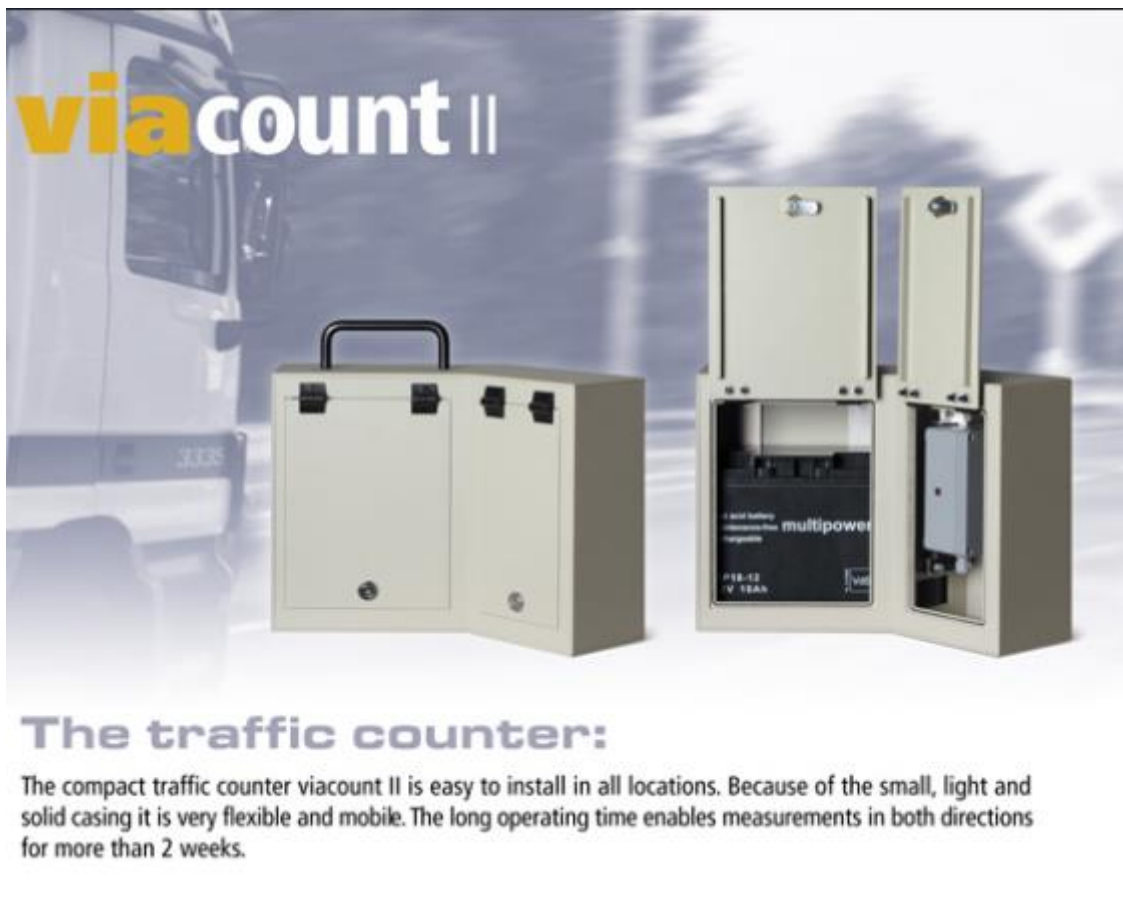
Figure 1:6 - Viacount traffic counter that are used for traffic measurements in this thesis

As a part of the fieldwork in this task it is registered traffic figures for many of the roads. These data are measured by a traffic meter called ViaCount (<http://www.viatraffic.de/engl/viacount.html>), see Figure 1:6. The data were then recorded into RoSy so that they could be considered when the load on the roads is calculated. It is possible to read out the total number of vehicles that have passed, and the number of heavy vehicles with SA10. Unfortunately, it has not been possible to obtain measurements on all the roads because the meter must be placed at least a week in each place, so it can record traffic numbers on weekdays and all hours. There is also a possibility that the data is not correctly if traffic has been measured in connection with holidays.

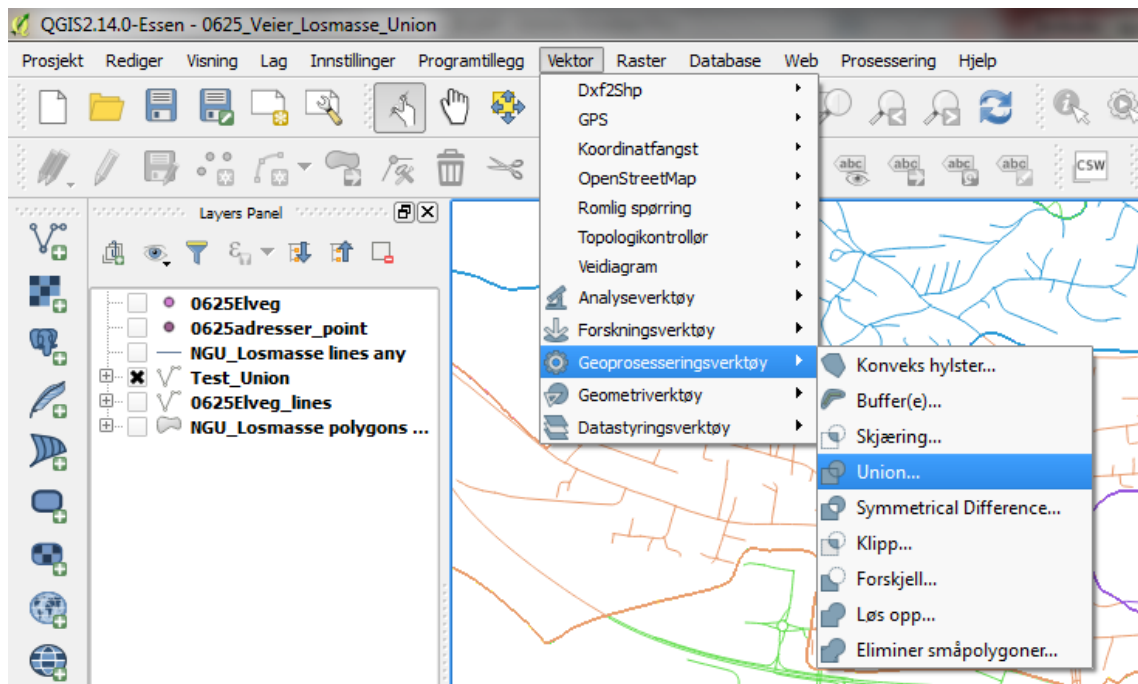
Figure 1:11 - Union function in QGIS

Data from state registration was registered both into an Excel spreadsheet and PMS RoSy. Thereafter, layers from NGU's soil maps, roadmaps from Norwegian Mapping Authority and roadmap with registered state from RoSy were exported to QGIS. Here the function "union" was used to extract data from the individual roads within the various soil conditions zones.

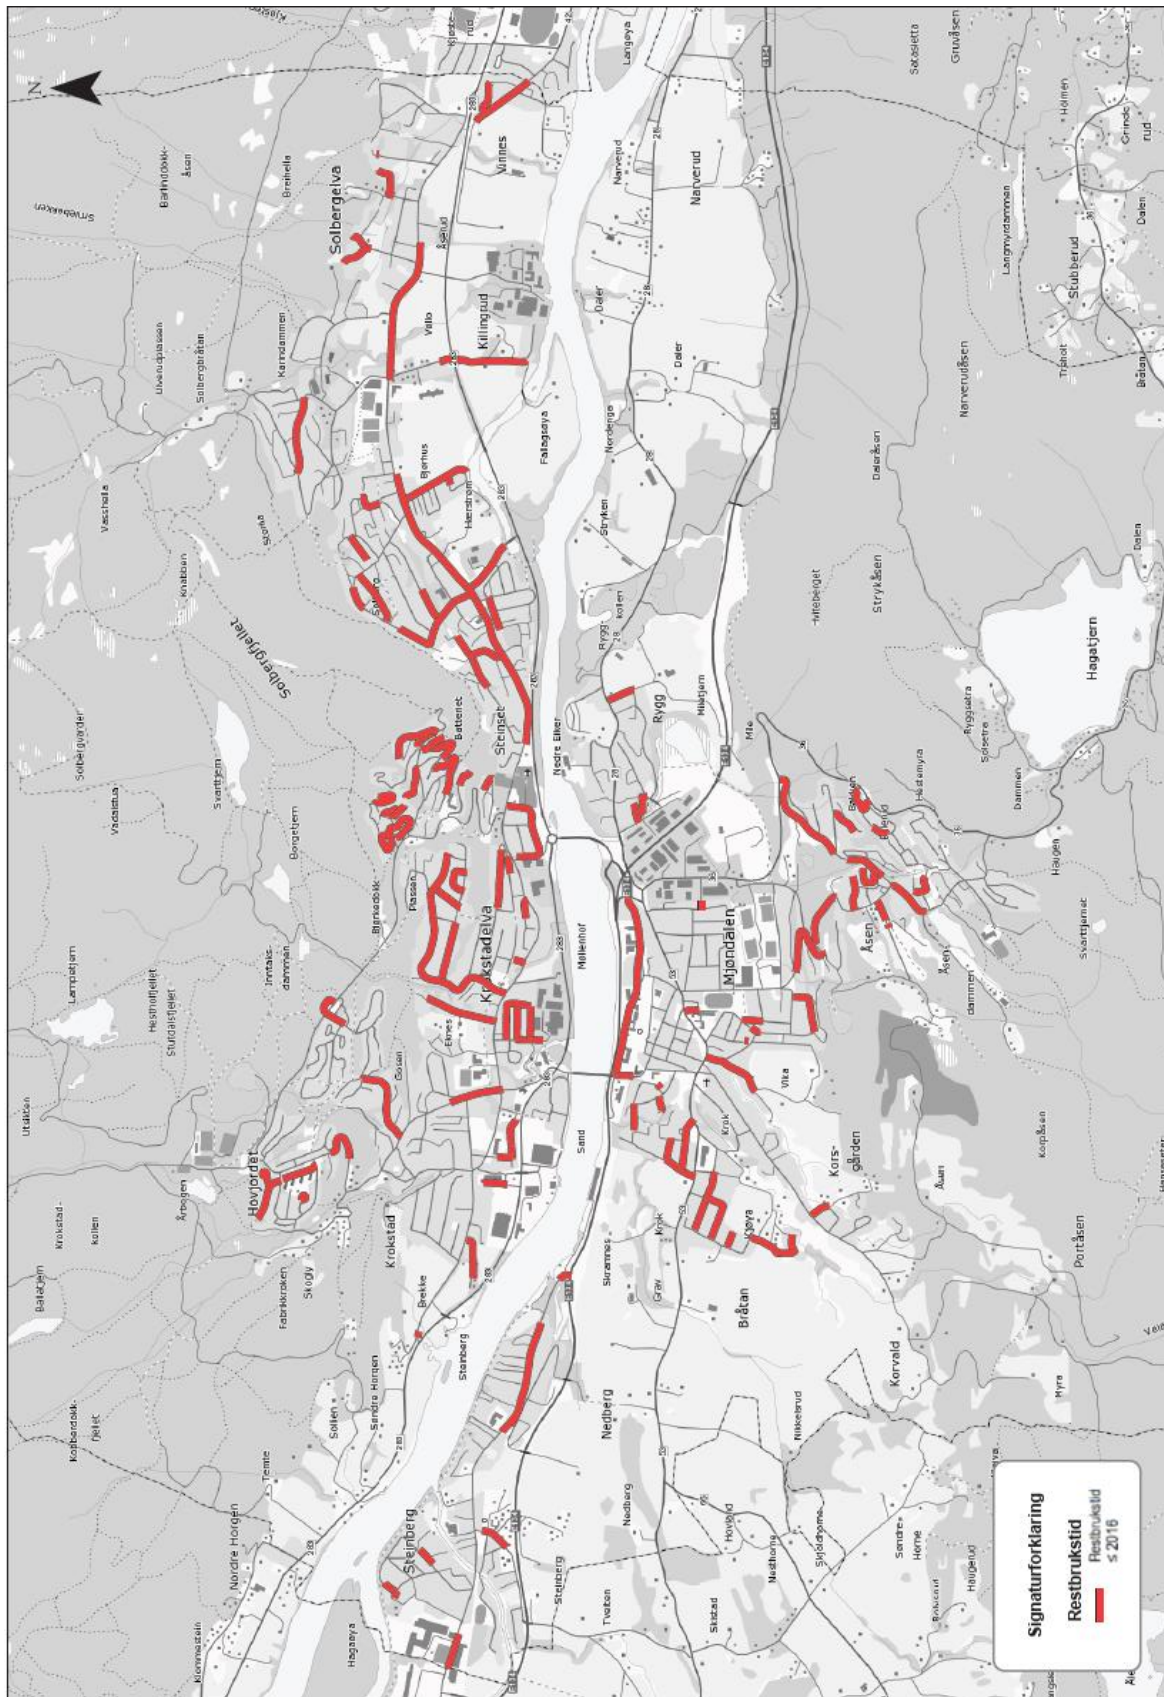
Figure 2:2 - Localization of low standard roads in Nedre Eiker (Finnerud and Sweco, no date)

On the next page appear low standard roads in Nedre Eiker in a map. The roads are marked with red color are low standard roads in 2016. Here you get a good overview of the areas low standard roads are.

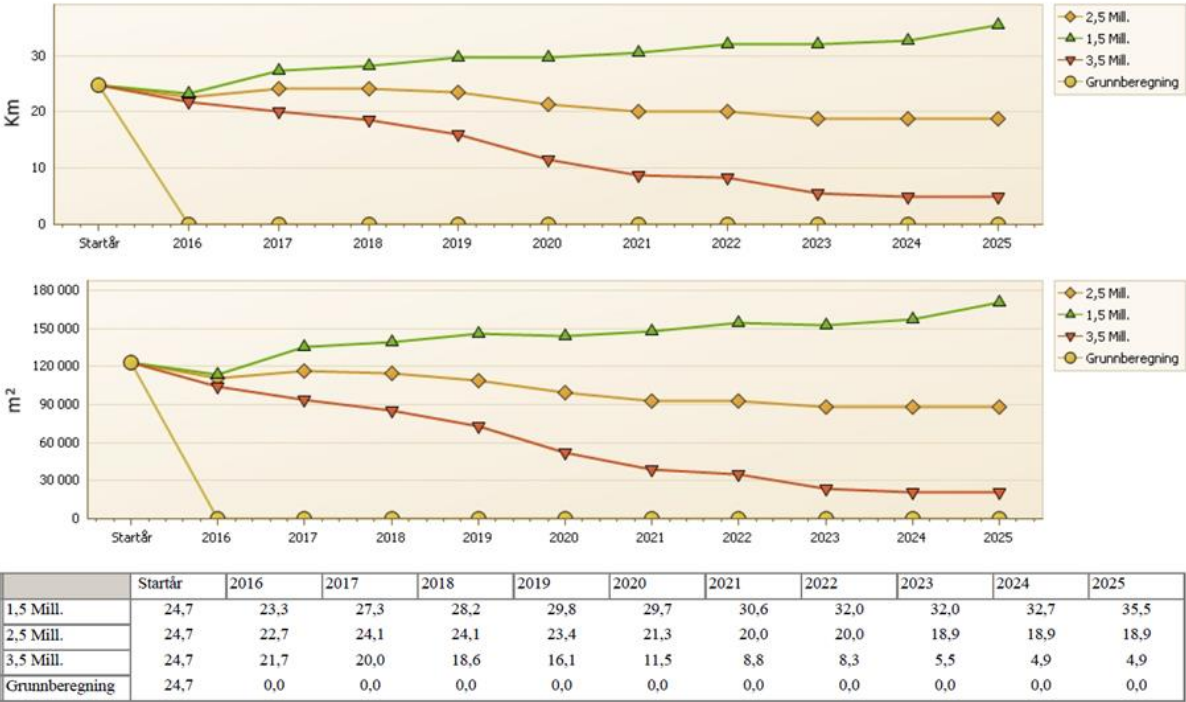
Figure 2:3- Overview of how the length and area of low standard roads will evolve over 10 years with various maintenance budget. (Finnerud and Sweco, no date)

Optimal solution means basic calculation. Ie that we spend as much money as are necessary to obtain maintenance backlog, and then what it is necessary not to get new low standard roads in the subsequent years.

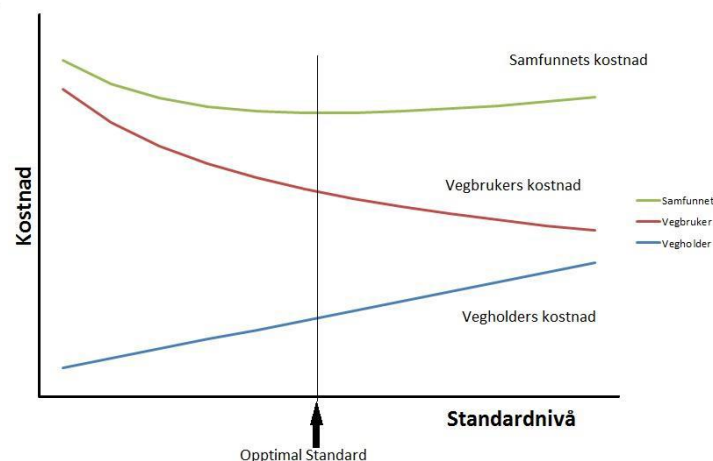
Figure 2:6 - The societal optimal standard for operations and maintenance tasks is the sum of road owner costs and road user costs (Aurstad et al., 2015)

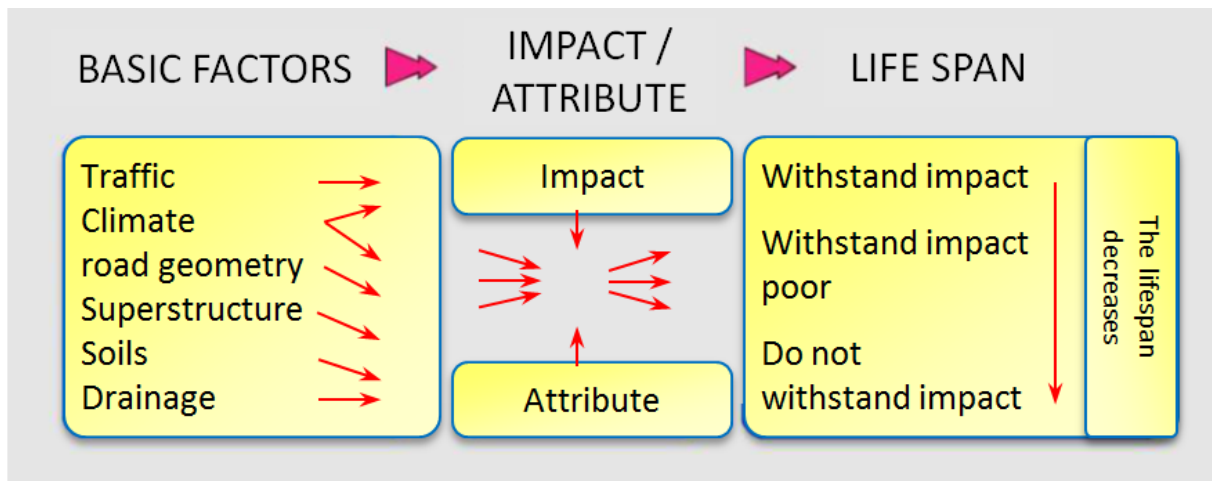
Figure 2:20 - Degradation factors. (Aurstad et al., 2015)

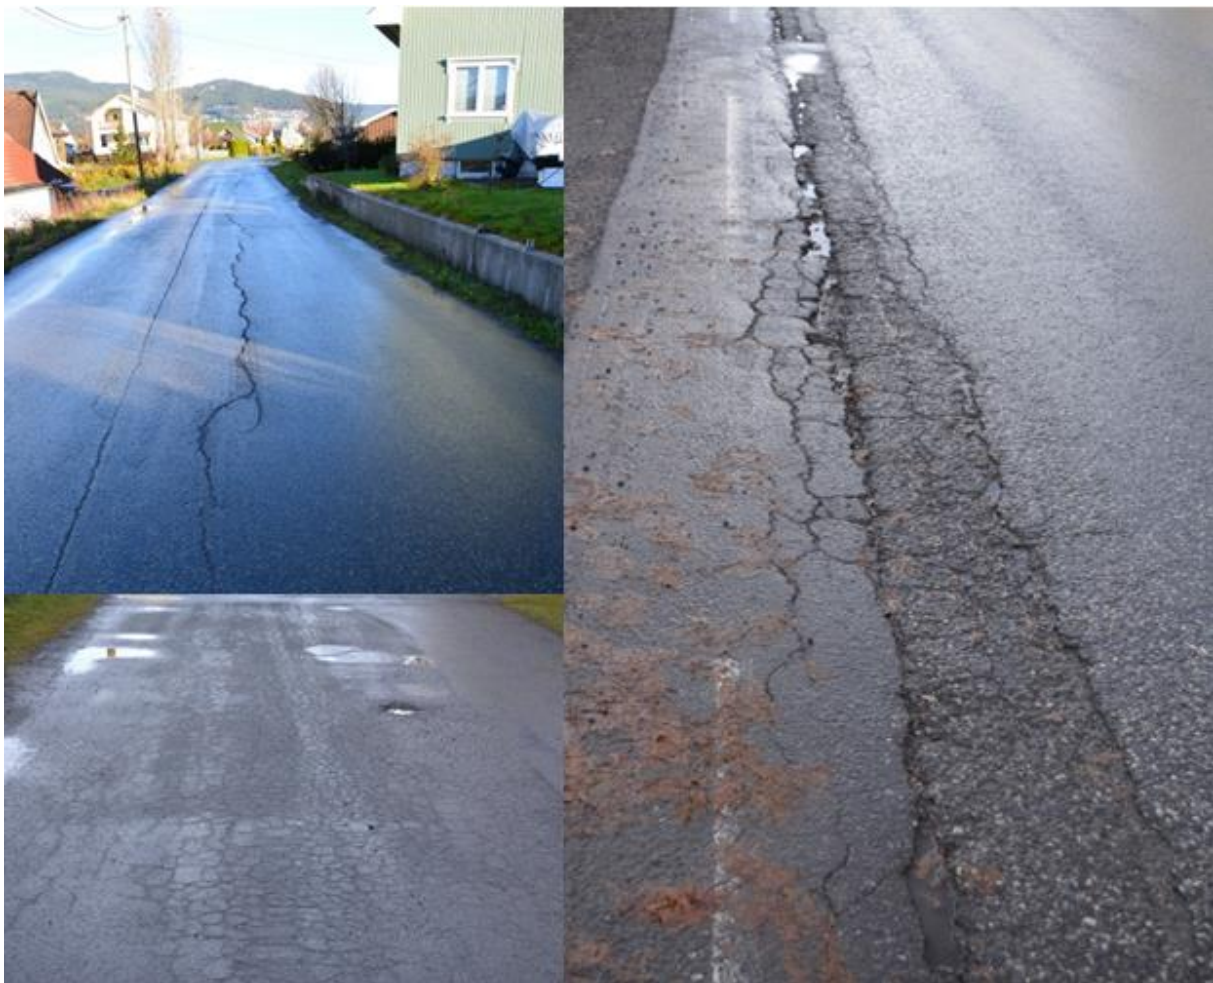
Figure 3:2 – Example of damages on an asphalt road (Photo: Erik Josepshon)

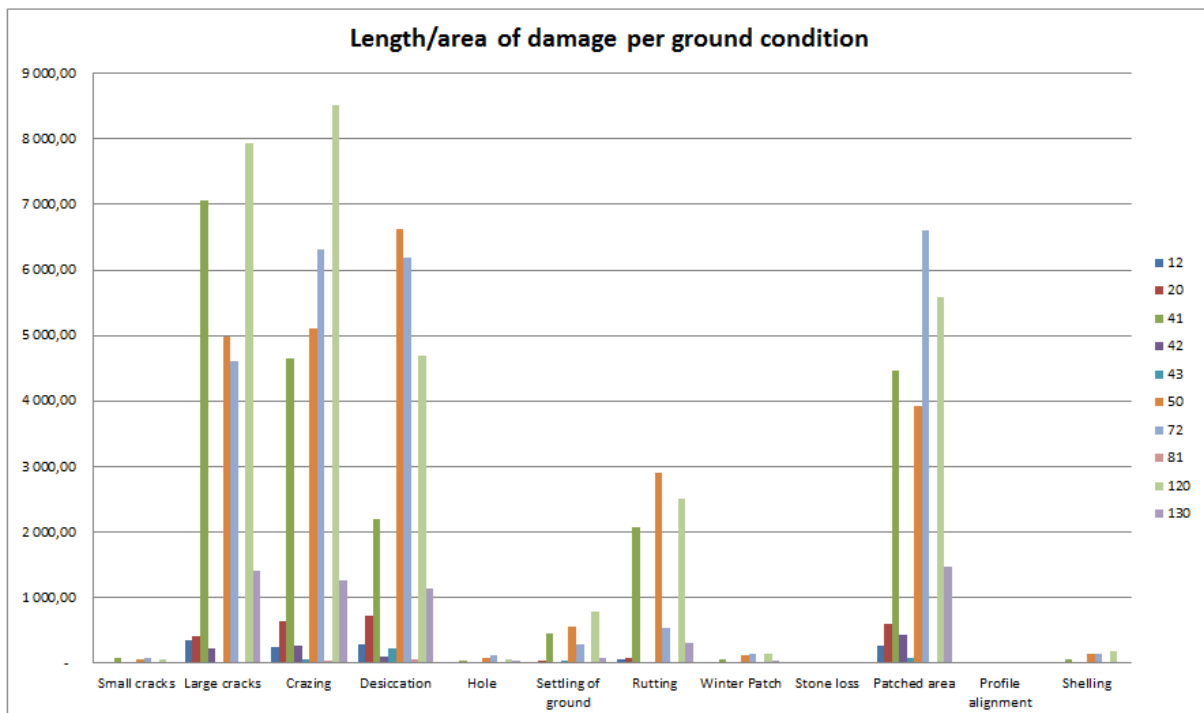
Figure 4:5 - Length/area of damage per ground condition, grouped by type of damage

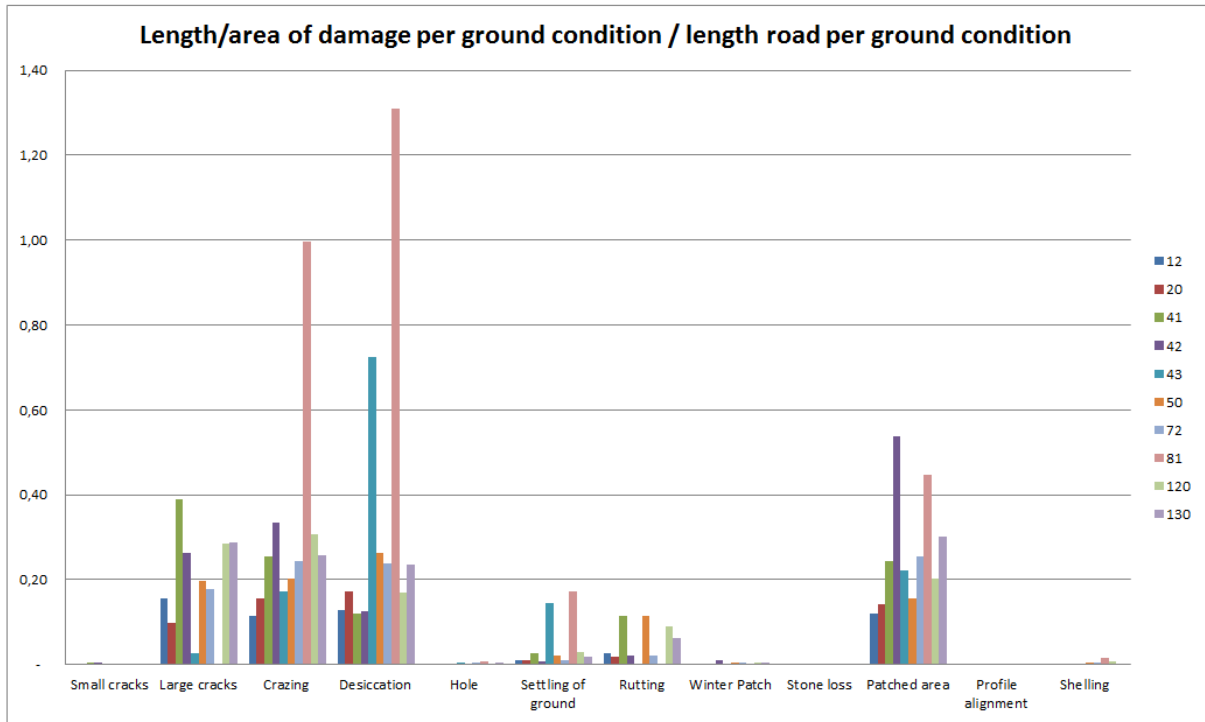
Figure 4:6 - Length/area of damage per ground condition / length road per ground condition, grouped by type of damage

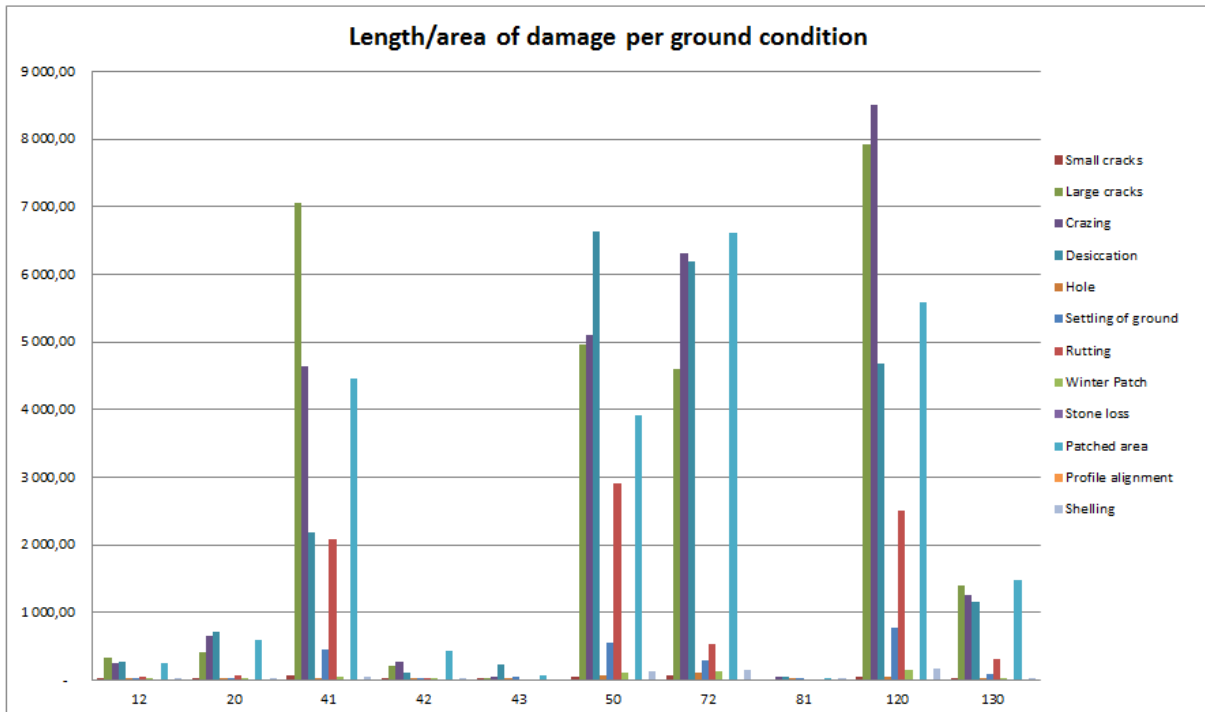
Figure 4:7 - Length/area of damage per ground condition, grouped by ground conditions

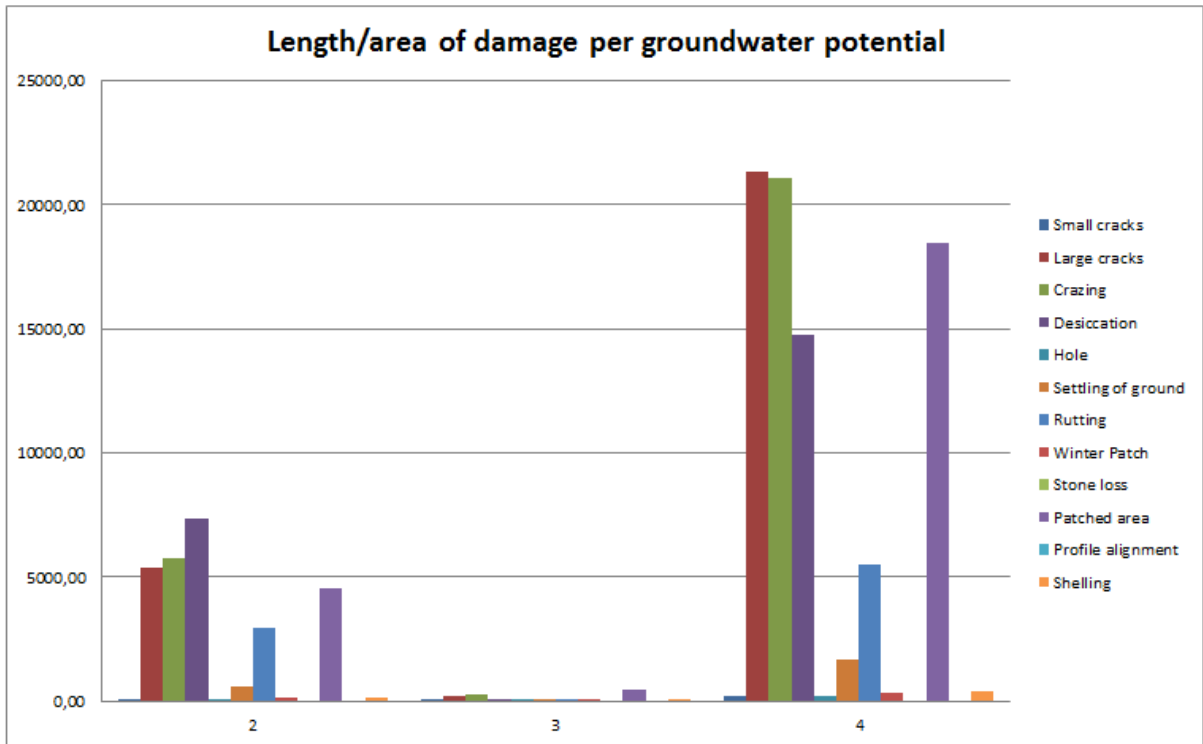
Figure 4:19 - Length/area of damage per groundwater potential, grouped by groundwater potential

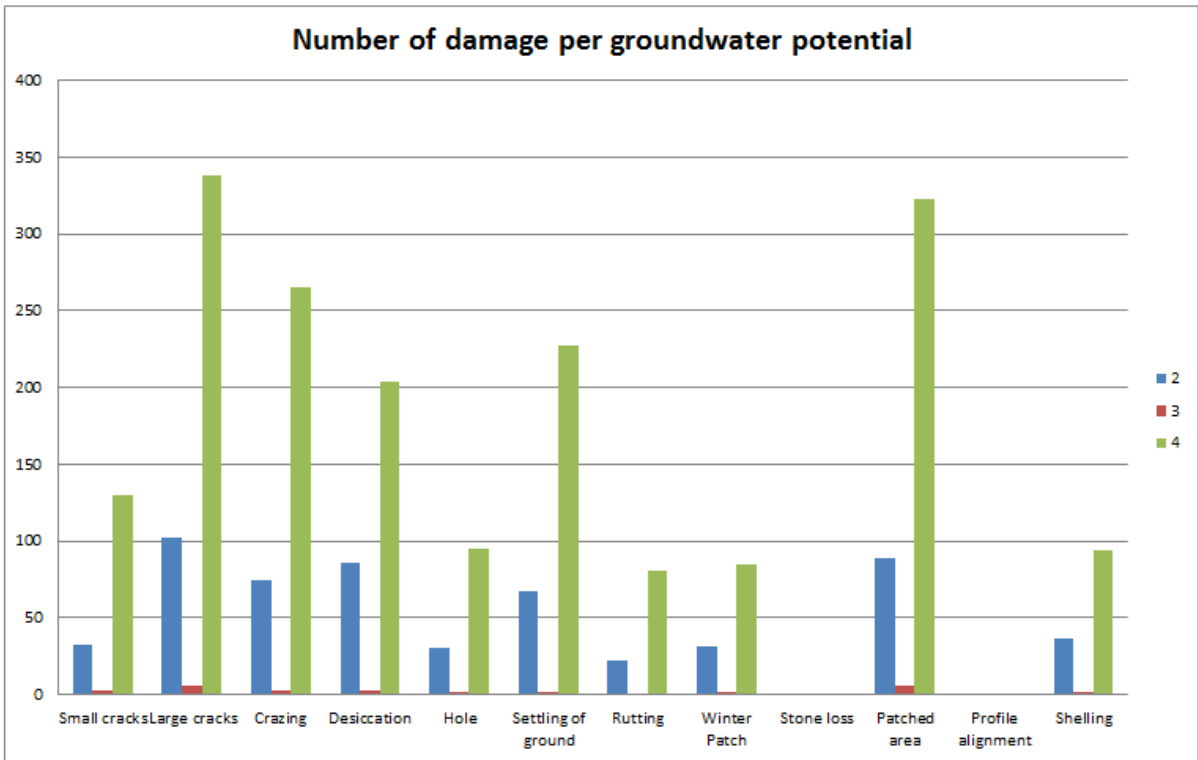
Figure 4:23 - Number of damage per groundwater potential, grouped by type of damage

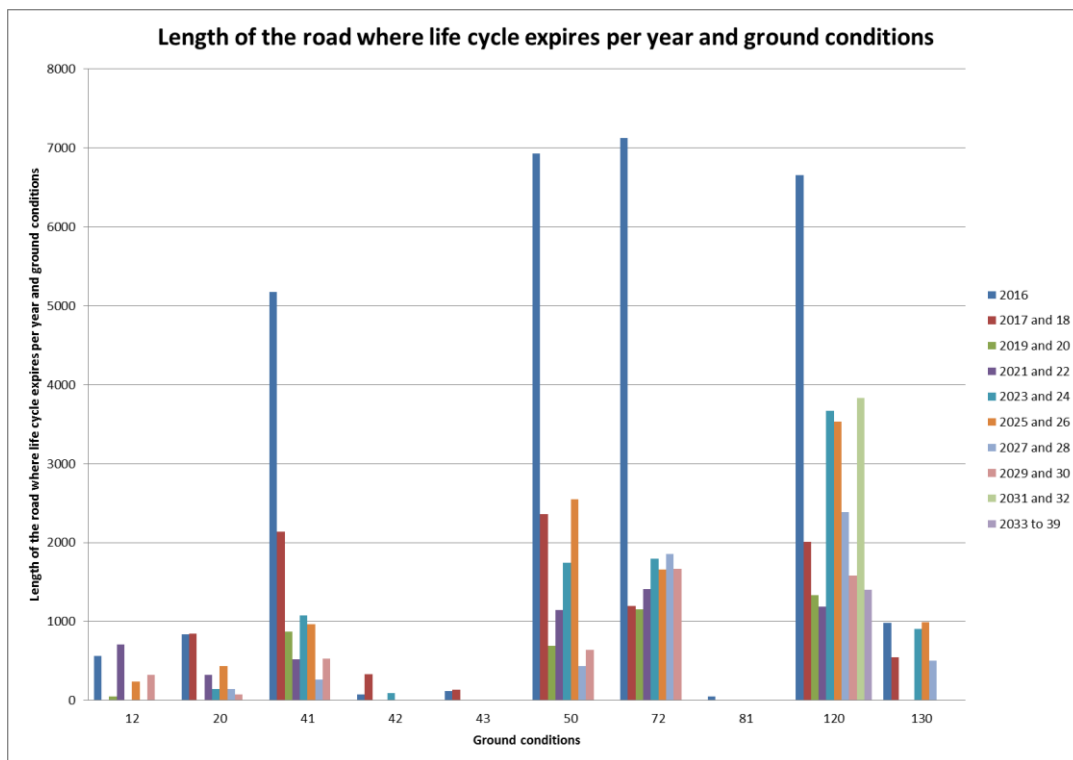
Figure 4:43 - Length of the road where life cycle expires per year and ground conditions, grouped by ground conditions

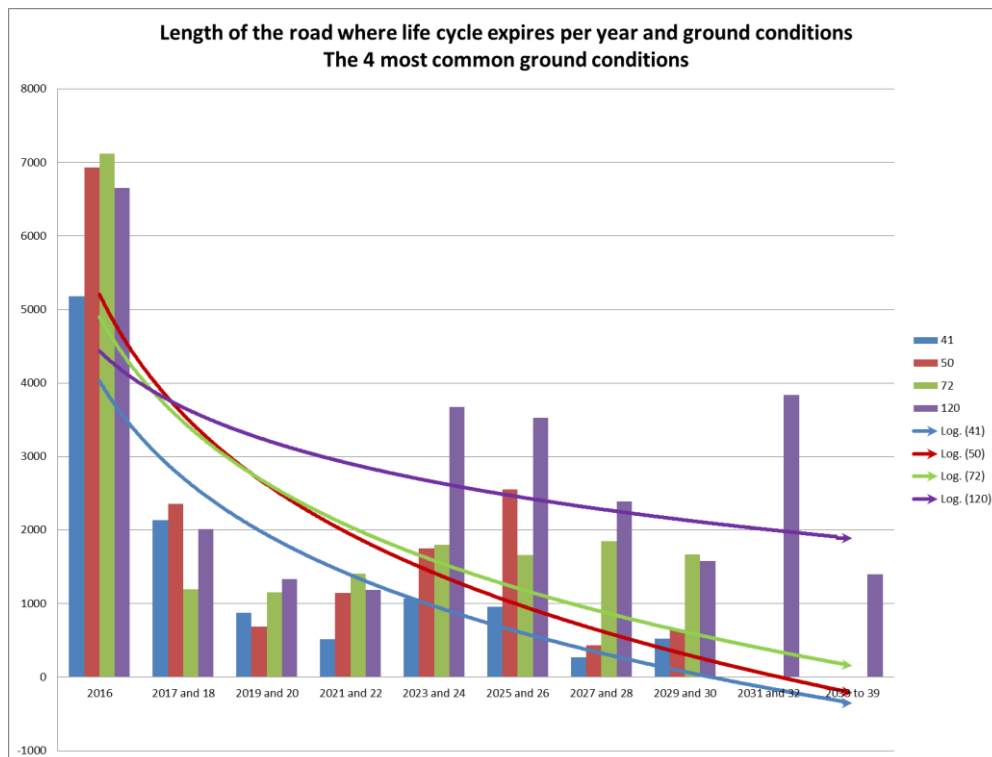
Figure 4:45 - Length of the road where life cycle expires per year and ground conditions, the 4 most common ground conditions. Grouped by year of expire.

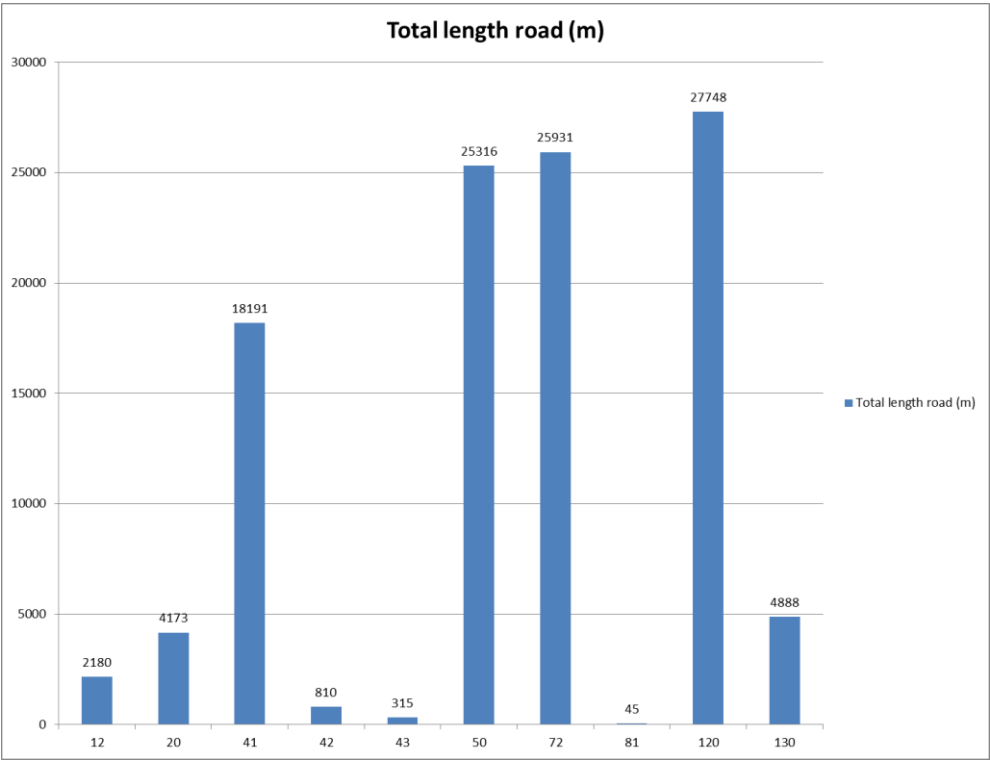
Figure 4:46 - Total length of roads in Nedre Eiker grouped by ground conditions
