Corrosion Protection under Thermal Insulation

Karen Sigbjørnsen

Mechanical Engineering

Submission date: June 2013

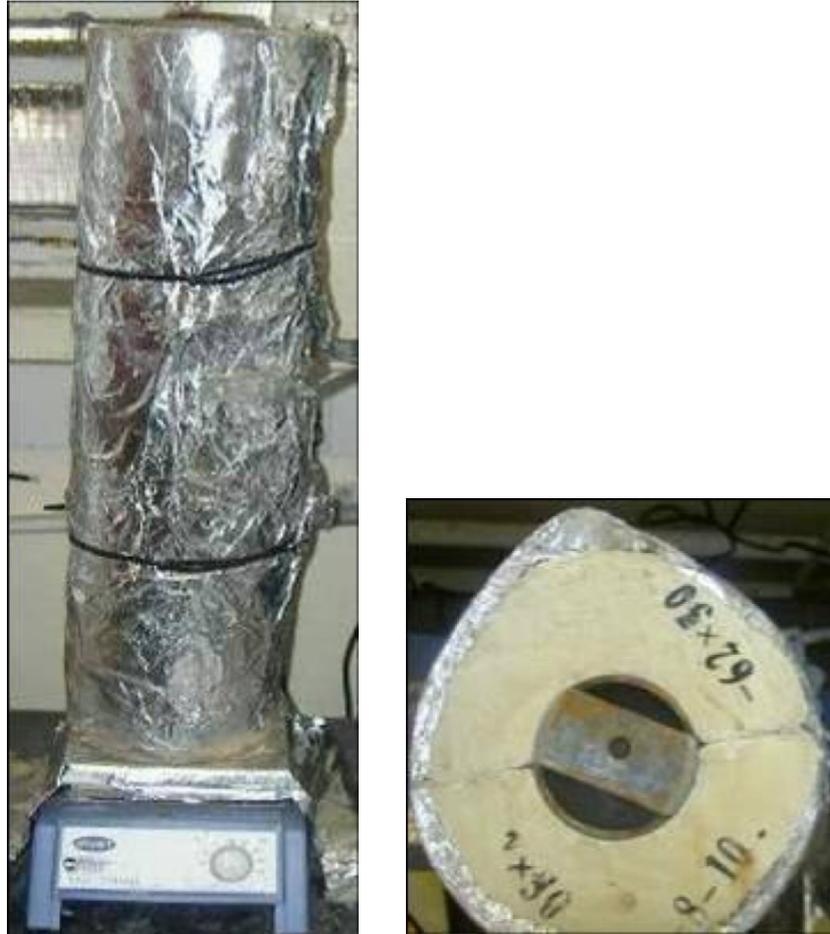
Figure 2.6 Assembly of cyclic pipe test [7].

The cyclic pipe test was developed by Halliday et al. [1]. A coated pipe is insulated with calcium silicate, sealed with aluminium foil and placed upon a hot plate, see **Figure 2.6**. Calcium silicate represents the worst-case scenario, as it is very wicking. The temperature at the hot plate is 450°C, and at the opposite end of the pipe the temperature is approximately 60°C. This system is cycled 30 times with 8 hours of heating followed by 16 hours of natural cooling. Before and after each heating cycle the insulation is wetted with 1 litre 1% NaCl solution, as would have been the case if there were a break in the insulation.

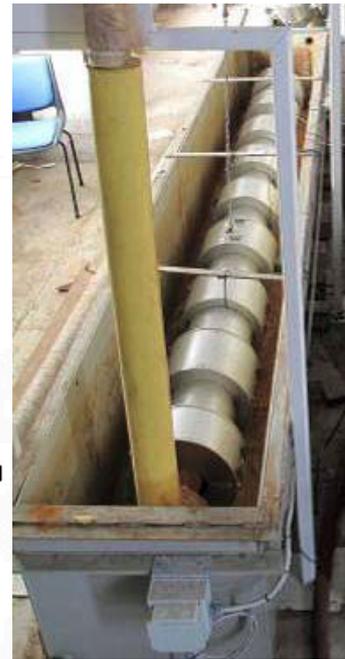
Figure 2.10 Sketch and photo of test rig used by Haraldsen [15].

The test cell consisted of test spools of carbon steel tube sections flanged together in open containers, see **Figure 2.10**. The containers were filled with seawater and drained immediately after the spools were fully submerged, which lasted for approximately 20 minutes. This was done three times a week. Steam was lead through the pipes to provide an internal temperature of 140°C. The ambient temperature was 15 to 20°C with 30-80% relative humidity.

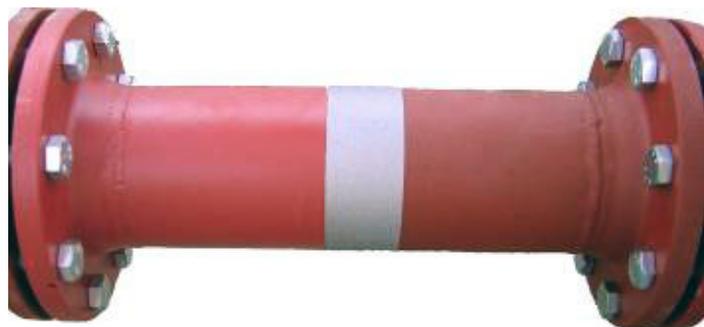
Figure 2.11 Test spool with two different coatings separated by a masked, un-coated area in the middle [15].

The test spools were 410 mm long and had an outer diameter of 115 mm and were coated with two different coatings with an un-coated area in the middle, see **Figure 2.11**. They had been used for CUI testing before and corrosion products and remains of old coating were present at the surface, as is the situation when maintenance is performed for a CUI system. Different surface pre-treatment were used to evaluate their effect on the coating performance. Mineral wool was used for insulation and both distance insulation system and insulation applied directly at the coating was tested. After the test was ended, the coatings, insulations, surface pre-treatment and application method and temperature were evaluated and divided into four categories; no, slight, medium or heavy. The evaluation was based on several criteria; disbonded area, visual impression, surface condition, and degree of blistering, cracking and corrosion creep.

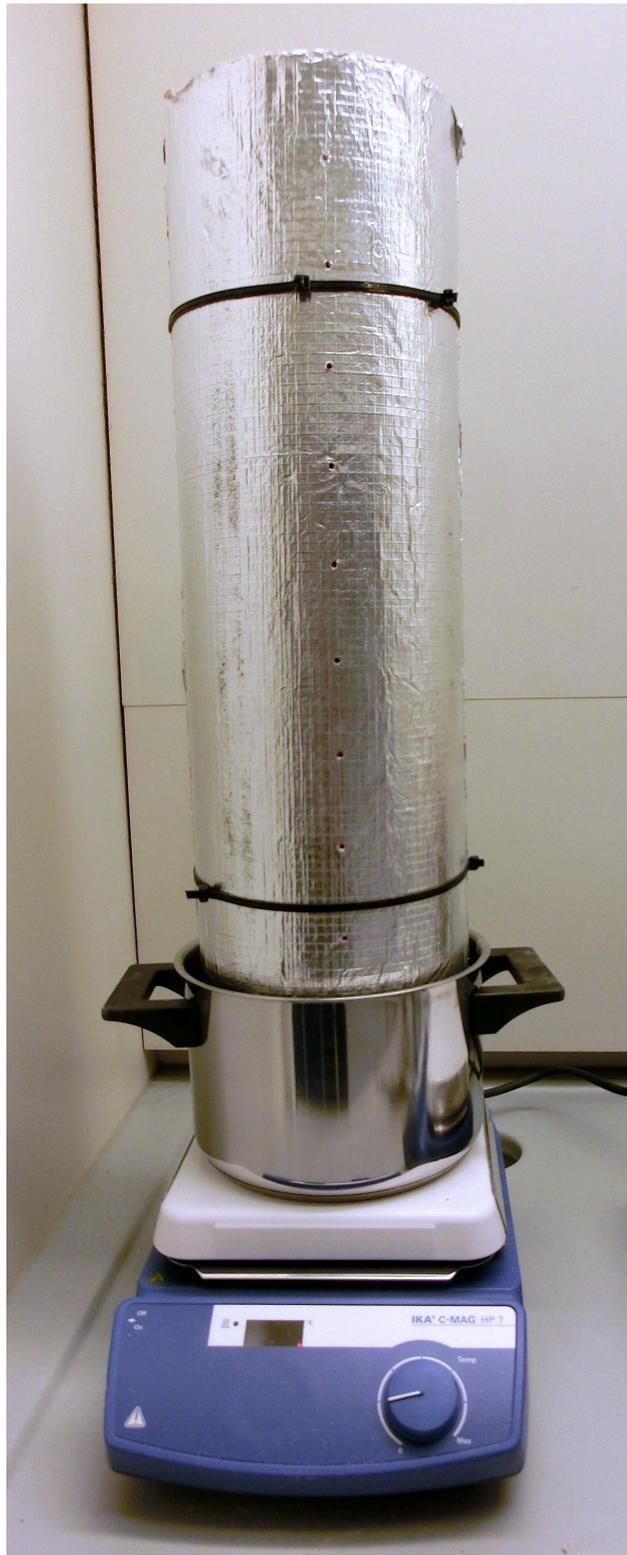
Figure 3.2 Test set-up with hot plate, casserole and insulated pipe.

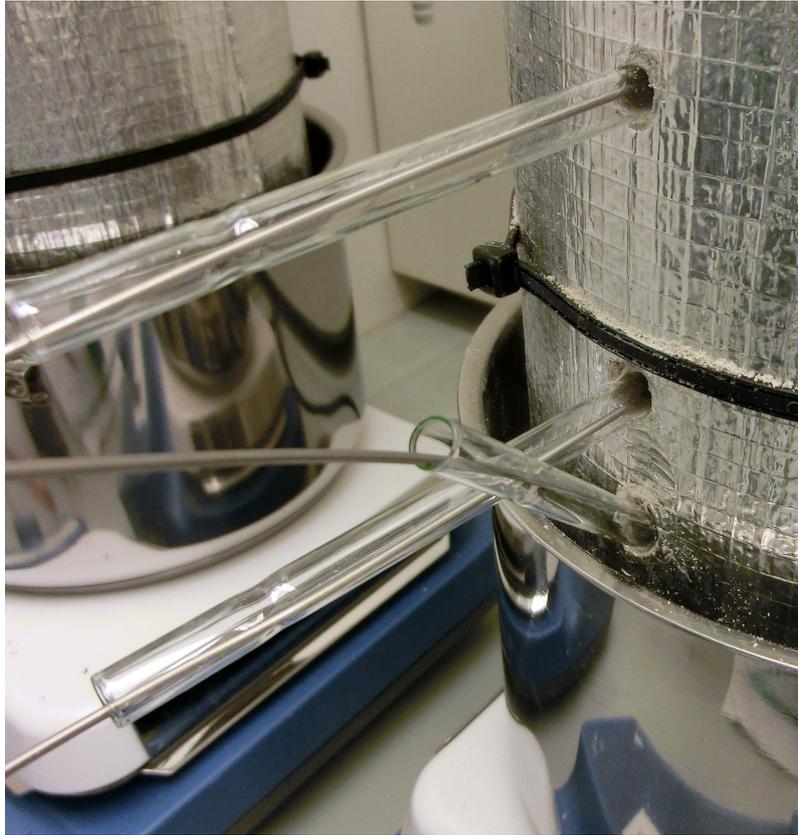
Figure 3.6 Angled thermocouple at the bottom of the pipe due to coverage by the casserole. Glass tubes were used to hinder corrosion of the thermocouple.

Four carbon steel pipes with outer diameter of 6 cm and length of 60 cm were coated with different coatings. Asbestos free calcium silicate insulation with a thickness of 5 cm was used and thin aluminium wrapping covered the insulation. During testing, the pipes were placed upon a hot plate for regulating the temperature. The test set-up is shown in **Figure 3.1a**) and the cross section of the pipe is shown in **Figure 3.1b**). A casserole was placed at the bottom of the pipe to hinder the electrolyte to get in contact with the hot plate, see **Figure 3.2**. At the top of the insulation, a 1-2 cm deep radial pit was cut out to drain the fluid homogeneously into the insulation, see **Figure 3.3**. Also, small holes were made every 5 cm along the length of the insulation to allow temperature measurements with thermocouples, see **Figure 3.4**. At the bottom of the pipe, the casserole covered two of the holes, and therefore an angled hole was made in order to be able to place a thermocouple near the pipe bottom, see **Figure 3.6**.

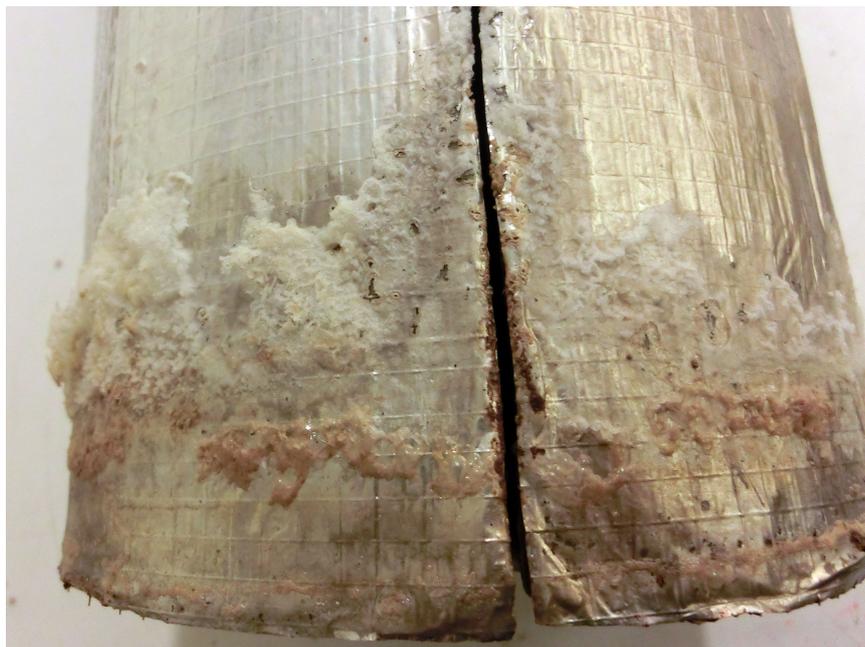
Figure 4.22 White deposit of presumably aluminium oxide at the insulation.

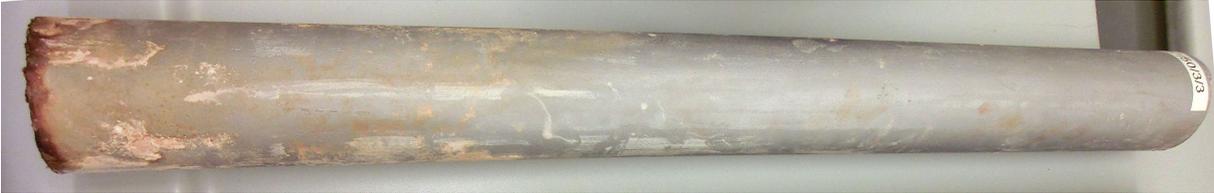
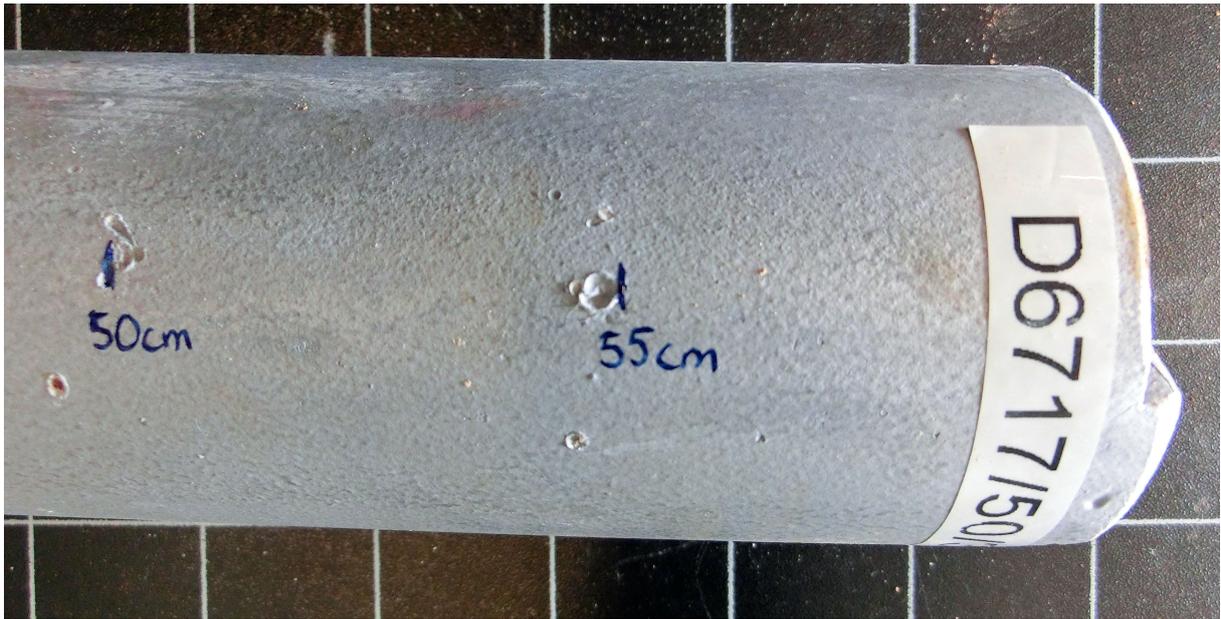
B.1 TMIC

100°C 90°C

Visual examination of the coatings displayed good results for the TMIC coating with only slight degradation and rusting at the bottom, see **Figure 4.14**. At one spot, 2 mm in diameter

and close to the bottom of the pipe, the coating had failed and rusting was seen. No blisters or cracks were found at the coating surface. Markings after the thermocouples were clearly visible, see **Figure 4.15**, and slightly rusting was seen at the markings closest to the hot plate.

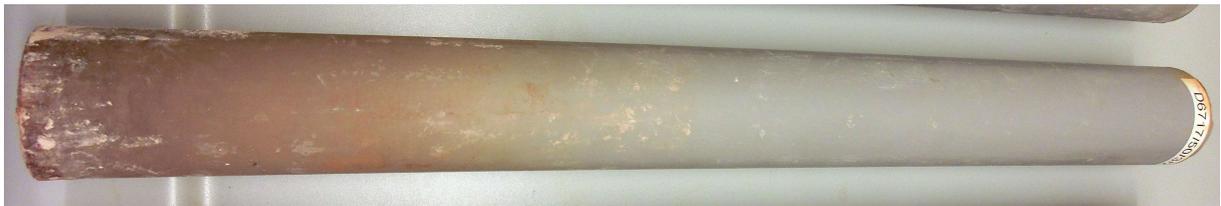
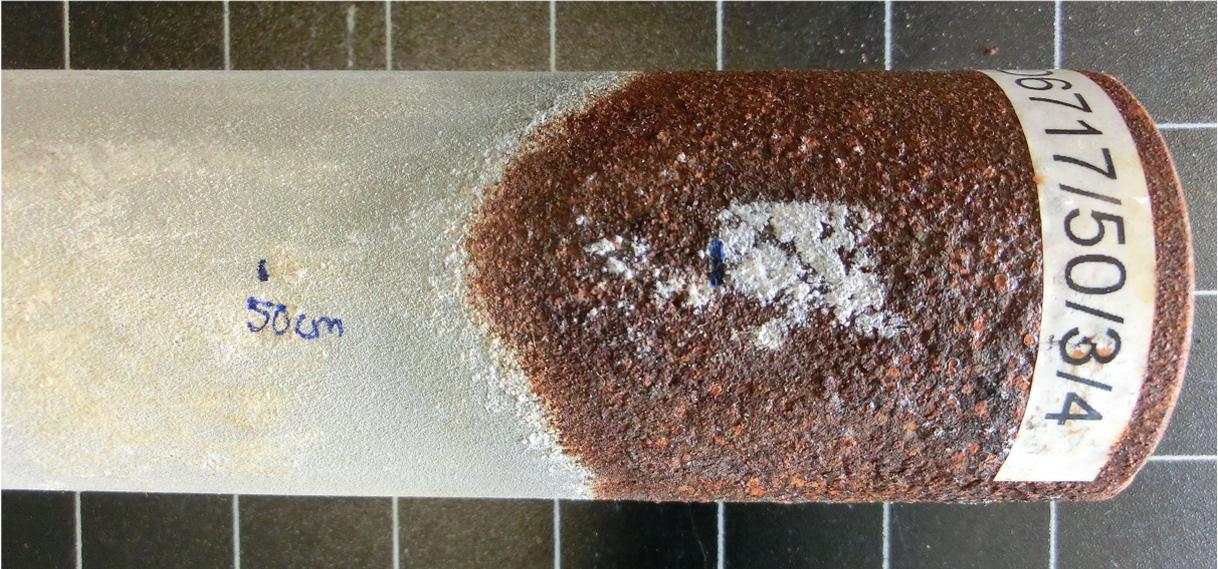
B.2 Epoxy phenolic

300°C 210°C 175°C

75°C 65°C

The epoxy phenolic coating failed for the highest temperatures, with blistering and rusting. Blisters were found in the 150 to 175°C area, see **Figure 4.18**, as well as in the area closest to the hot plate. According to ISO 4628-2, the degree of blistering was evaluated to be 4(S3) for the 150 to 175°C area and 4(S4) in the hottest area. Also rusting degree Ri 4 according to ISO 4628-3 was found closest to the hot plate, see **Figure 4.19**. The coating was clearly discoloured from approximately 140°C. However, almost no marks were seen after the thermocouples.

Except the 170°C-tempered area with blisters, no degradation was visually discovered for temperatures lower than approximately 220°C. In the 170°C-tempered blistered area, the thickness of the coating was found by optical microscope to be approximately 200 μm and areas with poor adhesion were seen. Better images of the areas with poor adhesion were taken in SEM, see **Figure 4.20**. Poor adhesion was seen for large areas of the coating in this region, however, the adhesion improved at temperature lower than approximately 160°C. Little
