Optimize Resistance to buckling under external hydrostatic Pressure of thin walled Composite Tubes

Mechanical Engineering Submission date: June 2014 Supervisor: Andreas Echtermeyer, IPM

Norwegian University of Science and Technology Department of Engineering Design and Materials

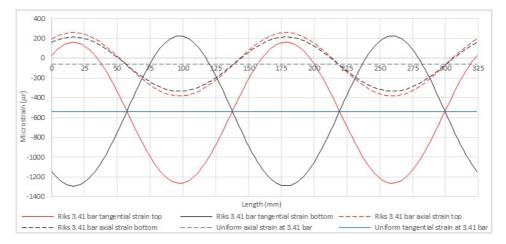
Figure 2.2: Tangengtial and axial strain around the middle circumference in the top and bottom ply of the $[89^{\circ}_{1}/12.7^{\circ}_{1}/45^{\circ}_{1}]$ layup at 3.41 bar. The tangential strain curve for the top ply can also be found in the paper, compared with optical strain measurements. As can be seen, the tangential strain has a very big bending component with opposite curves for the top and bottom ply while the axial strain has a very small bending component through the thickness. Also plotted is the strain at 3.41 bar from uniform deformation and it can be seen to coincide with where the respective buckling shape strain curves cross.

through the thickness, indicating little bending. The reason for the axial strain to have little bending is due to the two lobe deformation pattern constraining the axial strain so it doesn't develop any pronounced bending strains through the thickness. It can be seen in Figure 2.3 that there are some very high axial bending strains at the ends due to the FEA's idealization of the freely supported end constraints. However, the bending strain quickly diminshes straight after the ends due to the geometrical constraint caused by the two lobe deformation pattern. Also visible in the axial strain plot along the tube is the axial strain from uniform deformation, as also plotted in Figure 2.2. As for the circumferential plot it coincides with the strain where the curves cross. Looking at the strain from uniform deformation it can be seen that the buckling shape strain has got much higher peak values, indicating that there is a big difference in max buckling/burst pressure between internal and external (by nature even deformation) hydrostatic pressure.

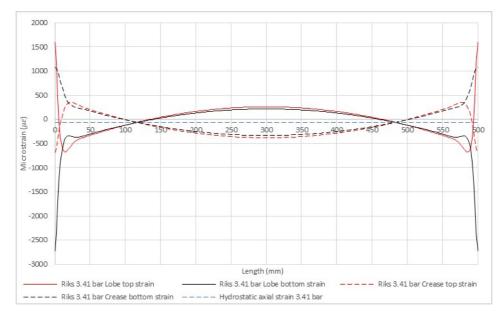
Figure 2.3: Axial strain along the length in the top and bottom ply of the $[89^{\circ}_{1}/12.7^{\circ}_{1}/45^{\circ}_{1}]$ layup at 3.41 bar for both the lobe, at 18 and 178 mm in Figure 2.2, and the crease shape at 98 and 262 mm. As can be seen, the axial strain has a very big bending component with opposite curves at the ends of the tube, where there is a lot of bending torque from idealized over-rigid constraints in the FEA. The reason why there is no bending strain through the thickness in the rest of the tube is due to the two lobe deformation shape constraining the strain. Also plotted is the strain at 3.41 bar from uniform deformation and it can be seen to coincide with where the respective buckling shape strain curves cross, as for Figure 2.2.

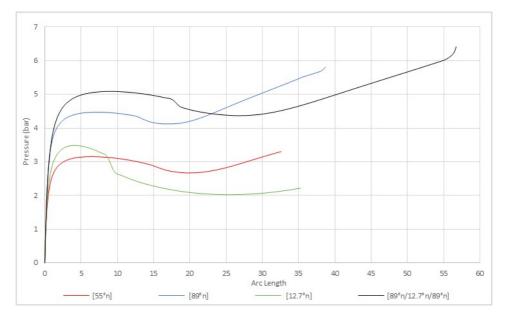
Figure 2.4: The pressure vs arc length graphs for the $[12.7^{\circ}_{n}]$, $[89^{\circ}_{n}]$, $[55^{\circ}_{n}]$ and $[89^{\circ}_{2}/12.7^{\circ}_{1}/89^{\circ}_{2}]$ layups. As can be seen, the $[89^{\circ}_{2}/12.7^{\circ}_{1}/89^{\circ}_{2}]$ layup withstand high pressure for a relatively long deformation (arc length) interval before reaching peak pressure.

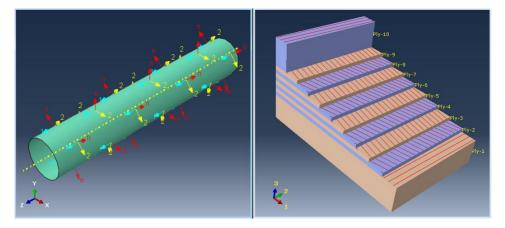
Figure 2.5: Layup in Abaqus showing direction of the material coordinate system, ply number and orientation of each ply for the produced $[89^{\circ}_{2}/12.7^{\circ}_{1}/89^{\circ}_{2}]$ layup. The ply number refers to Table 2.4.

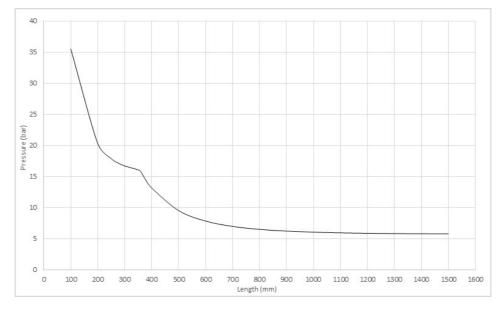
Figure 2.6: Length sensitivity analysis of the produced $[89^{\circ}_{2}/12.7^{\circ}_{1}/89^{\circ}_{2}]$ layup pre testing with material properties from the scaled material properties in T Table 5.4 and ply thicknesses as reported in Table 2.4.

on how the matching behaves at other lengths than 600 mm. Also visible in the graph is the change of curvature occurring at 350 mm. The change of curvature is caused by the buckling mode going from two lobe to three lobe. Since the mode change is caused by the length and thus the end effect, testing of a tube with predicted three lobe mode close to the mode change threshold length was also decided. Based on the above, the third tube was set to a length of 300 mm. Testing of a tube length predicted to have a three mode shape would also indicate if the tube from production actually has got a slight two lobe shape, as indicated by the good match with the elliptical two lobe shape in the paper. In other words, it can give an indication on whether or not the elliptical shape is an analysis parameter or an actual physical geometry.

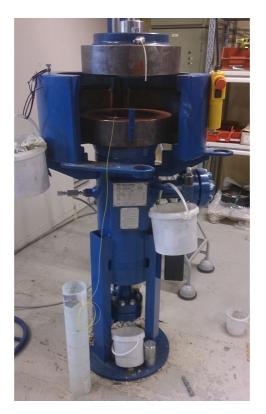
Figure 4.1: Autoclave and tube without endcaps, with the signal wire escaping the autoclave through the T-fitting seen on the left side of the autoclave.

Testing of the tubes was conducted by sealing the ends of the tubes with steel endcaps and applying pressure by water in the autoclave at the Institute of Engineering Design and Materials at NTNU. Strain readings were acquired from optical fiber glued to the surface of the tubes with the signal wire from the fiber escaping from the autoclave through a T-fitting. Figure 4.1 shows the autoclave and a tube with signal wire for fiber, but without endcaps.

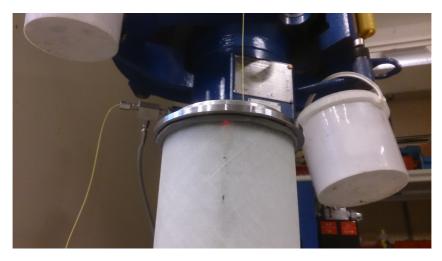
Figure 4.3: Endcap applied with stickytape. Also visible in the background is the T-fitting.

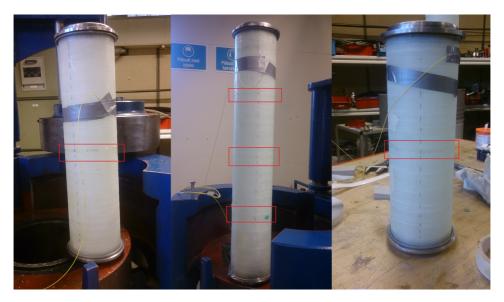
Figure 4.4: The 400 mm long tube (left), 600 mm long tube (middle) and 300 mm long tube (right) with endcaps. The 600 mm long tube had the fiber at 150 mm, 300 mm and 450 mm along the longitudinal axis. The other two tubes had the fiber at the middle at 150 mm for the 300 mm long tube and at 200 mm for the 400 mm long tube. The paths are outlined with red squares.

To meet these requirements, the 600 mm long tube had the fiber laid in three circumferential turns with a spacing of 150 mm along the central axis, same as for the tube in the project thesis described in the paper. The 300 mm long tube only had the fiber applied at one single circumference on the middle of the tube, to easily and without generating to much data reveal if the buckling mode of the length sensitivity analysis occurred. The 400 mm long tube had the fiber also laid at one circumference on the middle of the tube based on that the middle circumference strain reading proved to be the critical reading for the matching in the paper. The equipment used for measuring signals from the fiber was NTNU's fiber optic equipment. Details concerning the optical fiber can be found in the paper in Appendix A and for more indepth knowledge, see M. Haaheim's master's thesis [16].

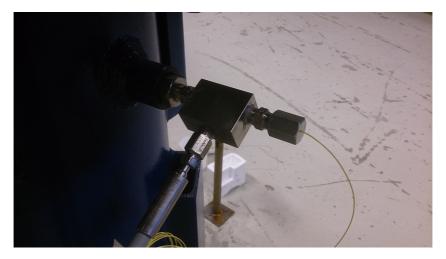
Figure 4.5: T-fitting with pressure hose and fiber escaping through end cap.

In order to get the signal wire securely out from the autoclave without leakage, a T-fitting was used together with an end cap. The end cap had a hole of 1 mm drilled for the signal wire. To keep the end cap water and pressure tight, Araldite Rapid was applied so that it filled up the inner cavity of the end cap, where the fiber went through. Figure 4.5 shows the T-fitting with the fiber escaping from the end cap and the pressure hose going into the T-fitting.

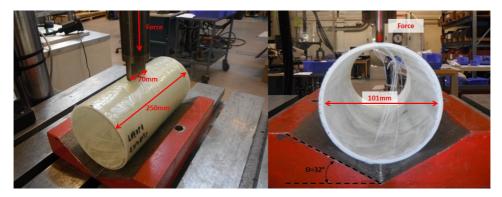
Figure 5.1: Perillo's ring compression test setup, the setup can be seen modelled in FEA in Figure 5.2. The figures are taken from G. Perillo's PhD thesis [21].

indicated in Figure 5.1 and the displacement was recorded at the same spot as the force, as can be seen in the graph in Figure 5.2 together with the FEA model. The filament wound material was found to have a volume fraction of 0.62, 14.8 % higher than for the vacuum infused samples at 0.54. Even though the volume fraction was higher, the E-moduli had to be reduced by 25 % compared to the volume fraction scaled values, as can be seen in the force/displacement graph. The total decrease in the E-modulus in fiber direction was 13.8 %, from 44.8 GPa to 38.6 GPa, however, a different scaling method was used than in this master's thesis and also more material data than just in the fiber direction was scaled. The decrease in E-moduli was concluded as being due to a higher void content, see G. Perillo's PhD thesis [21] for further information.

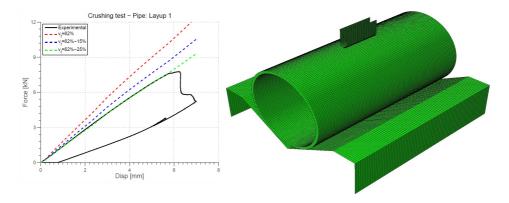
Figure 5.2: Perillo's ring compression test setup as modeled in FEA together with the force/displacement curve. The blue, red and green lines are with scaled material data with respect to volume fraction minus the percentage indicated to weigh up for higher void content. The figure is taken from G. Perillo's PhD thesis [21].

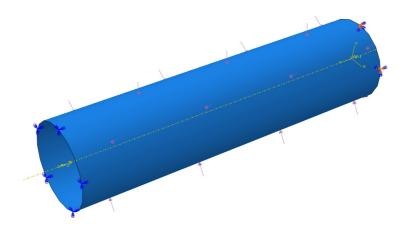
Figure 6.1: The fixed constraints on the 400 mm long tube needed for achieving matching between the FEA and the optical fiber strain results. The blue triads indicate the fixed constraint at each side of the tube.

To achieve a good a match as possible in the FEA for the 400 mm long tube, the imperfection was introduced through import from linear buckling analysis instead of modeling an ovality as for the 600 mm long tube. The buckling shape from the linear buckling analysis was scaled with a scaling factor of 0.18, corresponding to a radial deformation/ovality of ± 0.23 mm/0.46 % as the radial deformation of the linear buckling analysis was ± 1.275 mm. Besides importing the linear buckling shape, the end caps had to be modeled as fixed and not freely supported to yield a stiff enough behavior. Figure 6.1 shows the fixed constraint. Besides using the fixed constraints, the same longitudinal E-modulus as for the 600 mm long tube of 37738 MPa had to be used to achieve a stiff enough behavior.

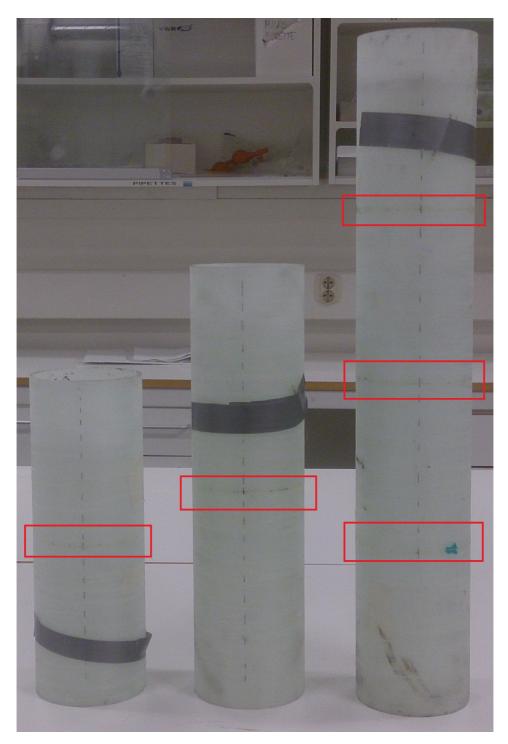
Figure 6.2: Picture of the tubes post testing with fiber paths highlighted with red squares.

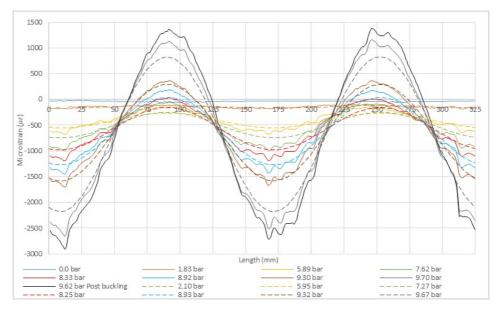
Figure 6.3: Strain measurements and FEA results at 150 mm on the 600 mm long tube from test nr. 1.

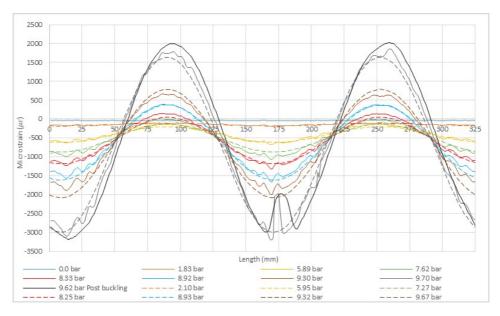
Figure 6.4: Strain measurements and FEA results at 300 mm on the 600 mm long tube from test nr. 1. The post buckling measurement have been smoothed, the original measurement can be found in the Appendix in Figure B.2.

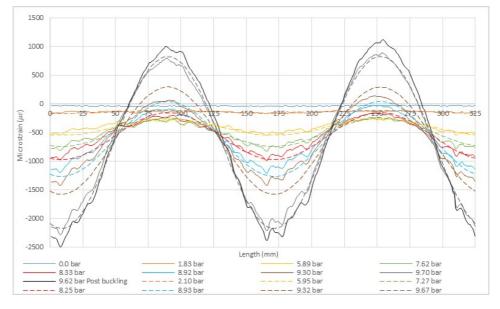
Figure 6.5: Strain measurements and FEA results at 450 mm on the 600 mm long tube from test nr. 1.

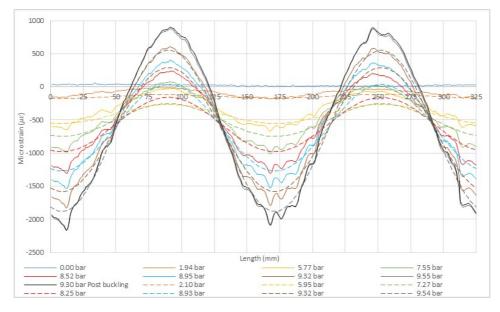
Figure 6.6: Strain measurements and FEA results at 150 mm on the 600 mm long tube from test nr. 2.

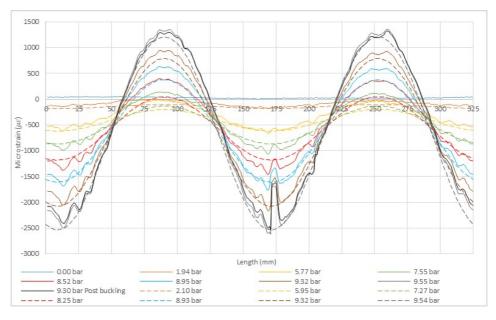
Figure 6.7: Strain measurements and FEA results at 300 mm on the 600 mm long tube from test nr. 2.

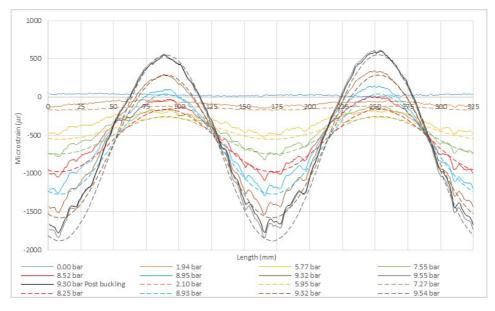
Figure 6.8: Strain measurements and FEA results at 450 mm on the 600 mm long tube from test nr. 2.

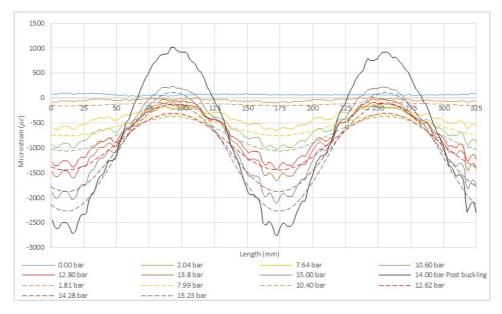
Figure 6.9: Strain measurements and FEA results at 200 mm on the 400 mm long tube from test nr. 1.

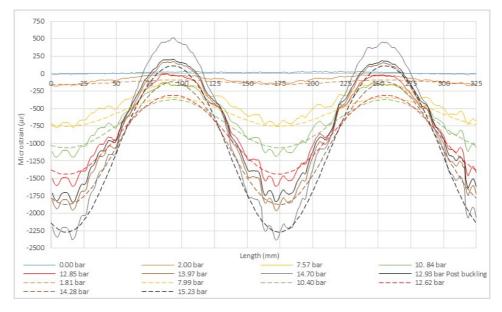
Figure 6.10: Strain measurements and FEA results at 200 mm on the 400 mm long tube from test nr. 2.

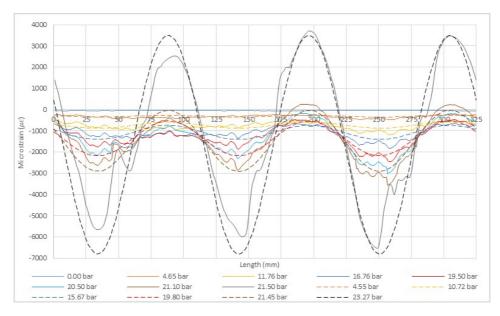
Figure 6.11: Strain measurements and FEA results at 150 mm on the 300 mm long tube. As can be seen the tube has got a three lobe buckling mode, indicated by the three peaks of the strain curve. The post buckling measurement have been smoothed, the original measurement can be found in the Appendix in Figure B.9.

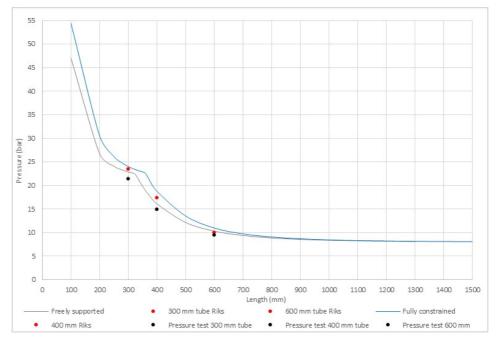
Figure 6.14: Length sensitivity analysis with both fixed and freely supported constraints.

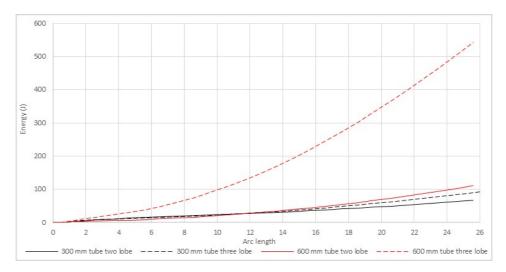
Figure 6.15: Comparison between strain energy with different buckling modes. As can be seen, the three lobe buckling mode requires a lot more work on the 600 mm long tube than the two lobe, likewise for the two lobe on the 300 mm long tube. However, the difference is a lot less on the 300 mm long tube due to the buckling pressure being closer to the buckling mode transition lengths buckling pressure, as can be seen in Figure 6.14.

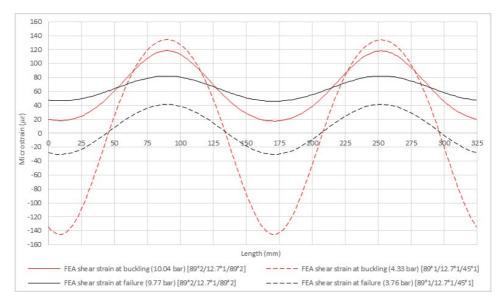
Figure 7.1: Shear strain at 300 mm on the 600 mm long tubes for the $[89^{\circ}_{2}/12.7^{\circ}_{1}/89^{\circ}_{2}]$ and the $[89^{\circ}_{1}/12.7^{\circ}_{1}/45^{\circ}_{1}]$ layup at the FEA predicted buckling pressure and at the increment closest to the buckling/failure pressure of the tests (9.75 bar and 3.5 bar).

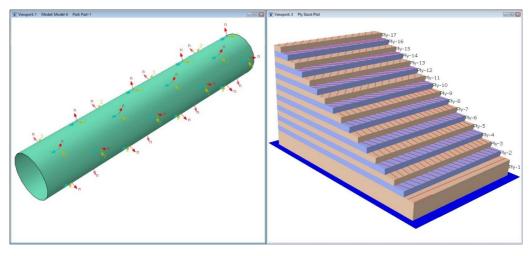
Figure 6 Layup in Abaqus showing the direction of the material coordinate system and orientation of each ply.

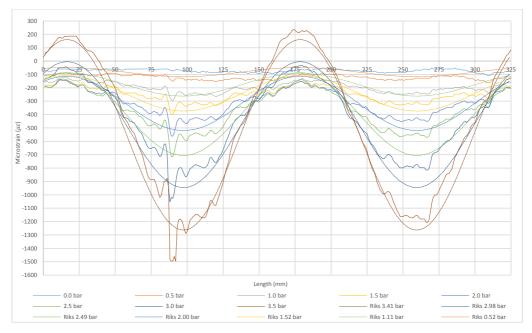
Figure 9 Optic fiber strain readings and FEA results comparison graph for the middle circumference (at 300 mm) of the tube. The dashed curves are from FEA and the continuous lines are from the optic fibers. The curves with equal color are at the same pressure.

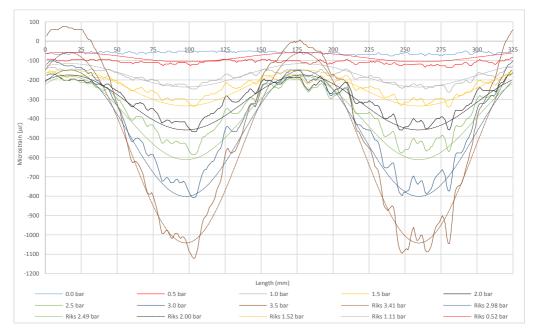
Figure 10 Optic fiber strain readings and FEA results comparison for the bottommost optic fiber circumference (at 150 mm) of the tube. The dashed curves are from FEA and the continuous lines are from the optic fibers. The curves with equal color are at the same pressure.

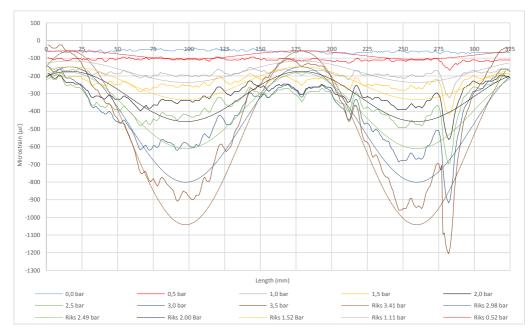
Figure 11 Optic fiber strain readings and FEA results comparison for the topmost optic fiber circumference (at 450 mm) of the tube. The striped curves are from FEA and the continuous lines are from the optic fibers. The curves with equal color are at the same pressure.

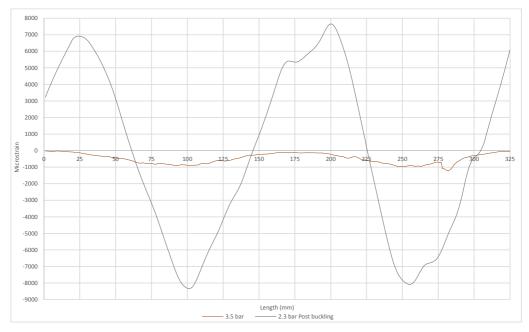
Figure 12 Optic fiber strain reading at 2.3 bar from the topmost optic fiber circumference of the tube (450 mm)after occurrence of the pressure dependent leakage, the reading has been smoothed in Matlab due to severe noise.

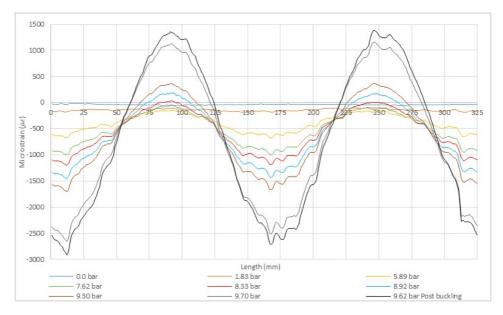
Optic fiber at 150 mm

Figure B.1: Strain measurements from optic fiber at 150 mm on the 600 mm long tube from test nr. 1.

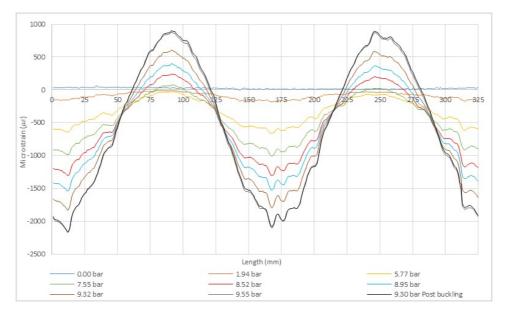
Optic fiber at 150 mm

Figure B.4: Strain measurements from optic fiber at 150 mm on the 600 mm long tube from test nr. 2.

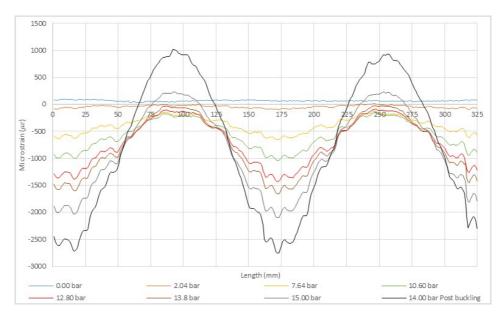
Figure B.7: Strain measurements from optic fiber at 200 mm on the 400 mm long tube from test nr. 1.

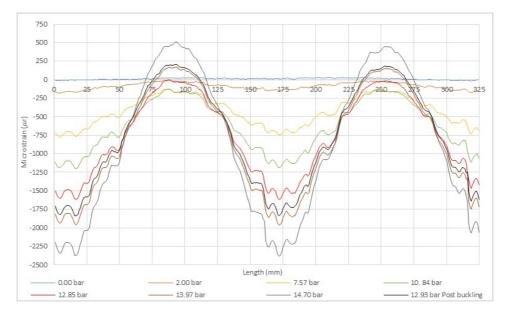
Figure B.8: Strain measurements from optic fiber at 200 mm on the 400 mm long tube from test nr. 2.

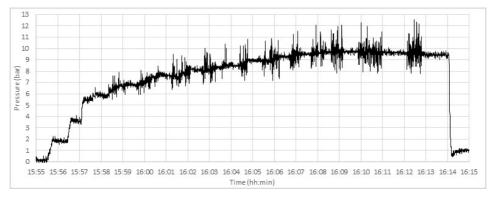
Figure B.10: Pressure reading from test nr. 1 of the 600 mm long tube.

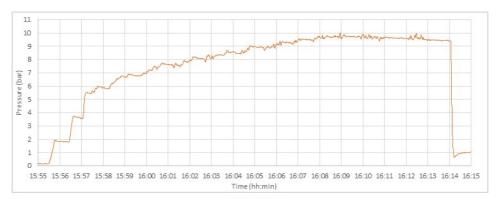
Figure B.11: Pressure reading from test nr. 1 of the 600 mm long tube, smoothed using Matlab.

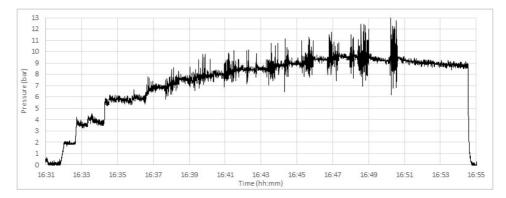
Figure B.12: Pressure reading from test nr. 2 of the 600 mm long tube.

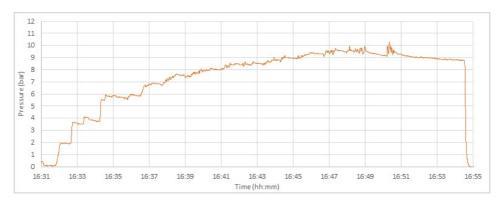
Figure B.13: Pressure reading from test nr. 2 of the 600 mm long tube, smoothed using Matlab.

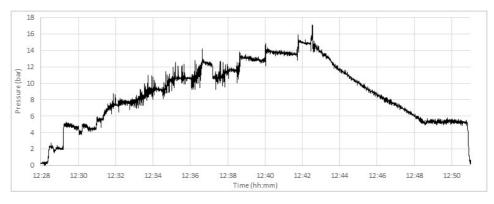
Figure B.14: Pressure reading from test nr. 1 of the 400 mm long tube.

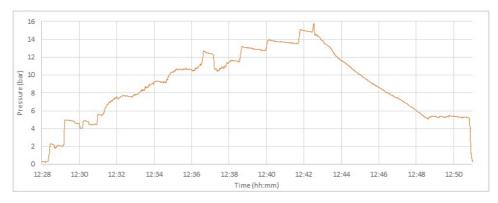
Figure B.15: Pressure reading from test nr. 1 of the 400 mm long tube, smoothed using Matlab.

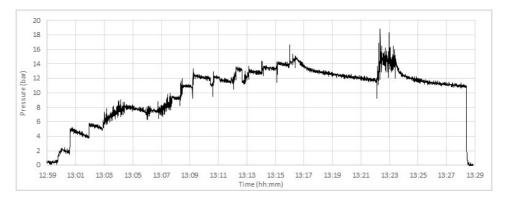
Figure B.16: Pressure reading from test nr. 2 of the 400 mm long tube.

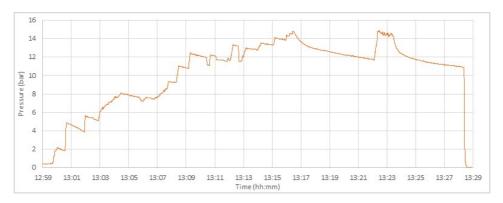
Figure B.17: Pressure reading from test nr. 2 of the 400 mm long tube, smoothed using Matlab.

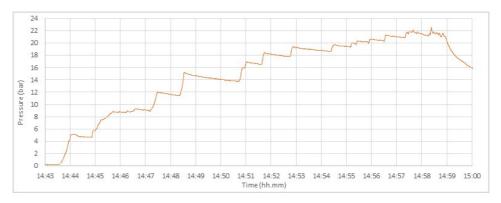
Figure B.19: Pressure reading from the 300 mm long tube, smoothed using Matlab.

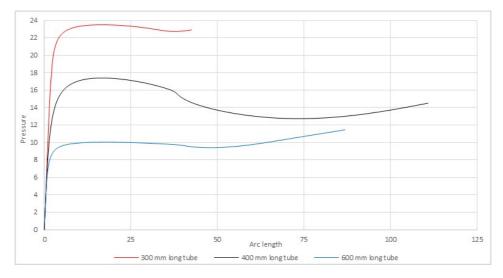
Figure B.20: The Load proportionality factor scaled so as to reveal pressure set against the arc length of the tubes.

analysis can be seen in Figure B.20 (for convenience, scaled so as to reveal pressure). To further support this, reading from the Riks analysis for the 600 mm long tube at 9.77 bar, the Tsai-Wu failure criterion reveals a max exposure factor of only 0.32, even though being just 0.27 bar from the buckling pressure and just 0.02 bar above the test's buckling pressure. Even though the layup likely developed a matrix failure enabling water to penetrate, it must be pointed out that the matrix failure strength is based on fracture strength. This means that the matrix can have developed cracks long before reaching the matrix failure strength, as indicated by the low exposure factor at the test's buckling pressure.

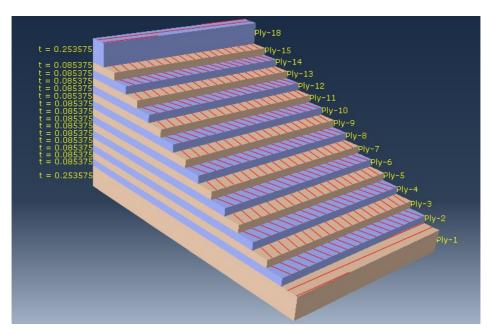
Figure D.12: Layup nr. 2, $[89^{\circ}_{1}/12.7^{\circ}_{n}/89^{\circ}_{1}]$ in Table 2.3.

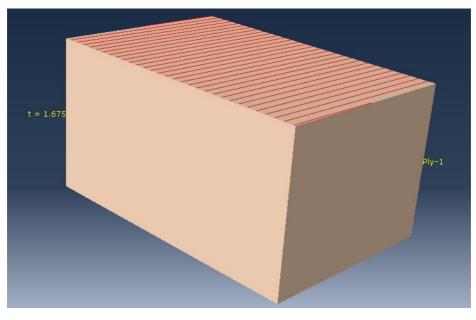
Figure D.13: Layup nr. $3,[89^{\circ}_n]$, in Table 2.3.

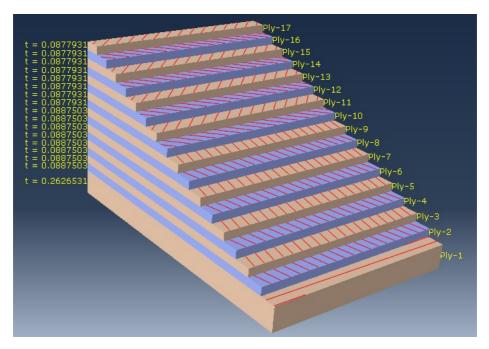
Figure D.14: Layup nr. 4, [89°₁/12.7°₁/45°₁], in Table 2.3.

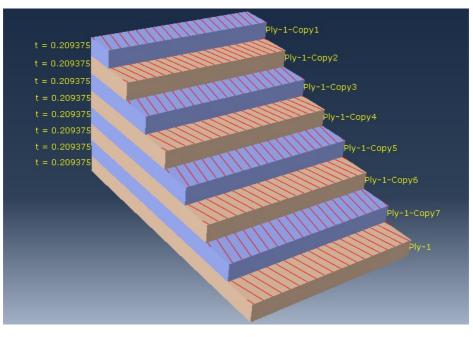
Figure D.15: Layup nr. 5, [12.7° *_n*], in Table 2.3.

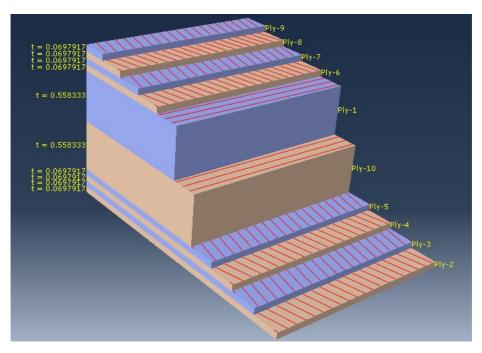
Figure D.16: Layup nr. 6, $[12.7^{\circ}_{n}/89^{\circ}_{2}/12.7^{\circ}_{n}]$, in Table 2.3.

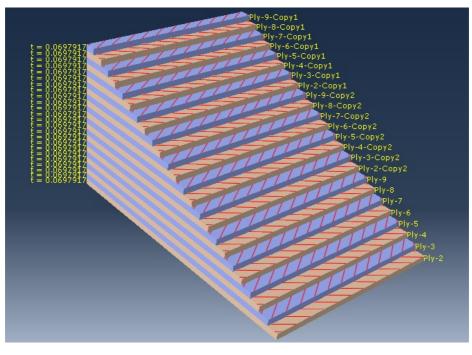
Figure D.17: Layup nr. 7, [55° *n*], in Table 2.3.

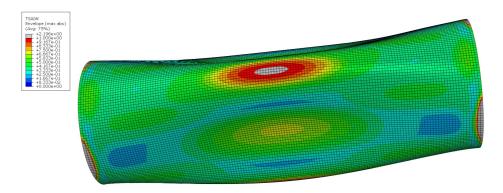
Figure D.20: Max exposure factor of the Tsai-Wu failure criterion through the thickness of the 300 mm long tube. The scaling factor is set to 5 and the failure pressure is 23.49 bar.

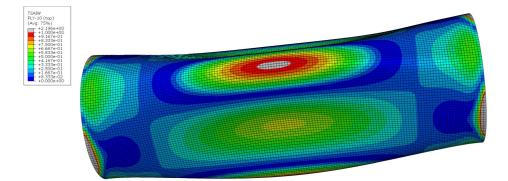
Figure D.21: Tsai-Wu failure criterion at the top of the top ply on the 300 mm long tube. The scaling factor is set to 5 and the failure pressure is 23.49 bar. As can be seen, the top of the lobe corresponds with the max exposure factor plot in Figure D.18, making it the most critical spot.
