The Unstable Rock Slope Kassen

A Hazard, Consequence and Stability

Assessment of the Rock Slope

Kaja Krogh

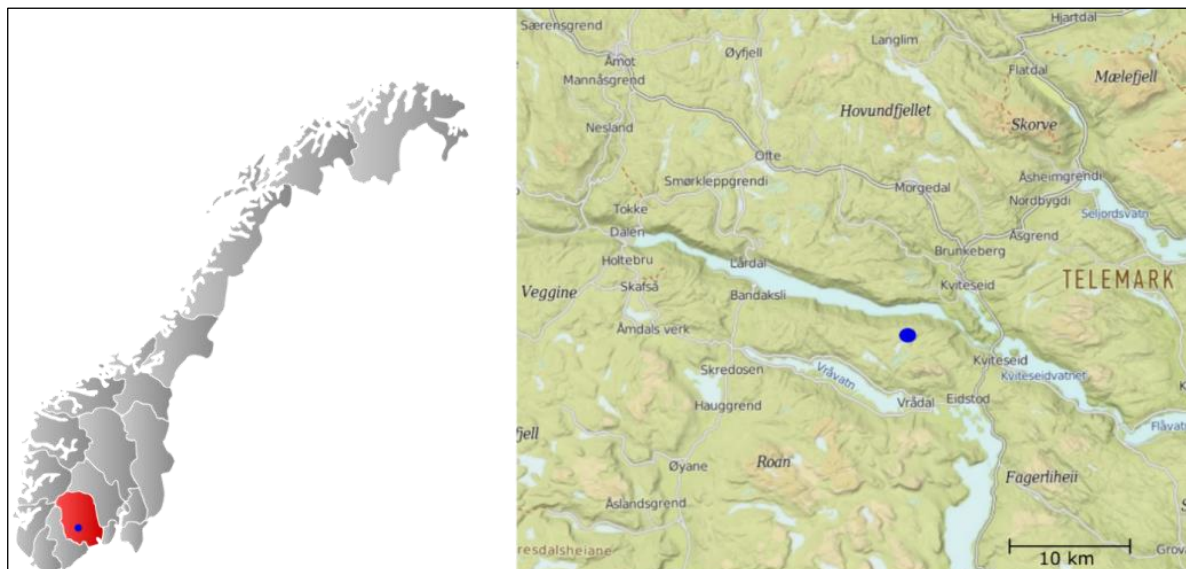
Figure 2: Kassen unstable slope is located in Kviteseid municipality in Telemark county.

The Kassen site is defined as a potential unstable slope due to very high rock mass deformation within the domain compared to the adjacent slopes. The site is located at the North shore, in the southeastern part of the 27 km long Bandak Lake (72 masl), shown in Figure 2. Bandak lake is orientated WNW-ESE, parallel to several other distinct structures in the region. A major fault zone is identified underneath the lake (Nilsen, Dons J.A., & Gyøry, 2013).

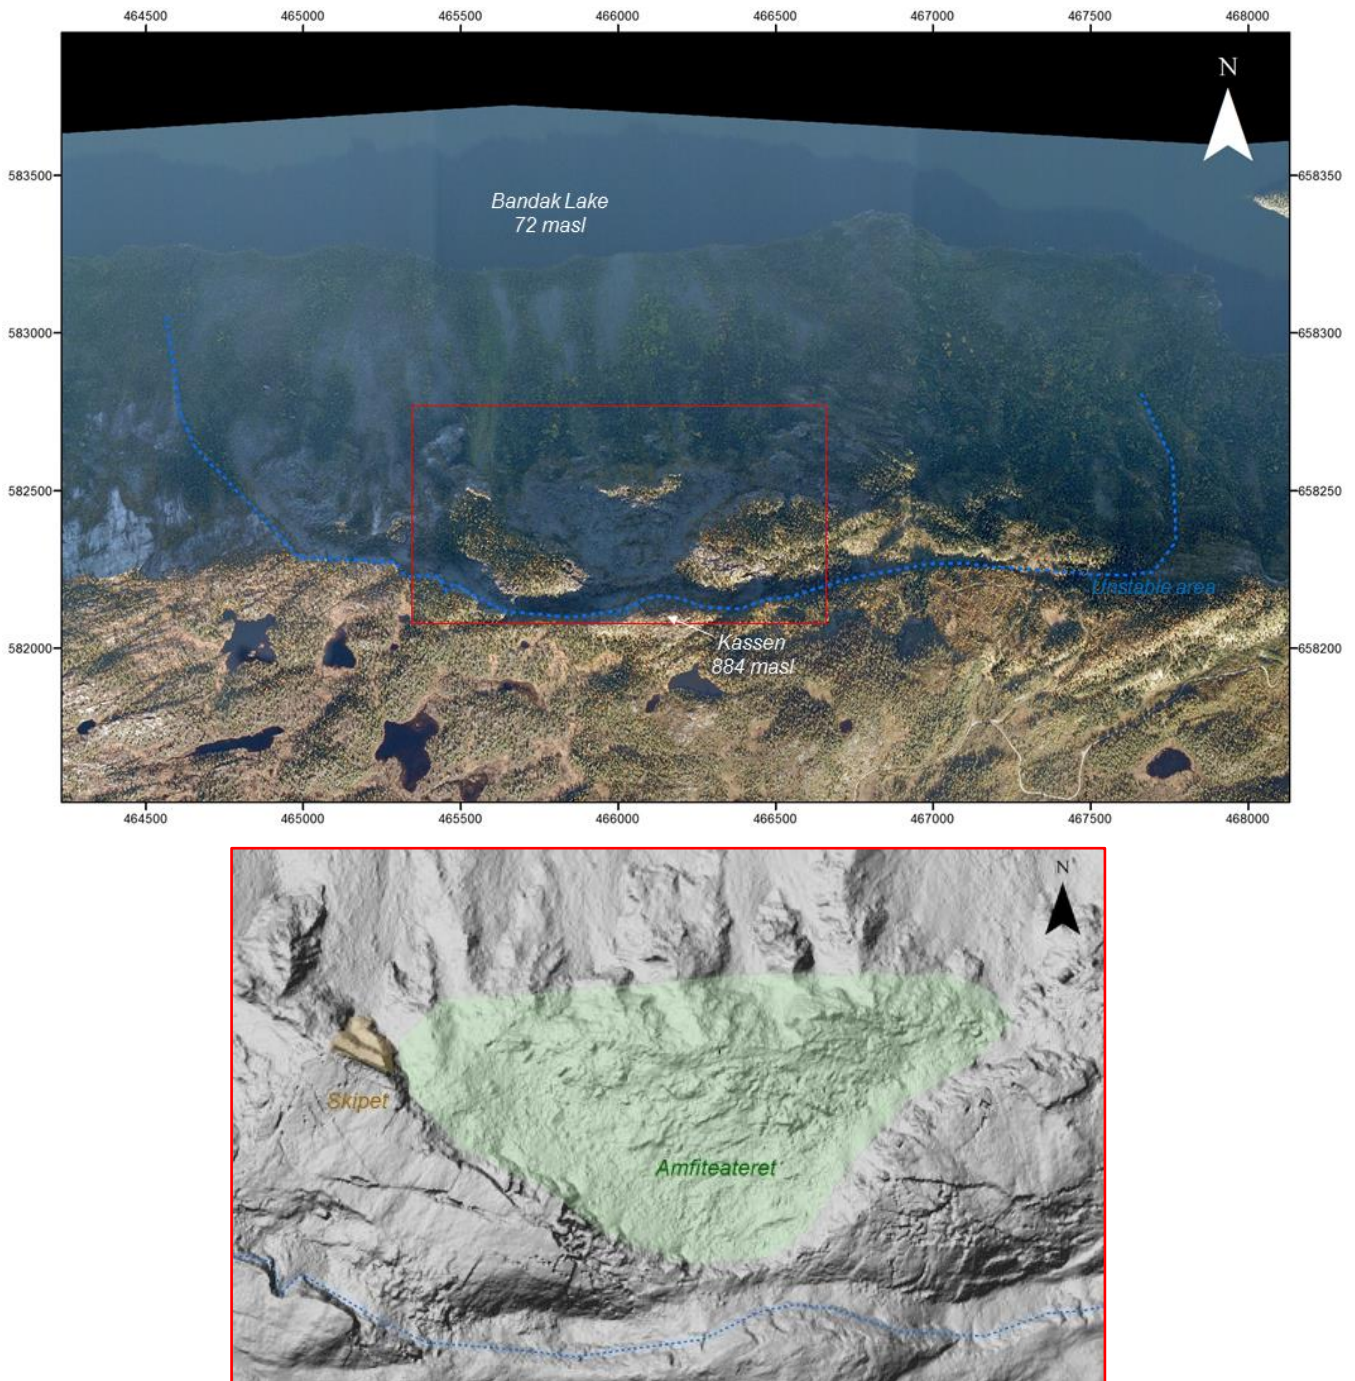
Figure 3: An overview of the unstable area (limits marked with blue) is given in the upper Orto photo. Notice the difference in degree of deformation and activity between the western and eastern part. The lower figure shows the DEM of the area marked with red, where the locations of Amfiteateret and Skipet are highlighted.

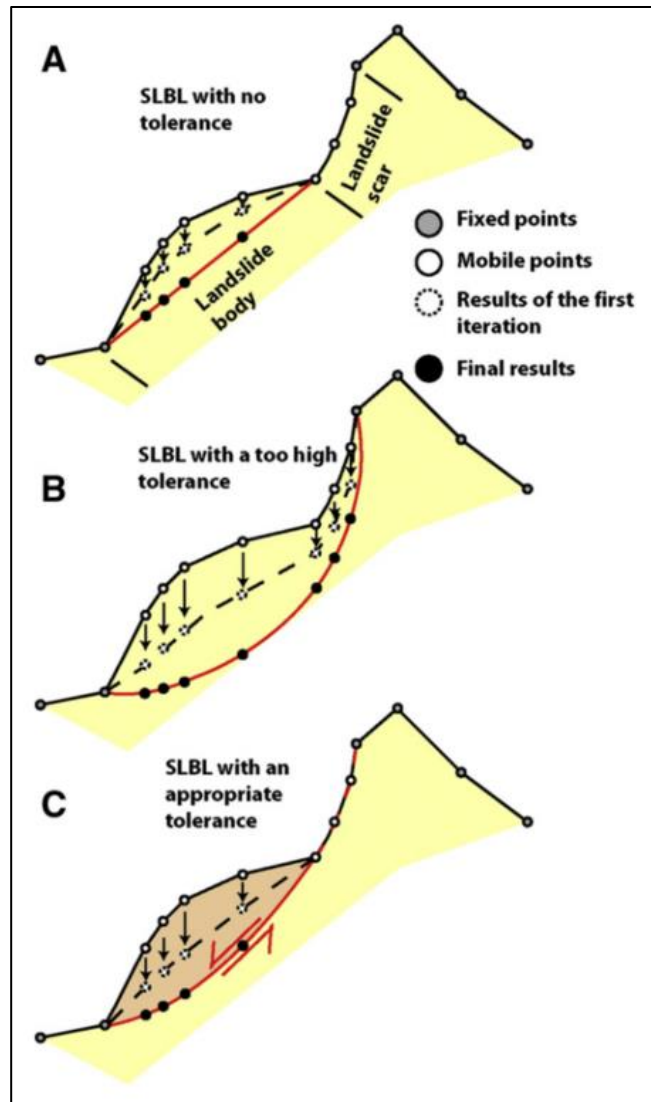
Figure 19: Example of an unstable slope with three sliding structures of different depth. A, B and C corresponds to C_{min} , C_{max} and C_{inter} . Modified from (Travelletti et al., 2010).

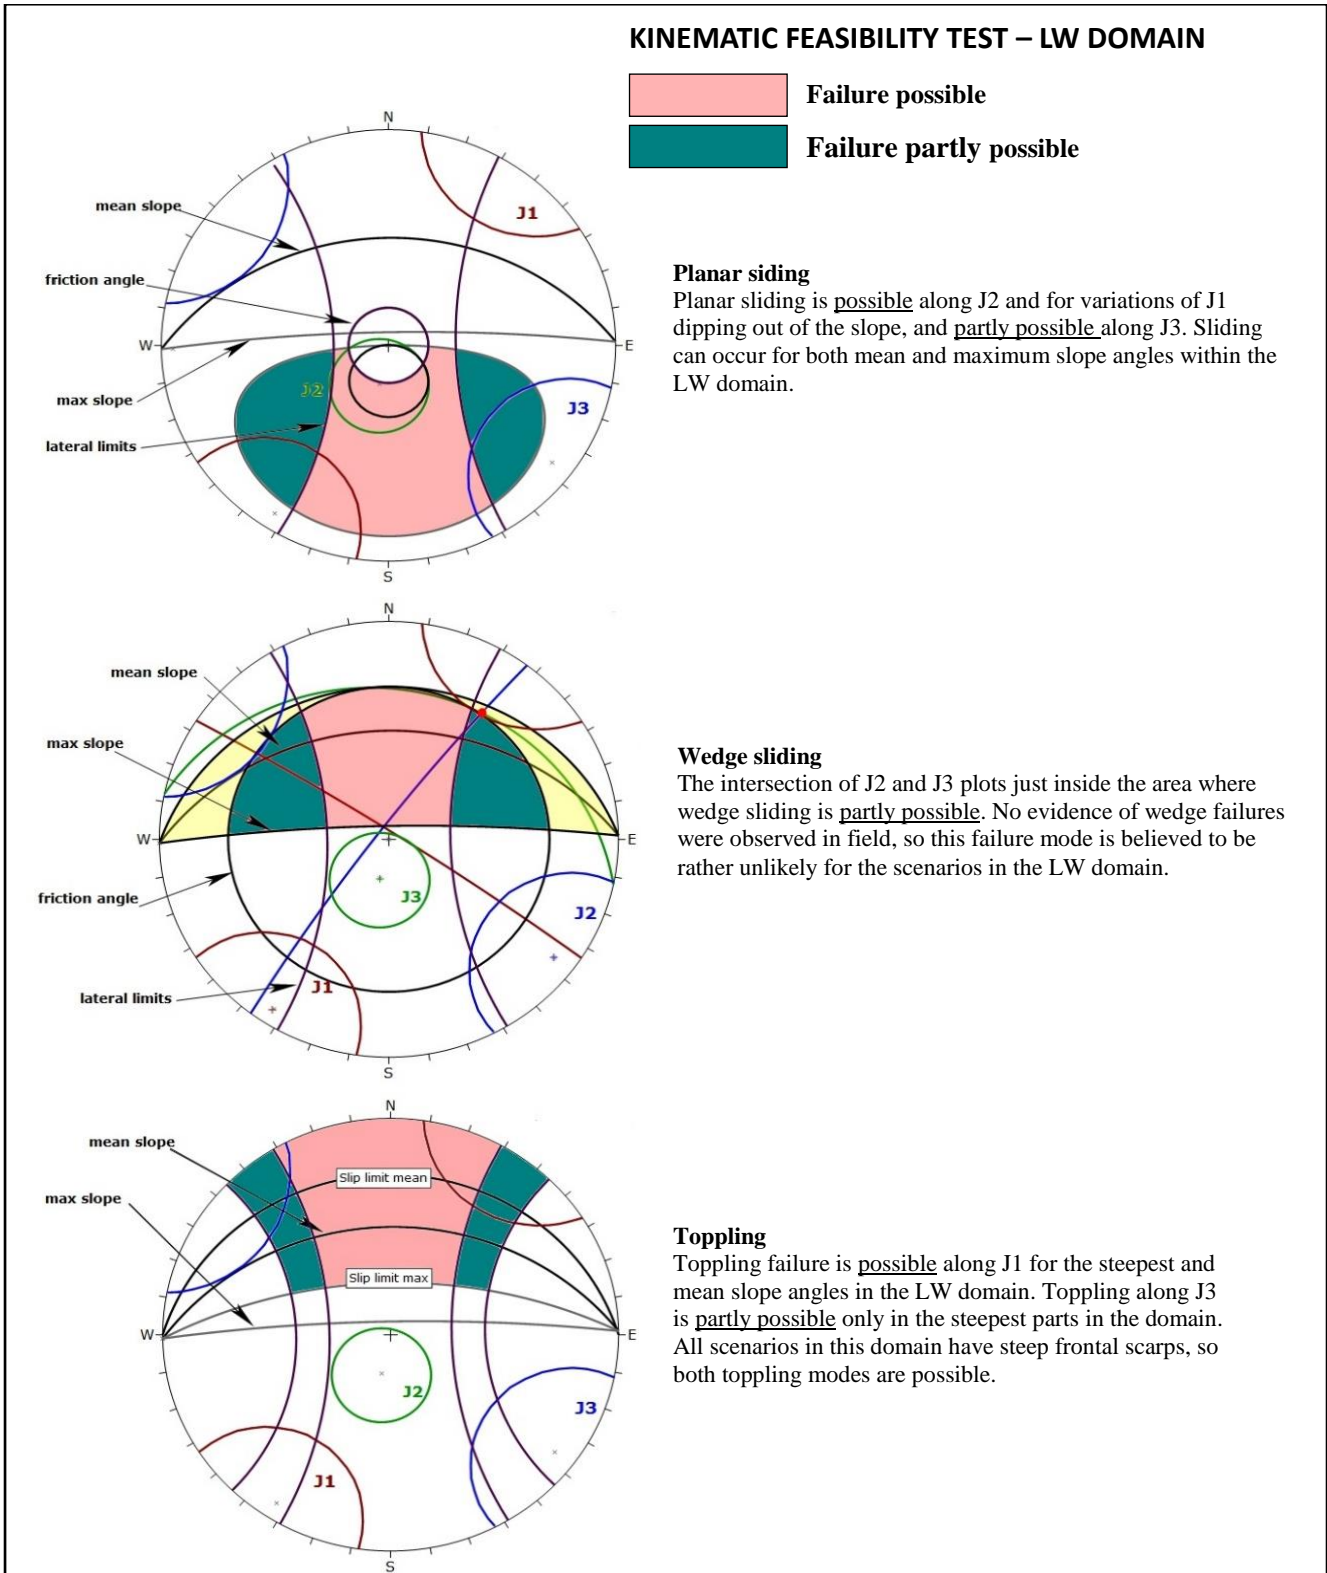
Figure 21: Kinematic feasibility test for the LW domain. Planar sliding and toppling is possible.

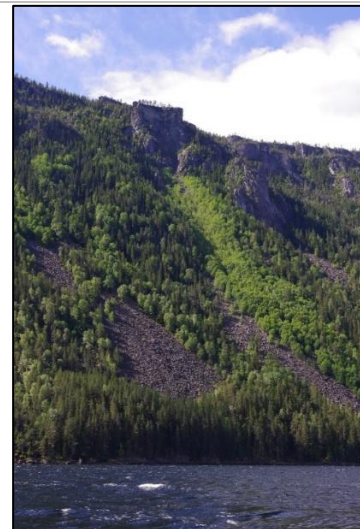
Scenario B			
Area [m ²]	4100		
Angle at backscarp [°]	90		
Basal angle at toe [°]	30		
H _{max} (m.a.s.l)	677		
H _{min} (m.a.s.l)	534		
Volume Min [Mm ³]	Runout Min [m] /	0.07	1045
Volume Mean [Mm ³]	Runout Mean [m]	0.11	1045
Volume Max [Mm ³]	Runout Max [m]	0.15	1045
<p>Left photo: Skipet is clearly visible as a prominent cliff. The light coloured vegetation indicates that the area is relatively active concerning rock fall activity.</p>

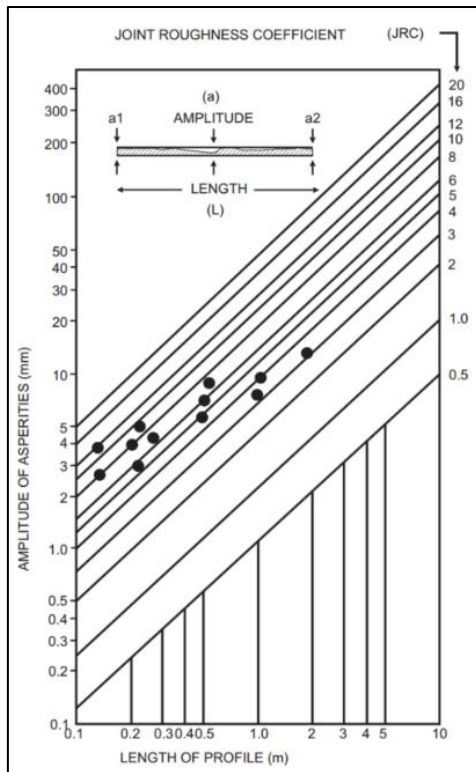
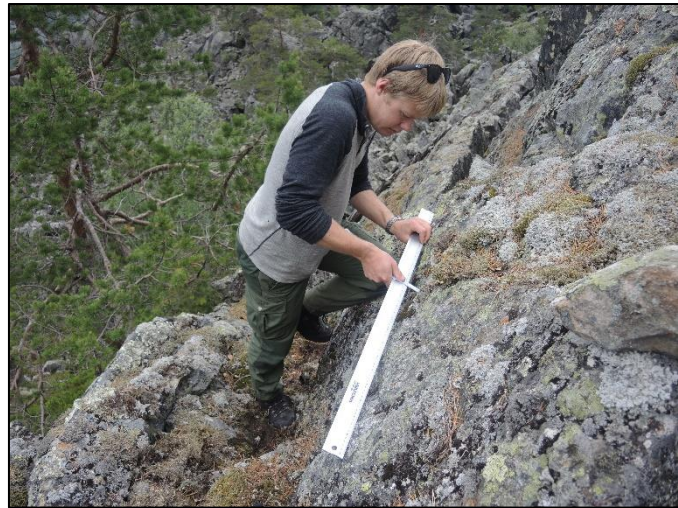
Figure 38: Chart to the left shows how to find the JRC value (Deere & Miller, 1966). The practical method in field is demonstrated in the upper right picture. At Kassen, a one-meter straight ruler was used.

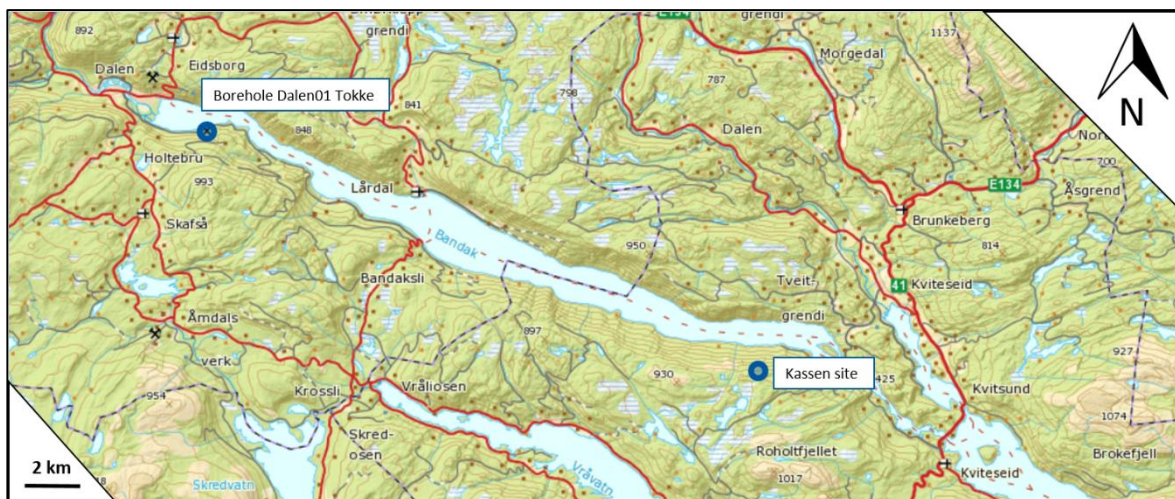
Figure 46: Location of Borehole Dalen01 Tokke where numeric values for the principle stresses are found.

No stress measurements exist for the Kassen slope, so the input numeric values for the principle stresses are found in a database presented by Hanssen (1998). This database have gathered all available information on three-dimensional rock stress measurements from both NTH (NTNU) and SINTEF archives, and is known as the newest collection of field stress measurements in Norway. The nearest borehole is *Borehole Dalen01 Tokke*, located in a north-facing slope at the western end of Bandak lake, 21 km away from the Kassen site (Figure 46). The stress regime at this point is assumed to be similar to the study site since the measurements were taken in a slope with the same orientation as Kassen and is adjacent to the same regional structures (such as Bandak lake).

The values obtained for the measured three dimensional stress field (magnitude and orientation) at the borehole *Dalen01 Tokke* is shown in Table 19.

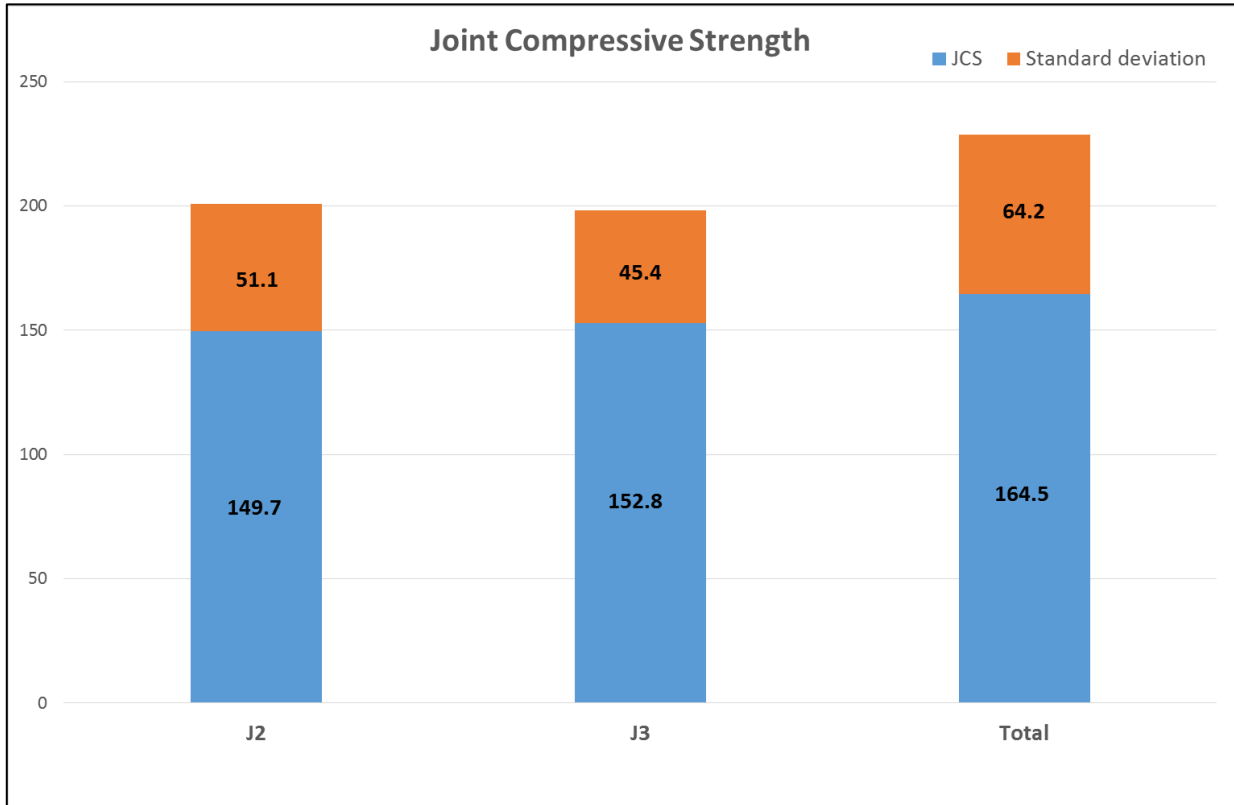
Figure 50: Mean JCS values and the standard deviation each joint set is graphically represented. The mean JCS value and standard deviation for all 26 measured surfaces (total) is also shown. All values are in Mpa.

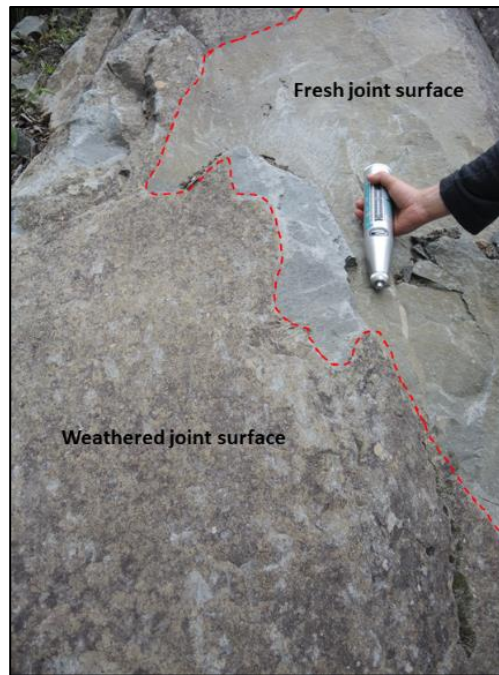
Figure 51: Surface showing both fresh unweathered rock where R is recorded and weathered rock where r is recorded.

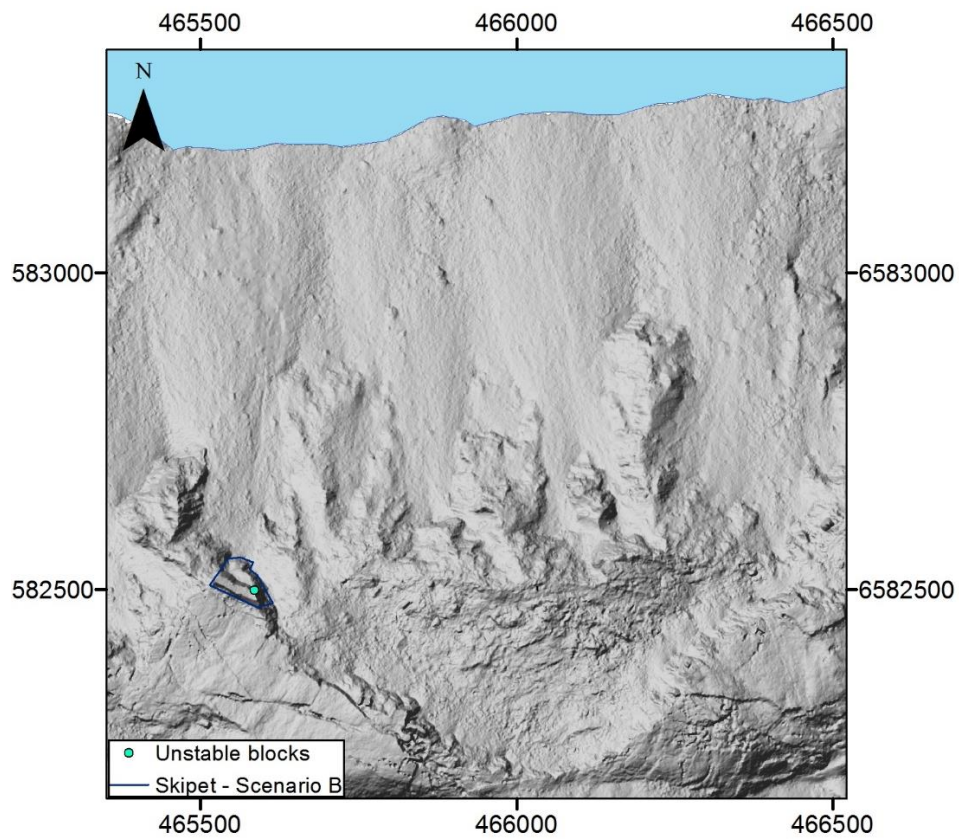
Figure 53: Location of the unstable blocks at the upper eastern side of Skipet.

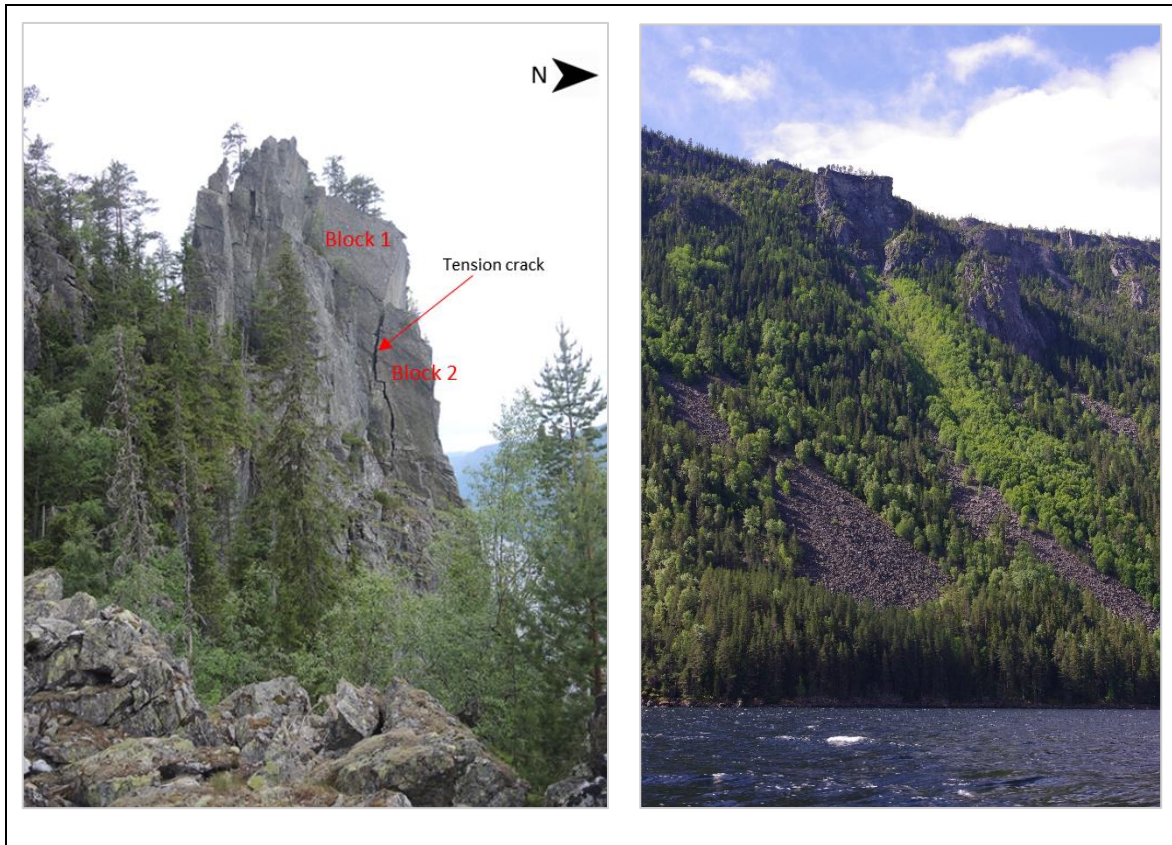
Figure 54: The left photo shows the two unstable blocks at Skipet. The light vegetation below Skipet in the right photo indicates that rock fall from Skipet has occurred in the past, and is believed to show the track from the 1985 event.

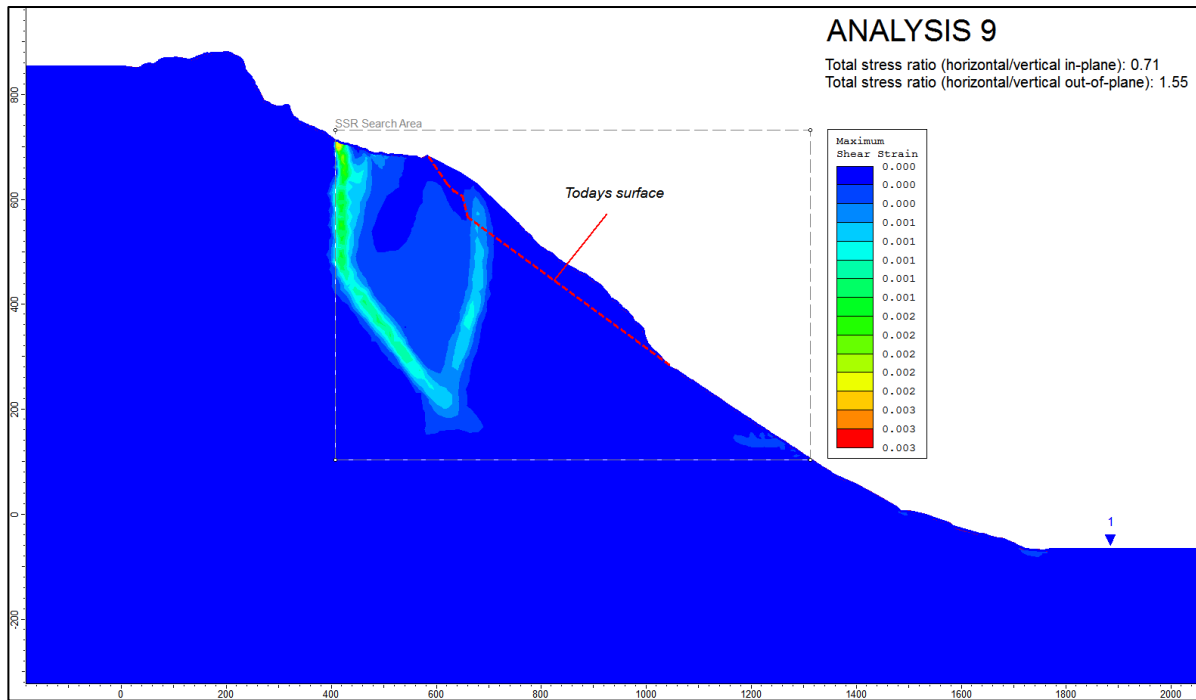
Figure 59: Shear strain plot for the model with field stress equal to the measurements from the borehole Dalen Tokke 01. Based on this plot it was decided to change the field stress to achieve a maximum shear strain plot representing a more likely failure surface.

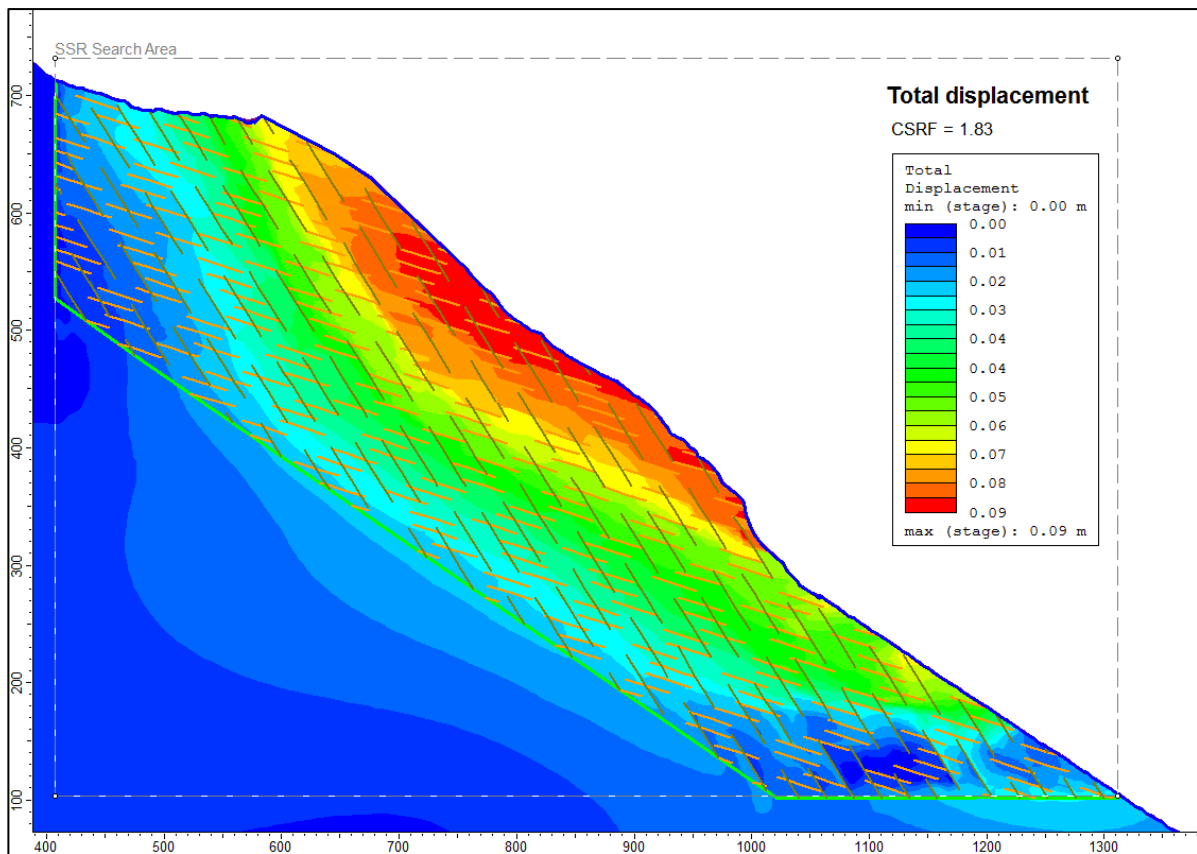
Figure 65: Zoom in of total displacement for analysis 5. Displacement contours partly align with joint orientation, indicating that displacement follow the joints. Irregular contours may indicate the failure of rock bridges, as the joints are modeled as discontinuous. Maximum displacement is 9 cm.

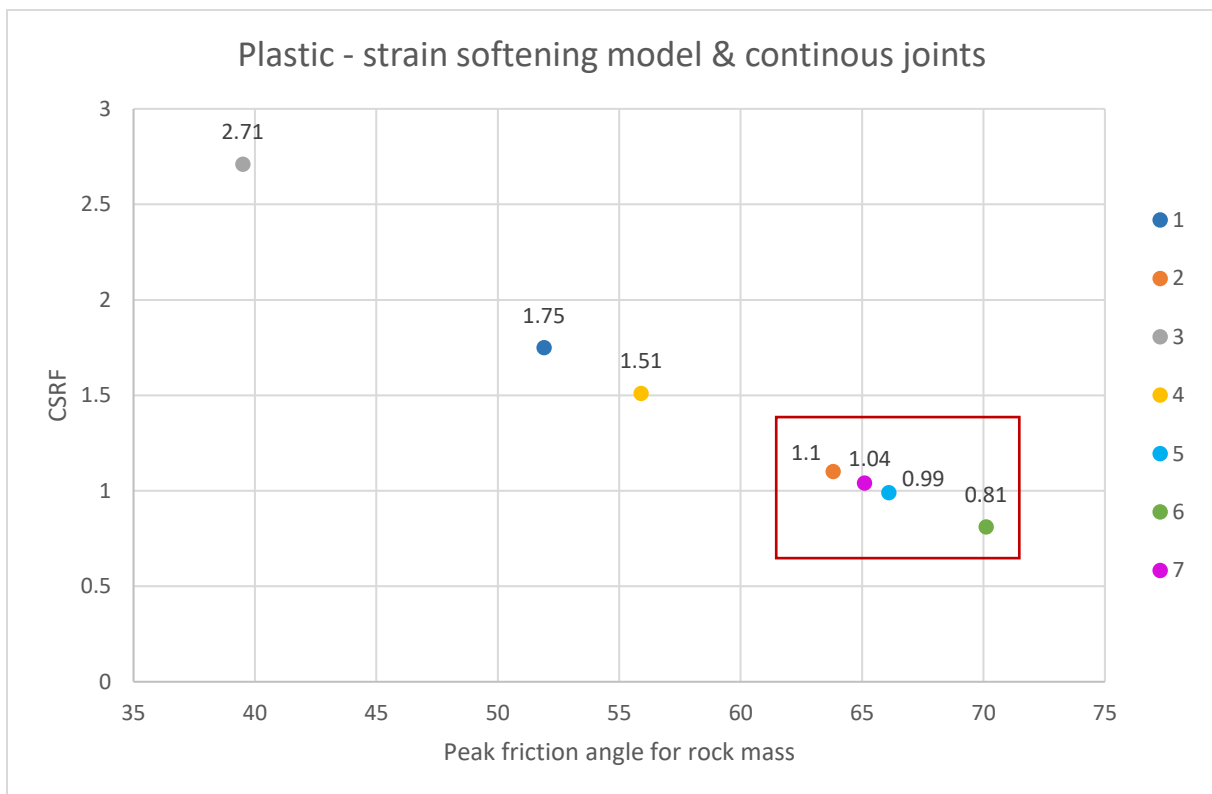
Figure 68: CSRF plotted against the factored peak friction angle for the rock mass. CSRF lower than one is per definition unstable, the analyses close or below this value are outlined with red.

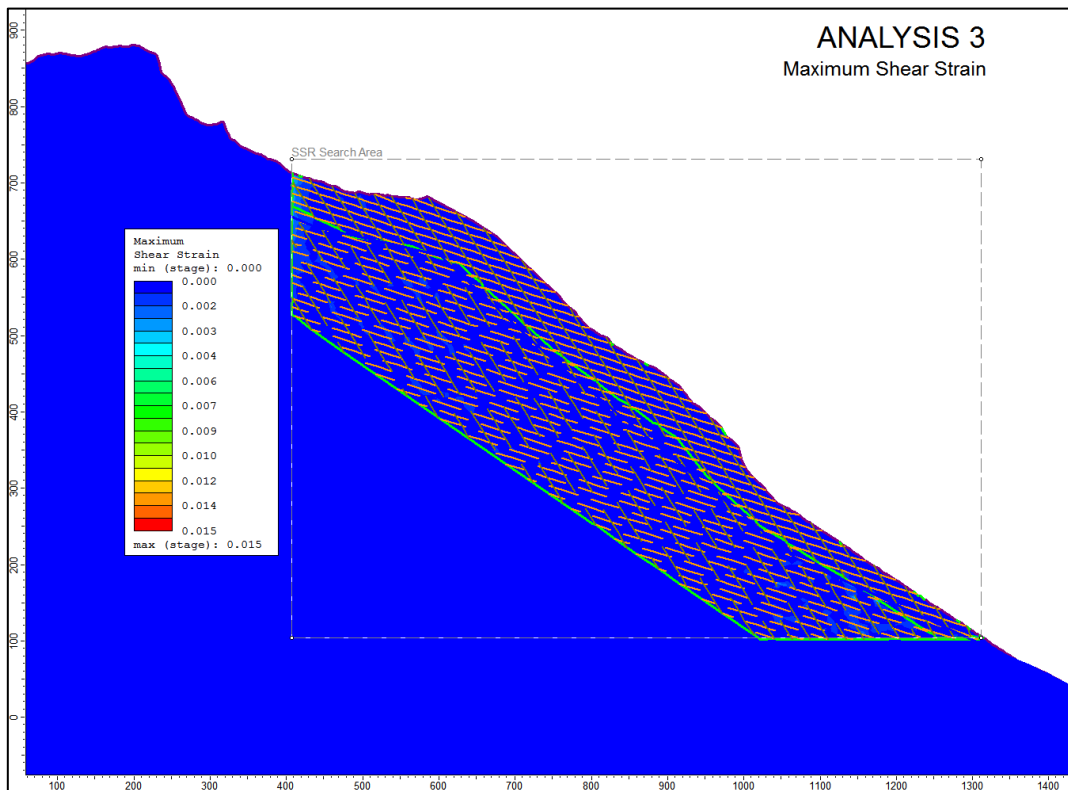
Figure 70: Maximum shear strain plot of Analysis 3 shows no visible shear strain and consequently no indication of the most likely failure surface. The reason for no visible shear strain is assumed to be that slip occurs only at the joint interfaces.

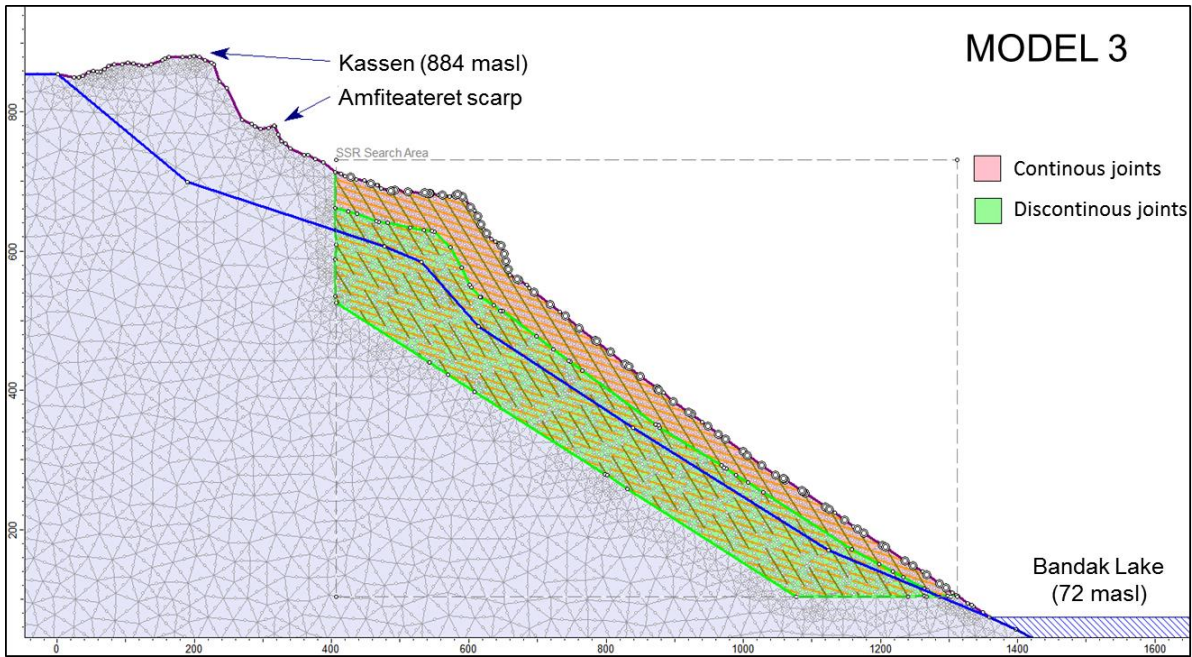
Figure 71: The geometry of Model 3 is the actual ground surface. The joints are added in two joint networks, the upper with continuous joints towards the surface and the lower with discontinuous joints.

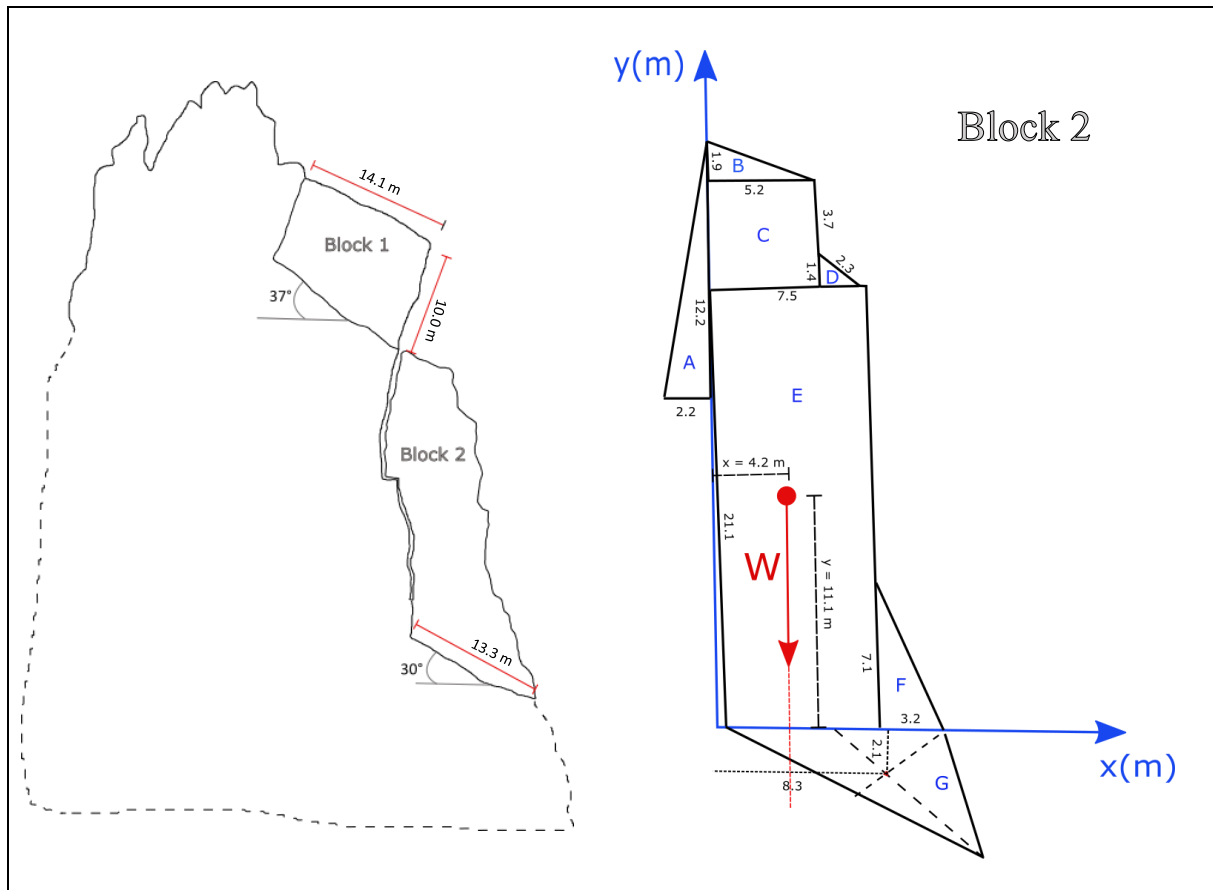
Figure 73: Both potential unstable blocks at Skipet is stable against toppling. For Block 2, the geometry was simplified in order to calculate the centroids of known figures such as triangles and squares.

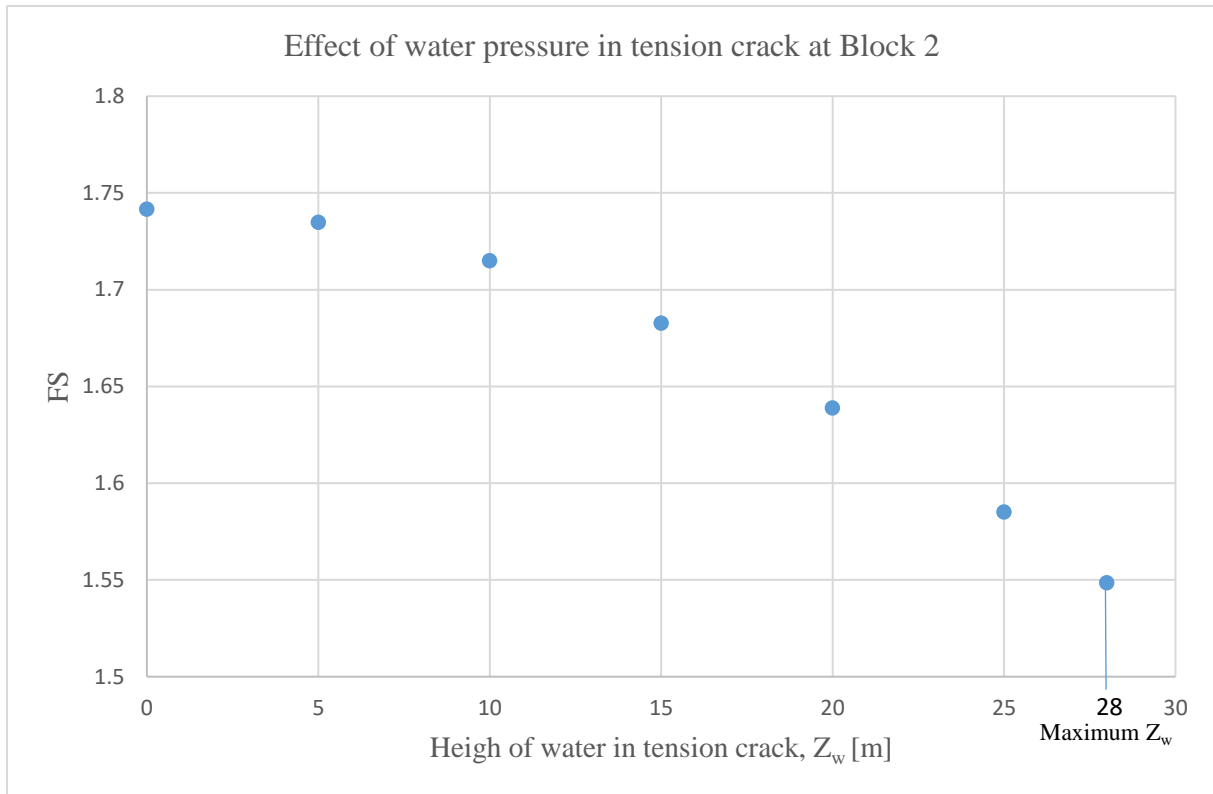
Figure 74: Diagram showing how the FS decreases with increasing water in the tension crack at Block 2. The block is still stable, even if water pressure acts over the entire length of the crack (maximum Z_w).

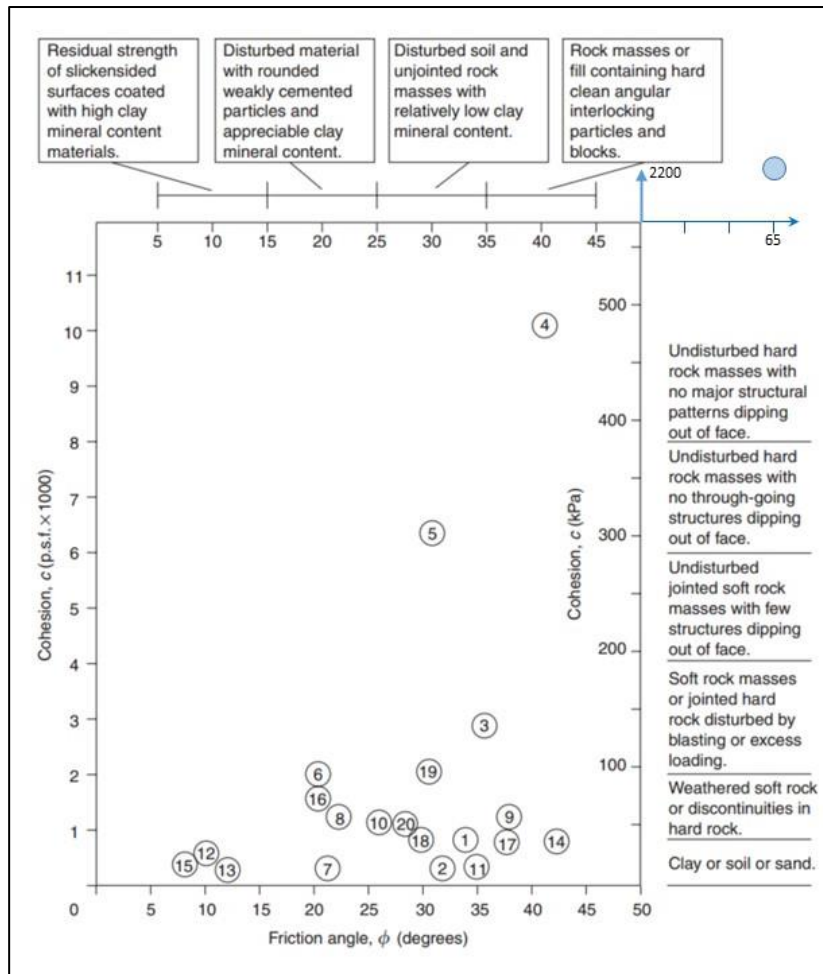
Figure 76: Chart showing friction angles and cohesive strengths for different rock masses found by back-analyses (Wyllie & Mah, 2004). The rock mass of amphibolite from Kassen is marked with a blue circle and show very high shear strength.

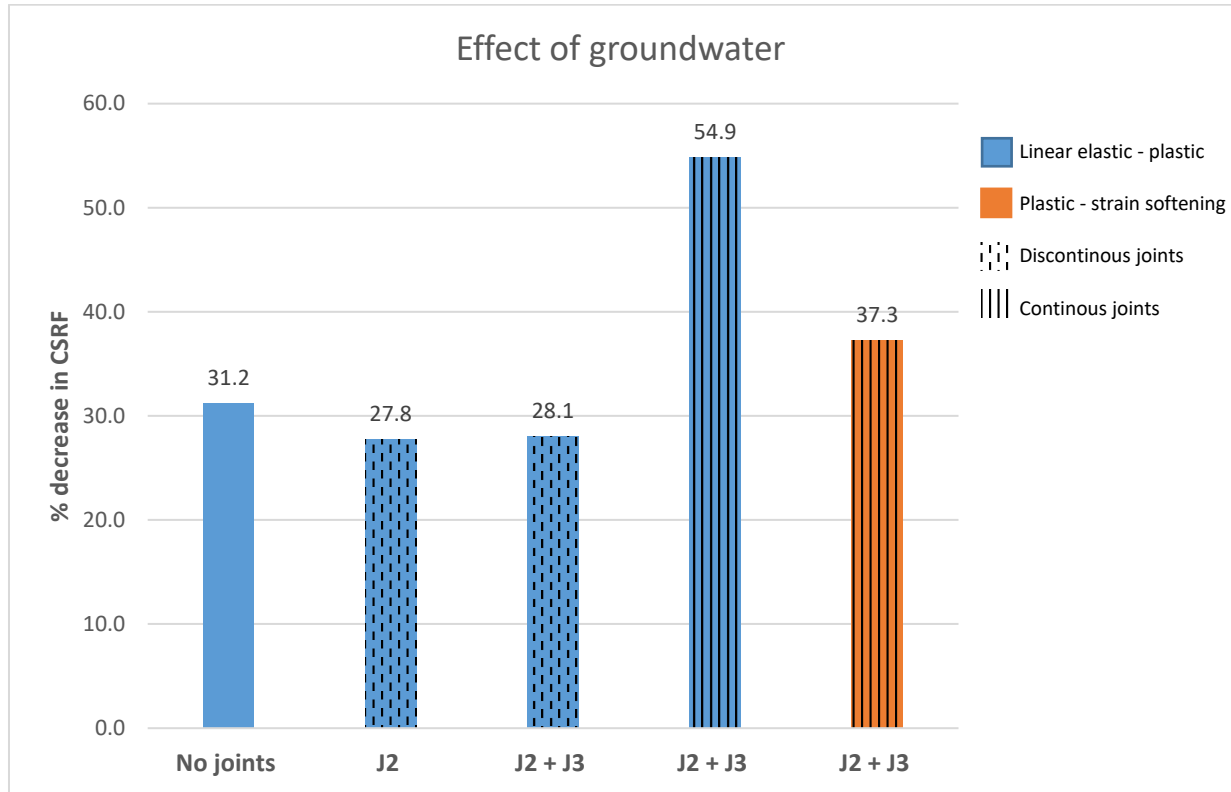
Figure 79: Comparison of the effect of lowering the groundwater table from high to present for different model set-ups. Dry slope conditions are not included in this comparison. All joints are assigned with their mean strength values.

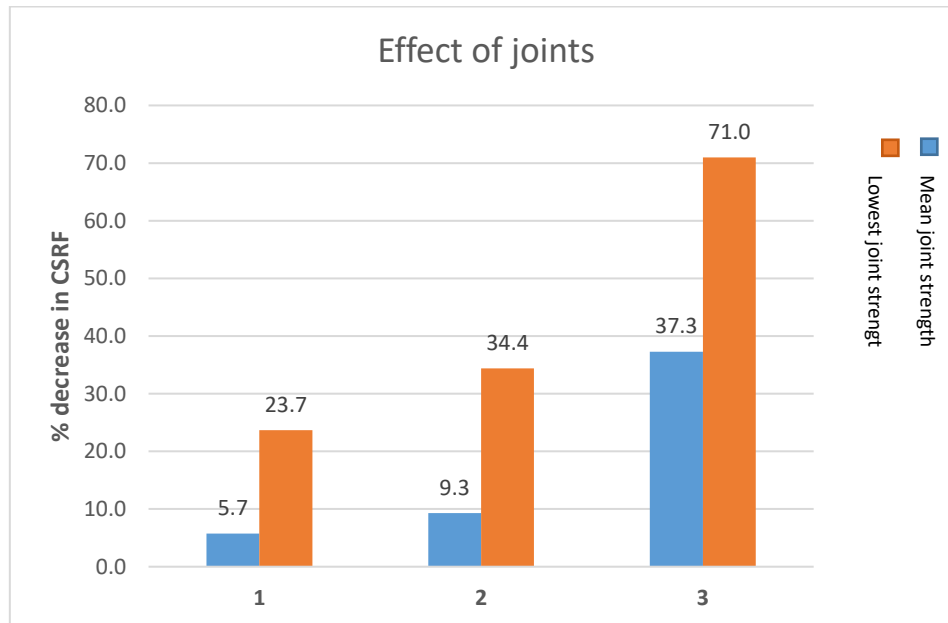
Figure 80: The effect of adding joints to the model analyzed through the percentage decrease in CSRF compared to a model without joints. In all analyses, the groundwater is high and the material and joint models are linear elastic – perfectly plastic.

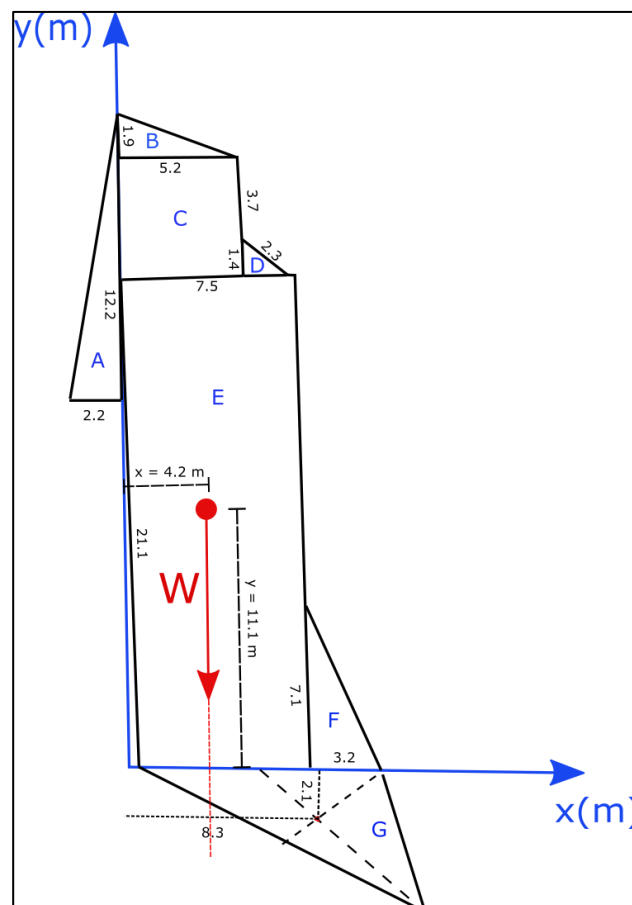
Calculations of the centre of gravity of Block 2. The Block was simplified into familiar shapes (triangles and rectangles), and the centroid for each figure was found in order to place the final centroid in Block 2. The results show that the centre of gravity falls inside the base of Block 2, and it will not topple.
