Preparation system, salt scaling, absorption and internal damage in the CEN/TS 12390-9 concrete frost test

MASTER THESIS 2017

SUBJECT AREA: Concrete Technology; fly ash concrete	DATE: 11.06.2017	NO. OF PAGES: 61 + 86
---	------------------	--------------------------

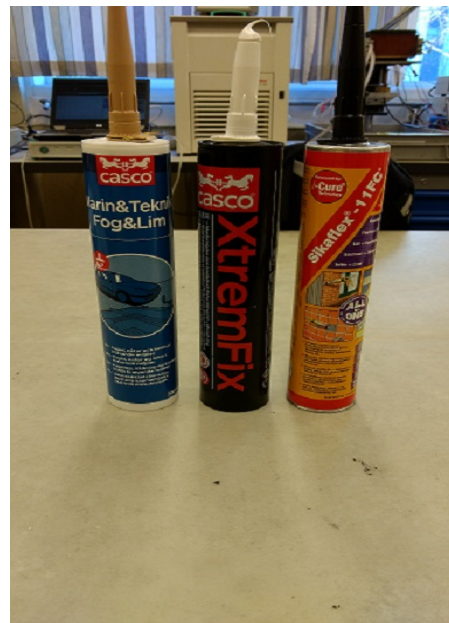
Figure 6: Adhesives

Casco XtremFix is a sealant adhesive produced to endure and tackle difficult challenges. The glue itself is extremely sticky and that which is glued together stays together immediately. It is very strong with the possibility to carry up to $200\text{kg}/\text{m}^2$. The adhesive has many qualities, such as: frost durability, good applicational abilities, good adhesiveness towards most surfaces as well as its strength when used on both horizontal and vertical surfaces.

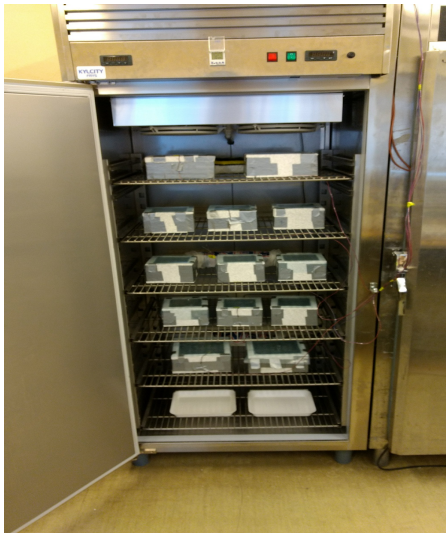
Figure 7: Freeze/Thaw Chamber

The four other thermocouples were each placed in different samples on the different shelves, seen in Figure C35:

- 1st. shelf: Old 150 by 150 sample.
- 2nd. shelf: New 100 by 100 sample; middle sample out of 3.
- 4th. shelf: New 100 by 100 sample; middle sample out of 3.
- 5th. shelf: New 150 by 150 sample.

As previously mentioned, as many cycles as possible will be ran before the best preparation system is chosen. This means that samples in the chamber will become fewer and fewer. Rotation of the samples in the chamber is necessary, i.e., for each new cycle, the samples will be placed on a different shelf than it was previously at, to give it a slightly different load during the new scaling cycles.

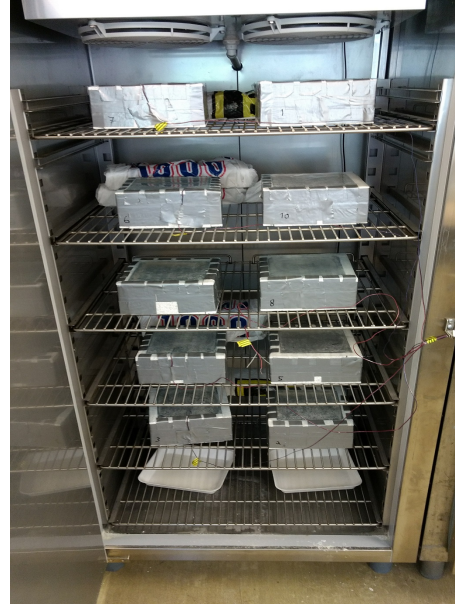
Figure 8: Series 2 samples

The samples followed the standard preparation procedure found in Table 1, with a few exceptions. They were cast on the 2nd and 4th of November. The air-entrained concrete was cast on the 2n, while the non-air-entrained was cast on the 4th. Meaning the samples had been in a water bath for 6 months before being used in the test. The application process with the butyl tape and adhesive took four days instead of the two day time window. This was because the preparation took slightly longer time as everything was fitted perfectly; from the insulation casing to the butyl tape and adhesive. Each sample also had their form oil removed with sand blasting 10 seconds on each side. This was to achieve a coarse and sandy exterior surface which would hopefully make the adhesive stick better.

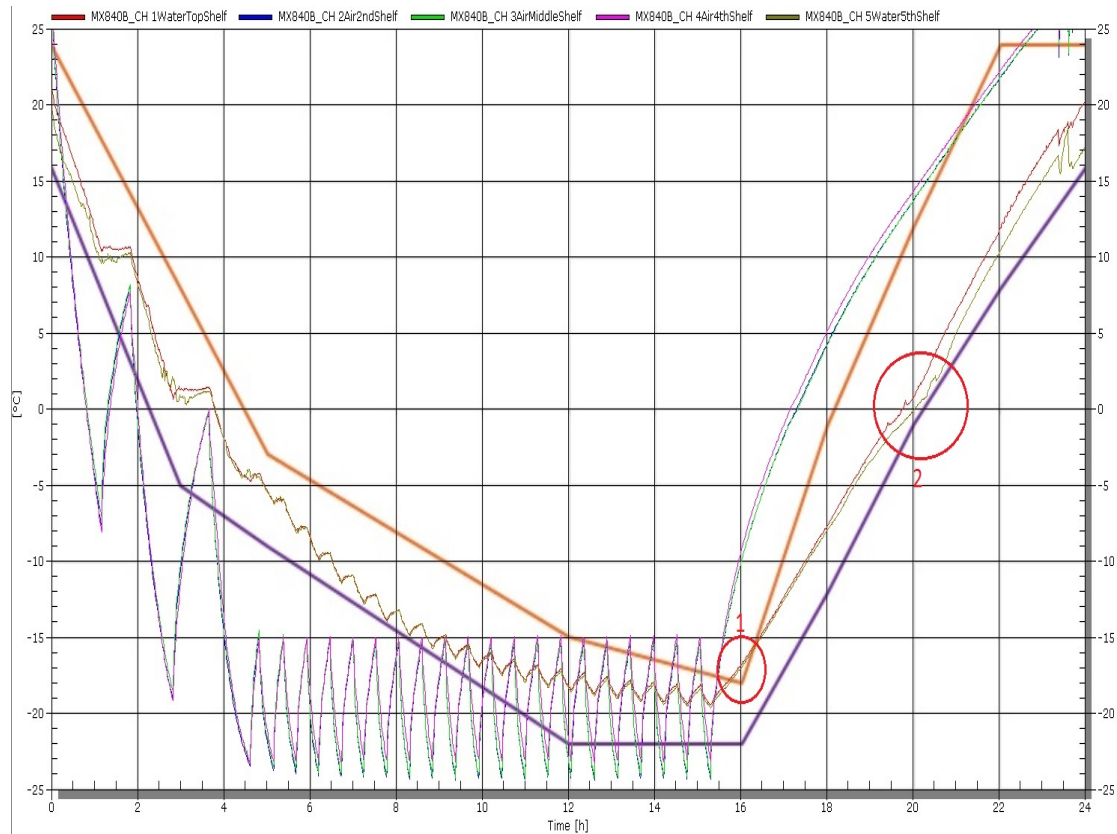
Figure 9: Cycle Test 3

The preferred cycle was achieved in test number 3 and the cycle achieved then looked like this:

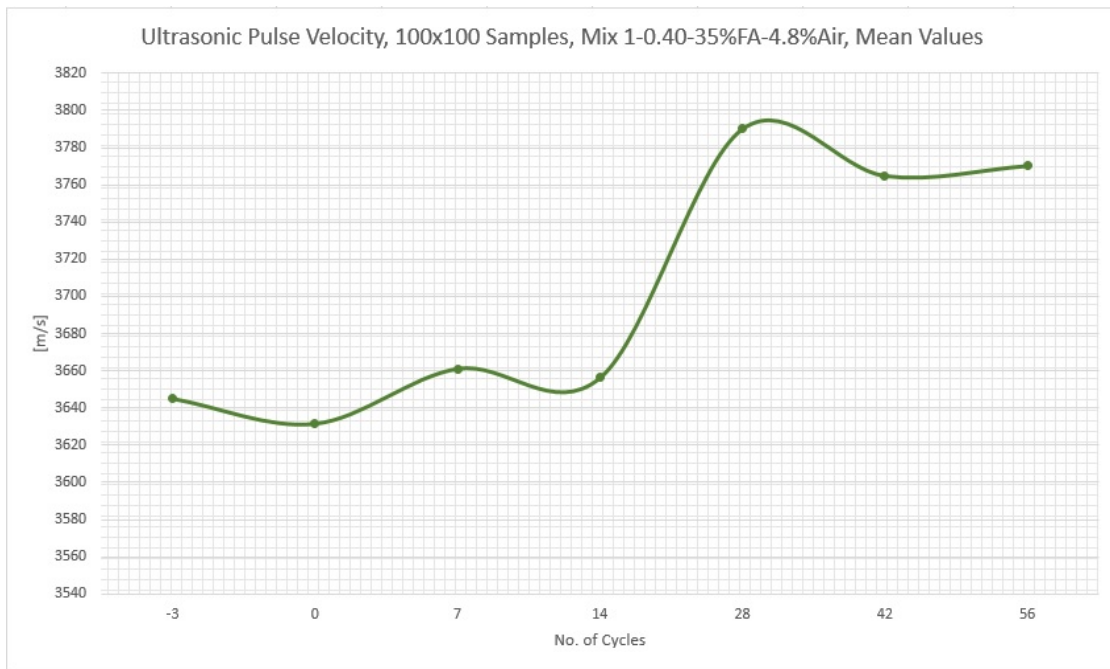
Figure 11: Transit Velocity, 100x100mm² samples, Material Test 1

The Table also shows that the highest readings on average are achieved on the 28th day of testing. This can also be seen on the progression of the mean UPV value in Figure 11 and 12 below:

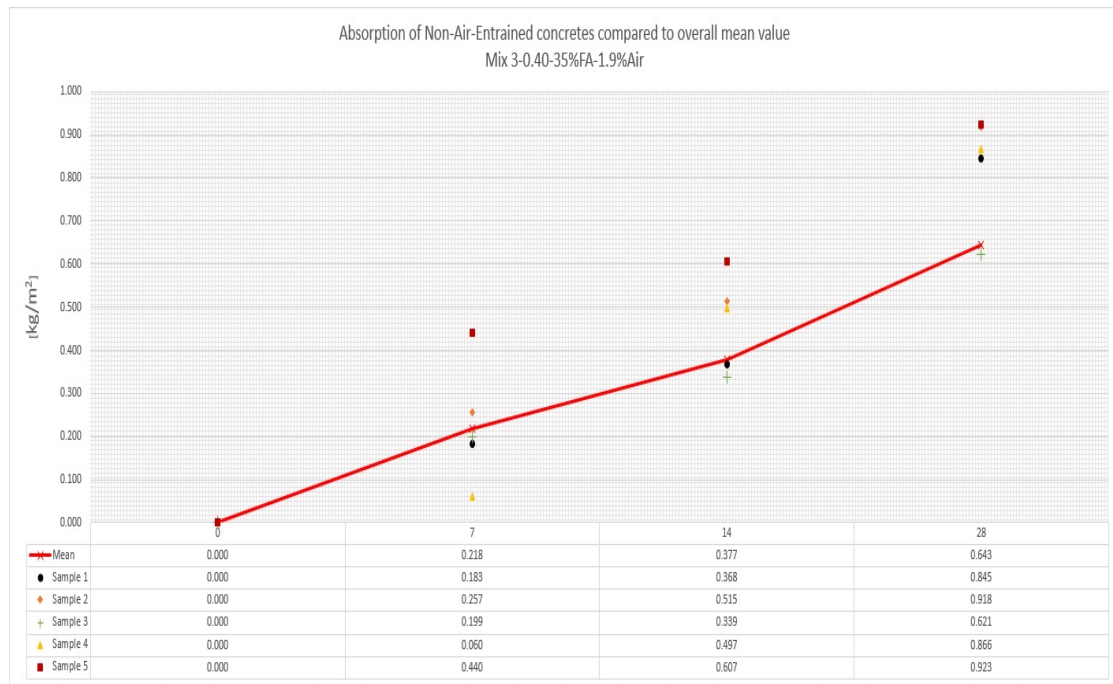
Figure 15: Absorption, 35% FA concrete, non-AEA

Figure 15 and 16 on the next page shows the absorption of the non-air-entrained and the air-entrained concretes compared to the mean value of the entire series.

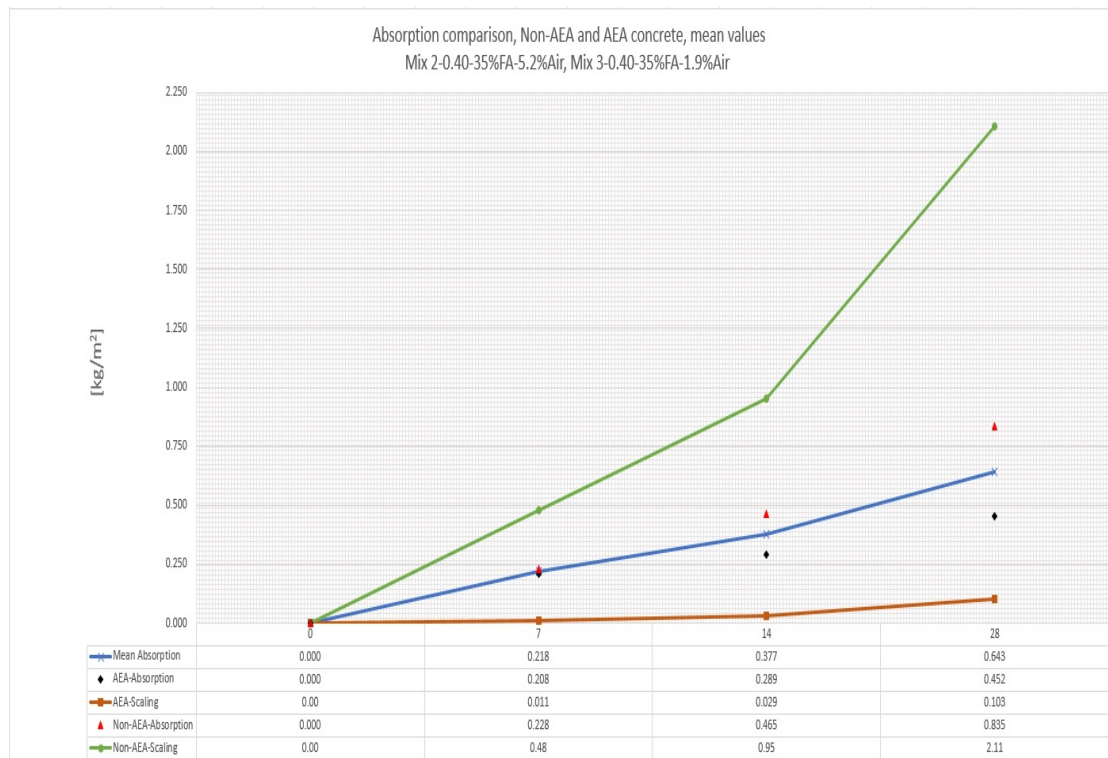
Figure 17: Correlation of Absorption and Scaling

A comparison of the absorption of the samples with the scaling has been performed and this is shown in Figure 17 below.

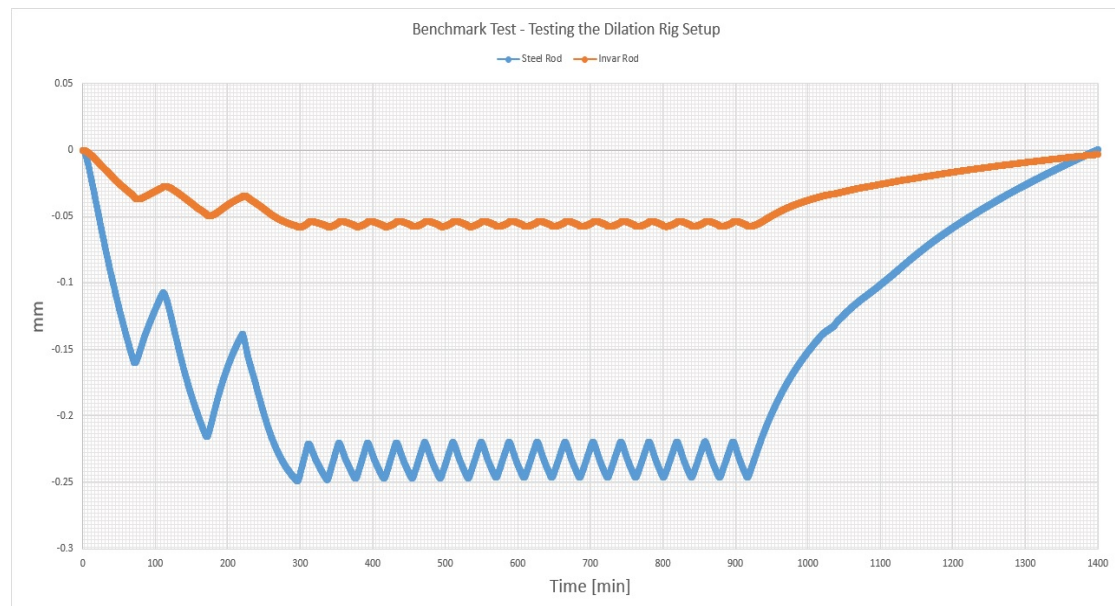
Figure 18: Part 1 Dilation Results

The main goal of Part 1 was to diagnose eventual difficulties with running sensitive equipment in the freeze/thaw chamber. The two samples, one invar rod and one steel rod, remained untouched for nigh on 24 hours in order to see if the chamber would provide any problems for future testing. The result of the measurements can be seen below in Figure 18.

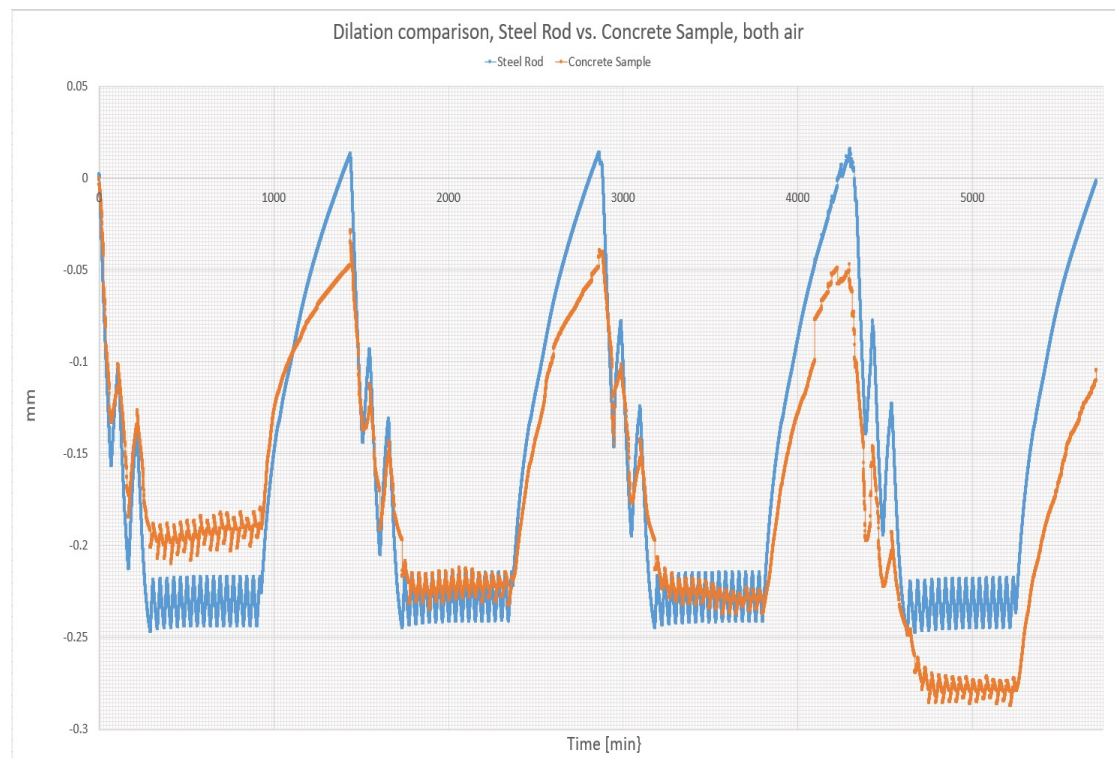
Figure 19: Part 2 Dilatation Results

The second part was a close to four day test of the dilatometry of a concrete sample compared to the iron rod sample. The main goal was to check the influence the temperature would have on a concrete sample, if the rig would be destabilized/disrupted during testing and test for uncertainties in with the chamber. In short it was a continuation of **Part 1**, replacing one of the rods with a concrete sample.

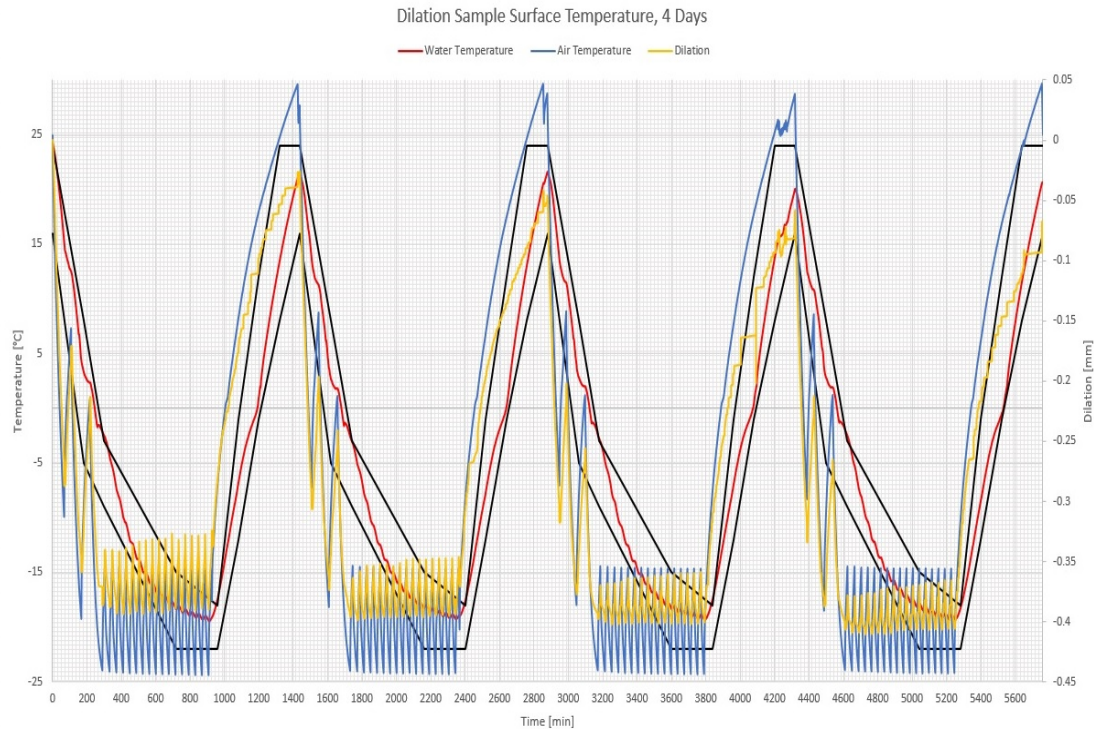
Figure 21: 4 Day Dilation. Correlation graph

Figure 21 below shows the dilation measurement for the first 4 days of the Part 3 test. It also displays the correlation of the dilation to the air and water and if solution on the test surface is well within the CEN/TS 12390-9 limits:

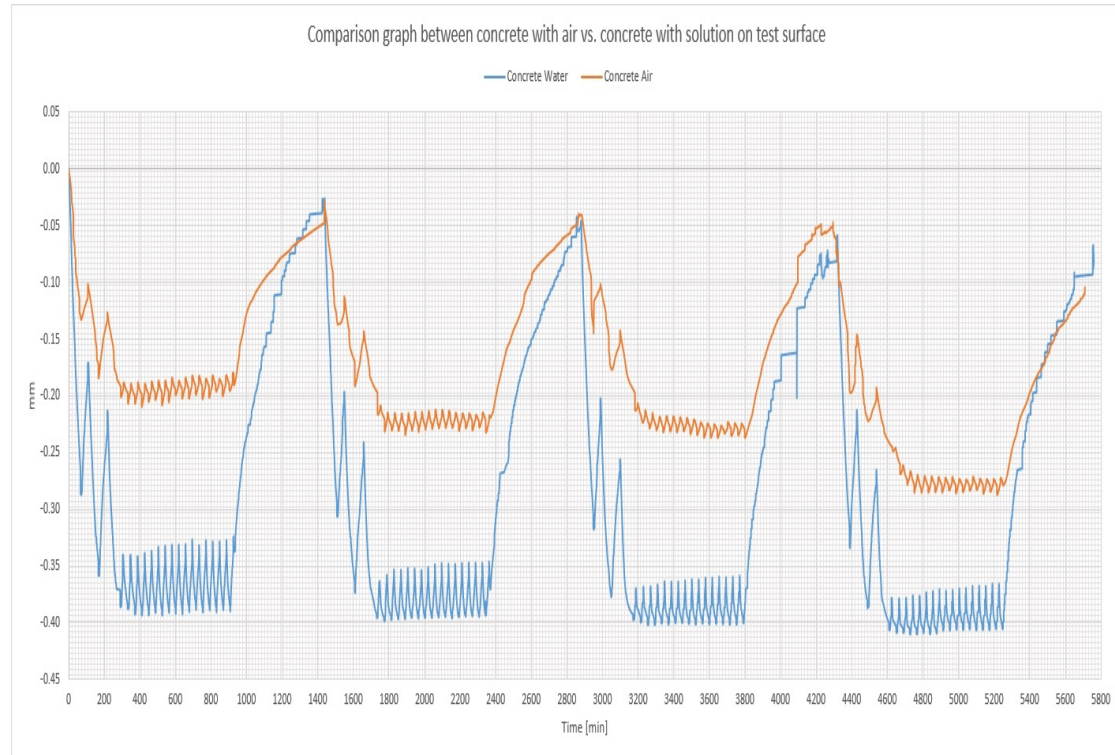
Figure 22: Dilation comparison; Part 2 vs. Part 3

One of the main goals is to compare the results of Part 2 with Part 3. Figure 22 below shows the dilation of Part 2 compared to Part 3:

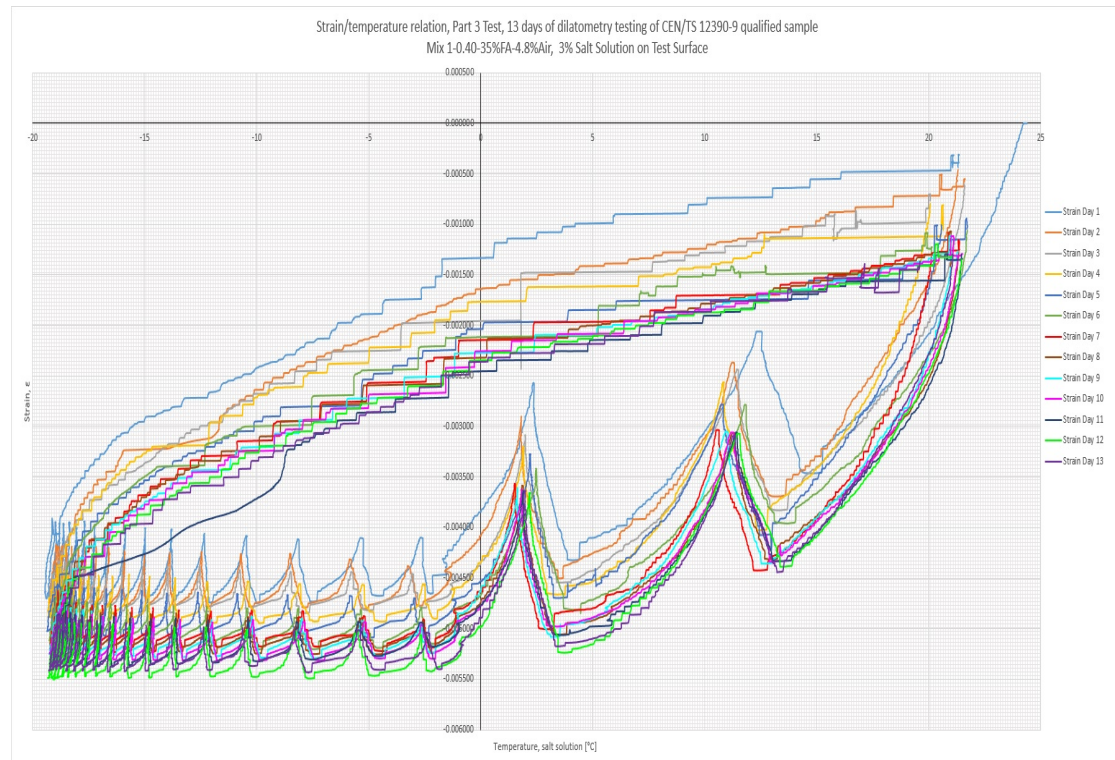
Figure 23: Strain/Temperature relation, Part 3

An important aspect to investigate regarding dilatometry of a sample is the strain/temperature curves the freeze/thaw cycles exhibits. This gives the clearest indications as to whether or not the internal strains in the concrete surpasses the strain capacity of the concrete. Normally a blank run would be run beforehand to correct the influence of the invar studs used in the samples, but this has not been done in this test. Figure 23 below illustrates this strain in comparison to the temperature for all 13 dilatometry cycles performed.

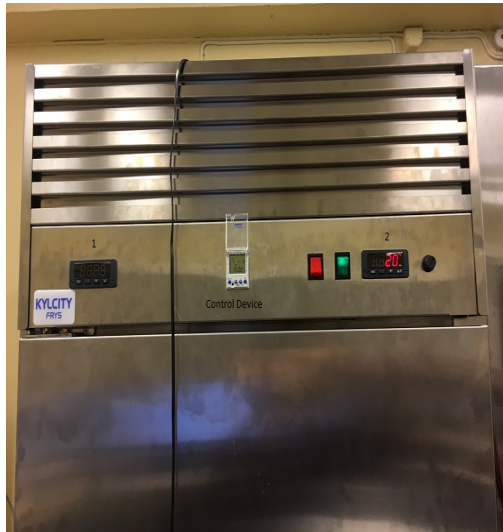
(a) Close up of the control center

A close up of the control center, the white display, and the two temperature screens are shown in figure B25a. The setup to complete a proper Borås test was calibrated by Ole Petter Vimo in the summer of 2016 as well as a guide on how to complete a test. A user manual on how to use the chamber is not found, so one can be found below.

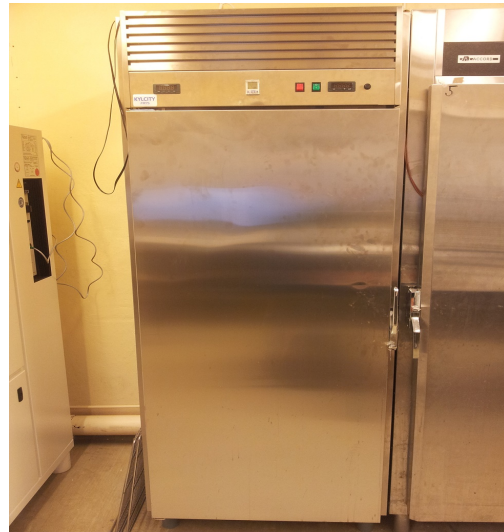
(b) KylCity freeze-thaw chamber

The freeze/thaw chamber used for the experiment is a *Kylcity freeze-thaw chamber* shown in figure B25b:

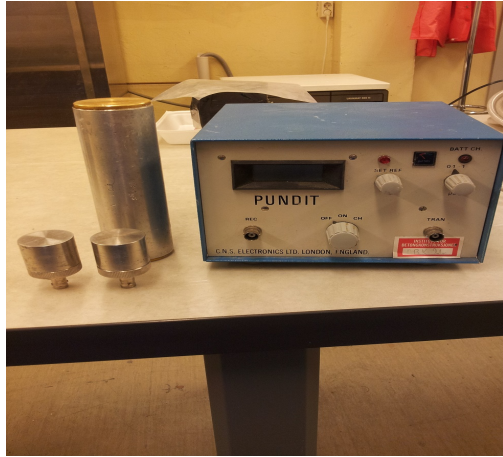
(a) UPV Equipment

To measure the ultrasonic pulse velocity a PUNDIT device, from C.N.S Electronics Ltd. London, is used. The reason for this is because it runs at a frequency of approximately 50kHz, which is optimal for the test to find ultrasonic pulse velocity through a concrete sample. As indicated by figure B26a, the equipment is dated, but it still does a proper job of finding the velocity through a material when calibrated correctly.

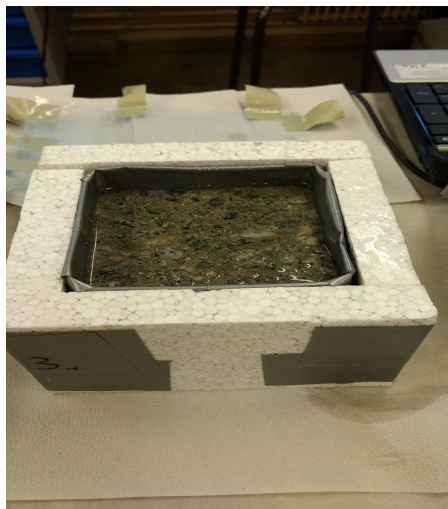
Figure E49: Sample 1, Material Test 1

The reference sample used was already in the climate room, having been there since October 2016, whilst also being from an older batch, cast in 2015. The content of the concrete is unknown. The collection of UPV showed no anomalies and it had the lowest transit times of all the samples 15, both before and after the test. But it increased slightly.

During the water saturation of the samples, the sample showed no signs of leakage and was given the green light to be used in the material testing. This was one of two samples placed on the third shelf in the freeze/thaw-chamber. The sample was not fitted with a thermocouple during testing. No refill was made during the seven day test period and it had a good water level, $\approx 3\text{mm}$ throughout the test, see Figure E49.

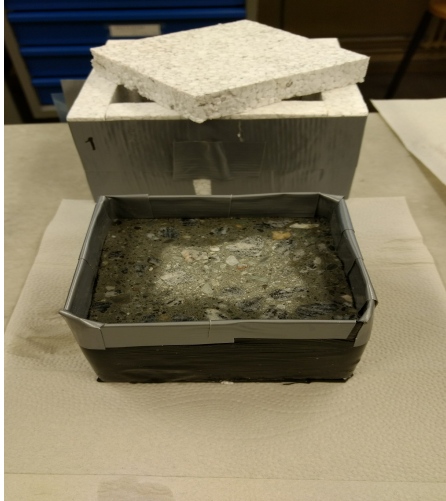
Figure E50: Sample 2, Material Test 1

The adhesive capabilities of the butyl tape significantly helped the application process. The adhesive itself, SikaFlex 11FC was easy to spread on the concrete surfaces as well. The EPDM bottom was fastened using more SikaFlex on the bottom surface. After the materials had been applied, the specimen was weighed and its UPV measured, showing no anomalies.

During the water saturation the sample showed no signs of leakage during the four days it was in the climate room and as such it was deemed fit for the 7 day freeze/thaw material test. The samples was placed on the top shelf in the chamber, flanked by two dummies, one on each side. It had a thermocouple on the water surface to read its temperature measurements since the top shelf is the shelf which often has the largest temperature swings. See Chapter 4.1

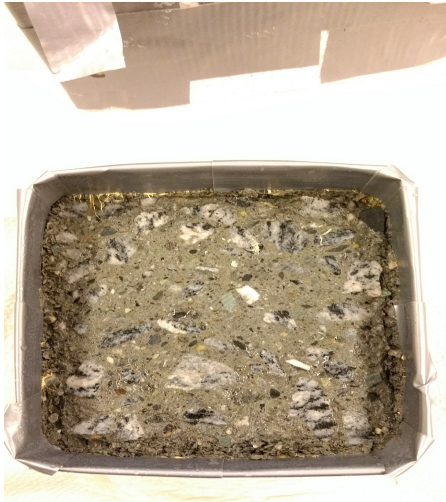
Figure E51: Sample 3, Material Test 1

The application on this sample was just as straight forward as it was for the previous SikaFlex sample. The adhesive used is slightly more *wet* than the SikaFlex one and as such it is easy to spread and distribute along the concrete surface. Nothing was attached to the bottom, as the CEN/TS 12390-9 Standard indicates that it is not necessary to have any material adhered to the bottom surface. It was also in order to see if there would be any differences between different setups.

The sample was considered fit for the seven day material test as it successfully passed the water saturation. During the test itself, the sample was placed on the third shelf in the freeze/thaw-chamber alongside the reference sample. This sample did not have a thermocouple to register its different water temperatures, since the middle shelves usually have lower variations between each cycle.

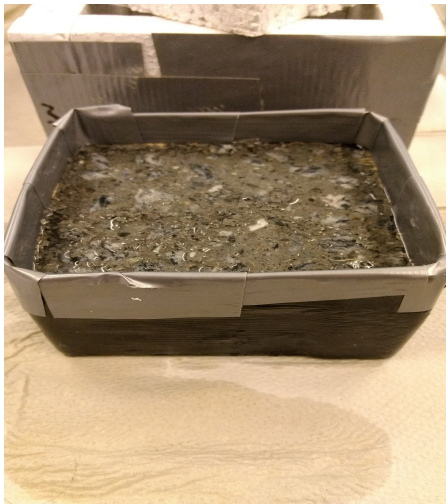
Figure E52: Sample 3, Material Test 1

After the testing was done slight condensation was noticed both on the outside and the inside of the polyester sheet. The sample was not refilled during the testing period and it was discovered that there was still water on the test surface, albeit not the 3mm it had at the test start. The sample had also scaled a decent amount, especially along the edges of the sample, in the interface zone between the adhesive and the concrete.

During further inspection it was discovered that the bottom insulation was wet and that there were wet marks on the bottom surface. Furthermore the butyl tape on the sides were found to be slightly loose. After removing it from the insulation, it showed that the sample had increased its weight greatly, but its UPV was relatively unchanged. Which is a fair result, but still not very reasonable. It would be expected that the UPV would be lower than the initial value.

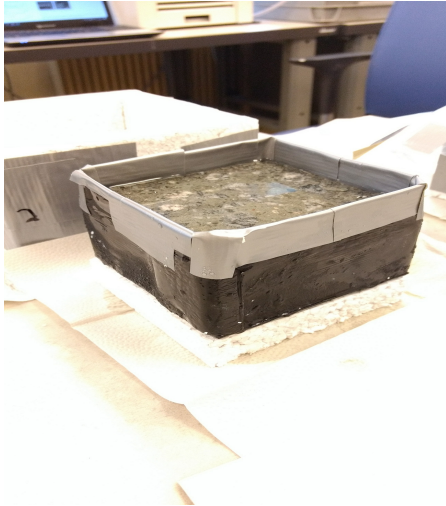
Figure E53: Sample 4, Material Test 1

The application of the XtremFix adhesive is slightly more cumbersome as it is thicker. It took more effort to distribute it around the sides and bottom of the concrete. On all the surfaces a butyl tape layer was attached to envelope the entire sample in an XtremFix and butyl tape casing except for the test surface.

After water saturation no leaks were found and the sample was then placed on the second shelf in the freeze/thaw-chamber for the seven day material testing. The sample had a thermocouple attached to its test surface to see its temperature development during the entire test period.

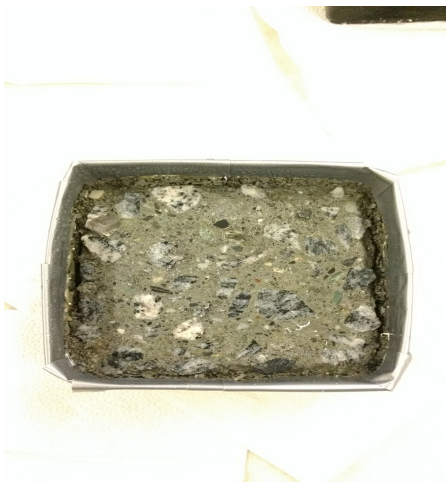
Figure E54: Sample 4, Material Test 1

After the test the sample was inspected and condensation was found on the inside of the polyester sheet. The condensation can explain why water was found on the inside of the insulation box as well as on the bottom of the sample. Leakage was also a possibility. It is also worth noting that there was a decent portion of water left on the test surface and the sample was not re-filled.

The amount of scaling, especially alongside the edges are detrimental to the sample. Even though it has managed to keep a good layer of water during the entire test, the scaling are of such a bad degree that once the top layer of concrete is removed, the sides easily detach from the concrete surface. See Figure E54. This might be because the adhesive is creating large tensile forces in the interface zone during freezing and thawing.

The UPV of the sample had increased slightly, as well as the weight. What's worth noting is that the UPV had to be taken from the two other sides than before the material test began. When trying to get a reading from the preferred sides nothing happened, most likely because of the increased void between the tape and concrete which occurred during the extensive process of getting out some of the scaled material from the sides. This might have influenced the result as the weight gain was a whopping 27,9 grams, showing that the sample absorbed a lot of water, which should have lowered the transit time through the sample.

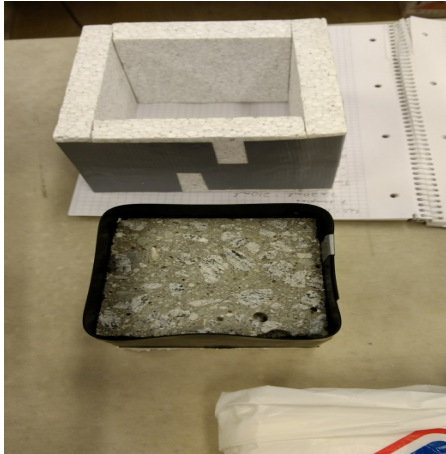
Figure E55: Sample 5, Material test 1

The rubber band material used to create a dam in this sample was fairly easy to apply, although special care had to be used on the edges between each side, as the rubber band material is not self-adhesive. This meant the process of applying it to the concrete sample was slightly more difficult than the butyl tape. Even so, the process was quite smooth and the SikaFlex glue seemed to attach nicely to both the rubber band and the concrete surface.

It became evident after the water saturating phase of the samples that this sample was in fact leaking quite heavily. It was decided that the sample would not be used for the seven day material testing. Since the sample did not qualify to undergo the seven day material testing, its UPV value and weight was not measured afterwards. It is expected that the UPV should remain the same since no changes has happened to the sample. Its weight might have increased slightly due to the water added during the saturation phase, which might have filled up its pores slightly.

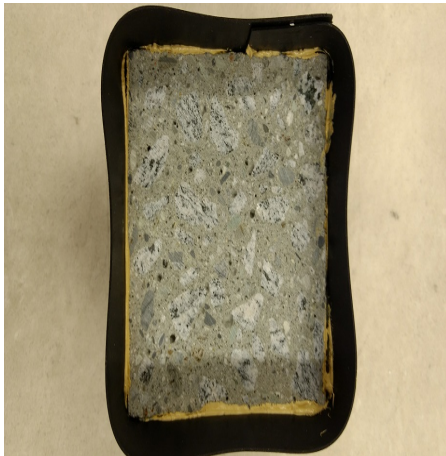
Figure E56: Sample 6, Material Test 1

This sample used the Marin og Teknikk adhesive, which is slightly more wet than SikaFlex. This made the application process slightly challenging as the adhesive used a long time to cure to both the concrete surface and the 1mm thick rubber band. Fastening the edges proved a challenge. To keep the rubber band in place while the sample dried weights had to be placed on the sample in order for it to fasten in an as proper way as possible.

Even with measures like: weights, caution along the edges and long procedure time were used, the sample did not want to adhere properly to every surface layer of the concrete. As evident by figure E56. There are many flaws, visibly close to every corner/edge, due to the rubber bands lack of flexibility, unless tightened and stretched in an obscene manner, around these sharp edges. The sample was therefore not deemed fit to be water saturated, and it did not pass the material testing, both due to its impracticality while applying and because it did not properly seal the sample to create a proper dam.

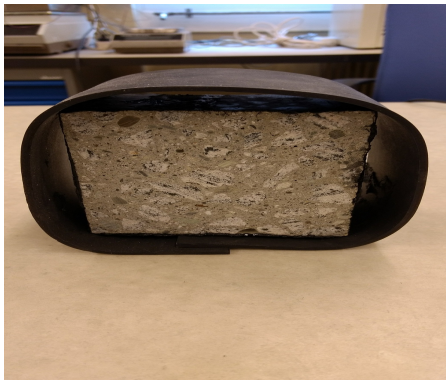
Figure E58: Sample 8, Material Test 1

This sample was very challenging due to the thickness of the EPDM material, the small size of the cubes, $100\text{mm} \times 100\text{mm}$, the lack of bond in the adhesive between the concrete and the material before proper setting. All of these factors made sure that this sample was virtually impossible to make.

The issues became very evident along the edges of the concrete, as the 3mm thickness of the EPDM sheet created an arch on both sides, not adhering to the concrete surface at all. Fixing this would require help to keep the material attached to the concrete until the adhesive actually adhered and dried.

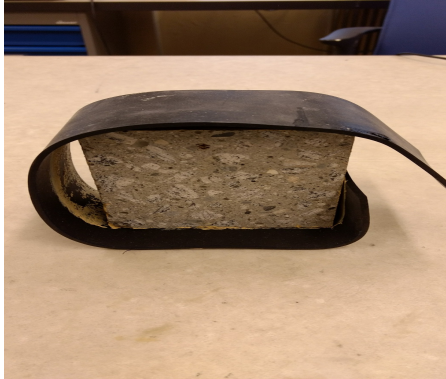
Figure E59: Sample 9, Material Test 1 system.

This sample suffers from the same problems as sample 8 and did not perform well. There were too many problems related to the adherence between the EPDM sheet and the concrete. Further problems were related to the inflexible rubber material being used. This was especially noticeable around the concrete edges. Different measures were taken in order to make a proper sample: clamps, weights, setting over night, but it would not comply.

This can possibly be explained with the adhesive *Marin og Teknikk* being very free-flowing and runny, especially when in the early phases of hardening.

This sample was considered to be impractical and no further testing was done with this preparation

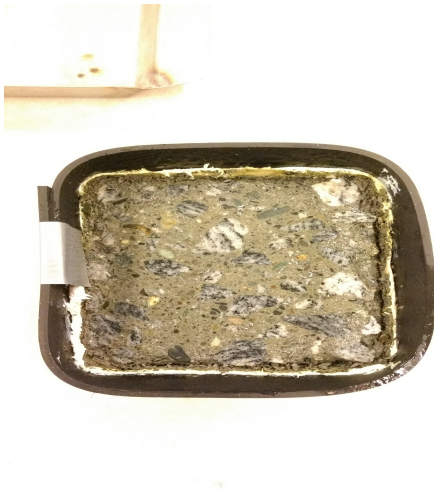
Figure E60: Sample 10, Material Test 1

The only sample using the 3mm thick EPDM sheeting that made it to the material test and it has the same issues, but the adhesive used was sticky enough to create a proper sample. The thickness of the EPDM sheet meant that this sample had the highest transit times of all tested samples. No leakage was found after the saturation stage and it qualified for the seven day material test.

The sample was placed on the 4th shelf in the freeze/thaw-chamber with a thermocouple monitoring its temperature. The cycle showed that the sample was within the CEN/TS 12390-9 test limits during most of the test. Afterwards condensation was found on the inside of the hat. Lots of water was also found on the bottom plate and the inside of the insulation. As Figure E60 shows the sample had scaled decently, especially around the edges.

The sides were completely loose on three out of four sides. This might explain the large weight increase and the slightly increased UPV value.

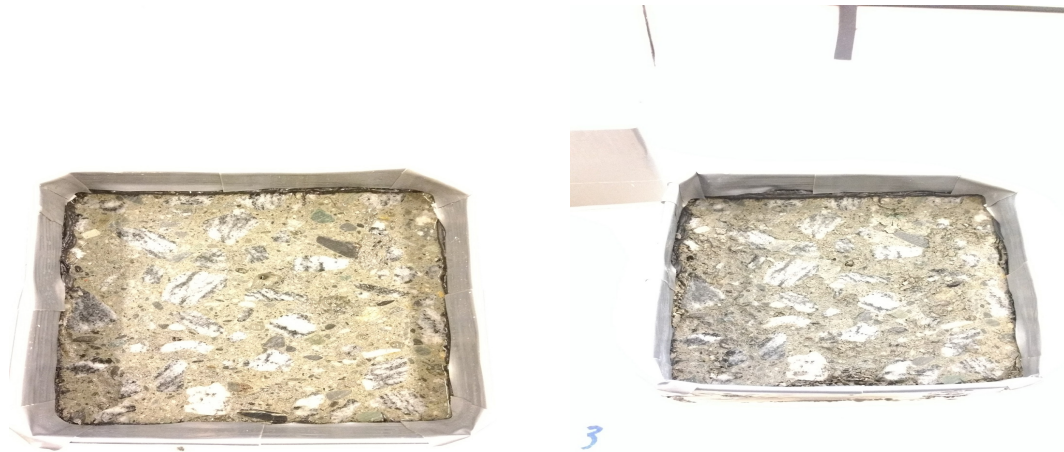
Figure E63: Damages, Sample 3, Material test 2

SSD; refilled 8 days prior. The sample scaled decently, both on test surface and on bottom, which can be seen on the bottom plate (Small concrete pieces). Bottom is wet; bottom plate as well. Regular water on the sides. Formation of small air pockets. Decent adherence on 3/4 sides.

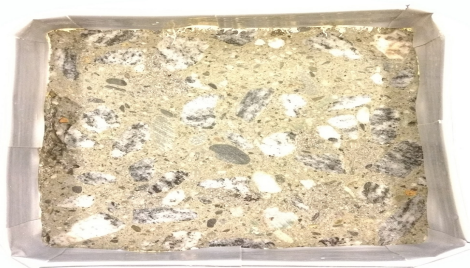
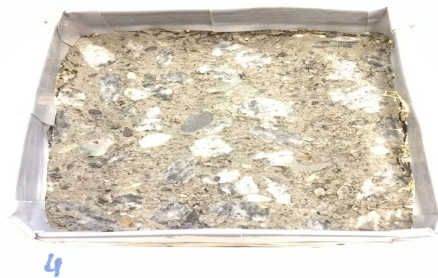
Figure E64: Damages, Sample 4, Material Test 2

Sample is SSD; refilled 8 days earlier. Visual scaling and a decent amount. Regular water on the sides, from condensation only. Three sides are decently adhered while the last is poorly adhered. Insulation box wet on the inside, bottom plate wet as well. Hat and insulation box is weak even after lots of maintenance.

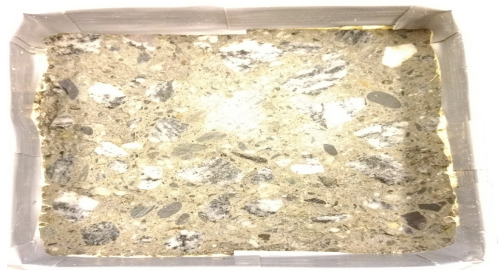
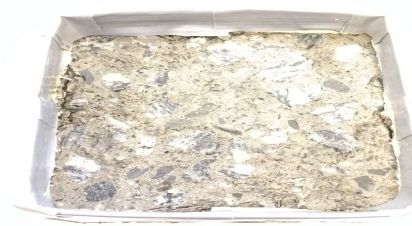
Figure E65: Damages, Sample 5, material test 2

When examined the sample was SSD; refilled 8 days prior. Low/decent amount of scaling which is evenly spread. One side is very poorly adhered, the three others are ok. They seem prone to water intrusion by now. Debris at edges. The sides were almost completely dry, still some air pockets. Wet bottom plate and inside of insulation.

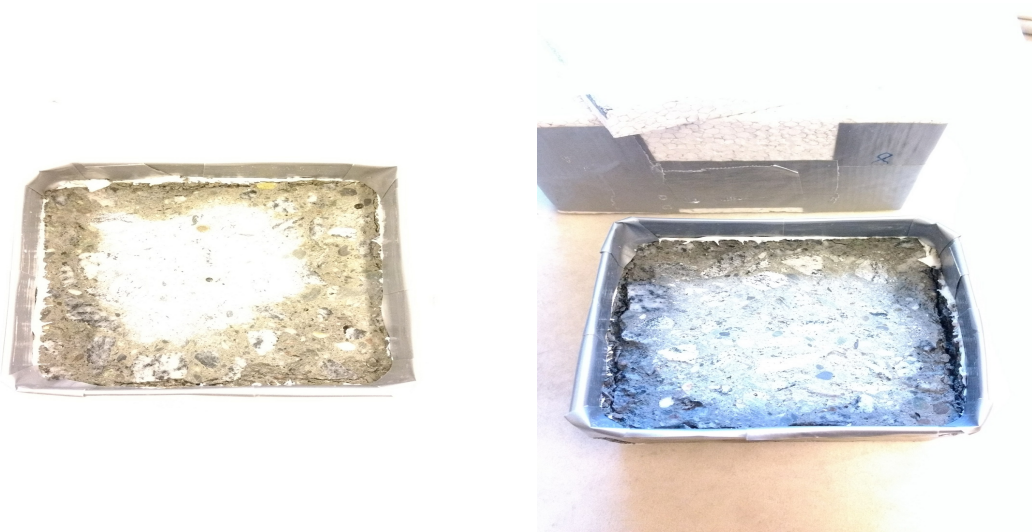
Figure E68: Damages, Sample 8, Material Test 2

The sample had retained a good amount of water; refilled some days before examination. The scaling is located at the edge, in the interface zone and is contributing to the poor adhesion on all sides. From Figure E68 it is seen that two of four sides are barely attached at all, and that continuing with the sample is pointless.

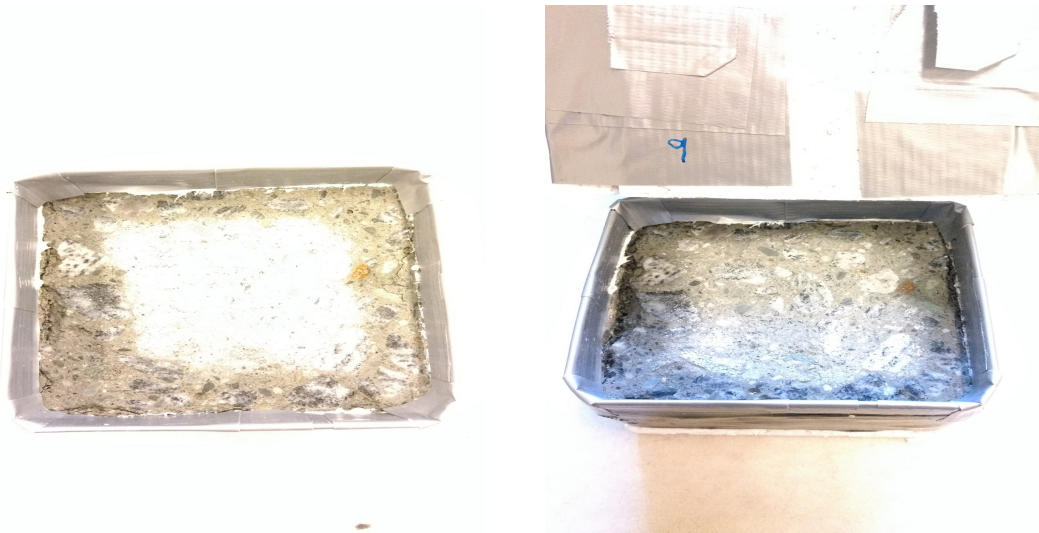
The sample had retained a good amount of water due to it being refilled some days prior to examination. Water was found on the bottom plate where small particles of concrete were found as well. The insulation was wet and the insulation hat had decent amount of condensation on it. The sample had scaled a decent amount, mostly in the interface zone. Further inspection showed that the sample had completely lost adherence on one side, making this sample unfit to continue testing.

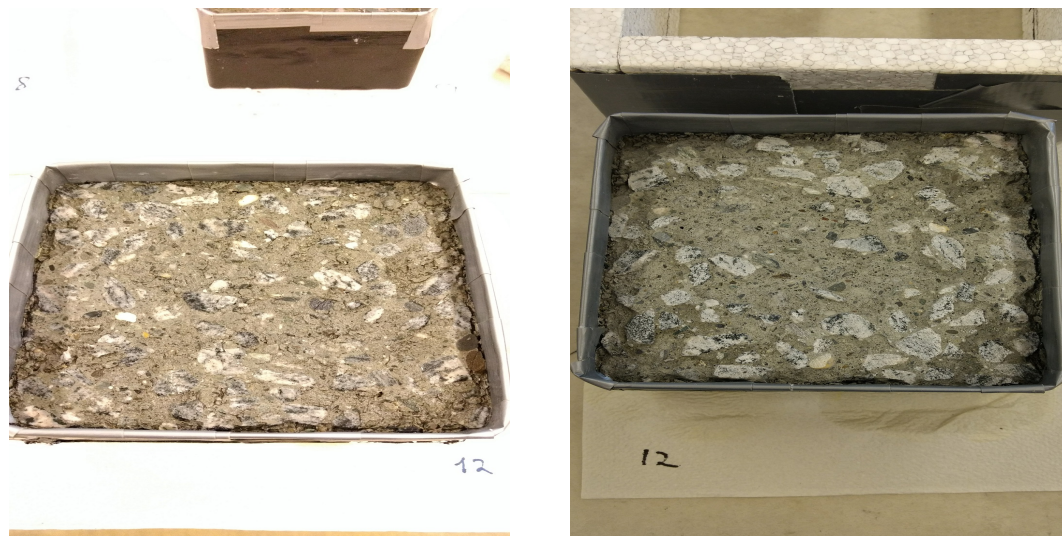
The sample is removed 8 days before test finish after its 59 cycles. All sides are poorly adhered, all of them are loose. The scaling is insignificant and the sample will not hold water.

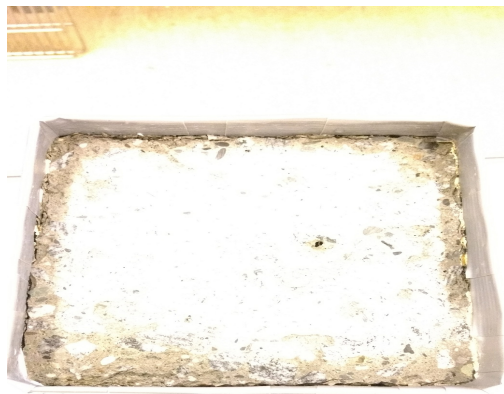
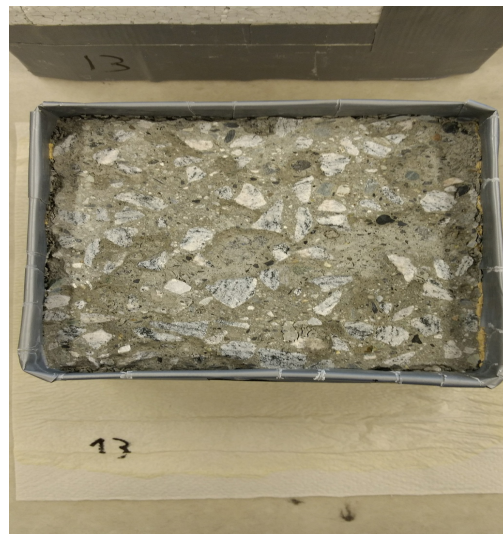
Figure E73: Damages, Sample 13, Material Test 2

Sample was removed after its 59th cycle (48th in Material Test 2) because it had no virtues left. See Figure E73b. Three of the sides are barely attached and the sample will not hold water. Yet one side is still very good and shows no adherence issues.

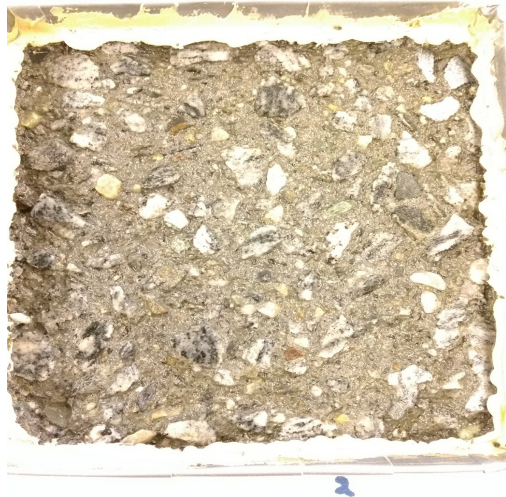
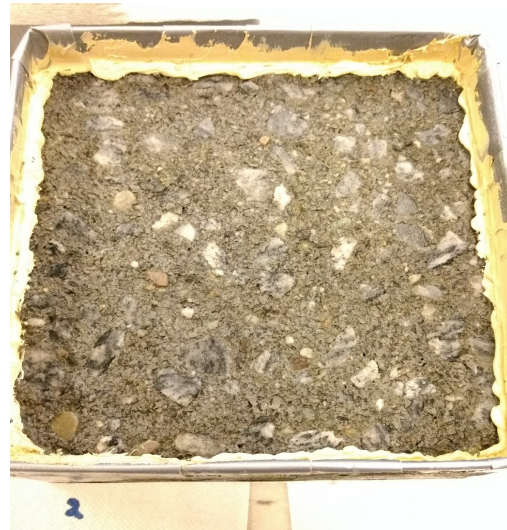
(a) Sample 2, Damages after 28 Cycles

The sample was in SSD conditions before examination started; not refilled. The scaling was very high, but also evenly spread on the sample, which can be seen in Figure E75b. The adhesion is also becoming very weak on at least two of the sides, illustrated in picture E75a. The water that was found on the sides of the sample and the bottom plate was not salty, meaning it is condensation. The sample also has some large air bubbles on the side.

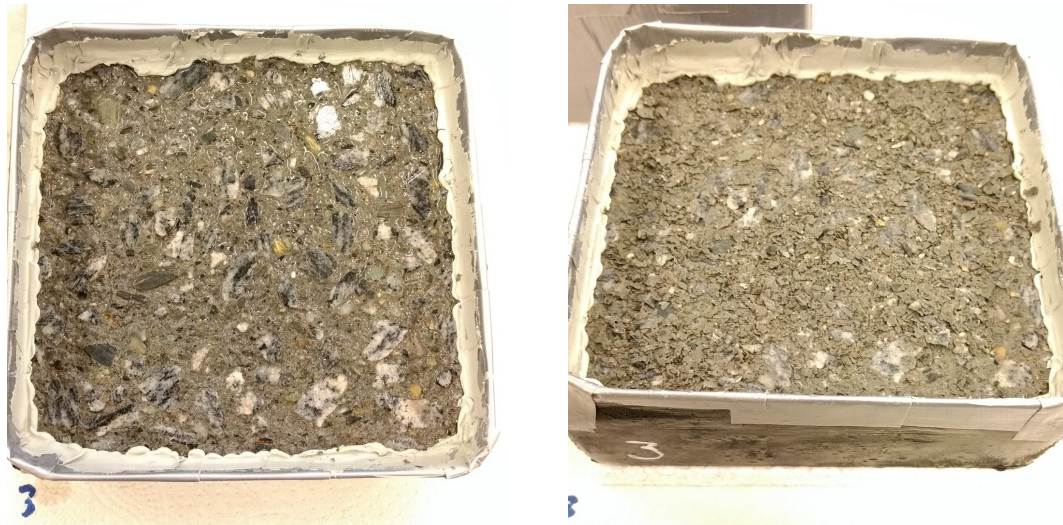
The sample is found in SSD conditions; not refilled. Larger amount of scaling than previously, seen in Figure E75b, evenly spread across the test surface. The damages on the sample found after 28 days can be seen in Figure E76a. In spite of the damages, the adhesion is still decent to good on most sides. Two sides are good, whilst the two others are slightly weaker/decent. Water and air pockets were found on the sides of the sample. The water was pure, no salty taste. Regular water was found on the bottom plate as well.

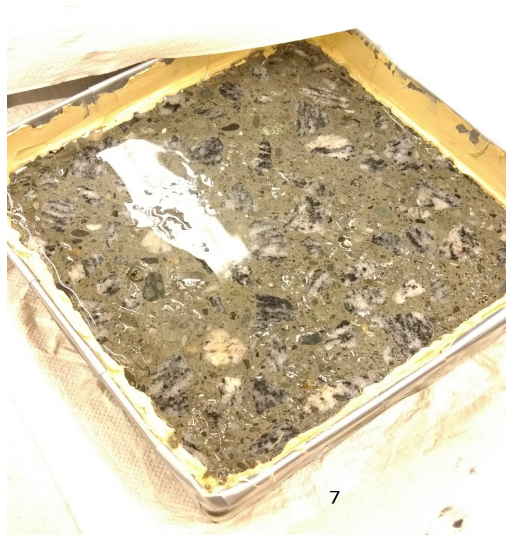
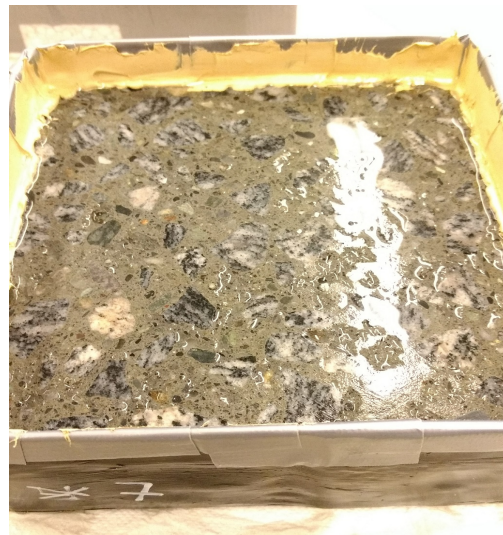
Figure E80: Damages, Sample 7, Series 2

The sample has retained a decent amount of water; a little under 2,5cm. There is some visible scaling on the test surface which is evenly spread out, which can be seen on Figure E80b. The water found on the sides are condensation mostly, but it carries the distinct taste of salt. The bottom plate has pure water on it. Some air pockets are found on the sides. The adhesion is still excellent and from Figure E80a it is difficult to see any disjointed parts between the adhesion and the concrete.

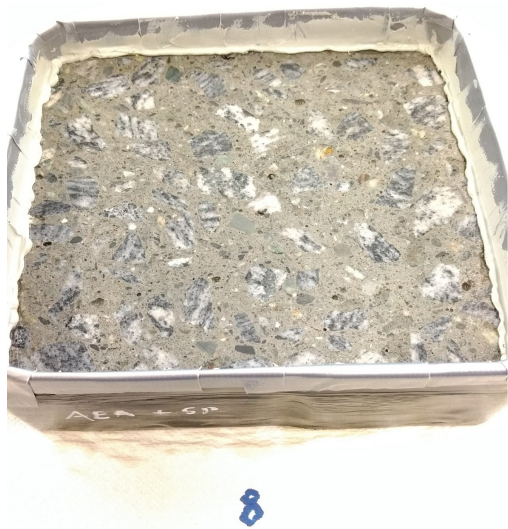
(a) Sample 8, Damages after 28 Cycles

The sample has retained a slight liquid layer on the top of the test surface, not SSD, but not very deep water layer. There is some mixed water on the sides of the sample. The bottom plate has regular water on it. The scaling is very low as well as the damages on the sample. The adhesion is very good, but one side is slightly weaker, see Figure ??, whilst the damages are almost negligible, Figure E81a.

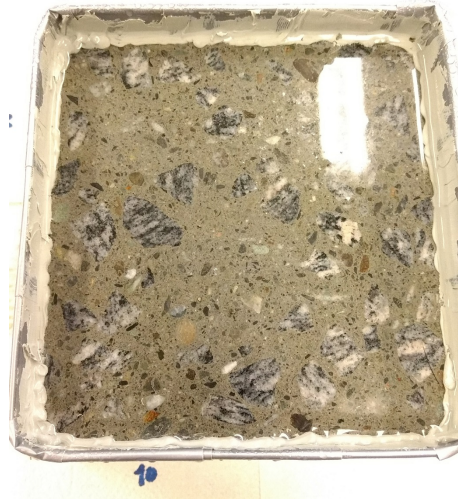
Figure E83: Damages, Sample 10, Series 2

The sample has retained a good amount of water, close to 3mm, without being refilled. The scaling is negligible and the damages are also negligible. The sample is in very good condition, except on one side where the adhesion is slightly weak. The liquid on the bottom sample and on the sides are regular water and air pockets are also located on the sides of the sample.
