# Distributed Sacrificial Anode (DSA) - Properties in Mud and at Elevated Temperatures in Seawater

Subsea Technology

Submission date: June 2017

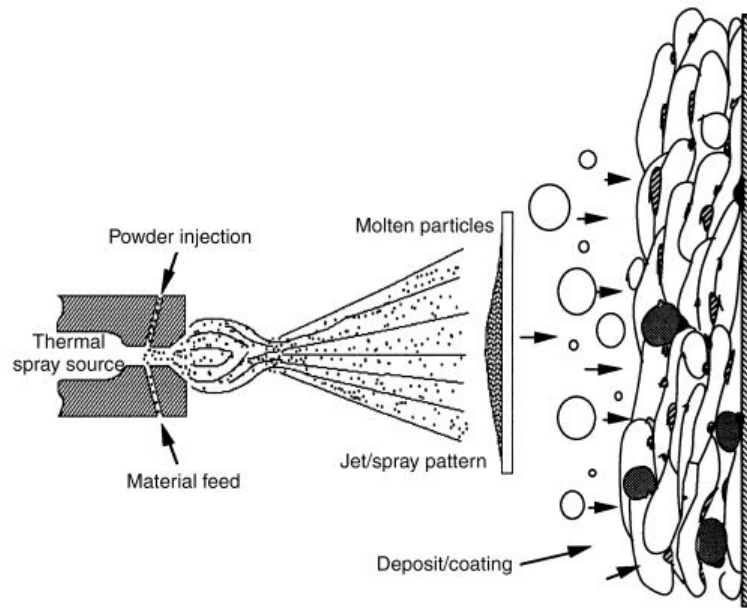
Figure 2.1: A thermal spray source accelerating molten particles on a substrate creating a TSC [1].

Continuously spraying will eventually cause an increase of thickness of the coating. Figure 2.1 [1] shows an illustration of a typical thermal spraying process. The thermal spray source together with high pressure gases melts the powder of the coating material and accelerates it towards the substrate in a spray pattern. The thickness is subsequently increased.

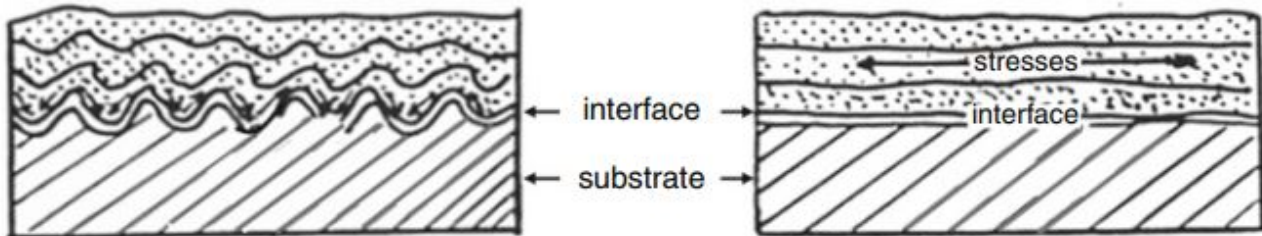
Figure 2.3: Stresses within a coating on a rough vs. a smooth substrate [3].

Figure 2.3 [3] shows a coating applied onto a rough surface vs a smooth surface. The rough surface will absorb residual stresses in a more efficient manner, resisting adhesion failure between the substrate and coating. The smooth surface will have reduced interfacial area and limited ability to absorb stresses, hence increasing the chance of adhesion failure.

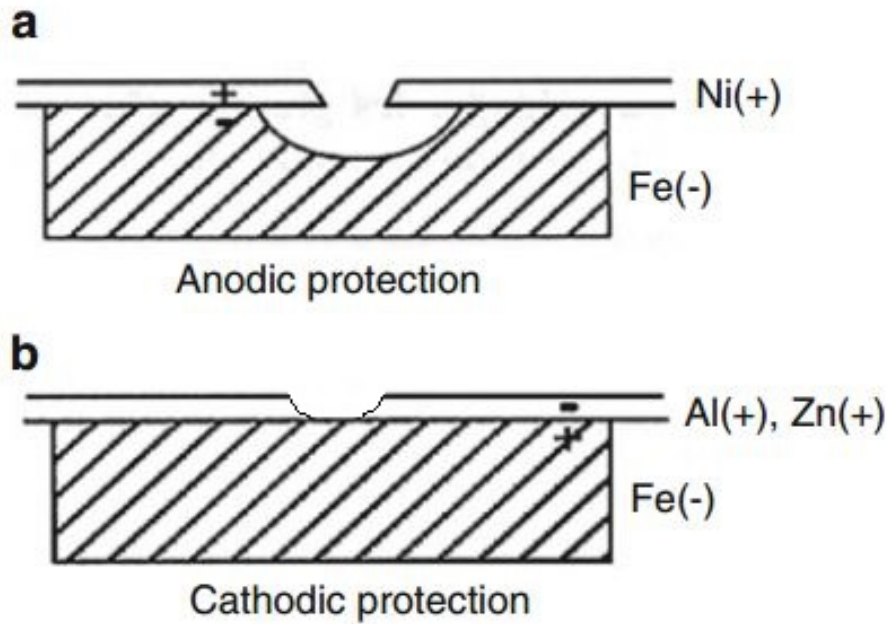
Figure 2.4: A cathodic coating (top) vs. a cathodic coating (bottom). Adapted from Fauchais [3].

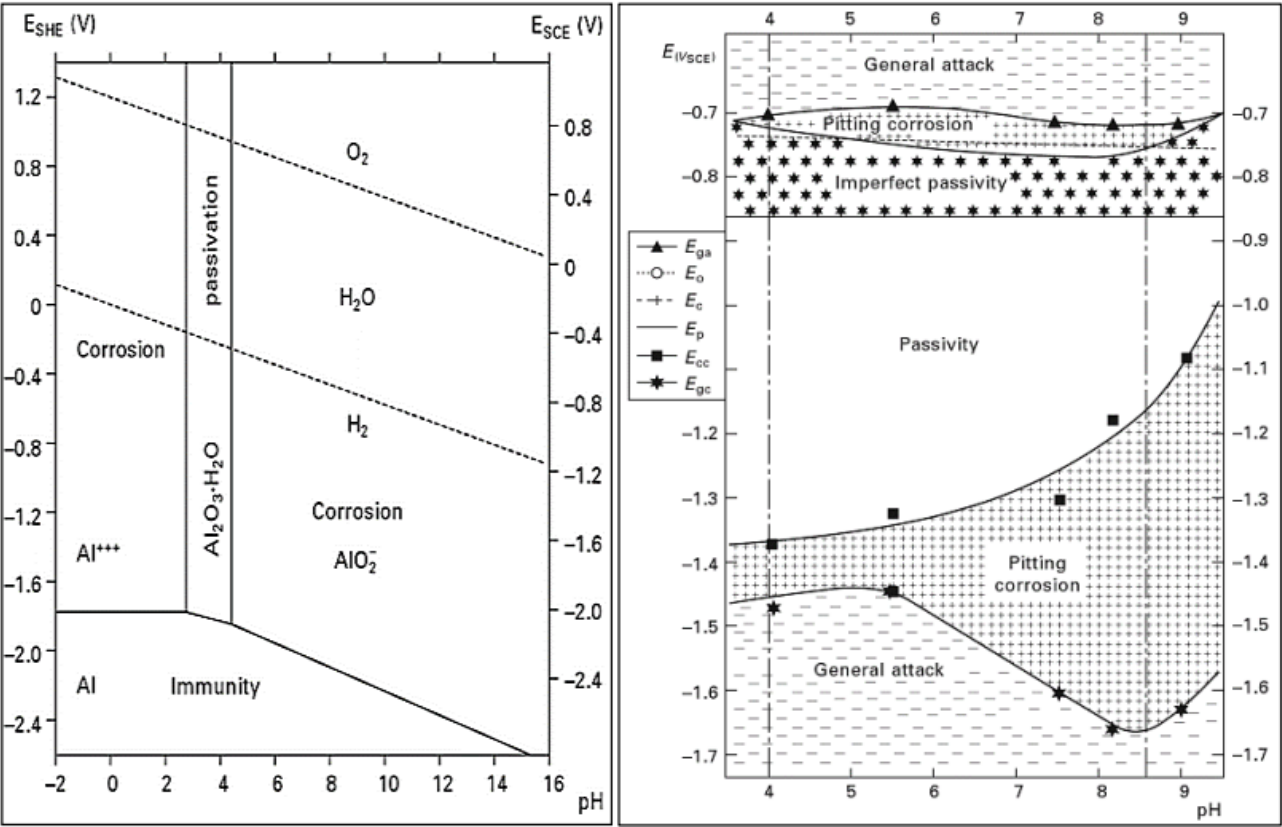
Figure 2.5: The left illustration is a Pourbaix diagram for pure aluminum in SW, while the right illustration is an experimental Pourbaix diagram for aluminum alloy 5086 in a chloride solution [4].

An experimental Pourbaix diagram for an alloy in the 5000 series is represented in the right part of figure 2.5. This shows that aluminum may be used in SW ( $\text{pH} \approx 8.2$ ) and remain passive in the range from approximately -860 mV SCE to -1200 mV SCE.

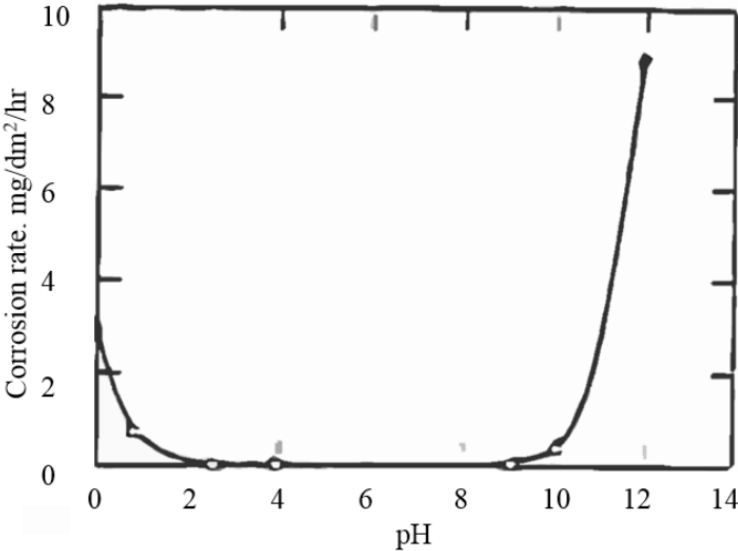
Figure 2.6: The corrosion rate as a function of pH [5].

The corrosion rate is thus dependant on the pH of the SW. Figure 2.6 shows the corrosion rate as a function of pH.

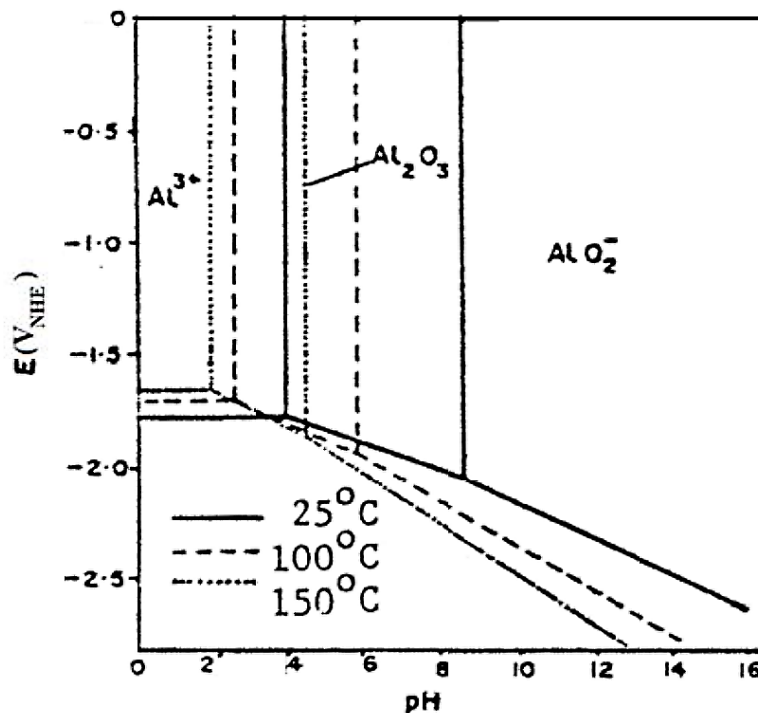
Figure 2.7: Effect of temperature on the passivity of aluminum in water, illustrated in a Pourbaix diagram [6].

The temperature affects the stability of the oxide layer. The general trend at high temperatures is that the oxide is stable within a narrower pH-range and that it shifts to left towards a more acidic solution. This means that the danger of corrosion increases in alkaline and neutral environments with increasing temperature [6]. Figure 2.7 shows Pourbaix diagrams for aluminum and the effect of increased temperature for the stability of the oxide layer.

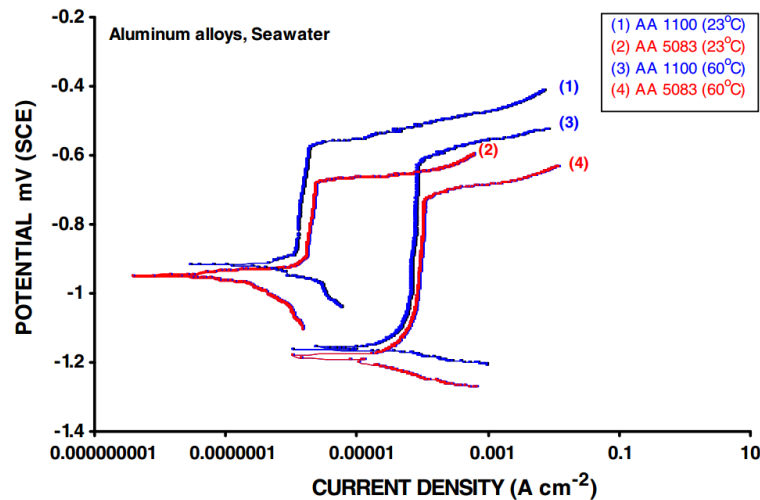
Figure 2.8: Polarization Curves for Aluminum alloys in SW at 23 and 60°C [7].

The effect of SW temperature on aluminum alloys was studied by Ezuber et al. in 2008 [7]. The aluminum alloys AA5083 (Al-Mg) and AA1100 (pure aluminum) were tested in stagnant seawater at 23 and 60°C. Recorded Polarization Curves revealed that increased temperature caused a negative shift in OCP by approximately 200 mV and a decrease in pitting potential values by 40 mV. Increased temperature also seemed to increase the passive current densities. Figure 2.8 shows the recorded polarization curves on pure Aluminum and Al-Mg at 23 and 60 °C.

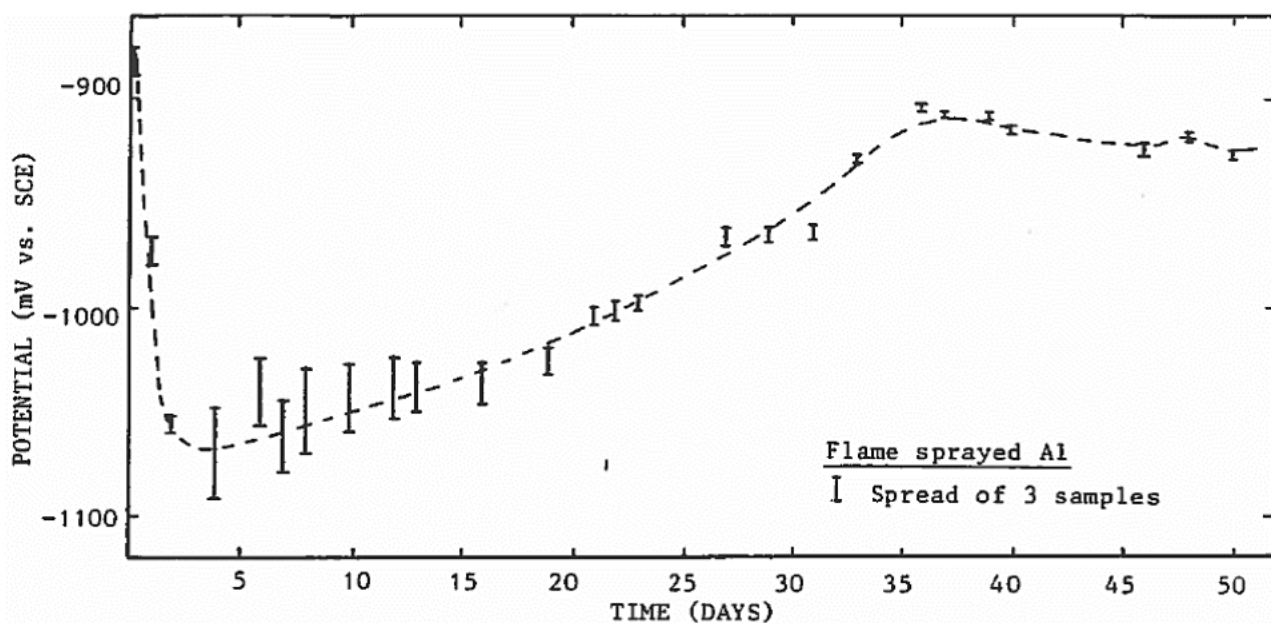
Figure 2.9: The open circuit potential of flame sprayed aluminum during exposure in SW [5].

Intermetallic particles that are present in TSA due to spraying process or impurities will initially cause high corrosion rates. This is because the particles are causing weakened spots for formation of the oxide, if they are electrochemically more noble than aluminum. The resulting corrosion mechanism is pitting, which was described in Section 2.2.2. The mechanism is mainly localized and will have greatest impact in the start of exposure. The micropits which are initiated around the particles increase the exposed area of the cathodic particles. The effect from this can be seen from Figure 2.9, where the open circuit potential (OCP) significantly drops from above -900 mV SCE to below -1050 mV SCE. During exposure, repassivation of the oxide will occur, due to removal or undermining of the intermetallic particles. This represents the slow increase in potential throughout the exposure period. [5, 4]

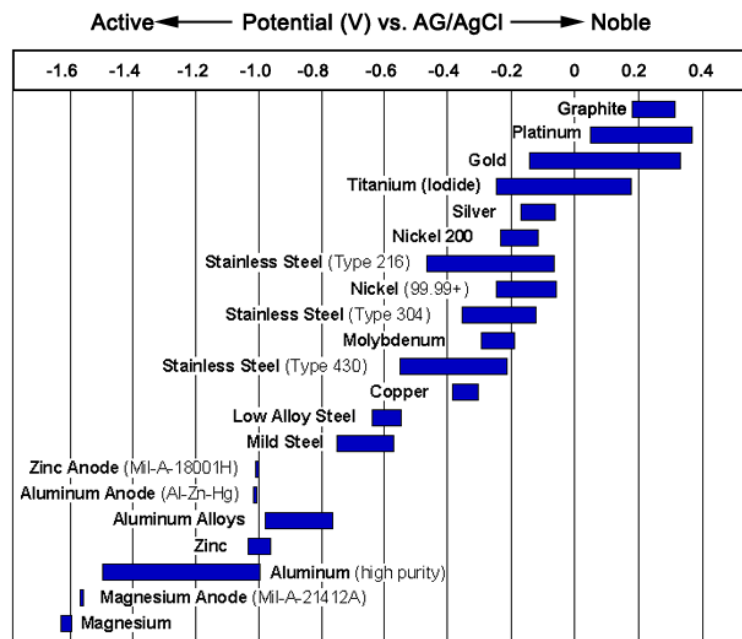
Figure 2.10: A general galvanic series of metal and alloys in seawater [8].

Figure 2.10 shows a general galvanic series of metal and alloys in seawater. It shows that Aluminum, Zinc and Magnesium are materials which have negative potentials compared with steel, and hence will have a driving force in providing protection currents to steel under exposure in seawater. Magnesium has a potential of approximately  $-1.6$  V Ag/AgCl in seawater, which will cause a strong driving force in providing protection currents. This can cause hydrogen embrittlement in some steel due to hydrogen evolution on the cathode. Aluminum and Zinc based alloys has a potential of approximately  $-1.05$  to  $-1.1$  V Ag/AgCl and are normally used as anode material in seawater with low resistivity. They will cause sufficient protection currents to steel and limit the chance of hydrogen evolution and problems from hydrogen embrittlement. Anodes from Magnesium alloys are often used in environments where the resistivity of the medium is high, where a strong driving force to overcome the potential drop is required [20].

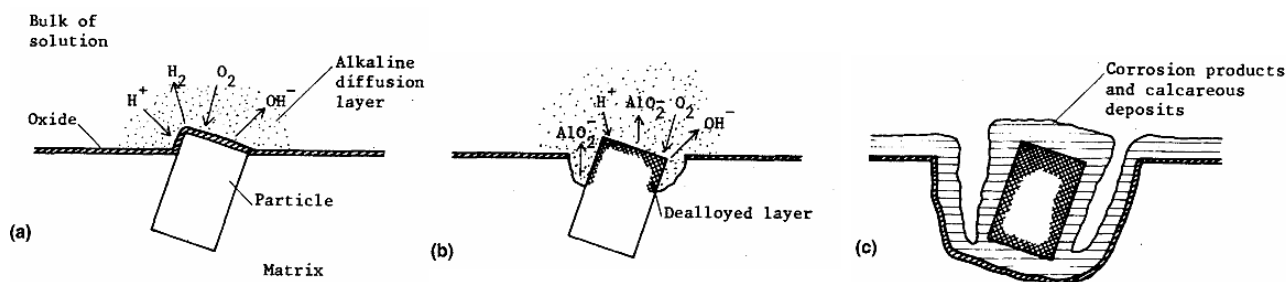
Figure 2.11: Schematic description of mechanism from CP of aluminum alloys in SW : (a) development of alkaline diffusion layer; (b) crevicing of matrix compound around the particle and selective dissolution of the particle; (c) repassivation of the surface after detachment or undermining of particle. Adapted from [5].

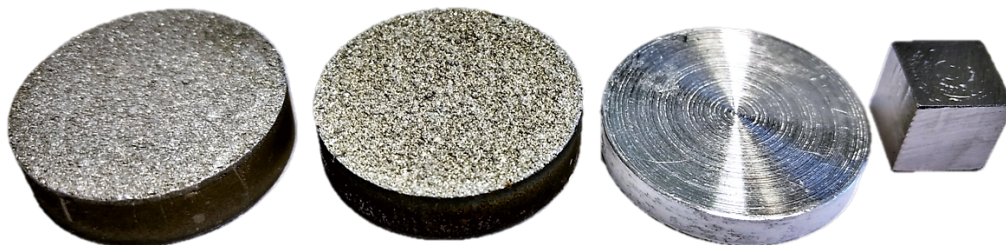
Figure 4.1: Front side of test samples -Left: DSA sample, 2nd Left: TSA sample, 2nd Right: Anode sample, Right: CS-cube.

The M3-rods are stainless steel and were included to ensure electrical contact with the CS-cubes in the bulk electrolyte of the containers, while shorter M3-rods were included to facilitate electrical contact on the unexposed side of the samples.

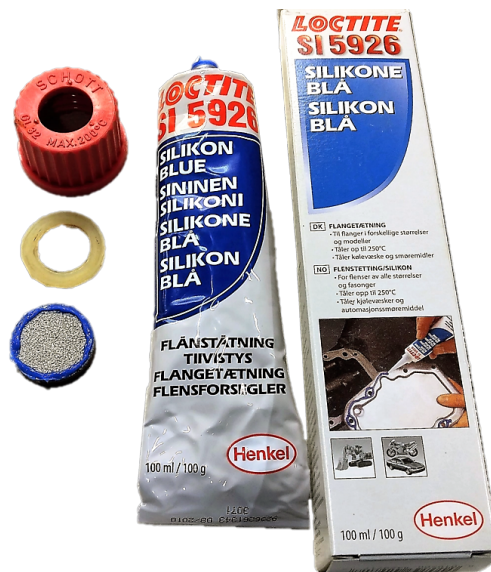
Figure 4.2: Application of blue silicon gel onto a thermally sprayed sample, creating an extra barrier against leakage.

Experiences from the project work [37] revealed leakage problems at the connections points, especially where the thermally sprayed samples were connected. In order to prevent leakage problems it was decided to apply blue silicon gel onto the surface of all samples. This created an additional barrier against leakage. The application of blue silicon gel onto a sample is presented in Figure 4.2.

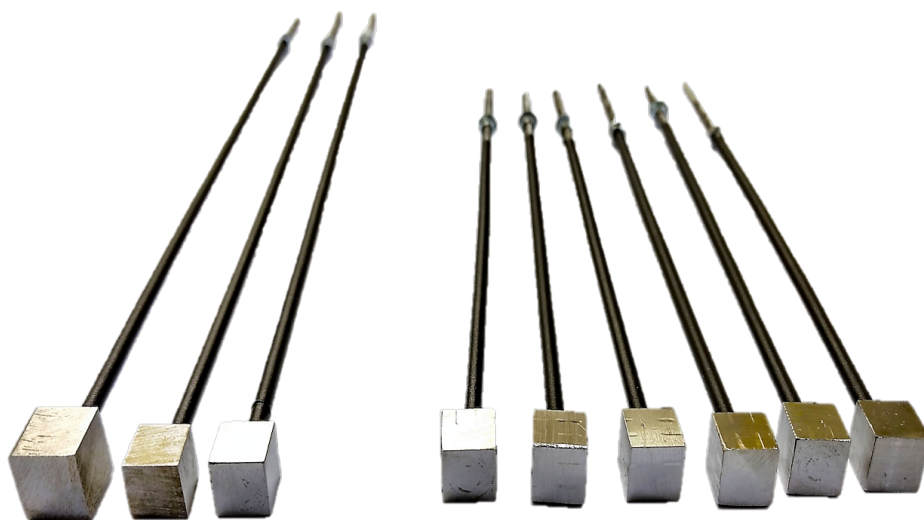
Figure 4.3: CS-cubes attached to M3-rods with shrinkable tubing.

The CS-cubes were securely tightened with the M3-rods using a shift key. This prevented looseness between the CS-cubes and the rods, which ensured proper electrical contact between the two. Heat shrinkable tubing was put on the part of the rods that would stand in the seawater. A heat dryer was used to shrink the tubing onto the rods. This ensured that only the CS-cube pulled current from the test samples. A picture of the CS-cubes attached to M3-rods with shrinkable tubing is presented in Figure 4.3.

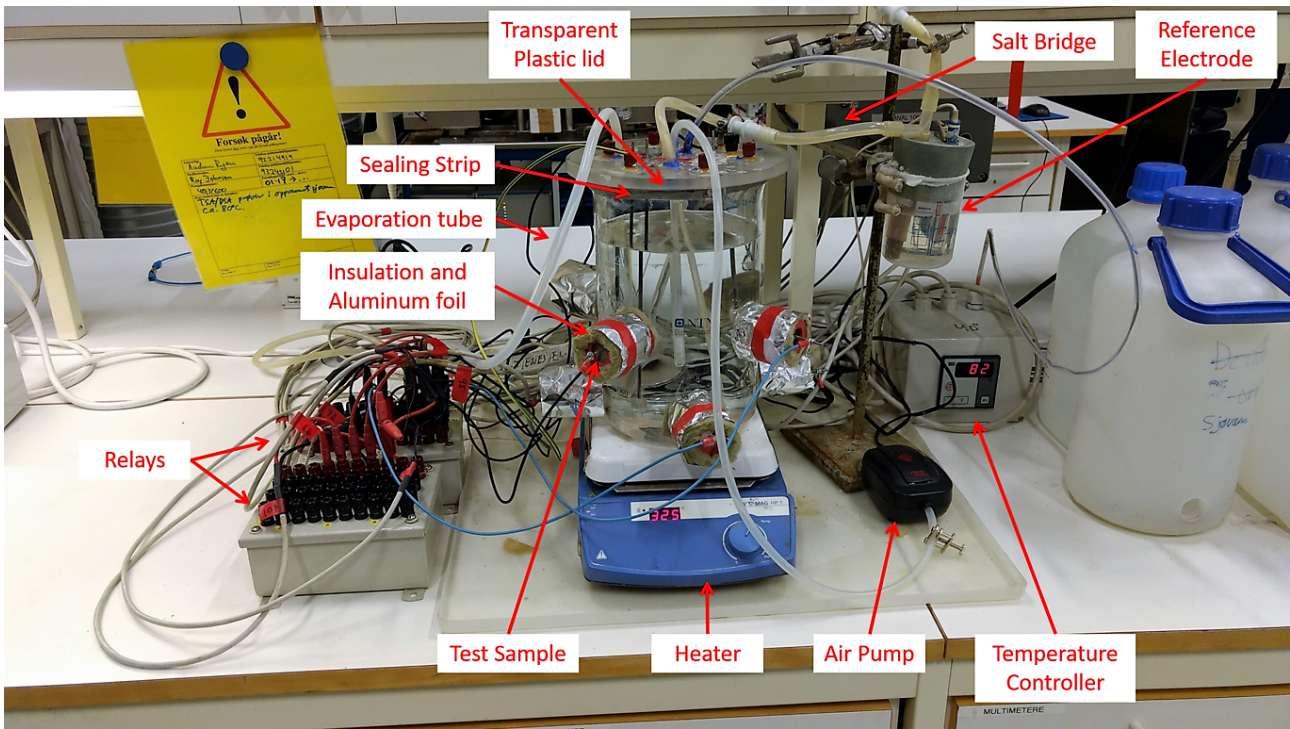
Figure 4.4: The 80°C experiment with general description of parts.

The general parts in the experimental design of the 80°C experiment is presented in Figure 4.4. A simple picture of the 22°C experiment with additional description of parts is presented in Figure 4.5.

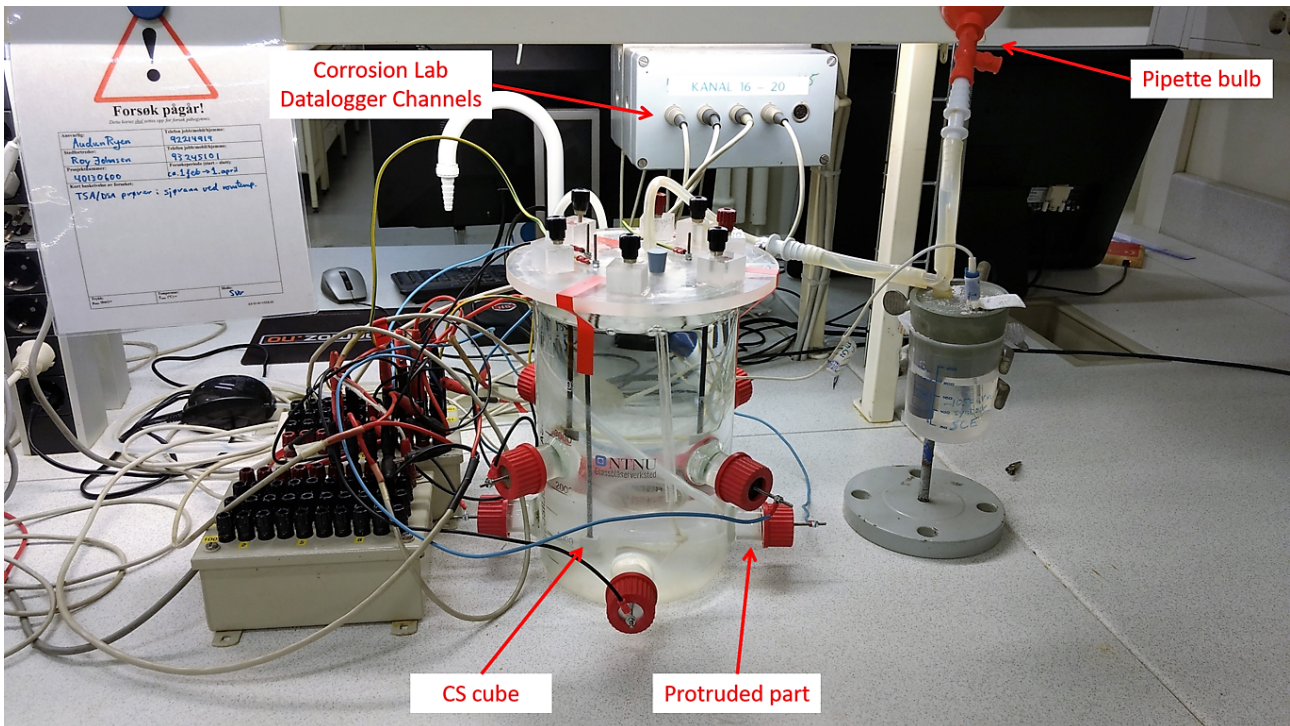
Figure 4.5: The 22°C experiment and additional description of parts.

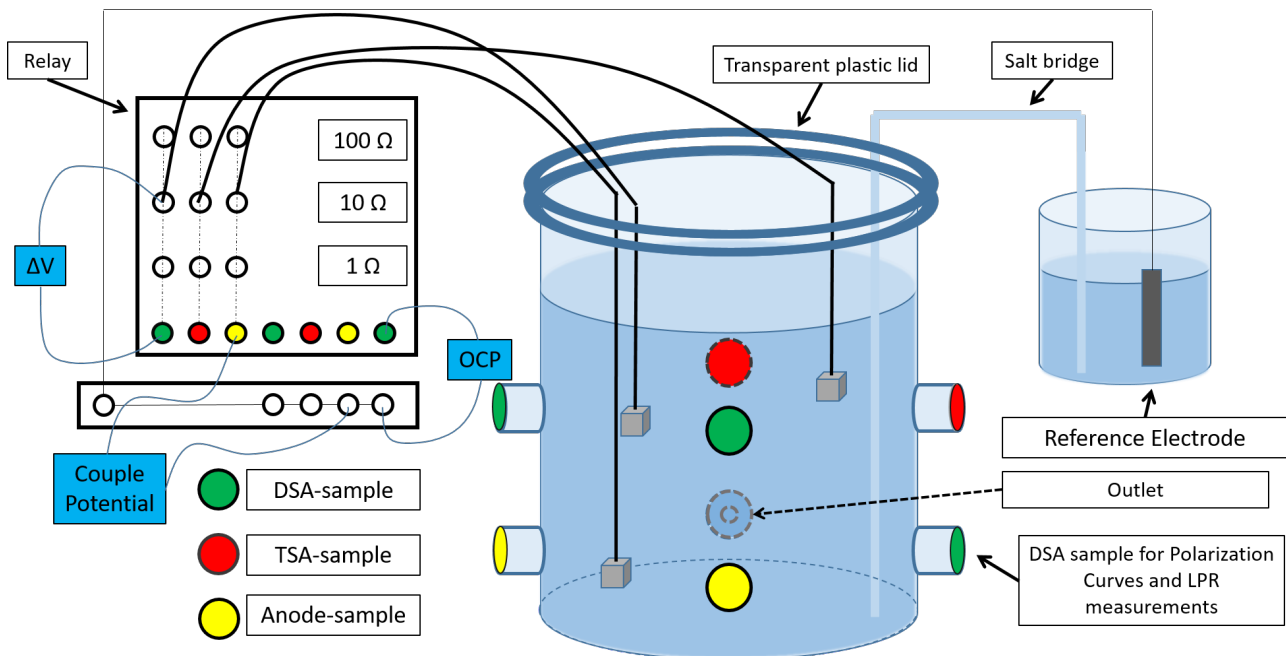
Figure 4.6: A simple schematic description of the setup of samples on each container.

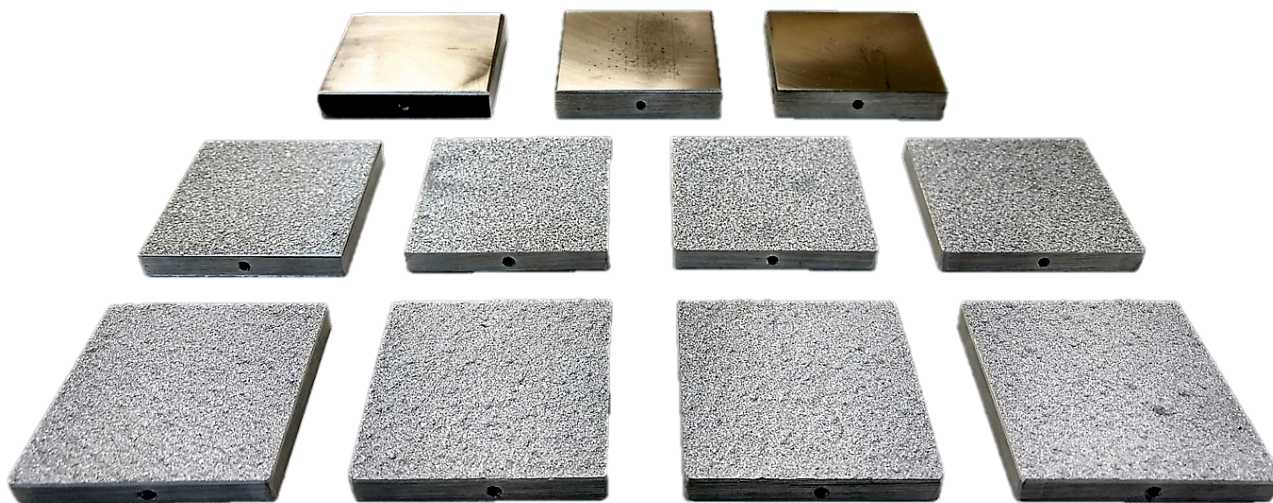
Figure 4.8: Test samples to be embedded in mud -Top: CS samples, Middle: TSA samples, Bottom: DSA samples.

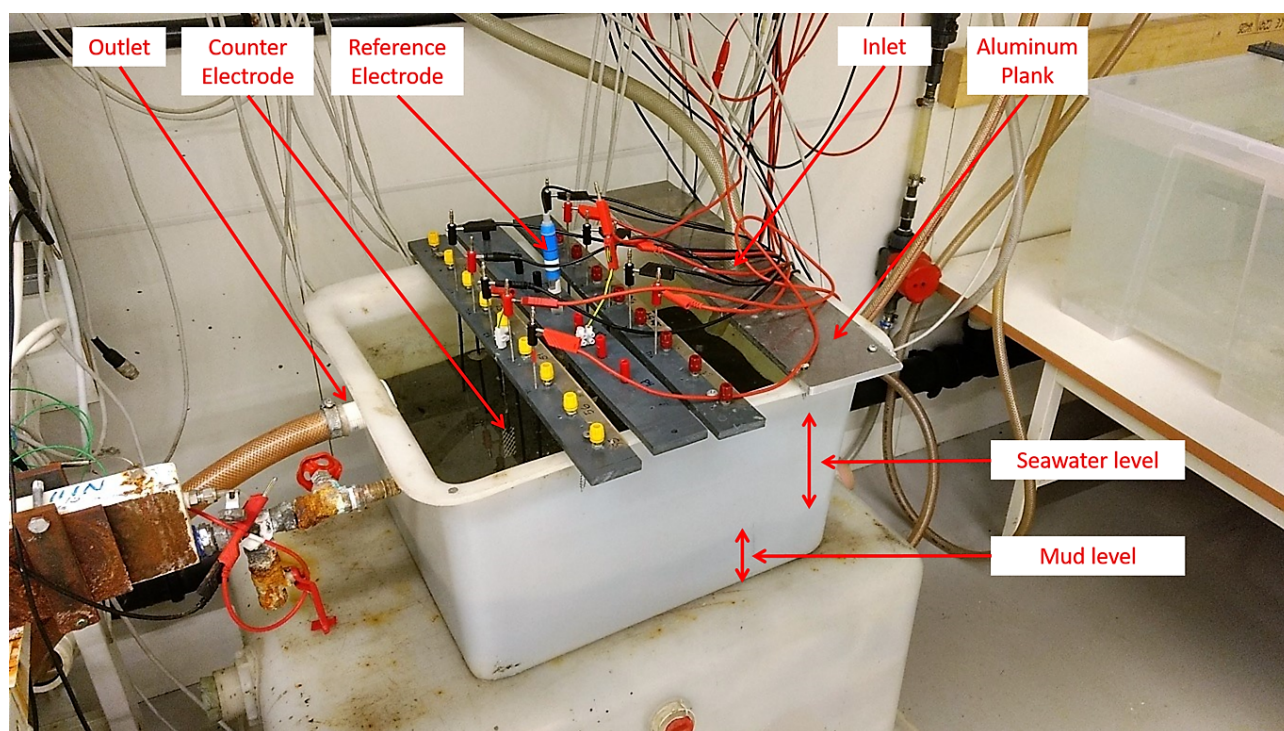
Figure 4.13: A general overview of the experiment in mud and description of parts.

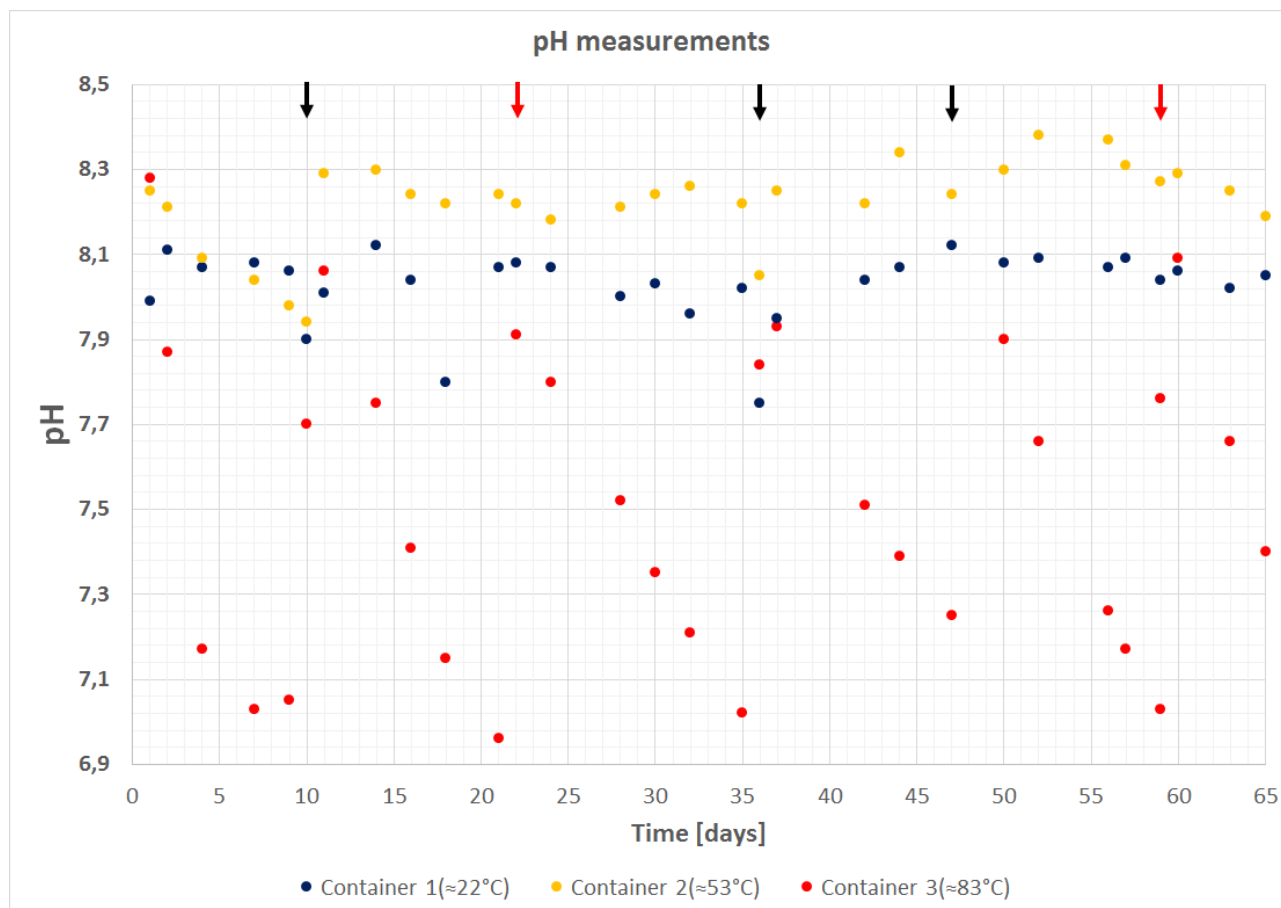
Figure 5.1: pH measurements of containers throughout exposure period. The arrows show when SW was replaced in the containers (Black = All containers, Red = 80°C container).

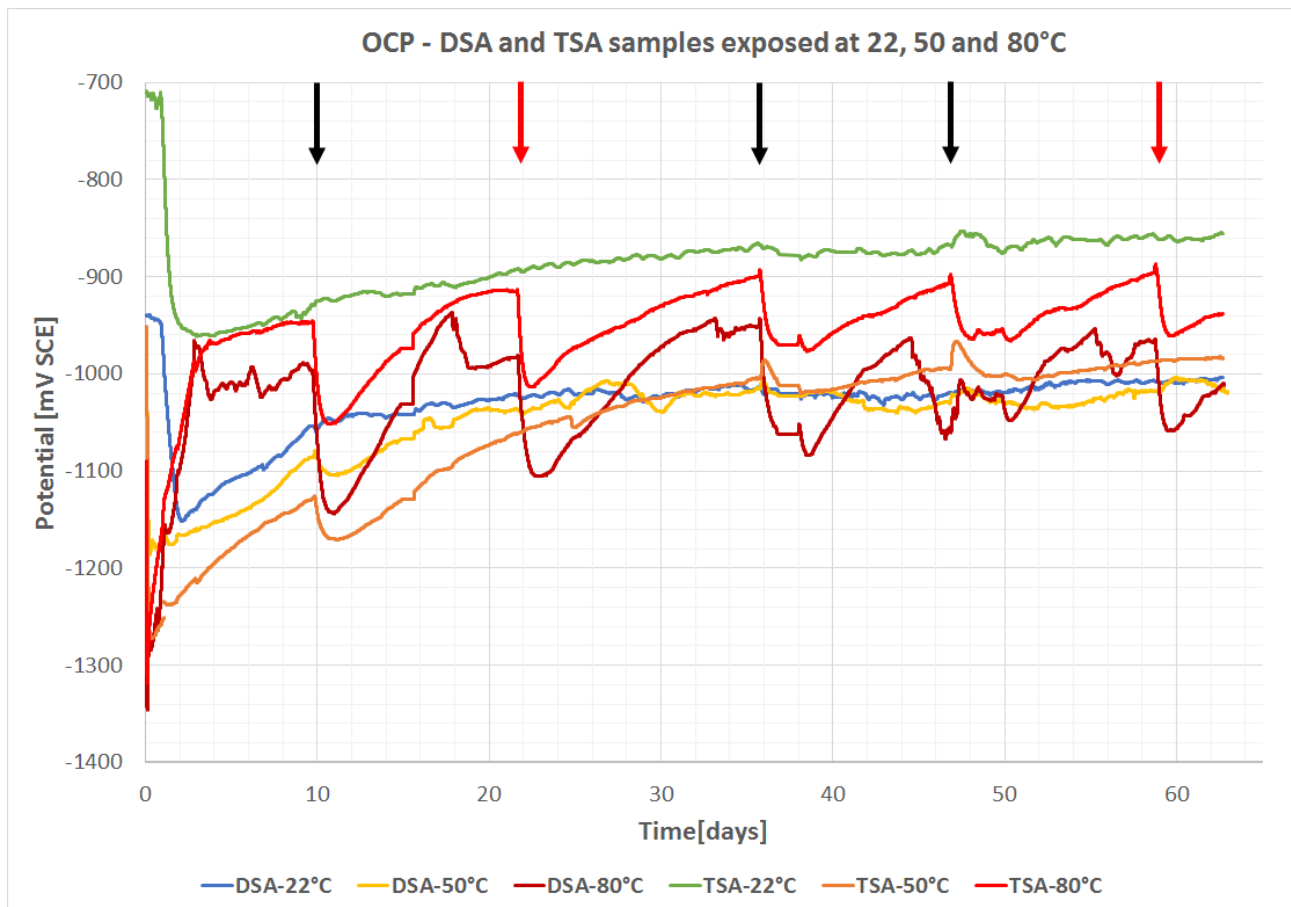
Figure 5.2: OCP of freely exposed DSA and TSA samples at all temperatures throughout exposure period. The arrows show when SW was replaced in the containers (Black = All containers, Red = 80°C container).

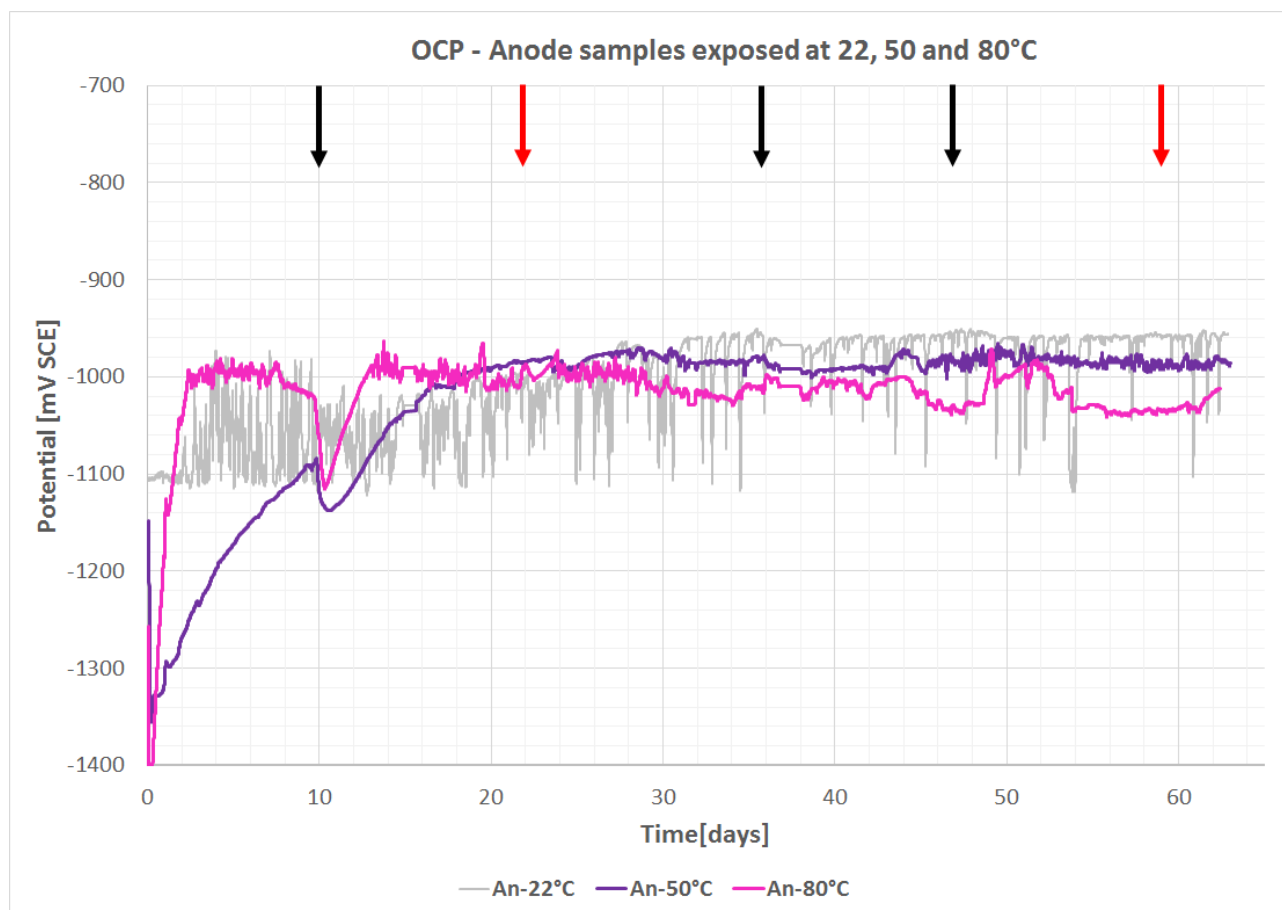
Figure 5.3: OCP of freely exposed Anode samples at all temperatures throughout exposure period. The arrows show when SW was replaced in the containers (Black = All containers, Red = 80°C container).

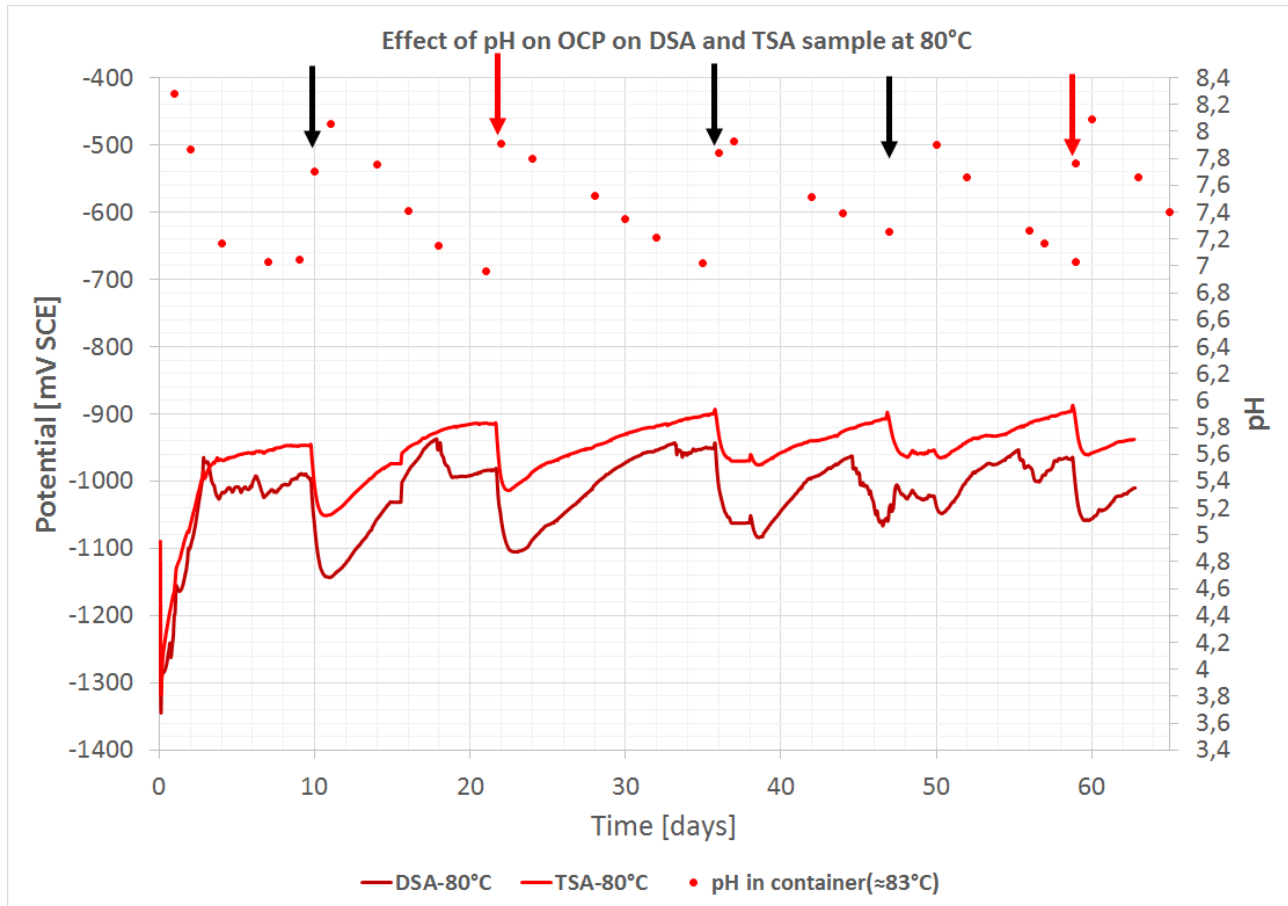
Figure 5.4: OCP of DSA and TSA samples at 80°C and pH measurements of the 80°C container throughout the exposure period. The arrows show when SW was replaced in the containers (Black = All containers, Red = 80°C container).

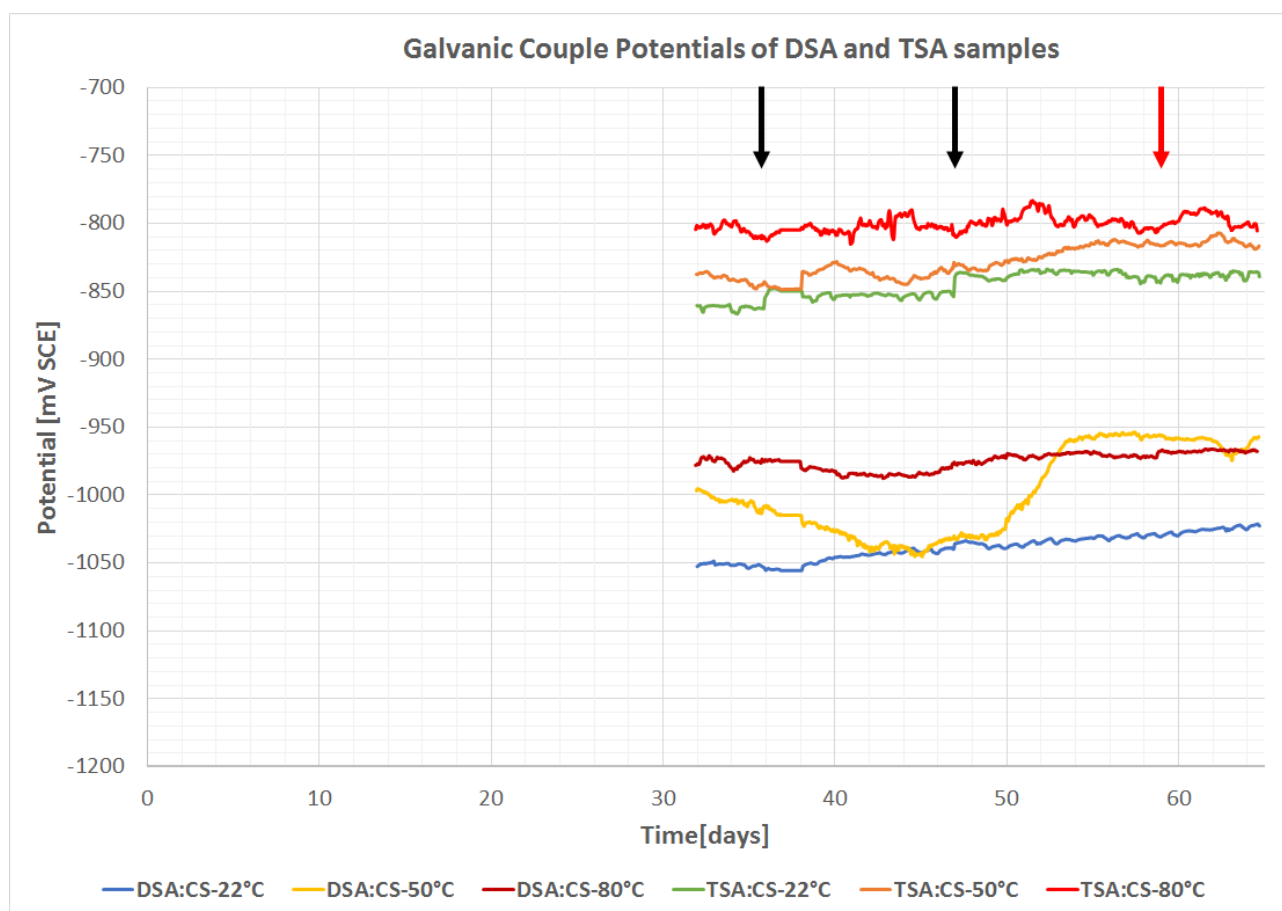
Figure 5.5: Galvanic couple potentials of DSA and TSA sample at all temperatures throughout the exposure period. The arrows show when SW was replaced in the containers (Black = All containers, Red = 80°C container).

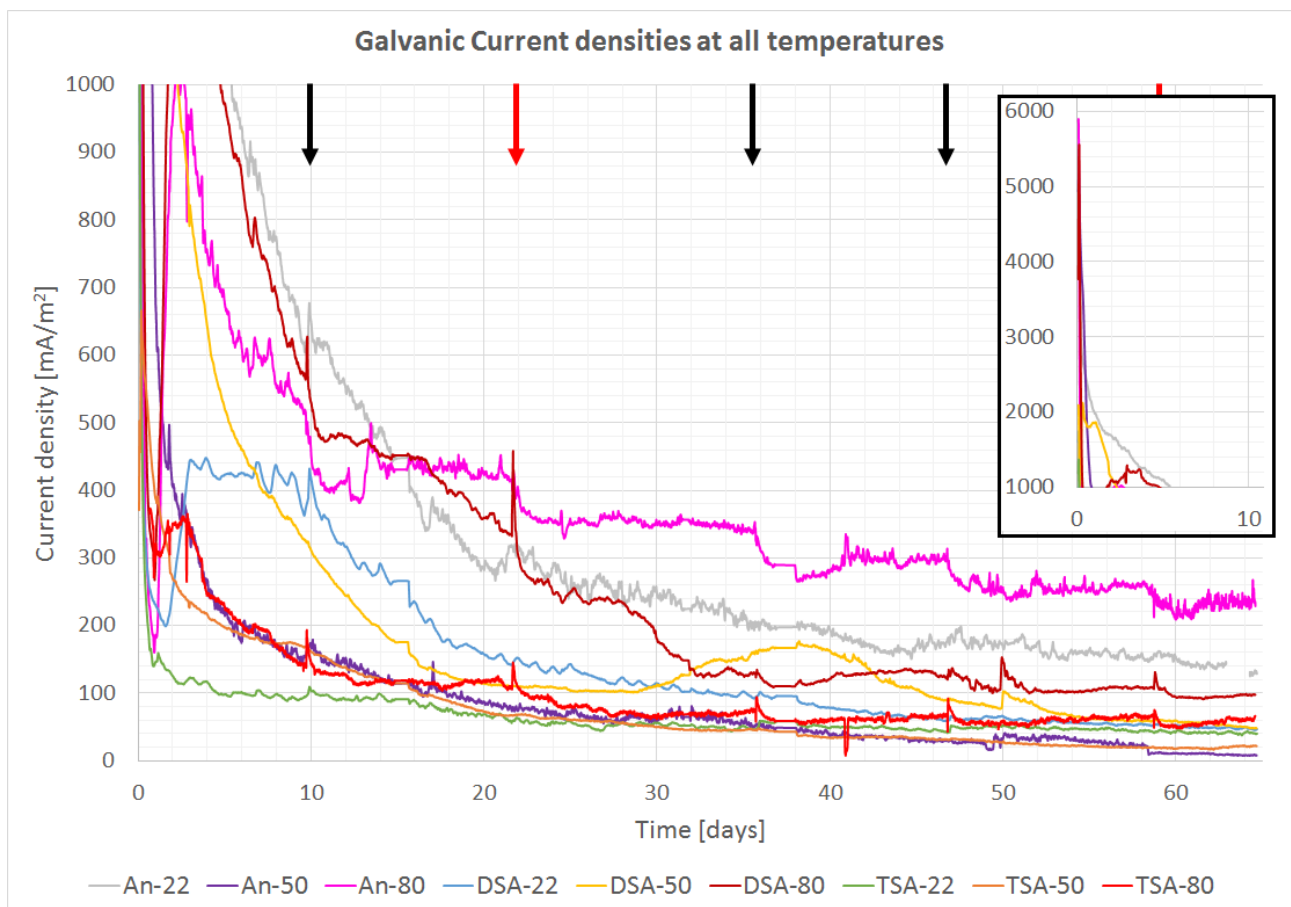
Small peaks can be observed at the times when SW was replaced in the containers.

Figure 5.6: Galvanic Currents of Coupled DSA, TSA and Anode samples at all temperatures throughout the exposure period. The arrows show when SW was replaced in the containers (Black = All containers, Red =  $80^\circ\text{C}$  container).

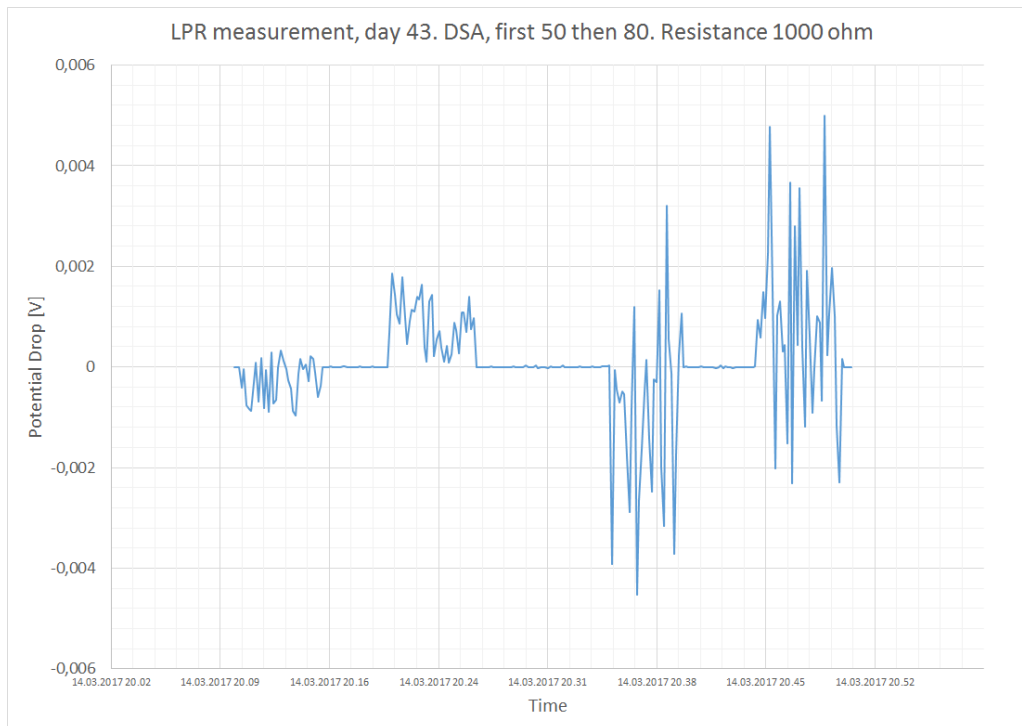
Figure 5.7: LPR measurement of the 50 and 80°C DSA samples at day 43 showing fluctuating behavior.

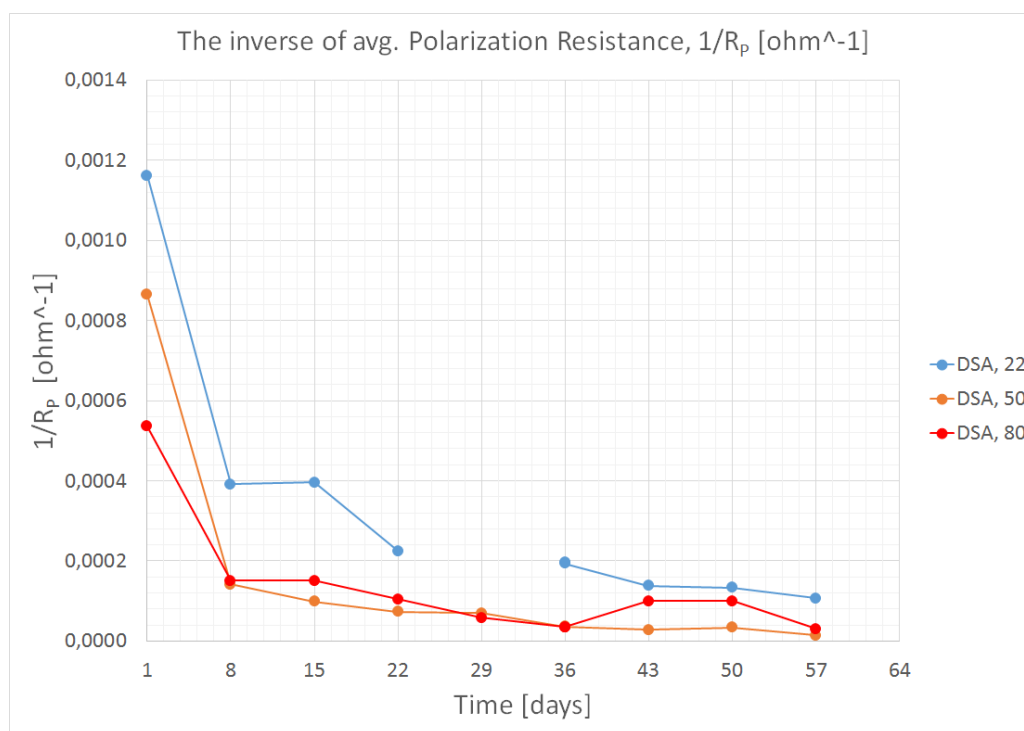
Figure 5.8: The results from LPR measurements of DSA samples at all temperatures, plotted as  $1/R_p$ .

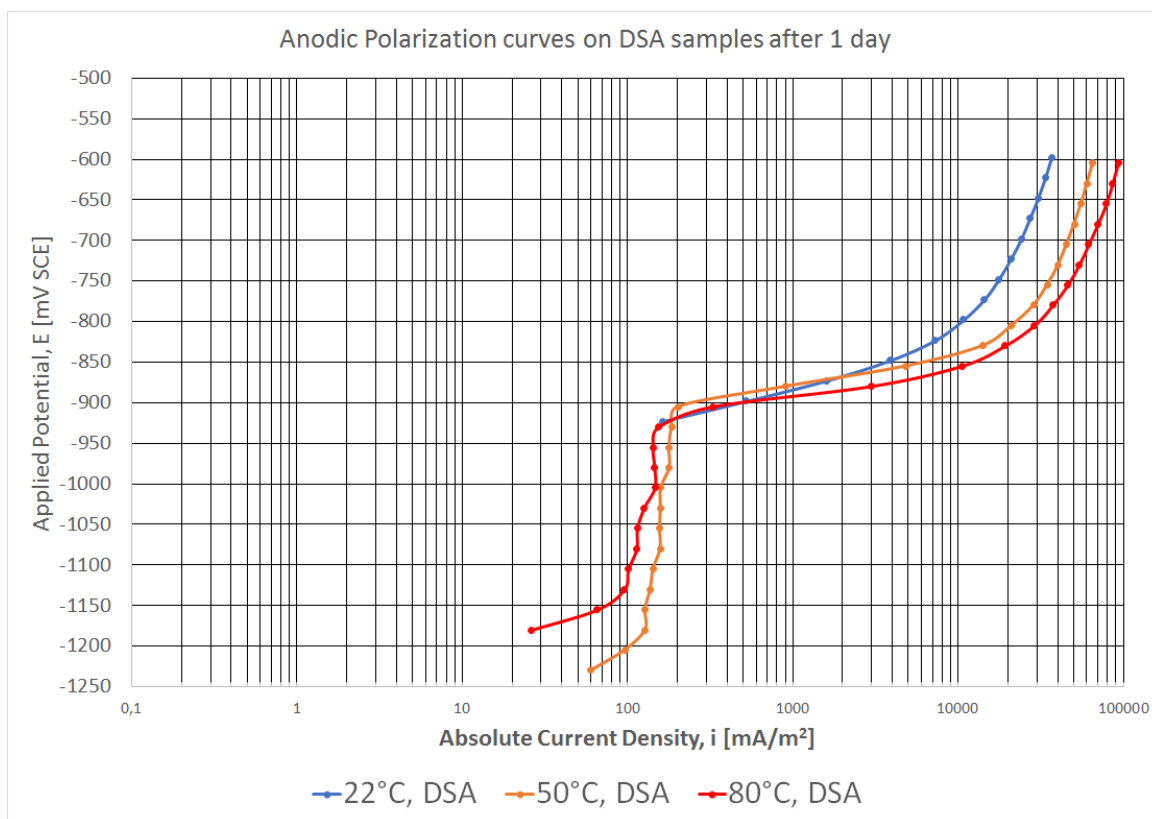
Figure 5.9: Anodic Polarization Curves recorded on DSA samples after one day of exposure.
