# Distributed Sacrificial Anode (DSA) - Properties in Mud and at Elevated Temperatures in Seawater

Subsea Technology

Submission date: June 2017

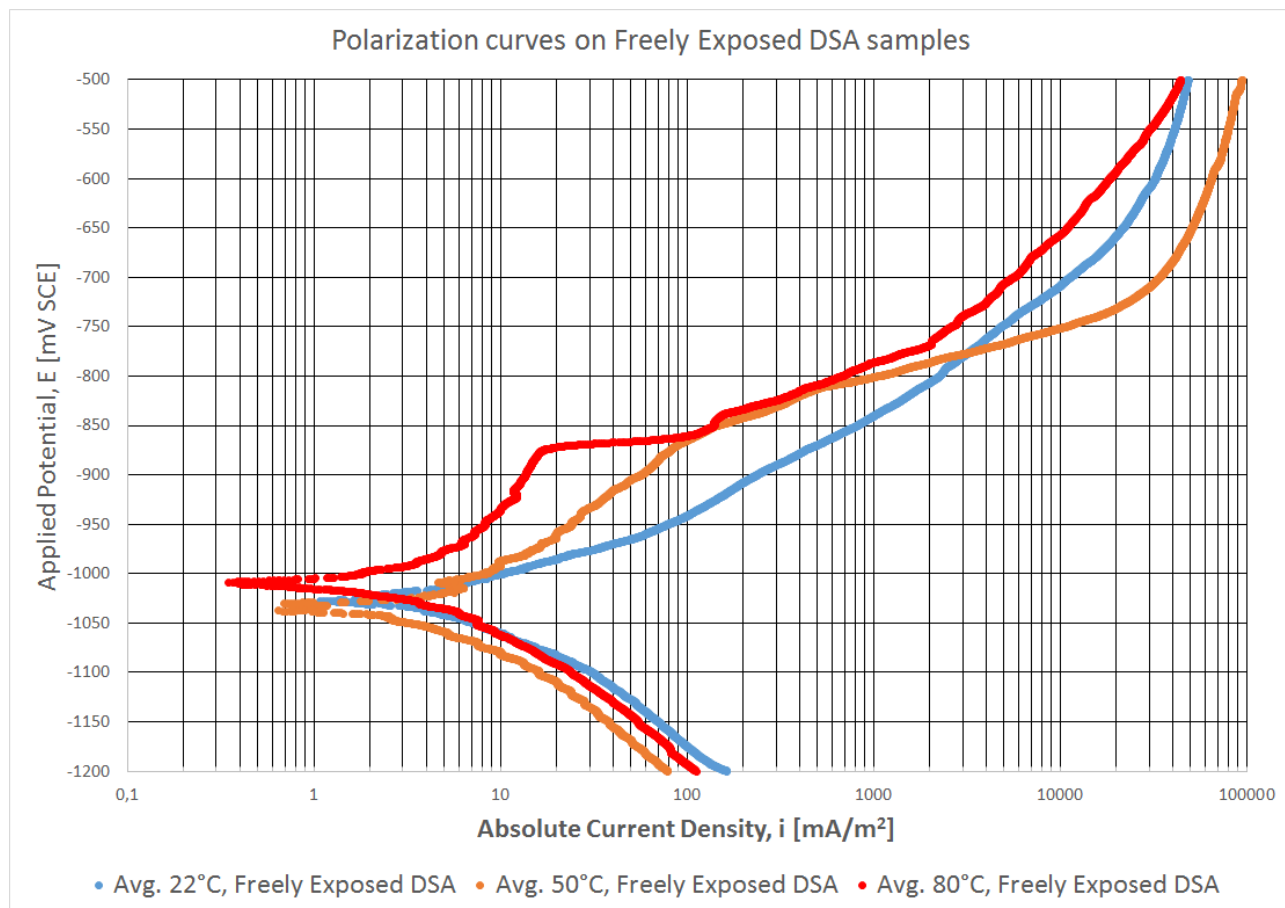
Figure 5.10: Recorded Polarization Curves on freely exposed DSA samples after 63 days.

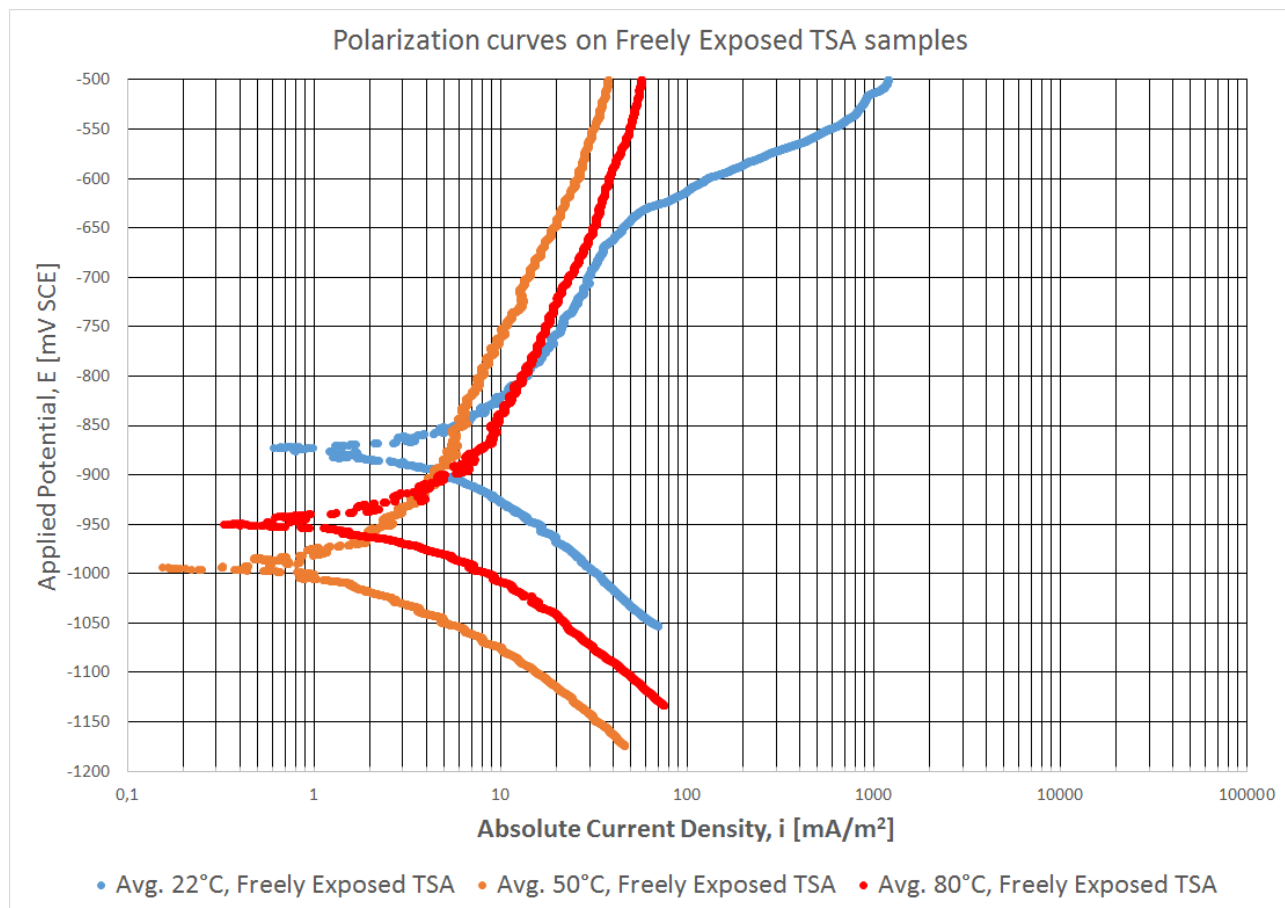
Figure 5.11: Recorded Polarization Curves on freely exposed TSA samples after 63 days.

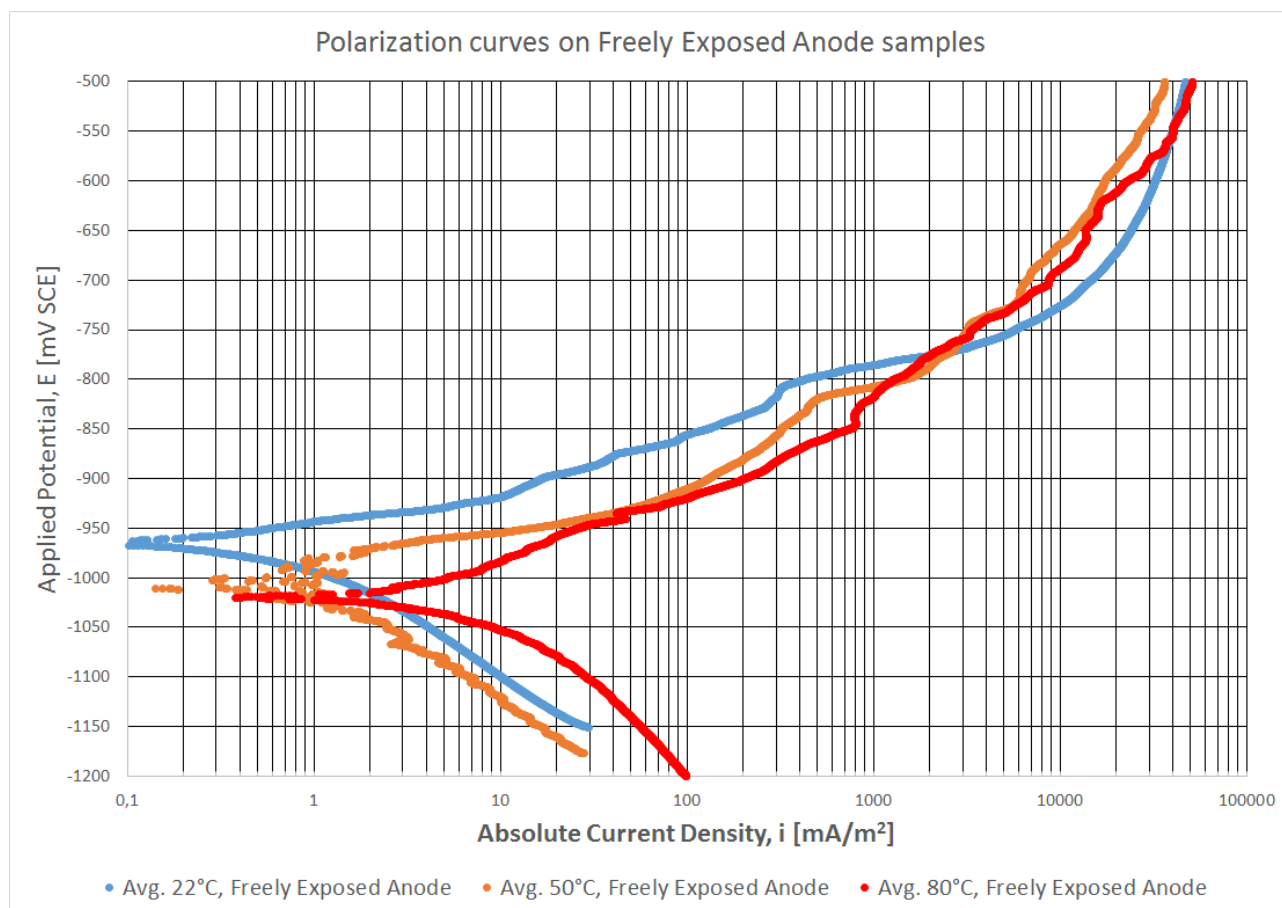
Figure 5.12: Recorded Polarization Curves on freely exposed Anode samples after 63 days.

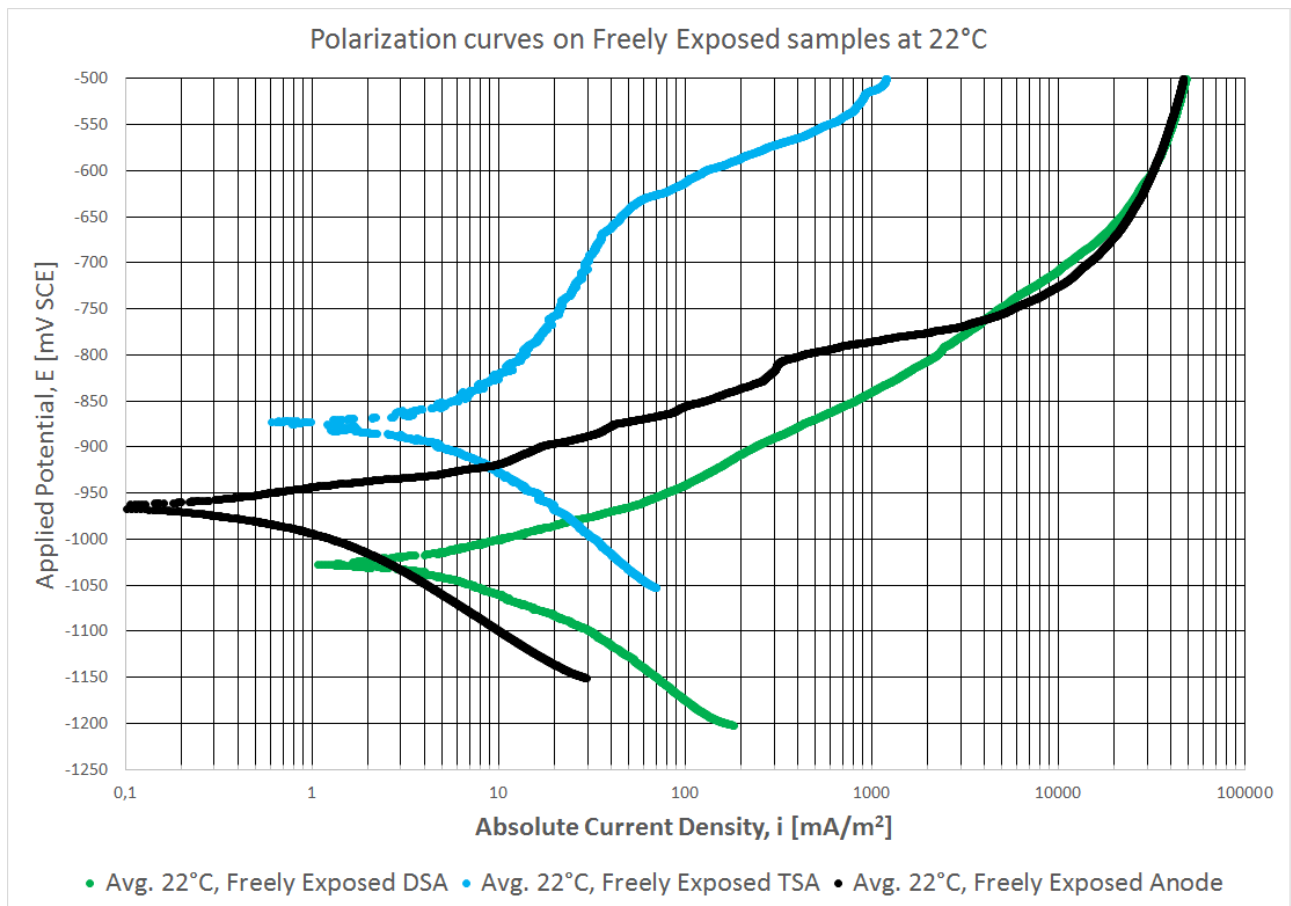
Figure 5.13: Recorded Polarization Curves on freely exposed samples at 22°C, after 63 days of exposure.

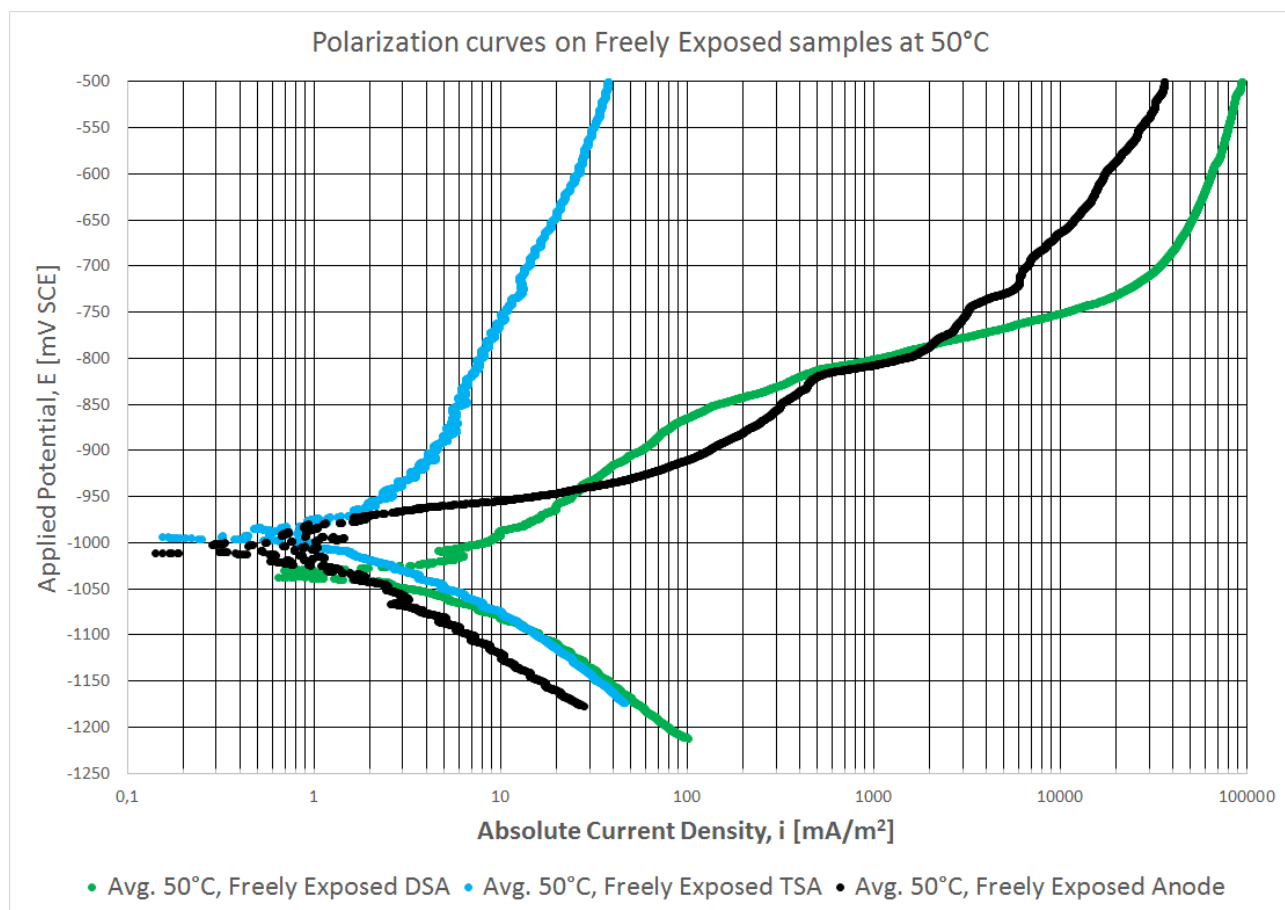
Figure 5.14: Recorded Polarization Curves on freely exposed samples at 50°C, after 63 days of exposure.

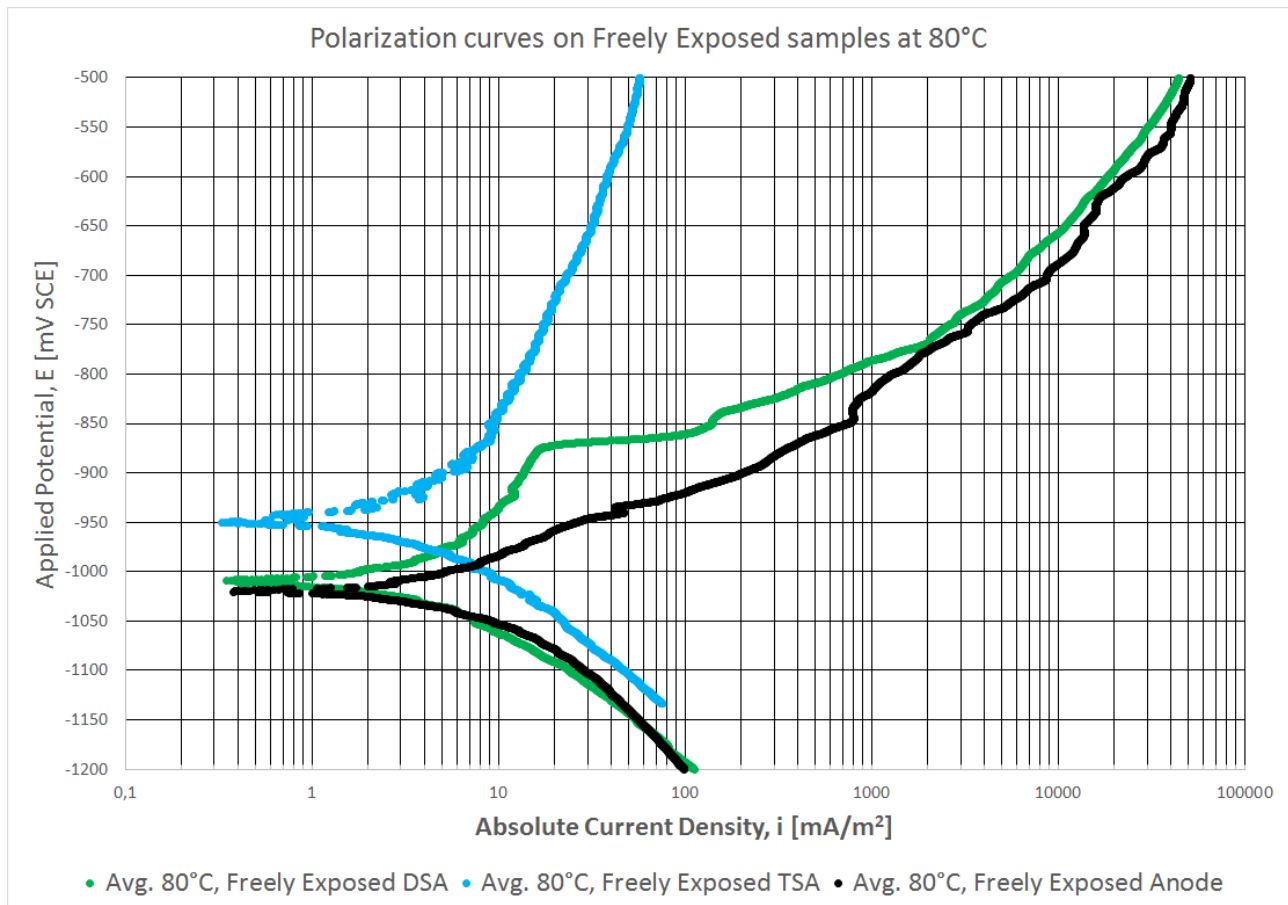
Figure 5.15: Recorded Polarization Curves on freely exposed samples at 80°C, after 63 days of exposure.

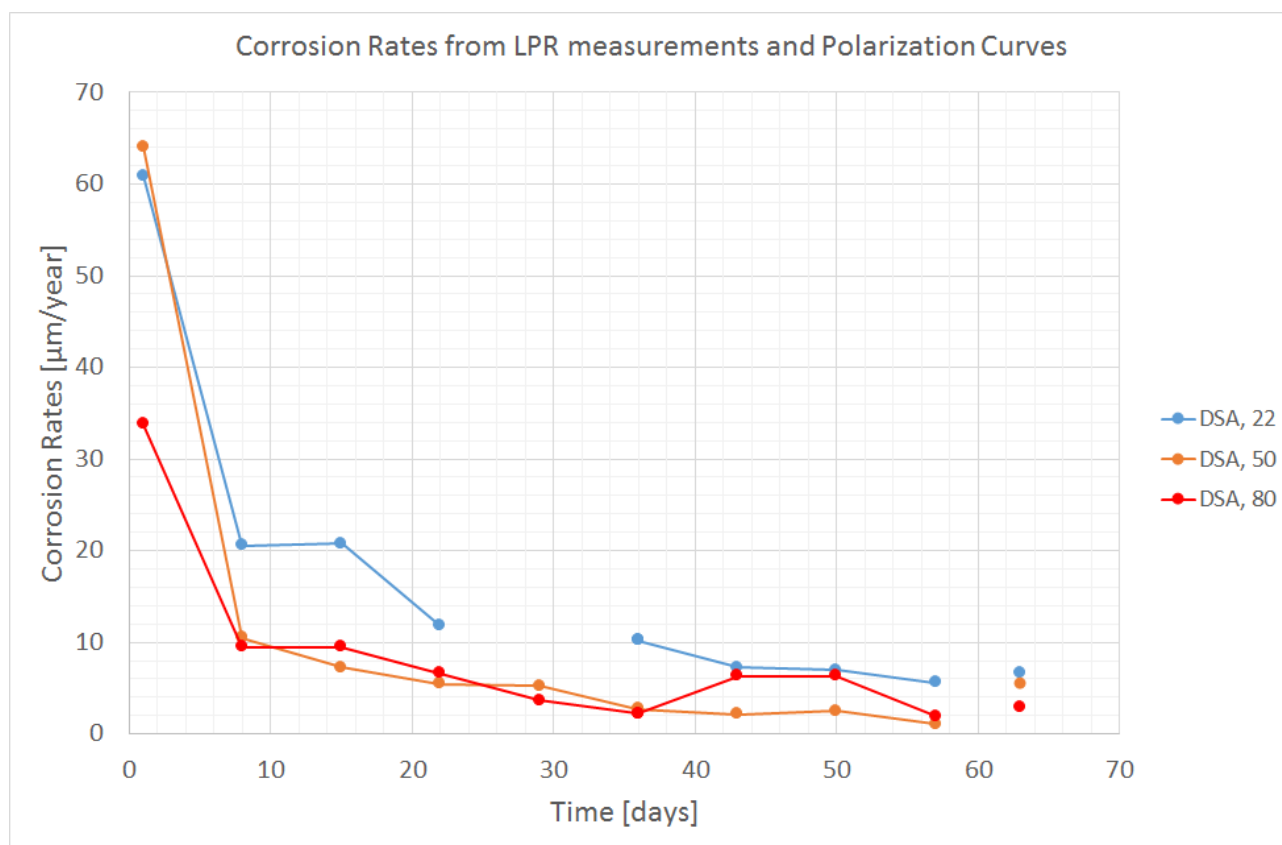
Figure 5.16: Corrosion rates from LPR on freely exposed DSA samples which were polarized at day 1. The three single points (day 63) are calculated from graphical solution of Polarization Curves.

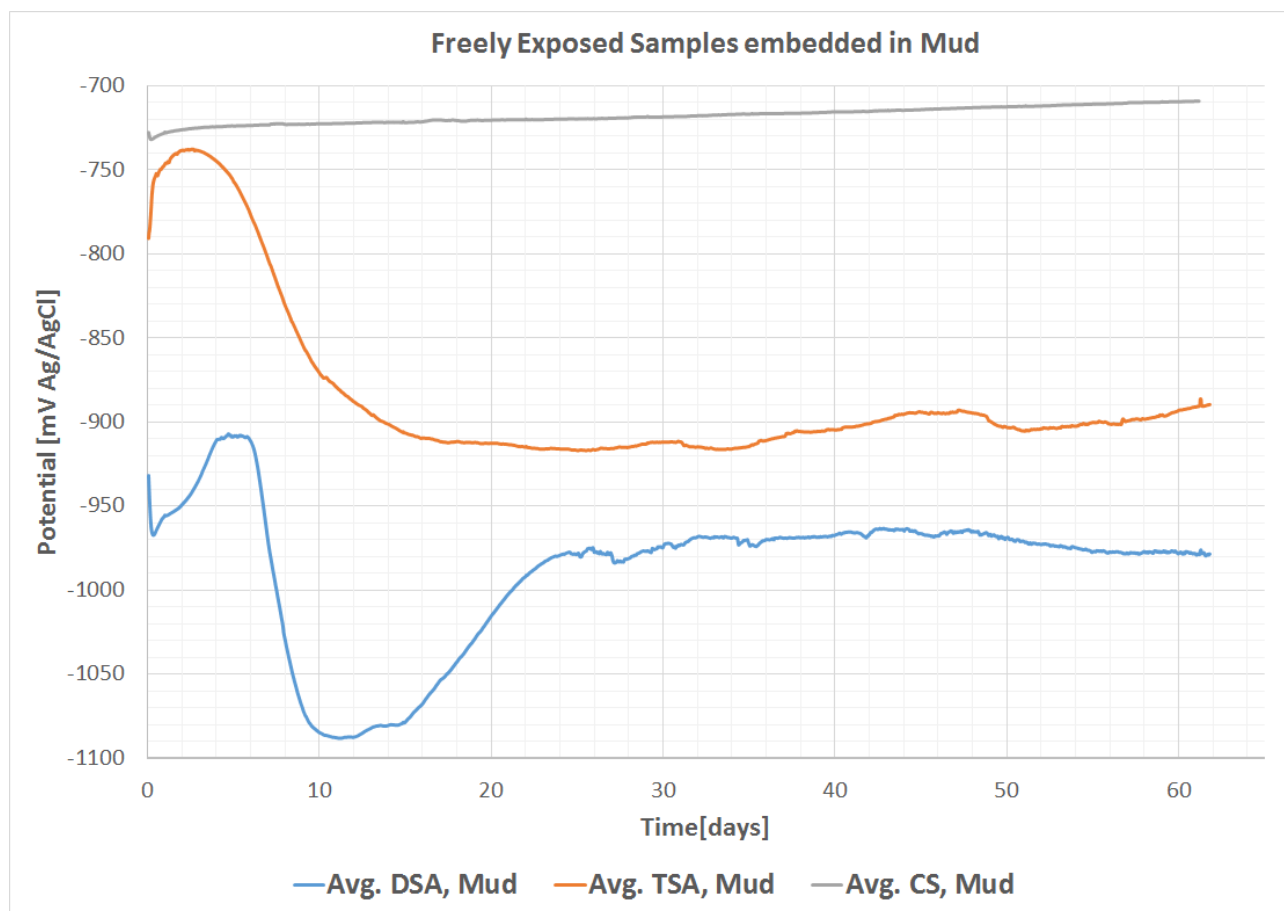
Figure 6.1: OCP of the freely exposed samples embedded in mud.

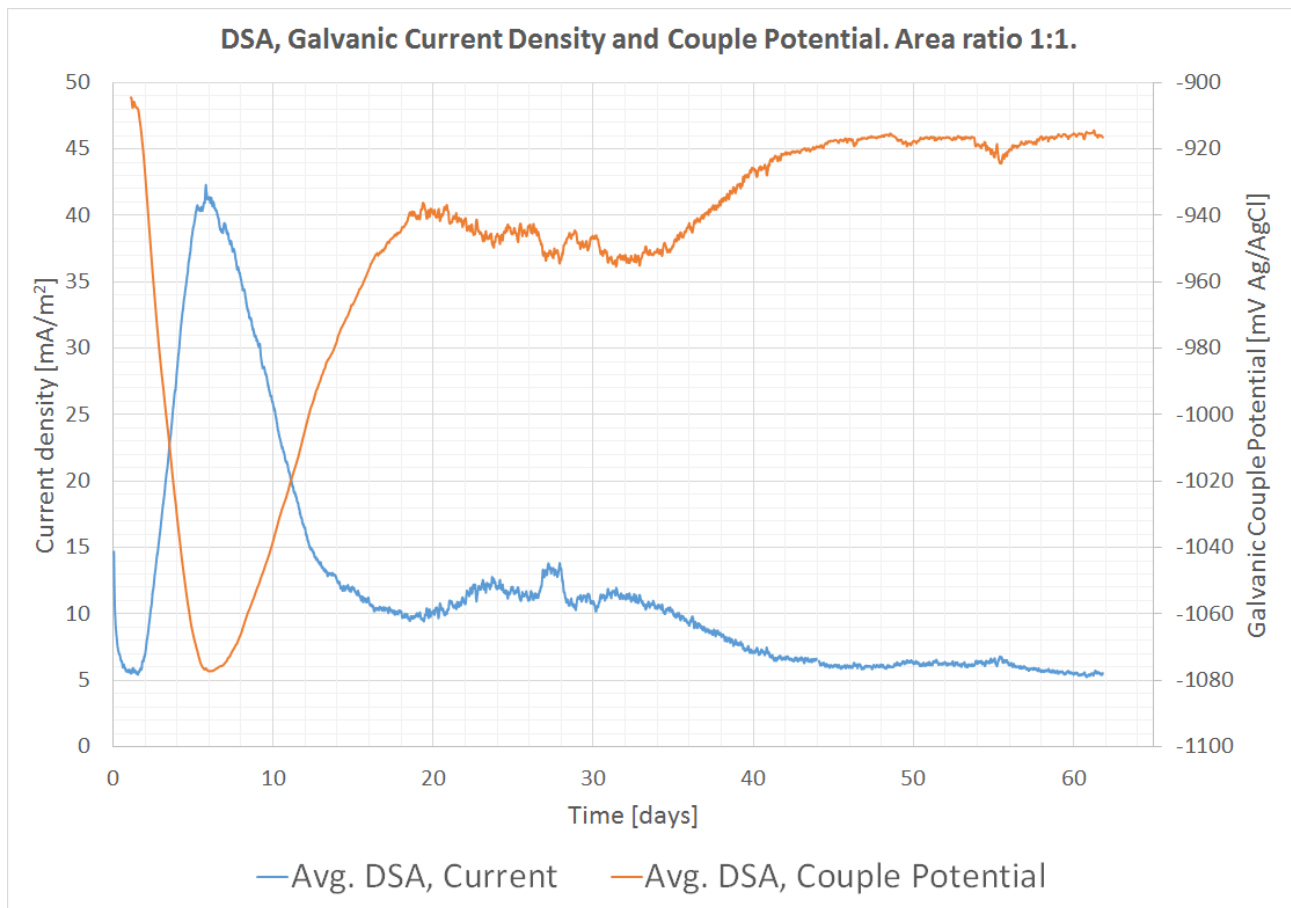
Figure 6.2: Galvanic current density and couple potential of a DSA:CS coupling embedded in mud.

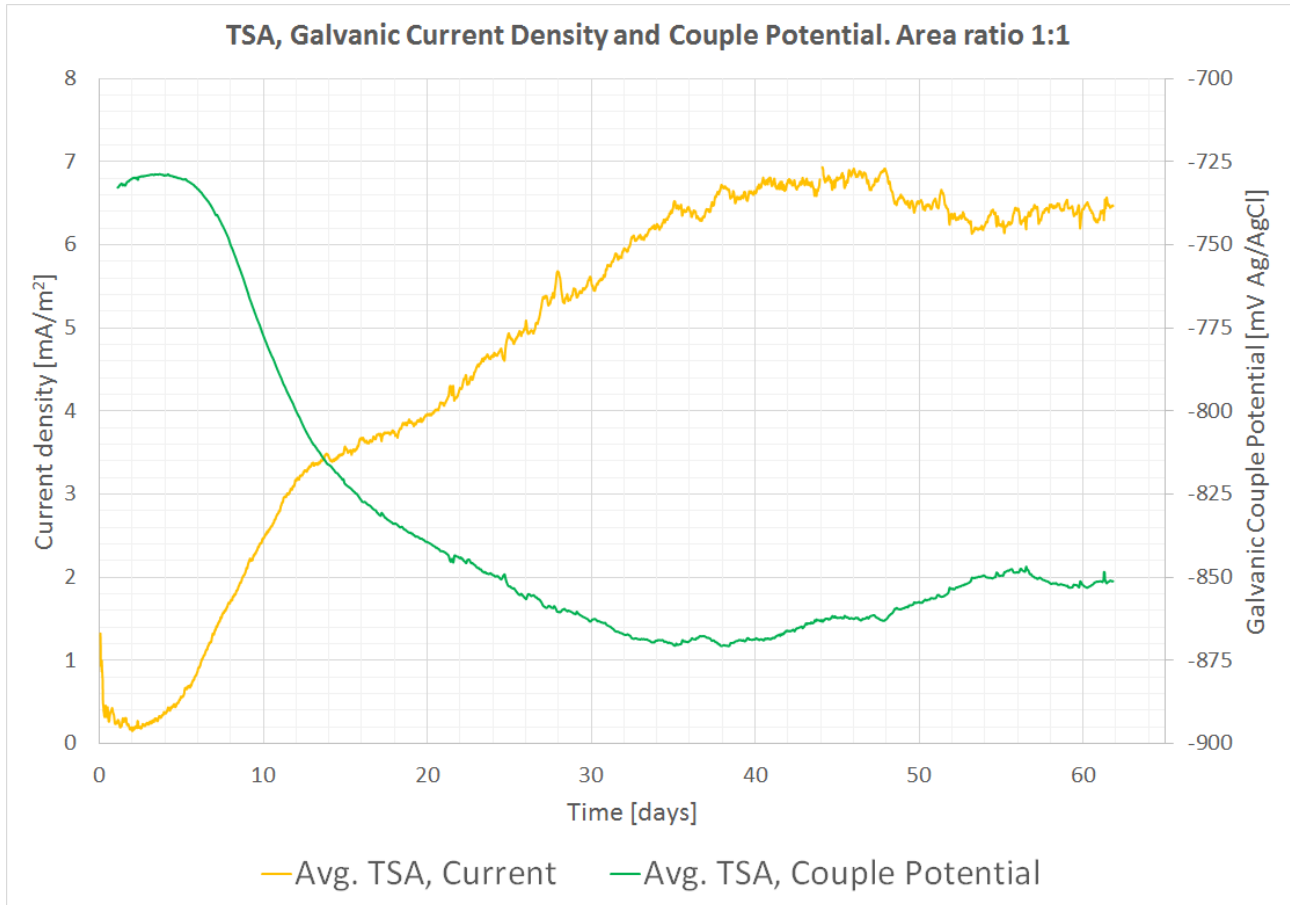
Figure 6.3: Galvanic current density and couple potential of a TSA:CS coupling embedded in mud.

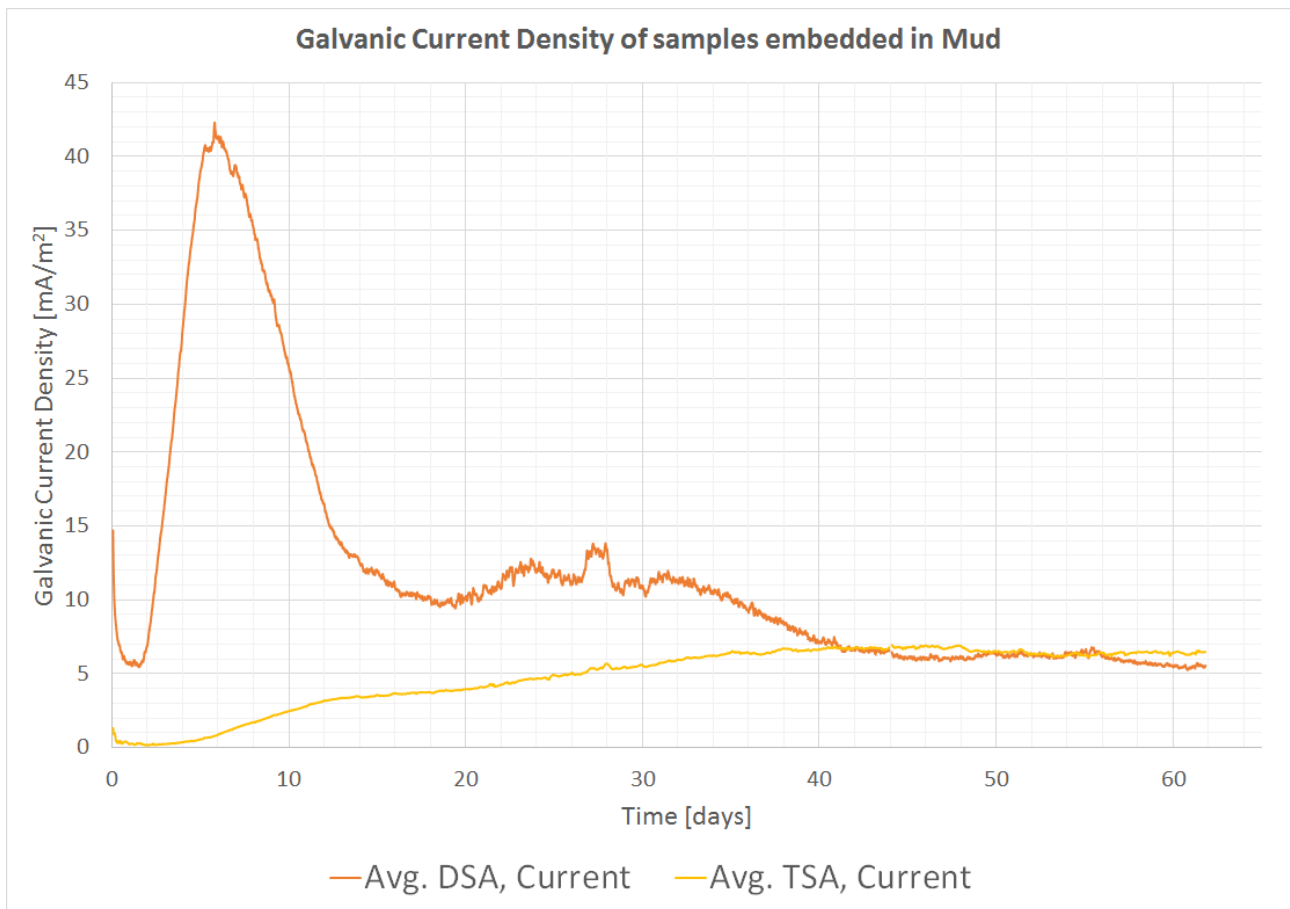
Figure 6.4: Galvanic current densities for the coupled DSA and TSA coating embedded in mud.

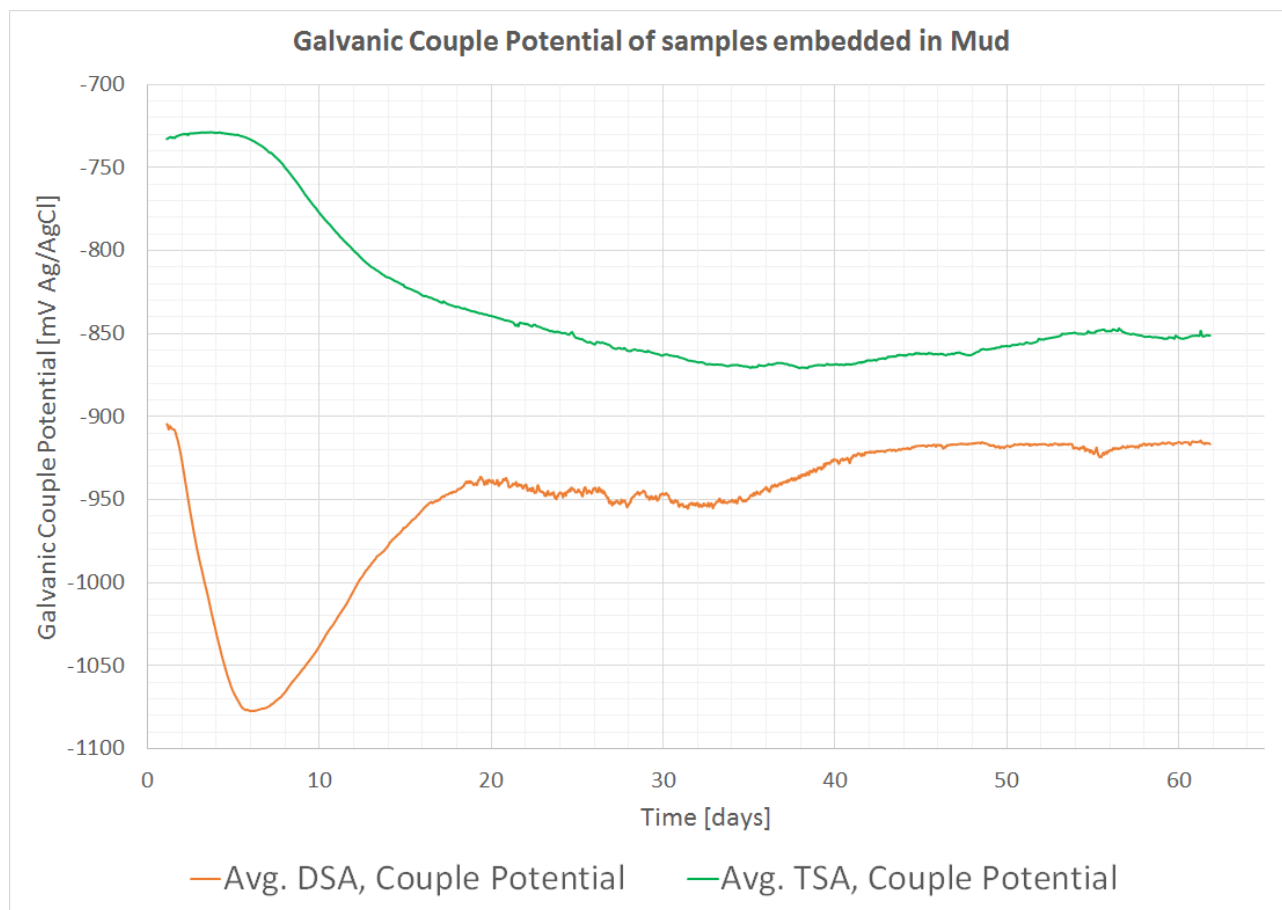
Figure 6.5: Galvanic couple potentials for the DSA and TSA coating embedded in mud.

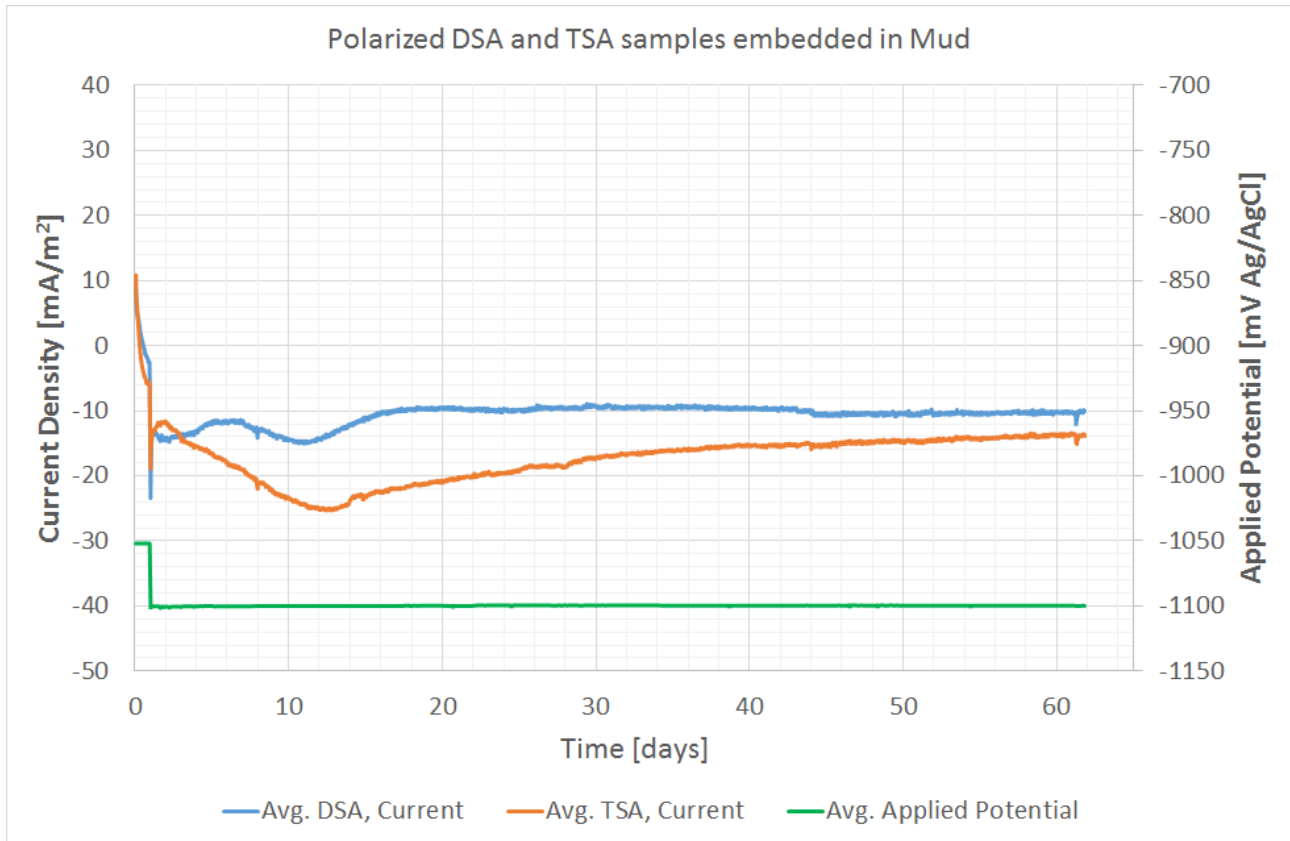
Figure 6.6: Current densities and applied potential of the potentiostatically polarized samples embedded in mud.

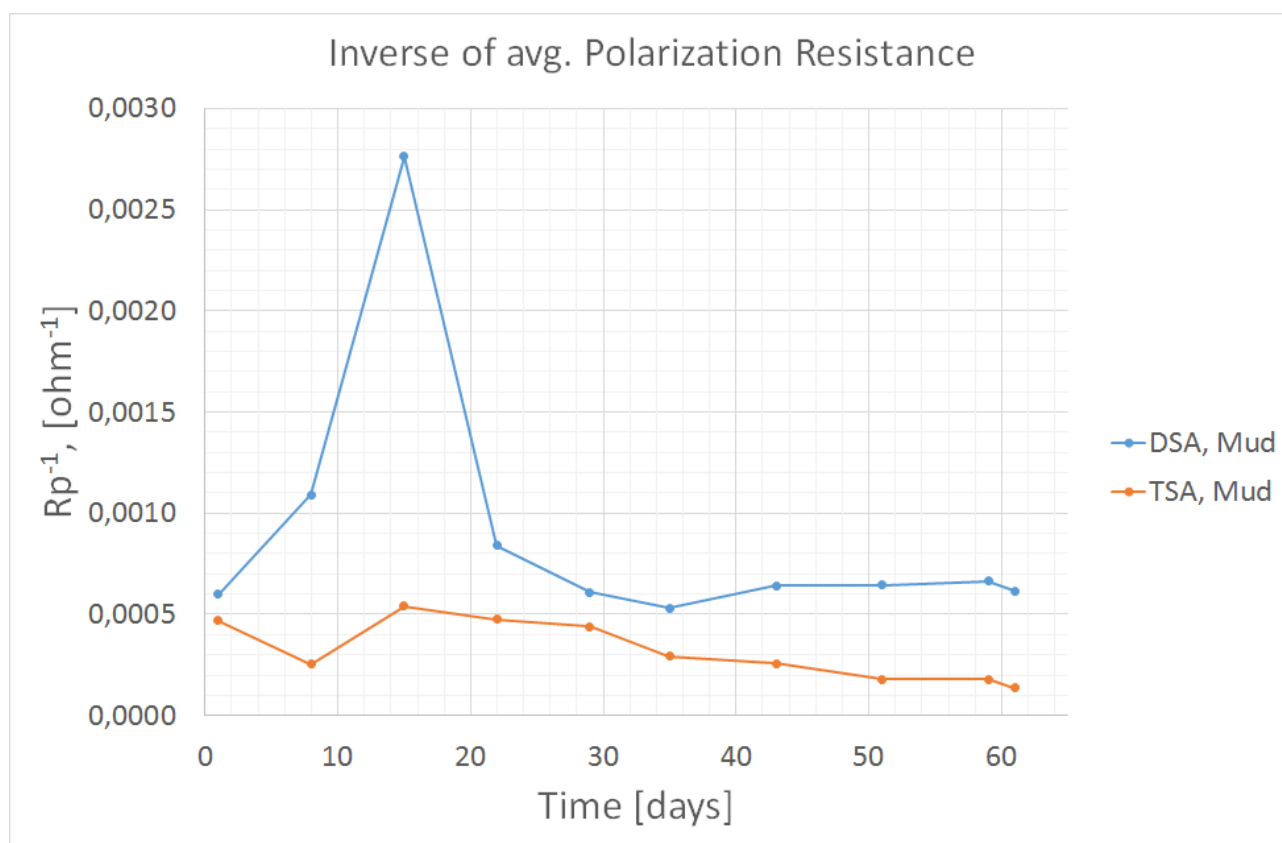
Figure 6.7: The results from LPR measurements in mud, plotted as  $1/R_p$ .

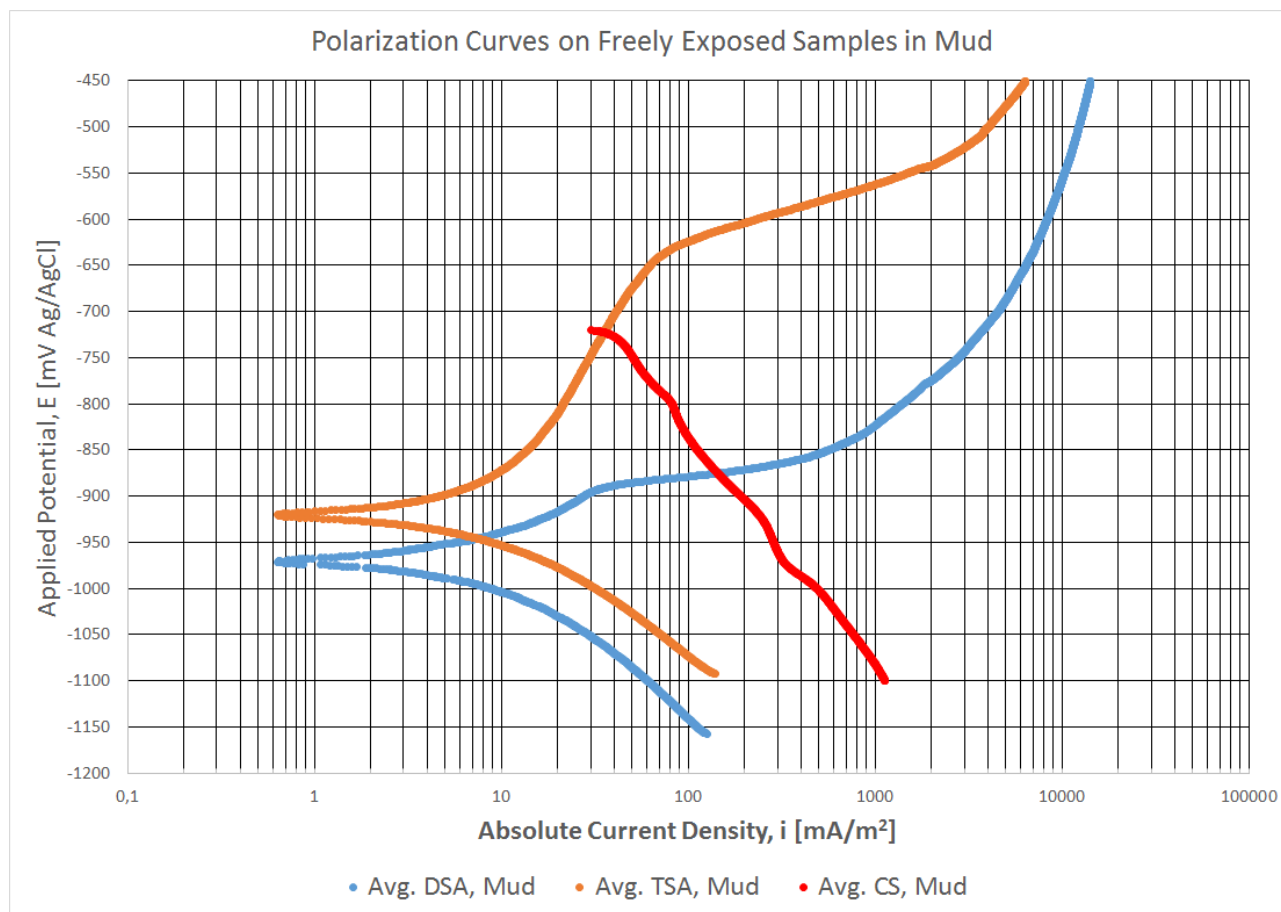
Figure 6.8: Recorded Polarization Curves on freely exposed samples in mud at day 61.

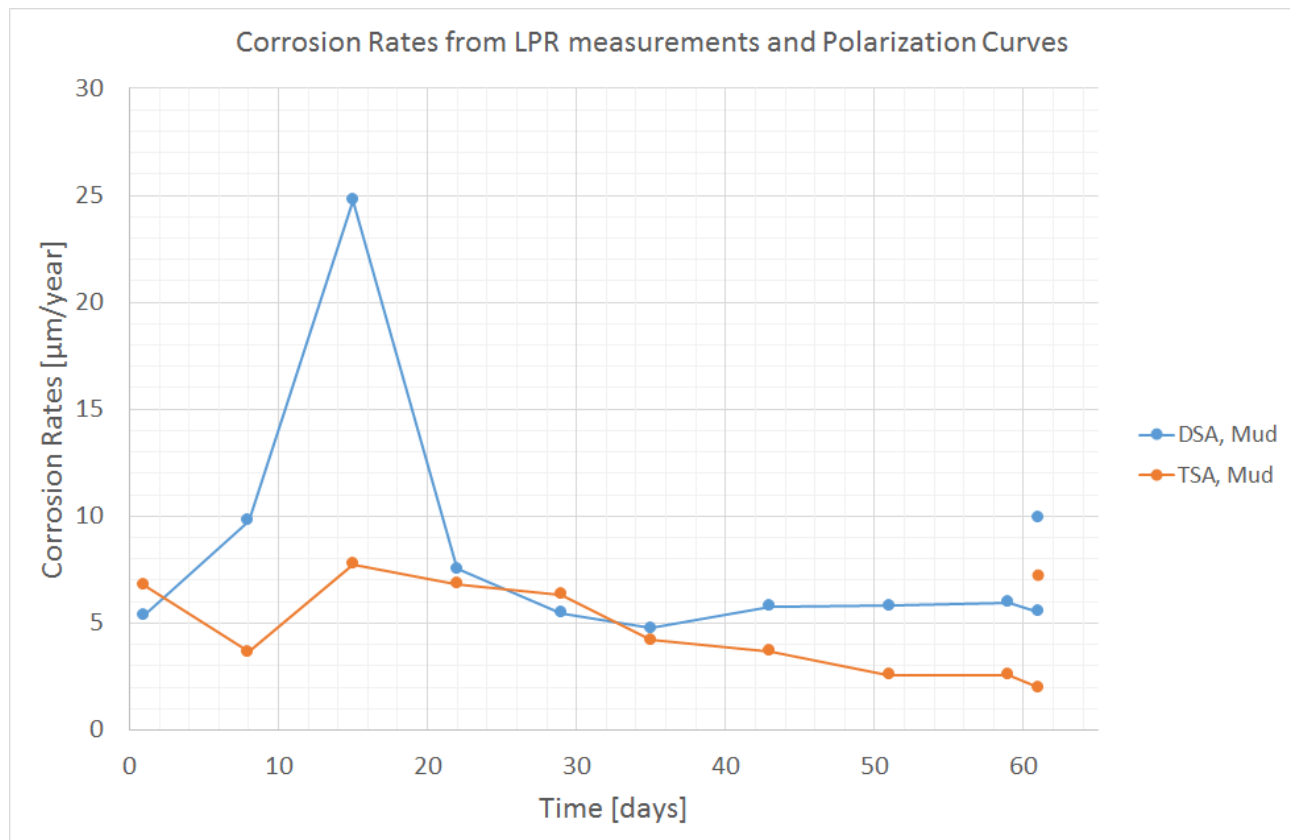
Figure 6.9: Corrosion rates from LPR on freely exposed DSA and TSA samples in mud. The two single points (day 61) are calculated from graphical solution of Polarization Curves.

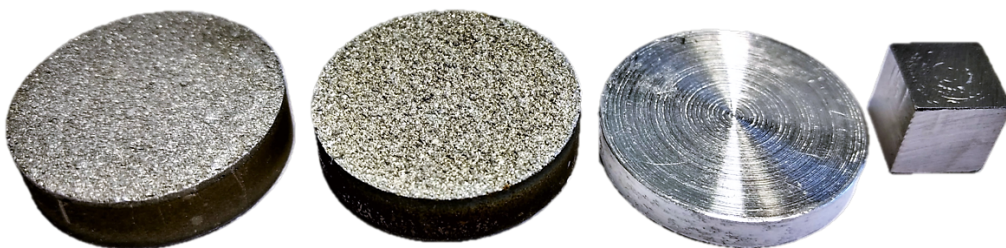
Figure 7.1: Initial surface conditions of test samples -Left: DSA sample, 2nd Left: TSA sample, 2nd Right: Anode sample, Right: CS-cube.

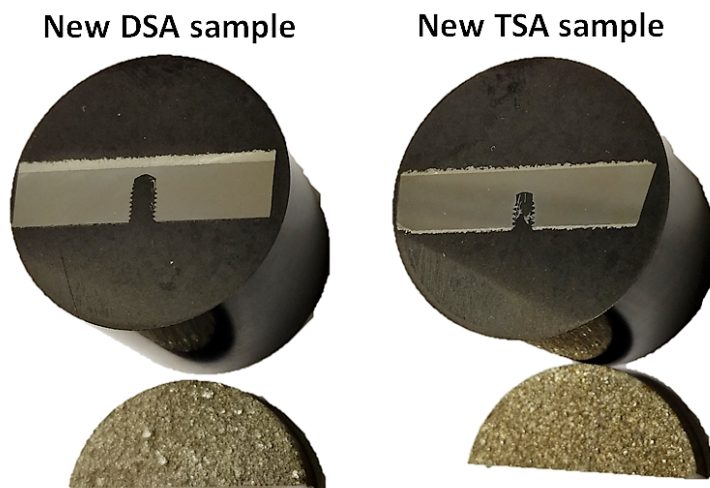
Figure 7.2: Cross section of new DSA and TSA sample.

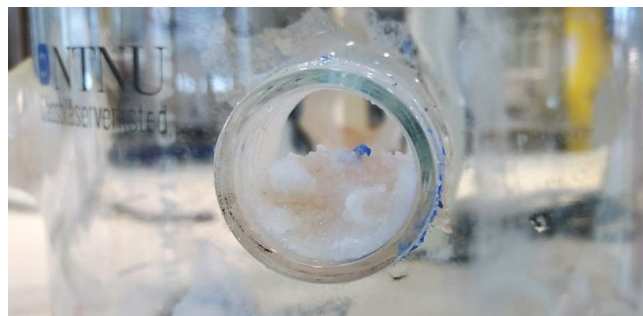
Figure 7.3: Corrosion products in the protruding part of 80°C container, where the coupled DSA sample was attached.

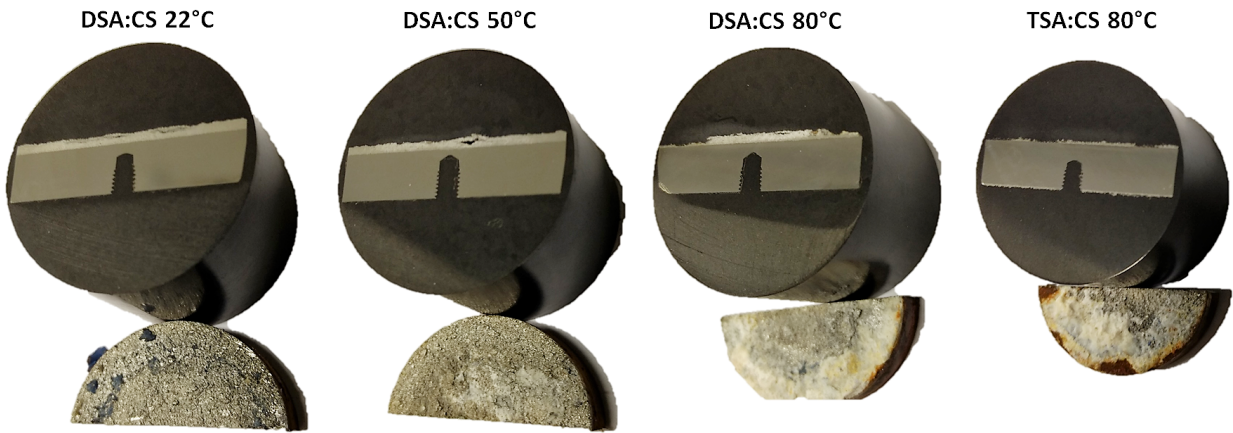
Figure 7.7: Cross sections of selected coupled samples at 22°C, 50°C and 80°C showing cohesive failure and crevice corrosion.

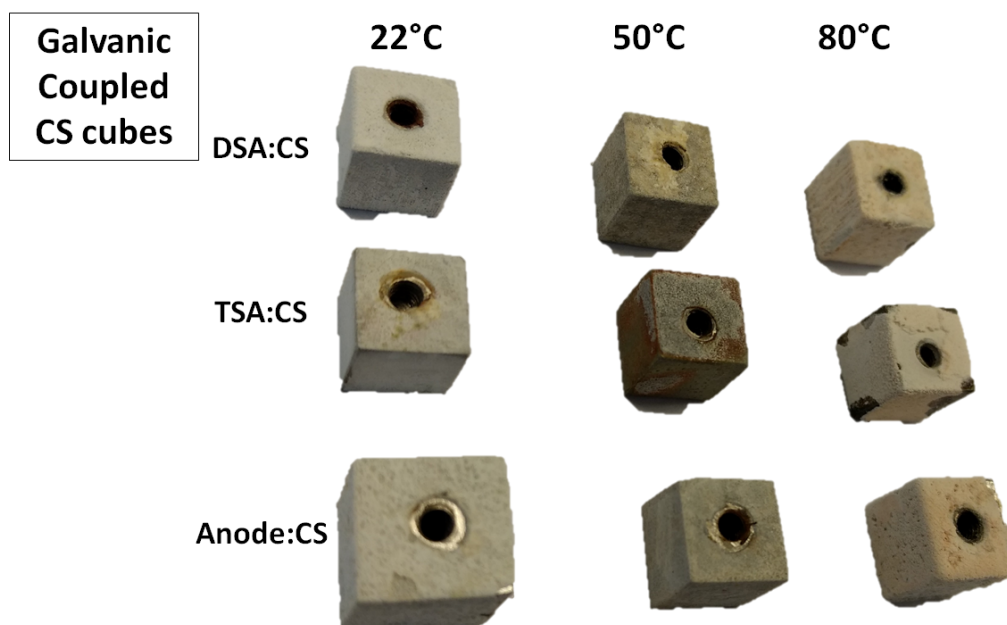
Figure 7.8: Galvanic Coupled CS cubes at all temperatures.

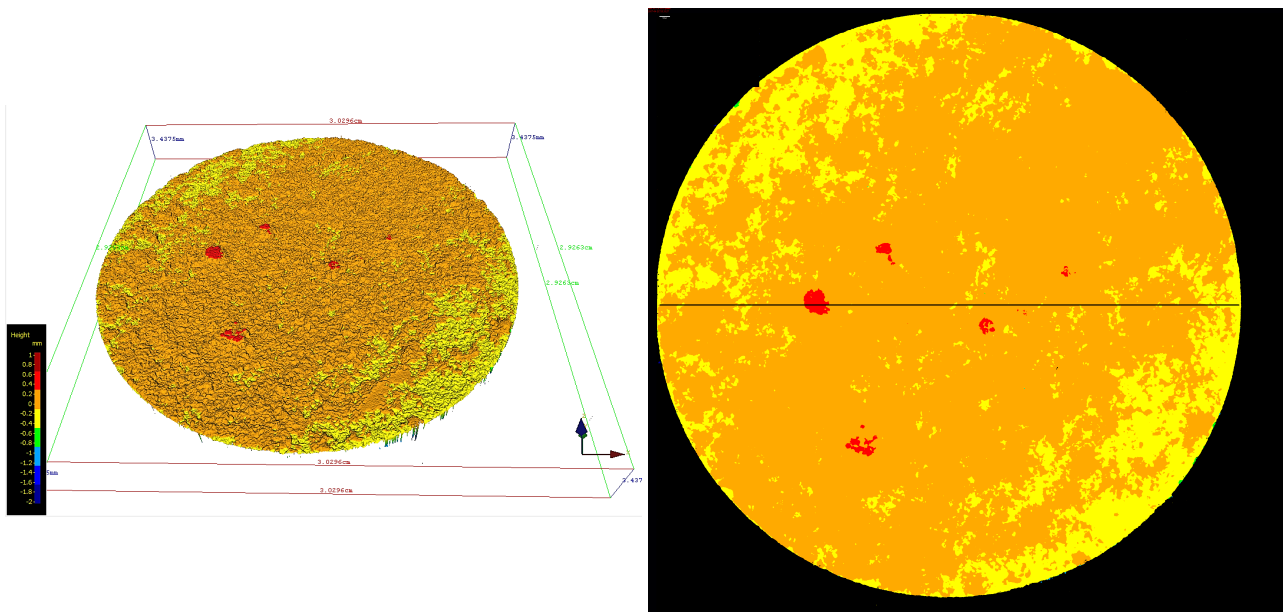
Figure 7.9: Left: 3D figure of a new DSA sample, showing the contour of the surface of coating. Right: 2D figure of a new DSA sample, showing the location for the line scan.

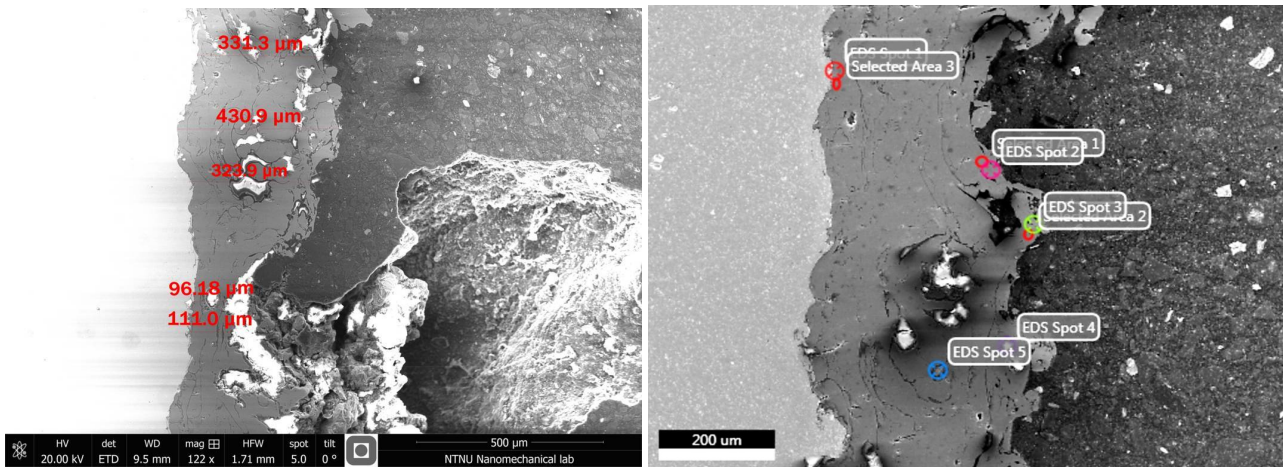
Figure 7.18: Left: Cross section measurements of galvanic coupled TSA sample at 22°C with significant degradation beneath rubber gasket. Right: Areas/Spots for EDS.

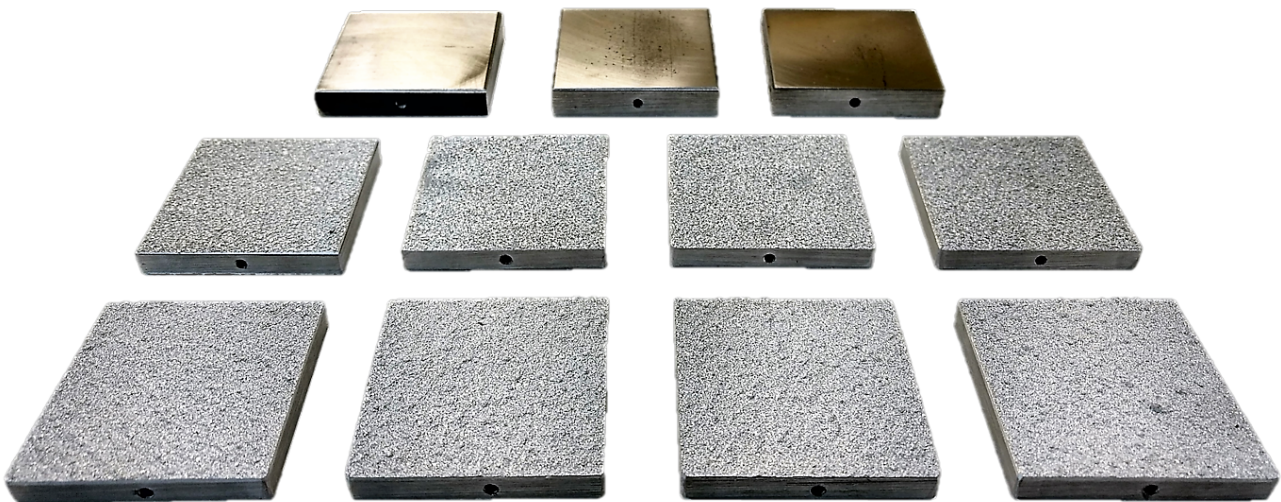
Figure 8.1: Test samples prior exposure in mud -Top: CS samples, Middle: TSA samples, Bottom: DSA samples.
