# Distributed Sacrificial Anode (DSA) - Properties in Mud and at Elevated Temperatures in Seawater

Subsea Technology

Submission date: June 2017

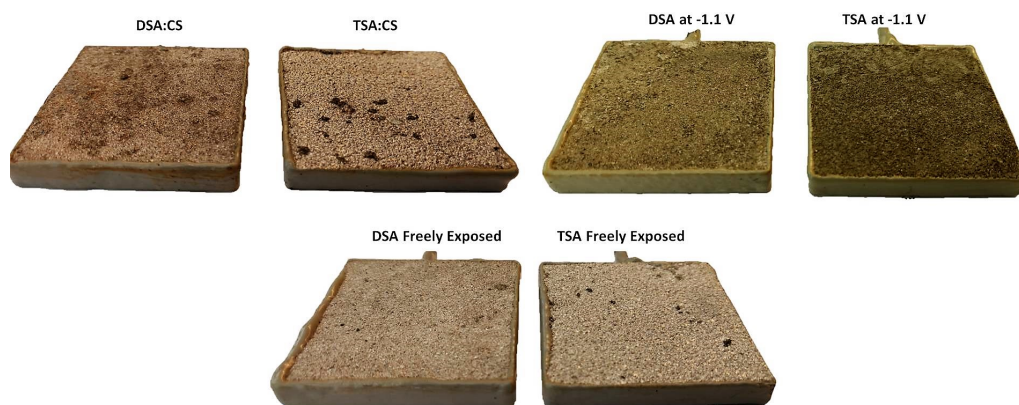
Figure 8.3: Samples embedded in mud after rinsing and brushing.

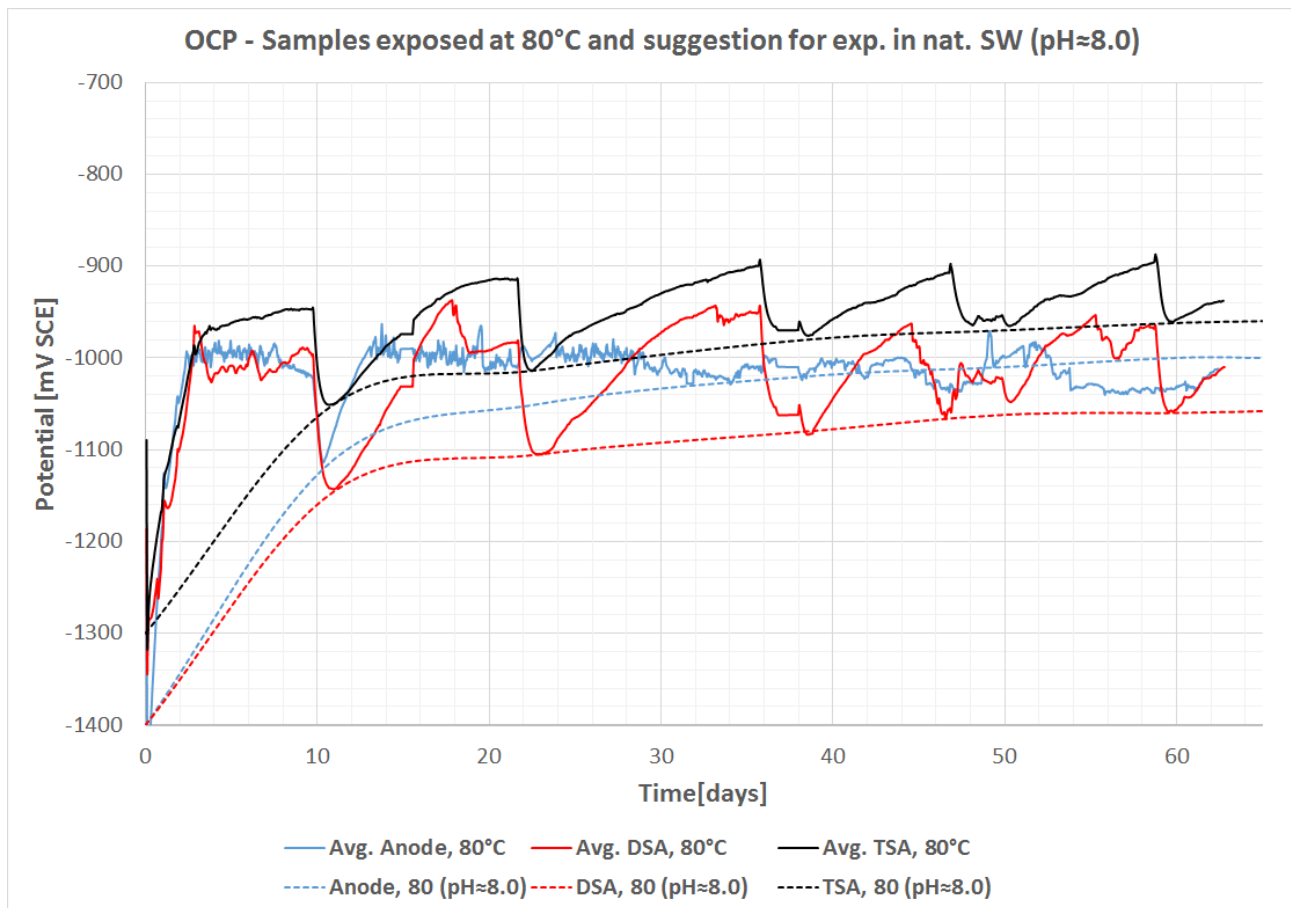
Figure 9.1: Suggestion for OCP development of samples at 80°C assumed applicable for real exposure conditions in natural SW.

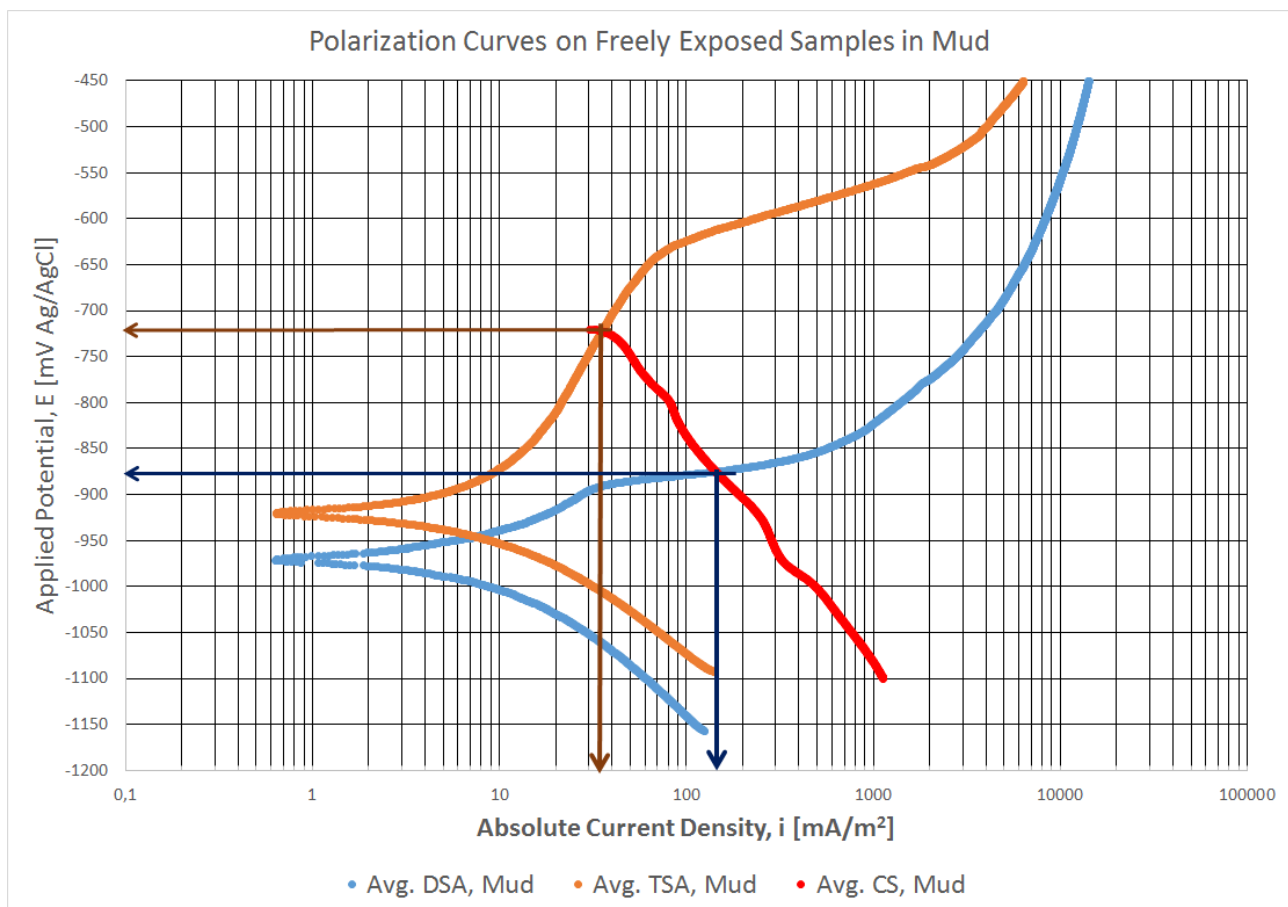
Figure 10.1: Coupling scenario of samples embedded in mud from Polarization Curves obtained after 61 days.

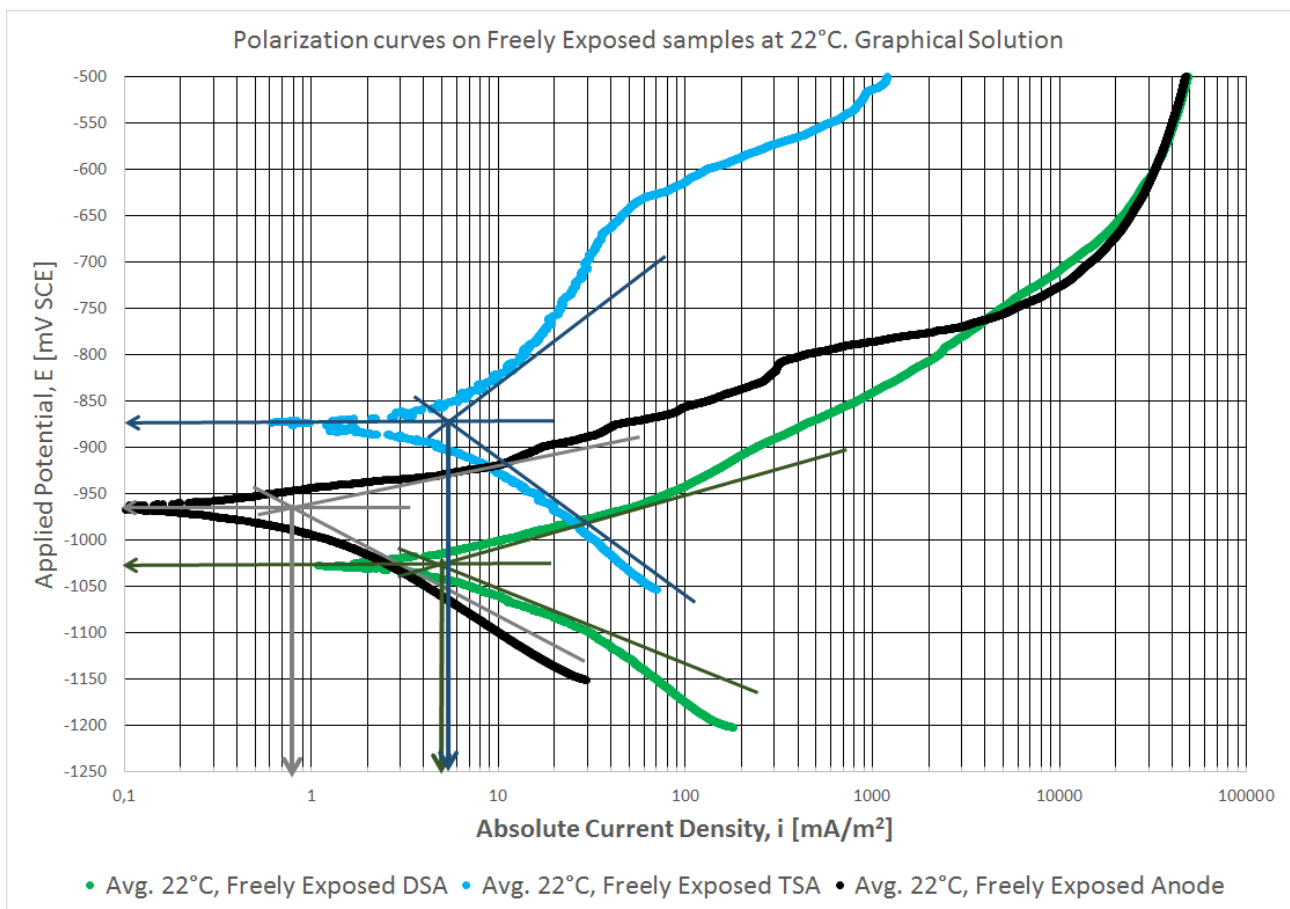
Figure B.1: Polarization Curves on freely exposed samples at 22°C with graphical solution. Day 63.

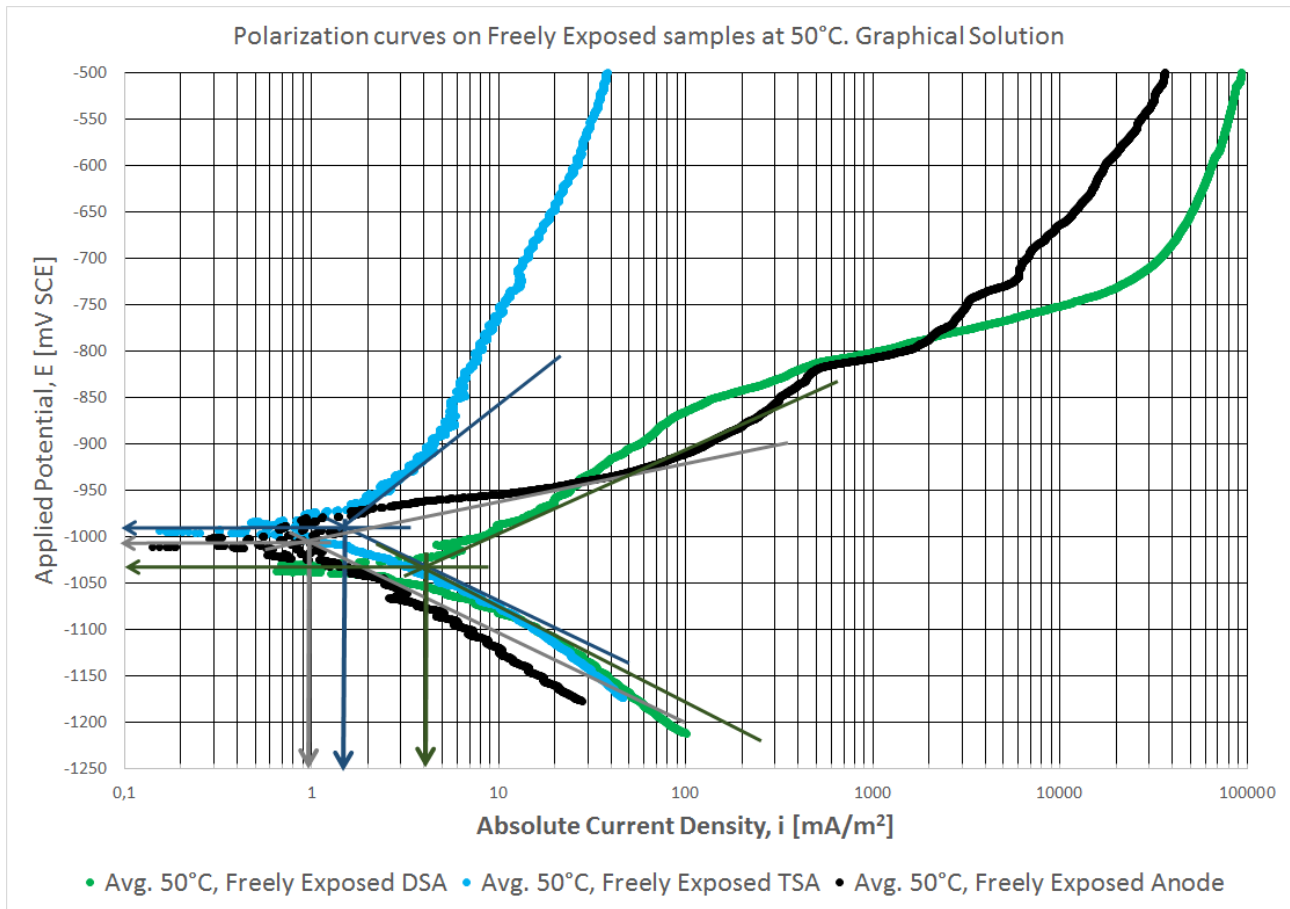
Figure B.2: Polarization Curves on freely exposed samples at 50°C with graphical solution. Day 63.

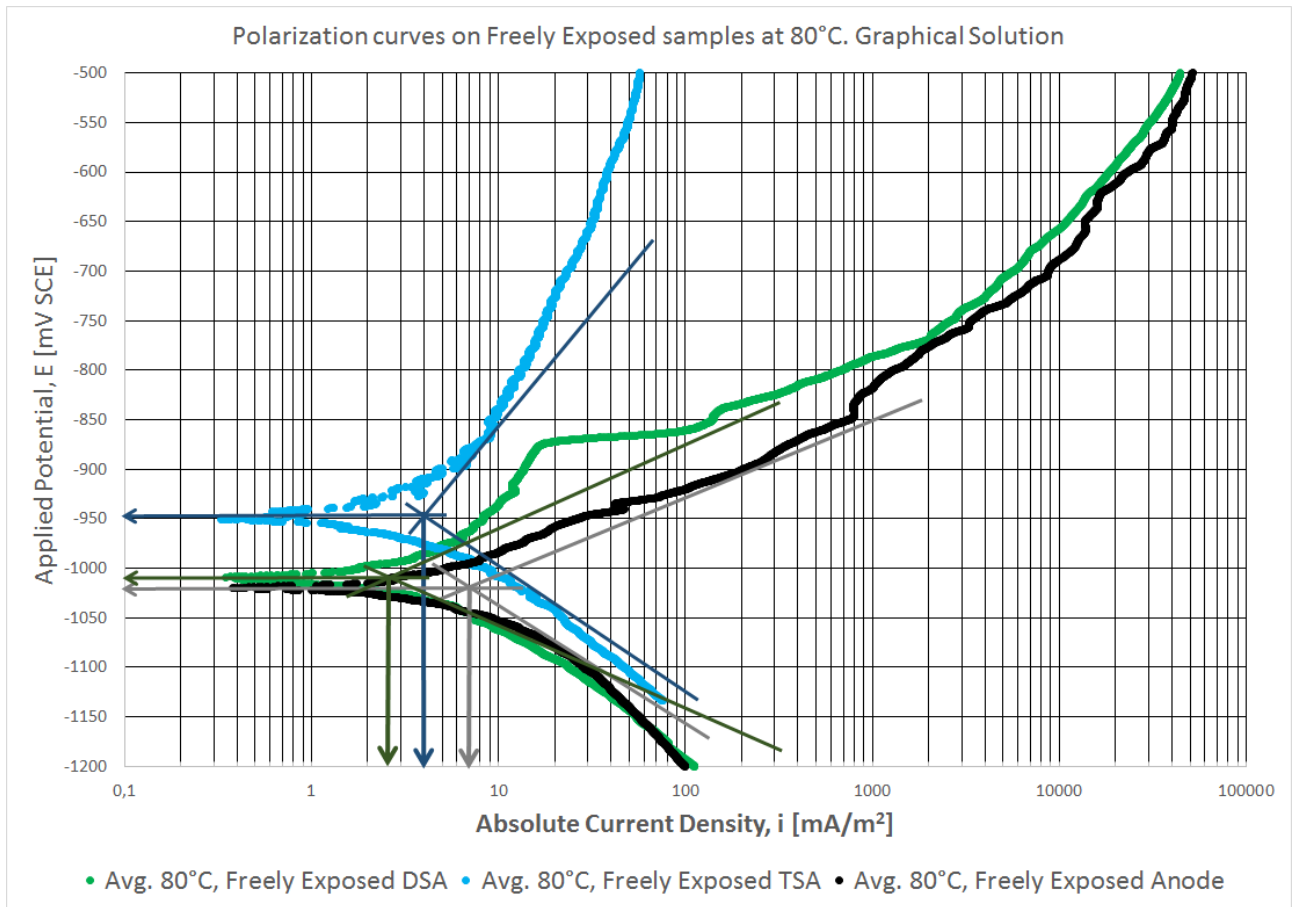
Figure B.3: Polarization Curves on freely exposed samples at 80°C with graphical solution. Day 63.

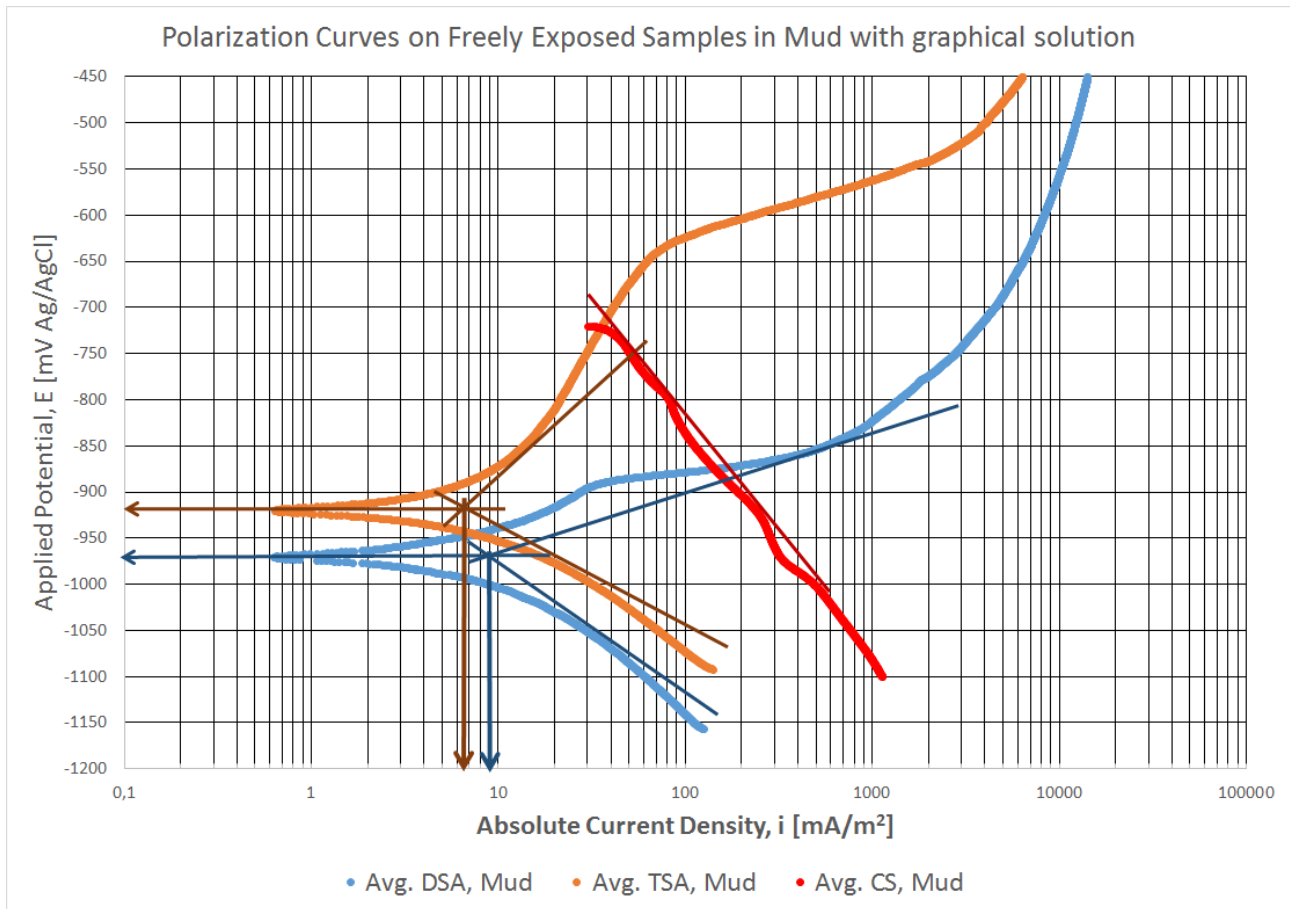
Figure B.4: Polarization Curves on freely exposed samples in mud with graphical solution. Day 61.

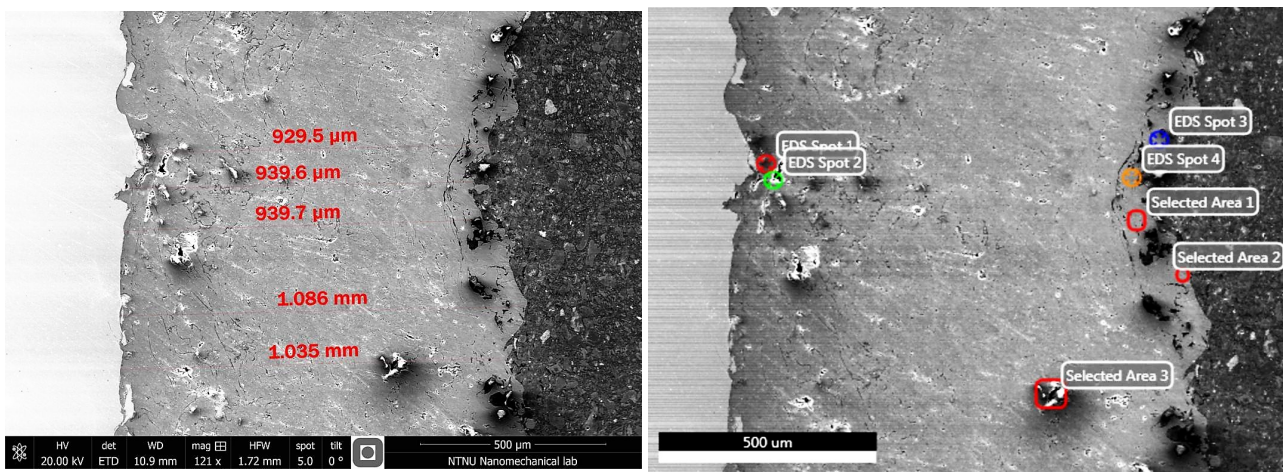
Figure C.1: Left: Cross section measurements of freely exposed DSA sample at 22°C. Right: Areas/Spots for EDS.

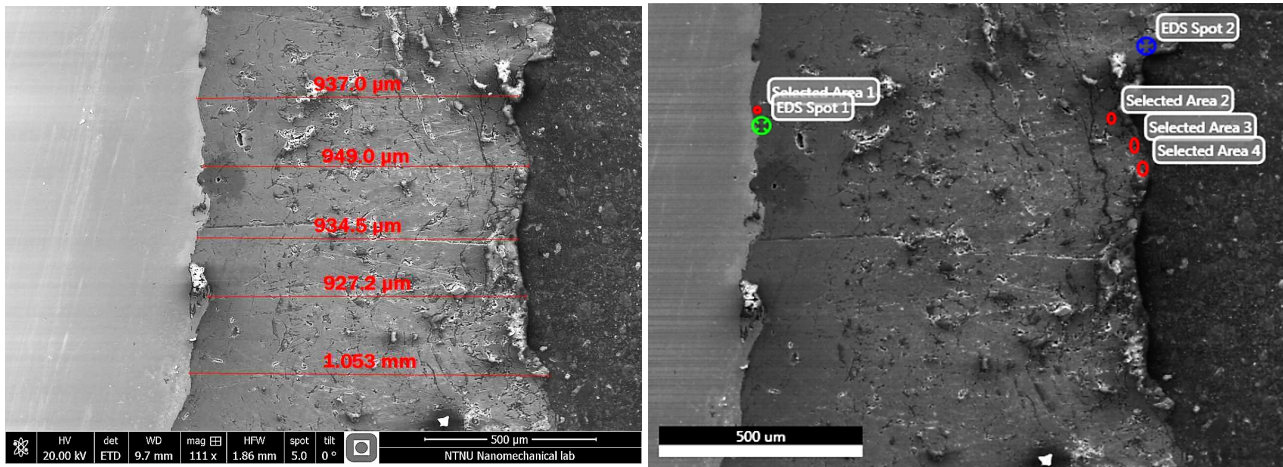
Figure C.5: Left: Cross section measurements of coupled DSA sample at 50°C. Right: Areas/Spots for EDS.

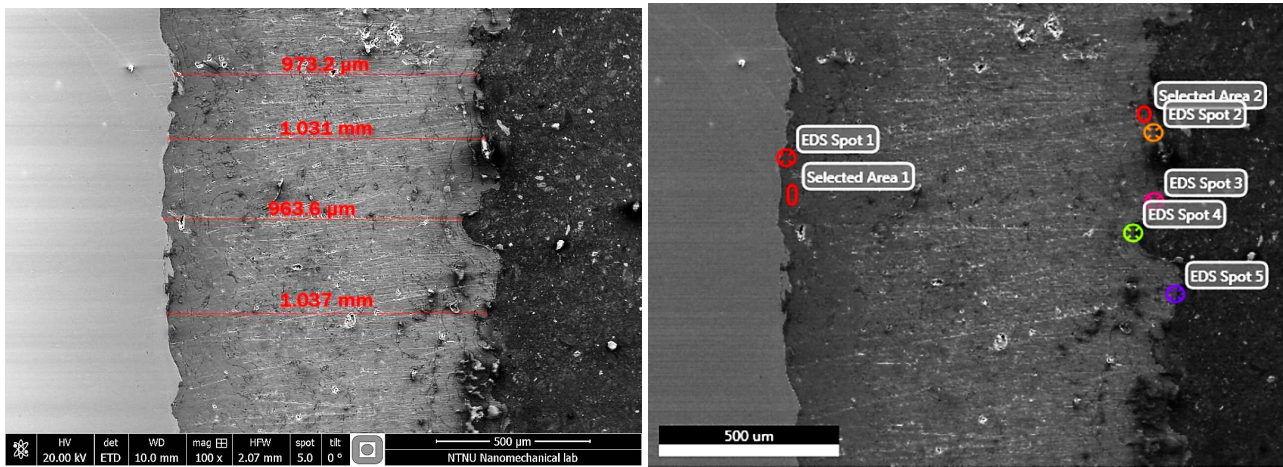
Figure C.9: Left: Cross section measurements on coupled DSA sample at 80°C. Right: Areas/Spots for EDS.

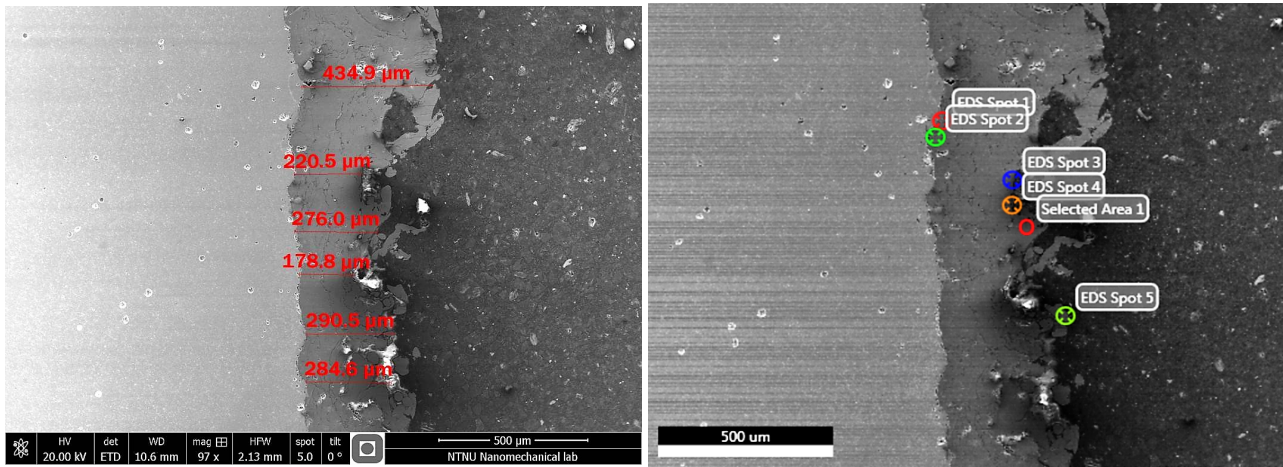
Figure C.10: Left: Cross section measurements on coupled TSA sample at 80°C. Right: Areas/Spots for EDS.

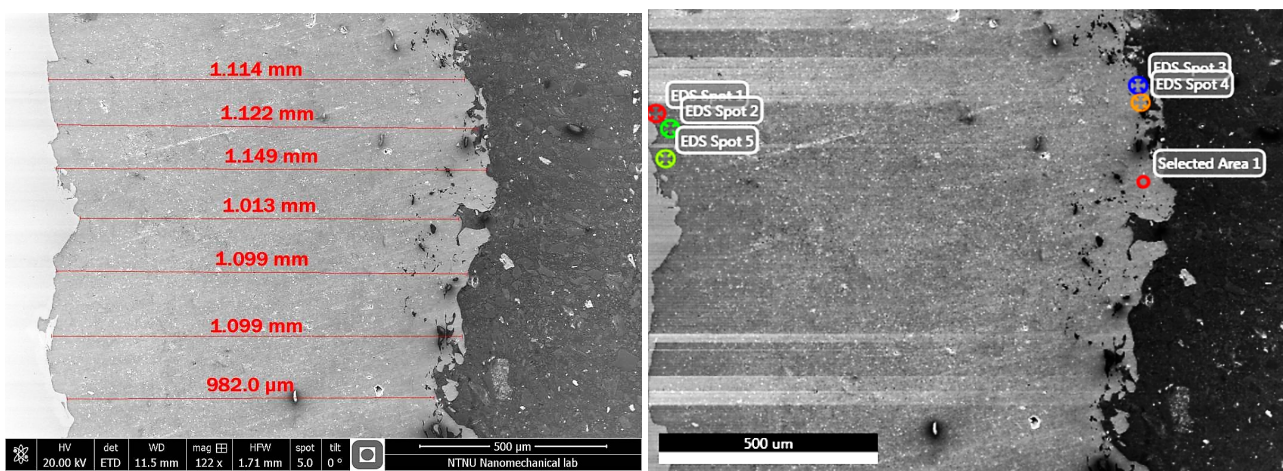
Figure D.1: Left: Cross section measurements of New DSA sample for exposure in Mud. Right: Areas/Spots for EDS.

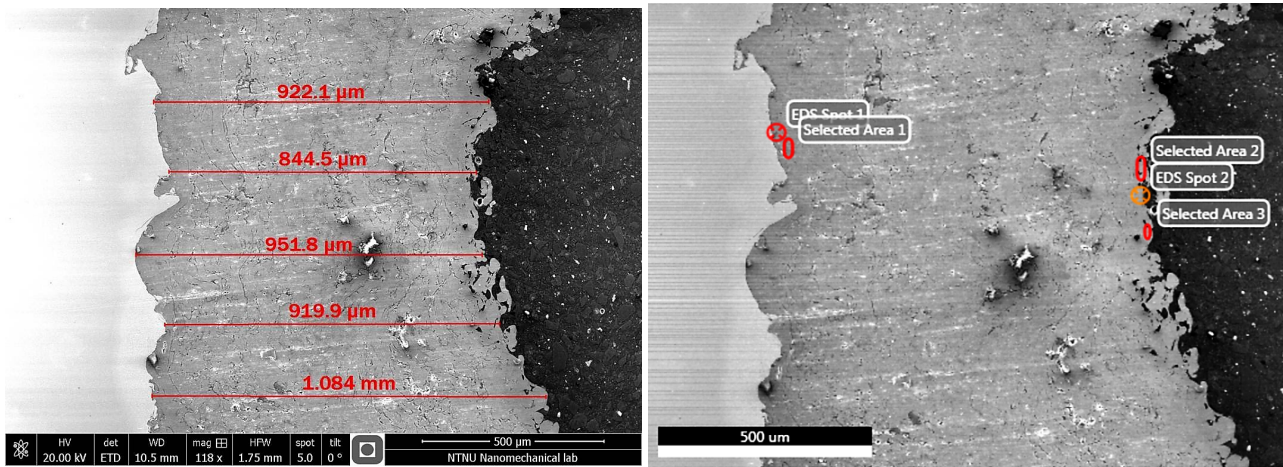
Figure D.3: Left: Cross section measurements of coupled DSA embedded in Mud. Right: Areas/Spots for EDS.

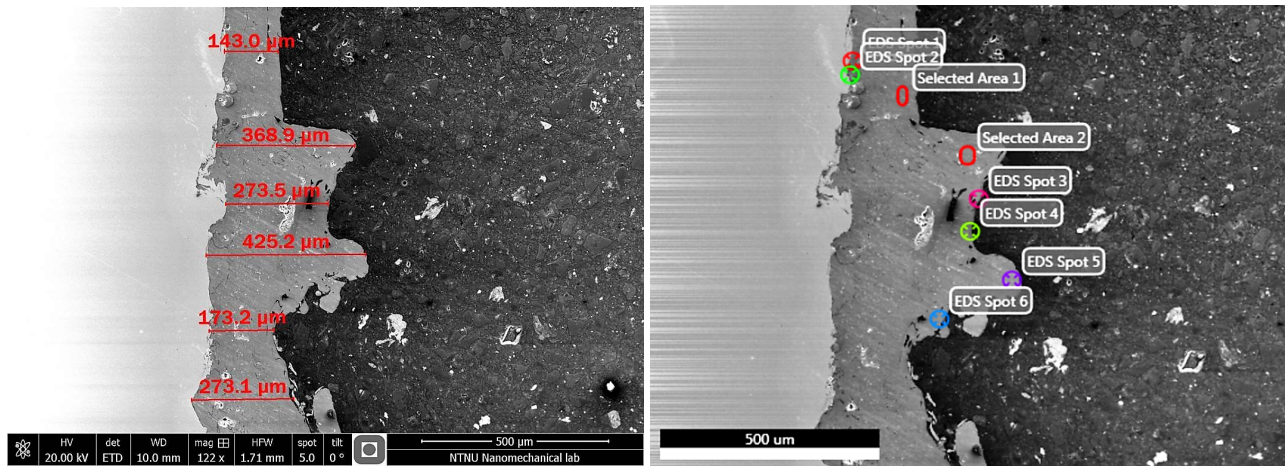
Figure D.6: Left: Cross section measurements of polarized TSA sample embedded in Mud. Right: Areas/Spots for EDS.

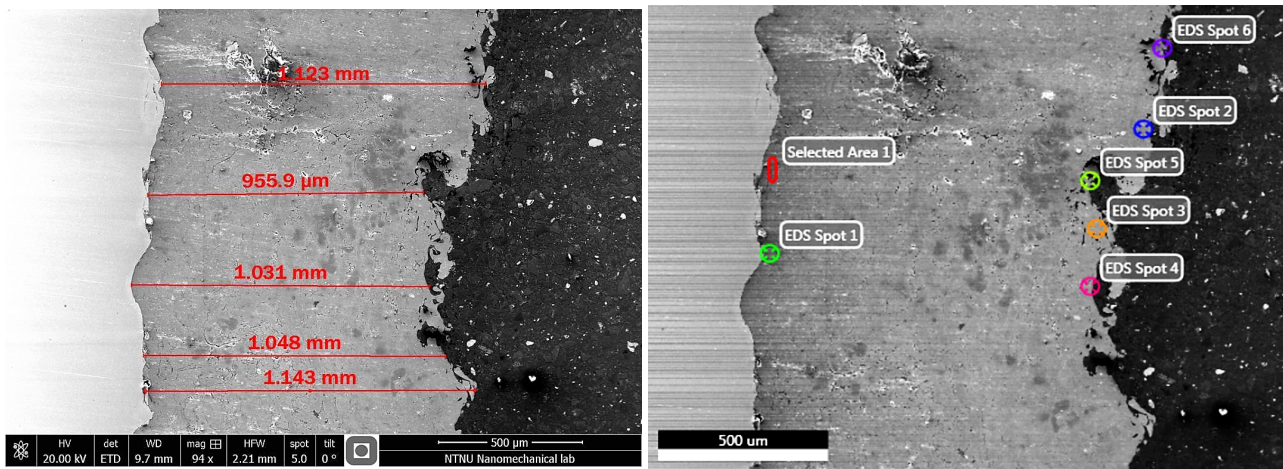
Figure D.7: Left: Cross section measurements of freely exposed DSA sample embedded in Mud. Right: Areas/Spots for EDS.
