# Cathode Wear Based on Autopsy of a Shutdown Aluminium Electrolysis Cell

Keywords: Potholes formation, cathode erosion, carbon cathode, aluminium reduction cell

To investigate cathode wear, an autopsy of a shutdown aluminium electrolysis cell was conducted. The original lining consisted of a fully impregnated and graphitized carbon block and the cell was shut down after 2461 days operation. The cell was cleaned down to the surface of the carbon cathode, revealing the profile of the cathode wear. Generally, the cathode wear was uneven across the cell with typical potholes. At a finer length scale, the wear was characterized by small “pitholes” resembling wide shallow pitting corrosion. Samples of the cell lining were obtained by drilling cylindrical samples at different locations in the cell. These samples were analysed with respect to phase composition and microstructure by a combination of X-ray computed tomography, optical and electron microscopy. The findings are discussed in relation to the current understanding of the underlying mechanism(s) for cathode wear.

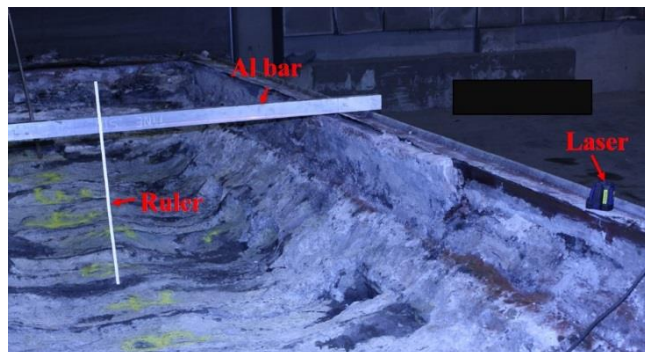
To obtain the wear pattern on the cathode bottom block, a laser, an aluminium bar and a ruler were used. Each of the individual cathode blocks were measured from one end to the other at regular intervals of 40 cm. The potholes that were observed were also

measured to determine their depths and diameters. The data obtained were used to characterize the appearance of potholes on each of the cathode blocks. Figure 1 is a picture of the measurement setup on the cleaned spent potlining.

Figure 1. Illustration of the measurement of the wear profile of the spent potlining. The blocks are numbered with yellow markings.

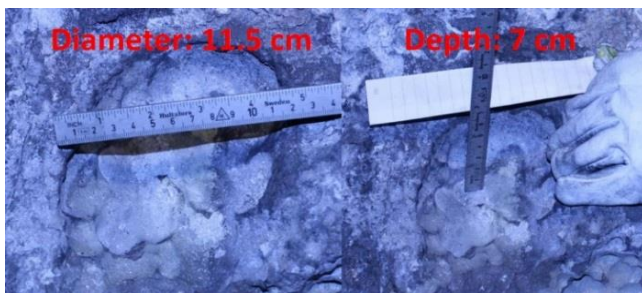
Wide shallow pitting with varying diameter (2-5 cm) and depth (1-2 cm) were observed over most of the surface of the cathode blocks. At some locations, typically along the sidewall, one could observe a cluster of these pittings that had joined to form a pothole with diameters of up to 12 cm and depth of 6-7 cm. A pothole showing the relatively smaller pittings within is shown in Figure 5.

Figure 5. A pothole showing the smaller pittings that joined to form it. The diameter and depth are also shown.

As most of the wide shallow pitting corrosion seems to be both restricted in width and depth, it is a good indication that this initiating pitting stops or slows down at some depth. The real cause for this is presently not determined, but a plausible explanation may be that bath components are involved in both the initiation and the slow down. A possible mechanism is that bath is slowly depleted of aluminium, resulting in two slow down mechanisms. One is that the wear is less in more basic bath (lower activity of aluminium for the formation of aluminium carbide) and, secondly, the fact that more basic bath may freeze out due to a higher melting temperature. When neighbouring wide shallow pits reduce the depth of the first pit, the process may start over again, creating new shallow pits within the original pit.

The presence of smaller pittings within the larger potholes, as shown in Figure 5, supports it that this is a central mechanism for pothole formations. Figure 5 shows that potholes seem to form from individual pittings joining under the right conditions. This kind of pothole formation is different from a single pothole formed as a result of chunks breaking off due to weaknesses or defects in the carbon lining [1]. The smaller wide shallow pitting seems to form as a result of electrochemical induced mechanisms. The circular nature of these pittings may suggest that convective patterns set by metal pad movement, or whirlpool effect on the metal pad close to the carbon surface, due to high current densities, play a part in their formation [1, 7].

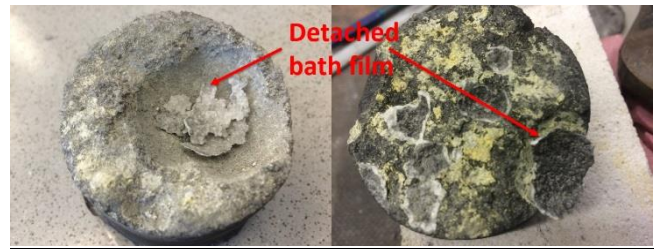
A thin layer of bath was observed covering the whole cathode surface. A picture showing this thin layer of bath that was detached from the autopsy samples is shown in Figure 6. Six different measurements of the thickness of this thin layer gave an average thickness of  $636 \pm 200 \mu\text{m}$ . Yellowish aluminium carbide was also

observed, especially at locations towards the ends of the cathode blocks where the erosion was highest and between the ramming joints and the cathode blocks. Aluminium carbide was clearly visible on the carbon cathode blocks as shown in Figure 6.

Figure 6. Autopsy samples showing the detached thin bath film. The yellow colour at the surface is aluminium carbide. Aluminium carbide could be observed under the detached thin bath layer on the sample to the left.

If this is an important wear mechanism, aluminium should have been observed on top of the carbon and the carbide layer, which was not observed. In the present autopsy, a thin bath film on top of both the carbon cathode and the carbide layer was observed. Most likely a thin bath film may have been present all the time from the start-up of the pot with bath [1]. If this is indeed the case, the aluminium metal will have reduced chances to wet the carbon cathode, making direct carbide formation a less likely scenario.
