MASTER'S THESIS

STUD. TECHN. ALEKSANDER E. AKSNES

DISCIPLINE: POWER ENGINEERING

English title: *"Degradation of XLPE and PEEK under high pressure by Partial Discharges"*

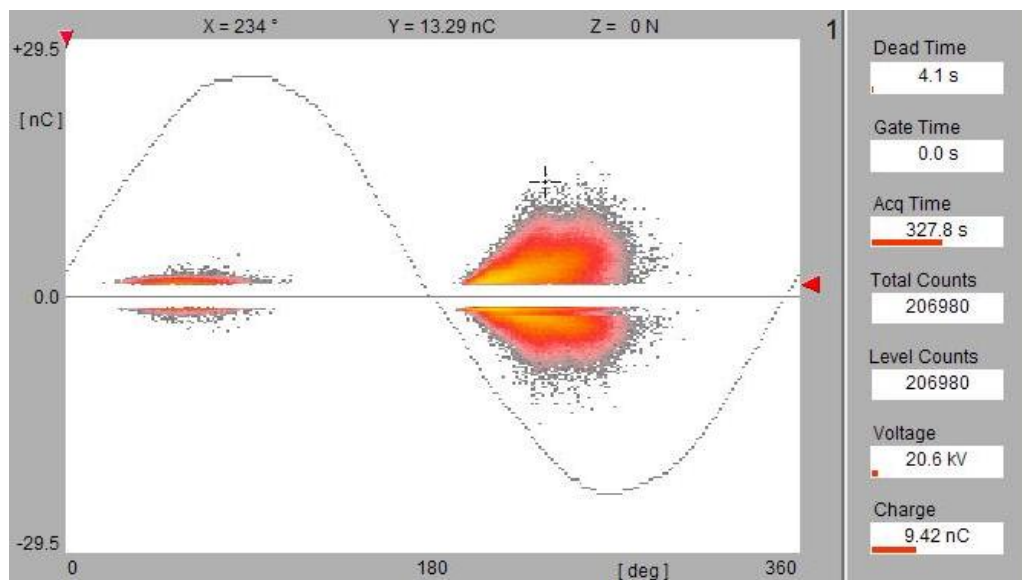
Figure 2.3: ICM phase plot of corona discharges. The plot is taken from an experiment on a XLPE disc during a student project prior to this master thesis.

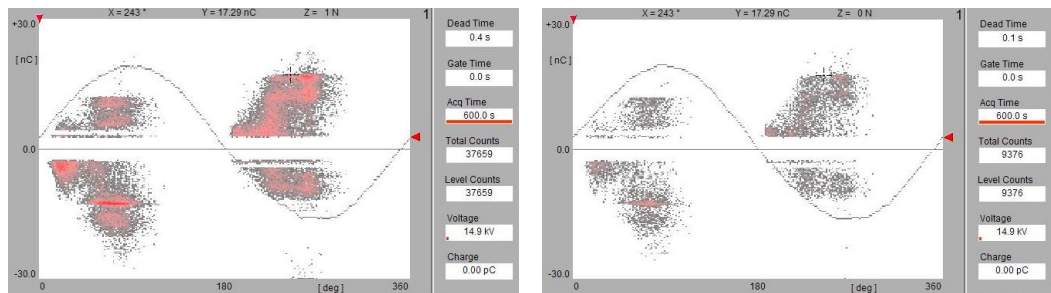
(a) Plot after 55 hours and 30 minutes.

(c) Plot after 55 hours and 50 minutes.

(d) Plot after 56 hours.

Figure 2.6: Series of plots where the discharges almost vanishes a little while, then comes back. The plots are 10 minutes apart. This is the effect byproducts from discharges in the tree channels might have on the discharge activity.

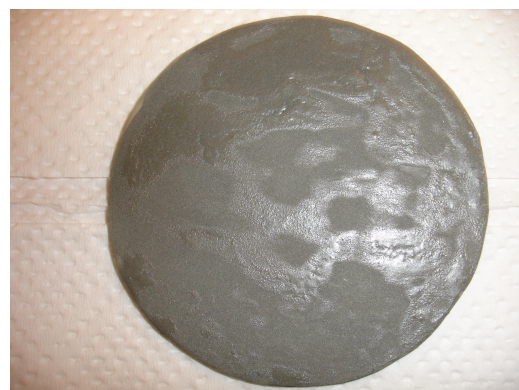
(a) XLPE sample.

(b) XLPE sample with varnish.

Figure 2.7: XLPE sample before and after applied varnish. Radius of the sample is 36.5mm

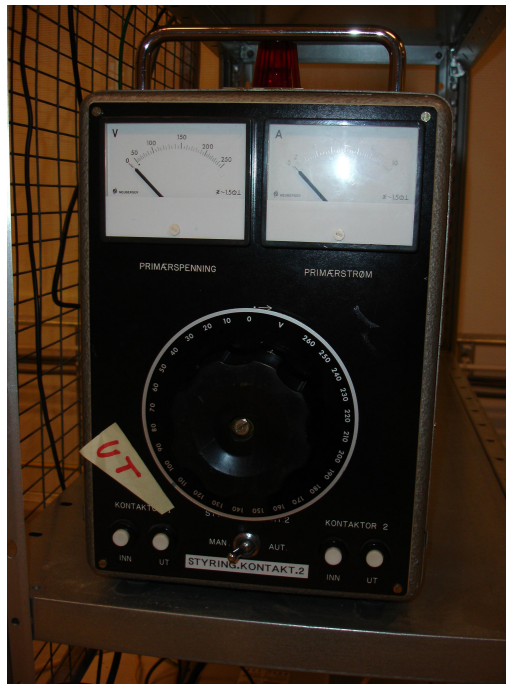
Figure 3.5: The variac used in the setup, supplying the low voltage input to the high voltage transformers.

A variable transformer(variac), see figure 3.5, is used in the setup to provide the high voltage transformer with power to the low voltage input.

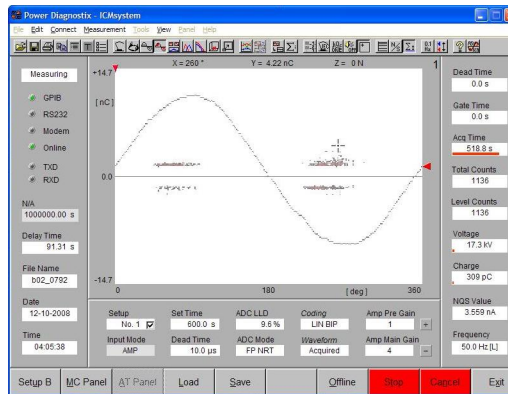
(a) ICM unit.

(b) Phase/amplitude plot.

The computer program is called ICM system, and is manufactured by Power Diagnostix. This program controls all displays and functions of the ICM unit through a graphical interface. The ICM used in this project is a single channel unit. It has 12 bit AD, which is compressed to either 8 bit unipolar or 7 bit bipolar.

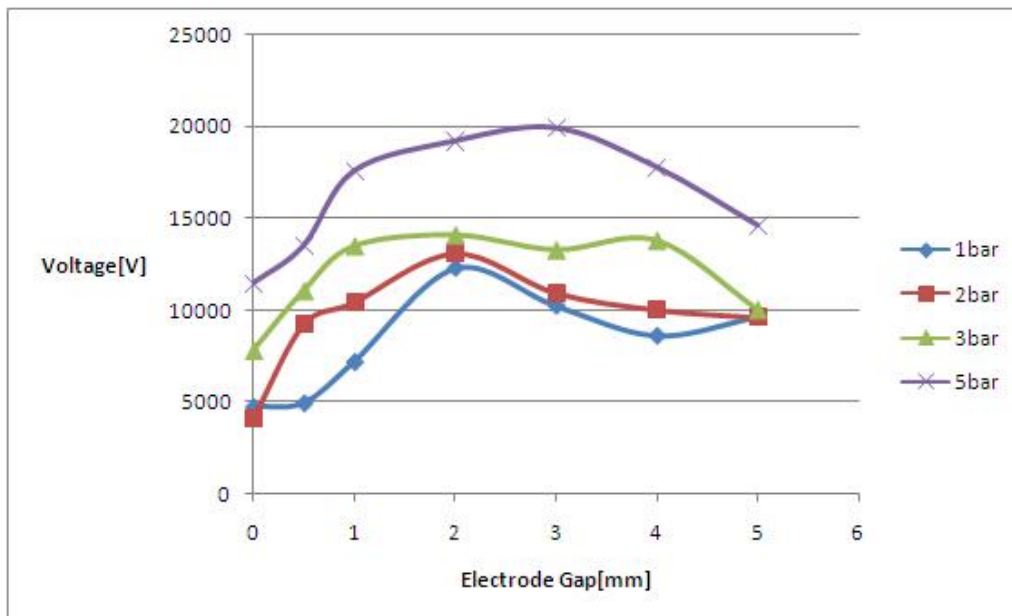
Figure 4.2: Plot showing the extinction voltages with the spark gap as variable for pressures 1, 2, 3 and 5 bar.

The results are presented in figure 4.1 and 4.2. The first plot shows the inception voltage as a function of spark gap for different pressures, and the second is a similar plot for the extinction voltage.

These plots did not turn out entirely as expected. The theory section 2.1.2. about surface discharges, explains that the changes in the electric field as the spark gap changes is greater for small spark gap values. This is also confirmed in the plots, as all pressures shows a steep climb from 0mm to 1mm. The 1 bar and 2 bar even continues climbing steadily to 2mm spark gap. As the spark gap increases, the changes made to the electric field are smaller, so the climbing of the graphs should diminish. What is observed however, is that the inception voltage reaches a maximum around 2-3mm gap, and starts decreasing towards 5mm gap.

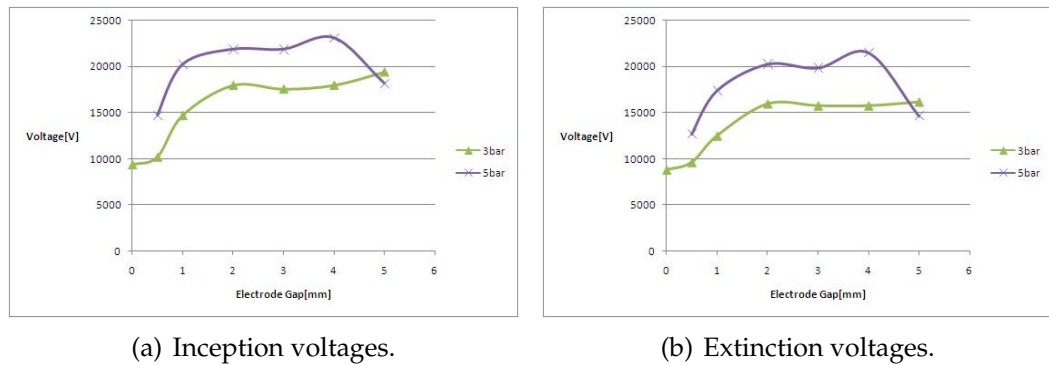
Figure 4.3: Plots showing the inception and extinction voltages with the spark gap as variable for pressures 3 and 5 bar. These tests were made as confirmation of the first set of tests.

As this result was somewhat surprising, a second set of tests was done for 3 and 5 bar only, to confirm the first results. These confirmation tests is shown in figure 4.3. This time the 3 bar graph shows a shape more in agreement of the anticipated results. The 5 bar is still reduced from 4mm to 5mm. It is possible that parameters like too little resting time in between tests or local conditions in the test setup causes the inception voltage to drop for the larger gaps.

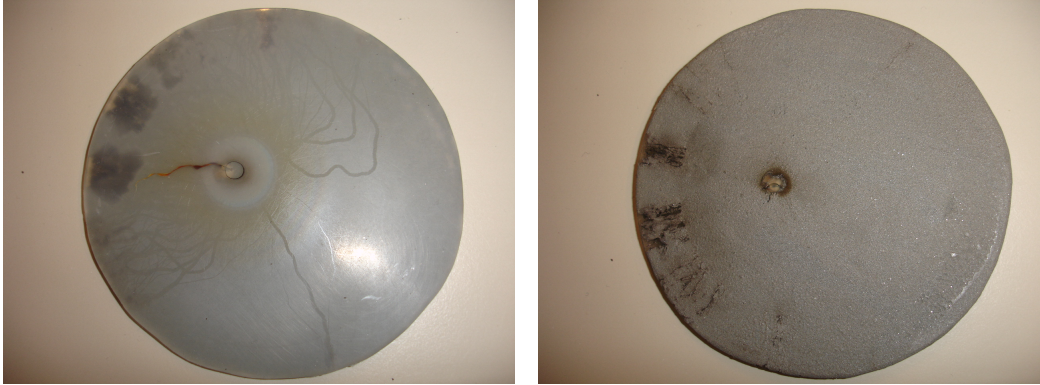
(a) Full picture showing a slightly displaced puncture through the material. The edges around the hole are burnt, and the surface of the material around the hole shows clear signs of currents going out from the center where currents has come around the edge to- and reaching towards the edge of the sample.

(b) Full picture showing the backside of the sample. There is a hole in the varnish where the puncture occurred, and traces can be seen in the varnish at the edge of the sample, wards the plane electrode.

(c) A light microscope image with a x12 enlargement. It shows the burnt edge and the circular crater at which the breakdown occurred. The material is melted around the sharp pointed hole, and there is a crack running outwards from the hole.

(d) A light microscope image with a x25 enlargement. It shows part of the crack produced by the puncturing of the material. The picture shows that the crack is almost flowing in a wave-like movement, and the inside of the crack is discolored by the charge running through it.

compared to 10mm for XLPE1. Figure 5(d) also shows burning along the crack, which was not present for XLPE1. Figure 5(b) shows the marks in the varnish from currents at the edge nearest the crater. These are the currents tracing along the surface, getting around the edge of the sample and going towards the plane electrode. The marks stops suddenly where the conducting part of the plane electrode begins.

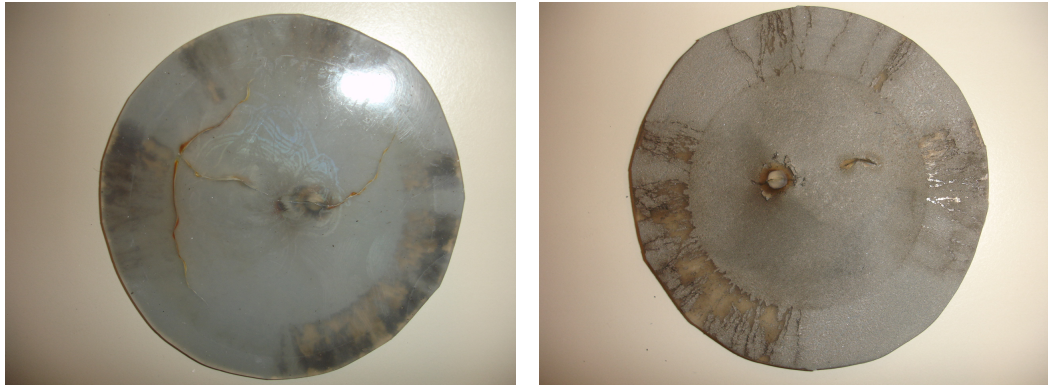
(a) Full picture showing the punctured sample and the large crack moving both to the right and to the left out from the center. (b) Picture of the backside showing large traces in the varnish from charges tracing towards ground.

Figure 4.6: Pictures of XLPE3 front and back, showing severe damage to the sample.

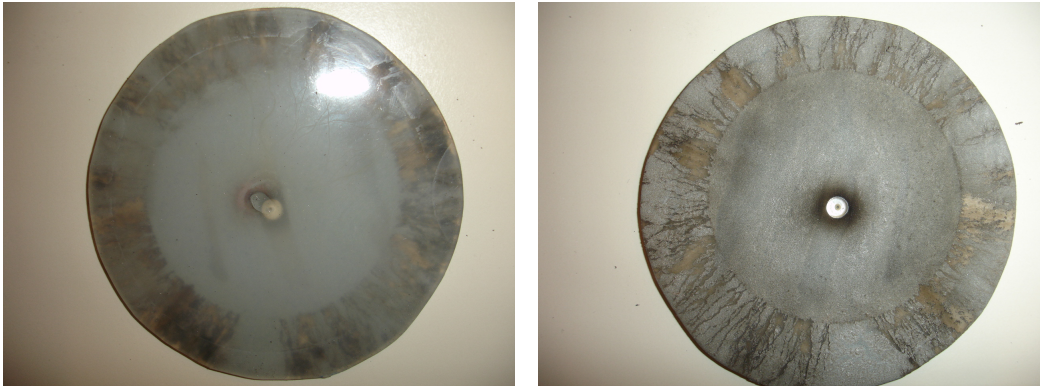
(a) Full picture showing the punctured disc. (b) Picture of the backside showing large The crater and hole is almost circular, and traces in the varnish from charges tracing to- there are no fractures or cracks extending wards ground. from the hole.

(c) A x6 microscope picture showing the crater and hole through the sample. (d) A x25 microscope image of the hole.

This sample is tested at 7 bar and 28.6 kV. As this is the same parameter values as XLPE3, it comes natural to compare the results of these two samples. In addition, the plots in figure A.4 shows much the same activity as XLPE3, seen in figure A.3. The outcome for the two is, however, completely different. Figure 4.8 shows four pictures taken of the sample after breakdown. The front does not show the same damage seen in XLPE3. Instead, there is a small crater, with a small hole going straight down to the plane electrode. There are no cracks or fractures to be seen around the crater. The backside, figure 8(b), does show proof that there has been a lot of discharges going around the edges to the plane electrode during the test. The blast from the breakdown has removed varnish around the hole in an almost perfect circle. The different results may have been caused by structural differences in the two samples, or some other unknown factor has taken effect. The experiment ran for 10 hours and 54 minutes before it broke down.

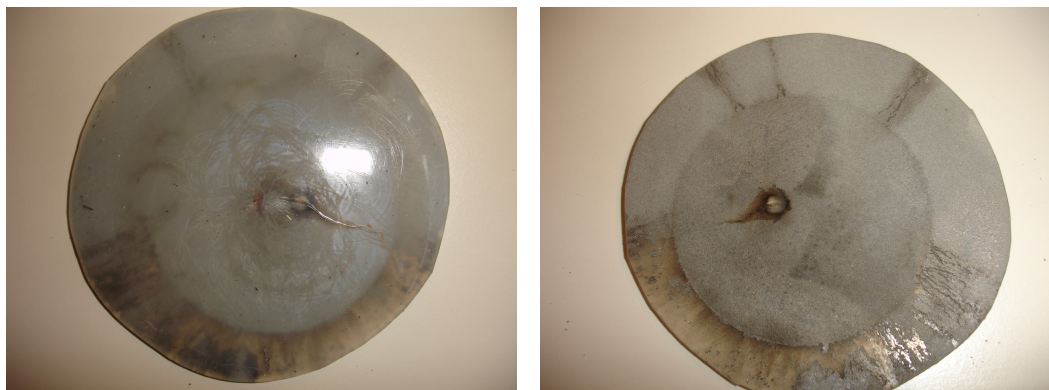
(a) Full picture showing the punctured disc. (b) Picture of the back side. There is a small crater and a crack leading to burnt edges, and the varnish on the lower side is almost removed completely from discharges going around the edge from the front.

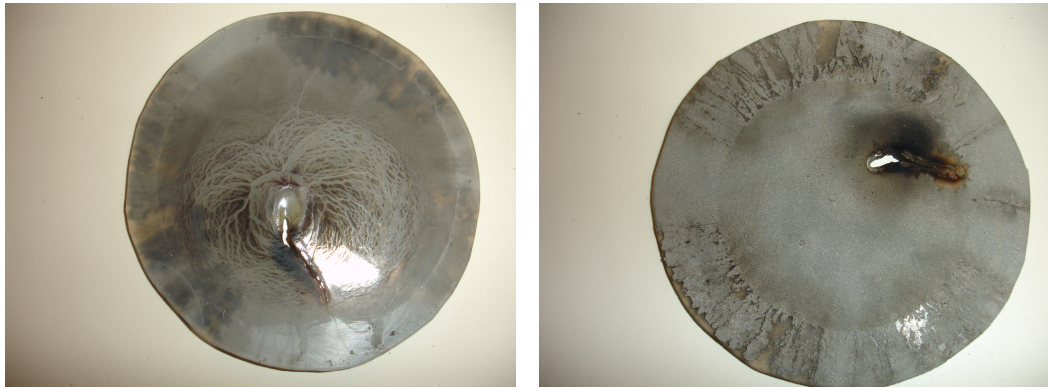
Figure 4.12: Pictures of XLPE8. The sample has sustained heavy damage from the breakdown. Sample radius is 36.5mm.

(a) Full picture showing the sample front. (b) The back of the sample also has a large crack going from where it was scorch mark from the breakdown, and var-punctured, and the crack itself is scorched nish has disappeared around the edges. with burning along the edges. The surface is covered in soot, enhancing the traces from the currents going over the edge towards ground.

(c) A x12 microscope picture the pattern engraved by surface currents.

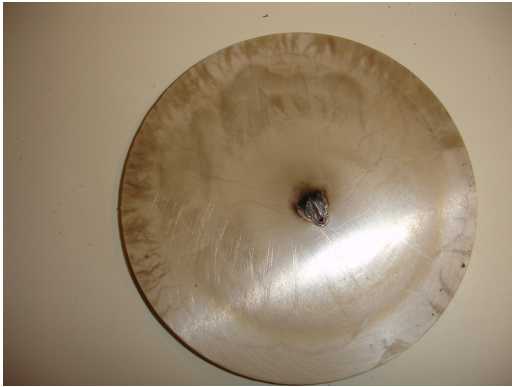
(a) Full picture showing the disc. There is a charred spot near the center, and there are traces of surface charges towards ground as lines going out from the center where surface charges has gone. There also is a flowing pattern in the surface near the edges of the disc.

(c) A x20 microscope picture showing a close-up of the puncture in front of the sample. It has a clear symmetry, and a melted trench stretches from the hole and inwards.

The pressure were lowered to 5 bar for the all the PEEK samples, which also caused the inception voltage to go down a little. PEEK1 was tested at 21.5 kV, and suffered a breakdown after 70 hours and 20 minutes. Although the voltage was a little less than for the XLPE samples, the partial discharge levels remained much the same as for the other material at higher voltages, and the plots look similar, see figure A.9 in appendix. Figure 4.13 shows some pictures taken of PEEK1 after breakthrough. One apparent thing is that the material seems to have reacted a little different from XLPE when punctured. The biggest difference from XLPE is seen right around where the disc was punctured. There is not a crater, like for XLPE, instead the area appears melted and transformed. Since PEEK is not a thermosetting material, it can be melted and remoulded. In comparison, the XLPE materials does not appear melted in the same way, just burnt and damaged. Figure 13(c) shows the punctured area enlarged x20. It has a clear symmetry, and the deep trench moving from the small hole is the symmetry axis. However, the material is so resistant that no crack appears through the disc.

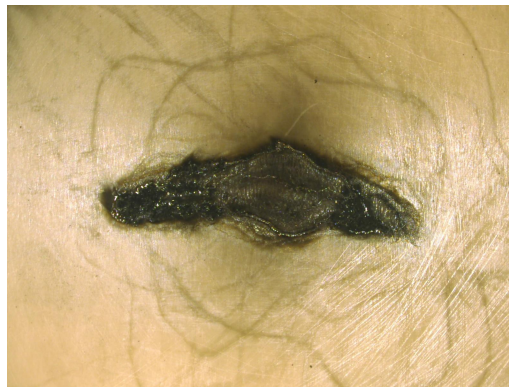
(a) Full picture showing the sample. There is a long, charred area going from the center, and there is a charred hole where the breakdown occurred. (b) The backside misses varnish at the edges, and there are paths in the surface from currents tracing along it towards ground potential.

(c) A x8 microscope picture showing a close-up of the puncture in front of the sample. The hole itself is to the far left of the charred area.

This sample was exposed to a voltage of 20.2 kV and 5 bar pressure. Even though this was even less than PEEK1, PEEK2 had a breakdown in less than 20 minutes of testing. The only reasonable explanation seems that the sample had some kind of defect or production error, causing the electrical field stress to be more than the material could handle even for a short period of time. This is an important result that shows the importance of good insulation materials when dealing with high voltage installations. A weak material may not give any warning before breaking down, causing mass failure. Figure 4.14 presents three pictures taken of the material after breakdown. Notice how far towards the edge the punctured hole is in figure 14(b), even though the electrode was placed at the opposite end

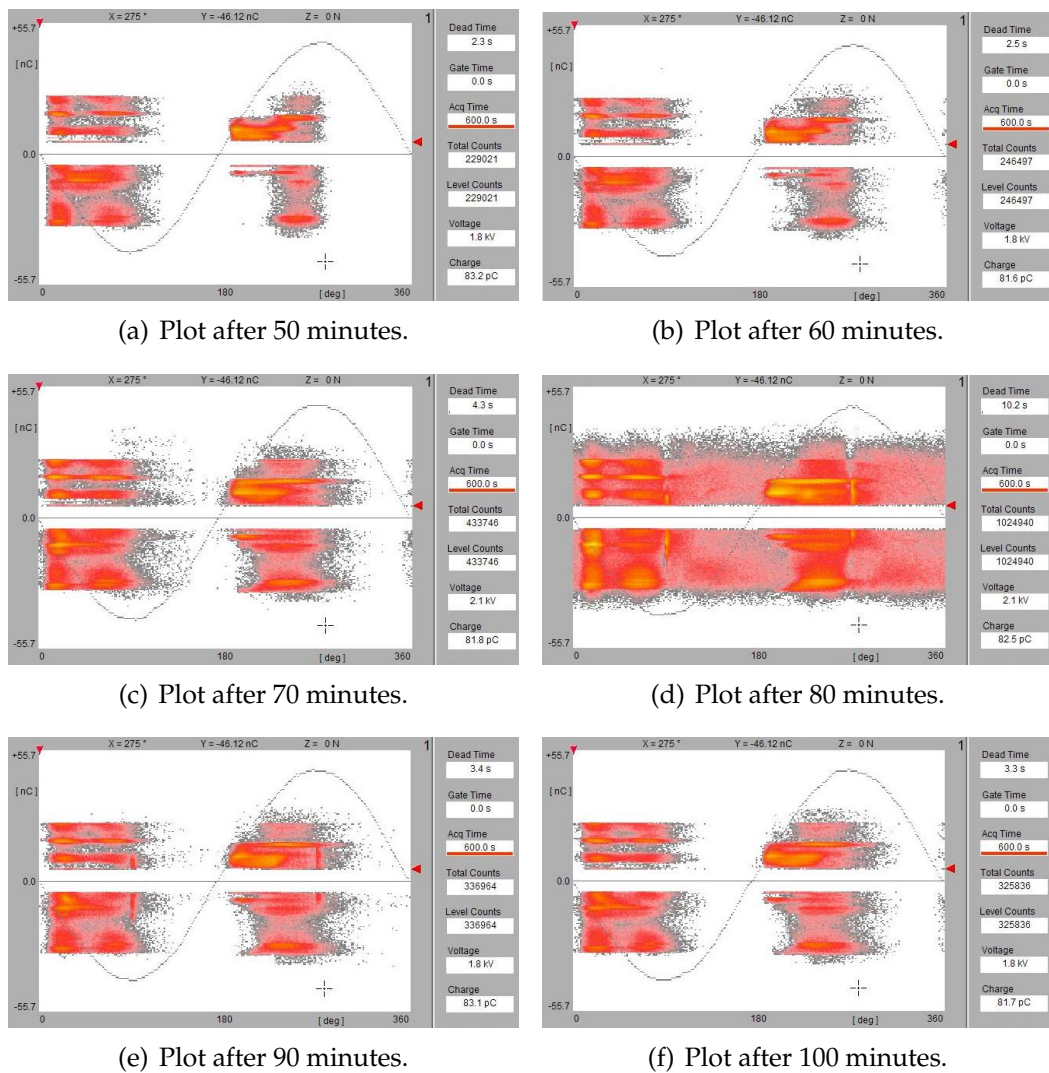
Figure 4.16: Series of plots from PEEK3. The plots are 10 minutes apart. After going normal for about 50 minutes, the activity suddenly increases drastically for a few minutes, before going back to normal levels.

Some of the plots for PEEK3 shows some interesting activity in the early stages of the experiment. Figure 4.16 shows six plots measured in succession between 50-100 minutes into the experiment. In figure 16(d) the activity suddenly increases to over 1 100 000 counts in ten minutes, which is more than five times the activity shown for the sample the rest of the time during testing. One reason for this might be a sudden physical change in the sample causing the electric field stress to increase notably. After a little while, another change may have caused the field to diminish to normal levels again. If the sample had any weak points to start out with, such a drastic change in discharge activity might as well have led to a quick breakdown of the system.
