Norwegian University of
Science and Technology

Investigation of metallic bipolar plates for PEM fuel cells

Chemical Engineering and Biotechnology

Submission date: June 2011

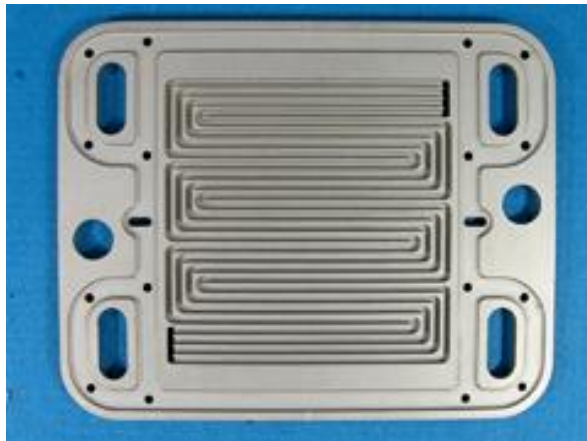
Figure 3: Nitrided metallic bipolar plate. The plate conducts the current between each cell in a stack, and the flowfield leads the gas through the cell. [9]

The bipolar plate (Figure 3) is a very important component in the PEMFC stack (Figure 2), accounting for the vast amount of research done to improve them. The bipolar plate accounts for about 80% of the total cell-weight and ca. 45% of the cell cost [3]. The tasks of the bipolar plate is to distribute the gas in the cell, manage the water in the cell, remove heat from active areas, prevent leakage and to conduct the current away from each cell [3].

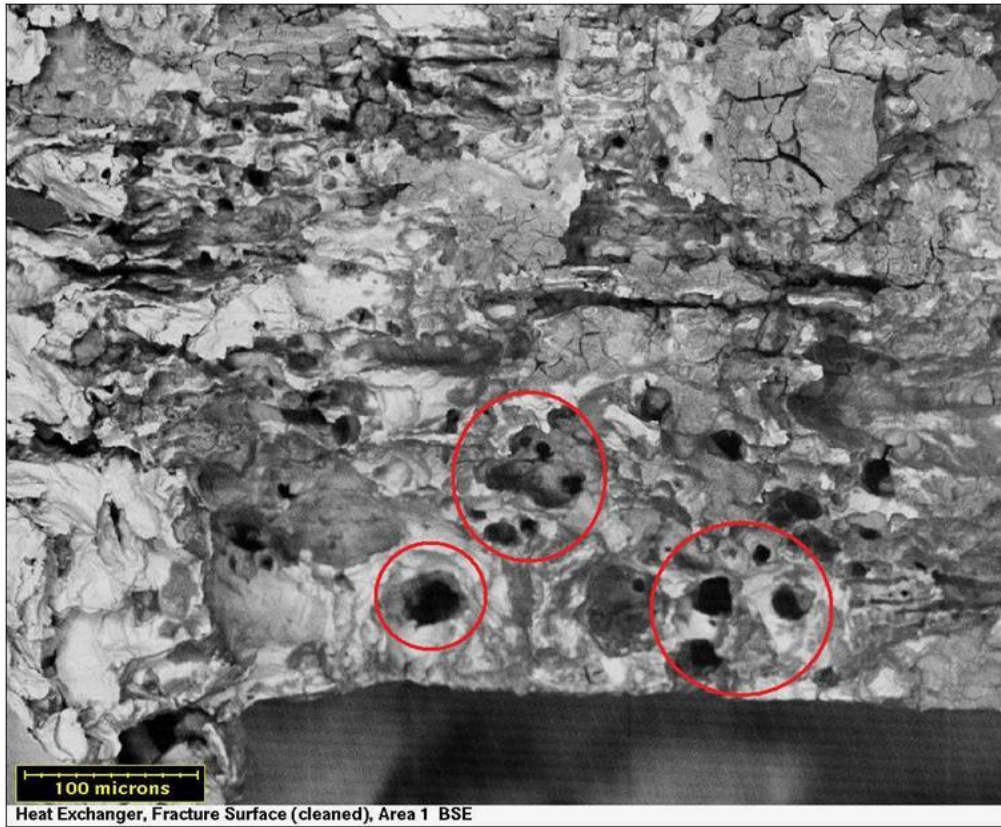
Figure 7: SEM (Backscatter mode) image showing pitting corrosion in 300 stainless steel [13].

Pitting corrosion appears on more or less passivated metals and alloys (section 2.4.1). Narrow pits, with radius no larger than the depth of the pit, can grow deep into the material. The shape of the pit may vary, but it usually has sharp edges (Figure 6). Pitting corrosion is hard to predict, because it accelerates very quickly and can work through the entire depth of a material before it is even noticed. Figure 7 shows how pitting corrosion in 300 stainless steel looks in the SEM. The pits are circled in the picture. [12]

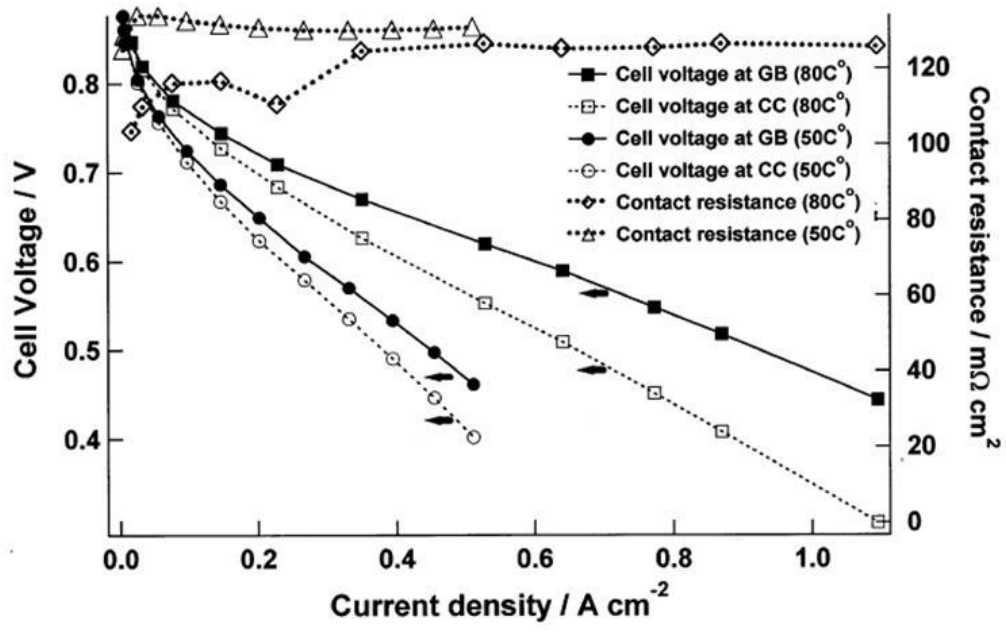
Figure 9: Cell potential and contact resistance as a function of current density [16].

Ihonen et al. [16] performed in-situ contact resistance measurements of plated and unplated 316 stainless steel in a PEM fuel cell. The results are presented in Figure 9, along with the cell potentials at different temperatures. They found that the in-situ measurements showed considerable scattering, because the pressure over the MEA in the operating fuel cell was hard to control.

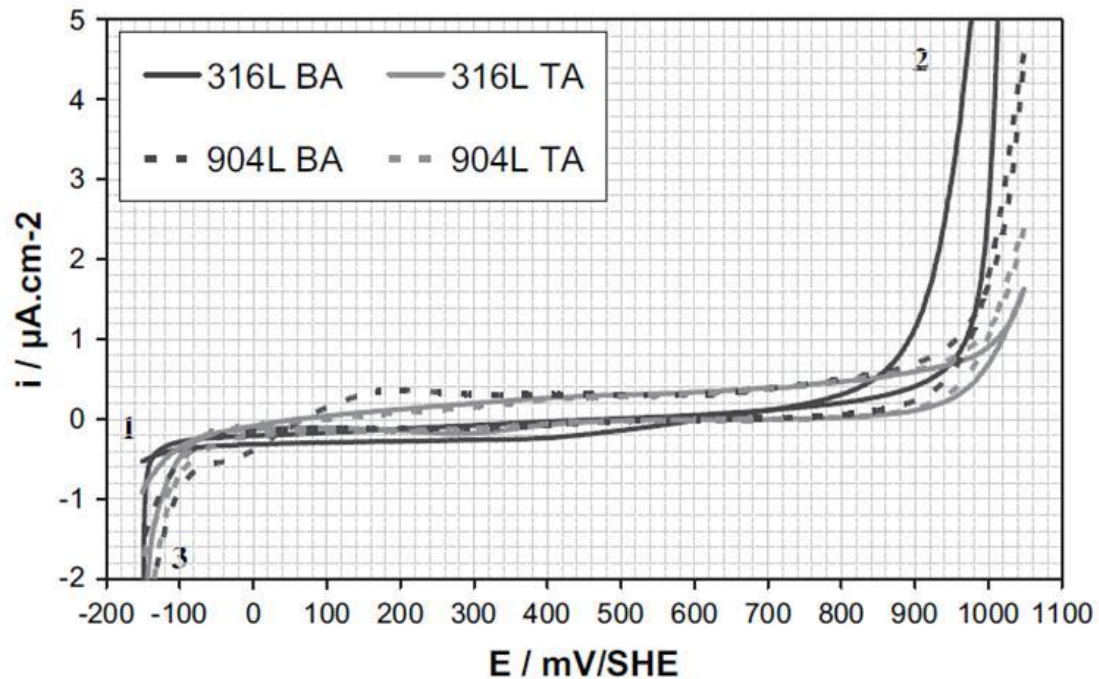
Figure 13: Polarization curves of 316L and 904L alloy with bright annealed and TA surface states in desaturated anodic electrolyte.

Andrè et al [23] obtained polarization curves by cyclic voltammetry between -150 and 1050 mV/SHE at 10mV/min. An Hg/Hg₂SO₄ electrode was used to avoid contamination of chloride, and different types of stainless steel were tested. The polarization curves are presented in Figure 13.

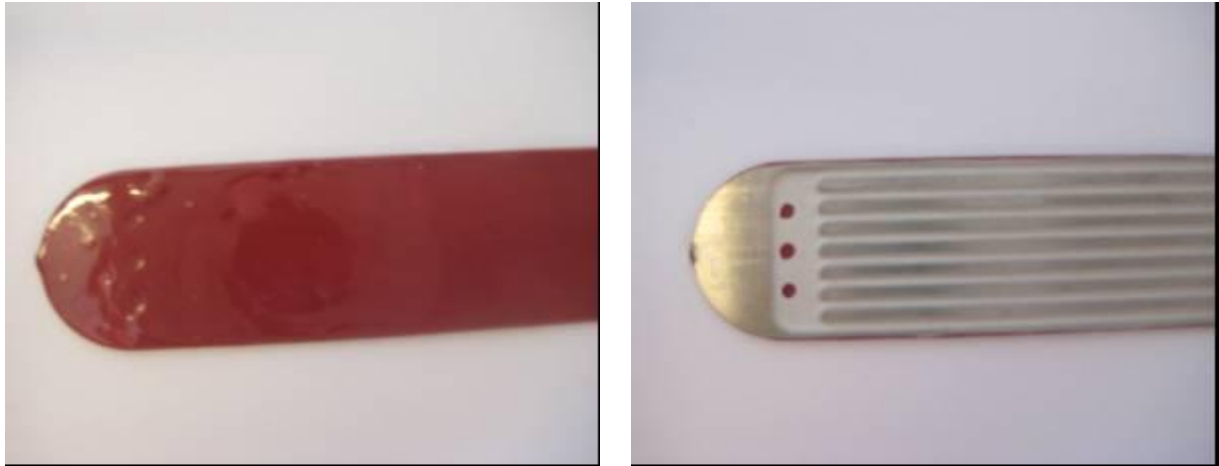
Figure 17: a) Stainless steel plate coated with nail varnish to avoid corrosion on both sides.
b) The front side of the bipolar plate which was not coated with nail varnish.

In the single test cells used for the in situ testing leading up to this project work, only one side of the stainless steel plate was exposed to the corrosive environment; the side facing the acidic membrane. To compensate for this, one side of the plate was coated with varnish, before putting into the electrolyte (Figure 17). This had to be done after the pre-polarization contact resistance test (section 3.1). The varnish also had to be taken off after finishing the corrosion test, in order to do test the contact resistance again. The varnish was taken off by use of acetone in a VWR ultrasound cleaner.

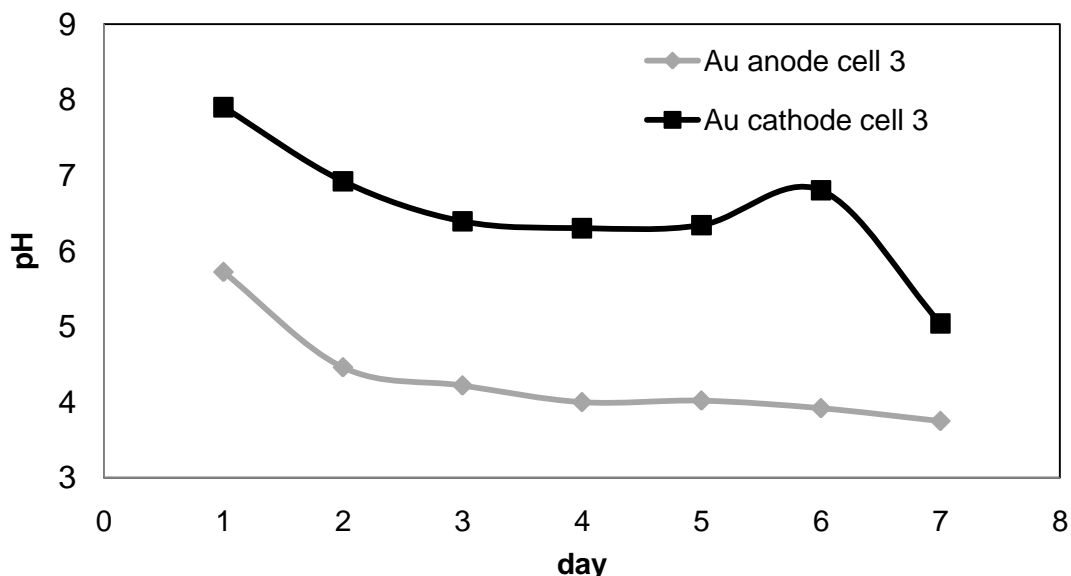
Figure 18: pH values measured from the water leaving a fuel cell running of several days.

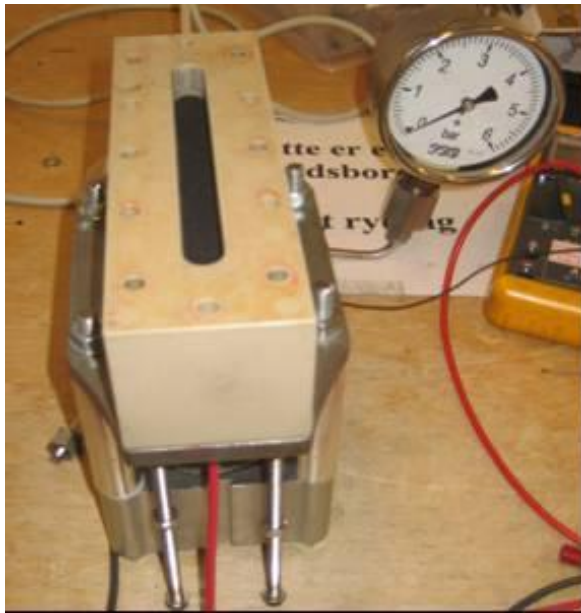
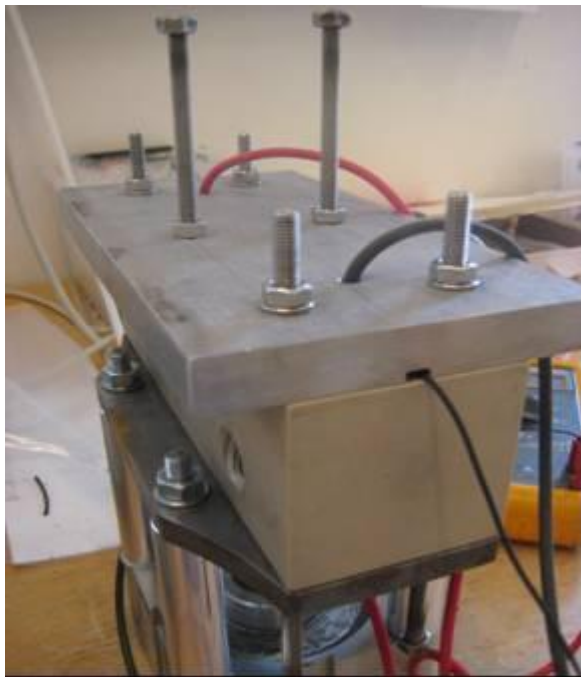
To test the contact resistance between the test bipolar plate and the gold coated bipolar plate used as standard, the plate was placed as shown in Figure 21a. The top part was then placed on top of the bottom part, and screws were used to keep the whole setup together (Figure 21c). The wire welded to the bipolar plate was put through holes in the copper and steel plate, and connected to the multimeter. Pneumatic pressure was then applied from underneath the setup, and potentials were recorded between the two plates as the pneumatic pressure was increased. These potentials were used to calculate the contact resistance as described in appendix E.

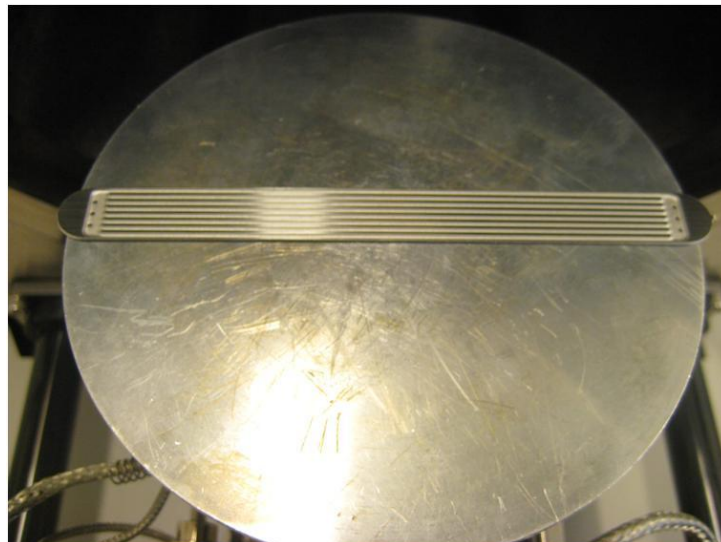
Figure 22: The bipolar plate attached to the sample table by carbon stickers.

Carbon stickers were used to attach the bipolar plate to the sample table (Figure 22). The height of the sample was measured before installing it in the SEM, to avoid crashing the electron canon into the sample when it was inside the SEM. The sample was put into the apparatus and the vacuum was turned on. A picture of the SEM apparatus is shown in Figure 15.

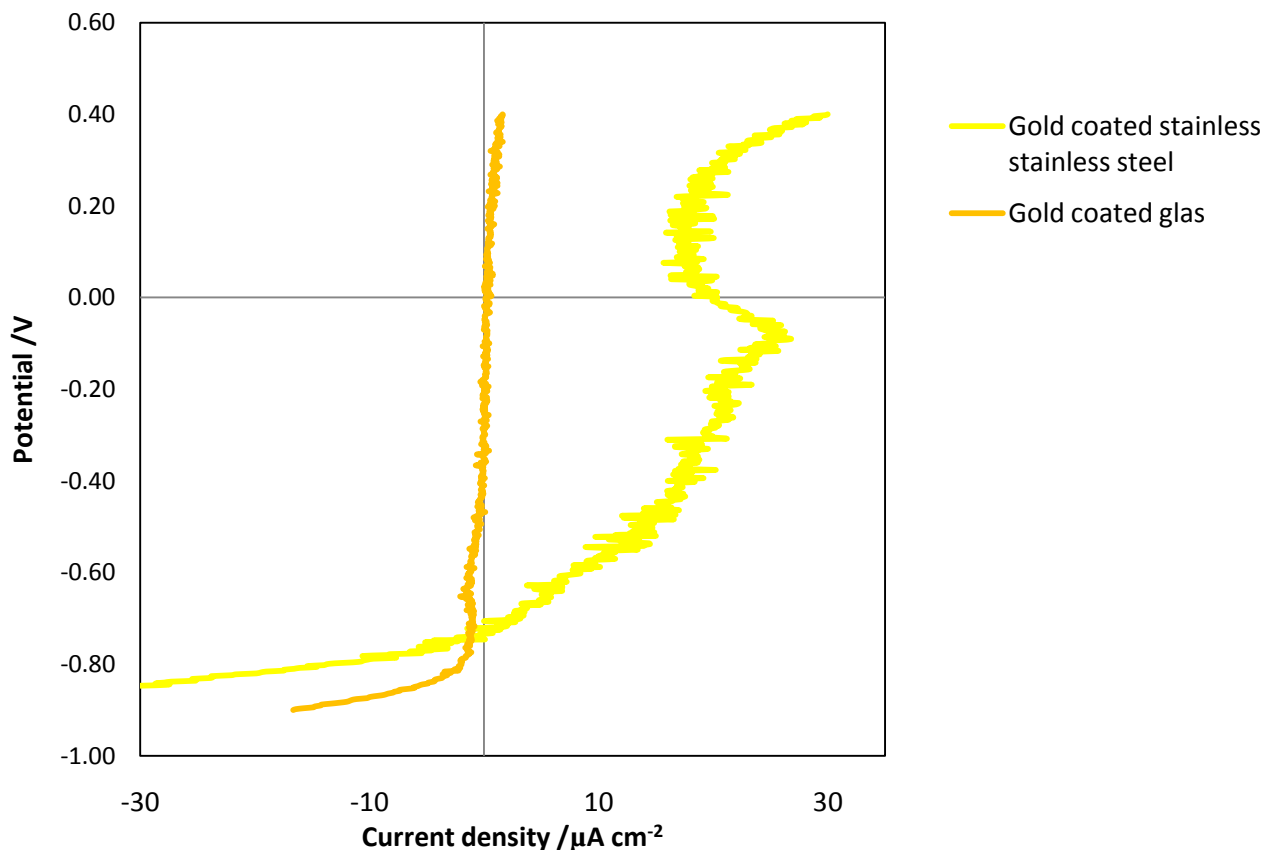
Figure 23: Gold coated glass and gold coated stainless steel, test 1; -0.9V to 0.4 V vs. Hg/HgSO₄ at 2 mV s⁻¹.

The gold coated stainless steel bipolar plate was chosen as standard because gold does not form oxide layers like stainless steel does, and gold coated steel should not corrode in the simulated fuel cell environment. The results from the sweep polarization test (test 1, Table 4) of the gold coated stainless steel plate is shown in Figure 23.

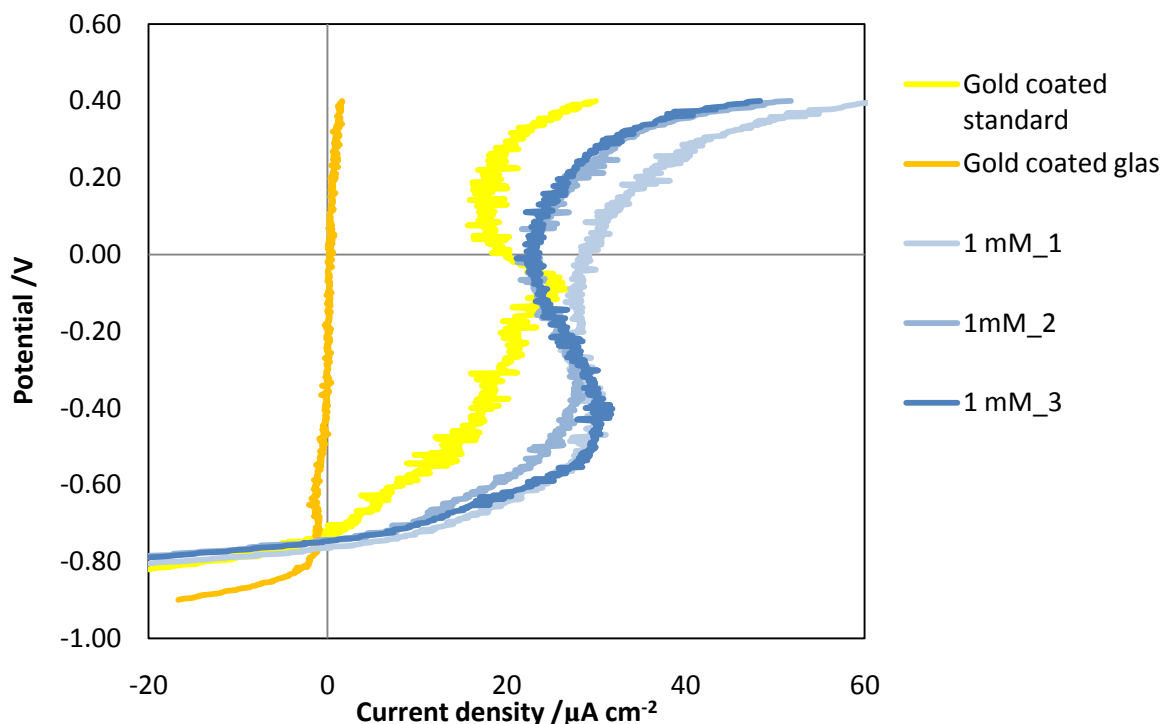
Figure 27: Reproducibility, test 1; -0.9V to 0.4 V vs. Hg/HgSO₄ with a scan rate of 2 mV s⁻¹.

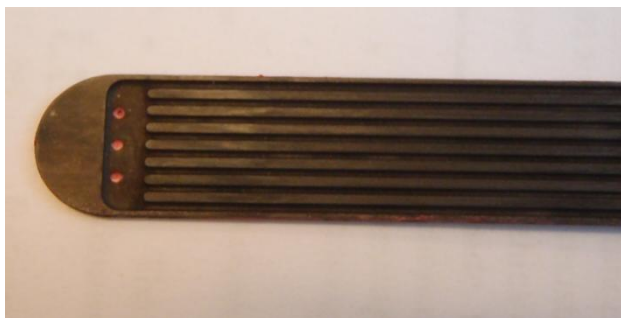
Figure 33a shows the plate that was tested in the 1 M solution of sulfuric acid when the potential was set to -0.717 V vs. Hg/HgSO₄ for 1 hour. This black color came from a layer that had formed on the stainless steel plates. This plate did not look like any of the other plates that had been tested. The layer could have consisted of some sort of iron oxide, which would show good conductivity compared to the chromium oxide layer usually formed on stainless steel. The conductivity of the stainless steel plates after the corrosion tests will be further discussed in section 4.2.4. The iron oxide layer could have increased the current densities to values that one would never find in an operating fuel cell. This could indicate that using a 1M sulfuric acid solution to accelerate the reactions that takes place inside a fuel cell, would actually provoke reactions that would never happened in a real fuel cell.

Figure 33: a) Used stainless steel bipolar plate, 1 M H_2SO_4 at -0.717 V vs. Hg/HgSO_4 for 1 hour. b) New stainless steel bipolar plate. c) Used stainless steel bipolar plate, 1mM H_2SO_4 at 0.293 V vs. Hg/HgSO_4 for 1 hour. d) Used stainless steel bipolar plate, 0.1 mM H_2SO_4 at -0.717 V vs. Hg/HgSO_4 for 1 hour.

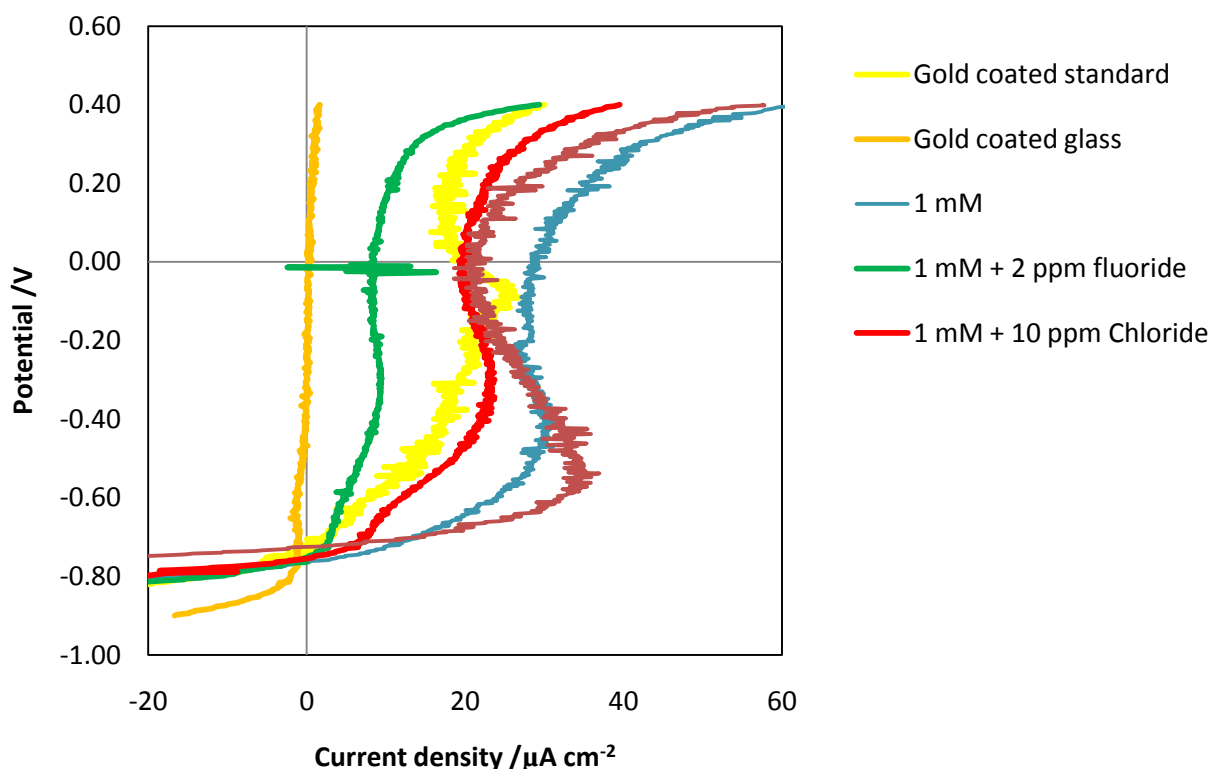
Figure 36: Addition of F^- and Cl^- , test 1; -0.9V to 0.4 V vs. $Hg/HgSO_4$ with a scan rate of 2 mV s^{-1} .

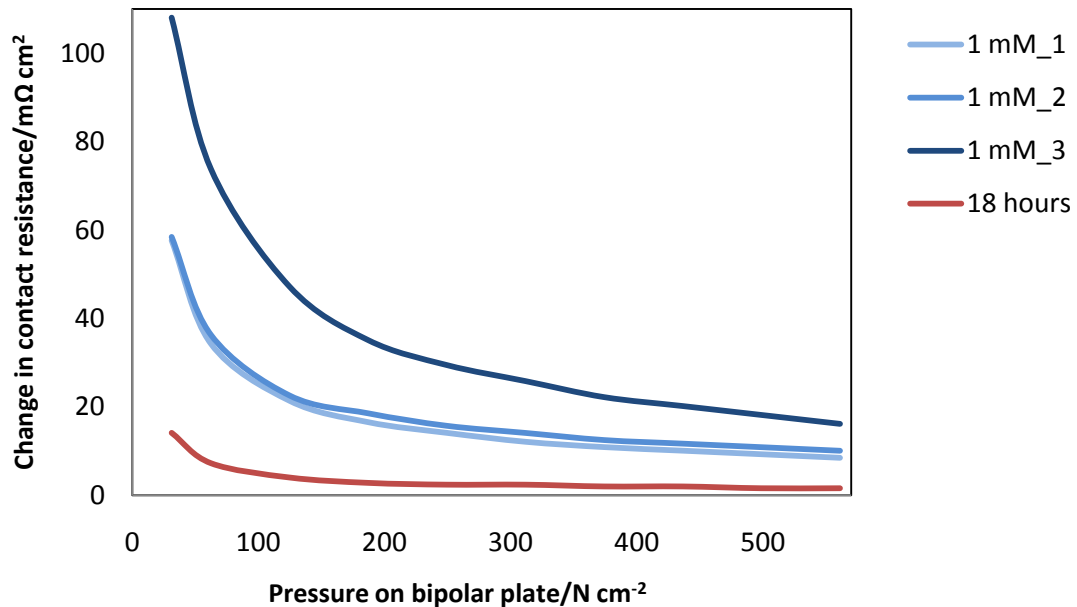
Figure 44: 1 vs. 18 hours, test 2; -0.717 V vs. Hg/HgSO₄ for 18 hours.

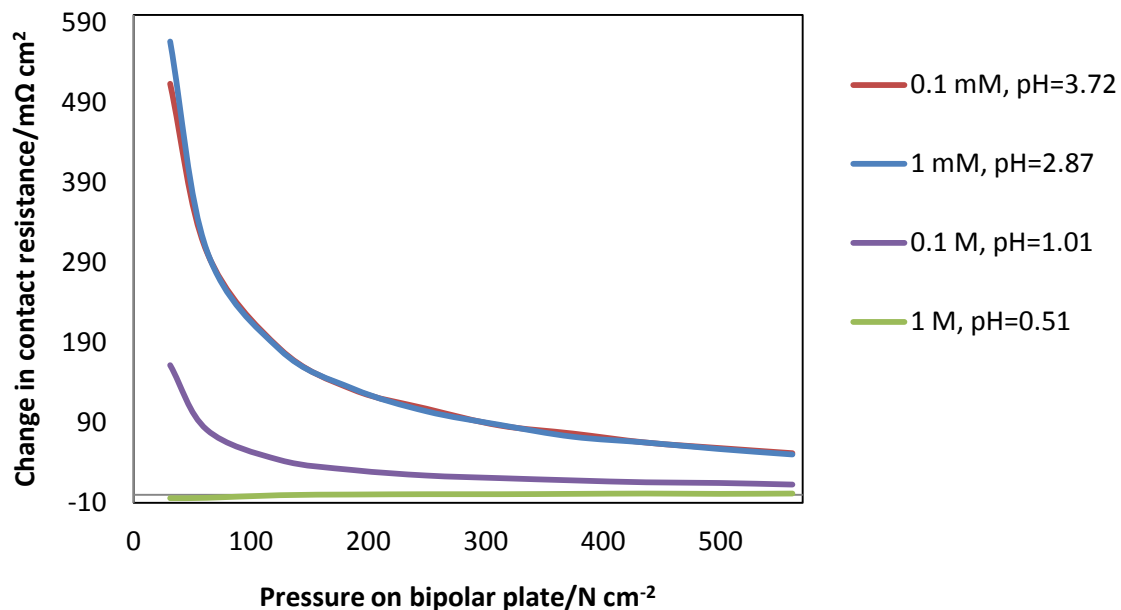
Figure 47: pH variations, test 3; 0.293 V vs. Hg/HgSO₄ for 1 hour.

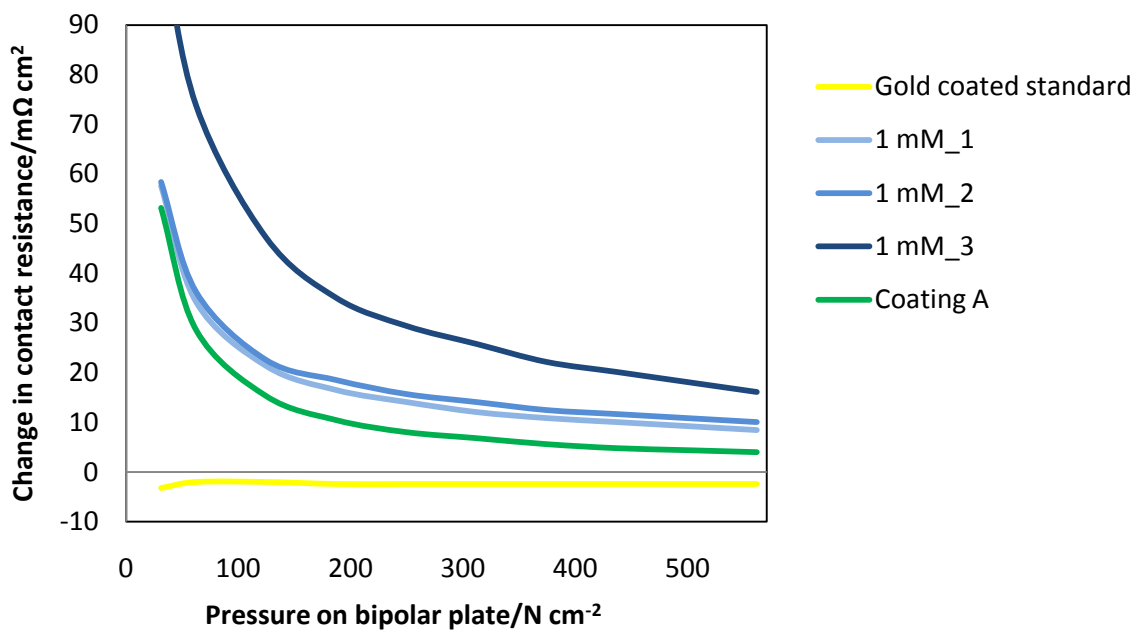
Figure 52: Coating A, test 2; $-0.717\ V$ vs. $Hg/HgSO_4$ for 1 hour.

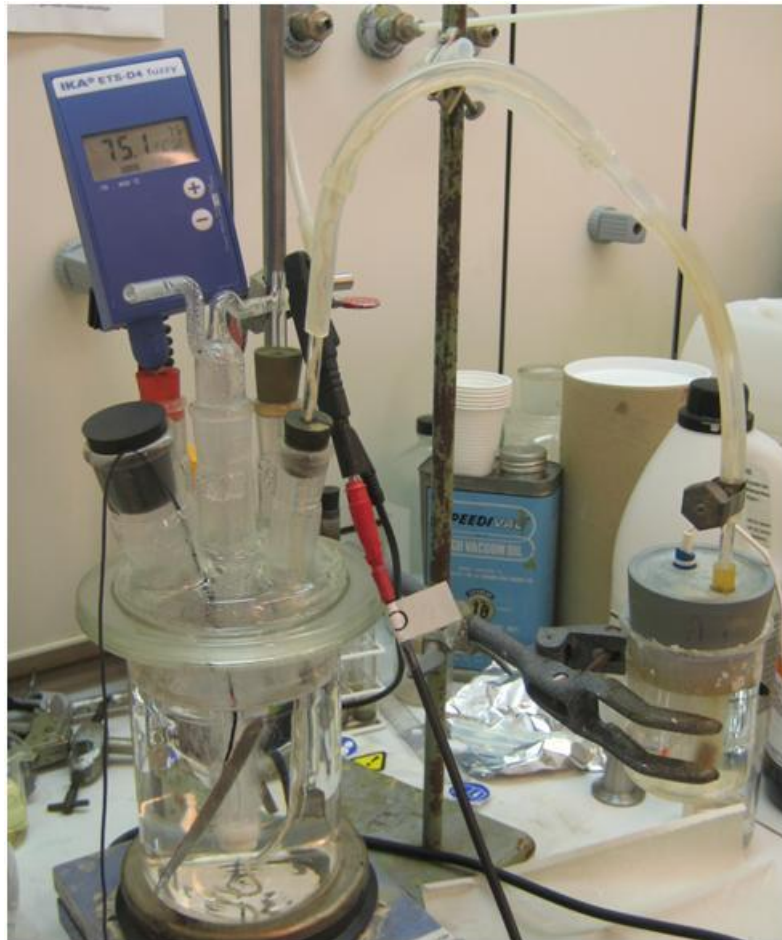
Figure A1: Picture of the polarization testing equipment.

The setup for the polarization testing equipment is shown in Figure 16, and a picture of the setup is shown in appendix A. This setup was made to simulate the environment experienced by the bipolar plates inside a fuel cell. Sulfuric acid was used as electrolyte because the MEA used in an operating fuel cell is pretreated in sulfuric acid, which in turn makes the environment inside the fuel cell acidic. The calculations done before preparing the electrolytes are shown in appendix B. An IM6 potentiostat (Zahner electric) was used and the reference electrode was a Mercury/mercury sulfide (Hg/HgSO_4) electrode. This electrode was chosen because it, compared to a lot of other reference electrodes, does not contain chloride. It was desirable to avoid any chloride in the electrolyte in order to avoid any undesired reactions. To make completely sure the reference electrode did not cause any unwanted reactions, it was connected to the electrolyte via a salt bridge (Figure 16). The counter electrodes were made of platinum, and two of these electrodes were necessary to compensate for the large surface area of the stainless steel plate (working electrode).

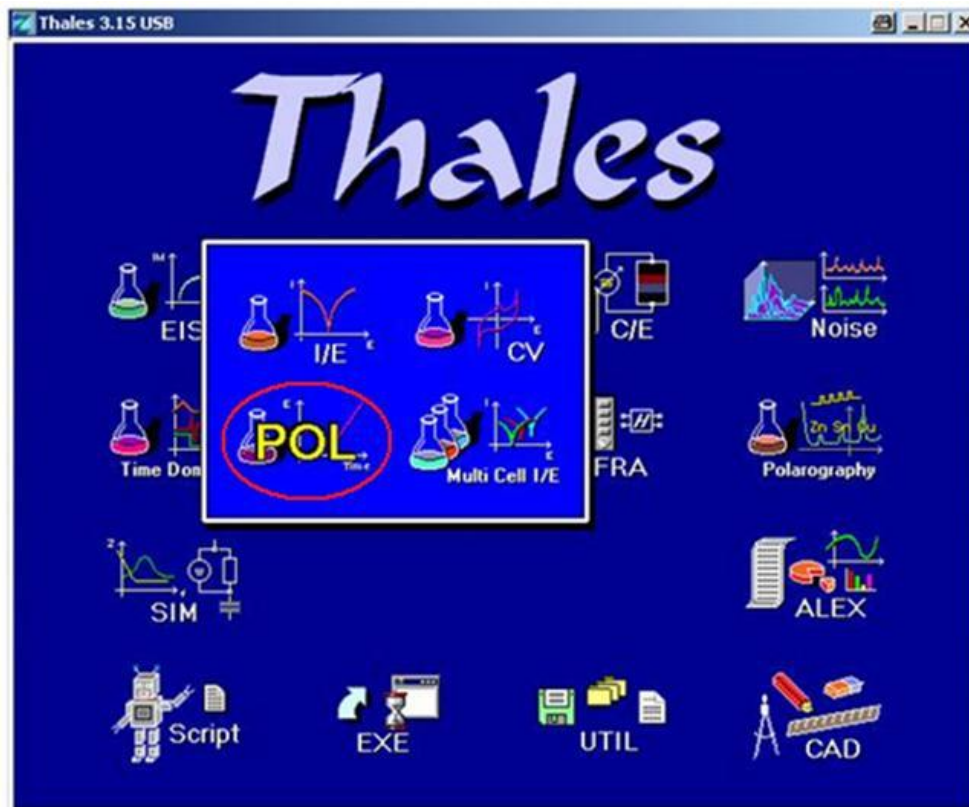
Figure C2: The window where polarization testing was chosen.

The first window in the Thales program is shown in figure C1. The green button was pushed to enter the program. In the next window (figure C2), POL was chosen to start the polarization part of the program. Figure C3 shows the window where the conditions for the polarization test were set. Phase 1 (*polarization*) was used for the tests run at constant potentials, which was applied along with the length of the tests and intervals between each measurement (Figure C3). Phase 3 (*linear scan*) was used for the test run between -0.9 V and 0.4 V, and the potentials were applied along with the scan rates (Figure C3).
