High Temperature Cathodic Disbonding of Organic Coatings on Submerged Steel Structures

Håkon A Holm Gundersen

Master Thesis, Spring 2011

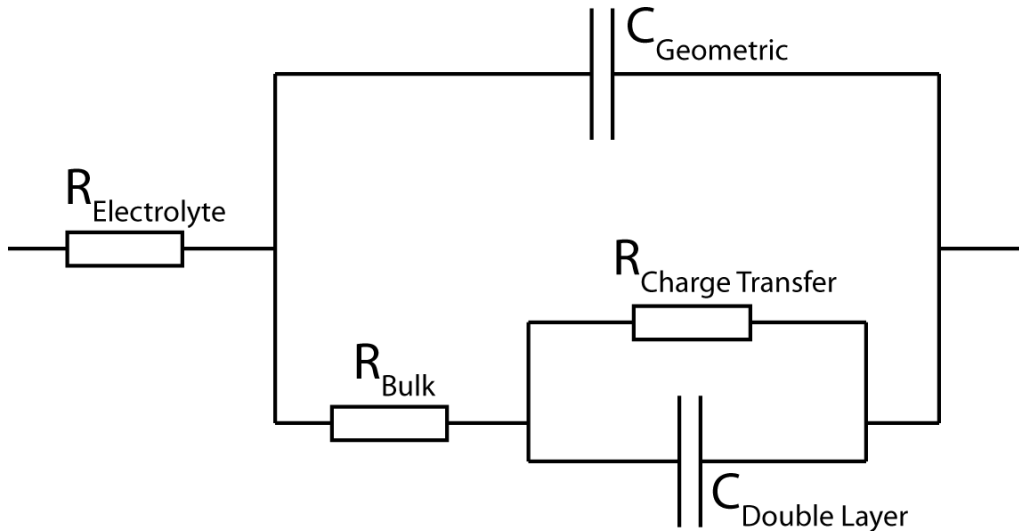
A non-perfect coating can be modelled by a more complex system, shown in figure 2.3.[53] Here, the capacitance called C_g is in parallel with a resistor (R_{Bulk}). This

Figure 2.3: Equivalent circuit for a non-perfect coating

bulk resistance represents ionic transport occurring through the coating, for a perfect coating this resistance would be infinite. In series with R_{bulk} we find R_{ct} and C_{dl} in parallel. R_{ct} represents the resistance of the charge transfer itself, also called faradaic impedance. C_{dl} is the capacitance of the electric double layer. The importance of this double layer and the effect coatings have on it was discussed in section 2.1.2. In addition to these another resistor, R_e coupled in series with the system shown in figure 2.3, is sometimes considered. R_e represents the resistance offered by the electrolyte itself. The size of R_e usually makes it insignificant compared to the rest of the system.

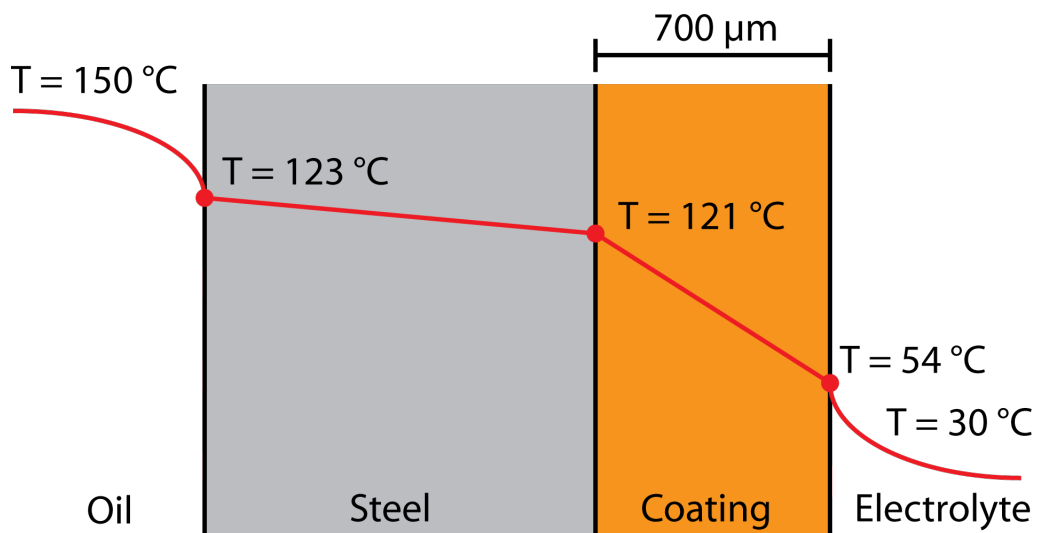
Figure 2.5: Calculated temperature profile

Heat is transferred through the steel and the coating by conduction according to Fourier's law of heat conduction. The heat is transferred from the oil to the steel and then from the coating to the electrolyte through convection according to Newton's law of cooling. Through calculations of Reynold's number and Prandtl's number, both the oil flow and the electrolyte flow were found to be turbulent. The Nusselt numbers were calculated, the value of the Nusselt number yielded the convection heat transfer coefficient. Finally the thermal resistances of the discrete steps presented in figure 2.4 were calculated and the temperatures at the steel surface, the interface between the steel and the coating and at the coating surface were found. The results of these calculations, for an oil temperature of 150 °C and a coating dry film thickness of 700 μm is found in figure 2.5.

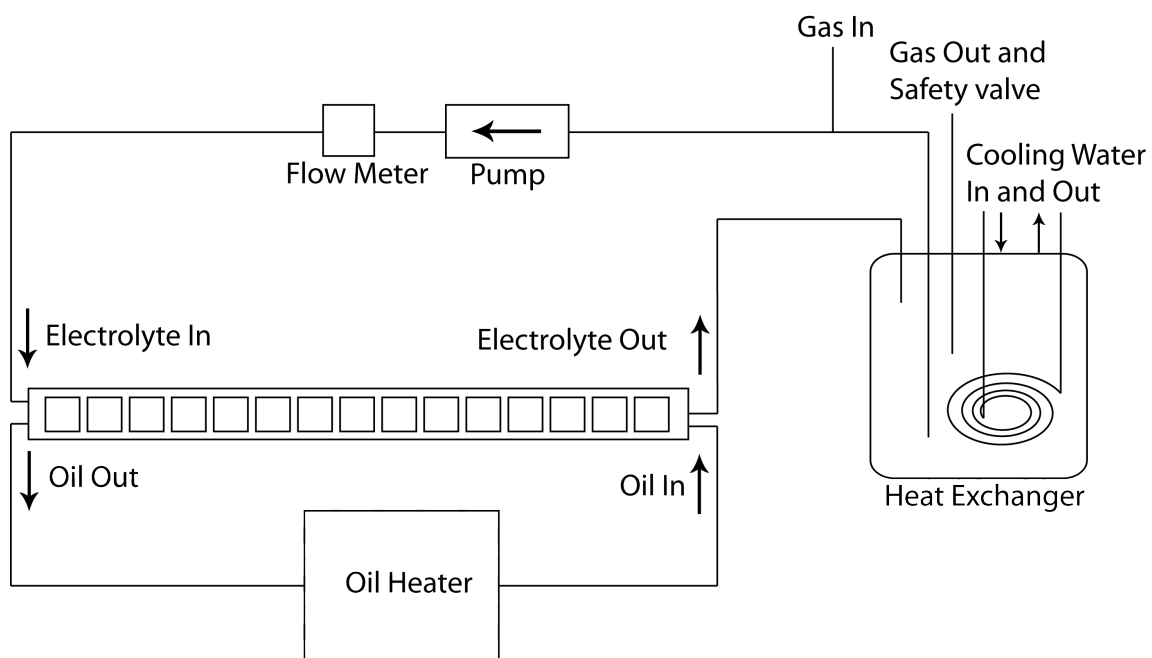
Figure 3.4: Schematic of the HTCD apparatus

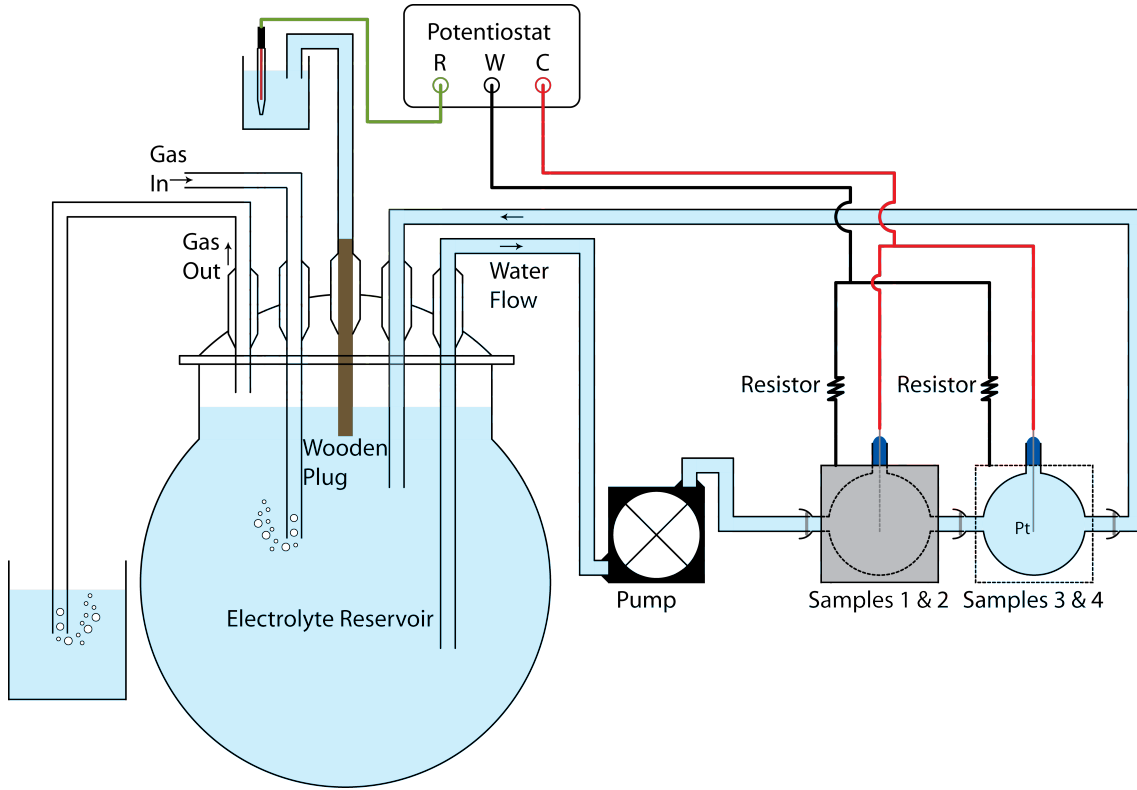
Figure 3.6: Setup for the oxygen diffusion experiment

The setup used was similar to the one described by Knudsen[2]. The sample plates were mounted in electrochemical cells that were connected in series forming one continuous electrolyte cycle. The sample plates were cathodically protected by a potentiostat applying a potential of $-1.2 V_{SCE}$ for the first 24 hours, later lowered to $-1.8 V_{SCE}$. The necessary protection current for each sample was measured by observing the potential drop over a resistor of $1 M\Omega$. The exposed area of each sample plate was 19.6 cm^2 . The electrolyte (3.5 w% NaCl (Aq)) was circulated through the cells and a larger reservoir. Nitrogen gas was bubbled through the electrolyte reservoir for some time to remove any oxygen present. A lack of oxygen could be observed through the necessary protection current. Once the protection current was stable, the electrolyte was saturated with air. The current was measured with the intention of calculating the diffusion coefficient based on the break-through time as presented in equation 3.1[2]. The setup used is presented in figure 3.6.

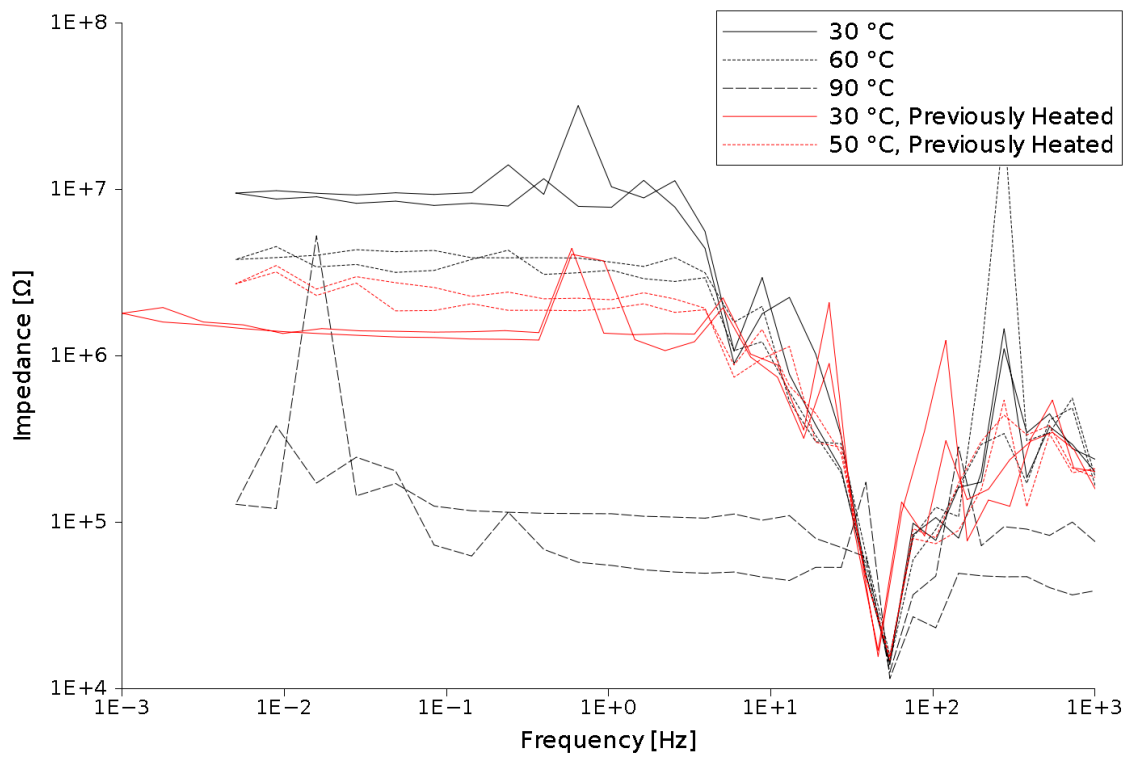
Figure 4.8: EIS with Previously Heated Samples

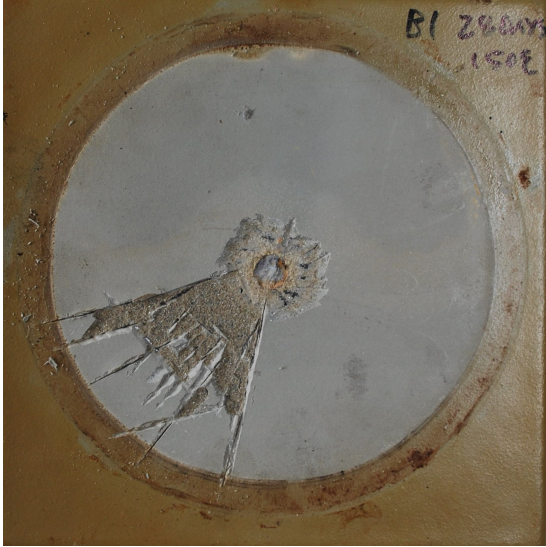
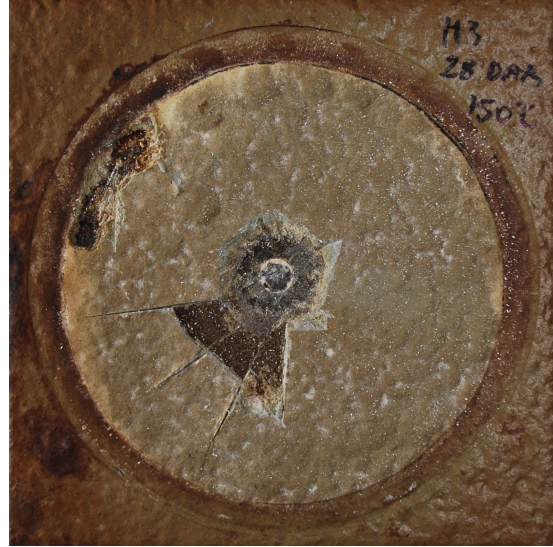
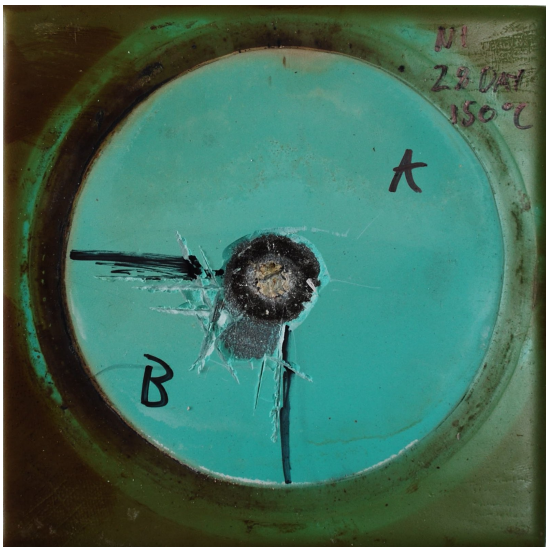
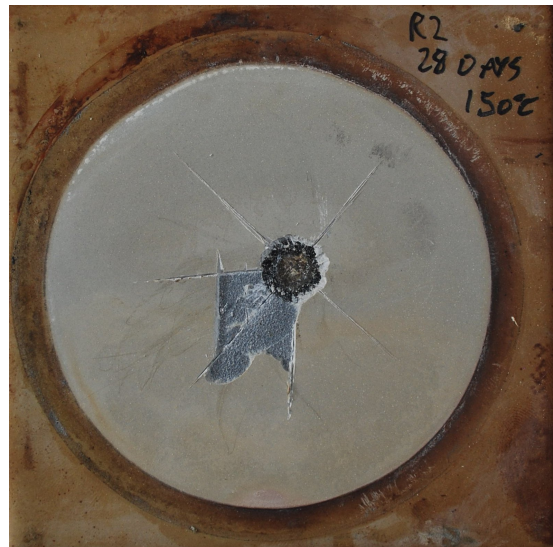
Products I (C.1c), K (C.1d) and N (C.1e) are examples where the discolored area is easily distinguishable. The contrast between the discolored area and the substrate in general is less obvious for products B (C.1a) and H (C.1b), though easily distinguishable in good light.

Figure C.1: Samples Dual-Tested with two Methods of Assessment

Assessing the disbonded area for very thick and hard coatings can be difficult. The scalpell that is normally used to perform the crossing cuts and the subsequent lift or peel breaks easily. More solid knives may perform without undue breakage, but have resulted in more extensive scratching of the surface beneath the coating. An alternate method, where a sturdy knife or sharp chisel is used to chip away the coating in an area around the holiday larger than the extent of the disbonding, is proposed. After the coating has been thus removed a discolored area on the substrate is clearly visible. The exact appearance of the discolored area differs from sample to sample, though a darkened ring is by far the most common. It is almost impossible to discern the strength of adhesion with this method, but the discolored area provides visual proof of the minimum extent of chemical changes beneath the coating. The images included here, figures C.1a, C.1b, C.1c, C.1d, C.1e and C.1f, show sample plates where the usual method of assessment was utilized around three quarters of the circumference of the holiday, while the new method was used along the last quarter. As can be seen, there is close, but not exact, correlation between the discolored area and the area that is easily lifted with a scalpel.

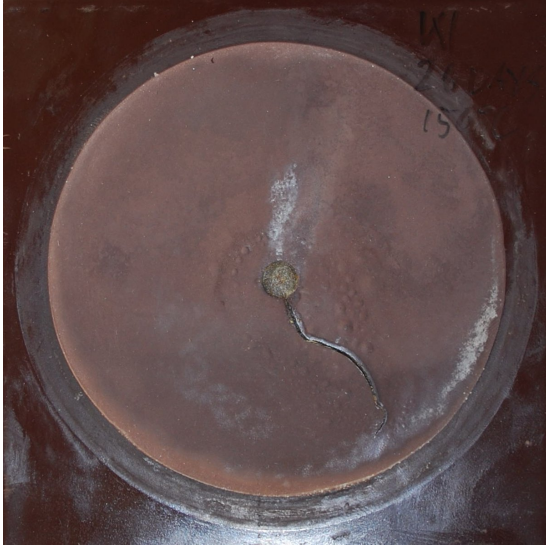
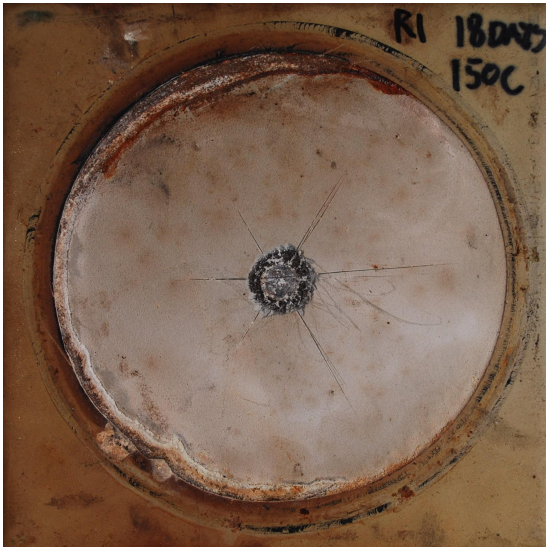
In figure D.1 two sample plates from the 18 day test are shown. Figure D.1c shows a sample of product R where damage along the edge is clearly visible. Figure D.1d shows a sample of product B where the damaged along the edge has been scraped in the fashion usually employed to assess the extent of disbonding, exposing the substrate underneath.

(a) Product K, Cracked

(b) Product K, Cracked, After Assessment

(c) Product R, Showing damage along the edge

(d) Product B, Showing damage along the edge

Figure D.1: Damaged Samples

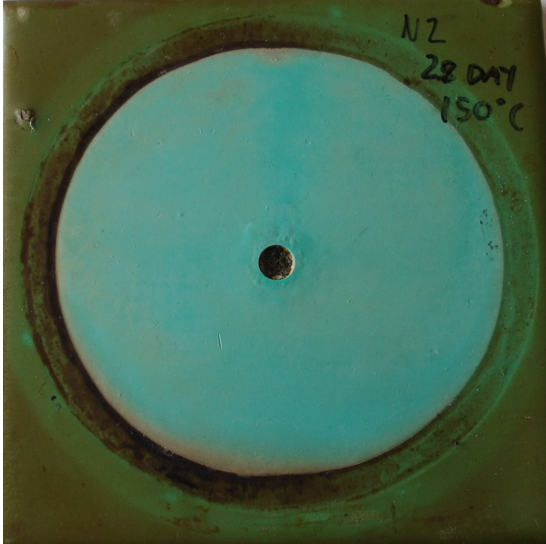
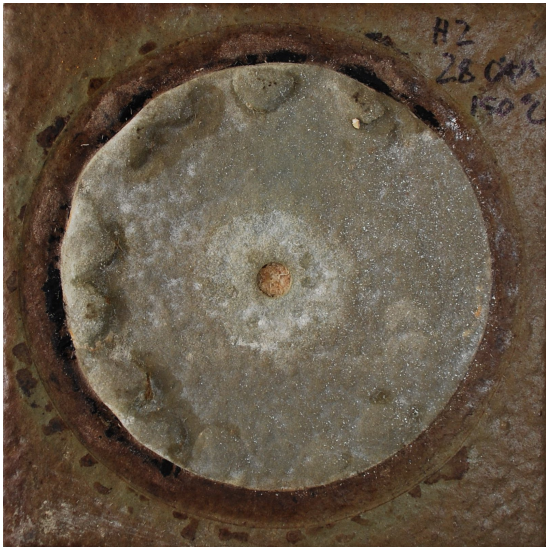
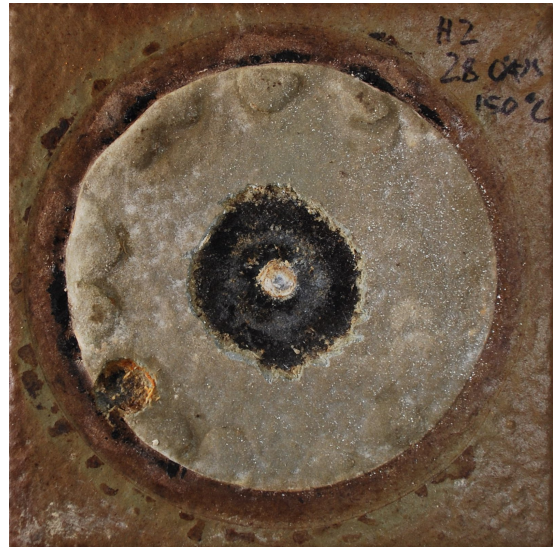
In figure D.2 two blistered samples are shown. Figures D.2a and D.2b show a detail of a sample plate of product N with tiny blisters located near the holiday and an overview picture of the sample after assessment. Figures D.2c and D.2d show a sample plate of product H with severe blistering before (D.2c) and after (D.2d) assessment.

(a) Product N, blistering in the disbonded area

(c) Product H, extensive blistering

Figure D.2: Products Showing Blistering

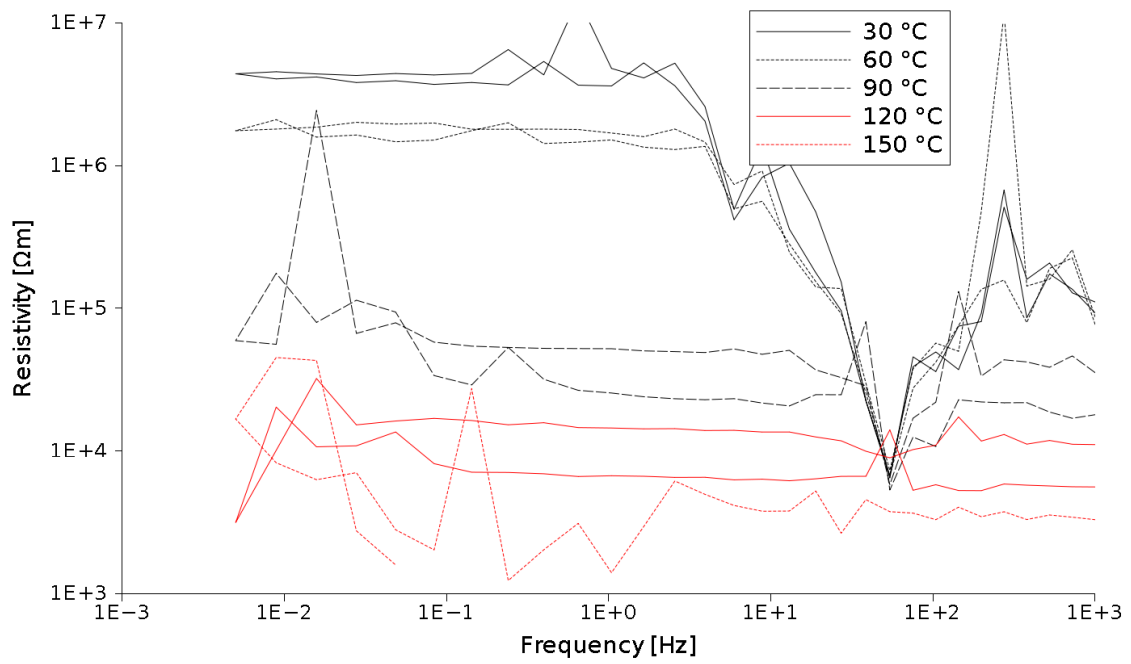
Figure E.2: EIS Results for Product I

Electrochemical impedance spectroscopy scans of products H, I, K and N for several temperatures from 30 °C to 150 °C are included in the following figures. Two graphs are provided for each product, one shows the impedance of the coating system, the other the bulk resistivity of the coating product after film thickness and the size of the exposed area has been taken into account.
