NTNU – Trondheim
Norwegian University of
Science and Technology

Fatigue of Welded AA6082 Alloys - Effects of PWHT and Shot Peening

Norwegian University of Science and Technology
Department of Materials Science and Engineering

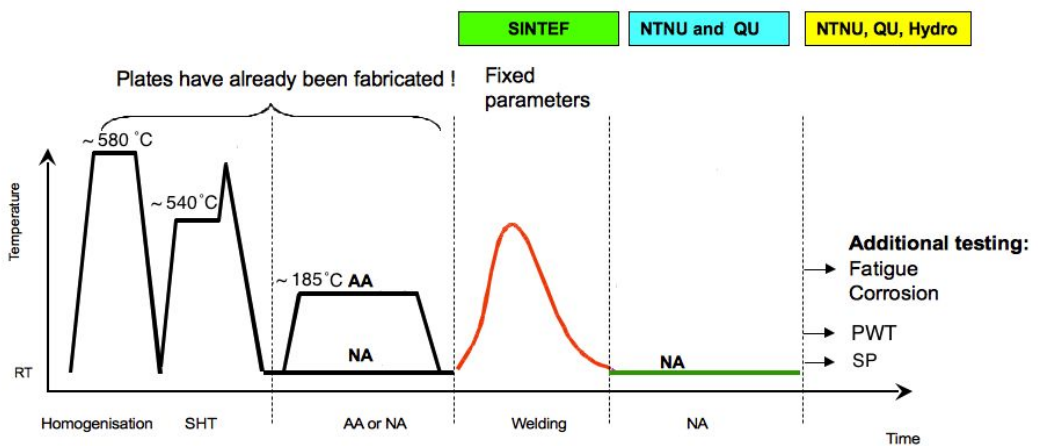
Figure 2.1: Processing of the aluminum profiles (Furu, 2012).

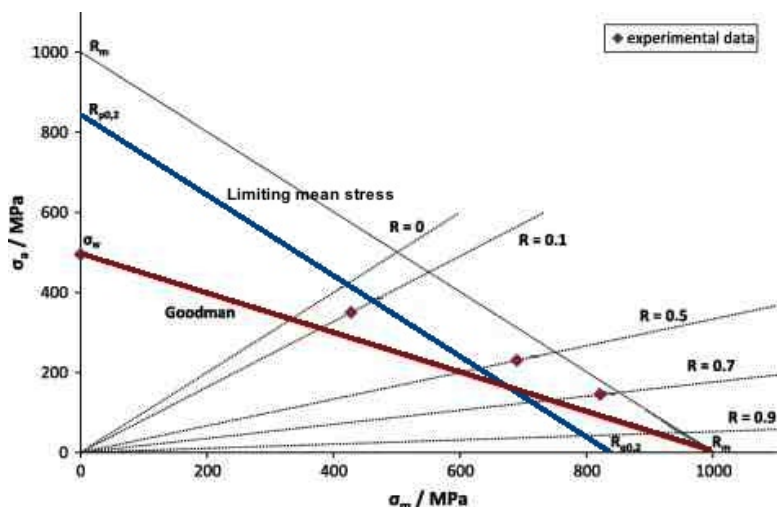
Figure 2.11: Goodman diagram showing the region of safe operating below the Goodman line and the limiting mean stress, and the region where the material may fail if operated at stresses above these lines (Kovacs et al., 2013).

The Goodman diagram below represents fatigue data by plotting the endurance limit of the material on the y-axis, σ_{ar} , and drawing a straight line to the ultimate tensile strength, σ_{uts} , on the x-axis. Below this line is the safe operating region, where a chosen mean stress, σ_m , applied relates to the maximum applied stress amplitude, σ_a , allowed in the safe region. The limiting mean stress is found by drawing a straight line from the yield strength on the x-axis to the yield strength on the y-axis. In the area above the Goodman line, the material may fail during operation. The Goodman relation is generally conservative, hence the error is such that it causes extra safety in the fatigue life estimations (Dowling, 2012).

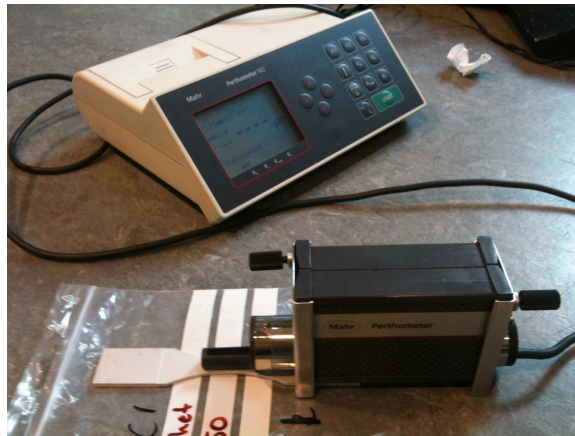
Figure 4.3: Mahr Perthometer M2 measuring the surface roughness of a shot peened specimen of AA6082.50.

The surface roughness was measured by using a Mahr Perthometer M2. A diamond head was used to track the peaks and valleys of the specimens, resulting in a surface profile. The perthometer calculated the different parameters, R_a , R_t , R_z over a length L_t . Three measurements were done per specimen. Figure 4.3 shows the perthometer measuring the surface roughness of one of the shot peened specimens of AA6082.50-T6.

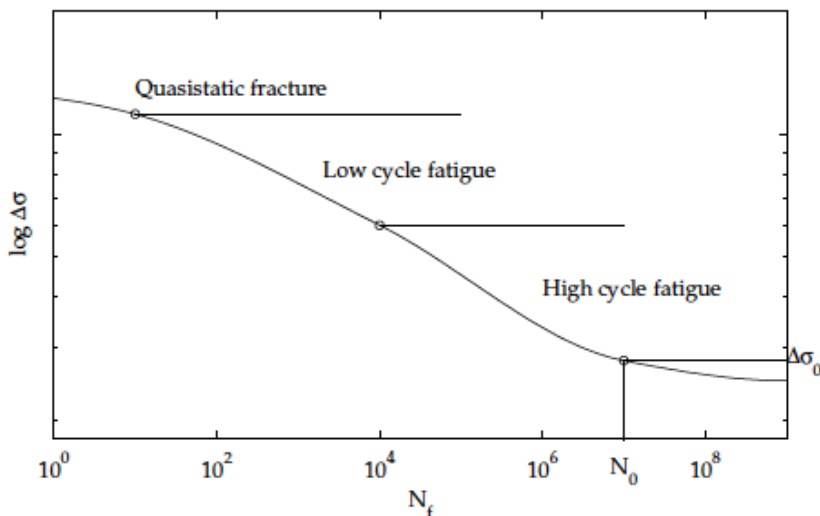
Figure 4.11: Different fatigue testing regions.

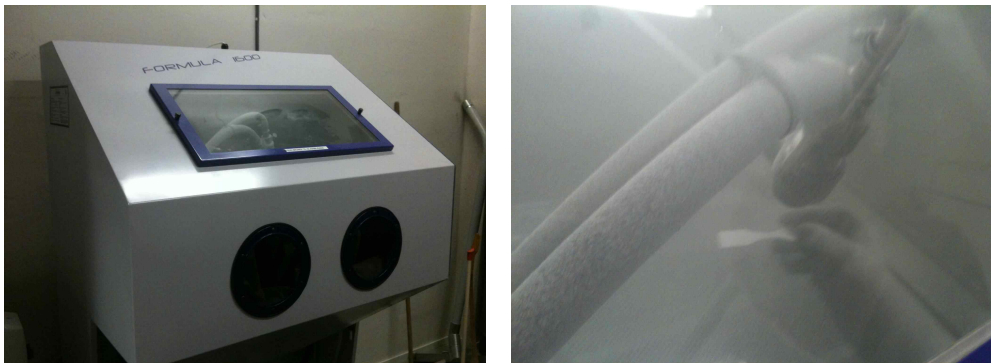
Figure 4.12: Shot peening of as welded specimens of AA6082.50-T6.

Shot peening of specimens post welding were conducted at the fine-mechanical workshop with the use of Guyson Formula 1600 machine, 8 weeks after being welded. Shots made of glass were shot at the specimen with high pressure air at 5.5 bar, accelerated through a nozzle directed at the specimens, shown in Figure 4.12.

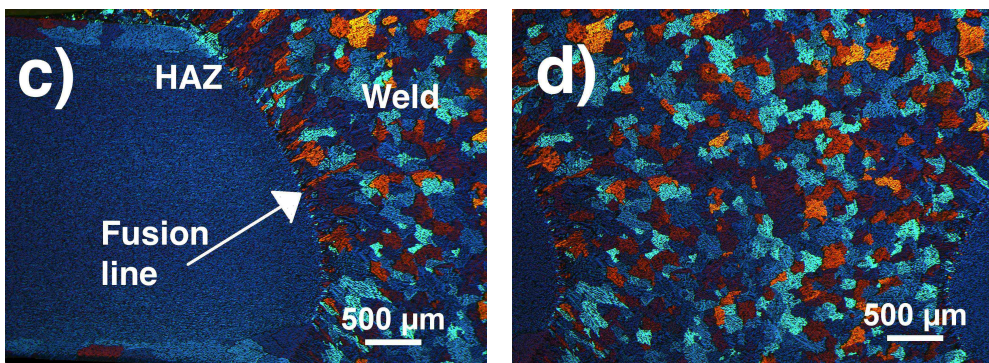
Figure 5.4: Micrographs of the welded AA6082.50, T6 temper condition. The micrograph to the left, c), shows all the features of the weld and the micrograph of the weld is to the right, d).

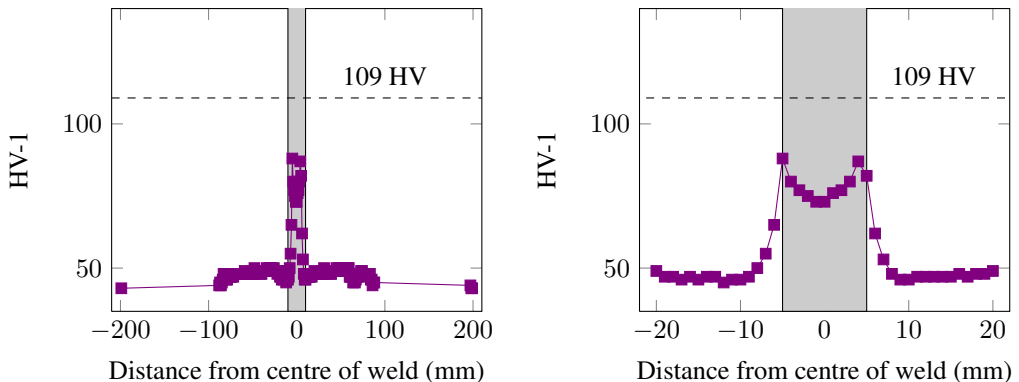
Figure 5.7: Hardness profile of the as welded AA6082.52, T6 temper condition. The gray area represents the weld bead and the dashed line is the measured hardness of the base material. The profile to the right is scaled the same as the following hardness profiles.

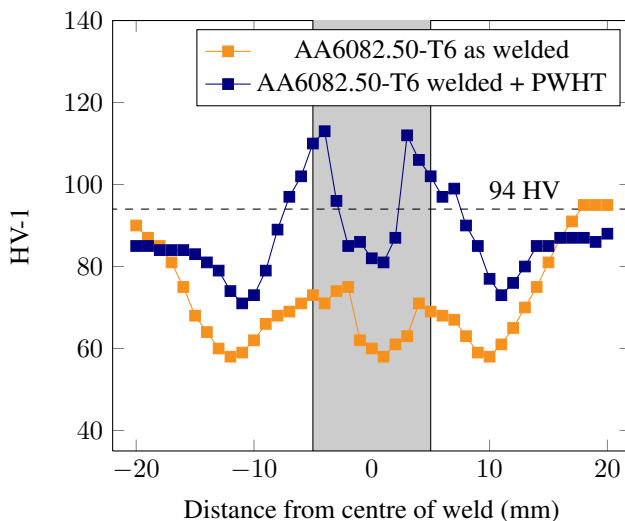
Figure 5.8: Hardness profiles of as welded AA6082.50, temper condition T6 before (orange) and after PWHT (blue). The gray area represents the weld bead and the dashed line is the measured hardness of the base material.

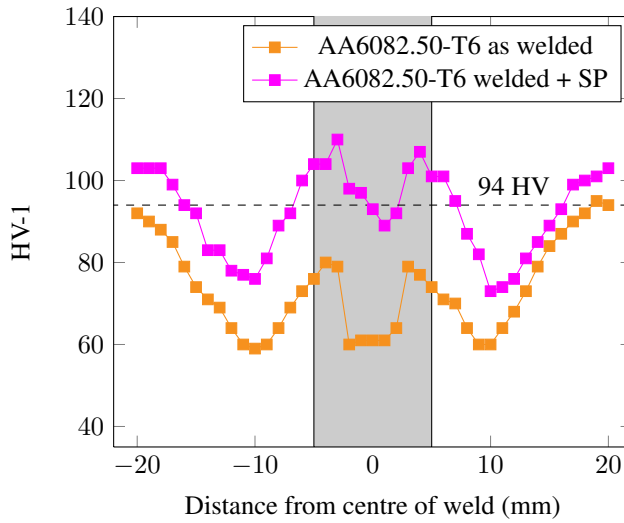
Figure 5.9: Hardness profiles of as welded AA6082.50, temper condition T6 before being shot peened (orange) and after (pink). The gray area represents the weld bead and the dashed line is the hardness measured of the base material.

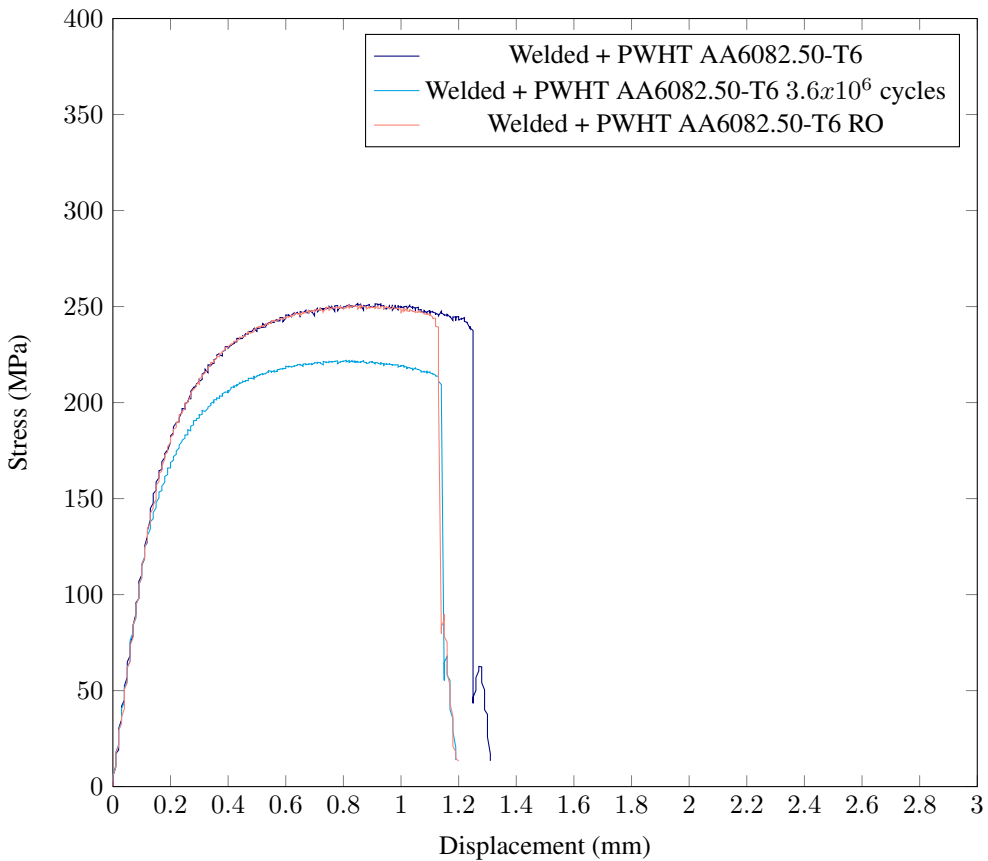
Figure 5.20: Tensile tests of the post weld heat treated specimens of AA6082.50-T6. The purple curve is the un-cycled specimen, the light blue curve is of a specimen undergone 3.6×10^6 cycles and the orange curve is the specimen deemed run-out.

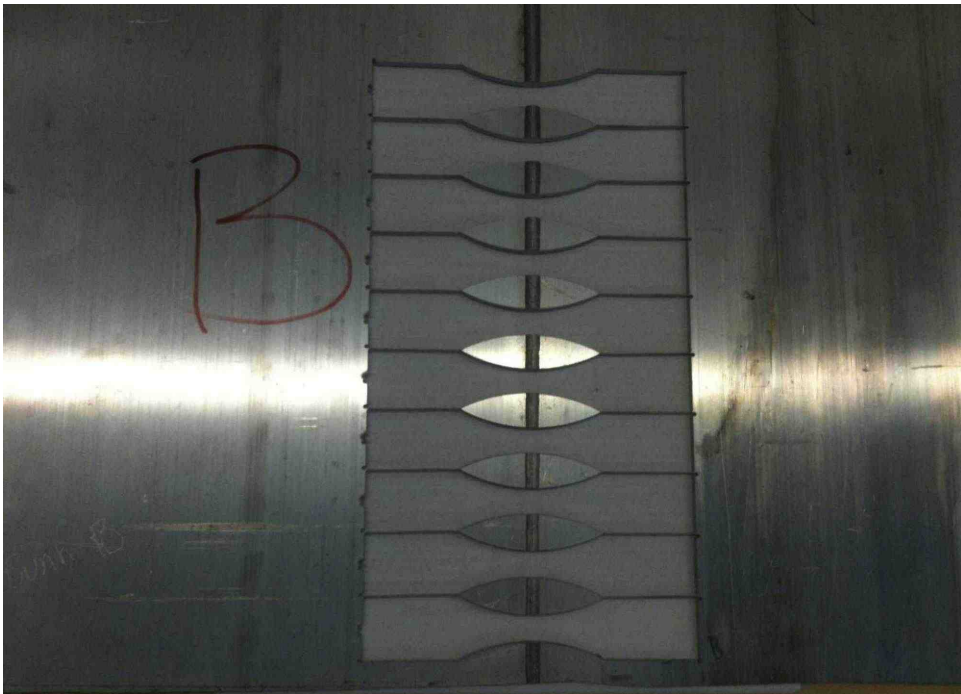
Figure B.4: How the specimens were taken out from one of the welded profiles. These specimens were post weld heat treated.

Figure B.4 show how the specimens were taken from one of the welded profiles. This was the profile that was post weld heat treated.
