# Sulfide Stress Corrosion Cracking Resistance of Modified ASTM A694 F60 Low Alloy Steel for Subsea Applications

Materials Technology

Submission date: June 2013

Norwegian University of Science and Technology  
Department of Materials Science and Engineering

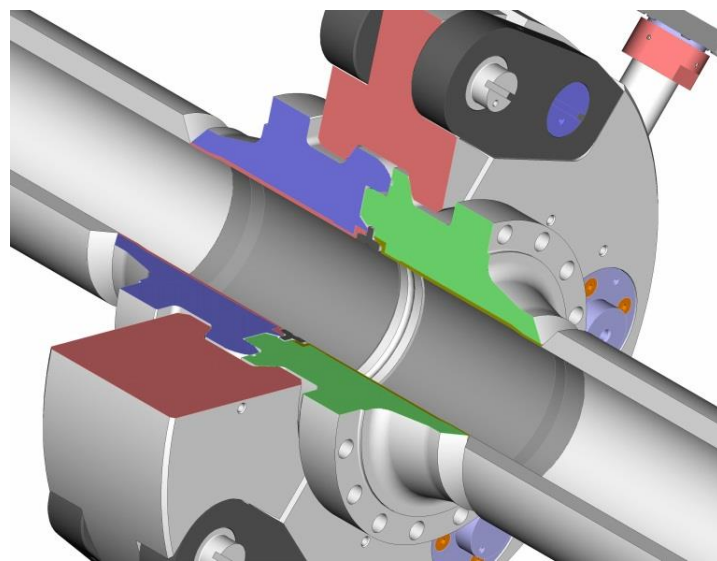
**Figure 1: Cross section of a connection system showing female (blue) and male (green) hubs, and clamp connector (red). [Provided by GE Oil&Gas]**

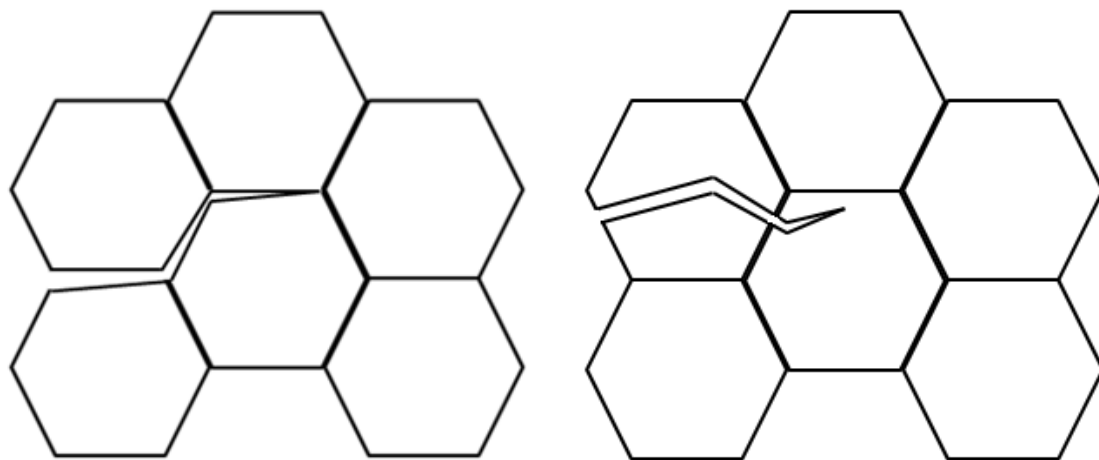
Figure 2: Intergranular (left) and transgranular (right) paths for cracking.

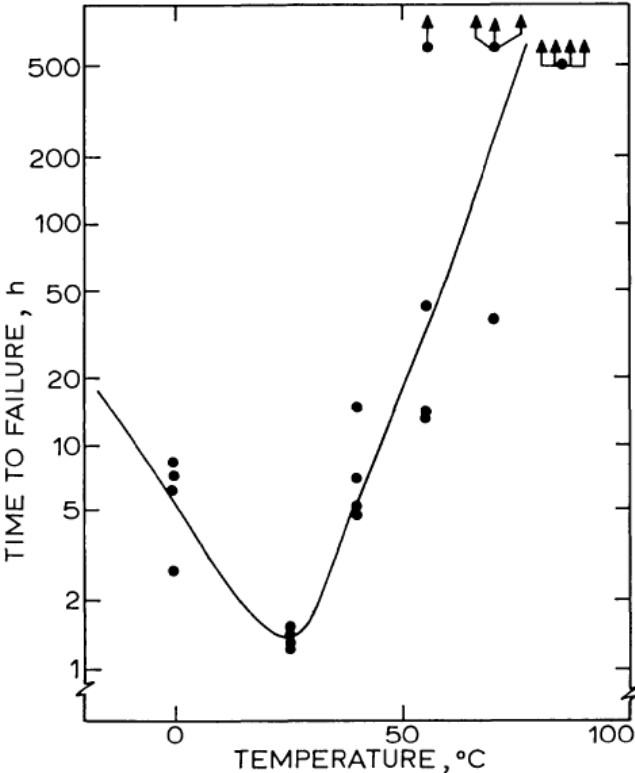
Figure 3: Time to failure by SSC versus temperature for a C-Mn steel, showing maximum susceptibility to SSC at about 25°C. [1]

The test temperature affects the cracking susceptibility as SSC is a temperature dependent phenomenon. For carbon and low alloy steels, the susceptibility to SSC reaches a maximum at about room temperature and the SSC resistance increases with increasing temperature. The temperature dependency is illustrated in Figure 3, where the time to failure is related to temperature for a C-Mn-steel. At low temperatures the diffusion rate of hydrogen is so slow that the critical concentration for SSC is never reached. While at higher temperatures, the

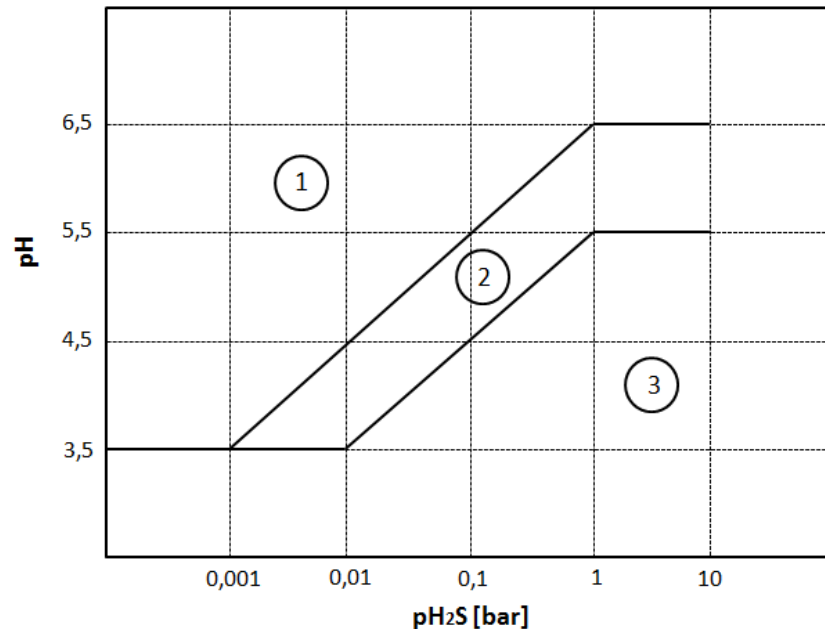
Figure 4: pH – pH<sub>2</sub>S diagram indicating the three regions of severity of the corrosive medium on SSC for carbon and low alloy steels. [7]

The severity of the two and most important parameters,  $H_2S$  partial pressure and pH, are expressed in the  $p_{H_2S}$  – pH diagram (Figure 4). Based on the three regions in the diagram, it shows that the susceptibility to SSC increases with decreasing pH and increasing  $p_{H_2S}$ . The diagram represents the general guidelines for the occurrence of SSC in carbon and low alloy steels. It is divided into three regions based on the severity of the environment. In region 1, SSC does not occur and it may be referred to as “sweet corrosion”. Region 2 is the transition zone where consideration has to be made regarding critical metallurgical requirements for the materials selected. Region 3 is the sour service region and represents the most severe

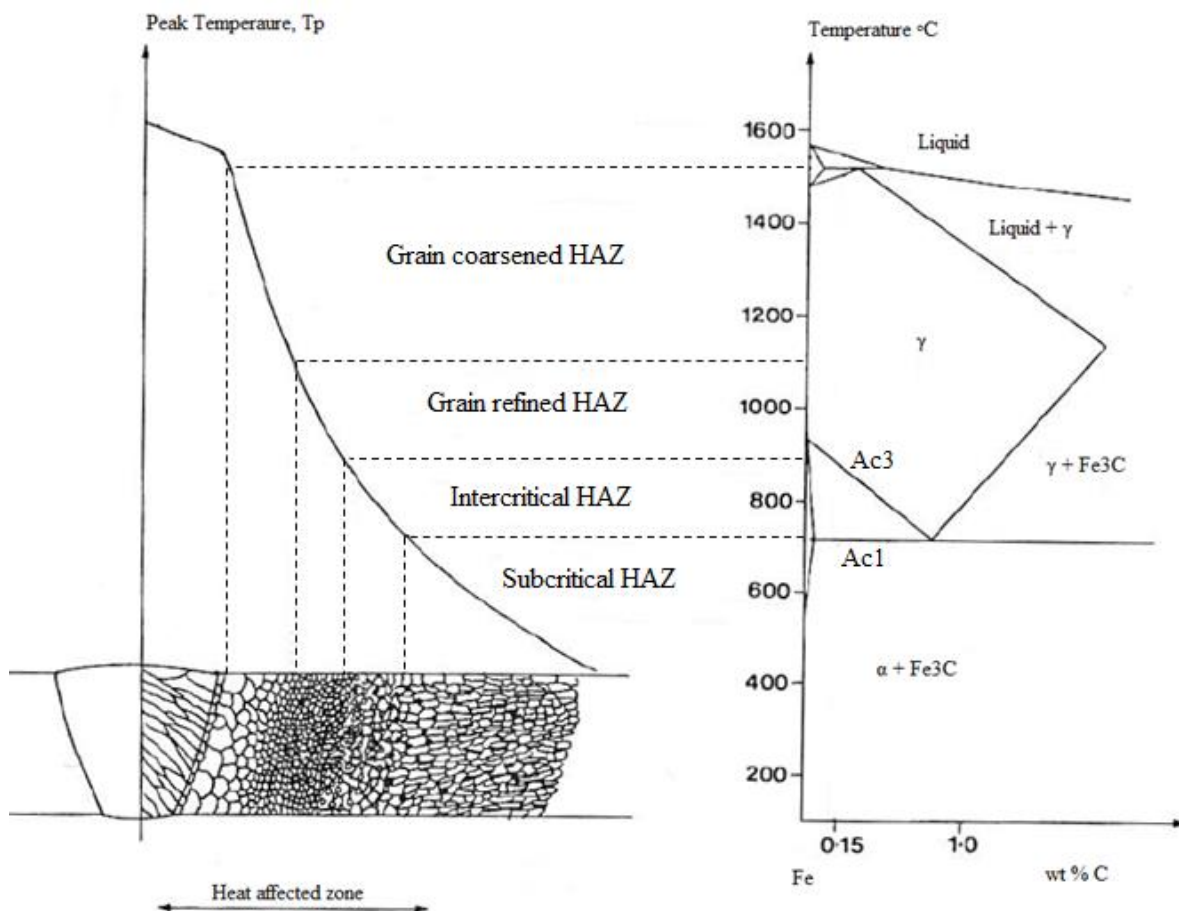
**Figure 5: Definition of regions in the heat-affected zone (HAZ). [34]**

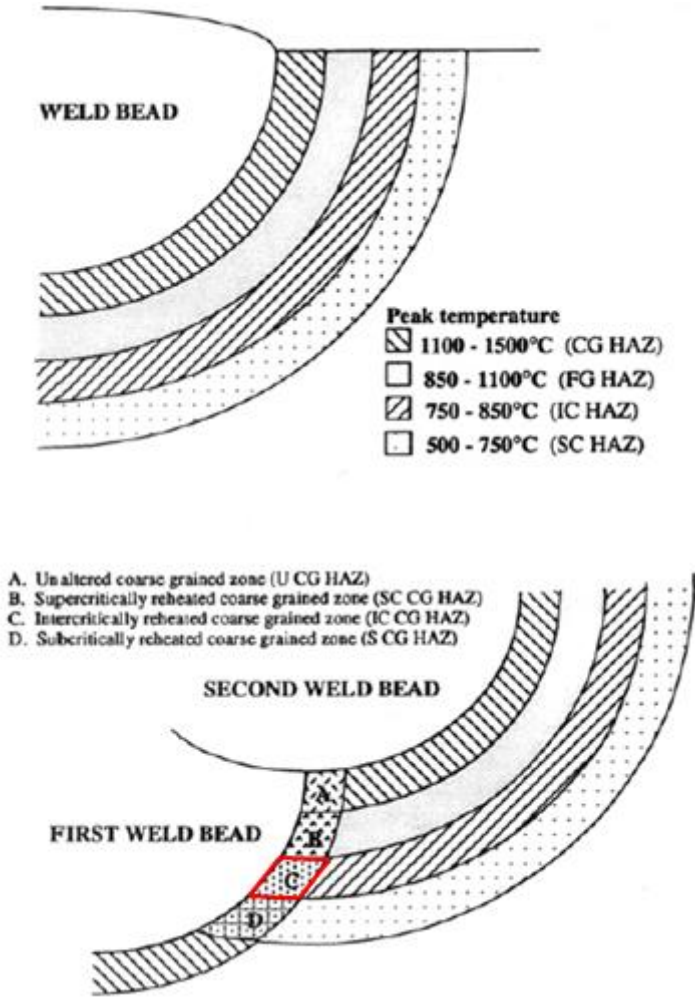
Figure 6: Microstructural changes of the HAZ by the first and second weld thermal cycle. [38]

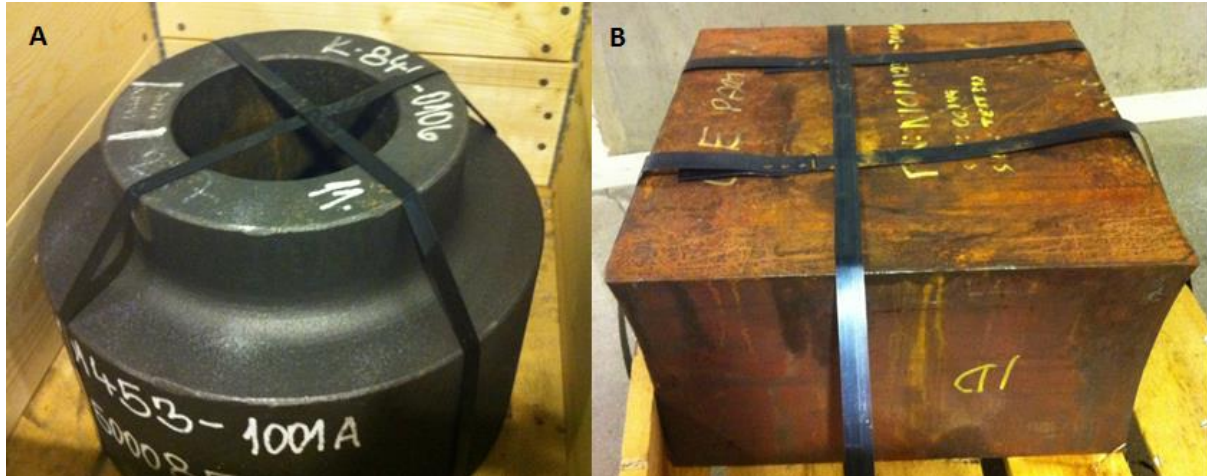
**Figure 7: Hub forging of material A (left) with wall-thickness 135 mm. Section of hub forging of material B (right) with wall thickness 350 mm.**

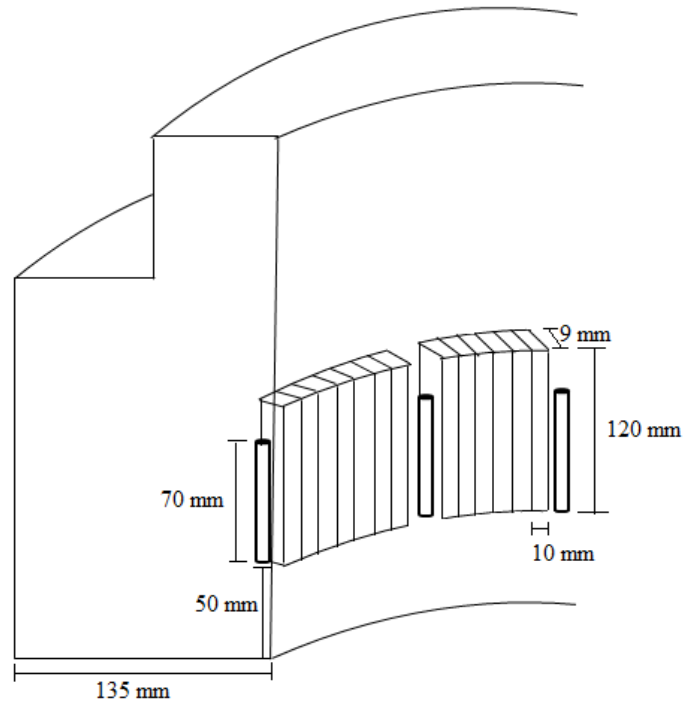
Figure 8: Sampling of tensile specimens and four-point bend-specimens from material A.

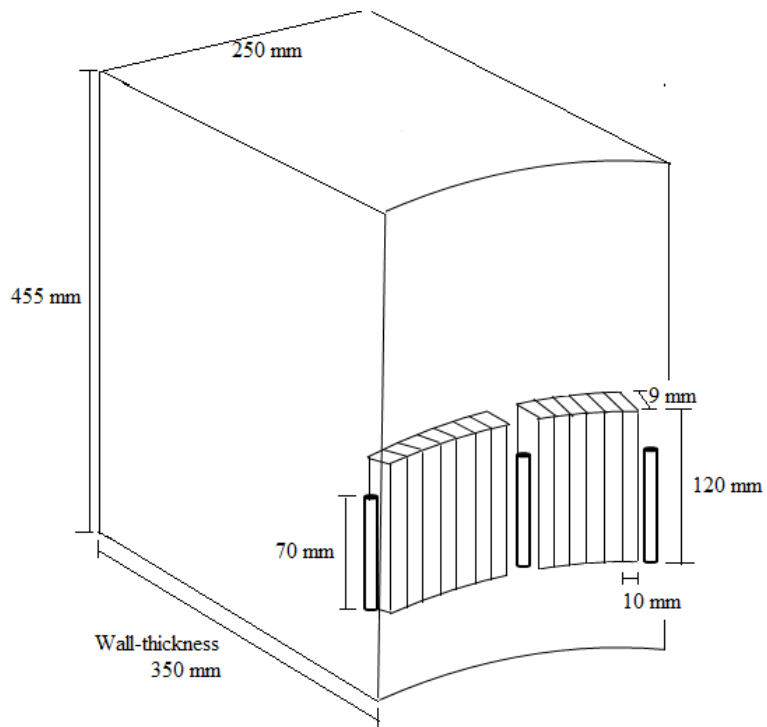
Figure 9: Sampling of tensile specimens and four-point bend-specimens from material B.

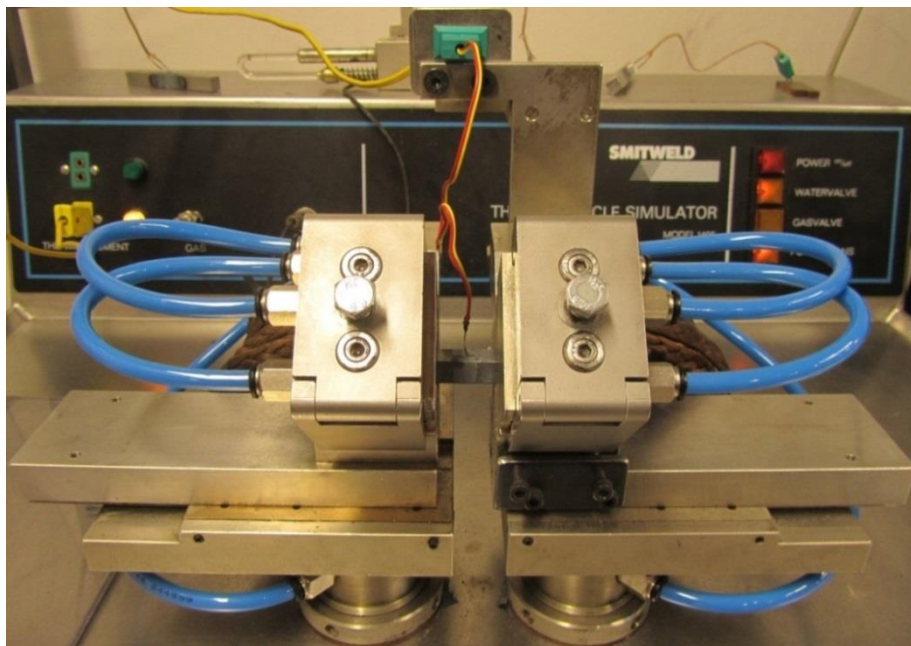
Figure 12: Equipment used for the thermal weld simulation, SMITHWLED Thermal Cycle Simulator.

The thermal weld simulations were performed on a SMITHWELD Thermal Cycle Simulator Model 1405 (Figure 12). The thermocouples were spot welded onto the center of the FPB-specimens before they were mounted into the instrument.

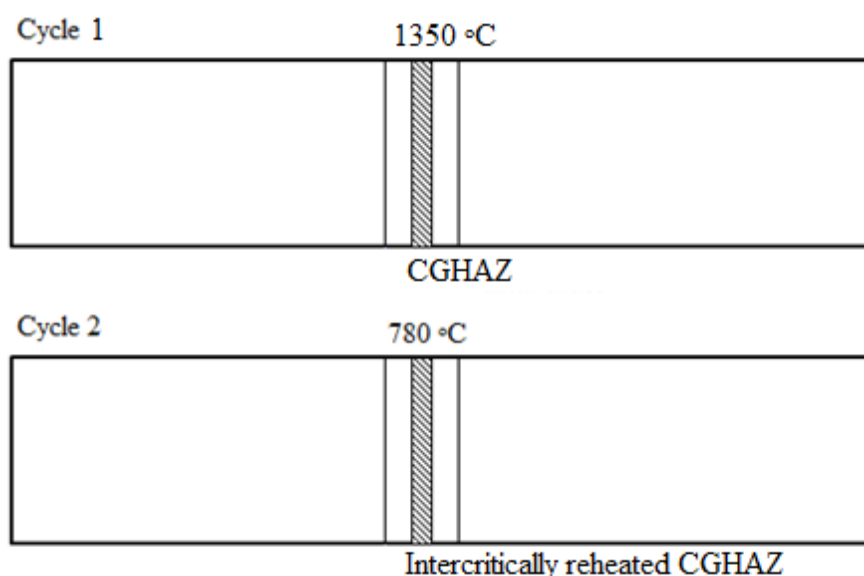
**Figure 14: HAZ regions of the specimens after the first thermal cycle (CGHAZ) and the second thermal cycle (intercritically reheated CGHAZ).**

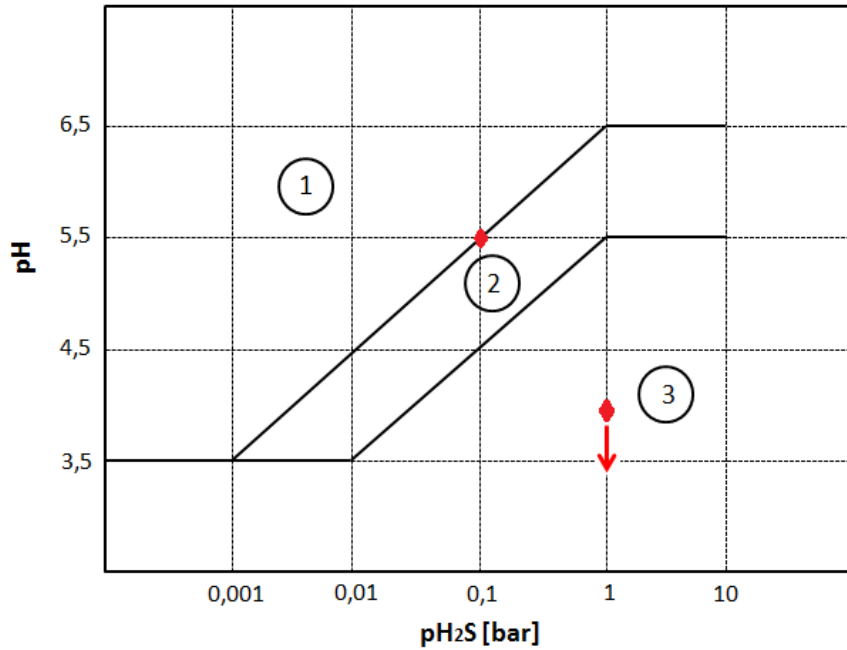
Figure 17: Environmental parameters for SSC test 1 and 2.

The severity of the corrosive mediums of test 1 and test 2 is expressed in the pH-pH<sub>2</sub>S diagram in Figure 17, showing that test 1, with a pH of 5.5 and a pH<sub>2</sub>S of 0.1 bar, represented the transition between region 1 and region 2, respectively the sweet region and the transition region, while test 2, with a pH ≤ 4 and pH<sub>2</sub>S of 1 bar, lies within region 3 which is the sour service region.

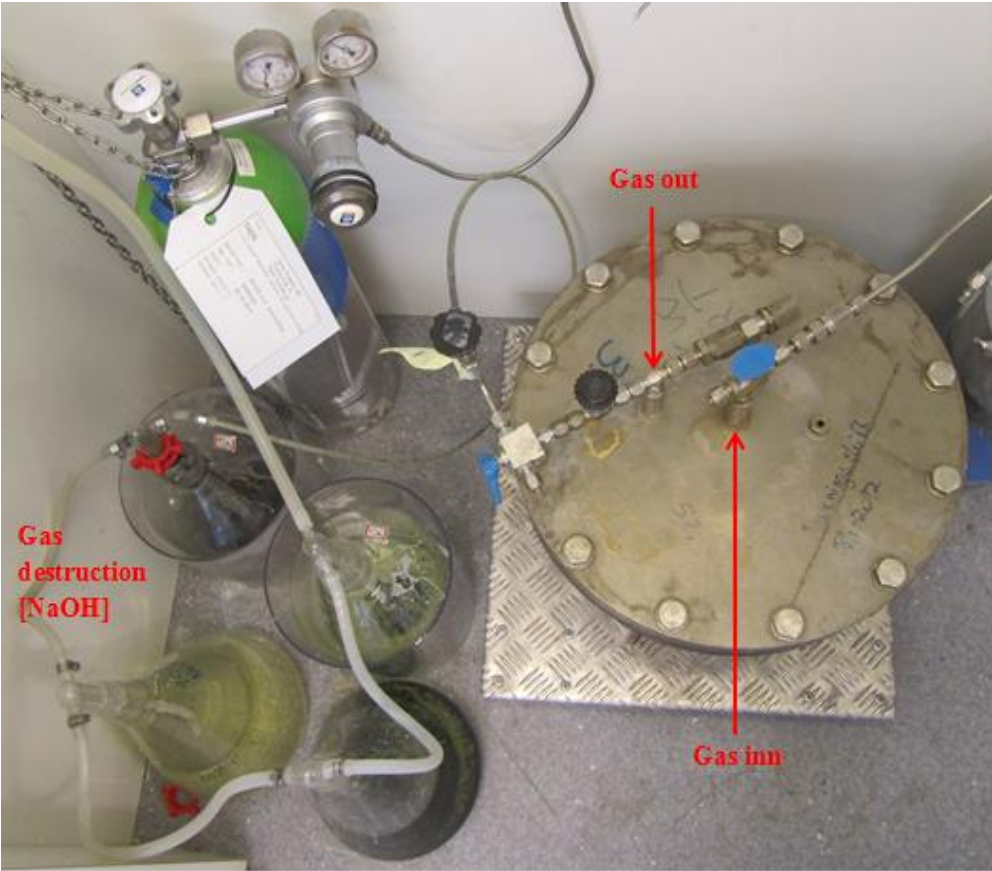
Figure 20: In laboratory test set-up, gas cylinder to the upper left, autoclave to the right and H<sub>2</sub>S gas destruction system to the lower left.

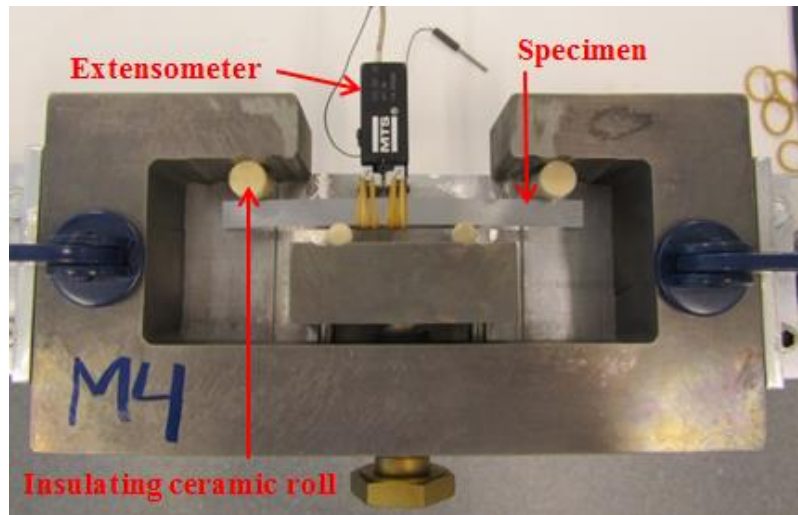
Figure 21: Specimen stressed in a jig with the extensometer strapped to the center of the specimen.

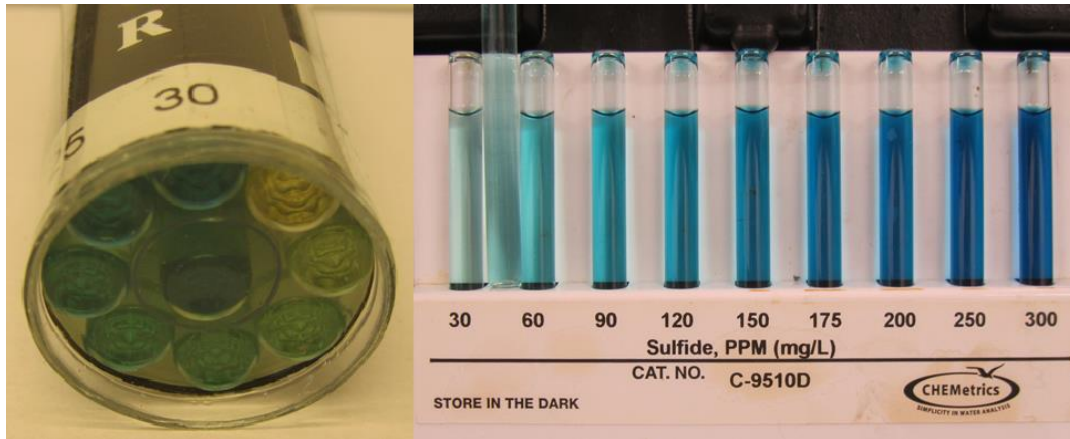
**Figure 22: Sulfide content of electrolyte in test 1 at about 30 ppm, on a scale from 0 – 30 ppm and 30 – 300 ppm.**

The sulfide content was measured on the CHEMetrics equipment and was compared both to the 0 – 30 ppm scale and the 30 – 300 ppm scale in Figure 22. The sulfur content of the electrolyte for test 1 was approximately 30 ppm, corresponding to the theoretical content calculated in equation 6. The pH was measured on the PHM210 Standard pH meter which provided an initial pH of 5.46 for test 1, while the final pH was 5.60. The bubbling of test gas through the electrolyte was reduced to approximately one bubble in the exhaust bottle per minute for the entire test time. In test 2, the sulfide content of the electrolyte was about 300 ppm as in Figure 23, corresponding to the theoretical content calculated in equation 7. The initial pH of test 2 was 3.0, and the final pH was measured at 3.73.

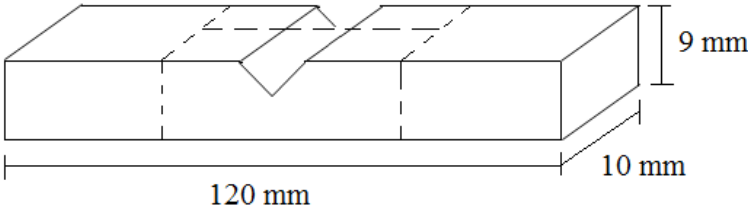
**Figure 24:** Sectioning of the specimens was performed along the dotted lines, providing a core section in the length direction for examinations.

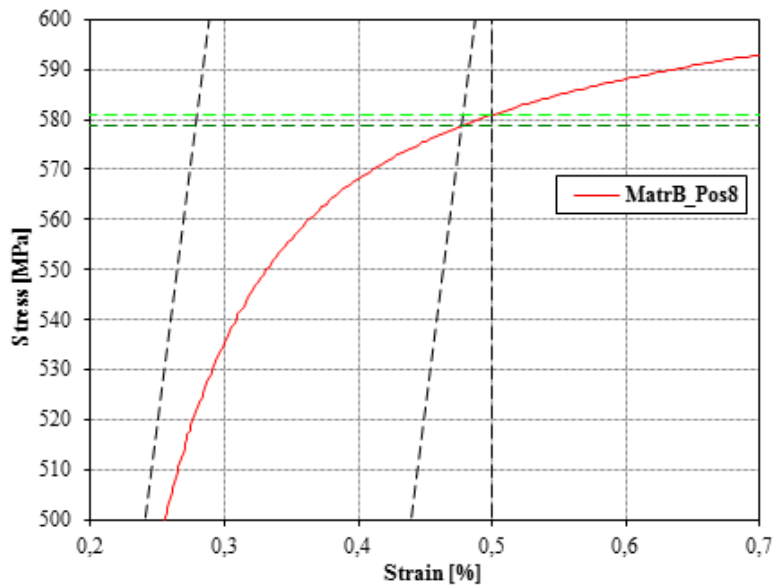
Figure 27: Section of a stress-strain curve for material B, showing a smooth curve.

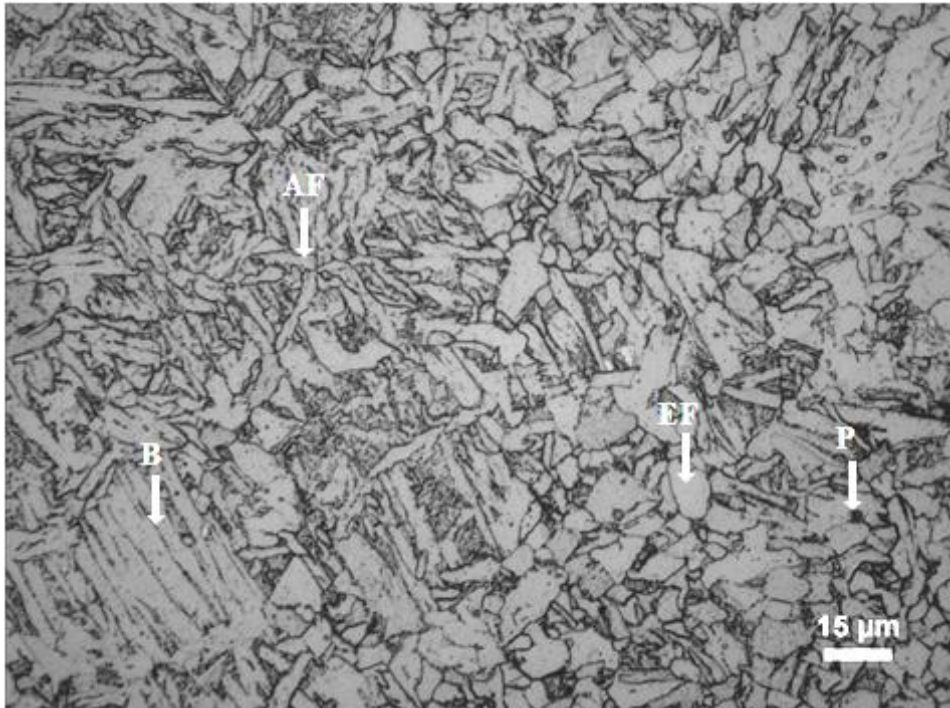
**Figure 28: Microstructure of material A, base material. Main constituents are acicular ferrite (AF), equiaxed ferrite (EF) with pearlite (P) and some bainite (B).**

The microstructure of material A at the position closest to the inner surface of the hub connector is illustrated in the micrograph in Figure 28. The microstructure mainly consists of acicular ferrite (AF), equiaxed ferrite (EF) with pearlite (P) and some bainite (B). Examples of the microstructure constituents are pointed out in the micrograph. Both acicular ferrite and bainite have lath like microstructures with a high degree of disorder, this is recognized in the micrographs. Acicular ferrite is distinguished from bainite as the laths of acicular ferrite are shorter than of bainite. The ferrite appears as rounded white grains, and the pearlite is observed as the small dark areas between the equiaxed ferrite grains.

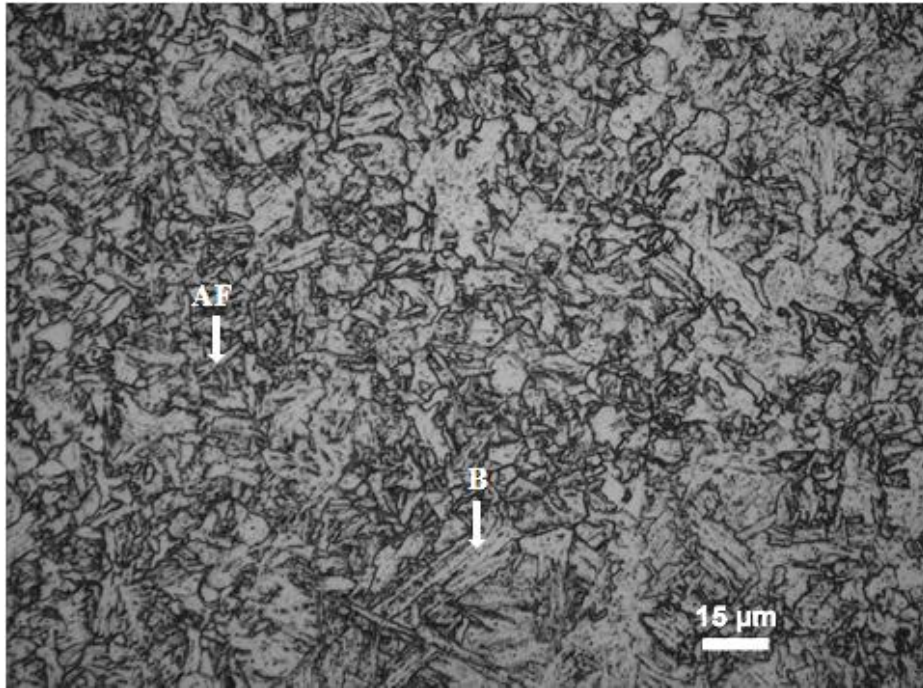
**Figure 29: Microstructure of material B, base material. Main constituents are acicular ferrite (AF) and bainite (B).**

The microstructure of material B, at the position closest to the inner surface of the hub connector, is illustrated in Figure 29. The microstructure mainly consists of acicular ferrite (AF) and bainite (B) which is pointed out in the micrograph. The acicular ferrite and bainite are distinguished by the lath length. The microstructure of material B is more fine-grained, with a higher degree of disorder, than the microstructure of material A.

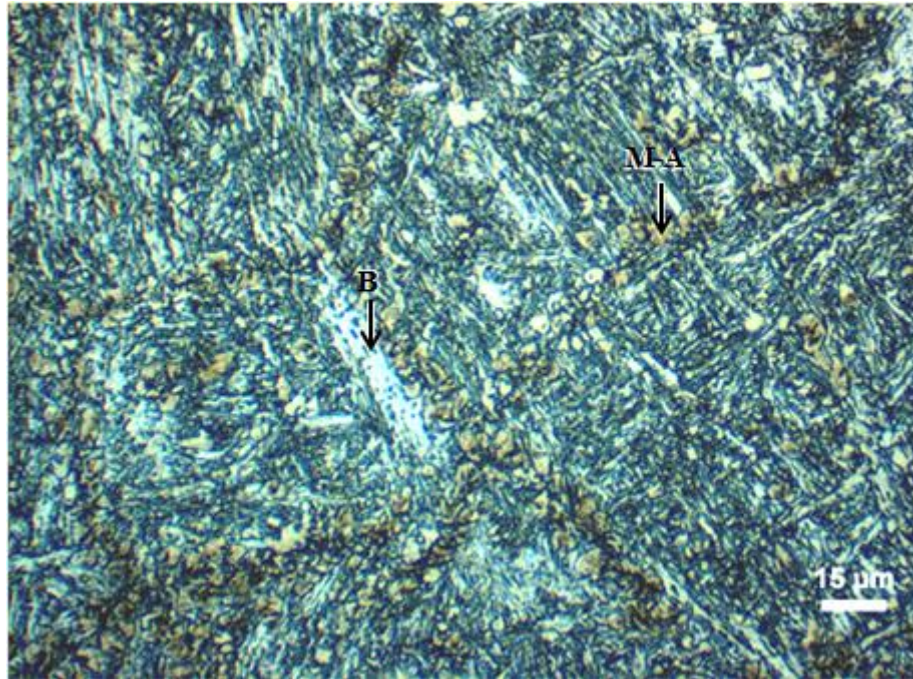
**Figure 30: Microstructure of the HAZ of material A. Main constituents are bainite and M-A constituents along the prior austenite grain boundaries.**

The microstructure at the center of the HAZ of material A is presented in Figure 30. The structure consists of large prior austenite grains with a lath-like structure inside the grains. The lath-like structure inside the grains is mostly identified as bainite as the laths follow the same direction. Slightly brown grains have grown along the prior austenite grain boundaries. These brown constituents are assumed to be M-A constituents, this was confirmed by micro-hardness measurements (section 4.3.3). The M-A constituents have grown in a “necklace” formation on the prior austenite grain boundaries. There is also some M-A constituents inside the grains which have grown from the lath boundaries of the bainite. The main microstructure constituents are pointed out in the micrograph. The microstructural features observed corresponds to the expected microstructure of the intercritically reheated CGHAZ.

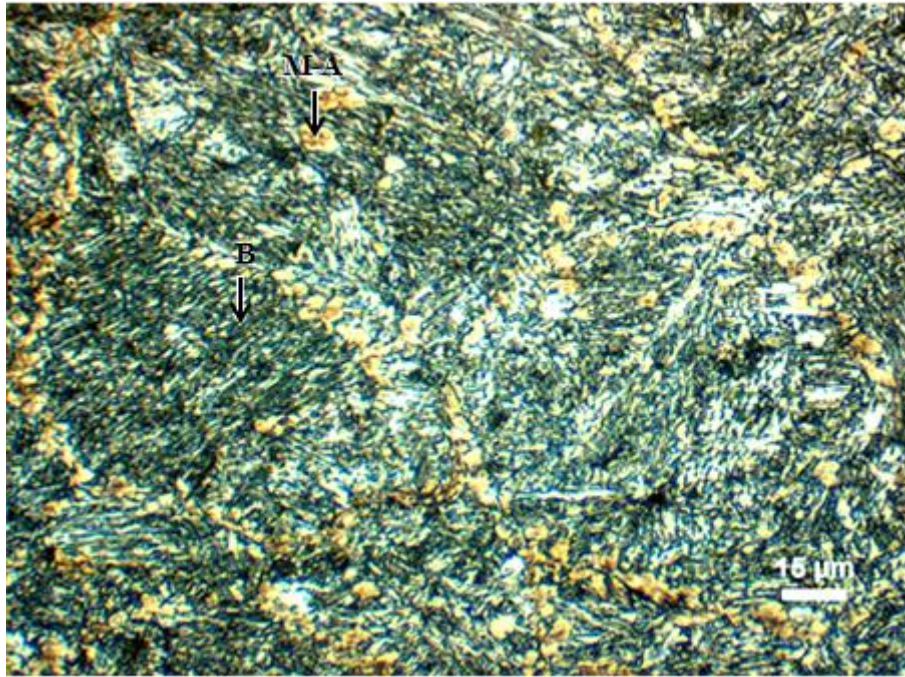
**Figure 31: Microstructure of the HAZ of material B. Main constituents are bainite and M-A constituents along the prior austenite grain boundaries.**

The microstructure at the center of the HAZ of material B is presented in Figure 31. The microstructure consists of the same elements as the HAZ of material A, where the main constituents are bainite laths inside the large prior austenite grains. On the prior austenite grain boundaries M-A constituents have grown in a “necklace” formation. In this structure there is also some M-A constituents inside the grains, as pointed out in the micrograph, which have grown from bainite lath boundaries.

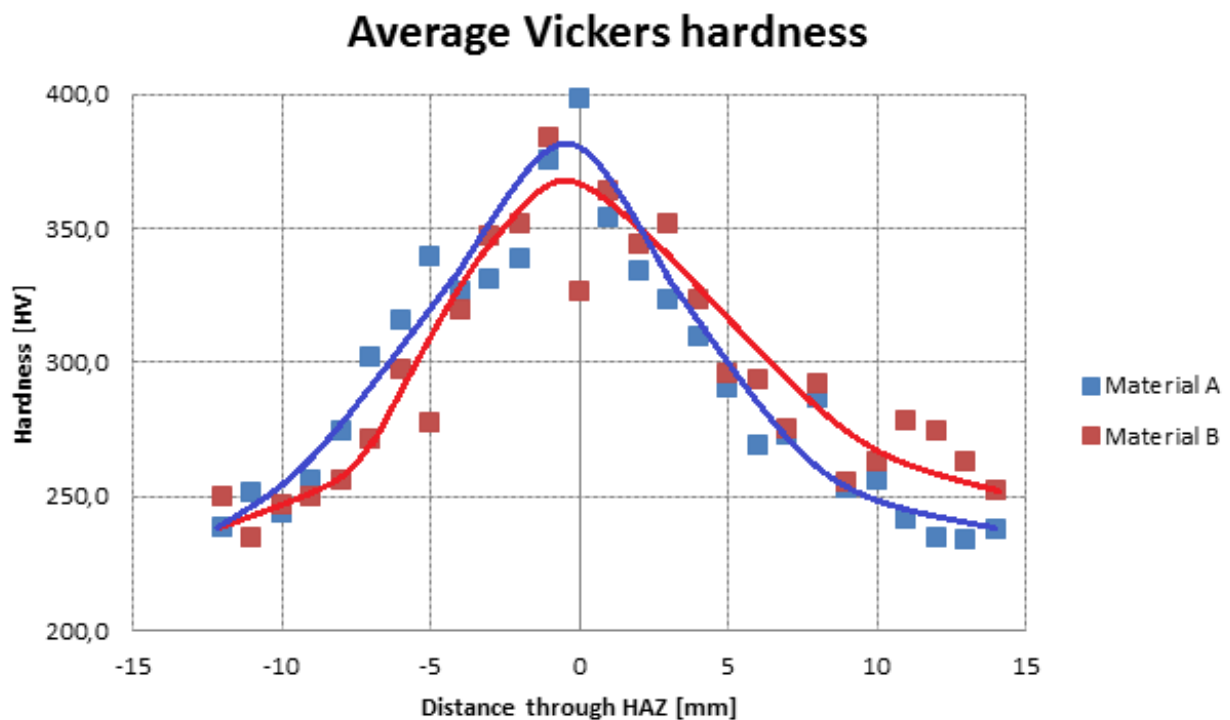
Figure 32: Vickers hardness (HV5) profile of the heat-affected zone of material A and B.

The hardness profiles of the HAZ of material A and B are illustrated in Figure 32. These results indicate that the hardness profiles of material A (blue) and material B (red) in the HAZ are similar and that the hardness is highest in the center of the HAZ for both materials, in the intercritically reheated CGHAZ. Each point on the curves is an average of three parallel measurements. There are some large variations in hardness values at positions close to each other. This may be a result of the various phases in the microstructure with different hardness levels. This is further studied by the micro-hardness testing. The data for the measured hardness of both materials are presented in Appendix E. The notches in the thermal weld simulated FPB-specimens were located at the center of the specimens and thereby at the region of the highest hardness of the HAZ.

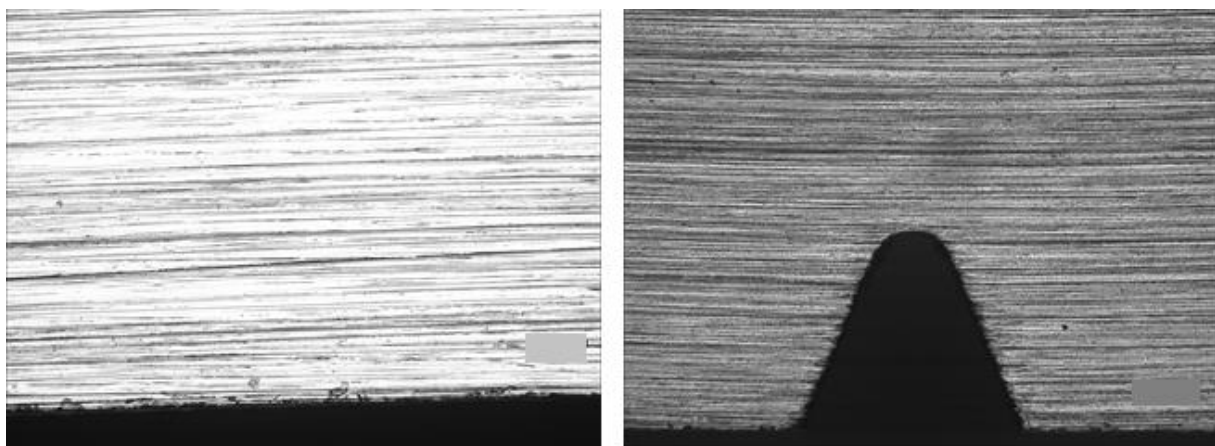
**Figure 33: Ground surface of base material (left) and area around notch (right) prior to testing.**

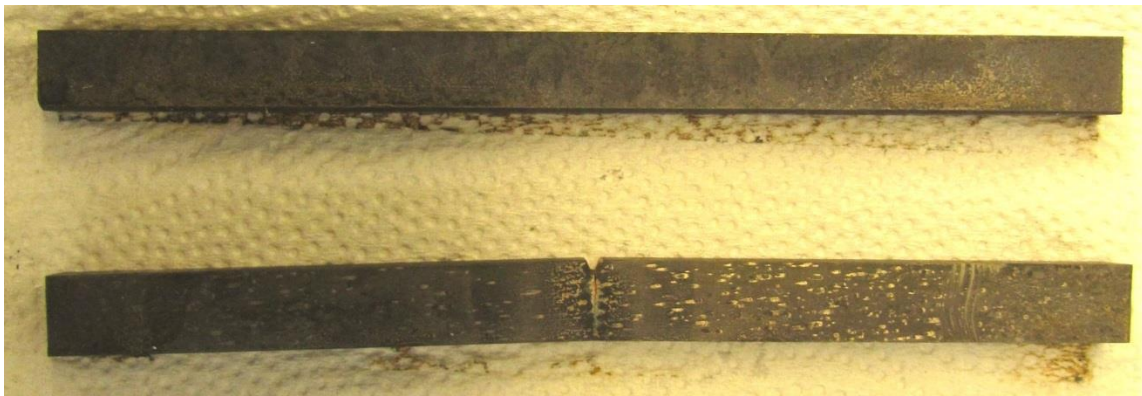
**Figure 34: Specimens as received from the autoclave in test 1. Upper specimen of base material, lower specimen is thermal weld simulated and notched.**

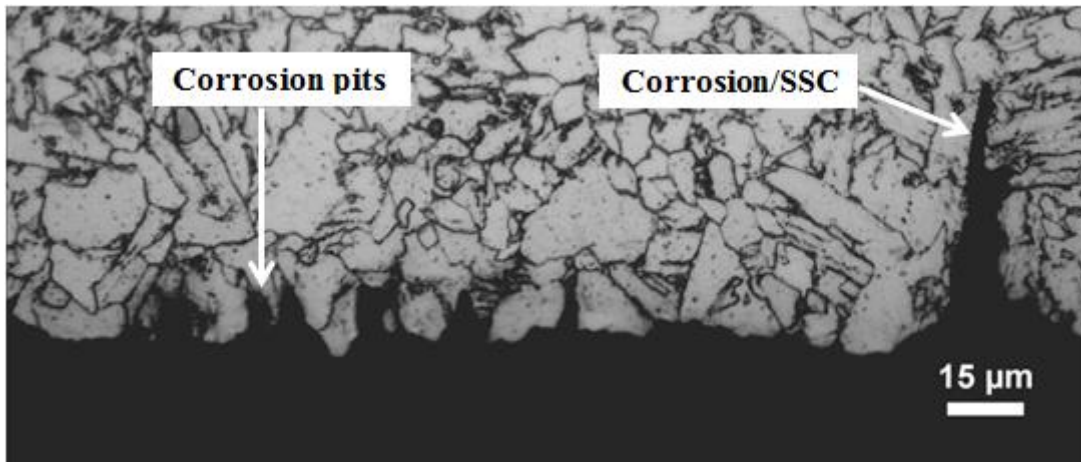
Figure 35: Corrosion attacks along the stressed side of the core section of base material A, 500X.

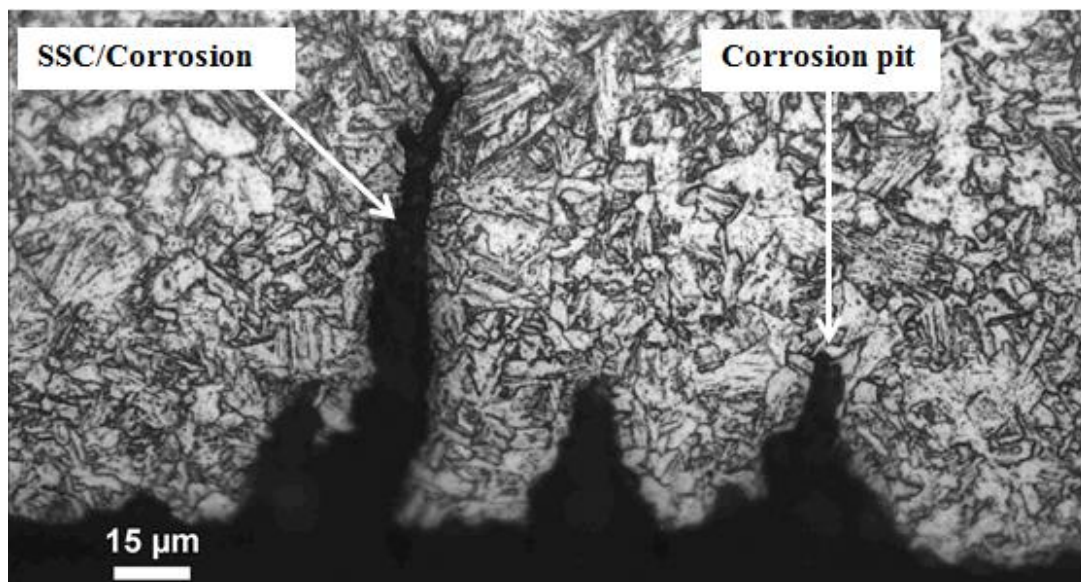
Figure 36: Corrosion attacks along the stressed side of the core section of base material B, 500X.

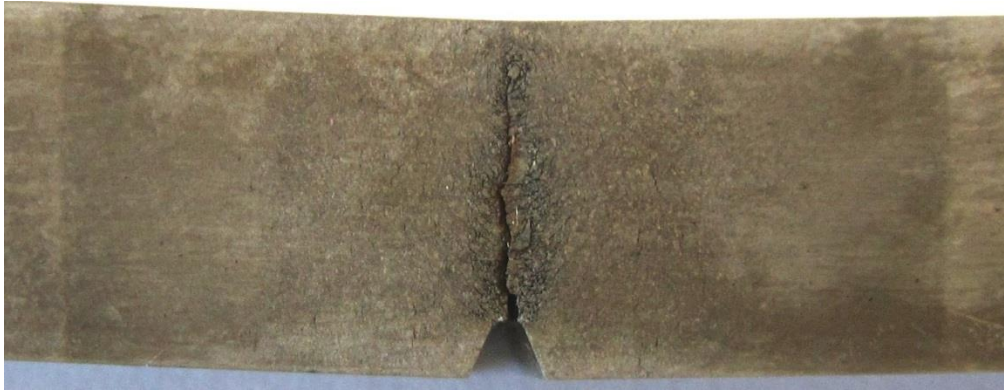
Figure 37: Macro photo of cracked specimen of simulated material B from test 1, crack lengths of 6.5 to 6.85 mm.

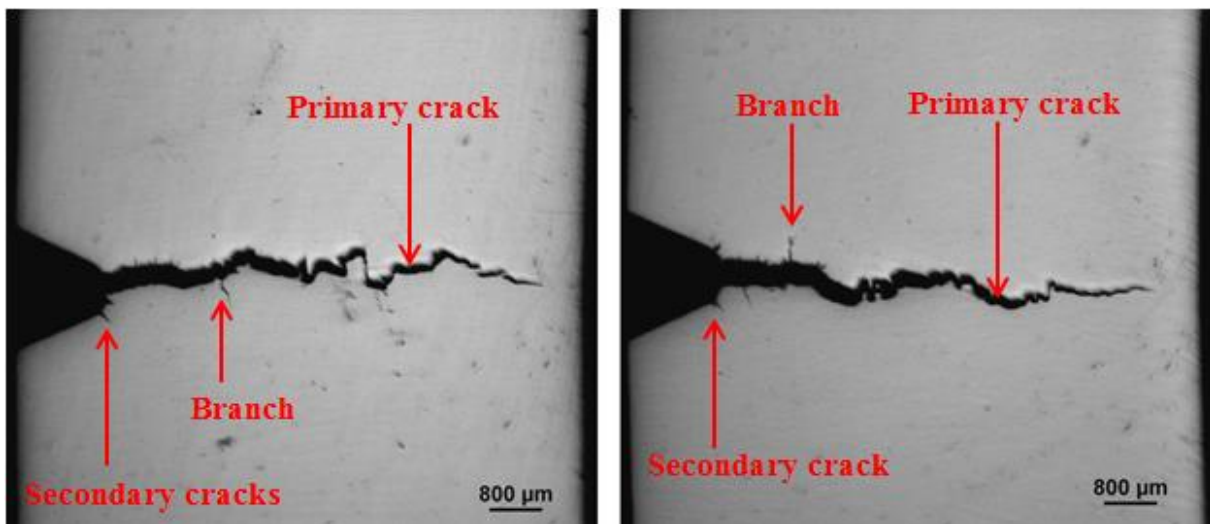
Figure 38: Cracks initiated at the notches in the thermal weld simulated specimens of material A (left) and material B (right) at 6X magnification. Crack lengths of approximately 6.5 mm.

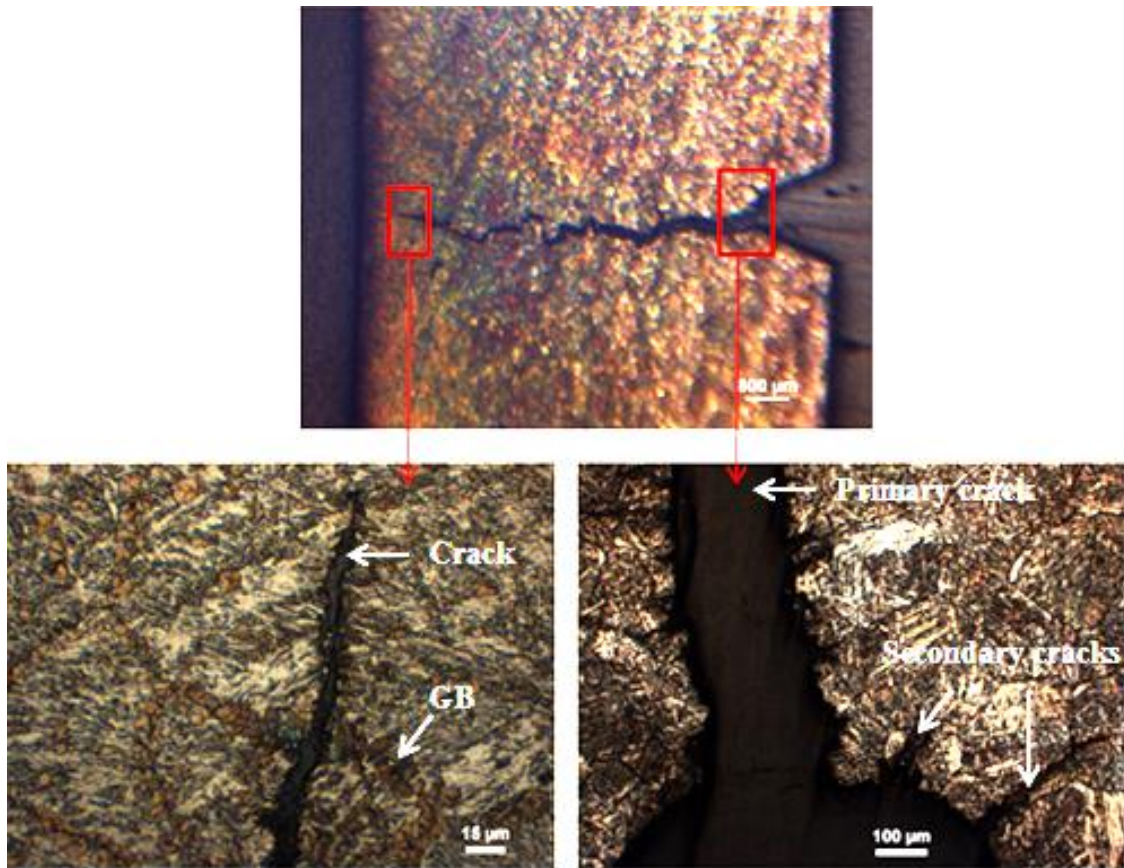
**Figure 39: Overview of SSC initiated at the notch in the HAZ in material A in test 1. End of crack (left) and initiation point with both primary and secondary cracks (right).**

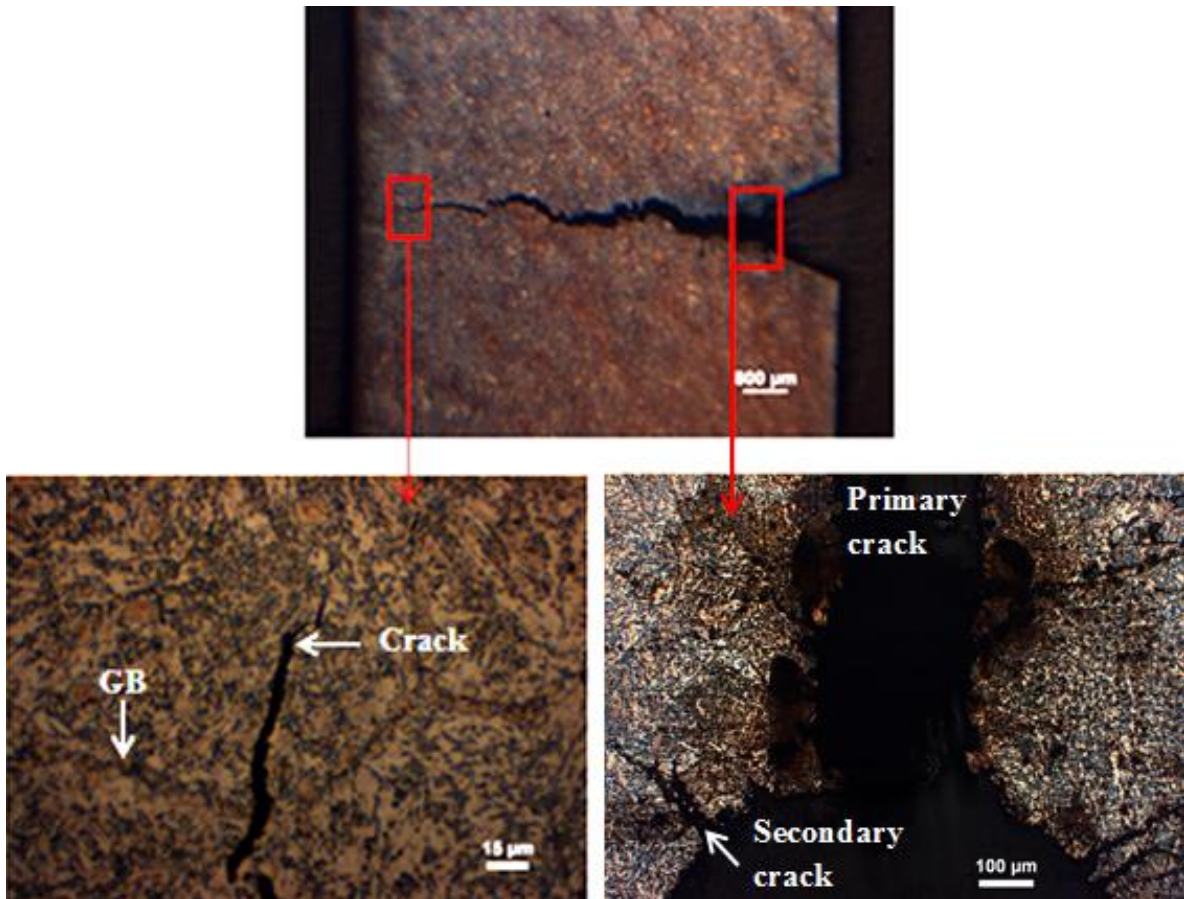
**Figure 40: Overview of SSC initiated at the notch in the HAZ of material B in test 1. End of crack at the left and initiation point of both primary and secondary cracks to the right.**

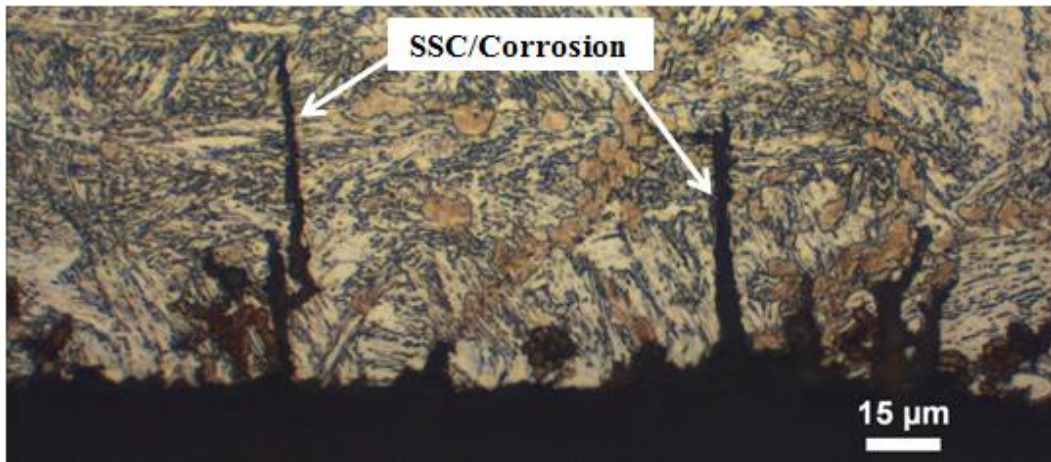
Figure 41: SSC at the core section along the stressed side of thermal weld simulated material A in test 1.

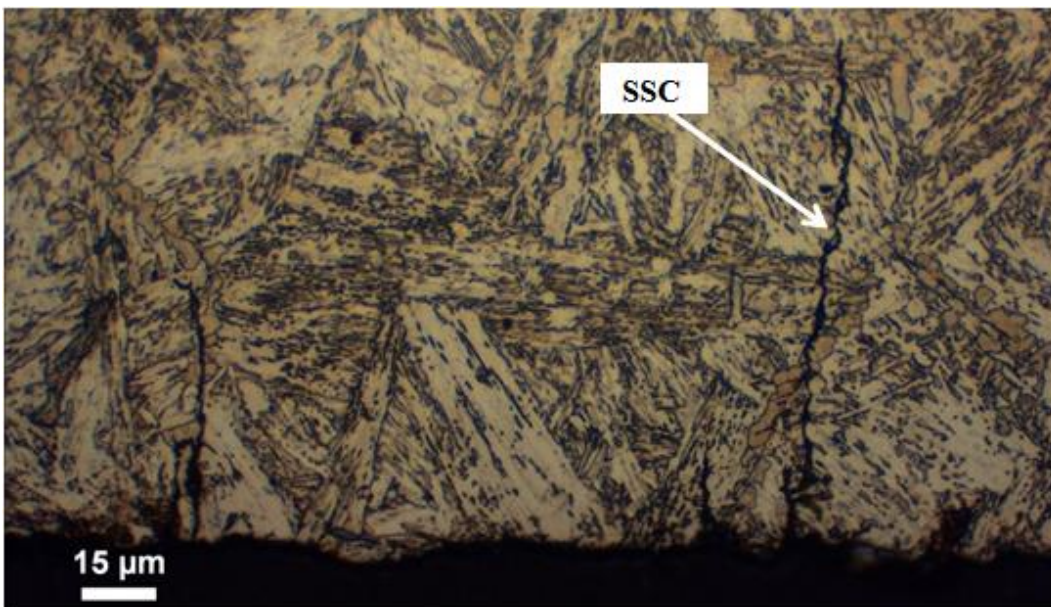
Figure 42: SSC at the core section along the stressed side of thermal weld simulated material B in test 1.

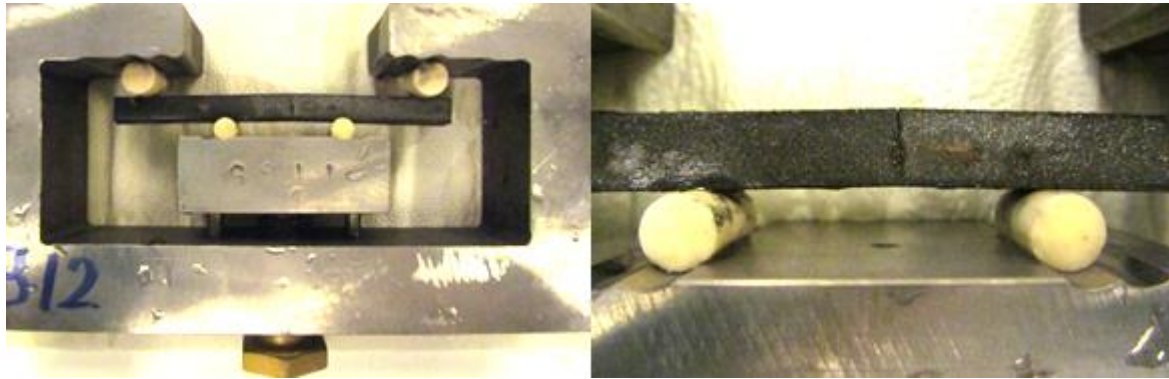
**Figure 43: Specimens as received from the autoclave still under stress in the jig.**

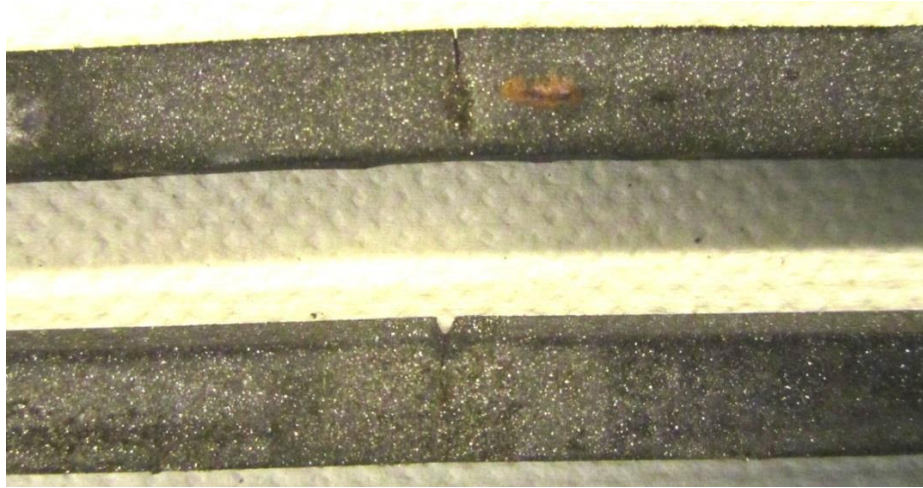
**Figure 45: Specimens as received from the autoclave in test 2. Base material B (upper specimen), HAZ of material B (lower specimen).**
