# Sulfide Stress Corrosion Cracking Resistance of Modified ASTM A694 F60 Low Alloy Steel for Subsea Applications

Materials Technology

Submission date: June 2013

Norwegian University of Science and Technology  
Department of Materials Science and Engineering

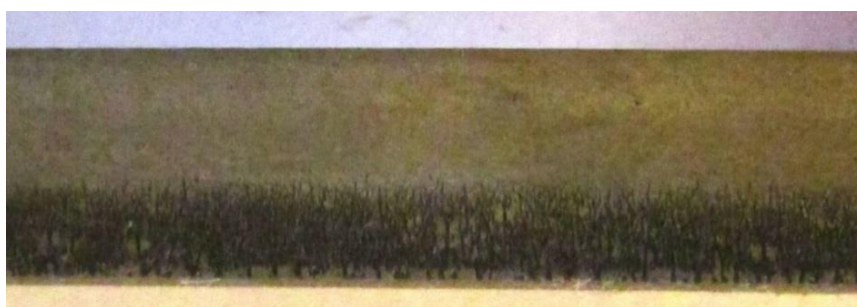
Figure 46: Macro photo of base material A, specimen from test 2. Severe cracking observed.

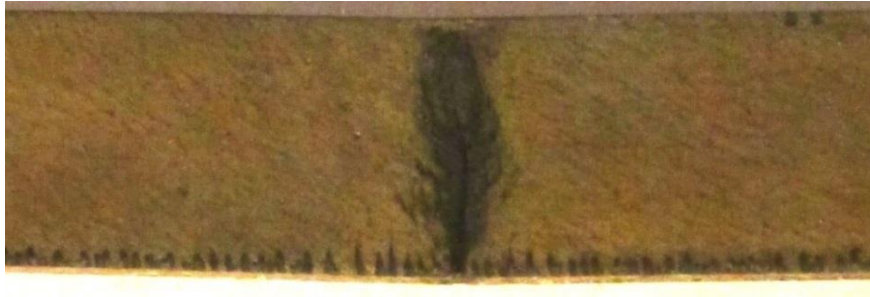
**Figure 47: Macro photo of base material B, specimen from test 2. Severe cracking observed.**

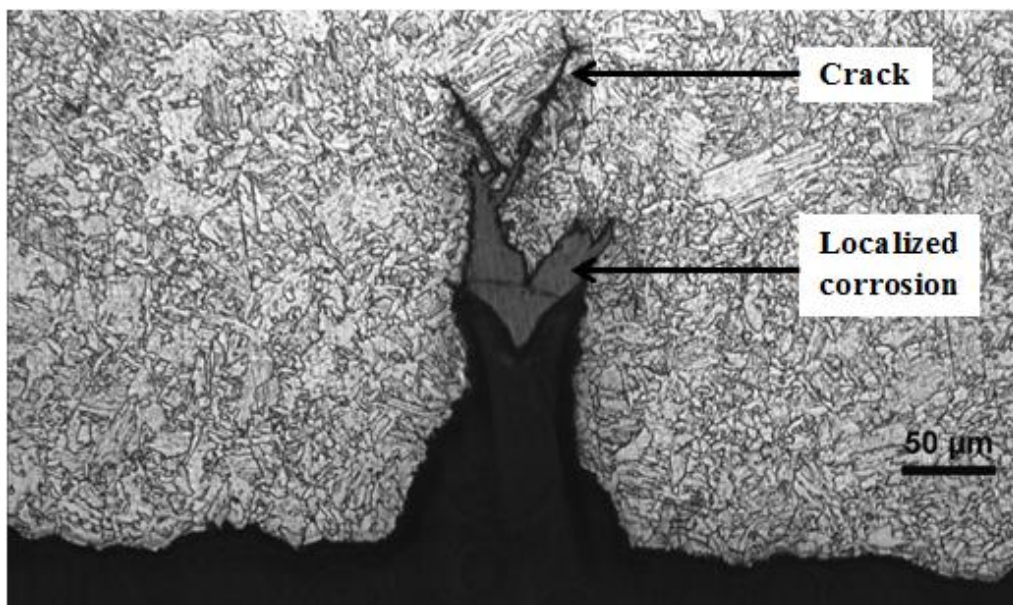
**Figure 48: Localized corrosion at the core section of base material A along the stressed side in test 2.**

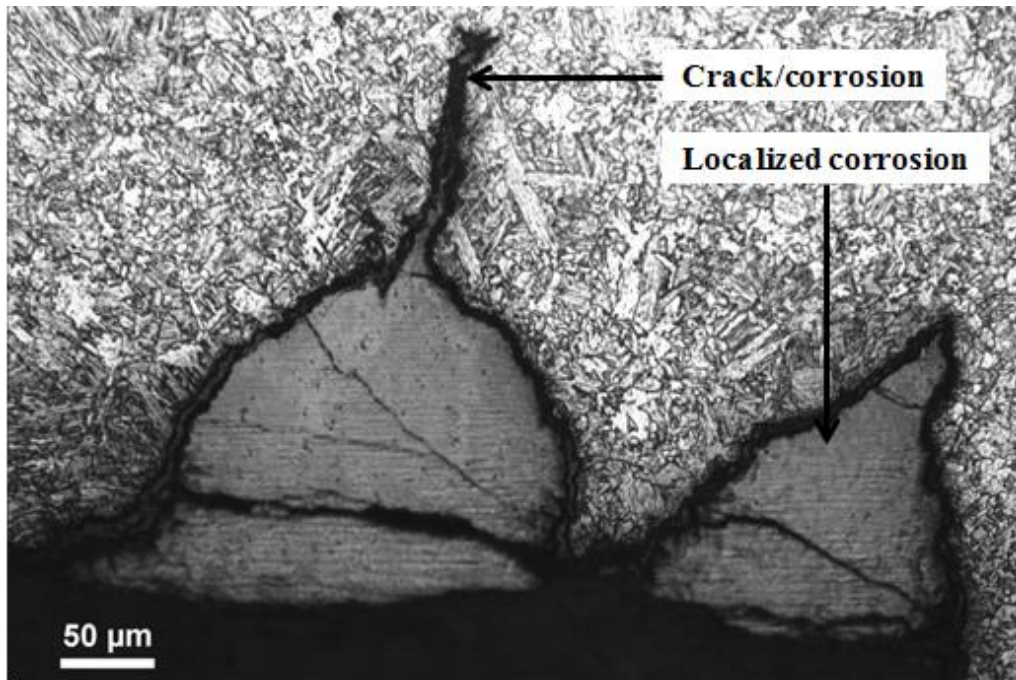
**Figure 49: Localized corrosion at the core section of material B along the stressed side, in test 2.**

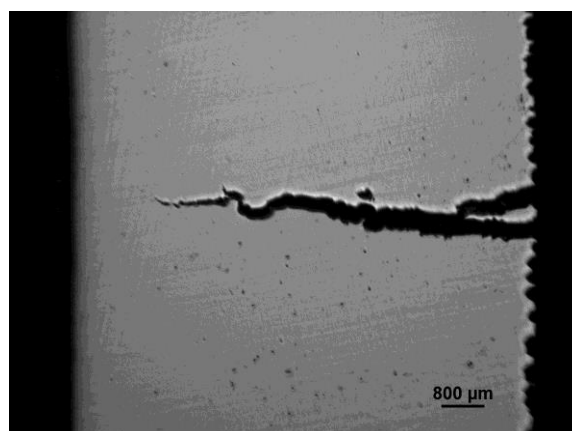
**Figure 50: Overview of base material B specimen. Crack length of approximately 7 mm.**

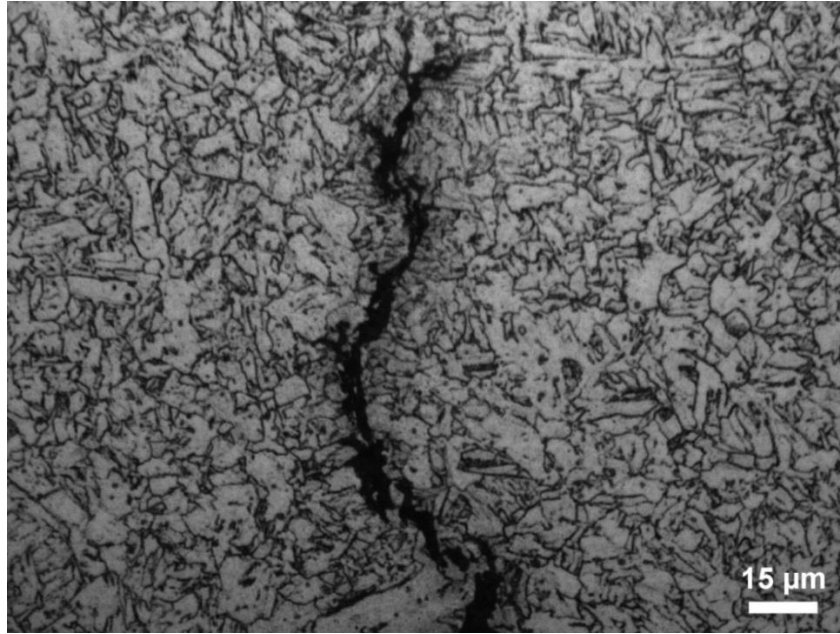
**Figure 51: End of primary crack in base material B in test 2, transgranular fracture path.**

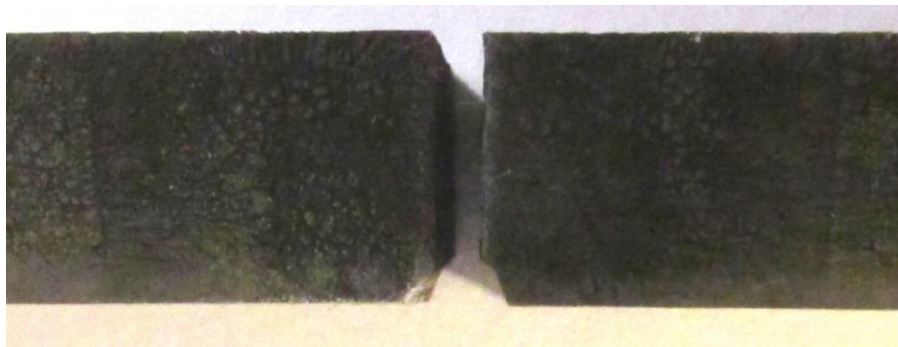
**Figure 52: Macro photo of the HAZ of material A from test 2. Specimen fully separated by cracking.**

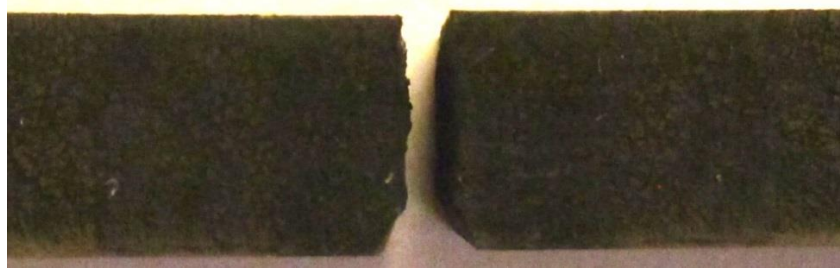
**Figure 53: Macro photo of the HAZ of material B from test 2. Specimen fully separated by cracking.**

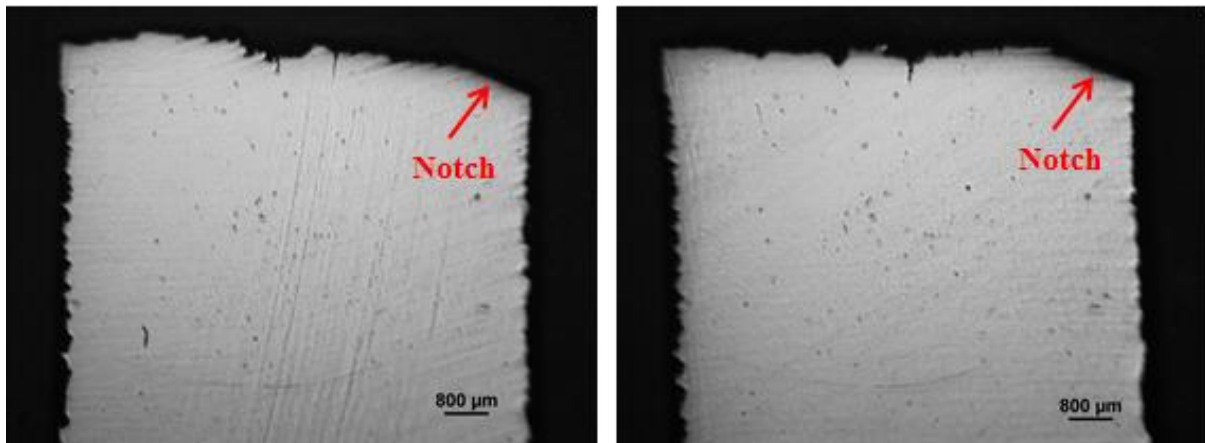
**Figure 54: Fully separated specimens of material A (left) and material B (right) at 6X magnification.**

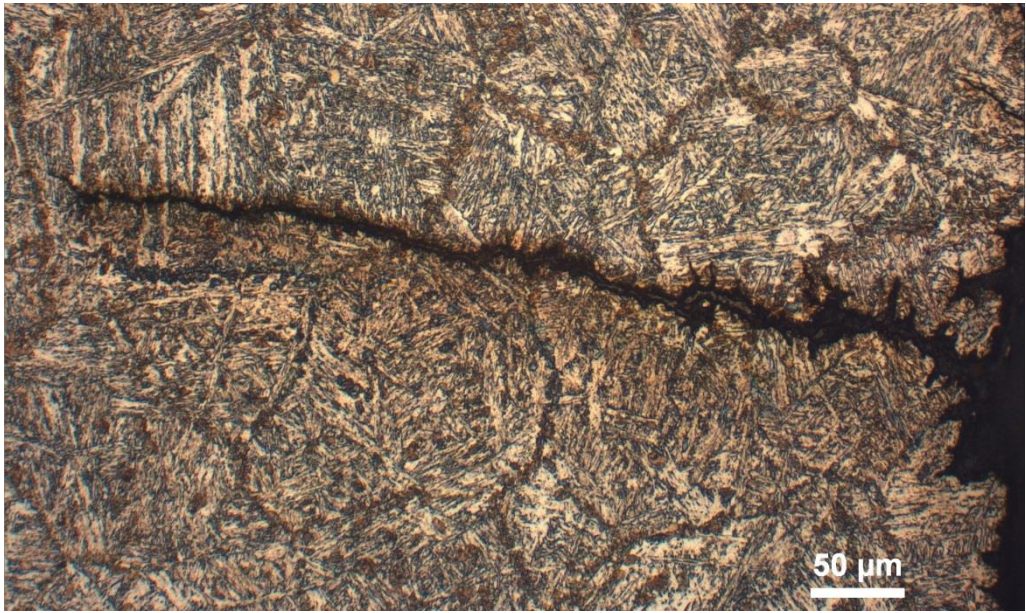
Figure 55: Transgranular branching from the primary crack of the HAZ of material A in test 2.

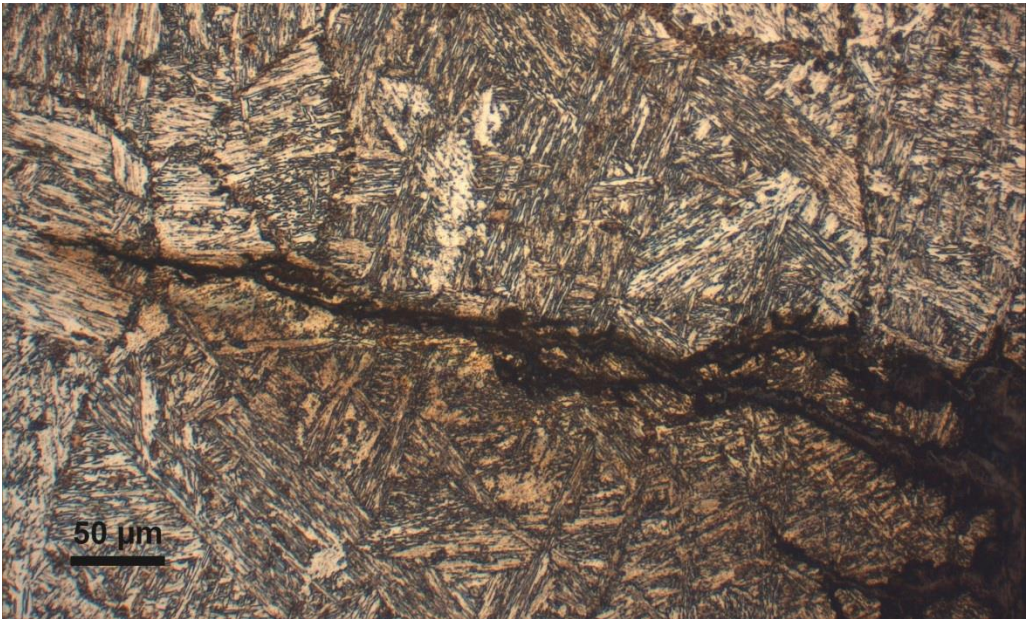
Figure 56: Transgranular branching from the primary crack of the HAZ of material B in test 2.

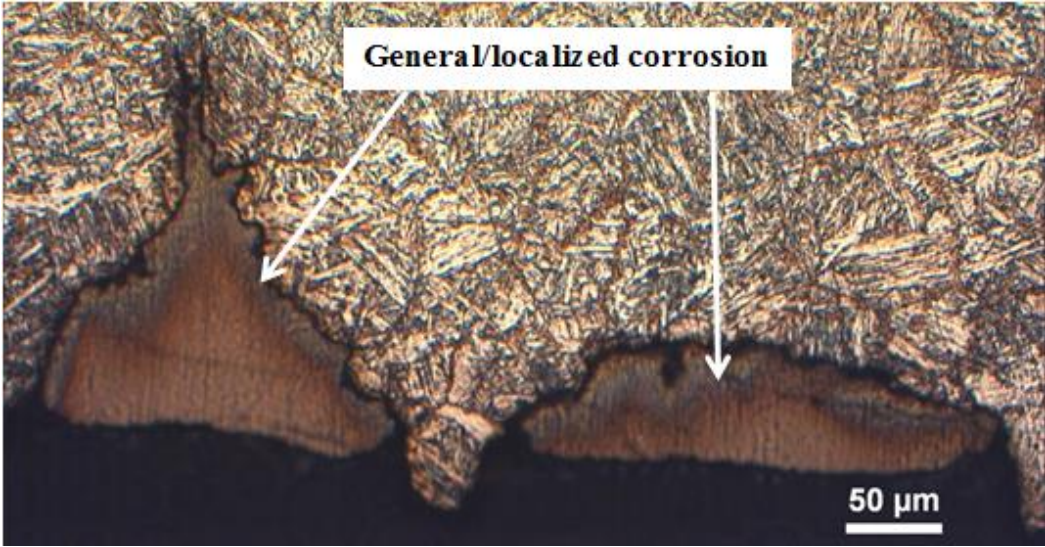
Figure 57: General/localized corrosion attacks along the stressed side of the core section of HAZ A, test 2.

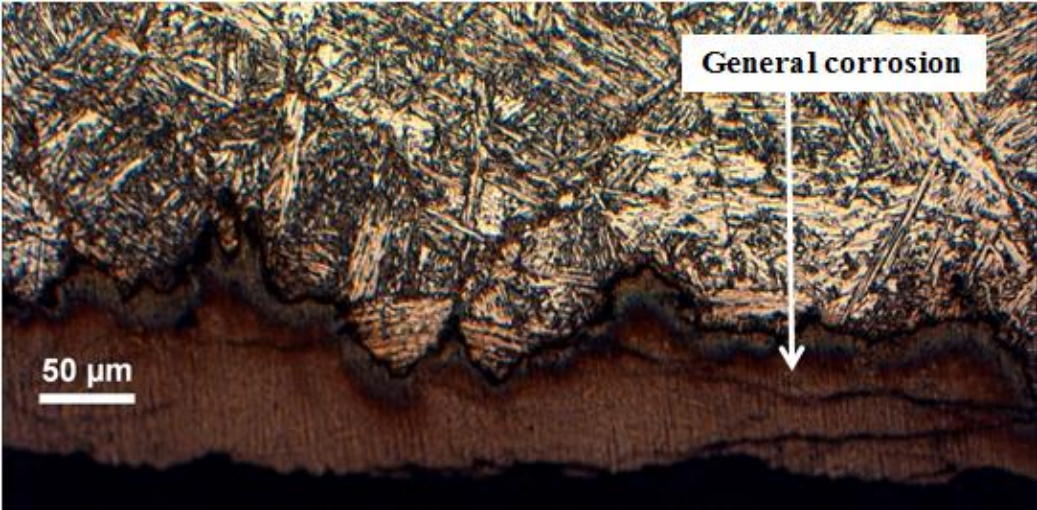
Figure 58: General corrosion attacks along the stressed side of the core section of HAZ B, test 2.

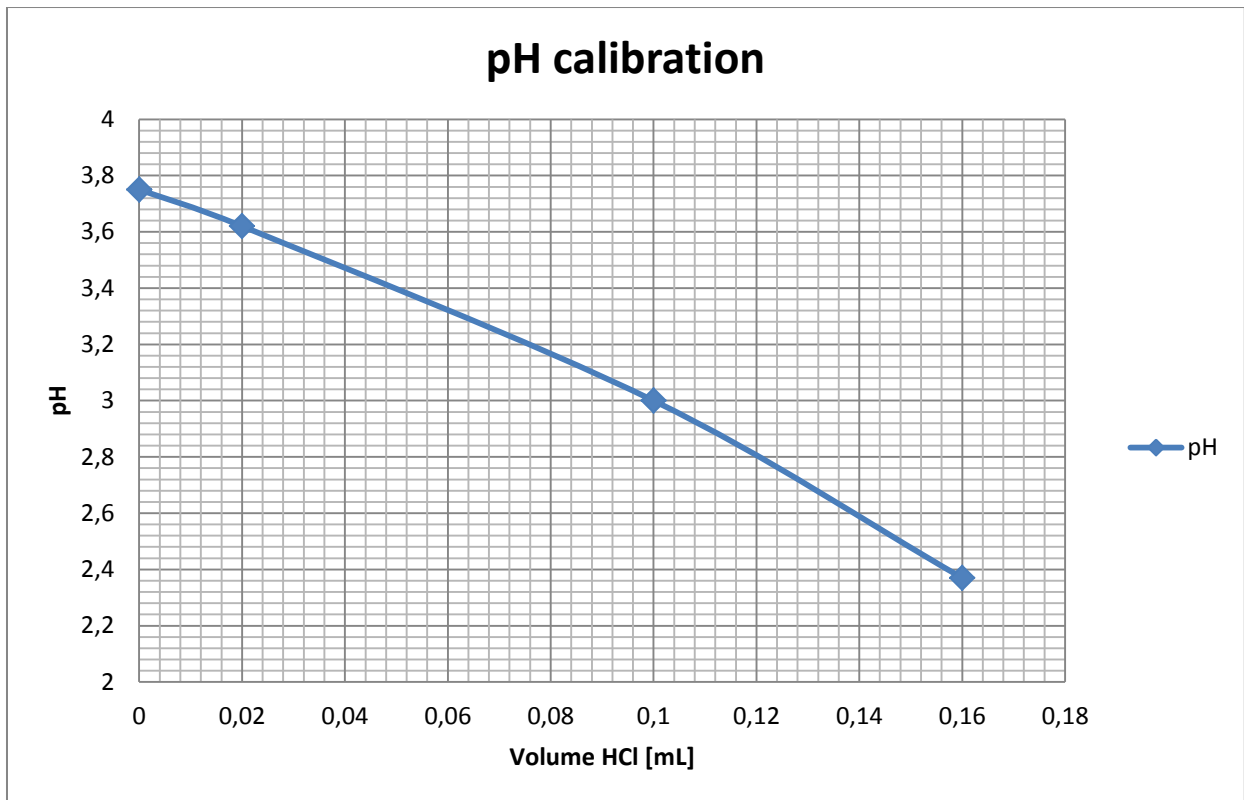
Figure C-1: pH versus volume of HCl added, for calibration of pH adjustments of test 2.

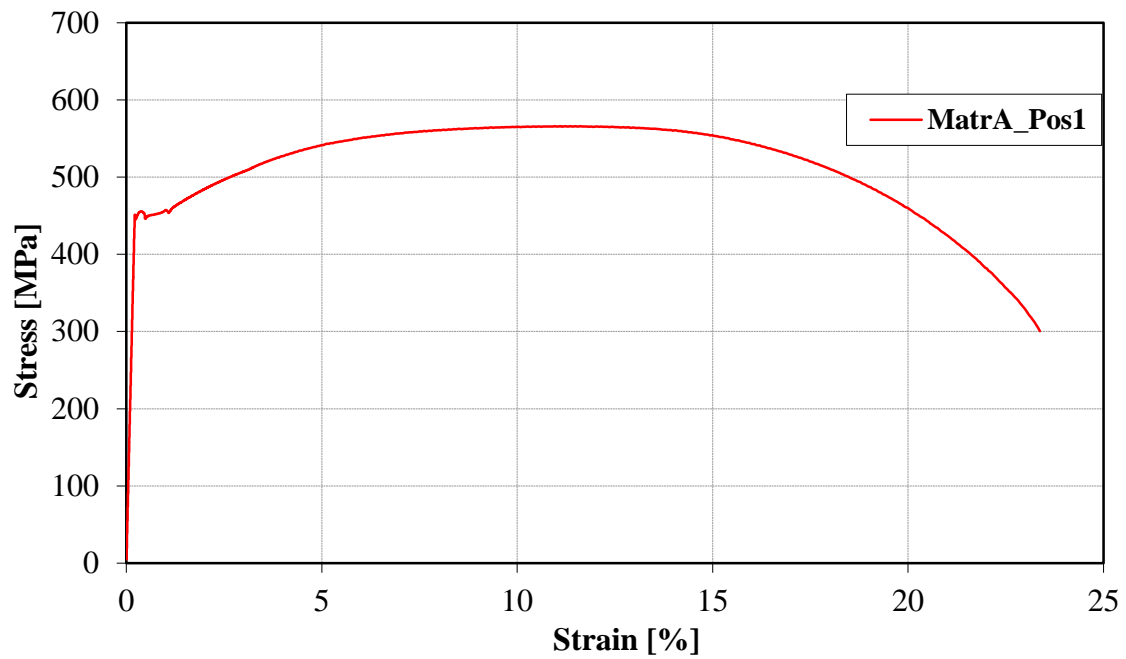
Figure D-1: Stress-strain curve for material A, parallel 1.

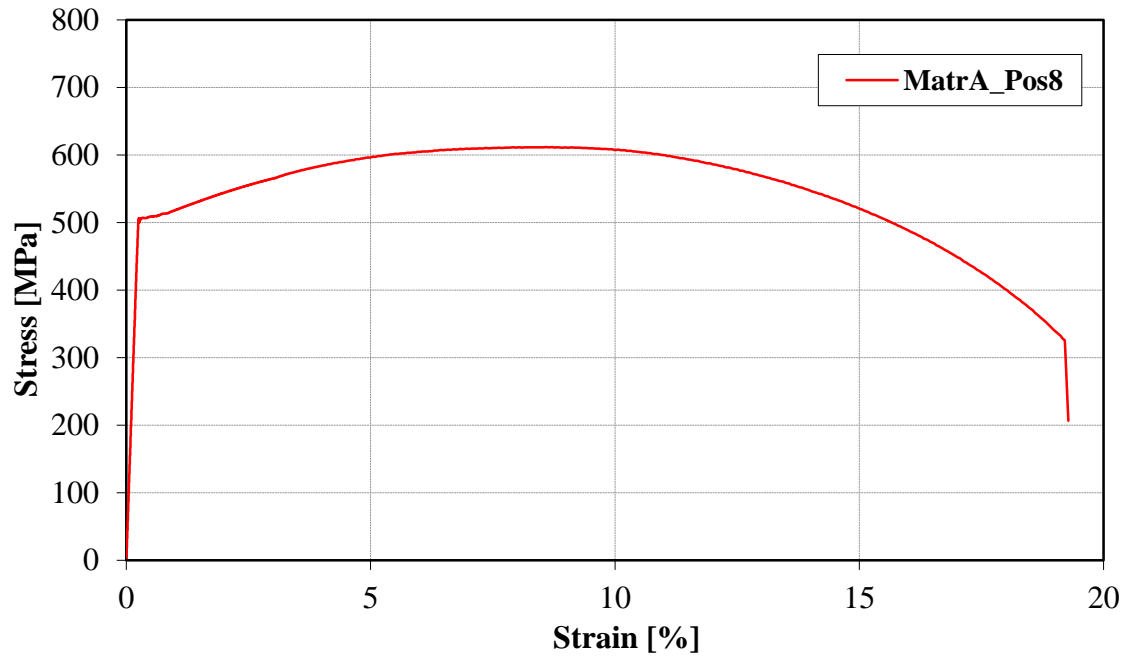
Figure D-2: Stress-strain curve for material A, parallel 2.

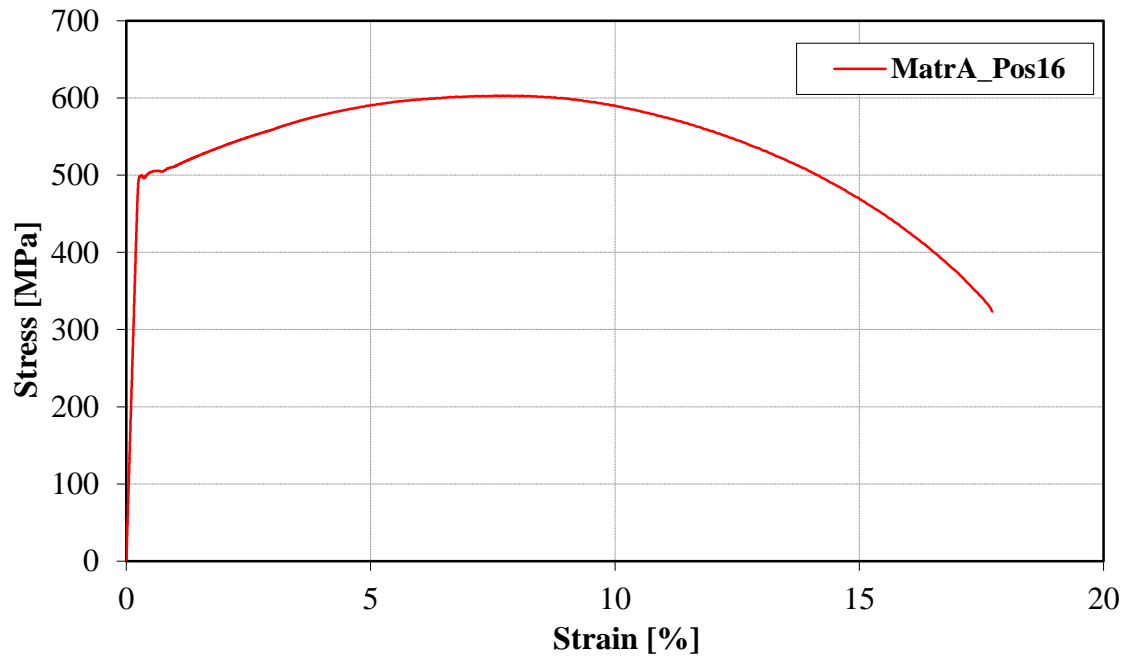
Figure D-3: Stress-strain curve for material A, parallel 3.

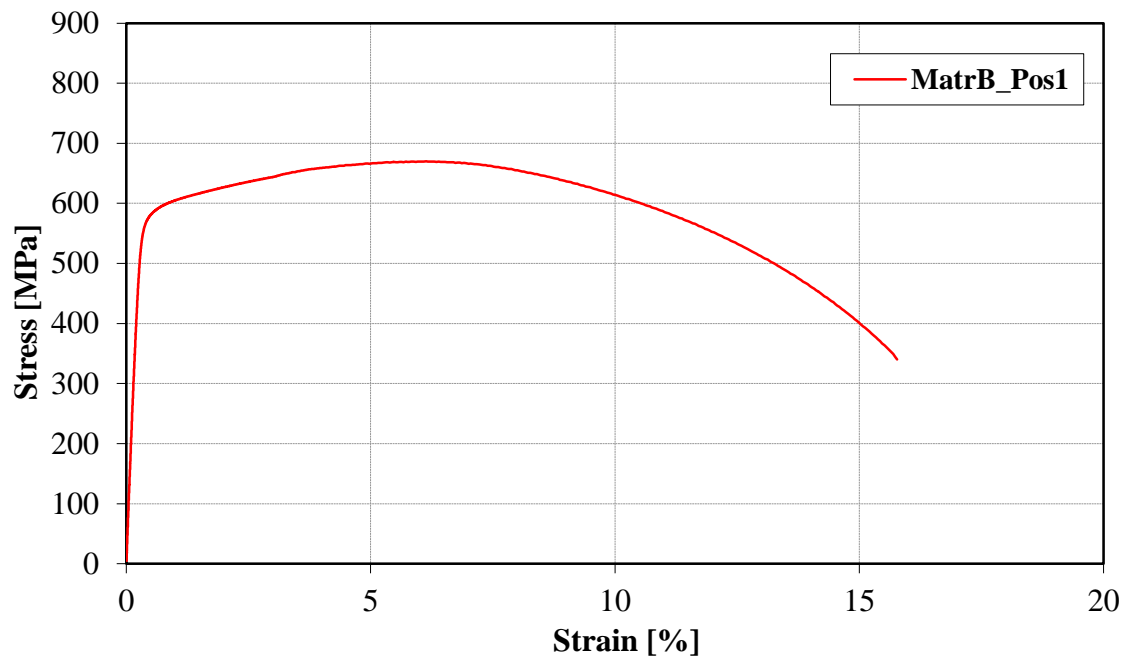
Figure D-4: Stress-strain curve for material B, parallel 1.

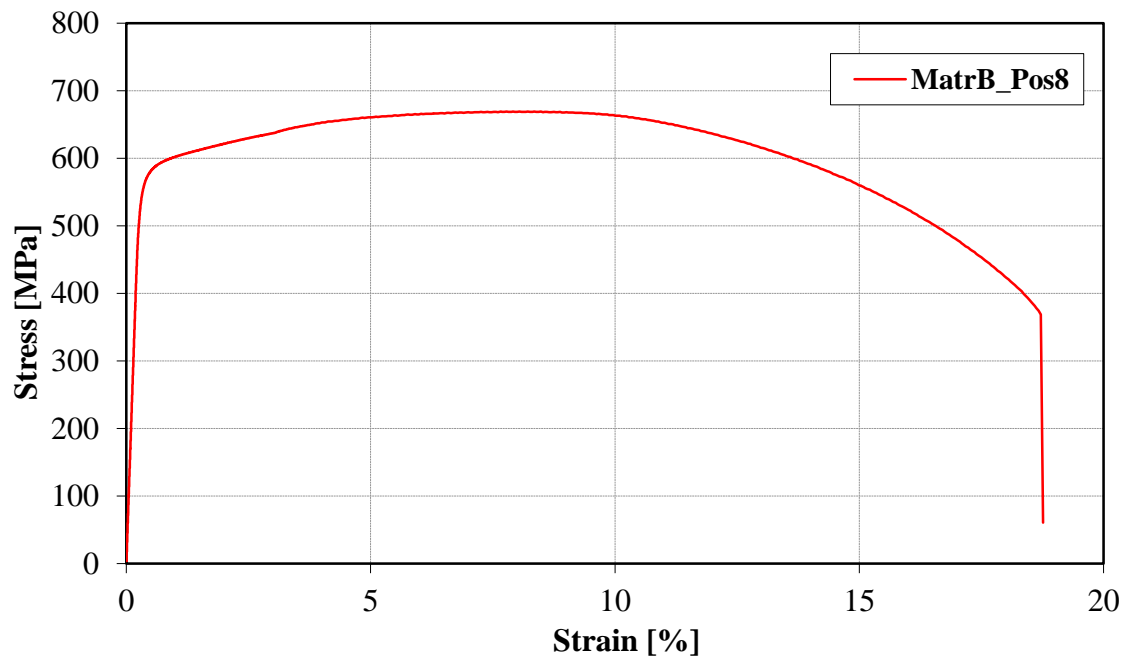
Figure D-5: Stress-strain curve for material B, parallel 2.

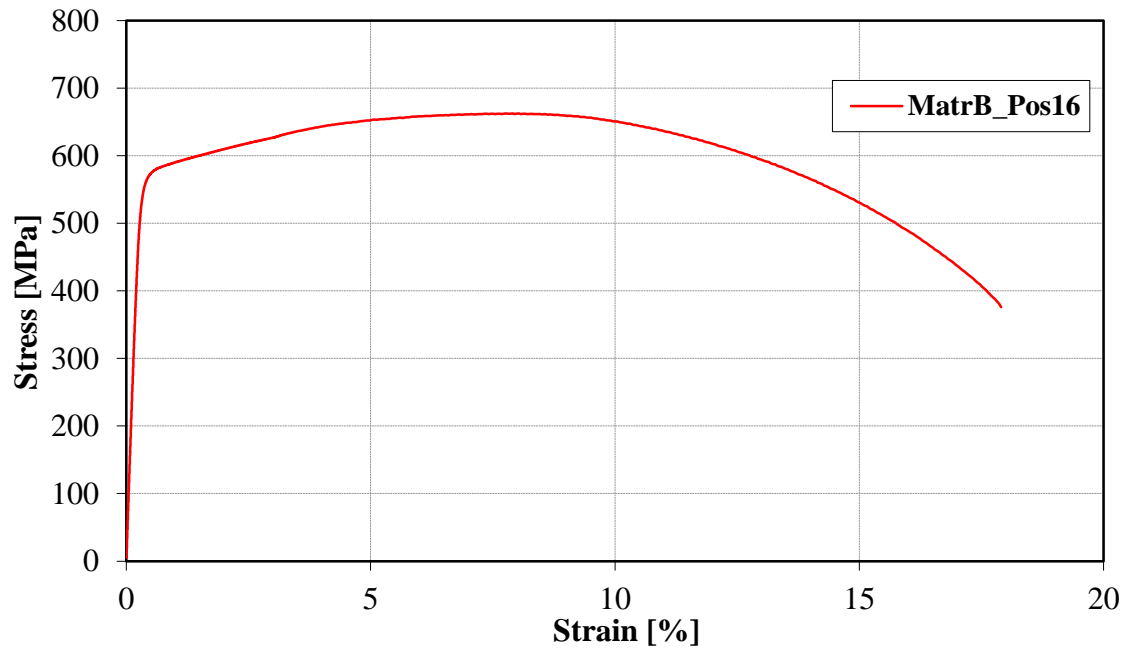
Figure D-6: Stress-strain curve for material B, parallel 3.

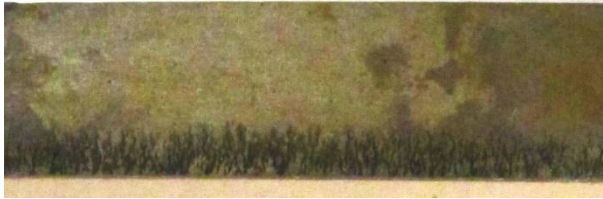
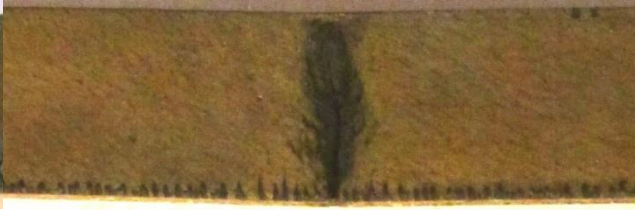
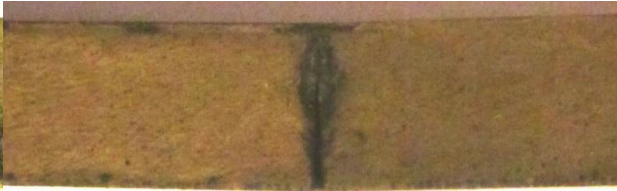
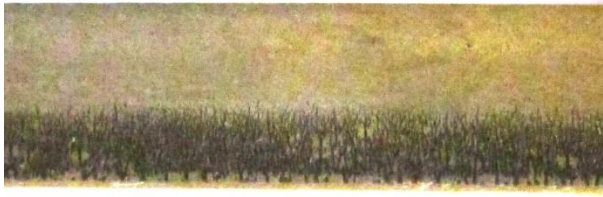
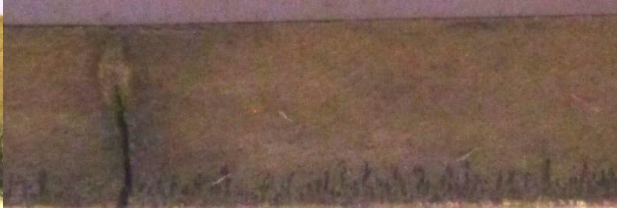
Table F-3: Macro photos of cracked HAZ specimens from test 2.

In test 2, cracks were observed in both the base material specimens and the HAZ specimens. Macro photos of all the base material specimens and HAZ specimens from test 2 are presented in Table F-2 and Table F-3 respectively.

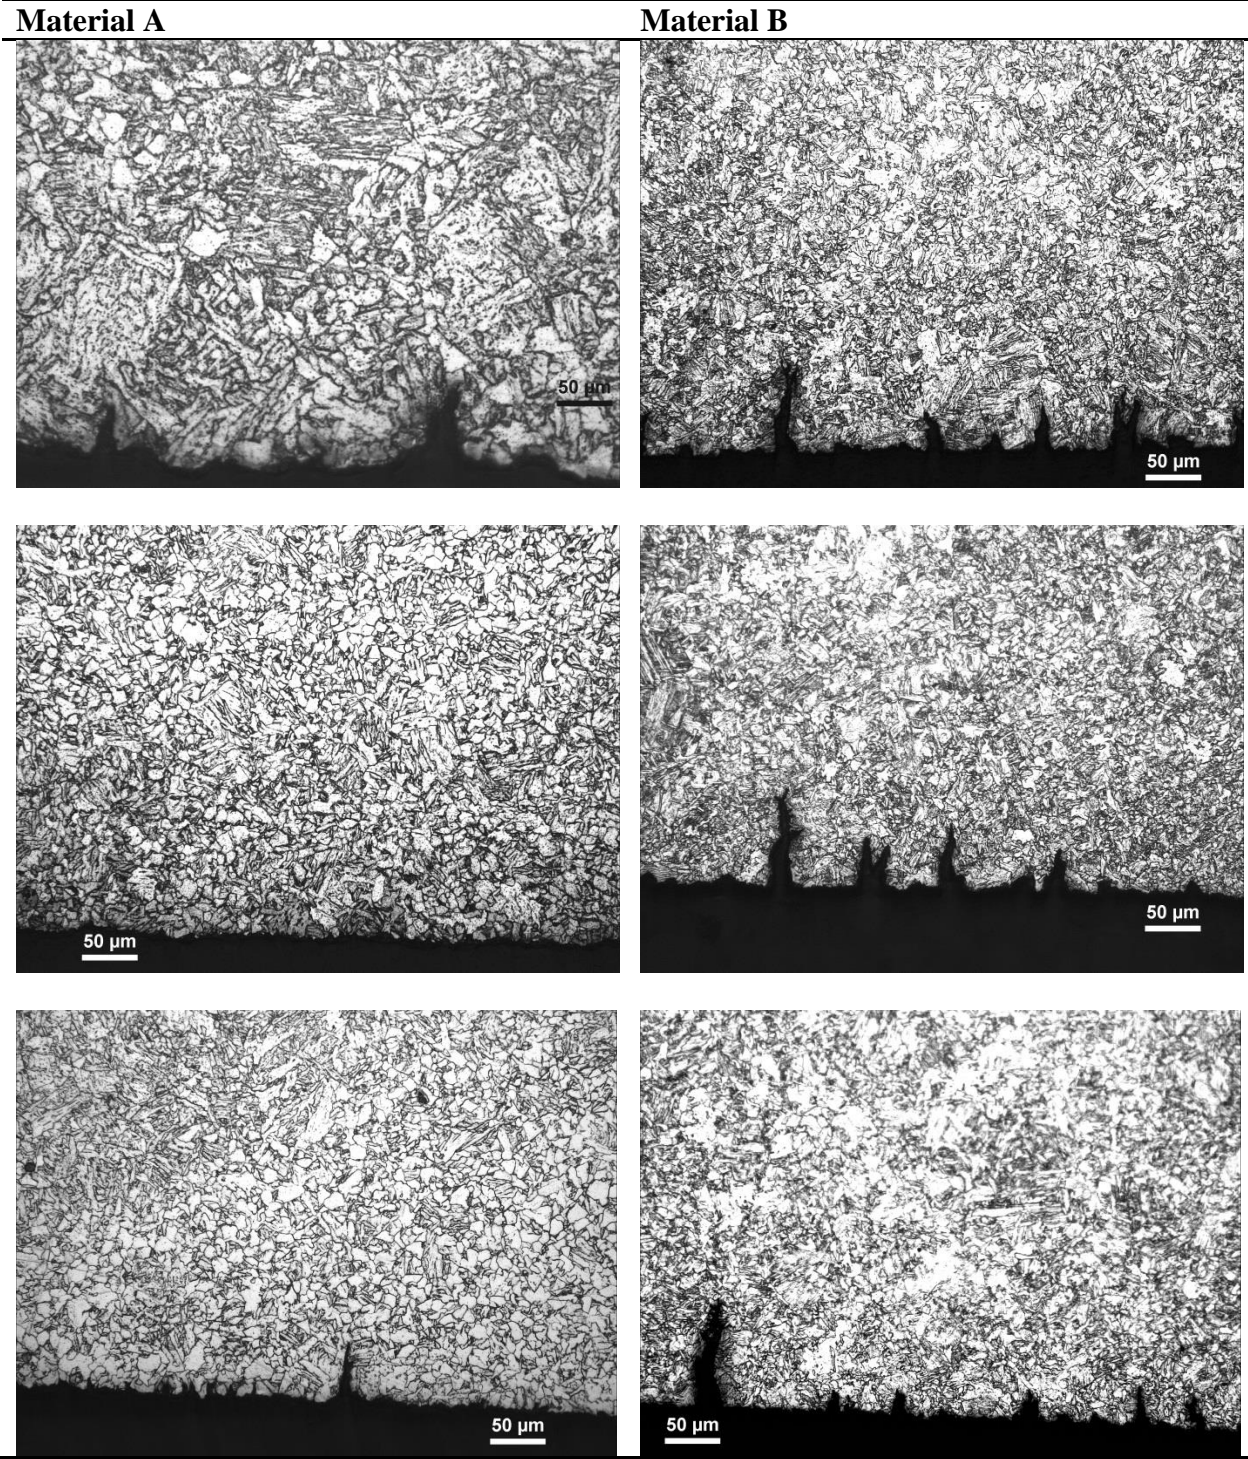
Table G-2: Micrographs of all FPB specimens of base material A and B in test 1.

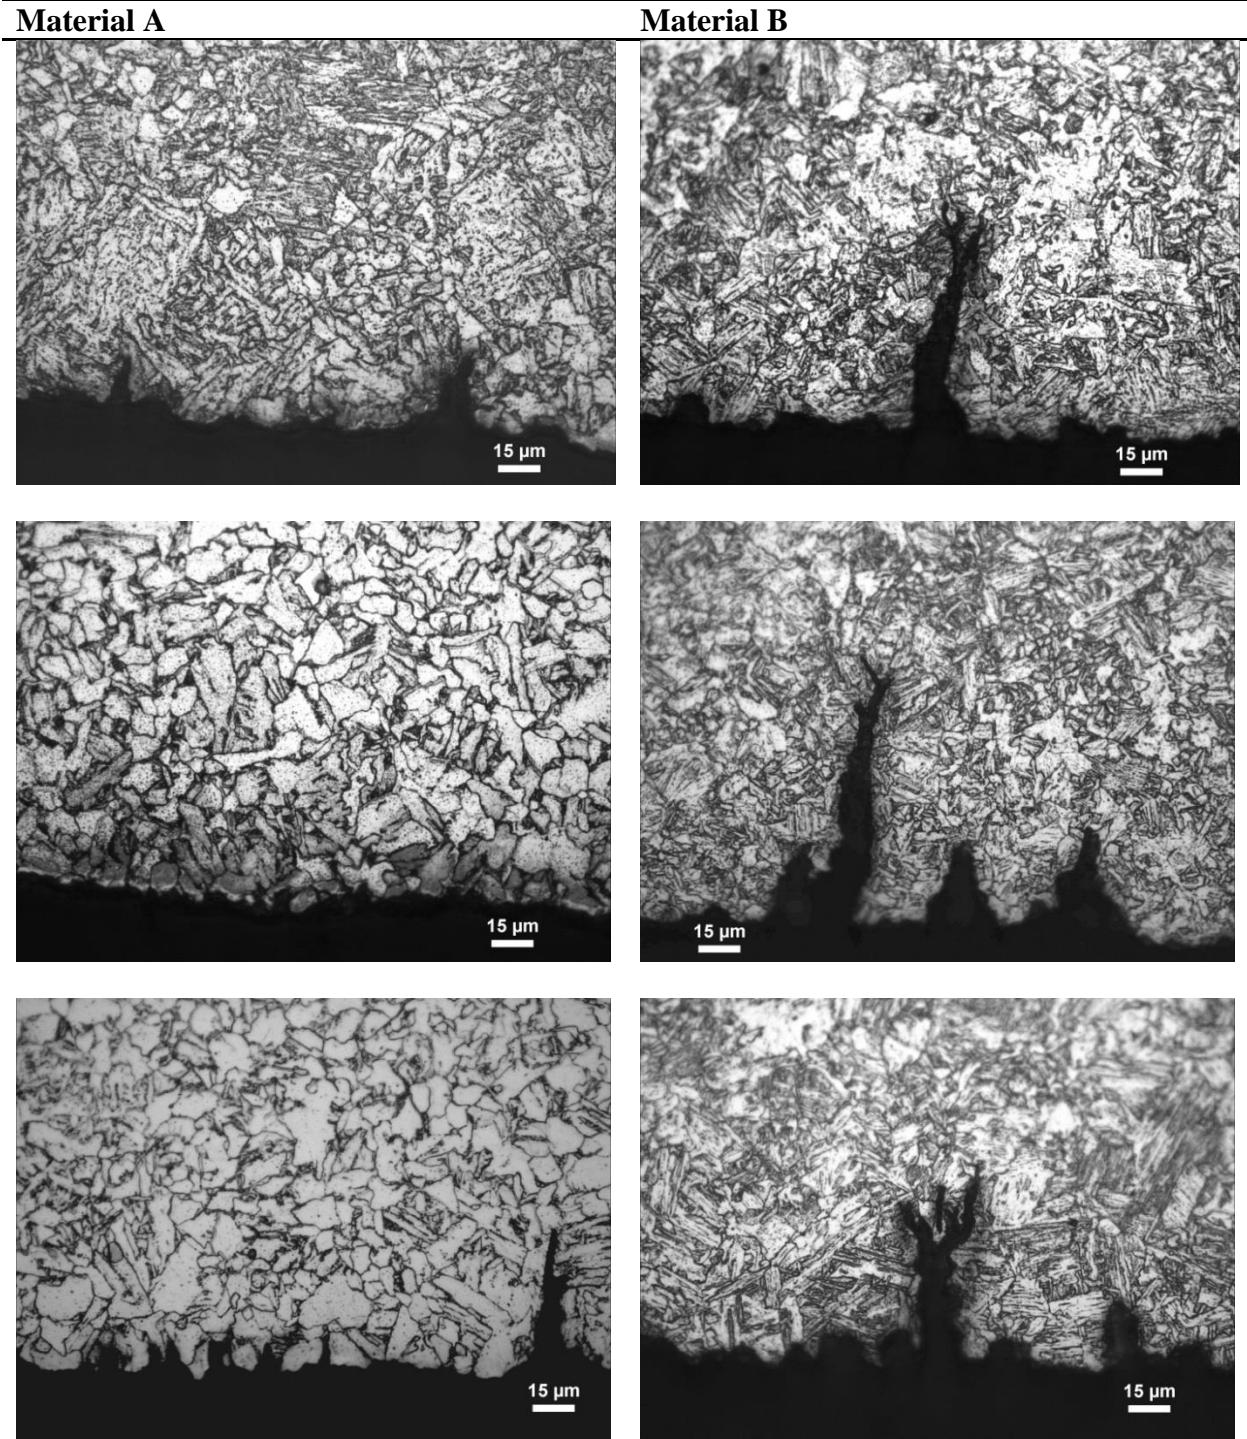
Table G-3: Micrographs of all FPB specimens of the HAZ of material A and B in test 1.

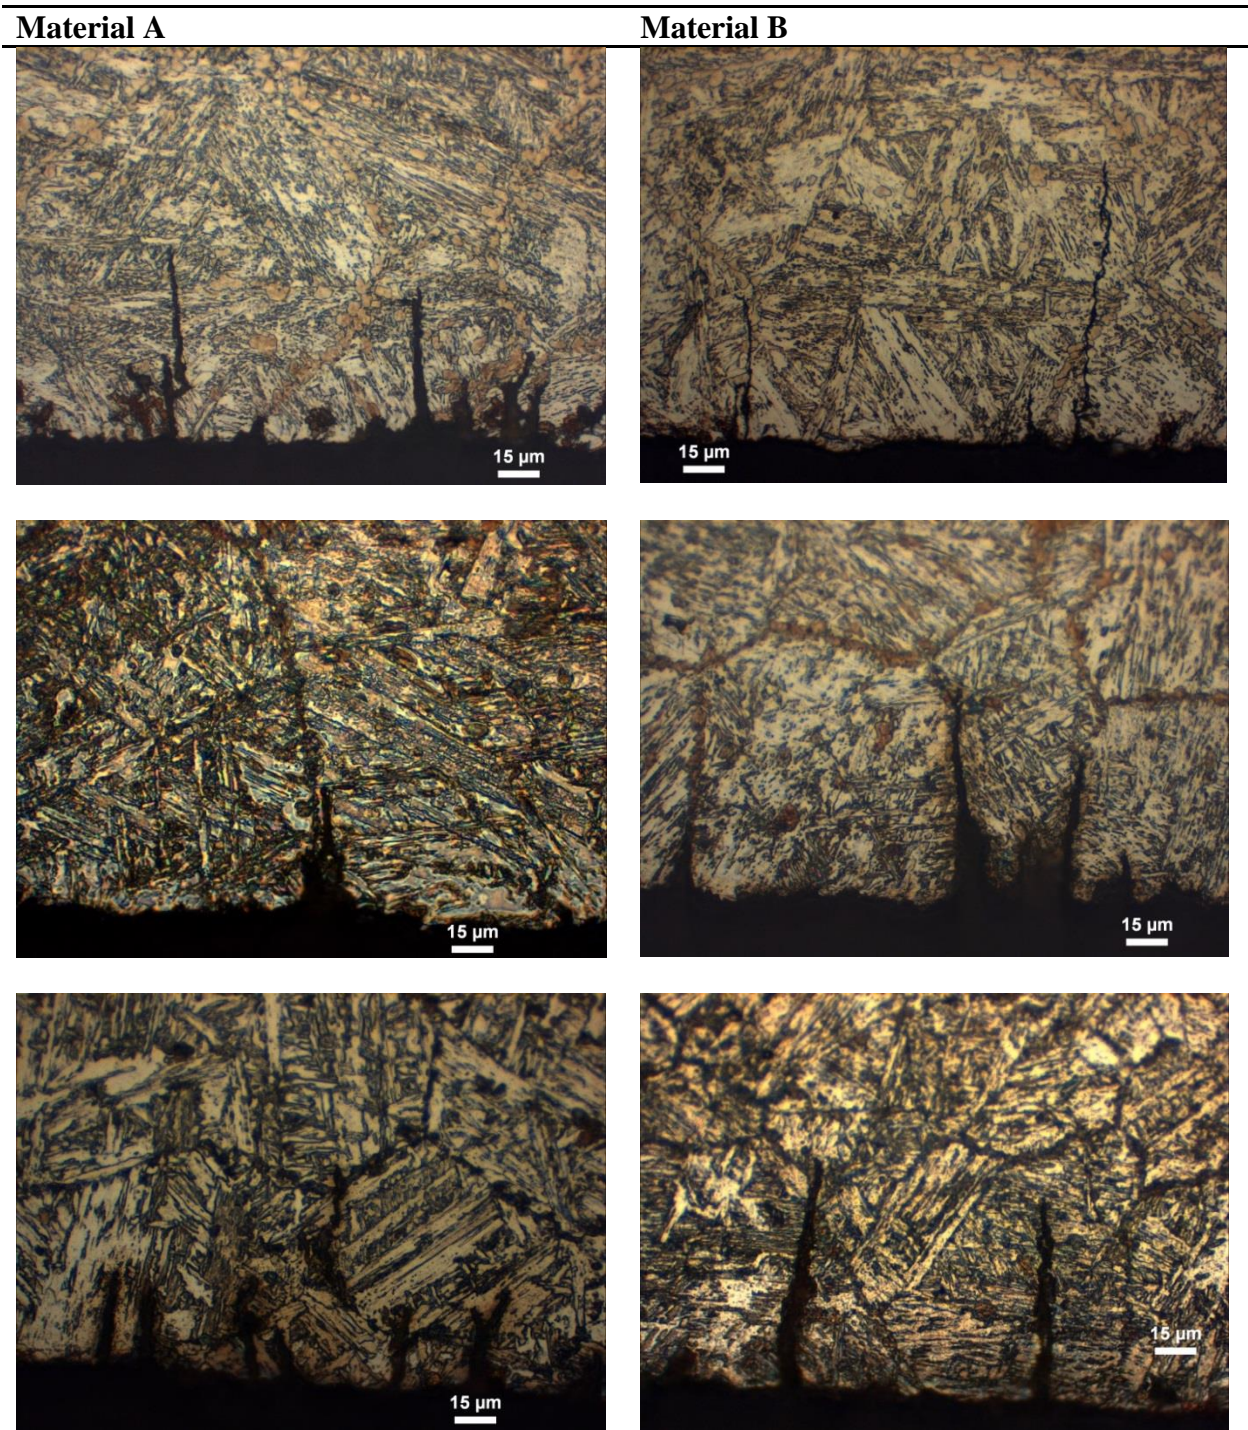
Table G-4: Micrographs of all FPB specimens of base material A and B in test 2.
