# Production and Characterization of a Zr-based Bulk Metallic Glass

The possibility of a future biomaterial

**Marius Hansen**

Norwegian University of Science and Technology  
Department of Materials Science and Engineering

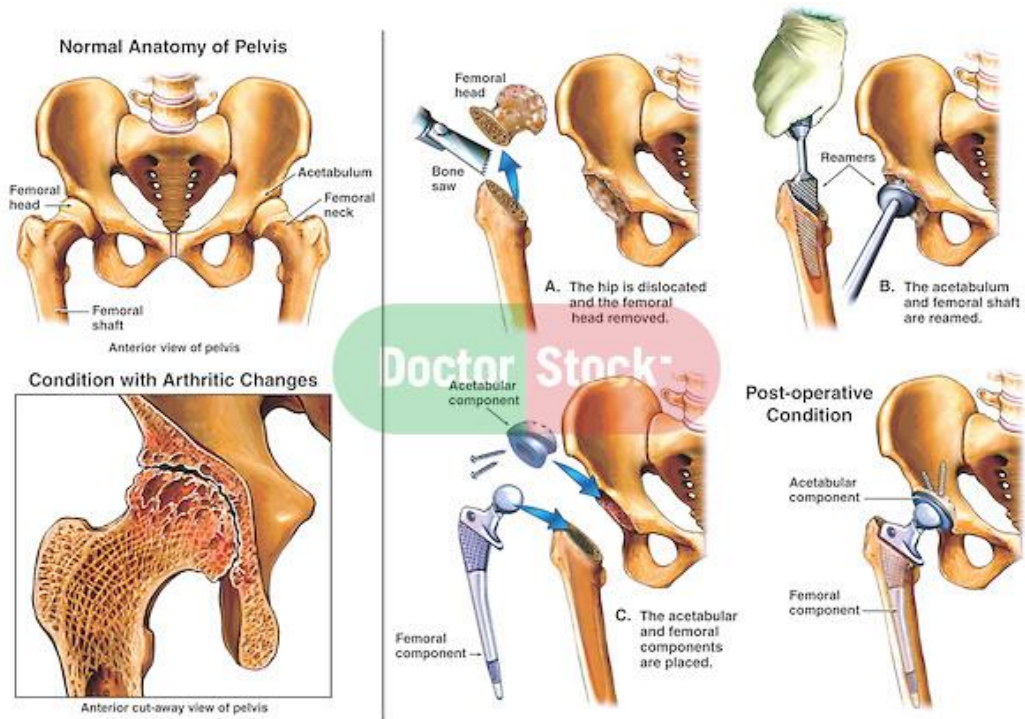
Figure 2-4: Illustration of hip replacement [19]

The total hip replacement is a surgical procedure where the whole hip joint is replaced by a prosthetic implant. A simple presentation of the procedure is shown in Figure 2-4.

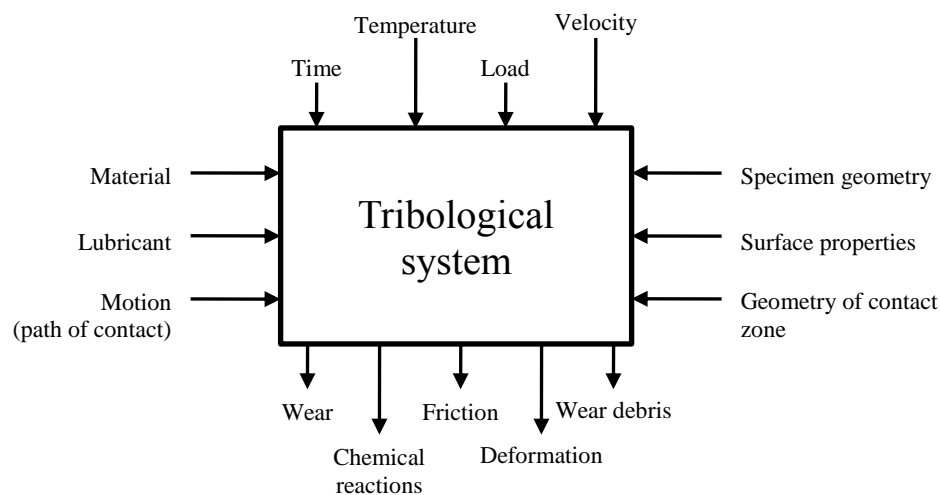
Figure 2-6: Parameters that influence a tribological system [50]

Tribology is defined as the science and technology of interacting surfaces in relative motion, including related subjects and practices [48]. Furthermore the tribological system is defined as a body whose functional behavior is connected with interacting surfaces in relative motion [49]. The parameters that influence the tribological system are presented in Figure 2-6.

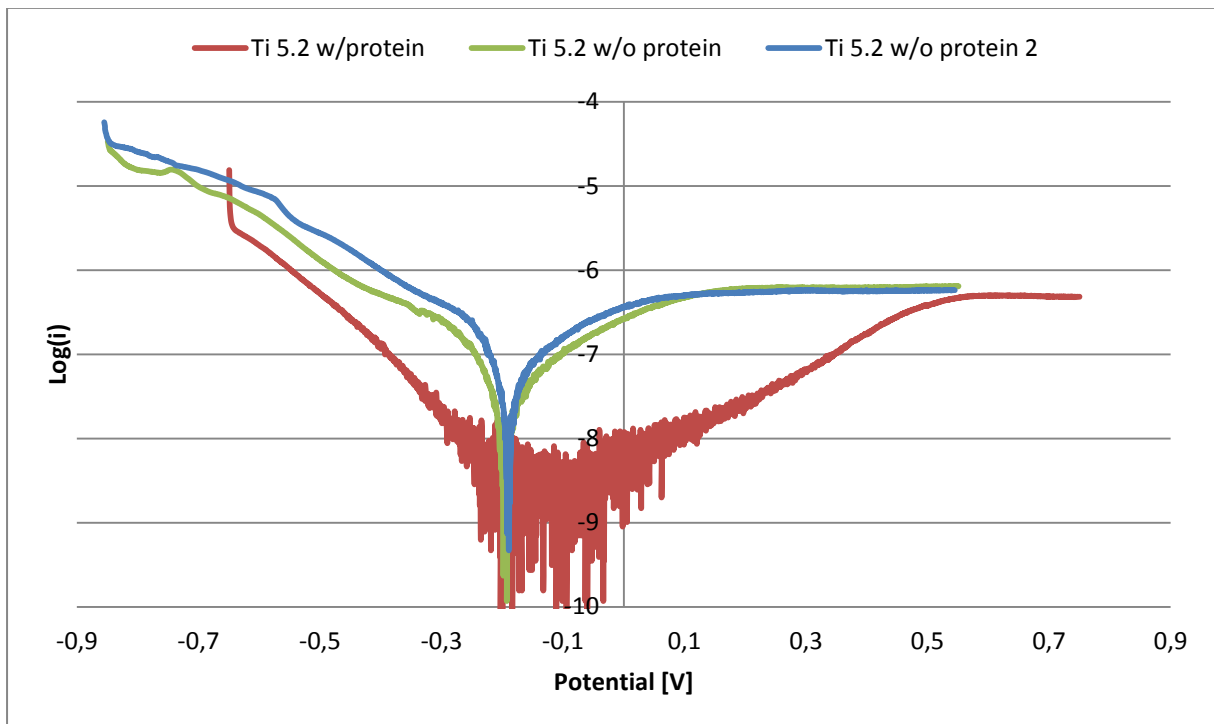
Figure 4-2: E-Log(i) for Ti 99.6 % in PBS with pH 5.2

$E_{corr}$  was found to be -0.2 V for Ti 99.6 % in PBS with added HCl, for the protein solution it was indeterminable as shown in Figure 4-2.

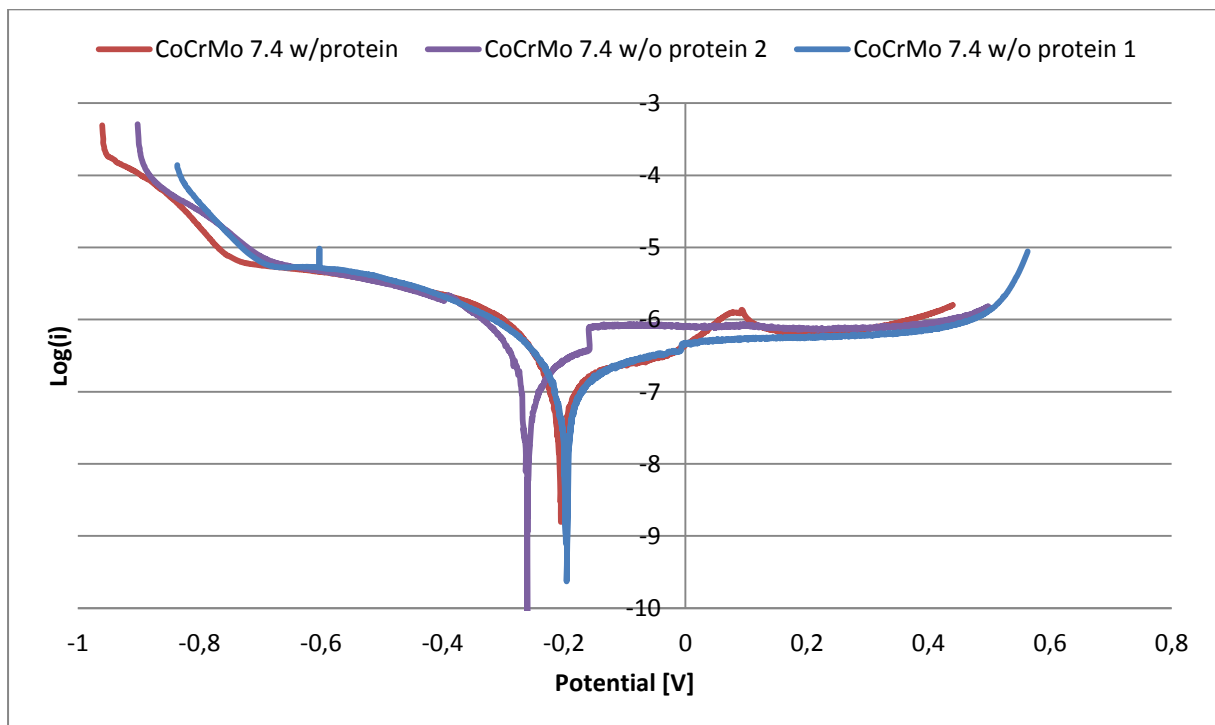
Figure 4-3: E-Log(i) diagram for CoCrMo in PBS

$E_{\text{corr}}$  was found to be on average -0.22 V for CoCrMo in PBS, and -0.2 for the protein solution. The results are shown in Figure 4-3.

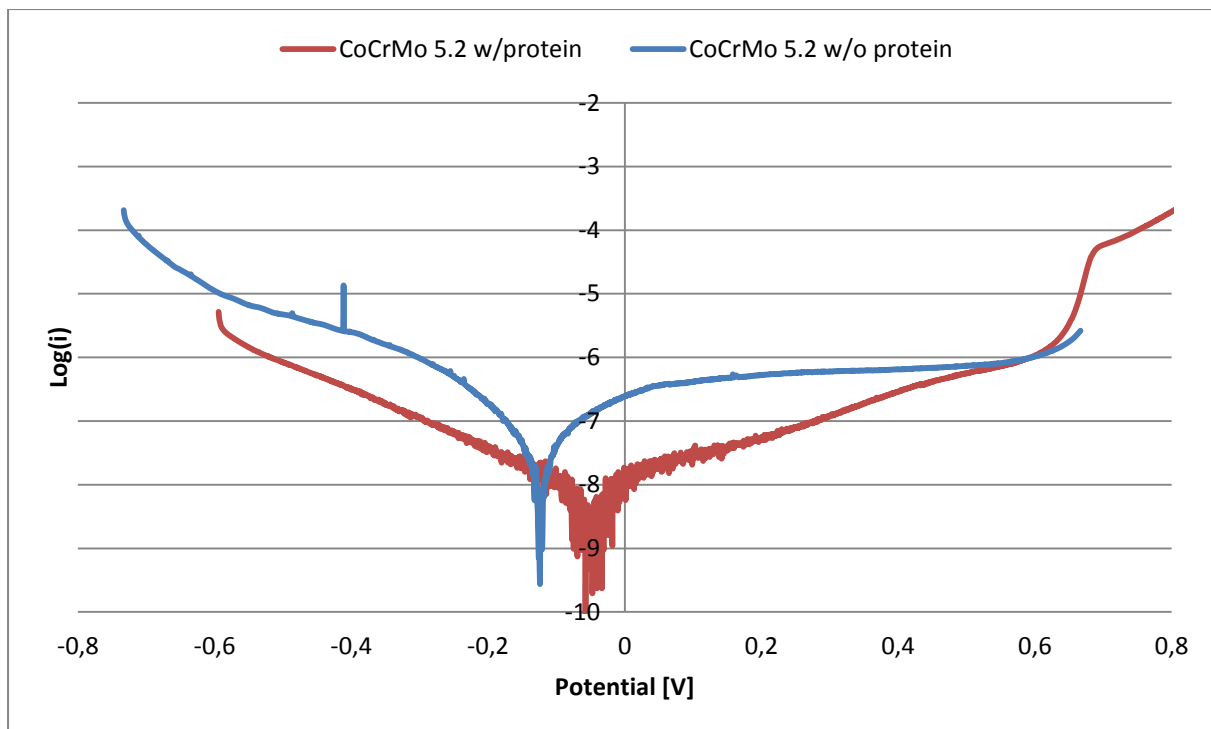
Figure 4-4: E-Log(i) diagram for CoCrMo in PBS with pH 5.2

$E_{\text{corr}}$  was found to be -0.12 V for CoCrMo in PBS with HCl, with protein added it was found to be around -0.04 V. The results are shown in Figure 4-4.

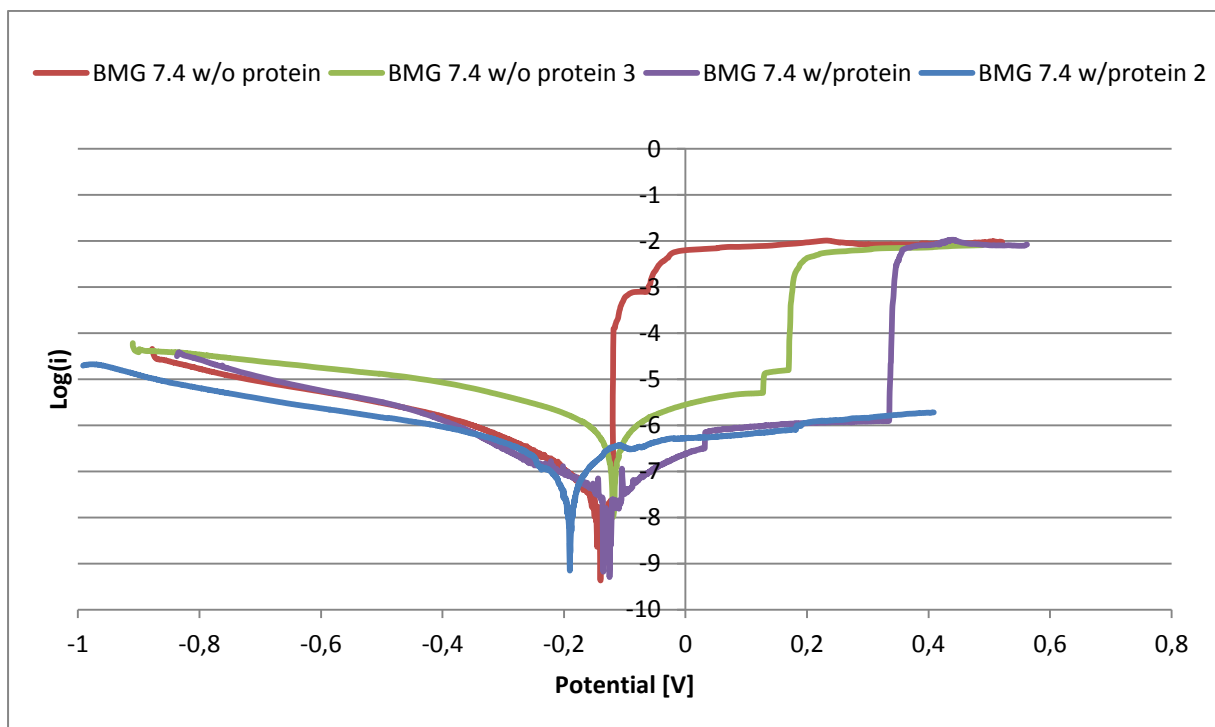
Figure 4-5: E-log(i) diagram for BMG in PBS

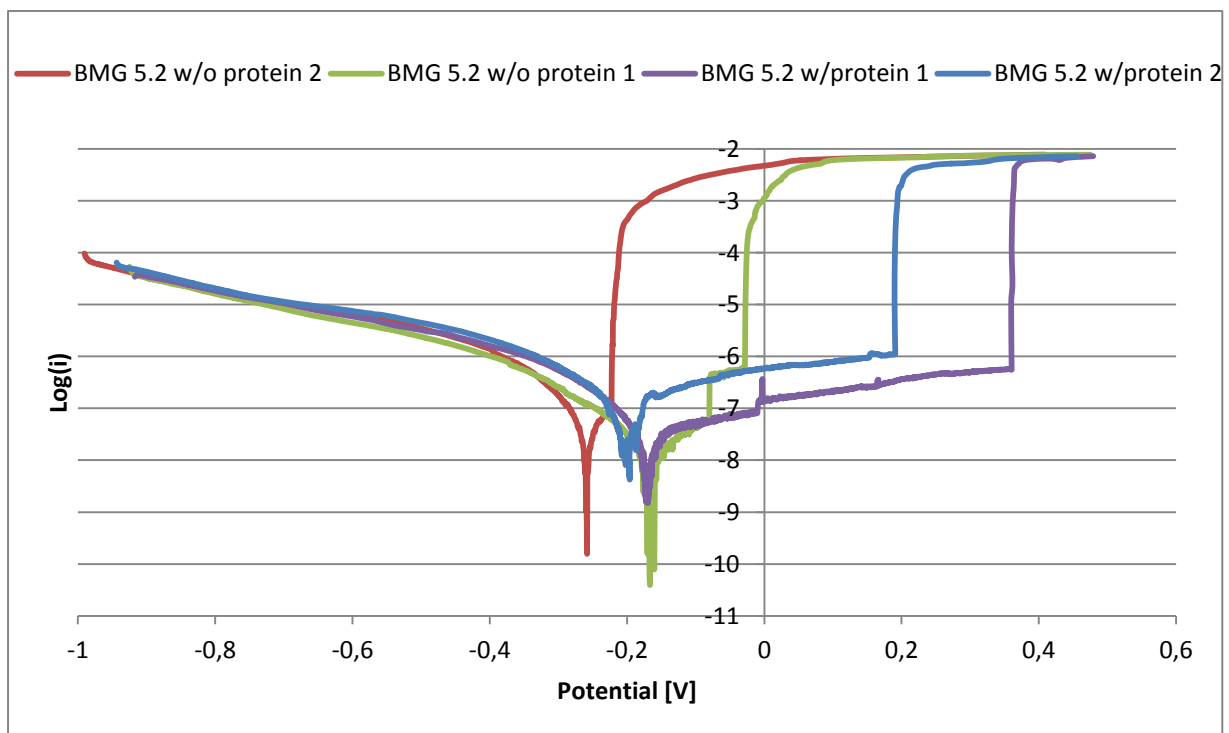
Figure 4-6: E-Log(i) diagram for BMG in PBS with pH 5.2

$E_{corr}$  was found to be -0.21 V for BMG in PBS with HCl, and -0.19 for the protein solution. The results are shown in Figure 4-6.

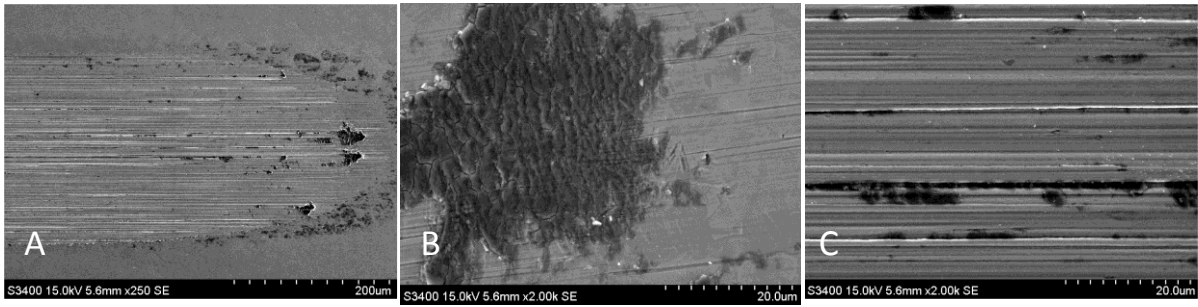
Figure 4-35: SEM images of wear track from CoCrMo PBS 7.4 tests. Magnifications: A x250, B x2k, C x2k

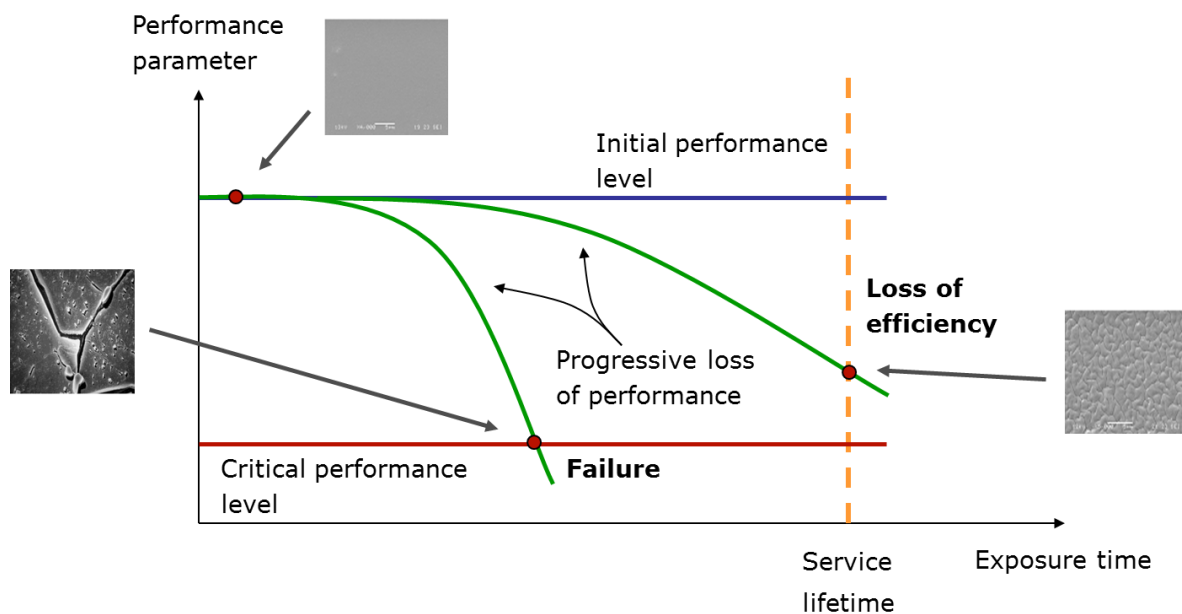
Figure 6-1: Material degradation over time [50]
