Past slope collapse and current unstable slopes along a cliff at Hyllestad Kommune

Geology

Submission date: June 2018

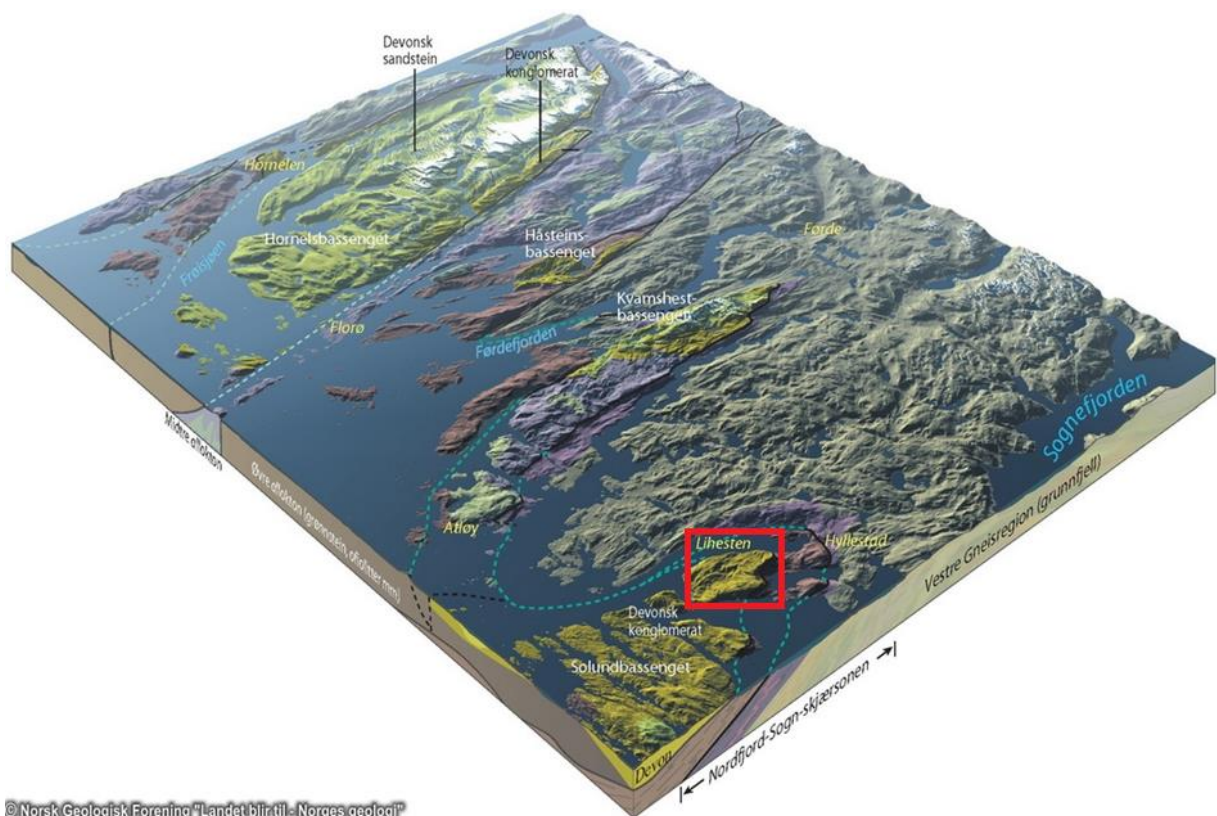
Figure 1.2: Figure showing the layering structure of the regional rock types. Purple and brown is part of the Nordfjord-Sogn shear zone. Yellow is Devonian sedimentary rocks, while grey is the Western Gneiss region. Field area is marked with the red square. Modified after Ramberg, *et al.* (2006)

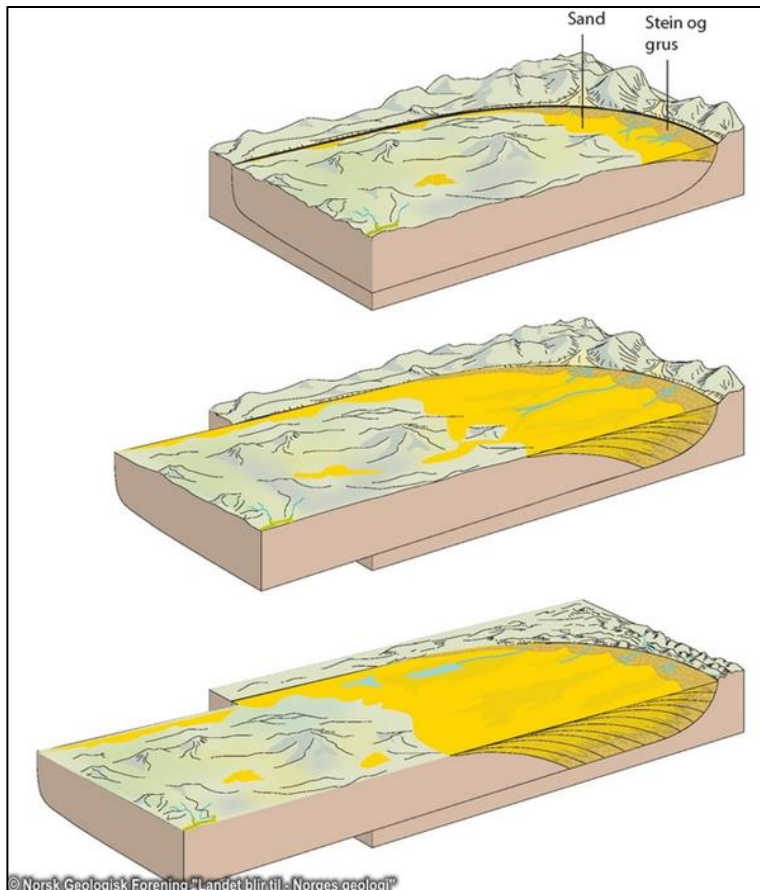
Figure 1.3: Model of the stratigraphic layering process in the sedimentary basins. (Ramberg, et al., 2006)

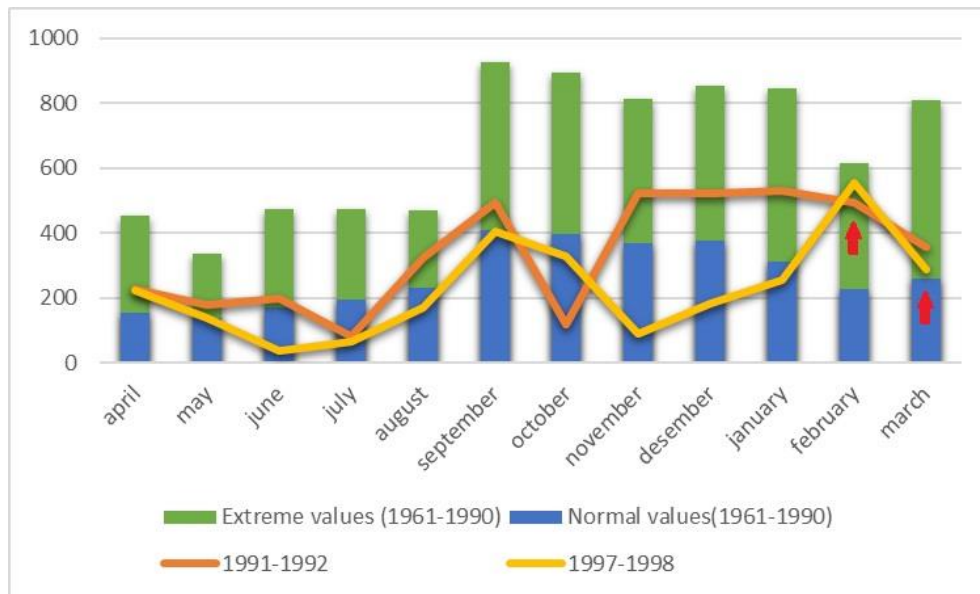
Figure 1.5: Change in precipitation (mm) the months prior to the events in February 1992 and March 1998, compared with normal values and extreme values in the period 1961-1990. (Norwegian Meteorological Institute, 2018)

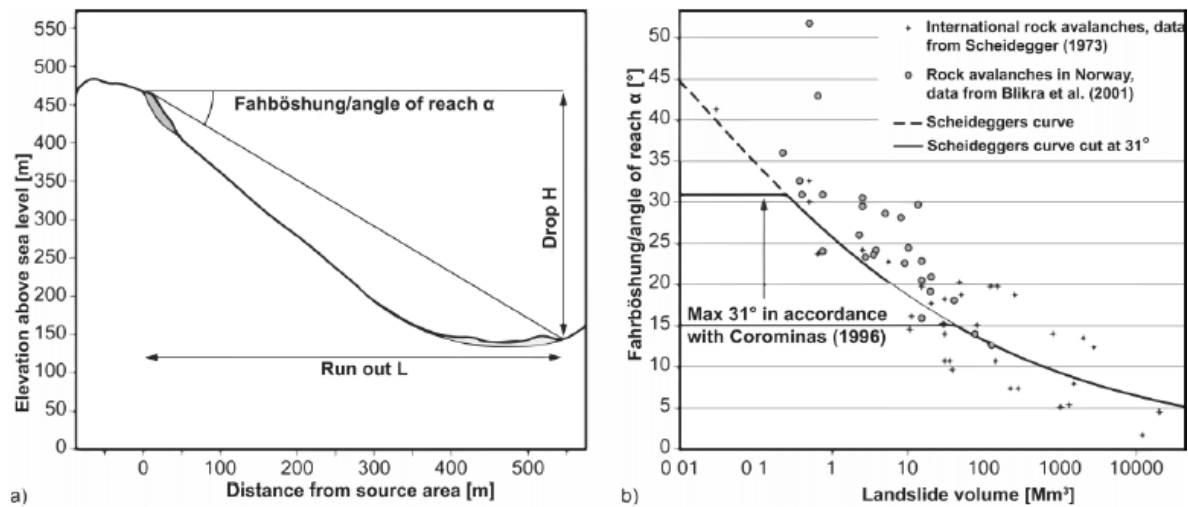
Figure 2.1: Empirical relation of the “angle of reach” of rock avalanches. a) Profile of a rock avalanche. b) empirical relation between “angle of reach” and failure volumes, based on international rock avalanches (Scheidegger, 1973). Scheidegger cut-off is shown as the truncated line with a constant “angle of reach” below a certain volume threshold (Corominas, 1996). Rock avalanches from Norway is plotted, showing in general a higher “angle of reach” than the Scheidegger curve (Blikra, *et al.*, 2001). Figure modified after Oppikofer, *et al.* (2016).

Landslides are classified by their type of movement. Within the classification of rock as the material content, the difference between a flow movement and other movement types is the excessive travel lengths (Hungri, *et al.*, 2014). Excessive travel lengths are defined by the Scheidegger curve. This is a direct relation between failure volumes and a height/length ratio proposed by Scheidegger (1973). At a certain volume threshold the deposit volumes deviate from the relation (Corominas, 1996). This cut-off is set to a volume threshold of 250 000 m³, where smaller volumes follow a truncation with “angle of reach” of 31 degrees (Figure 2.1).

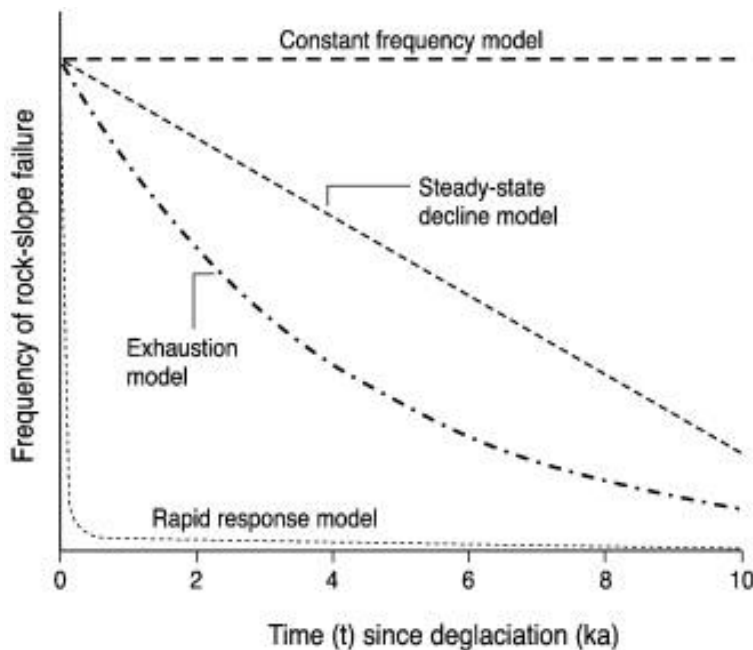
Figure 2.3: Models suggested for the distribution of rock slope failures over time. Modified from Ballantyne and Stone (2013).

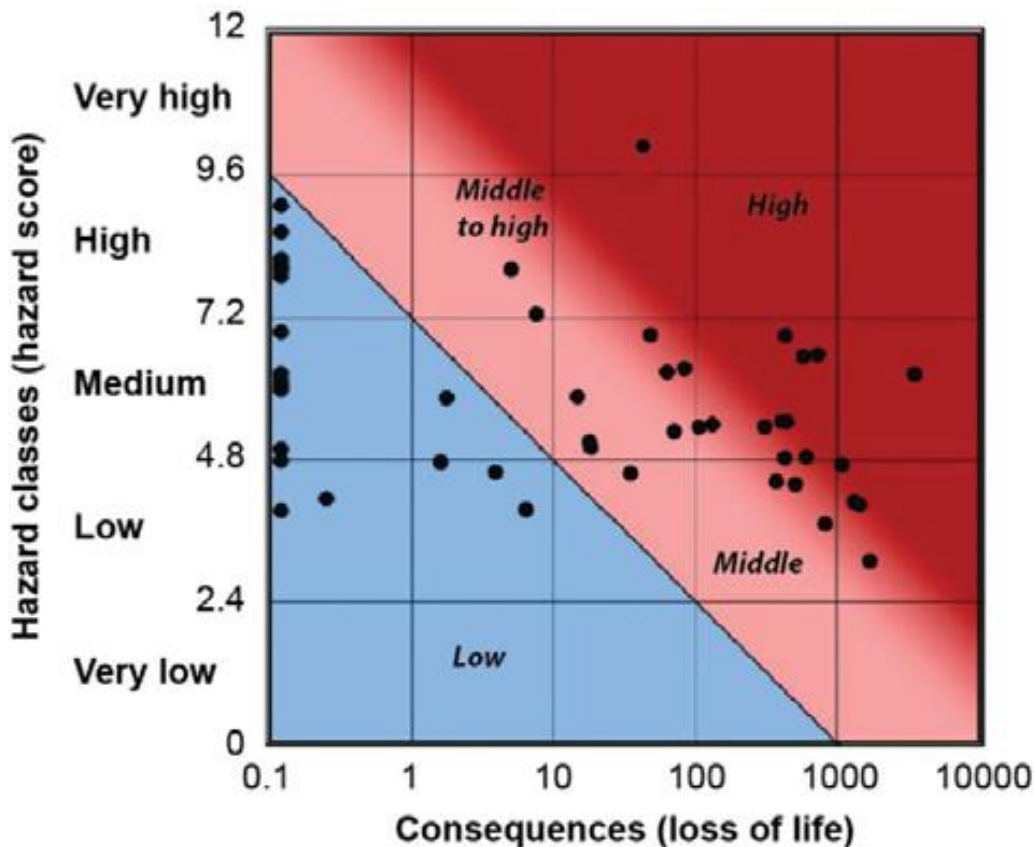
Figure 2.6: Risk classification matrix divided into four levels of risk, Low, Middle, Middle to high, and High. For unstable slopes plotted in the blue area, there is no need for further follow-up. For slopes plotted in the red area there is need for a more detailed assessment. The follow-up needed is in terms of monitoring and further investigations. (Hermanns, *et al.*, 2016)

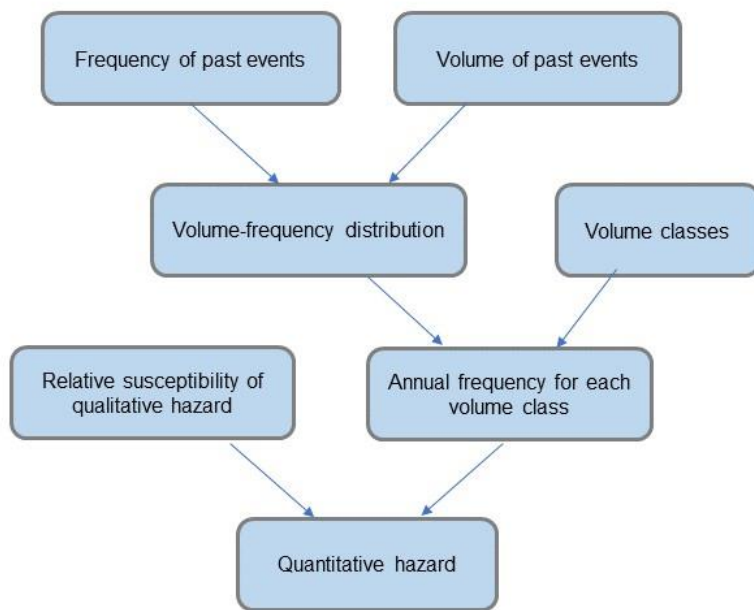
Figure 3.1: Workflow for the frequency analysis assessing frequencies of past events, volume-frequency of certain deposit volumes, and the workflow to define quantitative hazard based on past events.

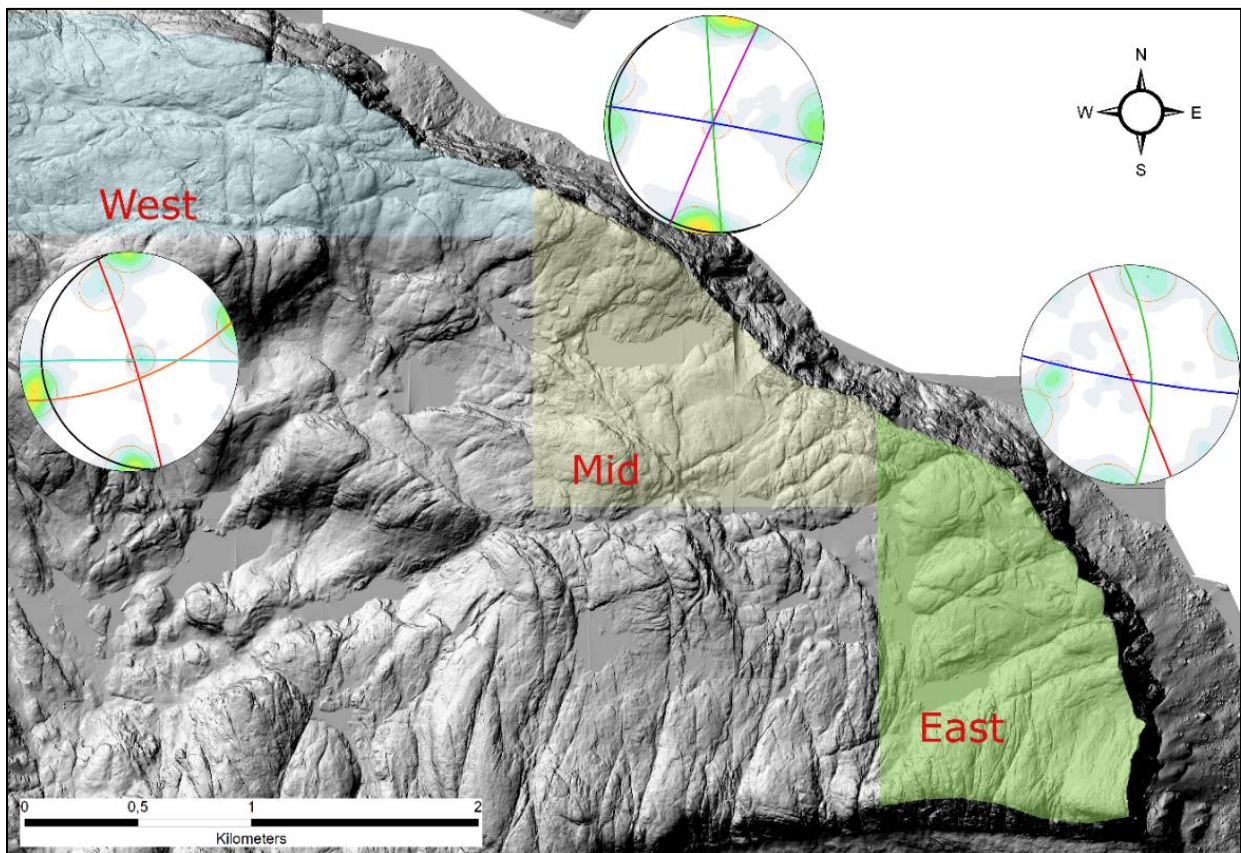
Figure 4.1: Structural domains, each showing the stereonet of the structural measurements taken inside their domain highlighted by their mean planes.

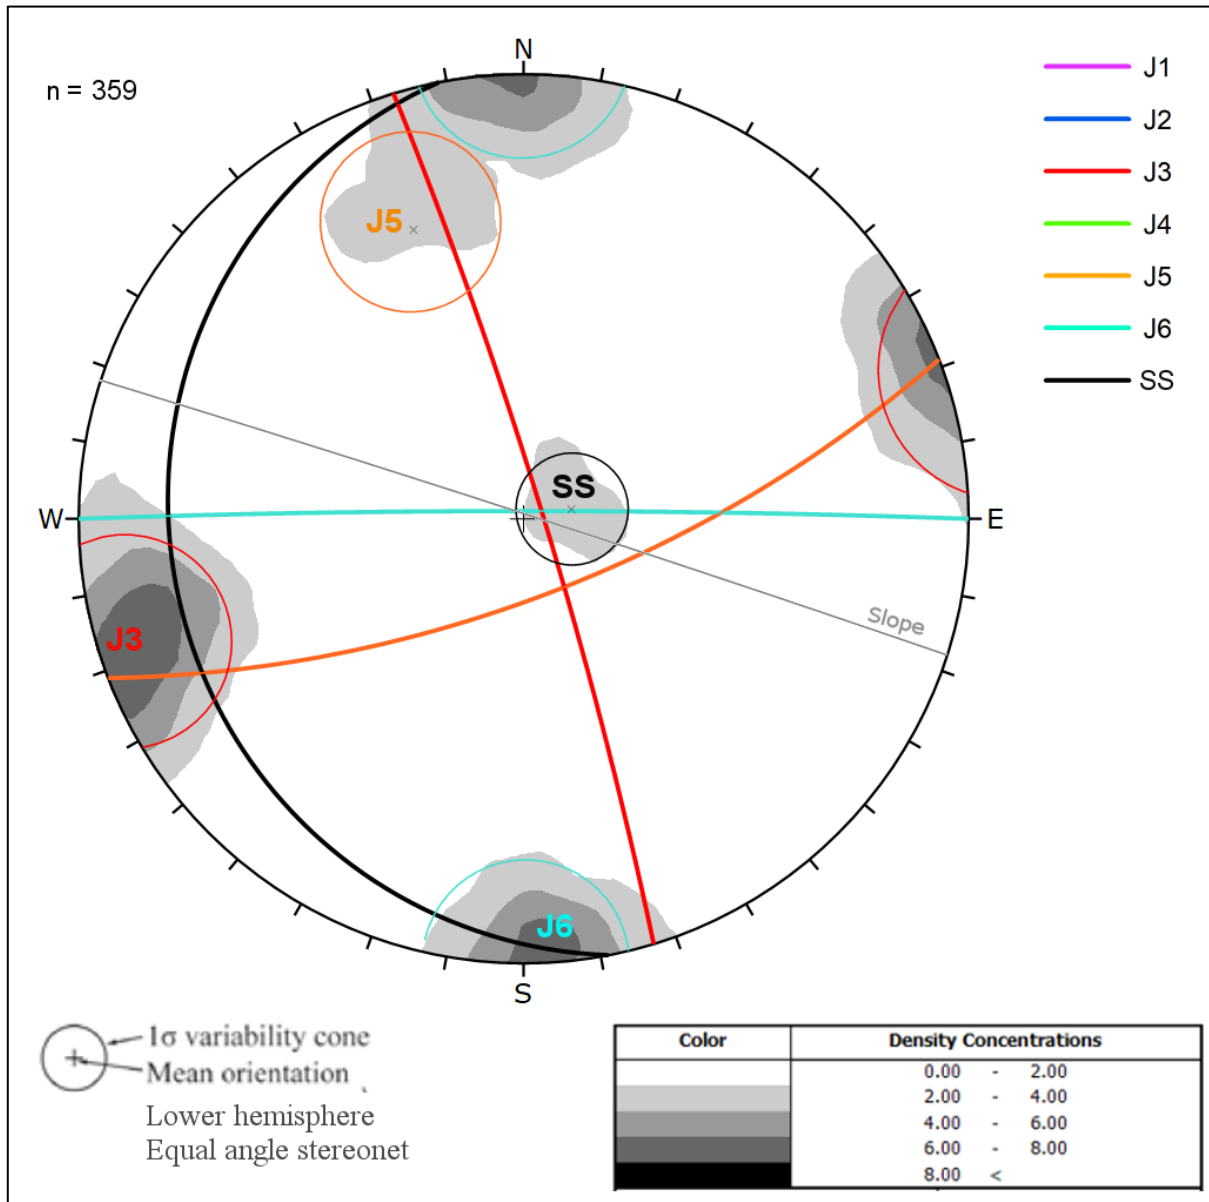
Figure 4.2: Stereonet of structural measurements in the western domain. J3 (red), J5 (brown), J6 (turquoise) and the bedding plane (black) is shown. J3 and J6 is showing a density concentration above 6%. J5 and the bedding shows a density concentration below 4%.

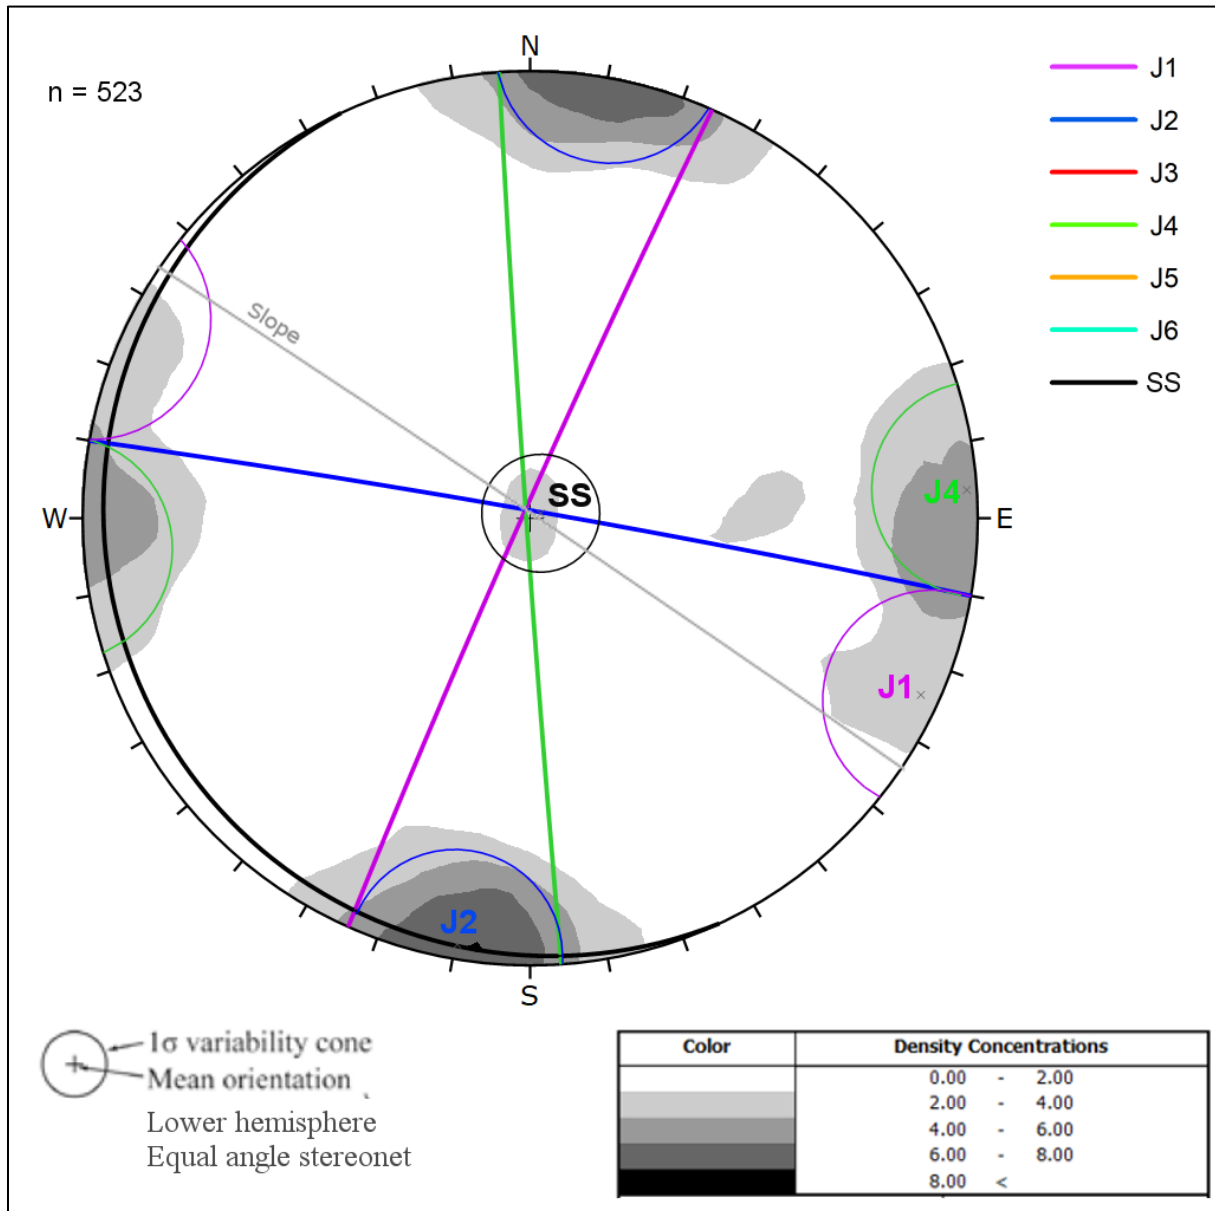
Figure 4.3: Stereoplot of structural measurements in the mid domain. J1 (purple), J2 (blue), J4 (green) and the bedding plane is shown in the plot. J2 is showing a density concentration above 6%. J4 is showing a concentration above 4%, which is marginally significant. J1 and the bedding is showing a density concentration below 4%.

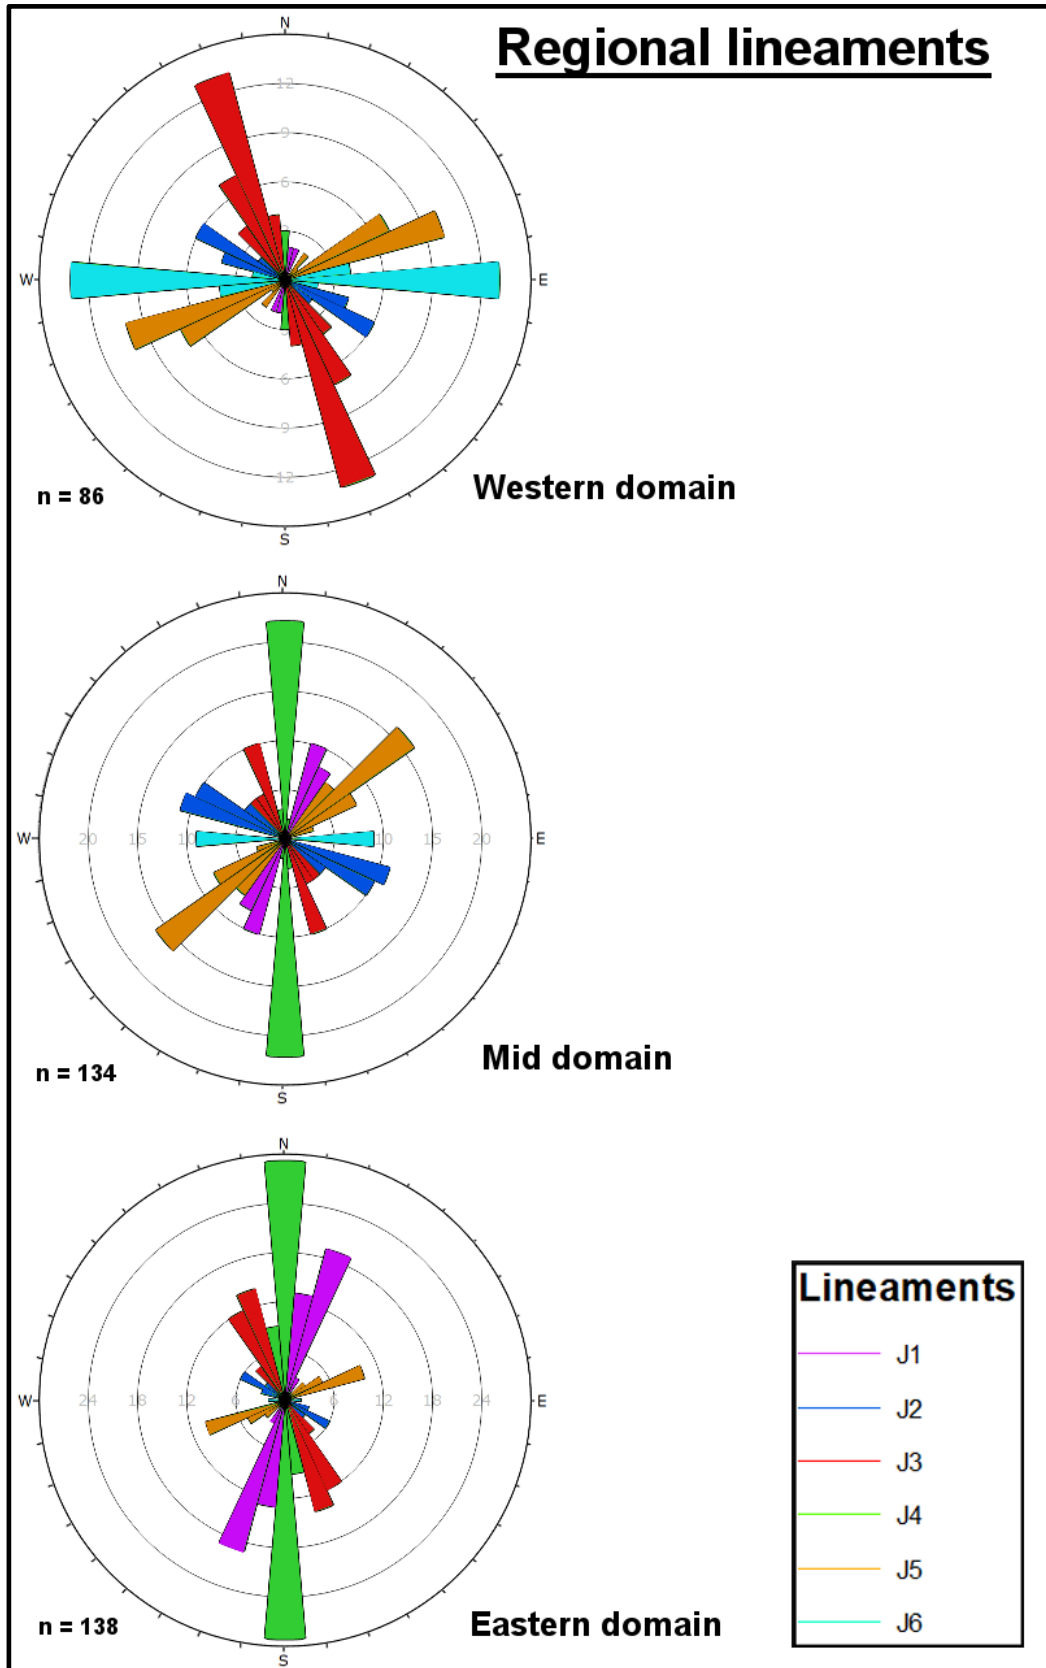
Figure 4.5: Resulting rosette plots from the structural analysis of regional lineaments for each domain.

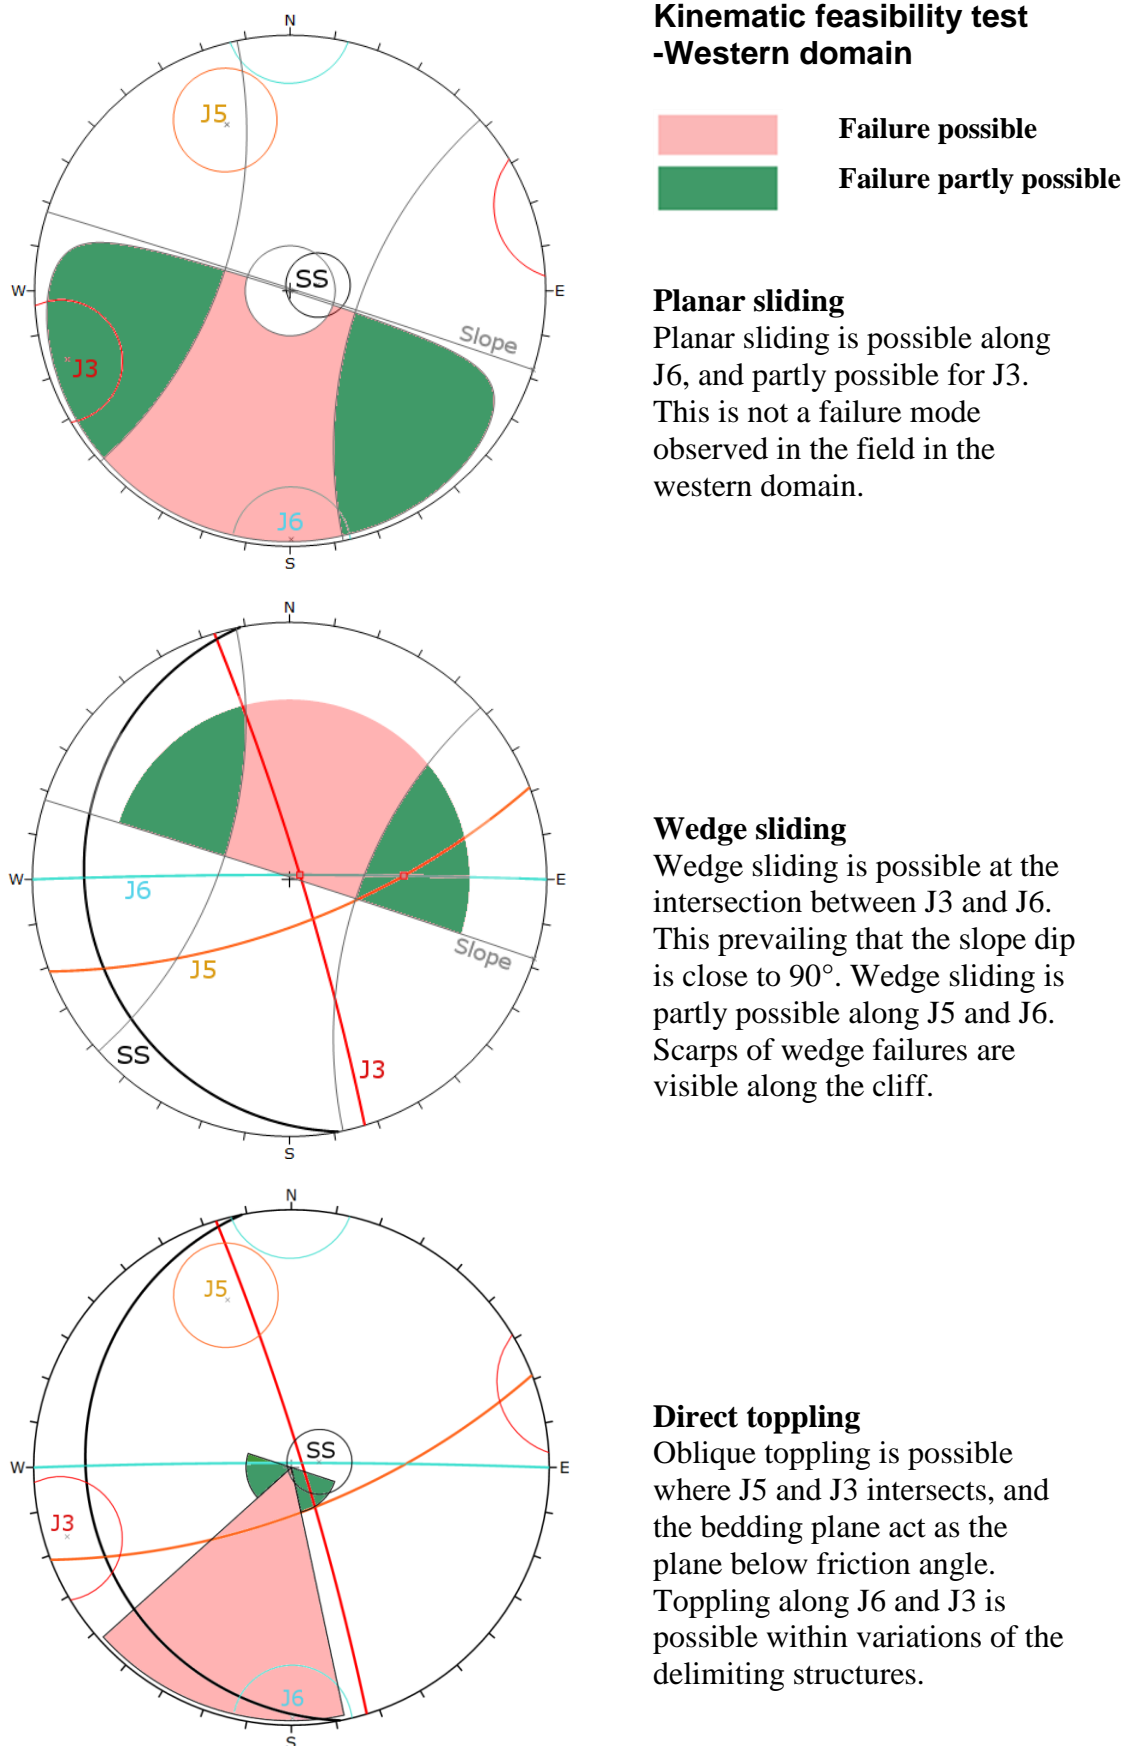
Figure 4.6: Kinematic feasibility test for the western domain. Planar sliding, wedge sliding, and oblique toppling is possible.

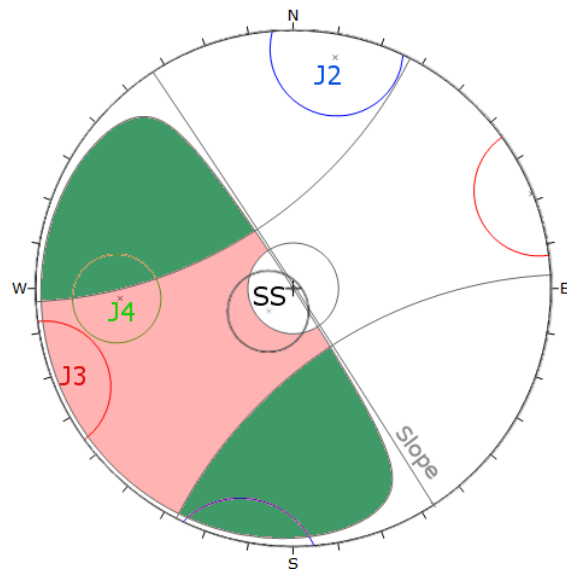
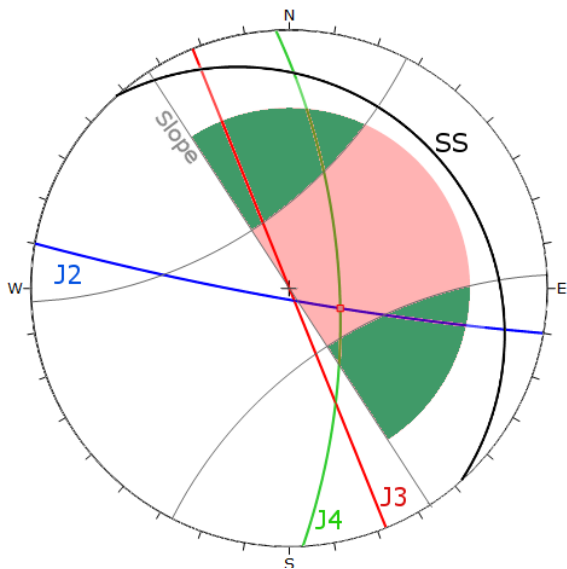
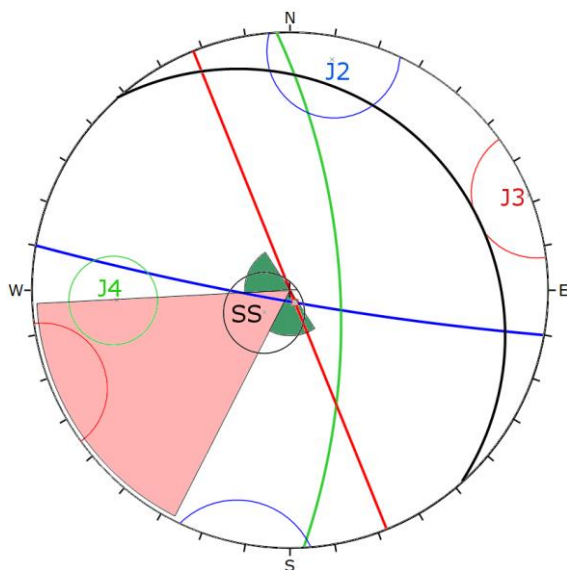
Kinematic feasibility test -Eastern domain

Wedge sliding

Direct toppling

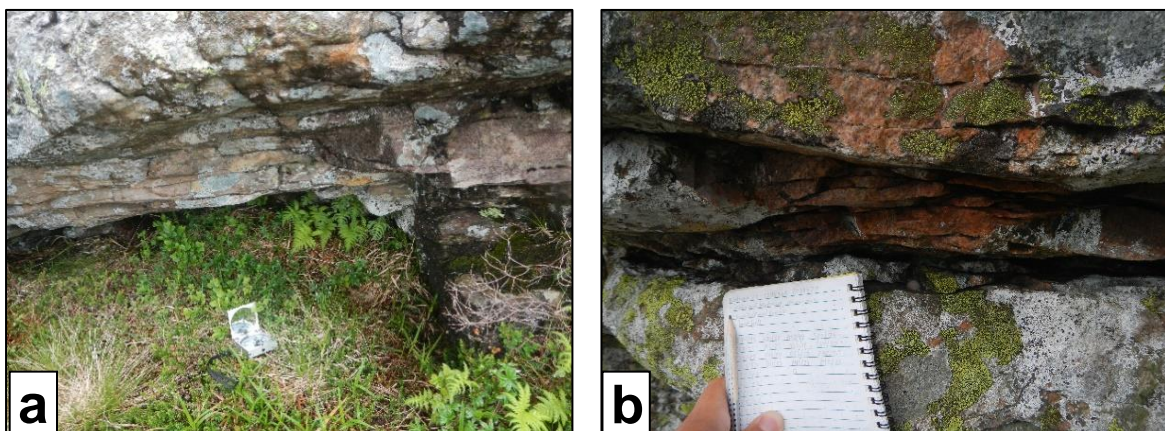
Figure 4.9: Bedding planes shown under overhanging cliffs. The bedding planes are almost flat. The bedding is seen over the whole area, but is best seen in the eastern domain, where these pictures are taken.

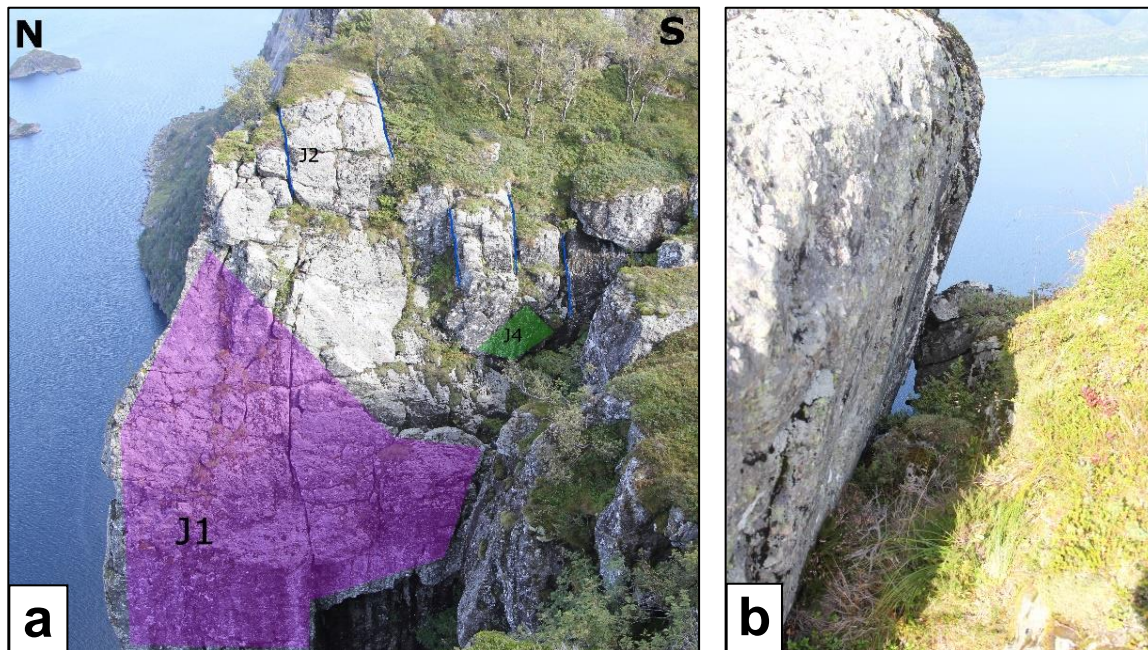
Figure 4.10: Pictures show structures following J1, seen as the purple plane in picture a taken from the west side of location 5 (chapter 4.4.2). The plane is sub-vertical and has a smooth surface. At this location, the joint set is seen with a spacing of 1m. Picture b shows a close-up of a structure at the same location with a variation of dip of 15degrees.

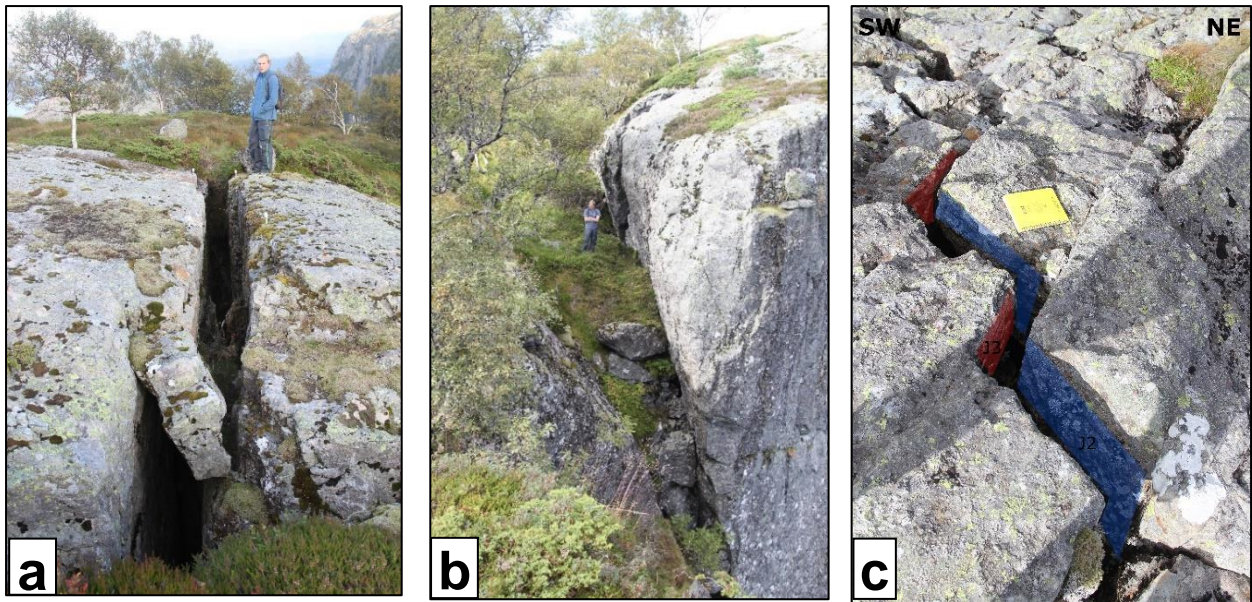
Figure 4.11: The structure has a smooth surface, and a very consistent persistence. As seen in picture b, variations in dip of the joint set up to 14 degrees is detected. As the joint set in the picture is measured to 75 degrees, this dip is barely inside the variability cone of the structural measurements. Picture c shows a stepwise structure, where the crack jumps between J2 and J3.

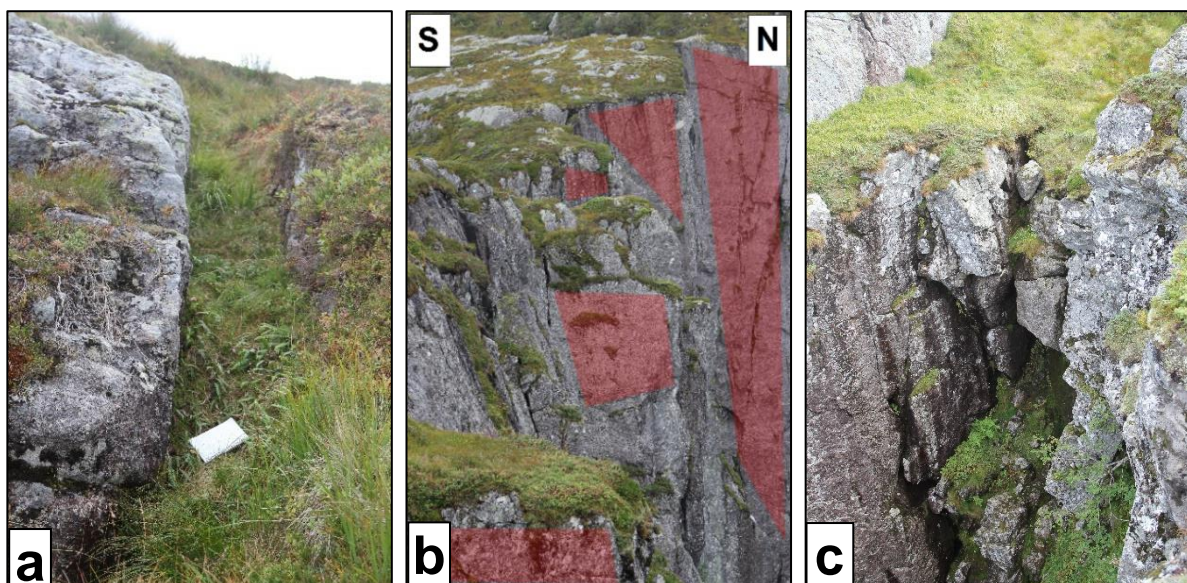
Figure 4.12: Pictures taken of structures following the orientation of J3. Surfaces are smooth, with opening of up to 50cm. Spacing is seen as close spacing in picture c, and spacing of $\approx 15\text{m}$ in picture b.

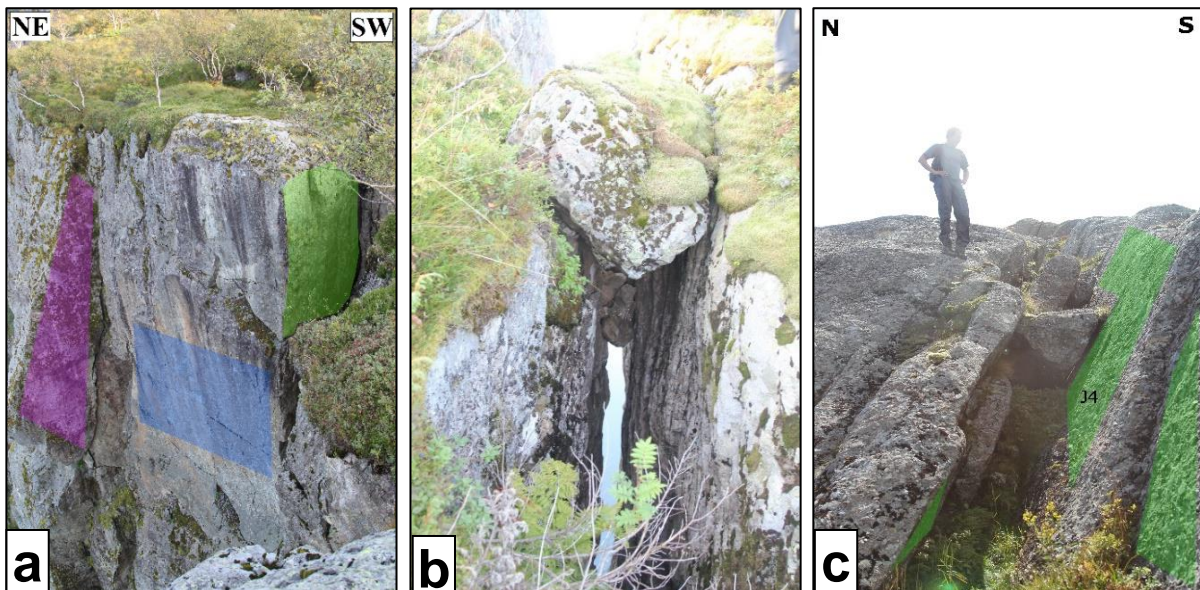
Figure 4.13: In picture *a*, J4 is the lateral limit of the unstable slope at location 6 (4.4.2). Picture *b* shows the same structure, a persistent structure with opening of 50cm. Picture *c* shows the smooth surface and close spacing of J4, dipping to the east at location 1 in the eastern domain (chapter 4.4.2).

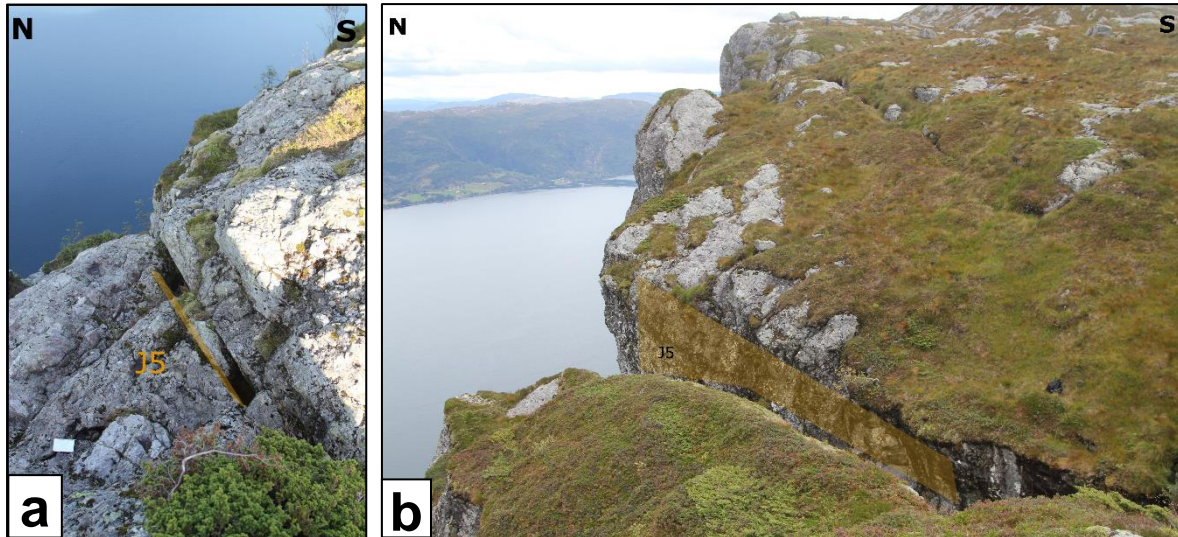
Figure 4.14: Picture *a* is taken at location 3 (chapter 4.4.2), where J5 is a water-bearing structure creating a lateral structure dividing the scenarios. Picture *b* is taken at location 8 (chapter 4.4.2), where J5 creates a backscarp with an opening of 2 meters. The irregular surface is seen at the back wall. The persistence of the crack is 20m, but the crack continues as a depression for 60m.

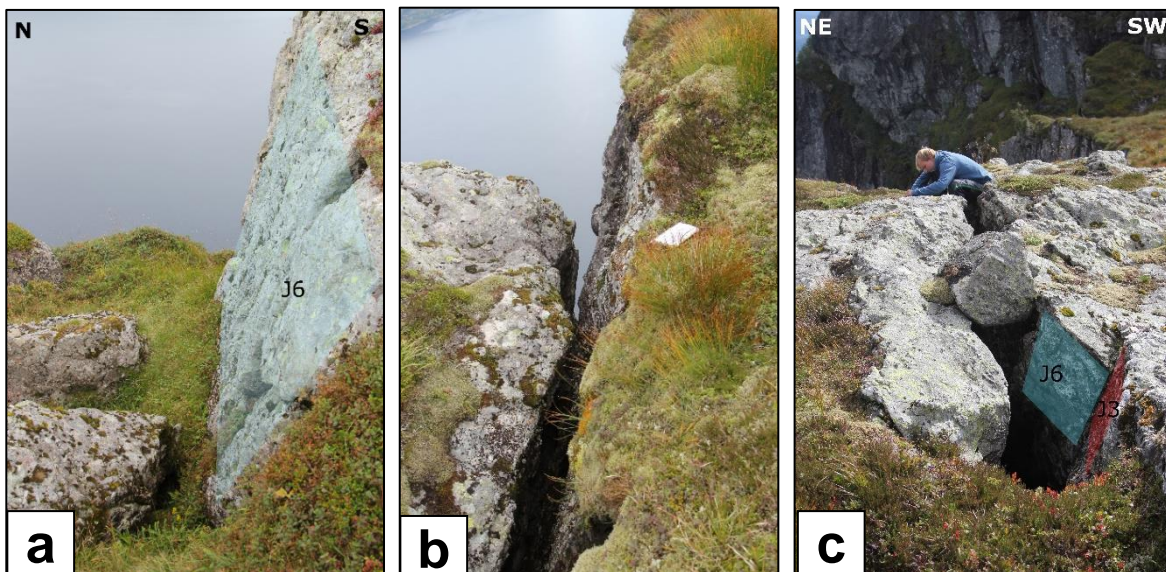
Figure 4.15: Picture *a* shows the irregular surface of J6. Picture *b* shows the back scarp of location 8(chapter 4.4.2), with an opening of 10 cm. Picture *c* shows a stepwise structure between J6 and J3, with a spacing of approximately 1m.

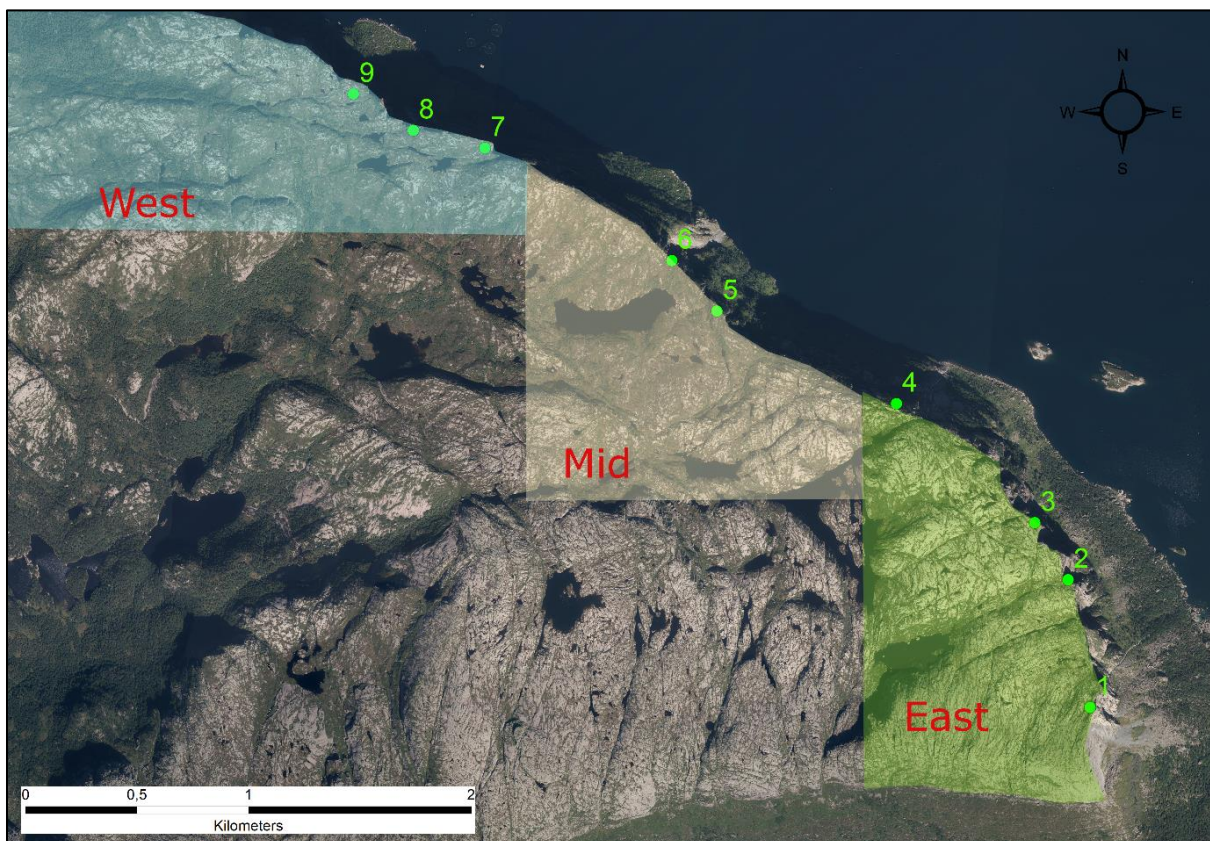
Figure 4.16: Orthophoto showing the locations of detected unstable slopes. The number connected to each unstable slope refers to the location in the further text.

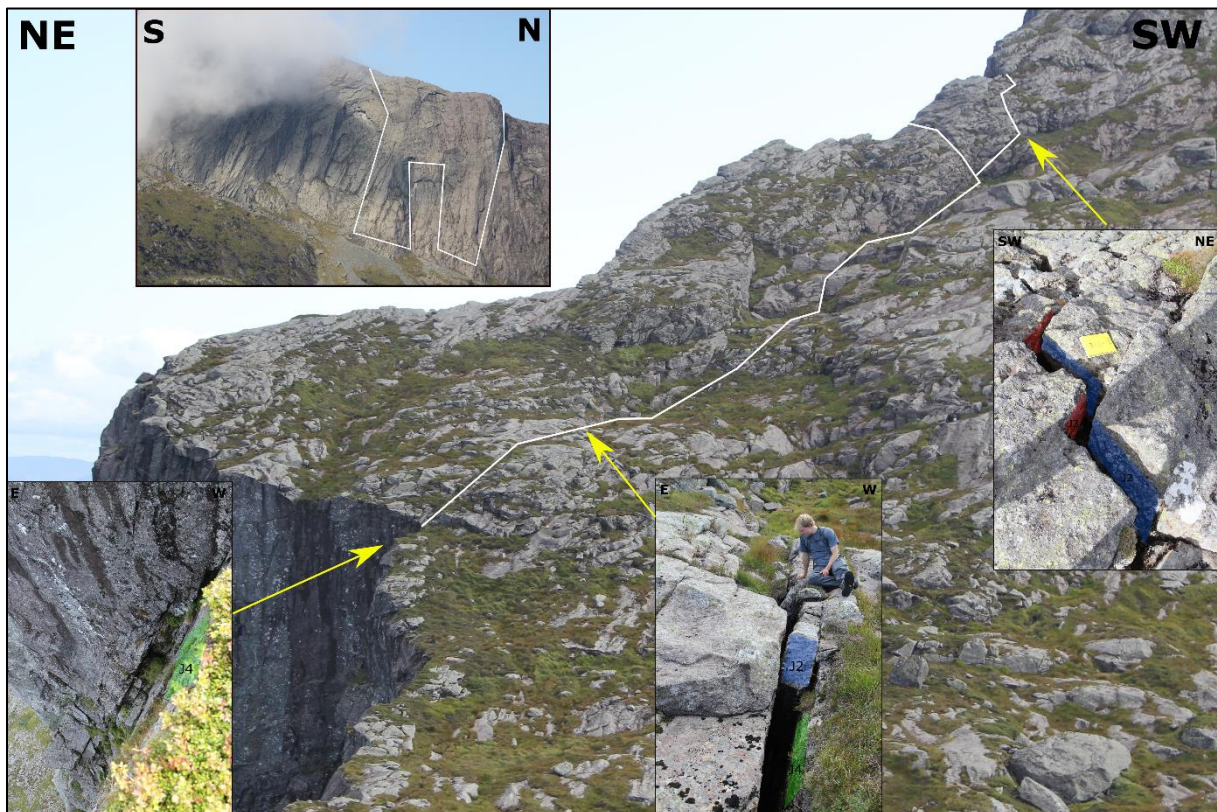
Figure 4.17: The white line follows the open back scarp detaching the unstable slope. Overview picture showing the unstable slope at the cliff face. Inserted pictures showing open structures along the back scarp and the southern flank.

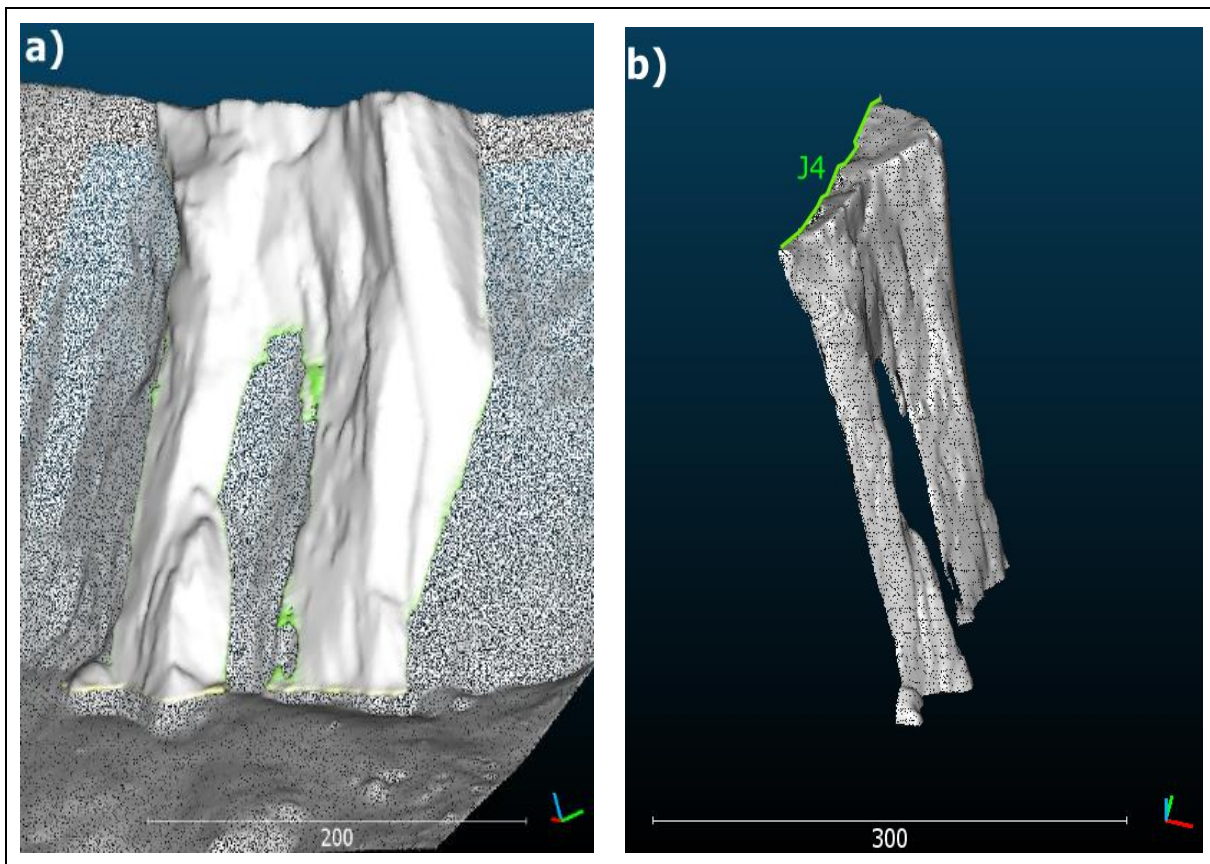
Figure 4.18: a) Scenario delimited by J4, with a toe line at 250m depth. The scenario consists of two columns separated at a depth of 120m. b) The rock mass of the scenario delimited by J4.
