Past slope collapse and current unstable slopes along a cliff at Hyllestad Kommune

Geology

Submission date: June 2018

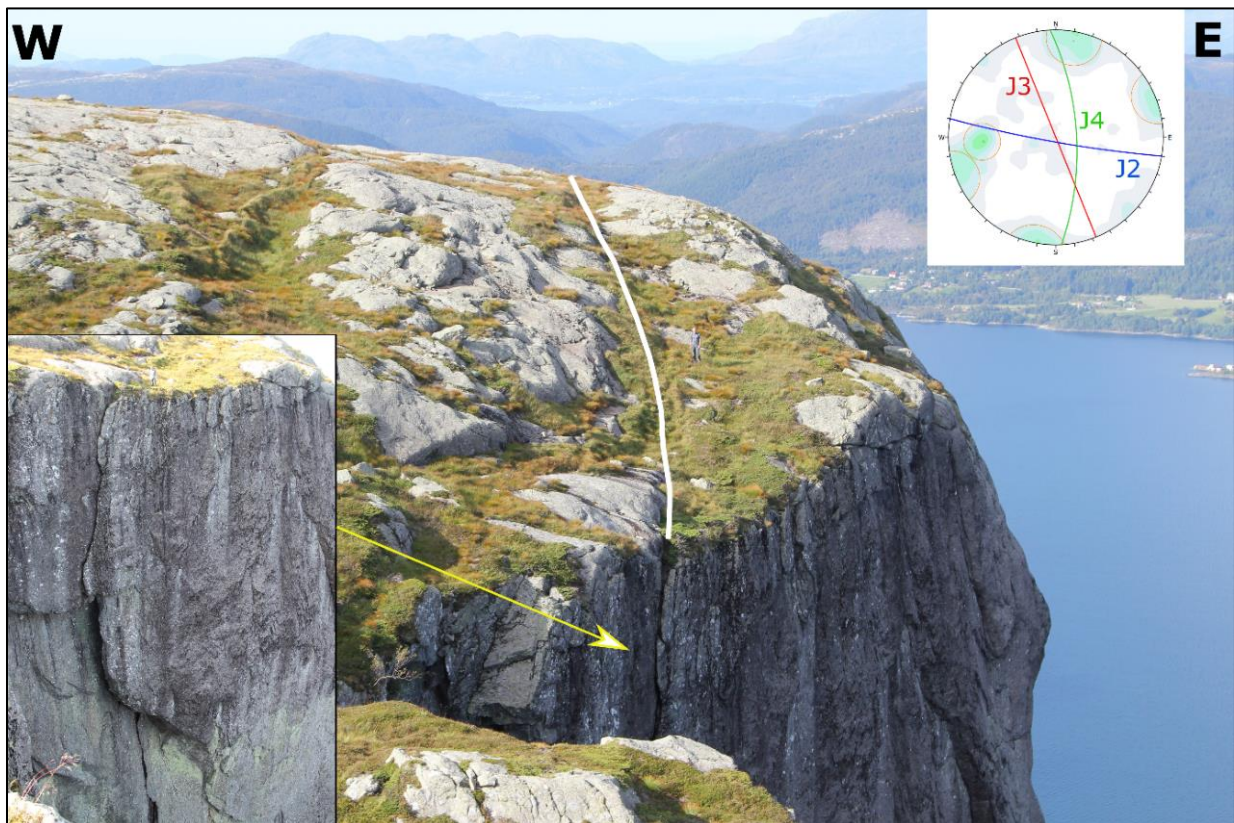
Figure 4.19: Main picture shows the depression intersecting the east flank with an open crack. Inserted figures show the fracture continuing down the cliff face, and that the depression follows a significant structure in the eastern domain, J4.

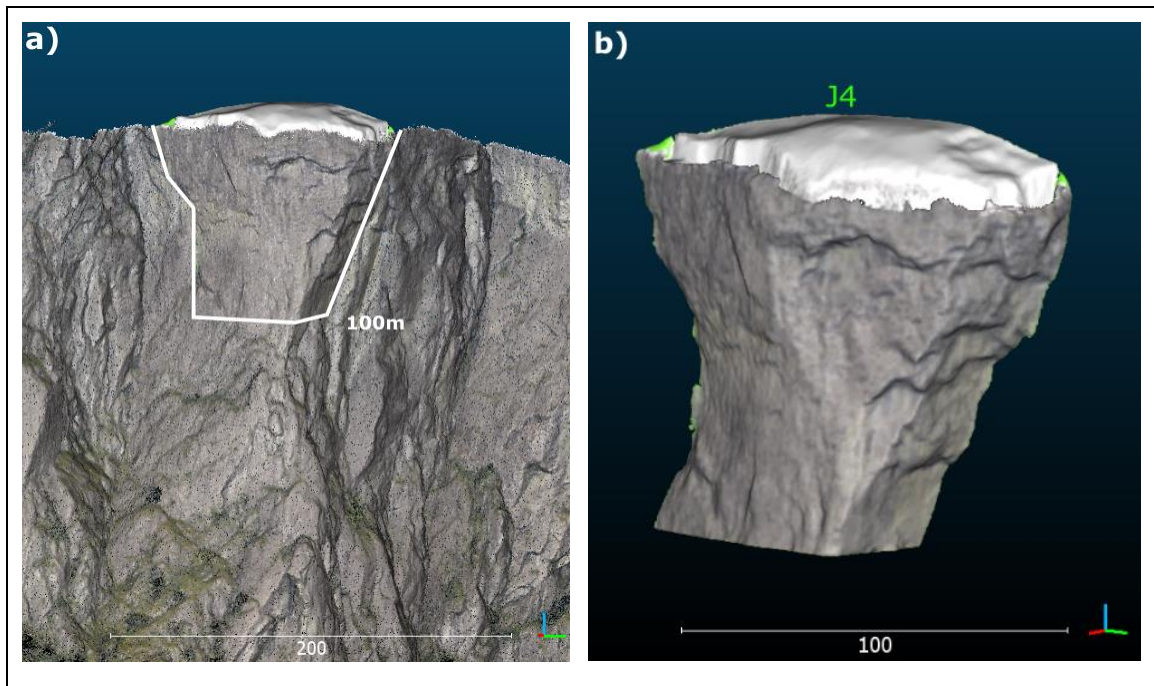
Figure 4.20: a) Picture from the 3D-model showing an overview of the block's position at the cliff face, with toe line at 100m depth. b) The rock mass of the unstable block delimited by J4.

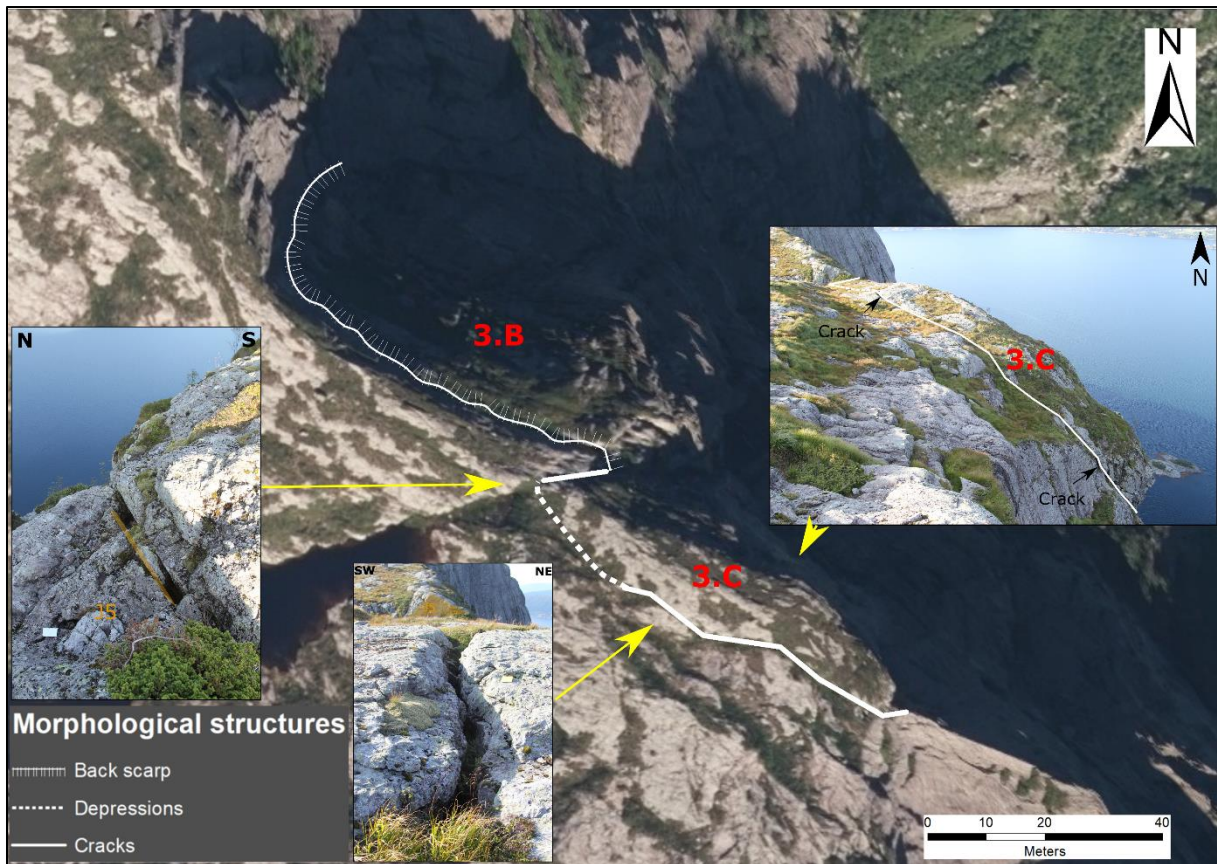
Figure 4.21: Orthophoto of location 3 showing the mapped morphological structures delimiting the two separate blocks of scenario B and scenario C. Inserted pictures show structures mapped on the orthophoto.

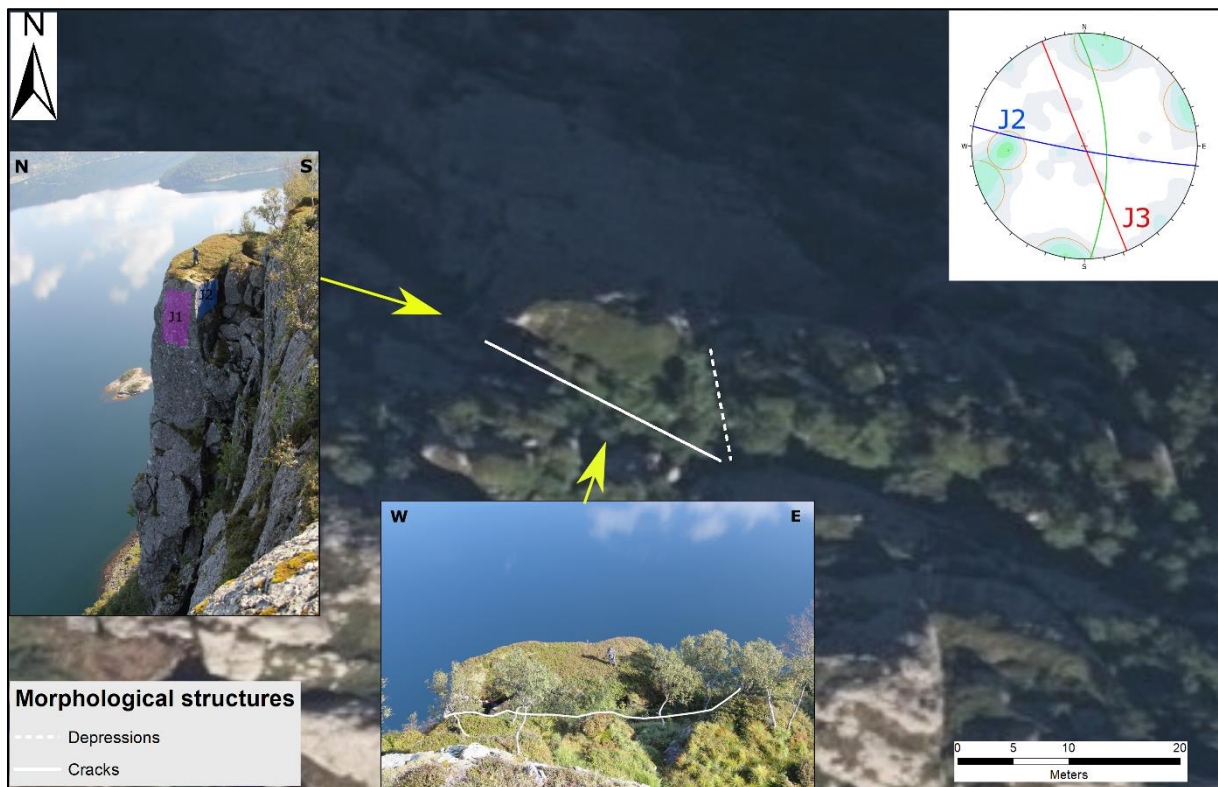
Figure 4.23: Orthophoto of location 4 showing the back scarp and the position of the depression along the orientation of J3. The inserted pictures show the back scarp from the side and from a birdview, as seen in the field. The stereoplot shows the significant structures of the domain surrounding location 4.

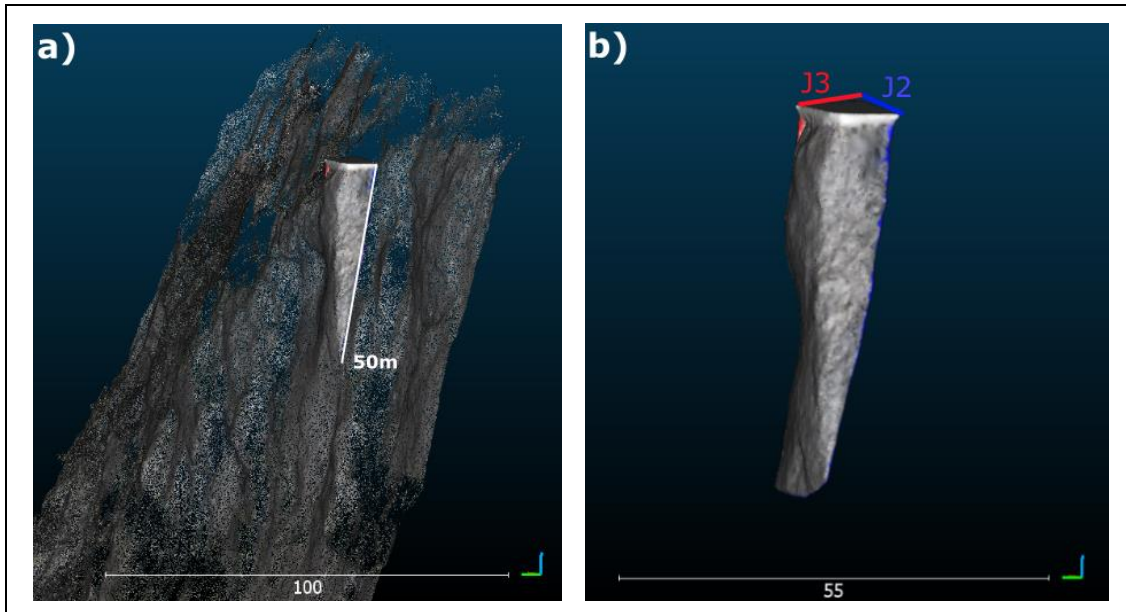
Figure 4.24: a) The unstable block is seen highlighted in the 3D-model. The toe is set to 50m below the top of the block. b) The block is controlled by structures following the orientation of J2 and J3.

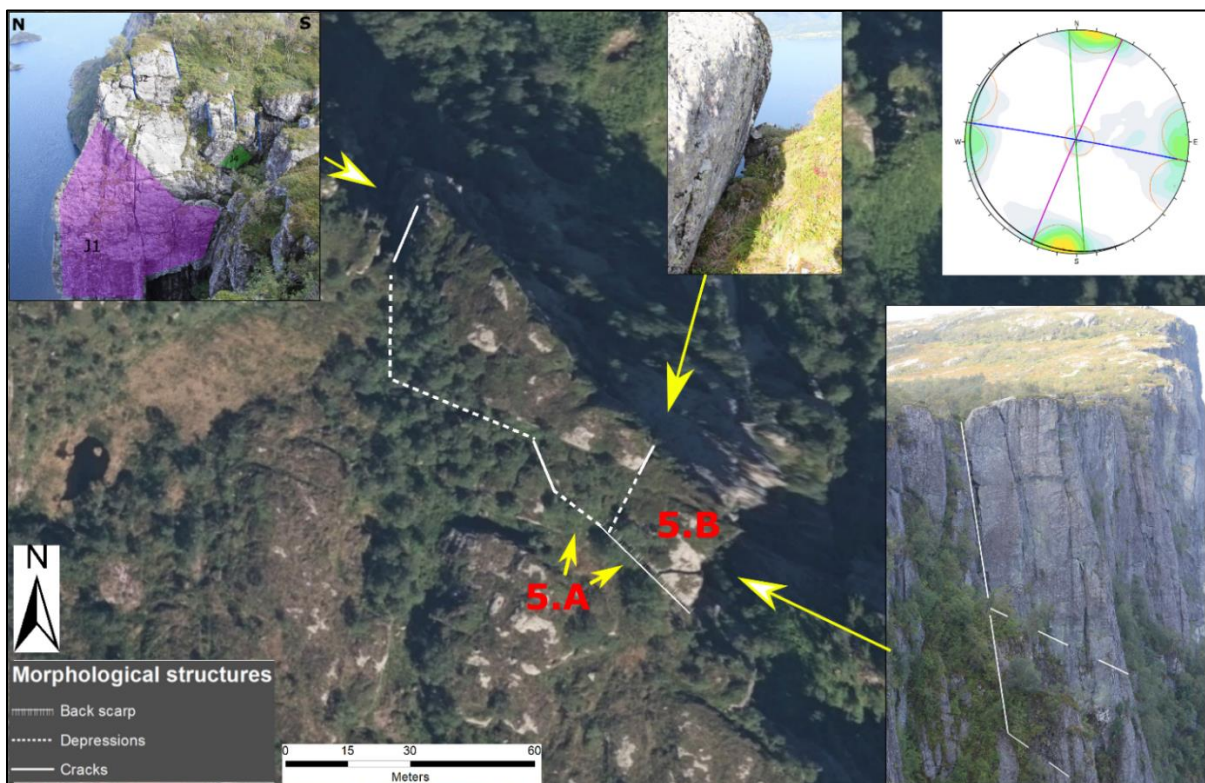
Figure 4.25: Orthophoto of location 5 with morphological structures drawn with white lines. Pictures are showing delimiting structures where upper pictures show lateral limits and the lower picture shows the interpreted toe lines of the scenarios at the eastern flank. The stereonet shows the significant structures for the mid domain.

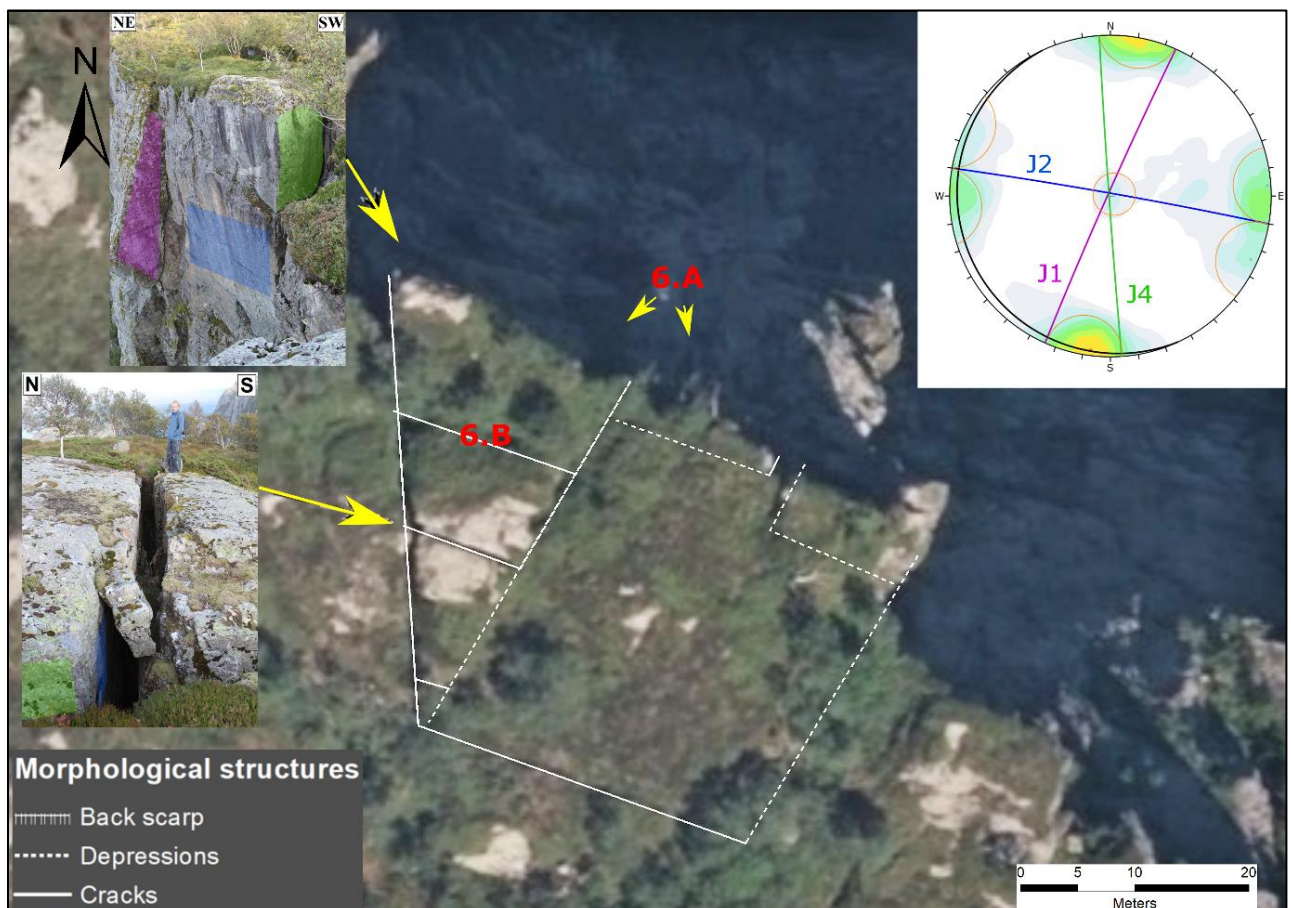
Figure 4.27: Orthophoto of location 6 with drawn morphological structures detected in the field. Pictures are showing delimiting structures, both back scarps following the orientation of J2 and flanks following the orientation of J1 and J4. The stereonet shows that the structures at the orthophoto coincide with the significant structures of the mid domain.

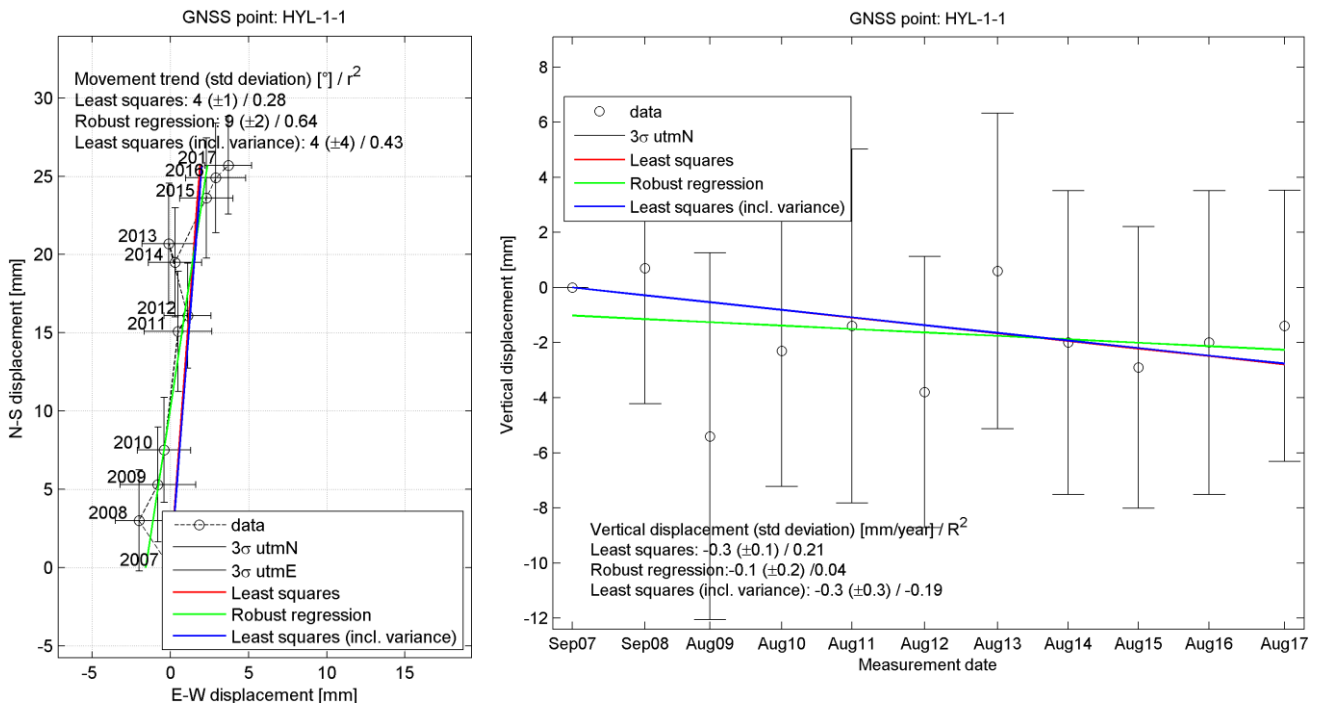
Figure 4.28: Analysis of the dGNSS-measurements of cumulative displacement of scenario 6.B in both horizontal and vertical direction.

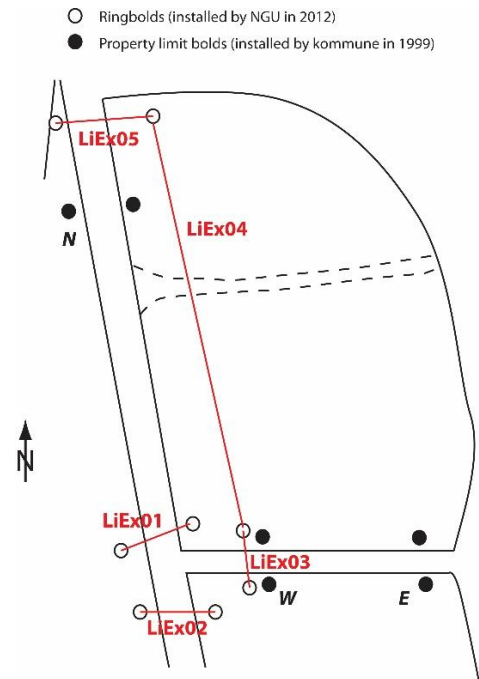
Figure 4.29: Placing of extensometer bolts, and the gaps measured at scenario 6.B.

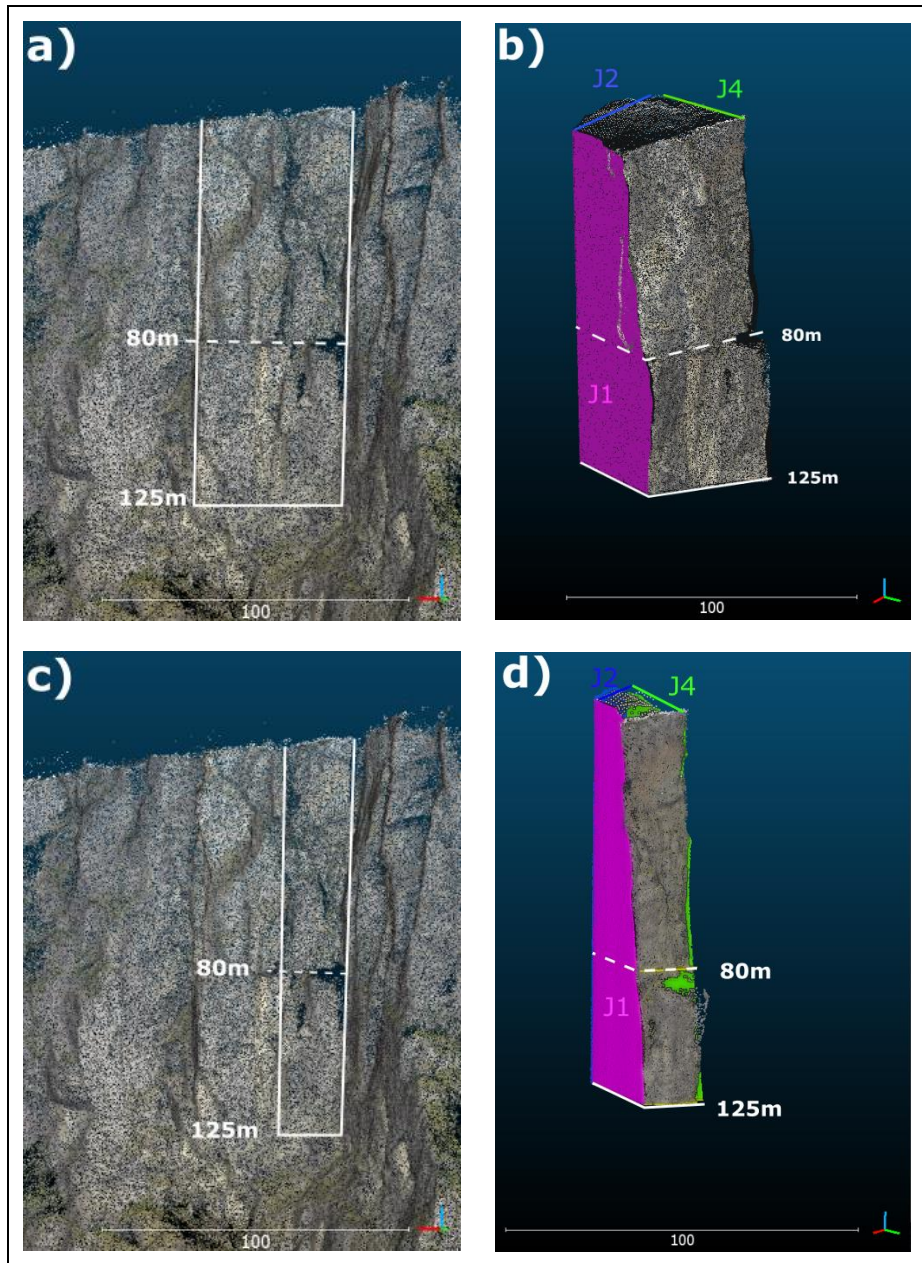
Figure 4.30: Figures from the 3D-model showing the unstable blocks of location 6. a) Overview of scenario A, with toe lines at 80m and 125m. b) Calculated volume of scenario A, with delimiting structures. c) Overview of scenario B. d) Calculated volume of scenario B with controlling structures marked.

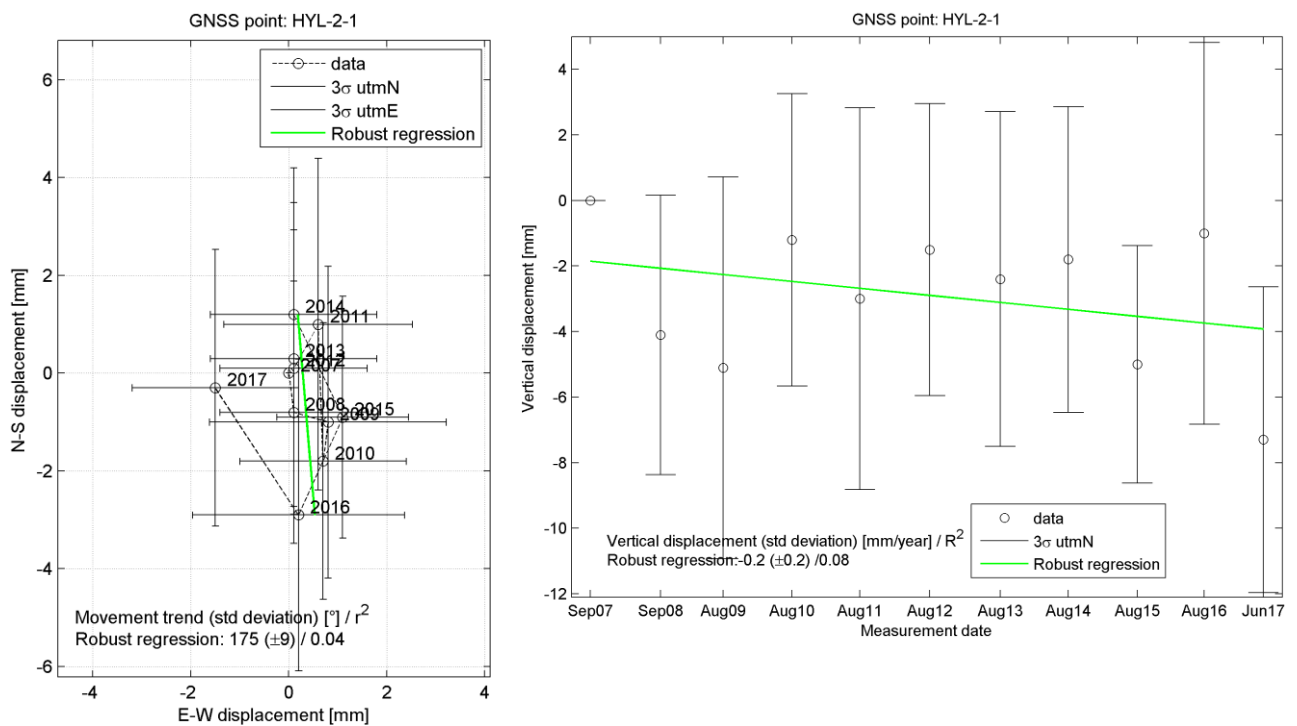
Figure 4.32: Analysis of the dGNSS-measurements of cumulative displacement of location 7 in both horizontal and vertical direction.

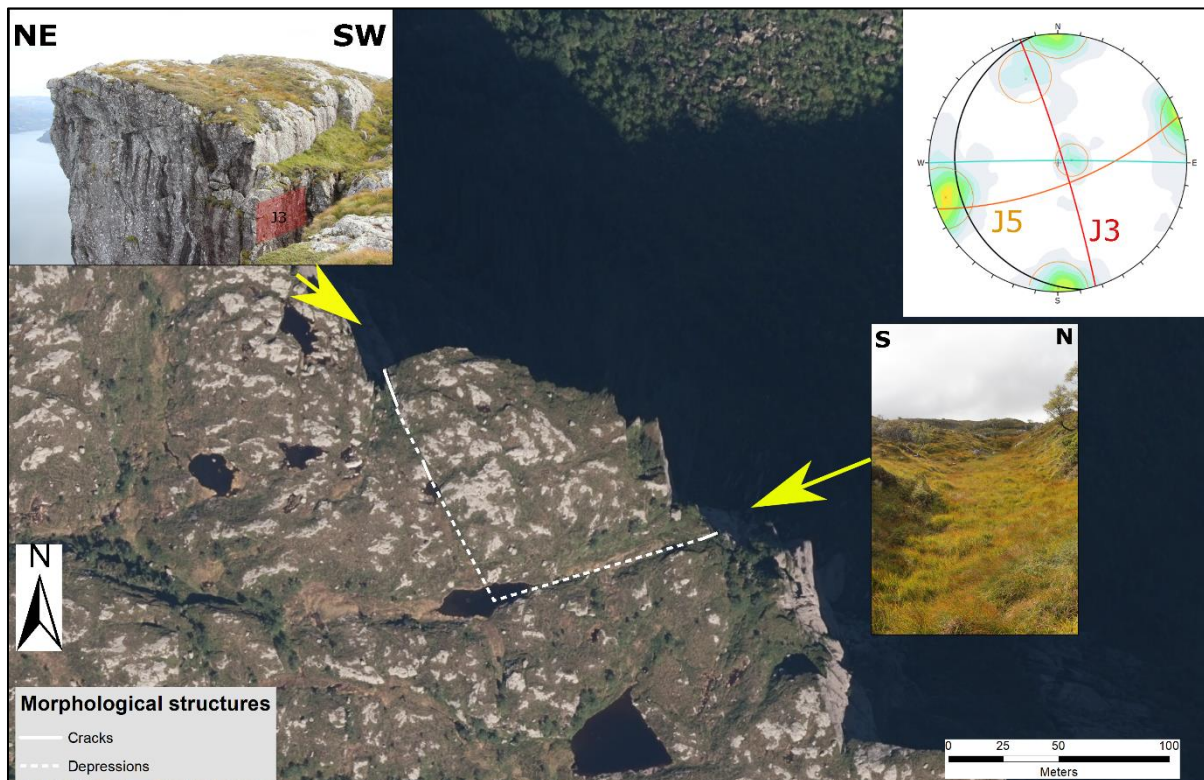
Figure 4.36: Orthophoto of location 9 showing the unstable block delimited by lineaments seen as depressions in the field, following the orientation of J3 and J5. Left picture shows the intersection between the lineament of J3 and the cliff face. Right picture shows the depression following the orientation of J5. The stereonet shows the coherence between the significant structures in the western domain and the lineaments in the orthophoto.

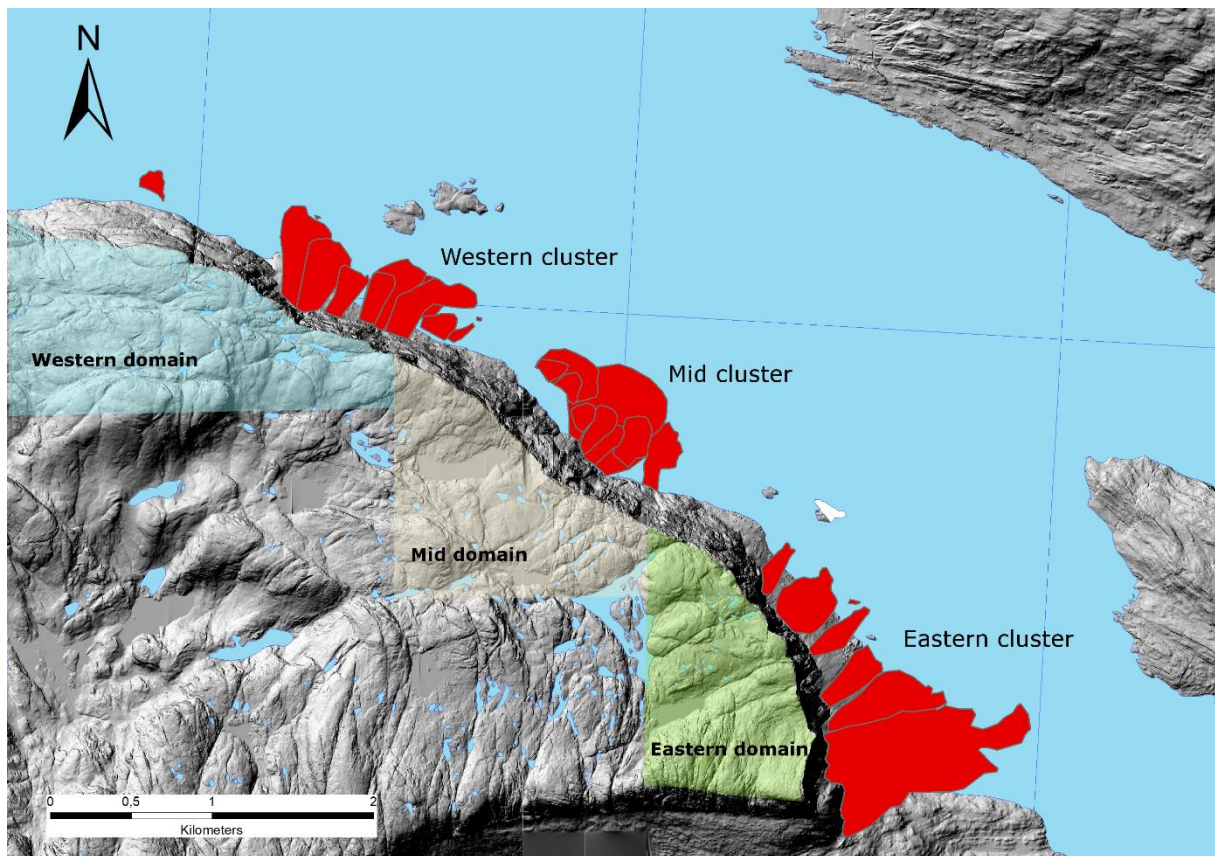
Figure 4.38: Overview of deposits detected in Aafjorden along the cliff of Lifjellet. The deposits cluster into three clusters called the eastern, mid, and western cluster.

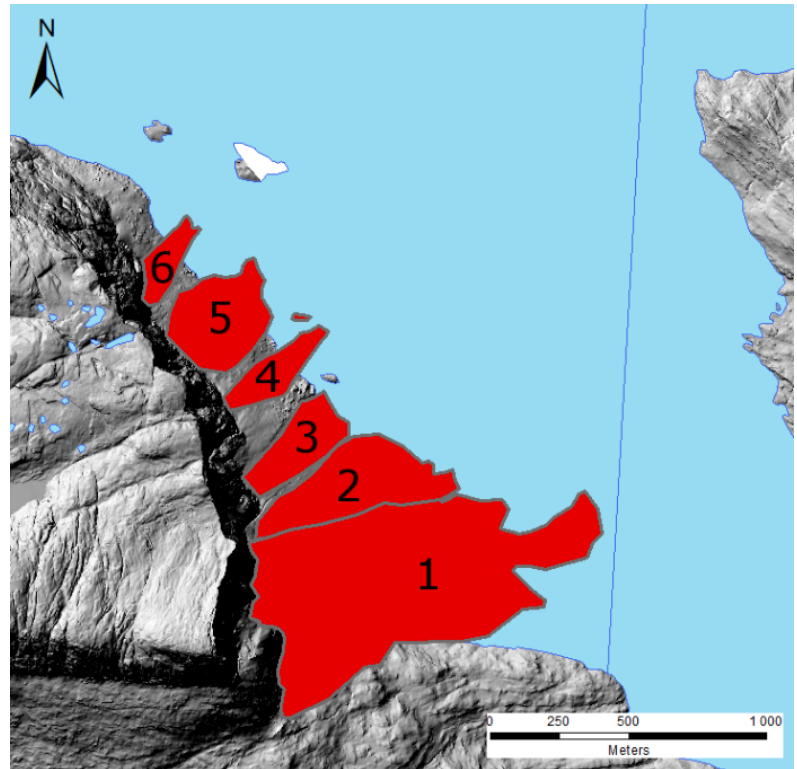
Figure 4.39: Mapped deposits based on the theory of depositing explained in chapter 2.1.4.

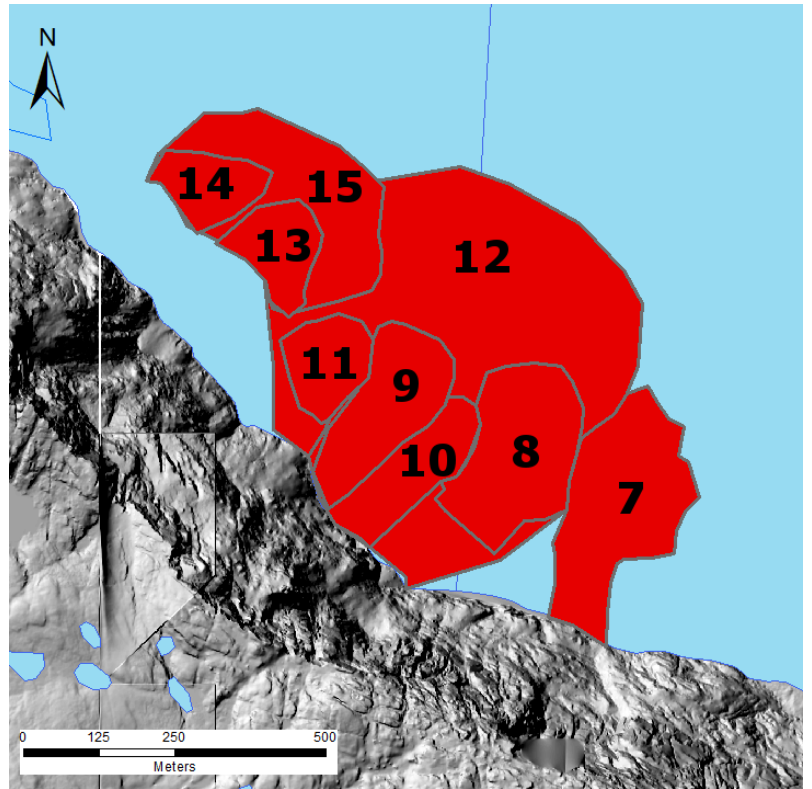
Figure 4.40: Mapped deposits based on the theory of deposition. The overlapping deposits have numbers based on their stratigraphic position.

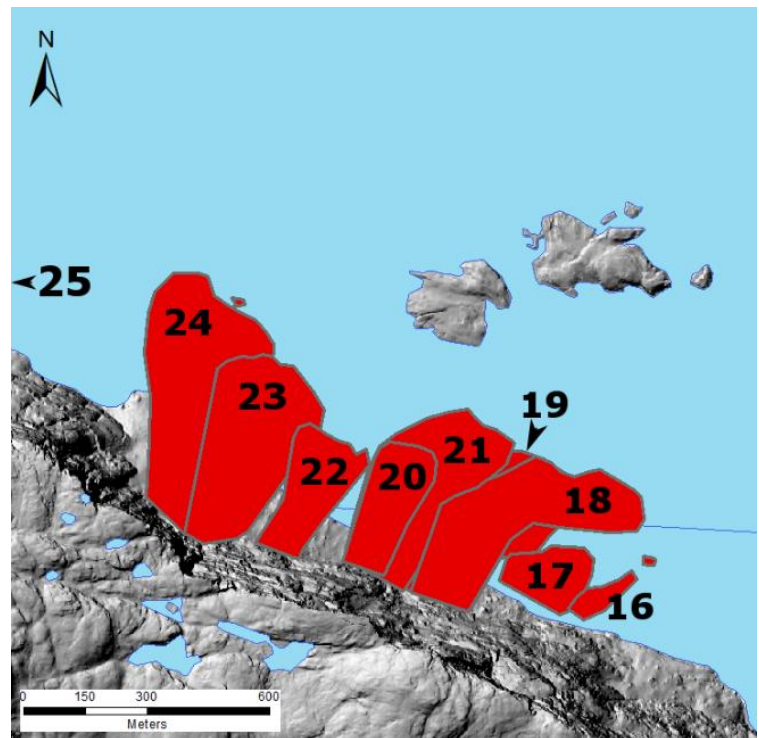
Figure 4.41: Mapped deposits shows a clustering of past events in the eastern domain.

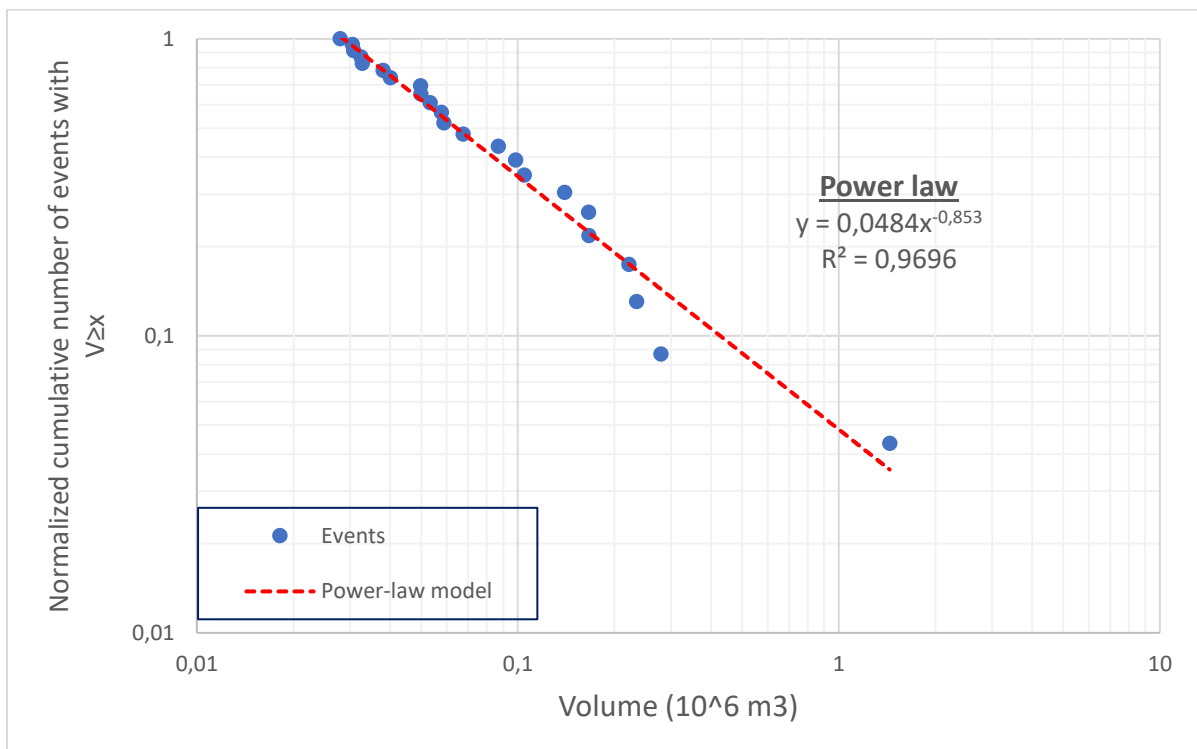
Figure 4.42: Plotted cumulated number of events against their volume size shows the best fit for the power-law model. The power-law equation is shown in the plot with accompanying exponents.

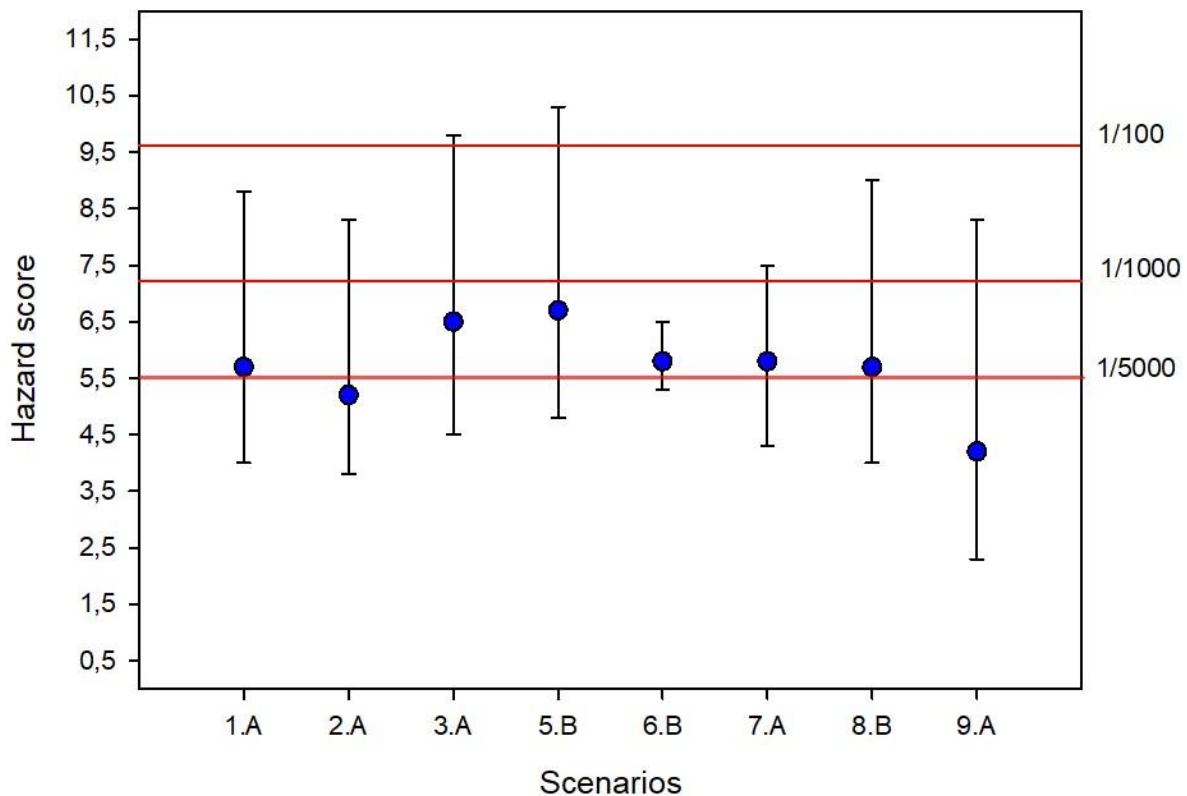
Figure 5.1: The scenarios with estimated highest hazard scores of each location displayed by their mean hazard score, and max and min values as uncertainty limits. Thresholds (red lines) represents an annual probability for the safety classes S1, S2 and S3.

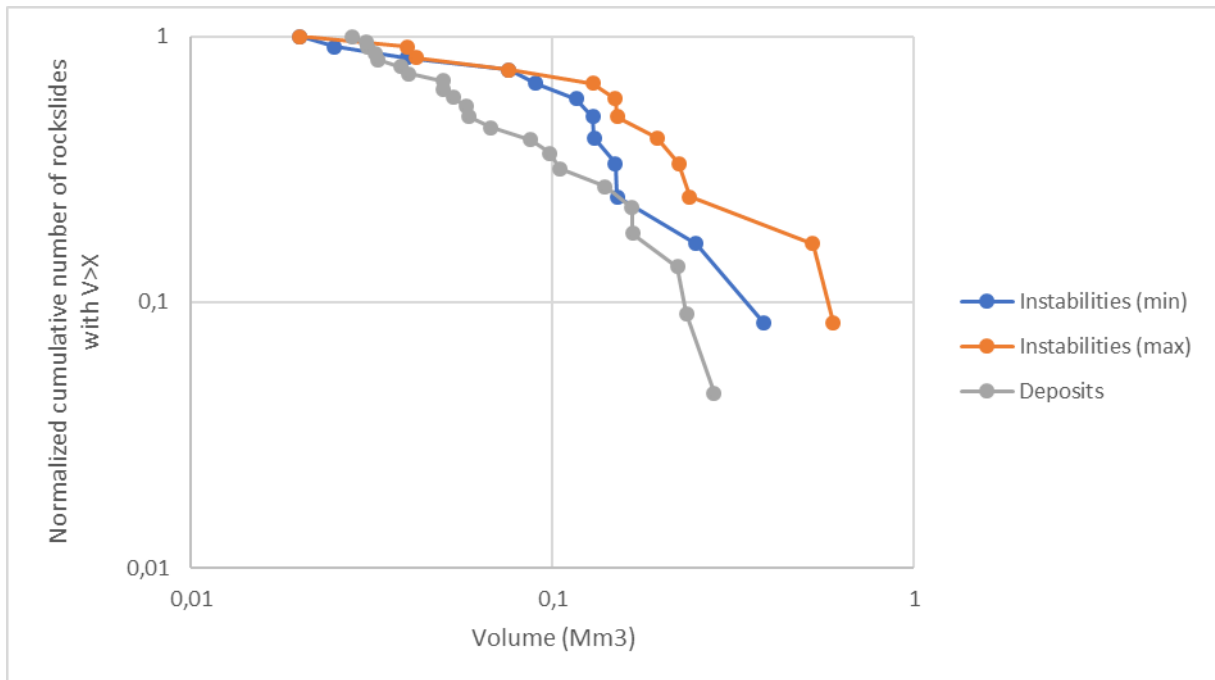
Figure 5.2: Volume-frequency distribution of the cumulated number of past events compared to the minimum and maximum calculated volumes of unstable slopes.

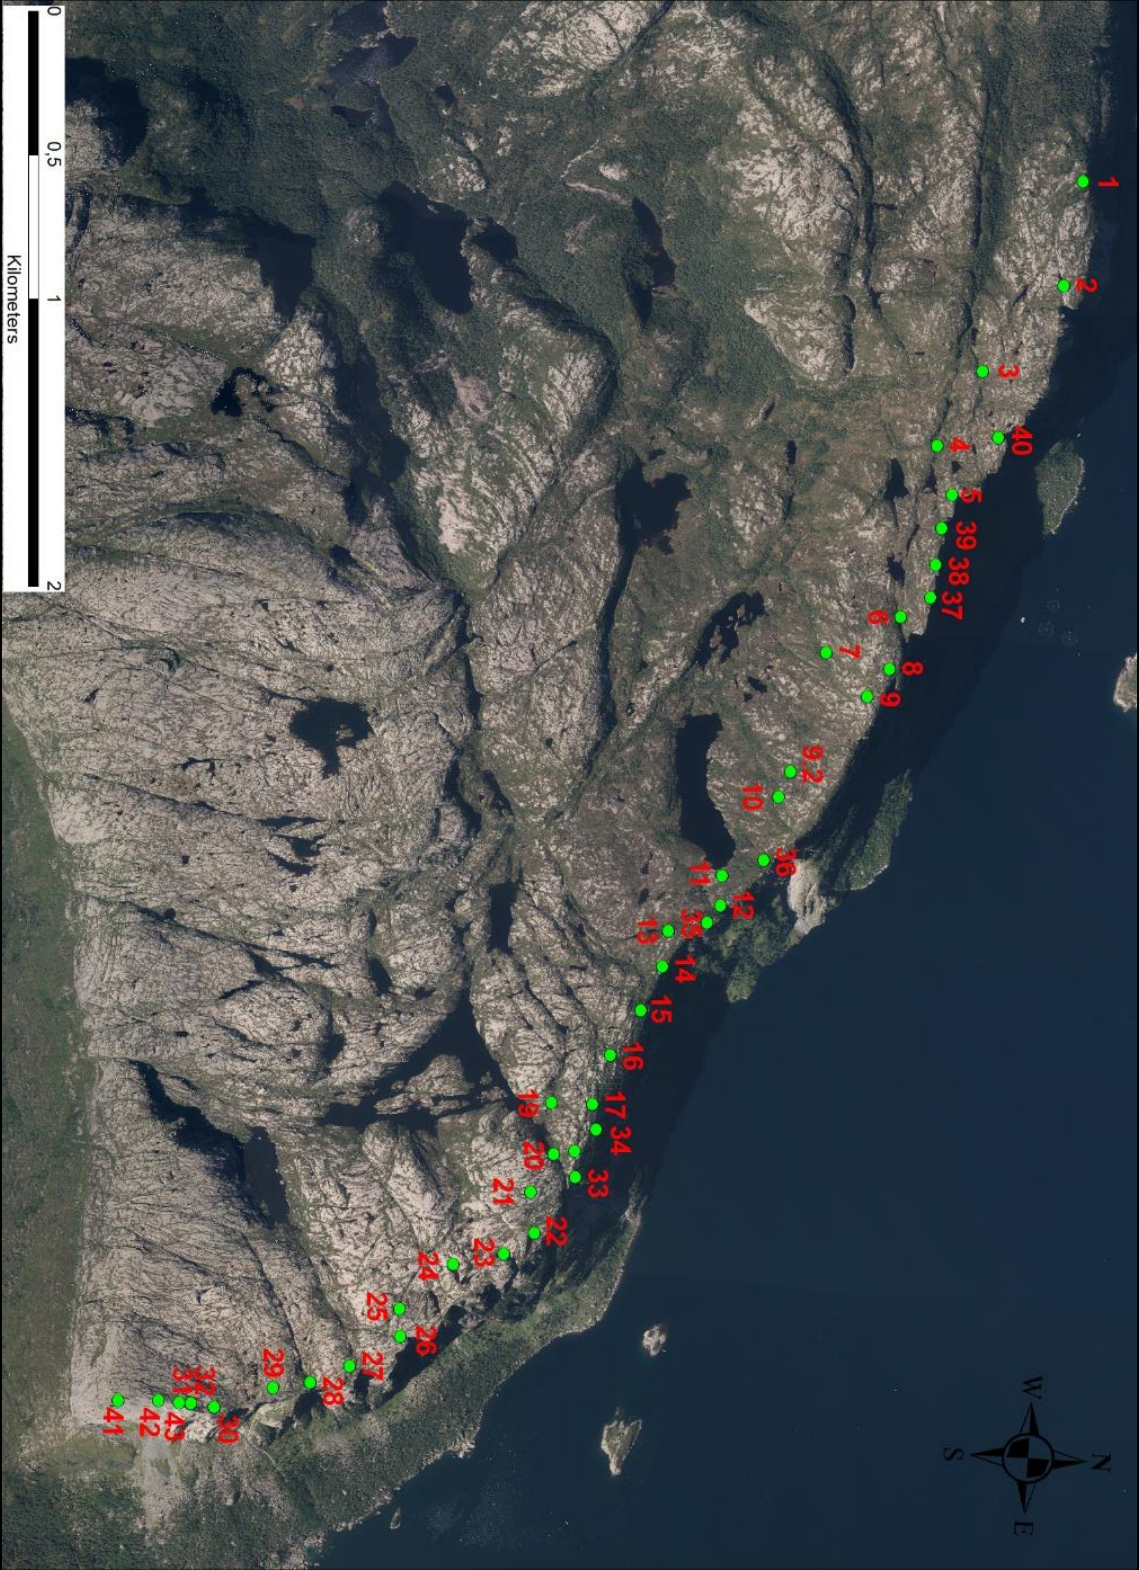
Appendix A

GPS-coordinates showing the position of the measurement stations.

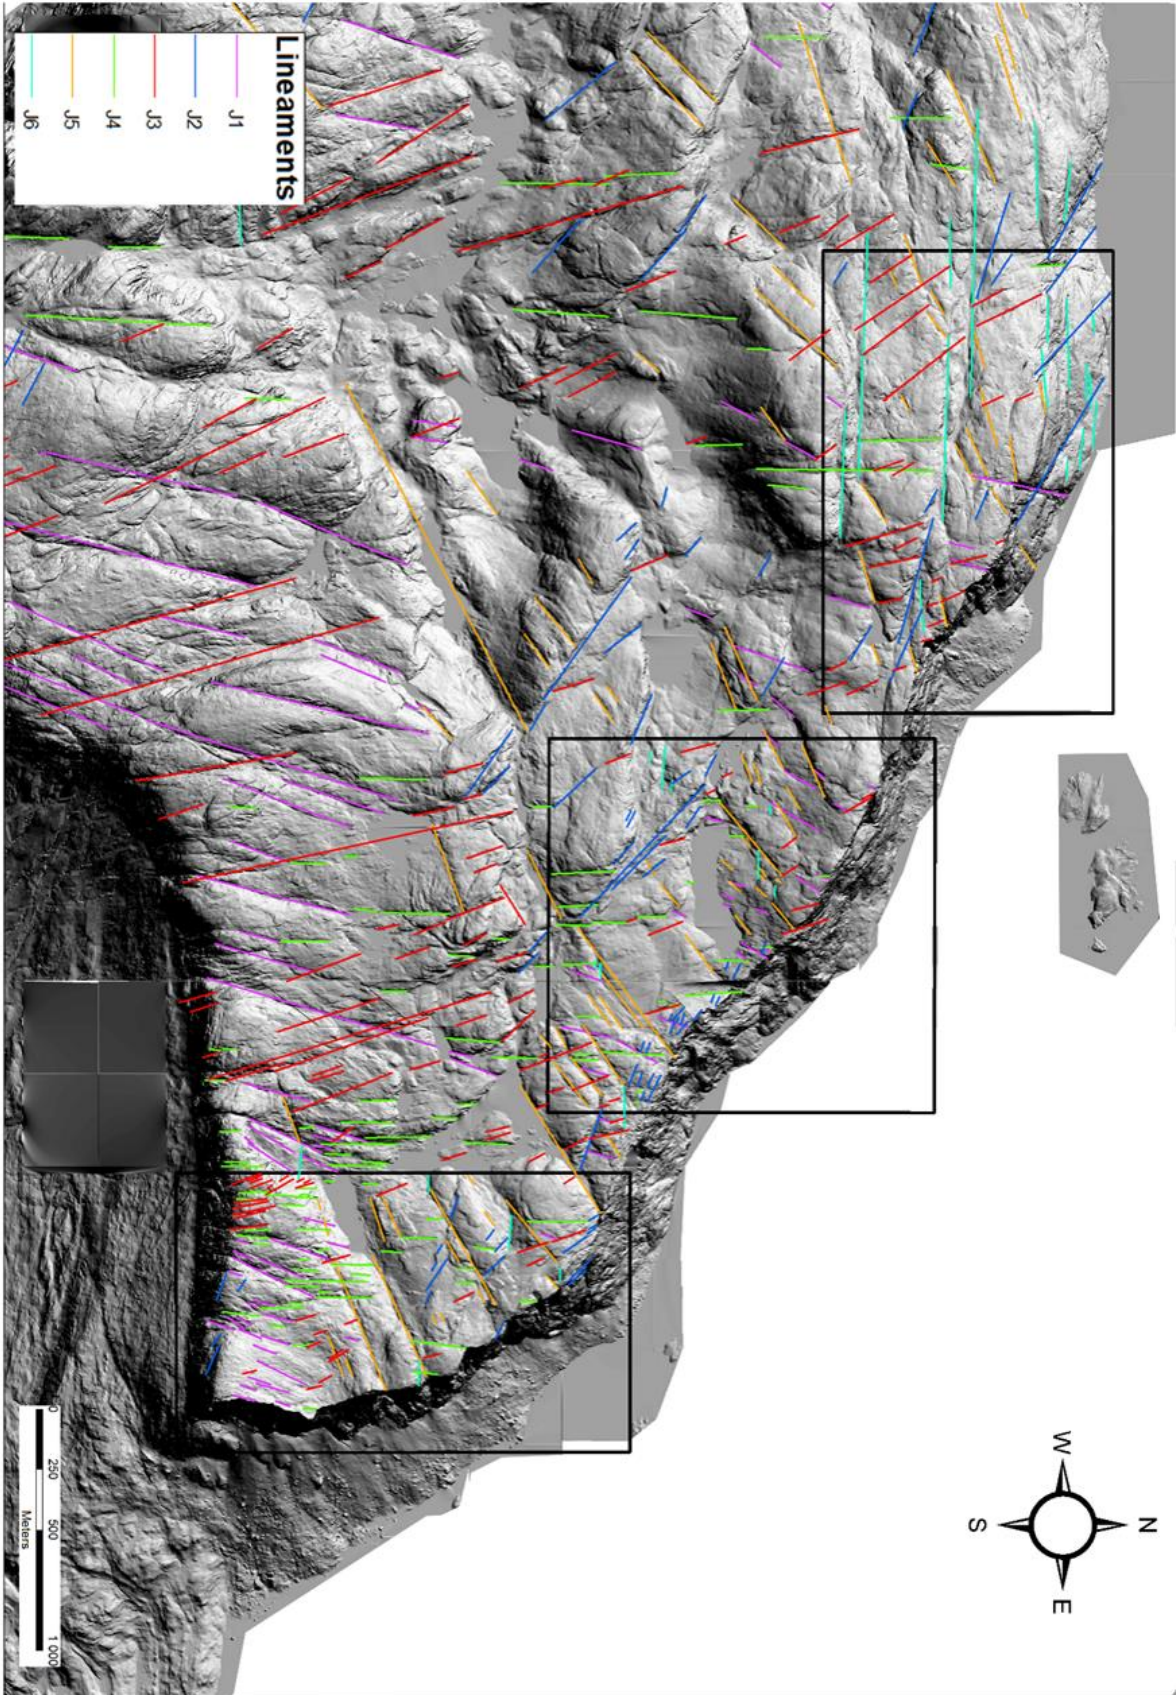
Hillshade map of Lifjellet, showing all lineaments mapped with colors according to orientation. The domains used for the individual lineament analysis for each domain is defined.
