# Analysis of the Prestura Rock Slope Failure and Quaternary mapping of Lake Tinnsjø, Telemark

**Hermann Hofseth Berntsen**

Norwegian University of Science and Technology  
Department of Geoscience and Petroleum

This thesis covers an analysis of the Prestura rockslope failure and quaternary mapping of lake Tinnsjø. The analysis of the Prestura rockslope failure involves a structural analysis, kinematic analysis, volume calculations, empirical run-out analysis and semi-empirical displacement wave analysis.

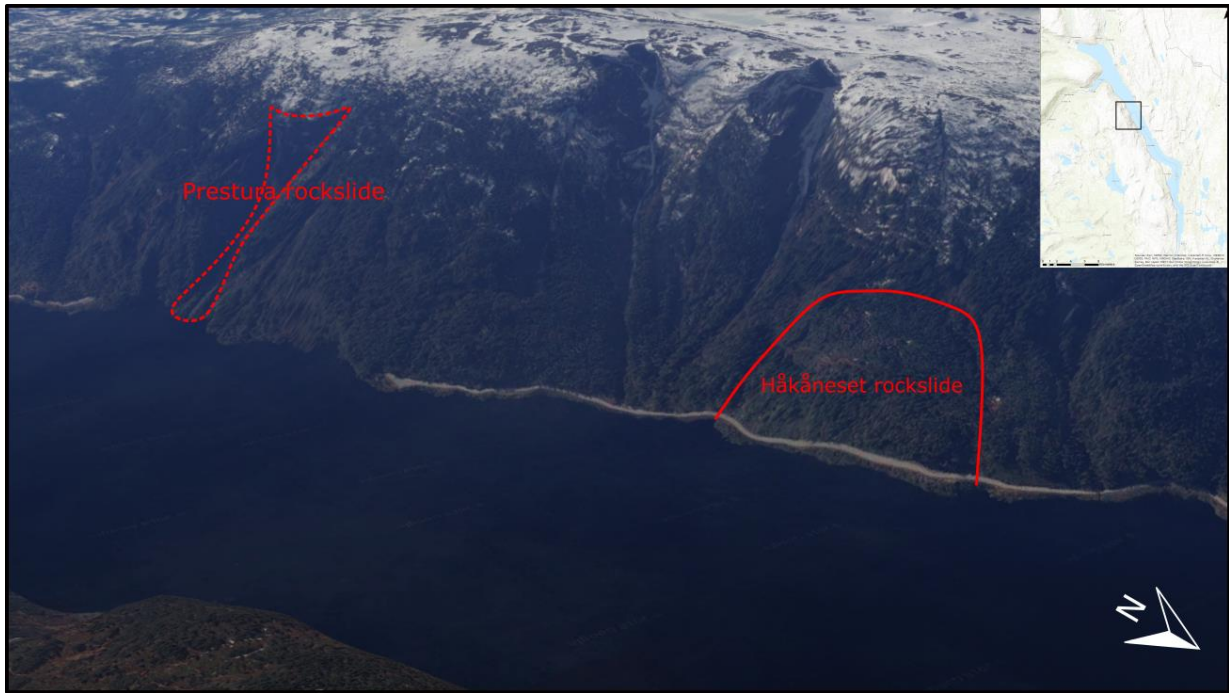
*Figure 5: 3D image of the unstable Håkåneset rockslide to the right and the prehistoric Prestura rockslide to the left. Located at the western margin of lake Tinnsjø. The outline of Håkåneset is defined by Sollie (2014), based on old bathymetrical data. Modified from Google earth.*

On the western shore of Lake Tinnsjø is the unstable slope Håkåneset localized. Håkåneset is a part of the Norwegian geological survey's (NGU) surveillance program. A potential rock avalanche might create displacement waves with potential hazardous consequences around the lake shore (Sollie, 2014). NGU's mapping program for unstable rockslopes is focusing on defining this hazard. However, preliminary displacement measurements (Sollie, 2014) indicate that deformation rates of today are very low. A similar event, which also might have created displacement waves, is the Prestura rockslope failure, located 2 km south of Håkåneset (Figure 5).

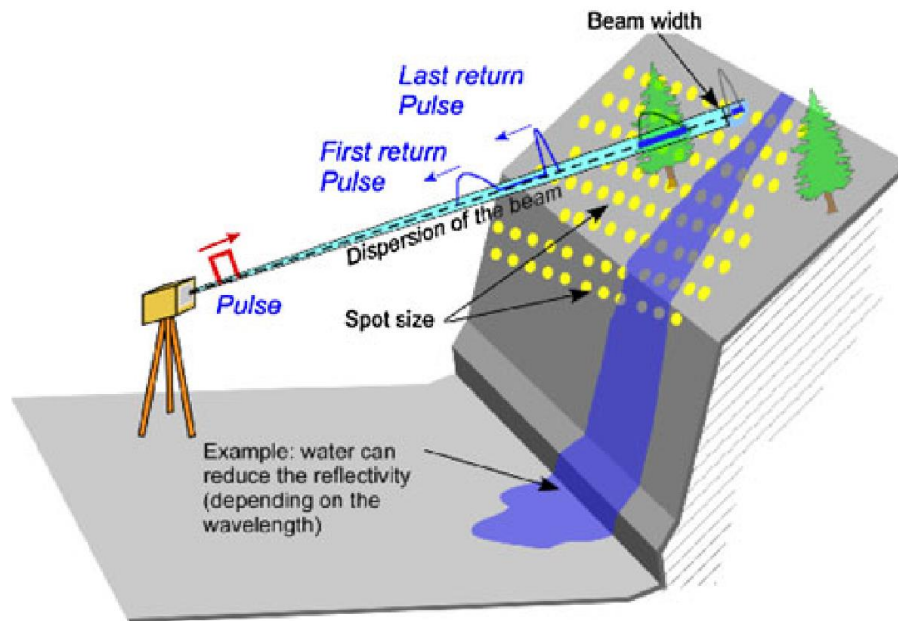
Figure 27: Main principle of LiDAR scan, modified from (Jaboyedoff *et al.*, 2012)

Figure 27 illustrates the main principles of the pulse method. The laser emits laser pulses, and these pulses are reflected when hitting various objects (ground surface, vegetation, constructions etc.). By recording the time ( $\Delta t$ ) it takes for a laser pulse to return to the sensor, it is possible to determine the distance to the object that caused the reflection of the pulse, and by knowing the position and the line of sight (LOS) of the laser scanner. It is possible to determine the position of the reflected surface, represented by x, y and z coordinates (Jaboyedoff *et al.*, 2012).

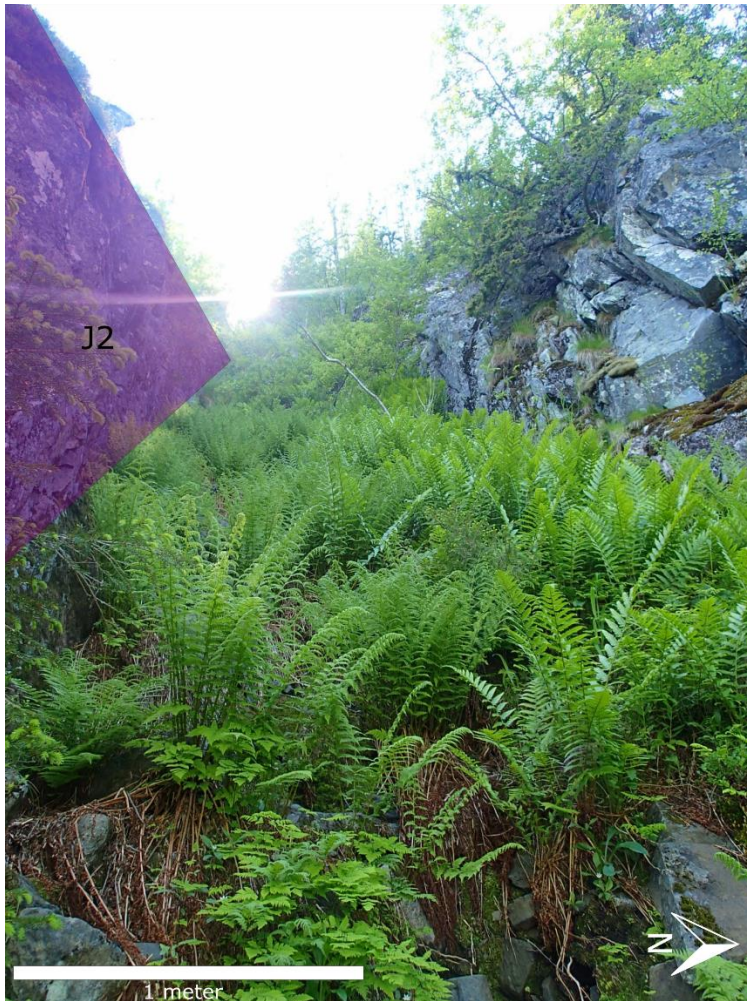
Figure 36: Photo of ENE-WSW striking weakness zone, with an aperture of 3m. Filled with vegetation and soil. Joint set 2 (J2) is dipping steep towards North.

J2 is dipping consistently to the north for the entire area. The joint surface is interpreted as smooth and planar with a persistence shown in Figure 36 and Figure 41, often over 4 meters, and over several km along the ENE – WSW striking weakness zones (Figure 35 and Figure 39). The aperture is usually less than a cm, except along the ENE-WSW dipping weakness zones, where it is observed up to 5 meters (Figure 36). The properties of J2 is summarized in Table 8.

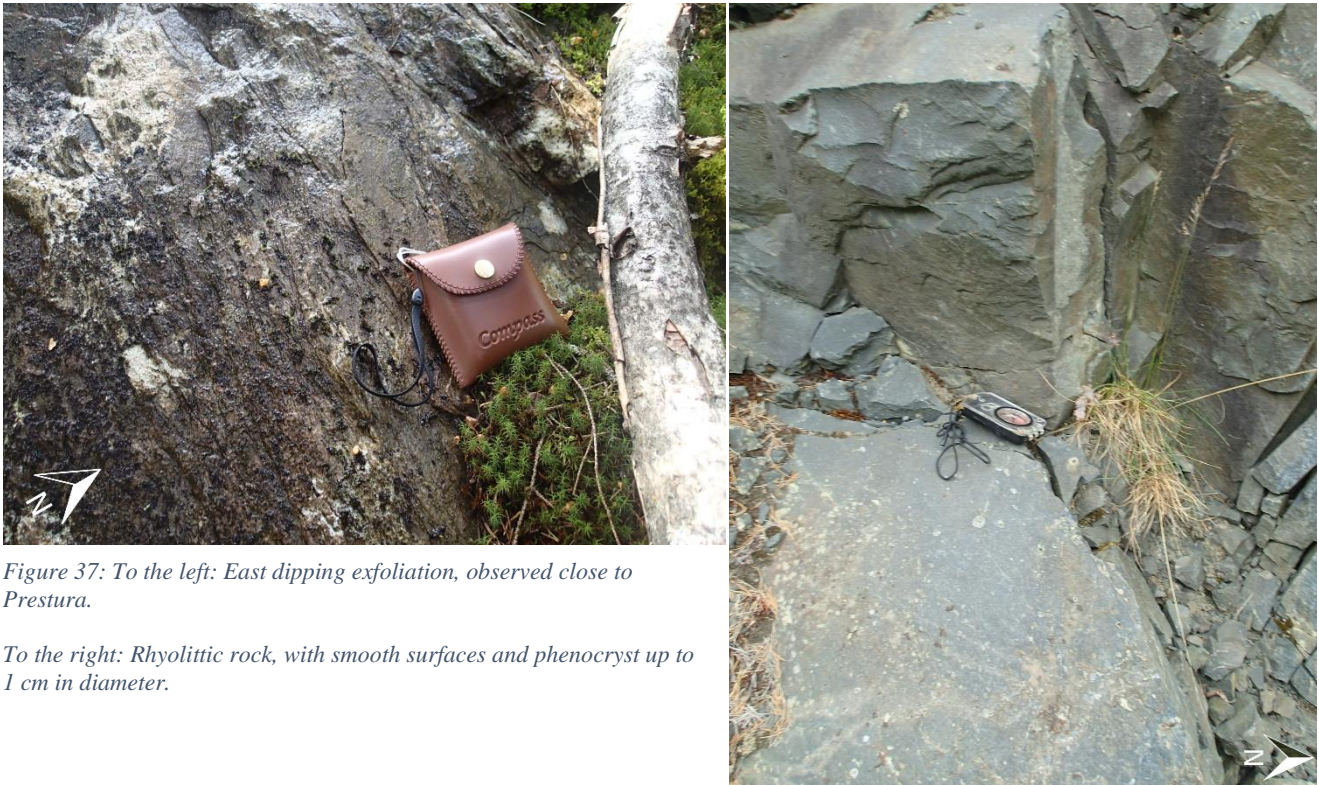
Figure 37: To the left: East dipping exfoliation, observed close to Prestura.

To the right: Rhyolitic rock, with smooth surfaces and phenocryst up to 1 cm in diameter.

The dominating bedrock in the area is interpreted as rhyolite (Dons and Jorde, 1979, Statens Vegvesen, 1989), characterized as a dark grey/brown fine grained rock with up to 1 cm diameter white mineralizations. These mineralizations are interpreted as phenocryst (Sollie, 2014, Statens Vegvesen, 1989) and consist of light minerals like feldspar, quartz and calcite. At several locations it is possible to observe exfoliation structures in the bedrock, dipping 60-80° parallel to the slope, towards east, as shown in Figure 37.

J1 is oriented parallel to the rock slope dipping towards the lake, interpreted as exfoliation joints. This is supported by the observation of schistosity (Figure 37), interpreted as exfoliation, having the same orientation as the measured J1 joint set. The joints are often covered by a thin, dark material that according to Statens Vegvesen (1989) consists of chlorite minerals, creating a smooth surface. J1 is the dominating joint set in the area and the easiest one to map, thus it is the most measured joint set (248 poles). From Figure 40 it is possible to follow J1 along the entire failure area of the Prestura rockslide, which is interpreted as the surface of rupture. The persistence is observed over 10s of meters and even several kilometres in the NNW-SSE striking weakness zones (Figure 35, Figure 39 and Figure 40), while the aperture of J1 is mostly observed as less than a cm. The properties of J1 are summarized in Table 7.

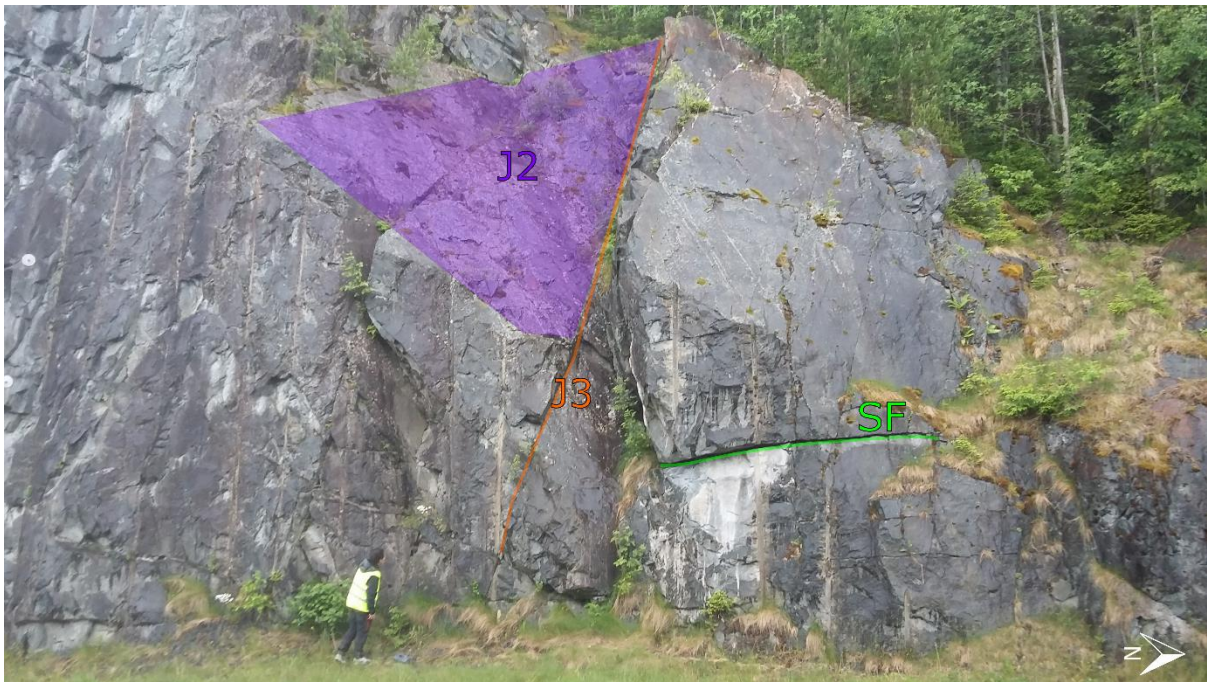
Figure 38: Location D2 (see appendix E) along the roadcut. SF is dipping nearly horizontal into the slope, with an undulating smooth surface. A wedge failure is observed in the middle of the picture, created by the intersection of J2 and J3.

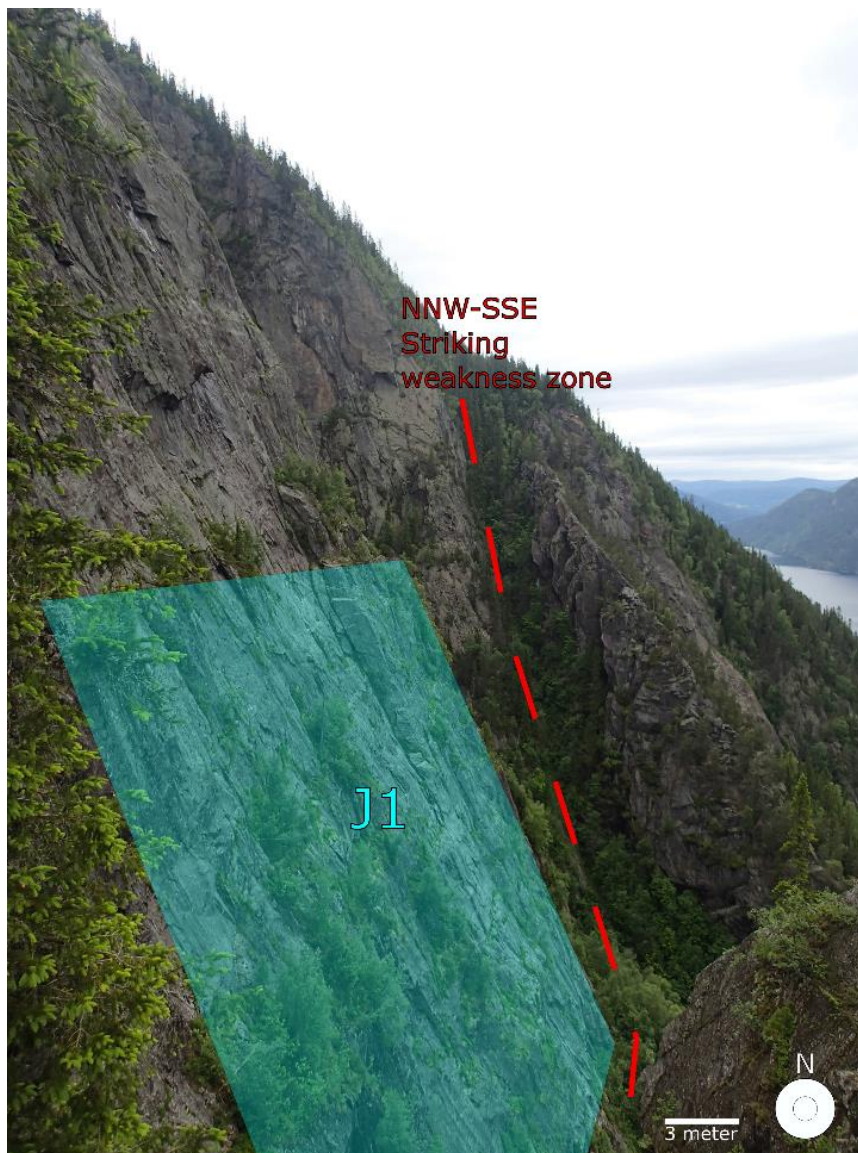
Figure 40: J1 and the NNW - SSE striking weakness zone oriented along the release surface of the Prestura rock slope failure, seen towards north.

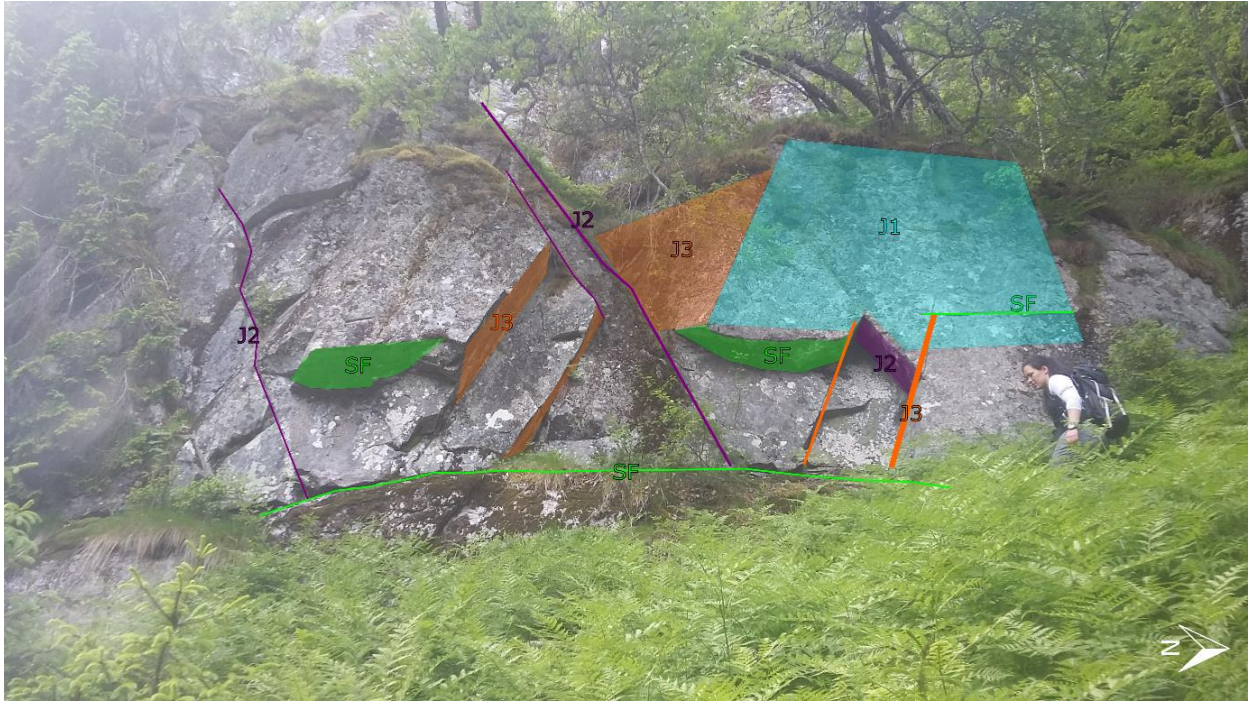
Figure 41: Locality C4 (see appendix E) north of the release surface. J1, J2, J3 and SF is evident in the terrain. J2 and J3 is creating small wedge failures along the steepest slopes. While SF is cutting J1 dipping into the slope.

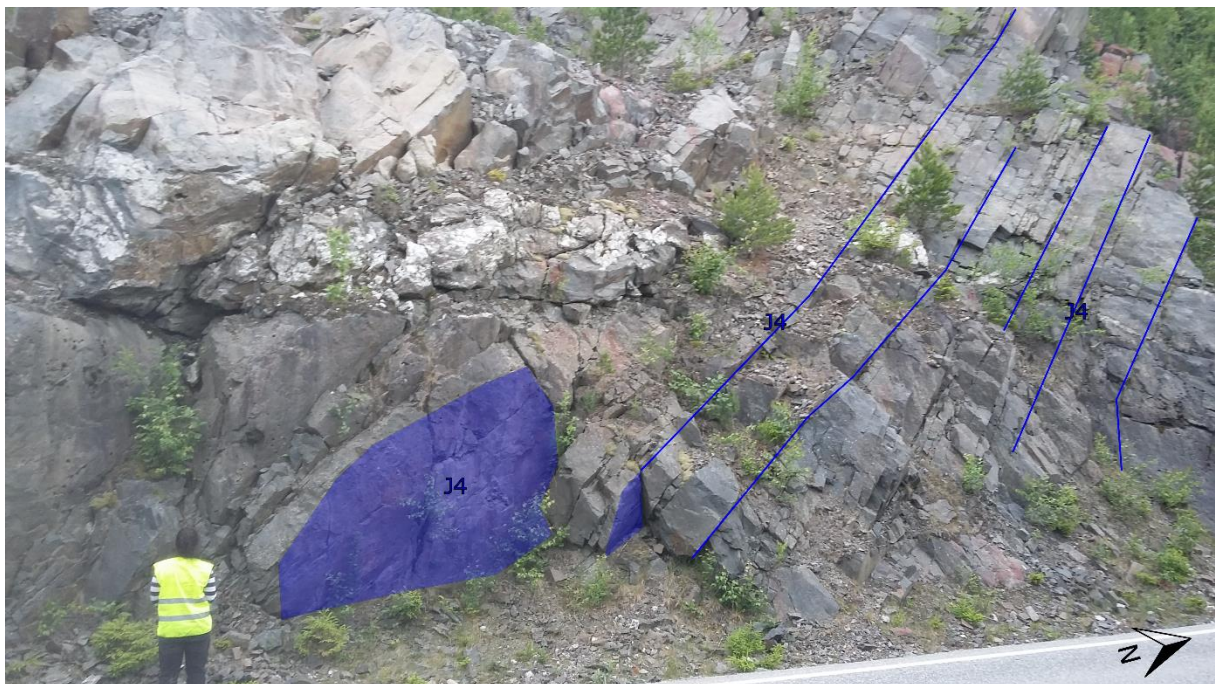
Figure 42: J4 observed at location D1 dipping into the slope.

J4 is dipping to the south-west, into the slope, as shown in Figure 42. The surface of J4 is considered smooth and planar, with a persistence up to 10s of meters, spacing from 0,5 to 1m and an aperture less than 1 cm. J4 is not as widespread as the other joint sets. It could only be documented at some specific locations (under 2% of the poles at the Prestura locality (stereonet 3) shown in the stereonet in Figure 39). This might be due to its almost vertical dip (almost 90°). Thus, it can be misinterpreted as J2 or J1 on several locations. However, by observing big rock bodies as shown in Figure 42, it is clear that J4 is a significant joint set. The properties of J4 is summarized in Table 10.

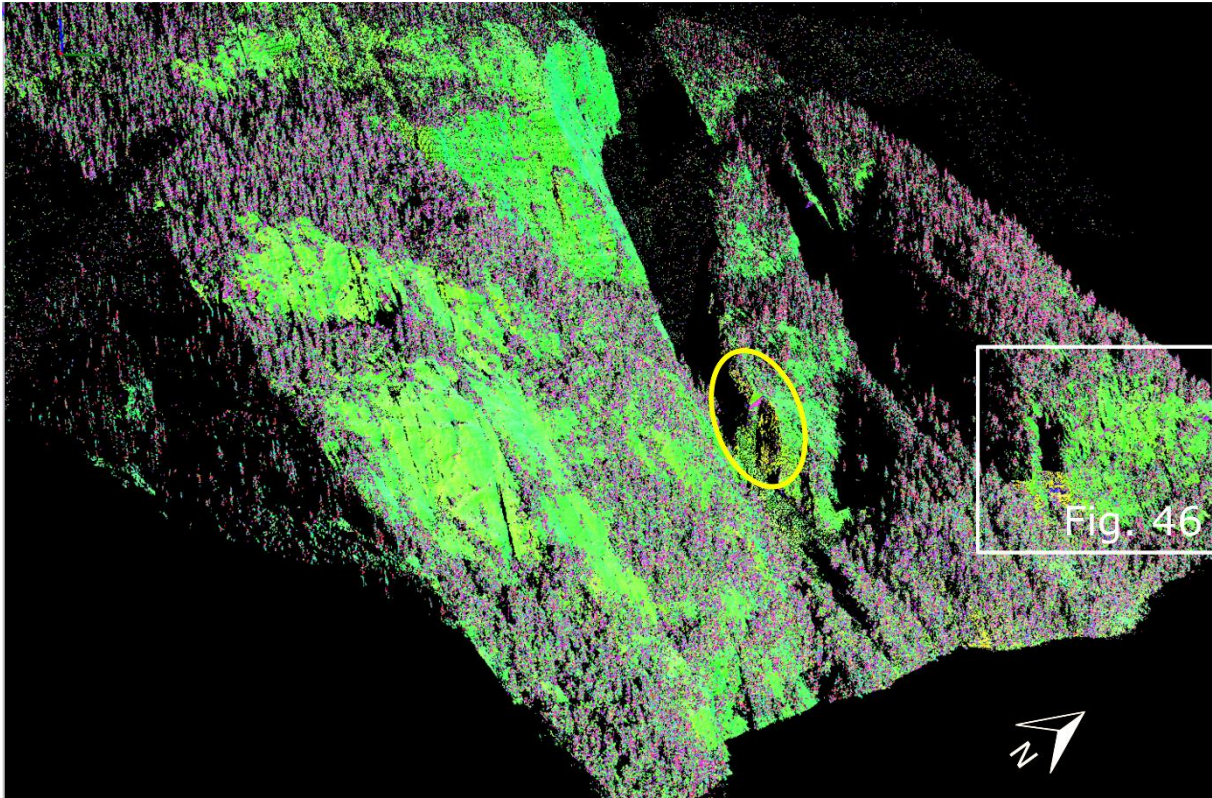
Figure 45: 3D image of failure area of the Prestura rockslide (with vegetation cover). Showing that the data in the northern lateral flanks is missing. The yellow circle represents the entire area of which yellow measurements are found.

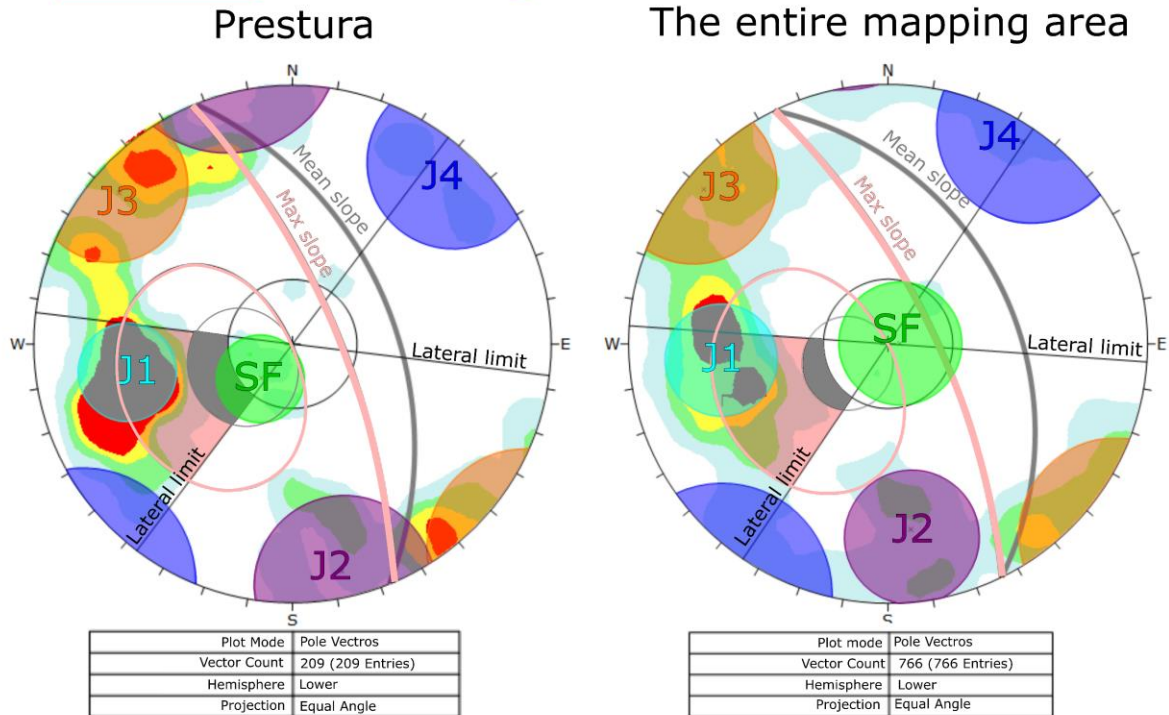
Figure 49: Kinematic feasibility test for planar sliding at Prestura failure area (left) and for the entire mapping area (right), showing variability cones of the poles for the mapped joint sets. Slope orientation, daylight envelope and failure envelopes are coloured pink for maximum slope dip and grey for mean dip.

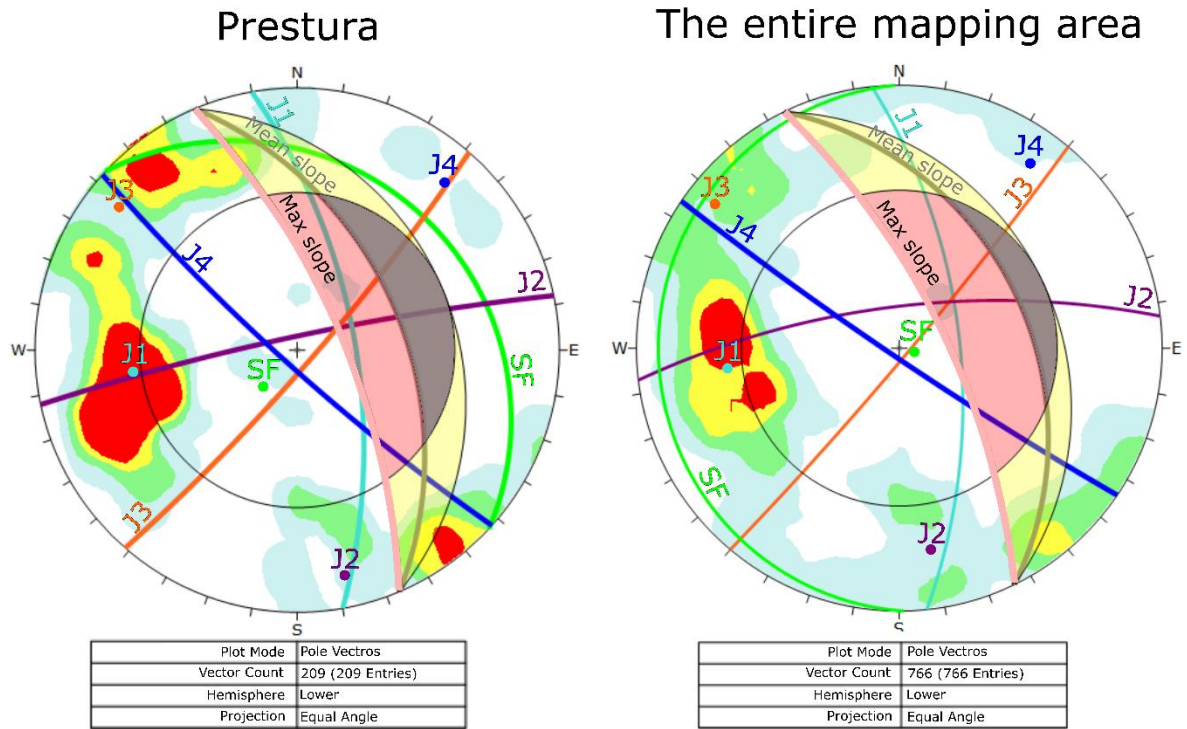
Figure 50: Kinematic feasibility test for wedge sliding at Prestura failure area (left) and for the entire mapping area (right), showing planes of the mapped joint sets. Slope orientation and failure envelopes are coloured pink for maximum slope dip and grey for mean dip.

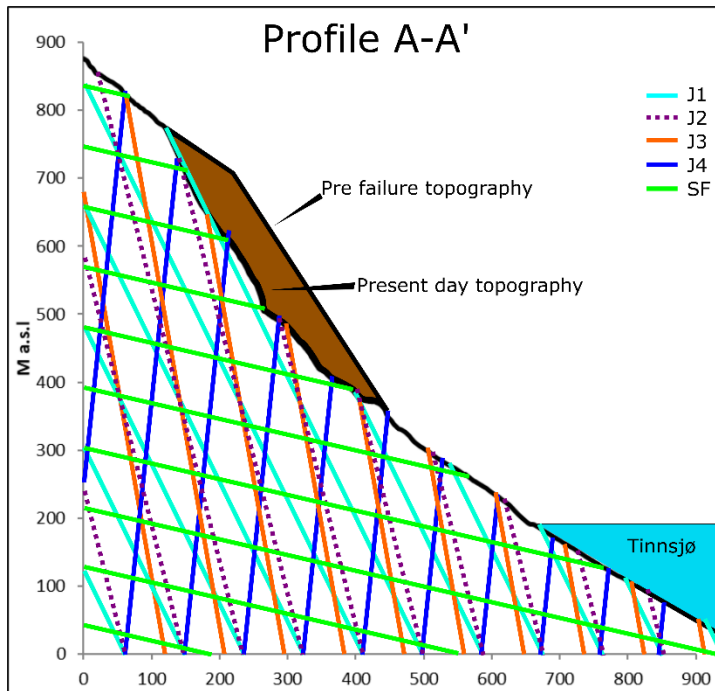
Figure 54: Reconstructed topographic profile of the failure area, showing the different joint sets. J1 is represented by its true dip, while J2, J3, J4 and SF is aligned using an alignment diagram ((Rowland et al., 2007), Appendix E)) The brown part is the most likely ante rockslide topography (ART) (see section 5.4.3) showing a possible slope topography pre-failure.

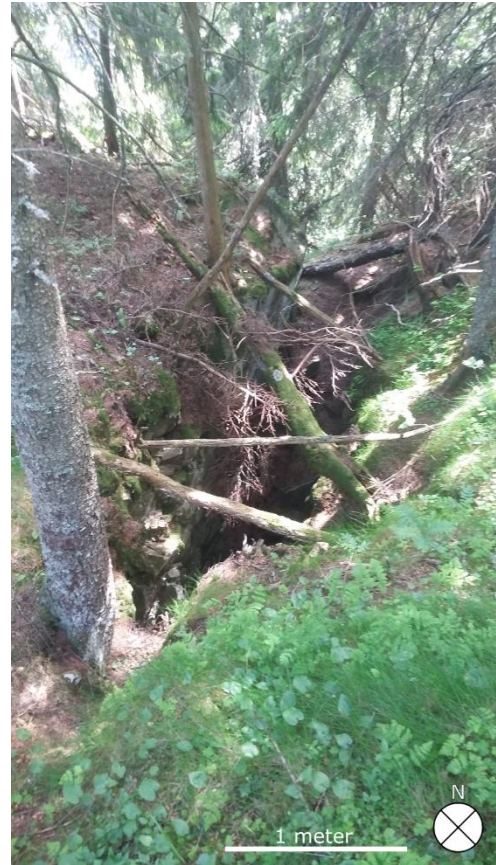
Figure 55: Picture showing well developed joint observed at location C.5 (see appendix E). The width is over 1 meter and the bottom is filled with soil and vegetation.

At the northern lateral surface of Prestura, a 1 – 2m wide NNE – SSE striking crack occurs with a persistence of 10 meters, illustrated in Figure 55. This is interpreted as evidence of previous movement at the northern flank of Prestura (location C5 in appendix E). However, this crack is filled with considerable amount of soil and vegetation. This indicates that movement is low or completely absent, suggesting a suspended or dormant slope.

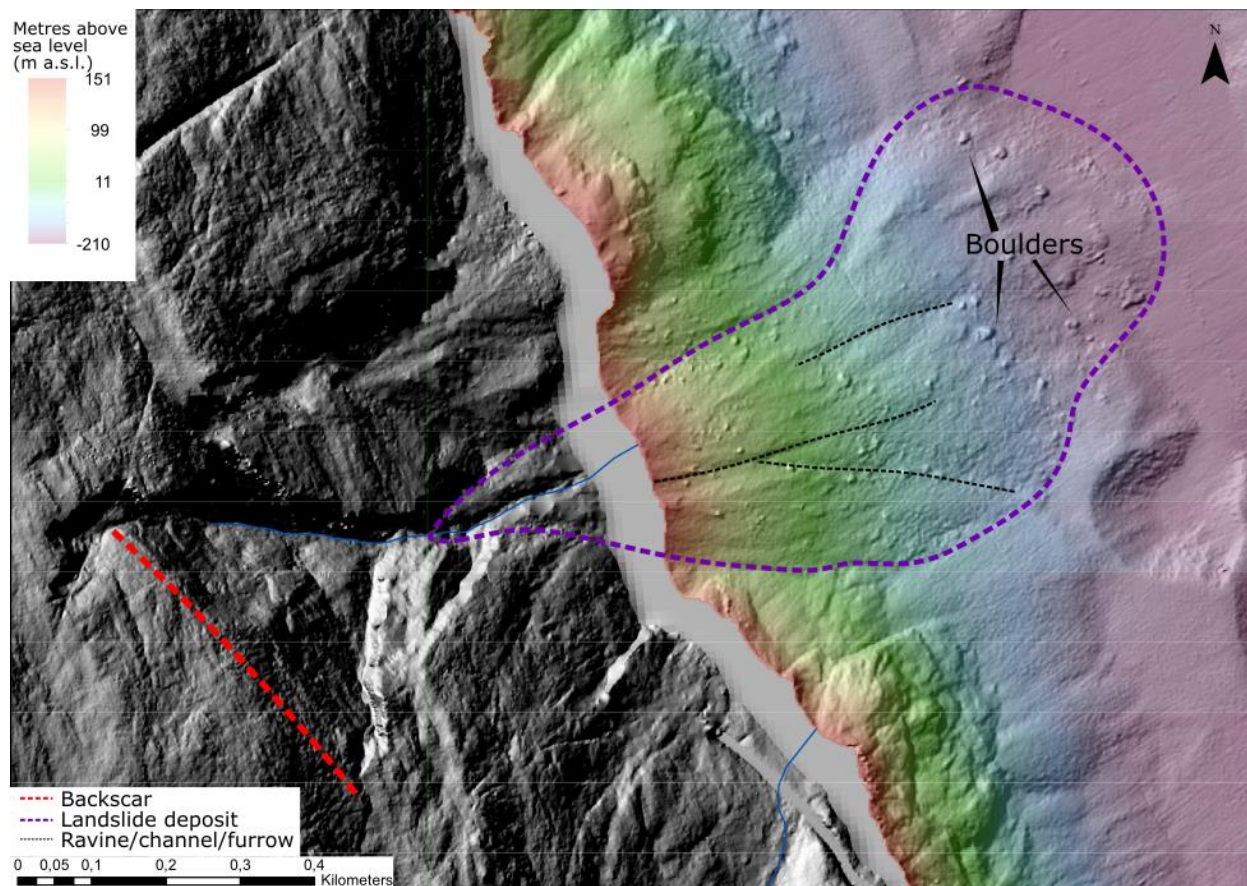
Figure 56: DEM of Prestura (Grey), with a bathymetrical model (coloured) representing the lake floor of Tinnsjø. The Prestura deposit is located east of the Prestura failure area, reaching the basin floor of the lake.

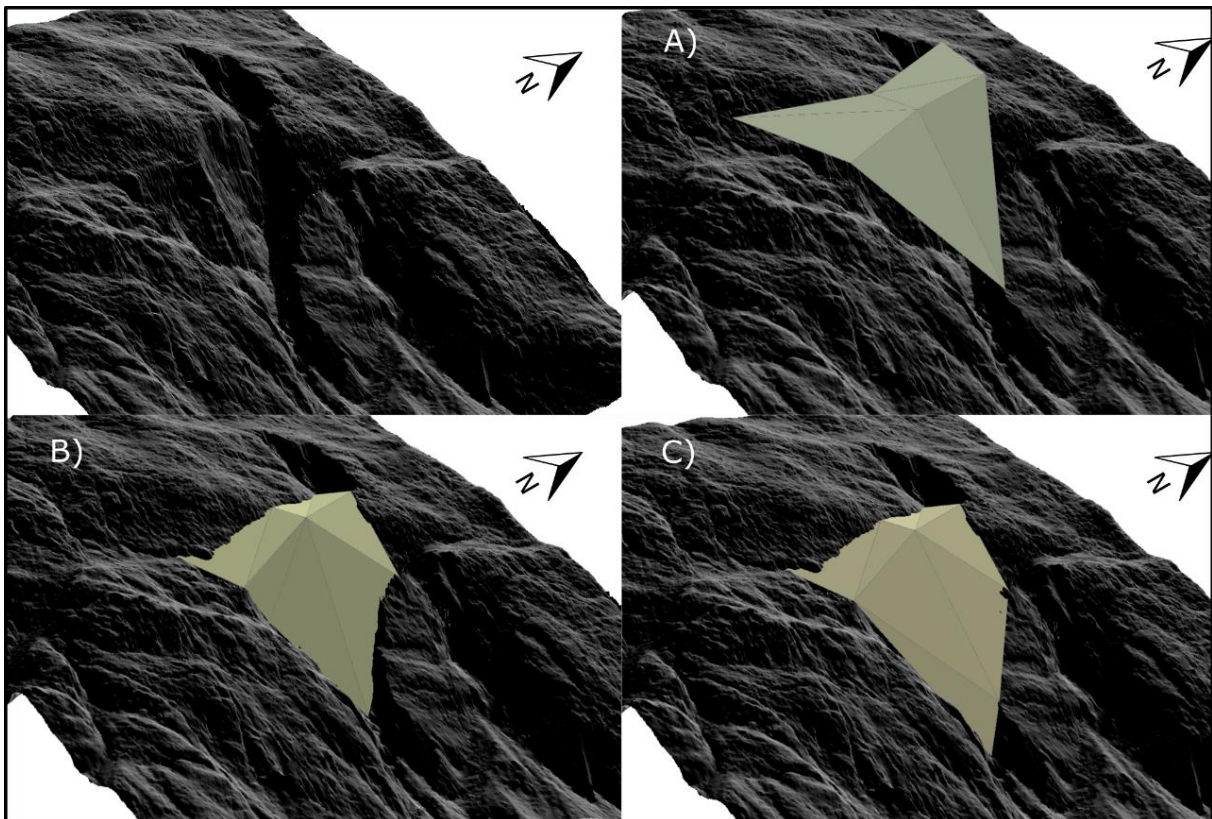
Figure 57: Ante Rockslide Topography (ART) reconstruction of the Prestura rockslide presented in ArcScene (ESRI, 2017b). A), Model a) based on method 1 (maximum volume), hovering above the topography. B), Model b) adjusted to the topography (minimum volume). C), Model c) adjusted to topography (most likely volume). The upper left picture represents the post failure topography.

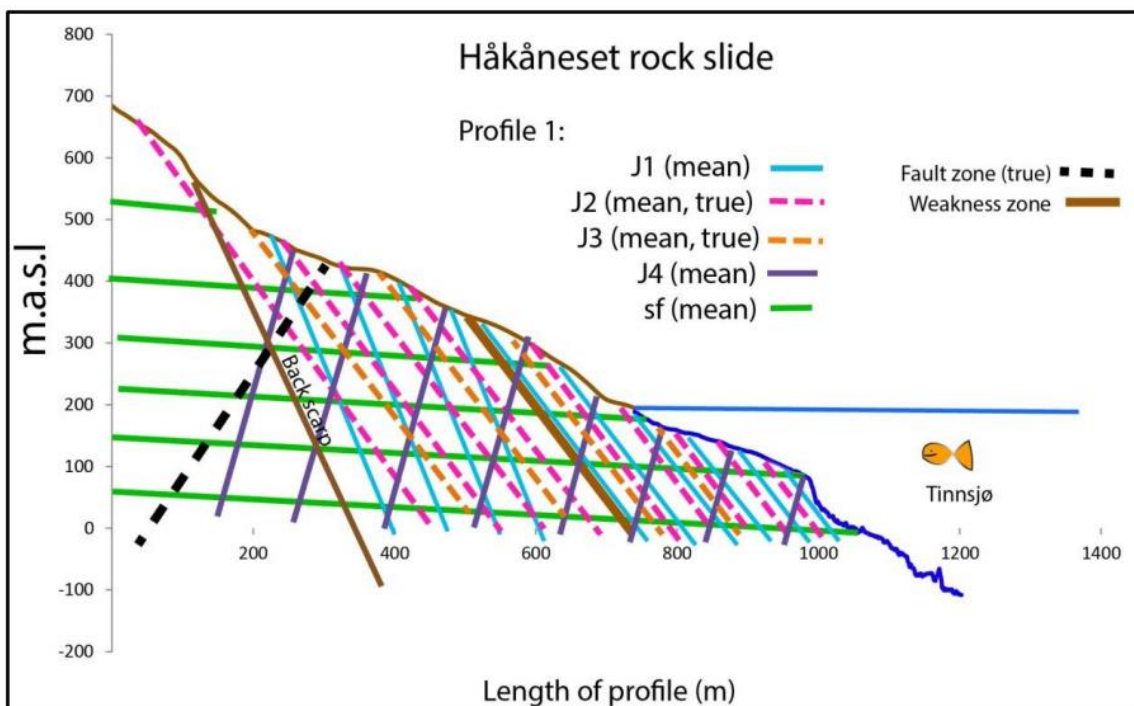
Figure 59: All mapped structures in a SW-NE profile of the Håkåneset rock slide. From (Sollie, 2014).

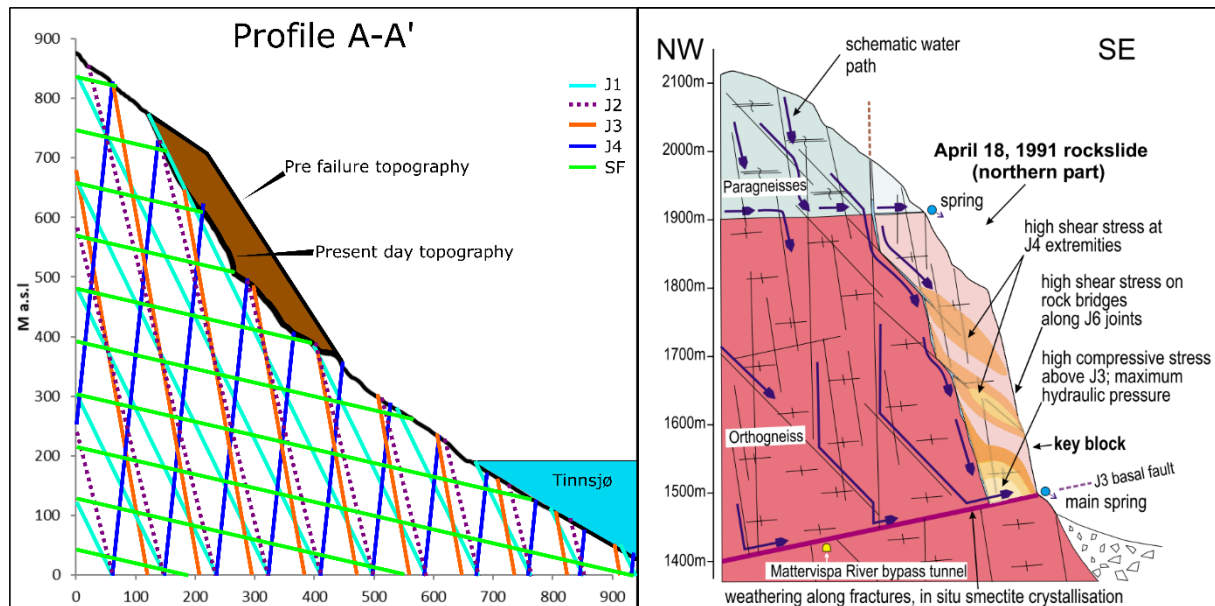
Figure 86: Simplified cross section of the Prestura rock slope (left) and Randa rock slope (right)(Sartori *et al.*, 2003). Both slopes having similar discontinuity orientations. Thus, similar potential failure mode.

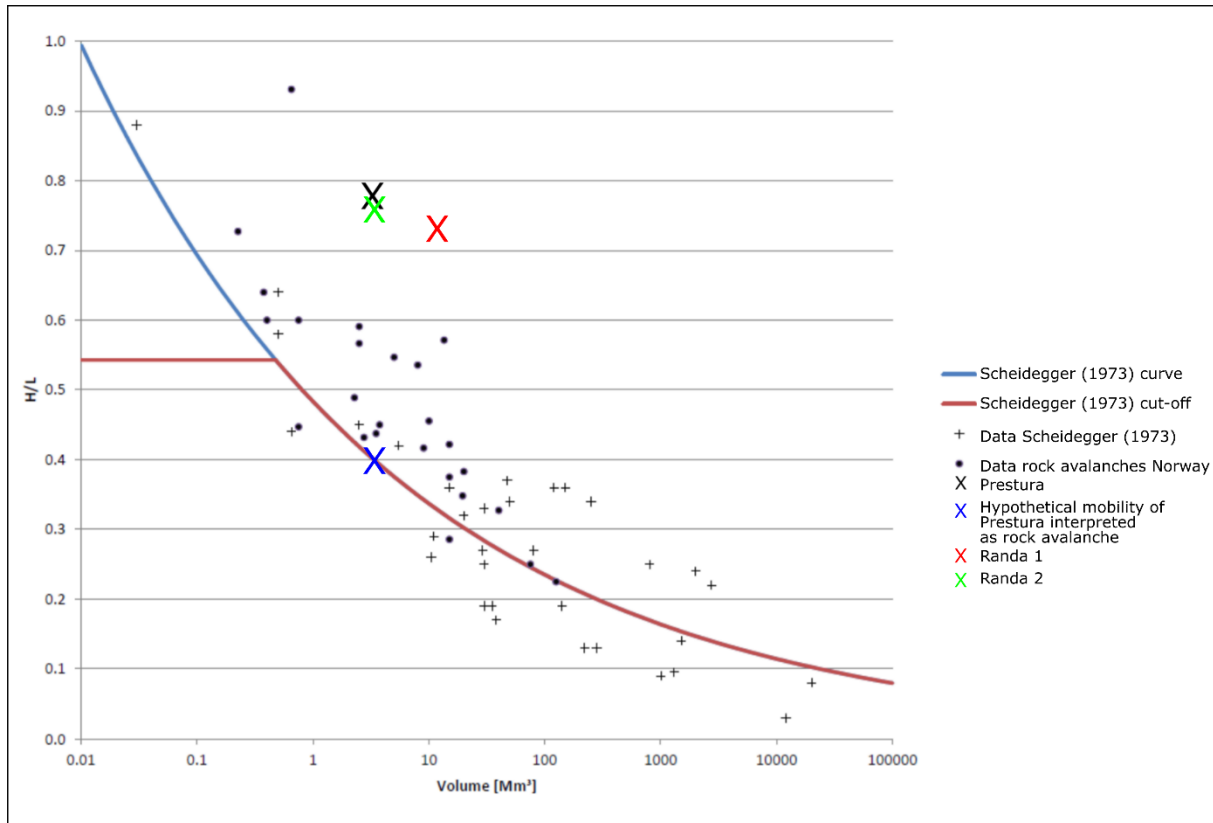
Figure 87: Prestura and Randa rockslides plotted in H/L vs Volume correlation diagram. The data for the Randa event are achieved from (Sartori *et al.*, 2003). Modified from (Hermanns *et al.*, 2012),
