Electric Motor Development for Shell Eco-Marathon

Manufacturing an ironless axial flux
permanent magnet Motor with Hallbach array
and Development of existing Motor for the
Shell Eco-Marathon Competition

Fredrik Vihovde Endresen

Master of Energy and Environmental Engineering

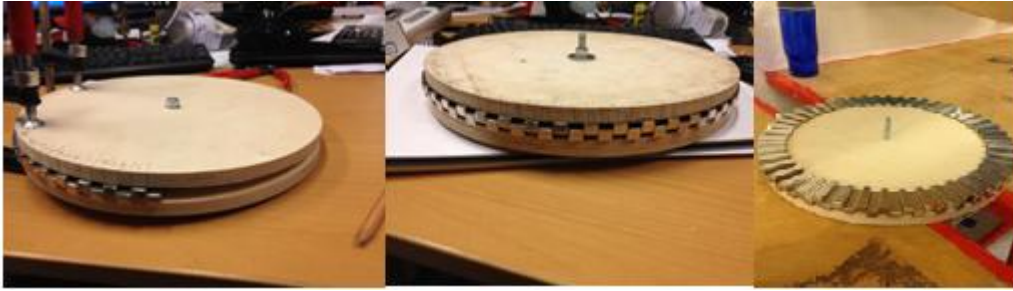
Figure 9 Assembly of Hallbach array

The magnets used were NdFeB N42 magnets. These were selected because of their magnetic strength and their thermal abilities. The magnets were assembled in a Hallbach array before they were attached to the rotor plates. Several attempts were made in order to find the right technique for doing this. The first attempt was to use a circular wooden plate with another wooden plate of a smaller diameter centered on top of the first. This way it was possible to control the shape and diameter of the array. This procedure was however unsuccessful as the magnetic field caused the magnets to turn out of position. This problem was fixed by adding a third circular wooden plate on top of the center plate to keep the magnets down. The plates were made of wood since wood is quick to work with and not magnetically conductive. When the magnets were arranged in the Hallbach array they kept themselves in position. This is however very unstable and sensitive to disturbances. An important challenge here was to keep all ferromagnetic material in a safe distance.

Before the magnets were to be attached to the rotor plates, both the plates and the magnets needed to be cleaned with acetone. Since the Hallbach array is a highly unstable arrangement they should not be exposed for longer periods of time and should definitely not be handled while they are exposed. Therefore a circular wooden plate with a slot for four magnets was designed. This made it possible to only expose the magnets being cleaned while providing support for the rest of the Hallbach array. This gave extra stability and worked well.

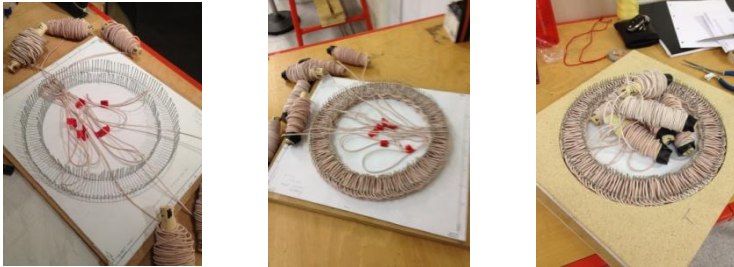
Figure 10 Winding production

The wire was wound on a wooden board. To ensure a clear layout of the wires a technical drawing was printed and stapled onto the wooden board. Nails were used to keep the wires in place. With three phases and 24 pole pairs, 288 nails were needed. Another wooden board was used to make an outer radius guideline. This was necessary to ensure the correct size of the coils and the wooden guideline had a diameter of 329 mm while the stator mold had a diameter of 330 mm. This provided a margin of 1 mm. 6 wires were then wound in a double layer wave winding. The winding was then tied up with 288 knots to replace the nails. Cotton string was used to tie the winding as this is not magnetically conductive. Steel wire was also considered as this would have an easier assembly but this was discarded as it would lead to a higher leakage flux. The nails were then removed.

After the wires had been wound, tied and properly fitted in the circumference ring, the wires were placed in the mold. For the vacuum casted stator the wires were Y-connected as shown in figure 20 before casting. Only three wires came out of the cast.

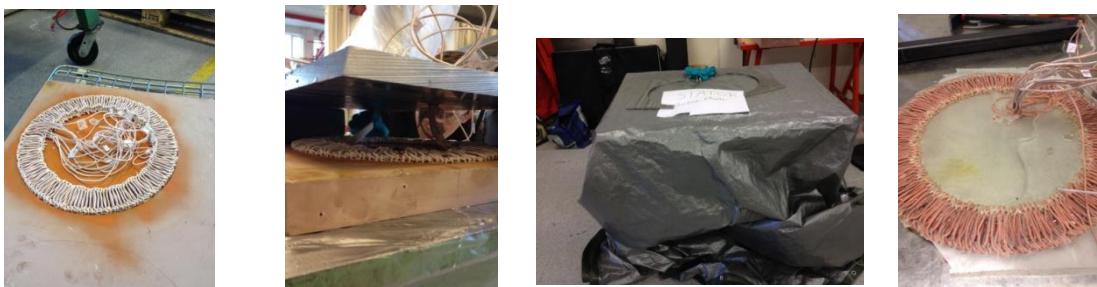
Figure 13 Stator production, open casting

The open casting technique using the eboard mold is an easier process than vacuum casting. The winding is placed in the mold with wire ends coming out of the top lid. Epoxy is poured in and the lid is pressed down. This causes some of the epoxy to overflow the mold. Afterwards the stator would cure at 70 degrees Celsius for four hours. When this open casting was performed the casting was somewhat unsuccessful due to a lack of epoxy. The resin to hardener ratio was 3,92:1 instead of the desired 5:1 and the total amount was too little. Still, this stator had many of the desired properties.

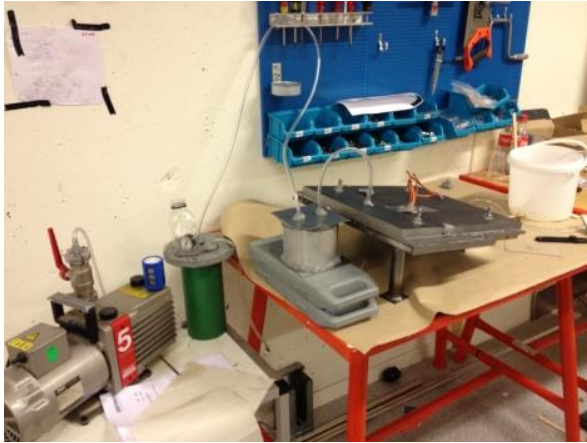
Figure 14 Setup for vacuum casting

As seen in figure 14, a vacuum pump was used to generate the vacuum (left). This pump was then connected with tubes to two safety chambers (green and grey cylinder) in series, before it was connected to the topside of the mold. On the first safety chamber there was a gauge showing the pressure difference between the internal and atmospheric pressure. The mold was slanted so the outlet tube was the highest point in the mold. From the other end of the mold, at the lowest point, an inlet tube went to a bucket of epoxy (right).

This configuration enabled the mold to be filled with epoxy in a controlled manner. The epoxy would flow into the mold and it was easy to see when the epoxy would come out of the topside. When this happened the outlet tube was blocked and the epoxy would continue to fill the mold until the pressure inside the mold was equal to the atmospheric pressure. One major challenge here was to keep all interfaces airtight. All connections were covered with sealing tape, but the mold was particularly challenging to seal. This might have been due to the weld created when making the mold as this may have created an air canal from the side of the mold. Also the distance between the pressure bolts was too long for supplying the right pressure in between the bolts. This problem was solved using clamps along the circumference of the mold. In order to check the cast procedure several test stators were made. When the first test stator was made it included three wires coming out of the mold for simulating the power cables and a bundle of litz wire was also tied tightly and put in the mold. This was done in order to examine how the epoxy would surround the litz wire.

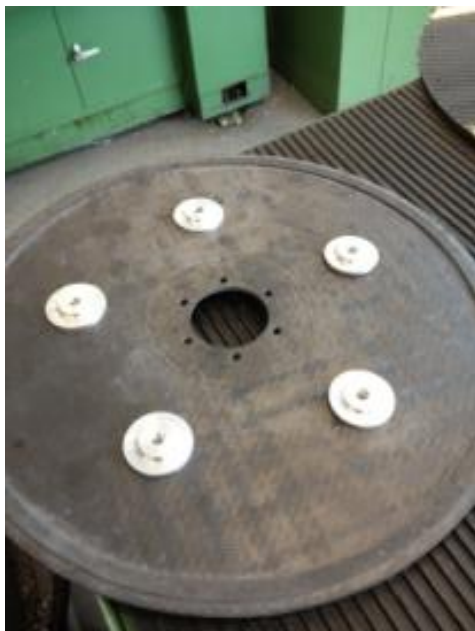
Figure 18 Rotor plate with threaded inserts

The stator was then mounted on the axle and the three power wires were lead through the hollow axle. The wires would then come out on the inner side of the engine, the side facing the car. The rotor plates were fitted with ball bearings in the center holes. The axle was then put through the ball bearing in the outer plate, with the stator still attached. The spacer ring was then put on, surrounding the stator. At last, the inner rotor plate was to be lowered onto the remaining parts. Since the magnetic forces are very strong, this process needed special tools. Five holes were made in the inner rotor plate. These holes were then fitted with threaded inserts of aluminum. These inserts would allow us to use threaded rods to lower the plate down in a controlled and level manner. The threaded inserts also distributed the forces on the carbon fiber, reducing the mechanical shear stress. The rods went through holes in the stator and down to the outer rotor plate. To reduce the wear on the outer plate, an aluminum ring was glued to the outer plate were the rods would come in contact. As the machine has 24 pole pairs, the inner plate had 24 possible positions relative to the outer plate. With all this equipment in place the inner plate could be lowered onto the rest of the engine.

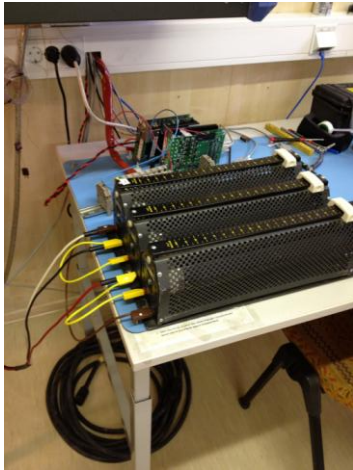
Figure 25 Resistor setup

Both engines were tested at Smart Motor. More tests were performed on the old engine as it was available for testing earlier and early showed a higher potential than the new. The tests were performed using the battery intended on board the car. In order to burn off the power supplied by the engine from the battery, three resistors were connected in a delta-connection. These were then connected to the terminals of a load engine. This was done because the electronics normally used to drive the test engine were not able to receive the generated power. In between our engine and the test motor a torque meter was connected. Thereby it was possible to control the torque by adjusting the resistors. This solution supplied constant torque for all steady states, but changed whenever the speed changed. This is due to the fact that the induced voltage is proportional to the speed, while the counter torque is proportional to the current. The current is a function of voltage and resistance. Therefore we were unable to check the transition between operating points.

$$V \sim \omega \quad I = \frac{V}{R}$$

$$\tau \sim I \quad \tau \sim \frac{\omega}{R}$$

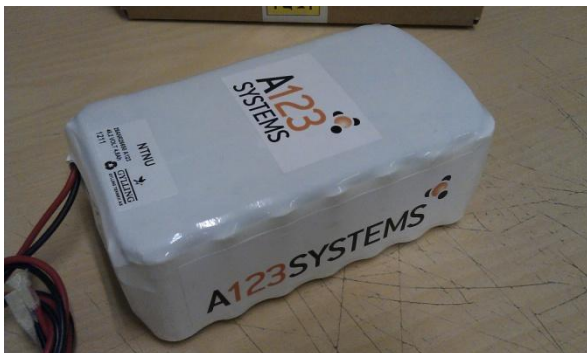
Figure 28 Battery used during racing

As suggested in the report from the specialization project^{viii} the back-up plan in case the new motor failed was to use the existing engine with a decreased air gap. The old engine was therefore modified. The spacer ring used in 2011 had been prolonged in the axial direction due to the voltage drop from the fuel cell which was used then. It was therefore believed that a battery should have been able to supply a more load independent voltage. The project had been sponsored by two suppliers of with different batteries. It turned out that the battery pack with the highest number of Ampere hours had a significant voltage drop. This did not occur at high load as with the fuel cell but somewhat in correlation with the energy delivered. To this problem one could either accept that it is not be possible to obtain higher speeds towards the end of the race or one could increase the air gap hoping that the reduction in back induced voltage would counteract the increased copper losses in order to maintain the necessary speed. It was chosen to increase the air gap and this withstood simple testing.

It was later discovered that the other battery pack had a much lower voltage drop. Unfortunately this battery pack had a lower energy capacity than the first battery. A third battery pack was therefore ordered, which had twice the capacity of the second. This was done shortly before the race and there was a great deal of uncertainty of whether it would be delivered in time. This battery was delivered to the team members transporting the DNV Fuel Fighter 2 down to Rotterdam when they passed through Oslo.
