Norwegian University of
Science and Technology

Corrosion Behaviour of Aluminium-Steel Welded Joints

Materials Technology (MIMT)

Submission date: June 2018

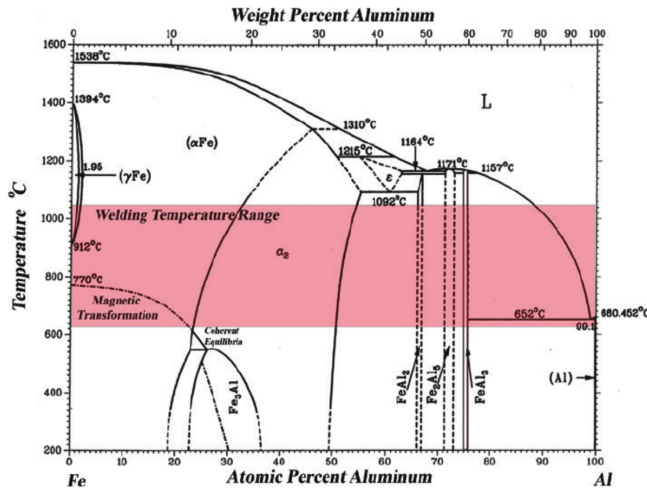
Figure 2.4: Al-Fe phase diagram showing which IMC can be formed during welding. The temperature range of welding is illustrated as the red area [29].

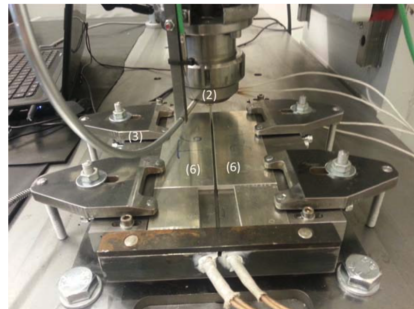
(a) Schematic representation of the HYB process. (b) The setup of the HYB process, where the HYB spindle extruder (2), steel fixture (3) and aluminium test plates (6) are indicated.

2.6a. The extruder head is clamped onto the base material plates which is separated to form a groove slightly smaller than the width of the extrusion die opening. The spindle extruder moves along the groove at a constant speed during the joining process and continuously extrudes filler material into the groove. The groove is completely filled with aluminium filler material and the resulting shear deformation that forms against the walls removes surface oxide layers and provides full metallic bonding. A picture of the process setup is shown in Figure 2.6b, it should be noted that this picture is not from this present project. A successful cold joining of an AlMgSi-alloy at T6 temper has been performed with HYB, resulting in no HAZ-softening [31, 38] and HYB has also recently been used to join aluminium and steel.

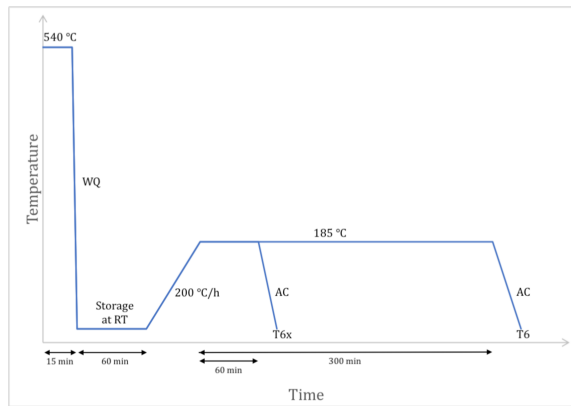
Figure 3.1: Schematic overview of the thermal history for used for both AlMgSi-alloys to obtain T6x and T6 condition, respectively. WC = Water quenched, AC = Air cooled, RT = Room temperature. Made by the author.

The heat treatment of the aluminium alloys was performed in Nabertherm N30/85HA, air circulation furnace. The heat treatment was carried out in two steps, solution- and precipitation heat treatment which is presented graphically in Figure 3.1.

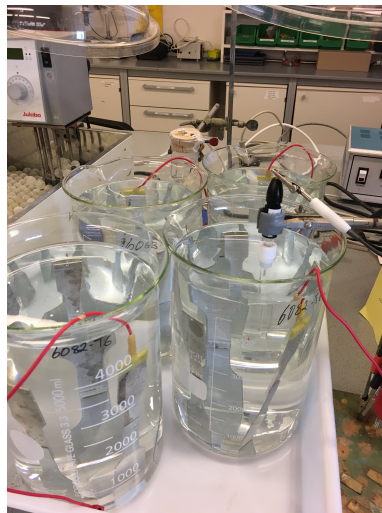
(a) Uncoated samples

(b) Coated samples with bee wax

(c) Samples in separate beakers

of OCP. The rest of the samples that were prepared with a cable connection were used for momentarily checks of the OCP by the use of a separate multimeter and reference electrode, this reference electrode was of the same type and model SCE as used for the continuous logging of OCP. This was done to check that the condition in each beaker was the same as in the one where the potential was logged before the samples could be collected. A picture of the test setup is shown in Figure 3.9.

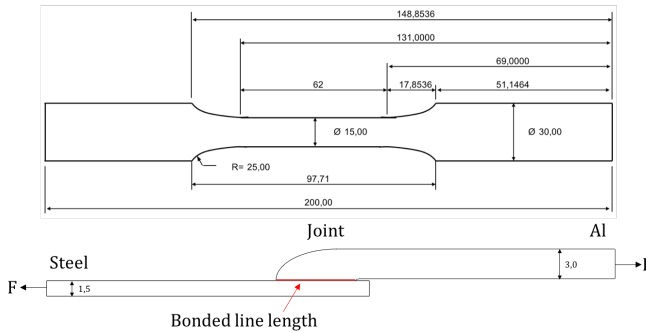
Figure 3.10: Dimensions of the tensile test specimens given in *mm*.

time. A single lap shear tensile test was performed to quantify the strength loss due to corrosion. The dimensions that were used for the tensile test specimens are presented in Figure 3.10. The tensile test was performed on w+b Series LFV 100 kN, servohydraulic universal testing machine in accordance with ISO 6892, standard for tensile testing of metallic materials.

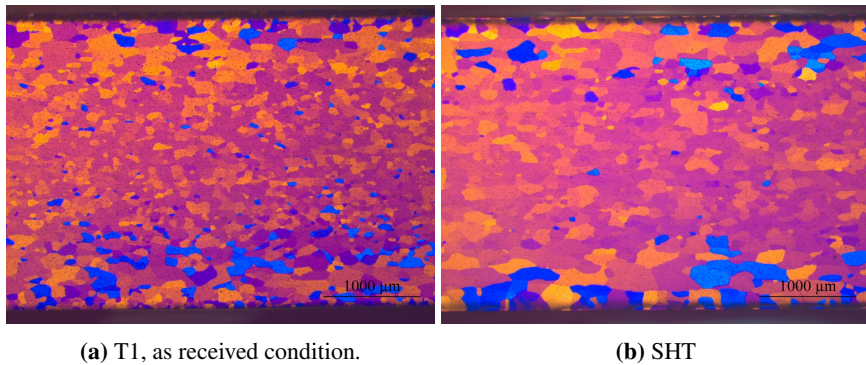
Both of the aluminium alloys, AA6063 and AA6082, were precipitation hardened to T6x and T6 condition. The microstructure of AA6063 consisted of equiaxed grains with an increasing grain size towards both surfaces. After solution heat treatment (SHT), grain growth was identified as shown in Figure 4.1.

Figure 4.1: Microstructure before and after Solution Heat Treatment (SHT) of AA6063.

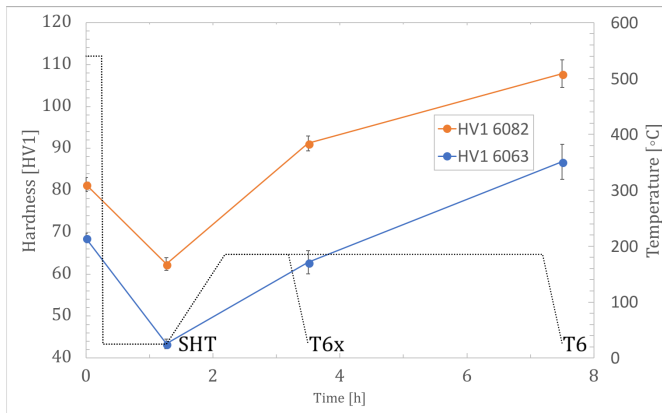
Vickers hardness was measured before, during and after the precipitation hardening process and the results are given in Figure 4.3, where the hardness evolution of both aluminium alloys are presented together with the temperature profiles used to achieve the T6x and T6 temper conditions. There was a decrease in hardness for both alloys when solution heat treated. When artificially aged the hardness increased above the as received T1 condition for both alloys.

Figure 4.3: Hardness evolution of the aluminium alloys, AA6063 (blue) and AA6082 (orange), during precipitation hardening including standard deviation. The temperature profiles for the two temper conditions is shown as dotted lines. SHT = Solution heat treated.
