Corrosion fatigue of an extruded 7046 alloy

Kyrre Stefansson Christiansen

Materials Science and Engineering (MTMT) Submission date: July 2018 Supervisor: Ola Jensrud, IMA Co-supervisor: Hans Jørgen Roven, IMA Otto Lunder, IMA

Norwegian University of Science and Technology Department of Materials Science and Engineering

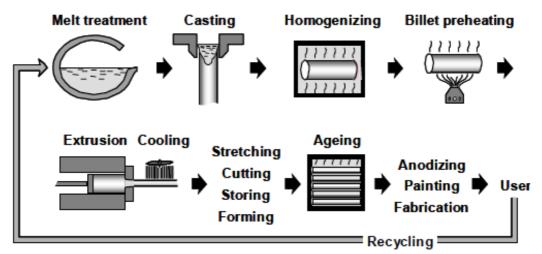
The processing steps before and after extrusion are presented in figure 2. First, the molten aluminium is heat treated to remove or prevent impurities from forming. Secondly, the aluminium is cast into billets and then homogenized. After casting the billets have a low workability [15], and by homogenization the effects causing this low workability is reduced. The final step prior to extrusion is pre-heating of the billet, in order to reduce the deformation resistance of the alloy.

Figure 2: Common processing steps before and after extrusion. From[14]

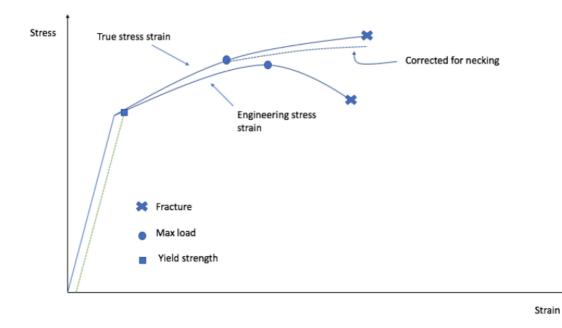
To determine the mechanical properties of a metal, uni-axial tensile testing is commonly used. During tensile testing, a specimen is subject to a controlled tension until failure. Due to work hardening, the stress required to continue plastic deformation will increase with increasing plastic strain. In figure 4, the engineering stress-strain curve is plotted together with the true stress-strain curve.

Figure 4: Stress-strain curve, illustrating the difference between engineering and true stress-strain. Reproduced from [4].

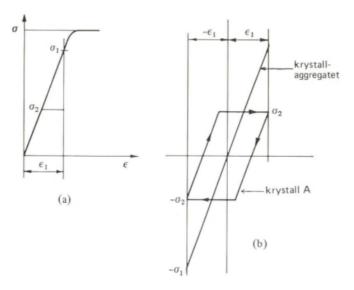
The scenario can be illustrated by a $\sigma - \varepsilon$ diagram, figure 6. The collection of grains are stressed elastically to σ_1 , which results in an elastic strain ε_1 . Grain A, with a yield strength of σ_2 , therefore experiences a combination of elastic and plastic strains equal to ε_1 . When the stress is reversed, figure 6 (b), the outcome is identical with grain A experiencing both elastic and plastic strains. For every stress cycle, the distortion caused by plastic deformation of grain A will lead to a small disorder in nearby grains leading to separation of atomic planes. This will eventually lead to stress concentrations building up, making slip in neighbouring grains with a less suitable orientation possible. [30]

Figure 6: (a) Illustration of yield strength for grain A, σ_2 , and applied stress on collection of grains σ_1 . (b) if the applied stress is changed to $-\sigma_1$, the collection of grains experience an elastic strain from ε_1 to $-\varepsilon_1$. Grain A experiences the same strain, but it is both elastic and plastic. From [30].

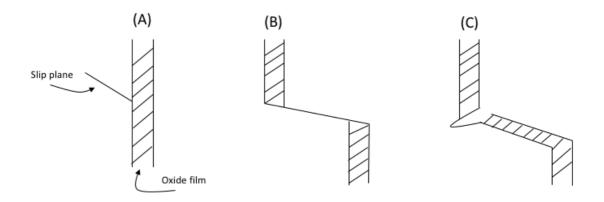
Another popular theory, for metals with an oxide film, is the rupture of the otherwise protective film on the metal surface. This model is an extension of the models proposed for anodic SCC under static loading. [37] When intact, the oxide film shields potential corrosion sites from the environment and prevents corrosion attacks. When the oxide film ruptures under continuous stresses, bare metal is exposed to the corrosive environment, acting as an anodic reaction site. Plastic deformation results in the exposure of very active slip planes, as illustrated by figure 7 (B). [38] The next step is dependent on the time of repassivation. If the time of repassivation is fast, one often avoids attacks. If the time of repassivation is slow, we get localized corrosion attacks as illustrated by 7 (C).

Figure 7: Mechanism of oxide film rupture. Made by the author, inspired by[38].

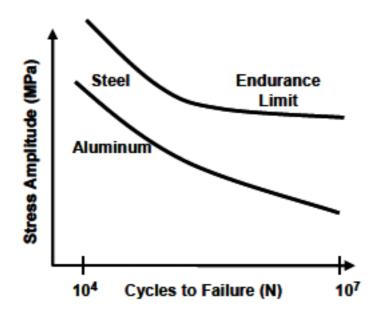
Most nonferrous metals, like Aluminium, does normally not have a well-defined endurance limit. The endurance limit identifies a stress level below where the specimen theoretically will withstand an infinite life. For metals without an endurance limit, the SN-curve will slope gradually downwards with decreasing stresses, as illustrated in figure 8. For such metals, the endurance limit is often defined as the stress level required to reach a high number of cycles. (for example 10⁶-10⁷ cycles) [42]

Figure 8: SN-curve illustrating the lack of endurance limit for Al. [31]

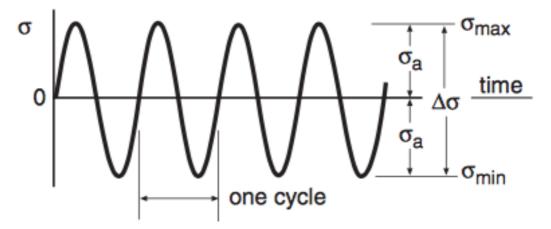
Figure 9: Cyclic loading and visualization of important fatigue parameters. [31]

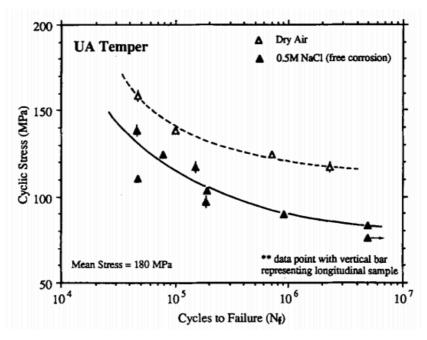
example of this is given in figure 10, where the dashed line represent dry air while the solid line represent the corrosive environment.

Figure 10: Comparison of lifetime in air and in a corrosive environment. From [44].

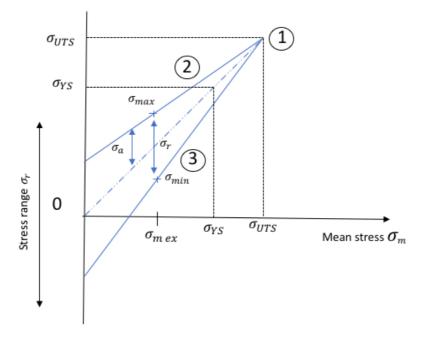
The Goodman diagram illustrates how a change in mean stress (σ_m) influence the stress range (σ_r). [4] To construct a Goodman Diagram, the ultimate tensile strength (σ_{UTS}) and yield strength (σ_{YS}) is marked on the two axes. A straight line is then drawn from each of the marked points until they cross, marked 1 in figure 11. Then, straight lines (marked 2 and 3 in the figure) are drawn from this point to σ_{max} and σ_{min} for a given mean stress (marked $\sigma_m ex$ in the figure). These lines can be extended until they cross the y-axis, illustrating the stress range corresponding to a mean stress (σ_m) of 0, i.e. R = -1. The Goodman relation is known to be conservative, i.e. the experimental results tend to be better than the prediction by the Goodman relation. [42]

Figure 11: Construction of Goodman diagram. Made by the author, inspired by [4]

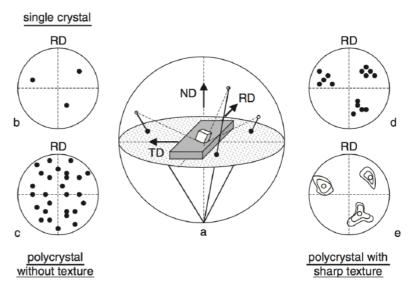
To represent texture, pole figures are commonly used. For each grain, a set of crystallographic directions are chosen(for example the <100> directions) and projected onto the equatorial plane, as depicted in figure 15. The group of <100> directions plotted on the equatorial plane is called the (100) pole figure, figure 15 (b). For a polycrystal with texture, the poles will be evenly distributed over the entire pole figure, figure 15 (c). If the material has texture, the poles will be grouped together, as shown in figure 15 (d).

Figure 15: (a) Stereographic projection of the (100) pole figure. (b) (100) pole figure for a single crystal (c) (100) poles with random texture (d) (100) poles for polycrystal with texture (e) Contour plot of the (100) poles for situation described in (d). From [56]

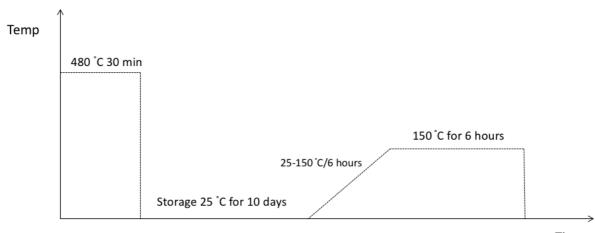
Two different temper states were investigated in this work, T6 and T7, i.e. peak aged and overaged condition. The heat treatment procedure for achieving T6 is presented in figure 17, performed at SINTEF Raufoss Manufacturing. The extruded profile was first solution heat treated at 480 °C for 30 minutes followed by quenching in water to room temperature. Then, the extruded profile was stored at room temperature for 10 days before artificial ageing. Within these 10 days fatigue and tensile samples were machined from the extruded profile. Finally, the machined samples were artificially aged in a two-step process: first heated from 25-150°C with a constant heating rate for 6 hours and then held at 150°C for 6 hours.

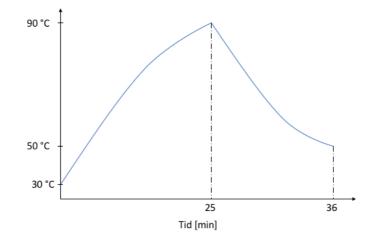
To achieve T7 condition the samples were given an additional heat treatment, presented in figure 18. The samples were heated from 30 °C to 90 °C in 25 minutes, and subsequently cooled down from 90 °C to 50 °C in 11 minutes. The temperature in the figure is the logged temperature of the sample. This procedure was performed by Benteler.

Figure 18: Additional heat treatment to achieve T7 condition. Made by the author.

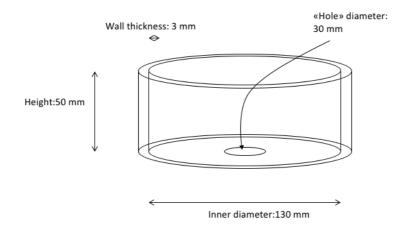
Figure 24: Dimensions of the largest chamber used for corrosion fatigue testing. Made by the author.

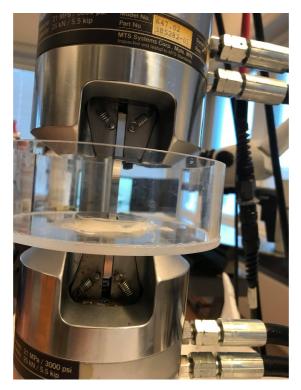
Figure 27: Image of sample mounted to chamber in fatigue machine.

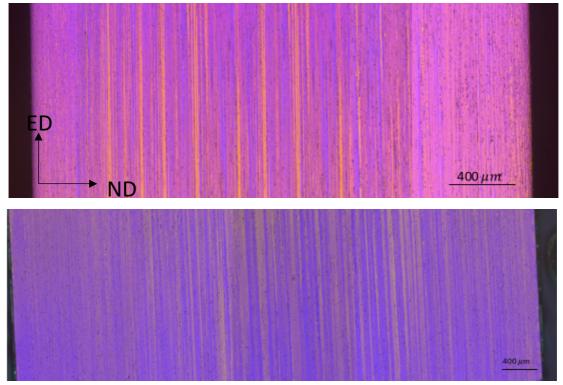
The light optical micrographs of the 7046 in the T6 and T7 temper state is presented in figure 30. The presence of dispersoids pinning the grain boundaries preserves the fibrous microstructure in the core of the microstructure. At the surface, where the strain accumulation is large, a recrystallized layer of approximately ~20 µm can be seen in figure 31. The fibrous microstructure is most prominent in the center of the sample, where we clearly see how the grains are elongated in the extrusion direction. Closer to the surface the fibrous grains are thinner and less visible from the micrograph. The additional heat treatment to achieve T7 condition (peak temperature of 90 °C) is not high enough for additional grain growth. The axes are valid for both figures.

Figure 30: Microstructure of T6 samples (top) and T7 samples (bottom). 5x magnification.

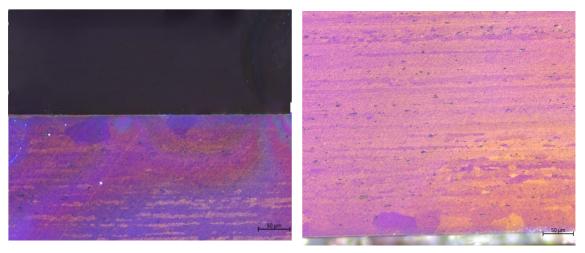
Figure 31: Thin, recrystallized layer on both sides of cross section. The scale bar is 50 µm. magnification is 10x.

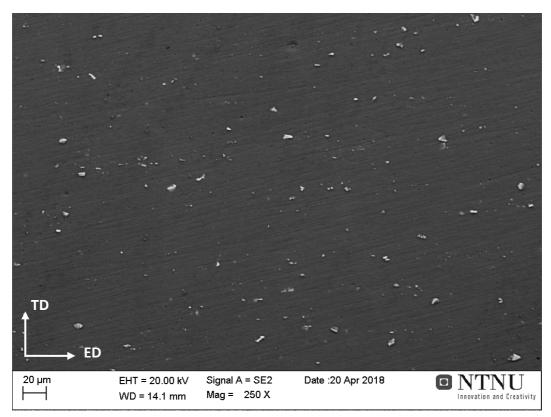
The particle structure of the material is shown in figure 32 and 33. The particle distribution for both the extrusion and longitudinal plane are presented. The particles can be seen as the white spots. The particles seem to be slightly aligned along the extrusion direction, although no clear pattern is observed. The particle distribution is inhomogeneous, consisting of areas with both higher and lower particle density. The particles in this material are a mixture of small and larger sized particles. For the particle characterization by imageJ, the particle distribution images presented below were tweaked to increase the contrast between the particles and the matrix, making the characterization easier. The tweaked images uploaded to imageJ have been attached in appendix C.

Figure 32: SEM image of the particle distribution in the extrusion plane. 250x magnification.

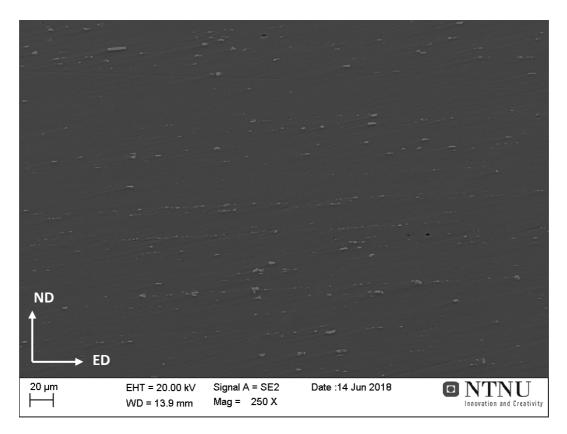
Figure 33: SEM image of the particle distribution in the longitudinal plane. 250x magnification.

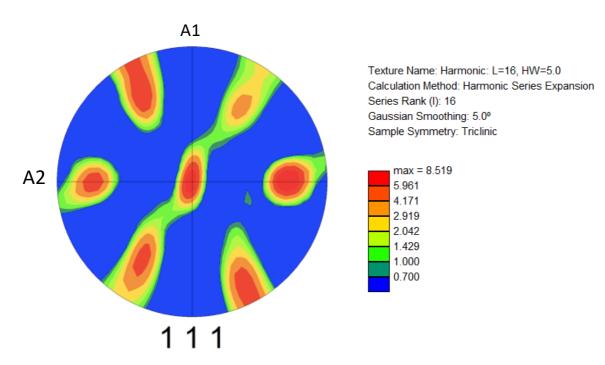
The texture of the material was investigated to get an indication of the degree of mechanical anisotropy. The specimen investigated was in T6 condition, but as there is no evolution in the grain structure following additional heat treatment to T7 condition, see section 4.1, the presented pole figure is representative for this temper state as well. The scanned area used to generate the pole figure have been added in appendix D. A detailed investigation on the effects of texture and texture evolution was not intended in this study.

Figure 34: Pole figure of the material with corresponding intensity scale.

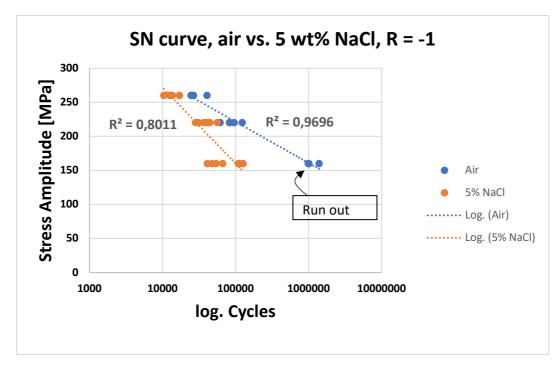
A comparison of fatigue results obtained for samples in 5 wt% NaCl solution and samples tested in air is presented in figure 37. The plots are presented as fatigue life as a function of stress amplitude. The dashed lines represent the best fit regression line. The results show a considerably lower fatigue lifetime for the samples tested in 5 wt% NaCl compared to air. With a lowered stress amplitude, the difference in lifetime between 5 wt% NaCl and air increased. The stress amplitude corresponding to a lifetime of 10⁵ cycles is presented in table 12.

Figure 37: SN curve for samples tested in 5 wt% NaCl and air.

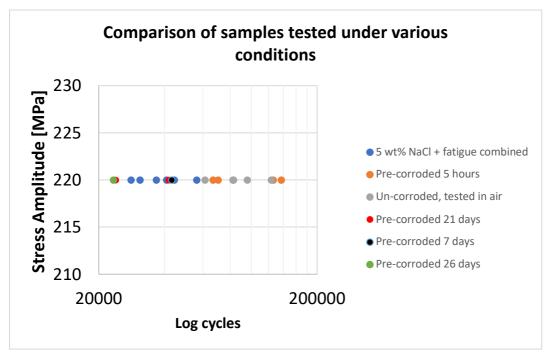
The intention of this section is to give a better understanding of how the salt solution effects the samples. Therefore, a comparison of samples tested at a stress amplitude of 220 MPa under various conditions is carried out, presented in figure 38. Un-corroded samples tested in air, samples pre-corroded for various times and subsequently tested in air as well as samples exposed to a combination of fatigue and 5 wt% NaCl (i.e. tested in the chamber) were investigated. The samples that were exposed to a combination of fatigue and 5 wt% NaCl had a lifetime ranging from ~2.8-5.6*10⁴ cycles, corresponding to an exposure time of ~1.5 – 3 hours. The samples pre-corroded for 5 hours had a longer lifetime, suggesting that the combined effect of fatigue and corrosion is detrimental to fatigue life. Interestingly, no consistent difference was found in lifetime between samples exposed to the salt solution for 5 hours and samples fatigue tested in air. For longer exposure times, 7, 21 and 26 days respectively, clear decreases in fatigue lifetime are observed. For these exposure times, a clear link was found between exposure time and fatigue lifetime, where the samples exposed to 26 days performed worst and the samples exposed for 7 days best.

Figure 38: Comparison of samples tested at 220 MPa under different conditions.

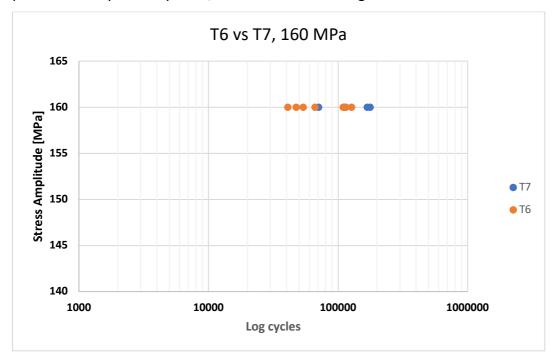
This section is concerned with a comparison of T6 and T7 tempered samples, tested in 5 wt% NaCl at a stress amplitude of 160 MPa. The tests revealed no significant difference in lifetime between T6 and T7 tempered samples, as seen by figure 39. It must however be stressed that the sample is small, definitely too small to draw any conclusions, and tests should also be conducted at other stress amplitudes. The best way of representing corrosion fatigue susceptibility is to compare the lifetime in air with the lifetime in the salt solution. The results from the fatigue testing in air performed by SINTEF revealed that the temper states performed very similarly in air, as can be seen from figure 40.

Figure 39: Comparison of corrosion fatigue behavior for T6 and T7 tempered samples.

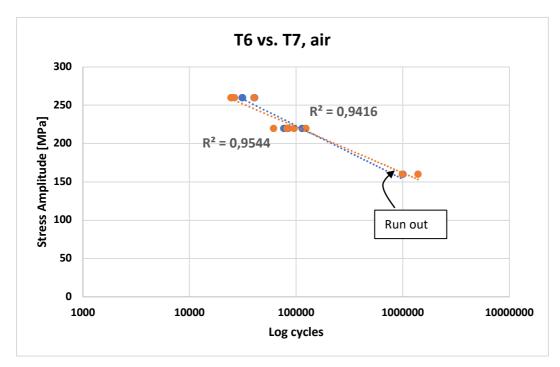
Figure 40: SN curve for T6 and T7 tempered samples tested in air.

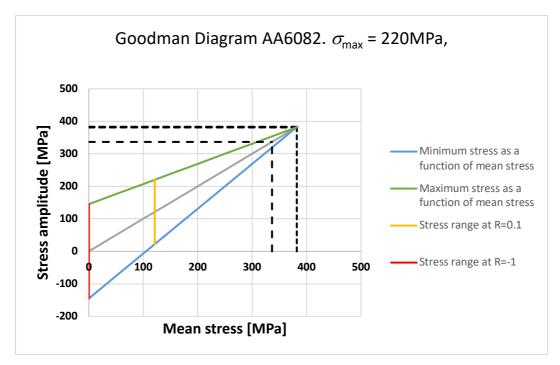
The work in this master's thesis is a continuation of work done by Lindstad[58] on AA6082. In his work, Lindstad investigated the effect of different surface finishes on corrosion fatigue life. Only machined samples, i.e. similar samples to those evaluated in this thesis, were compared. Lindstad used an R value of 0.1 in his work, while the present work was done with an R value of -1. To account for this difference in mean stress, a Goodman diagram was designed, following the method described in section 2.4.4. The result is presented in figure 41.

Figure 41: Goodman Diagram constructed to compare corrosion fatigue behavior of AA7046 and AA6082.

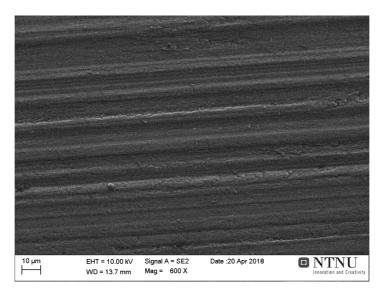
Figure 42: Air, 160 MPa, 1.38*10⁶ cycles. 600x magnification.

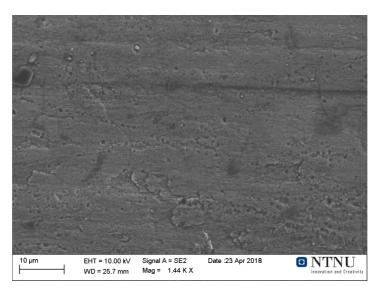
Figure 43: 5 wt% NaCl, 260 MPa, 1.7*10⁴ cycles. 1440x magnification.

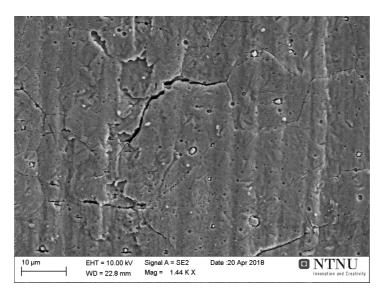
Figure 44: 5 wt% NaCl, 220 MPa, 5.6*10⁴ cycles. 1440x magnification.

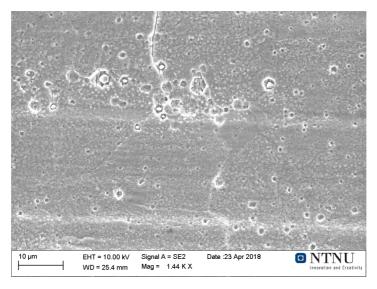
Figure 45: 5 wt% NaCl, 160 MPa, 1.09*10⁵ cycles. 1440x magnification.

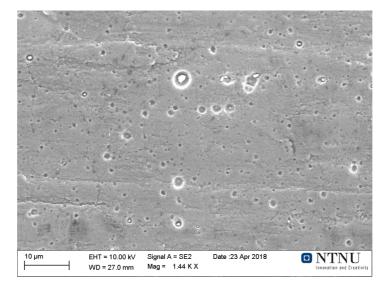
Figure 46: 5 wt% NaCl, no load. 1440x magnification.

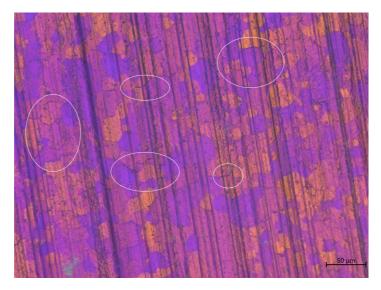
For the samples presented above there also seems to be some preferential attacks along the grain boundaries. To further investigate this, the specimen presented in figure 44 was anodized in as-extruded condition and investigated in light microscope, see figure 47. The view plane is the ED-TD plane. Here, the surface recrystallized grains mentioned in section 4.1 are clearly recognizable, as well as the die lines. The abovementioned attacks along the grain boundaries is also visible. Inside the white circles we see how black "lines" can be seen separating the grains, suggesting a grain boundary attack.

Figure 47: LOM image illustrating grain boundary attacks, encircled in white. 10x magnification. The scale bar is 50 μ m.

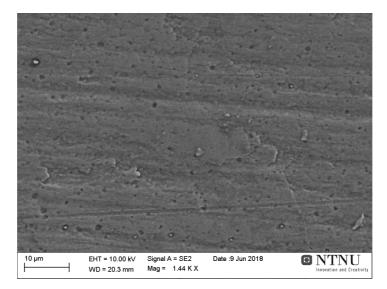
All pre-corroded samples were tested at a stress amplitude of 220 MPa. For the sample exposed to the salt solution for 5 hours, figure 48, only small pits are observable on the sample surface. For 7 days exposure, figure 49, the pits have clearly increased in size (notice the magnification difference). For 26 days exposure, figure 50, the corrosion attacks are more severe, and the characteristic die lines are no longer visible. The small "notches" observed on the surfaces in figure 49 and 50 are likely corrosion products not removed during submersion in the $CrO_3 + H_3PO_4$ solution.

*Figure 48: 7*104 cycles, 5 hours exposure. 1440x magnification.*

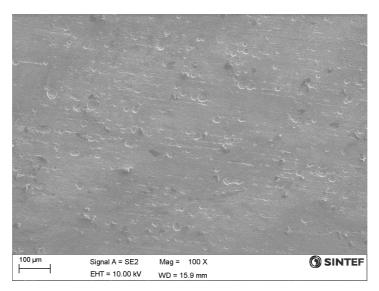
*Figure 49: 4.3*104 cycles, 7 days exposure. 100x magnification.*

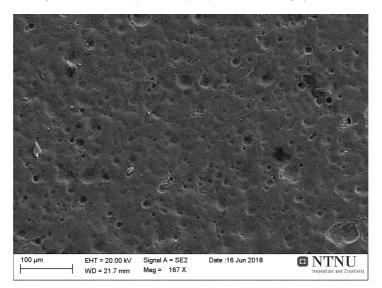
*Figure 50: 2.3*104 cycles, 26 days exposure. 167x magnification.*

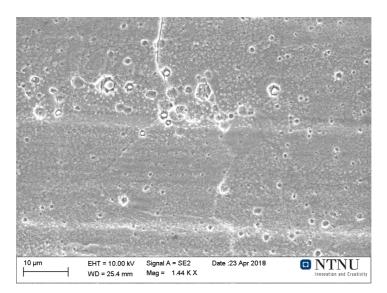
In this section a sample in T6 and T7 condition is compared, figure 51 and 52 respectively, tested at the same stress amplitude of 160 MPa. The maximum pit diameter for the two temper states are approximately the same, but the number of pits seem to be slightly higher for the T6 tempered sample. A microcrack is also visible for the T6 tempered sample.

Figure 51: 5 wt% NaCl, 160 MPa. T6. 1440x magnification.

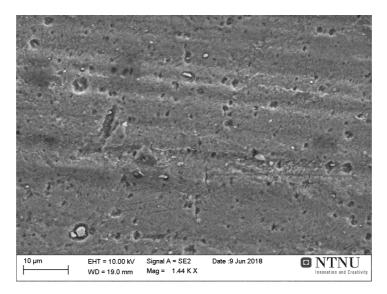
Figure 52: 5 wt% NaCl, 160 MPa. T7. 1440x magnification.

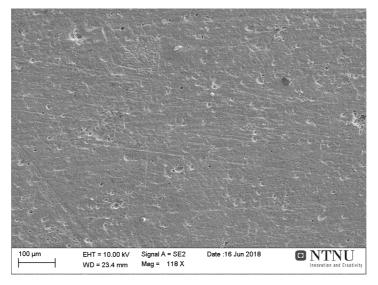
An interesting observation that were clearly visible for the pre-corroded samples exposed at longer times was a difference in pit size and density between the extruded and machined surfaces of the fatigue samples. In figure 53 and 54, a sample exposed to the salt solution for 3 weeks before fatigue testing is presented. As we see from the figure, pit size and density is evidently higher for the machined surface. The same trend is clear for a sample exposed to the salt solution for 26 days, figure 55 and 56, where the machined surface clearly contain more and larger pits than the extruded surface.

Figure 53: Extruded surface, 21 days exposure. 118x magnification.

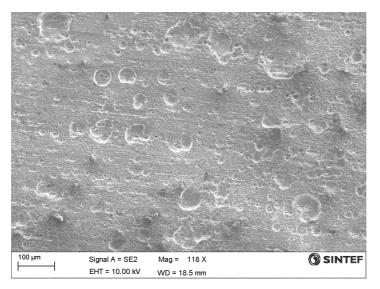
Figure 54: Machined surface, 21 days exposure. 118x magnification.

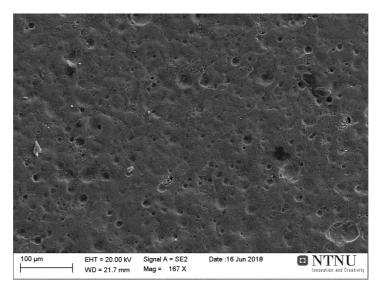
Figure 55: Extruded surface, 26 days exposure. 167x magnification.

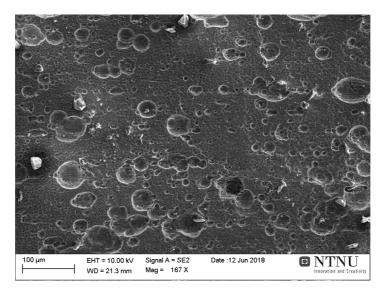
Figure 56: Machined surface, 26 days exposure. 167x magnification.

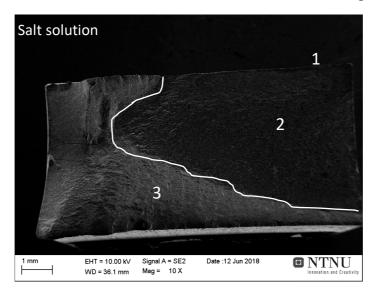
always was found in the corner area between the machined and extruded surfaces. The numbers 1-3 denote characteristics of fatigue failures, where 1 denote crack initiation site, 2 denote area of crack propagation while 3 denote area of final fracture. The final fracture, as commonly observed in fatigue, created a 45° angle with the loading direction. The white line in figure 57 illustrates the end of the fatigue fracture zone. For the samples tested in salt water, the size of this zone was found to increase with increased fatigue lifetime.

Figure 57: Sample fatigue tested at 160 MPa, representative for the samples tested in salt solution.

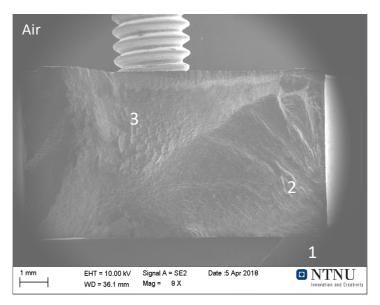
Figure 58: Sample fatigue tested at 160 MPa, representative for the samples tested in air.

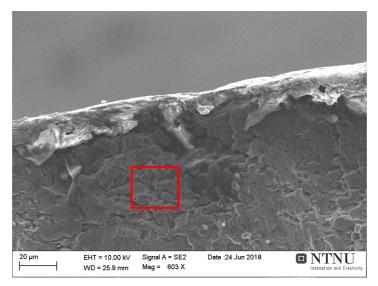
Figure 59: Magnification of potential crack initiation site. Found for sample tested at 220 MPa.

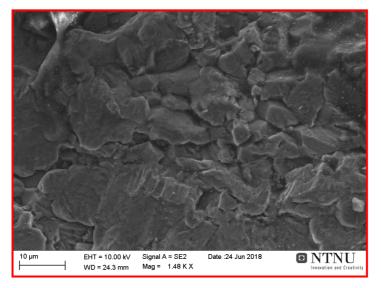
Figure 60: Magnification of the crack initiation site presented in figure 57.

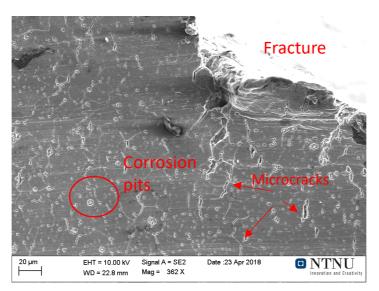
Figure 61: Extruded surface of sample tested at 160 MPa.

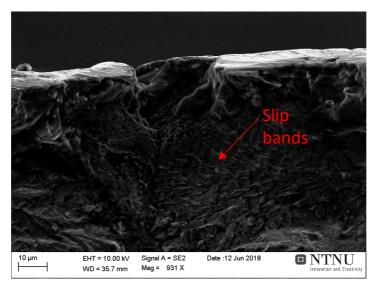
Figure 62: Fracture surface of sample presented in figure 61.

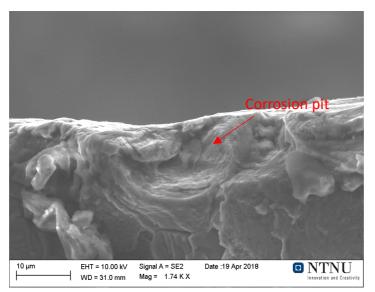
Figure 63: Corrosion pit at the fracture surface for sample tested at 160 MPa.

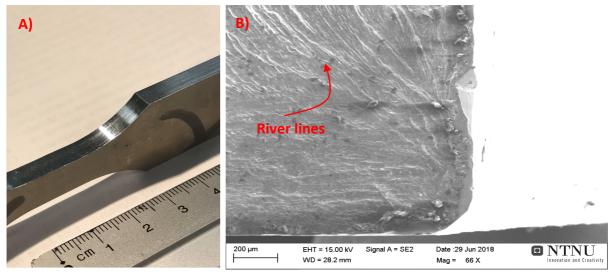
Figure 64: (A) shows an image of the fatigue specimens, illustrating the sharpness of the corner separating the machined and extruded sides. (B) is a magnification of the fracture surface, where river lines are seen emanating from the corner.

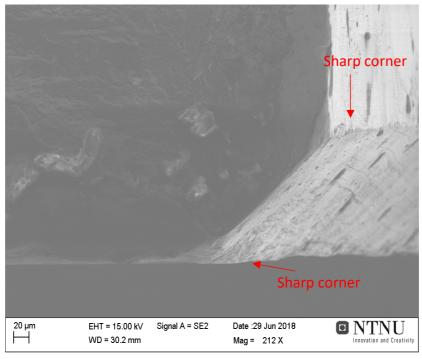
Figure 65: Illustration of the sharp corners separating the machined and extruded surfaces.

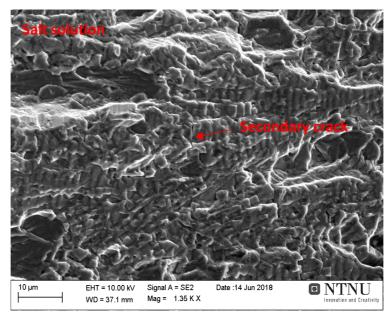
Figure 66: Striation morphology for samples tested in salt water.

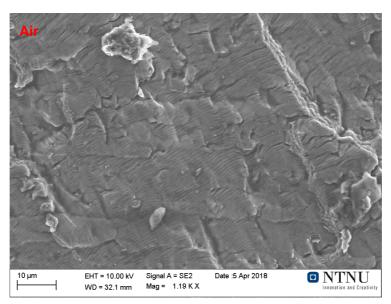
Figure 67: Striation morphology for samples tested in air.

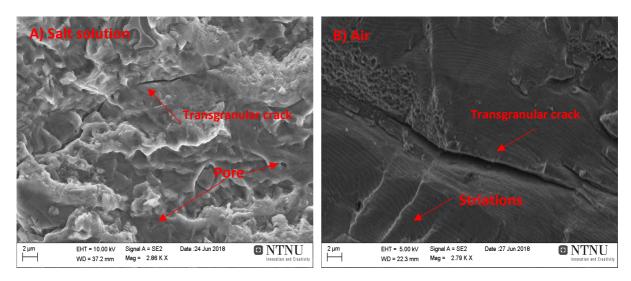
Figure 68: (A) stage II crack growth for samples tested in salt solution. (B) Stage II crack propagation for samples tested in air

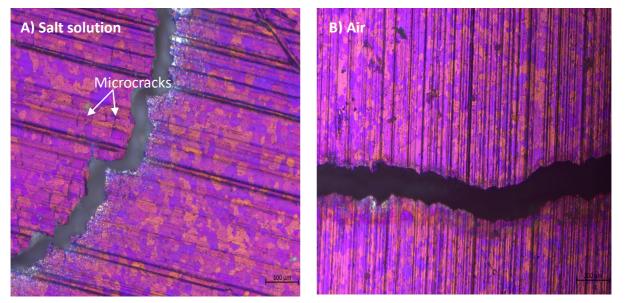
Figure 69: LOM micrographs illustrating the transgranular crack propagation found for samples in salt water and in air.

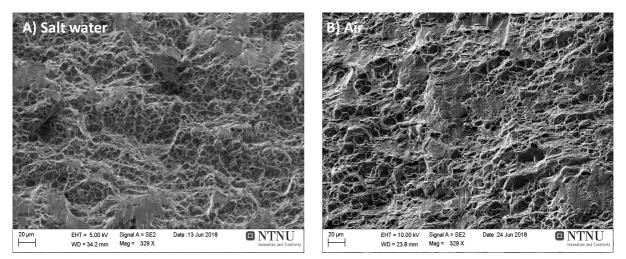
Figure 70: Final fracture appearance for samples tested in salt water (A) and in air (B).

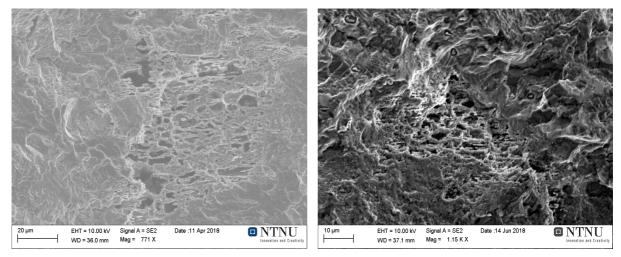
Figure 71: Localized corrosion sites found on the fracture surface found for some of the samples tested in the salt solution.

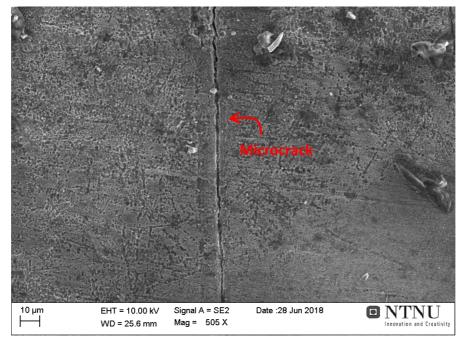
Figure 72: Illustration of large microcrack found for T7 tempered sample.

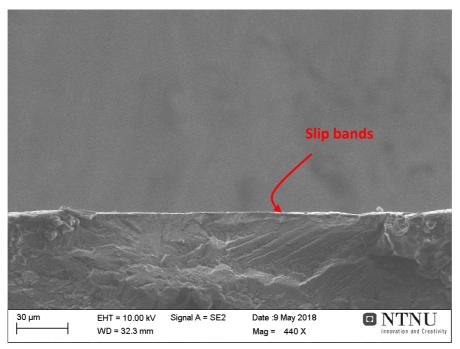
Figure 73: Magnification of crack initiation site for T7 tempered sample.

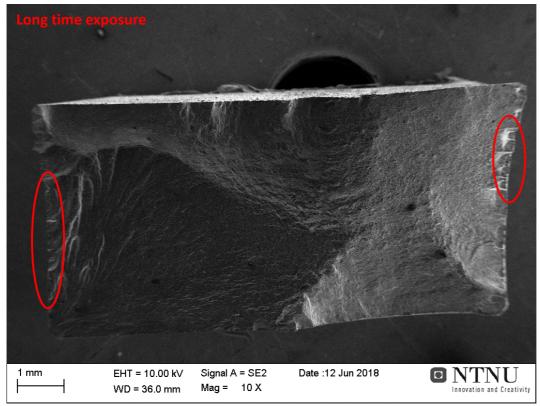
Figure 74: Overview of fracture surface for samples pre-corroded in salt water for long times (more than 5 hours).

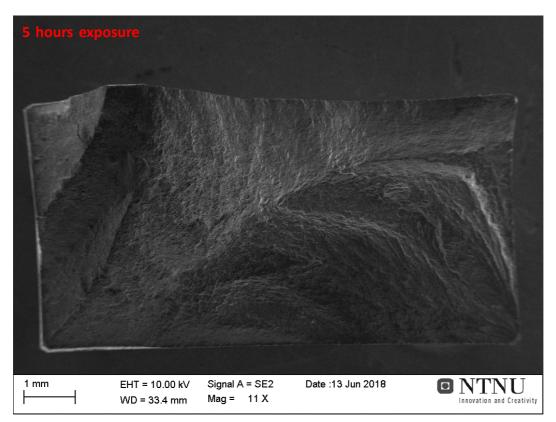
Figure 75: Overview of fracture surface for samples pre-corroded in salt water for 5 hours.

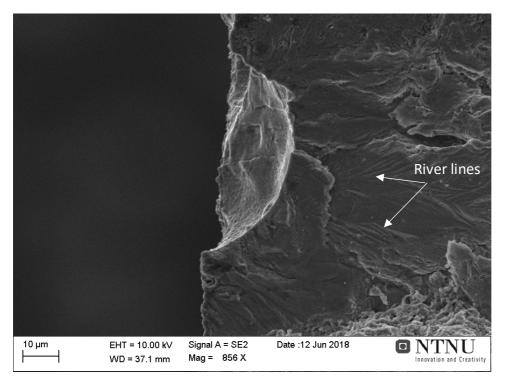
Figure 76: Crack initiation mechanism for samples pre-corroded for long times.

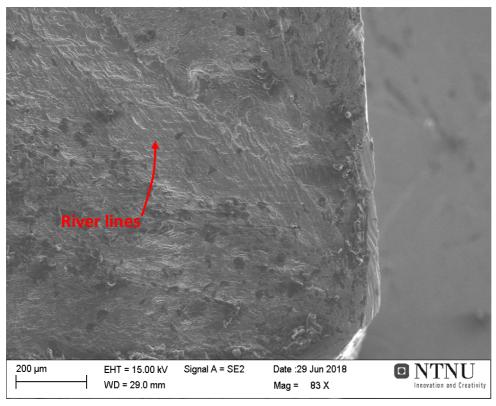
Figure 77: Crack initiation at corner for samples pre-corroded for 5 hours.

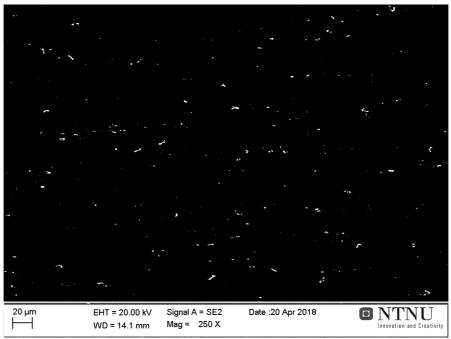
Figure 82: Particle distribution in extrusion plane.

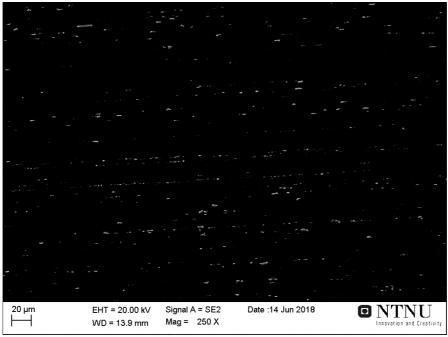
Figure 83: Particle distribution in longitudinal plane.

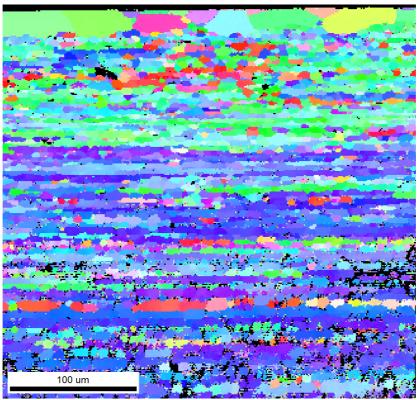
Figure 84: Area scanned to generate pole figure for 7046 alloy.
