# Study on the long-term stability issues of the headrace tunnel of Ulset Hydropower Project

Master's thesis in Geotechnology  
Supervisor: Krishna Kanta Panthi  
June 2019

Norwegian University of Science and Technology  
Faculty of Engineering  
Department of Geoscience and Petroleum

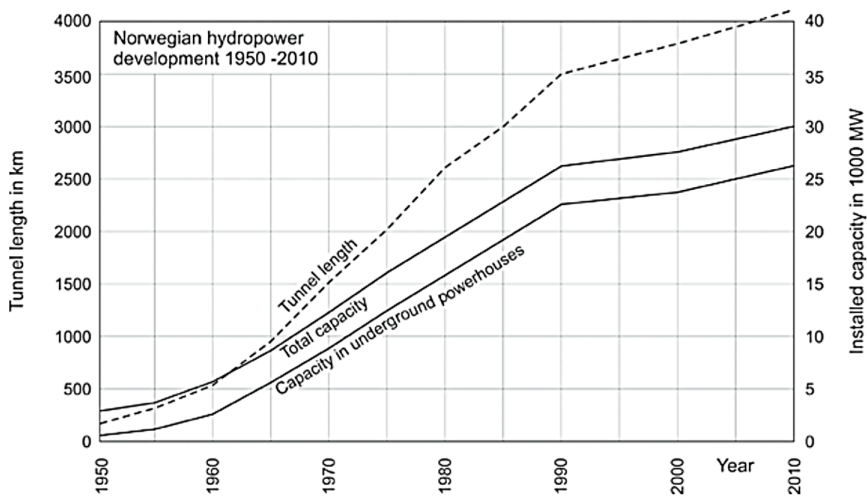
**Figure 2.1:** The total length of excavated hydropower tunnels from 1950 to 2010, together with the installed capacity from underground powerhouses and the total capacity from hydropower (Broch, 2013).

It shows that the capacity from underground powerhouses make up most of the energy production, and of the world's 600-700 underground powerhouses 200 of them can be found in Norway. From 1960-1990 an average of 100 km of tunnels were excavated each year. Today, 4000 km of underground water tunnels have been excavated. Based on these facts Broch (2013) states that the Norwegian electric industry is in fact an "underground industry".

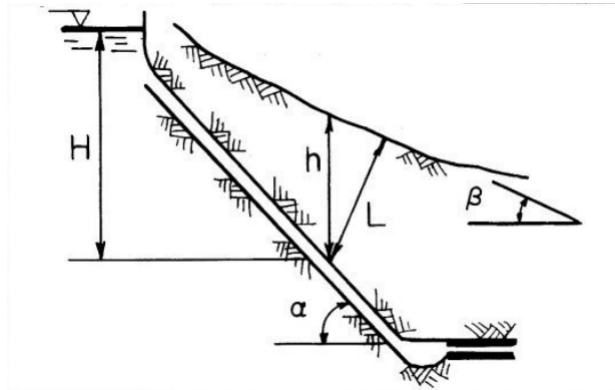
**Figure 2.3:** Illustration of the definition of parameters in the different rule-of-thumb (Broch, 2006).

where  $h$  is the vertical depth of the point studied (m),  $H$  the static water head and  $c$  is a constant, which was 0.6 for valley sides with inclinations up to 35 degrees and increased to 1.0 for valley sides of 60 degrees. Figure 2.3 illustrates the definition of the parameters.

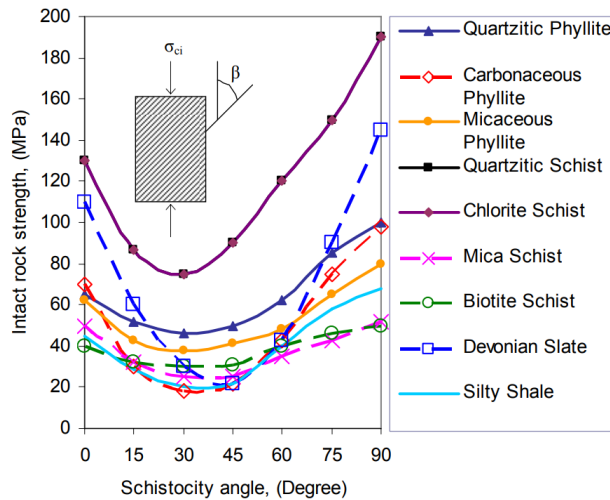
**Figure 3.6:** The uniaxial compressive strength of different rocks with the schistosity planes at different angles to the loading direction (Panthi, 2006).

The uniaxial compressive strength will be effected by the angle of loading to the weak layers in the rock. Figure 3.6 illustrates this effect, and shows that the rock strength is lowest when the loading direction is 30 degrees to the schistosity planes. The greatest strength is obtained when the planes are perpendicular to the loading direction (Panthi, 2006). It is important to have in mind the direction of these planes in rock samples, since testing at different angles may give different results.

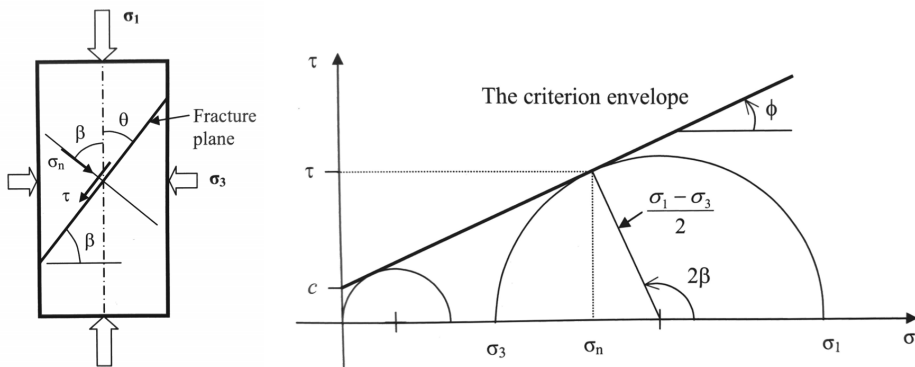
**Figure 3.7:** Rock core under deviatoric loading with stress components on the fracture plane (left) and graphical presentation of the Mohr-Coulomb failure criterion (right) (Li, 2017b).

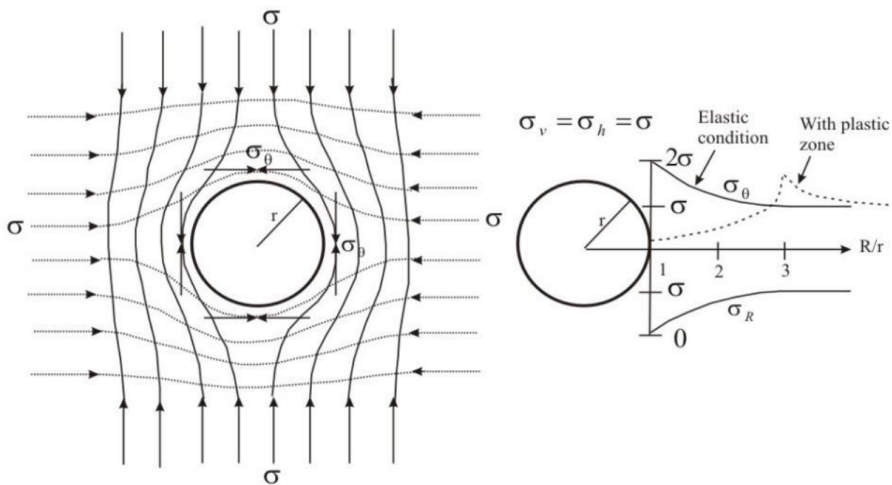
**Figure 4.2:** Stress trajectories in rock mass around an circular opening (left) and tangential and radial stresses under elastic and non elastic conditions (right) (Panthi, 2006).

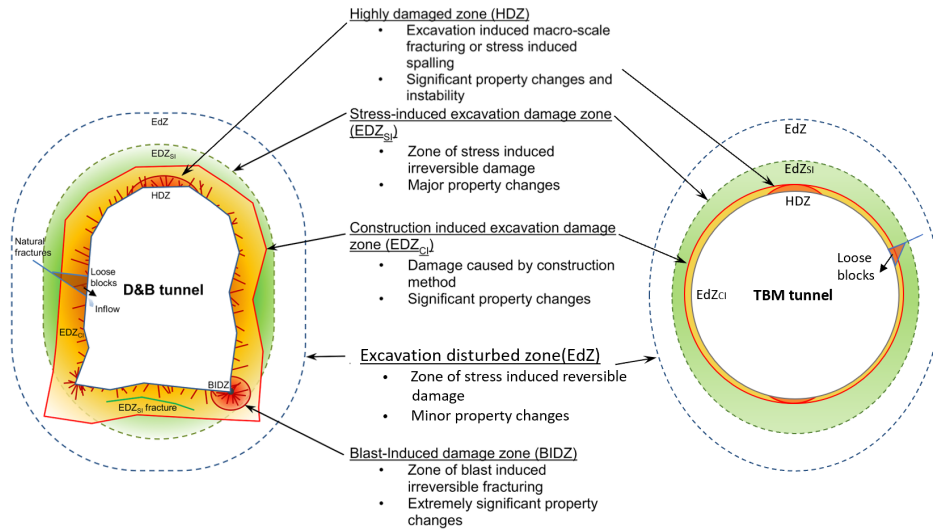
**Figure 4.4:** Excavation damage divided into different zones. Modified from (Siren et al., 2015).

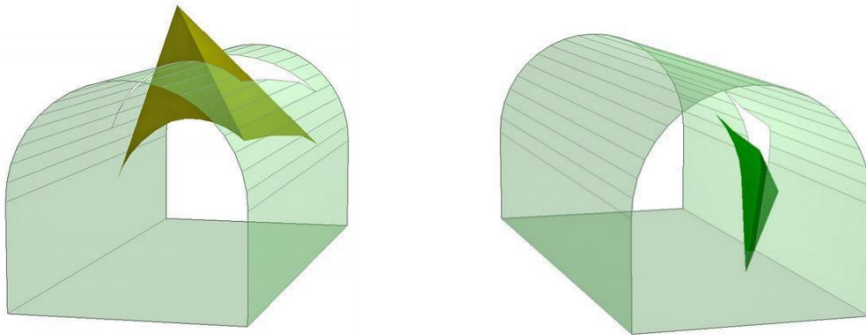
**Figure 4.5:** Wedges formed by three intersecting structural features in the roof (left) and the wall (right). These wedges may fall or slide if the restraint around the opening is too small (Hoek, 2007a).

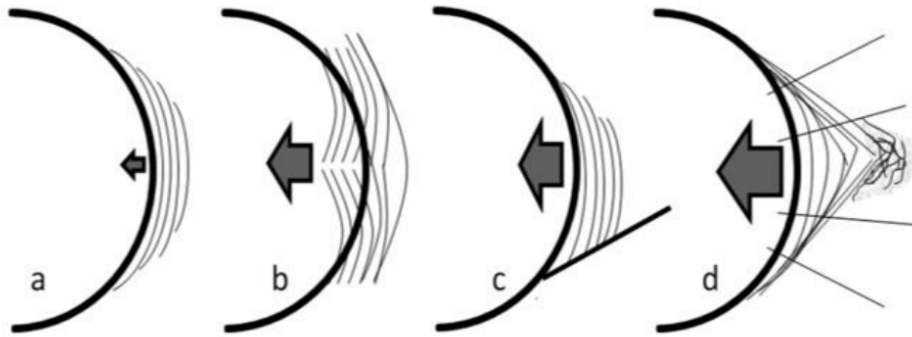
**Figure 4.6:** Propagation of stress induced failure in a brittle rock mass. a) Non-violent spalling b) bursting through buckling c) spalling intersecting with structure and d) dilational yield (Diederichs, 2014).

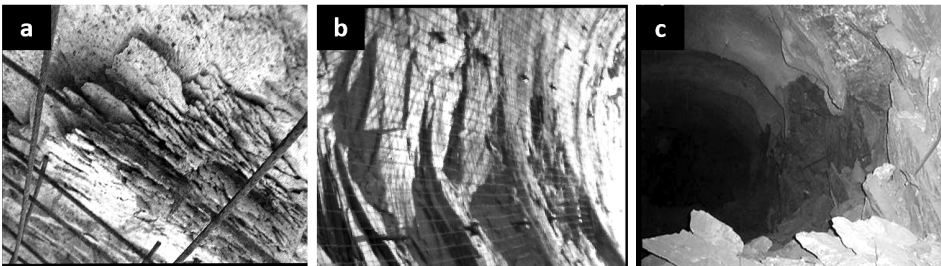
**Figure 4.7:** Increased level of spalling. a) minor surface parallel spalling in crown, b) release of 50 cm of spalled ground in TBM tunnel and c) strain-burst of a notch shape spalling zone in deep mine drift. Modified from (Diederichs, 2007).

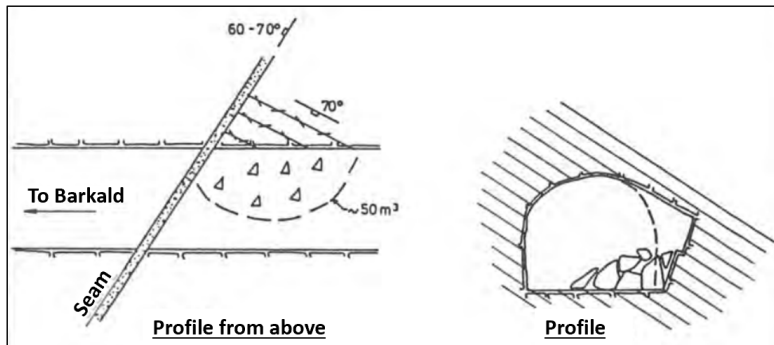
**Figure 5.4:** Illustration of the Tysla collapse. Modified from (Kjølberg, 1985).

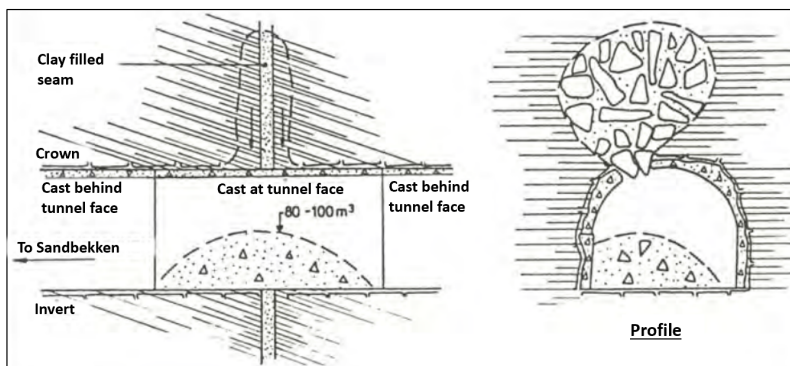
**Figure 5.5:** Illustration of the sandbekken collapse. Modified from (Kjølberg, 1985).

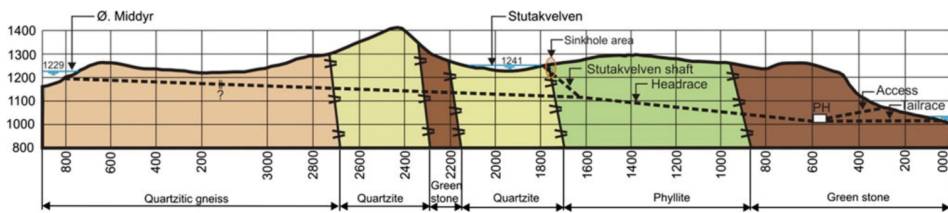
**Figure 5.6:** Longitudinal profile and geology of the water system at Svandalsflona HPP. The weakness zone between the quartzite and phyllite intersects the Stutakvelven shaft, the sinkhole is indicated by a red circle (Panthi, 2014a).

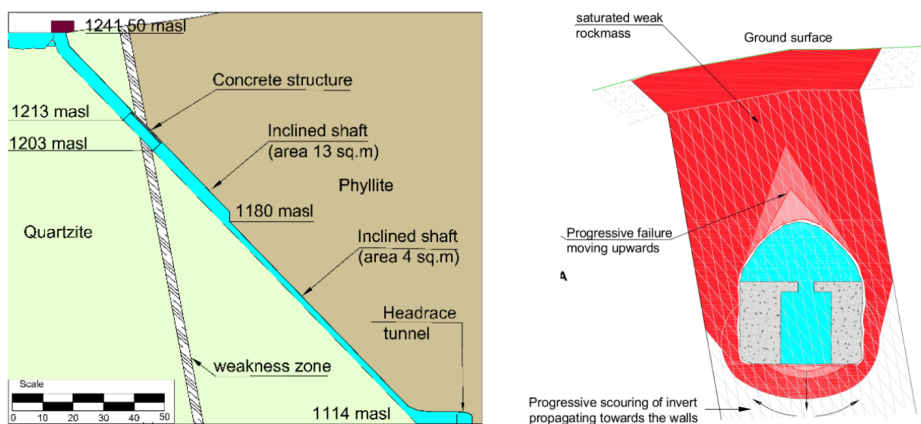
**Figure 5.7:** Profile of Stutakvelven shaft showing the collapsed area (left) and possible failure sequence of the weakness zone and concrete support (right) (Neupane and Panthi, 2018).

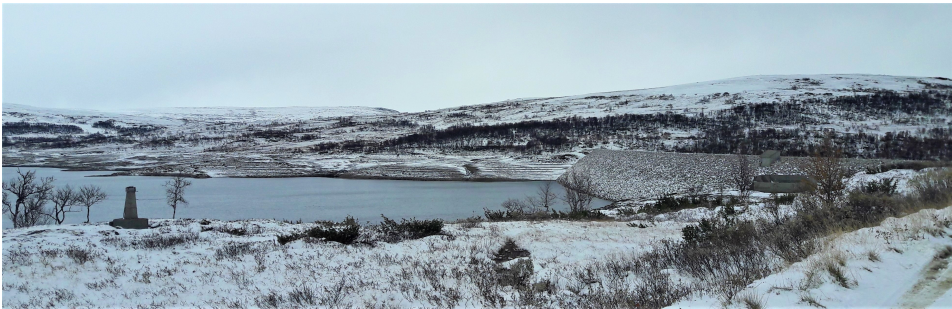
**Figure 6.2:** Falningsjøen embankment dam seen from the reservoir on the left side.

Water is retrieved from two intake areas at Ulset HPP, Falningsjøen and Sverjesjøen reservoirs, and from the rivers Ya and Russa. Falningsjøen is the main reservoir and is raised 25.5 m by an embankment dam with an impervious core of moraine material. The river Ya is transferred to Falningsjøen through a tunnel, and the side river Russa is connected to this tunnel through a shaft (Eiken et al., 1986). The water elevation at Falningsjøen can be regulated between 872.5 m and 825.0 masl, yielding a storage capacity of 125 million m<sup>3</sup> of water (Trønderenergi, 2018).

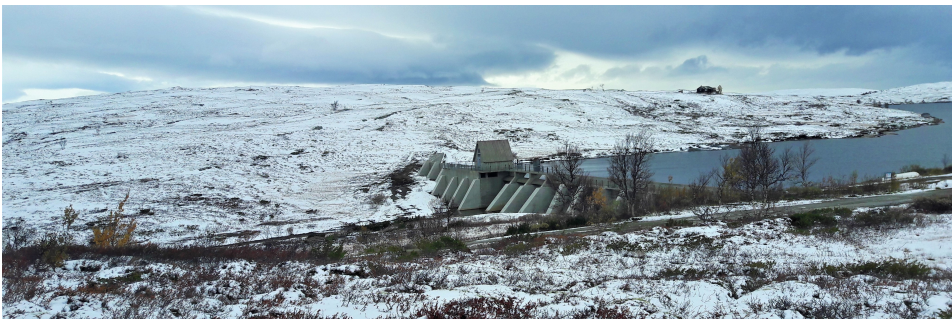
**Figure 6.3:** Sverjesjøen buttress dam seen from the right side of the reservoir.

Sverjesjøen is raised 4.8 m, between 872.5 and 867.5 masl, by a concrete buttress dam as can be seen in Figure 6.3. This gives the reservoir a storage capacity of 7 million m<sup>3</sup> (Eiken et al., 1986). Water is led to the headrace tunnel through a 60° steep shaft. Sverjesjøen intake functions as a submerged intake when the water elevation in Falningsjøen exceeds 867.7 masl. It acts as a brook intake when the water elevation at Falningsjøen drops below 867.7 masl (Dahlø et al., 1988).

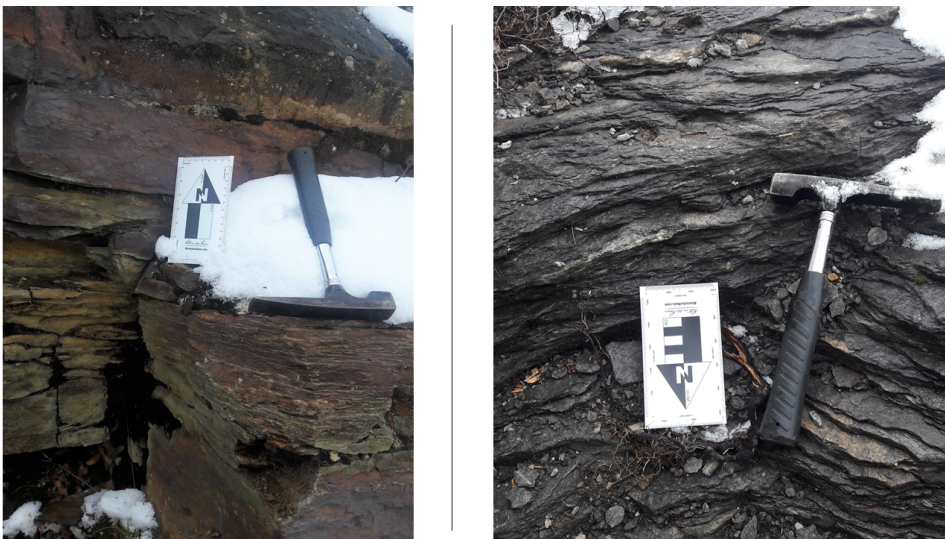
**Figure 6.7:** Quartzitic schist by Falningsjøen at location 1 (left) and more weathered with schistosity at location 8 by Sverjesjøen (right).

By Falningsjøen the quartzitic schist is observed along road cuts and by the access tunnel. Here the rock mass has only been exposed to the elements since 1980, and appears massive and medium strong. The rock mass is grey in colour and has a brown/red coating. It is fine grained with a distinct foliation. Towards Falningsjøen and the powerhouse area the quartzitic schist is more weathered, with an even more distinct schistosity. The difference can be seen in Figure 6.7.

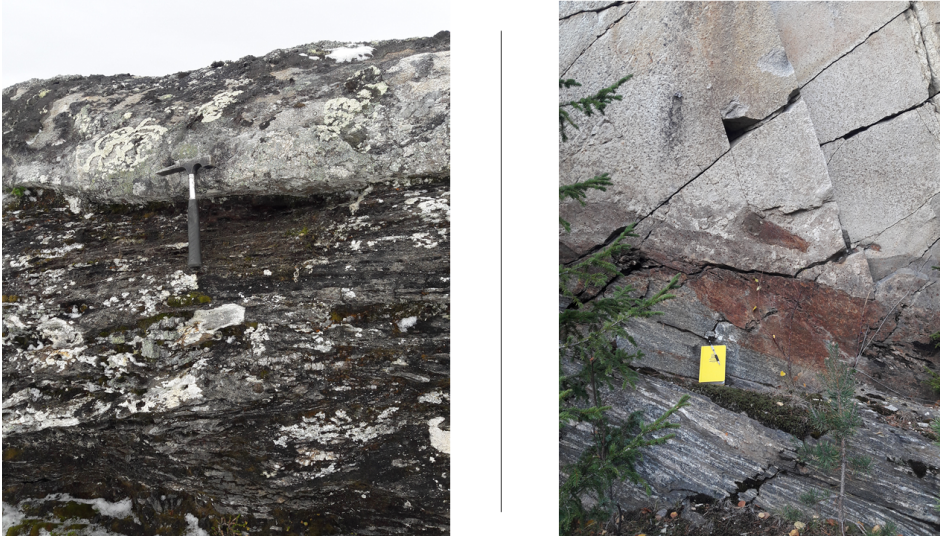
**Figure 6.8:** Trondhjemite over quartzitic schist at location 7 Sverjesjøen (left) and 14 powerhouse area (right). The trondhjemites are from different intrusions.

The trondhjemite was easily distinguished from the quartzitic schist by the light color and massive appearance. It has a white or beige color with medium coarse grains.

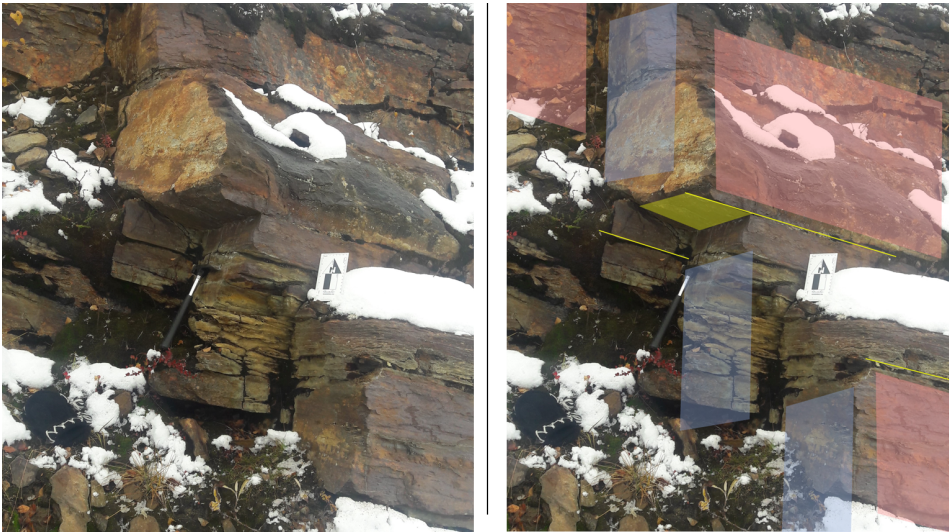
**Figure 6.9:** Grey quartzitic schist by Falningsjøen, with a brown/red coating. To the right the joint planes are illustrated with colour: foliation joints (yellow) and crossjoints (red and blue).

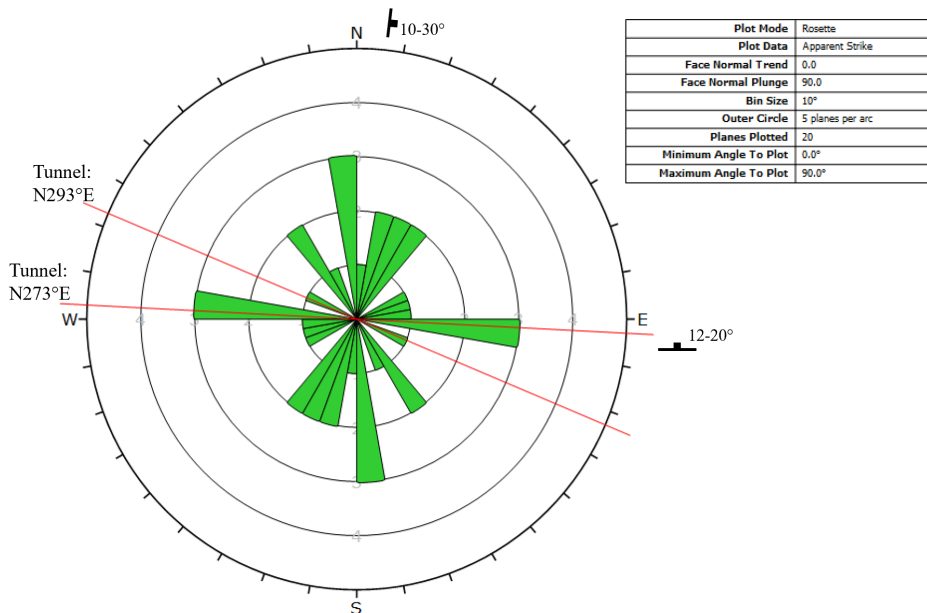
**Figure 6.10:** Rosette plot of foliation joints from the project area.

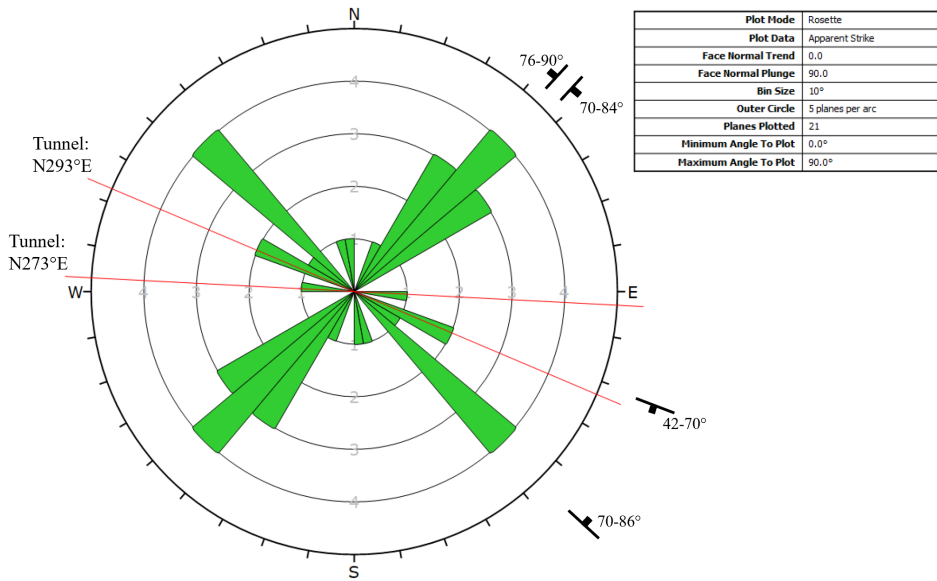
**Figure 6.11:** Rosette plot of cross joint measurements from the project area.

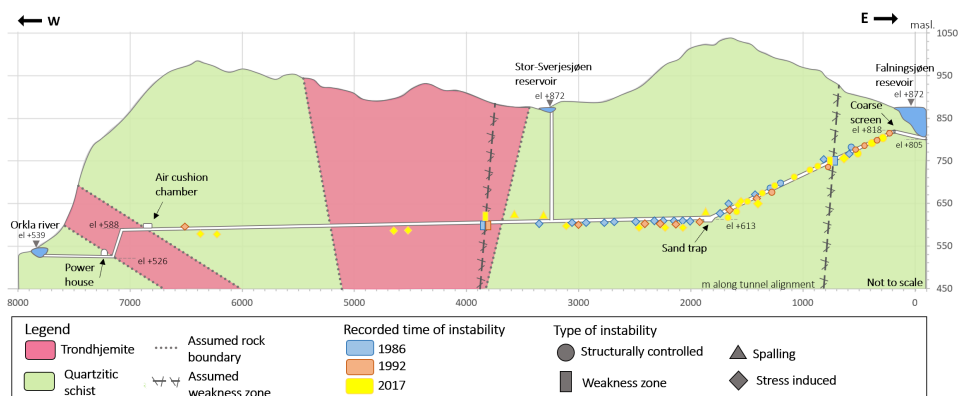
**Figure 6.14:** Overview and timeline of the different instabilities/failures in the headrace tunnel. The different shapes represents the failure category and the colours represent the year the failure was registered.

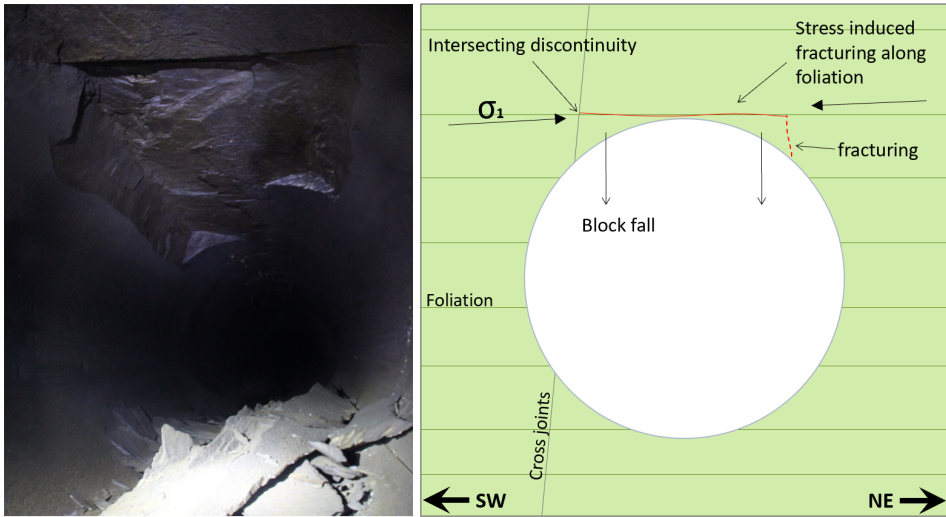
**Figure 6.16:** Notches left in the roof from stress induced failure at 2585 m from the coarse sediment screen (left).

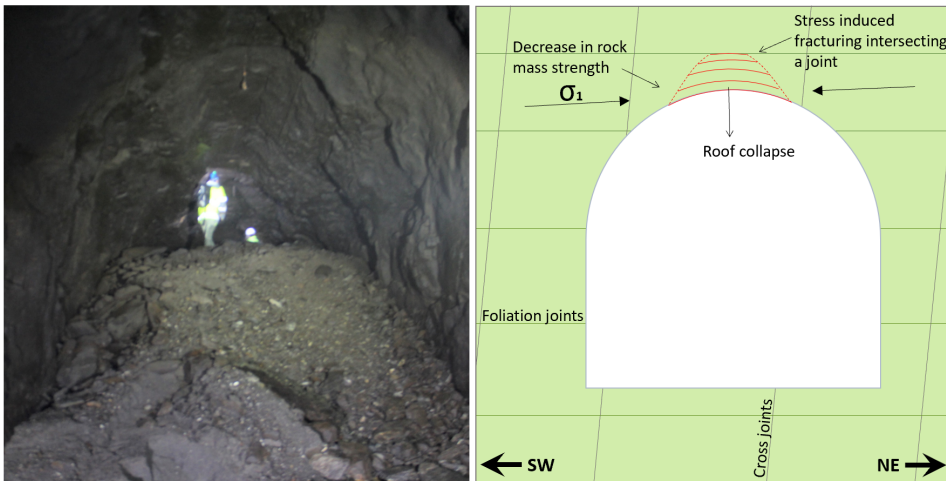
**Figure 6.17:** Material from roof collapse causing sediment to be deposited, which leads smaller and medium scale blockages in the D&B tunnel (left). Fracturing induced by high stresses propagates into the rock mass, as the rock mass strength decreases, finally intersecting a foliation joint causing a roof collapse (right).

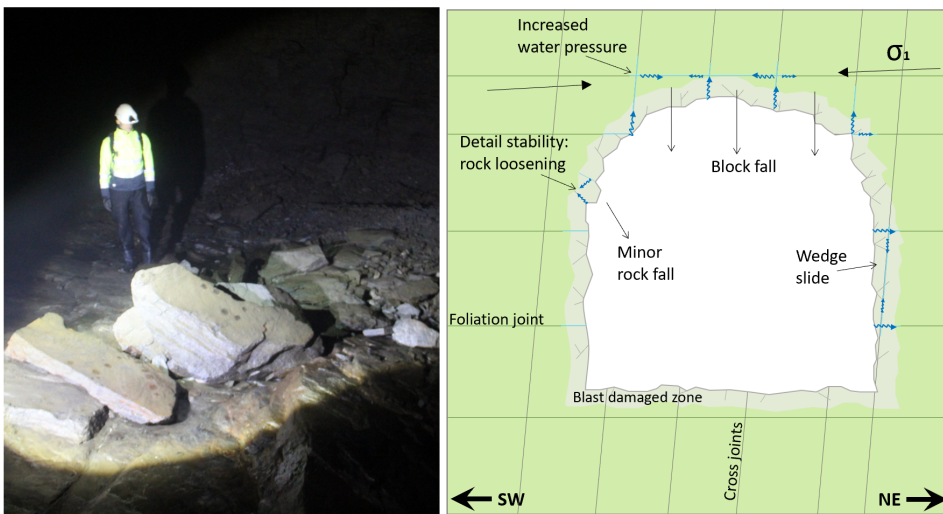
**Figure 6.18:** Block fall at 229 m downstream of the coarse sediment screen (left).

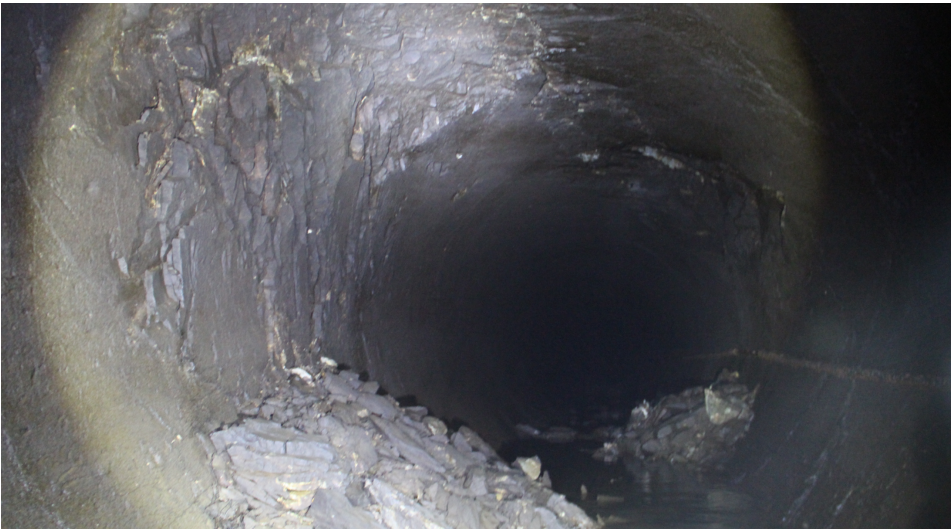
**Figure 6.19:** Weakness zone in the headrace tunnel 650 m downstream of the Sverjesjøen shaft.

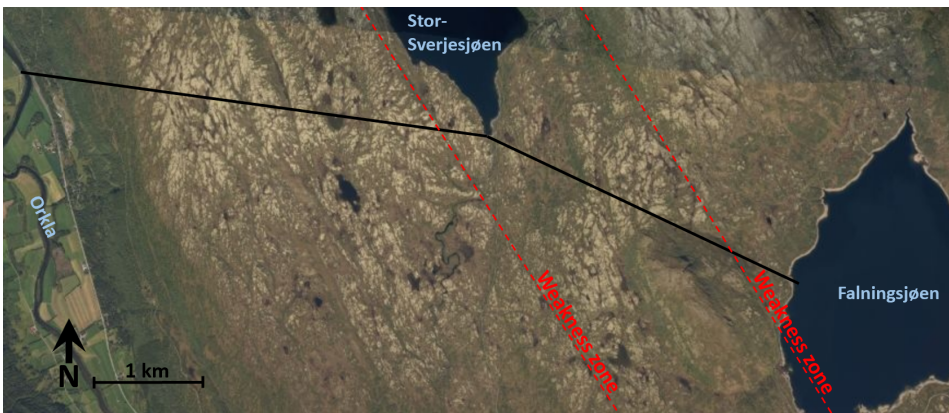
**Figure 6.20:** Black line illustrates the tunnel system and the red dotted lines represent possible weakness zones found in the tunnel.

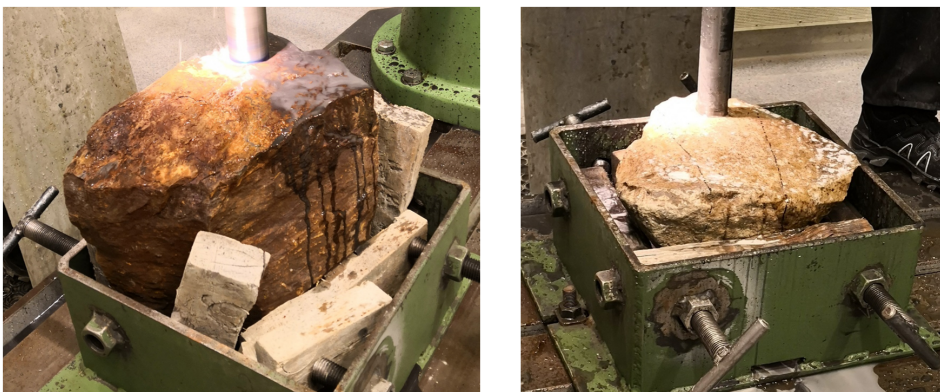
**Figure 7.1:** Rock core extraction from the quartzitic schist (left) and trondhjemite (right) samples.

Two rock samples, quartzitic schist and trondhjemite, were collected during field work for testing. Both samples can be seen in Figure 7.1.

The quartzitic schist sample was found by the access tunnel at Falningsjøen, marked as location 1 in the engineering geological map in Appendix A. The trondhjemite was collected from the access tunnel by the powerhouse area at location 14. The schist sample had a red coating, but the proper color of the rock can be seen in the grey bore water. When boring cores from the quartzitic schist some of the cores were divided into parts, because of a few weak foliation layers in the samples. The trondhjemite sample was rounded, and there was a slight discoloring of the trondhjemite approximately two centimeters into the cores from the surface layer. Both samples had indications of weathering, which can have an impact on the test results.

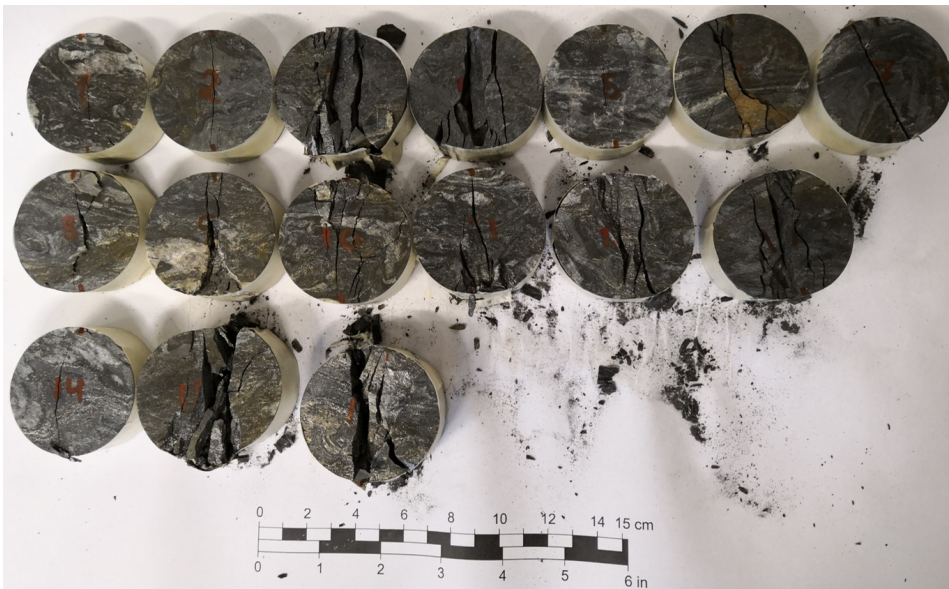
**Figure 7.2:** The disc formed test samples after failure, the quartzitic schist samples failed in a explosive manner.

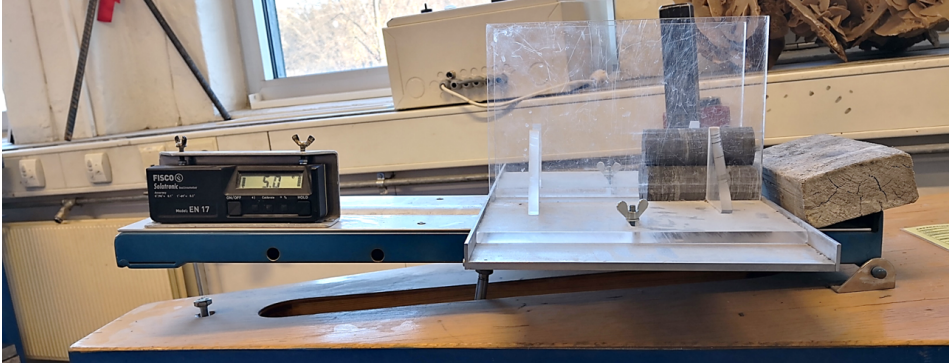
**Figure 7.3:** Apparatus used in the tilt testing. The cores slide less than 10% of the length onto a wood plank to minimise the wear of the rock surface.

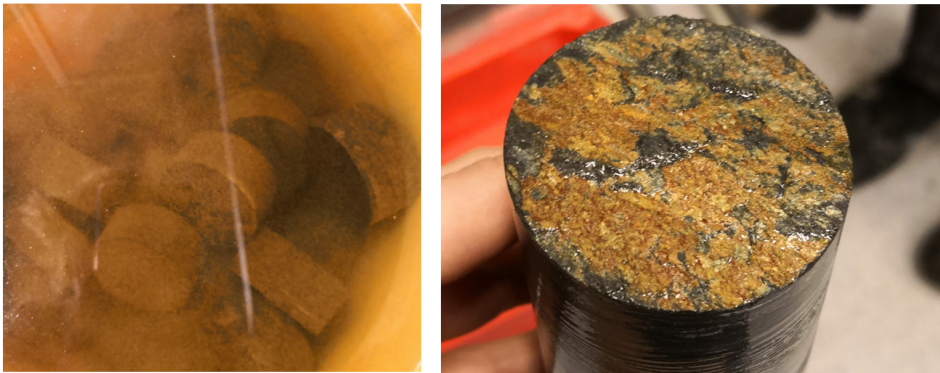
**Figure 7.4:** Red substance accumulated in water used to saturate the test samples(left). The same red substance was found on a weak plane which divided the rock cores during drilling.

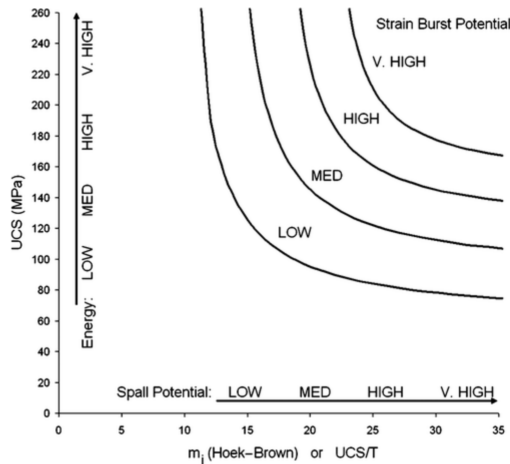
**Figure 8.1:** Potential for rock spalling/rock burst based on compressive and tensile strength of intact rock. (Diederichs, 2007).

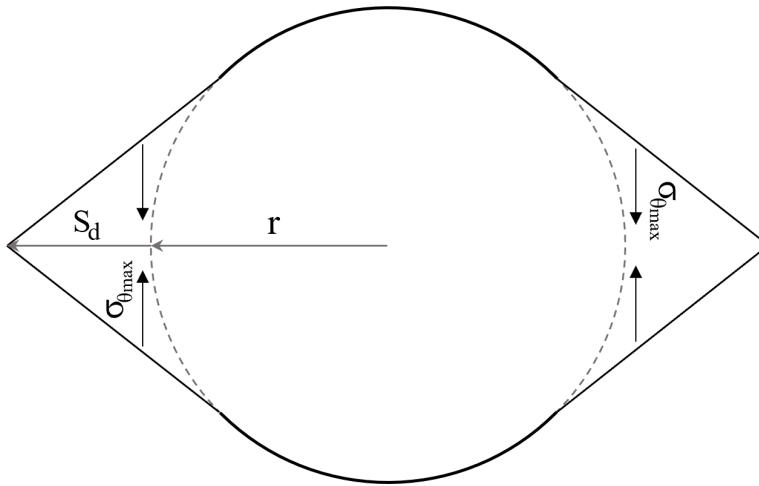
**Figure 8.2:** Illustration of depth of spalling due to high tangential stress (re-produced after (Martin and Christiansson, 2009)).

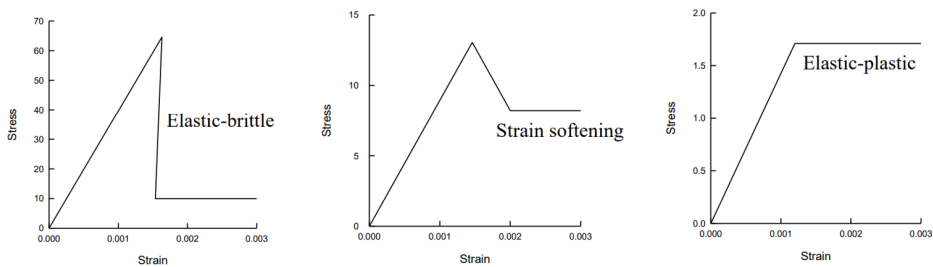
**Figure 8.5:** Post-failure characteristics for different quality rock masses. Very good quality rock mass (left), average quality rock mass (middle) and poor quality rock mass (right) (Hoek, 2007b).

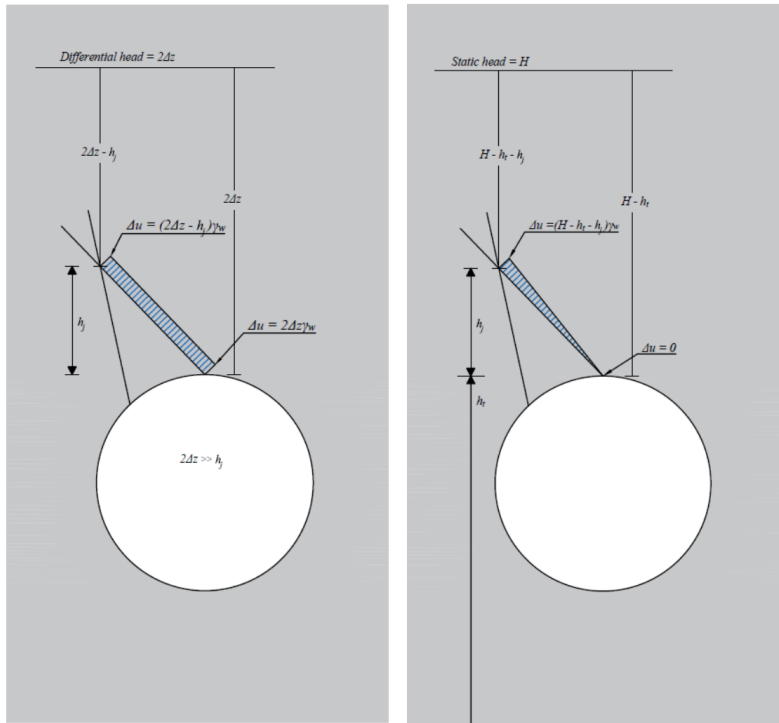
**Figure 8.7:** Differential pressure in joints due to mass oscillations (left) and due to draining (right) (Halseth, 2018).

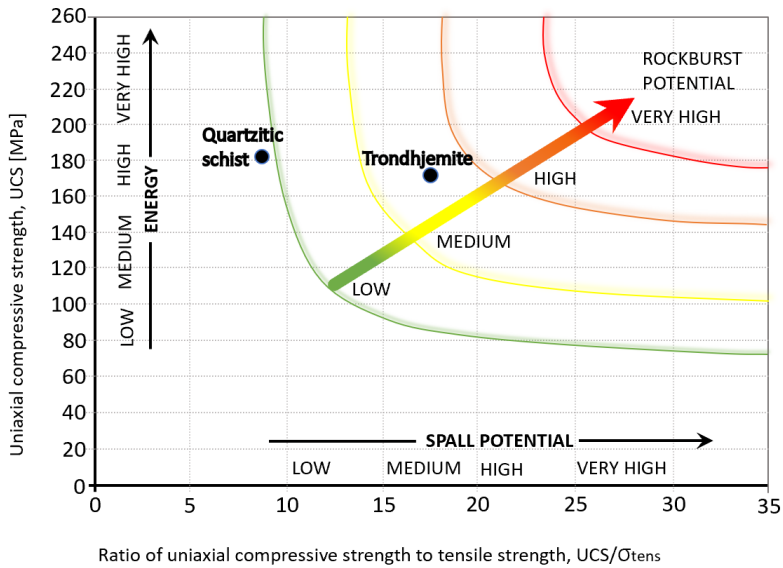
**Figure 9.1:** Potential for rock spalling/rock burst based on compressive and tensile strength of intact rock. Quartzitic schist and trondhjemite are plotted with red crosses (Re-produced after (Diederichs, 2007, 2014)).

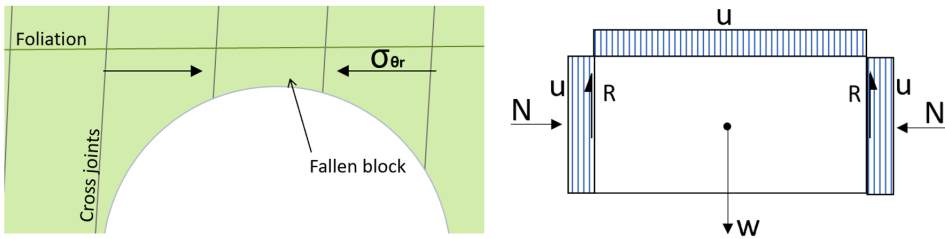
**Figure 9.2:** Illustration of a simplified situation of the block fall (left) and the forces acting on the block (right).

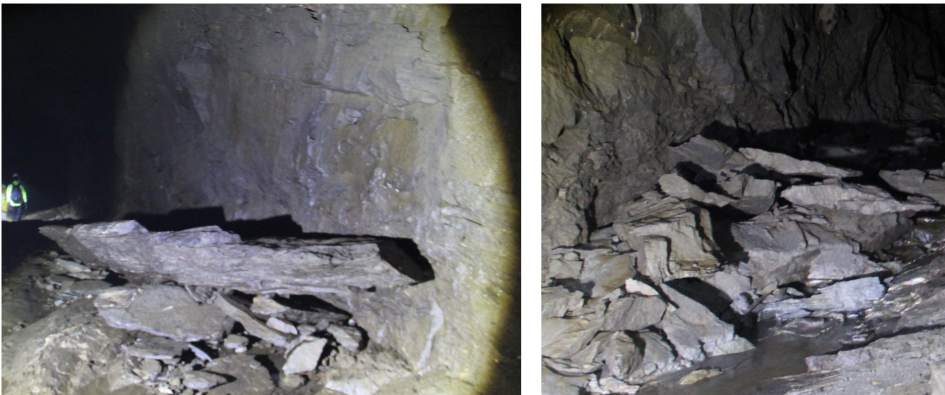
**Figure 9.4:** Wedge failure in right wall at approximately 350 m from the CSS (left) and wedge failure in left wall 900 m from CSS (right).

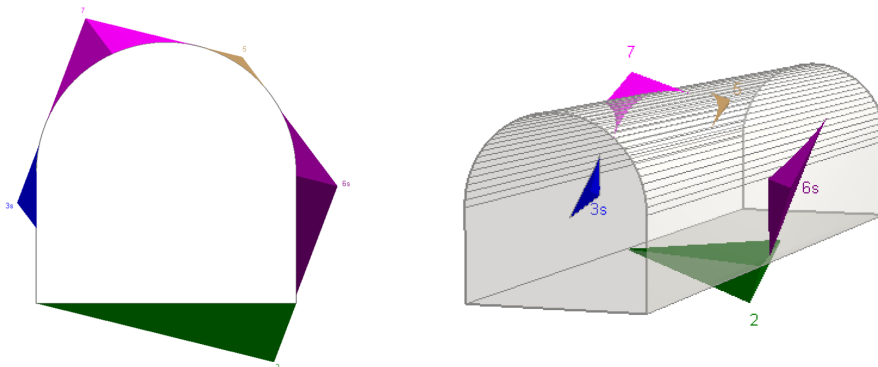
**Figure 9.5:** Five possible wedges from the Unwedge analysis, seen from the front of the tunnel (left) and in 3D from the side (right). The blue and purple wedges (3 and 6) will be used in the further analysis.

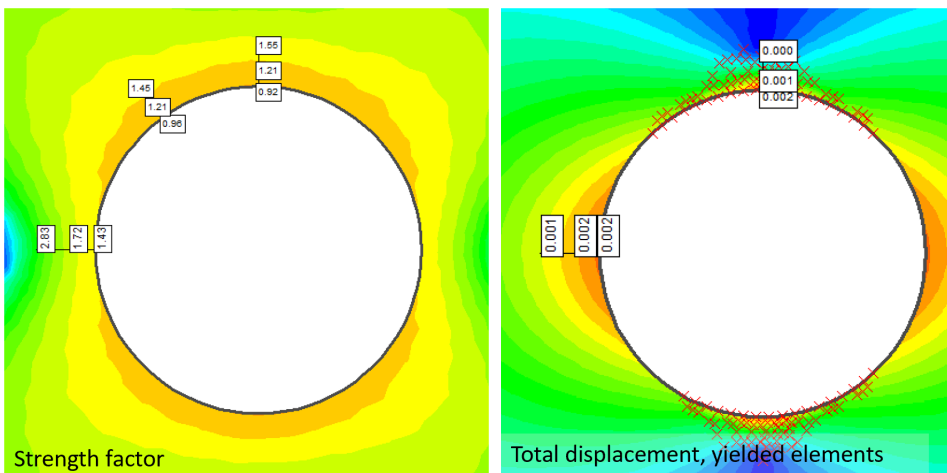
**Figure 9.8:** Strength factor (left), total displacement and 90 yielded elements (right). The yielded elements reach 0.6 m into the rock mass from the crown.

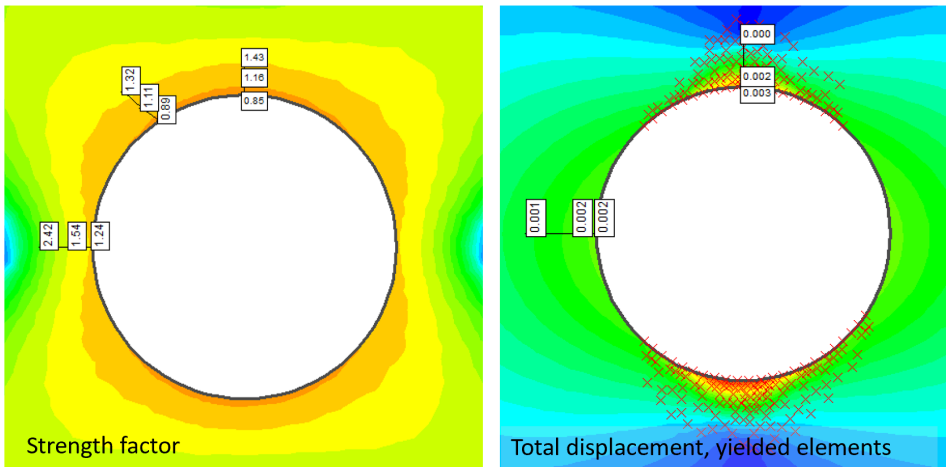
**Figure 9.9:** Strength factor (left), total displacement and 138 yielded elements (right).

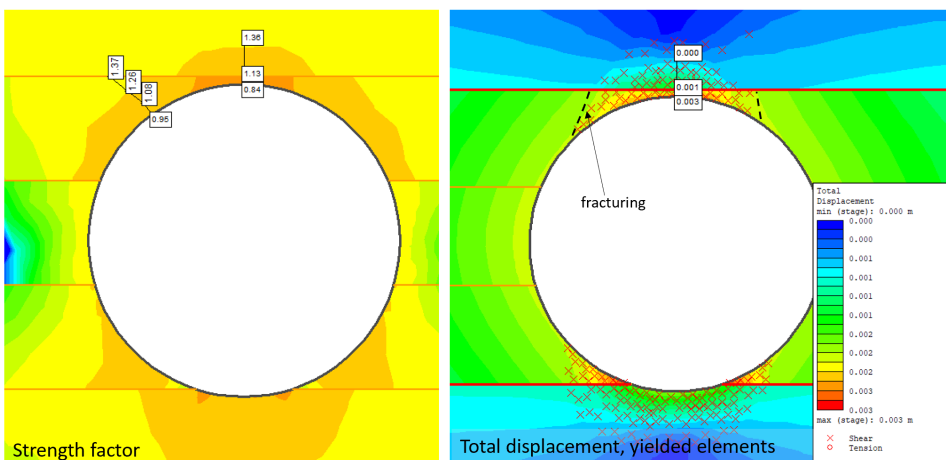
**Figure 9.10:** Strength factor (left), total displacement and 204 yielded elements (right).

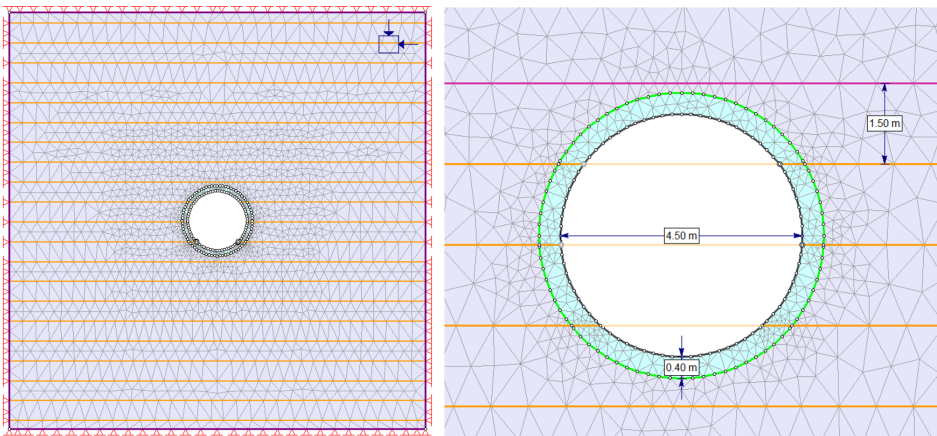
**Figure 9.11:** Model geometry for analysis of failure development due to rock mass and joint strength reduction.

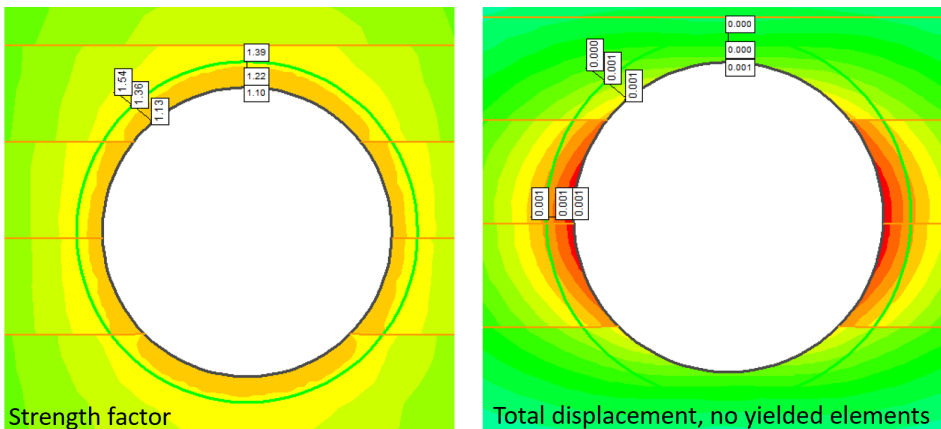
**Figure 9.12:** Strength factor (left), total displacement and no yielded elements (right).

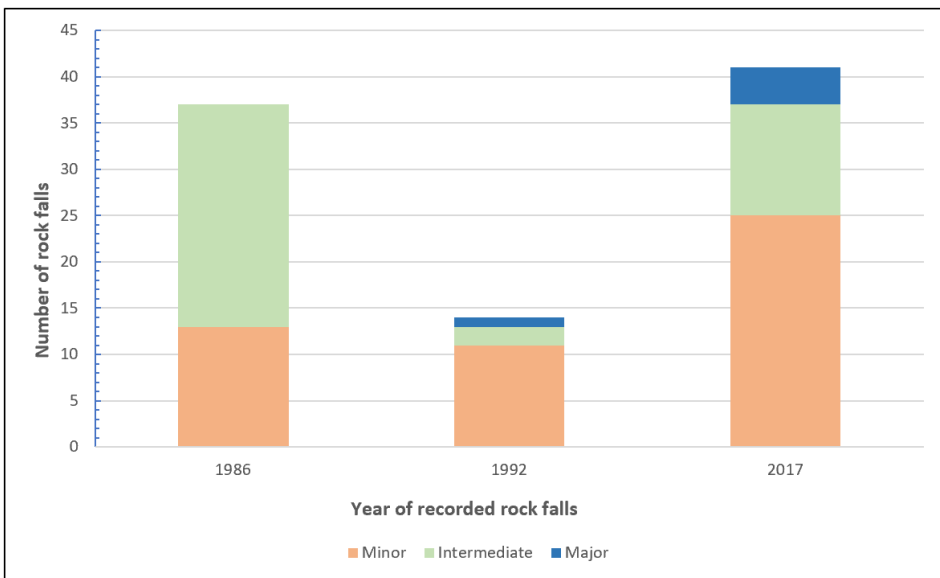
**Figure 10.1:** Number of rock falls recorded in 1986, 1992 and 2017. The rock falls are divided into minor, intermediate and major rock falls.

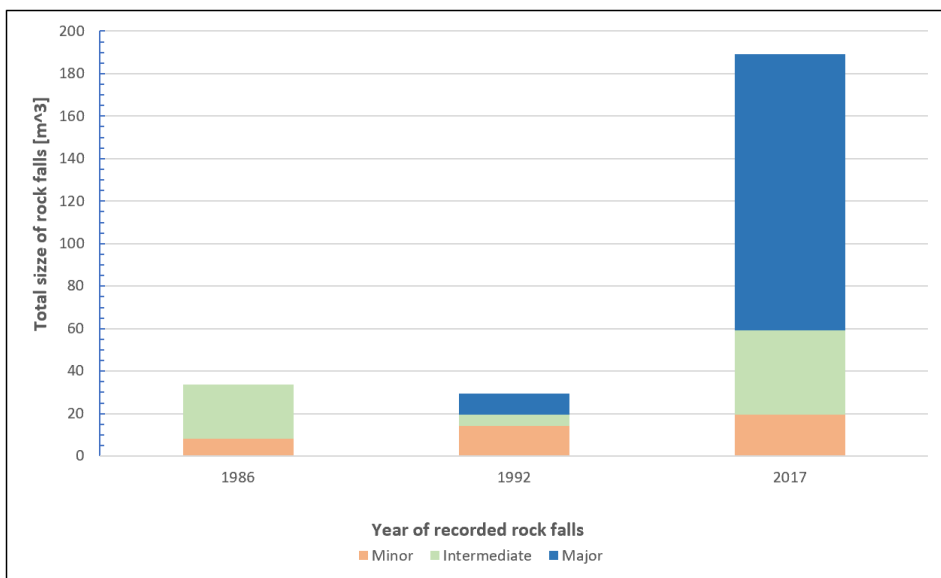
**Figure 10.2:** Total size of rock falls recorded in 1986, 1992 and 2017. The rock falls are divided into minor, intermediate and major rock falls.

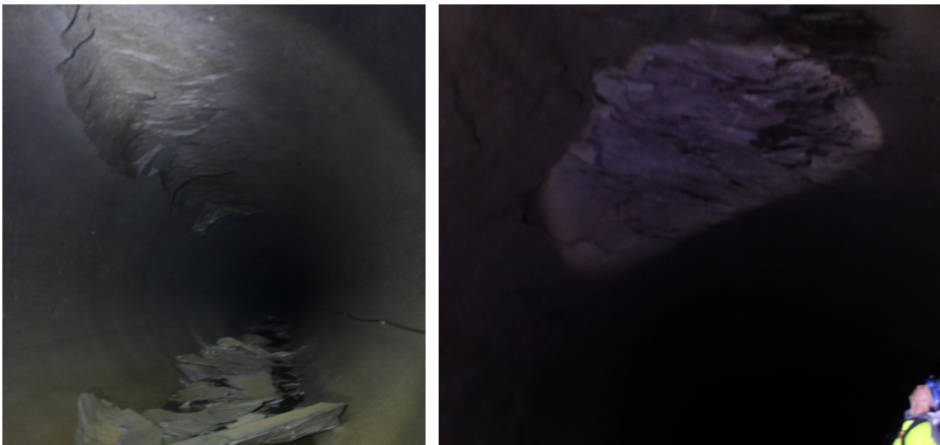
**Figure 10.3:** Stress induced rock fall just after the first watering (left) and instability which has developed over time causing inward movement of crown and rock falls (right).

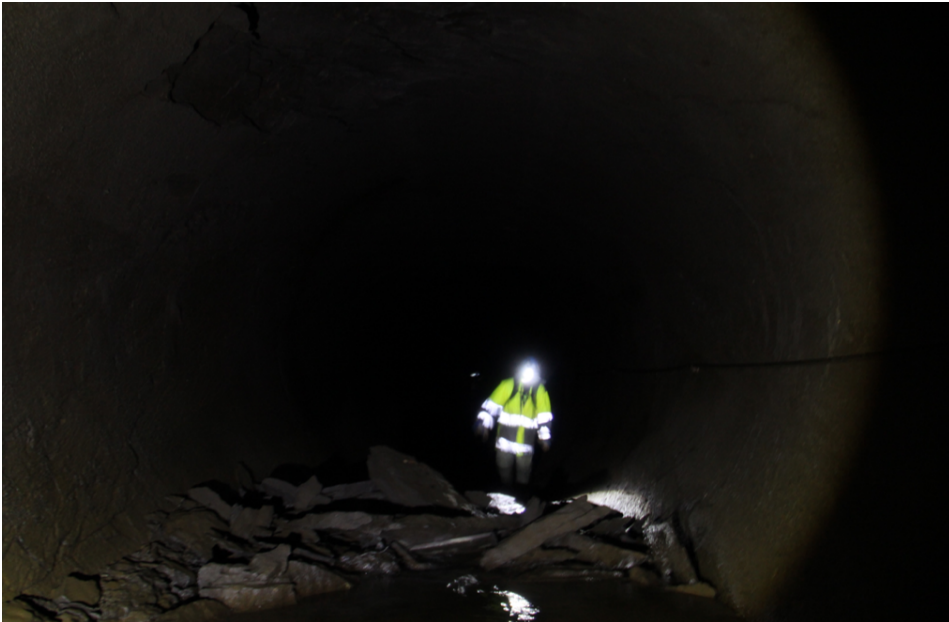
**Figure 10.4:** Rock fall due to stress induced failure in the crown 6230 m downstream of the CSS.

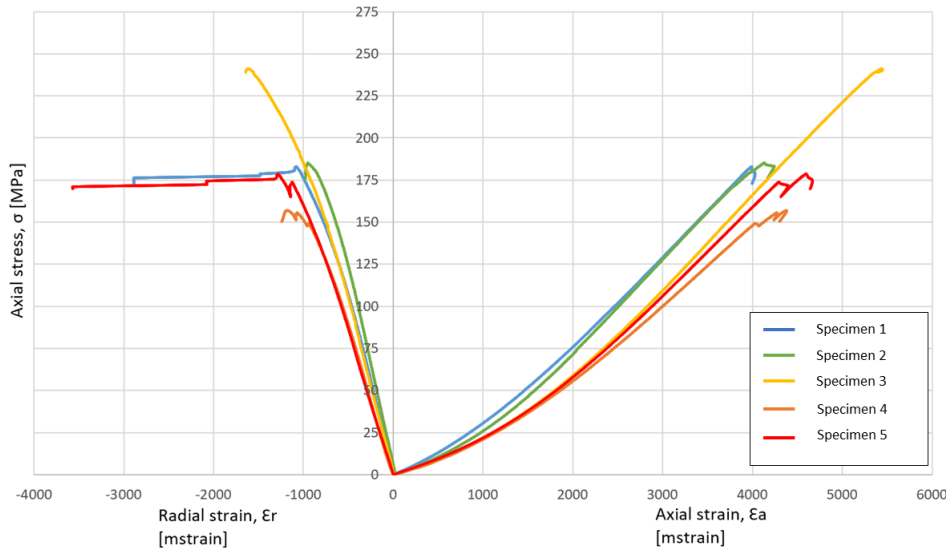
**Figure D.1:** Stress-strain curves from uniaxial compression test for quartzitic schist.

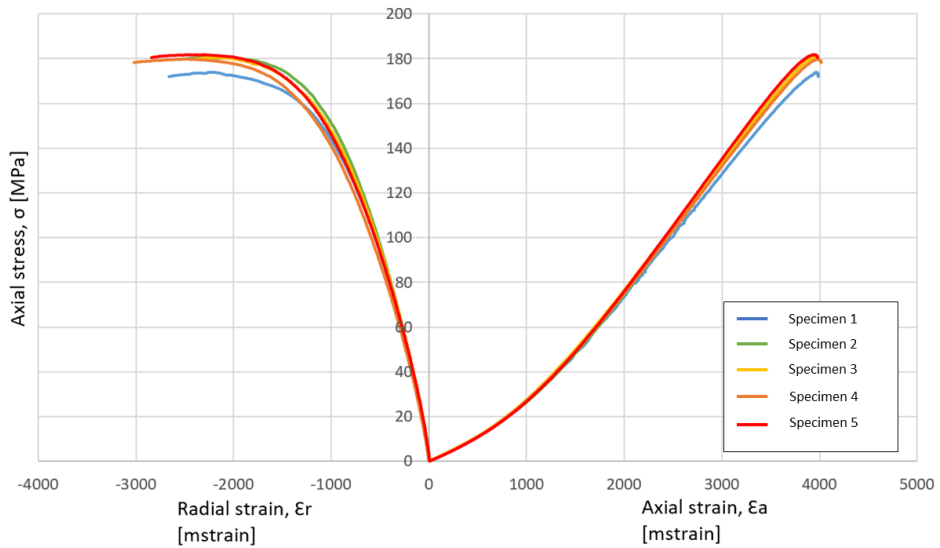
**Figure D.2:** Stress-strain curves from uniaxial compression test for rondhjemite
