# Study on the long-term stability issues of the headrace tunnel of Ulset Hydropower Project

Master's thesis in Geotechnology  
Supervisor: Krishna Kanta Panthi  
June 2019

Norwegian University of Science and Technology  
Faculty of Engineering  
Department of Geoscience and Petroleum

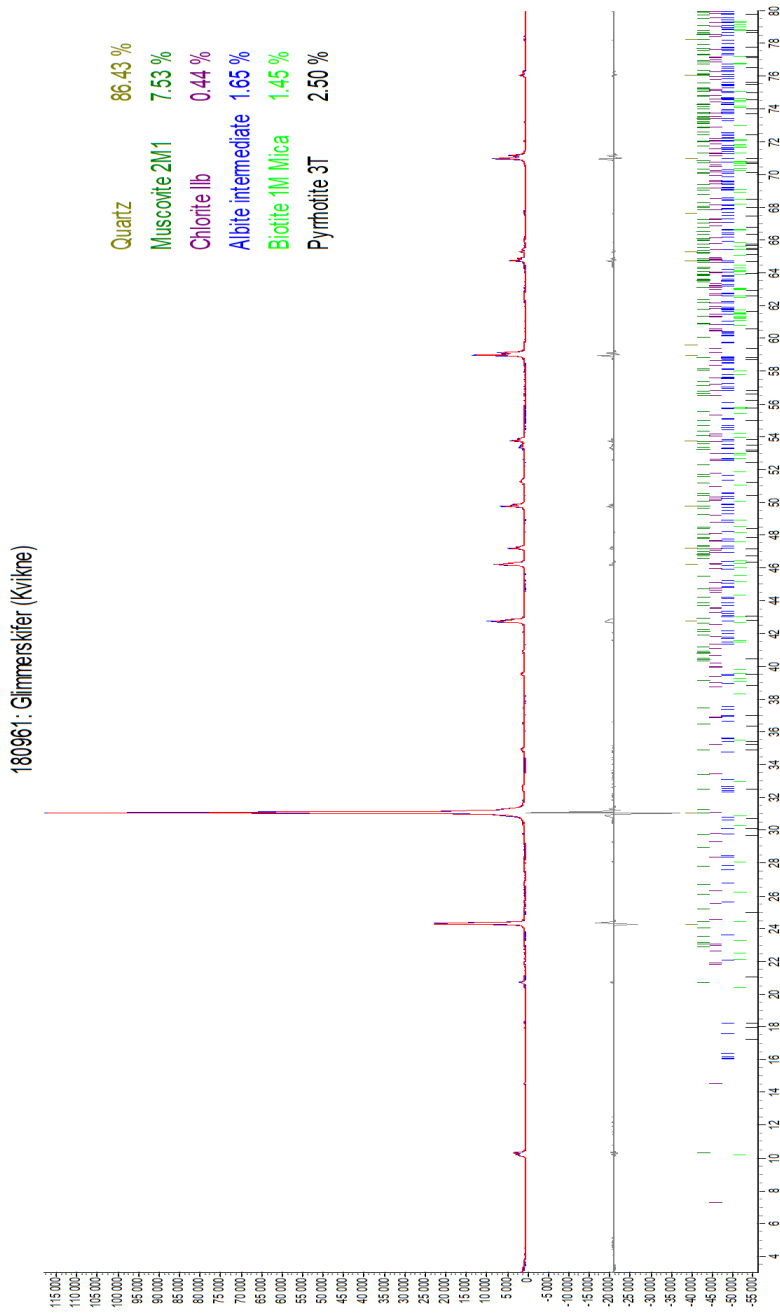
Figure D.3: X-ray diffraction results for quartzitic schist, performed 27.11.2018

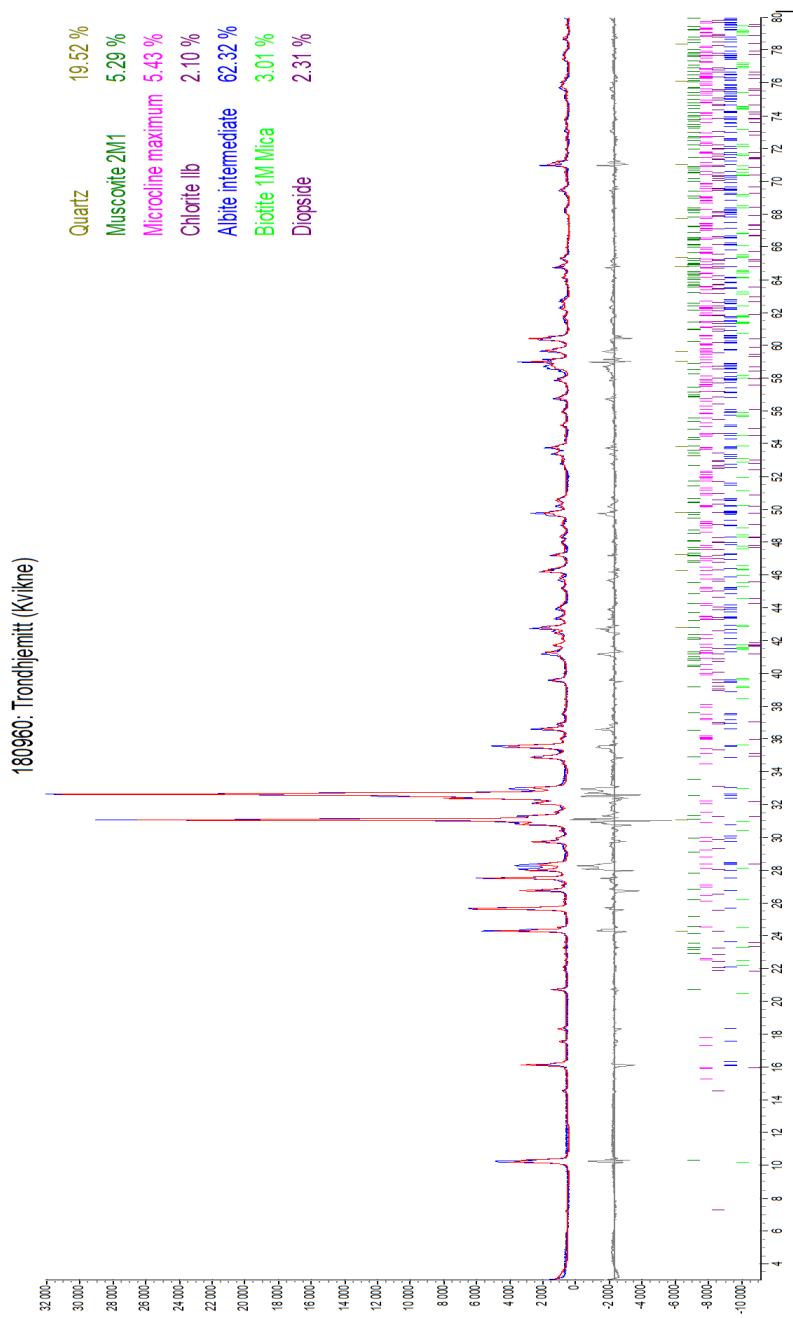
Figure D.4: X-ray diffraction results for Trondhemite, preformed 27.11.2018

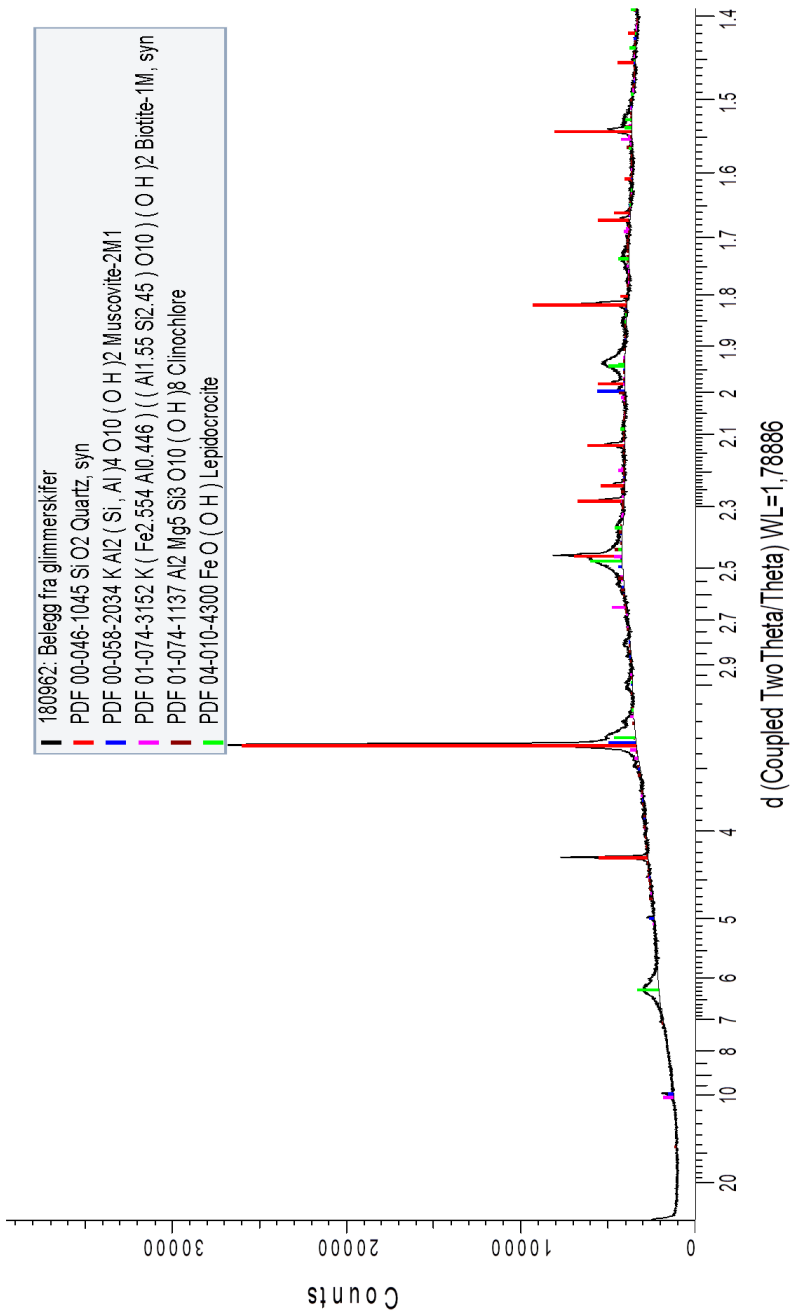
**Figure D.5:** X-ray diffraction results for substance found in water after saturation of quartzitic schist, preformed 27.11.2018. The substance is believed to be the same coating/joint filling in the quartzitic schist.
