Image recognition applied to condition assessment of wastewater manholes

Master's thesis in Civil and Environmental Engineering

Norwegian University of Science and Technology
Faculty of Engineering
Department of Civil and Environmental Engineering

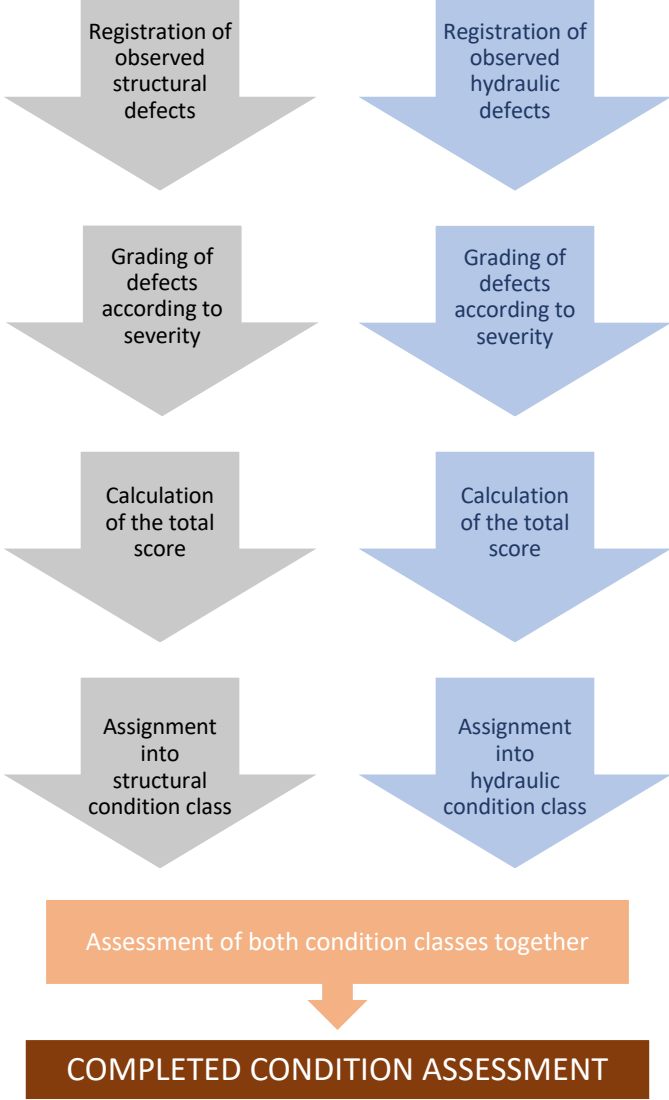
Figure 1: Flow chart of the proposed condition assessment of wastewater manholes.

of a new defect category, which for now will be labelled "Structural condition". All defects should be described, graded and weighted in a similar way as defects in category "Hydraulics". This will lead to new group of total score thresholds which will reflect the structural condition of a manhole construction and will consequently assign manholes into structural condition classes. The presented manhole report also proposes how to assess both hydraulic and structural condition classes together in order to achieve a complete assessment of the inspected manholes. Assignment of manholes into condition classes according to the critical functions will make the understanding of the calculated score much clearer. Additionally, different types of intervention actions should be implemented depending on the nature of the function affected by either hydraulic or structural defects. Therefore, a structure of the manhole report where manholes are assigned to functional condition classes will contribute to easier decision-making regarding the implementation of preventive measures. The person performing the assessment will know better whether the improvement of the manhole condition requires an operational intervention such as flushing, a structural intervention such as reconstruction of manhole components, or a combination of both. A flow chart of the proposed reliability-based condition assessment procedure is presented in Figure 1.

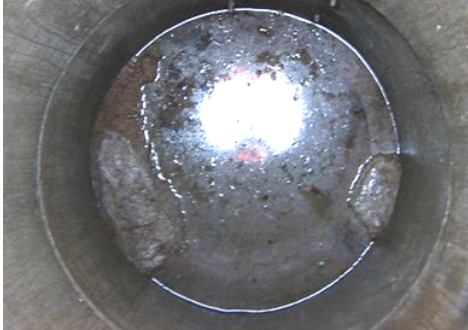
Failure category: HYDRAULIC FAILURES		
Defect	Description	Picture example
Water level	The observed level of water inside the manhole. Intense turbulences in the water flow through the manhole can occur when the water level rises over the top of the channel resulting in the suction of air and consequently giving high energy losses (Hafskjold, 2009).

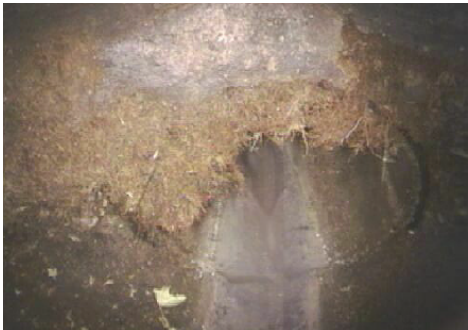
Roots	Roots of trees or other plants are growing into the manhole through joints, defects or connections resulting in reduced cross-sectional area of the invert channel and/or increase of the invert channel roughness.

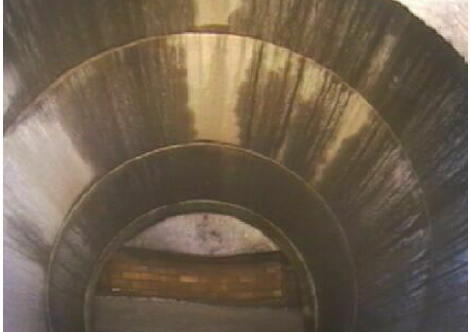
<p>Infiltration</p>	<p>Ingress of water through the wall of the manhole, joints or defects in the wall, benching or channel of the manhole resulting in increase of the flow through the manhole.</p>

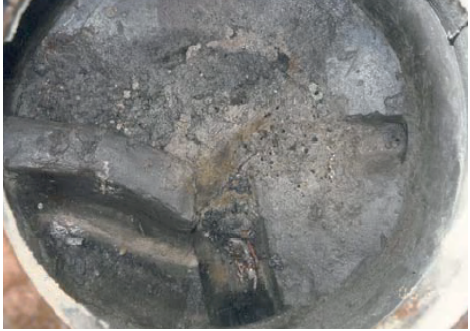
<p>Settled deposits</p>	<p>Deposited material such as sediments or other bottom deposits are observed in the invert channels, resulting in the reduction of the cross-sectional area of the invert channel and/or increase of the invert channel roughness.</p>

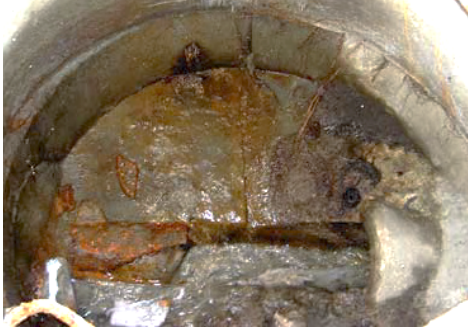
<p>Attached deposits</p>	<p>Materials that stick to the invert channel resulting in the reduction of the cross-sectional area of the invert channel and/or increase of the invert channel roughness.</p>

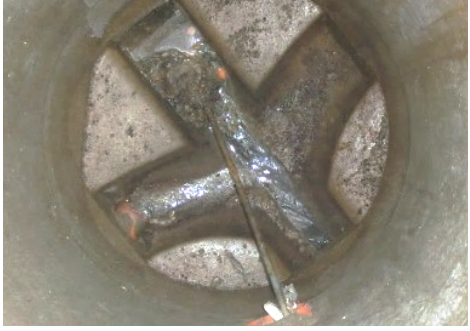
<p>Obstacles</p>	<p>Foreign objects in the bottom section of the manhole resulting in the reduction of the cross-sectional area of the invert channel.</p>

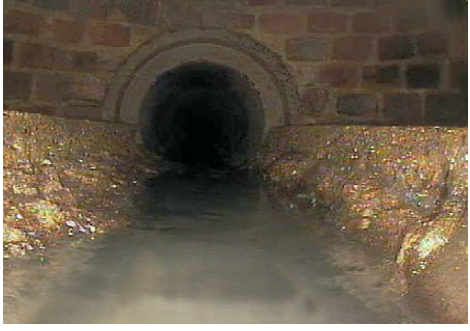
<p>Surface damage of the channel</p>	<p>Inner side of the manhole channel is affected by aggressive media (corrosion) or wear (erosion) resulting in increased invert channel roughness.</p>

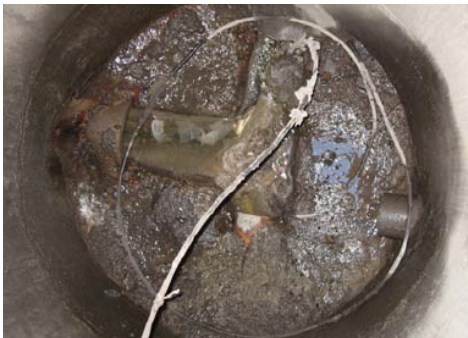
<p>Manhole bottom</p>	<p>Condition assessment of the bottom section including benching, invert channels and corresponding slopes. A poor condition of the bottom section can contribute to operational disturbances, as well as inadequate, reverse or a complete lack of slope.</p>

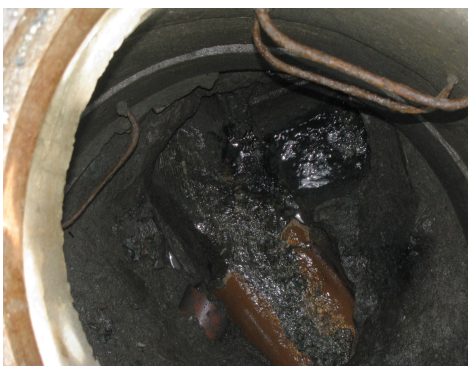
<p>Transition during change of construction</p>	<p>Transition during change of material, dimension, direction or cross-section resulting in contribution to operational disturbances. Depending on the type of observed change, the resulting impact may involve the reduction of the cross-section, increase of the channel roughness, and/or contribution to infiltration, exfiltration or build-up of inputs.</p>

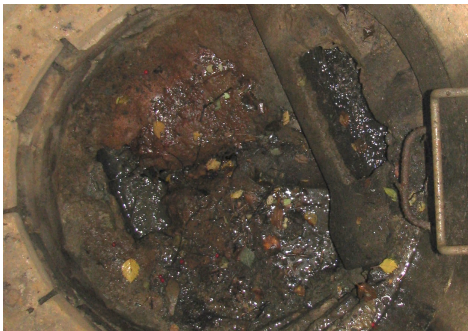
<p>Signs of overflow</p>	<p>Visible signs of overflow of wastewater into stormwater pipe or vice versa inside the manhole. The resulting impact on manhole hydraulics include increased flow in one pipe and decreased flow in the other pipe.</p>

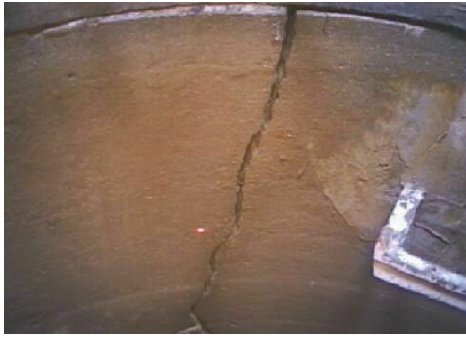
Failure category: STRUCTURAL FAILURES		
Defect	Description	Picture example
Fissure/ fracture	A fracture occurs in the manhole material as a result of the exceeded load bearing capacity or the structure is physically fractured, resulting in compromised integrity of the manhole structure.

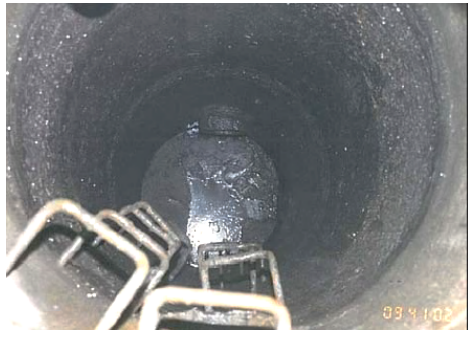
Surface damage	Inner side of the manhole structure is affected by aggressive media (corrosion) or wear (erosion) resulting in compromised integrity of the manhole material.

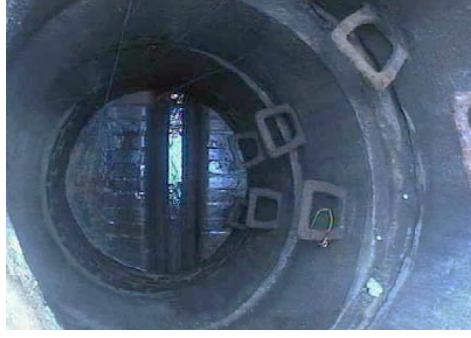
Displaced joint	One of the manhole chamber elements is not centered. Adjacent chamber elements are displaced in relation to each other. The resulting impact represent compromised integrity of the manhole structure.

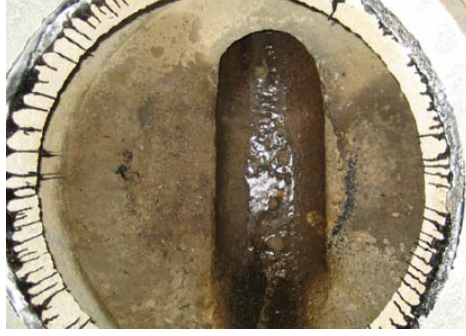
Intruding sealing material	All of or part of the material used to seal a joint between two adjacent chamber elements is visible and intruding into the manhole.

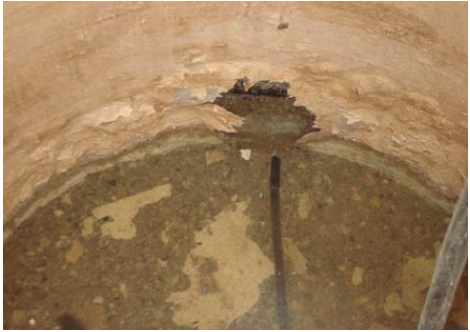
Production failure	A production failure is occurring in the manhole resulting in compromised integrity of the manhole material. Such failures include, but are not limited to, casting defect, honeycombing of concrete, defective lining, defective weld, porous material etc.

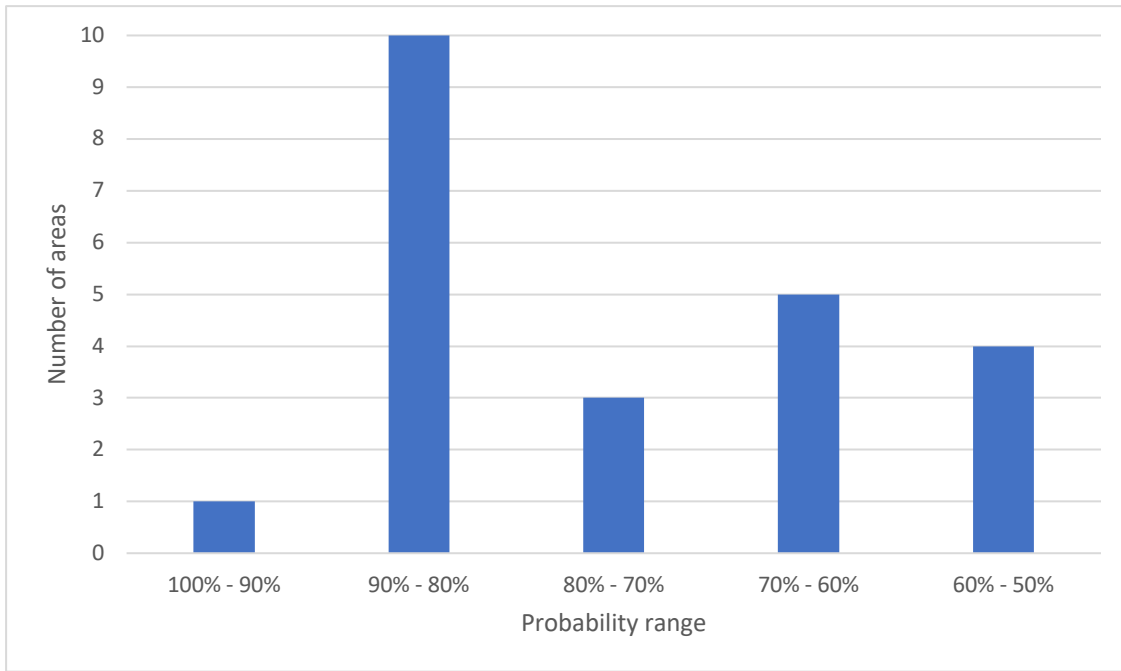
Figure 15: Distribution of areas with prediction above probability threshold of 50%.

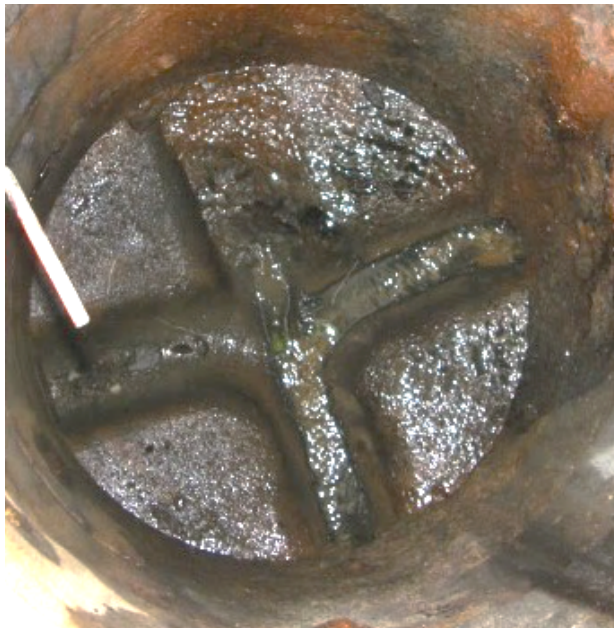
Example 1

Observed failures with corresponding grades, weights and calculation of the total score:

Observation		Grade	Weight	Grade*Weight
Type	Code			
Water level	HWL	1	0	0
Infiltration	HIN	1	0,1	0,1
Settled deposits	HSD	2	2	4
Surface damage	HSF	2	2	4
Manhole bottom	HMB	1	0,5	0,5
			TOTAL	<u>8,6</u>

Total score of 8,6 places this wastewater manhole into hydraulic condition class H2.

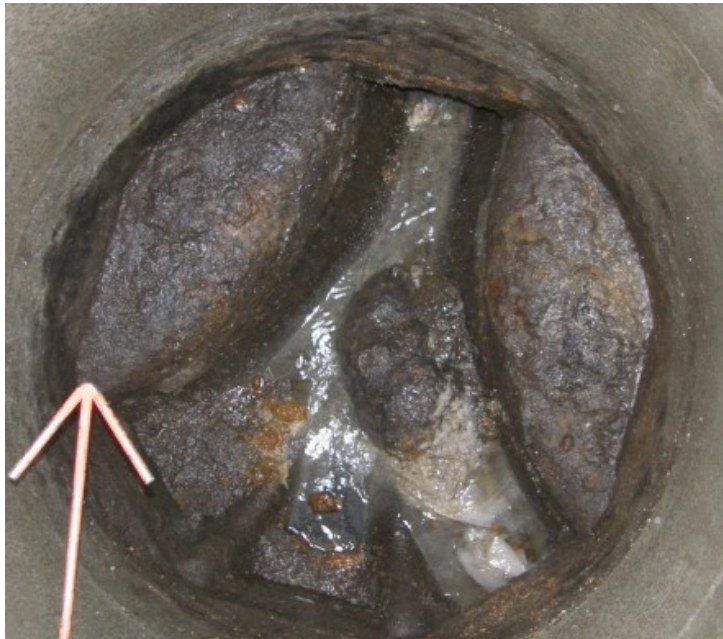
Example 2

Observed failures with corresponding grades, weights and calculation of the total score:

Observation		Grade	Weight	Grade*Weight
Type	Code			
Water level	HWL	1	0	0
Settled deposits	HSD	3	4	12
Attached deposits	HAD	1	0,5	0,5
Surface damage	HSF	2	2	4
Manhole bottom	HMB	1	0,5	0,5
			TOTAL	<u>17</u>

Total score of 17 places this wastewater manhole into hydraulic condition class H2.

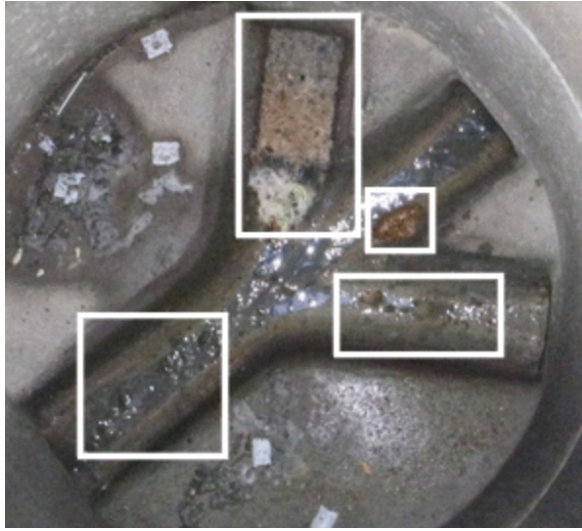
Four areas to be detected. Three smaller areas are expected to be predicted as "HSD 0-10%", while the largest area on the top of the image should be predicted as "HSD over 10-50%".

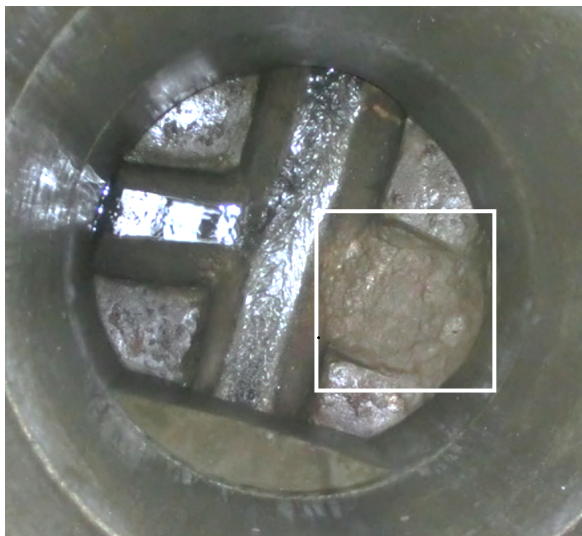
One area to be detected. This area is expected to be predicted as "HSD over 90%".

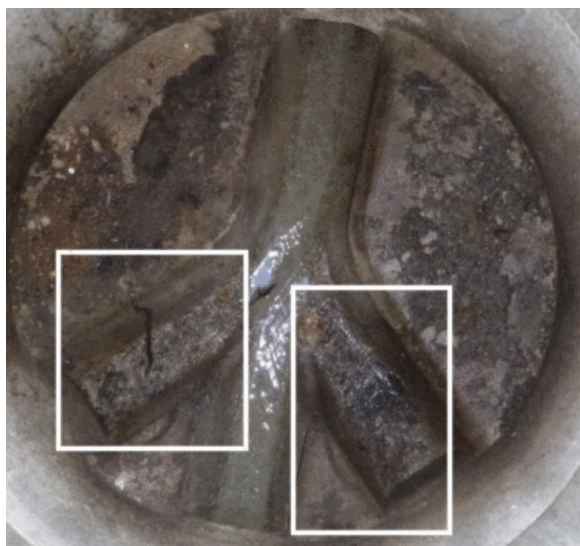
Two areas to be detected. The area to the left is expected to be detected as "HSD 10-50%", while the area to the right is expected to be detected as "HSD 0-10%".

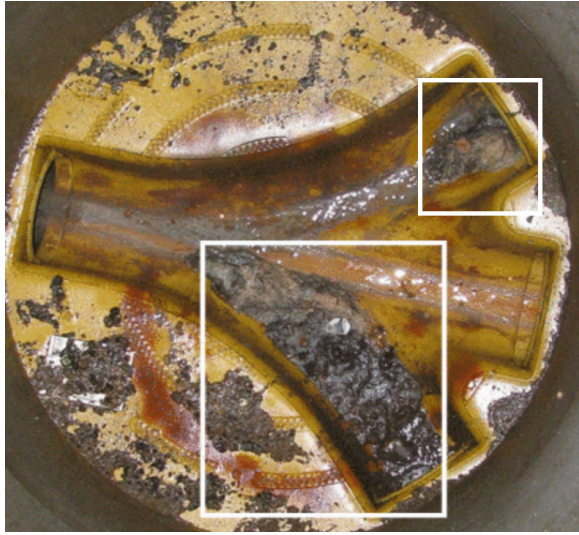
Two areas to be detected. The area on the top of the image is expected to be tagged as "HSD 0-10%", while the area on the bottom of the image is expected to be tagged as "HSD 10-50%".

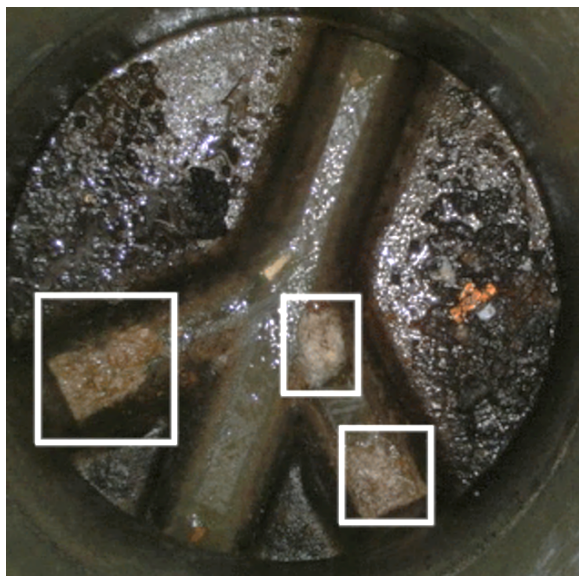
Three areas to be detected. All are expected to be tagged as "HSD 10-50%".

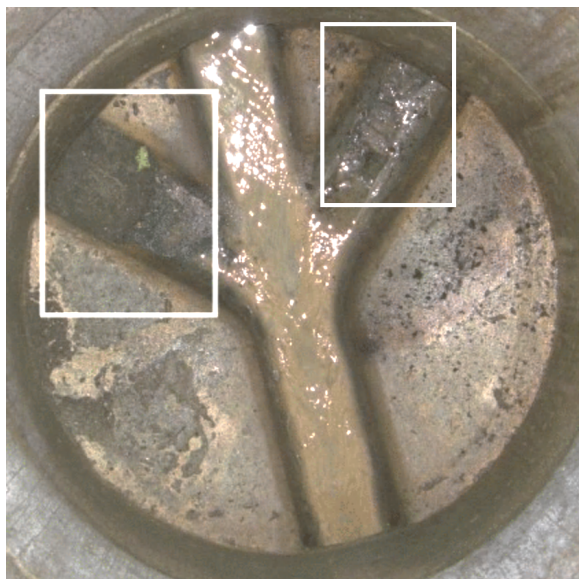
Two areas to be detected. The area to the left is expected to be predicted as "HSD over 90%", while the area to the right should be predicted as "HSD 10-50%".

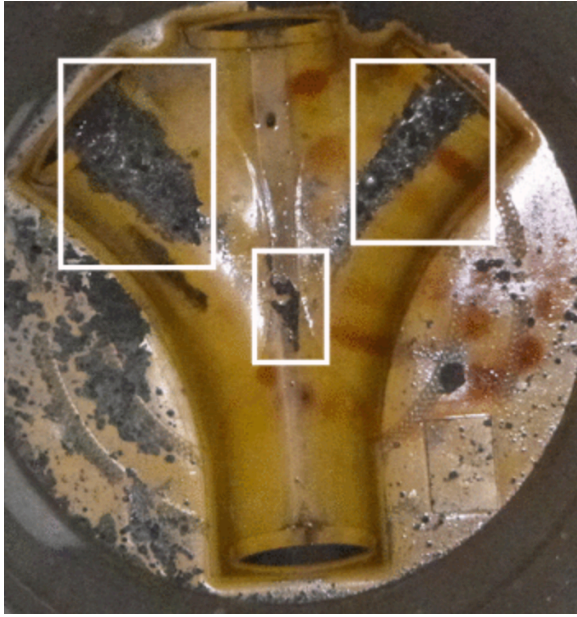
Three areas to be detected. All of the areas are expected to be predicted as "HSD 0-10%".

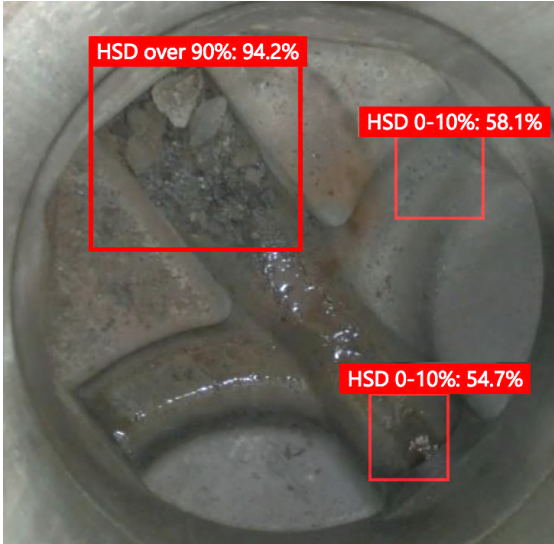
<p>The image shows a top-down view of a manhole with three red bounding boxes highlighting specific areas. The top-left box is labeled 'HSD over 90%: 94.2%'. The top-right box is labeled 'HSD 0-10%: 58.1%'. The bottom-right box is labeled 'HSD 0-10%: 54.7%'.</p>	<p>Three out of four areas were recognized and tagged correctly. The "HSD over 90%" defect grade was predicted with 94.2% certainty, which is the highest obtained among all predictions. The two other "HSD 0-10%" tags received 58.1% and 54.7% certainty, respectively. However, one additional area of type "HSD 0-10%" in the other side channel, was not recognized by the model.</p>

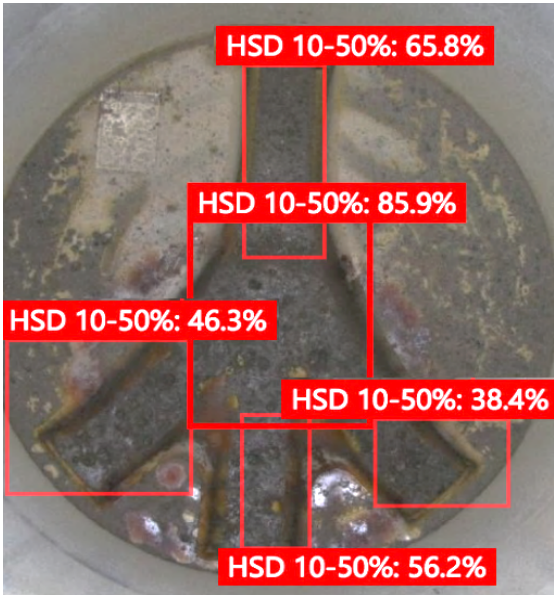
<p>The image shows a top-down view of a manhole with five red bounding boxes highlighting specific areas. The top box is labeled 'HSD 10-50%: 65.8%'. The middle box is labeled 'HSD 10-50%: 85.9%'. The bottom-left box is labeled 'HSD 10-50%: 46.3%'. The bottom-middle box is labeled 'HSD 10-50%: 38.4%'. The bottom-right box is labeled 'HSD 10-50%: 56.2%'.</p>	<p>Five out of five areas were predicted correctly. All of the tags represent the "HSD 10-50%" defect grade. Starting from the prediction on the top of the image, the tags received following percentages of certainty; 65.8%, 85.9%, 46.3%, 38.4% and 56.2%.</p>

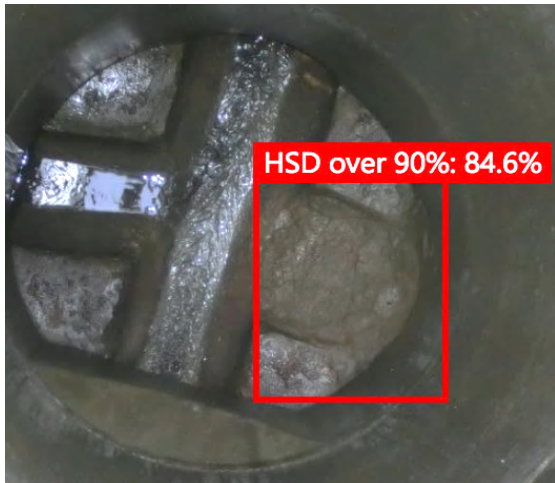
The area was predicted correctly with "HSD over 90%" tag and a high certainty of 84.6%.

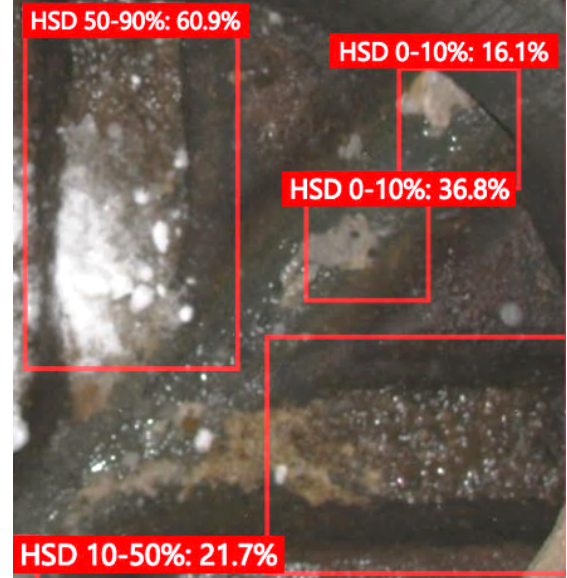
<p>Four out of four areas were predicted correctly. Two of the tags represented the "HSD 0-10%" defect grade. The obtained certainty of these tags was 16.1% and 36.8%, respectively. The area tagged into "HSD 50-90%" received 60.9% certainty and the "HSD 10-50%" tag received 21.7% certainty.</p>

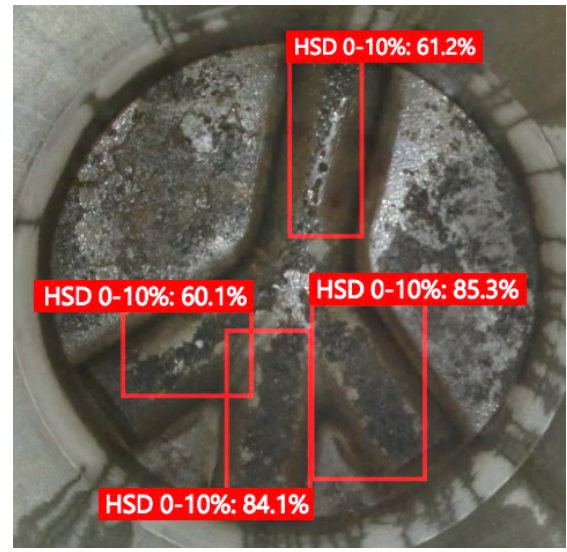
<p>Four out of four areas were predicted correctly. All of the tags represent the "HSD 0-10%" defect grade. Starting from the prediction on the top of the image, the tags received following percentages of certainty; 61.2%, 85.3%, 60.1% and 84.1%.</p>

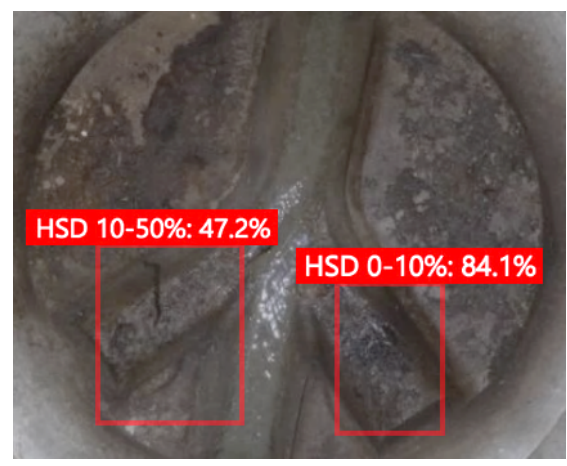
<p>Both areas were predicted and assigned into correct defect grade. The tags have been predicted with varying certainty. One of the tags received 47,2% certainty, which is slightly below probability threshold of 50%, while the other tag received 84,1%.</p>

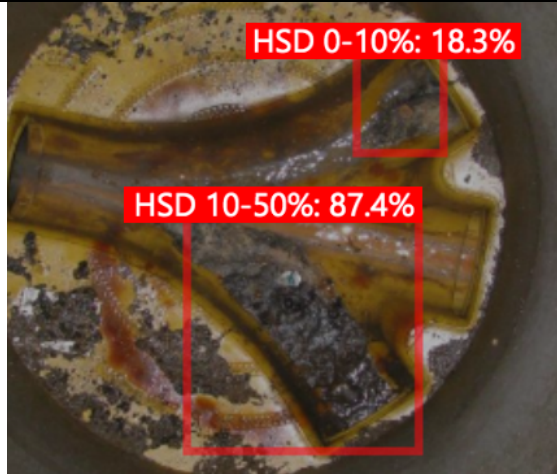
Both areas were predicted correctly. However, the certainty of predictions varied greatly. One tag has been predicted with high certainty of 87,4%, where the other tag received only 18,3 % certainty.
