A two-stage numerical analysis approach for the assessment of the settlement response of the pre-damaged historic Hoca Pasha Mosque

Dalgıç, Deniz; Hendriks, Max; Ilki, Alper; Broere, Wout

2018

International Journal of Architectural Heritage

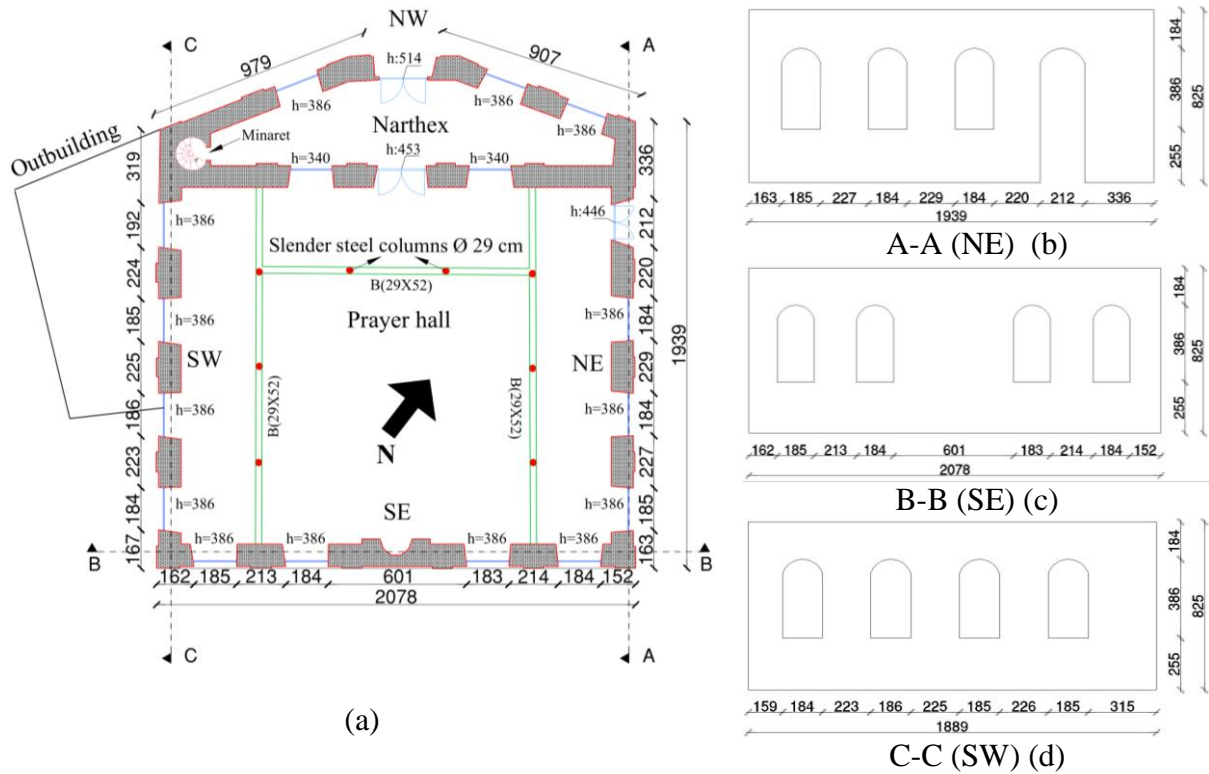
Fig. 1: (a) As-is drawing of the ground floor elevation of the Hoca Pasha mosque and (b,c,d) section views (dimensions in cm) (Akgun, D., 2016)

The Hoca Pasha Mosque was rebuilt in 1868 replacing the previous one destroyed by a fire (Sefer and Ahunbay, 2015). As seen in as-is drawings shown in Fig. 1a, the main structural system of the mosque relies on plastered 900 mm thick load bearing masonry walls made of solid bricks and mortar joints. An outbuilding with a separate reinforced concrete frame system was built next to the main building (Fig. 1a). The mosque has large arched windows (w×h: 1840×3860 mm) in all of the façades and doors in the northwest (NW) and northeast (NE) façades (Figs. 1b, c and d). An internal wall of almost half of the storey height divides the narthex and prayer hall. The mosque is actually a one-storey building, but there is a mezzanine floor inside. The mezzanine floor, that is constructed with steel and timber joists, and the roof are both supported by slender steel columns, situated inside the mosque, and the external masonry walls. The overall wall height is 8.25 m from the wall bottom to the eave. During the examinations, any particular foundation system was not observed except for the main walls extending approximately 1 m downwards into the ground as common as in the

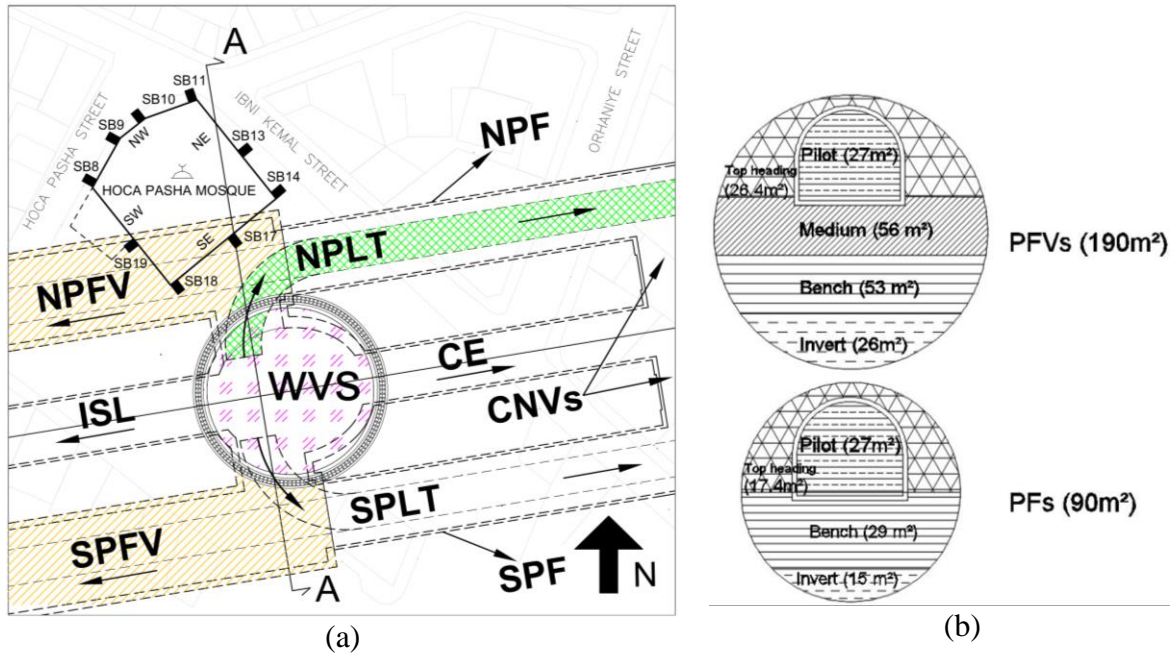
Fig. 2: (a) Location and neighbouring excavation works (b) Tunnel cross-sections (modified from Method Statements for Excavation and Support Works, 2008).

The excavations of the tunnels (NPF, SPF, hereinafter referred to together as PFs, and CE) and the ventilation chambers (NPFV and SPFV, hereinafter referred to together as PFVs) were carried out using the New Austrian Tunnelling Method (NATM), approximately 50 m beneath the ground surface. The PFVs have the largest cross-section with 17 m diameter among all tunnels excavated for the Sirkeci Station. The length of the PFVs is 35 m. While the NPFV partly under-passes the mosque at a skewed angle, the centre line of the SPFV is at a 40 m in plan distance from the closest corner of the mosque (Figs. 2a and 3). In order to increase the face stability and limit deformations, tunnel cross-sections larger than 50 m² (as the PFs and PFVs) were divided into sub-sections (Fig. 2b). Then, each sub-section was

excavated sequentially starting from the pilot tunnel sub-section (respectively succeeded by the excavation of the top heading, the medium heading, the bench cut and the invert). The NPLT, which became quite influential on the mosque settlements, was actually a sub-section excavation of the NPF having a 27 m² cross-sectional area (Method Statements for Excavation and Support Works, 2008).

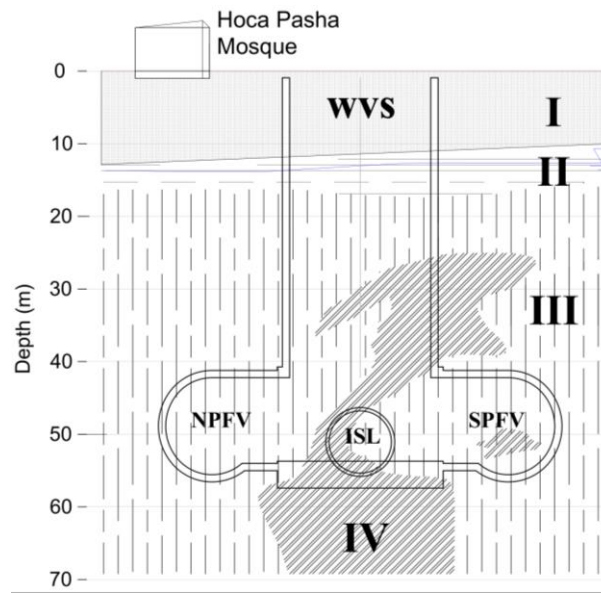
Fig. 3: Sectional view of the excavation site and geological sections (A-A section in Fig. 2a) (modified from Method Statements for Excavation and Support Works, 2008).

greywacke mass, comprised of mudstone, sandstone and claystone, which are the components of the Trakya Formation. The sections shown with IV are identified as diabase.

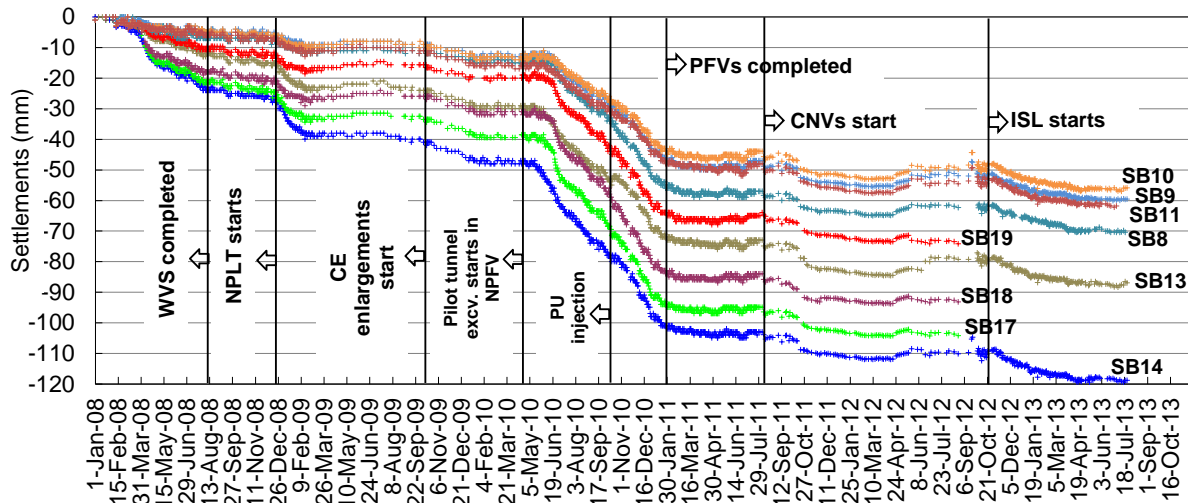
Fig. 4: The settlement time-history of the mosque (modified from Monthly Monitoring Reports, 2008-2013)

As expected, settlement readouts measured on the southeast (SE) (where SB14, 17 and 18 were attached) and southwest (SW) (where SB8 and 19 were attached) façades which were relatively closer to the WVS, NPLT and NPFV excavations have been higher than the other readouts. After the completion of the WVS excavation, the rate of measured settlements of the

mosque decreased, until the pilot tunnel excavations SPLT and NPLT started. Sudden increases in the slopes of the settlement versus time curves point out that the NPLT excavation, specifically the curvilinear section, has become quite influential. Between February 2009 and April 2010, an increase presumably due to CE pilot tunnel excavation and enlargement excavations in the PFs was observed. From April 2010 onwards, the settlements significantly increased again. This time, the reason was the pilot tunnel and enlargement excavations in the PFVs. It should be particularly highlighted that the pilot tunnel and the enlargement excavations in the NPFV played a major role in this increase. In order to limit the settlements at that stage, two ground stabilizations and a following uplifting application were carried out. The first ground stabilization attempt was a cement injection procedure performed horizontally from the inside of the WVS towards the mosque. In addition to cement injection, horizontal steel rods were driven into the soil in order to compact the ground under the mosque. The second attempt was aiming at both ground stabilization and uplifting the severely settled parts of the mosque. For this purpose, vertical steel rods, 7 m long and 36 mm in diameter, were driven into the soil with an inclined angle at every 40 cm around the main external masonry walls. After performing a primer polyurethane (PU) injection, uplifting was performed through a secondary and deeper PU injection. Consequently, an upward movement (up to 3 mm) around SB13, 14 and 19 was obtained. The effect of uplifting can be seen in the settlement time history of SB13 in Fig.4 between September and November 2010. All of the excavation works in SPFV and NPFV tunnels were finalized towards January 2011.

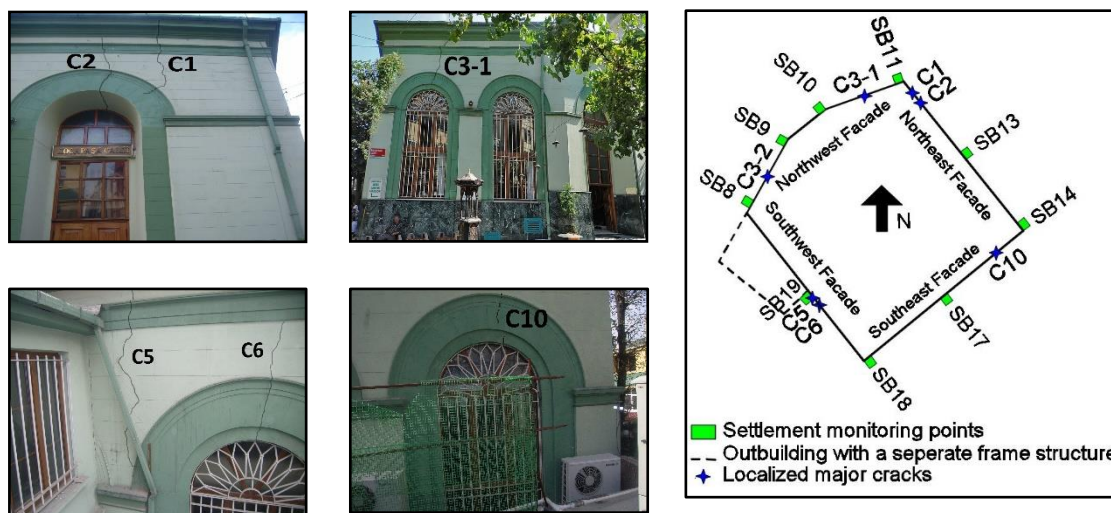
Fig. 5: The pre-existing localized cracks and their locations in the plan of the mosque

A conditional survey conducted before the commencement of the excavations revealed the presence of pre-existing localized cracks (C1, C2, C3-1, C3-2, C5, C6 and C10) in all of the façades (see Fig 5) (Detail Survey Report, 2008). These cracks all began at the door and window arches, either at the vertices or closer to the bottom of the arches. They have propagated upwards to the eaves almost vertically. The cracks were also visible from the inside of the mosque. While C1 and C2 above the arched door of the NE façade were the widest, C3-2 and C10 above the arched windows in the NW and SE façades were the narrowest cracks. The observed initial width of these cracks varied from 5 to 10 mm. The locations of the pre-existing localized cracks in the ground plan are also given in Fig. 5. As is, the building was classified as moderately damaged by the inspection team considering its “prior to all excavations” and estimated post condition.

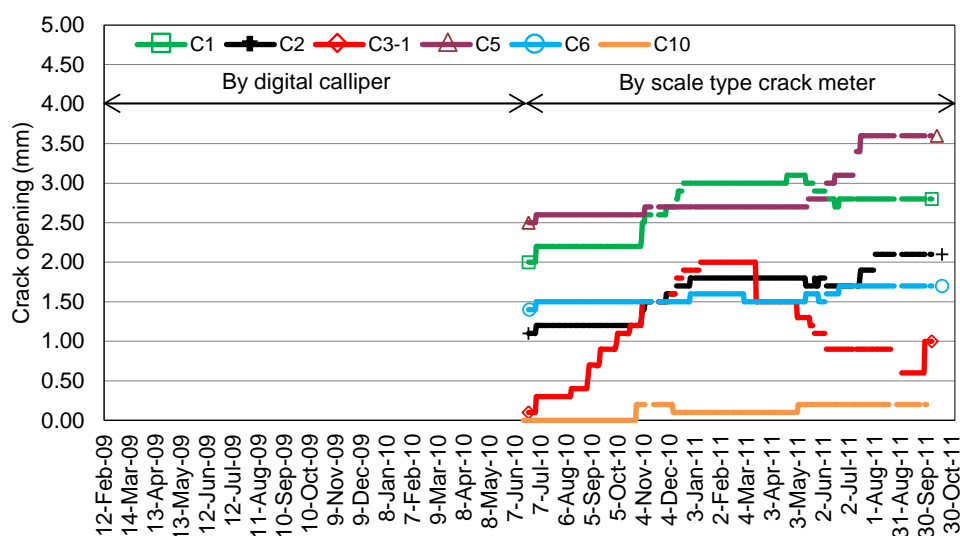
Fig. 6: Opening and closures of the pre-existing localized cracks

Fig. 6 shows the variation of the widths (crack activity) of the major pre-existing localized cracks. Although a trend cannot be given for the initial data obtained by the digital

Fig. 6 shows that crack C3-1 widens and closes significantly during the NPFV excavations. As the mosque settlements slow down towards March 2011, a closing is observed for this crack. Another increase in the activities of C1 and C2 is noted during the top heading and medium sub-section excavations of NPFV. The C5 and C6 cracks seem to be influenced least by the NPFV excavations. However, an increase in their widths is observed as of June 2011 possibly due to the CNV excavations. Crack C10 shows minor variation throughout the excavations.

Note that the crack activities given in Fig. 6 are in general agreement with the wall distortions given in Fig. 8. For instance, the lowest activity in the C10 crack is in line with the lowest distortions experienced by the SE wall and the variations of the width of crack C3-1 are in line with the increases and decreases in the distortions of the NW wall. However, a direct comparison between crack activities (openings and closings) and variations of calculated wall distortions may not always be straightforward due to:

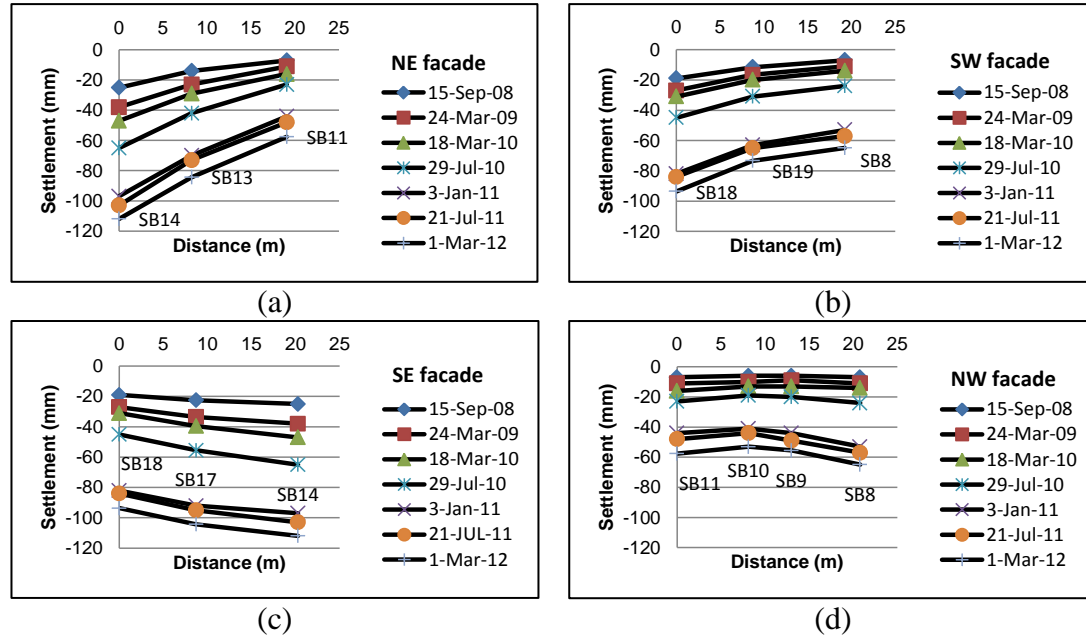
Fig. 7: Monitored settlements along the main masonry walls

Monitored settlement response of each external masonry wall is examined by the authors using conventional deformation measures, namely angular distortion, deflection ratio and rigid rotation. For this purpose, the monitored wall settlement profiles are provided in Fig. 7 considering seven key dates i.e. after the completion of the WVS excavation (15 September 2008), after the completion of the curvilinear NPLT excavation (24 March 2009), before the

NPFV excavations (18 March 2010), after the completion of the NPFV pilot tunnel excavation (29 July 2010), after the completion of the entire NPFV excavations (3 January 2011) and before and after the CNV excavations (21 July 2011 and 1 March 2012). As seen, while the SE façade experiences sagging (a convex settlement profile), the others experience hogging (a concave settlement profile) throughout the excavations.

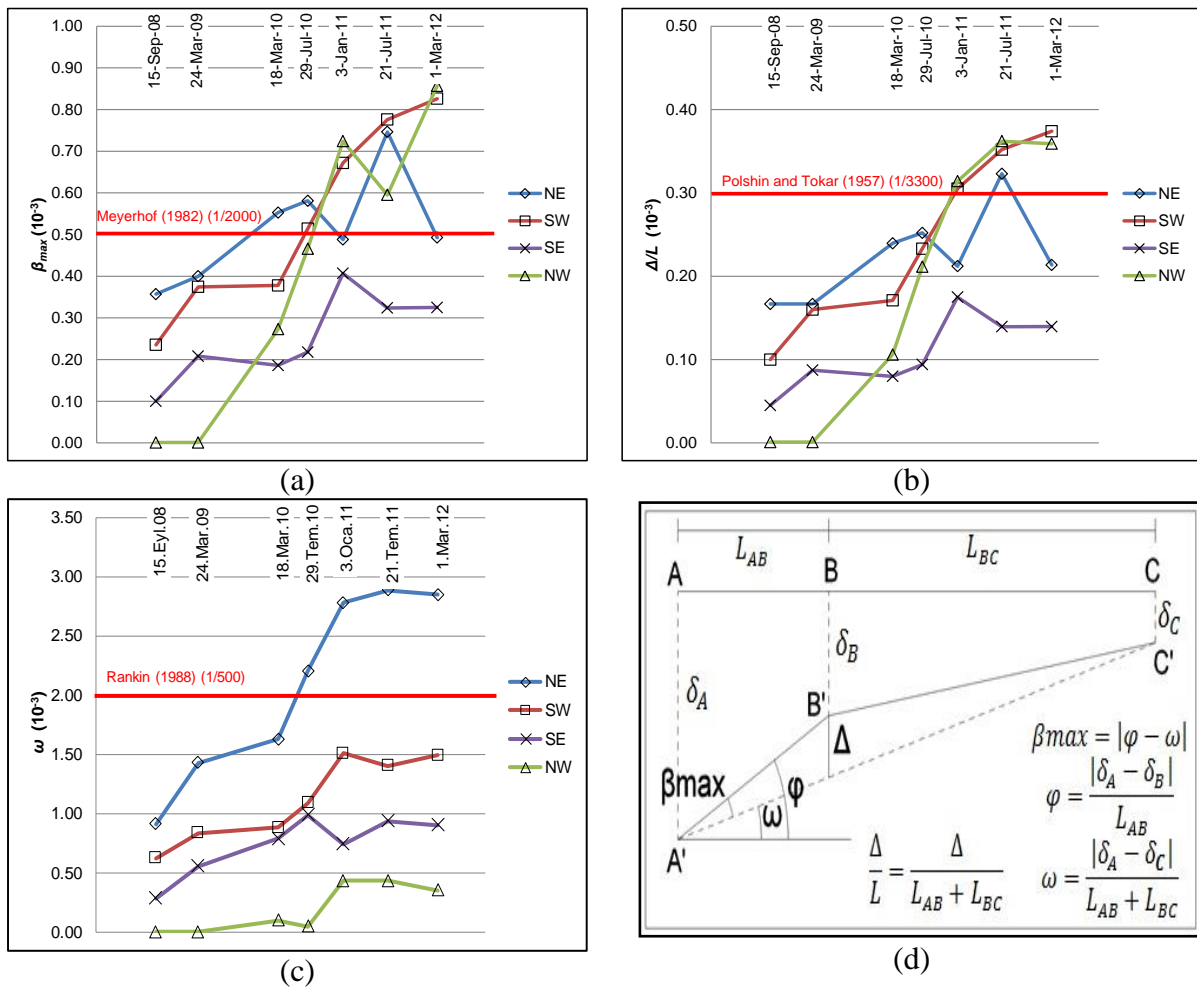
Fig. 8: Calculated wall distortions: (a) angular distortion, (b) deflection ratio and (c) rigid rotations

Based on the wall settlements at these considered dates, the maximum angular distortion (β_{max}), the deflection ratio (Δ/L) and the rigid rotation (ω) values of the façade walls are calculated (Figs. 8a, b and c, respectively). β_{max} is the largest angular distortion value (β) calculated as the rotation of the straight line connecting two adjacent monitoring points relative to their tilt (Boscardin, 1980). Δ/L is the ratio of relative deflection between two monitoring points to the distance between them (Burland and Wroth, 1974). ω is the rigid rotation of the façade wall defined by the settlement readouts of two outmost monitoring points. Calculation of these measures are schematically explained in Fig. 8d. Three internationally accepted empirical limit values $\beta_{max} = 0.0005$ (1/2000) (Meyerhof, 1982), $\Delta/L = 0.0003$ (1/3300) (Polshin and Tokar, 1957) and $\omega = 0.002$ (1/500) (Rankin, 1988) are also

indicated in Figs. 8a, b and c. The first two values show the cracking limit of unreinforced load-bearing masonry walls in hogging. Note that the $\Delta/L = 0.0003$ value is obtained by interpolating the linear wall length to wall height ratio (L/H) versus Δ/L relationship of Polshin and Tokar (1957). For the derivation of $\Delta/L = 0.0003$, L/H is taken as 3. Note that the cracking limits for sagging would be higher (i.e. more tolerant). $\omega = 0.002$ suggests the limit between negligible and slight damage.

The β_{max} versus time and Δ/L versus time graphs in Figs. 8a and 8b show that the wall distortions due to WVS (according to values dated 15 September 2008) and curvilinear NPLT (according to values dated on 24 March 2009) excavations are lower than the proposed limit

values. Enlargement excavations in CE and SPFV result in an increase in β_{max} and Δ/L values of the NE and NW walls (see the variation between 24 March 2009 and 18 March 2010). The pilot tunnel excavation in NPFV became very influential between April 2010 and July 2010. In this period, a sharp increase in the distortion values of the most of the walls is observed. Until the completion of the NPFV excavations in January 2011, the wall distortions continue increasing with the exception of the NE wall. In the last two periods (3 January - 21 July 2011 and 21 July 2011 - 1 March 2012), the NE and NW walls experience both increases and decreases in their distortions. Conversely, the distortions of the SW wall monotonically increases in these two periods. The distortions of the SE wall are relatively small. On the other hand, while the NE wall experiences the highest rigid rotation, the NW wall has the lowest value (Fig. 8c). The calculated maximum rigid rotation is 0.0028 (1/345) for the NE wall and slightly exceeds the limit proposed by Rankin. From 3 January 2011 onwards, rigid rotation values almost level off. At the end of the PFV excavations (January 2011), considerably different rigid rotations are experienced by the parallel NE and SW walls. Presumably, this situation might have resulted in additional shear forces in the connecting SE and NW walls and at the corner connections.

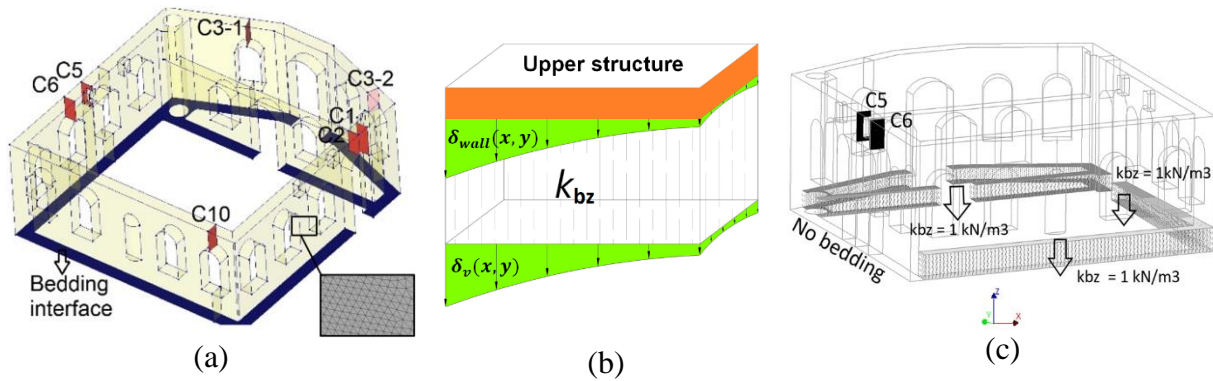
Fig. 9: (a) Mosque model geometry (b) Interface model and (c) interface configuration for the isolated SW wall

The geometry of the used building model is shown in Fig. 9a. Recalling that the walls have a thickness of 900 mm and diaphragm actions of the roof is not relevant for the type of loading, the mezzanine floor, the roof, the internal columns and the minaret are not included in this model since their contribution to the overall stiffness is considered as negligible. These sections might have minor damage due to differential settlements. Since this damage will be less critical, the investigation of the response of these sections is out of focus of the current study. The masonry walls are modelled using solid tetrahedron (3 sides, 4 nodes) elements (TE12L). Meshed element size is 250 mm in all dimensions. Bricks and mortar joints are not considered separately in the model and masonry is represented homogenously using linear elastic material properties (the continuum model described previously by Lourenco, 1996) (Table 4). Due to the historical character of the mosque, no destructive test on the masonry could be performed to determine the actual mechanical properties. Instead, three different Young's modulus (E_{m1} , E_{m2} and E_{m3}) are adopted. E_{m1} and E_{m2} (350 and 1000 MPa, respectively) are assumed to cover the range of representative values of these typical load bearing masonry walls, constructed in the same era with similar techniques and materials (Ispir and Ilki, 2013). The higher E_{m3} (10000 MPa) is included to distinguish the effect of Young's modulus (Table 4).

The localized and already open pre-existing cracks are simulated with vertically aligned linear elastic discrete interfaces. The interface elements are triangular elements (T18IF) which are inserted between two planes in a 3D configuration. They have 3 opposite nodes on each side of the interface and each node has 3 translation degrees of freedom in x , y and z axes. In order to reveal the effect of localized cracks, two extreme conditions are considered: cracks with very low interface stiffness (almost zero) and excluding the crack interfaces from the model (no cracks). For the former, interface stiffness values in the normal direction k_{czi} are calculated theoretically using Eq. (1). That is, the interface stiffness is set as

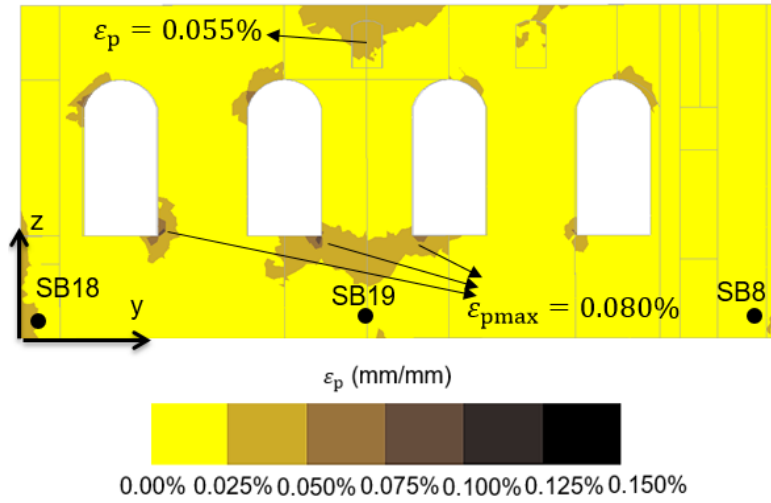
Fig. 10: ϵ_p distribution in SW without C5 and C6 crack interfaces ($E_m = 350$ MPa)

Figures 10 and 11 show the deformation and crack opening results obtained for the SW wall without and with crack interfaces (C5 and C6), respectively. In the first case, it is seen that the major principal tensile strains (ε_p) concentrate around the small niche at the upper side of the wall as well as the bottom parts of the central windows. The maximum principal tensile strain (ε_{pmax}) reaches about 0.080%. This value exceeds slightly the tensile strain range (0.038% - 0.060%) that was previously reported by Burhouse (1969) as the onset of visible cracking in the brick masonry walls. The presence of the C5 and C6 cracks in the second case results in a remarkable change in ε_p distribution. It is seen that the C5 and C6 cracks reduce the strain levels in their vicinity, however they result in an increase in the strain levels at the bottom parts of the central windows. The maximum principal tensile strain reaches about 0.1%. In both cases, the damage class of SW wall is assessed slight damage based on the comparison made between ε_{pmax} and the suggested limiting tensile strain intervals of Boscardin and Cording (1989) (see Table A.1 in appendix).

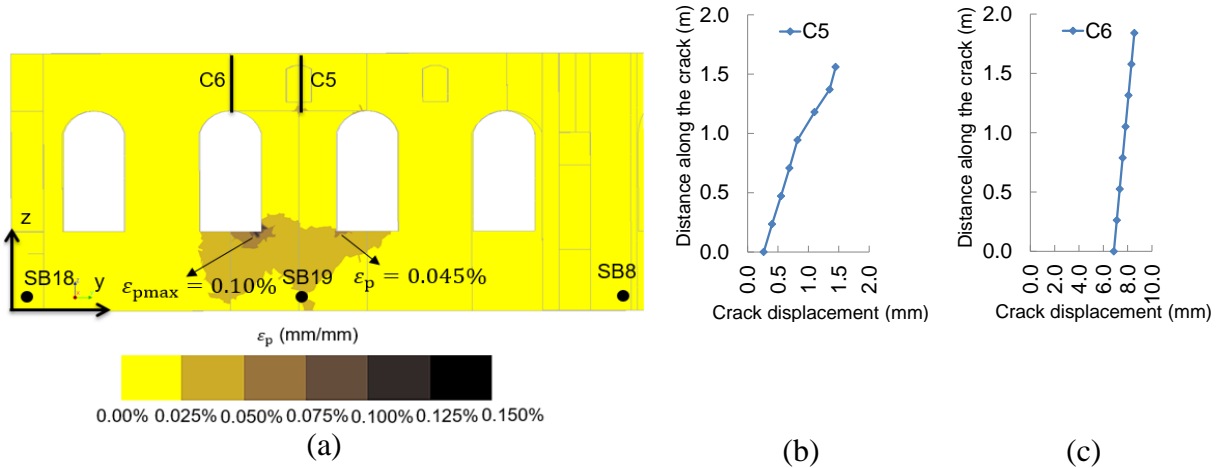
Fig. 11: (a) ϵ_p distribution in SW wall with crack interfaces and relative crack displacements of (a) C5 and (b) C6 cracks ($E_m = 350$ MPa)

The variation of the relative crack displacements (δ_{cz}) along the height of the C5 and C6 cracks are shown in Figs. 11b and c, respectively. Crack C6 is opening more uniformly and widely, whereas C5 widens more at the upper part and relatively less. A direct comparison of numerical and monitored crack openings is not straightforward due to aforementioned restrictions. Instead, making comparisons based on the summed crack openings of the two cracks makes sense. The analysis yields that the total crack opening of C5

and C6 (C5 + C6) ranges from 7 to 9.5 mm from the bottom to the top of the cracks. The sum of the monitored crack openings (C5+C6) (at the end of July 2011 in Fig. 6) is 5.3 mm.

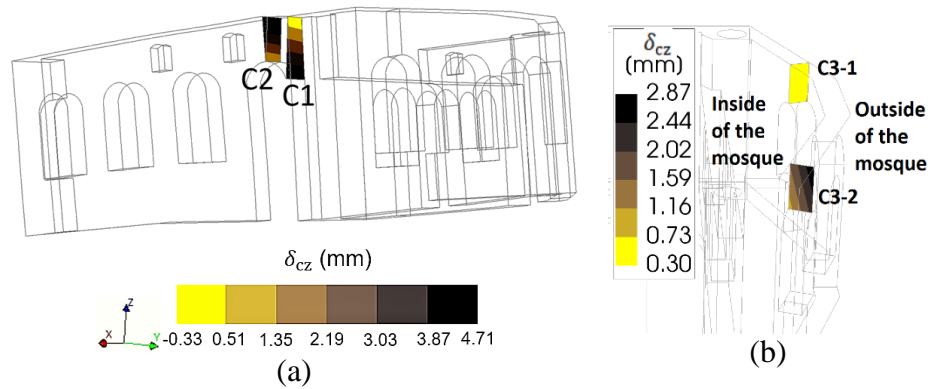
Fig. 12: Rotation of crack interfaces from (a) perspective (C1&C2) and (b) side view (C3-2)

An in-plane rotation is observed for the wall portion between the C1 and C2 cracks in NE wall (Fig. 12a). Due to this rotation, while the C1 closes at the upper part C2 widens and

the other way around at the bottom part as observed from the outside of the mosque. For these crack interfaces, the overall relative crack displacement (δ_{cz}) from bottom to upper tip varies between -0.33 mm (closing) and 4.71 mm (opening). On the other hand, a diagonal out-of-plane rotation is observed for the C3-2 crack in the NW wall (Fig. 12b). Finally, the SE wall experiences the lowest distortion compared to other walls in which the C10 crack tends to close.

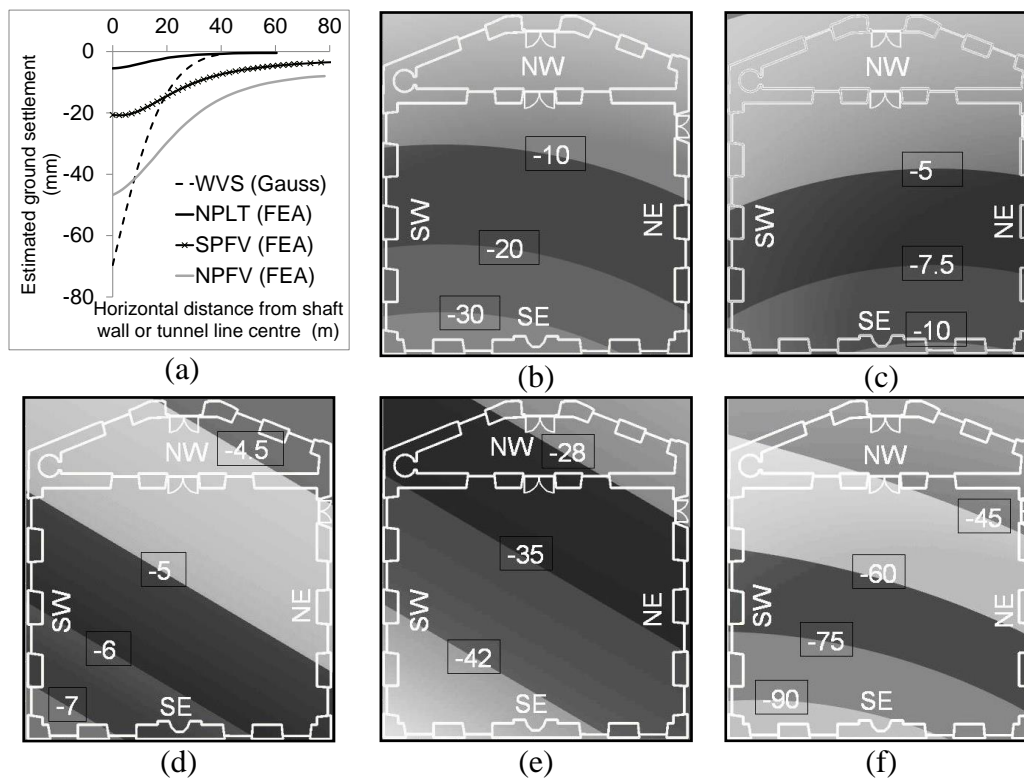
Fig. 13: (a) Reported or derived 2D free-field ground settlement estimations which are used to produce settlement fields and 3D settlement field contours generated for (b) WWS, (c) NPLT, (d) SPFV, (e) NPFV and (f) combination of WWS, NPLT, SPFV and NPFV excavations

Free-field ground settlements due to tunnel excavations were obtained from the numerical analysis results reported by the contractor company (Fig. 13a) (Prediction of Ground Surface Settlement Report, 2011). In these analyses, 2D plane strain conditions were considered. Man-made fill (I) and clayey silty sand (II) layers were modelled using an elasto-plastic Mohr-Coulomb model. Besides the elastic properties, anisotropic damage parameters were

used to reduce the shear modulus of the greywacke (III). Damage parameters were determined through back analyses based on the monitored crown and spring line settlements of the concerned tunnels. Fig. 13c, d, and e show the contours of the settlement fields which are produced based on the numerical simulations (Fig. 13a). As seen, the curvilinear NPLT excavation yields curved settlement contours and the SPFV and NPFV form skewed line contours corresponding to the geometry and position of these tunnels. In line with the monitoring results of the mosque (Fig. 4), the settlement contours resulting from the NPFV excavation indicate much higher settlements in comparison with the NPLT and SPFV excavations. Figure 13f shows the combination of all settlement contours resulting from the WVS shaft and NPLT, SPFV and NPFV tunnels. Note that this combined settlement field corresponds to a site settlement stage when the NPLT, SPFV and NPFV tunnels were completed (at the end of July 2011). A sagging due to combination of the settlement contours of the WVS and NPLT can be noted for the SE wall. The other walls are hogging. This situation is also in line with the monitored responses of these walls. However, two discrepancies between estimated and actual settlements should be highlighted and the probable reasons should be discussed:

- Although the estimated settlements are increasing towards the SE-SW corner (SB18) due to closeness of this corner to the WVS, SPFV and NPFV excavations (see Fig. 2a and Figs. 13b, d and e), a more severe settlement was measured in reality for the SE-NE corner (SB14). The reason of reading higher settlement from SB14 monitoring bolt might be due to a possible local discontinuity and stiffness difference in the relatively thick and loose man-made fill. The region has been a trade and residential centre over the centuries and many archaeological relics including ancient building parts and wells have been discovered (Fig. 14) (Iwano et al., 2013).

The second stage analyses are performed using the combined 3D settlement field shown in Fig. 13f (Table 7). The Analyses 1 (reference), 2 and 3 aim to investigate the effect of the Young's modulus of the masonry. Analyses 1, 4, 5 and 6 investigate the effect of the bedding stiffness using a constant Young's modulus of the masonry. Analyses 7 and 8 study the effect of the leaving out the pre-existing crack and bedding interfaces, respectively. In analysis 9 both interfaces have been left out.

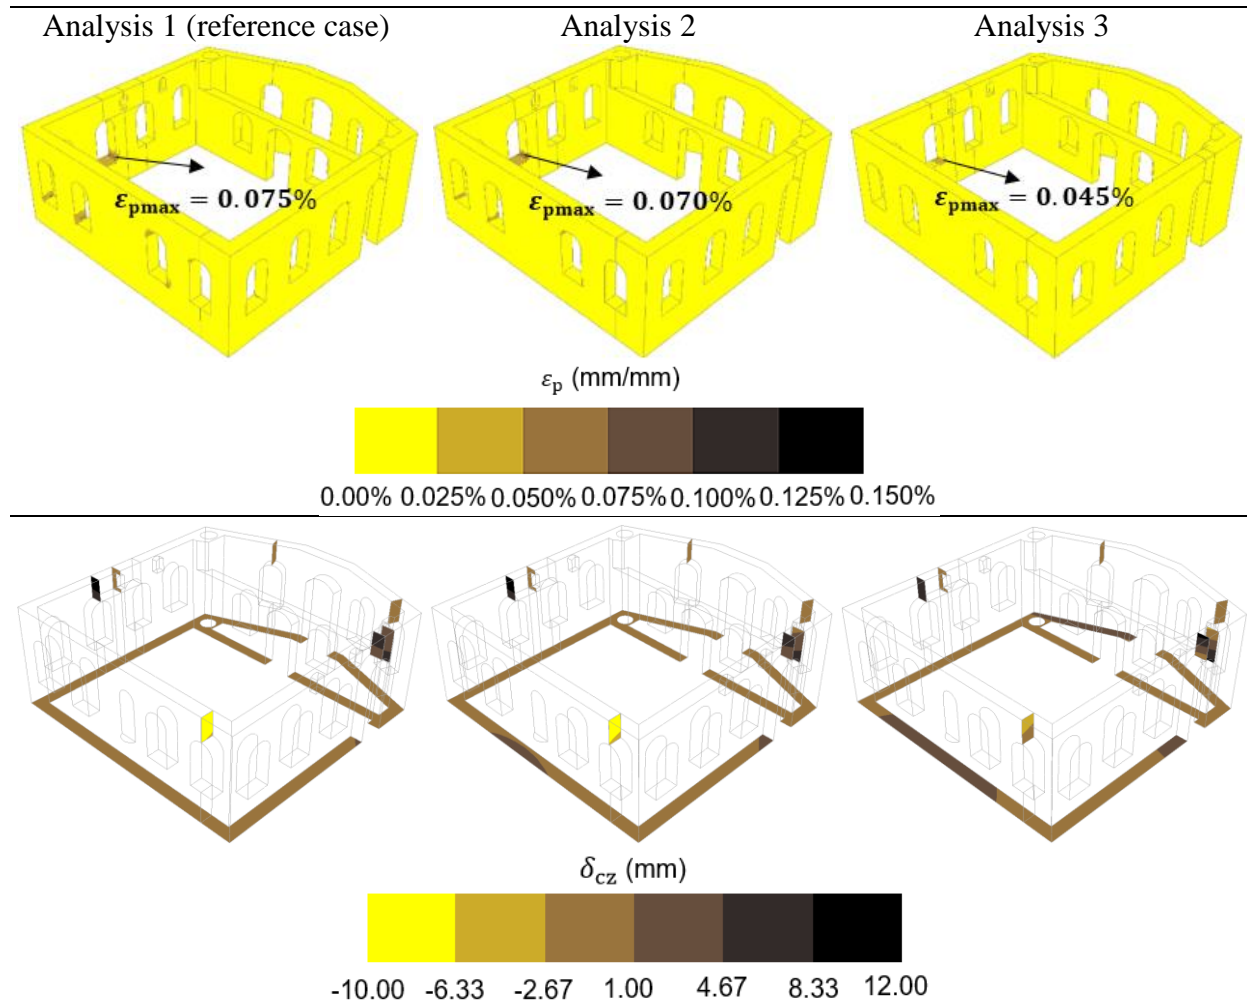
Fig. 15: The results of the Analyses 1, 2 and 3 (Variation of the masonry stiffness)

The results of Analyses 1, 2 and 3 show that an increasing structural stiffness through the increase of the Young's modulus of the masonry walls affects the conformity of the walls to the applied prescribed deformations. The more homogenous distribution of the bedding displacements (relative displacements of the bedding interface are being close to zero) in Analysis 1 indicates that the structure, which has the lowest stiffness, mostly conforms to the applied prescribed deformations (Figs. 15 and A.1). This situation eventually results in higher principal tensile strains within the structure. Increasing structural stiffness results in increased relative displacements in the bedding interface (Figs. 15 and A.1). The magnitude of the maximum principal tensile strain decreases and the structure tends to remain undeformed. This result is completely in line with the findings of previous studies of Potts and Addenbrooke (1997) and Son and Cording (2005). They established a relationship between soil/structure stiffness ratio and potential building distortions and observed that as this ratio decreases, the building distortions decrease.

As the structural stiffness increases, C1 tends to widen at its bottom part and close at its upper part in a more pronounced manner. The C2 acts the other way around due to rotation of the wall portion between C1 and C2 crack interfaces as observed in the first stage analysis of NE wall in section 5.1. The summed magnitude of the relative displacements of C5 and C6 crack interfaces decreases slightly. Cracks C3-1 and C3-2 have the lowest relative displacement regardless increasing stiffness. As the Young's modulus increases, C10 changes to a partial opening from a closure (Figs. 15 and A.1).

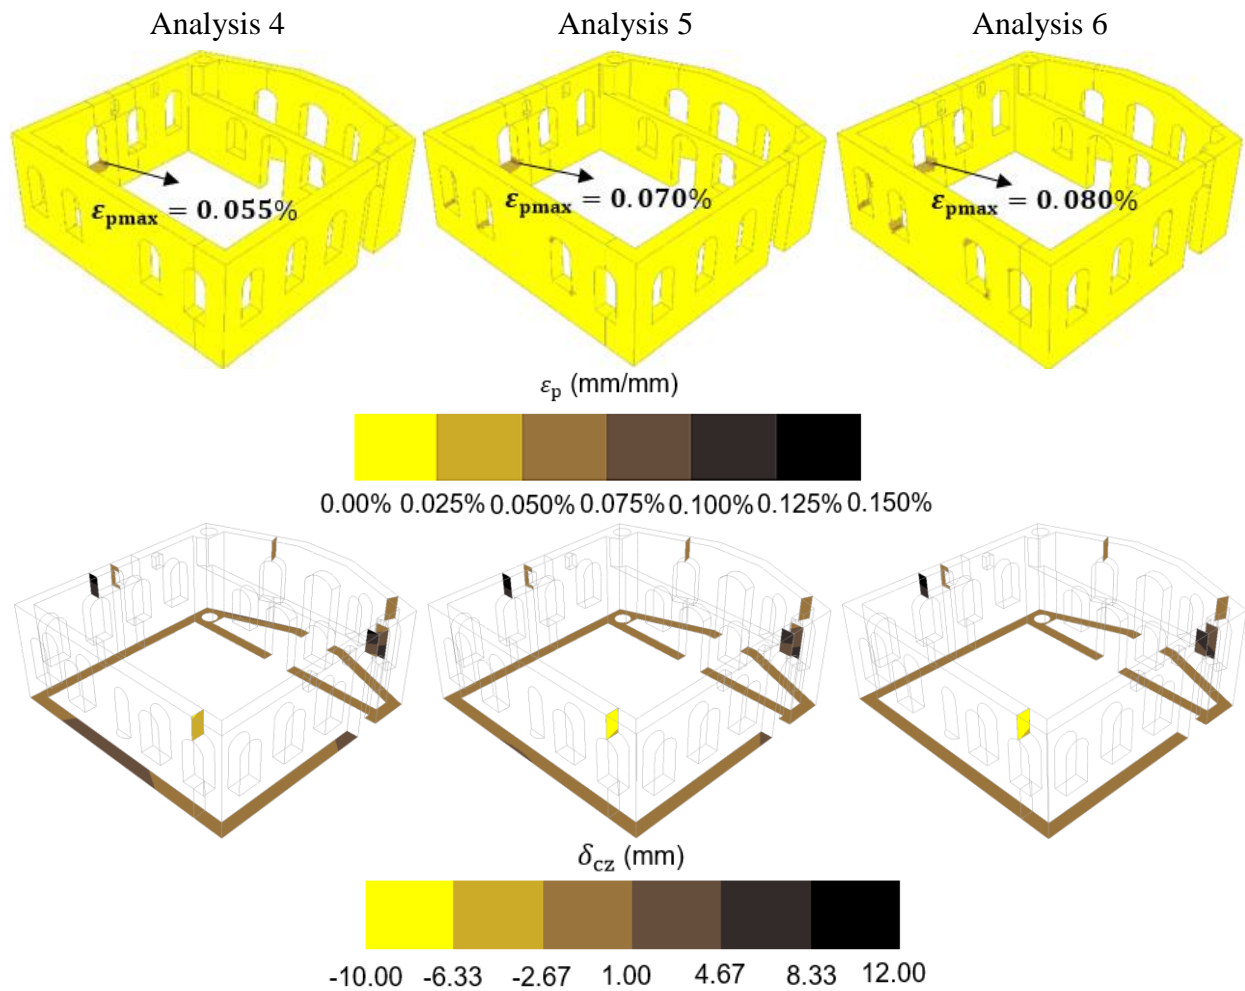
Fig. 16: The results of the Analyses 4, 5 and 6 (Variation of the bedding stiffness)

Increase of the soil stiffness is simulated with the increase of bedding stiffness. As the bedding stiffness is increased from k_{bz1} to k_{bz4} (through the Analyses 4, 5, 1 and 6, respectively) a remarkable increase of principal tensile strain in the walls is observed (Figs. 15 and 16). This is because higher bedding stiffness yields higher stress in comparison to a soft bedding subjected to same magnitude of prescribed settlement deformation. Recall that increasing soil/structure stiffness ratio results in increases of the structural distortions. On the other hand, a stiffer bedding interface leads to a more uniform relative displacement distribution which almost equals to zero in magnitude (see Analysis 6). As the bedding stiffness increases, the relative displacements of the localized cracks change insignificantly. Analysis 8 can be considered as the extreme case in terms of the bedding stiffness ($k_{bz} \rightarrow \infty$).

For this analysis, while an increase in the tensile principal strain values is observed, the relative displacements of the localized cracks are similar to those obtained for other bedding stiffness values.

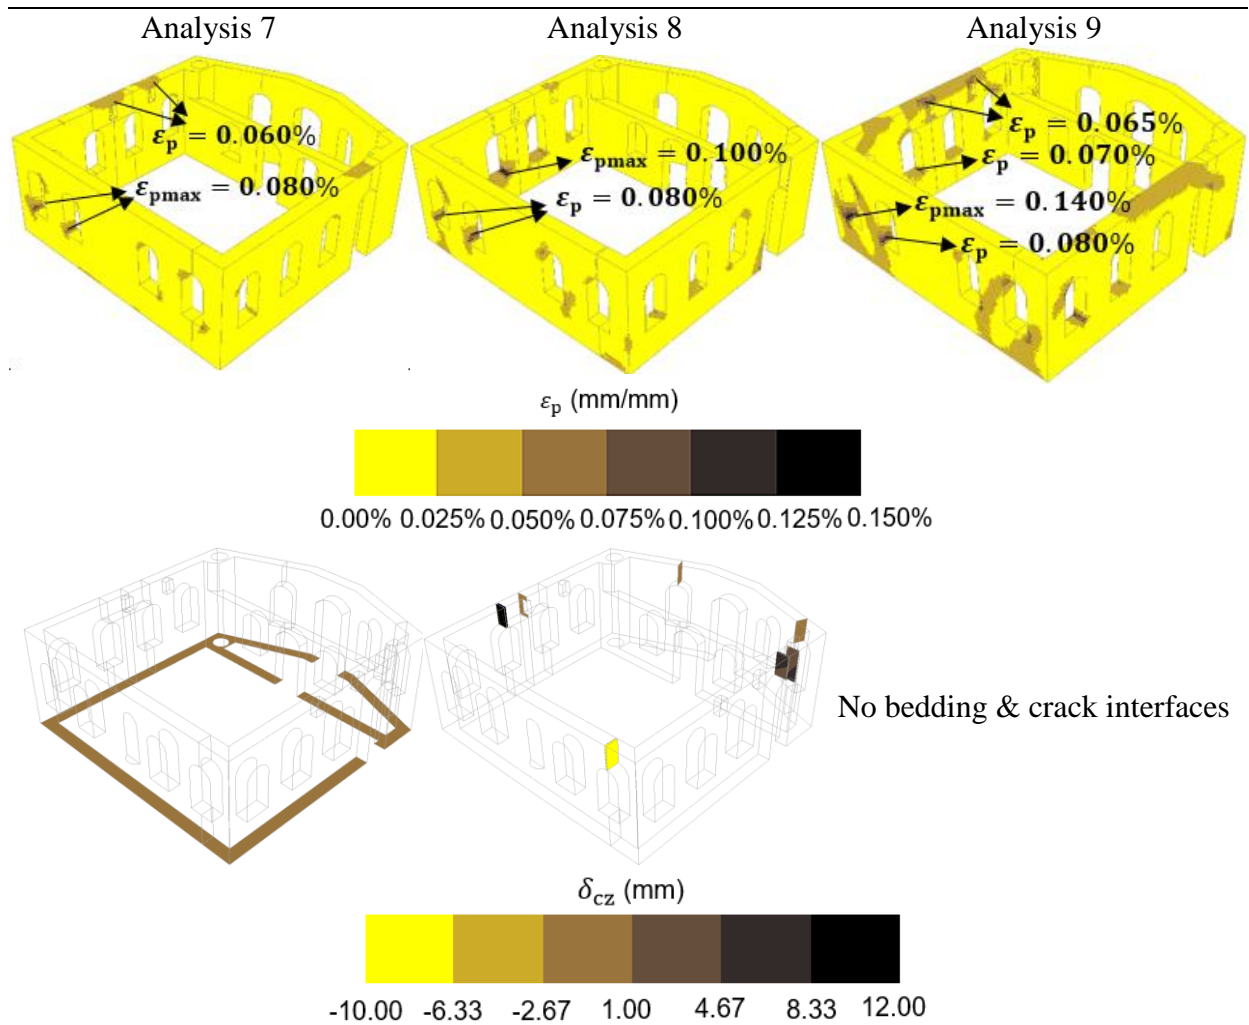
Fig. 17: The results of the Analyses 7, 8 and 9 (Variations of pre-existing cracks and bedding)

Finally, comparing the results of Analyses 1 & 7 and 8 & 9 shows that the presence of pre-existing cracks reduces the principal tensile strains in the close vicinity of the cracks, but results in an increase in other neighbouring sections (Fig. 17). This result was also observed in the previous section 5.1 in which each wall was examined separately. Since the model used in Analysis 9 does not include crack interfaces, a concentration of principal tensile strain appears at the upper sections of the SW and NE walls. Although principal tensile strains reach the highest magnitude in Analysis 8 and 9, the maximum principal tensile strain does usually not

exceed 0.14 % which corresponds to slight damage according to Table A.1. This result is also in line with the results found in previous section and site observations.

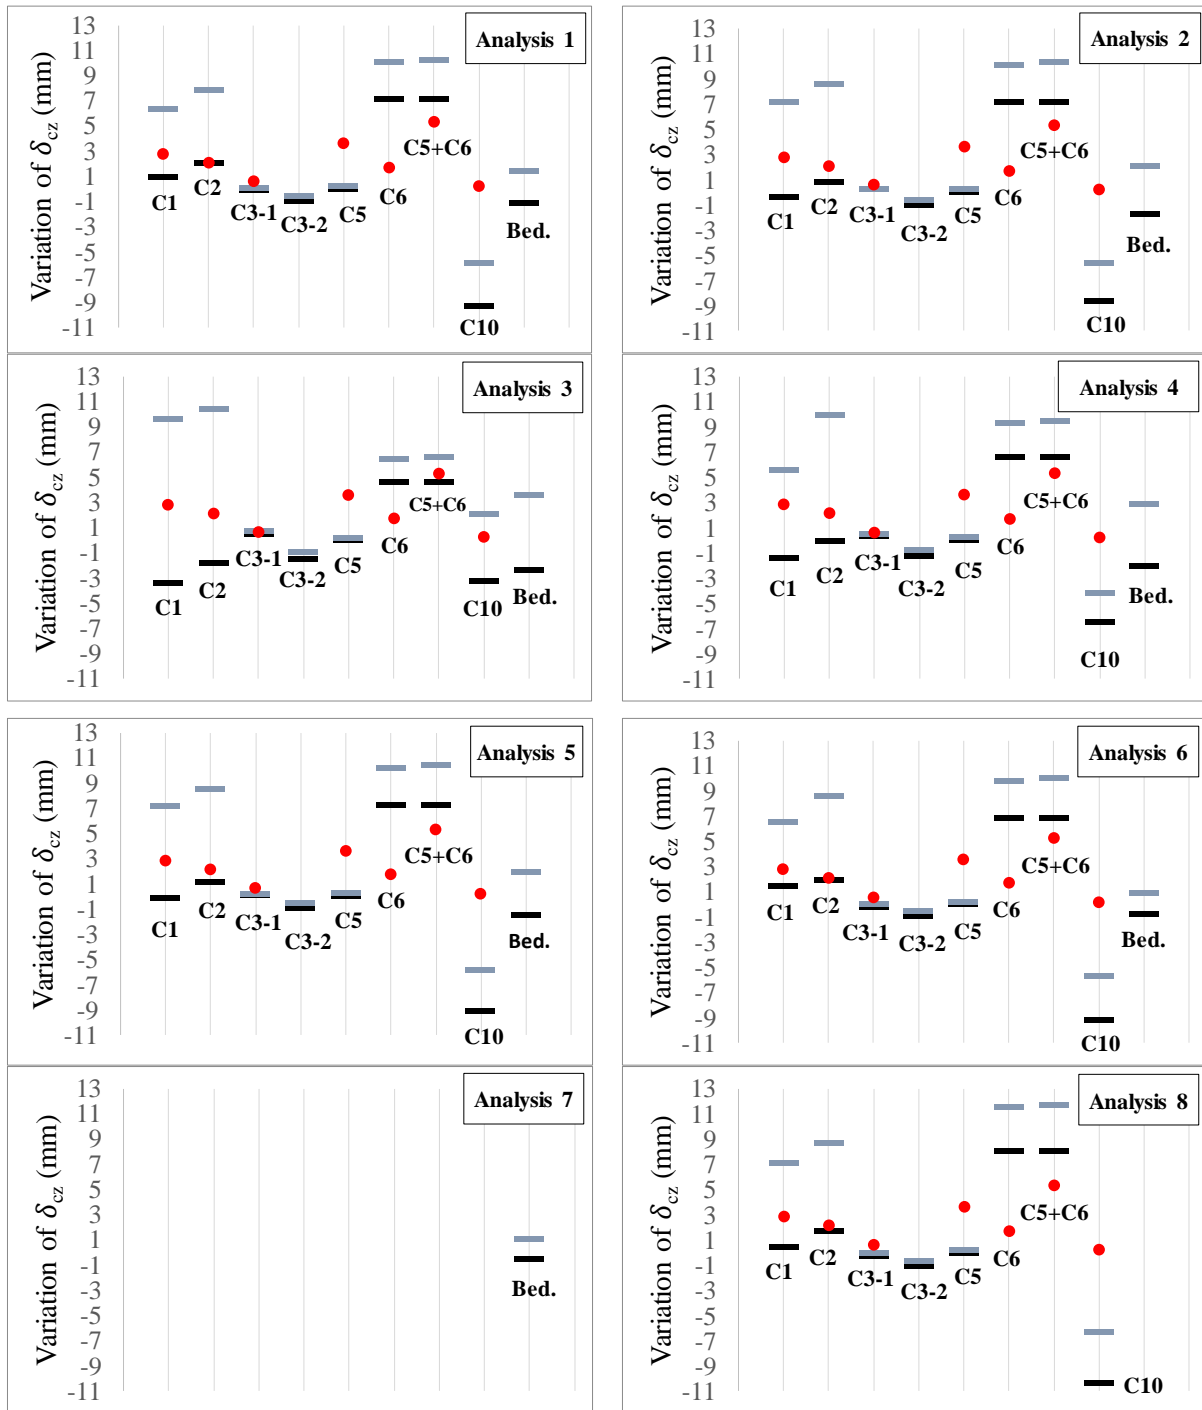
Fig. A.1: The ranges of variation of relative displacements of crack and bedding interfaces
