In-depth assessment on the structural geological and engineering geological condition of the weakness zone at Svandalsflona HPP

Master's thesis in Geotechnology
Supervisor: Krishna Kanta Panthi
May 2019

In 2008, a cave-in occurred in Stutakvelven inclined shaft at Svandalsflona hydropower project (HPP) followed by a sudden burst flood in 2009 killing two people. This thesis is an in-depth assessment on the structural geological and engineering geological condition of the weakness zone intersecting the shaft, with the purpose of analysing the cave-in.

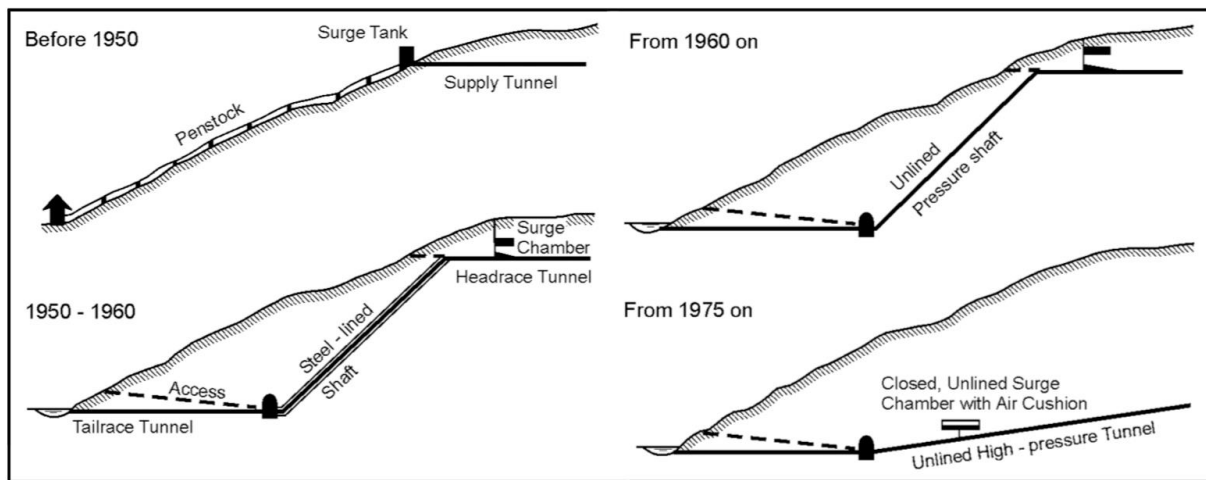
Figure 1. The general development of Norwegian hydropower design principles (Palmstrøm and Broch, 2017).

Figure 1 found in Palmstrøm and Broch (2017) illustrates the development of Norwegian hydropower design principles. Before 1950 the conventional building design was a surface powerhouse and steel-penstock. In the 1950s the hydropower constructions were placed underground normally with a steel-lined shaft. The 1960s represents a change in the design philosophy where unlined tunnels were utilised and became the conventional design. In the 1970s the simple calculation method called “rule-of-thumb” was introduced, based on that the rock overburden should be significant enough to induce rock stresses counteracting the water pressure in tunnels. The rule-of-thumb were updated after some cases of instability, and a new rule-of-thumb was presented. Despite of this, the criterion still has its weaknesses, and is today only used as a quick preliminary design estimate. One of the weaknesses is that the criterion does not account for low rock stresses. From 1975 and onwards the preferred design is unlined high-pressure tunnels with a closed surge chamber with air cushion to reduce water hammer (Nilsen and Thidemann, 1993). As an alternative to the surge chamber, surge shafts may be

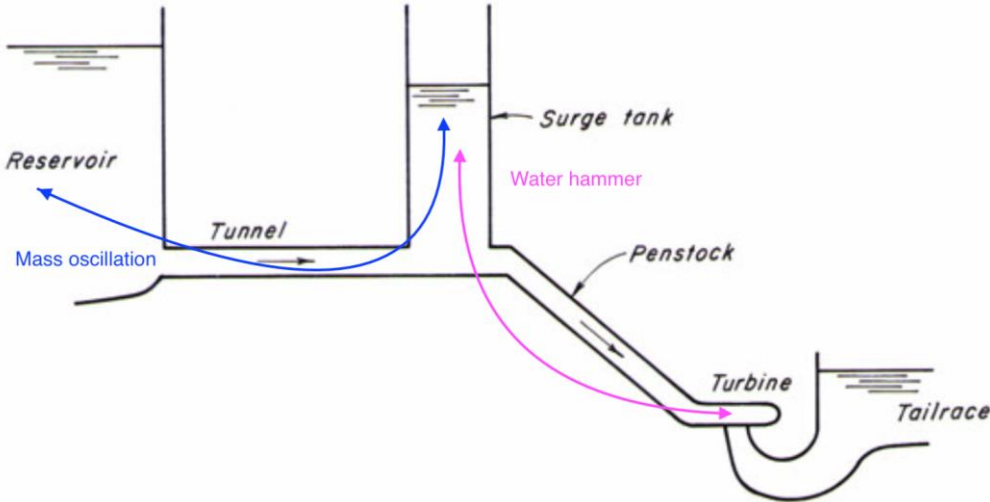
Figure 2. Illustration of a set-up using surge tank with water transients indicated. Figure modified from Chaudhry (1979).

surface where it reflects back towards the turbine. The amplitude of the pressure wave is mainly dependent on the tunnel length and the closing or opening time of the valve at the powerhouse. The magnitude of this wave can cause serious damage to both the tunnel and the turbine. Normally, it is not possible to always keep a certain closing or opening rate, thus, shortening the length between the nearest free surface and the turbine is the only viable option. This is achieved by using surge tanks such as closed air chambers and shafts with open surface to the atmosphere, illustrated in Figure 2 (Chaudhry, 1979).

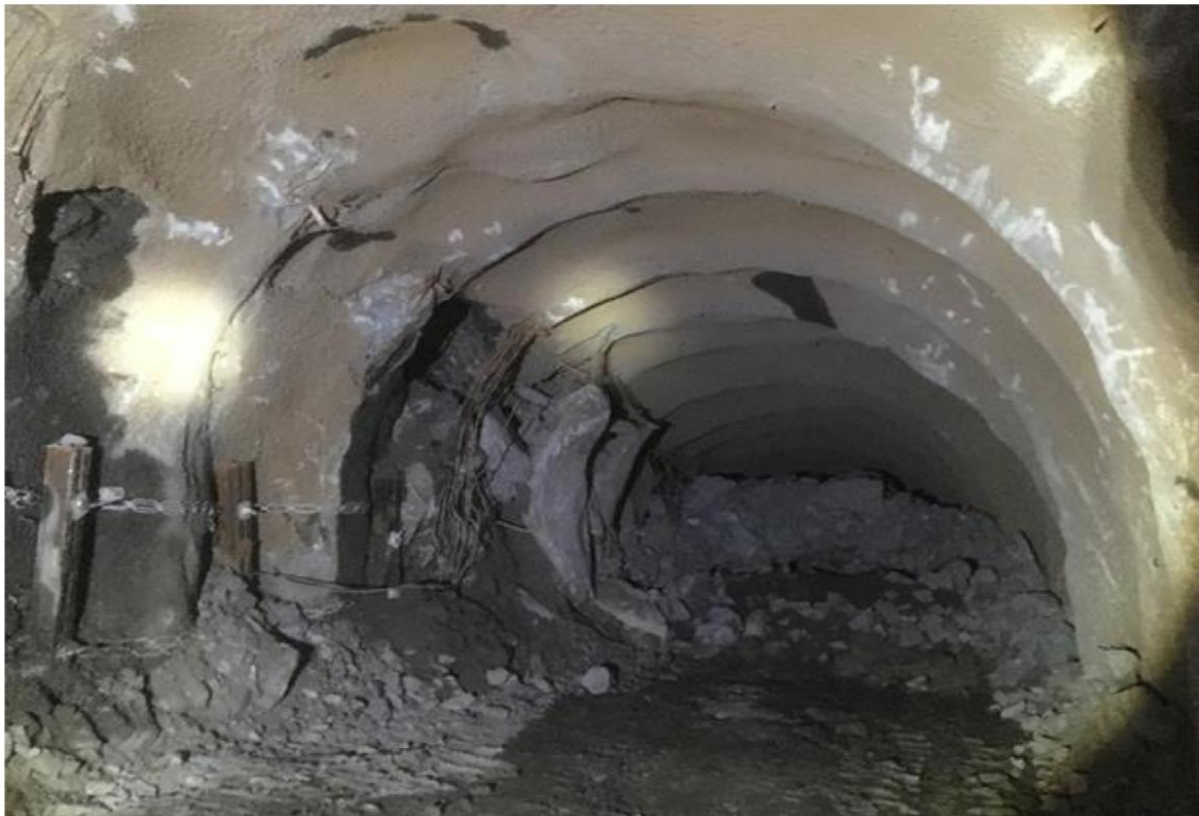
*Figure 3. Failure of the reinforced ribs of sprayed concrete and slide in the Matre Haugsdal tunnel in 2017
Brende et al. (2018).*

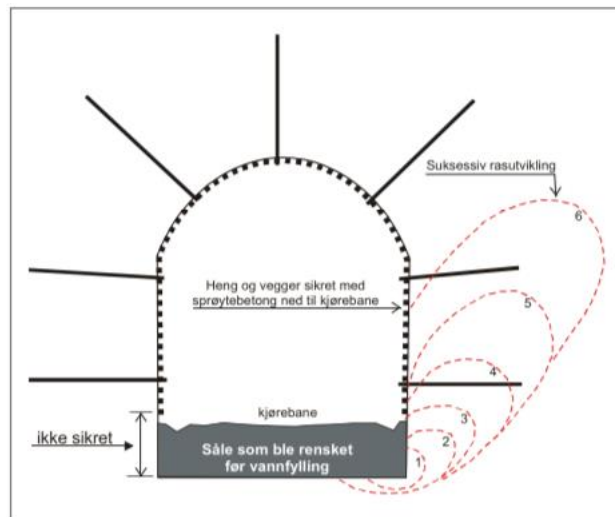
Figure 4. Illustration of the development of the cave-in in 1991 at Nedre Vinstra HPP. This could most likely occur due to the unlined invert and lower part of the walls (Palmstrøm, 2018).

This collapse caused 3 ½ months of continuously tunnel-work, as it was necessary to excavate a bypass-tunnel through the weakness zone. This new tunnel was secured with reinforced ribs of sprayed concrete and 50 cm cast concrete in the invert.

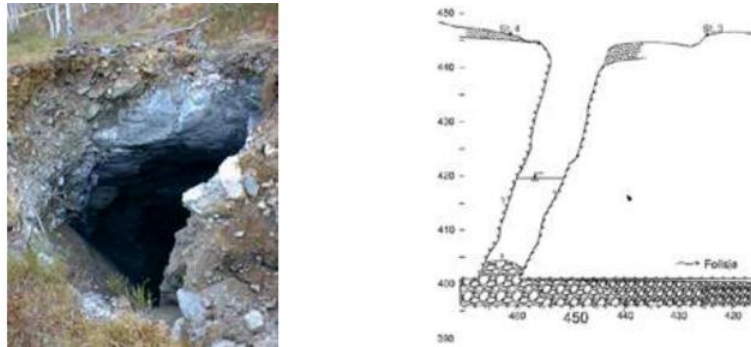
Figure 5. The cave-in at Trollheim HPP where a sink hole appeared at the surface (Palmstrøm, 2018).

after 35 years of operation. This was caused by a cave-in which filled the tunnel with deposits of more than 300 m Figure 5. The geology consists of mica schist and mica gneiss with several distinct joint sets. At the cave-in, a 40-50 cm thick inclined clay zone above the tunnel was observed. This zone was commented by workers during construction, noting that minor rock falls occurred. The tunnel was left unsupported allowing the cave-in to gradually develop (Palmstrøm, 2018).

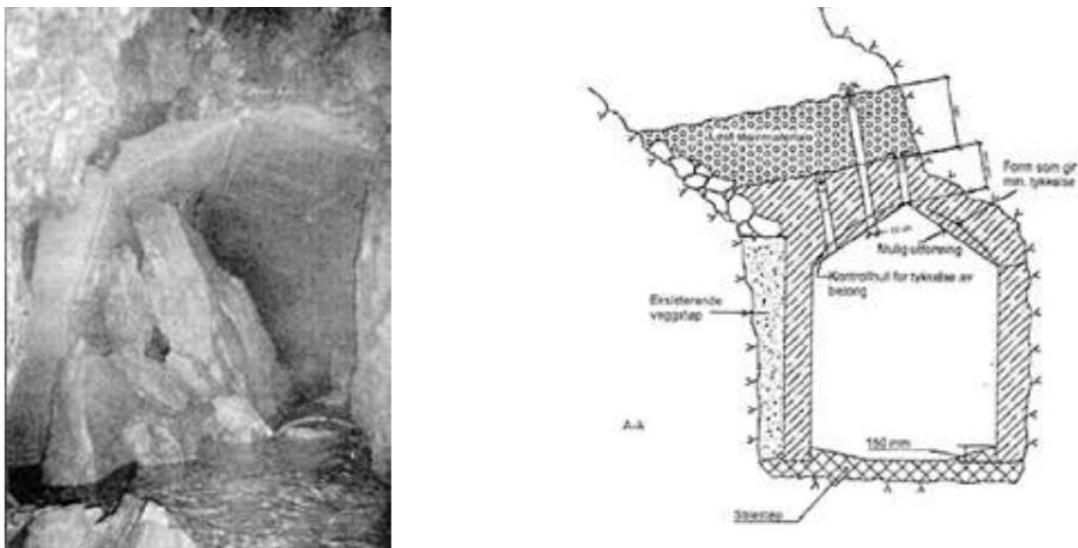
Figure 6. The cave-in at Mauranger HPP with old failed concrete support. Here it was constructed a new support with dampening masses on the roof of the support construction (Palmstrøm, 2018).

In a transfer tunnel, a cave-in occurred caused by failed cast concrete lining. Figure 6 shows the old concrete, which was used again during the new support design. It was discovered that the weakness zone was not entirely covered by the old cast concrete which consequently led to the development of the cave-in near and over the cast concrete support (Palmstrøm, 2018).

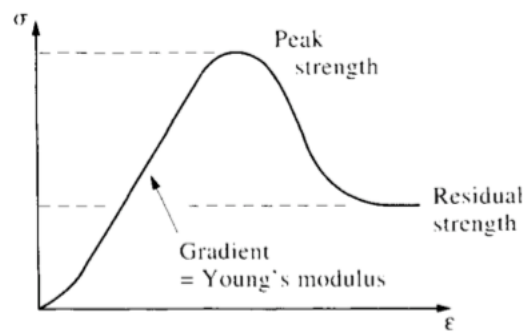
Figure 7. Stress-strain curve obtained by measuring the axial stress (σ) and the axial strain (ϵ) in uniaxial compressive testing (Hudson and Harrison, 2000).

From the stress-strain curve, rock properties such as the peak-strength (σ_{ci}), intact deformation modulus (E_i) and post-failure behaviour can be determined (Hudson and Harrison, 2000).

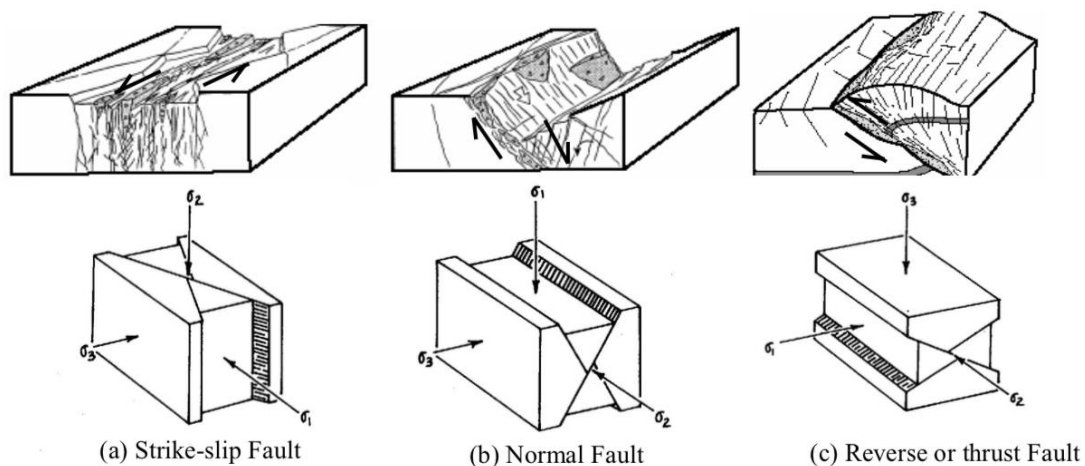
Figure 8. Anderson fault theory on strike-slip fault, normal fault and reverse or thrust fault, from Panthi (2006).

Weakness zones can often be seen as lineaments or depressions in the terrain. The type of weakness zones can generally be categorised as either crushed zones caused by faulting or other tectonic activity, or continuous areas of particularly weak rock (Nilsen and Thidemann, 1993). Anderson, referred in Panthi (2006), has suggested three fault regimes based on the principal stresses, namely normal faults, reverse- or thrust faults, and strike-slip faults Figure 8.

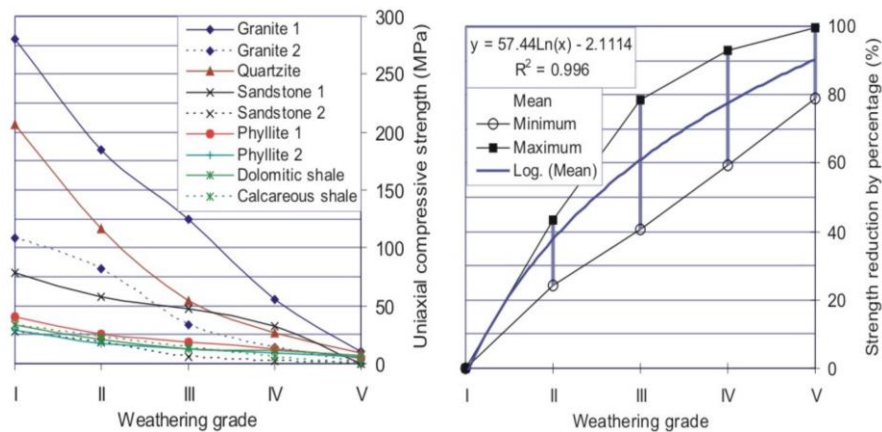
Figure 10. Weakening of rock due to weathering (Panthi, 2006).

Weathering of rocks occurs as mechanical disintegration and chemical decomposition. Mechanical breakdown causes opening of joints, occurrence of new joints and fracturing of individual mineral grains. In cold climates, frost shattering breaks down rocks by expanding water inside cracks, joints and other discontinuities. The chemical decomposition breaks down rock mass by dissolution of minerals, leading to transport of ions and formation of new clay minerals. Weathering is seen as discolouration of the rock and occurs at the surface, as well as at depth in existing joints and discontinuities (Nilsen and Thidemann, 1993). Ultimately, rock disintegrates into soil losing all or almost all its strength (Panthi, 2006) as seen in Figure 10.

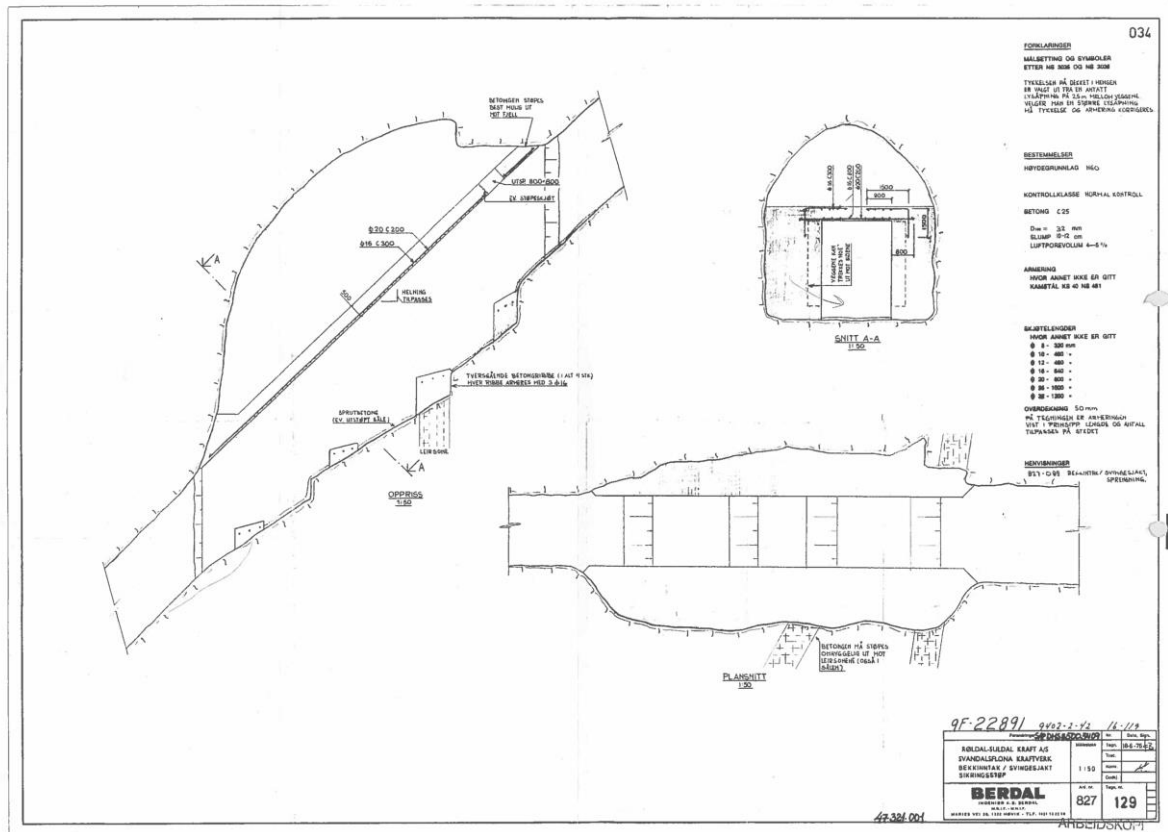
Figure 18. Construction drawings of the concrete lining in the shaft where the weakness zone intersects (Berdal AS, 1978b).

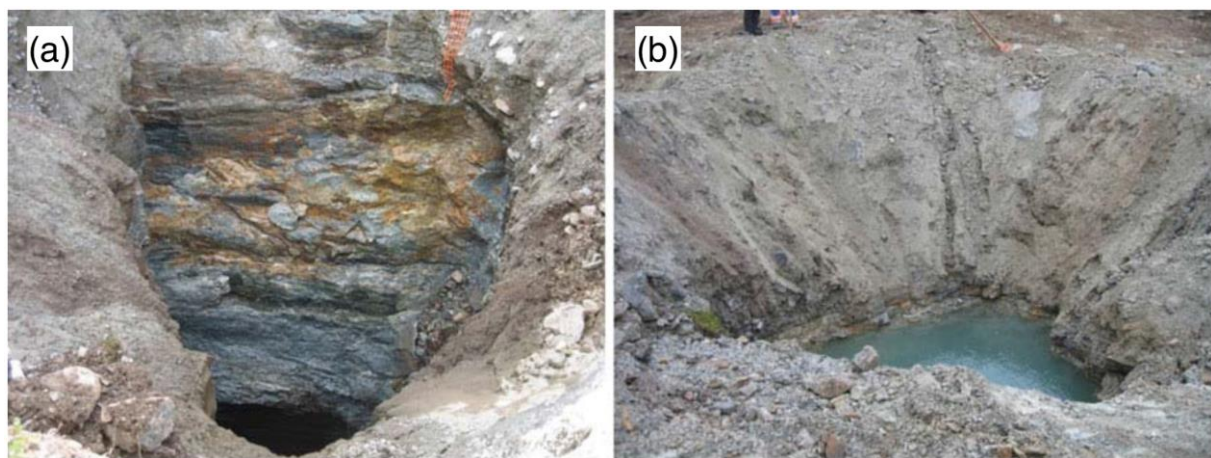
Figure 20. (a) Rock mass in sink hole (July 2008). (b) Water-filled sink hole in September 2008 (Photos by Norsk Hydro referred in Panthi (2014)).

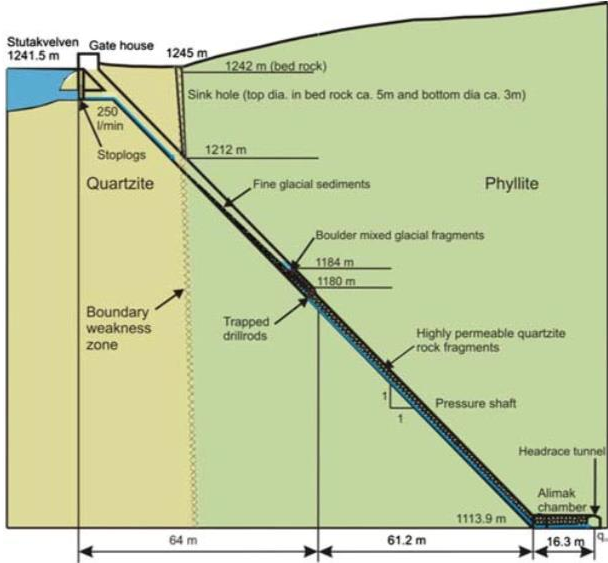
Figure 21. Illustration of the situation in Stutakvelven shaft after the initial collapse from Panthi (2014). Note the transition in the shaft cross-section at elevation 1180, and that the slide deposits have clogged where the shaft narrows in. It is illustrated that the slide deposits have some permeability. Sink hole has a diameter of approximately 3 m at tunnel depth.

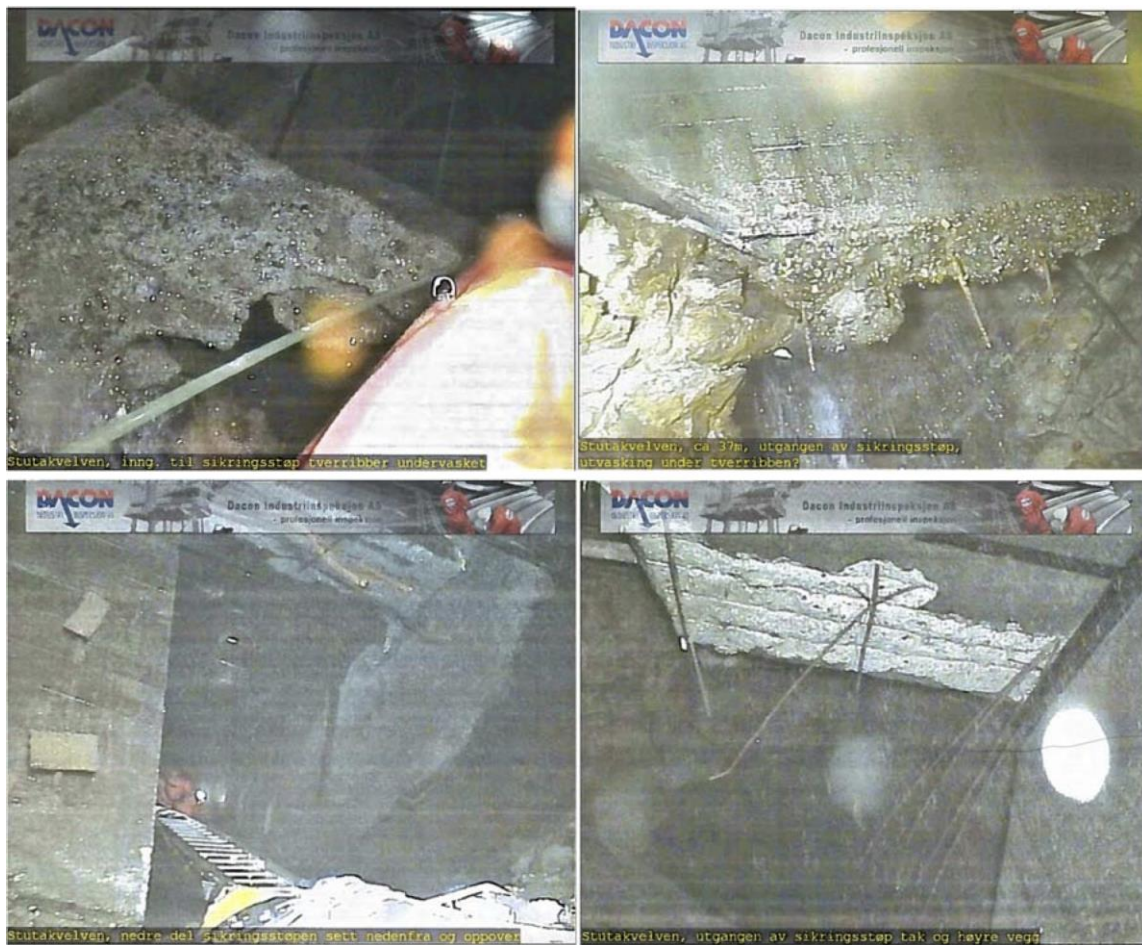
Figure 22. Indicates outwash under the brace beams in the invert where the clay zones exist. The cast concrete is damaged in walls and in the crown in the lower end. Photo taken post both the collapse and the sudden burst flood, and originates from Neupane and Panthi (2018).

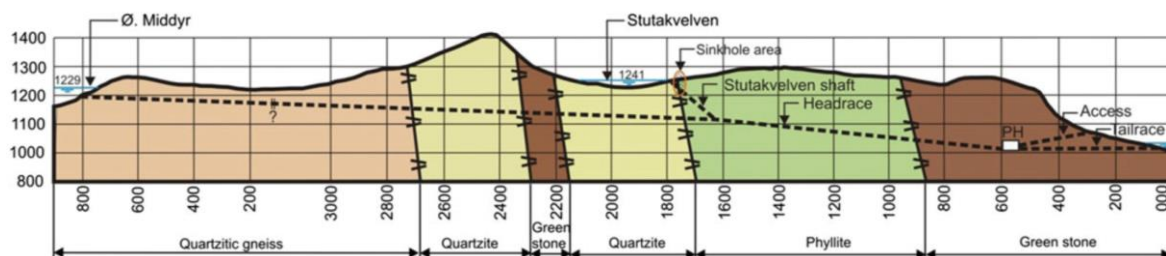
Figure 24. Longitudinal profile of waterway system and geological conditions of the Svandalsflona hydropower project (Panthi, 2014).

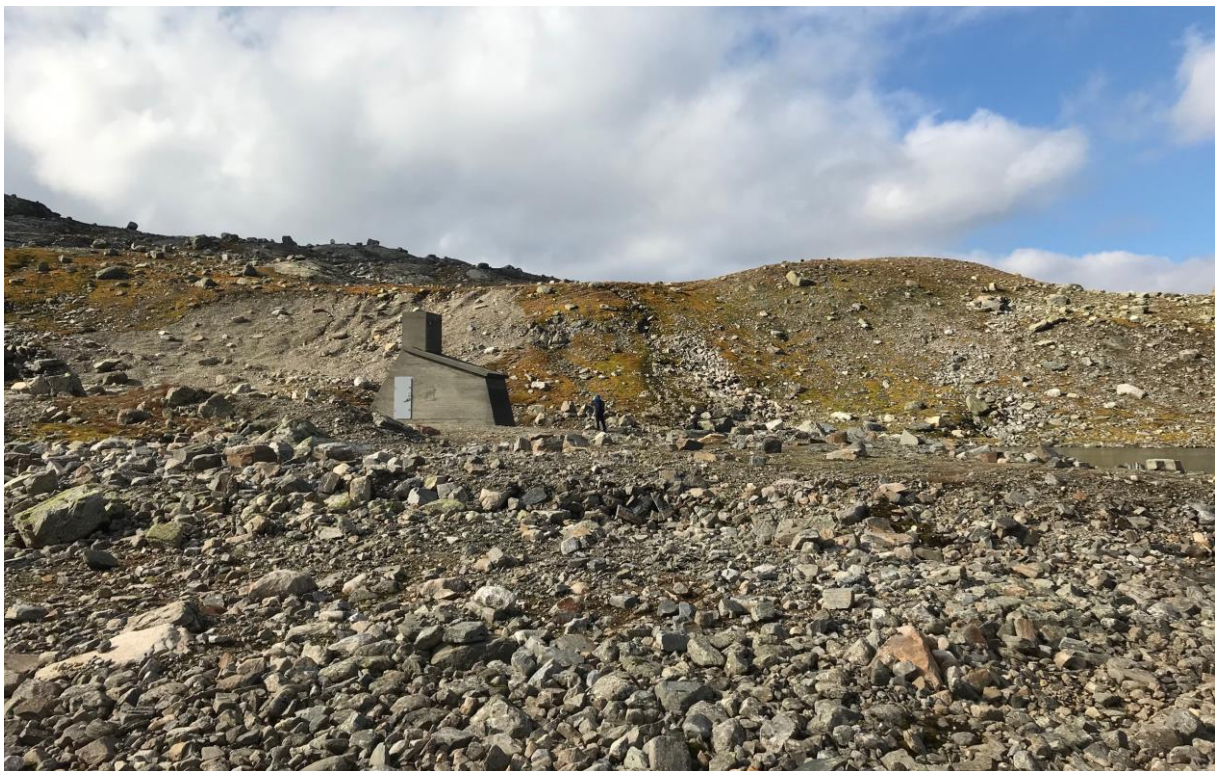
Figure 27. Gate house and the area covering the sink hole on the left backside of the gate house, seen as a terrain scar. Photo taken towards WSW, looking downstream the shaft, oblique to the weakness zone 17.

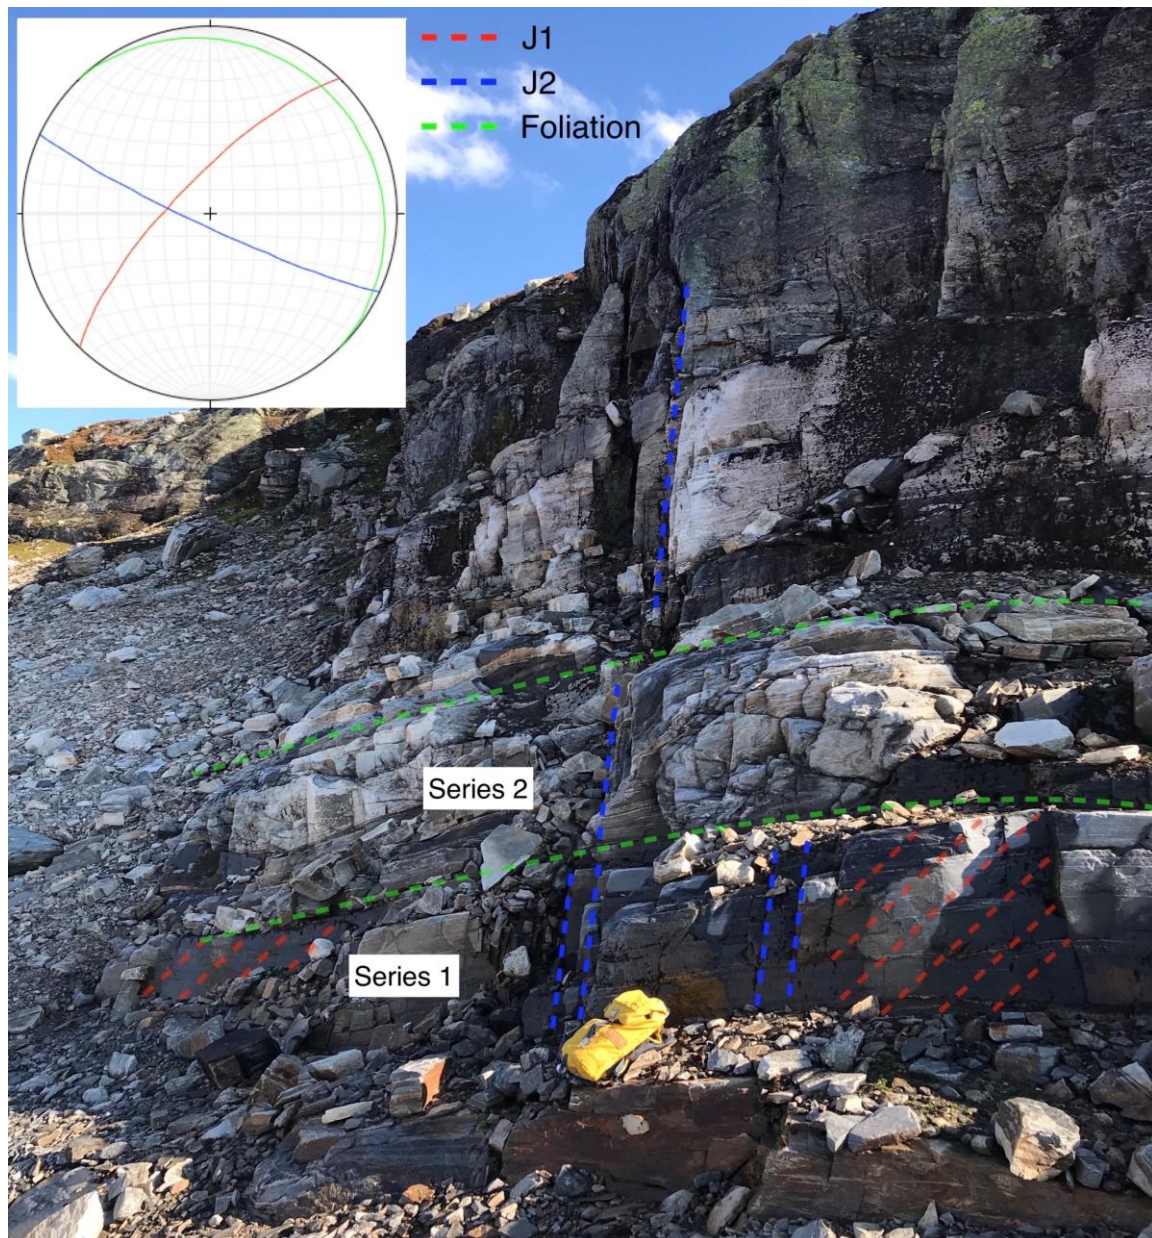
Figure 30. Location 1.5 found at the weakness zone 18, where samples of series 1 and 2 were collected. The length of the rucksack is approximately 45 cm, and the photo is taken towards direction ESE (106°). The stereographic projection shows the mean values of the measured joint sets.

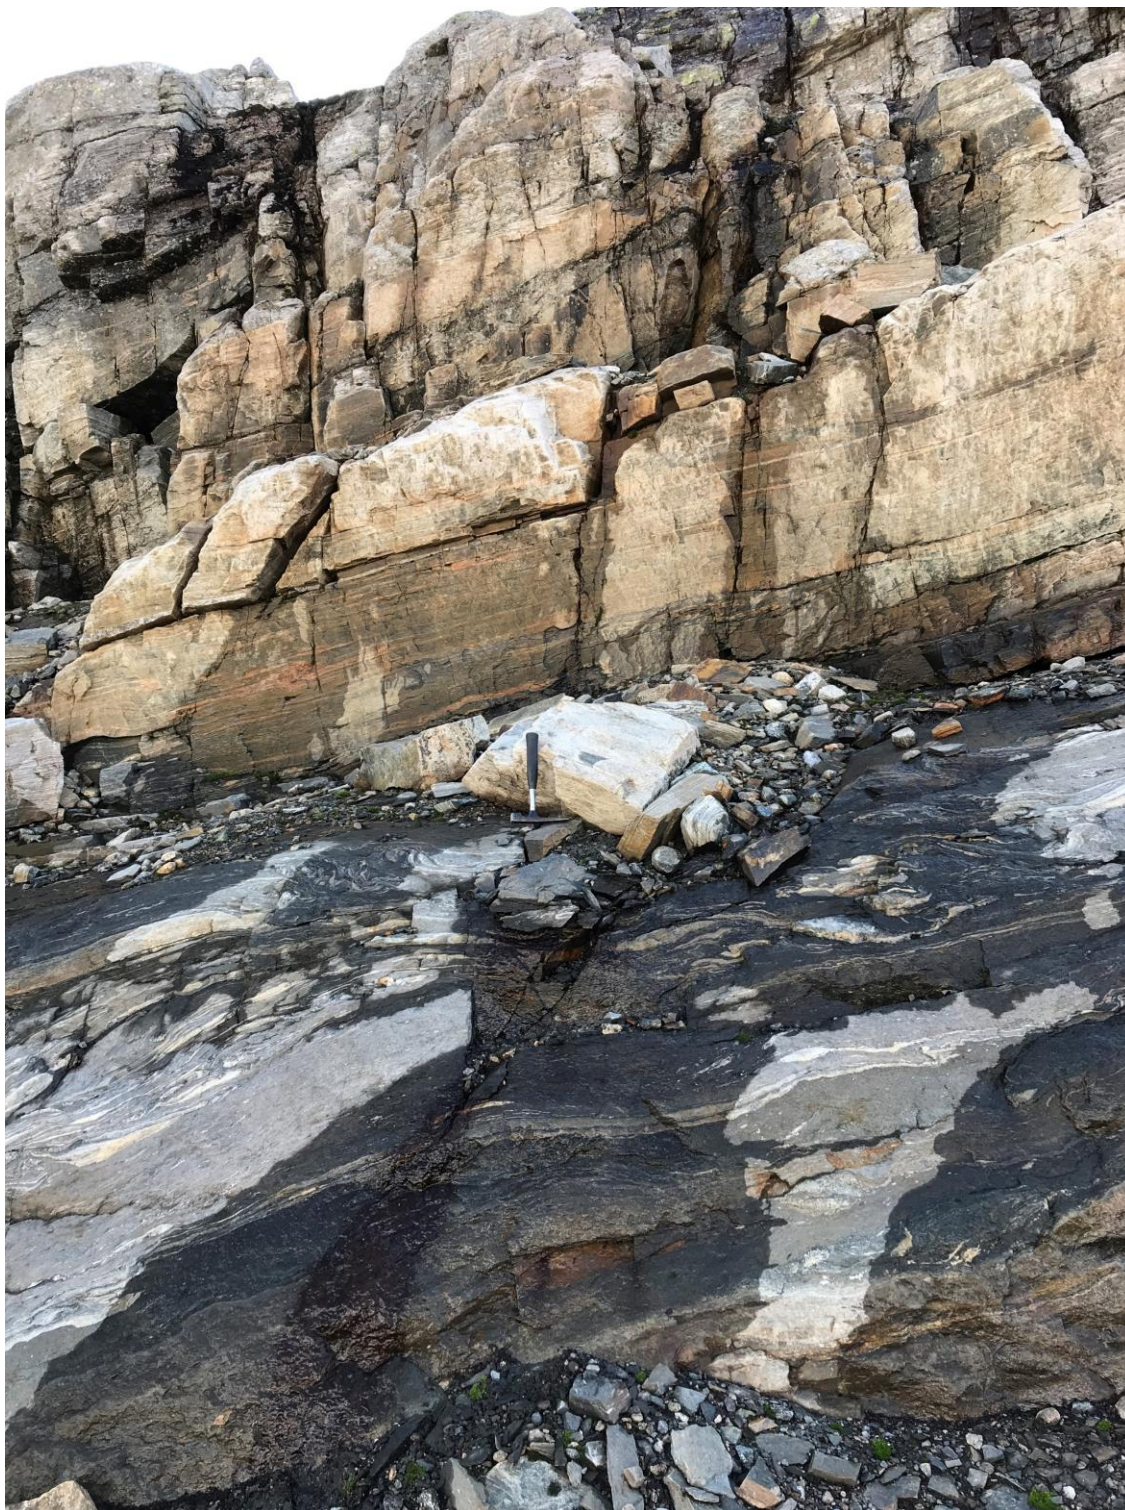
Figure 31. Deformation zone in location 1.5. Picture taken towards east-southeast (114°).

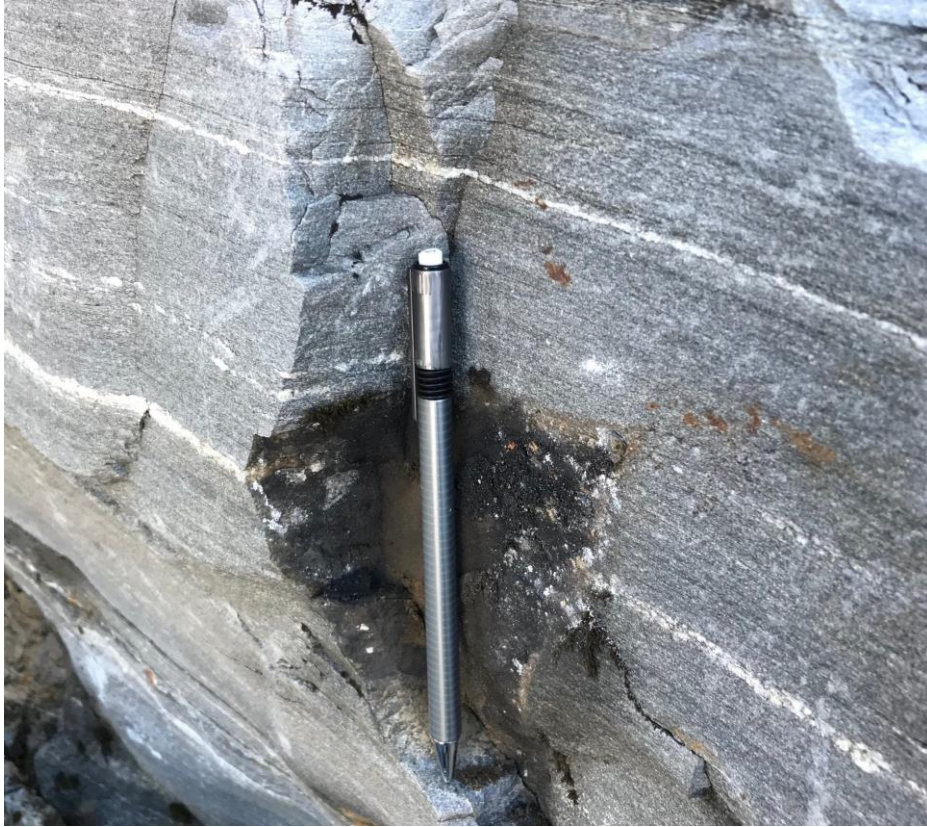
Figure 32. Joint infill location 1.5 in the layer “series 1”. Silty or sandy clay coating. Alternating darker and lighter foliation. The photo is taken towards direction SE (132°).

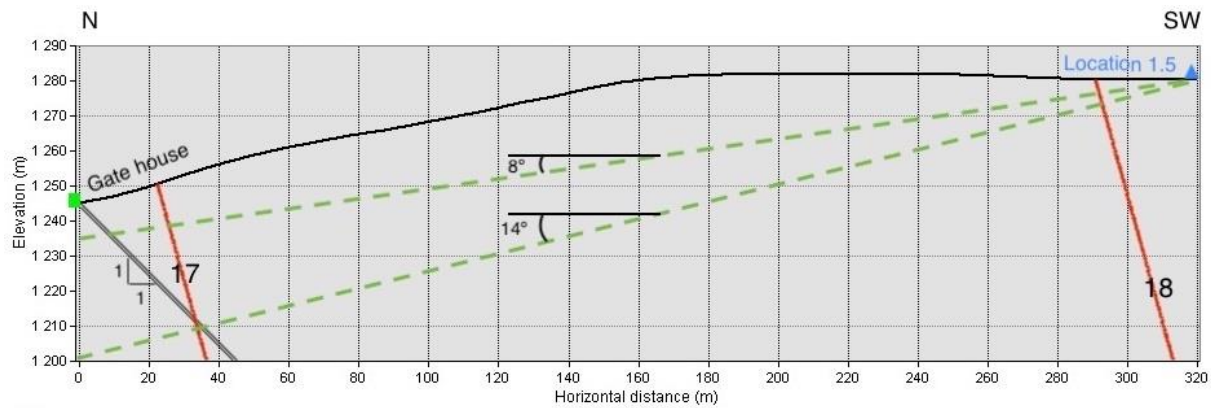
Figure 33. Illustration of how the rock mass at location 1.5 could be representative for the rock mass in the shaft. Vertical-horizontal axis not to scale. The cross-section N-SW is shown and marked as adjacent cathetus in the overview map in Figure 29.

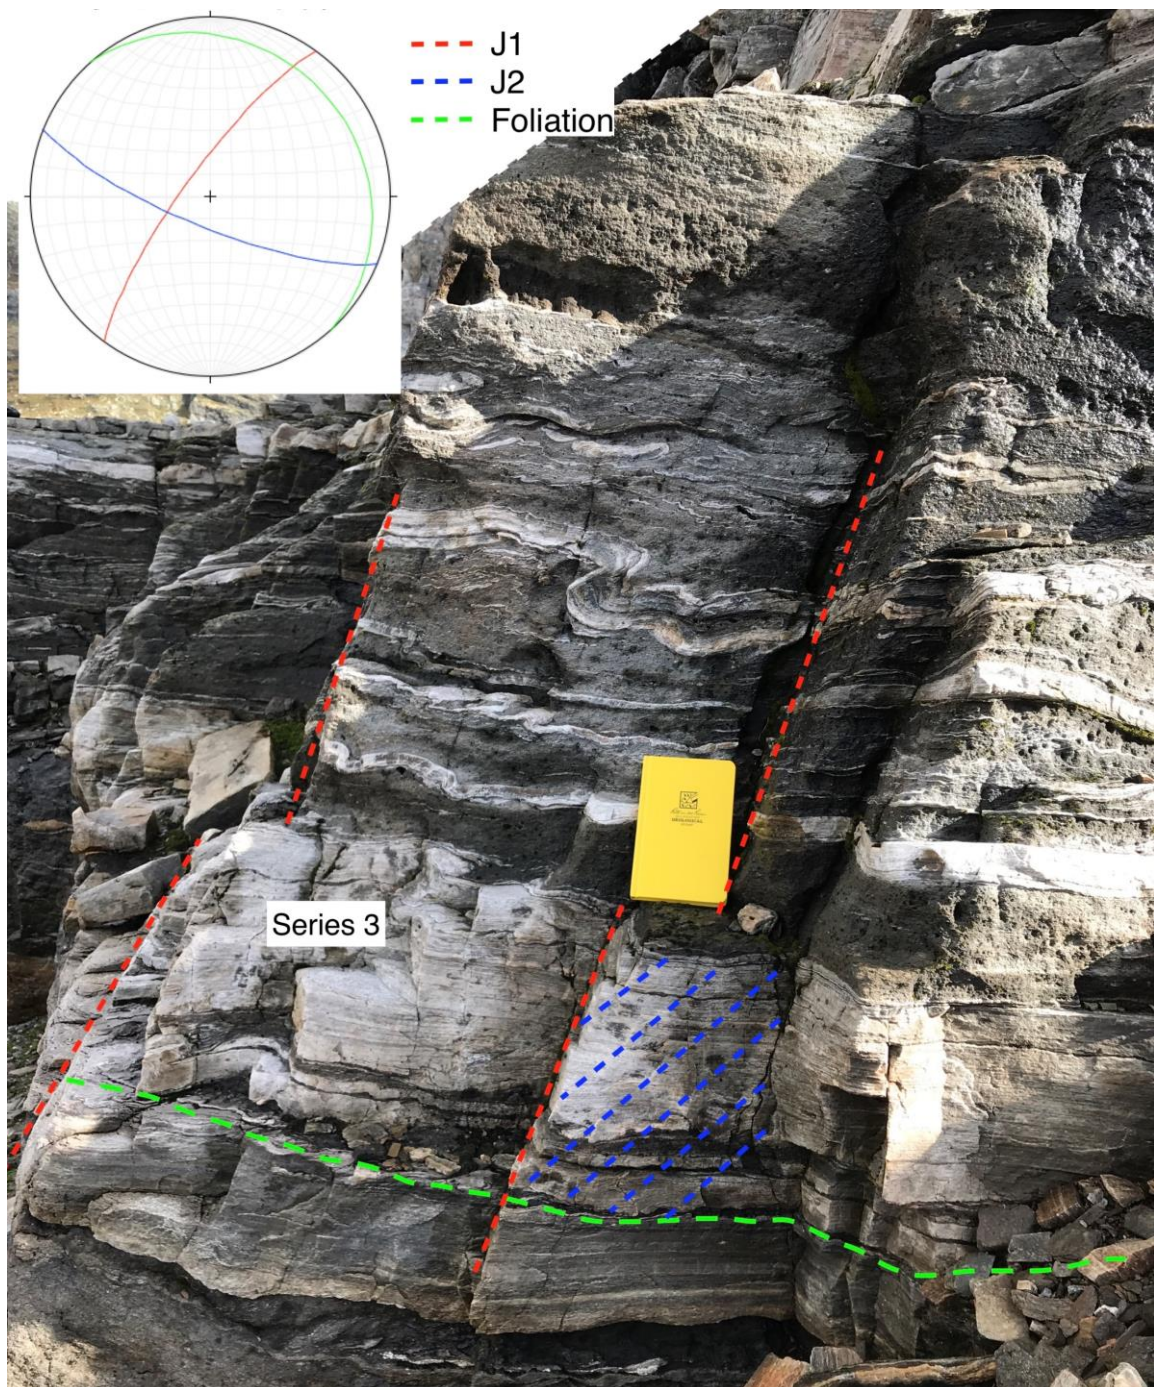
Figure 34. Location 2.1 where series 3 was sampled. Joint set 1 is indicated with red stippled lines, joint set 2 with blue stippled lines and the foliation joint set is indicated with a green stippled line. The geological sketch book for scale is 20 cm, and the photo is taken towards direction northeast (038°). The presentation of the stereographic plot is the mean values of the measurements.

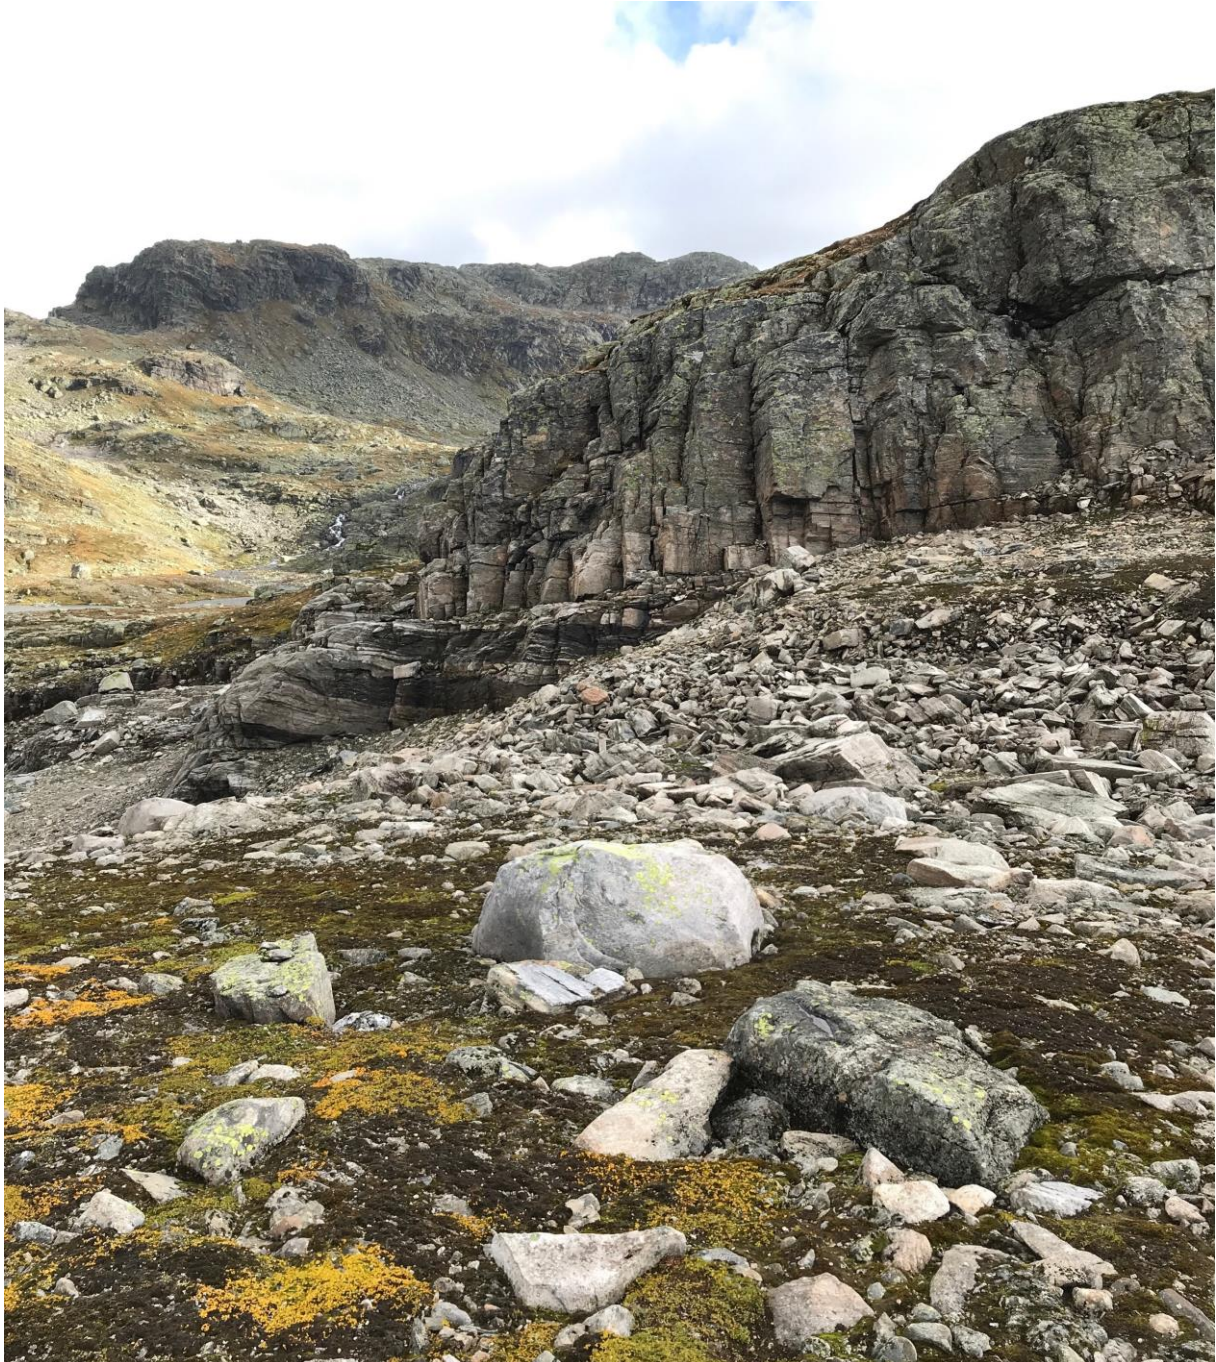
Figure 35. Overview of the location 2.1, where the sample which constitutes series 3 was collected. Picture takes towards northeast (049°).

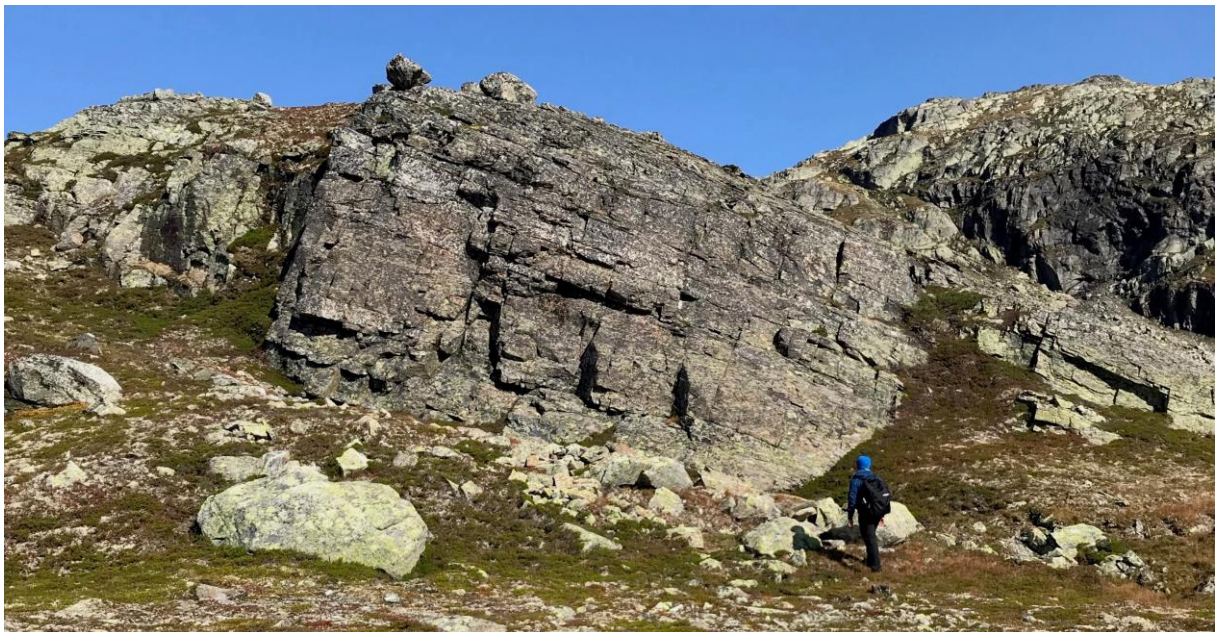
This area is marked as quartzite by both Berdal AS (1978c) and Jorde (1977) and is located on the north side of weakness zone 17. The rock mass is apparently more solid with a higher Q-value, but also here three distinct joint sets can be seen (Figure 36). All three joint sets have a persistence more than 3 m. The J1 joints are dipping steeply towards northwest, with a spacing of 40-60 cm. The J3 joints are dipping steeply towards west-southwest, with a spacing of 100 cm. The foliation joints are dipping gently towards east, with a spacing of 10-20 cm. The J2 joints are not observed at this location, however, the J3 joints are approximately rotated 30 degrees (N→E) relatively to the J2 joints and could originally be oriented as J2 joints. This could mean that deformation has reoriented J2 joints to J3 joints in this location, and it is therefore not certain that these J3 joints exists in the shaft area.

Figure 36. Rock mass at location 4. Bibek for scale.

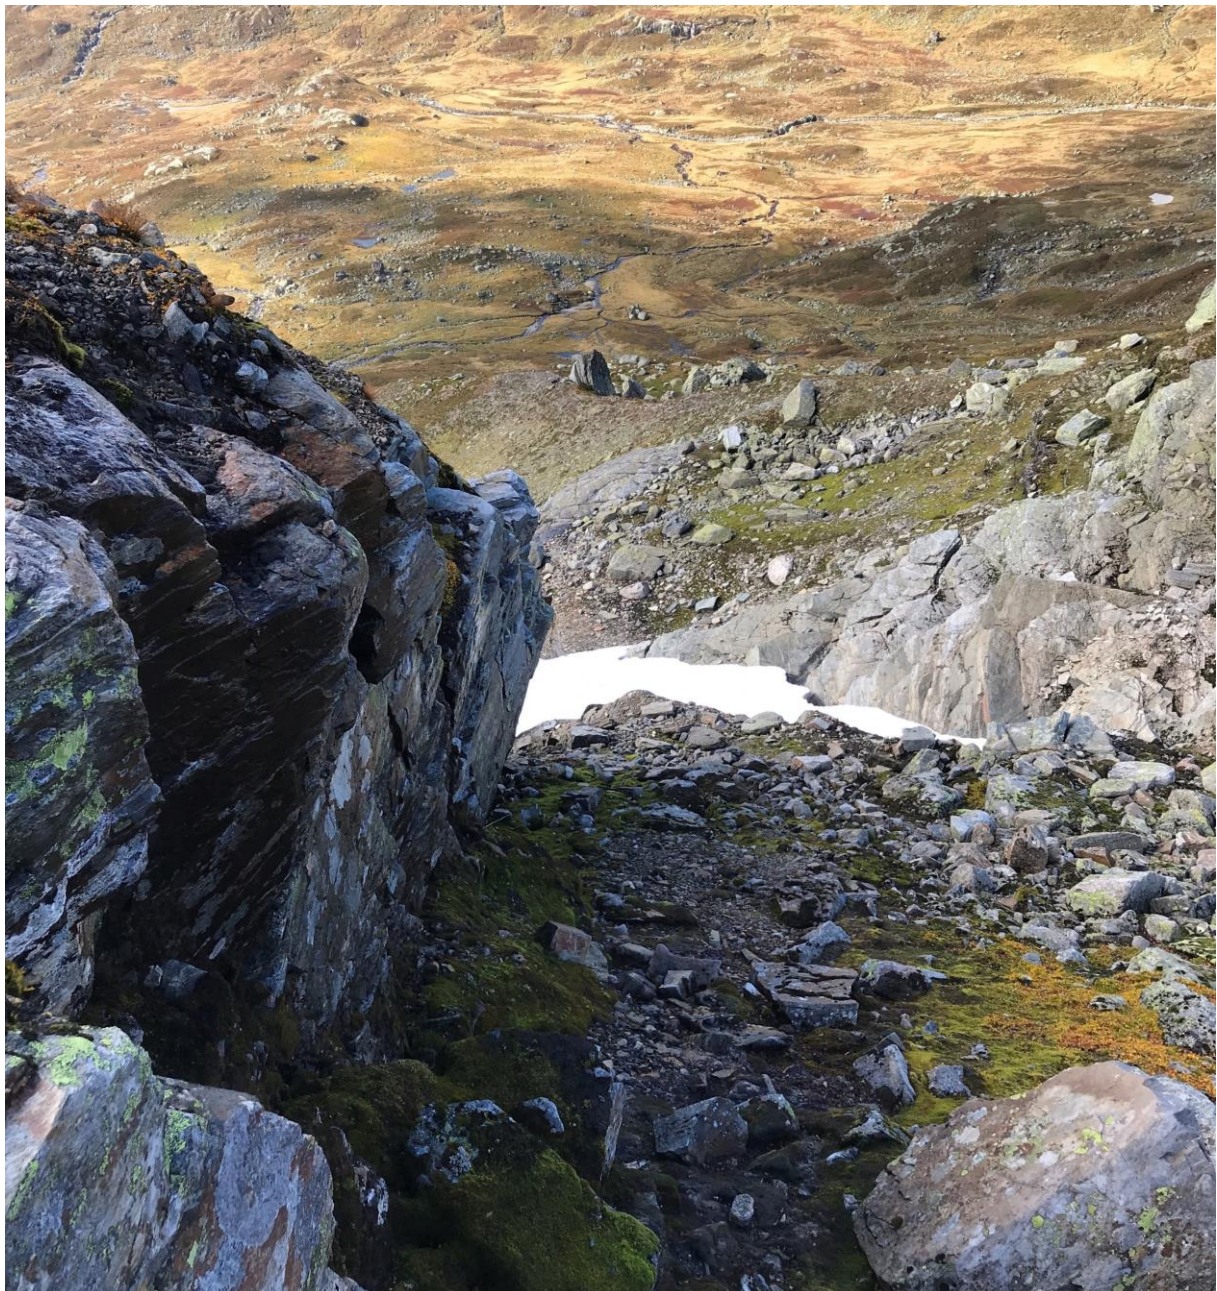
Figure 38. Location 1.7.3 where the fault plane of weakness zone 17 is found. Picture taken towards N284°E.

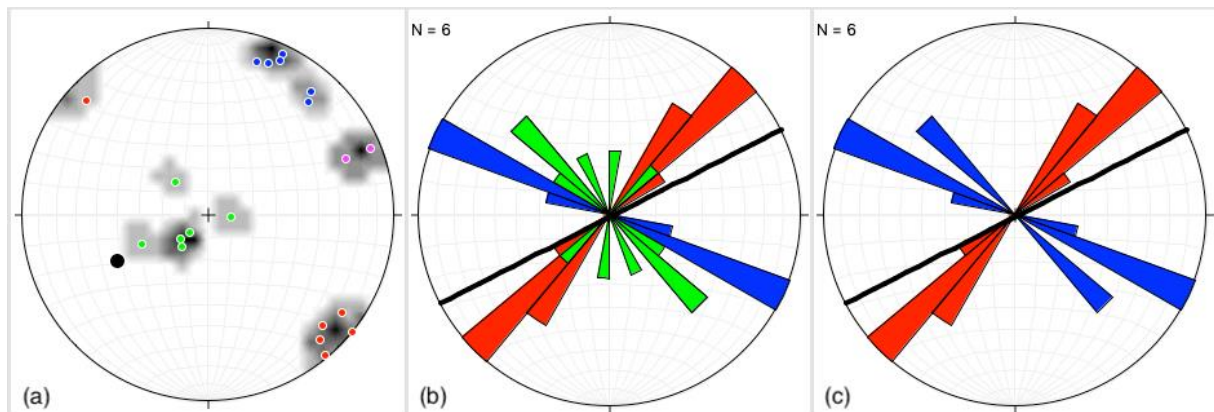
Figure 39. The mapped joint sets at Stutakvelven shaft area, whereas J1 is shown as red markings, J2 as blue, foliation joints as green and J3 as pink (only in (a)). Each pole plot represents the mean value of each set at each location. (a) Pole plot of all measurements mapped, and the shaft presented as a line (black dot). (b)(c) Joint sets considered most relevant for Stutakvelven inclined shaft area. Stutakvelven shaft is presented as a black line. Figure (c) is shown without the foliation joints to present the full extent of J2. The stereographic projection of these joint sets with their associated localities are found in Figure 40.

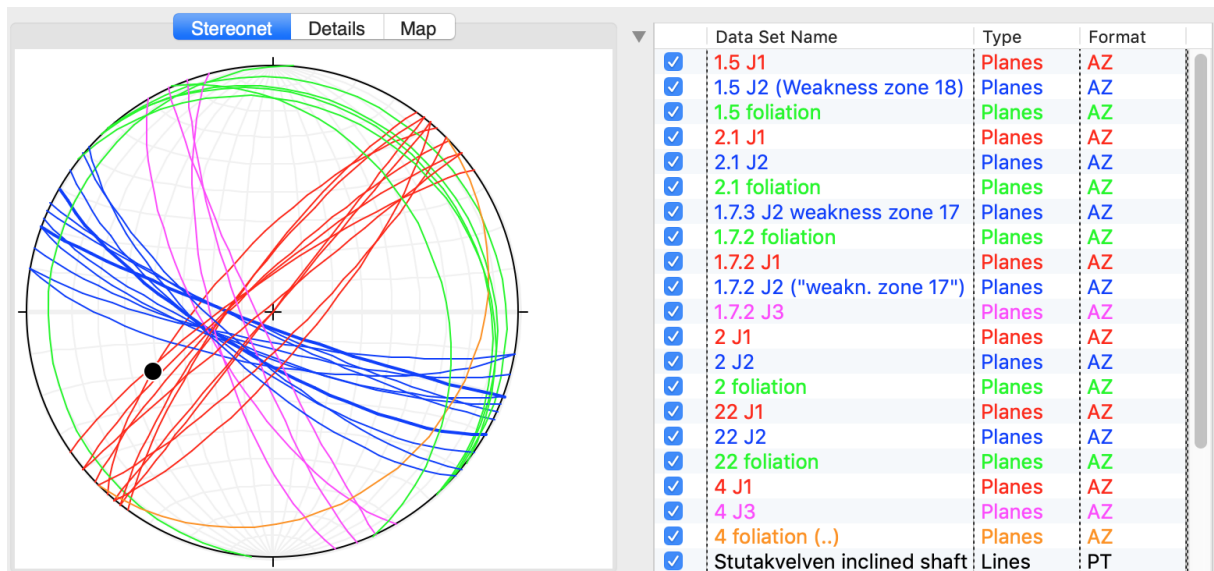
Figure 40. Stereographic presentation of measured discontinuities at Stutakvelven inclined shaft area. The orientation of the shaft is illustrated as a line (black dot). Joint set 1 is shown with red great circles, joint set 2 (J2) is shown with blue great circles (weakness 17 zone with thick blue great circles) and the foliation/foliation joints are shown with green (and orange) great circles.
