In-depth assessment on the structural geological and engineering geological condition of the weakness zone at Svandalsflona HPP

Master's thesis in Geotechnology
Supervisor: Krishna Kanta Panthi
May 2019

In 2008, a cave-in occurred in Stutakvelven inclined shaft at Svandalsflona hydropower project (HPP) followed by a sudden burst flood in 2009 killing two people. This thesis is an in-depth assessment on the structural geological and engineering geological condition of the weakness zone intersecting the shaft, with the purpose of analysing the cave-in.

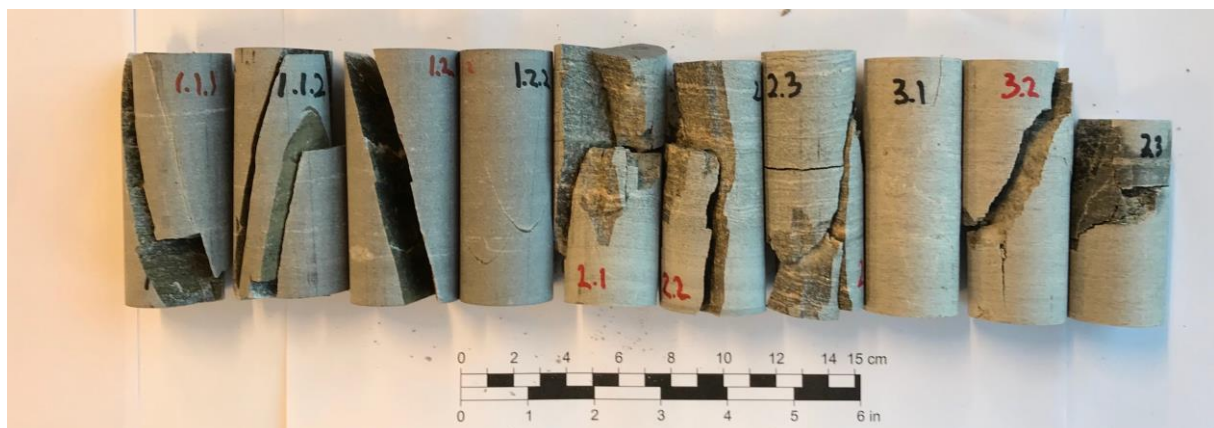
Figure 43. Cores after the uniaxial compressive test.

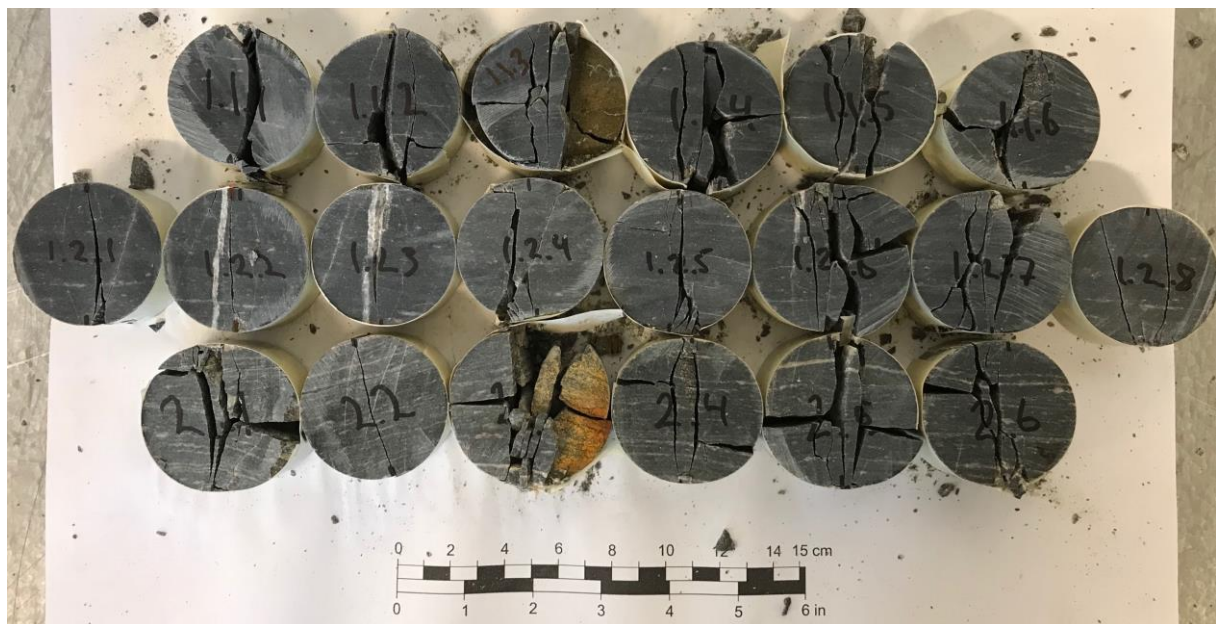
Figure 44. Discs after the Brazil tests. Note the weathered planes normal to the viewing direction.

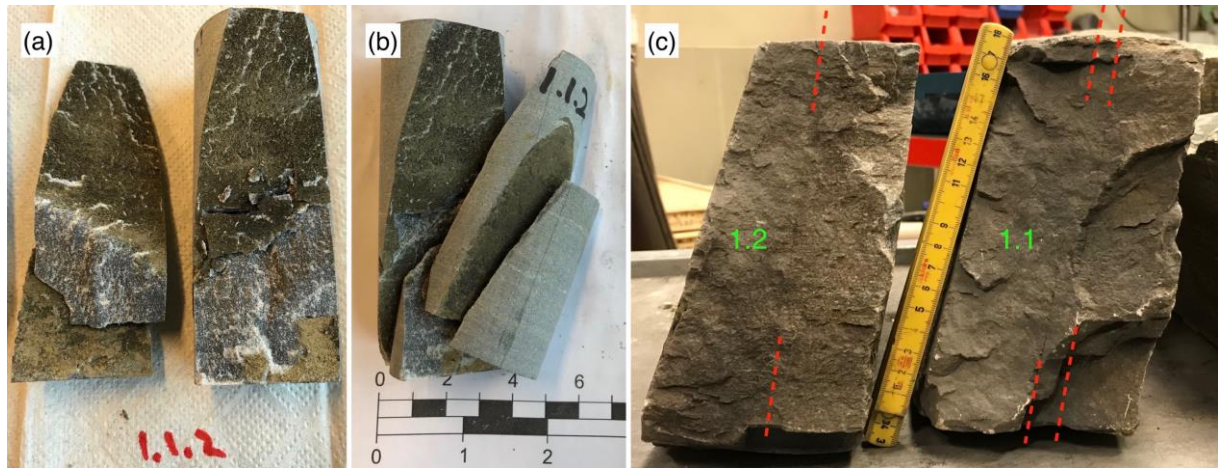
Figure 45. (a) and (b) show the unfavourable joint sets and spacing in rock sample 1.1 and 1.2. Some degree of weathering along these joint planes may be seen as discolouration of the surface. (c) shows the discontinuities pre-drilling. The shape of the field samples indicates the joint sets measured at location 1.5.

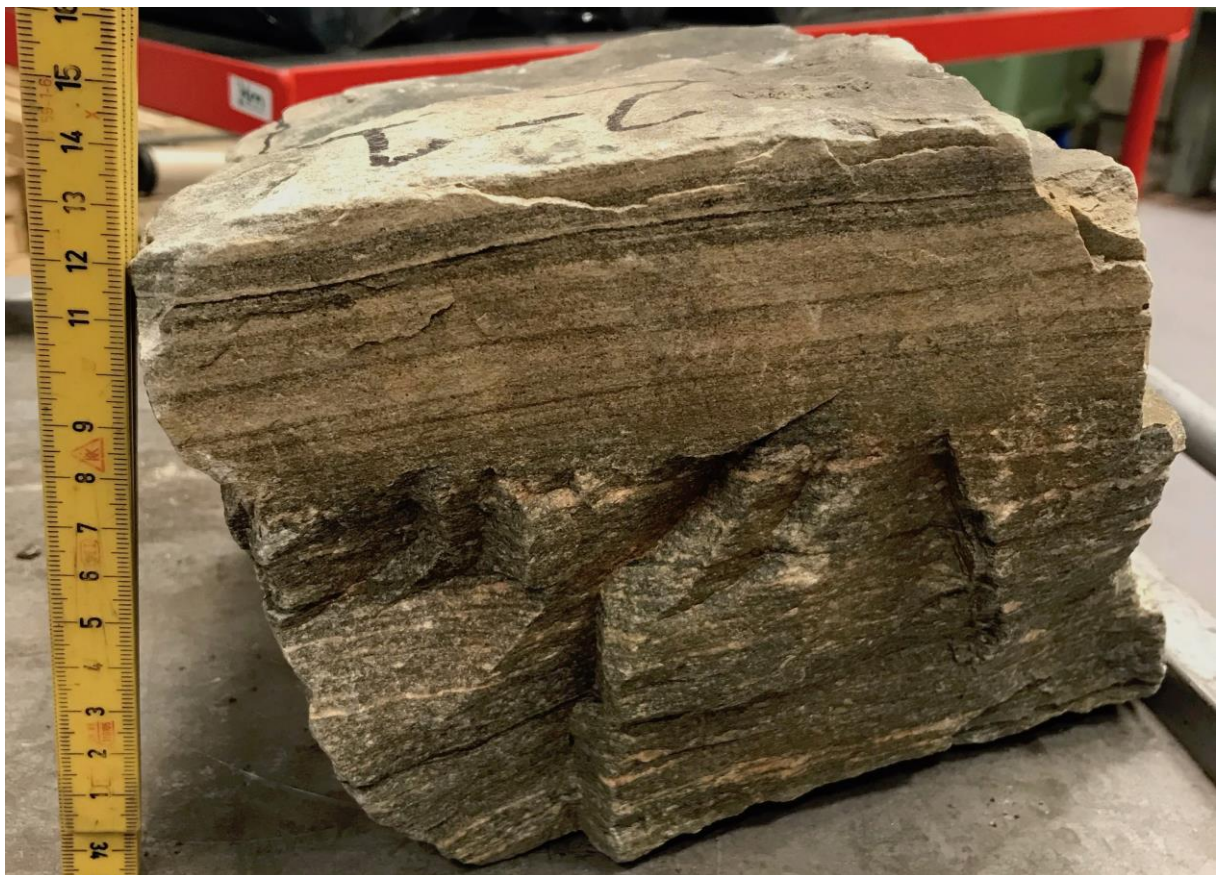
Figure 46. Rock sample which constitutes series 3.

Series 3 may also be classified as very strong in the strongest direction, that is, normal to the foliation. However, the strength parallel to the foliation is only medium, which makes the tested rock samples highly anisotropic, according to the point-load classification. The series 3 has twice the mica content as series 1 and 2, approximately 15 percent, and twice the chlorite (Table 14). The specimen in this series is not as stiff as in the two other series, with almost 10 GPa lower E-module and 0.1 lower Poisson's ratio. This specimen is also more affected by saturation. This series has a density of approximately 2.65 g/cm³ and the sample brought from the field is shown in Figure 46.

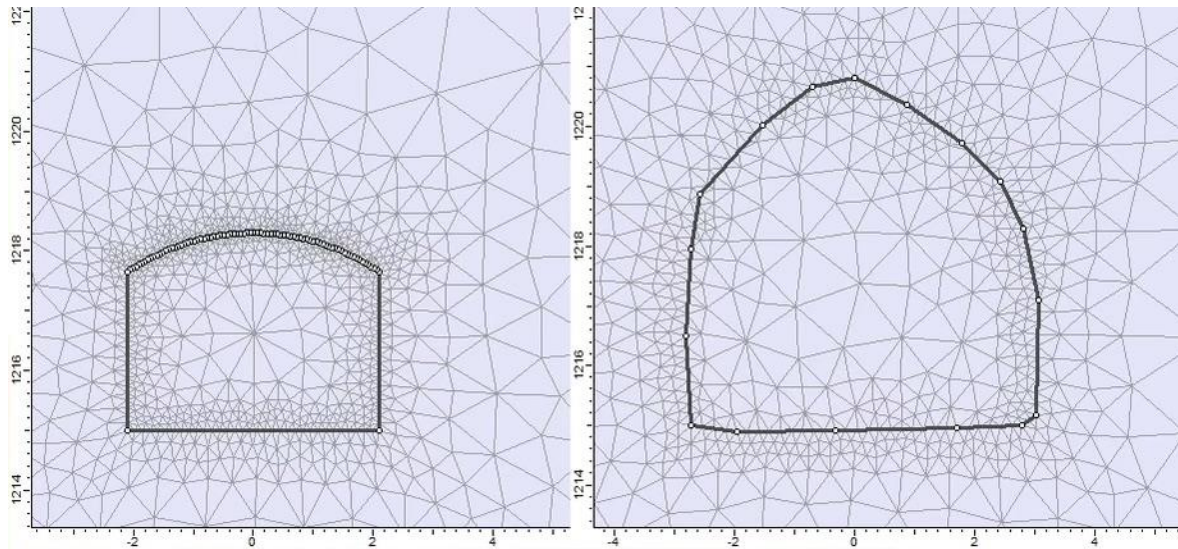
Figure 48. Intended cross-section compared to the actual cross-section in the weakness zone. Excavation boundaries based on the construction drawings in Figure 19.

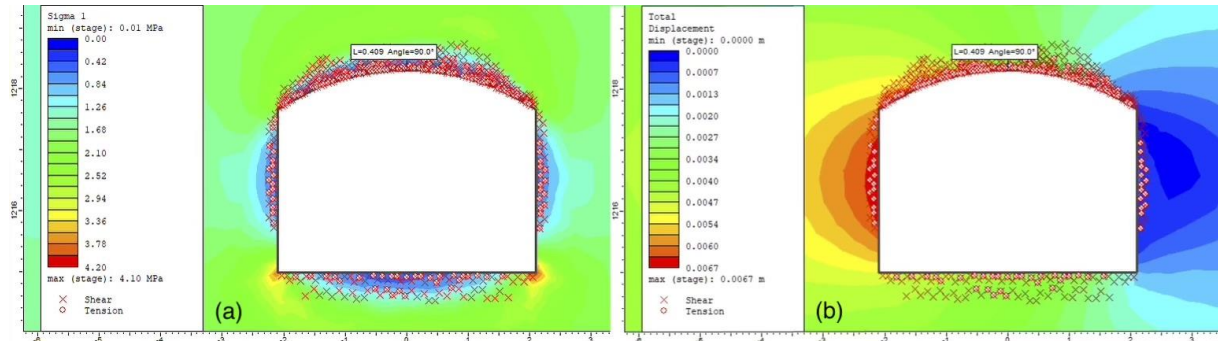
Figure 56. Adjacent rock mass of the weakness zone at Stutakvelven. (a) Major principle stress with yielded elements. (b) Displacement and yielded elements. Maximum displacement in left wall looking upstream ($6,7 \cdot 10^{-3}$ m).

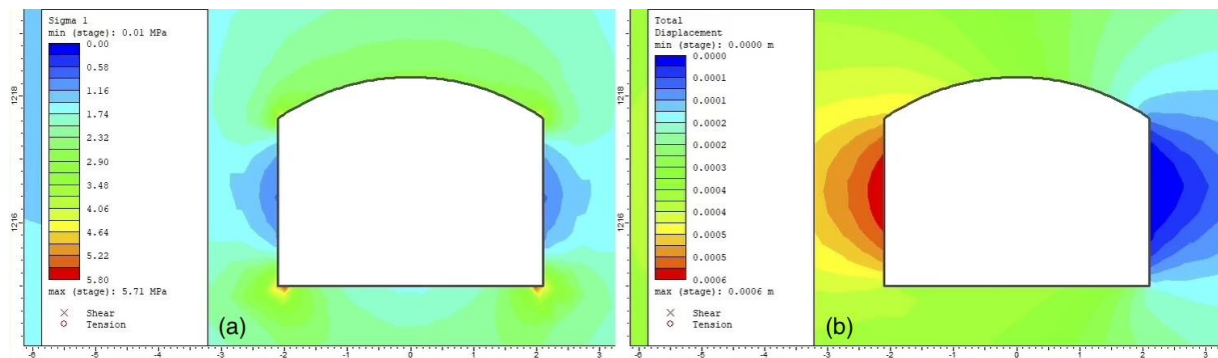
Figure 57. Surrounding rock mass of the weakness zone at Stutakvelven. (a) Major principle stress with zero yielded elements. (b) Maximum displacement of $6 \cdot 10^{-4}$ m.

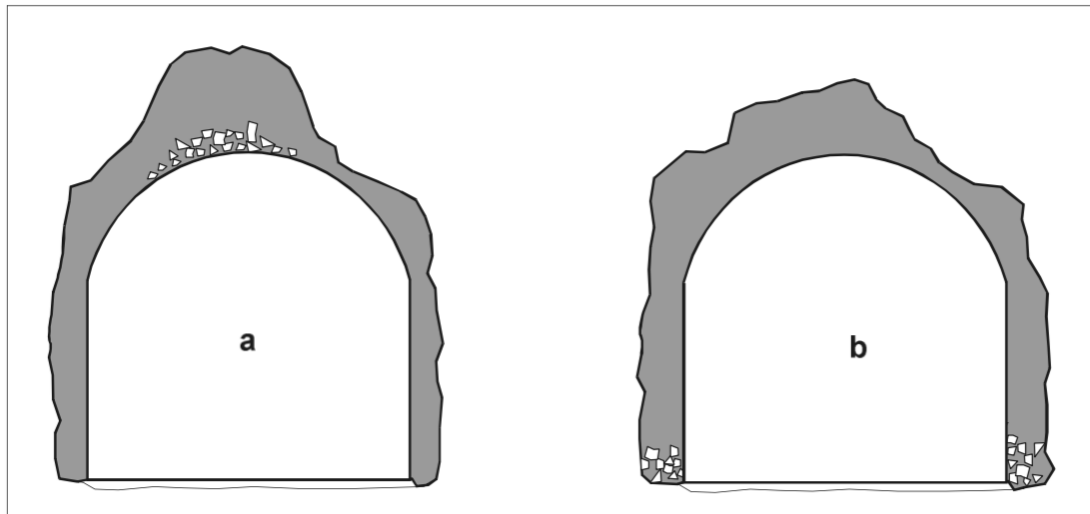
Figure 60. Illustration by Kjølberg referred in Palmstrøm (2003) of bad quality cast concrete. (a) Outfall during casting. (b) Outfall pre-casting post-formwork.
