# Influence of Local Weather Conditions on Ventilation of a Pitched Wooden Roof

**Abstract:** This paper investigates the influence of temperature and wind conditions on ventilation of the air cavity beneath the roofing in a full-scale pitched wooden roof construction. The potential for condensation in the air cavity is studied. The relevant roof construction is equipped with 81 thermocouples and four air velocity measurement devices. A weather station at the site records outdoor temperature and wind conditions. Five periods between 2016 and 2018 are investigated. The findings show distinct periods of below-ambient temperature and positive condensation potential in the ventilated air cavity of the roof. A relation between low wind speed and positive condensation potential is shown. Difference in size of periods with below-ambient temperature and periods with positive condensation potential implies that the materials in the roof regulate the humidity in the air cavity. Large negative peaks in the condensation potential indicate dry-out of the construction.

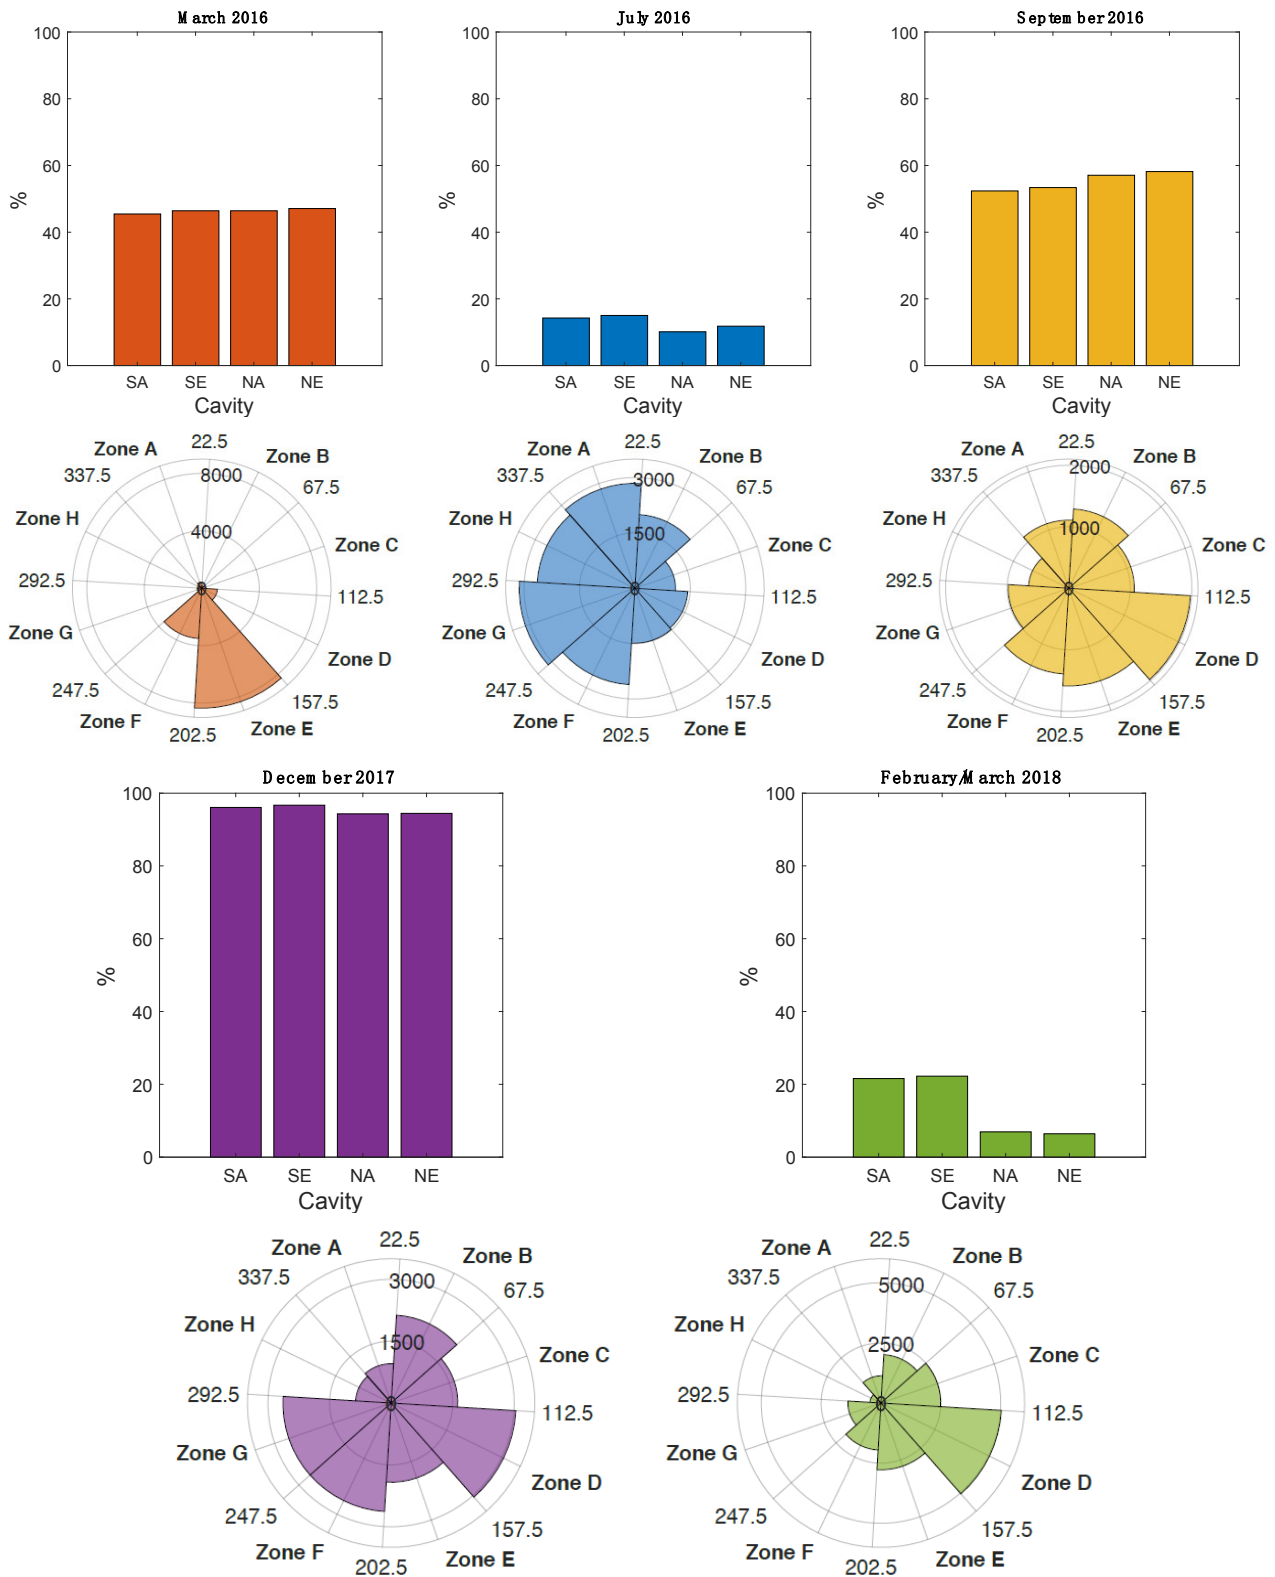
Fig. 3 The bar charts present the percentage of each period with lower temperature on the rear side of the roofing than in the outdoor air. The polar charts show the occurrence of wind from different directions towards the house. The radial axes in the polar charts represent the number of measurements within a zone. Note that the scale of the radial axes varies between the different periods.

In this paper, the temperature and condensation conditions in the ventilated air cavity of a full-scale pitched wooden roof have been investigated. Five periods between 2016 and 2018 were included in the study. How the temperature in the air cavity depends on the outdoor temperature and wind is presented in Fig. 3. The subsequent  $CP_i$  in periods with below-ambient temperature in the air cavity is examined in Figs. 4 and 5.

The measurements from the roof at ZEB Test Cell Laboratory demonstrated long periods of below-ambient temperature in the ventilated air cavity beneath the roofing. During the spring and autumn periods, the measurements at the rear side of the roofing showed temperatures below the ambient temperature for approximately 50% of the time. This is in line with the results found by Gullbrekken et al. [10]. In the December period, below-ambient temperature was measured close to 100% of the time. There was no snow on the roof in this period. Low outdoor temperatures and periods with clear sky may have contributed to large cooling of the roof and the subsequent low temperatures at the rear side of the roofing. During the second winter period, in February/March 2018, comparatively small intervals with below-ambient temperature were measured. Snow,

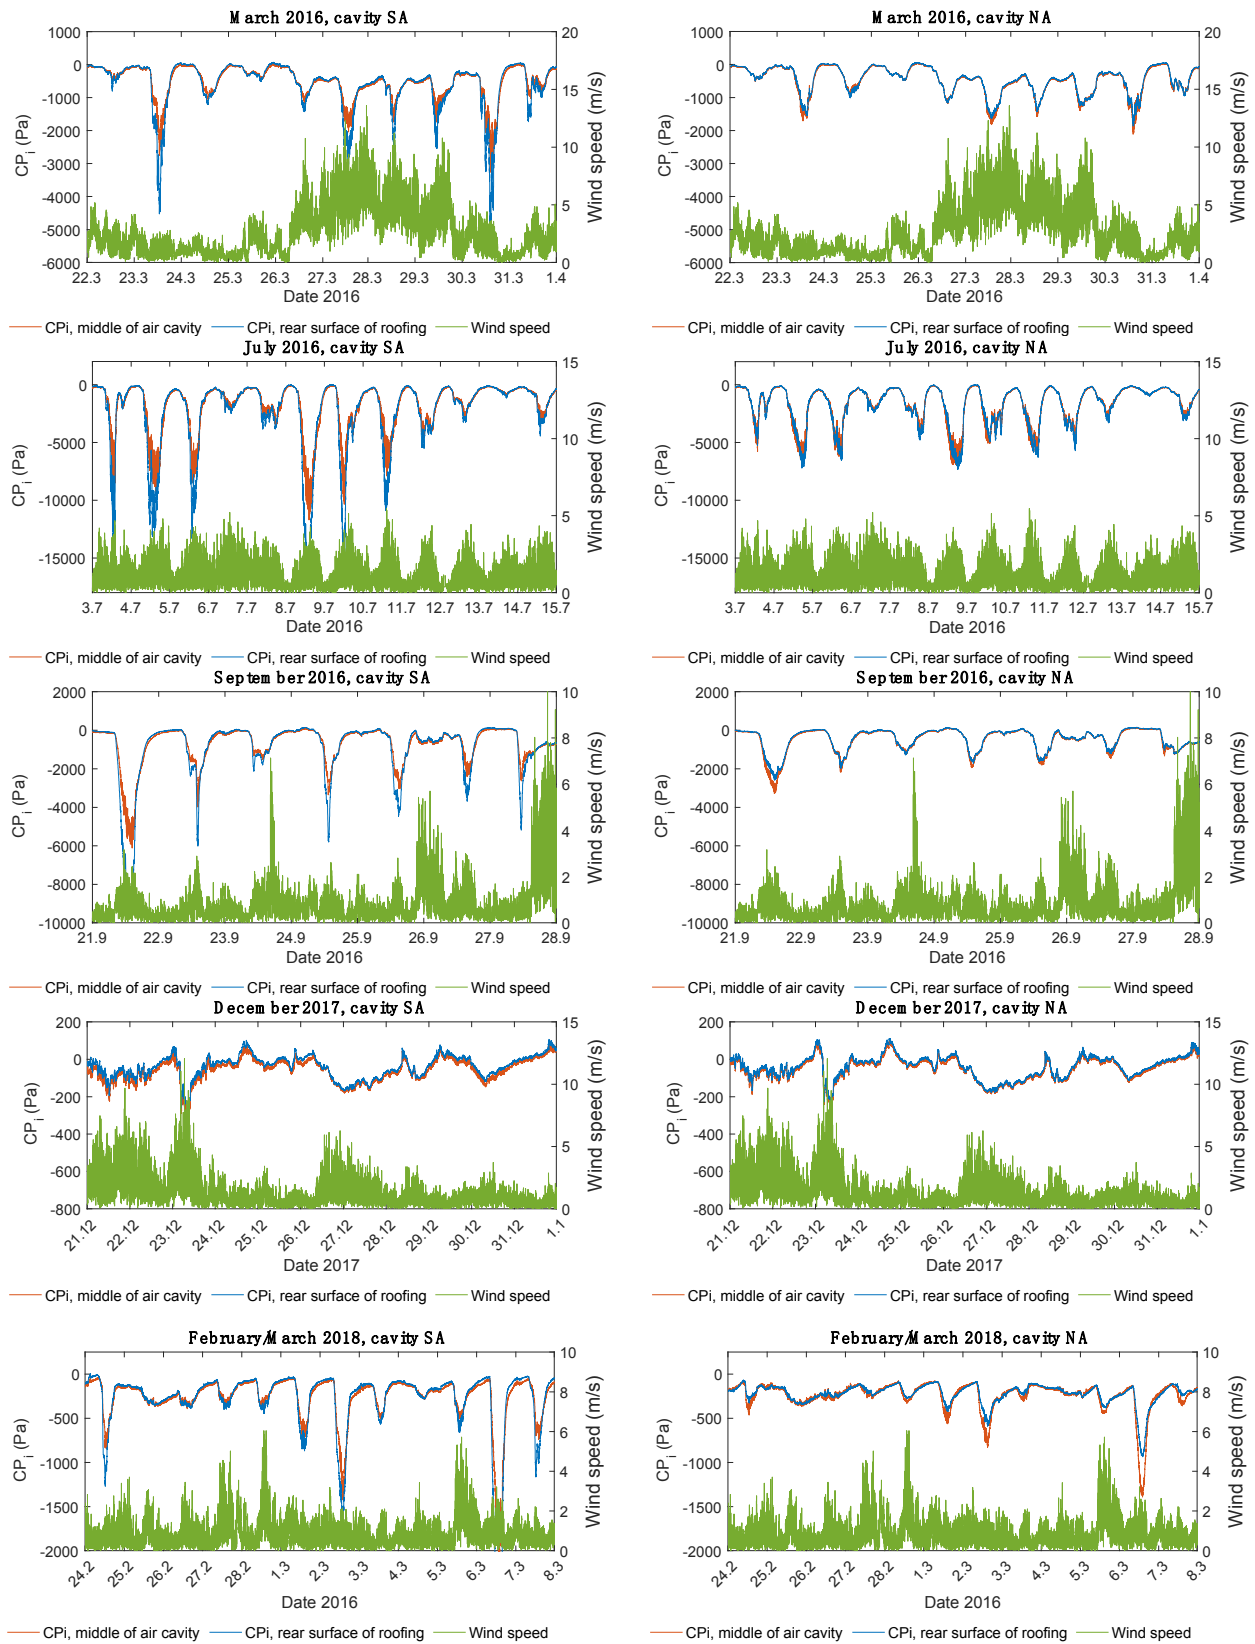
Fig. 4 Variation in  $CP_i$  and wind speed in the five periods. Results for cavities SA (left) and NA (right) are presented. Note different axes scales.

180°, 225°, 270°, 315° ± 22.5°. The angle of 0° corresponds to wind approaching perpendicular to the wall on the northern side of the building (zone A). Fig. 4 shows  $CP_i$  in the air cavity and wind speed as a function of time. Fig. 5 compares the risk of condensation in the different periods. In Fig. 5 results are not given for February/March 2018, as no positive  $CP_i$  was found in this period.

As recorded in Fig. 4, differences in  $CP_i$  were found when comparing the southern and the northern side of the roof. Due to heating by the sun, the negative peaks in  $CP_i$  were much larger on the southern side. The large negative peaks in  $CP_i$  correspond to the points of time with high temperatures in the air cavity found by Gullbrekken et al. [10]. The periods of positive  $CP_i$  were larger on the northern side of the roof. Together with the smaller size of negative peaks, this implies that the risk of condensation is higher at the northern side. A larger  $CP_i$  was also observed for the rear side of the roofing than for the middle of the air cavity. However, the rear side of the roofing also had a larger dry-out potential because of greater heating of the roofing during the day. This decreases the risk of long-term

A relationship was also shown between variation in wind and  $CP_i$ . Periods with larger wind speed corresponded to periods with low  $CP_i$ , and the opposite. However, it is not unambiguous that high wind speed leads to small  $CP_i$ , as large negative  $CP_i$  to a great extent is influenced by the temperature conditions in the air cavity. Yet, Fig. 4 shows that the positive peaks

of the  $CP_i$  decreased when the wind speed increased, and the opposite. It was also found that the wind speed was very low, i.e. below 1 m/s, during most of time when the  $CP_i$  was positive. This implies that wind speed is of importance for the condensation situation in the air cavity. Gullbrekken [14] showed that most weather stations in Norway had a daily average wind speed larger than 1 m/s more than 250 days of the year. This indicates good conditions for ventilation of roofs. However, the present paper found that the studied periods had wind speeds less than 1 m/s during 27-75% of the time. Accordingly, in cases with condensation risk it is important to study the local climate conditions in order to make sure ventilation of the air cavity is satisfactory.

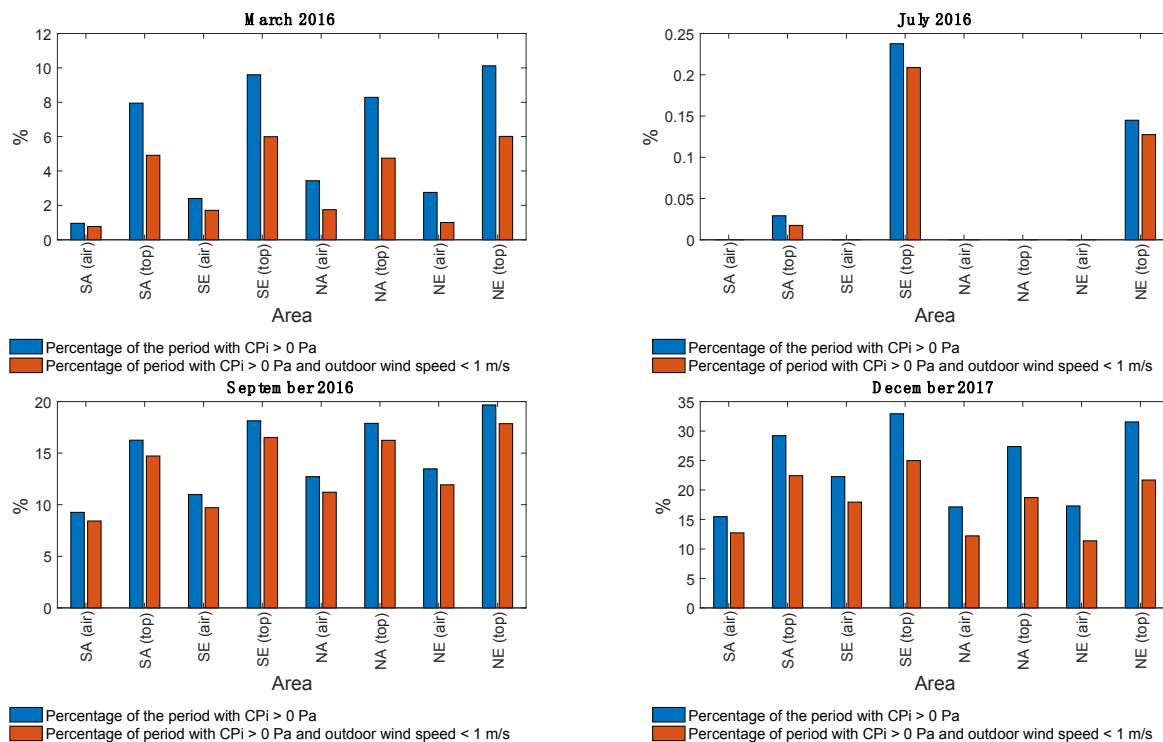
**Fig. 5** Percentage of each period with positive  $CP_i$ , and percentage of each period with positive  $CP_i$  at the same time as the wind speed is  $< 1$  m/s. Note different axes scales.
