Operational Lifetime of Snowplow Blades

Master's thesis in Civil and Environmental Engineering
Supervisor: Alex Klein-Paste
June 2020

Norwegian University of Science and Technology
Faculty of Engineering
Department of Civil and Environmental Engineering

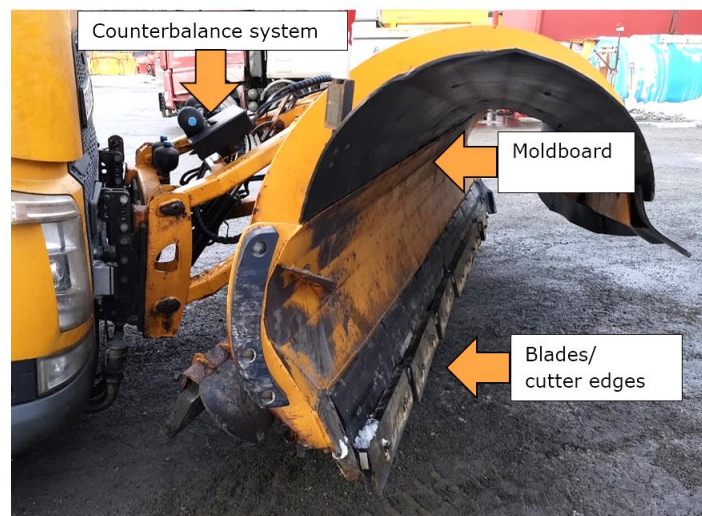
Figure 1.1: Main parts of a snowplow

Some plows are more advanced and include more hydraulic and movable parts than others. Regardless of complexity and configuration the plow typically consists of a moldboard, a counterbalance system, and blades (7). Figure 1.1 illustrates the different parts. The moldboard is the main body of the plow. It pushes, transports, and throws snow to the side. To reduce downward forces from the plow on the pavement, plows are fitted with a mechanical or hydraulic counterbalance system. Plow blades are the parts of the plow that scrape along the road surface to loosen snow and ice.

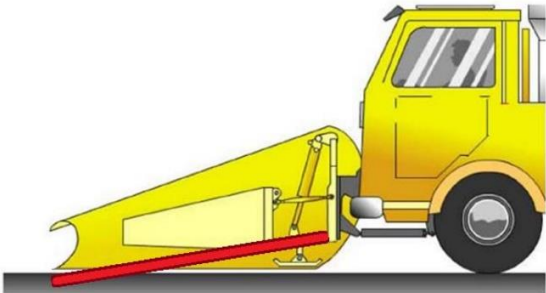
| Adjustment | Illustrations line of action of plowing force, from NPRA textbook (9). |
|--|--|
| <p><u>Too high plow adjustment:</u> Makes the line of action of plowing force intercept the road behind the tip of the plow. The plow may lift or “jump”. This typically gets worse with increased amount of snow and higher plowing speeds, which increases risk of lost vehicle control (9).</p> | |

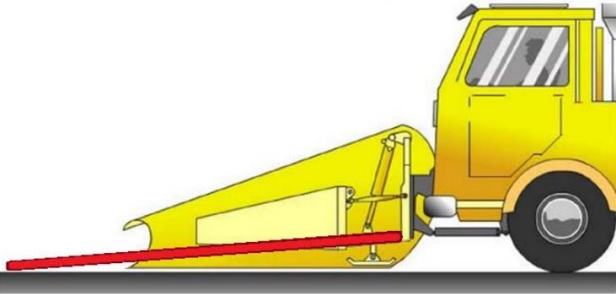
| Adjustment | Illustrations line of action of plowing force, from NPRA textbook (9). |
|--|--|
| <p><u>Too low plow adjustment:</u> Makes the line of action of plowing force pass over and go further than the plow tip. Pushing the plow harder towards the road surface, <u>increasing the load on the blades</u> and risk of the truck “driving over” the plow (9).</p> | |

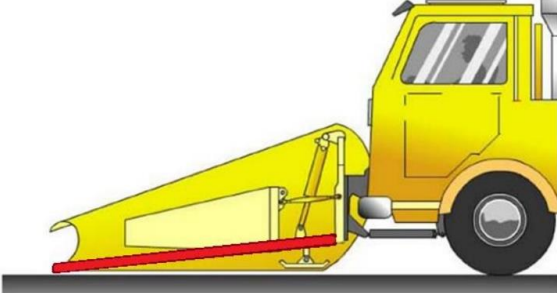
| Adjustment | Illustrations line of action of plowing force, from NPRA textbook (9). |
|--|--|
| <p><u>Correct plow adjustment:</u> For a correct adjusted plow, the line of action of plowing force goes through the tip of the plow.</p> | |

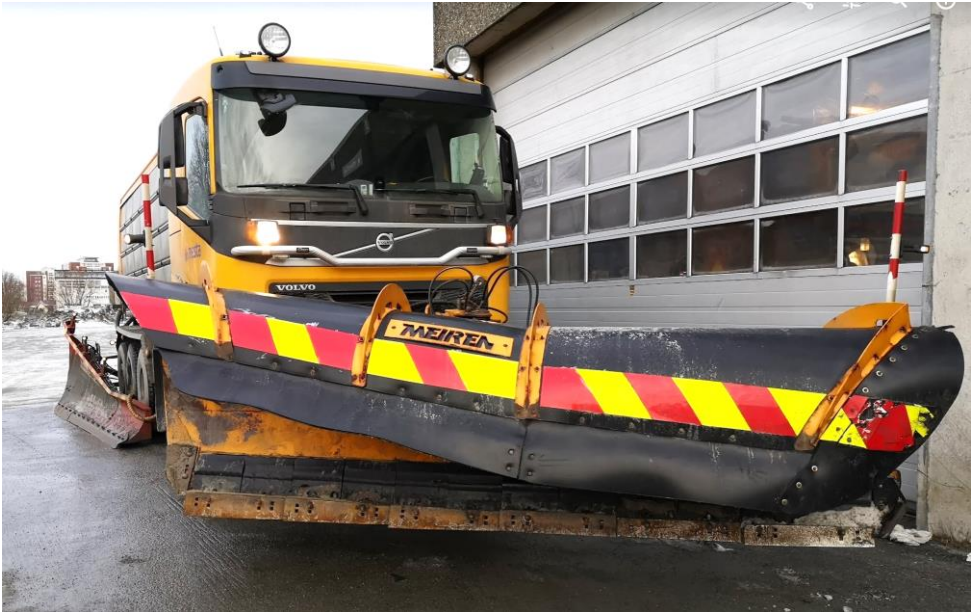
Figure 3.2: Plowing equipment used. Volvo truck, Meiren MSP plow and wing plow. Blade holders are the black parts behind/ directly above the blades.

To cover the whole width of the road and the adjoining highway ramps, five trucks in a gang plowing is used. The leading truck is one of Mestas own trucks, a Volvo FH540 8x2, while the others are operated by subcontractors. The Volvo is the truck followed in this thesis. It is equipped with a front combination plow of the type Meiren MSP 3704 LH, a wing plow and a brine spreading system, which may be in use in between plowing. Blades included in this study will be mounted on the Meiren MSP. There is room for six 2feet blades mounted with bolts on the Meiren MSP. The blades are mounted with bolts on the plow via blade holders made from polyurethane, which deforms and moves backwards when hitting obstacles (44). The equipment is shown in Figure 3.2.

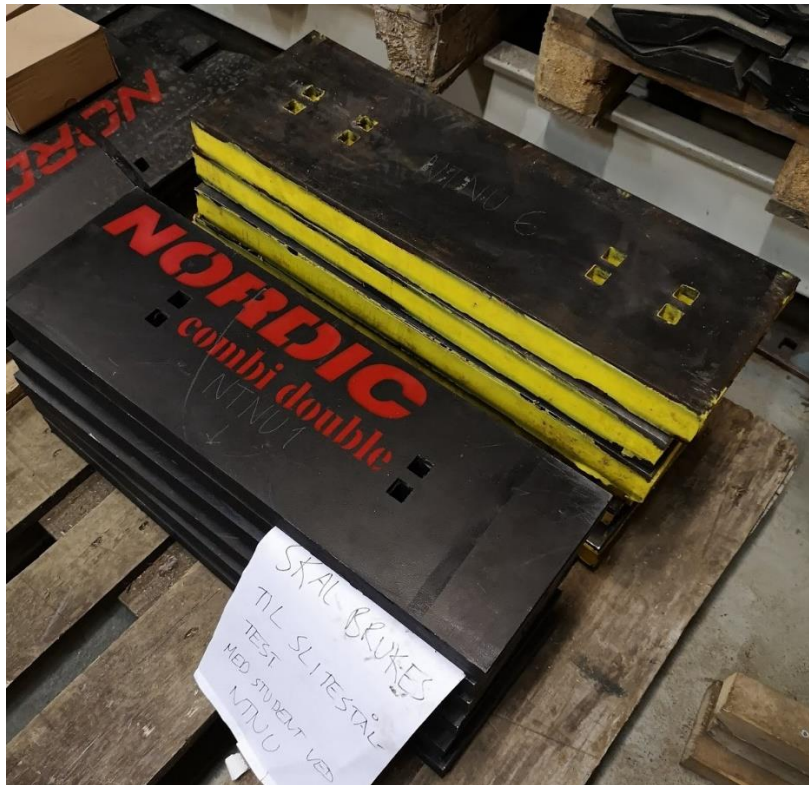
Figure 3.3: Snowplow blades used by Mesta and tested in this thesis

| Blade type | Description |
|---|--|
| Steel/polyurethane | Locally produced reversible blades, made from steel plates with yellow polyurethane in between. These blades were produced in advance of an earlier winter season by a local producer, to be tested by Mesta. Blade thickness ≈ 47 mm. |

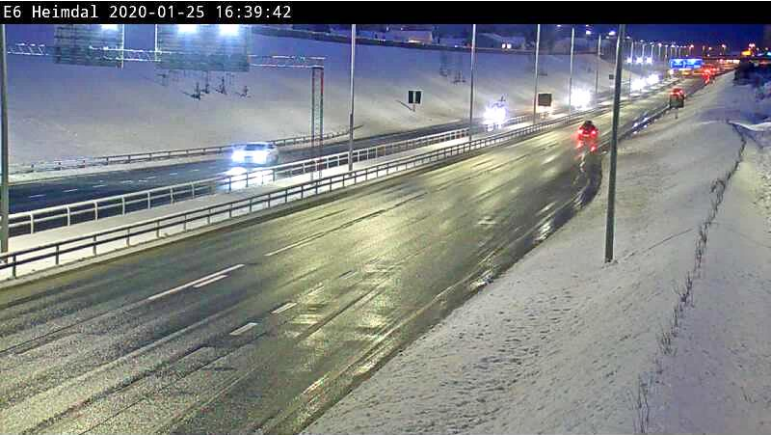
| Coverage | Description/picture |
|---|---|
| <p>0 %</p> <p>Assigned value: 0</p> | <p>Bare wet asphalt. No snow covering the road or road markings on the sides.</p> |

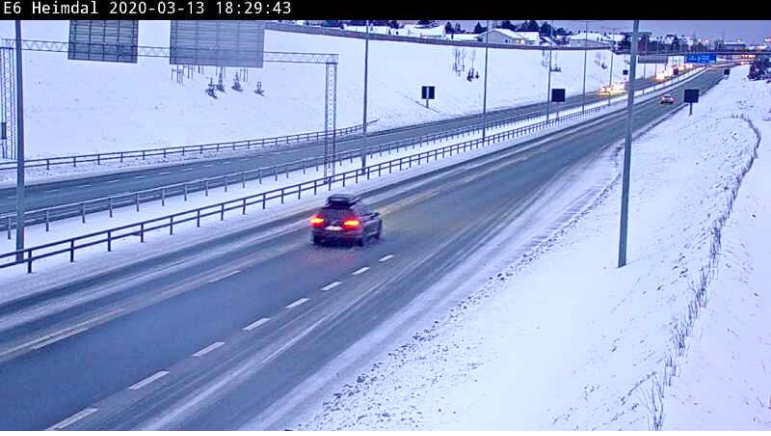
| Coverage | Description/picture |
|---|---|
| <p>0 < 25 %</p> <p>Assigned value: 25</p> | <p>Mostly bare wet asphalt. Some patches of snow/ice/slush, or snow covering road markings on the sides.</p> |

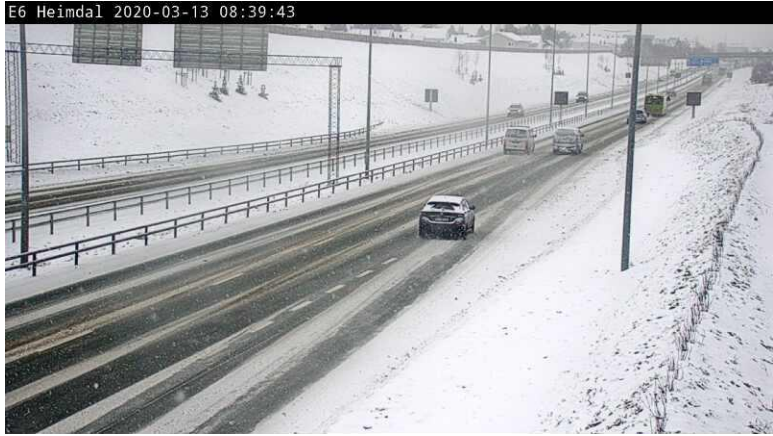
| <p>25<50 %</p> <p>Assigned value: 50</p> | <p>Some snow/ice/slush on the road, with bare tire tracks. <u>Clearly visible</u> that the salt has started to melt the snow/ice, leaving wet asphalt. Especially in right lane, which may be almost cleared of snow.</p> |

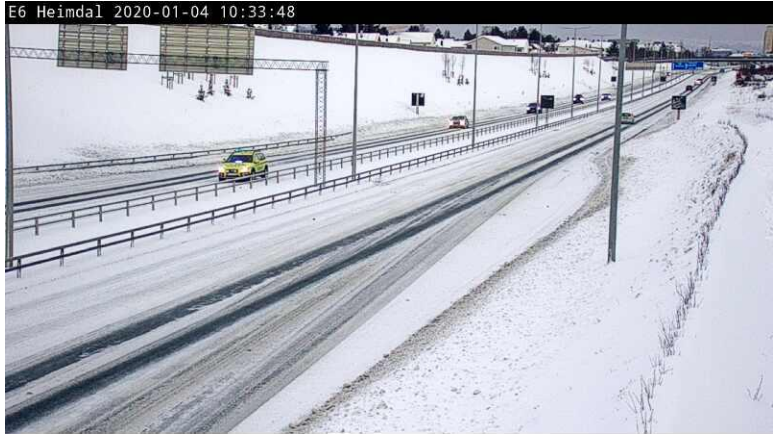
| <p>50<75 %</p> <p>Assigned value: 75</p> | <p>Snow/ice/slush covering everything except the tire tracks in the right lane.</p> |

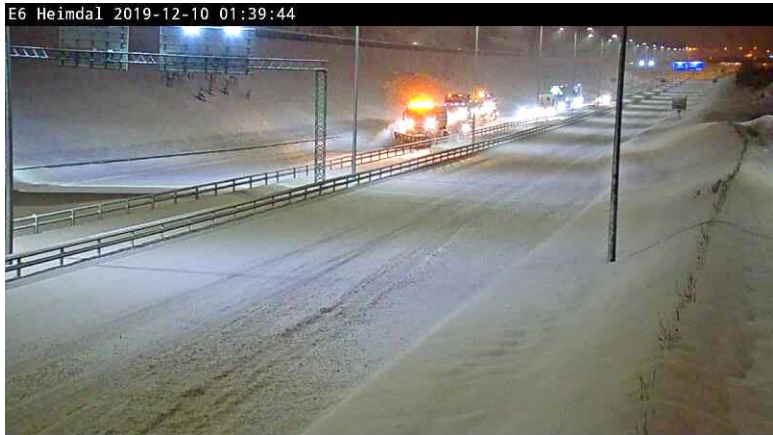
| <p>75≤100 %</p> <p>Assigned value: 100</p> | <p>Road totally covered with snow.</p> |

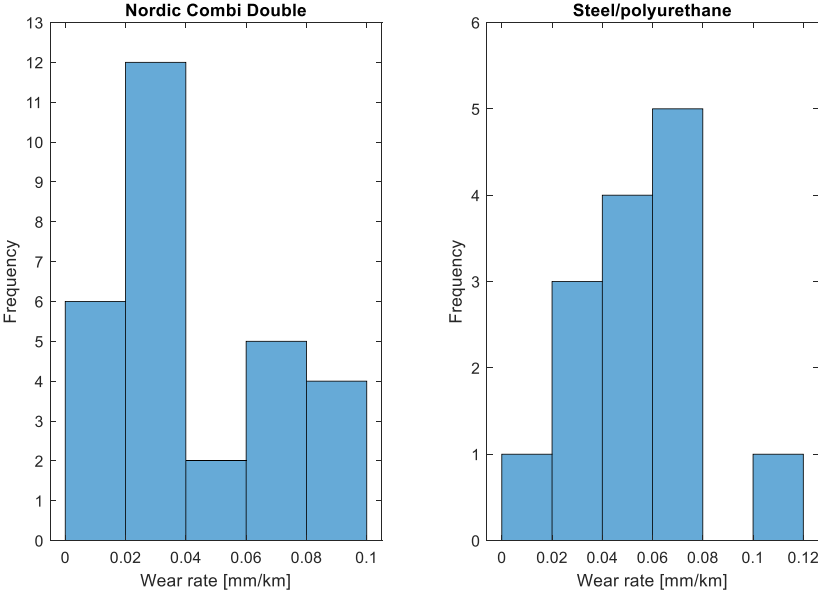
Figure 4.3: Average wear rate distributions for measurements, sorted by blade types

Distributions of wear rate [mm/km] for the two blade types are presented in Figure 4.3. The wear rate in these charts are the wear rate along the plow for each measurement presented in Appendix C. The values are sorted into sections of 0.02 [mm/km] to find a frequency distribution.

Figure 4.3 illustrates the variation in wear rate from the individual measurements. Supporting the observation that the wear rate varies, from section 4.1.1. The highest frequency for the Nordic Combi Double corresponds to a lower wear rate than for Steel/polyurethane. Note that there are more data points for Nordic Combi Double than for Steel/polyurethane. The highest individual wear rate value is found for Steel/polyurethane, and lies between 0.1-0.12 mm/km.

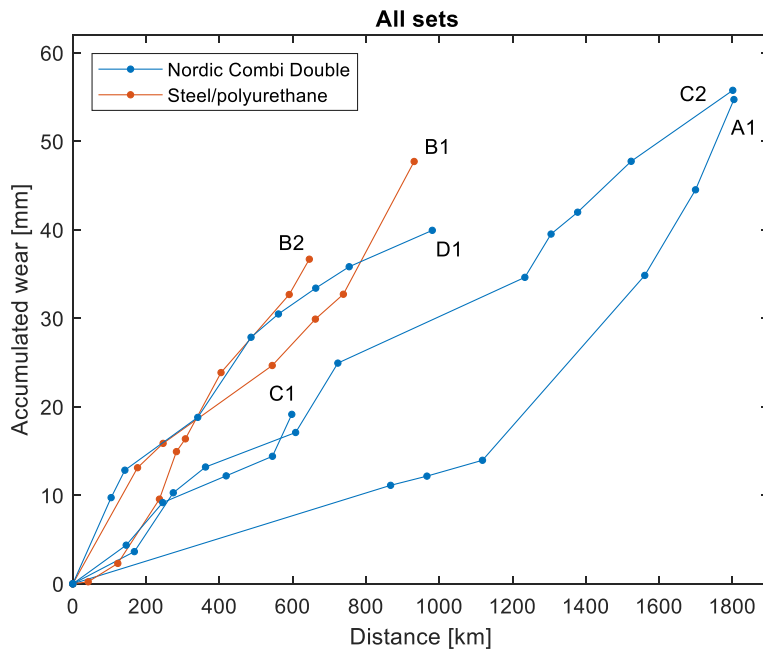
Figure 4.4: Accumulated wear all sets

From previous subsections it is found that the development of wear varies from set to set and the type of blade. A plot that compare the sets and blade types are presented in Figure 4.4. This plot shows the development of the average accumulated wear for each set, and the blade type. The graphs are the same as in Figure 4.1 and Figure 4.2, only without boxes.

From Figure 4.4 the variation in wear development between sets can be observed more clearly. The Steel/polyurethane blades seems to wear out faster than the Nordic Combi Double, with a steeper slope (higher wear rate). However, the D1 set follows the Steel/polyurethane development for the first five measurements, around 500 km. The high wear rates in the beginning of set D1 can also be observed in Appendix C, where there are tree high wear rate values in the first four measurements.

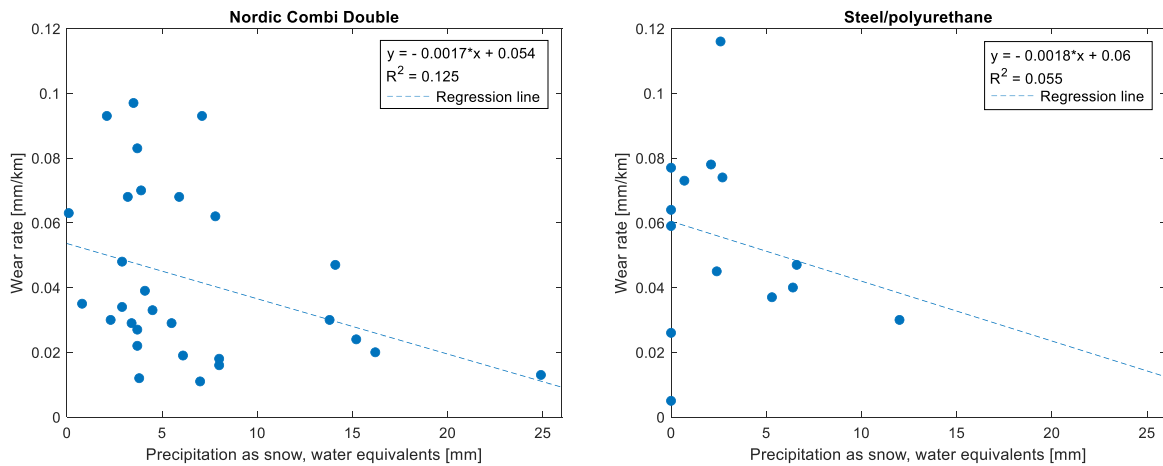
Figure 4.6: Wear rate versus precipitation as snow

Using the processed precipitation data from the five MET weatherstations along the test site (Appendix E), scatter plots of wear rate [mm/km] versus precipitation as snow [water equivalents, mm] are made for each blade type. Plots are presented in Figure 4.6.

In Figure 4.6 the regression lines for both blade types implies a decreased wear rate with increased amount of snow. The slopes of the regression lines are also similar.

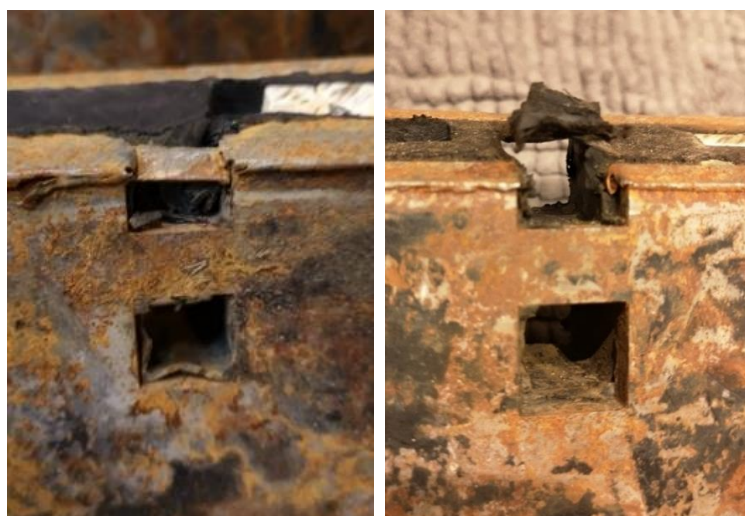
Figure 4.11: Damaged mounting holes, from blades worn down too far

For set A1 blade number 3 and 5 were worn down all the way until the backside of the lower mounting holes were damaged. Figure 4.11 shows the backside of the mounting holes where there is very little, or no steel material left for mounting when reversing the blades. These holes were supposed to be the upper mounting holes when the blades were to be reversed into what should have been set A2. Instead of reversing set A1 it was replaced with set B1. Leaving an unused blade set (A2) useless.

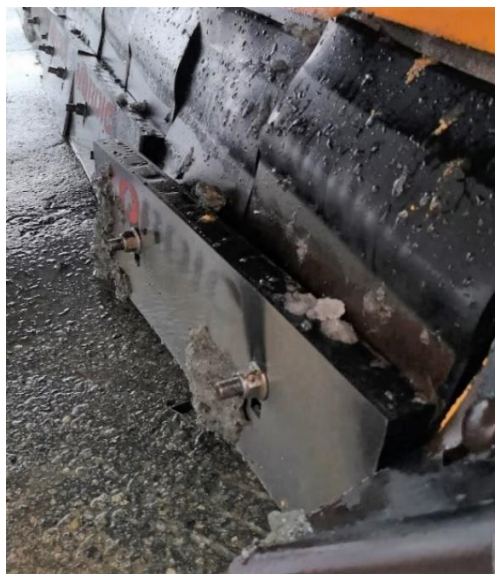
Figure 4.13: Bended blade, due to damaged blade holders

After an impact with a curbstone around 12.01.2020 blade number 6 became bent because of damages to the blade holders. This condition affected blade number 6 in set B2 and C1 before the blade holders were replaced. Figure 4.13 shows how blade 6 is pointing slightly more outwards on the left side compared to the rest of the plow. Resulting in lower rake angles for blade 6 in set B1 and C1.

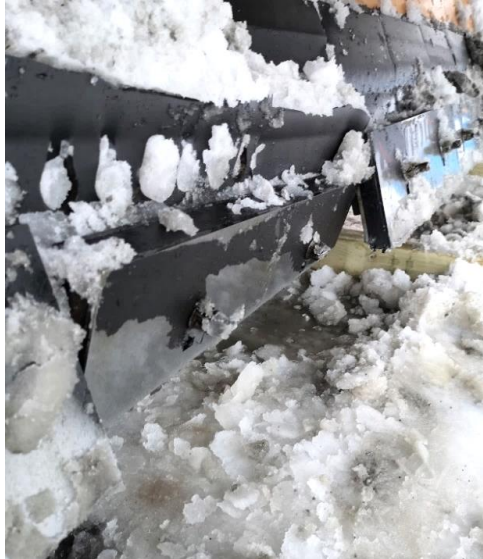
Figure 4.14: Broken blade holders

Blade holders behind blade number 3 failed 05.02.2020. The result was that blade 3 in set C1 was pushed down and dragged along the surface while plowing, instead of cutting. Figure 4.14 shows how the situation was for blade 3 until the blade holders were replaced. When the blade holders were replaced blade 3 was useless, and much material was worn away on this blade in an improper way, compared to the others. Therefore, the entire set had to be reversed.

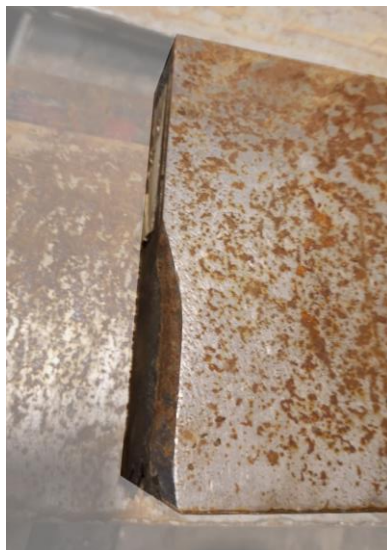
Figure 4.15: Steel chipping on Nordic Combi Double in one of the center plow positions

On some blades, chunks of steel have been lost. Especially in the front of the plow (blade position 6) were several of the sets experienced rounded corners. But steel chipping was also observed other places in the middle of the plow, as snow in Figure 4.15. Steel chipping is likely caused from impact with obstructions in the road. However, steel chipping did not seem to influence the wear rate in any way, and no limitations on blade life were observed due to steel chipping in this thesis.

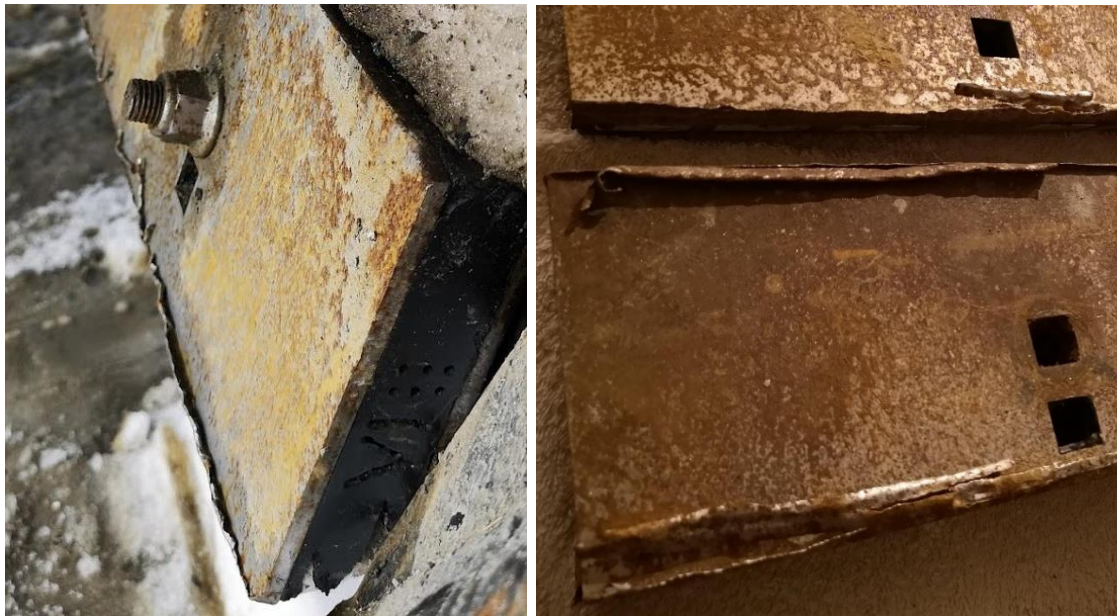
Figure 4.16: Steel buckling on blades

Throughout the winter, steel was often observed to curl in front of the lower edge of the blades. However, the amount and thickness varied. Figure 4.16 presents some example pictures, one where blades are mounted on the plow, and one after a blade is removed after both sides are used. The buckling is plastic deformation of the steel, which might occur when temperature rises and softens the material, resulting in a flow of material under the pressure of the blade forces (51), and is likely caused by excessive heat generation from the scraping process. This steel buckling effect might not influence the wear rate directly. It will probably influence the plowing results because of a "ski tip effect", which pushes the plow over the snow, compressing, instead of scraping and removing snow and ice. However, the heat that causes the steel buckling might increase the blade temperature, which influences wear rate (38) and the blade lifetime (15). This was experienced in another study on Kuper Tuca SX composite blades, where an early failure of the blades occurred due to heat, which caused the rubber in the blades to melt (21).

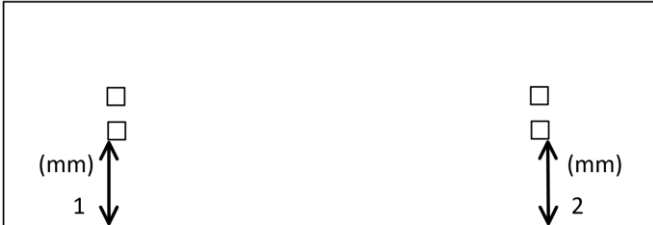
MEASURING POINTS ON BLADE:

Figure to the left shows measuring points 1 (Left) and 2 (Right) for a single blade. From lower installation holes (bottom corners furthest from blade center) to the lower edge of the blade.
