Investigation of causes to blistering of asphalt pavements

Masteroppgave i Veg, jernbane, transport og geomatikk

Juni 2020

Norges teknisk-naturvitenskapelige universitet
Fakultet for ingeniørvitenskap
Institutt for bygg- og miljøteknikk

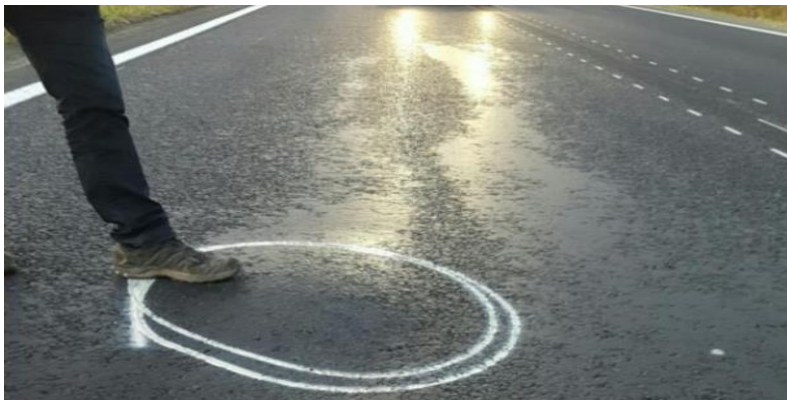
In recent years blistering of asphalt concrete overlays on airports runways and roads seem to have become more apparent in Norway. Blisters with diameters typically about 20 – 100 cm have been observed forming on certain asphalt concrete overlays in warmer weather. There have mainly been reports about blister problems in structures with asphalt concrete overlays over asphalt concrete base courses, concrete pavements, or concrete bridge decks. They have been observed forming immediately after paving as well as after a while, and both new and old repaved pavements have experienced problems. **Figure 1** show a photo of a typical asphalt pavement blister.

Figure 1: Blister in a Norwegian asphalt pavement road (Hovin, 2018)

Few investigations of the phenomenon have been conducted in Norway and there is no thorough explanation for the problem. Only minor studies conducted by the NPR (Norwegian public roads administration) have provided some information, and otherwise the available information is mainly through observations and documentation of cases. The preliminary findings from the NPR investigations can be summarized as follows (Hovin, 2018):

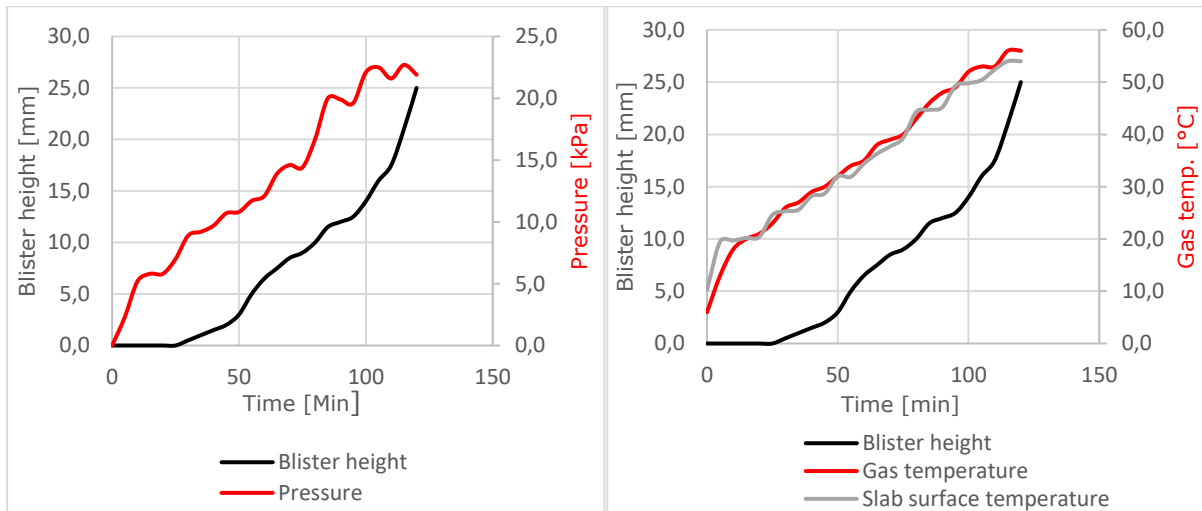
In Figure 7, results from blister test 1 are presented. Within 30 minutes the pressure and temperature inside the model had risen to 9 kPa and 26°C, and a measurable blister had occurred. After 110 minutes of heating, the pressure and gas temperature had increased to 22 kPa and 53°C, and the measured blister height was 17.5 mm. At this point large cracks occurred, and the blister growth rate accelerated because of the reduced resistance to deformation. The blister was therefore considered to be broken, and the test was stopped because any registration of the cooling phase could possibly provide invalid data.

Figure 7: Blister test 1 (4 cm slab)

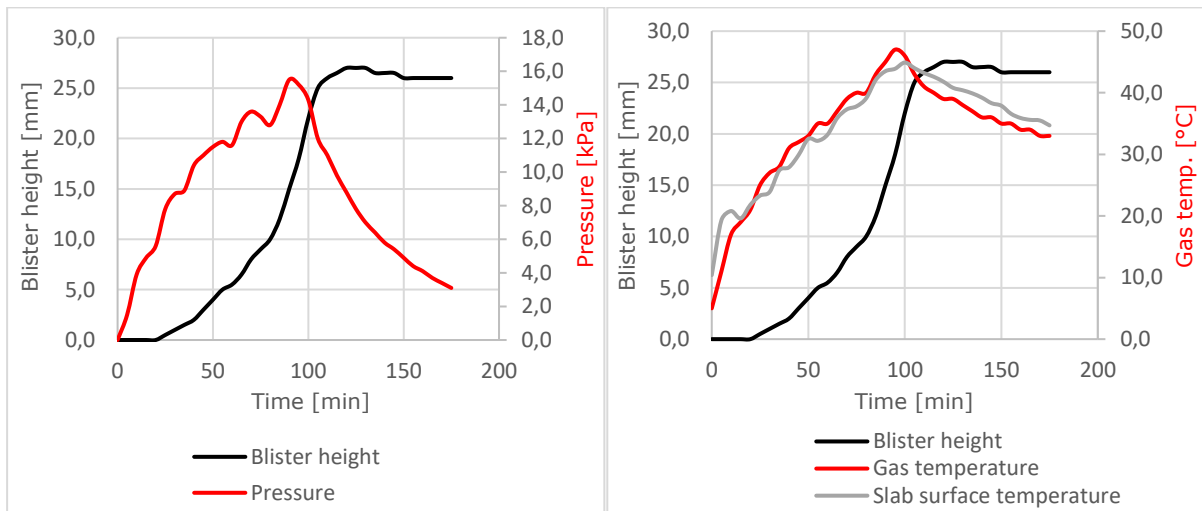
Figure 8: Blister test 2 results (3 cm slab)

The results from the blister experiment showed that vapor pressure and expansion of air can produce sufficient pressure to form a blister in a 3 cm and 4 cm thick asphalt overlay. After 30-50 minutes of heating with a starting temperature of 5-8 °C the gas temperature had reached 25- 32 °C and a measurable blister height of 1-3 mm had occurred in all the tested asphalt concrete slabs. The three slabs were tested at slightly different maximum temperatures, and only test 2 and 3 included the cooling phase. This was because in test 1, large cracks occurred at the top of the blister towards the end of the test and the blister was considered to be broken.

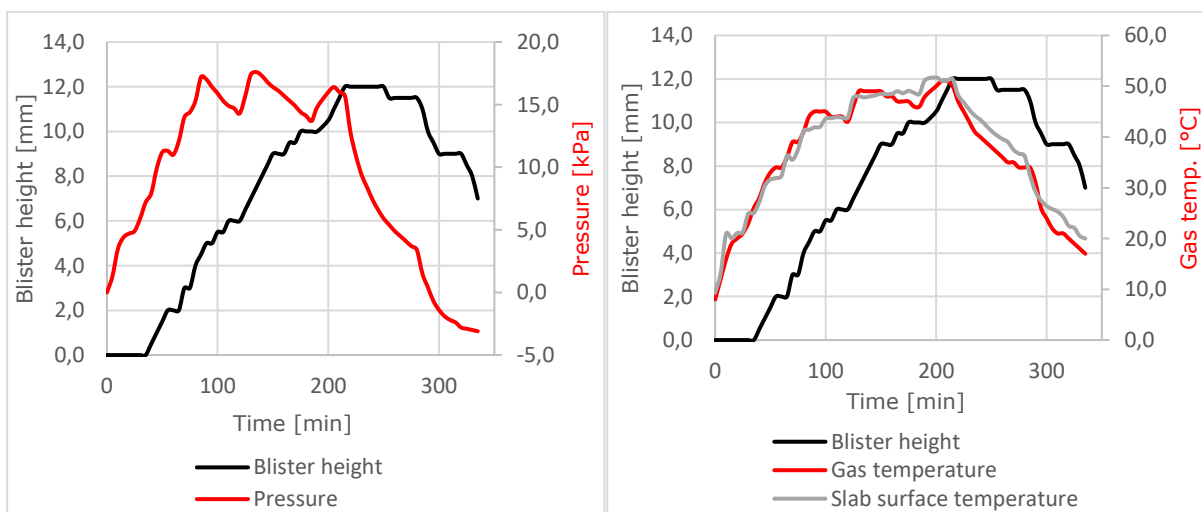
Results from test 3, shown in **figure 9**, where performed in the second 4 cm slab and was run over 335 minutes. The last 120 minutes were in the cooling phase. The test was run at a lower maximum temperature than test 1 and consequently the maximum blister height was somewhat lower. As in Test 2, the height was maintained even after the cooling phase was initiated, and not until the pressure had dropped to about zero, began the blister height to decline significantly. However, the blister did not contract completely and towards the end there was recorded a negative pressure of 3.1 kPa inside the blister model.

Figure 9: Blister test 3 results (4 cm slab)

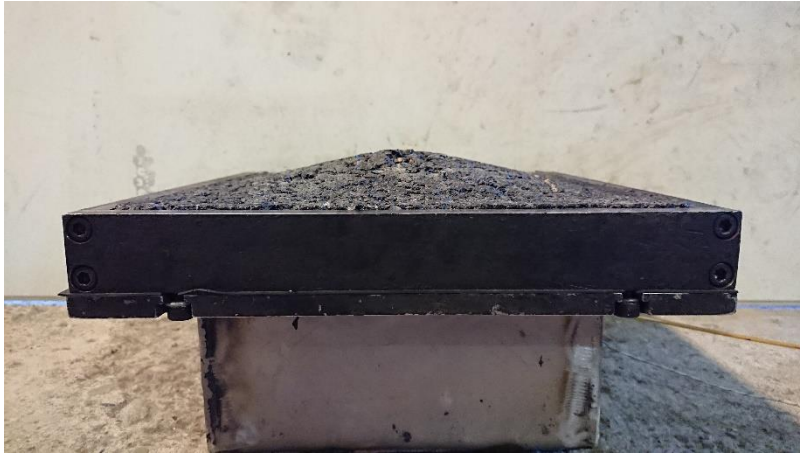
In **Figure 10** a photograph of the blister occurred in test 1 is shown.

Figure 10: Blister after test 1

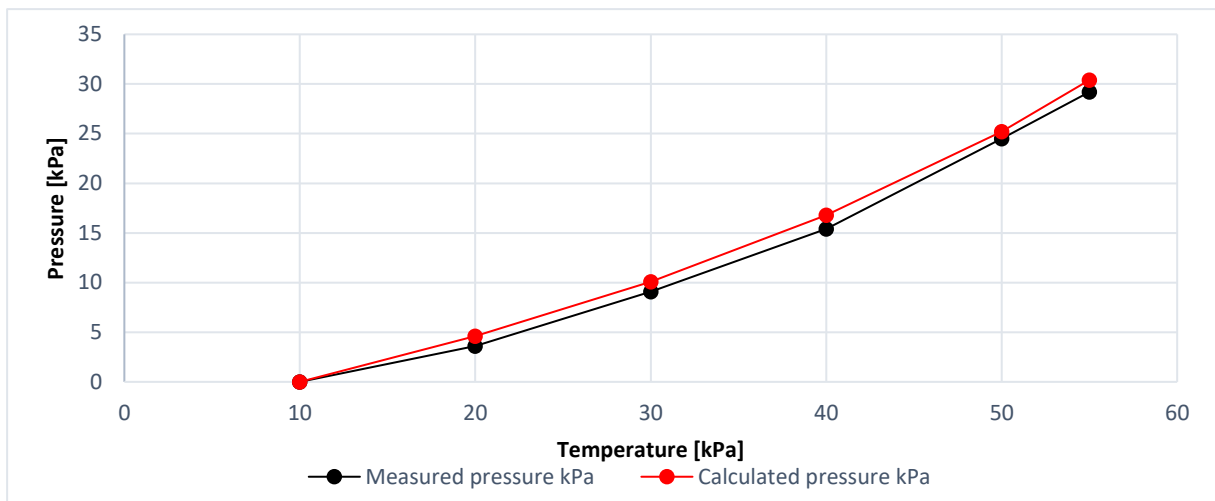
Figure 1: Calculated and measured pressure

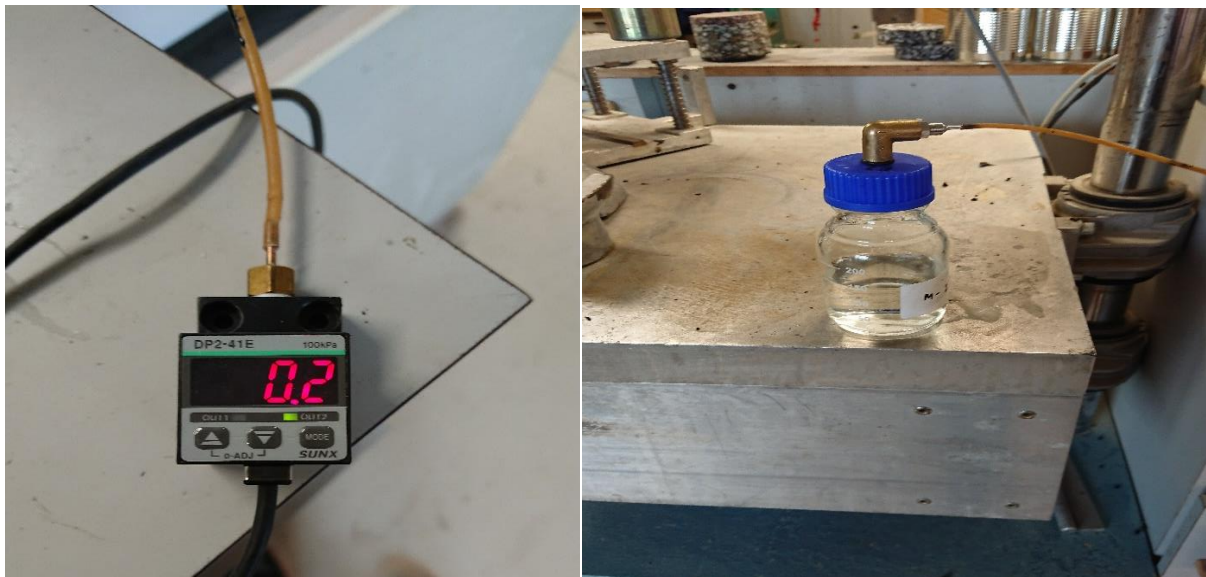
Figure 2: SUNX DP2-41E pressure sensor and bottle for measuring air and vapor pressure.

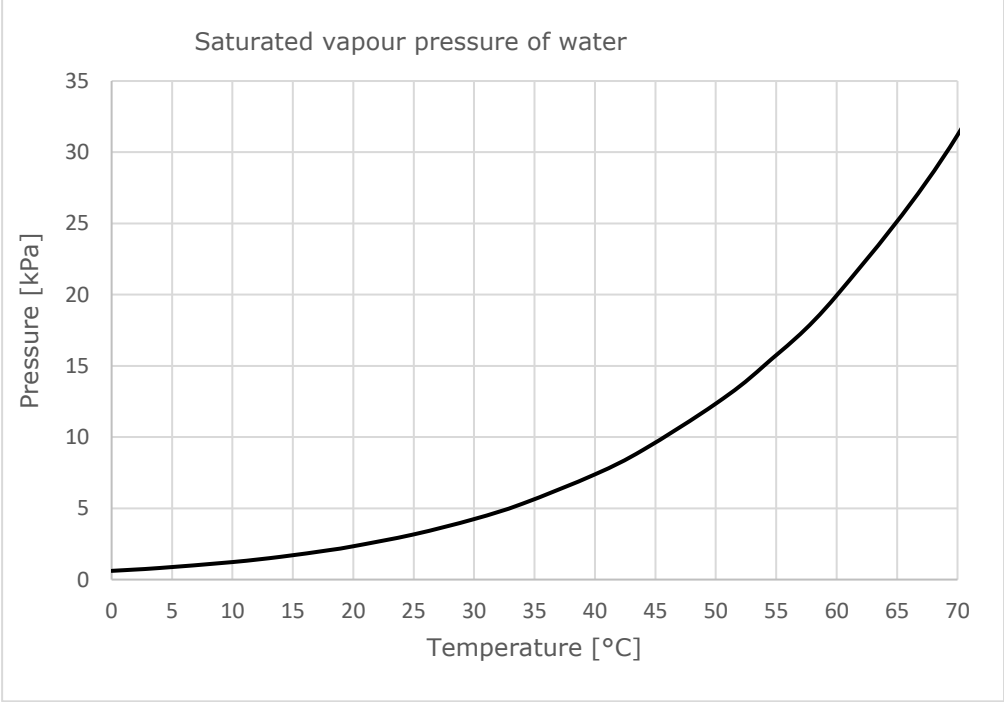
Figure 3: Saturated vapor pressure of water

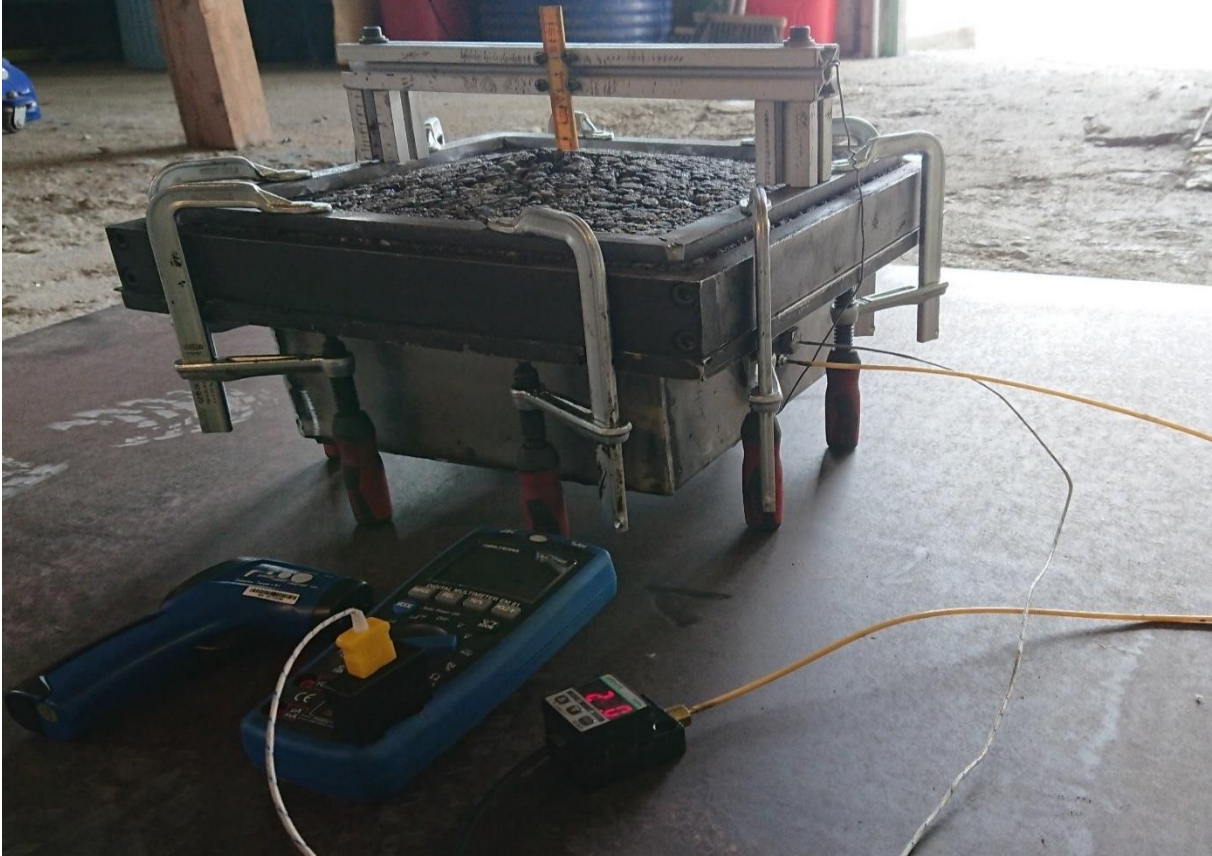
Figure 4: Complete blister test model with measuring equipment.

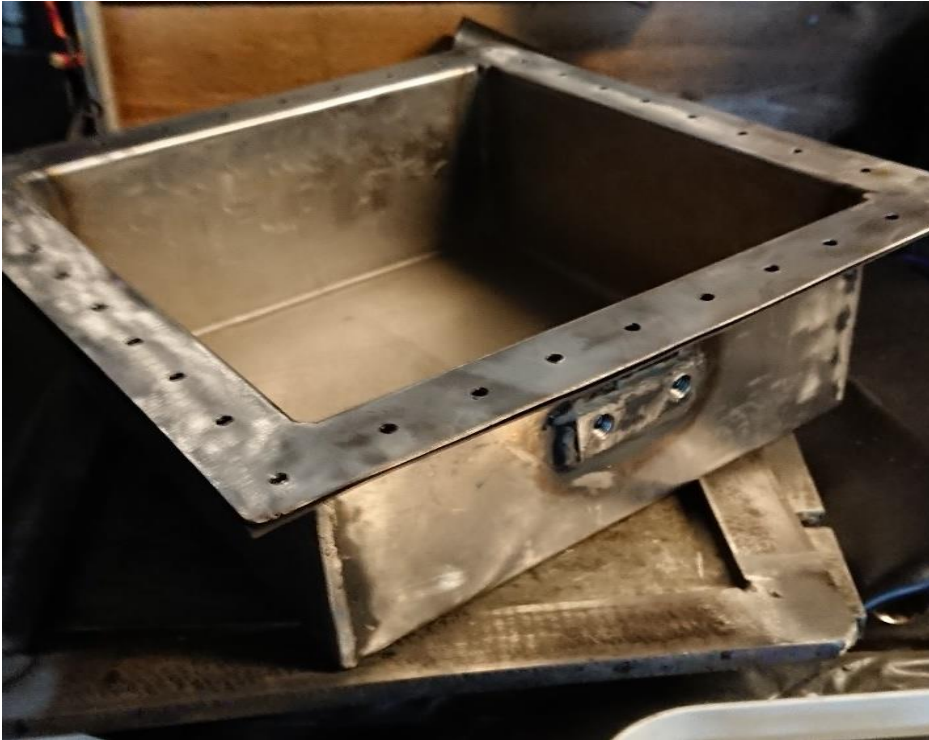
Figure 6: Steel box to be mounted underneath the aluminum plate.

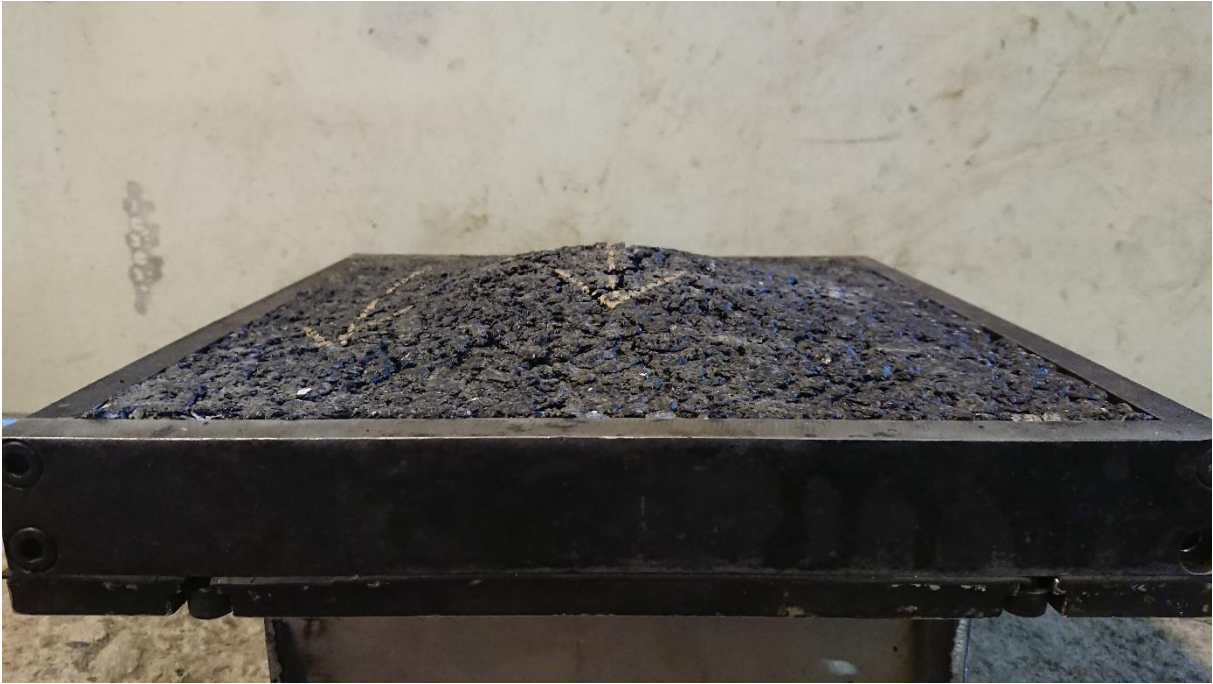
Figure 8: Blister from test 1 (4cm slab) with visible cracks on the top.
