Solveig Askevold Ulsund

Evaluation of Measures to Improve Indoor Environment in Norwegian Schools

Master's thesis in Energy and Environmental Engineering

June 2020

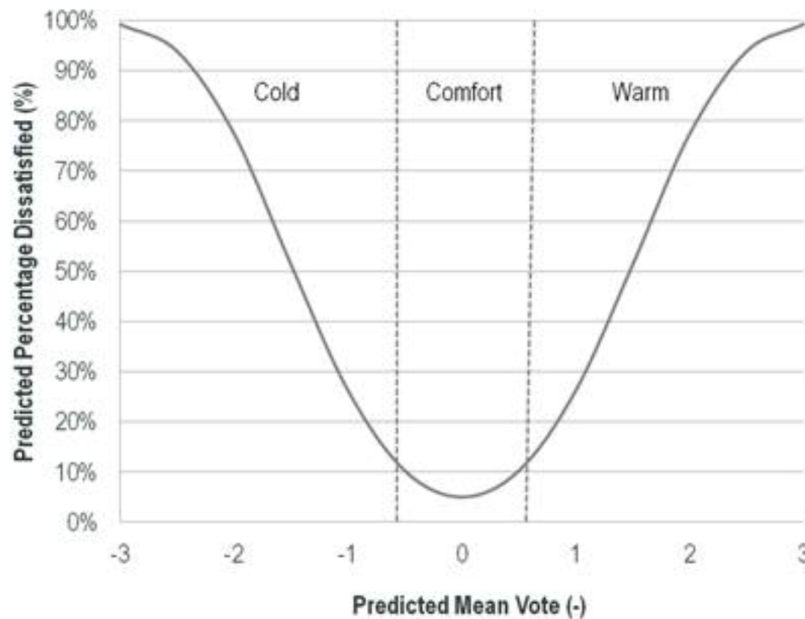
Figure 2.4: Relationship between PPD and PMV [6]

embroidered in appendix A. For occupants with the sensation "thermal neutral" (PMV=0), there is predicted that 5 % will be dissatisfied with the environment. For the thermal sensations "Hot" and "Cold" (PMV=3 and PMV=-3), there is predicted that 100 % of the occupants will be dissatisfied with the thermal environment. [9]

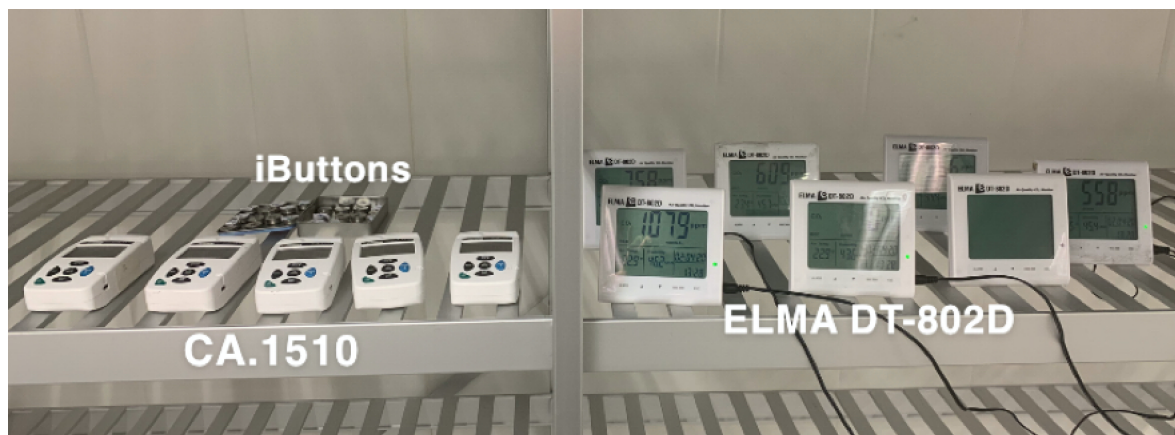
Figure 3.1: Instruments used in the field measurements. CA.1510 (in front, left), iButtons (back, left), and ELMA DT-802D (right)

For the field measurements, each room in the three schools are equipped with similar instrumental set up. The instrumental set up includes instruments that measures the following parameters; air temperature, carbon dioxide, relative humidity, supply, and extract temperature and outdoor temperature. When measuring the three first parameters, there are used to different types of sensors; ELMA DT-802D [ELMA] and CA.1510 [CA], both from the same manufacturer (Elma instruments). The supply, extract, and outdoor temperature are measured using a device called iButton DS1922L [iButton]. The different instruments used are displayed in figure 3.1.

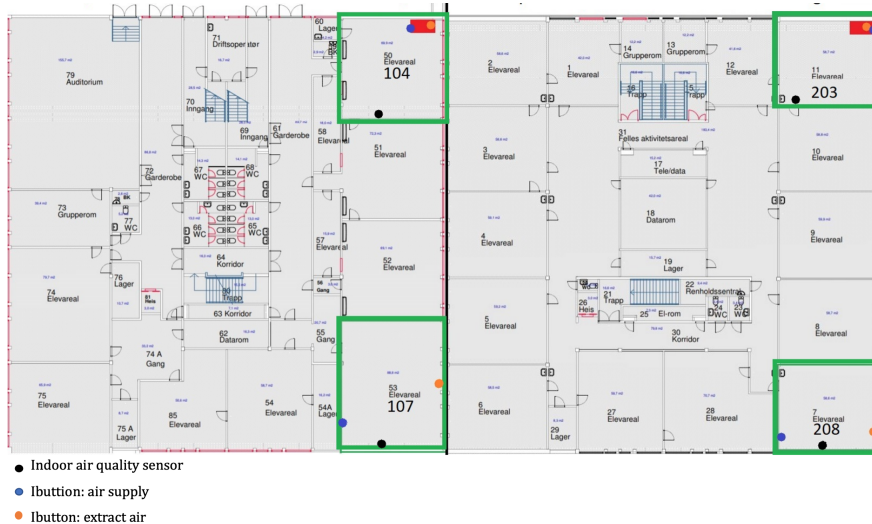
Figure 3.8: Floor plan of ground floor (right) and second floor (left) for Sunnland school. The rooms included in the field measurements are marked with a square. The measurement tools are marked with a dot; black is the indoor environment sensor, blue is the iButton measuring supply air and orange is the iButton measuring extract air [35]

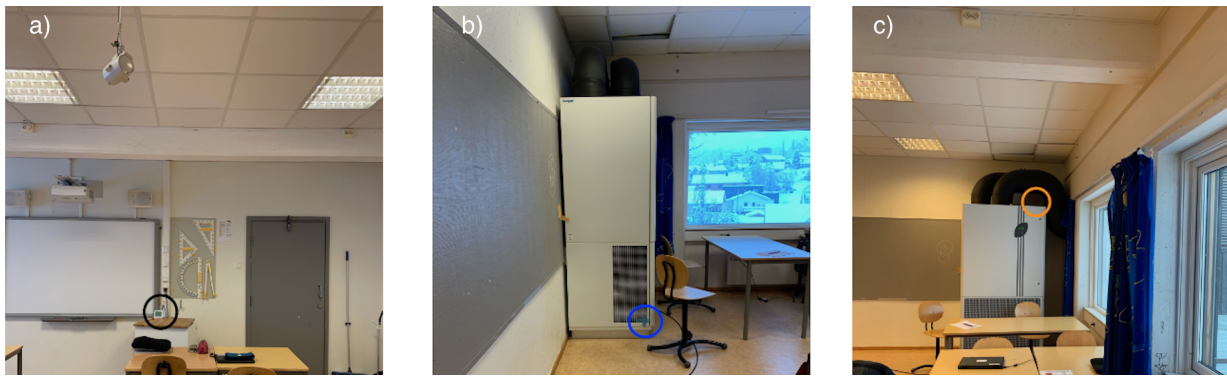
Figure 3.9: Location of placement of sensors in classroom 104. a) Sensor, measuring air quality b) Sensor measuring temperature of supply-air, and c) Sensor measuring temperature of extract-air

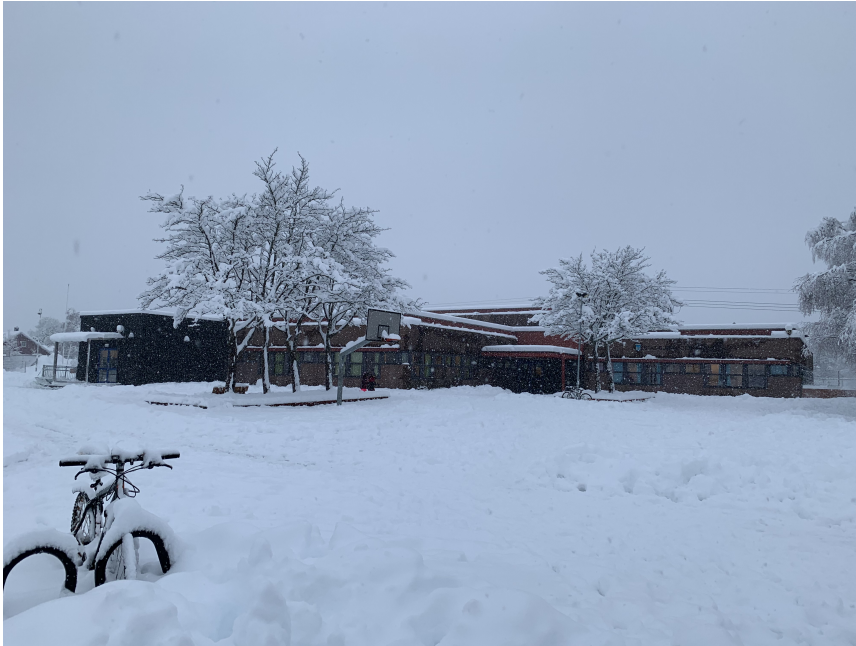
Figure 4.1: Stabbursmoen school

Stabursmoen, seen in figure 4.1, is both a primary and secondary school and is located at Heimdal. Residential buildings are surrounding the school. The main building was built in 1979 and has later been supplied with a pavilion that contains several specialized classrooms. The net area of the school is 5183 m². Today, the school holds around 430 pupils and 50 employees. The main building consists of three floors, where a technical room occupies the third floor. [35]

Initially, the school was built as an open area school, but it was later reconstructed by separating the classrooms with dry-walls without doors. The technical systems have not been adjusted regarding the new structure for the floor area, neither the light fixtures. It is no doubt that parameters like temperature, airflow, and lighting conditions are affected by the new structure. [35]

In 2013, the school was categorized as yellow, and later in 2017, the school was degraded into the critical red category. The report from 2017 stated that the building is in need of extensive rehabilitation, both indoors and outdoors. The roof, windows, doors, elevator, ventilation,

electrical, and plumbing needs to be replaced. The foundation, exterior walls, and the building's drainage also needed rehabilitation. The inside would need to be renovated afterwards. Today, the situation has aggravated. Trondheim municipality has planned a total rehabilitation for Stabbursmoen school to be finished in 2022. [7][20]

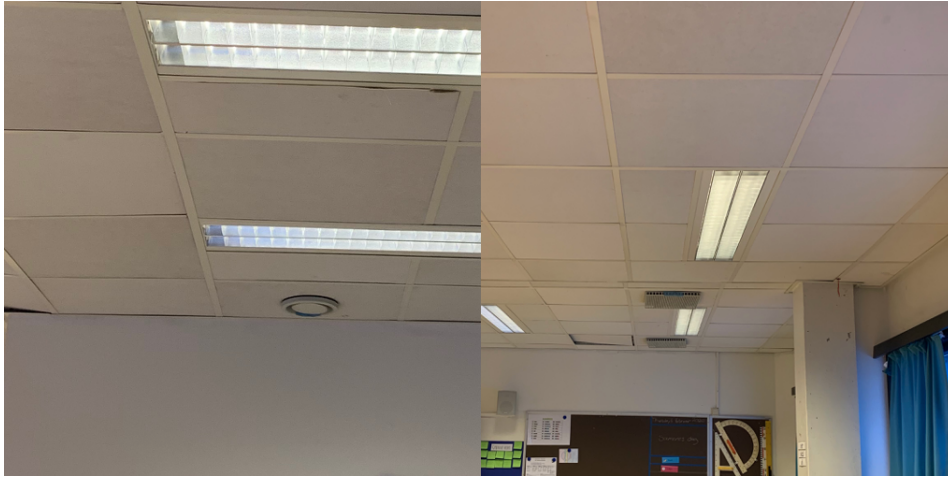
Figure 4.2: An example of the ventilation distribution system at Stabbursmoen school. A typical extract is seen left in the picture and a typical air supply grill is seen to the right

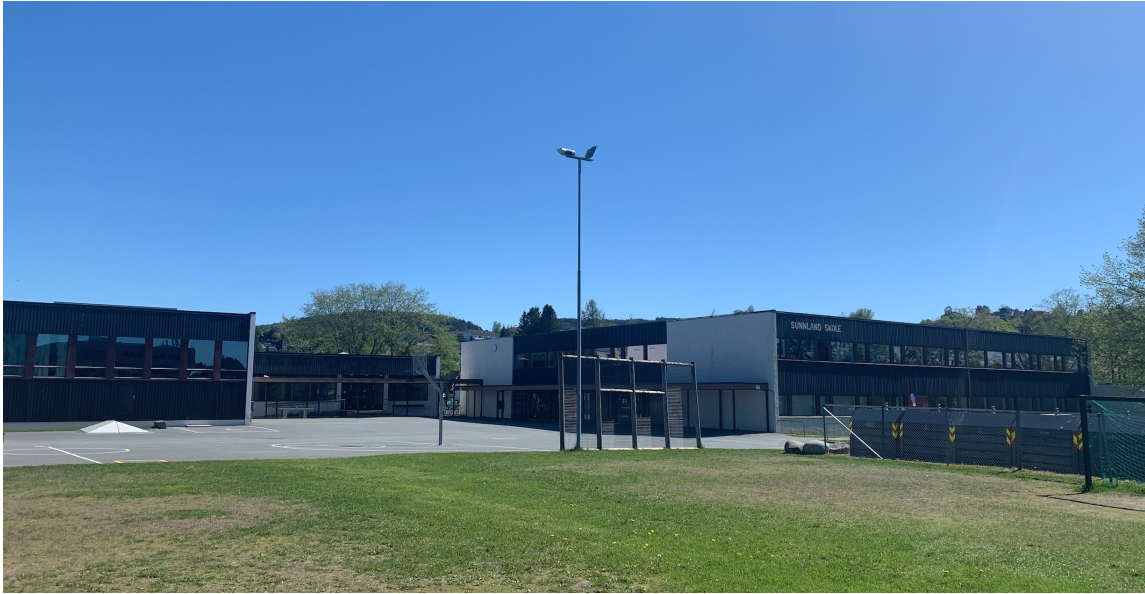
Figure 4.3: Sunnland School school

Sunnland school, seen in figure 4.3 is a secondary school with pupils from 8 – 10th grade. The school enrolls approximately 320 pupils and 35 employees. It consists of two buildings and a pavilion, where the net area of the main buildings area 4250 m² [20]. The school is located at Nardo, surrounded by office buildings to the west and residential buildings to the east. The main road, E6, passes 150 m away from the school, and thereby leads to some polluting of the air.

Sunnland is currently one of the oldest existing secondary schools in Trondheim. The oldest building is from 1956 and is today functioning as the administration building. Also, there are teacher offices, gymnasium, and other specialty rooms located in the building. The main building was constructed in 1978 and is the building where most of the classrooms are located. This building has had major upgrades that conducted over time. [35]

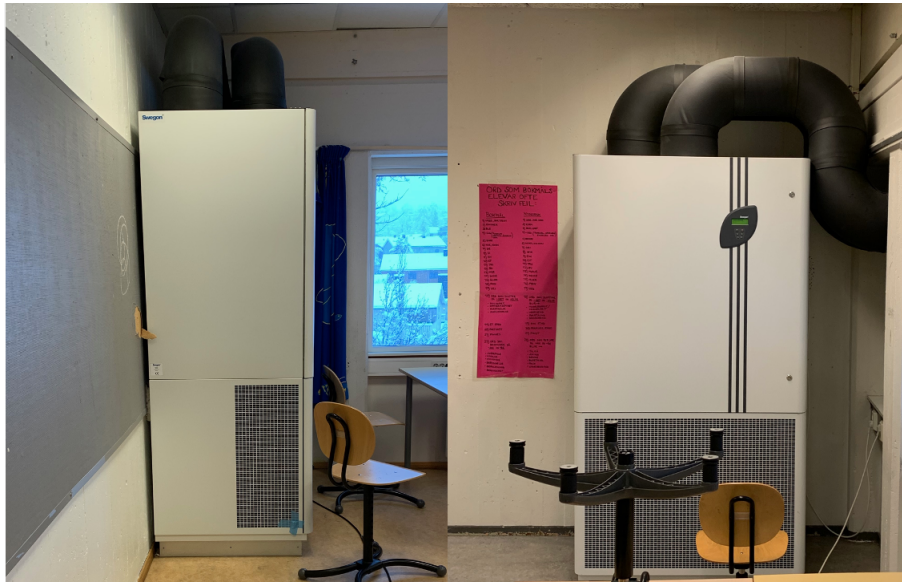
Figure 4.4: An example of a classroom ventilation aggregate from Swegon. This type of ventilation unit supplies to four classrooms at Sunnland school

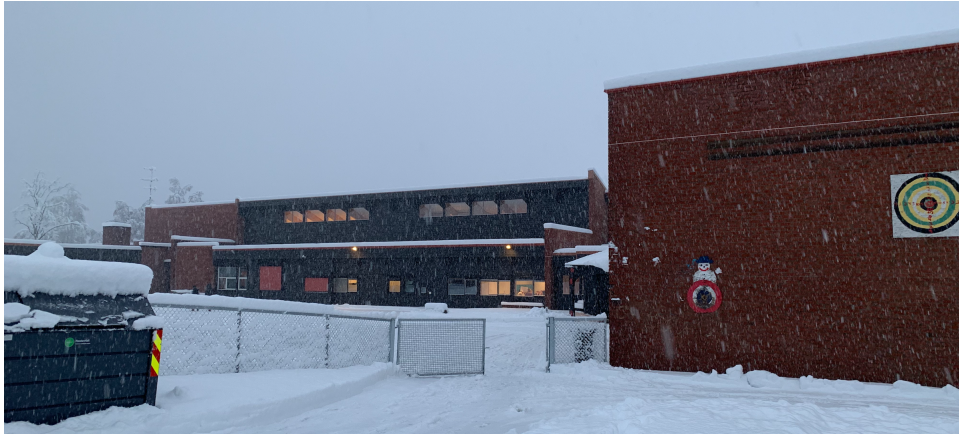
Figure 4.5: Sørborgen school

Sørborgen school, seen in figure 4.5 is a primary- and secondary school located in the old Klæbu municipality, which was merged with Trondheim municipality, January 2020. The school is located in rural surroundings, nearby a football field, forest, and residential buildings. The school hosts around 420 pupils. [35]

The reason Sørborgen is included in this project has a different background than the two other case schools. Unlike the other schools which are awaiting upgrades, Sørborgen was rehabilitated and expanded with a new section in 1996. Later on, the school has been supplemented with an extension to the main building, which was finished in 2018. The school thereby consists of one old part and a new part, that are connected. The status quo today is that the school is not waiting for any major upgrades or refurbishments. The new building has no known indoor environment problem today. However, the old building still does. [35]

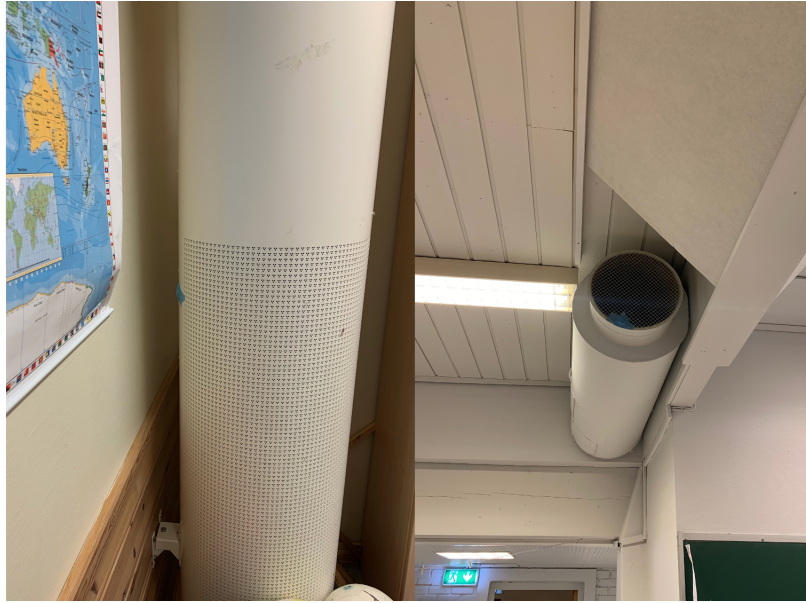
Figure 4.6: An example of the displacement ventilation distribution system at Sørborgen school. A typical extract is seen left in the picture and a typical air supply grill is seen to the right

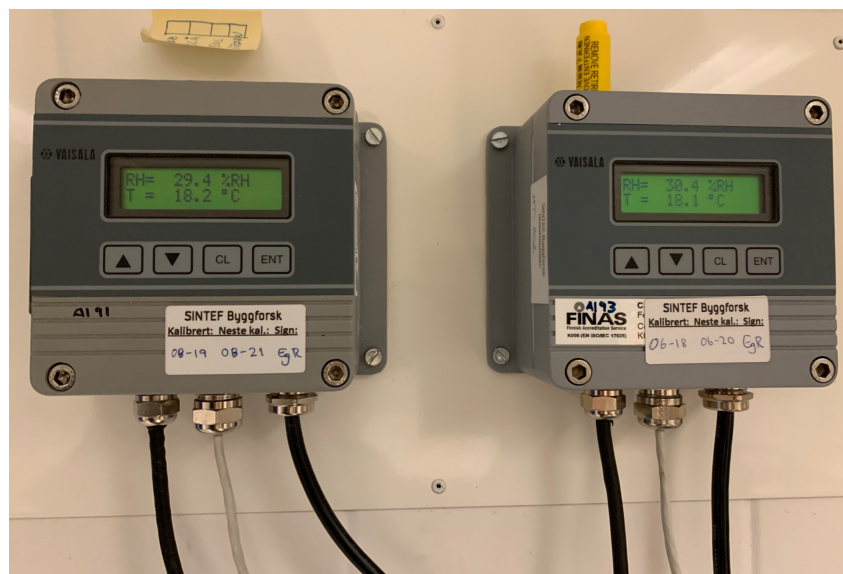
Figure B.4: Temperature for climate chamber
