Fatigue life estimation of Norwegian railway bridges

Master's thesis in Mechanical Engineering

December 2020

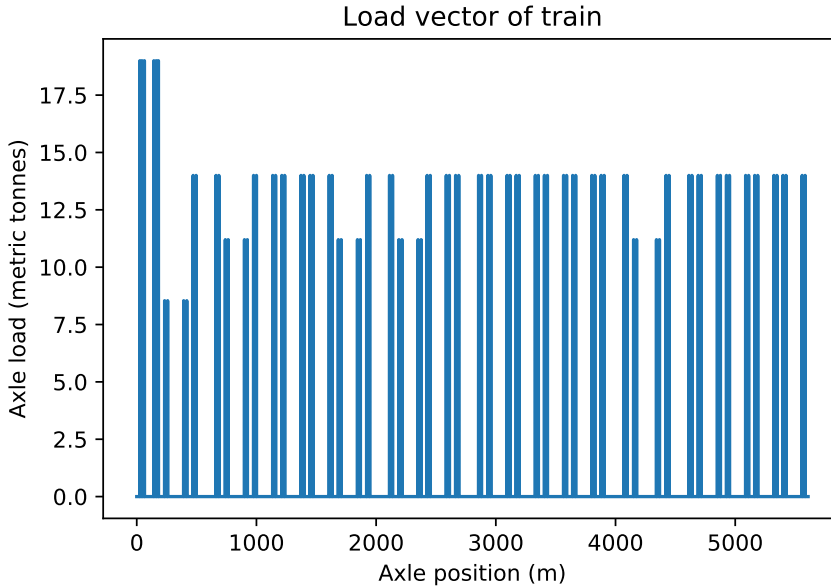
Figure 3.4: Static load function of T4 reference train, found in [9].

in equation 2.5. The static load function is formulated by combining the load magnitude of the axles combined with the axles positions along the train. Such a static load function can be seen in figure 3.4, being the load vector for the T4 reference train defined below.

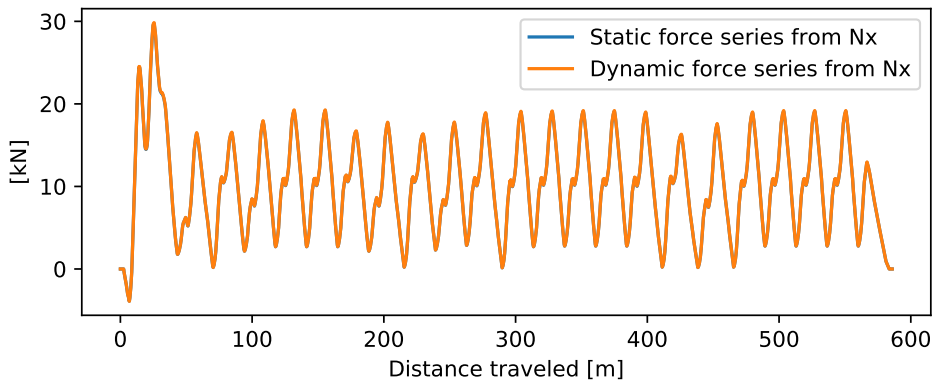
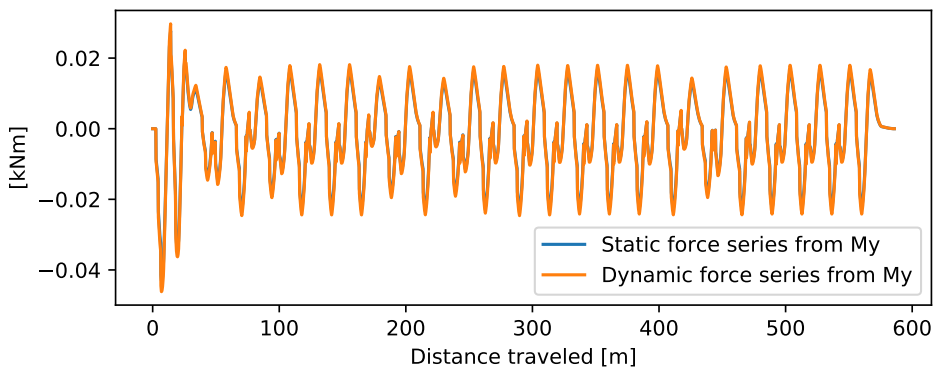
Figure 3.5: Static and dynamic response for vertical axle load by axial force N_x , bending moment for strong axis M_y and bending moment for weak axis M_z for section point 1 in element 23021 on the Lerelva bridge, in positive direction.

Taking the convolution of the influence lines for the vertical axle load shown in figure 3.3 and the static load function as shown in 3.4 will as explained above and in the theory section provide the static response z_0 for this train at this given point of the bridge. The static and the dynamic response of the T4 reference train on the element 23021 is demonstrated in figure 3.5. The dynamic response is found by multiplying the static response by the dynamic amplification factor as explained in equation 2.6.

This total stress response is calculated for all force components additional to the response for vertical axle load shown in 3.5 by summing the different stress contributions as explained above. The normal stress contribution from N_x , M_y , M_z and total normal stress for selected element can be seen in figure 3.6.

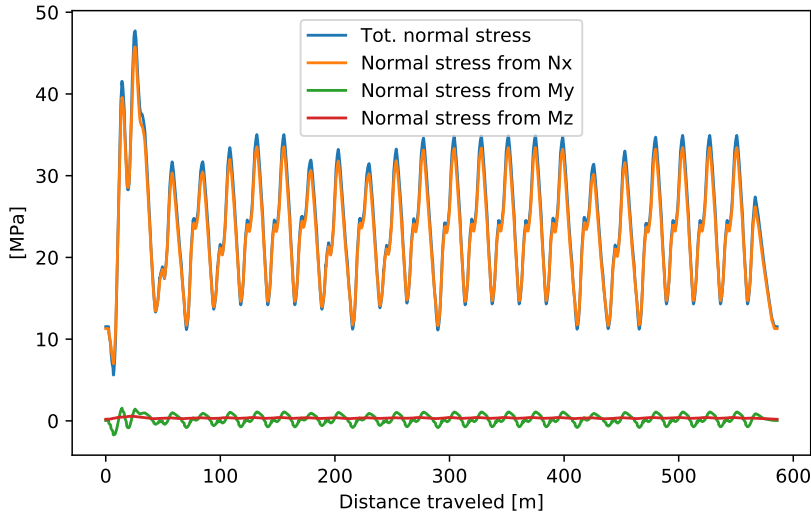
Figure 3.6: The total normal stress in positive direction on Element 23021 Section Point 1 of the Lerelva bridge caused by T4 reference train.

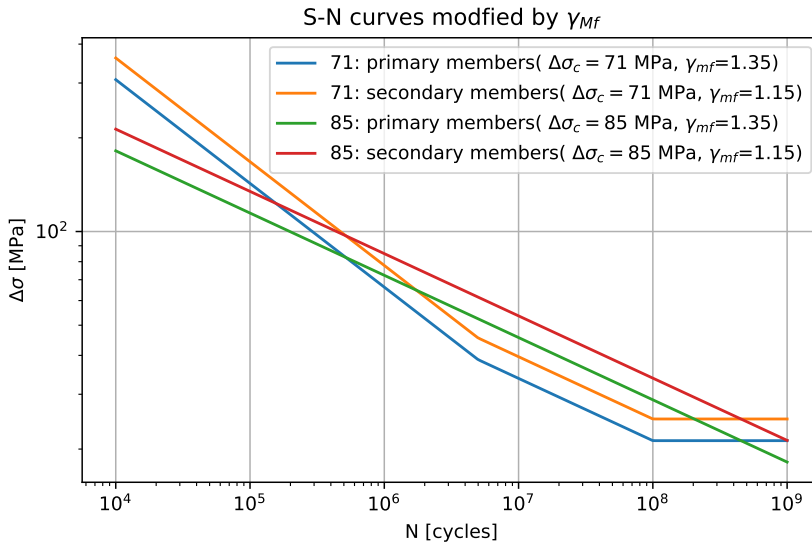
There are two curves for each of the detail categories ds85 and EC3.71. This corresponds to the two different partial safety factors for fatigue resistance γ_{Mf} defined in the Eurocode [7], for a safe life assessment method these are defined to be 1.15 for structural details with a low consequence of failure and 1.35 for structural details with high consequence of failure. The structural details with low consequence of failure are categorised as secondary and the structural details with high consequence of failure are categorised as primary in this report. The partial safety factor is introduced to the calculations by dividing the detail category of the endurance curve by the partial safety factor to obtain the endurance curve including the safety factor.

Figure 3.7: Endurance curves for detail category ds85 and EC3.71 modified by γ_{Mf} .

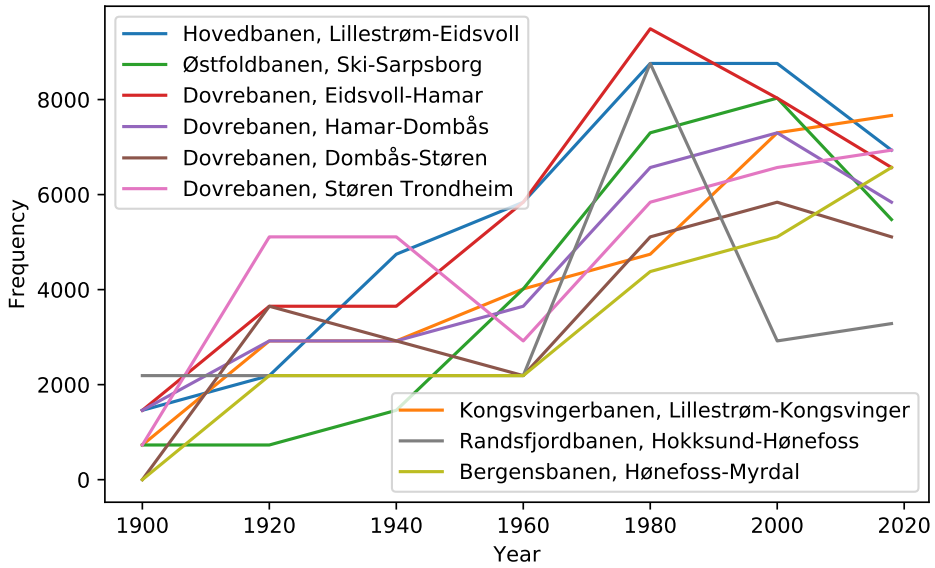
Figure 3.8: Linearly interpolated train passages for freight trains on selected lines on the Norwegian railway network from 1900 to 2018.

The dataset gathered from the linear interpolation of freight and passenger trains in tables 3.1 and 3.2 are displayed in the graphs in figures 3.8 and 3.9. The plots of these datasets show the the number of yearly passages of both freight and passenger trains of the sub-lines afflicting the analysed bridges on a yearly basis from 1900 to 2018. These values will be used to estimate the already inflicted fatigue damage D_0 for all components points on the bridges.

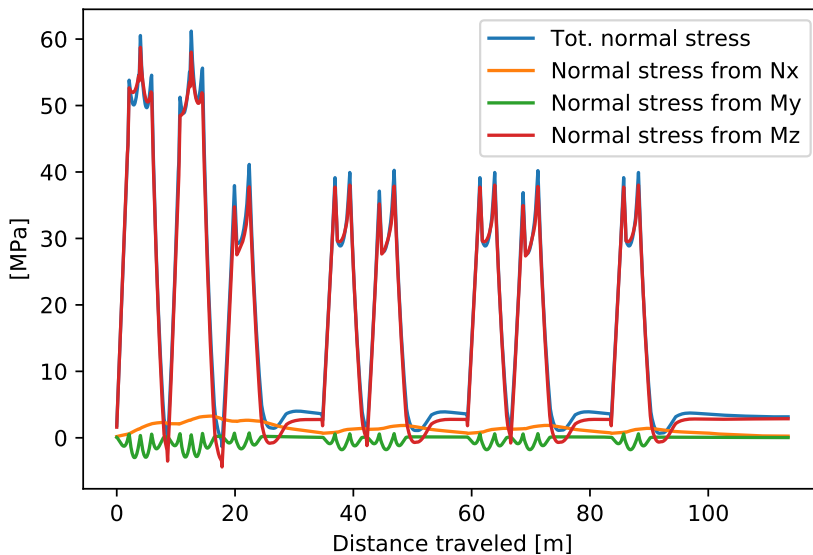
Figure 4.1: Reproduced stress time series for normal stress - Longitudinal grillage - total and individual contributions from force components for train LMP4 passing in positive x-direction.

The first element chosen is the most damaged element on the bridge over Lerelva. This element is located at the longitudinal grillage of the bridge. Given that the influence lines and the cross-section data are input data not altered from the report, but the load models are build using the pacril package, a different way of defining the load models than the original report, giving a potential error source. Therefore, the first comparable results that can expose any possible errors in the recreated models and calculations are the Stress time series. This will ensure that the normal stresses for N_x , M_y and M_z are correctly modelled for the vertical and the transverse loads. The calculated stress time series for the normal stress in the most damaged element by train LMP4 is presented in figure 4.1.

By comparing the stress time series in figure 4.1 reproduced in the calculations for this report with the stress time series LMP4 train in figure 4.2 taken from the original report it can be observed that the graphs in these two figures are identical. The same comparison can be made with all the stress time series from the calculated and the original report and the comparison will show that the results are the same. The stress time series in the reproduced calculations are modelled correctly. This provides that the influence lines are imported in the same way as in the original report and the new definition of the original load model are corresponding with the load model used in the original report.

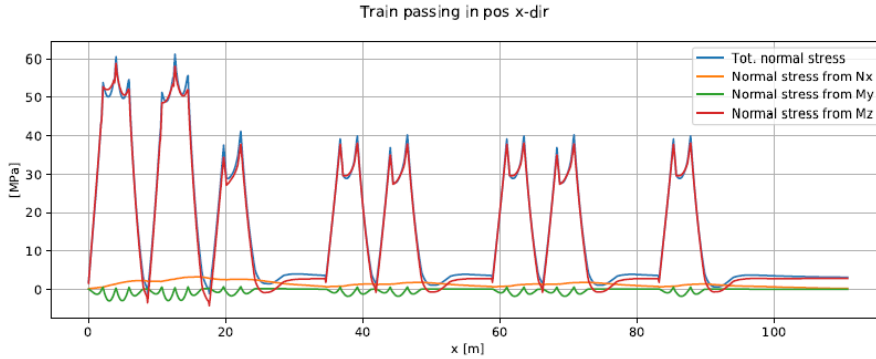
Figure 4.2: Original stress time series for normal stress - Longitudinal grillage - total and individual contributions from force components for train LMP4 passing in positive x-direction. Taken from [3] with permission from author.

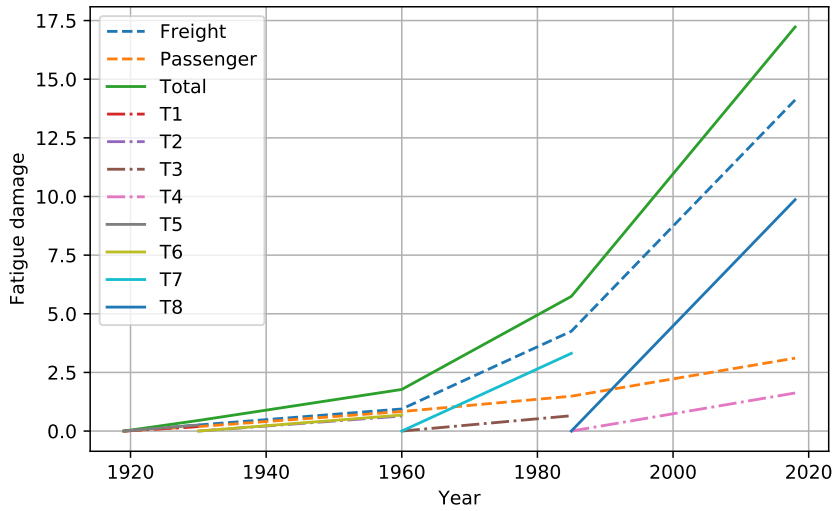
Figure 4.3: Accumulated fatigue damage from construction year to 2018 from trains on element 23024.

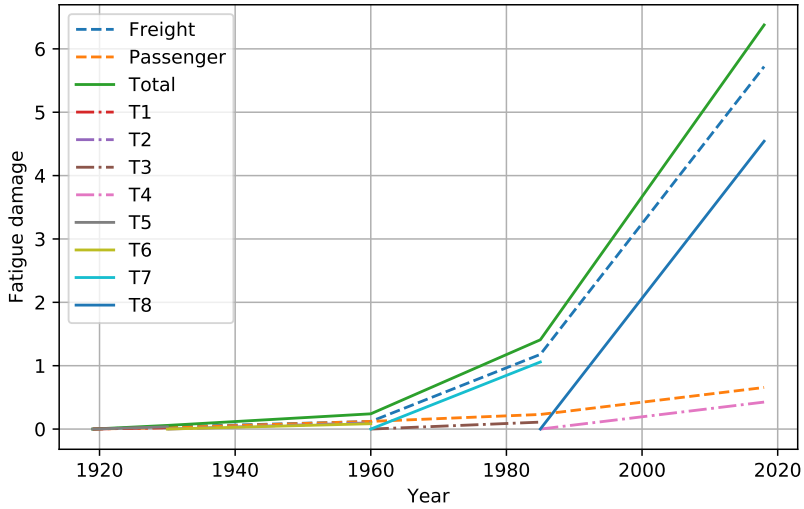
Figure 4.5: Accumulated fatigue damage from construction year to 2018 from trains on element 24061.

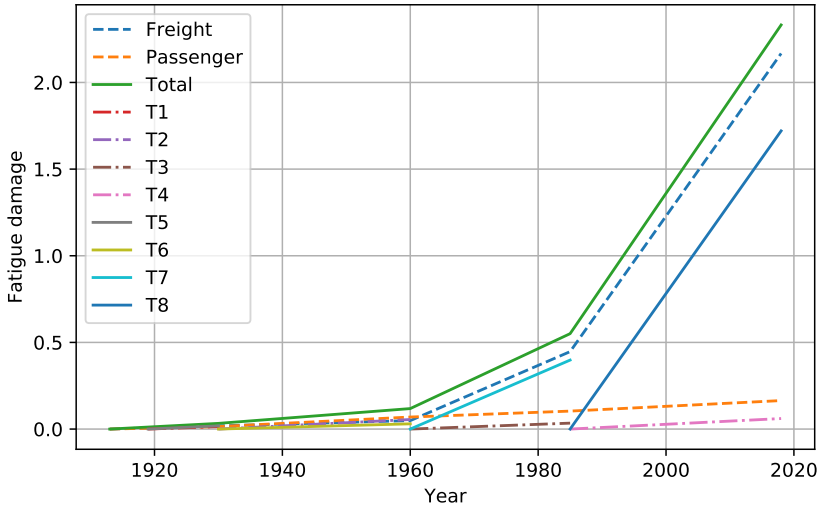
Figure 4.8: Accumulated fatigue damage from construction year to 2018 from trains on element 11021.

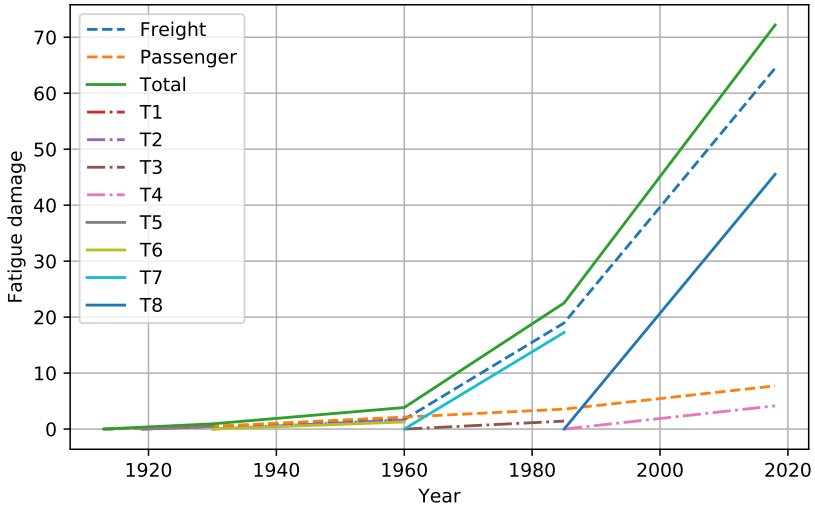
Figure 4.9: Accumulated fatigue damage from construction year to 2018 from trains on element 81081.

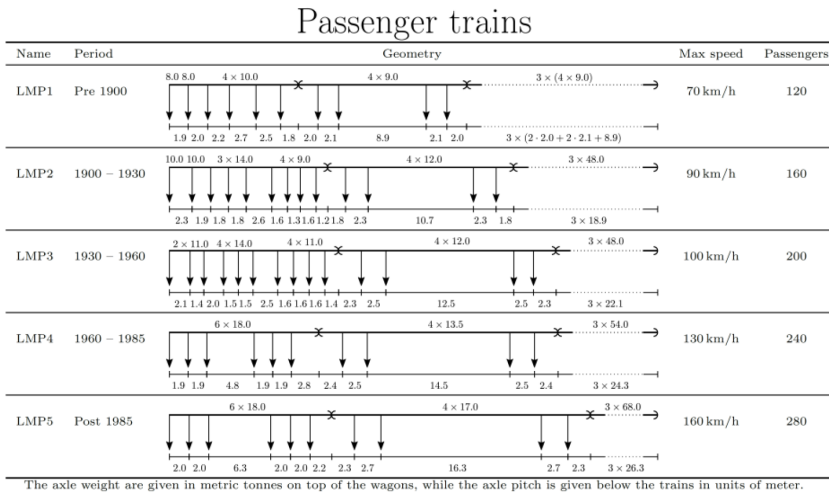
Figure A1: Load model for passenger trains used in fatigue estimation by Bane NOR in 2018.

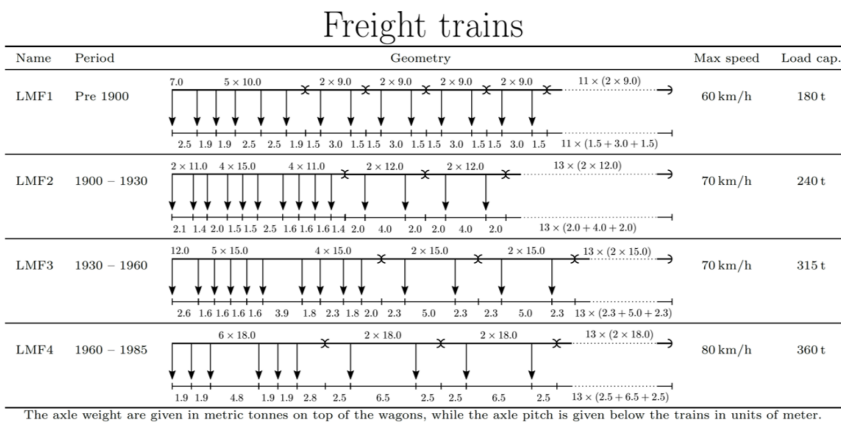
Figure A2: Load model used for historic freight trains in fatigue life estimation by Bane NOR in 2018.

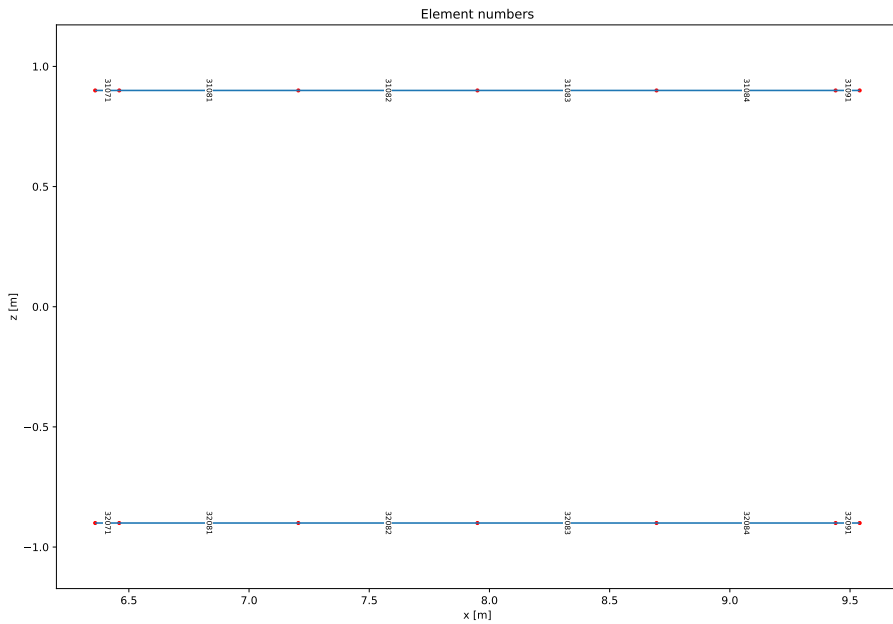
(a) Longit. grillage - part 1

(b) Longit. grillage - part 2

Figure D1: Discretisation of the element numbers on the Brummund bridge.

(c) Longit. grillage - part 3

(d) Longit. grillage - part 4.

(e) Longit. grillage - part 5
