NTNU
Norwegian University of
Science and Technology
Faculty of Engineering
Department of Geoscience and Petroleum

Mapping of Shrinkage Cracks with Dye Penetrant on Sprayed Concrete Cores

July 2020

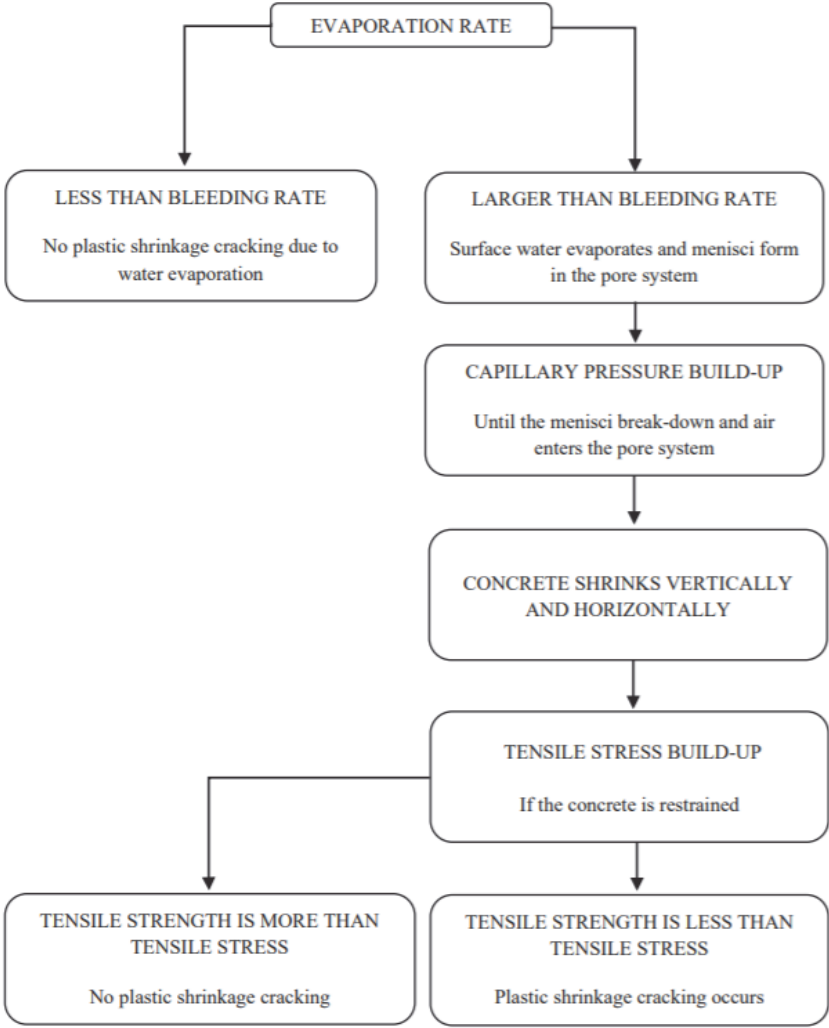
Figure 7: Stepwise development of plastic shrinkage cracks. Found in Sayahi (2019).

Plastic shrinkage cracks are often the first cracks to develop in concrete structures (Sayahi et al. 2014). Figure 7 shows the stepwise development of plastic shrinkage cracks in concrete. The first steps of the figure were explained in the development of plastic shrinkage. The rest of the steps are explained here.

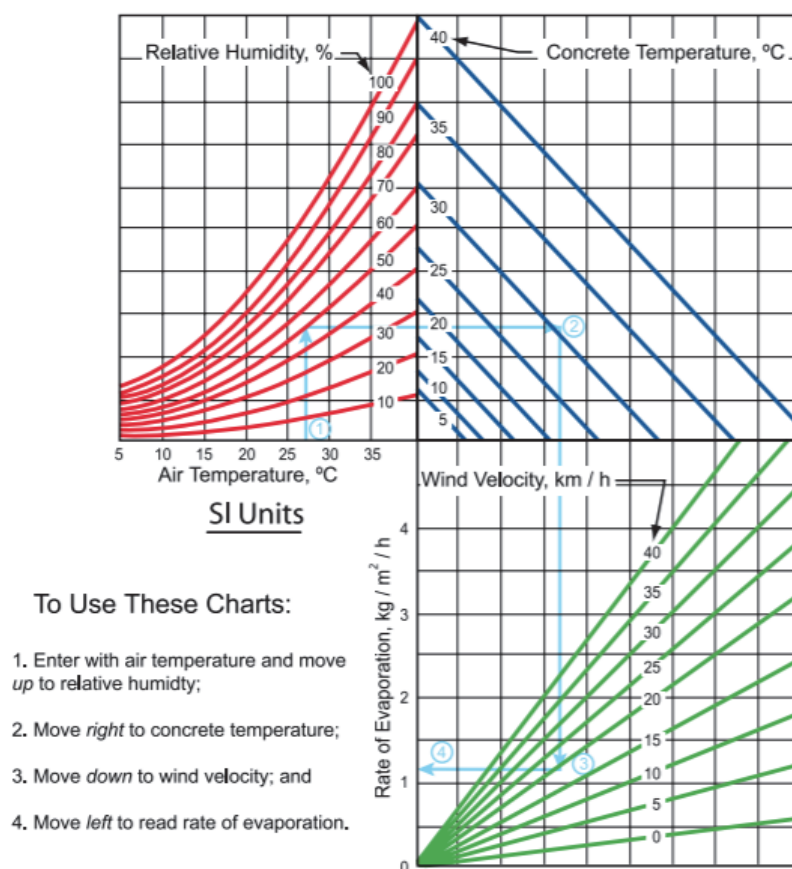
Figure 9: Evaporation diagram. The light blue arrows show an example. In the example, the air temperature is $27^{\circ}C$, the relative humidity is 50%, the concrete temperature is $31^{\circ}C$ and the wind velocity is 19 km/h . That gives an evaporation of $1,2 kg/m^2/h$. Found in ACI (2007).

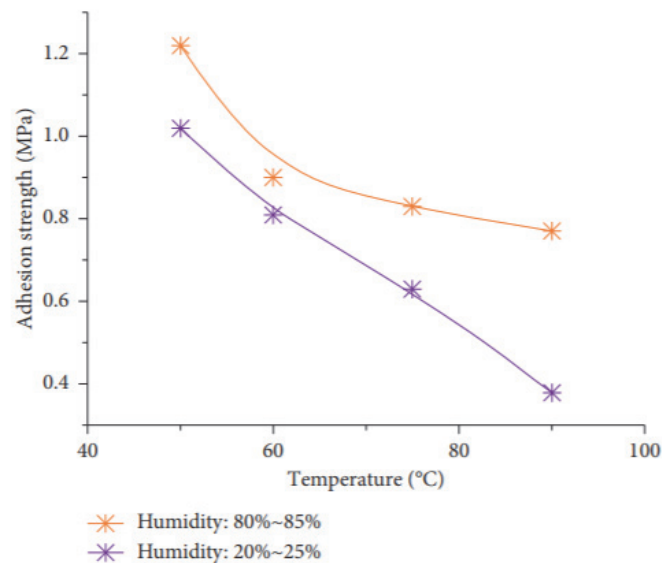
Figure 11: Rock-concrete adhesion strength at different humidity levels at different temperatures. Found in Duan et al. (2019).

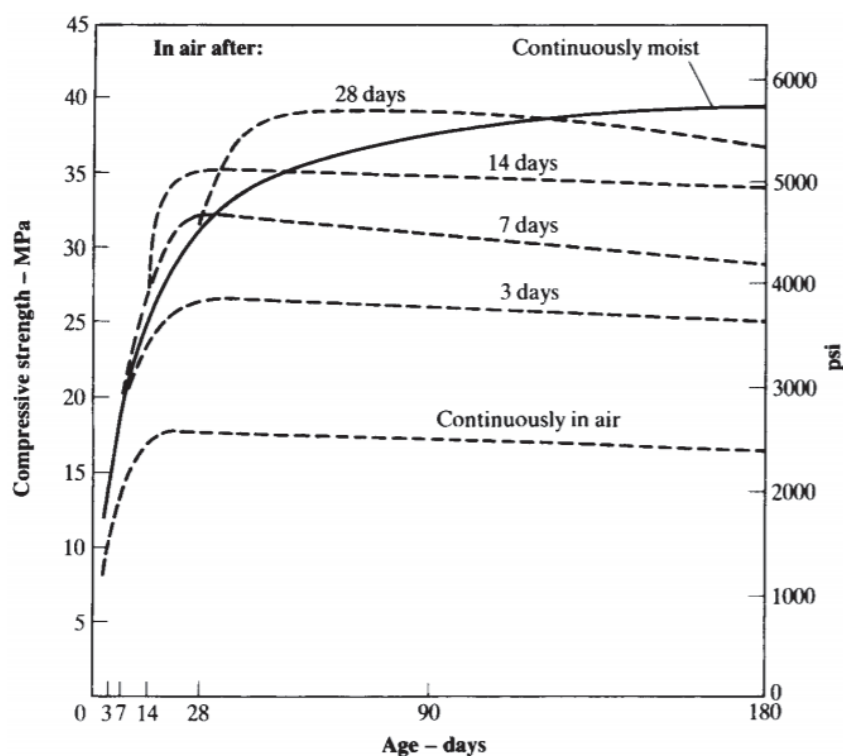
Figure 12: Influence of wet curing on compressive strength for a concrete with w/c ratio of 0.5. Taken from Neville & Brooks (2010).

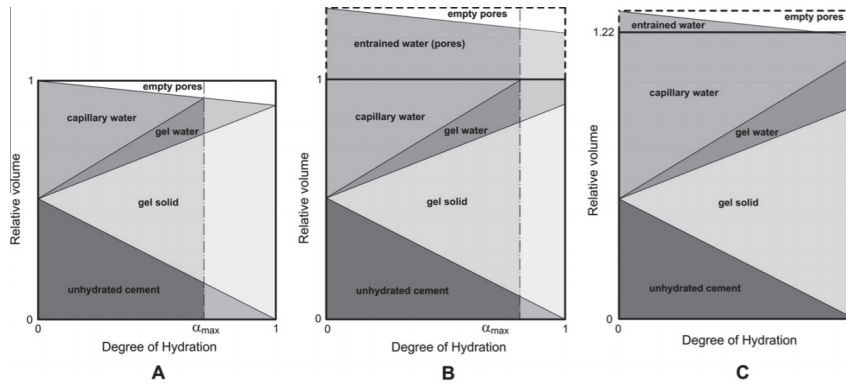
Figure 14: (A) Closed system, $w/c = 0.32$. The hydration stops when the free water is used. The maximum degree of hydration α_{max} is 0.71. (B) Closed system with reservoir with internal curing water, $w/c = 0.32$ and $w_e/c = 0.19$. The hydration stops when there is no more space for the gel to grow, even though there is access to free water. The maximum degree of hydration α_{max} is 0.83. The pore volume in this situation is more than three times larger. (C) Closed system with reservoir with internal curing water, $w/c = 0.45$ and $w_e/c = 0.06$. Since w/c is > 0.42 full hydration ($\alpha_{max} = 1$) is possible. In this situation there are no need for entrained water. The entrained water only contributes to creating a larger pore volume. (In both (B) and (C) it is assumed that the capillary pores are fully saturated if there is internal curing water in the reservoirs.) Taken from Hasholt et al. (2012).

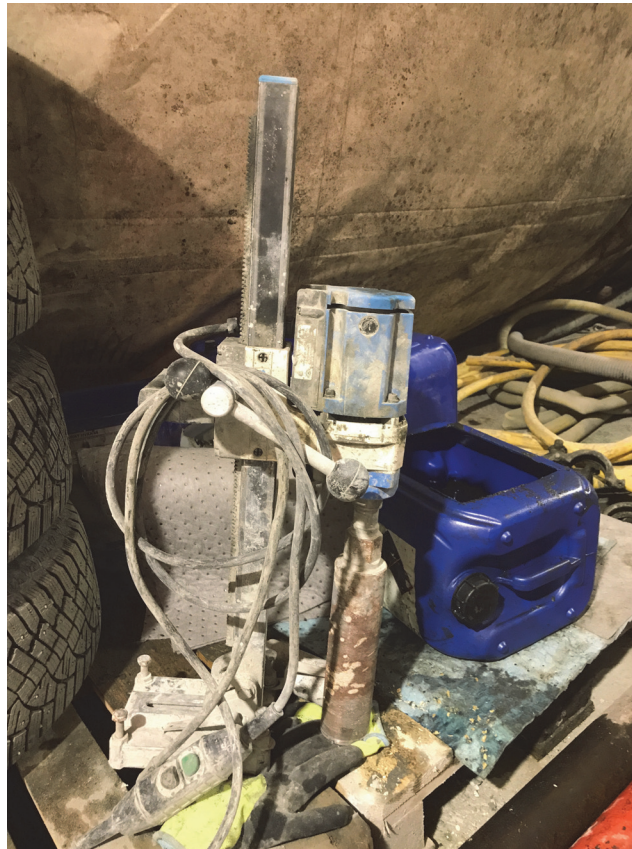
Figure 19: Boring machine, Shibuya TS-92, used to get the sprayed concrete samples.

The equipment used for the coring was a Shibuya TS-92 boring machine. That is light and compact machine. It is easy to carry (Shibuya 2020). The machine is fastened to the tunnel wall during the coring. This is to keep the machine stable during the coring to get nice and straight cores. Figure 19 shows the boring machine used to get the cores from the two tunnels.

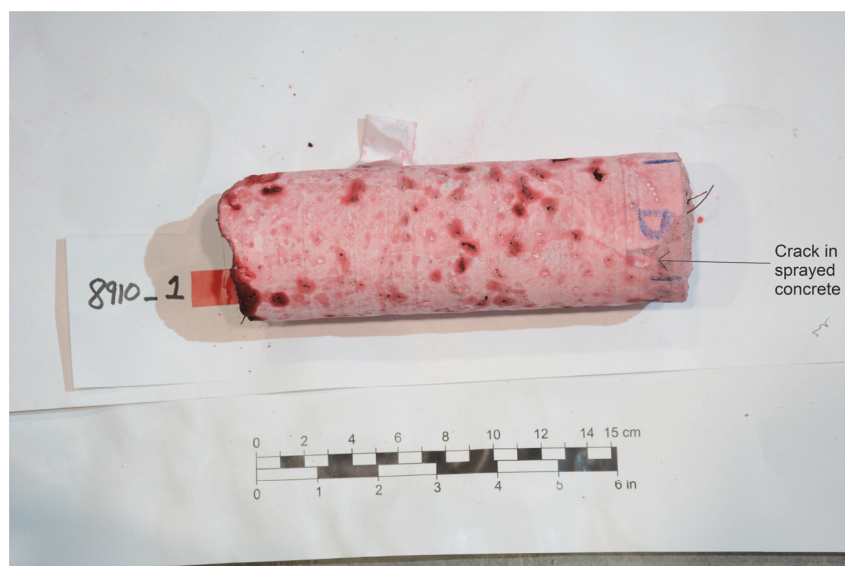
Figure 26: Dye penetrant crack mapping on sprayed concrete core nr. 1 from profile number 23917 with an arrow showing the crack on the core.

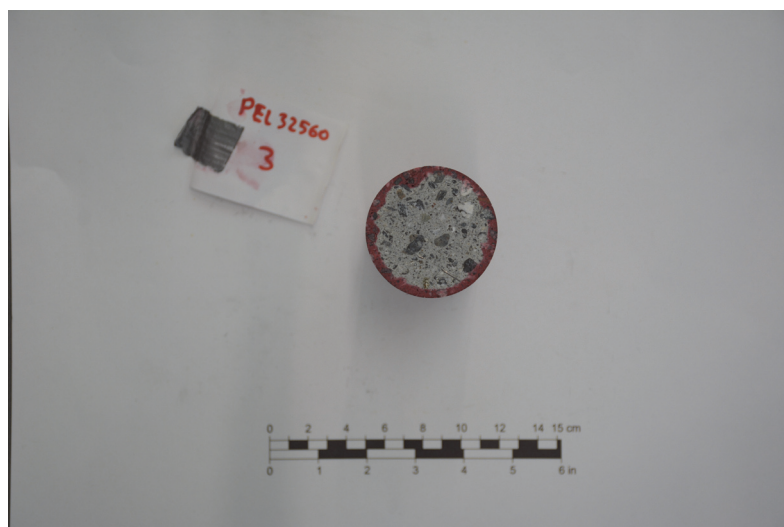
Figure 28: Penetration depth of dye on sprayed concrete core 3 from profile 32560.

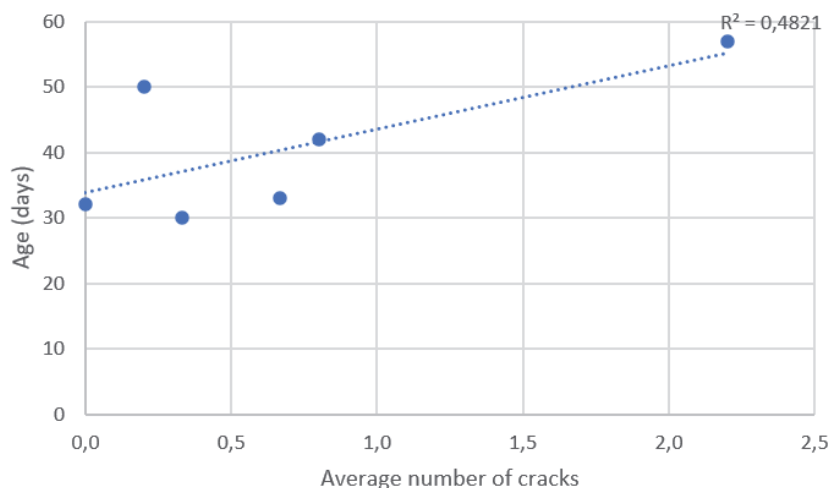
Figure 29: Plot of the amount of cracks against the age of the cores at testing with a trendline. The R^2 is 48%, which indicates a connection between the age and the amount of cracks.

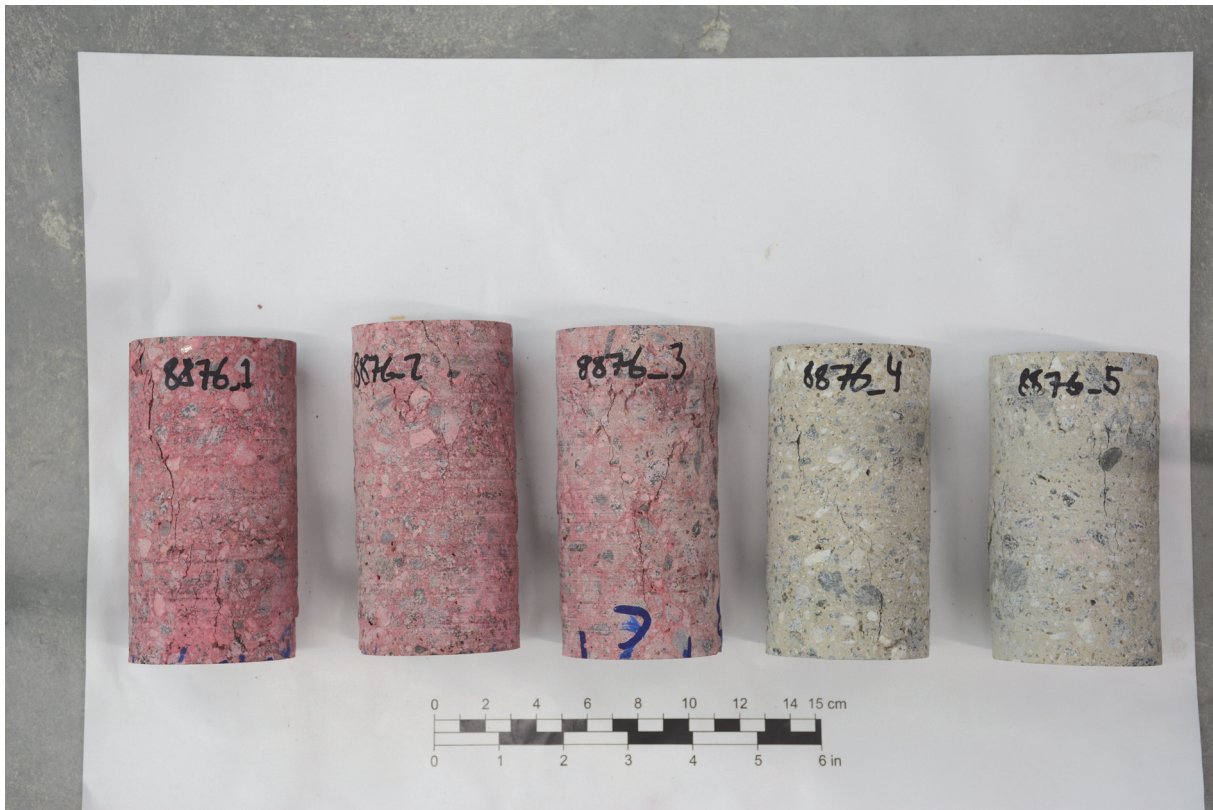
Figure 31: All cores from profile 23903 after compressive strength testing, with failure patterns.

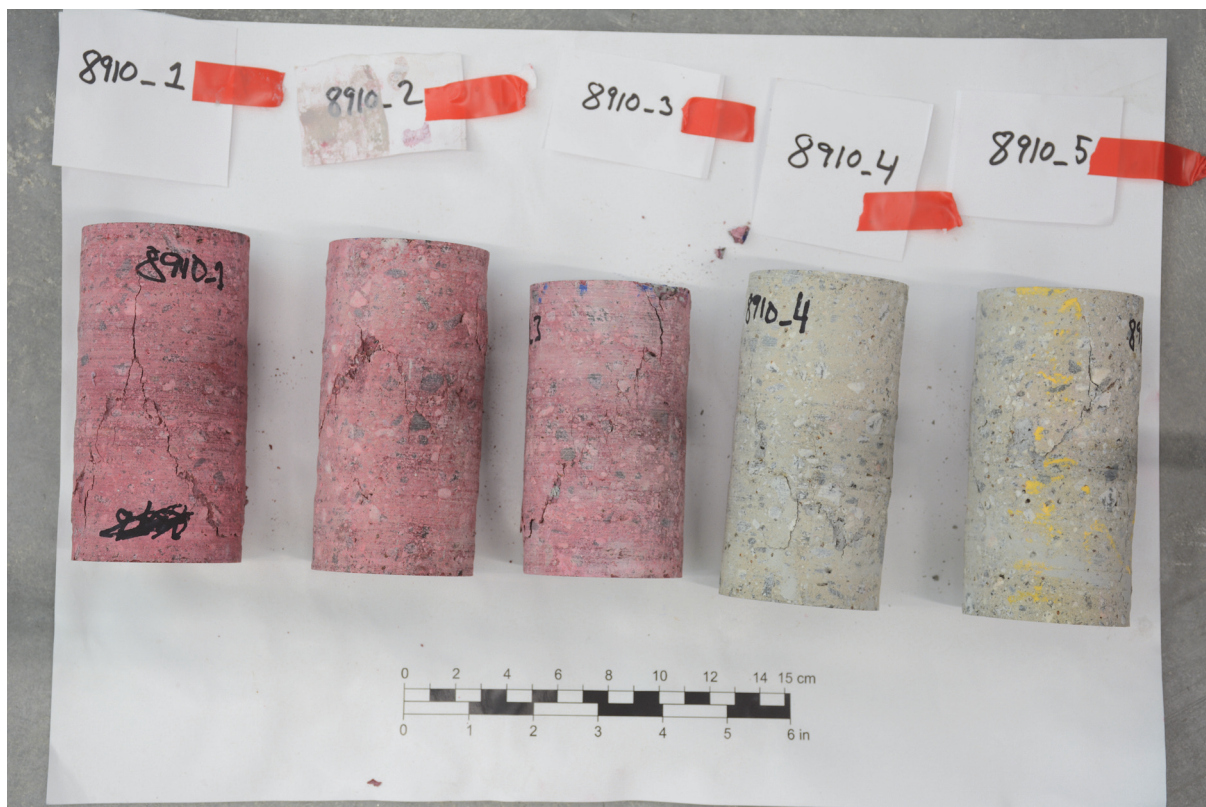
Figure 33: All cores from profile 23917 after compressive strength testing, with failure patterns.

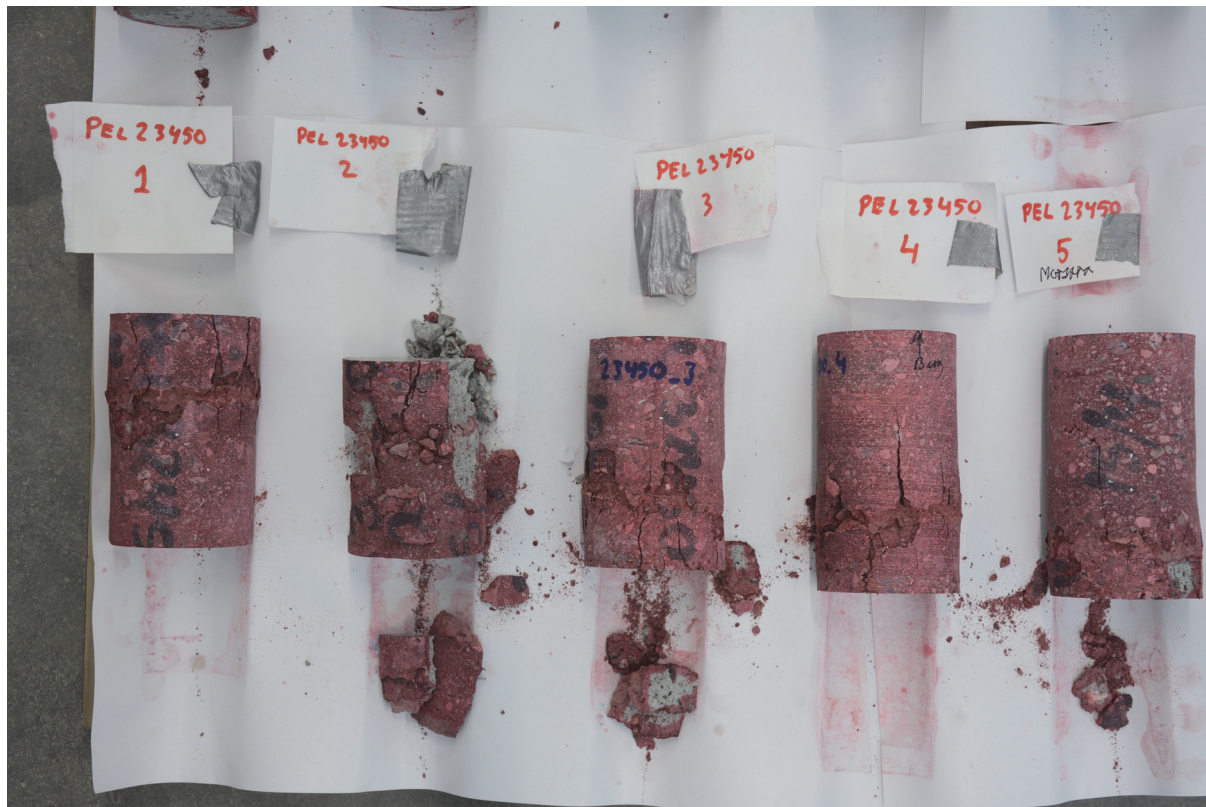
Figure 34: All cores from profile 32450 after compressive strength testing, with failure pattern along the boundary between two sprayed concrete layers.

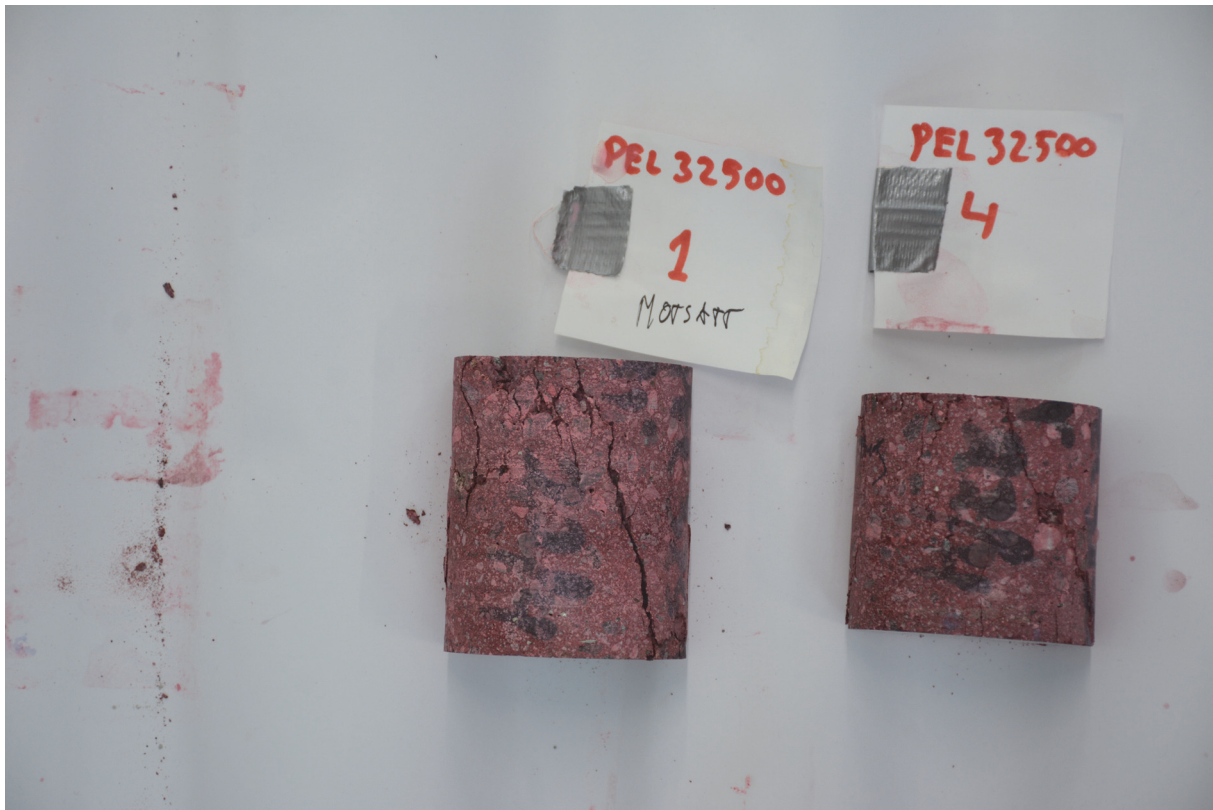
Figure 35: Two cores from profile 32500 after compressive strength testing, with failure patterns.

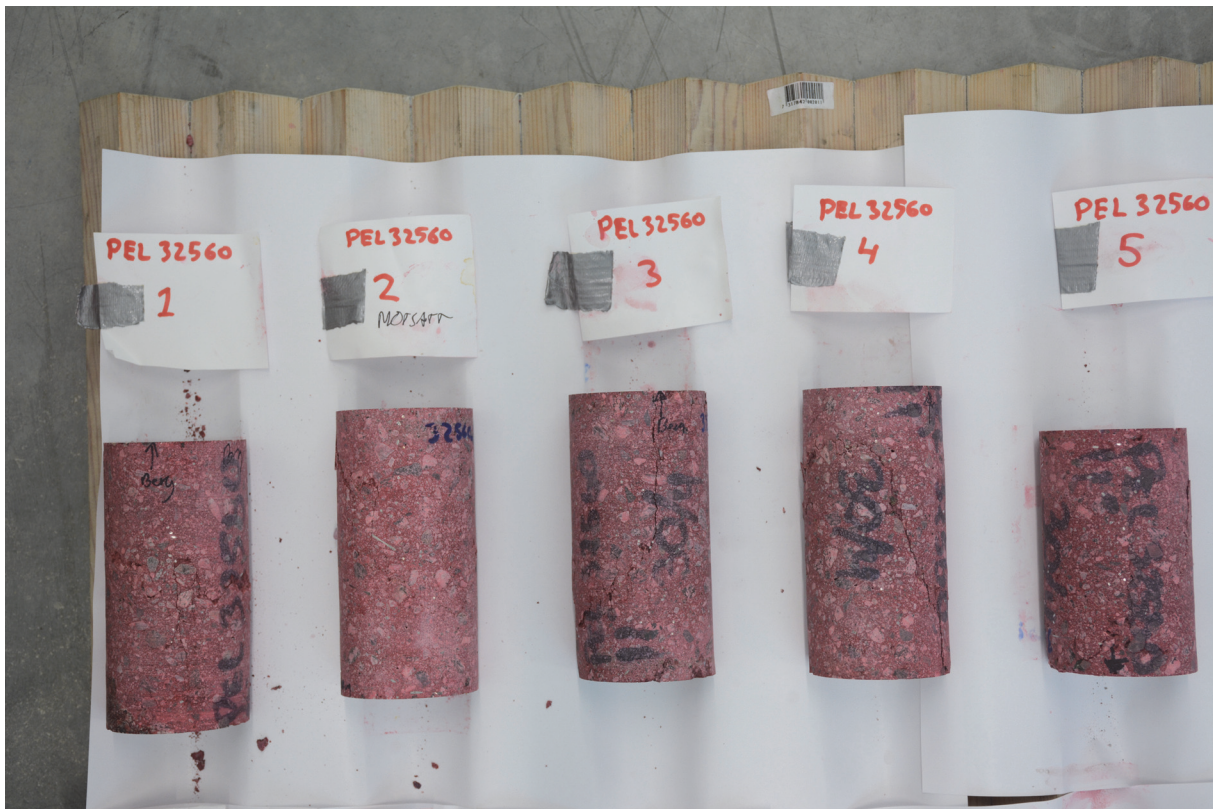
Figure 36: All cores from profile 32560 after compressive strength testing, with failure patterns.

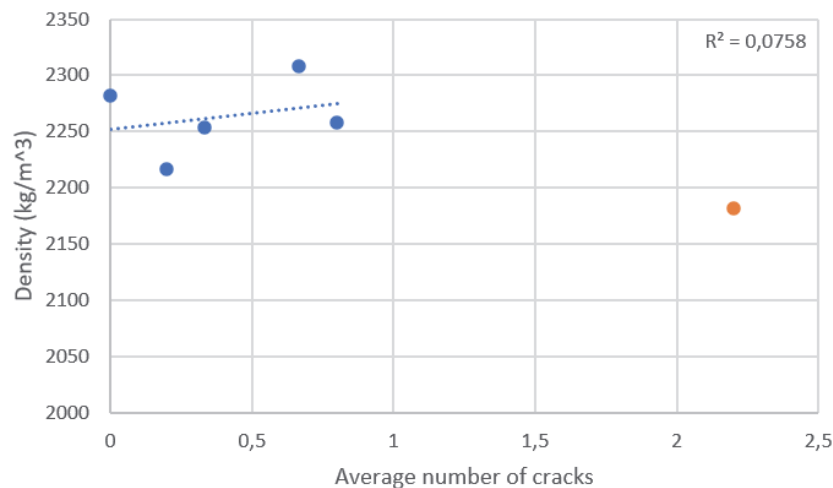
Figure 41: Average number of cracks plotted against the average density for each location.

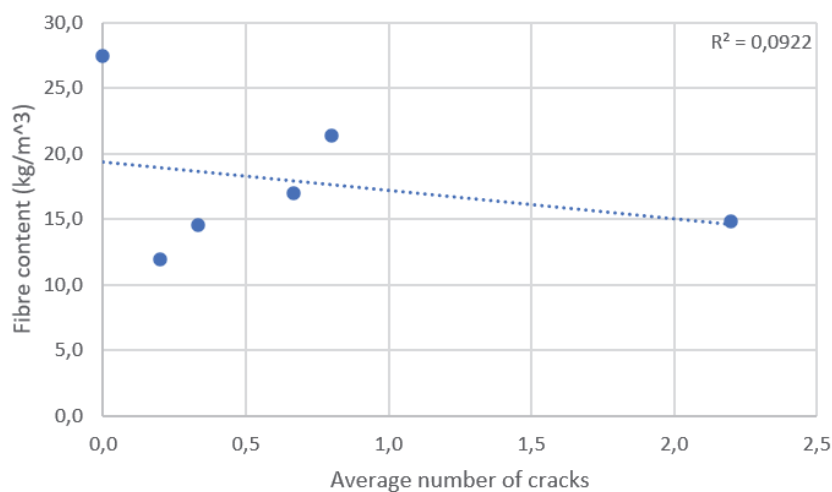
Figure 42: Average number of cracks plotted against the average fibre content for each location.
