# Pitched unventilated wood frame roof with smart vapour barrier – field measurements

N S Bunkholt<sup>1</sup>, L Gullbrekken<sup>1</sup>, B Time<sup>1</sup> and T Kvande<sup>2</sup>

<sup>1</sup> SINTEF Community, 7046 Trondheim, Norway

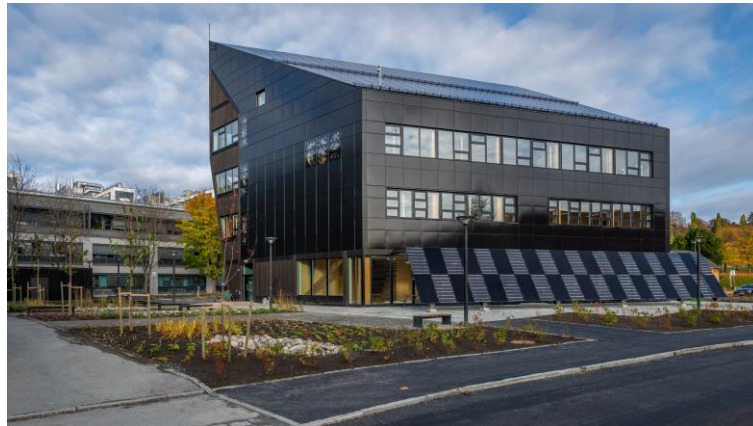
**Figure 1.** The ZEB Laboratory in Trondheim, Norway. Photo: m.c.herzog / visualis-images.

To improve the knowledge on hygrothermal conditions in unventilated wood frame roofs, a field study is carried out on the ZEB Laboratory, a full-scale zero emission office and educational laboratory building located in Norway (Trondheim), see Figure 1. The building was constructed during 2019–2020. The ZEB Laboratory is a ZEB-COM building [11] supposed to work as a research tool in development of climate-friendly and climate adapted buildings. Hence, renewable energy production on the building must account for emissions linked to construction (C), operation (O) and materials (M) of the building.
