# The Spirit of Time—The Art of Self-Renovation to Improve Indoor Environment in Cultural Heritage Buildings

**Abstract:** The purpose of this paper is to explore the challenges of an old low-standard urban district with a strong historical and cultural heritage and propose more sustainable renovation solutions, acceptable for the residents and municipality. The challenges of physical renovation or refurbishment are complex due to poor condition of the buildings, municipal ownership and governance, mixed management with community and low rents, which are insufficient to cover the costs. The paper discusses the proposed solutions of living standards, supported by the research in two directions: (i) available resources and reuse of materials, (ii) developing a renovation guidance for inhabitants from the building physics perspective, including indoor environment quality. Challenges related to energy efficiency are addressed from the decision-making perspective to overcome the barrier of lack of motivation to invest in energy-efficient measures at the individual and community level. The interdisciplinary approach complements engineering-focused studies with a focus on the comfort con

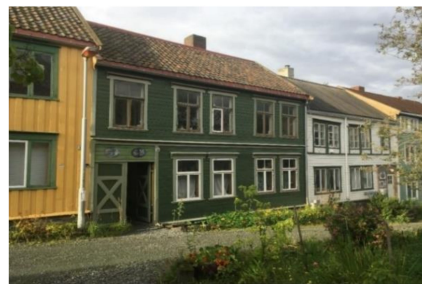
Wooden buildings (Figure 4) are houses with bedrooms and kitchen. Each house does not necessarily have a bathroom. The community shares few bathrooms. Most of the houses were built at the end of 19 century; they are now deteriorated even though people tried to keep them in a satisfactory condition. Most of them are two-story houses. In the area, we can notice a sloping terrain, some gardens, pebbles on the ground, and brick floor in some paths. There are no paved roads or sidewalks between houses. The site is located near the Strandveien road with cars and bus. There is some lighting next to the main road but not in the smaller paths between houses. There is also the railway right next to houses. Most of the houses do not have any basements except the storage room for the ancient milk shop.

**Figure 4.** Svartlamon wooden buildings (NTNU).

Foundations are in bad condition. Houses have many windows, but they are damaged, showing problems with condensation and humidity. All the facades are painted; however, the painting is very old and is deteriorating (Figure 5). Roofs are not insulated, and all houses have a steep roof. Many houses have tile roof. Clay tiles are a traditional kind of roofing material, it is a material that is both widely available and easy to shape into forming a channel to direct the flow of water. Some of the houses have a corrugated metal roof which is inexpensive and quick to install. Mainly, the rainwater gutters and downpipes are in good condition close to the roof, but the lower parts are worse (leakages), causing constant humidity on the walls, allowing moisture to seep into the houses, so molds, fungus, and mosses are spotted. They affect the health and well-being of people. The façades are complicated to insulate due cultural protection, so the design of the facades and windows should be original. Walls, doors, windows, partitions, and finishes are wooden and old.

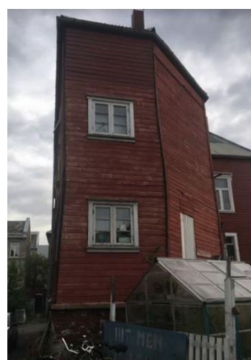
Many walls are not straight, and they lean (Figure 6), likely because the houses were built on poorly compacted embankments or on a heterogeneous soil. No drainage systems could be seen around them. Some of the load bearing elements are rotten. Even some entry doors are not straight. Most of the houses do not have any bathroom, and the only sink in their house is the kitchen one. The houses with bathrooms share them. The plumbing system is old and partly maintained but not to the standards that we can find in newer houses. The electrical system is at its full capacity, old but safe.

Figure 6. Leaning house (NTNU).

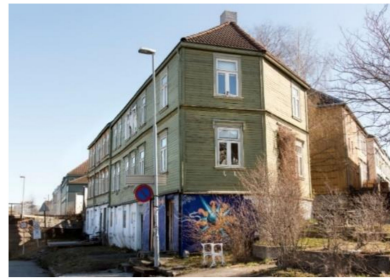
A typical example of housing block is presented: two buildings Strandveien 19 and 21 (Figure 7), from 1893, with four flats each, shared facilities in the common basement, and a shop in the ground floor. The foundation material is stone; basement walls are made of brick, and upper floor levels have a wooden structure. During the time only some small interventions were done, and foundations were stabilized in 2001; a wind barrier on the north façade was installed in 2016, and the damaged wooden panels were replaced (Figure 8). Both houses need major refurbishments as some foundations and walls are falling apart, and the structure is in a very bad condition, showing many cracks.

Figure 7. Strandveien 19 and 21 (Trondheim Municipality, 2016).

A comparison of the floor plans shows some smaller changes in the usability of the space in the floors and basement. An apartment in the basement is changed to a bathroom and storage place for inhabitants, and some internal walls were removed to create a larger common space. In one of the flats in the second floor, an extra bedroom and own bathroom was built.

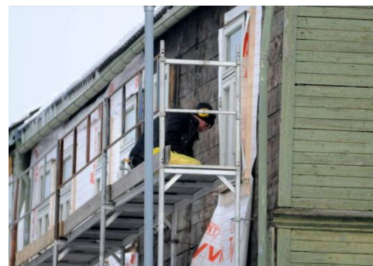
Figure 8. Renovation of the façade (Trondheim Municipality, 2016).
