Assessment on the 2014 Jure Landslide in Nepal – a disaster of extreme tragedy

K. K. Panthi

Norwegian University of Science and Technology (NTNU), 7491 Trondheim, Norway

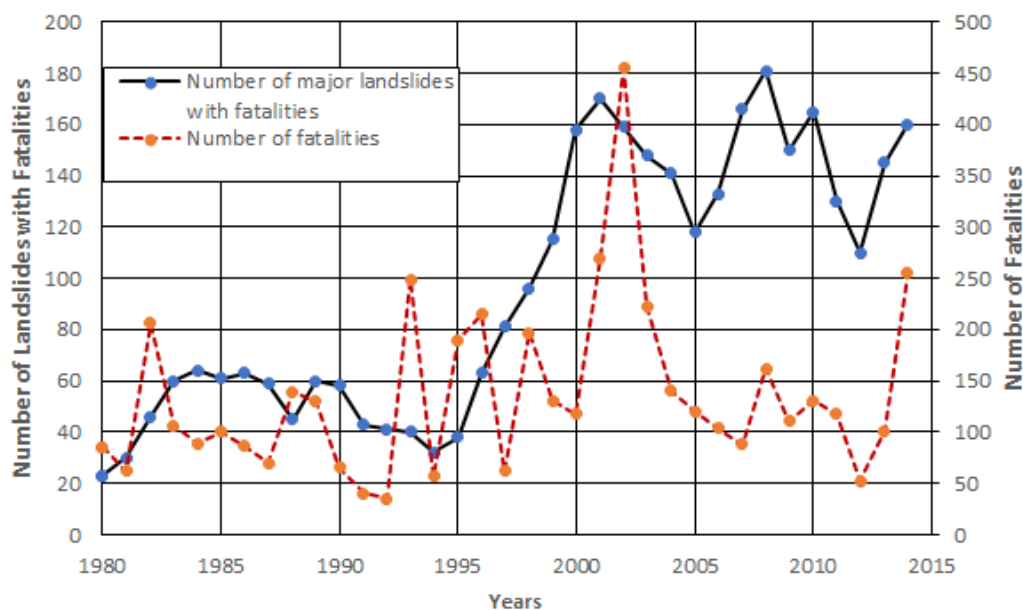
Figure 1. Landslides and loss of human life in Nepal between 1980 and 2015.

As one can see in figure 1, landslide is among the major geohazard risk in Nepal. Almost 4200 landslides with fatalities have been registered since 1980 (>100 landslides/year) and about 6100 people lost their life during the same period, which shows an annual average over 150 fatalities.

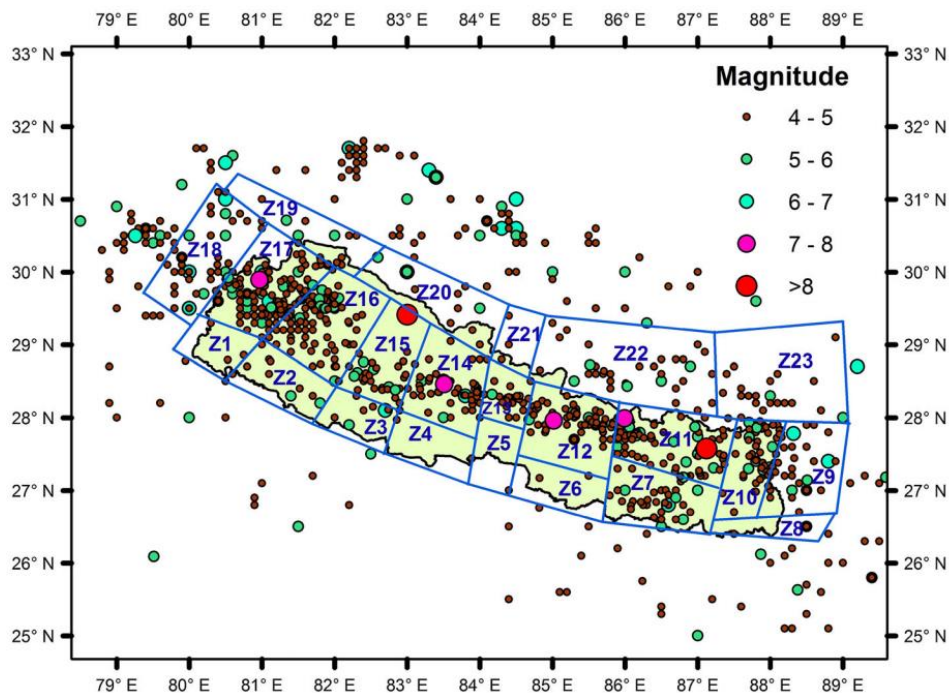
Figure 3. Seismic source zones and spatial distribution of earthquakes in and around Nepal [10].

In general, earthquakes in the Himalaya occur along major thrust systems such as Main Frontal Thrust (MFT), Main Boundary Thrust (MBT) and Main Central Thrust (MCT). However, as can be seen in figure 3, majority of earthquakes have been concentrated at and near the MCT area. The recorded prehistoric major and great scale (large-scale) earthquakes ($M > 7$) of past 500 years in the Himalayan region collected from various sources are summarized in the table 1.

- Repeated occurrence of prehistoric earthquakes of different scales as presented in figures 3 and 8 cause persistent ground acceleration, which have instigated to the extension of pre-existing discontinuities, formation of tension cracks at the top of the landslide, formation of many other joints and cracks in the rock mass and loosening that occurred on the upper layer rock mass material of steeply dipping topographic slope of Jure area.
- The continuous rainfall during June and July of 2014 caused full saturation in the rock mass. The heaviest rainfall (140 mm) on 30th and 31st July overloaded already saturated rock mass. The combination of overloading and maximum groundwater pressure along the slip surface, which dramatically reduced the shear strength may have been the main source for the disaster of this scale.

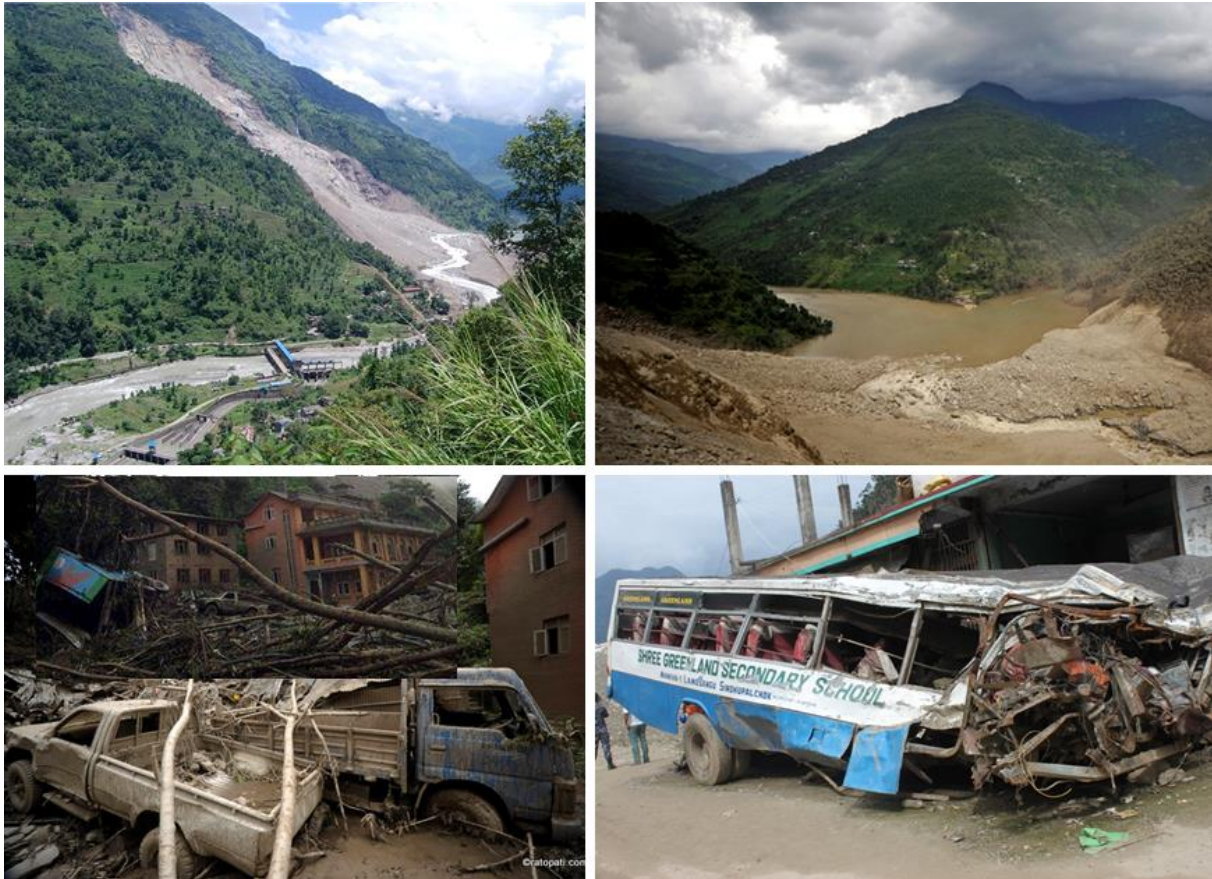
On the night of 2nd August 2014 (02:30 AM), an estimated 5 to 7 million cubic meter solid volume landslide struck in a densely populated village called “Jure” in Sindhupalchok District located at about 80 km northeast from Kathmandu, the capital of Nepal, on the bank of Sunkoshi River. Even though landslides are common in Nepal during monsoon and during large scale earthquake episodes, this slide was among the deadliest in Nepalese history. The slide caused death to 156 people sleeping at their home, displaced 436 people, 120 houses were destroyed or buried, 37 houses were partially damaged, part of the Araniko highway (approximately 2 km length) was completely damaged. Figure 4 below

shows the slide and upstream part of Sunkoshi hydropower project, the formation of dam and lake due to landslide mass and damaged houses and vehicles.

Figure 4. Jure landslide, damming of Sunkoshi River and damages caused by landslide.

An approximately 50 m high of dam was created by the slide damming Sunkoshi River about one km upstream from the Sunkoshi barrage of Sunkoshi hydropower project (upper two photos of Figure 4), which resulted to the formation of approximately 3 km long lake upstream (Figure 5, left). The partial dam-burst that occurred after overtopping caused significant damage to the headwork structures of the Sunkoshi HPP (figure 5, right) and on the Araniko highway.

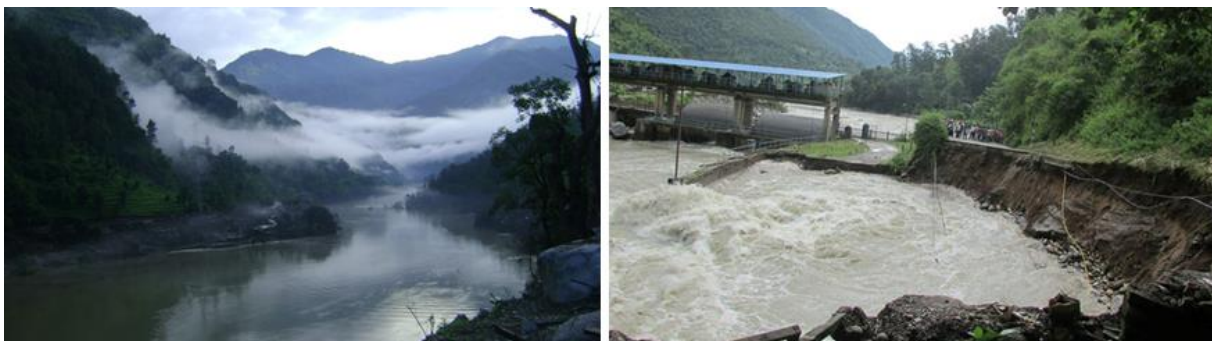
Figure 5. Lake formed by the landslide (left) and damage to road and headwroks of Sunkoshi HPP.

It took almost 45 days for the authorities and Nepal army to drain the lake. The continuous drainage work helped to avoid complete failure of the landslide made temporary dam and potential catastrophic damage downstream valley due to sudden flooding. The slide obstructed main transportation network between Nepal and Tibet-China and the Araniko Highway was reopened only after about 4 months by the end of November 2014.
