Anatomy of a mega-rock slide at Forkastningsfjellet, Spitsbergen and its implications for landslide hazard and risk considerations

Kuhn, D., Redfield, T.F., Hermanns, R.L., Fuchs, M., Torizin, J. & Balzer, D. 2019: Anatomy of a mega-rock slide at Forkastningsfjellet, Spitsbergen and its implications for landslide hazard and risk considerations. *Norwegian Journal of Geology* 99, 41-61. <https://dx.doi.org/10.17850/njg99-1-03>.

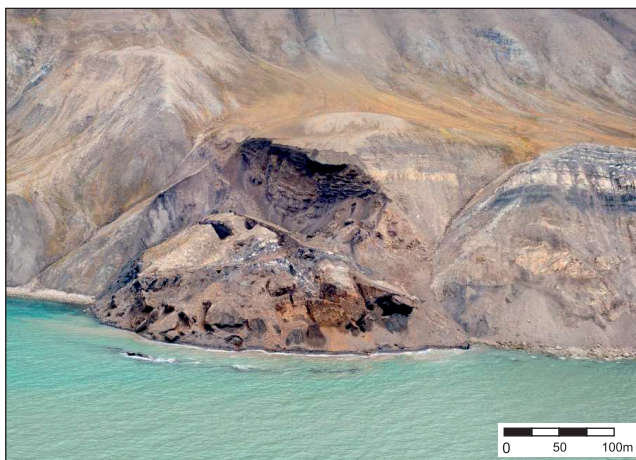
Figure 2. Recent sea-cliff failure of $\sim 300,000 \text{ m}^3$ rock on August 2016 (photo by John Christian Nygaard (2016), published in *Svalbardposten*, 12.08.2016, <http://svalbardposten.no/nyheter/stort-jordskred/19.7460>). Active mass-wasting processes along the coastline of Forkastningsfjellet illustrate the need for a detailed study and hazard evaluation. See Fig. 1C for location.

Recently, a relatively small ($\sim 300,000 \text{ m}^3$) landslide was released along the NE end of Forkastningsfjellet, a part of the coastal strip adjacent to Longyearbyen, Svalbard's administrative city (Fig. 2). Much of the seaward face of Forkastningsfjellet was itself mapped as an unstable mountainside affected by postglacial landslides and block faulting (Dallmann et al., 2001; Albertsen, 2016). The renewed instability of a small portion of the site illustrates the need for a comprehensive evaluation of slope stability of the greater Forkastningsfjellet area. In this paper, we describe the structural development of the mountainside, analyse the kinematics and potential conditioning factors of landslide activity and give a preliminary landslide hazard assessment in relation to a potential future catastrophic rock-slope failure event. This is of high importance for local risk management. The investigation is part of a collaborative effort of the Bundesanstalt für Geowissenschaften und Rohstoffe (BGR) and the Norwegian Geological Survey (NGU) to identify potentially active large-scale mass movements in the Spitsbergen area that pose a potential threat to Svalbard's coastal communities and their relationships to climate change.

Several young mass movements have been mapped along the coastline. The youngest landslide, first reported on August 12, 2016, affected the coastal scarp of Block 10 (Figs. 2, 6, 8 & 13A, B). Slope failure affected the outcropping sequence of Rurikfjellet Formation and the Festningen Member. Movement occurred along a steep slightly curved and concave surface of rupture leading to a chaotic displaced mass that was disintegrated into various blocks. In the central part, the head moved almost vertically downward by about 50 m even sustaining the original orientation of the cliff-top drainage rills with a backward tilt. This displacement took place between 4 pm and 6 pm as suggested by observations from bypassing ships (Røsvik, 2016) suggesting a minimum velocity of rapid following the classification by Hung et al. (2014). However, very or extremely rapid are also possible velocity classes for the event.

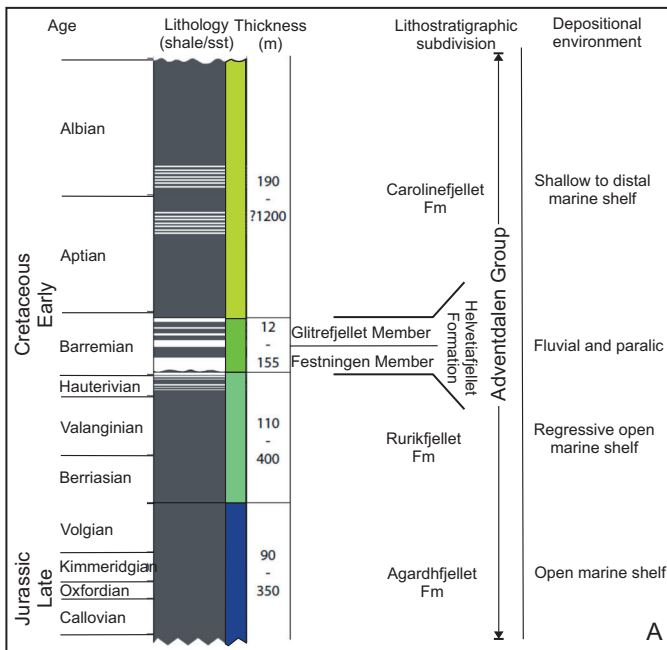
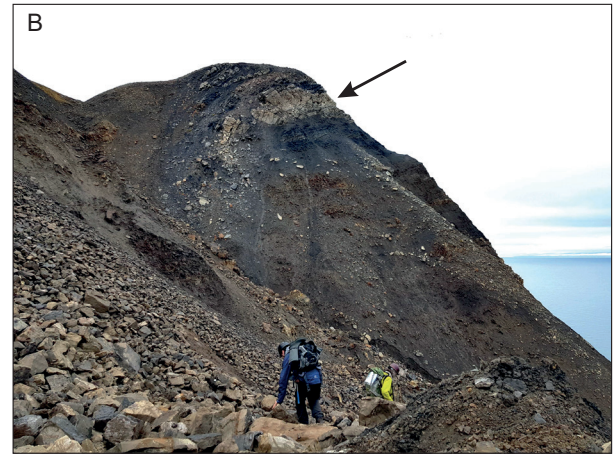
Figure 3. (A) Lithostratigraphic succession of the study area (modified from Midtkandal et al., 2007 after Mørk et al., 1999). (B) The light sandstones of the Festningen Member (black arrow) make up the basal part of the Helvetiafjellet Formation. The strongly fractured rocks form prominent cliffs and serve as a marker horizon to deduce displacements.

For our study, we divided the rock slide into three compartments, described individually below. Although we present new structural data, physical access to many of the blocks was not possible. Our given displacement amounts were principally deduced from offsets of the cliff-building beds of the Festningen Sandstone Member (Fig. 3B).

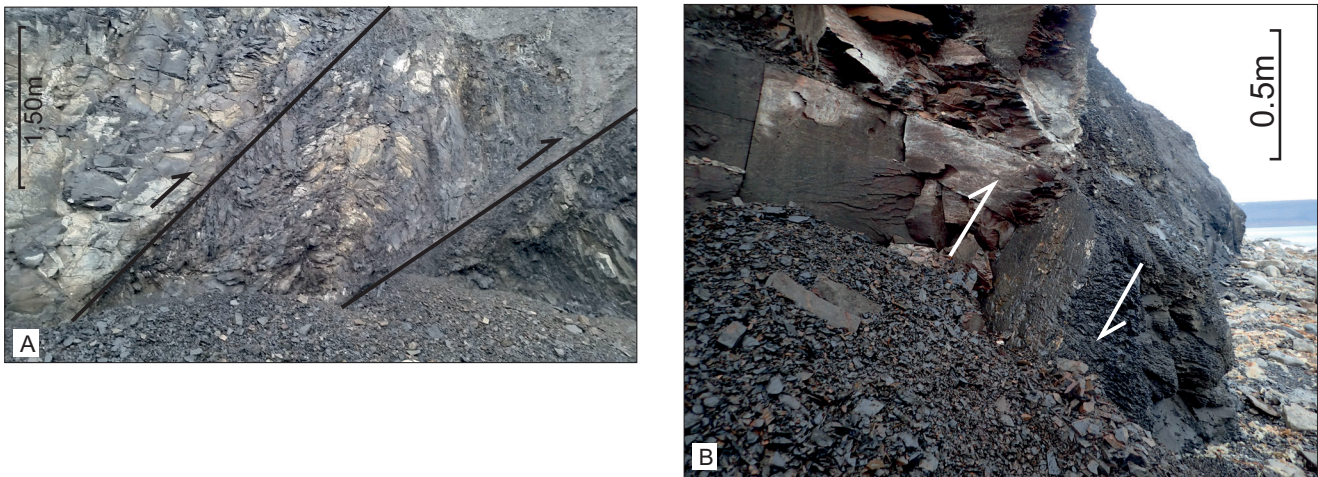
Figure 4. NW-SE-striking thrusts affecting the Rurikfjellet Formation. Outcrops (A) and (B) are situated along the Forkastningsfjellet coastline to the south of the southern limit of the rock slide. See Figs. 1C & 5 for location.

formations, which generally dip gently to the southeast. The sequence was affected by compressional to transpressional tectonism, commonly attributed to the development of the transpressional West Spitsbergen Fold-and-Thrust Belt (WSFTB) along the western coast of Spitsbergen during the Eocene (Bergh et al., 1997; Braathen et al., 1999; Tessensohn & Piepjohn, 2000; CASE Team, 2001; Dallmann et al., 2001). Such folds and faults can be well observed along the coastline at the southern border of the study area, occurring mainly in the outcrops of the Rurikfjellet Formation (Fig. 4A, B; see Fig. 1C for location).

so-called ‘Z-Fold’ affected the overlying sediments of the Helvetiafjellet Formation at the southern extension of Forkastningsfjellet (Fig. 4). These structures were linked to the eastern zone of the West Spitsbergen Fold-and-Thrust Belt, a thin-skinned, foreland, fold-and-thrust belt that is characterised by WSW–ENE-oriented shortening and which evolved during a transpressional event in the Eocene (Harland, 1969; Dallmann et al., 1993; Maher et al., 1995; Bergh et al., 1997; Piepjohn et al., 2016).

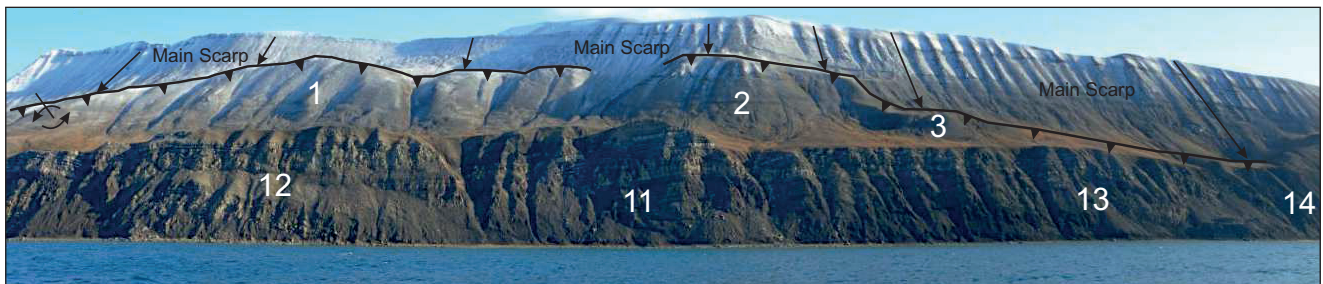
Figure 7. General view of the central segment of the Forkastningsfjellet rock slide with the block numbers; view to the east. The arrow at the left margin indicates counterclockwise slope-normal rotation of the downsiding Block 1. Vertical depression during the main movement created three scarps and connecting terraces. The steep coastal scarps are affected by active erosion and gravitational mass wasting.

To the north, an increasing vertical displacement across the main scarp produces an arch-shaped outline of Block 1 with a ramp-like north-sloping bench indicating a simultaneous down sliding and counterclockwise rotation of the northern extension of Block 1 (Fig. 7).

5, 7 & 8). To the south, a clear southwest-dipping surface drop between Blocks 11 and Block 13 is developed (Fig. 7), indicating a transfer fault that accommodates the different relative displacements of the neighbouring blocks. The flat ends at the southern limit of the main landslide body at Block 13 where an additional local escarpment between the flat surface and Block 3 indicates a local fault-bounded separation between Block 3 and the depression.

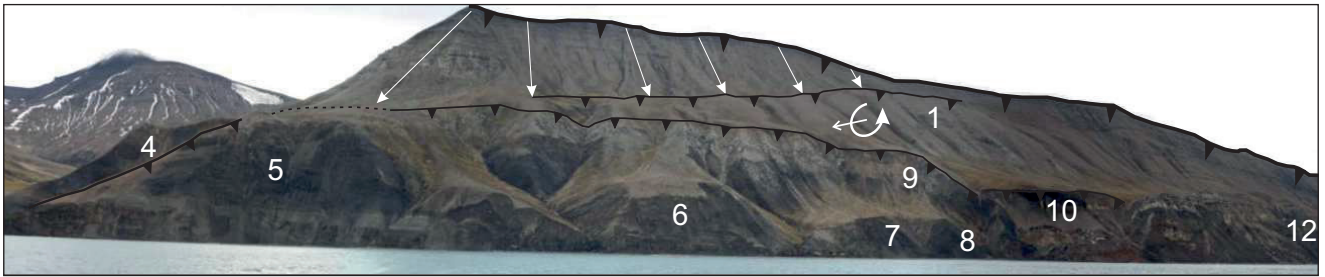
Figure 8. Northern segment of the Forkastningsfjellet rock slide with the numbered slide blocks and the bordering Carolinedalen valley to the left. Note the staircase alignment of the coastal blocks (Blocks 6, 7, 8) due to increasing vertical displacement from north to south. Arrows indicate displacement amounts along the main scarp (view to the southeast).

More landslide activity was mapped at the coastal cliffs of Block 5 and Block 6 (Fig. 8). Debris cones and elongated terraced deposits of talus, deposited at beach level, mark the unstable slope sections that are composed of the weak and erodible sedimentary rocks belonging to the Rurikfjellet Formation which are, in turn, overlain by the strong and more resistant sandstones of the Festningen Member. As the blocks are tilted backwards towards the main scarp, the existing joint system of the beds shows rotation into a more slope-parallel orientation, thereby

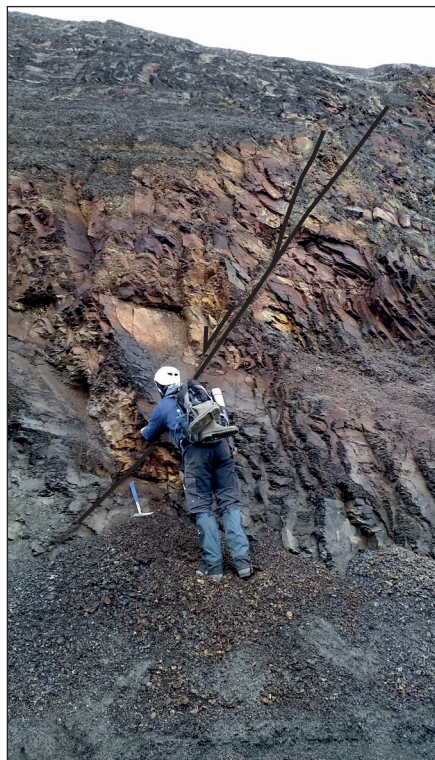
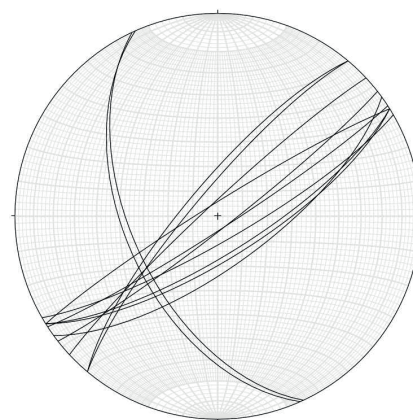
Figure 9. Normal fault at the southern margin of Block 5 (Figs. 5 & 8), offsetting pervasive NE–SW-striking sheeting joints. The sheeting joints dip steeply out of the face and further reduce the stability of the slope.

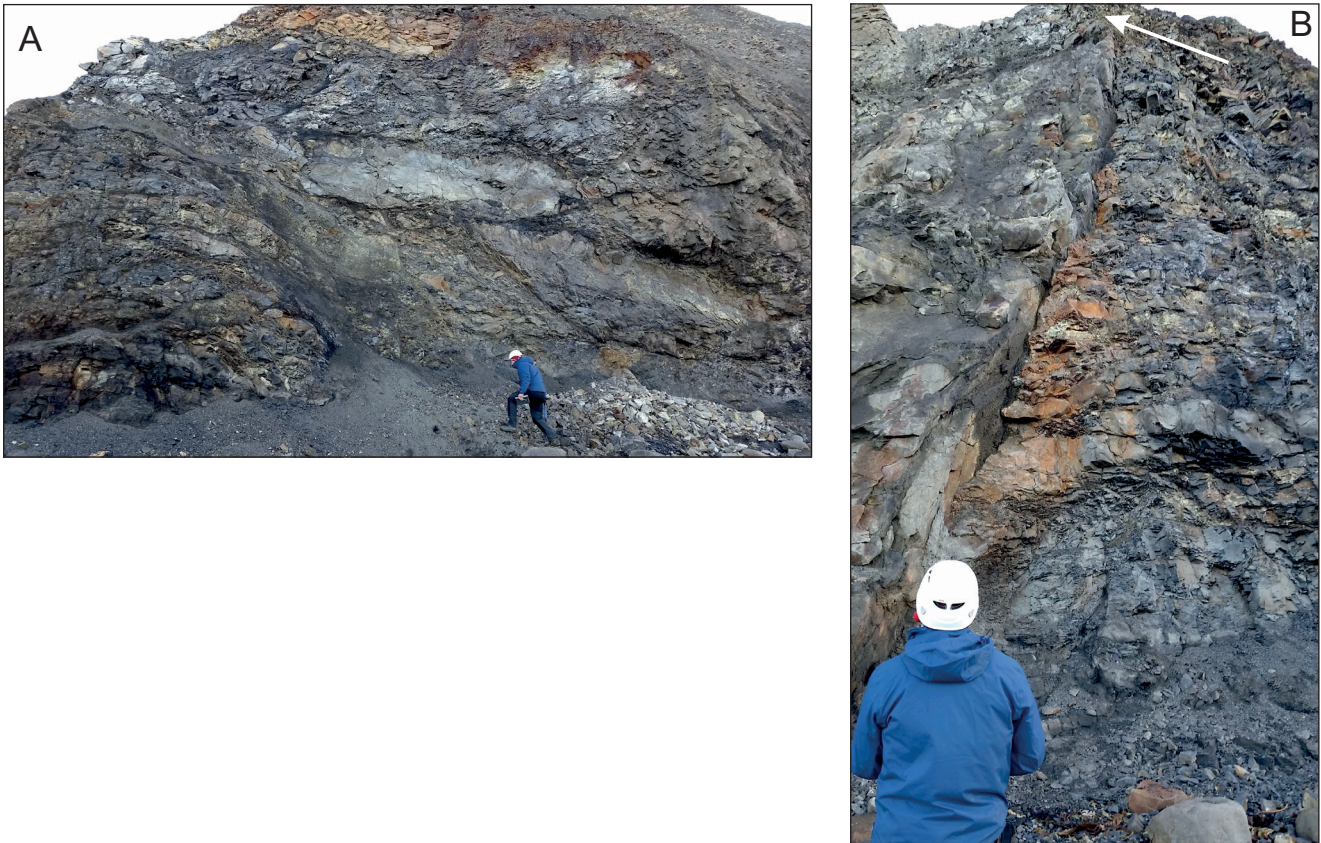
Figure 10. (A) View of the coastal cliff section of Block 4 (view to the east). Note the stacked lens-shaped sandstone blocks and intervening sheared mudstones and shales that are interpreted as slide blocks attributed to a synsedimentary collapse zone affecting the Rurikfjellet and lower Helvetiafjellet Formation. (B) Southern boundary of the collapse zone. The light sandstone to the left was deposited against a fault buttress formed in the underlying flat-lying Rurikfjellet beds. On the top, the channel fill deposit is overlain by a sequence of sandstones and siltstone beds (white arrow) indicating reestablishment of undisturbed sedimentation.

At the coastal cliff of Block 4 and the northern edge of Block 5, a puzzling outcrop can be observed that shows a major disruption of the normal bedding attitude and the structural features can be easily confused with brittle tectonic structures (Fig. 10A). Elongated lens-shaped sandstone blocks are stacked and shifted against each other and are juxtaposed with variably coloured and strongly fractured mudstone and sandstones packages, giving the impression of a chaotic mix of heterolithological units. The sandstone blocks show sharp tops and bases and are delineated by thin layers of sheared mudstone along downwardly curved sliding surfaces that plunge out of the slope.

In the central part of the outcrop, a trough-like, northwest-plunging, channel fill deposit of light sandstone is preserved that was deposited against a fault buttress formed in the underlying flat-lying Rurikfjellet beds (Fig. 10B). The re-establishment of undisturbed sedimentation after the complete infill of the depression is indicated by overlying sandstone beds.

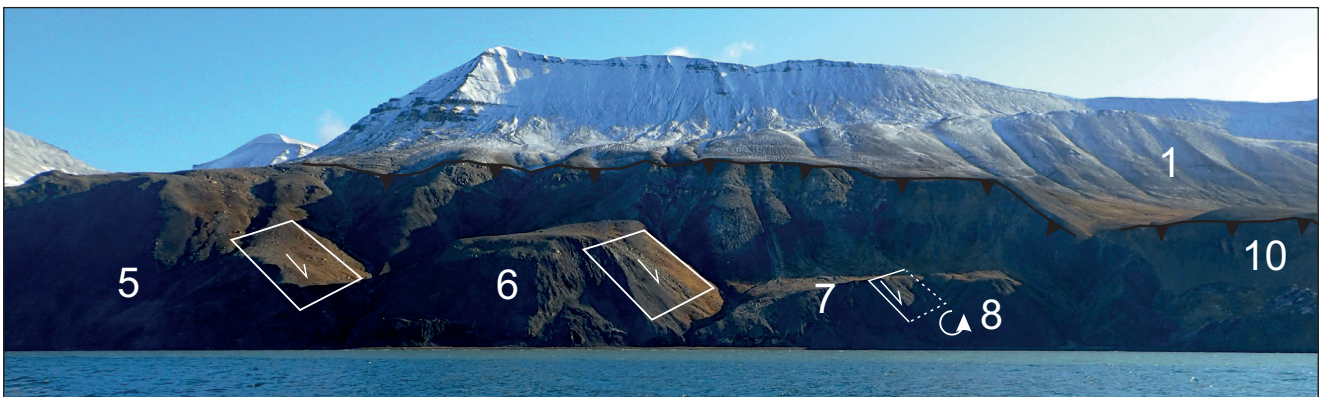
Figure 11. Stair-stepped arrangement of coastal blocks 6, 7, 8 and inferred fault planes. The recent landslide of Aug. 2016 is situated at the right margin. View to the east.

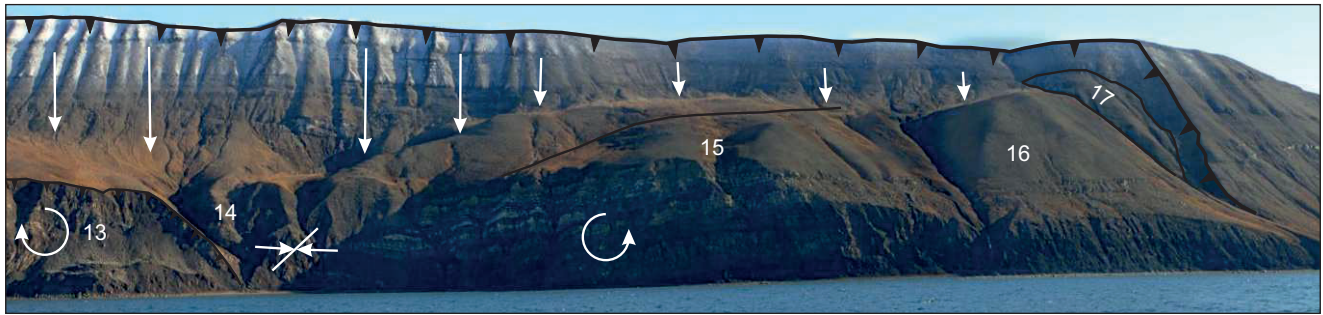
Figure 12. Southern Segment: Southern segment of the Forkastningsfjellet rock slide with the numbered landslide blocks; view to the southeast. Note the opposing rotation trends to the north and south of Block 14 and the active sea-cliff erosion at Block 13. Arrows indicate displacement amounts of Block 16 along the main scarp.

At the southern flank of the rock slide, the NE–SW-striking main scarp changes orientation into the ENE-oriented lateral scarp (Figs. 5, 6 & 12). The displaced rock mass in the hangingwall of the main sliding plane was divided into four separate fault blocks with variable slip directions and displacement amounts. Due to the change in orientation of the main scarp, the block movement is partitioned into a component of vertical dip-slip with a slope-parallel rotational component

A peculiar structural depression is developed at Block 14, which marks the transition from the central to the southern segment (Fig. 12). The block shows a vertical displacement of approximately 120 m and shows a

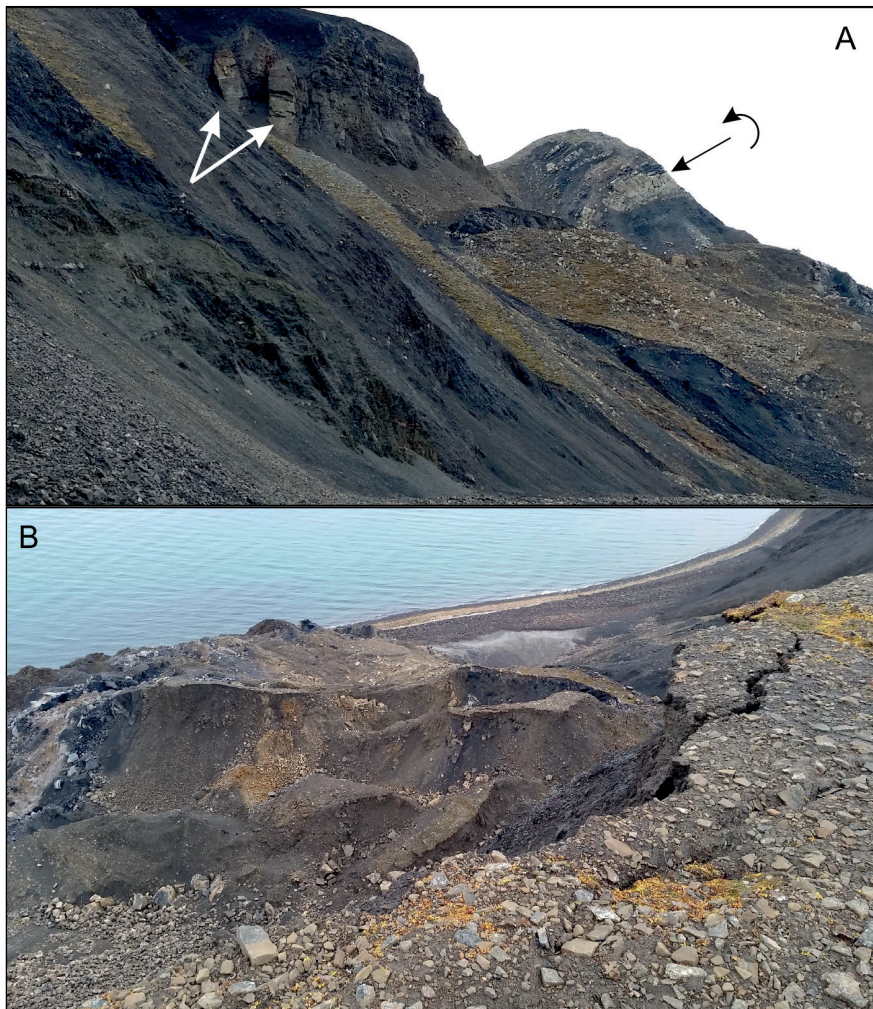
Figure 13. (A) The youngest landslide of August 2016 affected the coastal scarp of Block 10. Note the tilted columnar sandstone blocks directly beneath the landslide crown (see arrows) indicating a further imminent break away of the cliff crest. In the background, the coastal Block 12 shows bedding rotation of $\sim 25^\circ$ towards the main scarp (see arrow, view to the southwest). (B) Landslide crest and chaotic slide mass, view to the northwest.

Farther down the slope and at the flanks of the landslide the slide mass is separated into tilted and juxtaposed slump blocks and intercalated unstructured masses giving the displaced mass a stepped to jagged surface relief. During field inspection, a displaced rock mass of approximately 300,000 m^3 was estimated. Nevertheless, deep crevasses and arcuate cracks at the landslide crown and tilted columnar sandstone blocks beneath the crown (Fig. 13) lacking base support and ready to topple indicate ongoing landslide activity and a correlated retrogression of the slide into the crown. Though a detailed investigation could not be performed for reasons of time and safety, the slope movements are attributed to failure along steep coalescing discontinuities and the joint system.

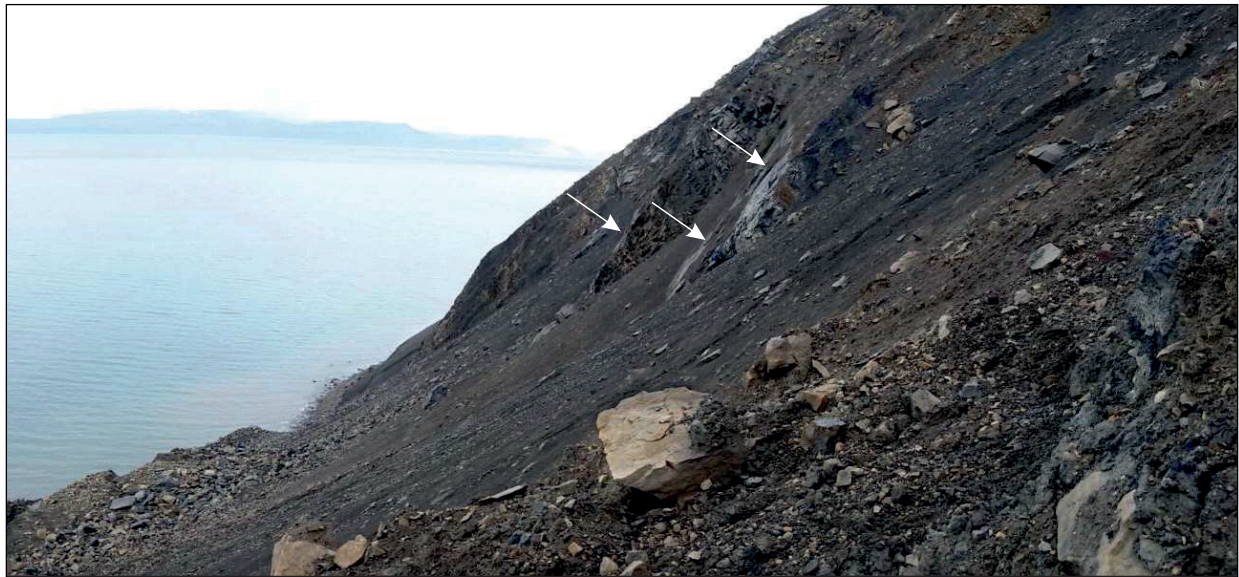
Figure 14. Active gravitational mass wasting along the coastal scarp of Block 13. Instability along adversely oriented slide surfaces (orientation: 26/55 NW) are a consequence of basal sea-cliff erosion and slope oversteepening. White arrows indicate slope-parallel sliding surfaces, view towards north.

At the southern limit of Block 13, a 150 m-long section of the coastal cliff is affected by a young, but undated slope failure event leading to elongated and benched deposits at beach level (Figs. 4 & 14). The displaced rock mass shows a stepped surface due to superimposed rock slabs, which moved successively downslope. The landslide is interpreted as a shallow translational slide of superficial rock blocks and debris that were displaced along planar surfaces of rupture that are governed by the steep slope-parallel dipping joint system of the back-tilted Block 13 (Fig. 14).

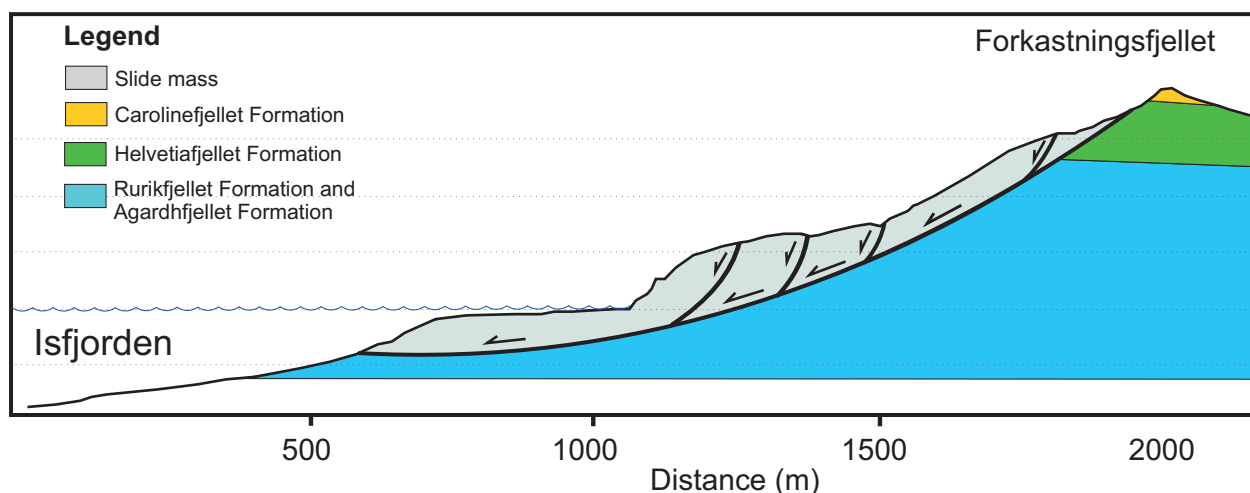
Figure 15. Generalised model and cross-section of the Forkastningsfjellet rock slide (section 6 in Fig. 5). Rock-mass fragmentation and rotational movement of the tilt blocks are attributed to rock-mass failure and westward displacement in the hangingwall of a listric basal décollement. This basal shear zone probably daylight at the submerged eastern slope of the Isfjorden (in scale 1:1).

Based on the described field observations, the Forkastningsfjellet rock slide is characterised as a multiple rotational rock slide that occurred principally on a spoon-shaped west-dipping failure surface. This listric failure surface produces the steep major fault scarp at the eastern limit of the rock slide and probably flattens downward into a low-angle detachment zone situated in the flat-lying bedding planes of the less competent shales of the lower Rurikfjellet/Adventdalen Group sediments. During the westward displacement, the rock mass broke up into secondary slumps and the associated scarps to form the observed stair-step pattern of displaced blocks and flats. Such a subdivision of the moving rock mass into relatively coherent and rigid back-rotated tilt blocks is a clear diagnostic feature of a rotational slide movement in the hangingwall of a listric sliding surface. The depth of the basal décollement is unknown, but it is assumed that it must ‘daylight’ in the west-dipping offshore slope of Isfjorden. From geometric considerations deduced from differential displacements of the rotated hangingwall blocks, a minimal depth of 60 m below sea level is assumed (Fig. 15).

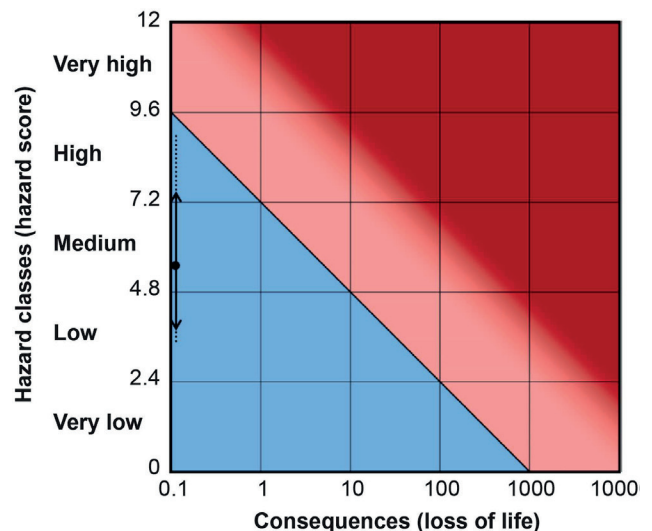
Figure 16. Preliminary hazard analyses for a development of the Forkastningsfjellet rock slide into a rock slide failure suggesting a mean medium hazard with uncertainties spreading between low and high following the Norwegian system for classifying hazard and risk on unstable rock slopes (Hermanns et al., 2012, 2013a). The large uncertainties on the hazard axis are due to missing data on deformation rates, past events and a lack of comparative data on the rock-fall activity. A failure of the Forkastningsfjellet rock slide will not have any direct consequence as there is no settlement nearby. However, an extremely rapid failure would trigger a displacement wave that would reach Longyearbyen. A preliminary run-up analysis is presented in the text, but a consequence analysis in regard to a possible loss of life has not yet been carried out as data on the distribution of people in the wave run-up area are not available at present.

most data are available from the Forkastningsfjellet rock slide based on our study. For a consideration of reactivation of the Forkastningsfjellet rock slide, we can determine that the back scarp and both lateral flanks, as well as the underlying sliding surface, are well developed because several tens of metres of deformation have been accommodated by those in the past. Our structural analyses suggest that inherited structures do not allow for planar sliding, wedge sliding or toppling of such a large volume. However, detailed structural data on several of the individual blocks are missing today. Uncertainties apparent in this assessment are displacement rate, acceleration and past events. These can be reduced in the future by acquiring bathymetric data and monitoring the rock slide. A very low velocity is suggested by the absence of opened cracks on the slope, although we cannot affirm that no displacement is taking place as surface processes may be masking rock slide activity. A higher weight for low-velocity classes is therefore justified. Earlier catastrophic events, acceleration or enhanced rockfall activity cannot be presently assessed as data are missing. The resulting hazard analysis results in a medium hazard class with large uncertainties spanning from low to high (Fig. 16).
