Rain Intrusion Through Horizontal Joints in Façade Panel Systems - Experimental Investigation

Master's thesis in Civil and Environmental Engineering
Supervisor: Tore Kvande
June 2022

Norwegian University of Science and Technology
Faculty of Engineering
Department of Civil and Environmental Engineering

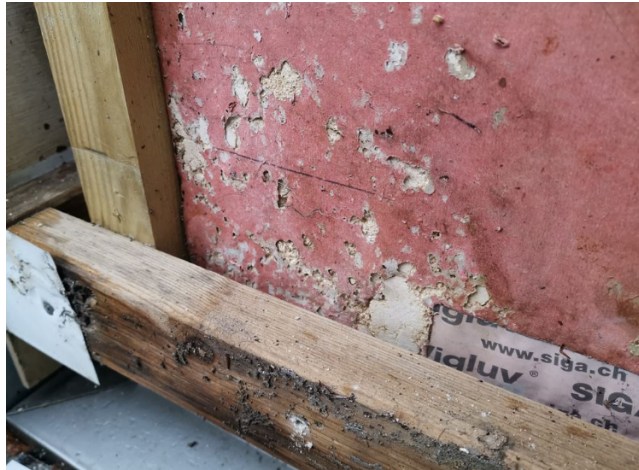
Figure 1.1: Large amounts of water intrusion through both vertical and horizontal joints in an apartment block in Bergen. One consequence is a decomposing wind barrier (Geving, 2022).

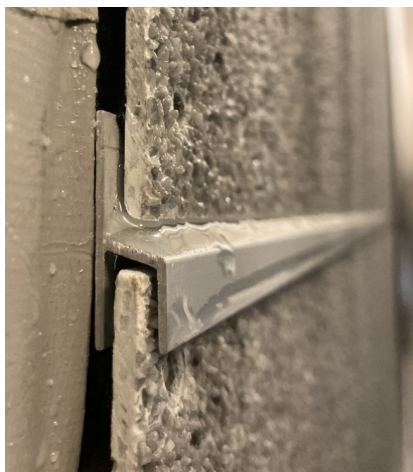
Figure 1.3: A h-profile in a joint. Photo taken during test no. 26 with Glass Fiber Rough and a h-profile.

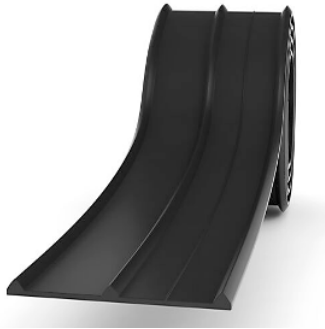
Figure 3.4: EPDM with grooves, used with fiber cement panels.

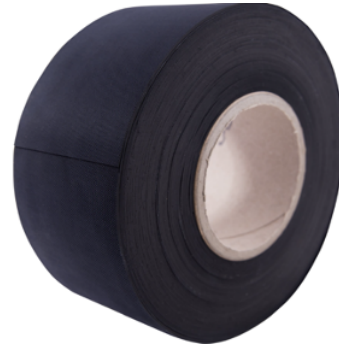
Figure 3.5: Plain EPDM used with Glass Flocksier and High Pressure Laminate panels.

After the frame and Lexan board were sealed six 30 mm x 48 mm vertical battens was mounted to the studs through the Lexan board by using $\phi 5.5$ 80 mm long screws with a distance of approximately 600 mm. This gave a 30 mm air cavity depth. At first only the top of the battens were fastened in order to mount the drainage system on the Lexan board, and seal the system beneath the battens. An ethylene propylene diene monomer (EPDM) gasket was stapled to the battens. Two types of EPDM gaskets were used according to recommendations from the façade panel suppliers. For the fiber cement panels an EPDM with grooves was used, see Figure 3.4, and for the rest of the panels a plain gasket was used, see Figure 3.5. The gaskets were 70 mm wide.

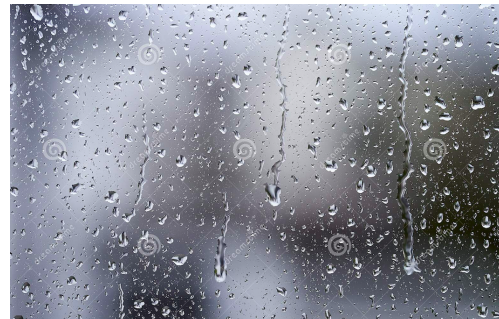
Figure 4.2: Water trickling down a surface, running droplets. Photo: Anatoli Weingart.

Droplet means a small drop of water and is used to describe water hanging or running down a surface. *Hanging droplets* often occurred on the edges of open joints if the joint width was sufficient, or as for instance shown in Figure 4.1 hanging off protruding elements. The term *running droplets* is used in relation to low water flow. The water trickles slowly and a clear droplet could be seen running down the panel or Lexan board, as shown in Figure 4.2.

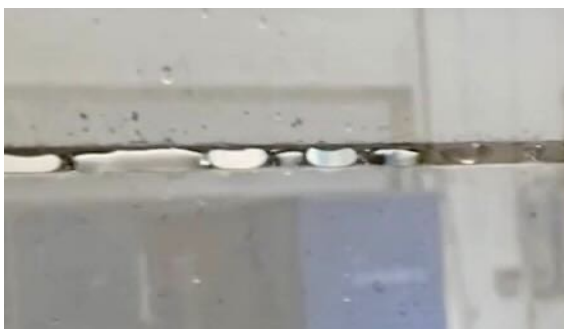
Figure 4.4: A partial water bridge in the lower joint. Photo taken during test no. 58 with Fiber Cement White panels and a 5 mm joint width.

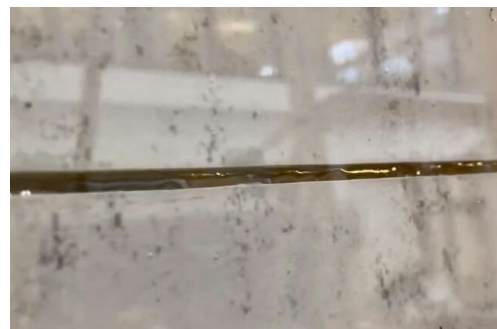
Figure 4.5: Water bridge that is continuous throughout the lower joint. Photo taken during test no. 43 with Fiber Cement Grey panels and a 3 mm joint width.

Water bridges occurred in the joints when the water flow creating water droplets was high enough to create a connecting bridge between the top and bottom edge of the joint. Furthermore the joint had to be at least < 8 mm for water bridges to occur. Figure 4.4 shows a *partial water bridge*, as there are air gaps in between the water bridges. Partial water bridges were usually observed in 5 mm joint. A *continuous water bridge*, as shown in Figure 4.5, had no air gaps and was continuous. In almost every test a continuous water bridge could be observed in the top joint, if the joint was open. Likewise it was often observed in a 3 mm joint.

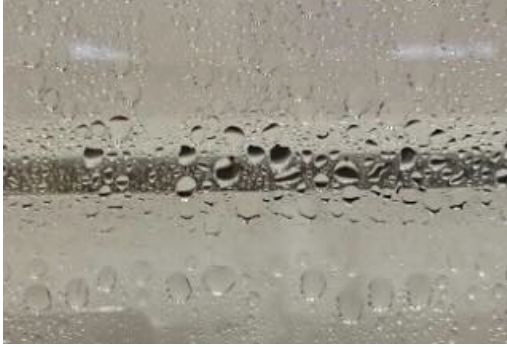
Figure 4.6: Direct spray through the top joint to the wind barrier. Photo taken during test no. 86 with Fiber Cement White and an 8 mm joint.

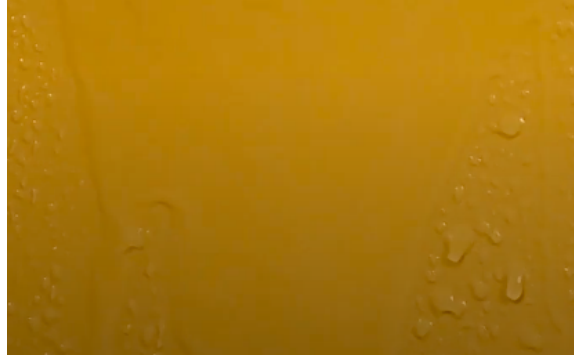
Figure 4.7: Water film on exterior side of panel. Photo taken during test no. 195 with HPL panels and a sealed top joint.

Water films occurred both on the exterior and interior side of the façade panels, in addition to flowing over the entire exterior joints. Usually, when a water film flowed over a joint, less water infiltrated the joint. Figure 4.7 shows an a water film on the exterior side of the panels.

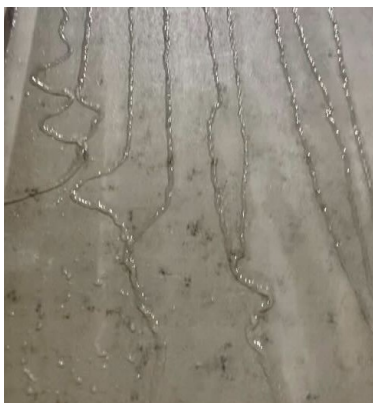
Figure 4.8: Water streams down the interior side of a panel. Photo taken during test no. 97 with Fiber Cement Grey panels and an U-batten.

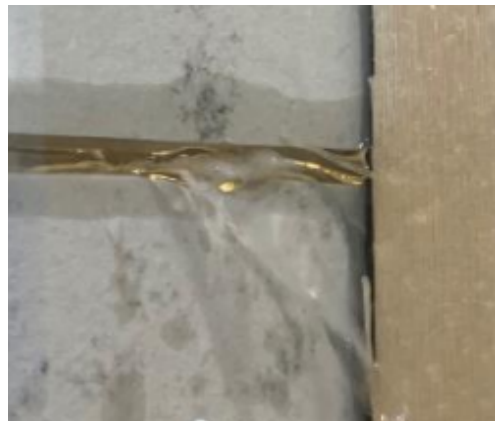
Figure 4.9: Ejection effect from a joint to the wind barrier (Mo & Lid, 2020).

For highly concentrated streams on the exterior side of the panels, water could infiltrate the joint and hit the wind barrier directly because of a horizontal flow component, this is referred to as the ejection effect. Figure 4.9 shows an example of the ejection effect. When this phenomenon occurred a lot water intrusion to the wind barrier was measured. It was however, a sporadic and unpredictable effect.

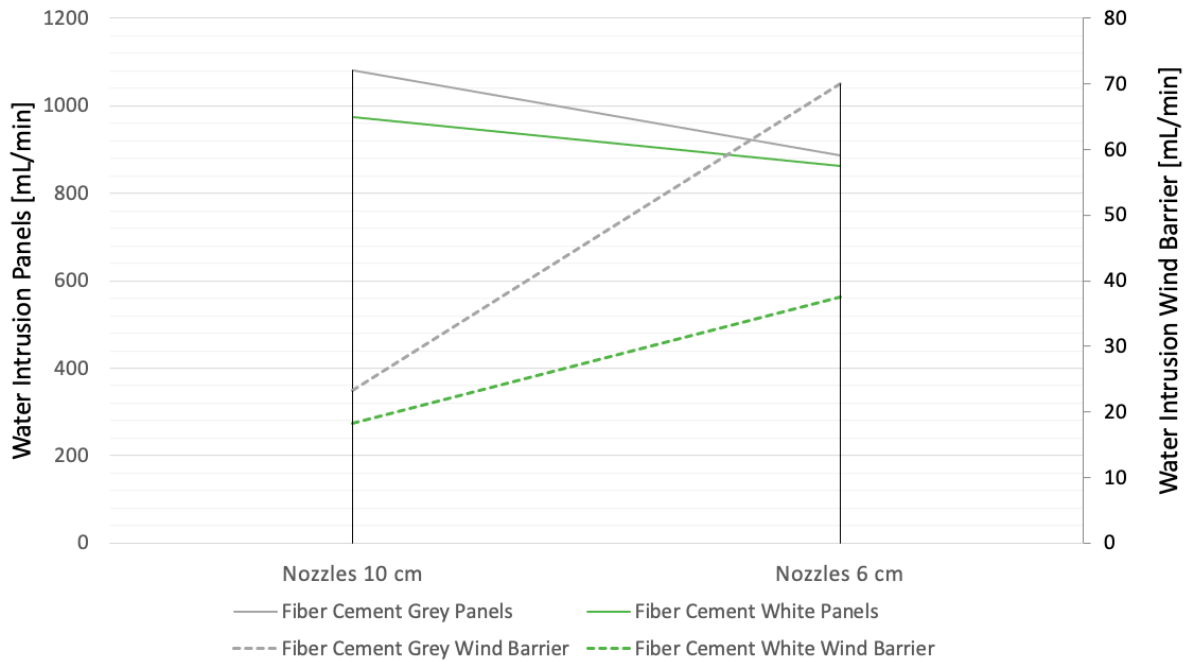
Figure 4.10: Water intrusion with a 5 mm open joint and different nozzle placements. The left vertical axis and solid lines show the water intrusion to the interior side of the panels. The right vertical axis and the dashed lines show the water intrusion to the wind barrier.

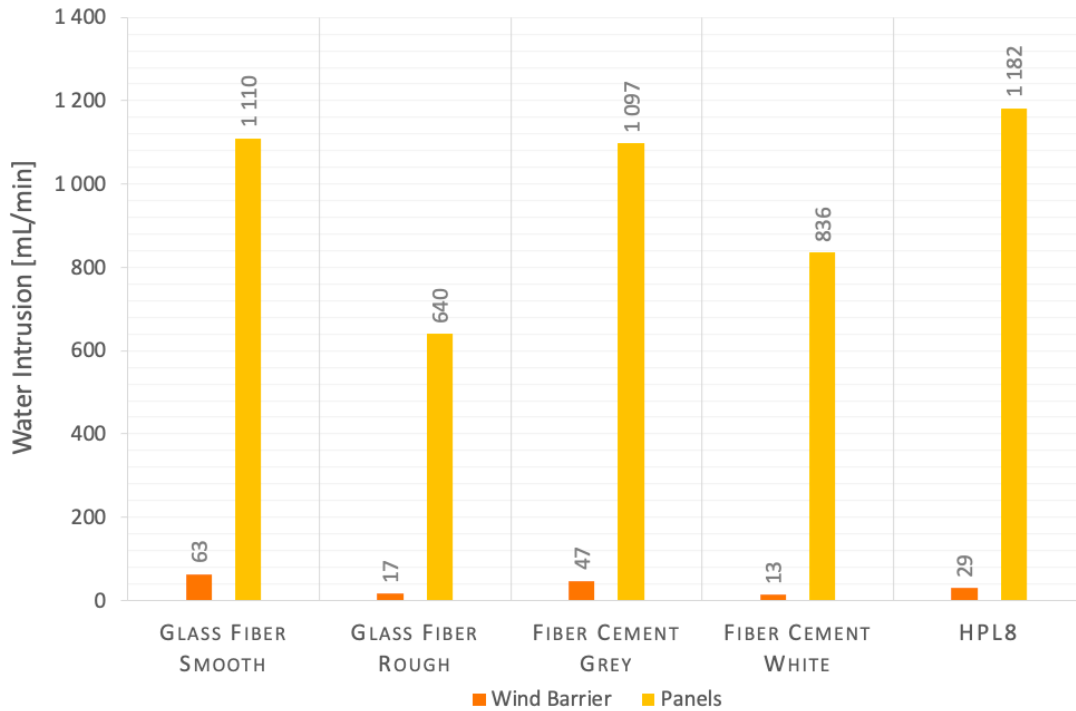
Figure 4.11: Average collected water intrusion on the interior side of the panels and on the wind barrier for the five different façade panels. Averaged over the parameters that are tested with all the panels; 5 mm, 8 mm, T1-profile, T2-profile, and sealed top.

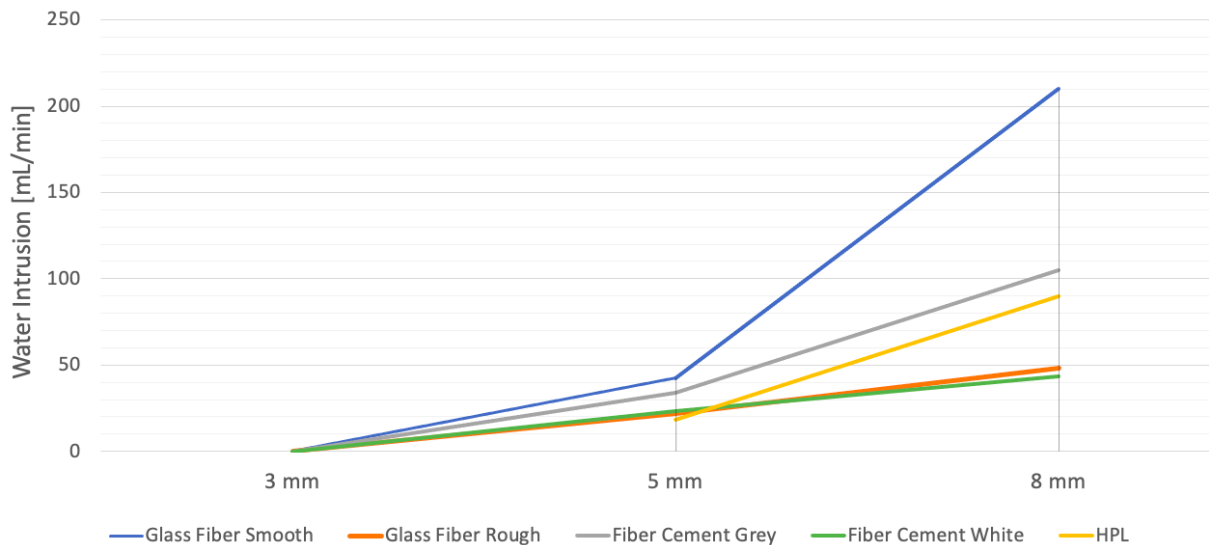
Figure 4.12: Water intrusion to the wind barrier for five different panels with 3, 5, and 8 mm joint widths.

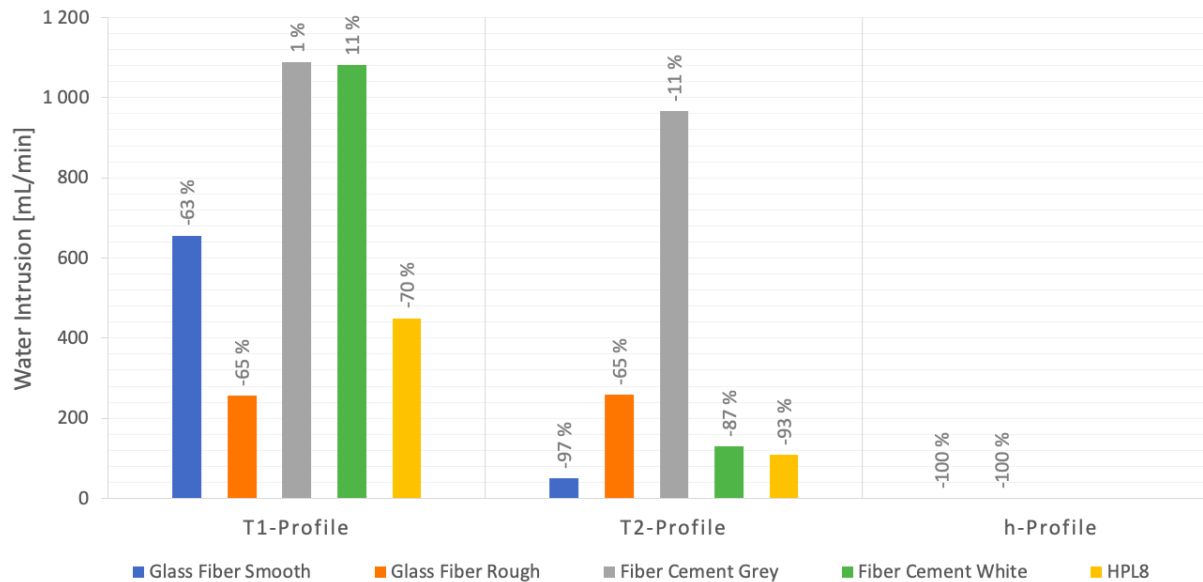
Figure 4.14: Water intrusion to the interior side of the panels using profiles within the joint: T1-, T2-, and h-profiles. The percentage change from the measured water intrusion with the standard recommendations in Table 4.2 is shown.

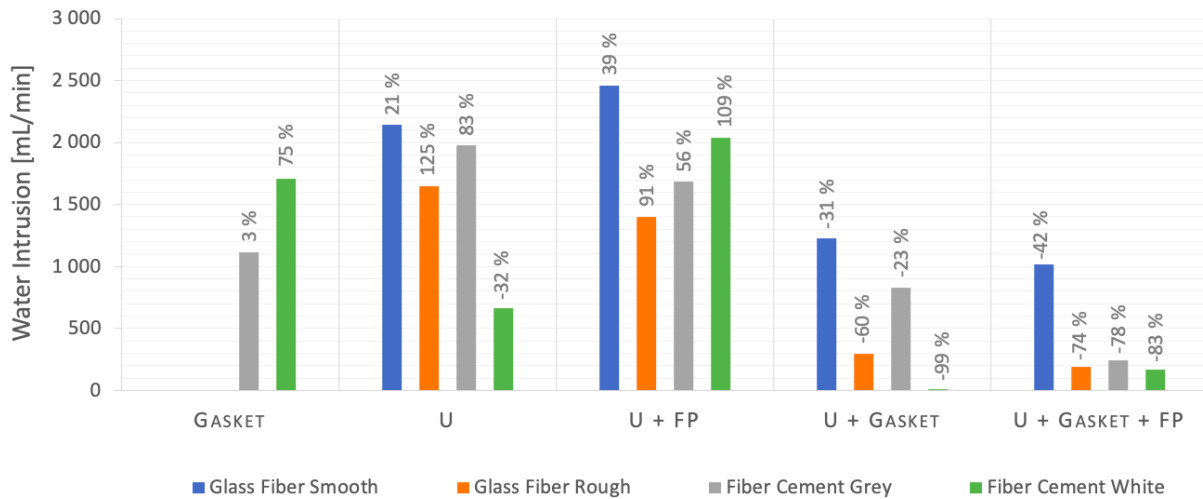
Figure 4.16: Water intrusion to the interior side of the panels using profiles behind the joint: Gasket, U-batten, U-batten + extra FP, U-batten + gasket, and U-batten + gasket + extra FP. Vertical axis gives the water intrusion in mL/min. The percentage change from the measured water intrusion with the standard recommendations in Table 4.2 is shown.

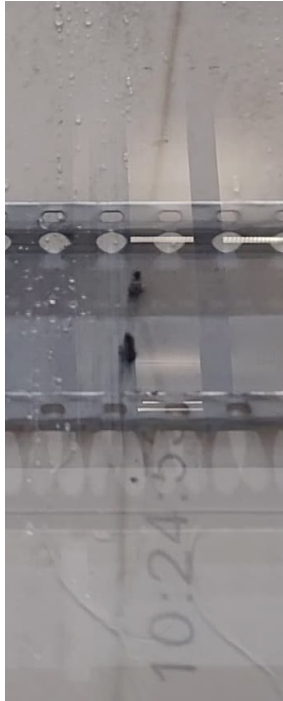
Figure 4.17: Crack in Fiber Cement White caused by extra fastening points, seen from the interior. Caused before testing with "U + FP" in test no. 118.

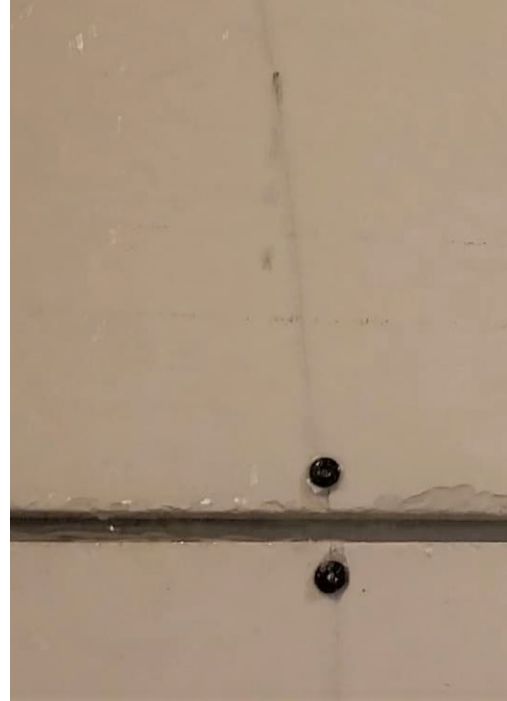
Figure 4.18: Crack in Fiber Cement White caused by extra fastening points, seen from the exterior. Caused before testing with "U + FP" test no. 118.

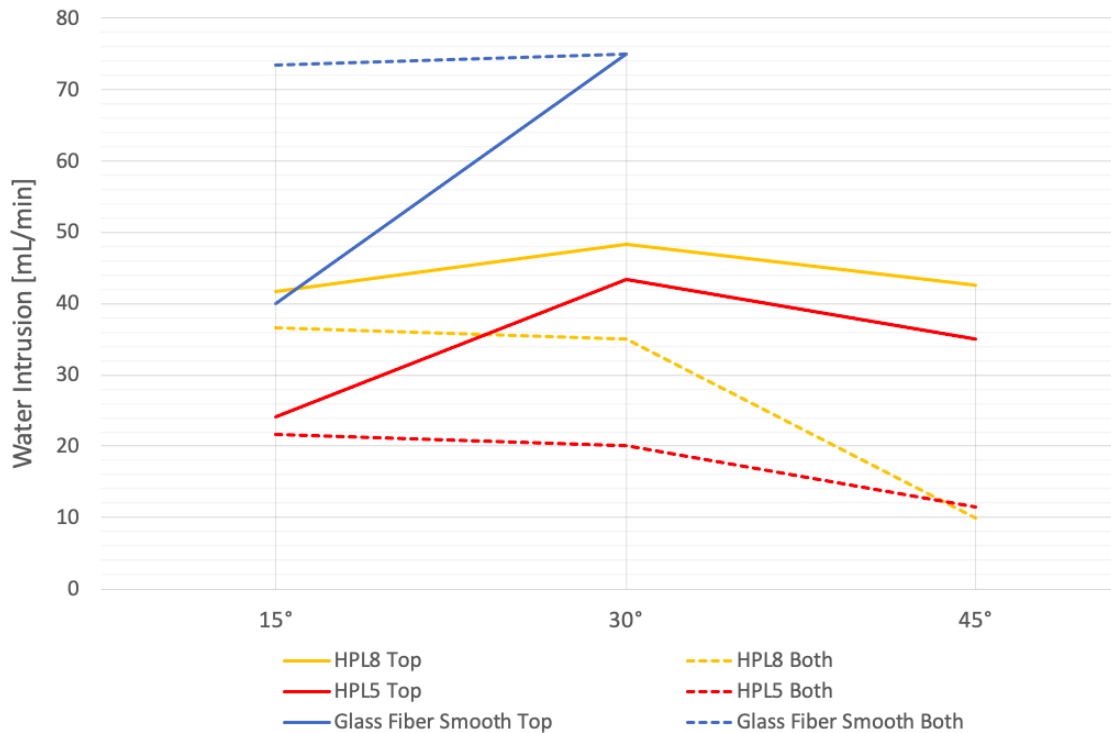
Figure 4.19: Water intrusion to the wind barrier for HPL and Glass Fiber Smooth with different bevelled joint designs. 15°, 30° and 45° represents the degree of bevelment. The solid lines represent the top-bevelled joints. The dashed lines represent the top-and-bottom-bevelled joints.

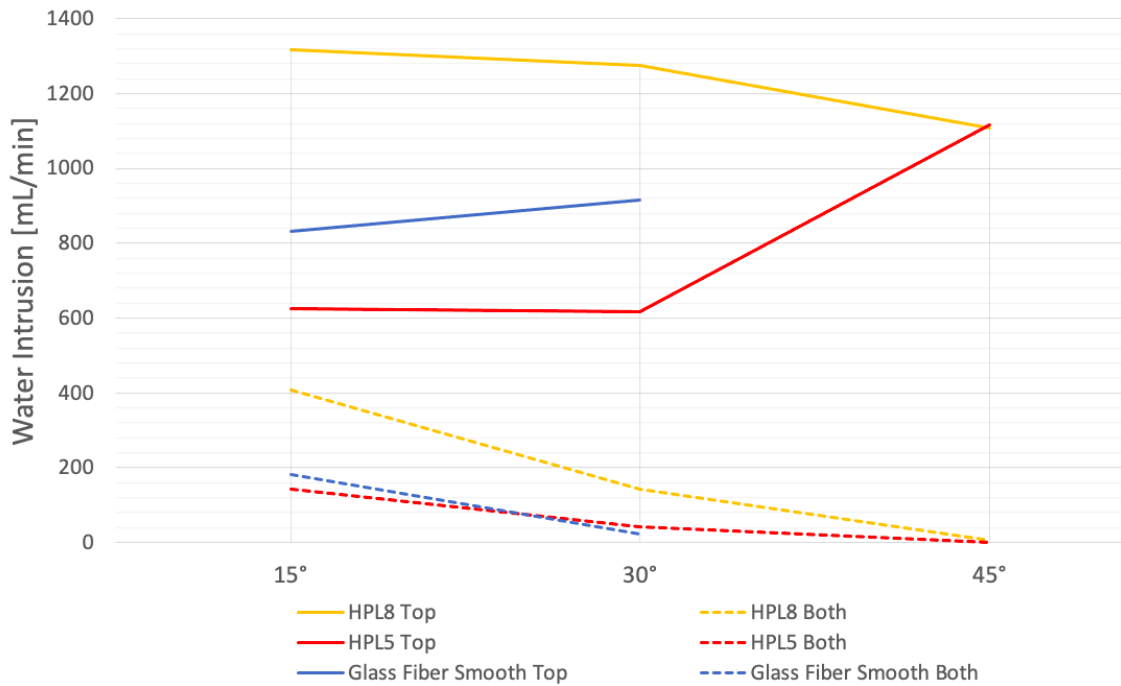
Figure 4.20: Water intrusion to the interior side of the HPL and Glass Fiber Smooth with different bevelled joint designs. 15°, 30° and 45° represents the degree of bevelment. The solid lines represents the top-bevelled joints. The dashed lines represents the top-and-bottom-bevelled joints.

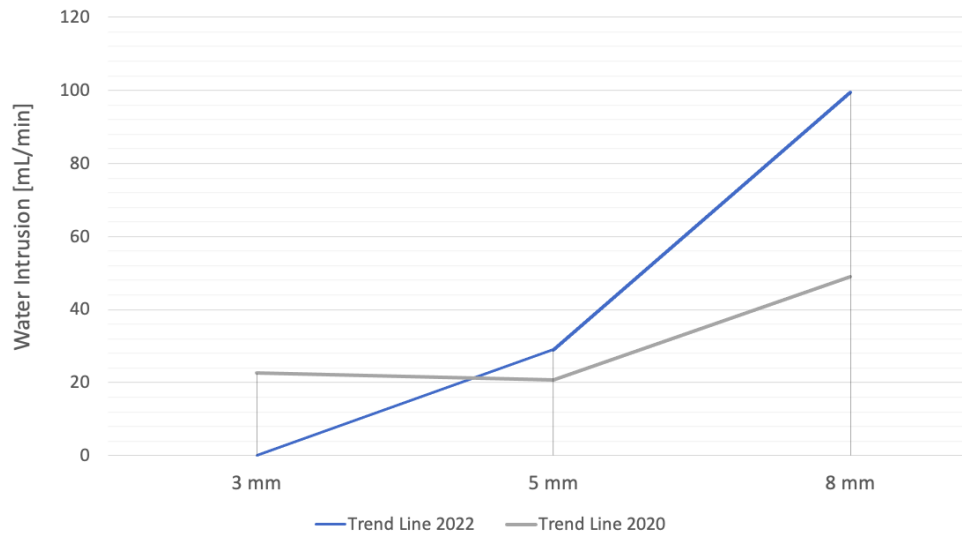
Figure 4.22: Water intrusion to the wind barrier with different joint widths. Comparison between the present study's (2022) laboratory results and Mo and Lid (2020) results. The results for the different panels are averaged to give a trend line.

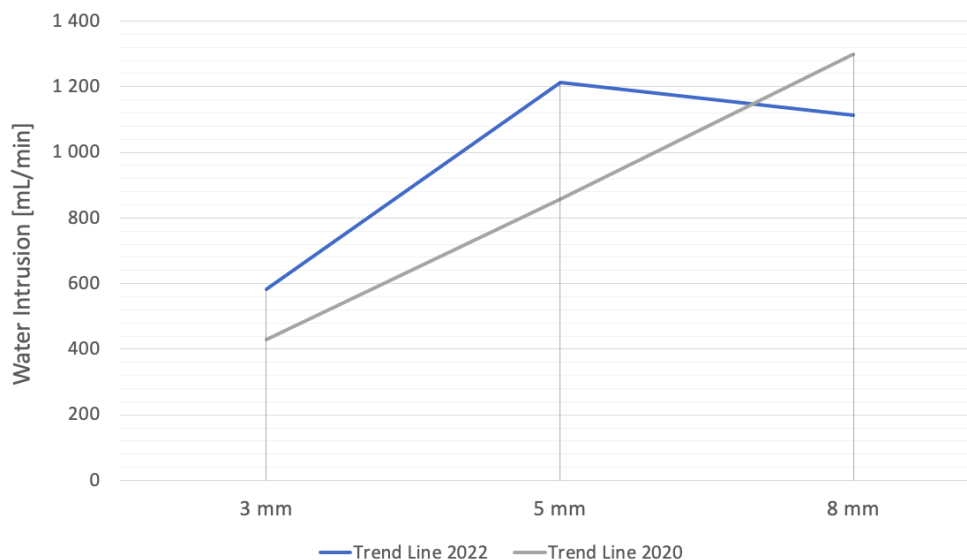
Figure 4.23: Water intrusion to the interior side of the panels with different joint widths. Comparison between the present study's (2022) laboratory results and Mo and Lid (2020) results. The results for the different panels are averaged to give a trend line.

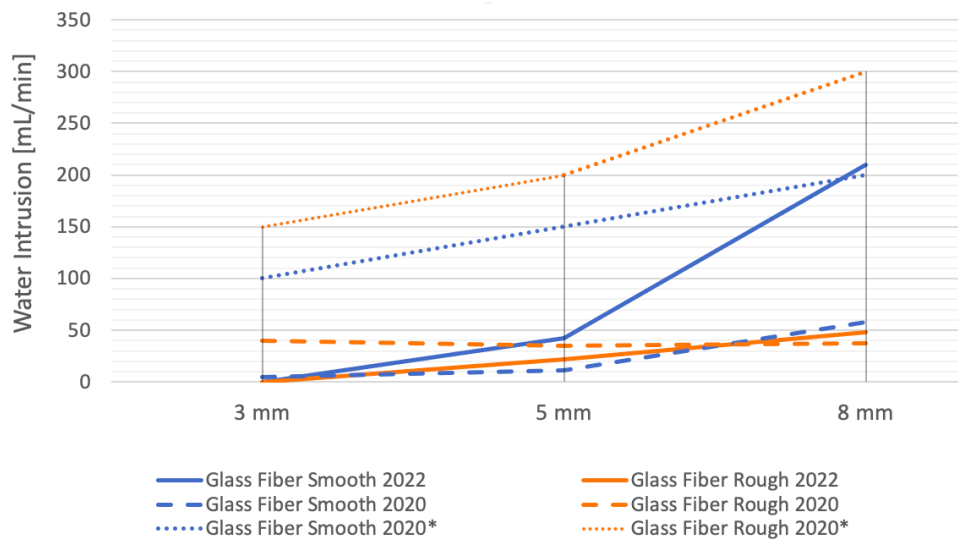
Figure 4.24: Water intrusion to the wind barrier with different joint widths using the glass fiber panels. Comparison between the present study’s (2022) laboratory results and Mo and Lid (2020) results, also including tests performed by SINTEF and NTNU personnel. Solid lines are the 2022 results, dashed lines are the 2020 results performed by Mo and Lid, and the dotted lines are the 2020 results performed by the SINTEF and NTNU personnel.

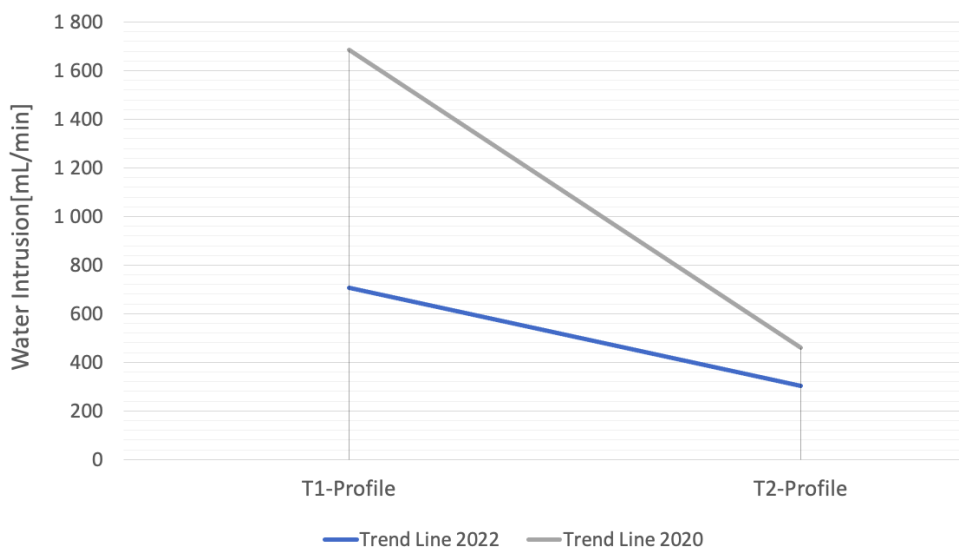
Figure 4.26: Water intrusion to both the wind barrier and interior side of the panels with a T1- and T2-profile. Comparison between the present study’s (2022) results and Mo and Lid (2020) results. The results for the different panels are averaged to give a trend line.

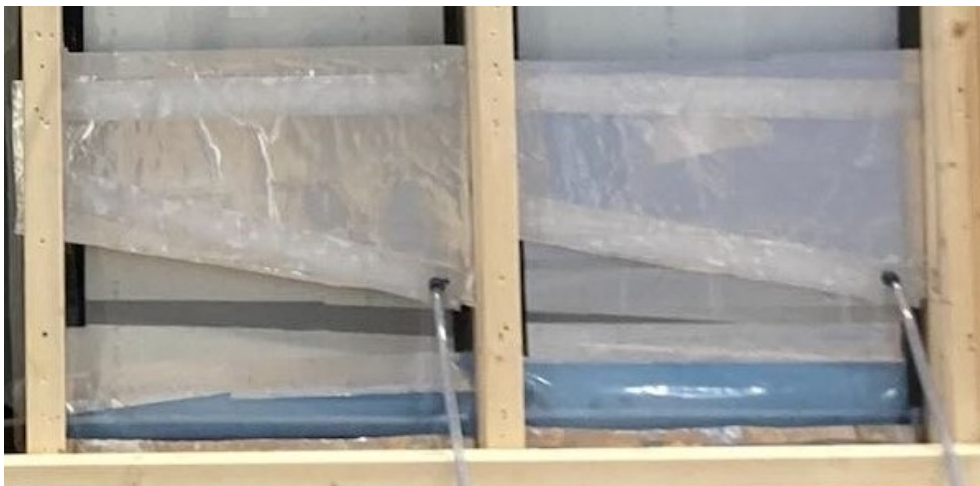
Figure 4.30: Gutter system seen from the interior side. Aluminium gutters above the blue plastic gutters.

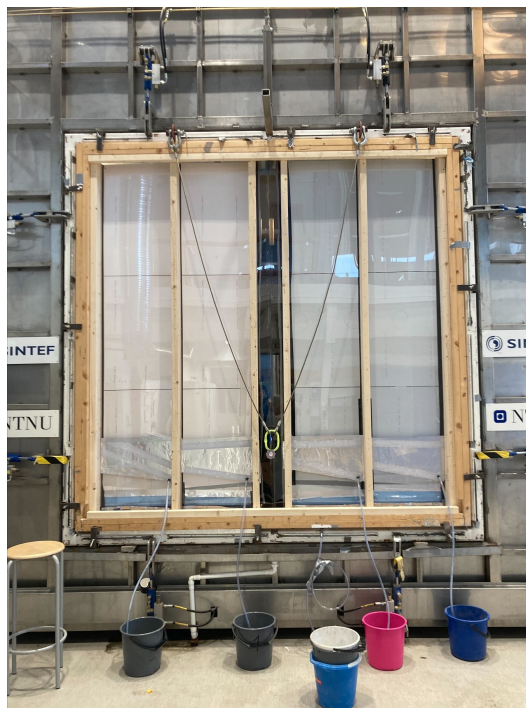
Figure 4. The test rig seen from the interior side. The water collecting system consists of buckets and tubes. Left side of the rig is test section 1, and right side is test section 2.

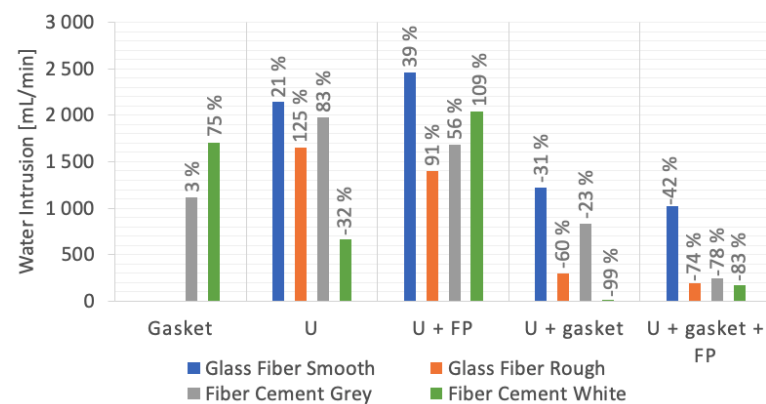
Figure 11. Water intrusion to the the wind barrier when profiles behind the joint were used. Gasket, U-batten, U-batten + extra fastening points, U-batten + gasket, and U-batten + gasket + extra fastening points. The percentage change from the water intrusion measured with the standard recommendations in Table 3 is shown.

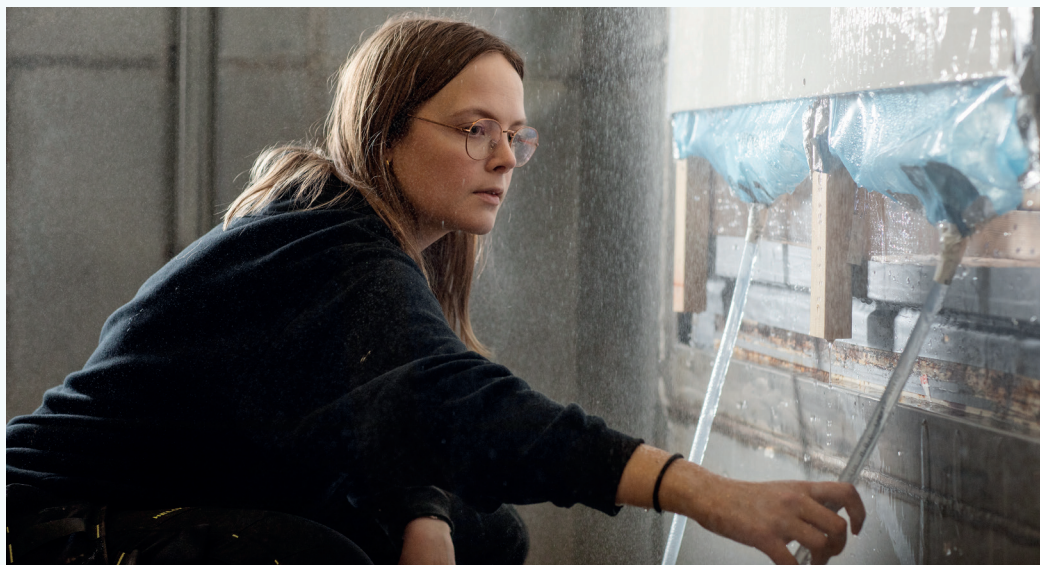
*Eva Armstrong Støver kontrollerer innretningen for oppsamling av vann som renner ned på baksiden av fasadeplatene under regnforsøkene.
Foto: Anne-Line Bakken.*

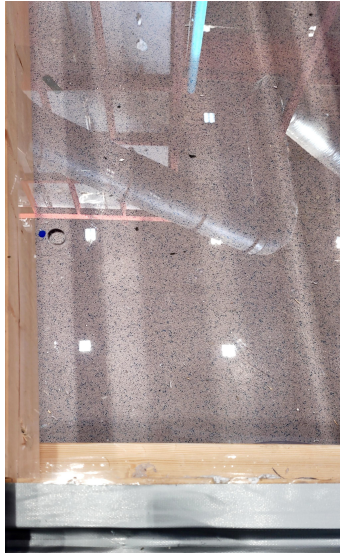
Figure C1: Hole with a diameter of 16 mm drilled through the Lexan board. The hole is drilled 40 mm from the left batten and 220 mm from the bottom horizontal batten. This ensures that the gutter is below the second joint. Four holes in total were drilled.

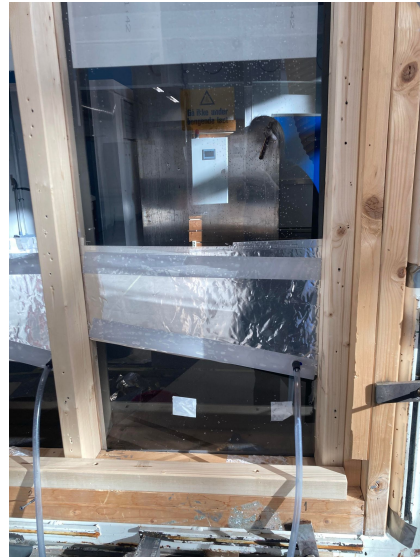
Figure C2: Tape placement for gutter system on Lexan board. Double-sided tape is used.

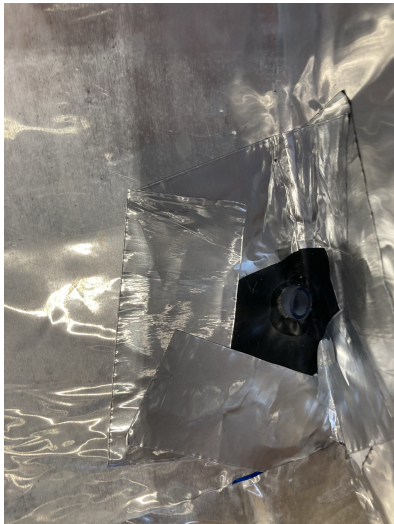
Figure C3: Closeup of a sleeve placed at the bottom of the gutter with a tube pulled through. The perimeter of the sleeve is sealed with aluminium tape.

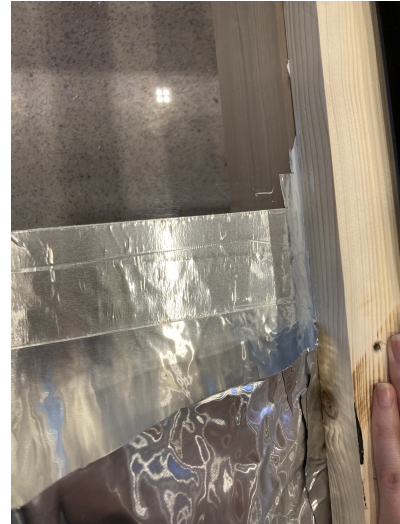
Figure C4: To avoid water intrusion behind or on the outside of the gutter system the top of the gutter is taped with aluminium tape and the sides are sealed with a waterproof sealant.

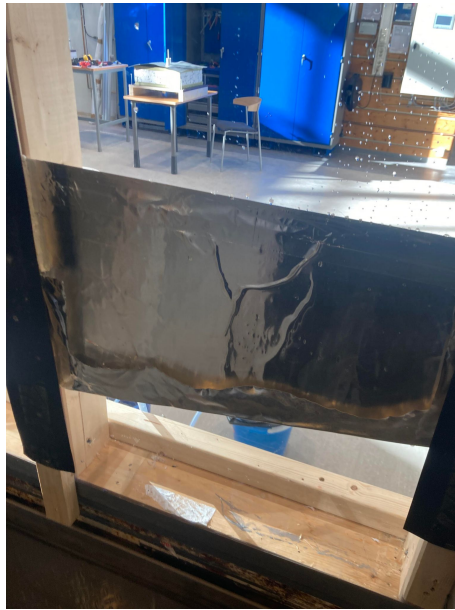
Figure C5: After a test measurement the gutters were improved by cutting them so that the edges did not touch the panels, and thereby get more water than they should.

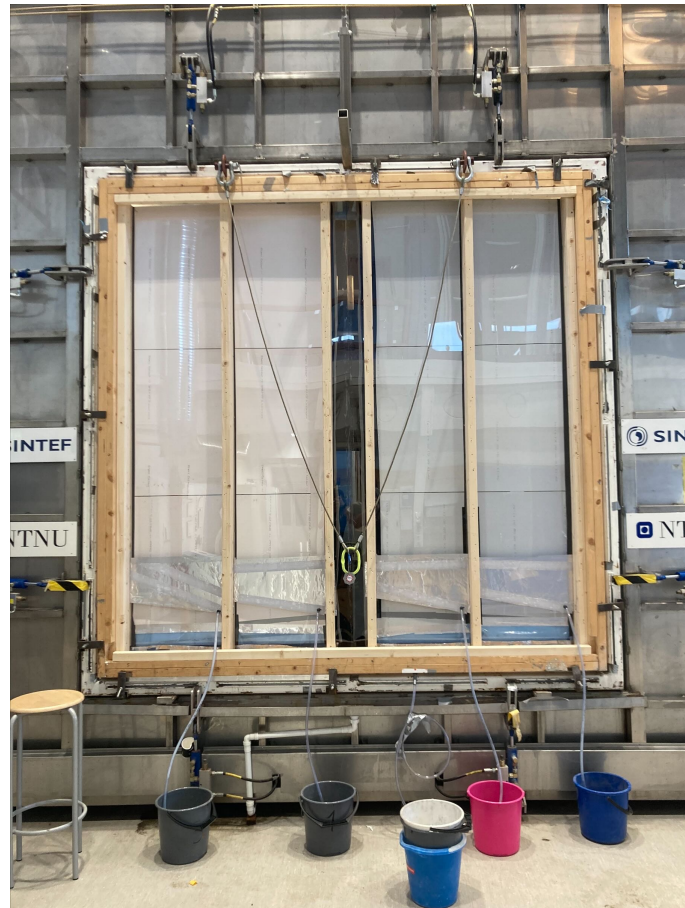
Figure C6: The water in the gutters were led via tubes to buckets, and then measured with measuring cups.

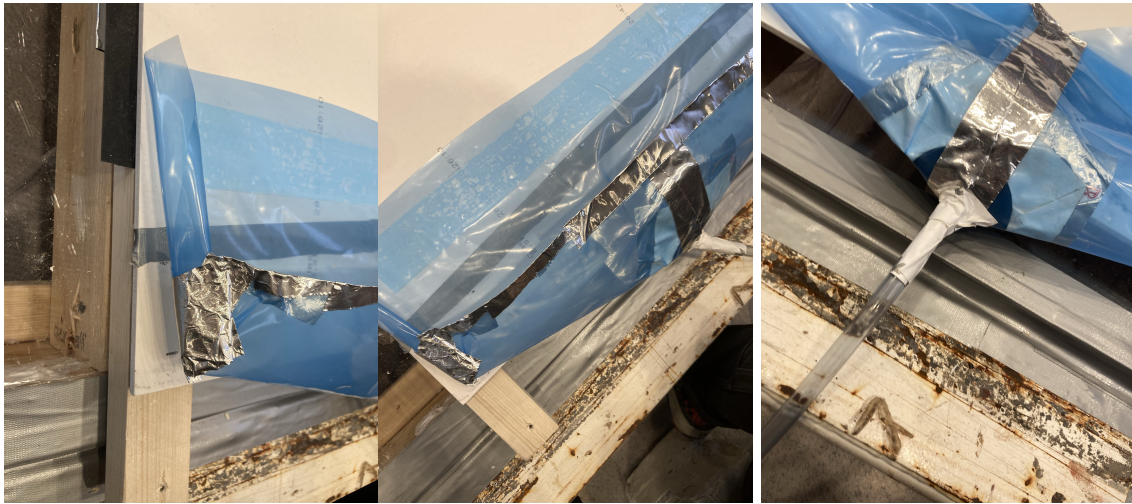
Figure C12: The foils were then cut and trimmed to a fitting shape. The sides of the gutter was ensured watertight by folding them behind and taping with aluminium tape

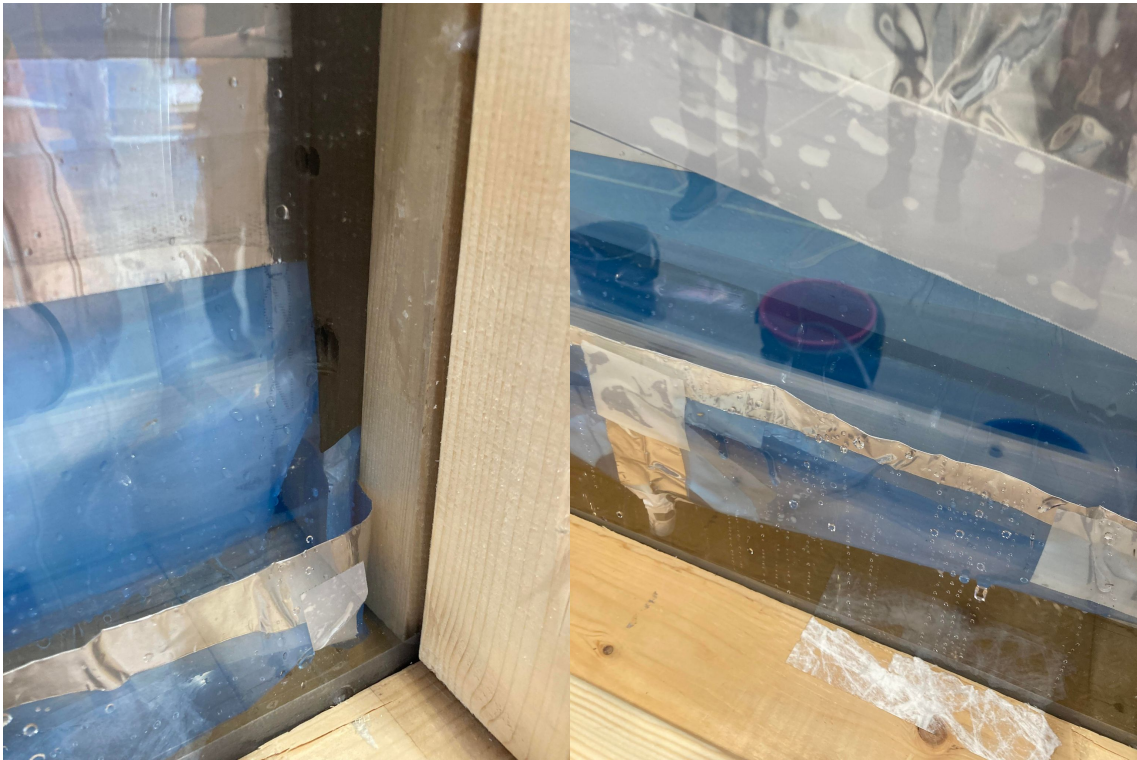
Figure C16: After the test rig is inserted in the driving rain apparatus the double-sided tape is fastened to the Lexan board.

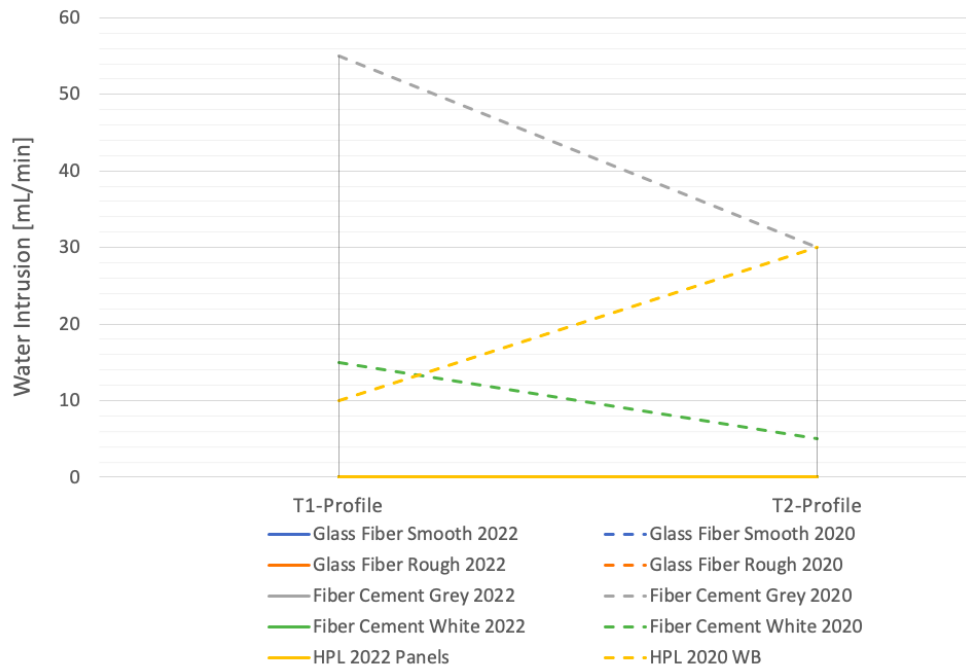
Figure J1: Water intrusion to the wind barrier with the two T-profiles. Comparison between this years laboratory results (2022) and Mo and Lid (2020) results (2020).
