Micro cracks in wind turbine bearings

Investigation of microstructural characteristics
and nanomechanical properties in White Etching
Cracks (WEC)

Master's thesis in Materials Science and Engineering
Supervisor: Ida Westermann, Anette Brocks Hagen
Co-supervisor: Vigdis Olden
June 2022

Norwegian University of Science and Technology
Faculty of Natural Sciences
Department of Materials Science and Engineering

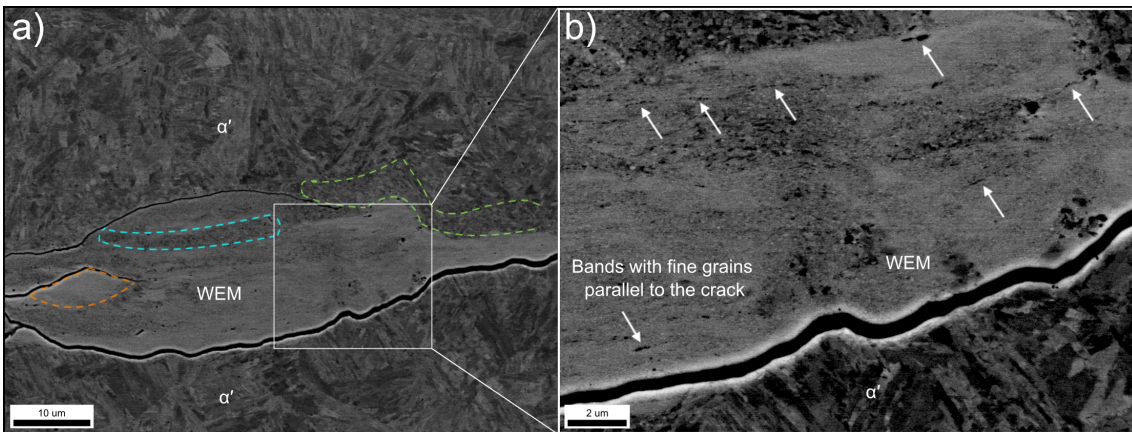
Figure 2.4. BSE and EPMA carbon analysis of WEM in area A3. a) BSE image of the A3 area, where coarse, fine and nano-crystalline grain structure is marked in respectively green, blue and orange. b) BSE image showing the nano-grained structure neighbouring the crack with arrows pointing to darker spots aligned in a direction parallel to the crack.

The BSE results presented in Figure 2.4 further confirmed the theory that the smooth areas consisted of nanocrystalline grains. Figure 2.4 a) showed that the WEM consisted of grains of different sizes, coarse marked with green, fine marked with blue and nano-crystalline marked with orange. The different categories of grains also seem to be gathered in horizontal bands. A high-magnification BSE image is presented in Figure 2.4 b) where arrows point to darker spots in the structure which seem to be parallel to the crack. Morsdorf et al. [12] have found voids similar to this which they suggest to be a proof of their moving crack theory[12].

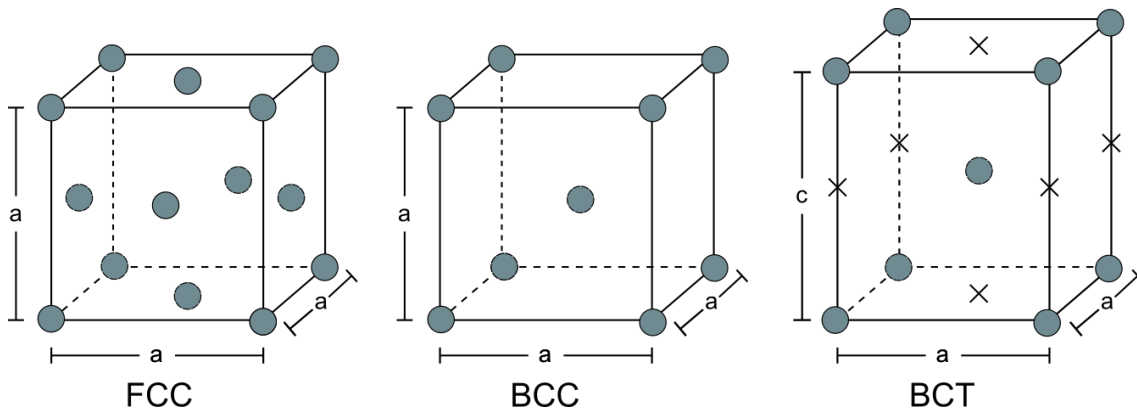
Figure 3.2. Illustrations of the face-centered cubic (FCC), body-centered cubic (BCC) and body-centered tetragonal (BCT) unit cell. Iron atoms are shown as circles while interstitial sites that may contain carbon are marked with X.

Austenite, also called γ -phase iron (γ -Fe), consist of a face-centered cubic (FCC) structure, shown in Figure 3.2. Austenite is found at temperatures above 723 °C, but can also be found as retained austenite by alloy additions such as nickel and manganese at room temperature. Austenite can dissolve considerably more carbon than ferrite, as much as 2.03 wt.% at 1146 °C [14].

Martensite consists of a body-centered tetragonal (BCT) structure, shown in Figure 3.2. The BCT structure has the same crystal structure as the BCC structure, but it is elongated in one direction. Martensite is formed in steels that have a rapid cooling rate from austenite, in a diffusionless shear transformation. The transformation results in large shears, volume expansion and high dislocation densities, where carbon atoms remain as interstitial impurities in the martensite, shown with Xs in the BCT unit cell in Figure 3.2. The martensite is created as thin plates or laths to minimise the strain energy, and it is very hard due to the strain the interstitial carbon adds to the structure [14].

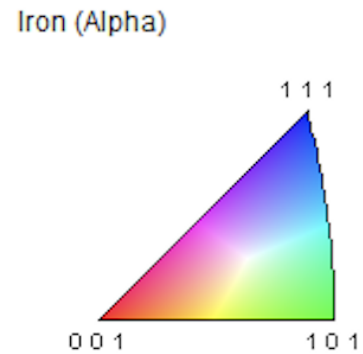
Figure 4.3. IPF key of Iron (alpha).

Inverse Pole Figure (IPF) maps are used to represent crystal orientation by assigning different colours depending on the crystallographic direction of a point compared to a predetermined reference axis. The meaning of the colours of the map can be determined from the IPF key. The IPF key, as shown in Figure 4.3, has three corners relating to the face $\{001\}$, edge $\{101\}$ and corner $\{111\}$ of the crystal, which is compared to the x, y or z reference axis of the material. Because of this, the IPF map will not show the complete crystal orientation, but only the plane that is normal to the chosen reference direction [92].

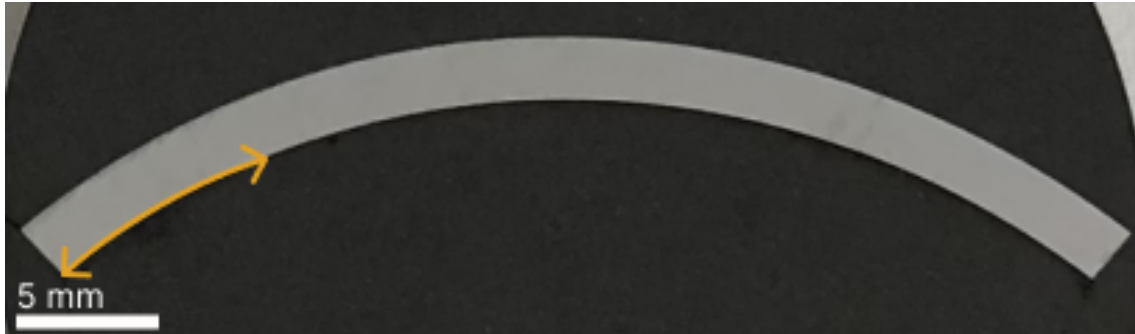
Figure 5.3. Analysed bearing section with orange line showing the area where WECs were observed.

The analysed bearing section can be seen in Figure 5.3. The orange arrow marks the area in which every WEC analysed in this thesis was found. Outside this area and in other bearing sections there was no observed WECs.

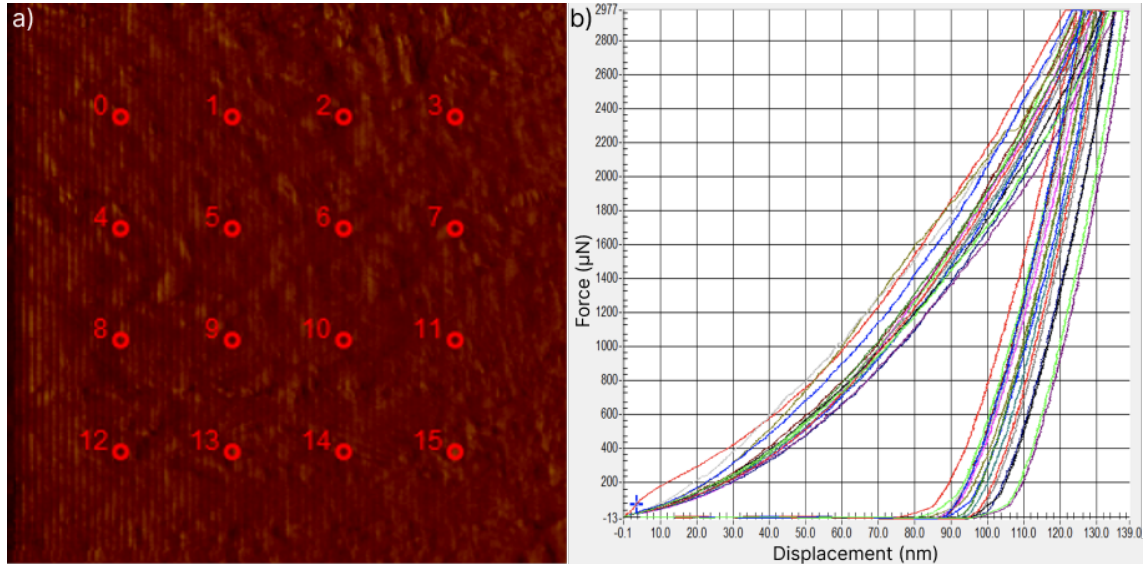
Figure 5.16. Indentation grid of martensite matrix. a) SPM image of indented area and b) load-displacement curves
