Future Design of Subsea High Voltage Cables for Offshore Renewables - Effect of Static Mechanical Stresses on the Insulation Lifetime

Master's thesis in Electric Power Engineering

Norwegian University of Science and Technology
Faculty of Information Technology and Electrical Engineering
Department of Electric Power Engineering

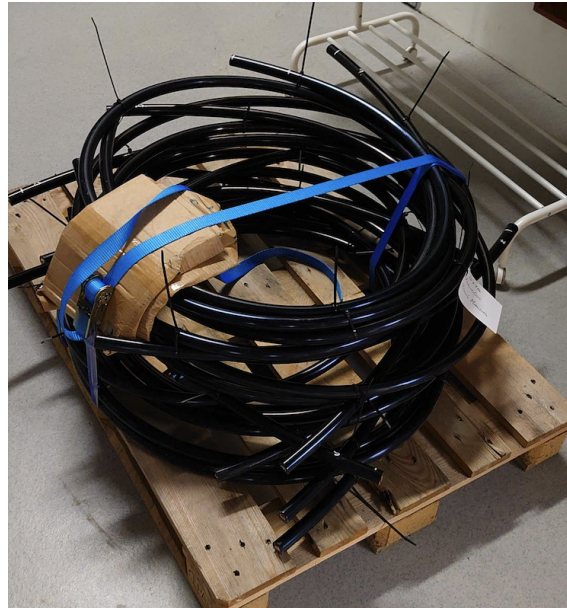
As seen in figure 12, the cables came in a raw state. The Cables were delivered in pieces of 4 meters each from the factory. The first order of action was to cut off 3 cm on each side of the cables with a saw to get a cleaner cut. The cables were cut using a cable cutter from the factory, which squeezed the ends. Squeezed conductor can lead to a poor connection between cable shoe and conductor.

Figure 12: Cable in the state they were delivered

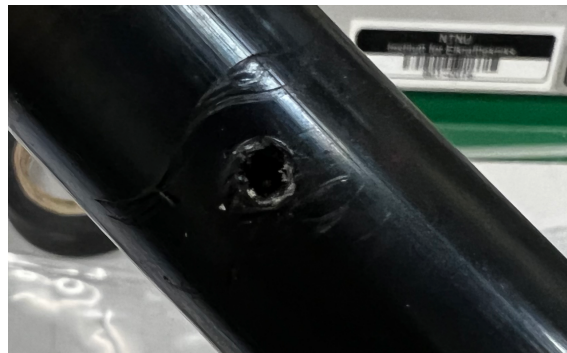
Figure 13: Manufacturing defect

It was also essential to check all the cables for manufacturing defects. One defect was found, as seen in figure 13, which is a hole in the insulation screen that goes into the conductor. This defect had to be removed.

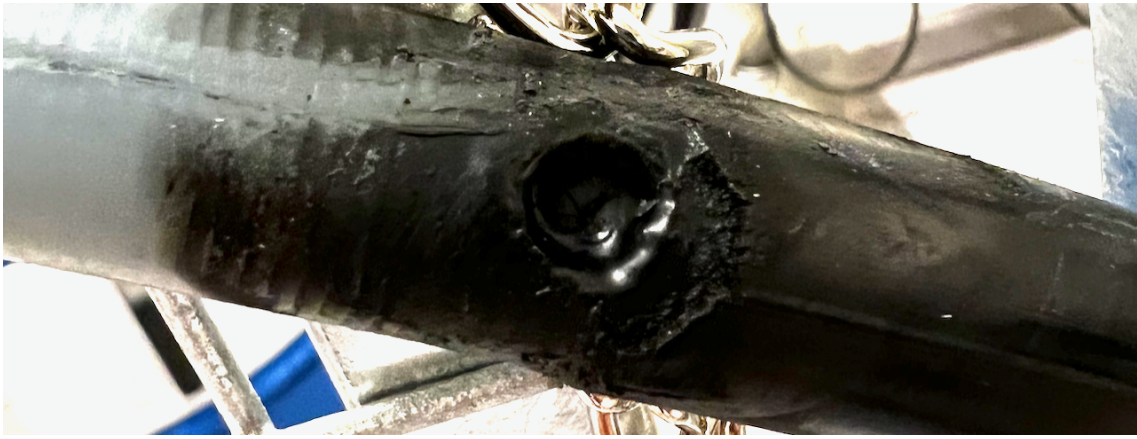
Figure 18: Picture of a breakdown in the termination

Figure 18 is an example of a breakdown in the termination. The cause of this breakdown probably is an air pocket between the stress control sheet and the insulation at the cut-back point.

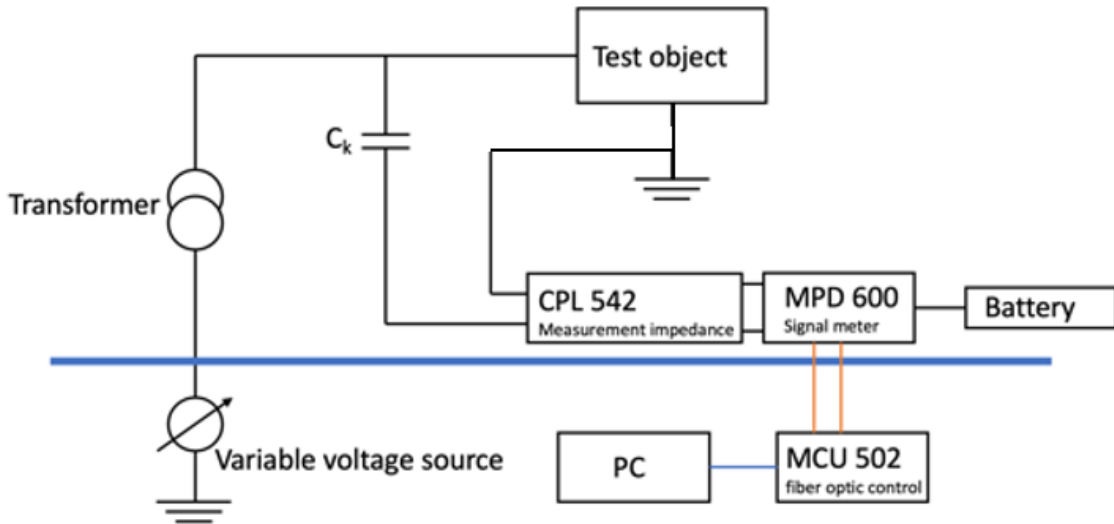
Figure 19: Measuring circuit

PD-measurement was done based on the measuring circuit in figure 19 using Omicron MPD600. C_k is a coupling capacitor, and the test object is connected in parallel. CPL542 is the measurement impedance with the possibility of measuring voltage over the test object. The MPD 600 advanced partial discharge measurement and analysis module are connected in parallel over the measurement impedance. There will be voltage drops in the circuit when there is PD activity. The coupling capacitor compensates for the voltage drop, and the compensation is measured over the measurement impedance.

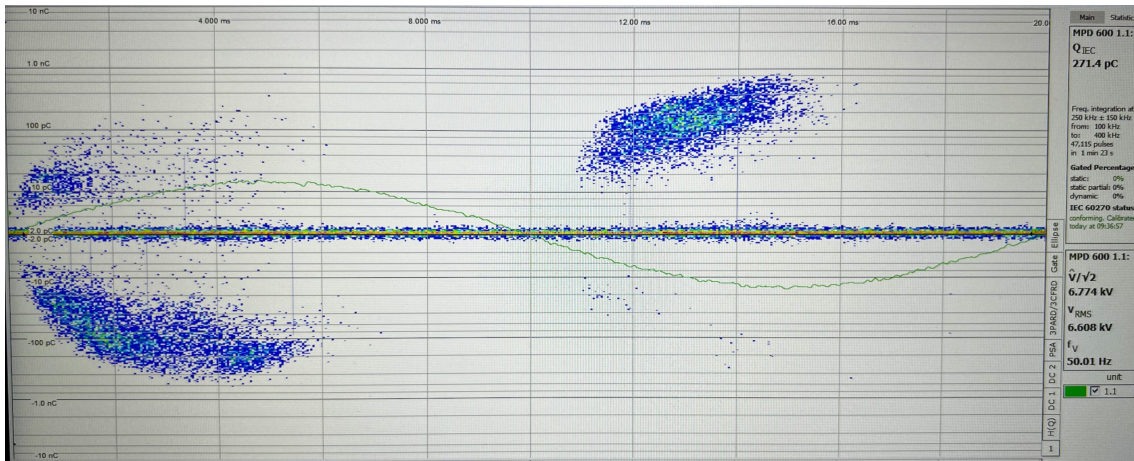
Figure 21: Cable failed PD-test at 6.7 kV

The first cable that failed can be seen in figure 21. It is unsure why there was PD at 6.7 kV, mainly because it should not be any PD at this voltage level from the cable even without the termination. However, leaving the stress control sheet and tape to settle for a day and washing the termination with isopropanol worked, and the cable passed the test at 36 kV the next day.

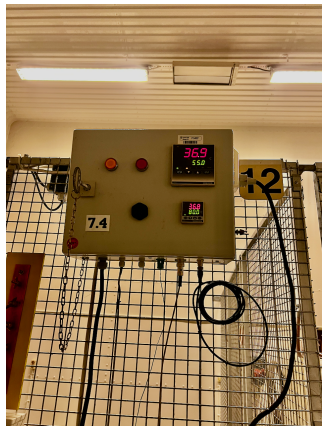
controller unit. Connected to the temperature controller are the primary target temperature sensor and a secondary temperature sensor which will cut power if the water temperature goes above a given temperature. There is also a fire alarm and water level sensor. The water level sensor has two stages. The first stage gives an alarm if the water goes below the first stage, and the second stage will cut power to the heater cable.

Figure 25: Temperature controller

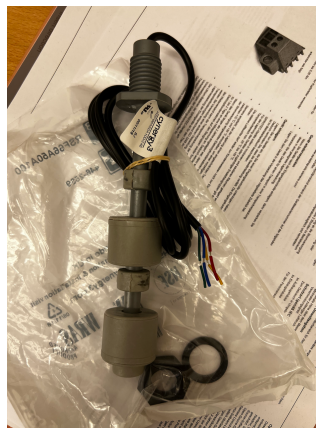
Figure 26: Water level sensor

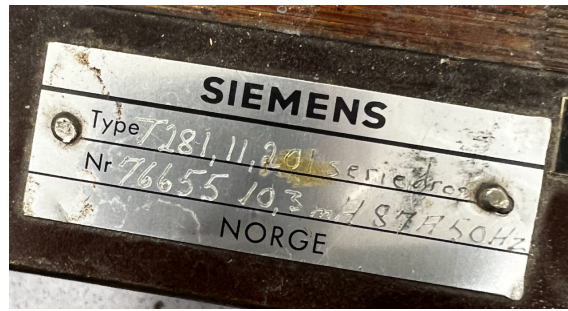
Figure 29: Nameplate of coil

Figure 29 shows the nameplate of the coil with an inductance of 10.3mH. The coil should ideally have been connected in parallel. However, the nameplate of the coil does not say anything about the voltage it can tolerate, and the datasheet was not possible to obtain. Therefore the coil was connected in series. It will consequently compensate to a lesser extent for the capacitive current. However, it will act as a filter for the current and voltage. There is harmonic resonance in the current without the coil, as seen in figure 30. This happens because the current delivered from the grid is not clean sinusoidal and resonates with the system's natural frequency. The coil moves the system's natural frequency thus removing harmonic resonance, as seen in figure 31. It is crucial to remove harmonic resonance from the system, especially on the voltage, as the terminations are increasingly susceptible to degradation from harmonic stresses.

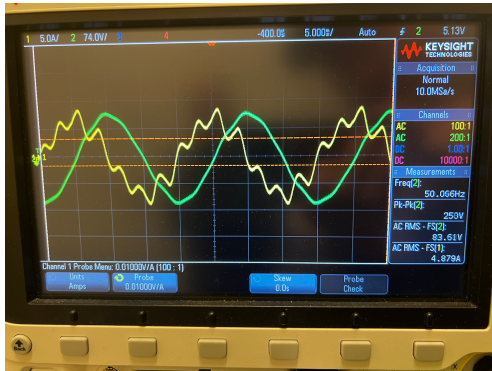
Figure 30: Without coil connected, the green signal is voltage and the yellow signal is current

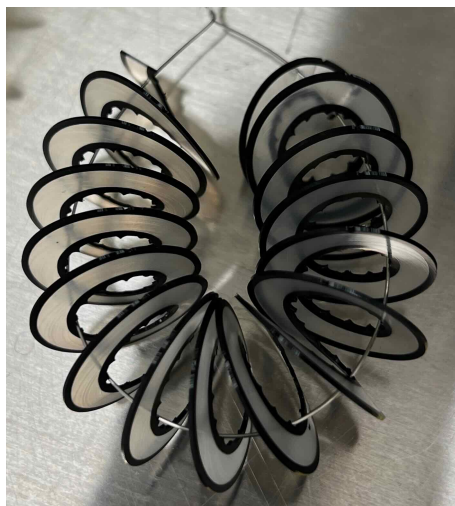
Figure 36: Picture of helically cut insulation.

The next step was to cut the insulation helically using a rotary knife. The insulation was cut with a thickness of 0.5mm and attached to steel wire as shown in figure 36

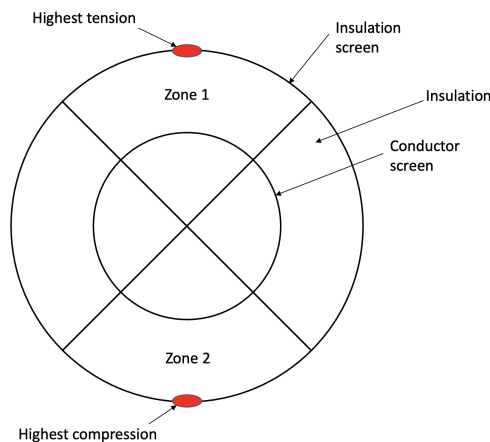
Figure 37: Illustration showing how the zones are divided

From each helicoids there was at least ten samples inspected. It was then documented the length of the longest bow-tie in each of the two zones. The size and location of vented water trees was also recorded, if found. In some cases the source of the vented water tree was also visible and therefor documented.

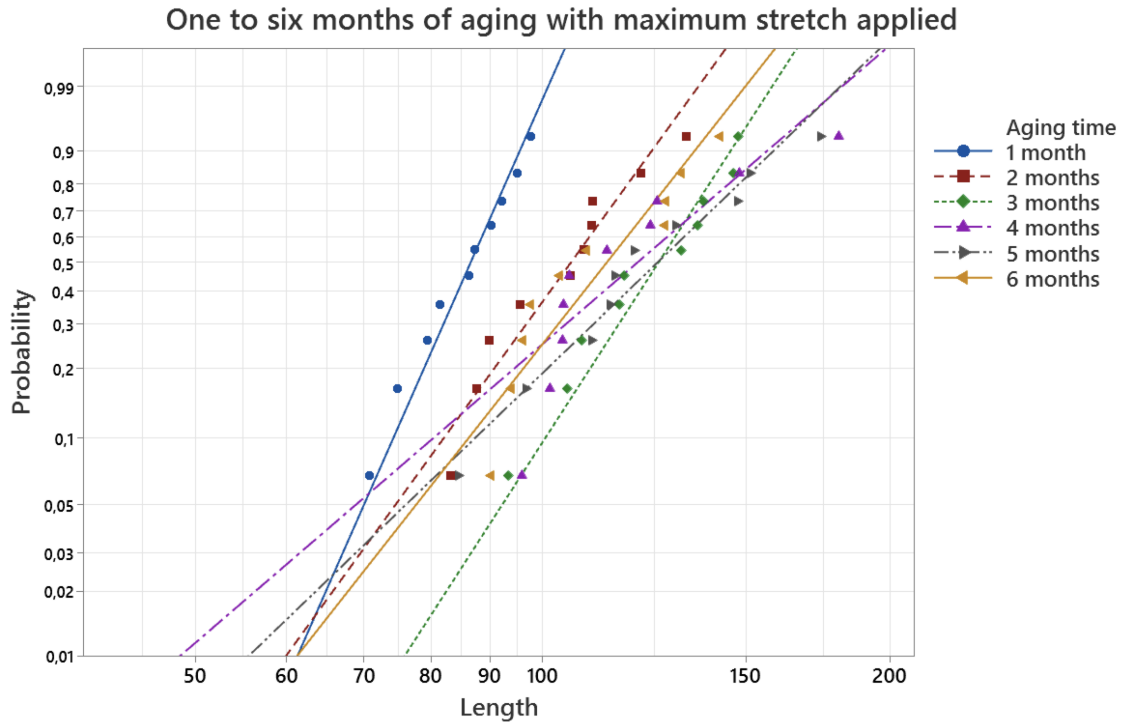
Figure 38: one - six months of aging with maximum stretch presented in Weibull probability plot

Figure 38 illustrates the development of length of the bow-tie trees from one month to six months of aging with maximum stretch applied. The 63% line is the scale parameter η , which represents the average value of the cumulative distribution function. As seen in the figure, the η is increasing fast from the first month to the third month. With very small $\Delta\eta$ between the test objects after the third month of aging. The low $\Delta\eta$ between each month indicates that the growth of the bow-ties has started to settle. The shape parameter β has a decreasing trend. This means that the spread is increasing, resulting in a higher probability of finding larger bow-ties. At the worst case with five months of aging there is a 95% chance of finding a bow-tie that is 170 μm or smaller. The development of β over six months is illustrated in figure 39.

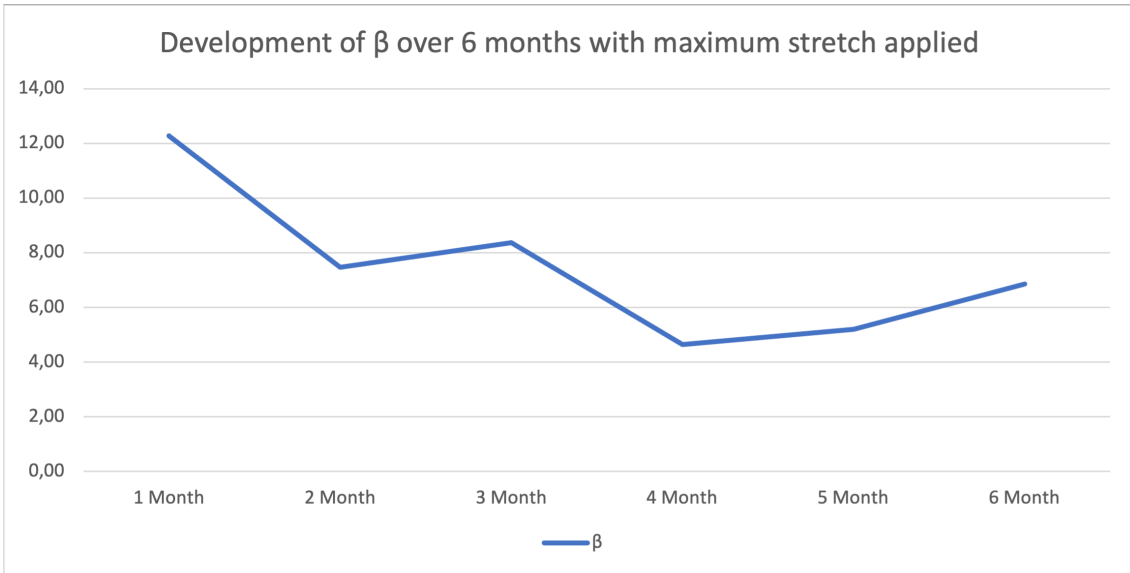
Figure 39: Development of β over 6 months with maximum stretch applied

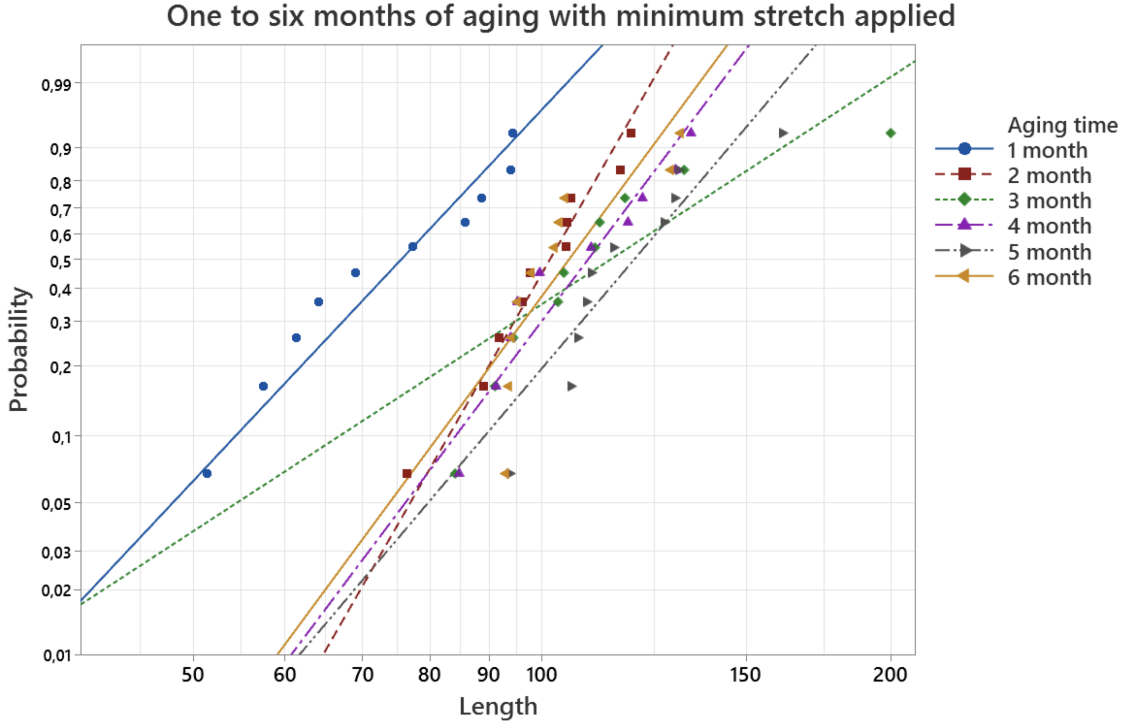
Figure 41: one - six months of aging with minimum stretch presented in Weibull probability plot

As seen in figure 41 with minimum stretch the β is more stable compared to maximum stretch with the exception of the third month which had one extreme bow-tie. This resulted in a very low β of 3.51 and a worst case scenario of 95% chance of finding a bow-tie that is 175 μm or less. However, the β value at 6.38 from the fifth month gives a better indication of the condition of the cable, and results in a 95% chance of finding a bow-tie tree with 155 μm in length or less. Figure 43 shows the same trend as in maximum stretch where the η increases rapidly the first three months and then tapers off.

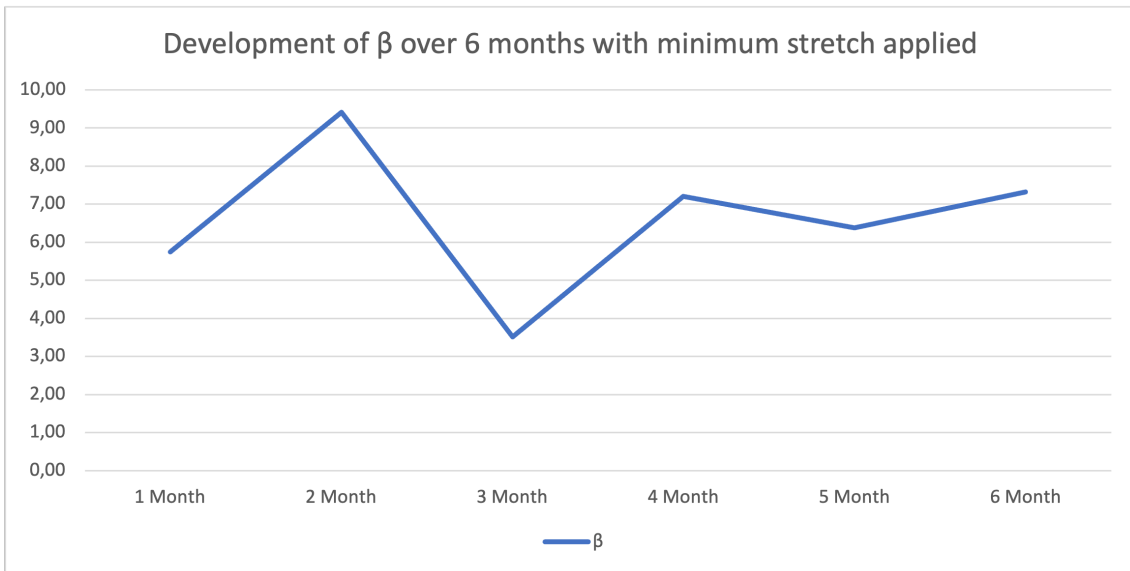
Figure 42: Development of β over six months with minimum stretch applied

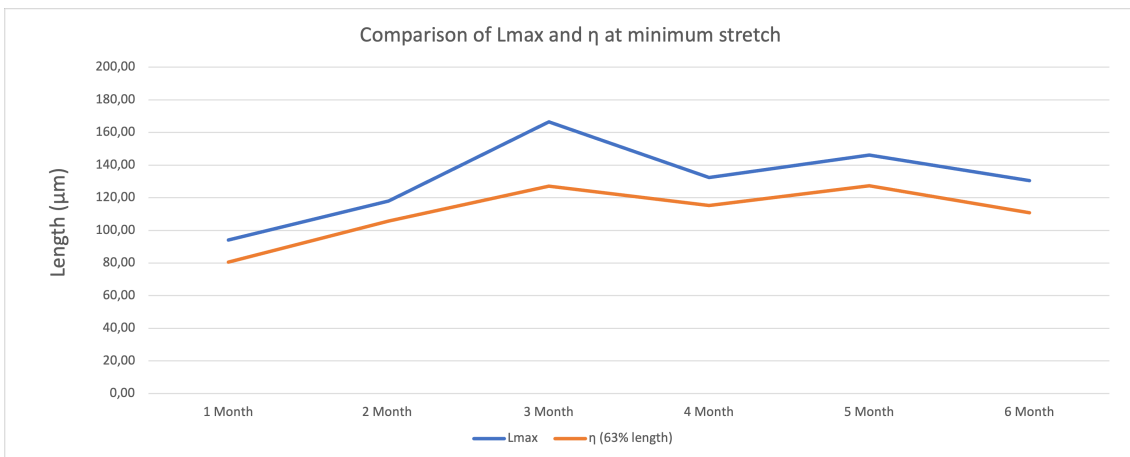
Figure 43: Comparison of L_{max} and η at minimum stretch vs. aging time

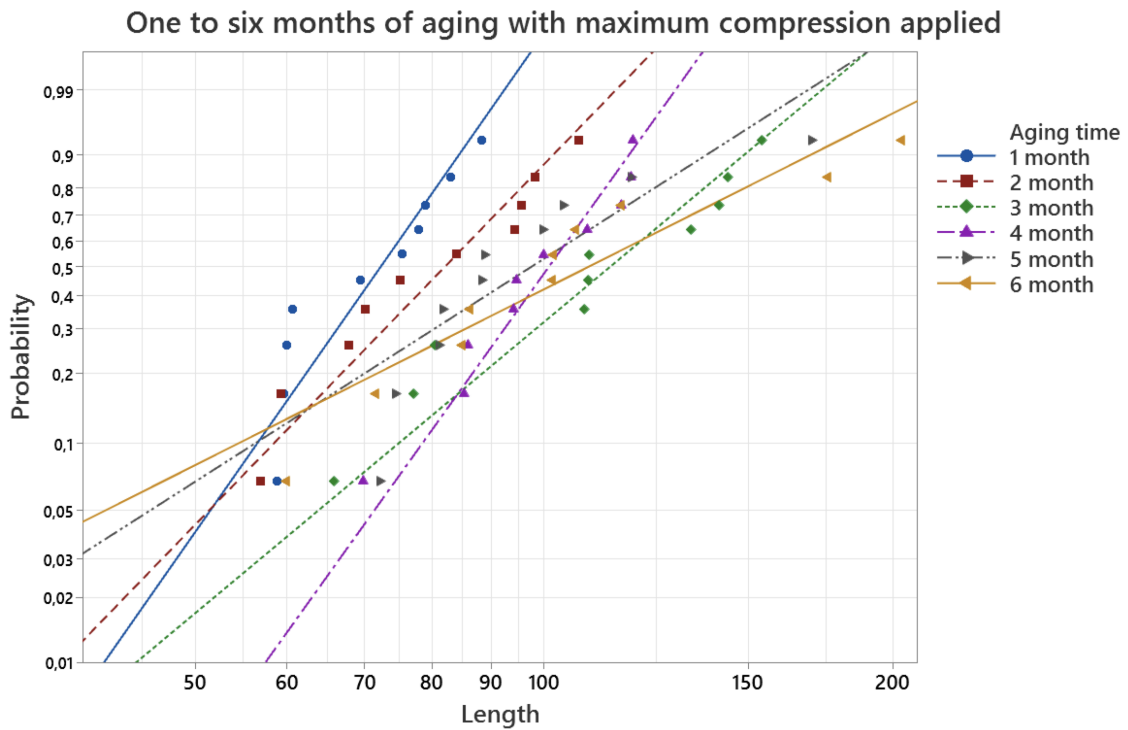
Figure 44: one - six months of aging with maximum compression presented in Weibull probability plot

Figure 44 illustrates the development of the length of the bow-tie trees from one month to six months of aging with maximum compression applied. As seen in this figure, the β is lower than in the stretch zone indicating worse condition in the compressed zone. Figure 46 shows that the η follows the same growth pattern as in maximum and minimum stretch.

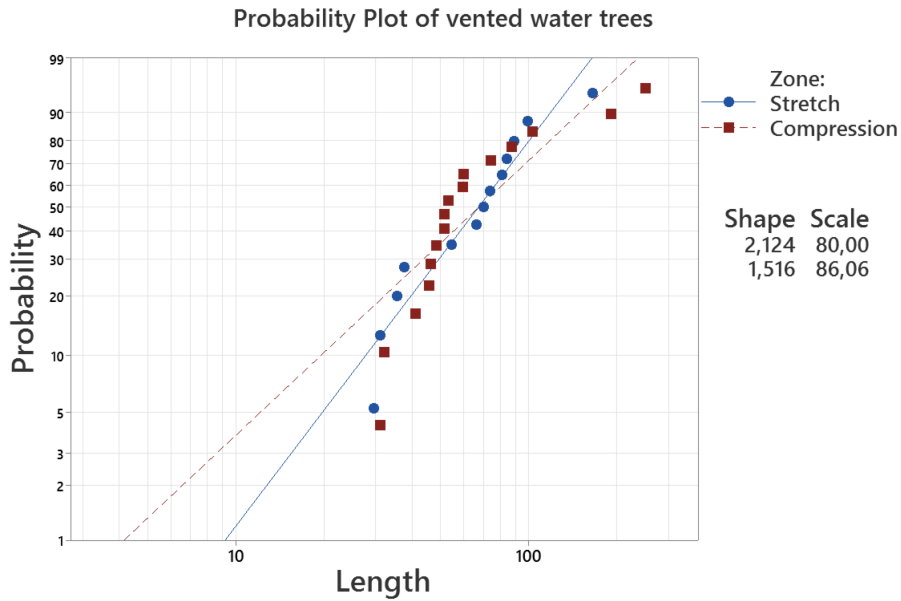
Figure 51: Weibull probability plot of the vented trees observed in stretch and compression zone

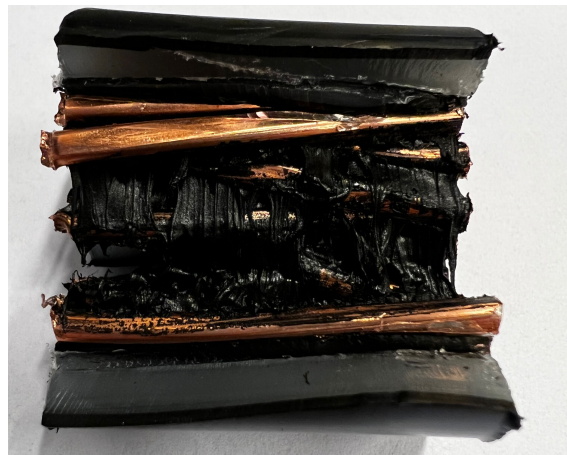
Figure 54: Picture of one of the test-objects cut open to confirm that there are strand-fill between gaps of the conductor strands
