Accessibility barriers and sustainable solutions: Case Elgeseter street

Master's thesis in Project Management

June 2022

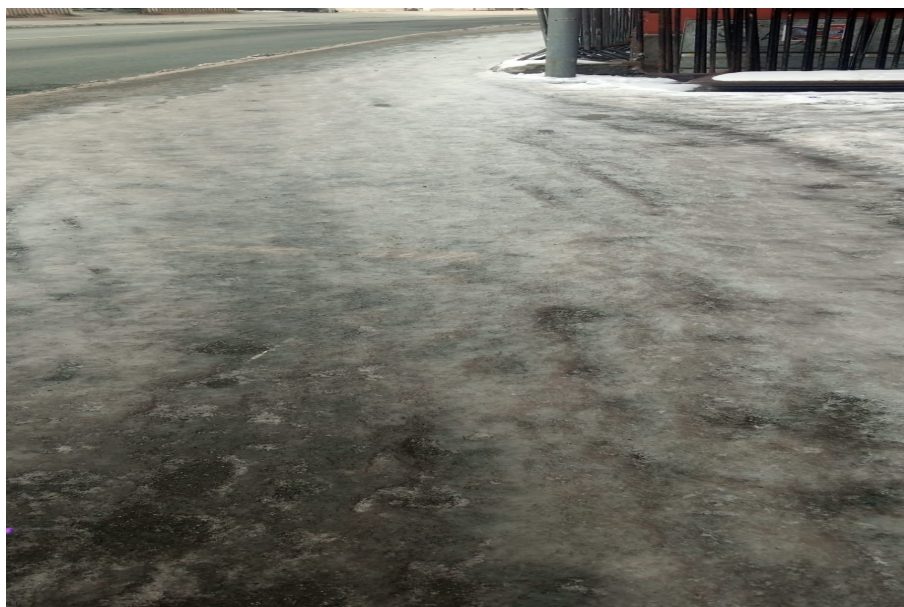
The slopes of the pedestrian’s lane from the crossings are unsuitable for all users, especially those who have mobility limitations. I observe how the slope around the Studentsamfundet bus stop is rugged for all users during the site observation. The slope of the pedestrian lane towards the klostergata is very high. In winter, this area is very slippery, which causes difficulties for all users, especially wheelchair users and people with mobility limitations. Figure [12], shows the slippery surface of the slope in front of student samfundet.

Figure 12: The slippery surface of the slope in the student samfundet [Photo: by author]

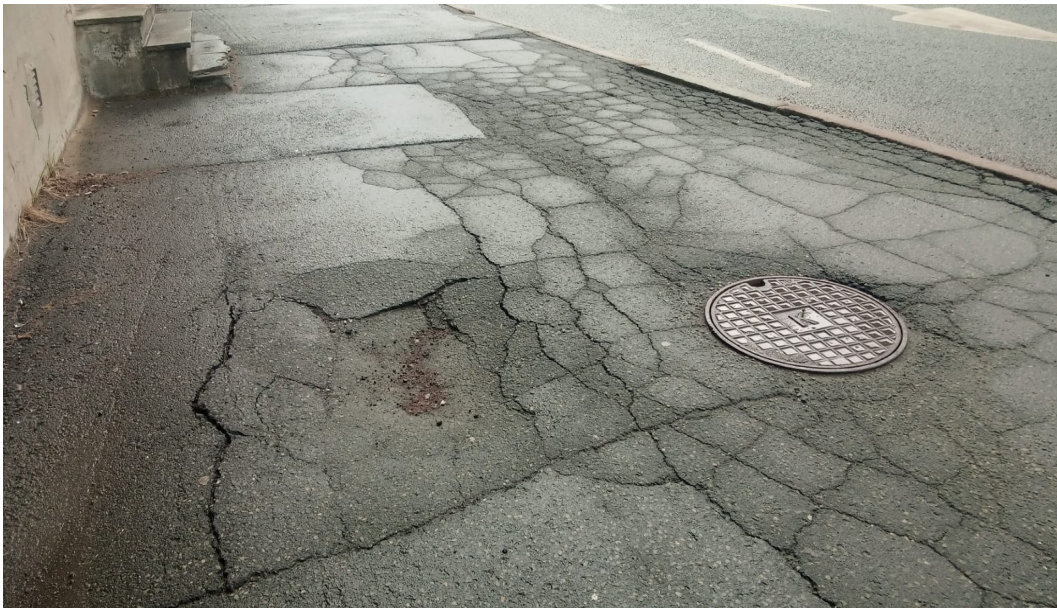
Figure 13: Damaged pedestrian pavement [Photo: by author]

I observed that the pedestrian lane slope is higher towards the edge of the buildings and very low towards the carriageway side during the site observation. Because of this, it causes accidents, and it becomes challenging to use the pedestrian lane during the winter when it is very slippery due to snow. In addition, the size of the pedestrian lane is very narrow in some places and very wide in others. For example, in front of Elgesetergate 30, 6, and 4 buildings the size of the pedestrian lane is less than 1.5m. Figure [18], shows one of the buildings located on the main street. Because of this building, the pedestrian lane is very narrow. During the interview, people shared the following experiences in the pedestrian lane:

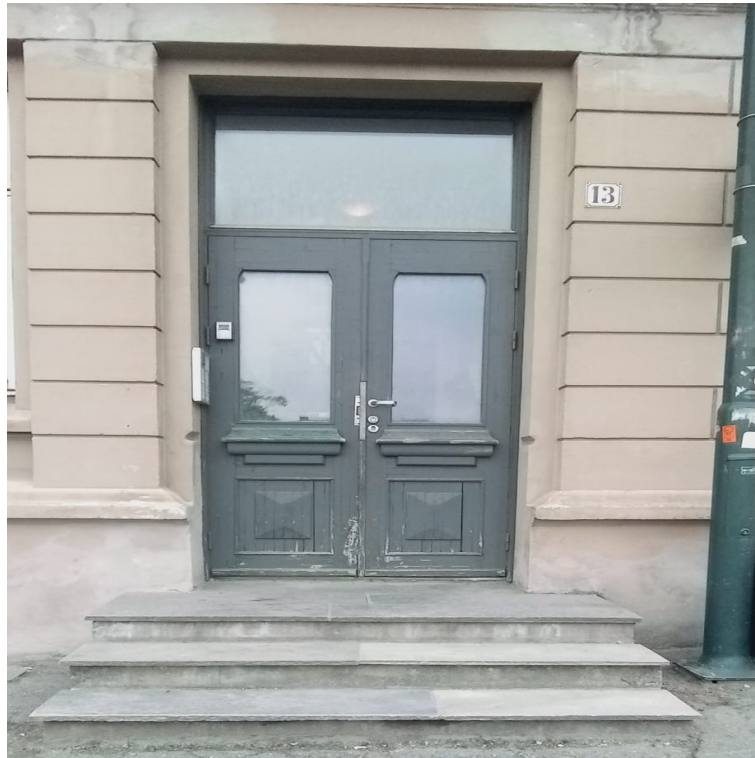
As per the result of the site observation, the door of sample building Elgesetergate 13 is old and not automatic, which is very difficult to open, especially for disabled people. The doors are from the 20th century and don't meet today's entrance standards. Another challenge in the entrance is the horizontal field in the main entrance. There is no flat field that can help wheelchair users turn around and reach the door bell.

During the site observation, also, I observe the stair of the main entrance. Unfortunately, the entrance of Elgesetergate 13 is only a stair, which shows that the entrance of the building is very poor from an accessibility perspective. Figure [16], shows the main entrance, including the stair and door of Elgesetergate 13.

Figure 16: Main entrance of Elgesetergate 13 [Photo: by author]

The buildings' current internal and external environment is challenging for everyone, especially those who have mobility limitations. Making this old building accessible for everyone needs high-level modification to the structural elements. In addition, improving the buildings may cause changing their architectural value. Moreover, the cost of improving the internal environment of the buildings will not be economical. Therefore, the accessibility to the buildings cannot be fully accessible to everyone in the future. But it can be possible to provide access at least to the first floor of all old buildings. In addition to the buildings, the current parking spaces in the area do not consider all users. In order to increase the attractiveness of the area and fulfill the neighborhood's modern standards, providing accessible parking is recommendable. Also, the route from the parking spaces to the entrance should consider all users.

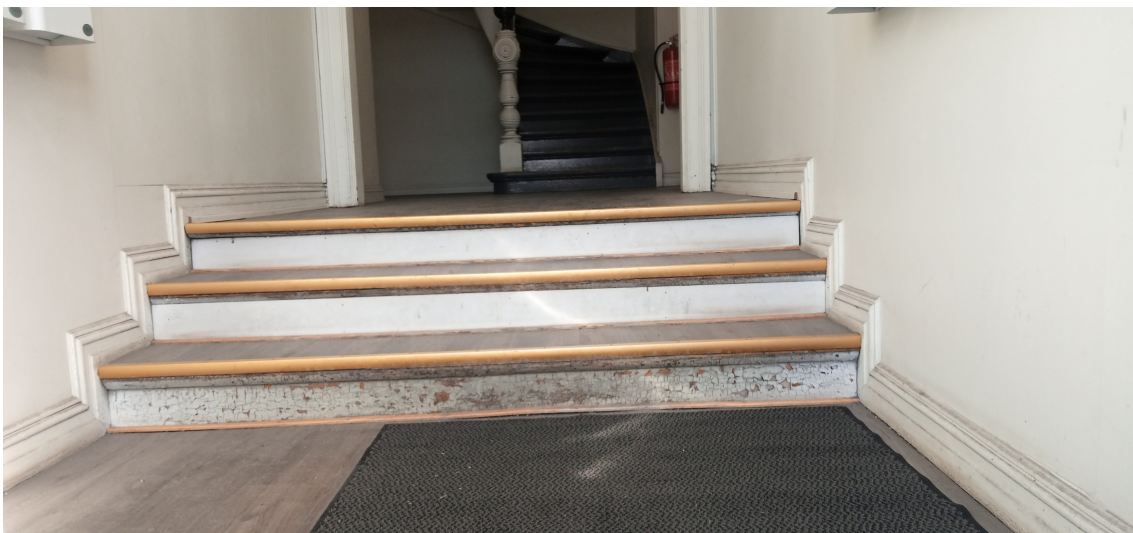
During the site observation, the internal environment was assessed for further evaluation of the accessibility of the building. The results of the site observation show that the internal environment of the buildings, including the entrance hallway, stairs, and corridors, is unpleasant for all users, especially those who have mobility difficulties. For example, during the site observation, I observed that the entrance hallway has steps that cause difficulties accessing the building. Figure [17], shows the steps in the entrance hallway of the Elgesetergate 13 building.

Figure 17: Entrance hallway of Elgesetergate 13 [Photo: by author]

The building has three floors, and it is without an elevator. The stair of the building is a winding type of stair, which is very difficult for older people and people with mobility difficulties. Also, the stair material is very slippery wooden without edge sign markings. During the site observation, we observed that the current situation of the stair does not fulfill modern standards. In figure [17], shows the stair type of the Elgesetergate 13 building.

Due to the old building standards, the building is not accessible for everyone, especially for disabled users. According to [TEK17 (2017)], building regulation building with three floors and above the elevator requirement is a must. The sample building, Elgeseter 13, is without an elevator, and the stair is a winding type of stair as shown in figure [17]. Winding type of stairs is not recommendable in buildings. TEK 17 building regulation (section 12 – 14) suggests that having a straight Running stair is easier to walk than a winding one. The building stair is a wooden stairs without a step edge color, and it is slippery. According to [TEK17 (2017)], the stairs edge should be visible to users with a maximum 0.04 m depth, and the surface finish material of the stairs should not be slippery. [Evcil (2009)], conducts a study on the built environment, and he concludes that stairs are the main obstacle in accessing buildings, especially for wheelchair users. As shown in figure [17], the hallway of the building is with stairs, which is challenging for people who have mobility limitations, especially wheelchair users. According to [TEK17 (2017)], (Section 12-4), the entrance hallway of buildings must be free of steps. In general, the accessibility of the internal environment of the building is challenging, and it does not meet today's standards.

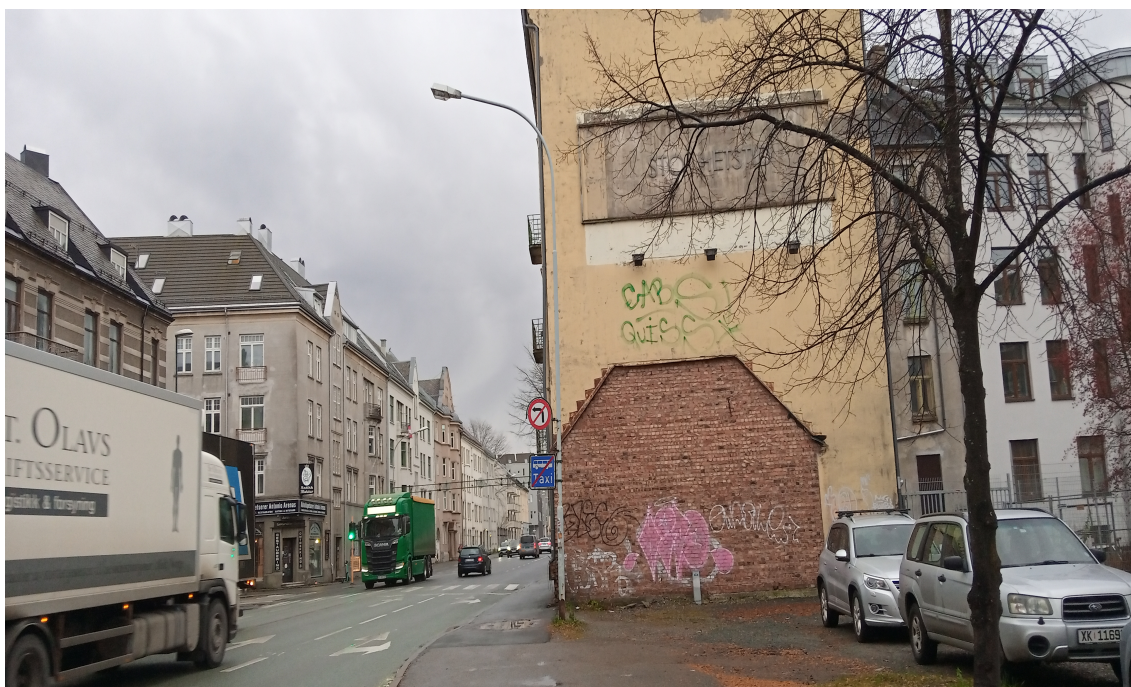
During the site observation, I observe how these three buildings' closeness affects the carriageway. Due to the location of these three buildings on the main street, the pedestrian lane is not comfortable for pedestrians. The actual distance of the buildings from the edge of the main road is less than 2 m. Figure [18], shows how the buildings are close to the main street.

Figure 18: Narrow pedestrian lane in front of Elgeseter gate 30B [Photo: by author]

The current size of the main Elgeseter street is inadequate to provide all necessary street elements, including a bike lane and pedestrian lane. The main reason is the location of Elgeseter 30B, 6, 4 buildings. The buildings are positioned very close to the main street. These three buildings have been closed since 2013 for different reasons; one of the reasons that I heard from the municipality is the safety of the buildings. The buildings are from the early 20th century, which requires refurbishment and protection. The buildings are the obstacles to provide bike and pedestrian lanes with current space for future street development. According to the results, these three buildings are considered to be demolished in the street future development.
