Durability of rock support in Norwegian road tunnels

NTNU
Norwegian University of Science and Technology
Thesis for the Degree of
Philosophiae Doctor
Faculty of Engineering
Department of Civil and Environmental
Engineering

Trondheim, October 2022

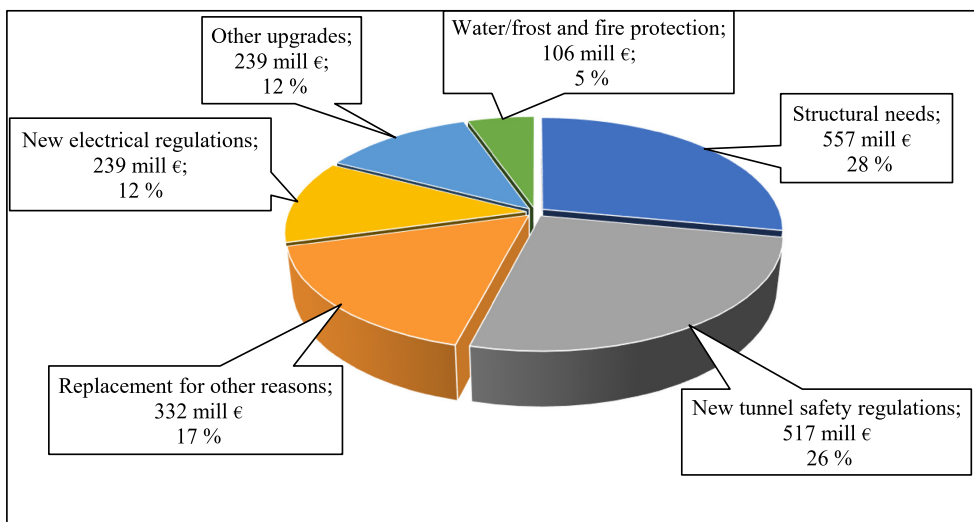
Fig. 1: Estimated distribution of upgrading costs in the 481 tunnels belonging to national road network in Norway by 2012 [3]. Costs are given in euro (2012).

The structural integrity of tunnels relies on the rock mass properties and the installed rock support. Over time materials degrade, and this includes the rock support exposed to the tunnel environment. Traditionally, the concern about degradation of rock support in road tunnels arises from a safety and cost perspective [1,2]. Regarding costs, the Norwegian Public Roads Administration (NPRA) undertook a survey in 2012 to estimate the cost of eliminating the maintenance backlog in the national road network [3] (this network is apart from other Norwegian road tunnels belonging to different counties). At that time, the number of tunnels in the national road network was 481, representing 4.6% of the length of the network. The resulting upgrading cost amounts to approximately 4 billion euro (2012), where approximately half of it corresponds to the upgrading of tunnels. The distribution of the needed investment in the existing road tunnels by 2012 is given in Fig. 1.

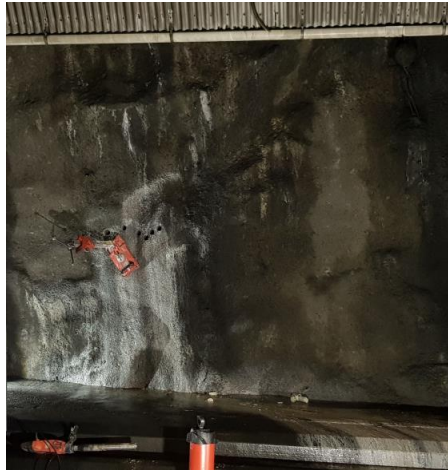
Fig. 3: Six shotcrete cores extracted in the Hitra tunnel at chainage 3+090 (approximately in the middle of the tunnel). The extracted cores are shown in Fig. 33.

In the case of the Frøya and Hitra subsea road tunnels, the main objective is to investigate the possible difference in the condition of the shotcrete exposed to fresh groundwater and exposed to saline groundwater. This means in practice drilling shotcrete near portal areas, and in the middle of these subsea tunnels.

Figs. 3-4 show two investigated locations in the Hitra and Frøya tunnels respectively.

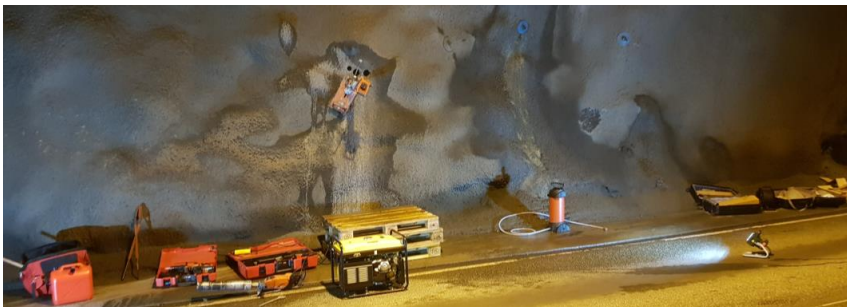
Fig. 4: Three shotcrete cores already extracted in the Frøya tunnel at chainage 8+070 near the north portal. The corresponding extracted cores are shown in paper 3, Fig. 5.

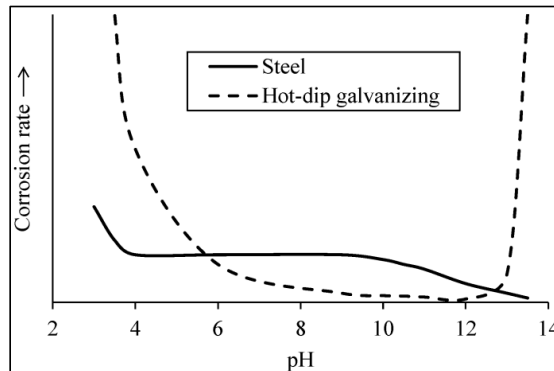
Fig. 13: Conceptual scheme of the corrosion rate of steel and hot-dip galvanizing as a function of the pH of the solution. Modified from [40,41].

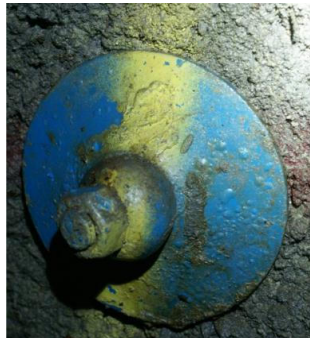
Fig. 18: Blisters observed in a rock bolt plate in the Oslofjord subsea road tunnel after 10 years of exposure [61].

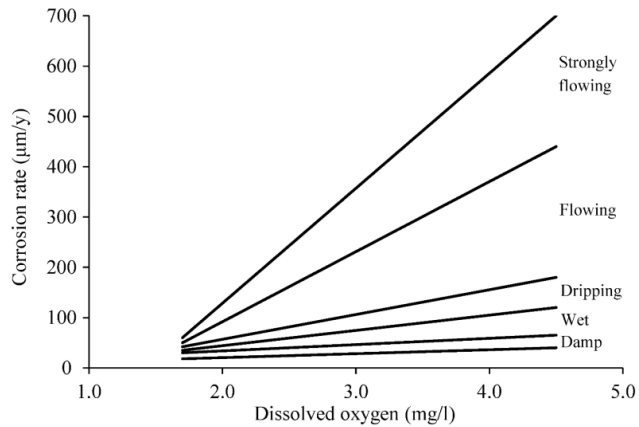
Fig. 19: Corrosion rate of steel plates measured in Australian underground mines as a function of dissolved oxygen and flow condition. Modified from [64].

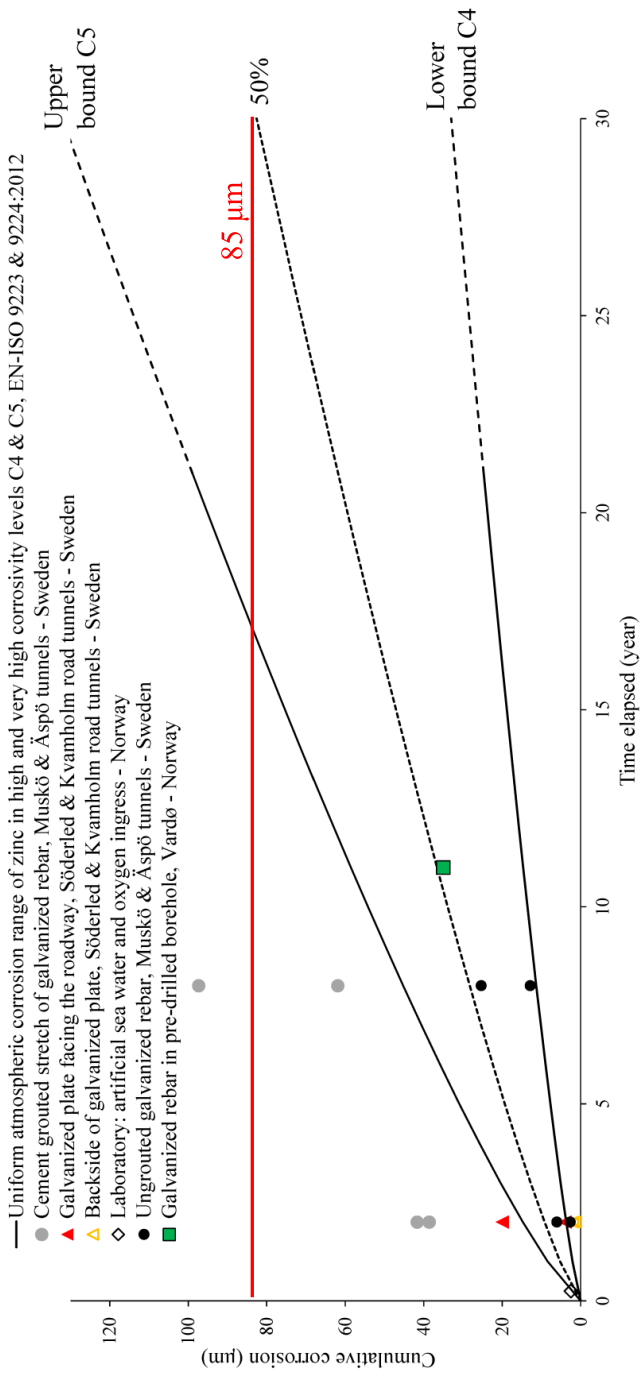
Fig. 20: Corrosion rates of hot-dip galvanizing exposed to saline environment collected from the Norwegian and Swedish literature. Modified from [34].

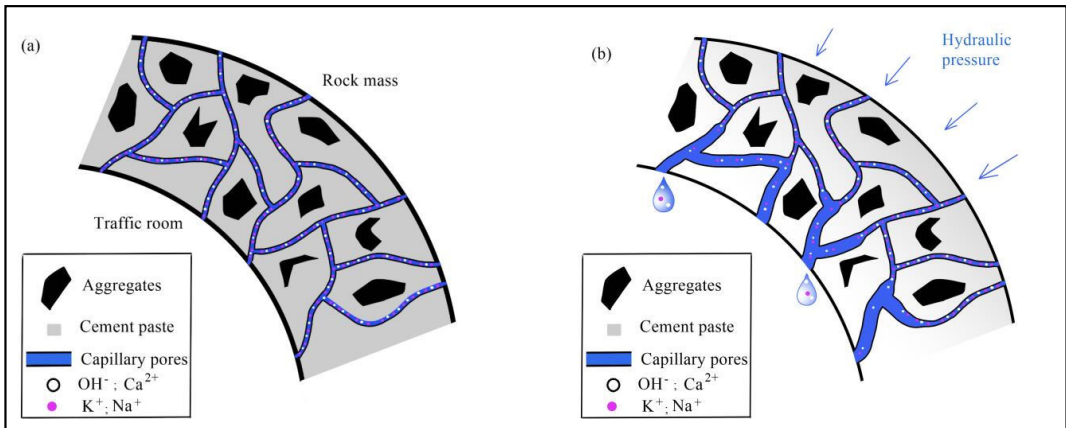
Fig. 22: Schematic representation of leaching in shotcrete caused by a unilateral hydraulic pressure triggered by groundwater. (a) Initial state of non-degraded shotcrete, and (b) leached shotcrete after some time exposed to a unilateral hydraulic pressure Modified from [76],[19].

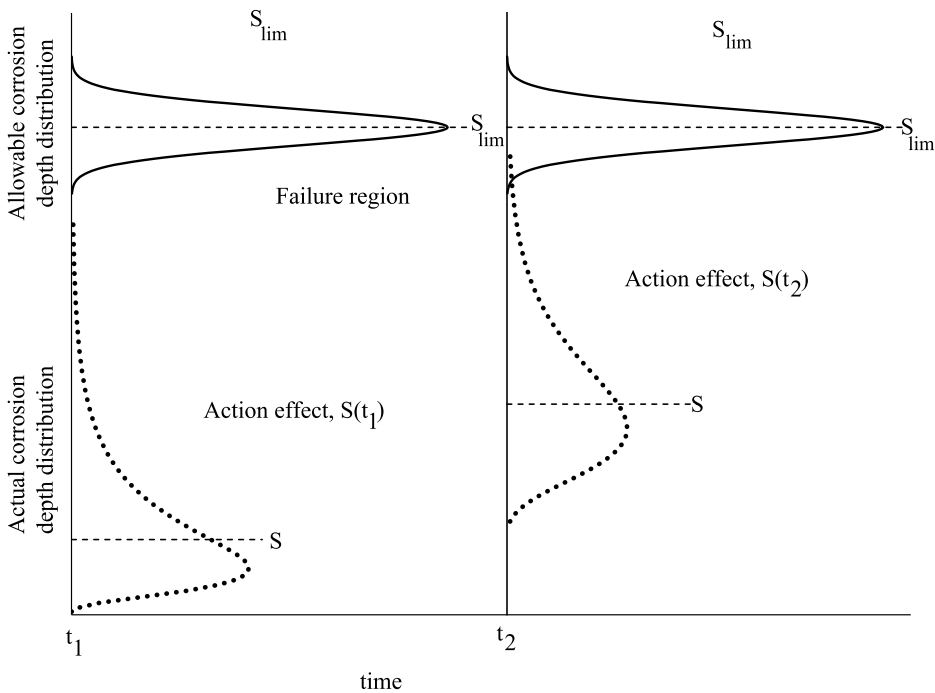
Fig. 1 Probabilistic limit-state approach for predicting the useful life applied to rock bolt corrosion. Modified from standard ISO 13823 (2008)

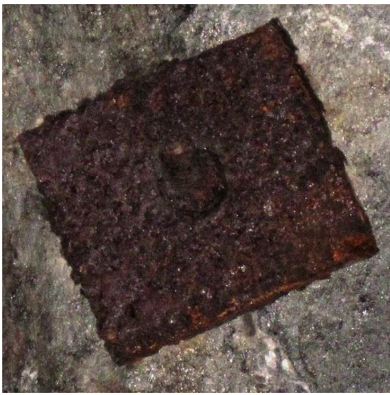
Fig. 4 Fully grouted uncoated rebar with unprotected steel accessories in the Hamregjøel tunnel after 47 years in service (Ongstad 2012)

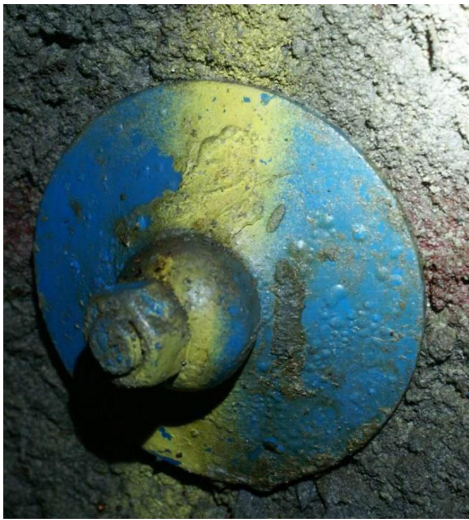
Fig. 12 Blisters observed in the rock bolt plate in the Oslofjord sub-sea road tunnel after 10 years of exposure (Ongstad 2012)
