The effect of bird droppings on the corrosion of structural materials used in offshore applications

Master's thesis in Materials Science and Engineering

Norwegian University of Science and Technology
Faculty of Natural Sciences
Department of Materials Science and Engineering

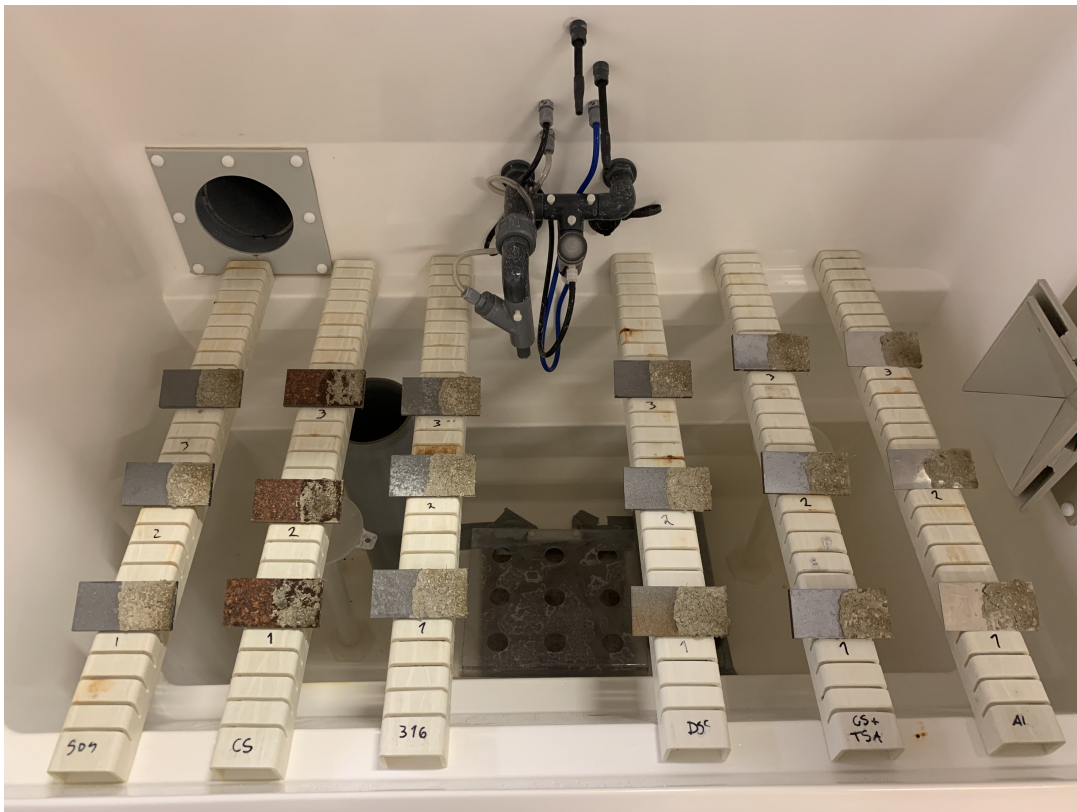
Figure 4: Picture of the samples after 49 hours of exposure in the salt-spray chamber.

The stainless steel samples show only some small discolouring on their surfaces, while the TSA and 6082 do not show any discolouring on the pictures in Figure 4. The carbon steel has discolouring on the whole surface visible in the picture. The first samples of carbon steel and 316 were removed from the chamber after this picture was taken.

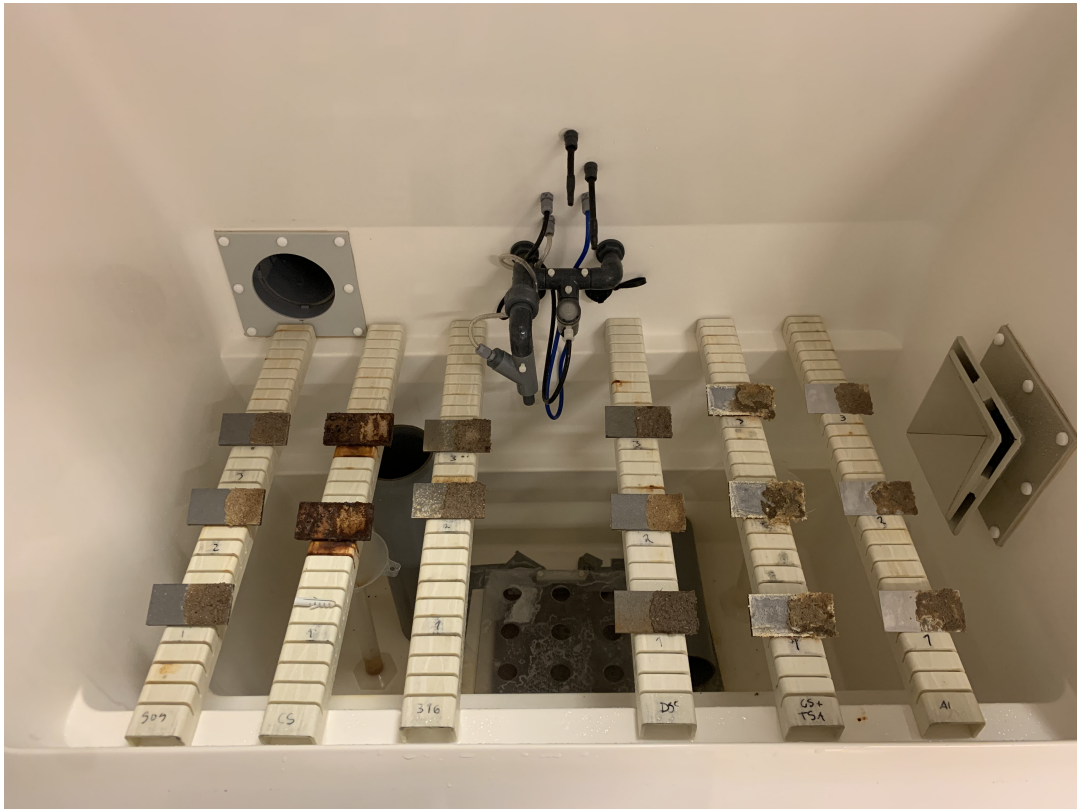
Figure 5: Picture of the samples after 334 hours of exposure in the salt-spray chamber.

Figure 5 show some development of corrosion of the carbon steel, indicated by the darker colour around the edges and corrosion product on the sample holder. There is a slight increase in the discolouring for DSS sample 1. Salt deposits have accumulated around the edges of the TSA, along with some salt deposits on the 316 stainless steel. After the picture was taken, one sample of each material was removed and the solution was acidified.

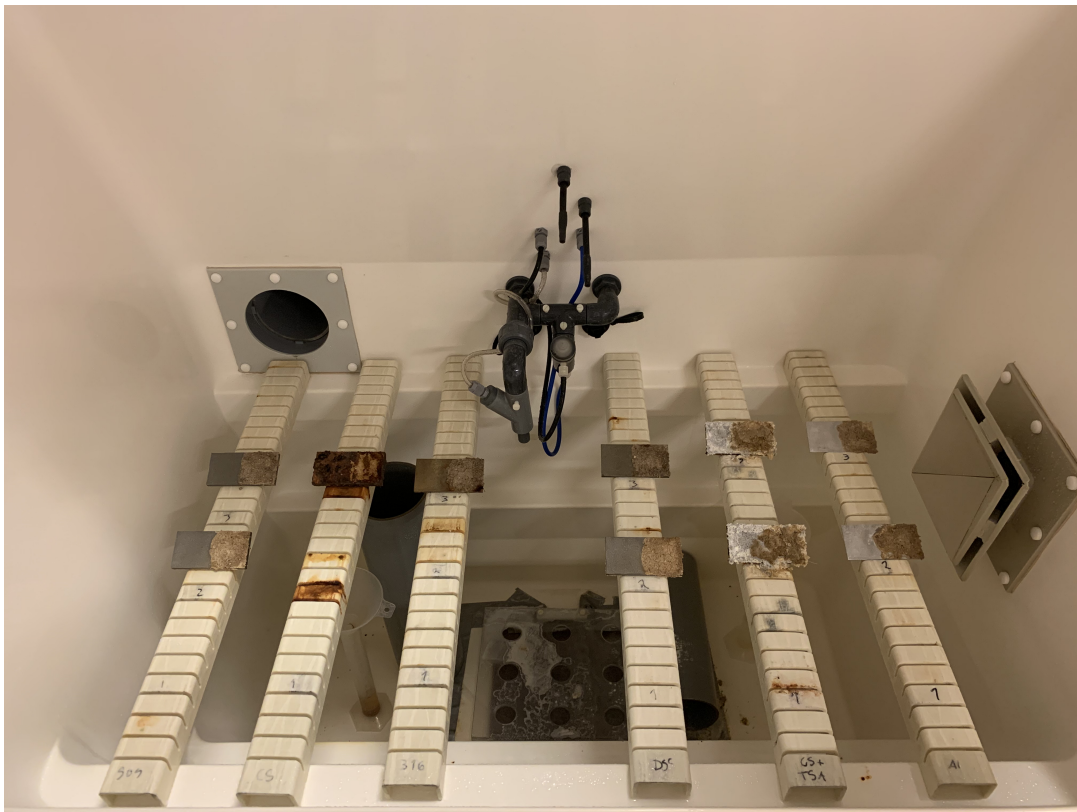
Figure 6: Picture of the samples after 592 hours of exposure in the salt-spray chamber.

The picture in Figure 6 does not show much difference in the condition for the carbon steel other than darker colour on the sample holder. 316 show some more discolouring, both on the plain side and in the bottom right corner. The 6082 has become somewhat more matte on the plain side, indicating some corrosion. The TSA has even more salt deposits on the surface. Carbon steel, TSA, and SDSS were removed after the picture was taken.

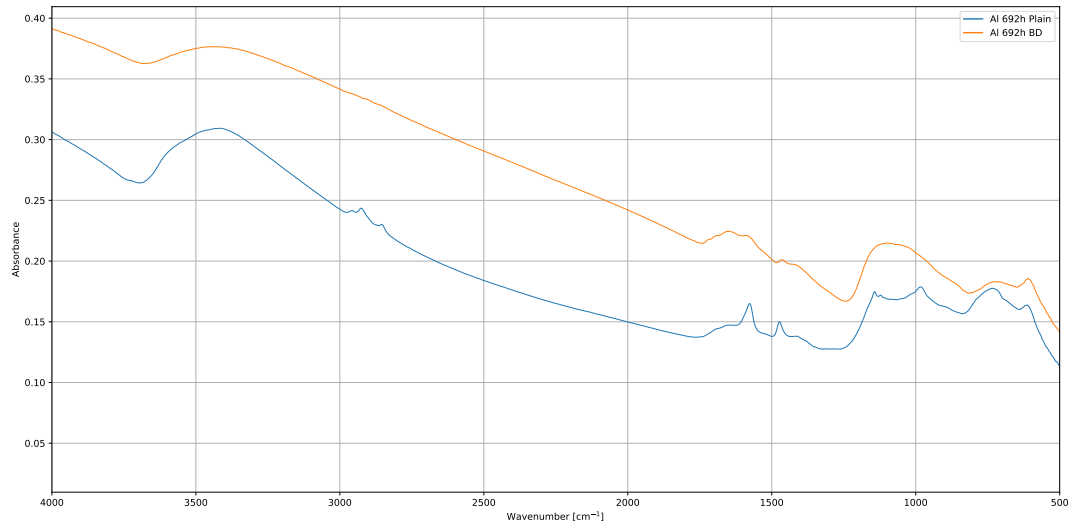
Figure 16: Comparison of the FTIR spectra for aluminium sample nr 3 with and without bird droppings that was in the salt spray test for 692h

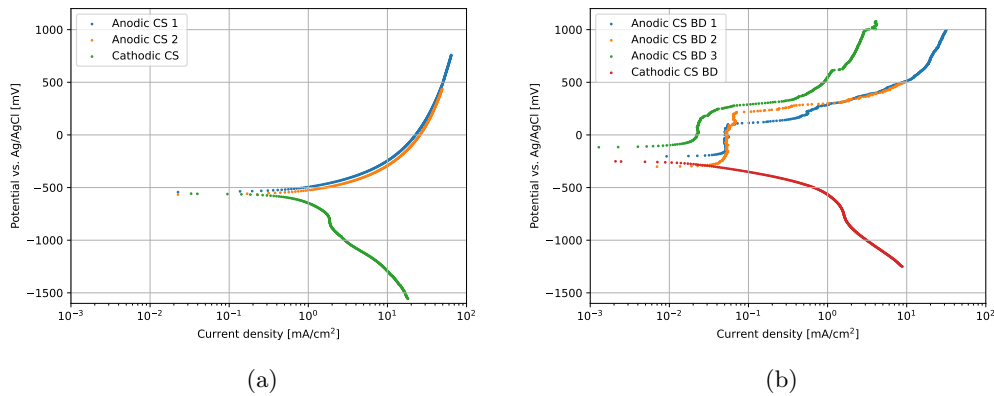
Figure 18: Polarization curves for carbon steel without (a) and with (b) bird droppings.

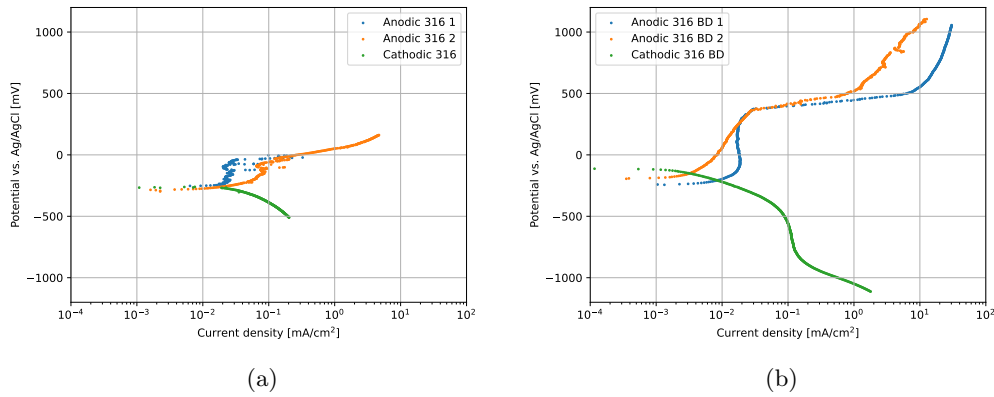
Figure 20: Polarization curves for AISI 316 without (a) and with (b) bird droppings.

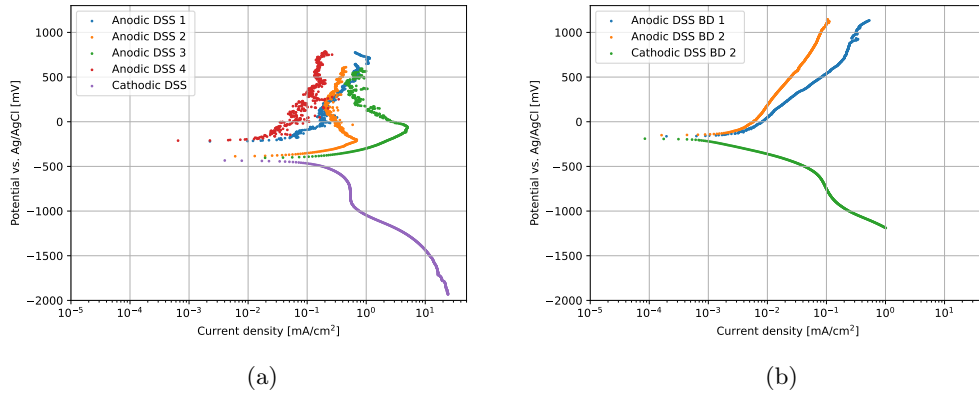
Figure 22: Polarization curves for 22% Cr duplex stainless steel (DSS) without (a) and with (b) bird droppings.

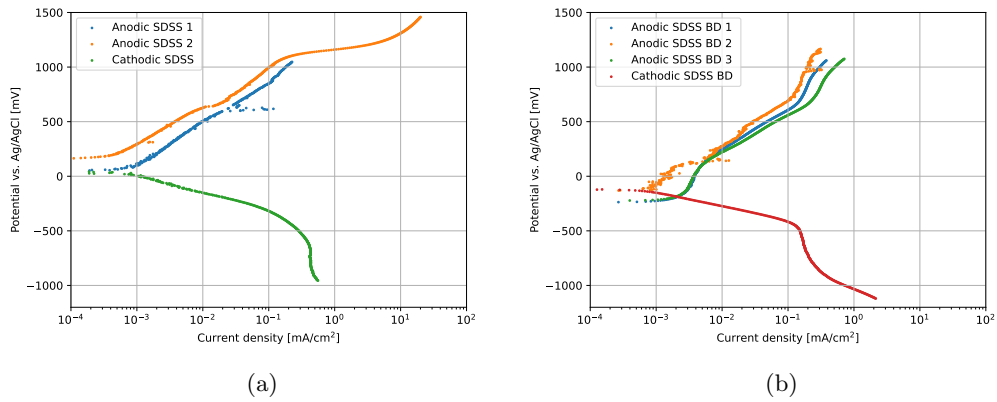
Figure 24: Polarization curves for SDSS without (a) and with (b) bird droppings.

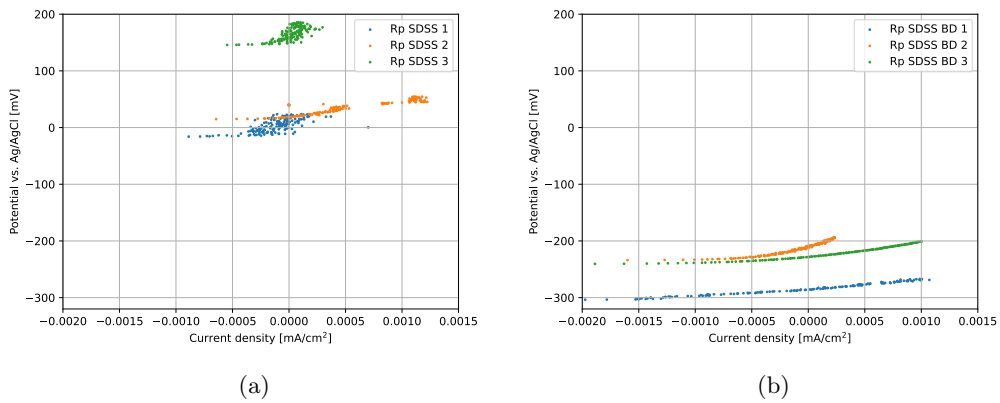
Figure 25: Polarization resistance for SDSS without (a) and with (b) bird droppings.

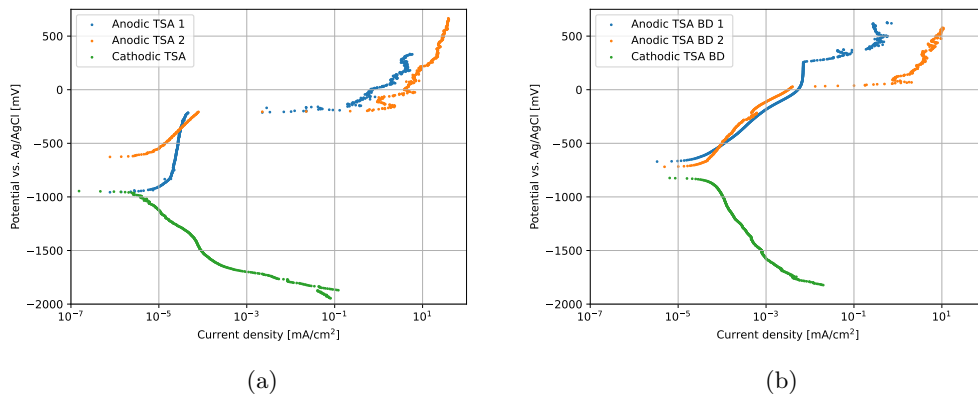
Figure 26: Polarization curves for TSA without (a) and with (b) bird droppings

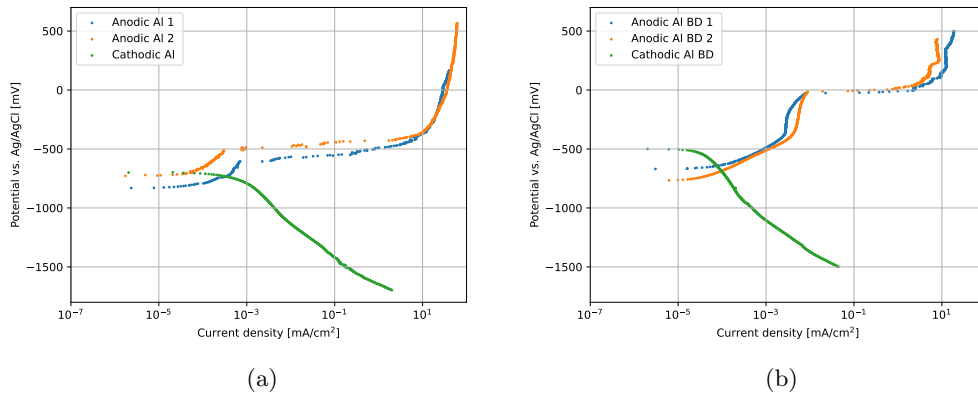
Figure 28: Polarization curves for aluminium 6083 without (a) and with (b) bird droppings.

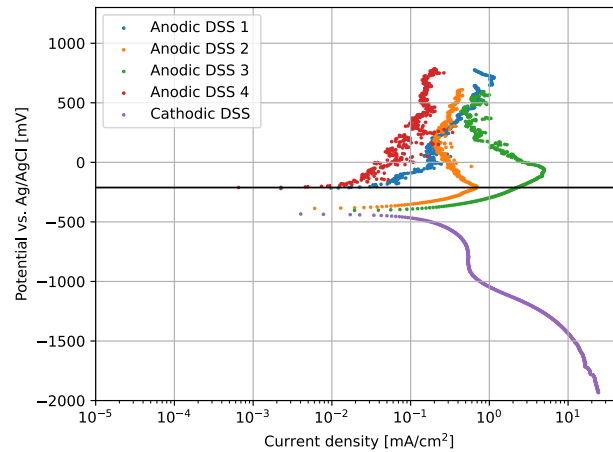
the range of -250 mV and 0 mV, the current has a sudden drop and eventually stabilizes between 0.1 and 1 mA/cm². This is because the material passivates. The blue and the red area do not show this behaviour. It is not believed to be due to the differences in the austenite and ferrite phases. The size of these phases is usually in the micron region, while the opening of the syringe is in the millimetre region. The area that is exposed to the electrolyte is therefore assumed to be larger than the austenitic and ferritic phases in the steel. Thus, the differences in the two behaviours of the anodic lines are not expected to be caused by running the measurements on different phases. The differences are rather believed to originate from the surface roughness, the roughness of a sample could affect the OCP. For the blue and red curve in Figure 22a, the first measurement starts just above -250 mV, which will be the OCP of the system. If we draw a horizontal line on this potential, as shown in Figure 30, it is clear that the OCP for the blue and red lines is at the same potential as the orange line starts to passivate. Thus, the DSS could have OCP above the passivating potential for the blue and red curves. There is also a difference in the potential, of which the passivation starts, for the orange and green lines. The difference in passivating potential could be due to roughness on the surface, impurities, or small differences in the microstructure.

Figure 30: Polarization curve of DSS without bird droppings, with a line that compares the OCP of the red and blue line with the passivation potential for the orange line.

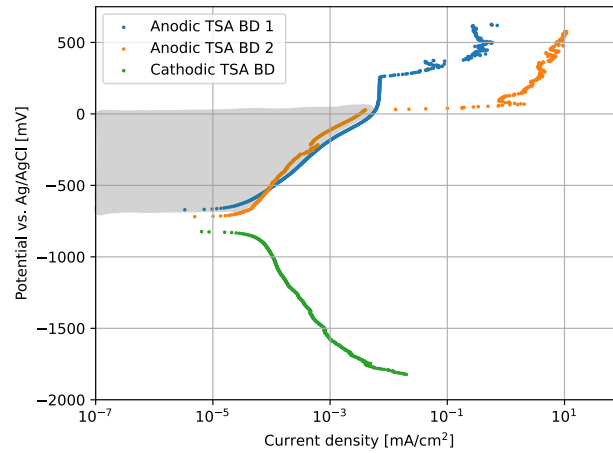
Figure 31: Polarization curves of TSA with bird droppings where the shaded area is related to the amount of dissolved metal ions.
